**Sunshine Canyon Landfill  
Independent Monitor  
Quarterly Site Monitoring Status Report  
July 1, 2016 – September 30, 2016**

**City of Los Angeles Department of City Planning**

**County of Los Angeles Department of Regional Planning**

December 22, 2016

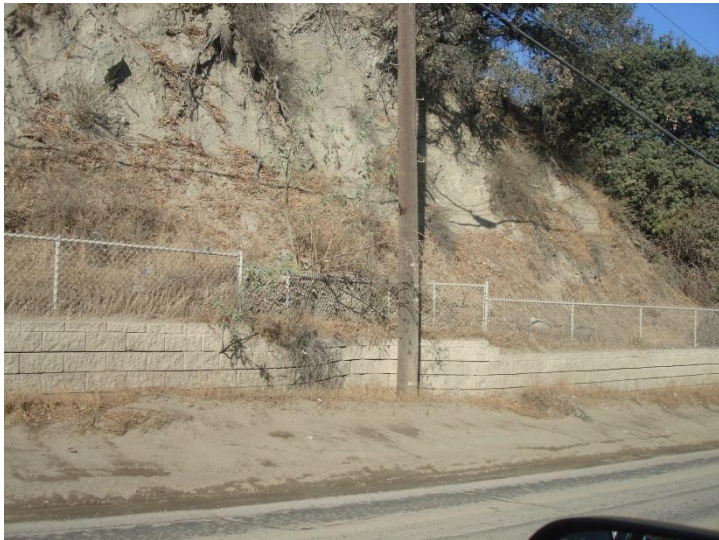
**Photo 366: Frontage Retaining Wall on San Fernando Road: July 27, 2016**

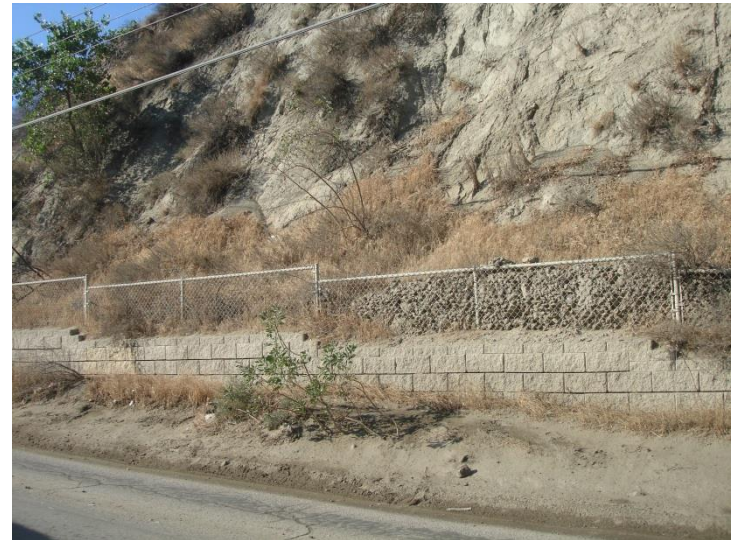
**Photo 367: Frontage Retaining Wall on San Fernando Road: July 27, 2016**

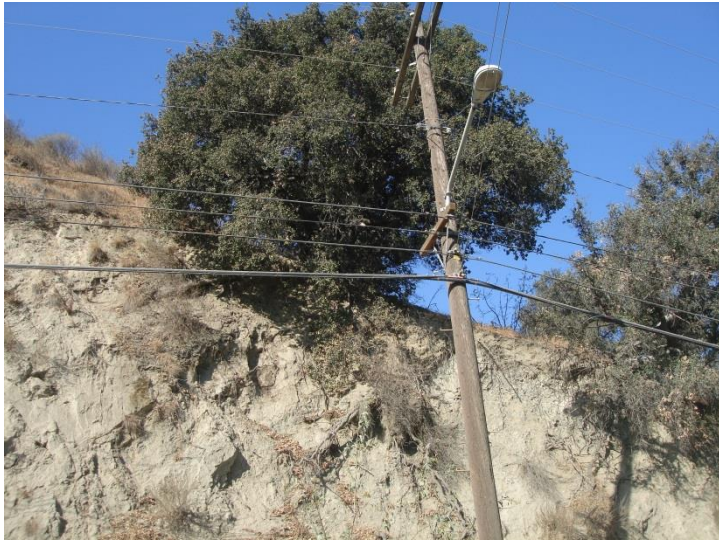
**Photo 368: Frontage Retaining Wall on San Fernando Road: July 27, 2016**

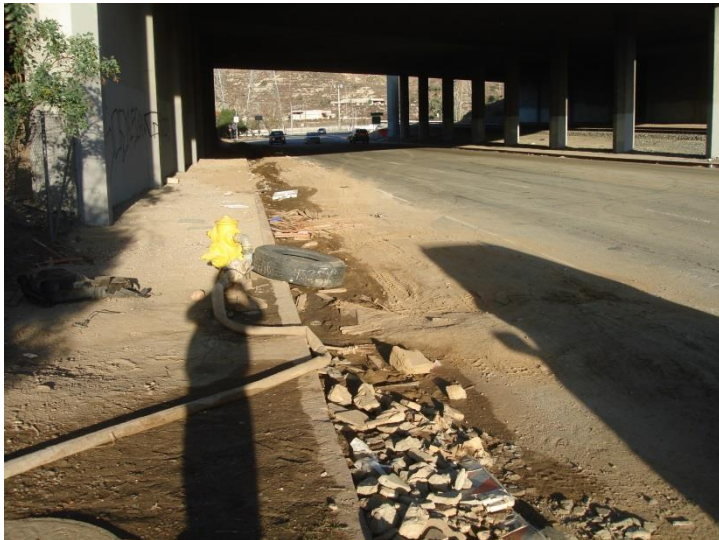
**Photo 398: San Fernando Road near I-5 overpass Graffiti: September 27, 2016**

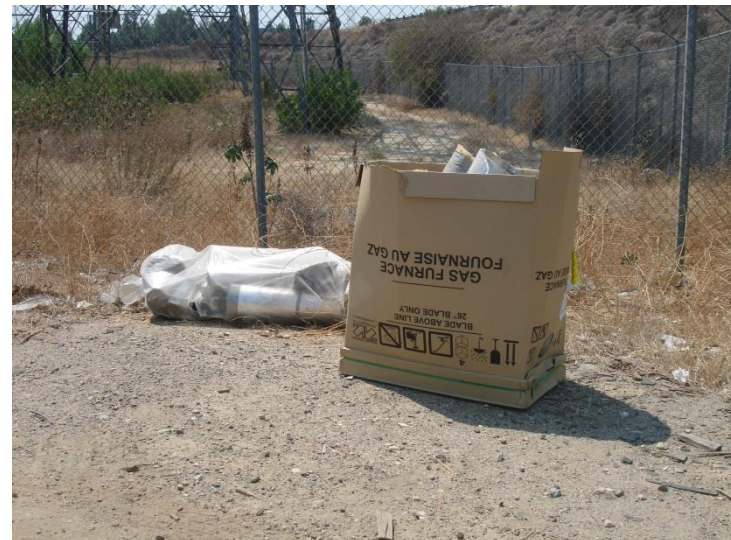
**Photo 403: Illegal Dumping San Fernando Road near I-5 overpass: August 24, 2016**

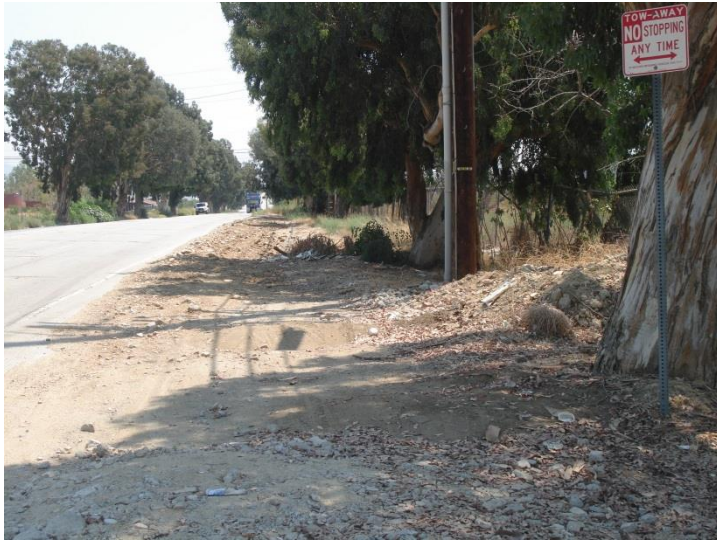
**Photo 404: Illegal Dumping San Fernando Road near I-5 overpass: August 24, 2016**

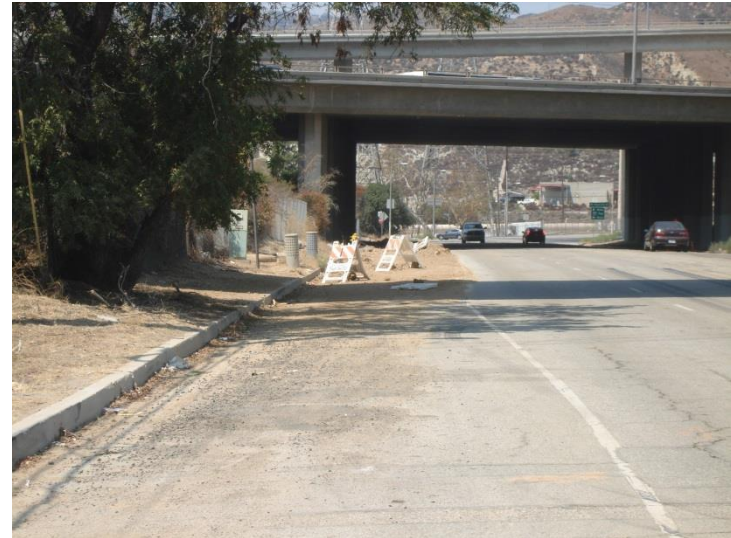
**Photo 405: Illegal Dumping San Fernando Road near I-5 overpass: August 24, 2016**

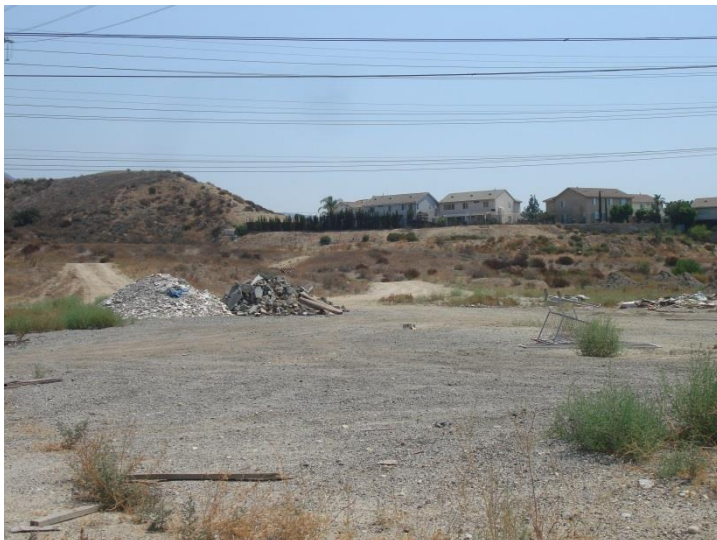
**Photo 406: Illegal Dumping San Fernando Road near I-5 overpass: August 24, 2016**

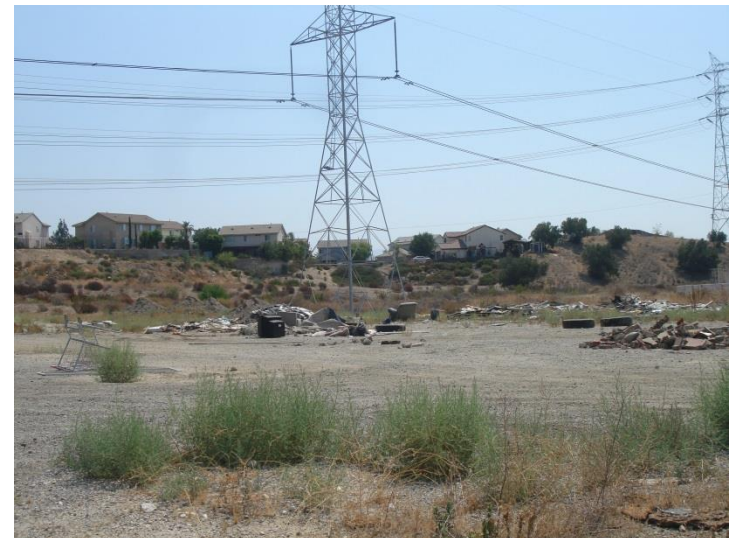
**Photo 407: Rancho Cascades Illegal Dumping: August 24, 2016**

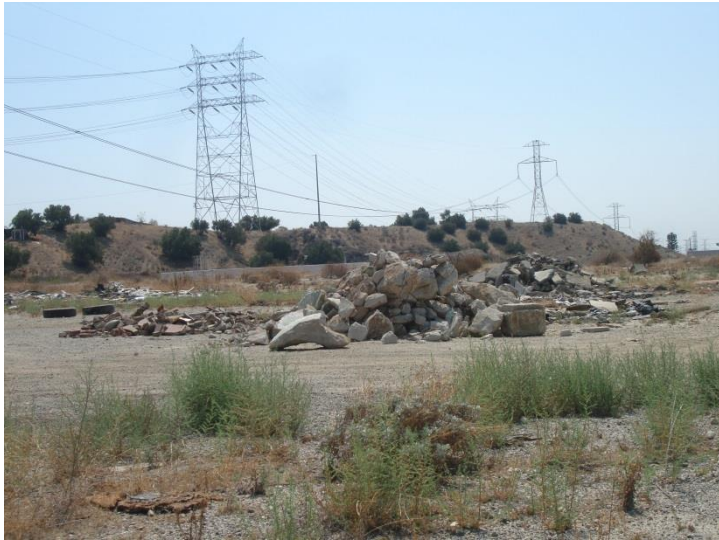
**Photo 408: Rancho Cascades Illegal Dumping: August 24, 2016**

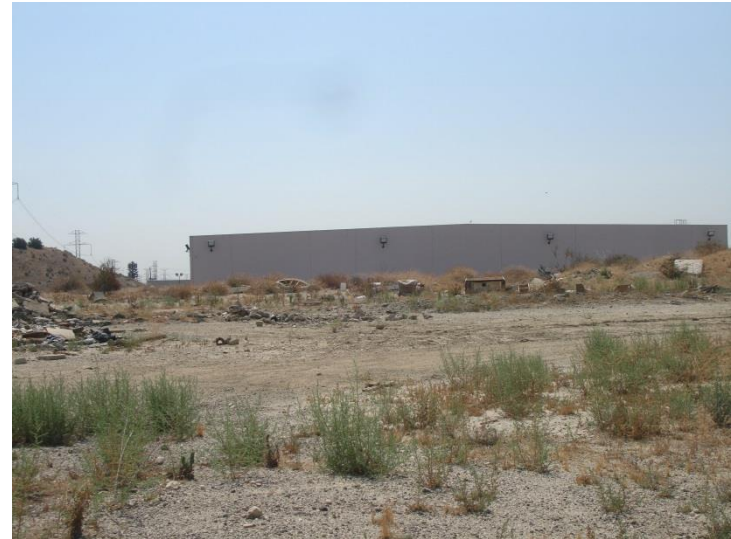
**Photo 409: Rancho Cascades Illegal Dumping: August 24, 2016**

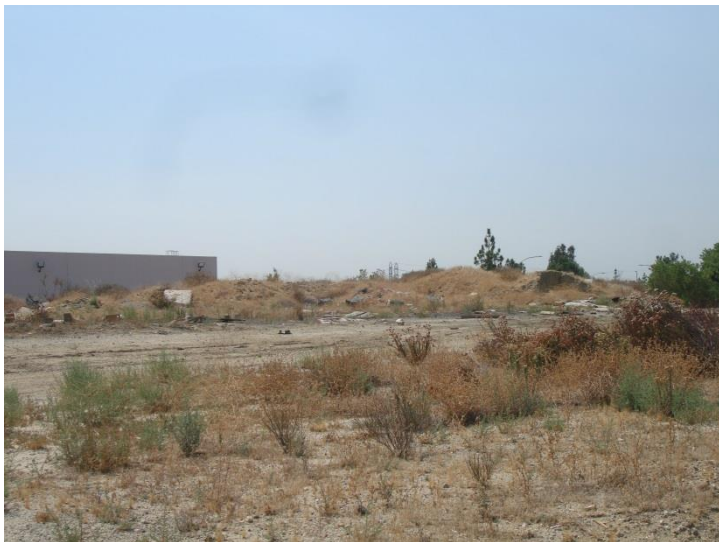
**Photo 410: Rancho Cascades Illegal Dumping: August 24, 2016**

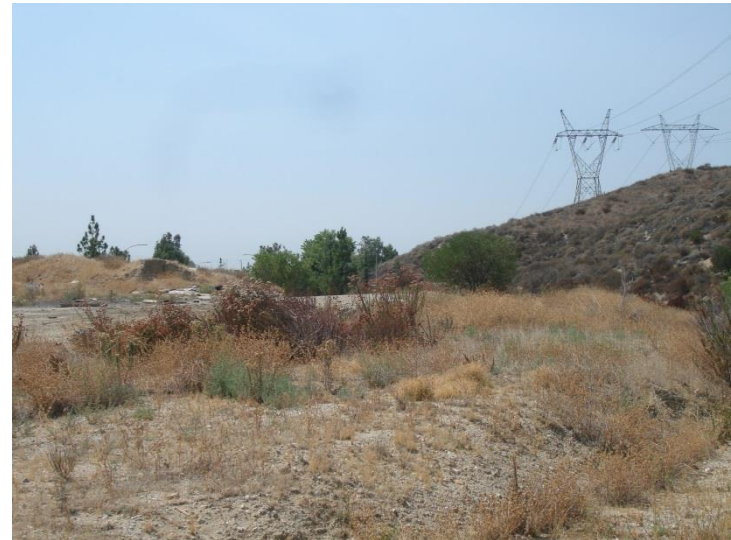
**Photo 411: Rancho Cascades Illegal Dumping: August 24, 2016**

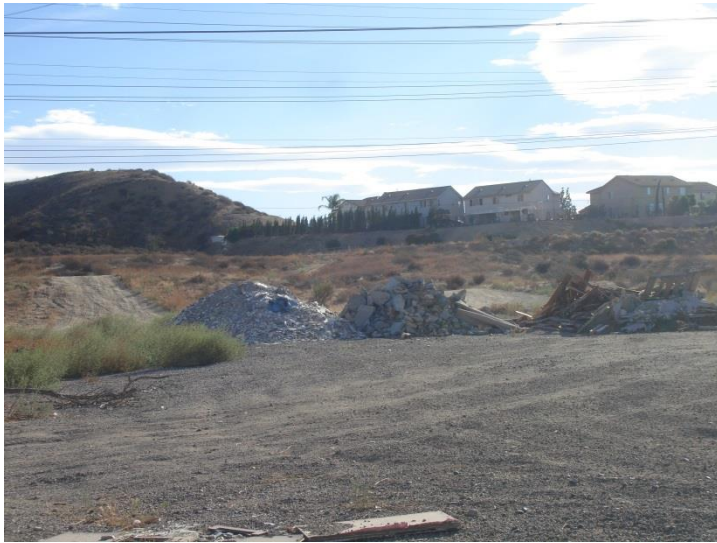
**Photo 412: Rancho Cascades Illegal Dumping: August 24, 2016**

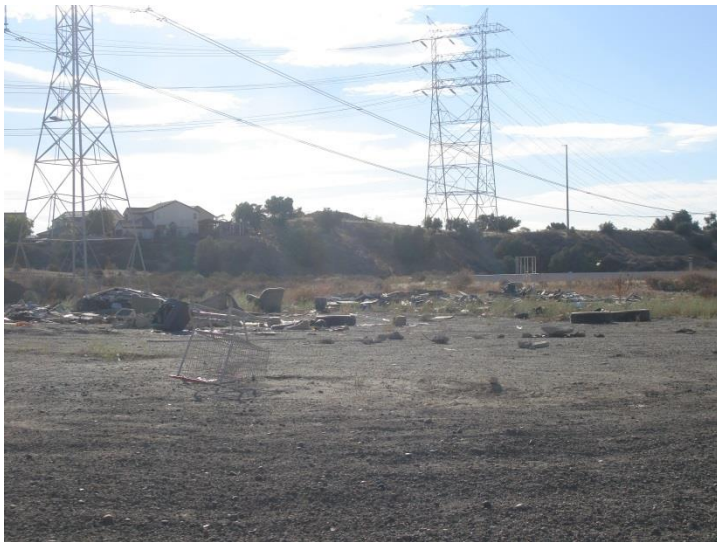
**Photo 414: Rancho Cascades Illegal Dumping: September 27, 2016**

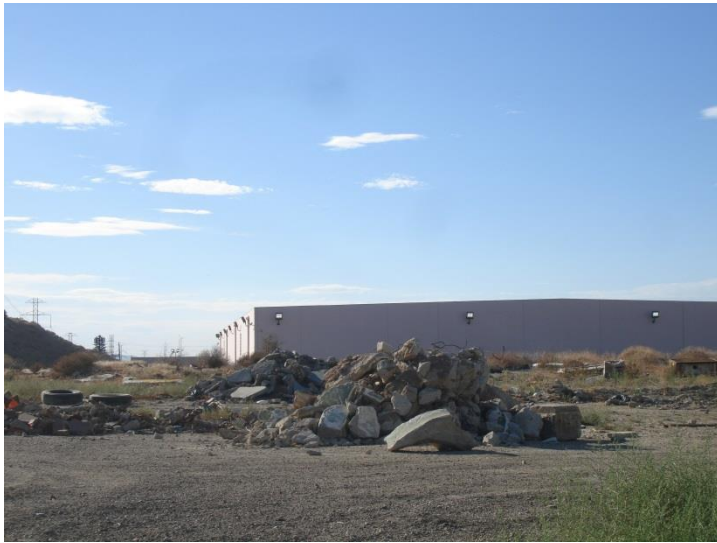
**Photo 416: Rancho Cascades Illegal Dumping: September 27, 2016**

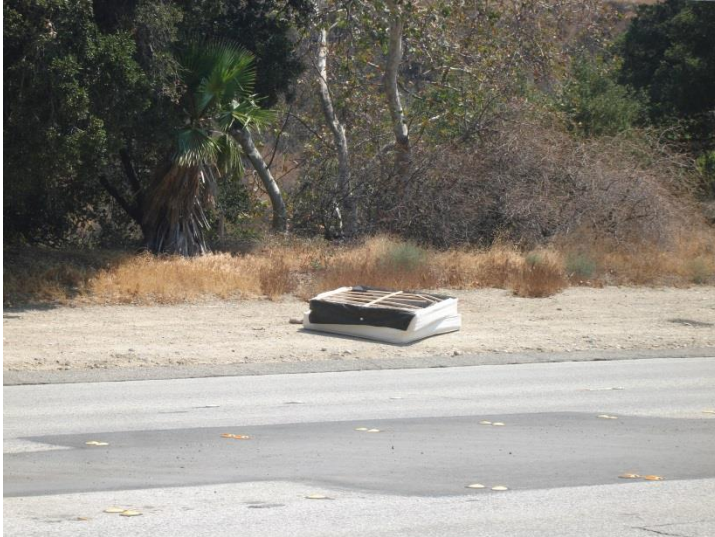
**Photo 418: Rancho Cascades Illegal Dumping: September 27, 2016**

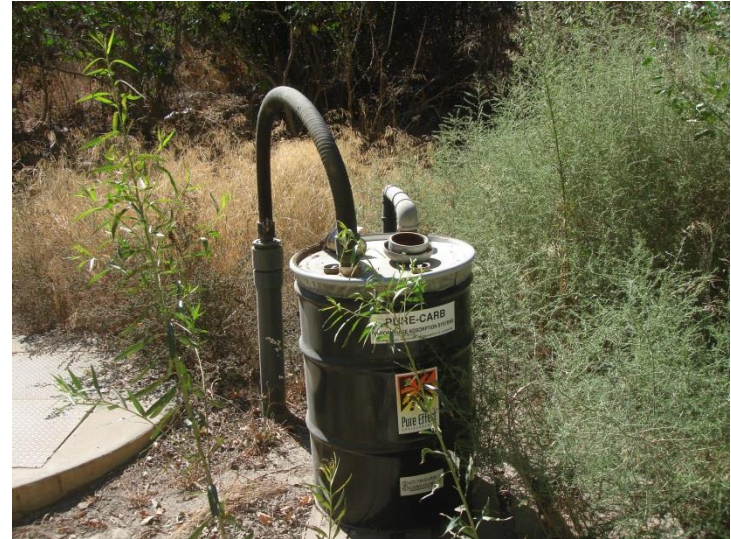
**Photo 429: Odor Detected at Sewer Connection Point: September 27, 2016**

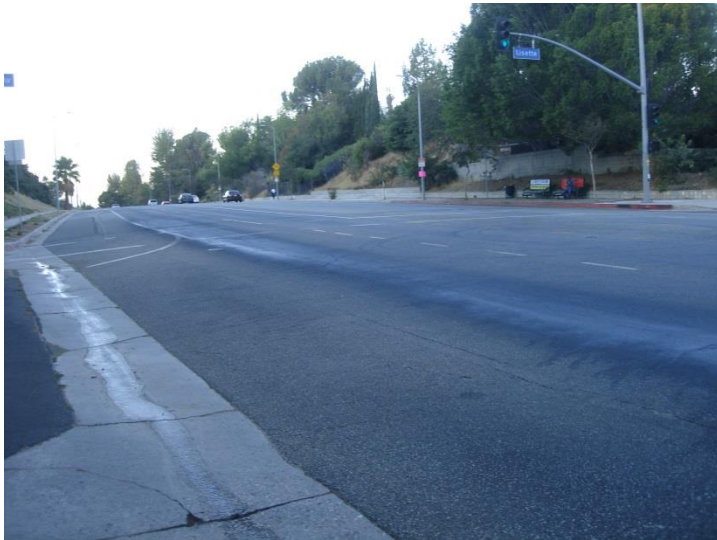
**Photo 430: Odor Detected at Sewer Connection Point: September 27, 2016**

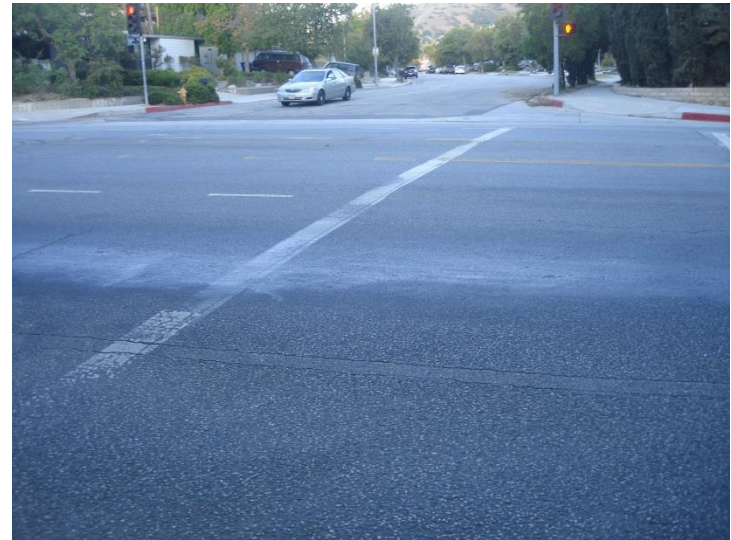
**Photo 431: Balboa and Lisette Odorous Roadway Liquids Tracks  
700am: September 27, 2016**

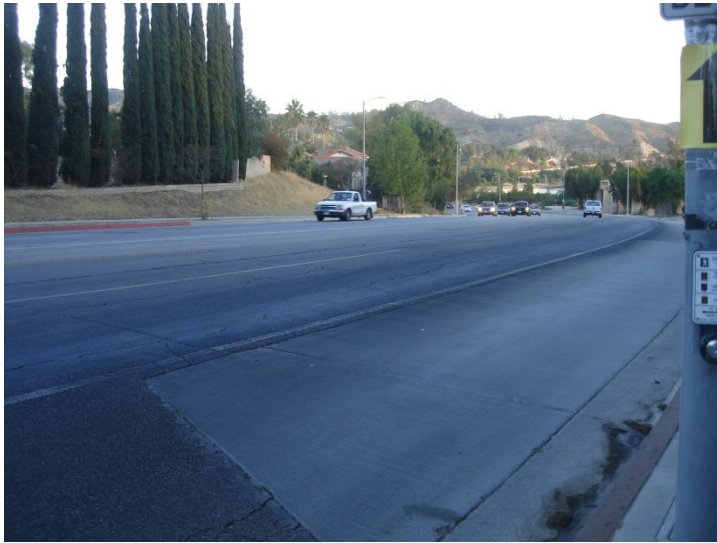
**Photo 432: Balboa and Lisette Odorous Roadway Liquids Tracks  
700am: September 27, 2016**

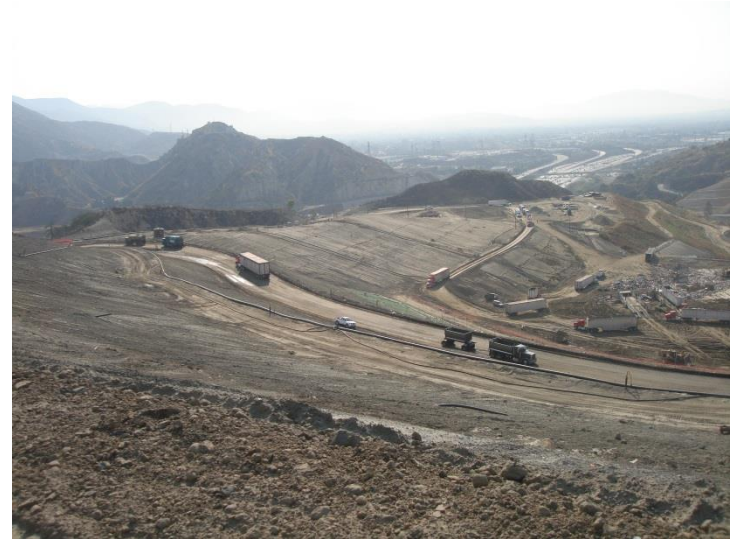
**Photo 465: Gas Detected-Gas Recovery Not Operational at this Location 900am: August 24, 2016**

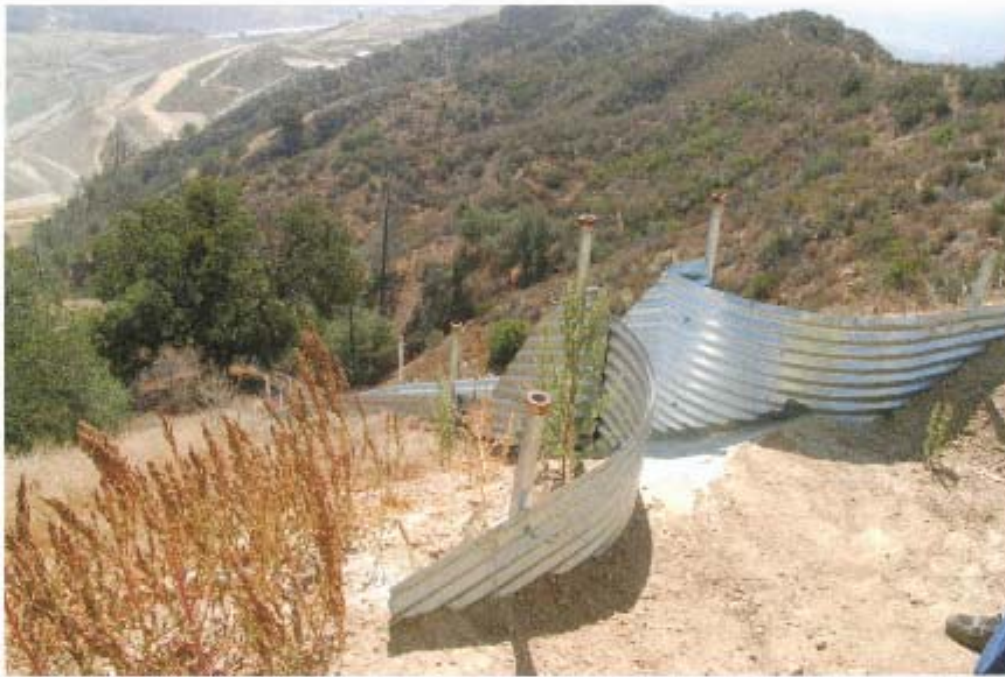
Photo 3: BMP for stormwater control at new pole pad #38

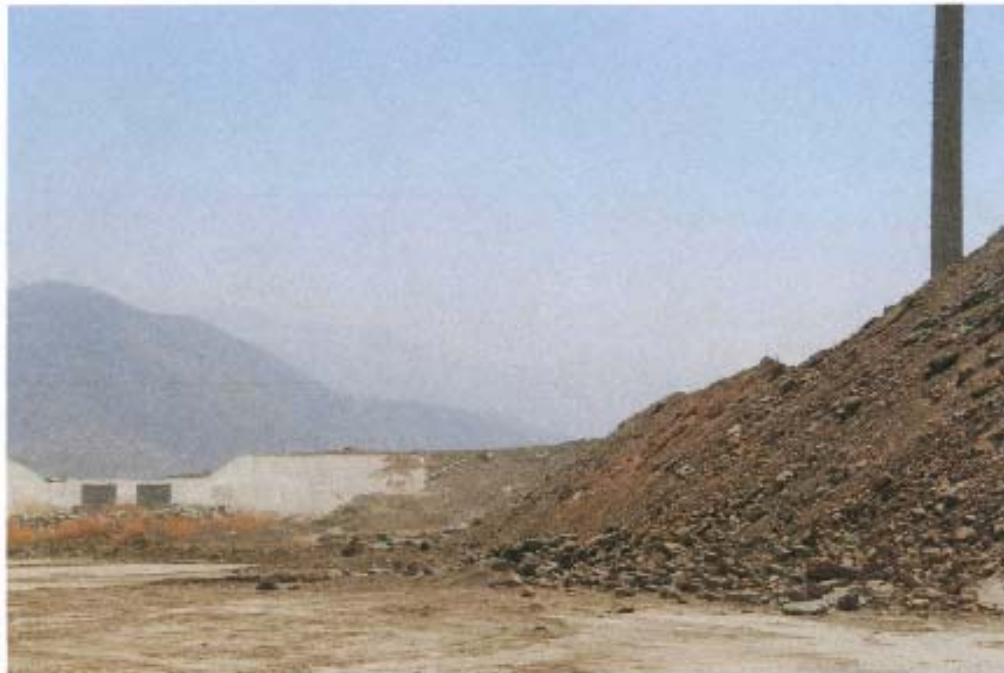
Photo 4: Soil in Basin A

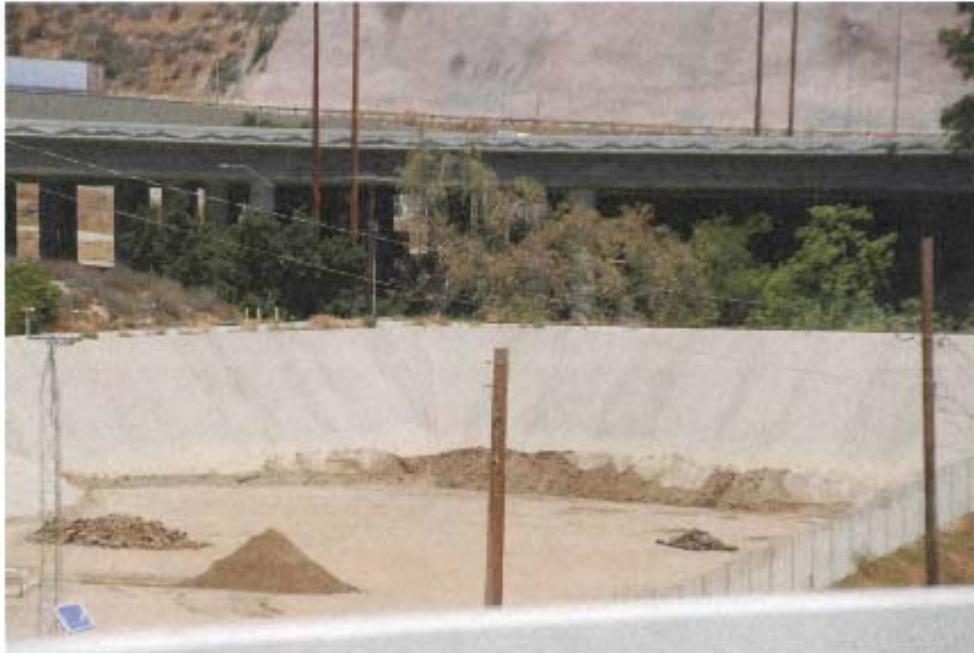
Photo 5: Status of cleaning in Terminal Basin

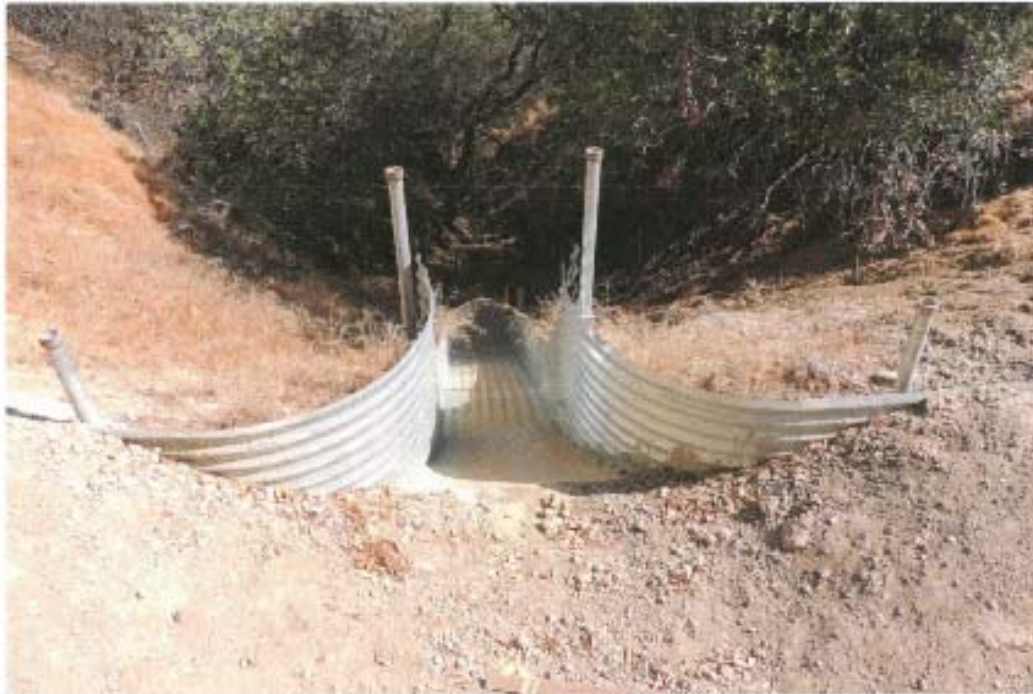
Photo 1: BMP for stormwater control at new pole pad #38

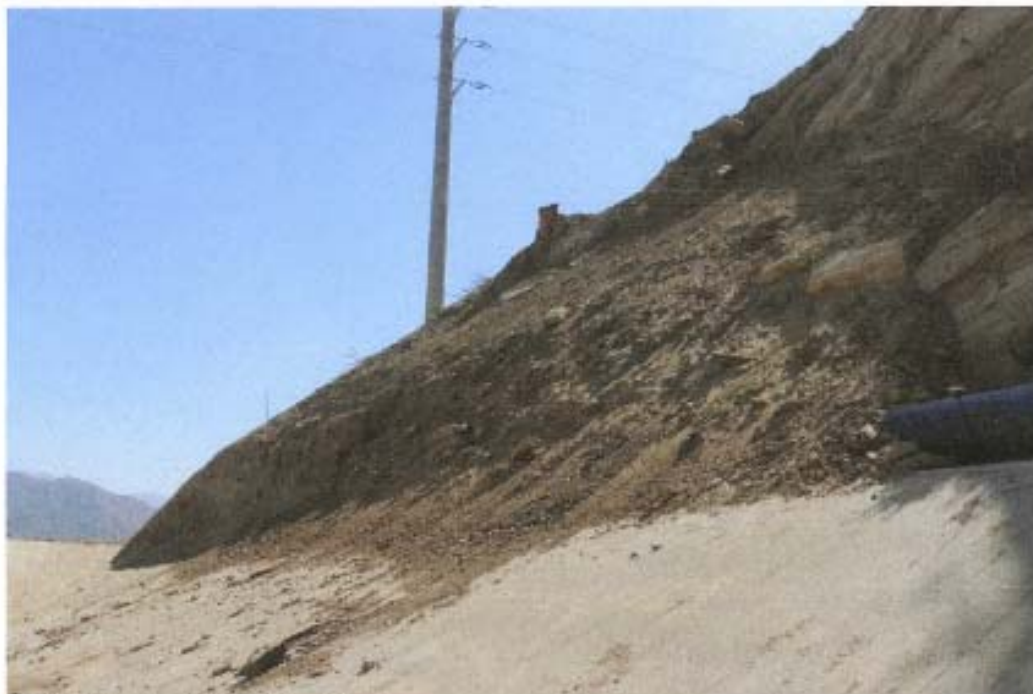
Drainage system	
<ul style="list-style-type: none"> <li>• Basin A: <ul style="list-style-type: none"> <li>– Basin was cleaned and all soil removed</li> <li>– there is a risk of soil sloughing of from the side slope recently worked during the grading operations for Edison new power poles (Photo 2) but the volume of soil should be minimal and not affect the performance of the basin. Soils that will slough off could be removed next spring after the 2016-2017 rainy season</li> </ul> </li> <li>• Basin B: <ul style="list-style-type: none"> <li>– totally clean</li> </ul> </li> <li>• Basin D <ul style="list-style-type: none"> <li>– totally clean</li> <li>– the drainage ditches along the side of the canyon are clean and open into the basin</li> </ul> </li> <li>• Terminal Basin</li> </ul>

Photo 2: Soil on slope of Basin A

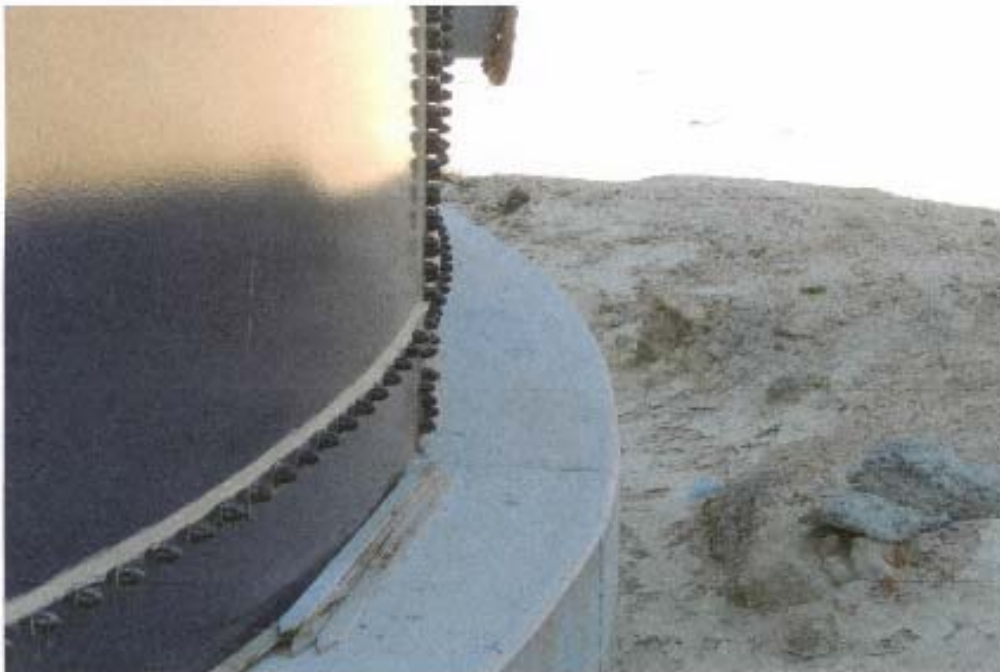
Photo 4: Ring foundation of water tank
