**Sunshine Canyon Landfill  
Independent Monitor  
Quarterly Site Monitoring Status Report  
April 1, 2017 – June 30, 2017**

**City of Los Angeles Department of City Planning**

**County of Los Angeles Department of Regional Planning**

October 10, 2017

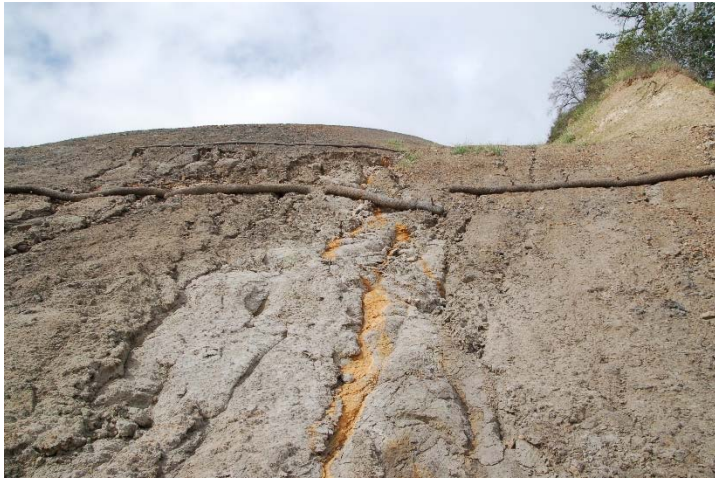
**Photo 5: Slope Erosion near Basin A: April 18, 2017**

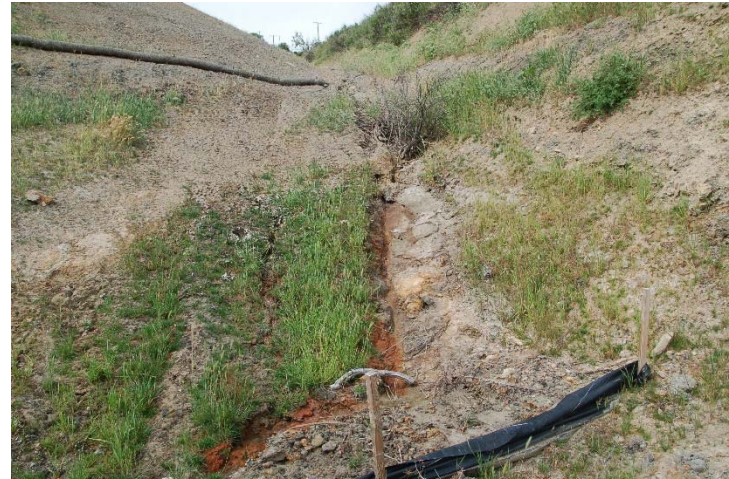
**Photo 6: Slope Erosion near Basin A: April 18, 2017**

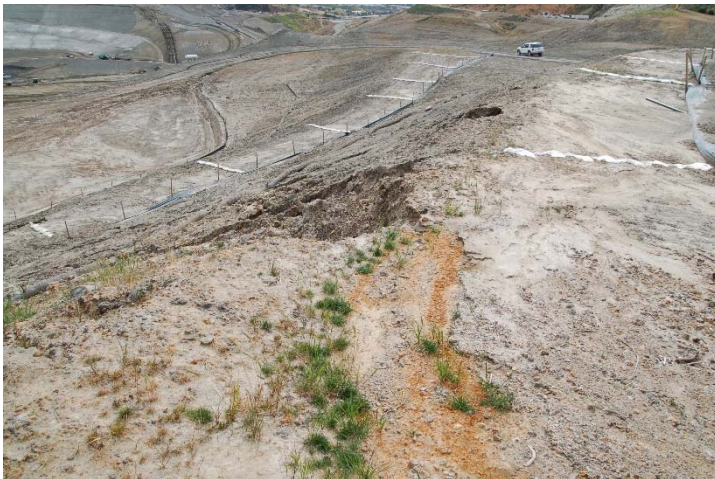
**Photo 7: Slope Erosion near Basin A: April 18, 2017**

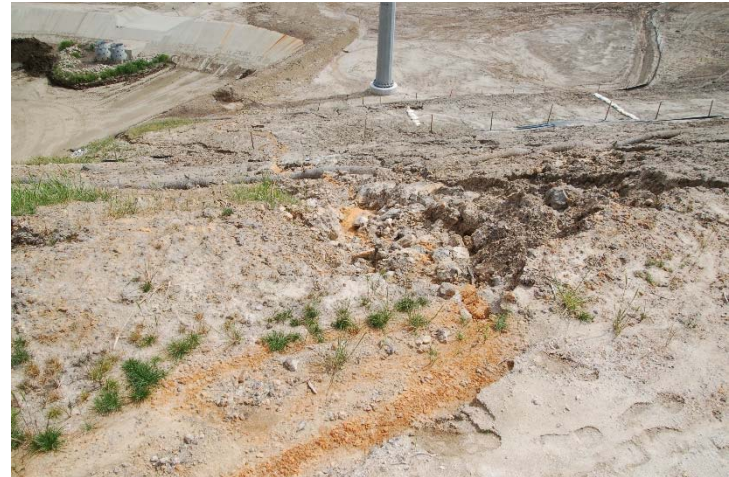
**Photo 8: Slope Erosion near Basin A: April 18, 2017**

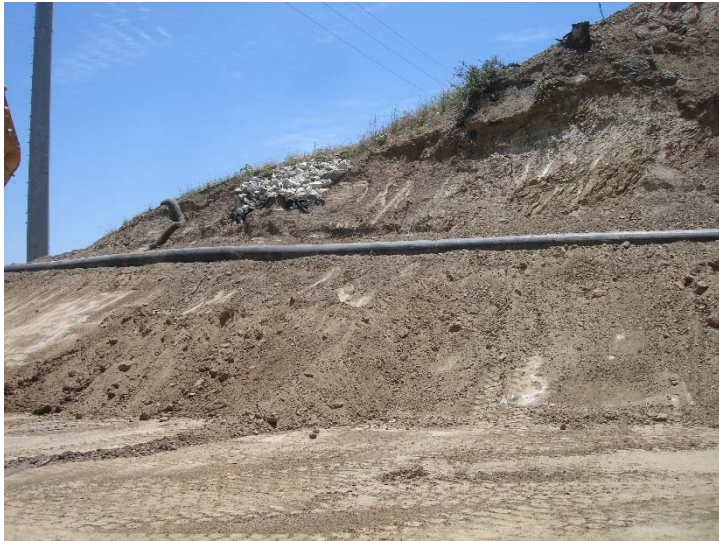
**Photo 41: Basin A: May 23, 2017**

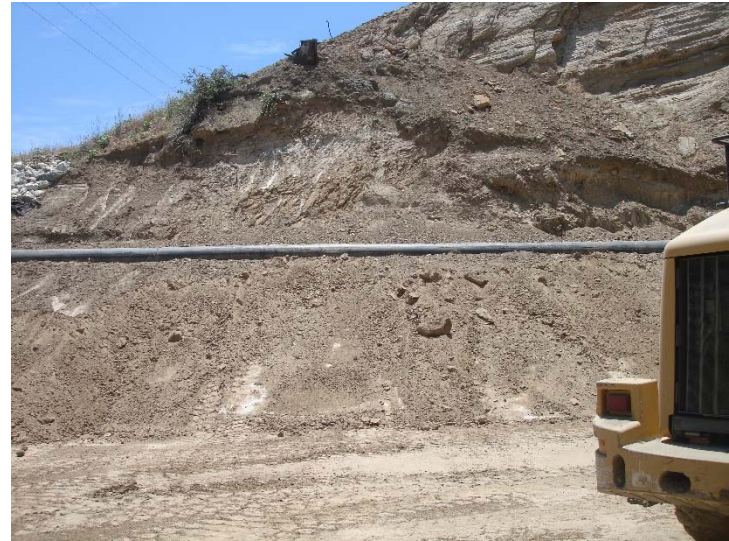
**Photo 42: Basin A: May 23, 2017**

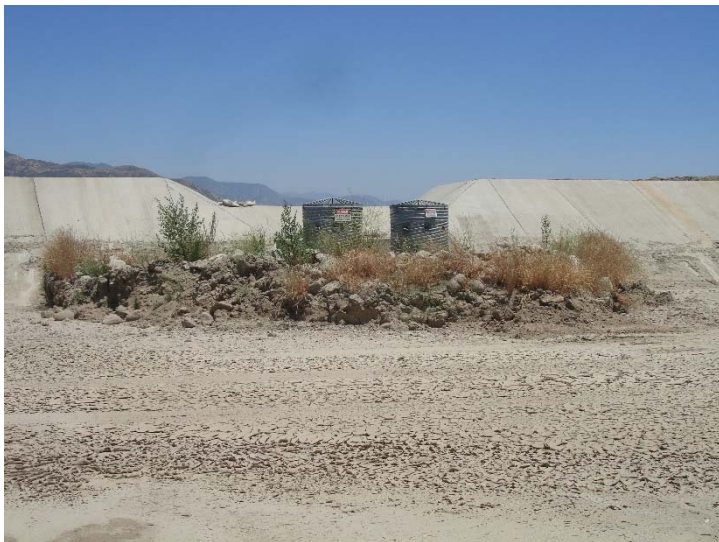
**Photo 43: Basin A: June 20, 2017**

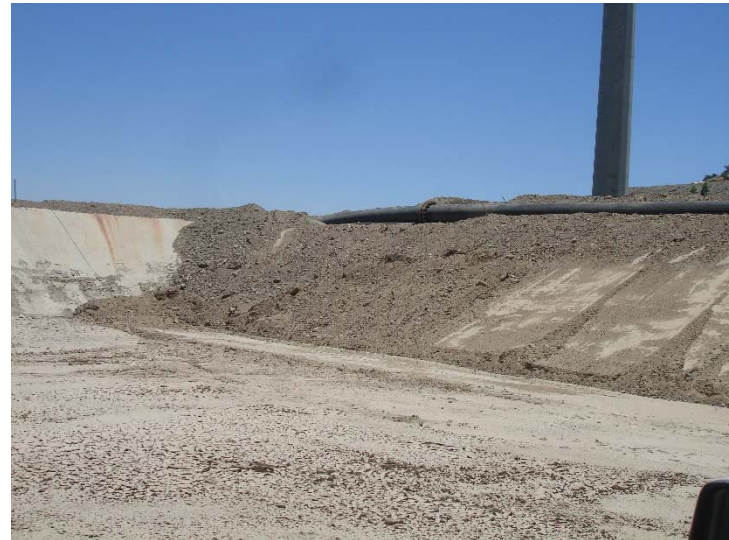
**Photo 44: Basin A: June 20, 2017**

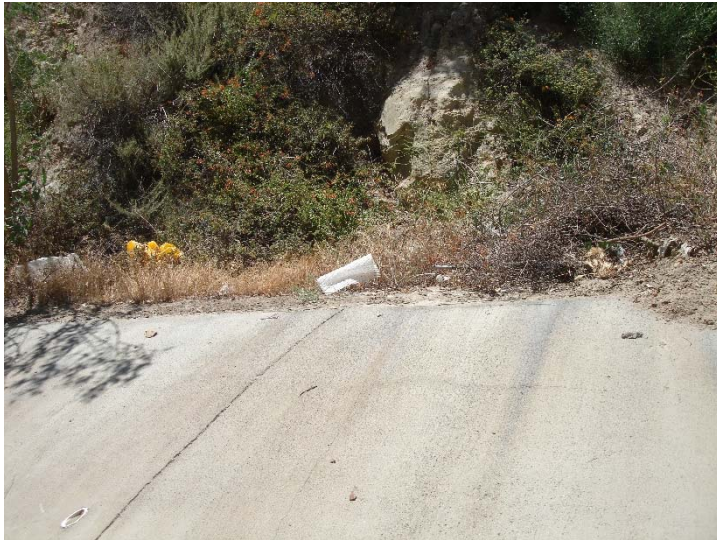
**Photo 45: Basin A: June 20, 2017**

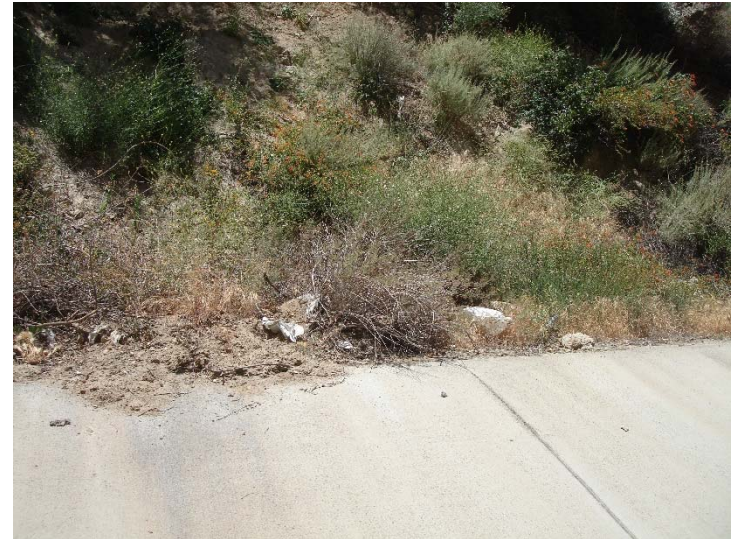
**Photo 46: Basin A: June 20, 2017**

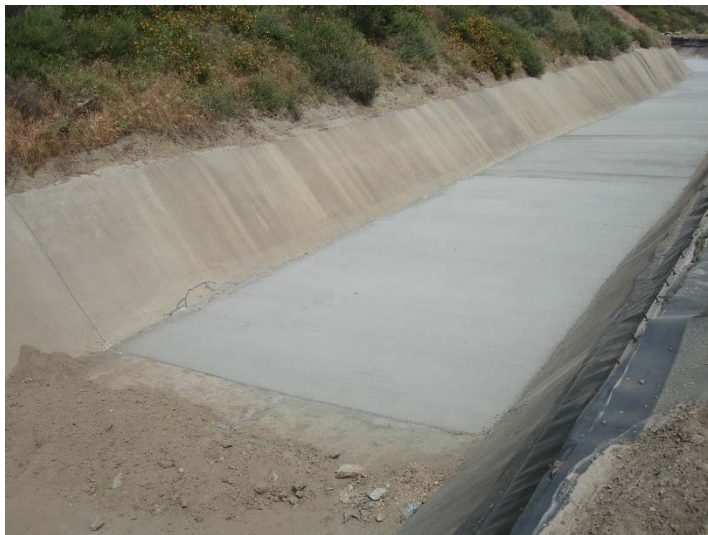
**Photo 47: Westside Drainage Channel Repair: April 18, 2017**

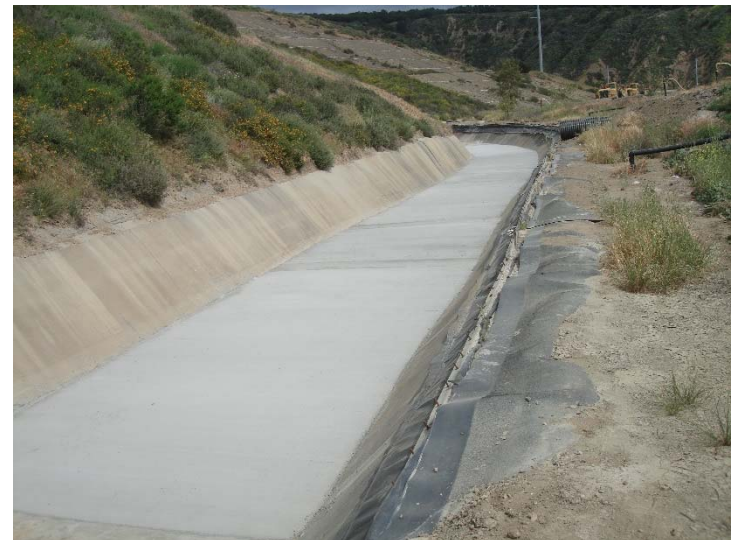
**Photo 48: Westside Drainage Channel Repair: April 18, 2017**

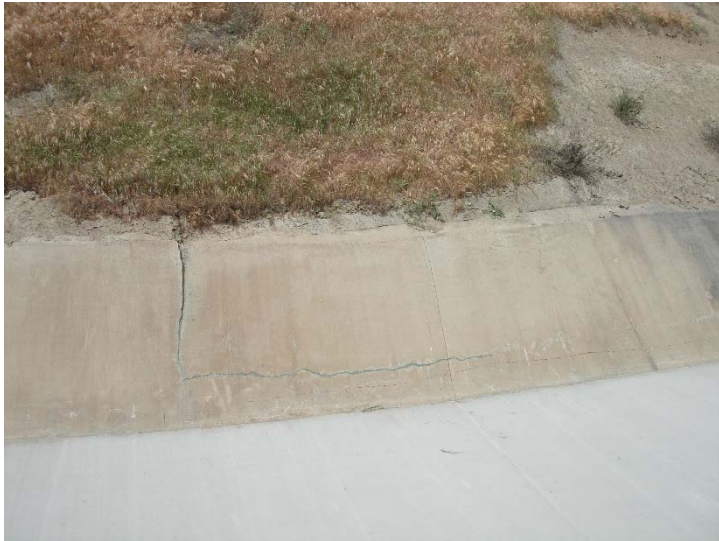
**Photo 49: Westside Drainage Channel Repair: April 18, 2017**

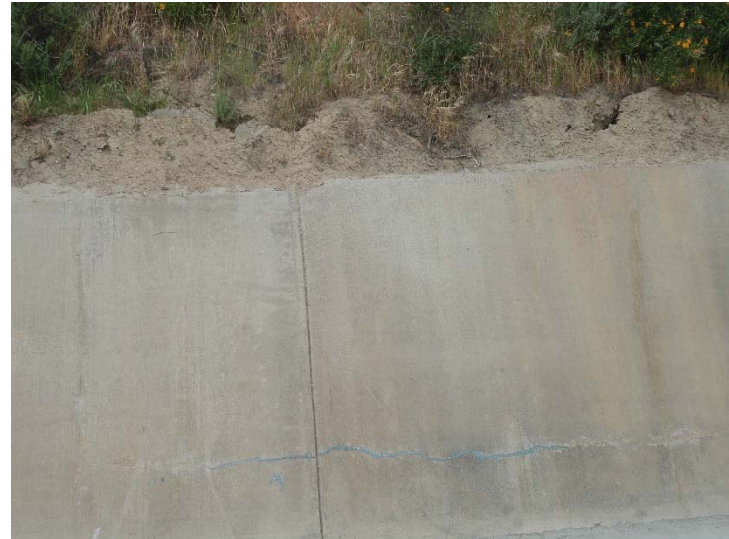
**Photo 50: Westside Drainage Channel Repair: April 18, 2017**

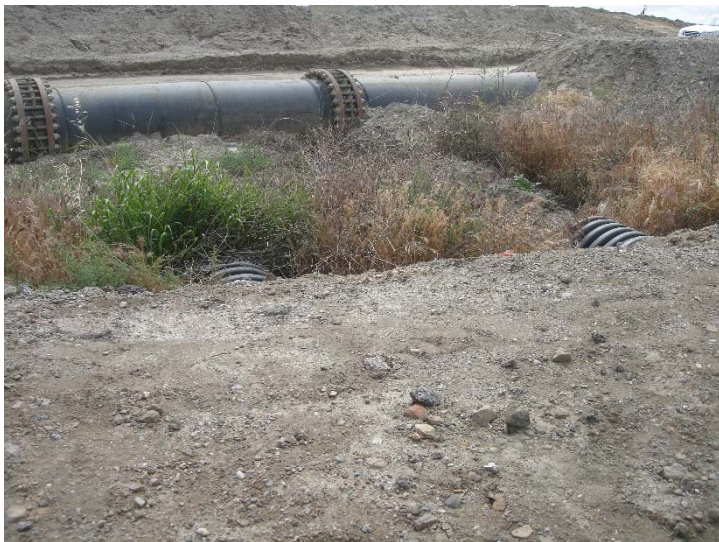
**Photo 51: Westside Drainage Channel Repair: April 18, 2017**

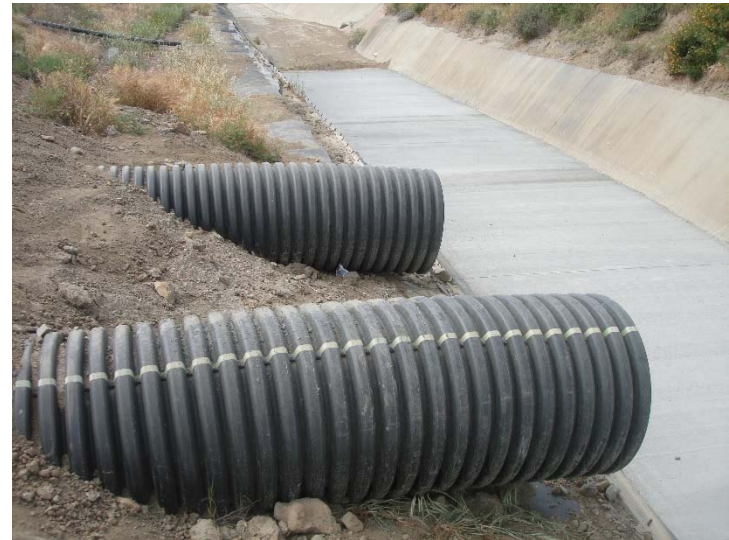
**Photo 52: Westside Drainage Channel Repair: April 18, 2017**

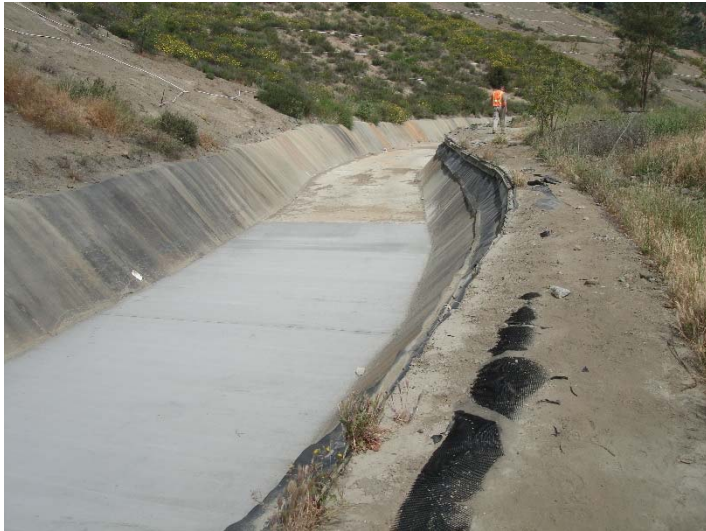
**Photo 53: Westside Drainage Channel Repair: April 18, 2017**

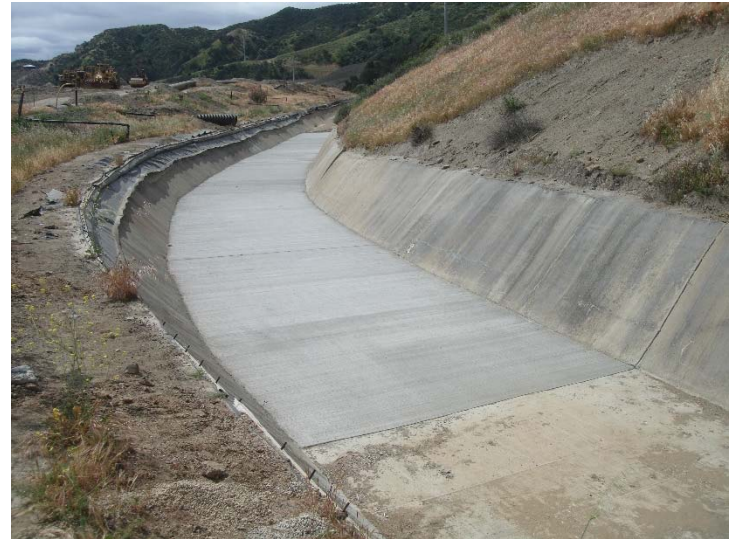
**Photo 54: Westside Drainage Channel Repair: April 18, 2017**

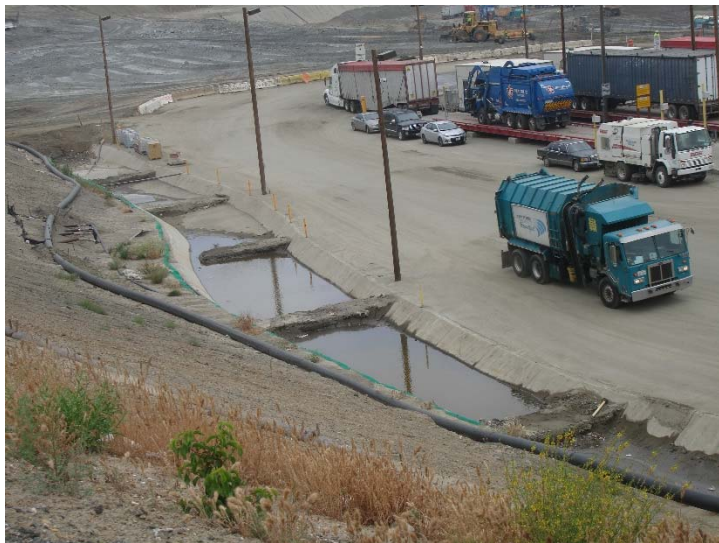
**Photo 55: Westside Drainage Channel Gabions: May 9, 2017**

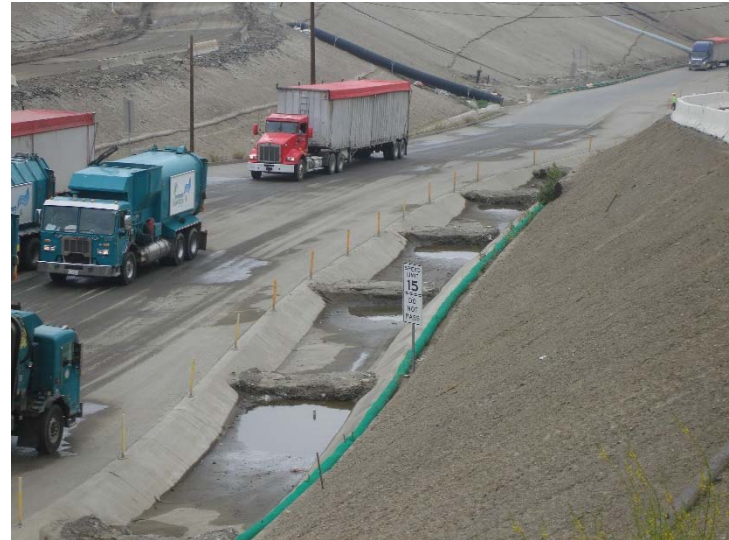
**Photo 56: Westside Drainage Channel Gabions: May 9, 2017**

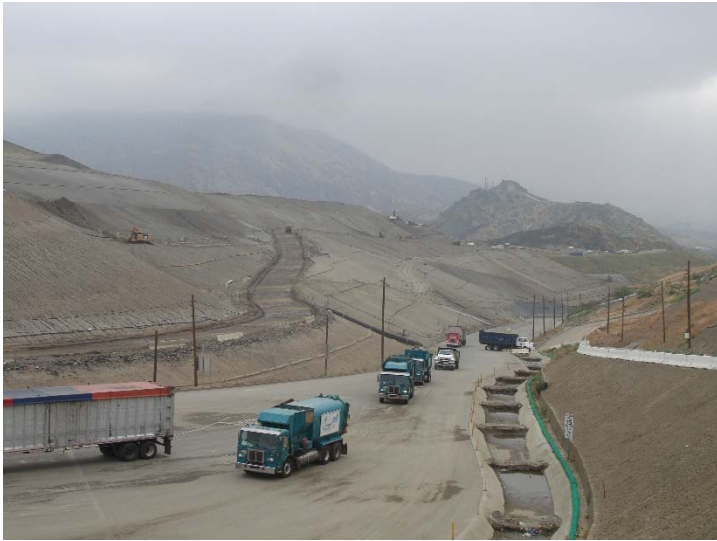
**Photo 57: Westside Drainage Channel Gabions: May 9, 2017**

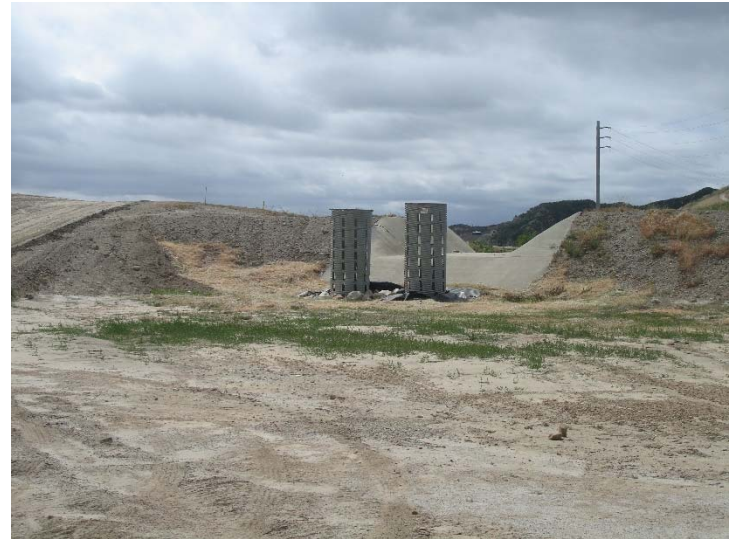
**Photo 58: Basin D: April 18, 2017**

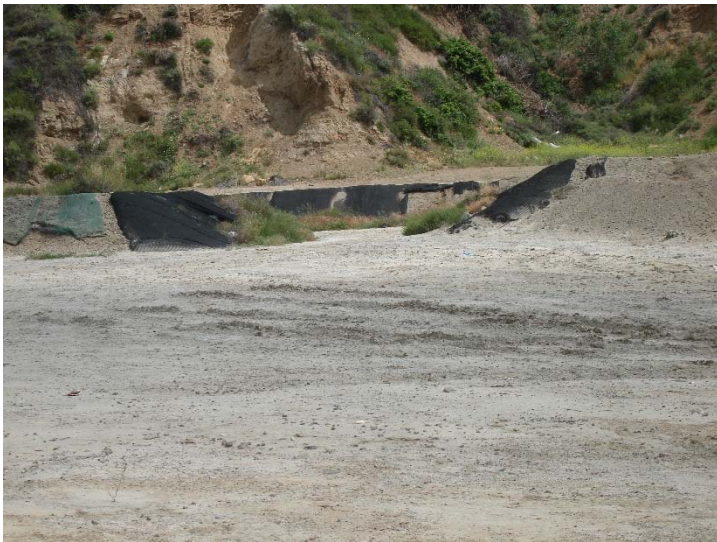
**Photo 59: Basin D: April 18, 2017**

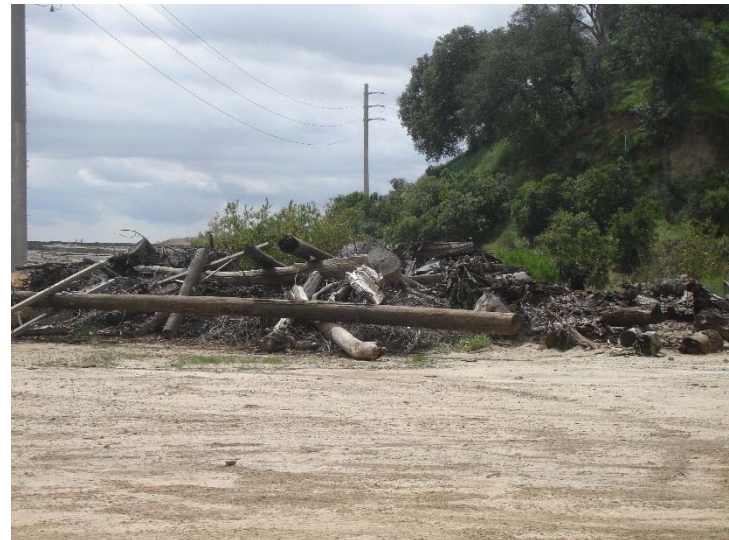
**Photo 60: Material Storage near Basin D: April 18, 2017**

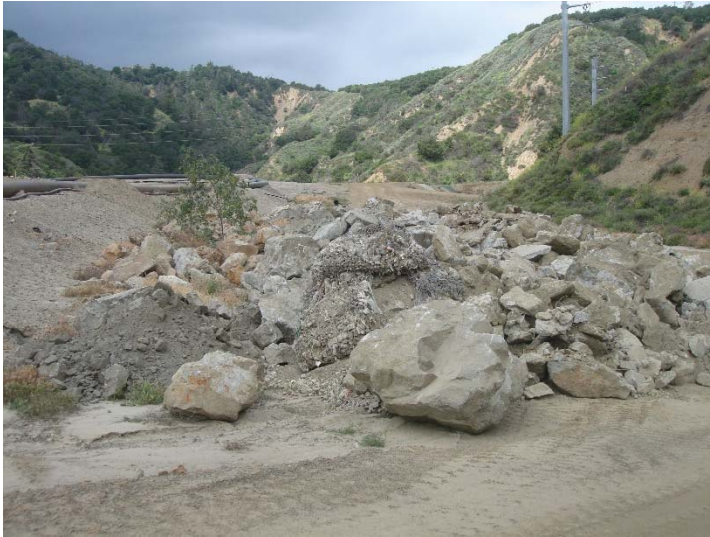
**Photo 61: Material Storage near Basin D: April 18, 2017**

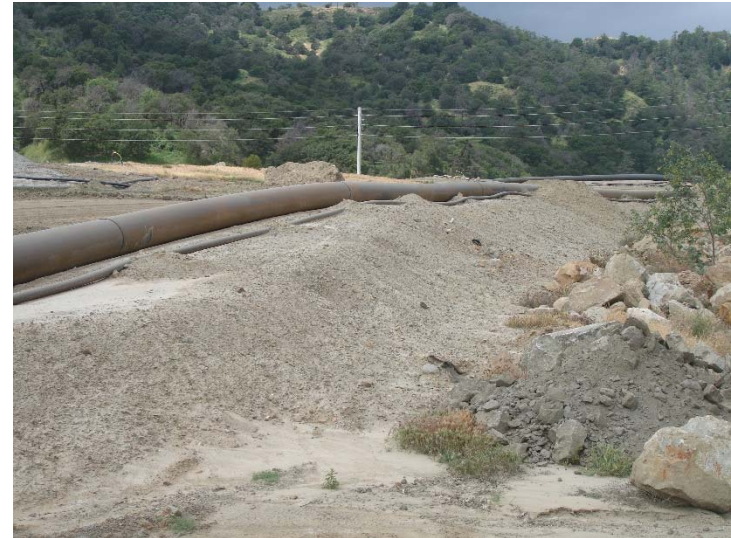
**Photo 62: Material Storage near Basin D: April 18, 2017**

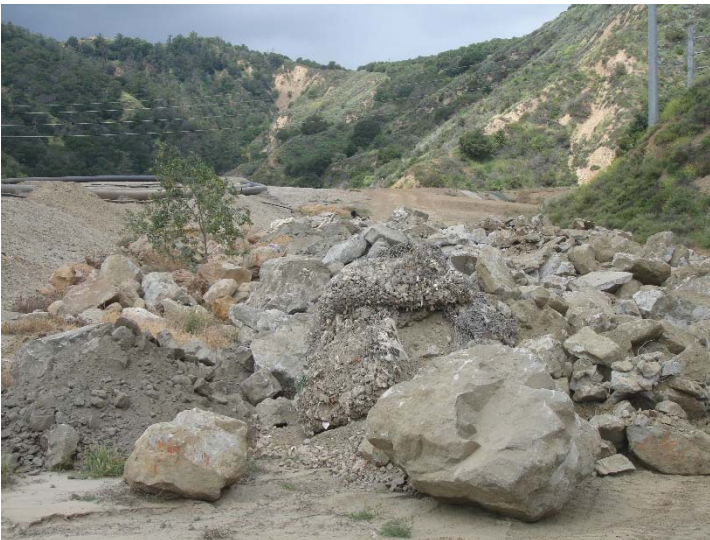
**Photo 63: Material Storage near Basin D: April 18, 2017**

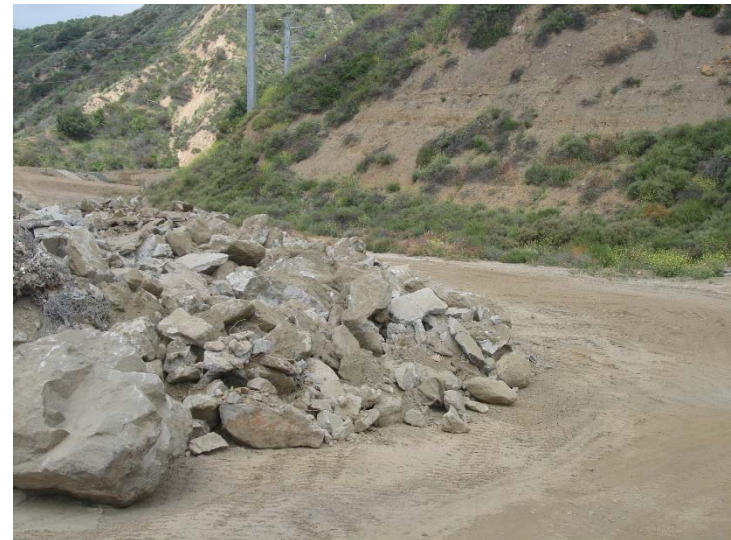
**Photo 64: Material Storage near Basin D: April 18, 2017**

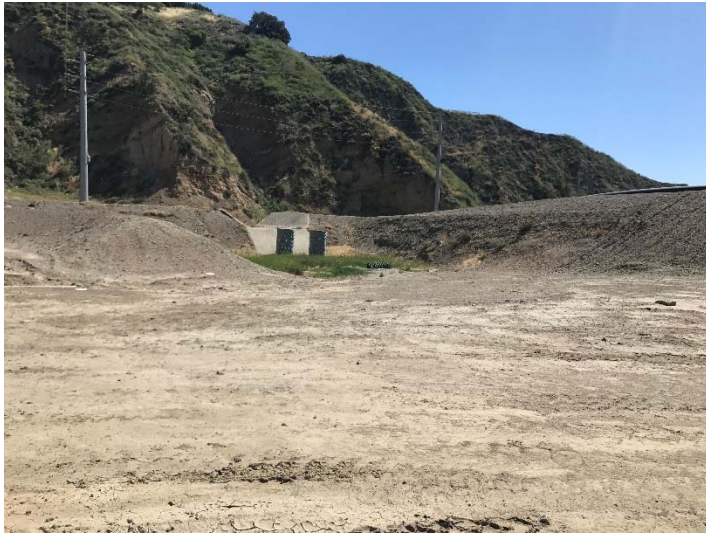
**Photo 65: Basin D: May 23, 2017**

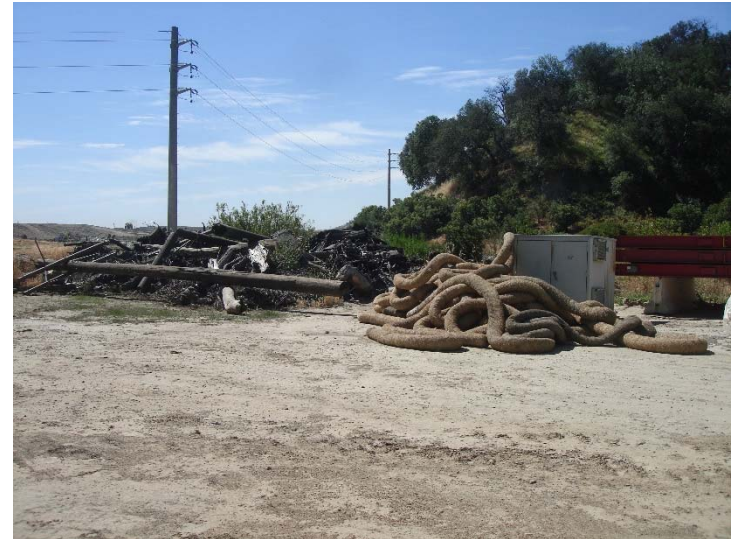
**Photo 66: Material Storage near Basin D: May 23, 2017**

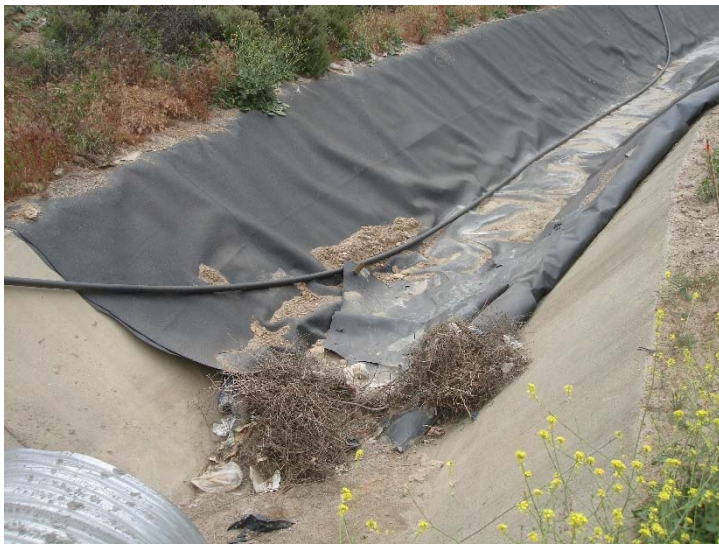
**Photo 67: Basin D Outlet Channel: April 18, 2017**

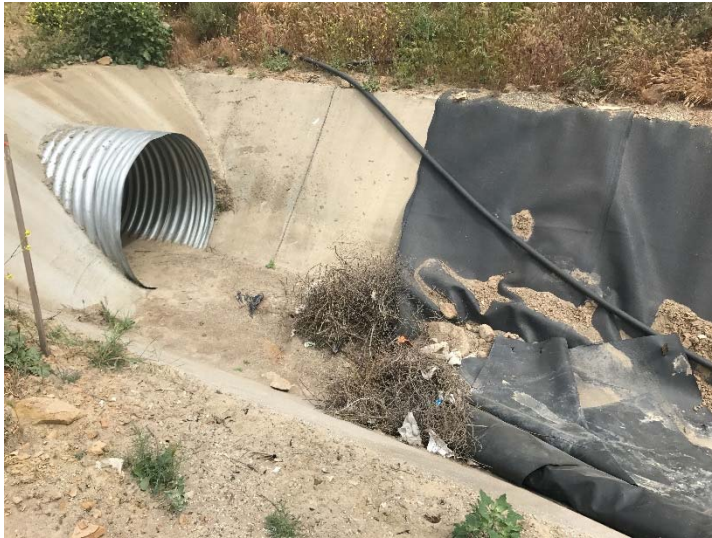
**Photo 69: Basin D Outlet Channel: April 18, 2017**

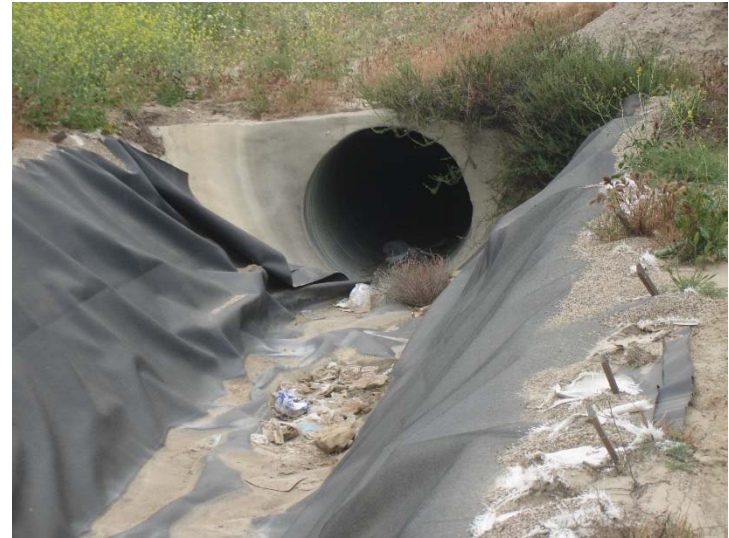
**Photo 70: Basin D Outlet Channel: April 18, 2017**

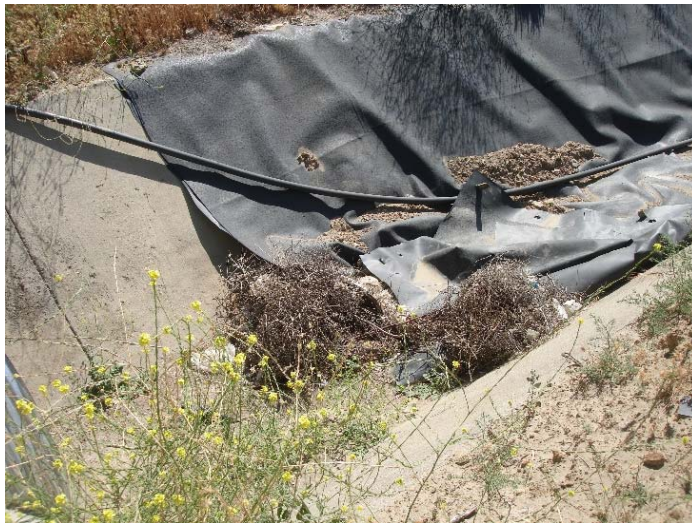
**Photo 71: Basin D Outlet Channel: May 23, 2017**

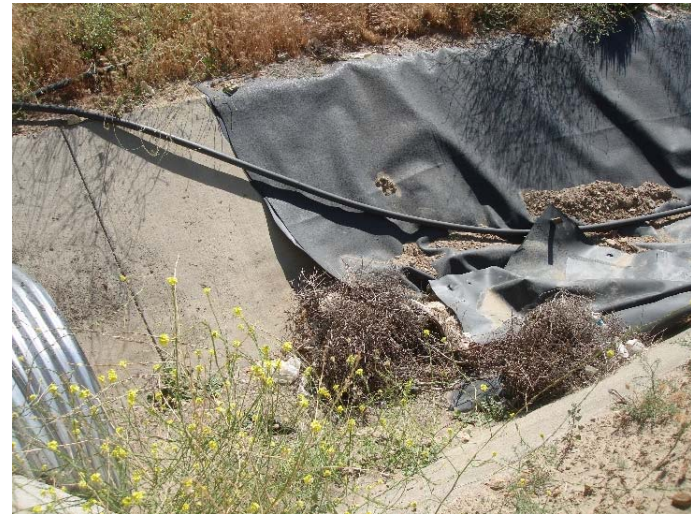
**Photo 72: Basin D Outlet Channel: May 23, 2017**

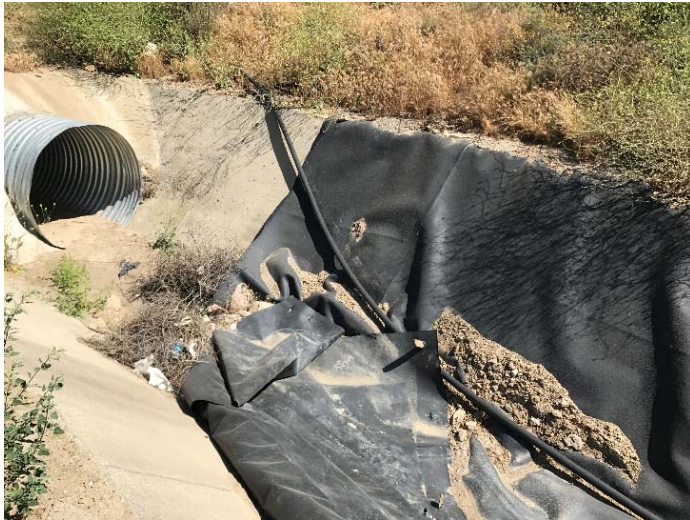
**Photo 73: Basin D Outlet Channel: May 23, 2017**

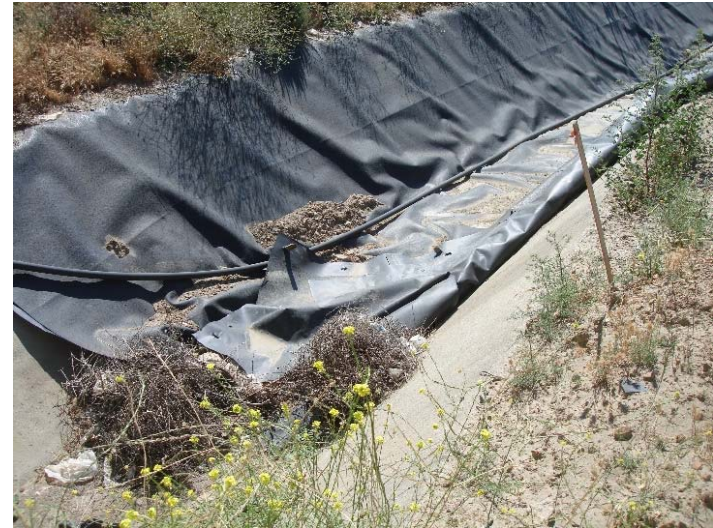
**Photo 74: Basin D Outlet Channel: May 23, 2017**

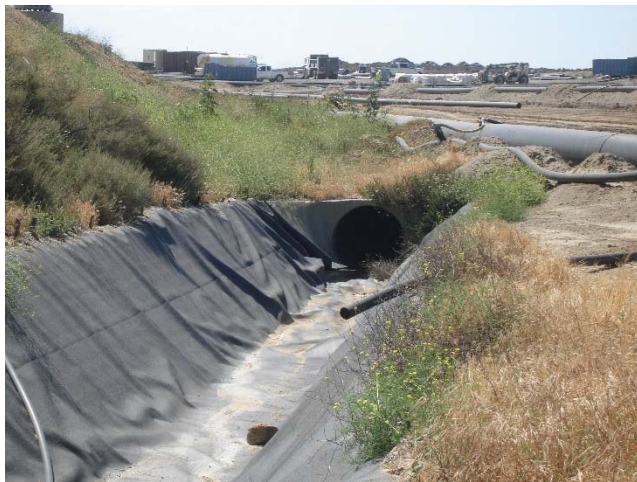
**Photo 75: Basin D Outlet Channel: May 23, 2017**

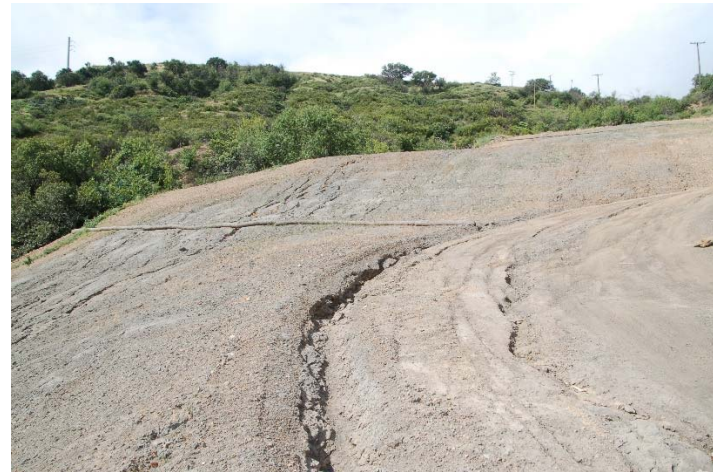
**Photo 76: Flare 3 Access Road Erosion Ruts: April 18, 2017**

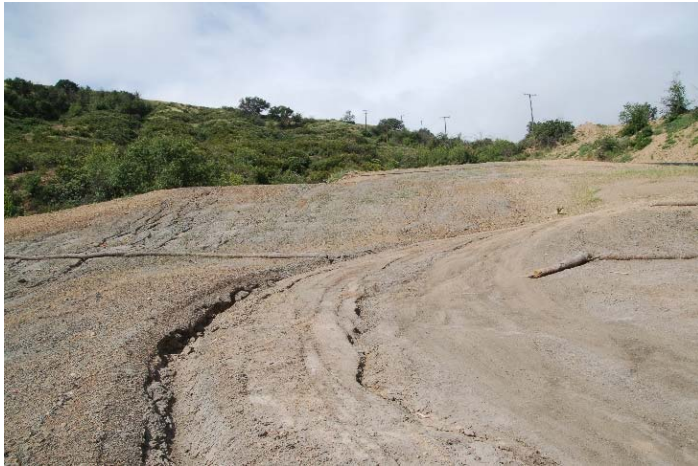
**Photo 77: Flare 3 Access Road Erosion Ruts: April 18, 2017**

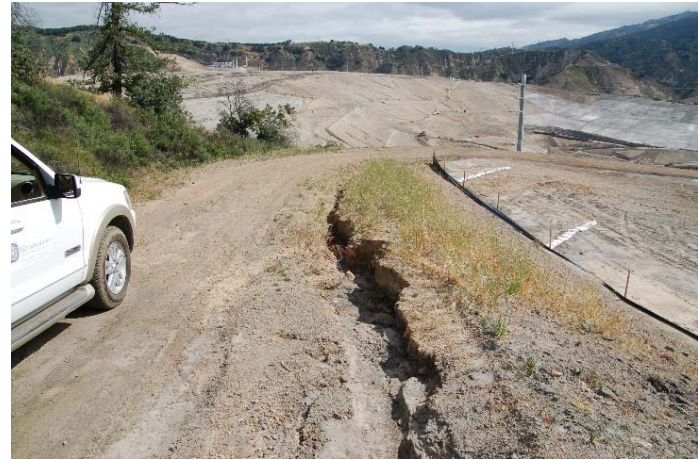
**Photo 78: Flare 3 Access Road Erosion Ruts: April 18, 2017**

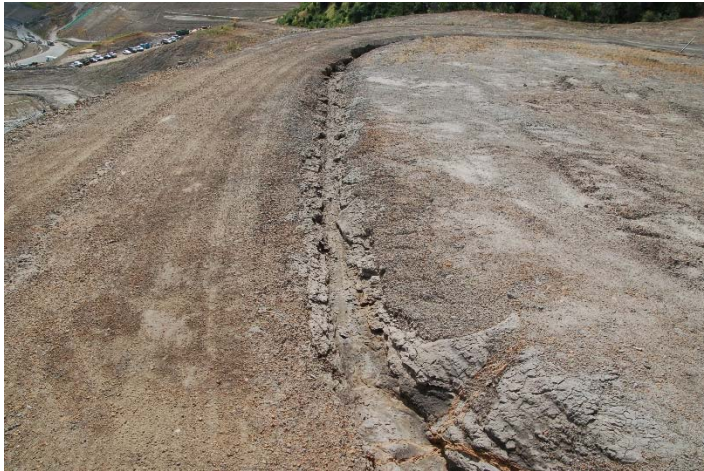
**Photo 79: Flare 3 Access Road Erosion Ruts: April 18, 2017**

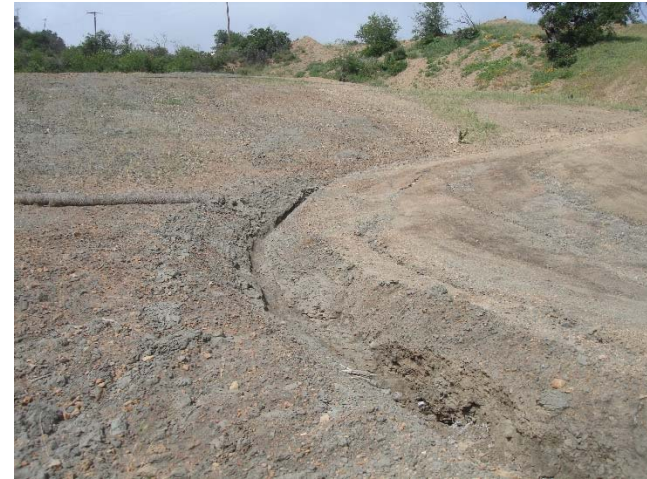
**Photo 80: Flare 3 Access Road Erosion Ruts: April 18, 2017**

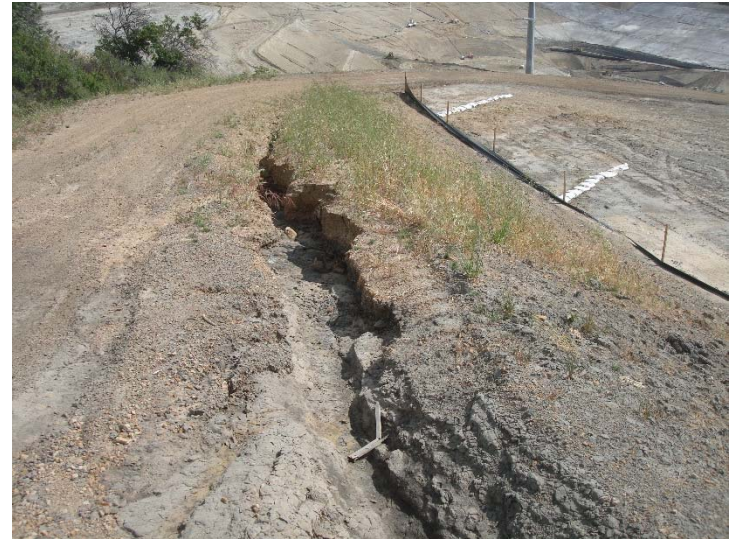
**Photo 81: Flare 3 Access Road Erosion Ruts: April 18, 2017**

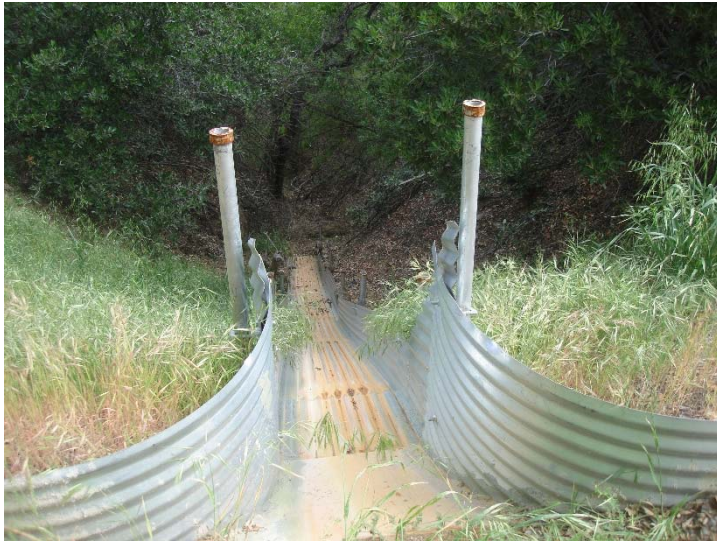
**Photo 88: Edison Pole 37 Drainage Slide: April 18, 2017**

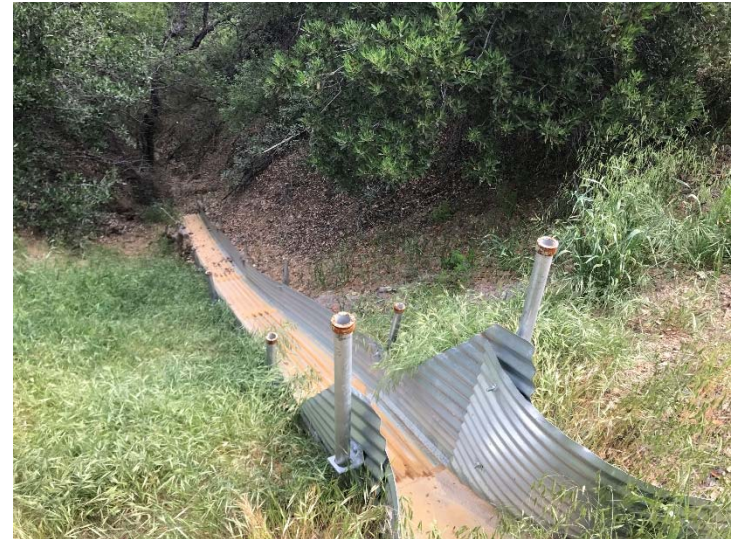
**Photo 89: Edison Pole 37 Drainage Slide: April 18, 2017**

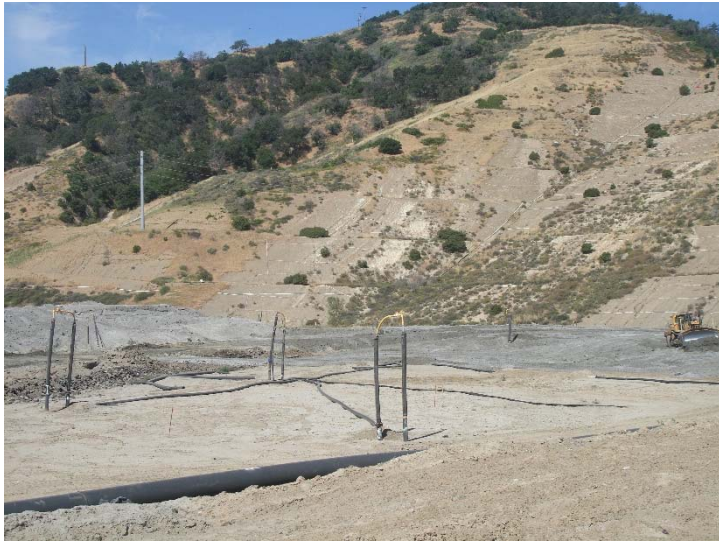
**Photo 120: County Top Deck: May 23, 2017**

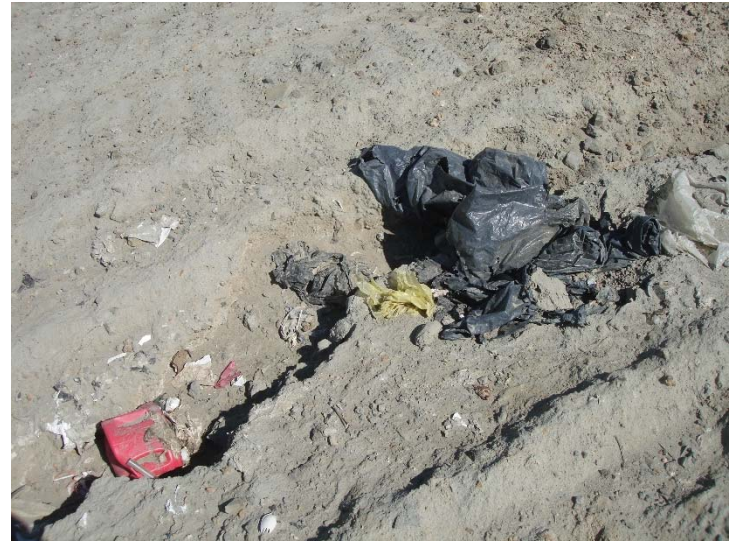
**Photo 121: County Top Deck: May 23, 2017**

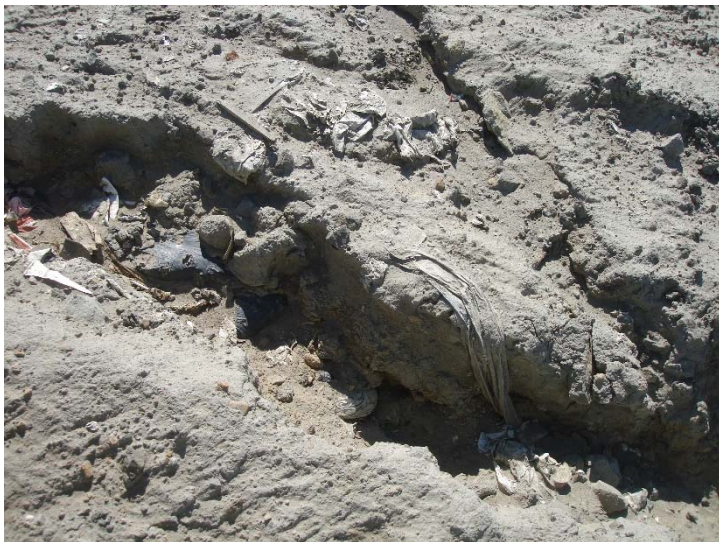
**Photo 122: County Top Deck near Stockpiled Soil: May 23, 2017**

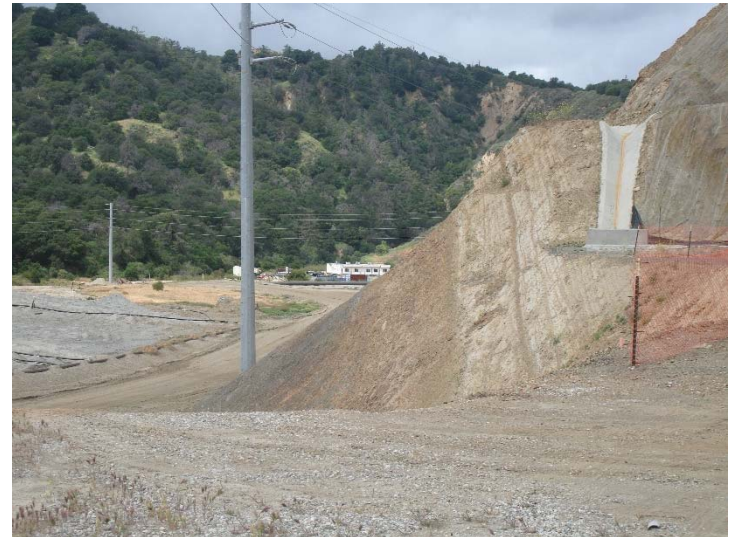
**Photo 123: County Top Deck near Stockpiled Soil: May 23, 2017**

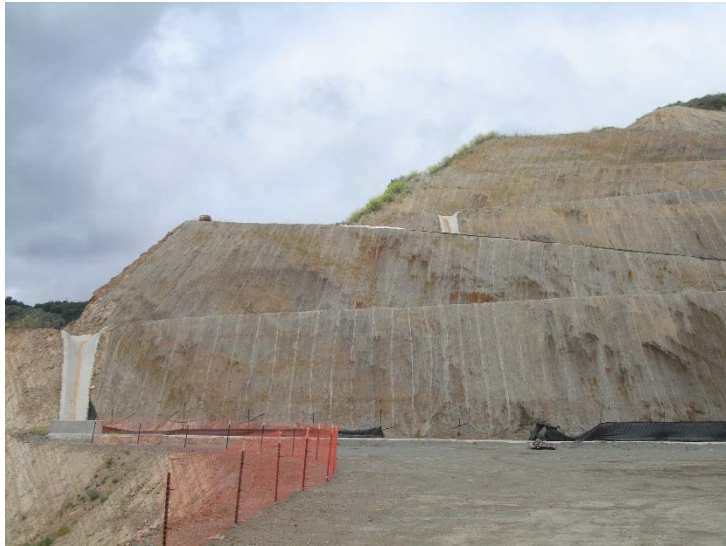
**Photo 124: Flare 11 Site Pad: April 18, 2017**

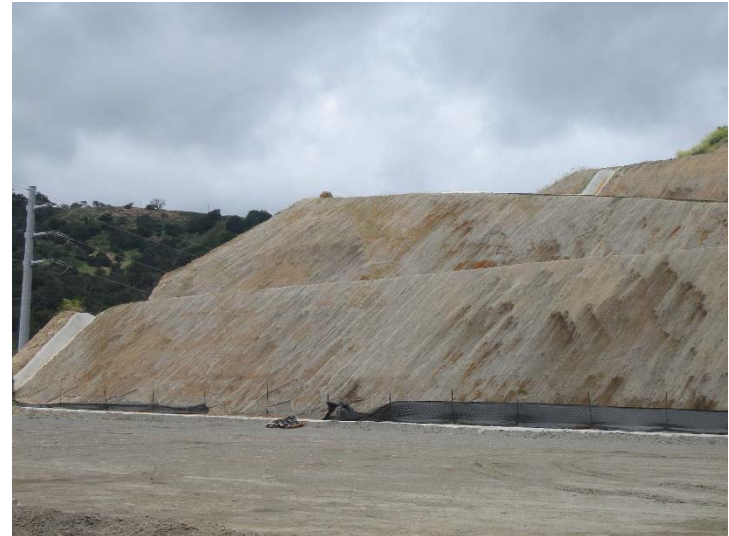
**Photo 125: Flare 11 Site Pad: April 18, 2017**

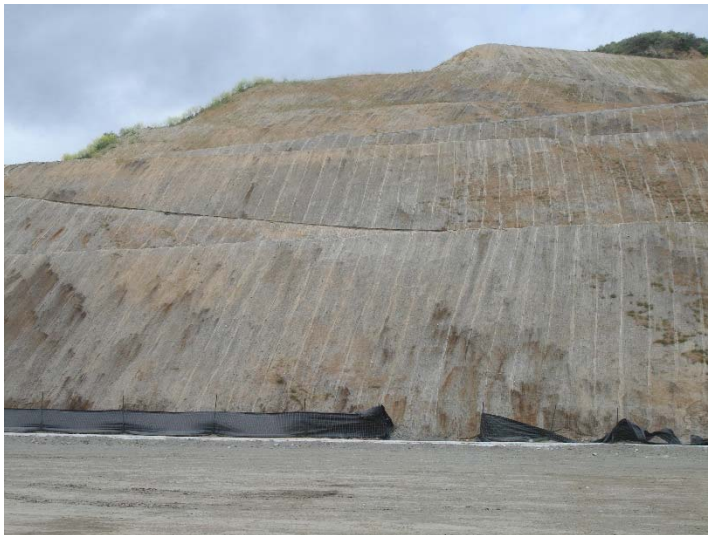
**Photo 126: Flare 11 Site Pad: April 18, 2017**

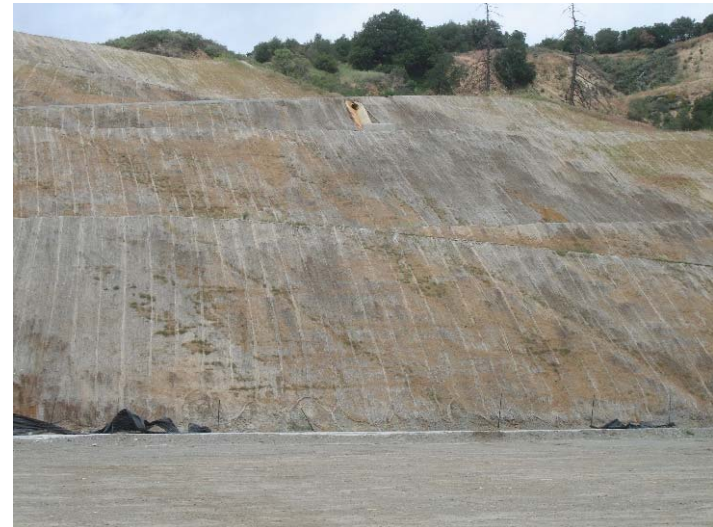
**Photo 127: Flare 11 Site Pad: April 18, 2017**

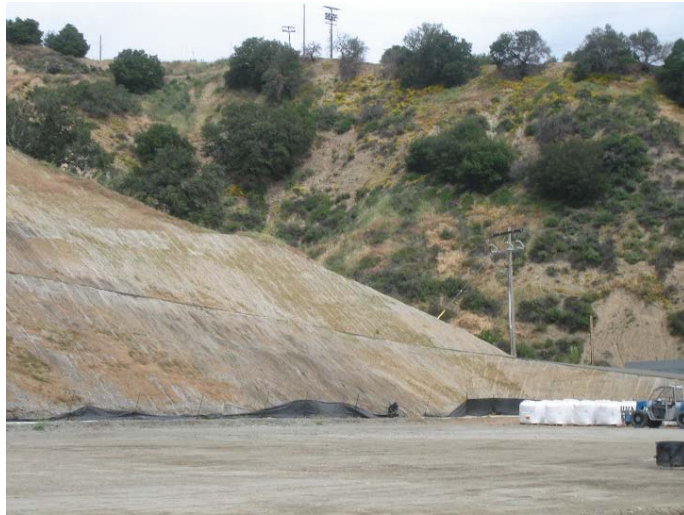
**Photo 128: Flare 11 Site Pad: April 18, 2017**

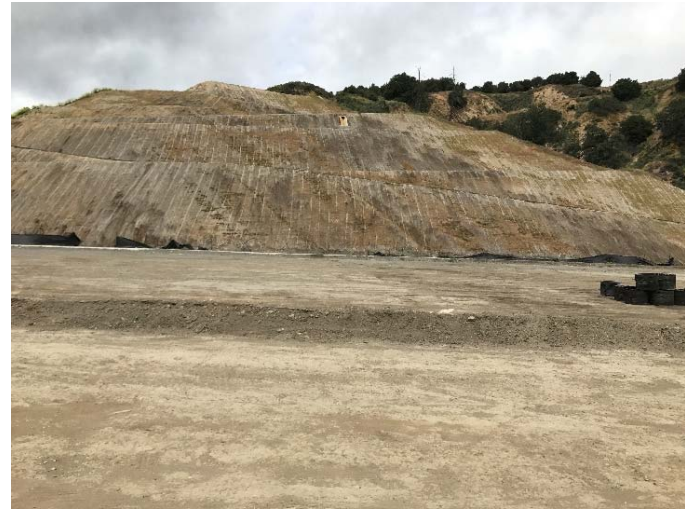
**Photo 129: Flare 11 Site Pad: April 18, 2017**

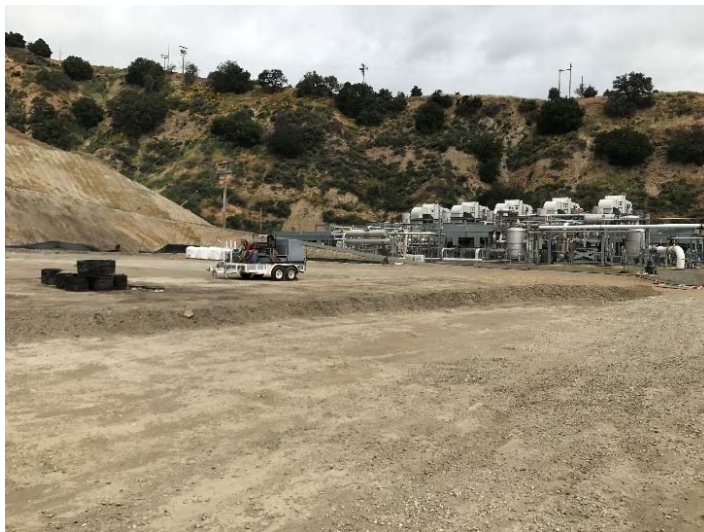
**Photo 130: Sunshine Gas Producers Facility: April 18, 2017**

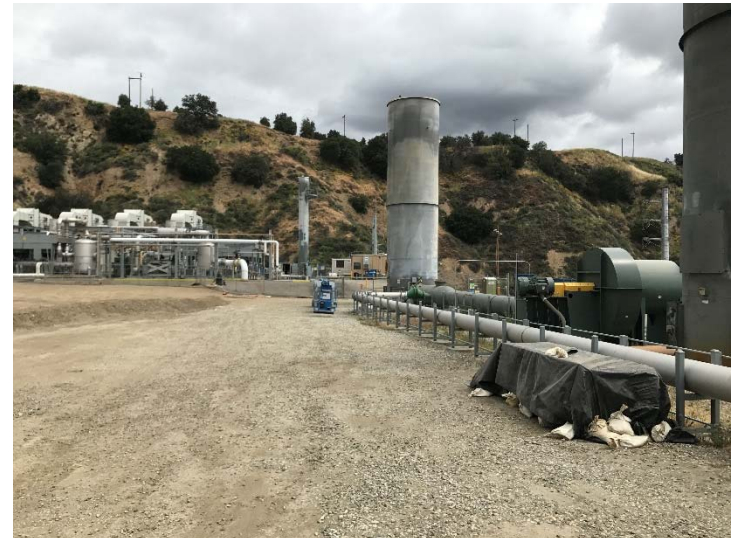
**Photo 131: Sunshine Gas Producers Facility: April 18, 2017**

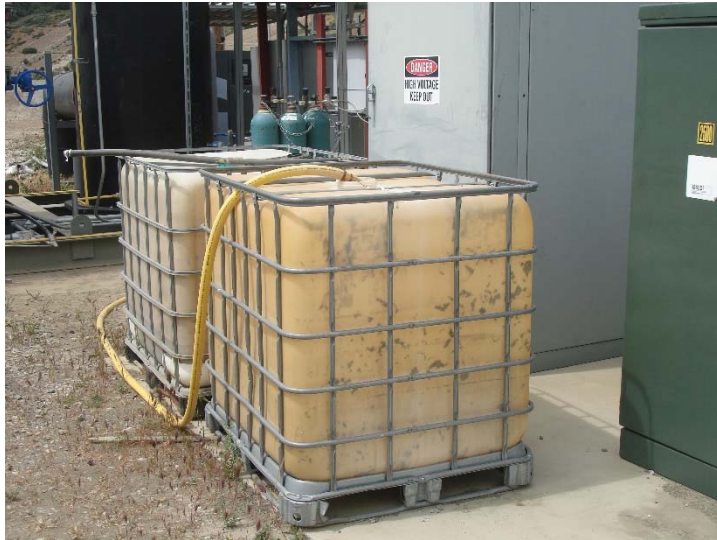
**Photo 132: Sunshine Gas Producers Facility: April 18, 2017**
