**Sunshine Canyon Landfill  
Independent Monitor  
Quarterly Site Monitoring Status Report  
April 1, 2017 – June 30, 2017**

**City of Los Angeles Department of City Planning**

**County of Los Angeles Department of Regional Planning**

October 10, 2017

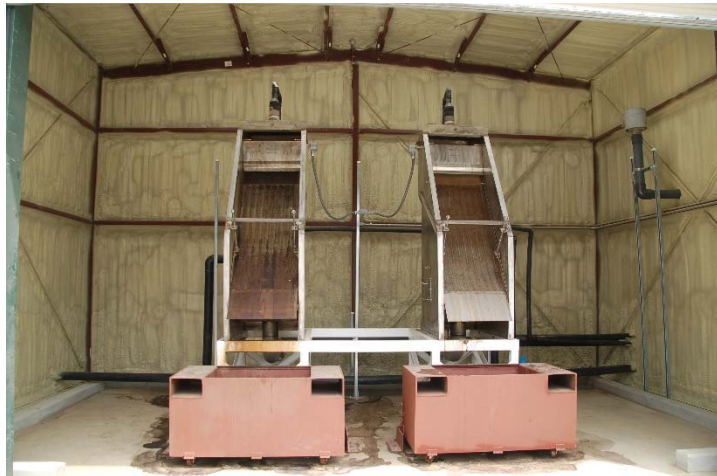
**Photo 134: Liquids Filter Systems: April 18, 2017**

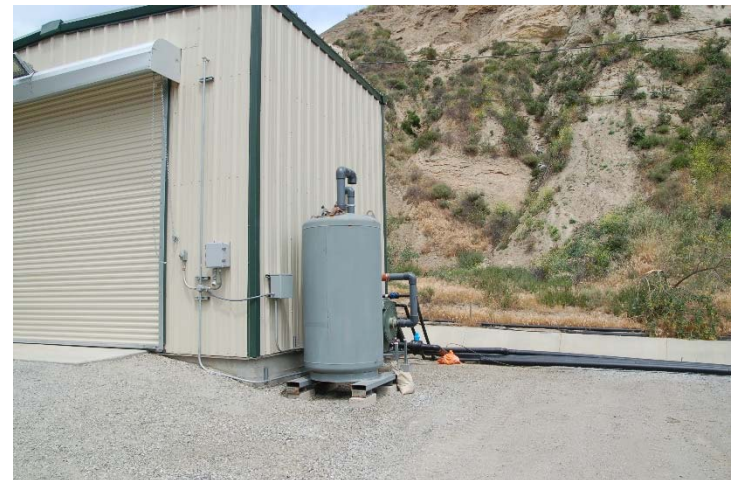
**Photo 135: Liquids Filter Systems: April 18, 2017**

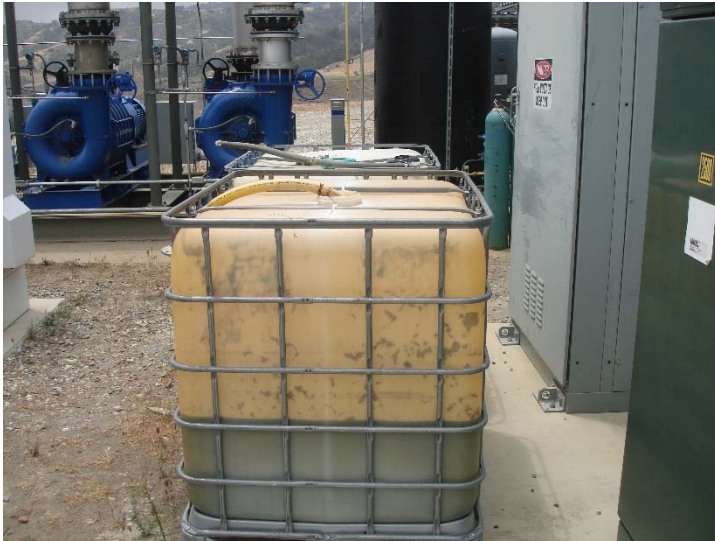
**Photo 136: Liquids Filter Systems: April 18, 2017**

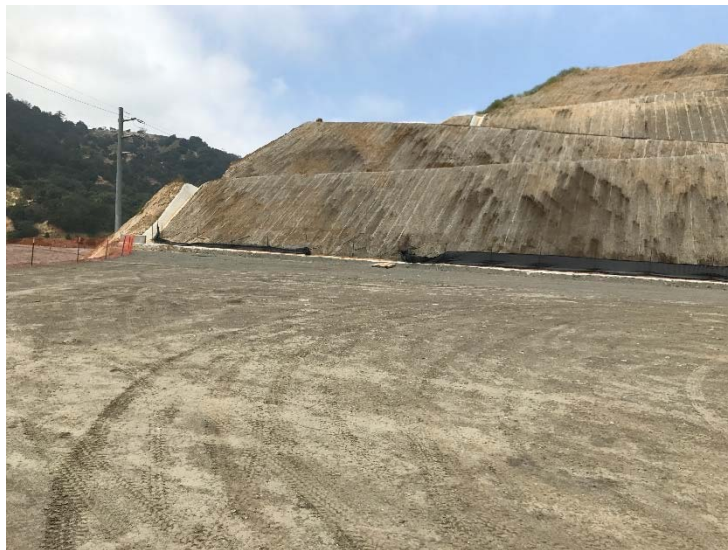
**Photo 138: Flare 11 Site: May 9, 2017**

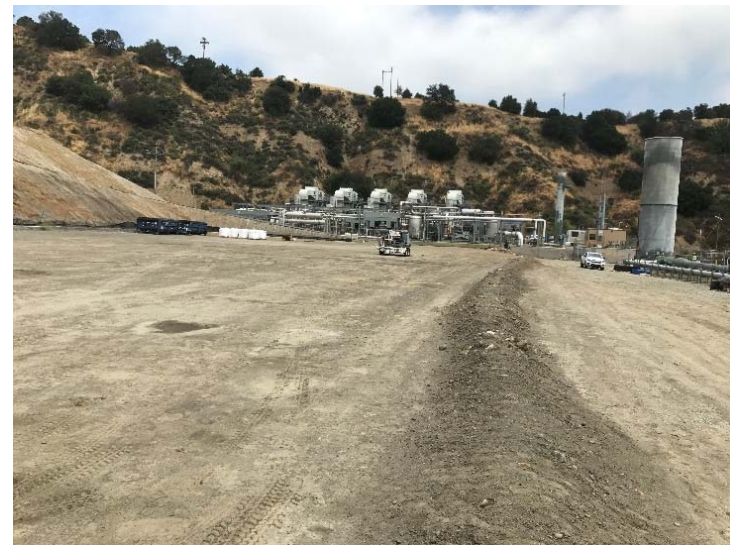
**Photo 139: Flare 11 Site: May 9, 2017**

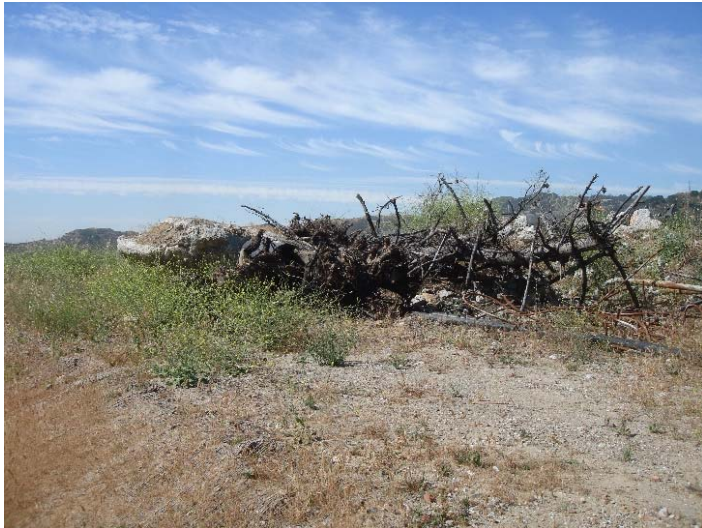
**Photo 140: Flare 11 Site: May 9, 2017**

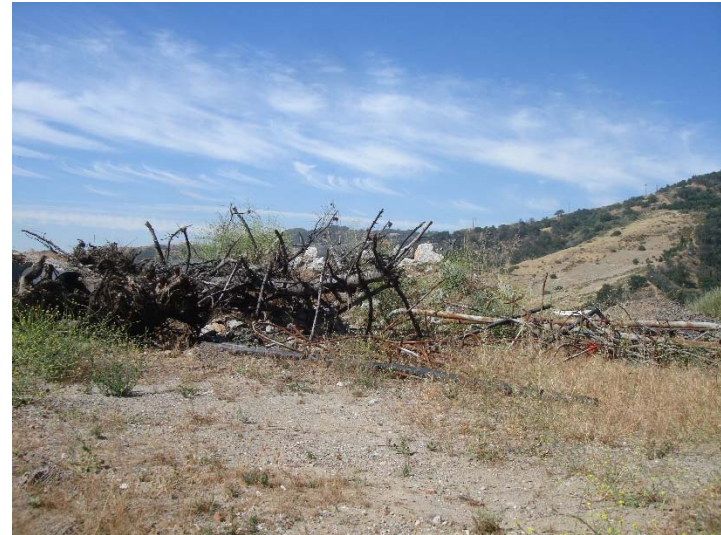
**Photo 141: Old Flare Site: May 23, 2017**

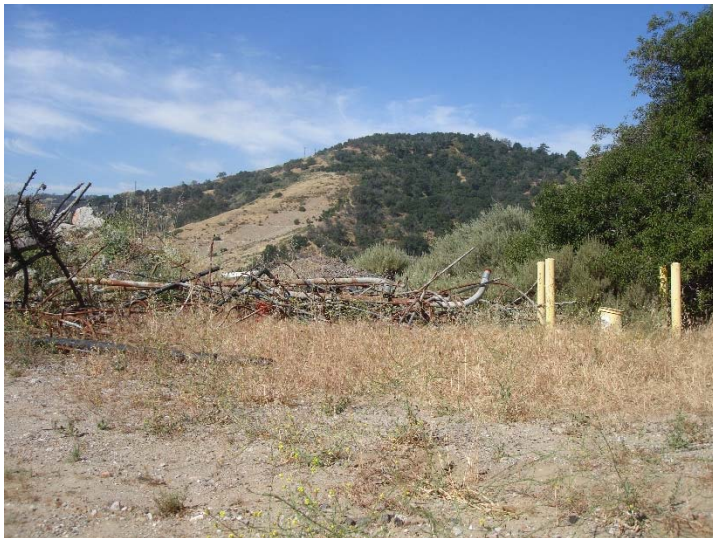
**Photo 142: Old Flare Site: May 23, 2017**

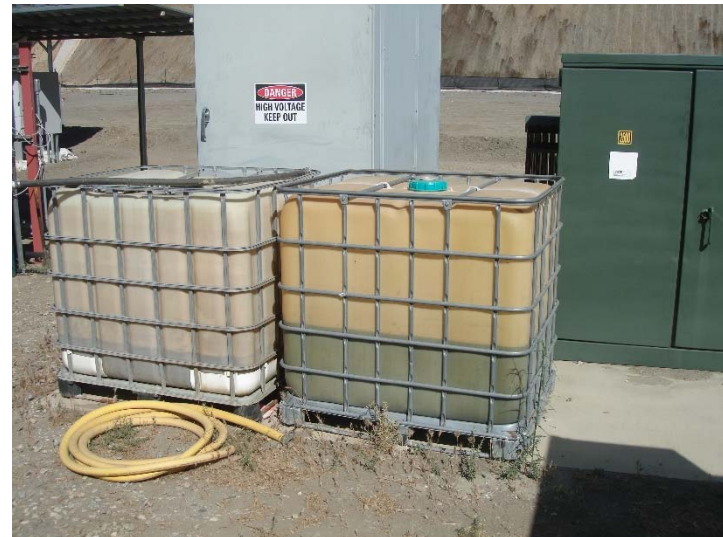
**Photo 143: Old Flare Site: May 23, 2017**

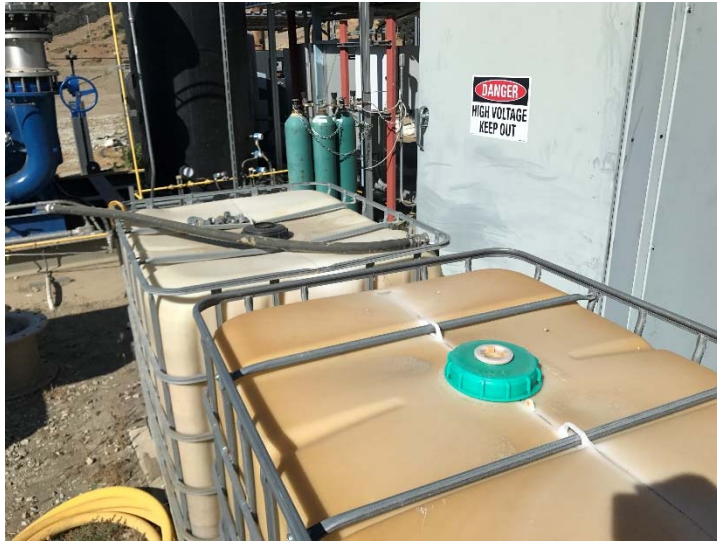
**Photo 144: Flare 9 & 10 Blower Knockout Liquids: May 23, 2017**

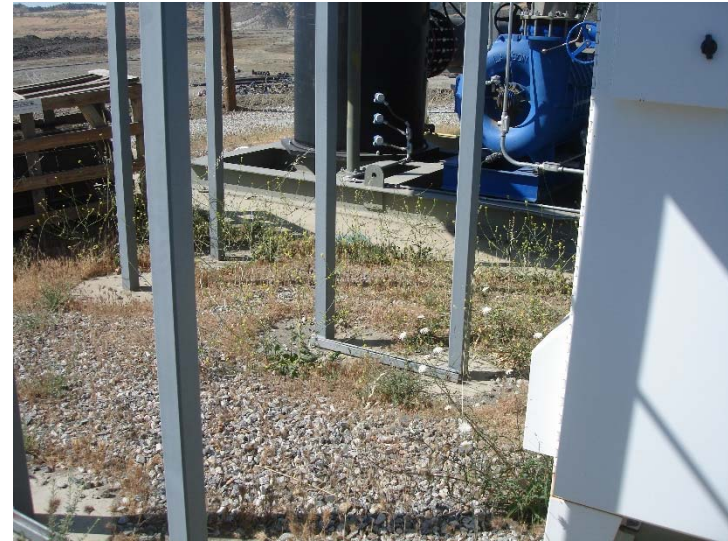
**Photo 145: Flare 9 & 10 Blower Knockout Liquids: May 23, 2017**

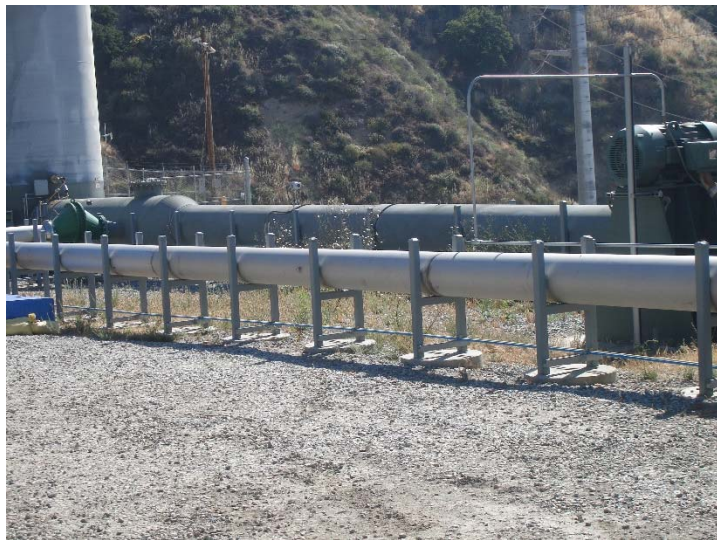
**Photo 146: Vegetation at Flare 9 & 10 Equipment: May 23, 2017**

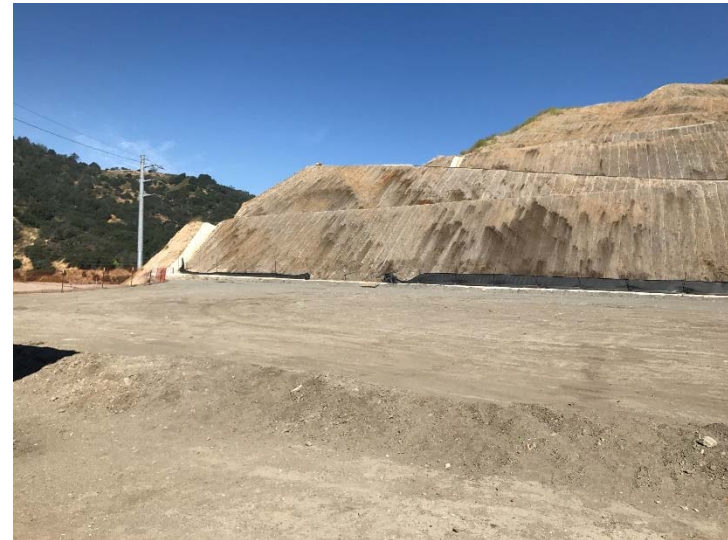
**Photo 147: Vegetation at Flare 9 & 10 Equipment: May 23, 2017**

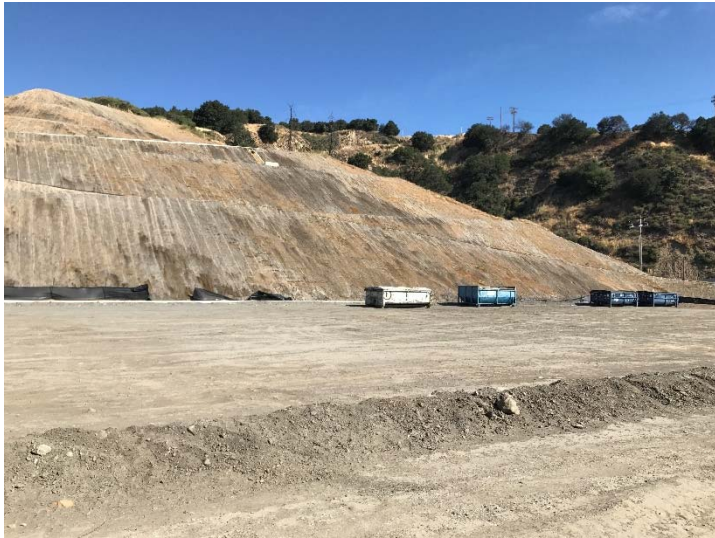
**Photo 148: Future Flare 11 Site: May 23, 2017**

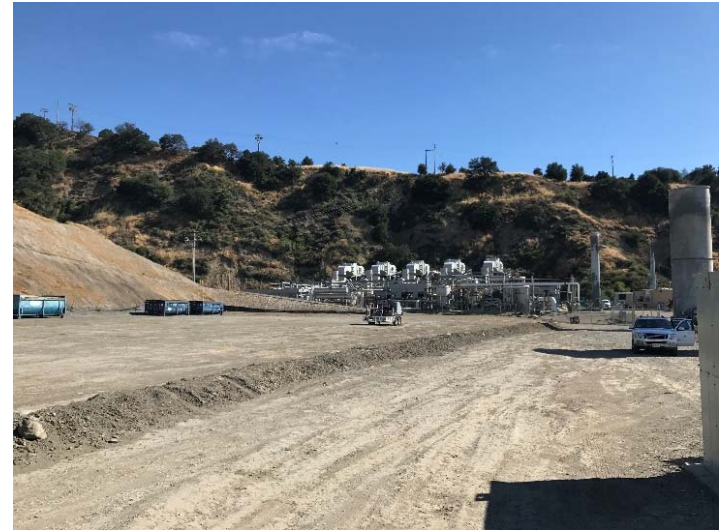
**Photo 149: Future Flare 11 Site: May 23, 2017**

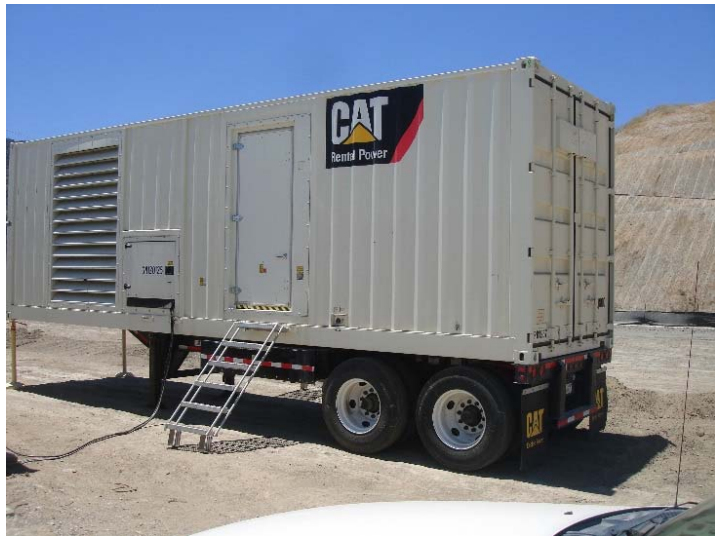
**Photo 150: Future Flare 11 Site: May 23, 2017**

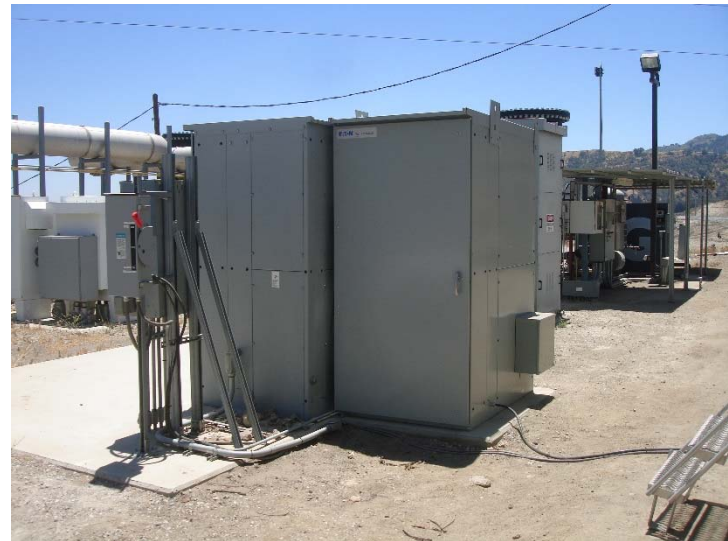
**Photo 151: Flare 9 & 10 Standby Power Supply: June 20, 2017**

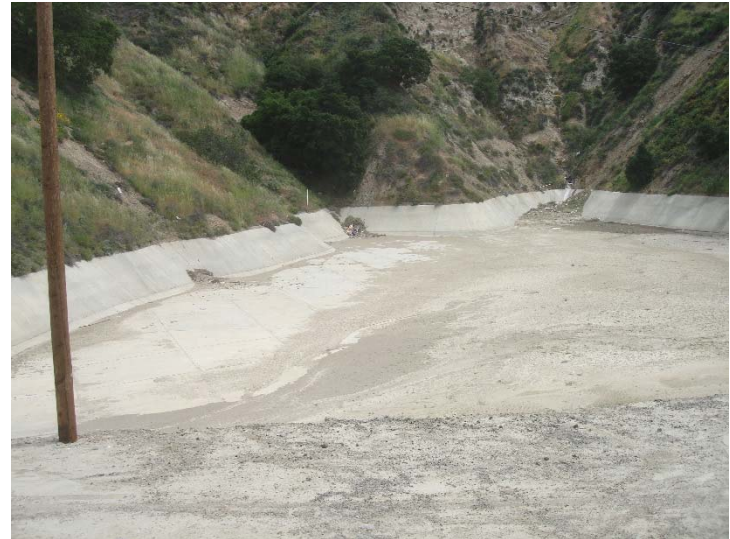
**Photo 153: Basin B: April 18, 2017**

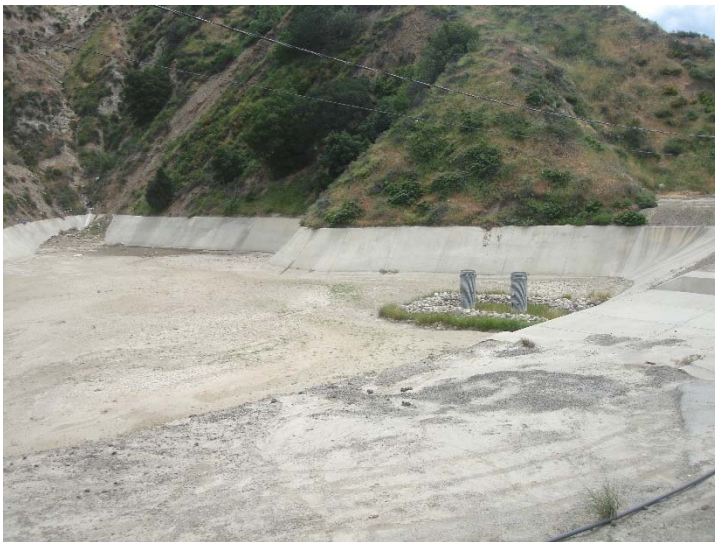
**Photo 154: Basin B: April 18, 2017**

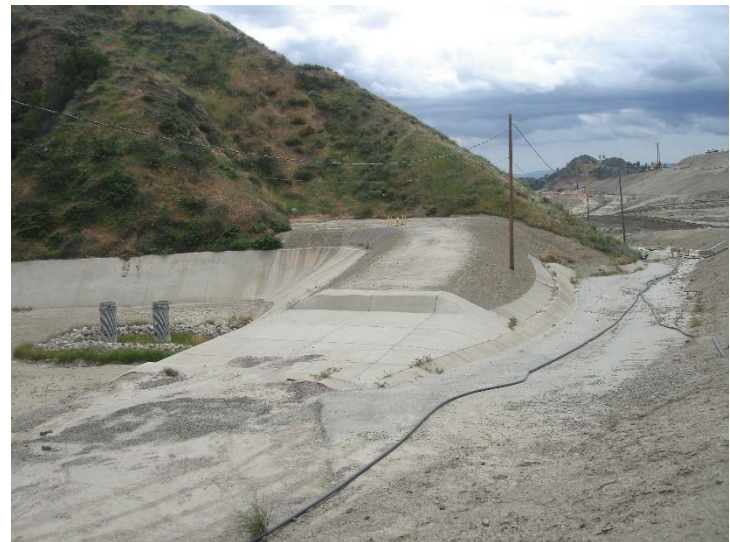
**Photo 155: Basin B: April 18, 2017**

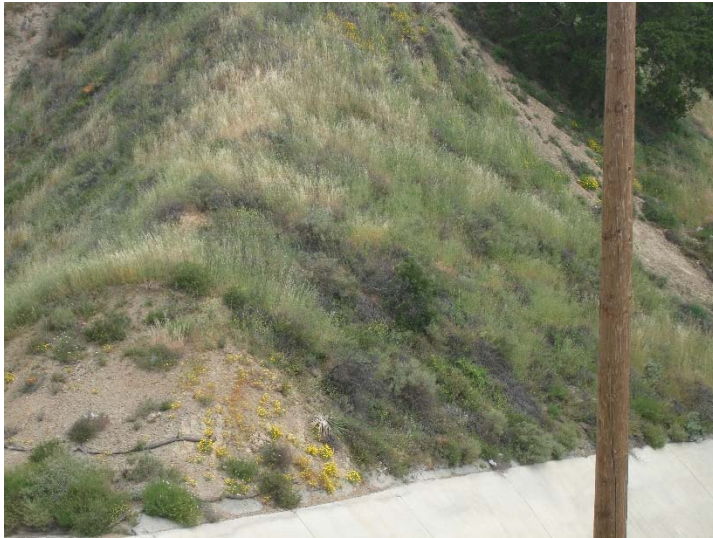
**Photo 156: Basin B: April 18, 2017**

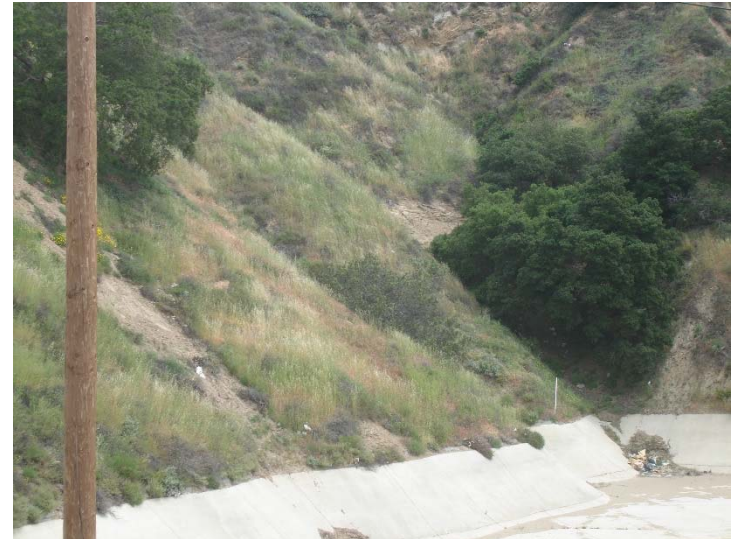
**Photo 157: Basin B Native Hillsides: April 18, 2017**

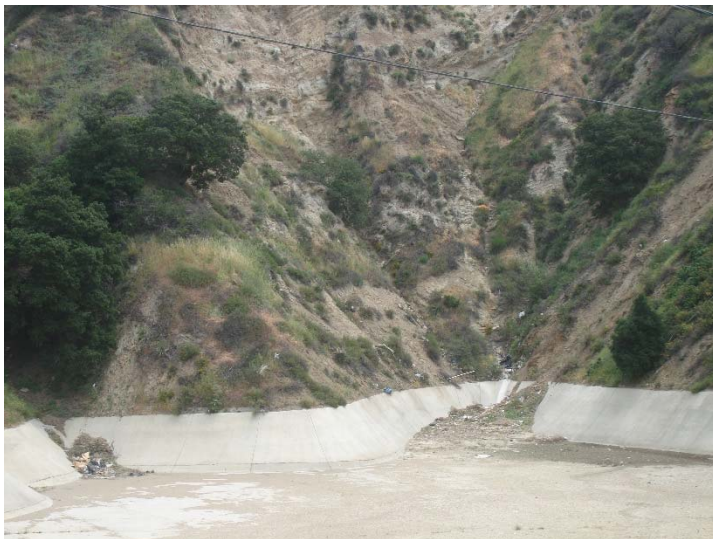
**Photo 158: Basin B Native Hillsides: April 18, 2017**

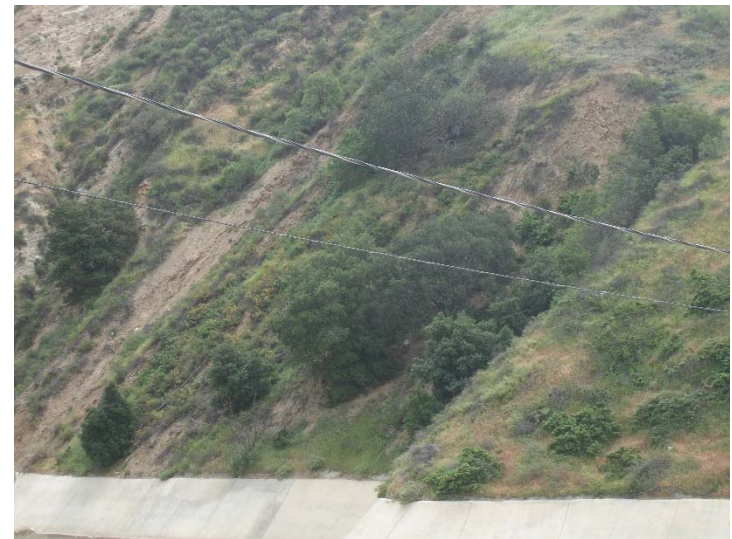
**Photo 159: Basin B Native Hillsides: April 18, 2017**

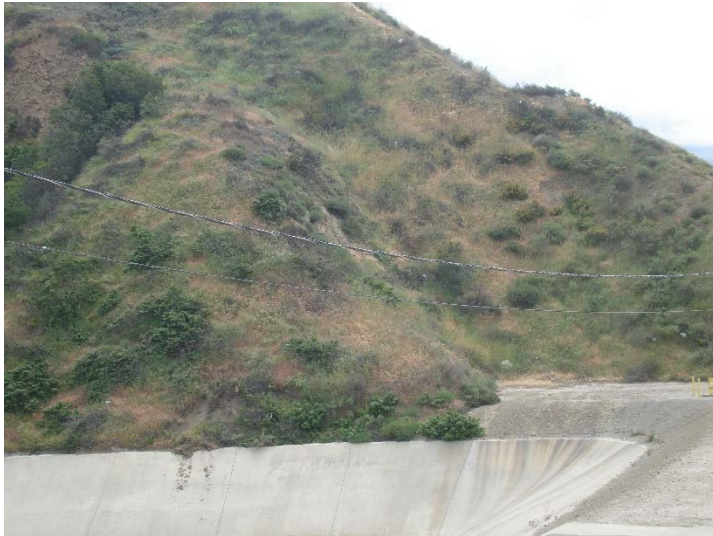
**Photo 161: Basin B Native Hillsides: April 18, 2017**

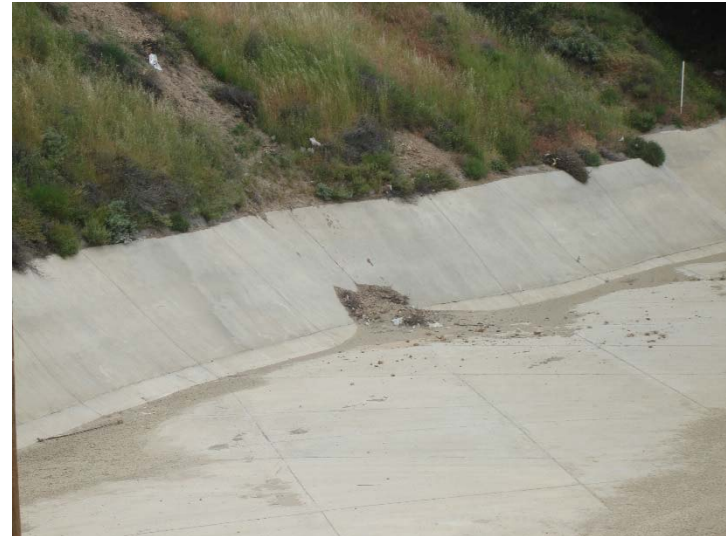
**Photo 162: Basin B Native Hillsides: April 18, 2017**

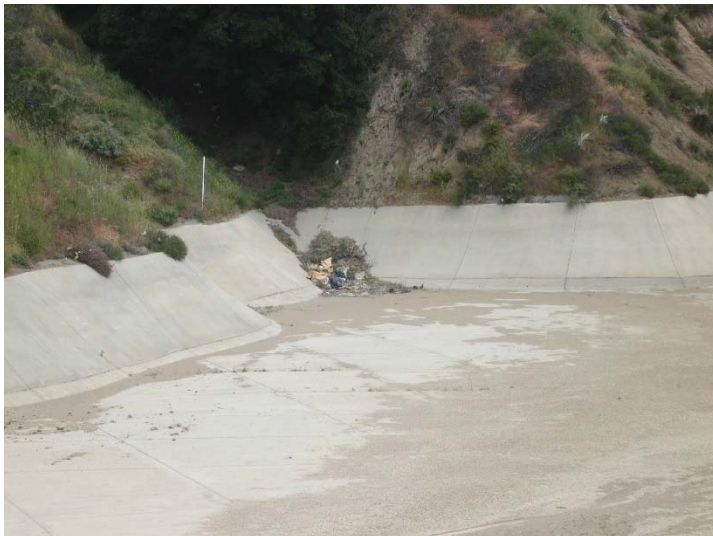
**Photo 163: Basin B Native Hillsides: April 18, 2017**

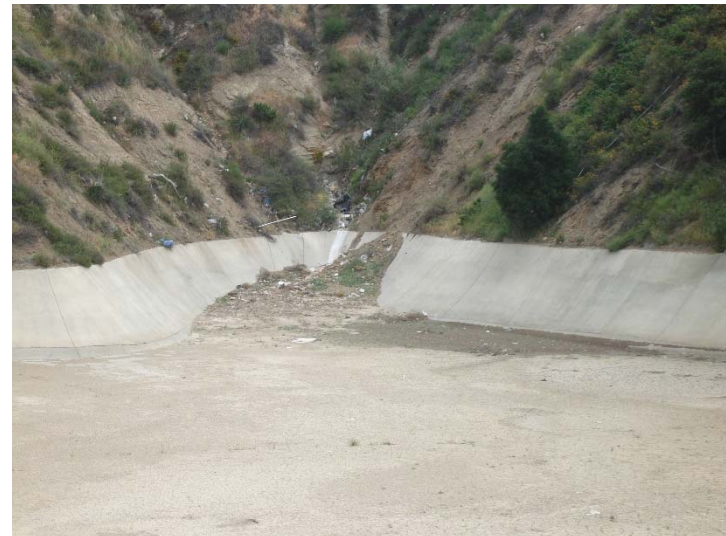
**Photo 164: Basin B Native Hillsides: April 18, 2017**

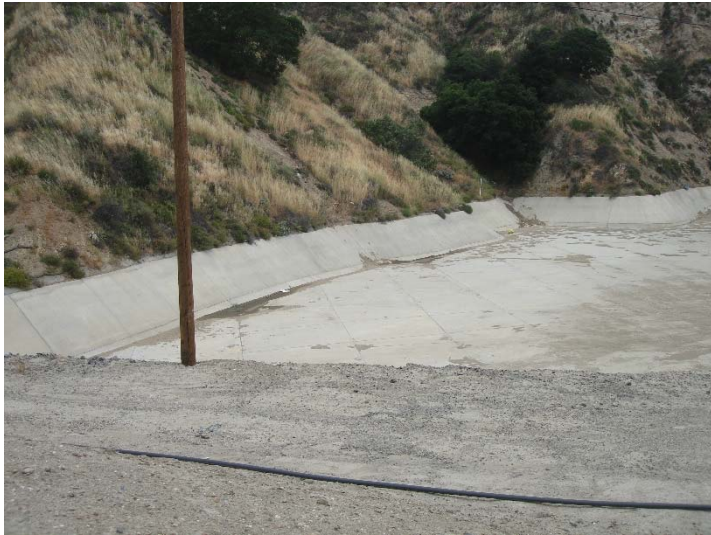
**Photo 165: Basin B: May 9, 2017**

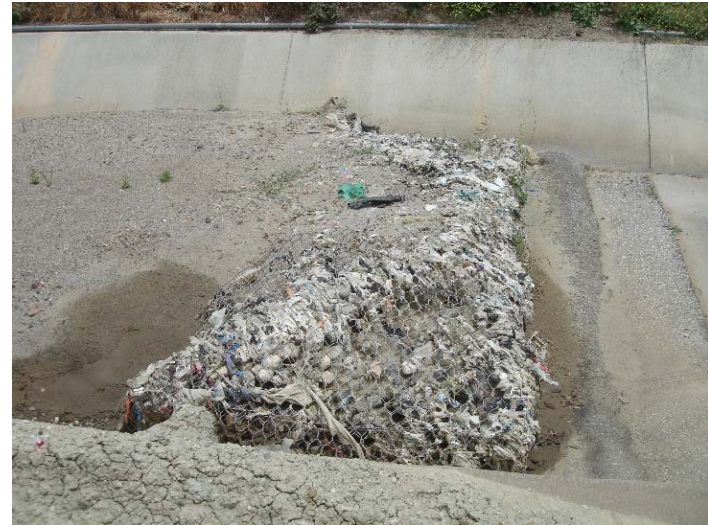
**Photo 178: Eastside Drainage Channel to Terminal Basin:  
May 9, 2017**

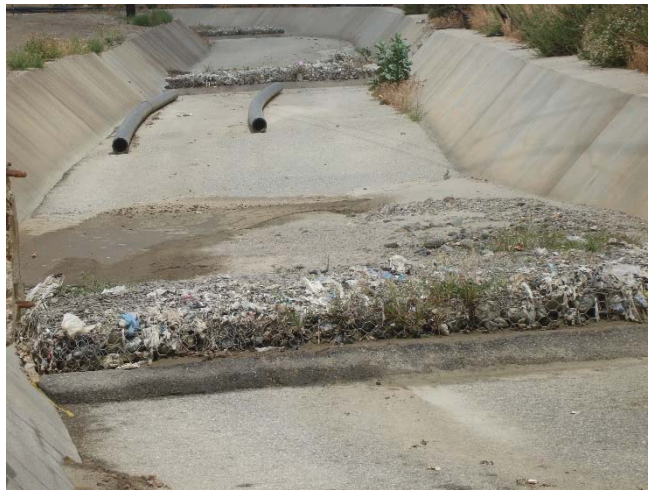
**Photo 179: Eastside Drainage Channel to Terminal Basin:  
May 9, 2017**

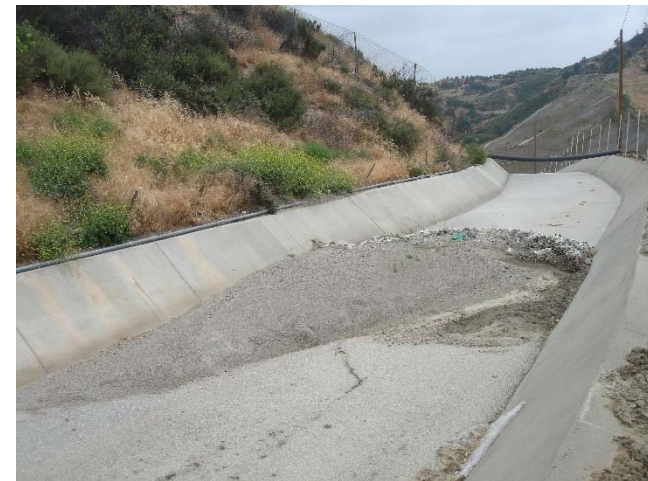
**Photo 180: Eastside Drainage Channel to Terminal Basin:  
May 9, 2017**

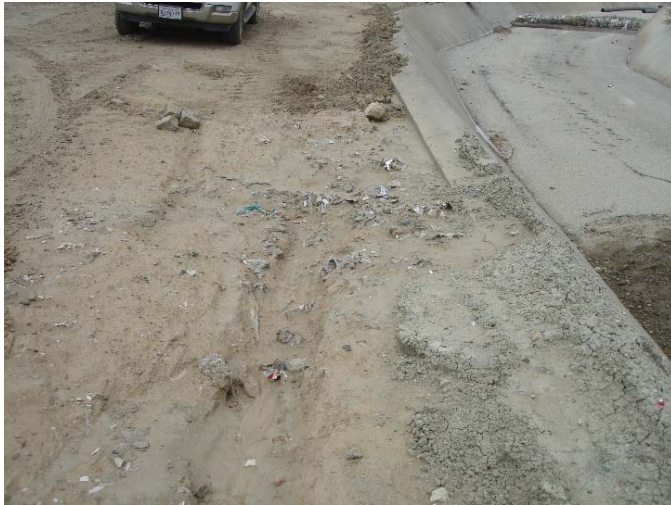
**Photo 181: Eastside Drainage Channel to Terminal Basin:  
May 9, 2017**

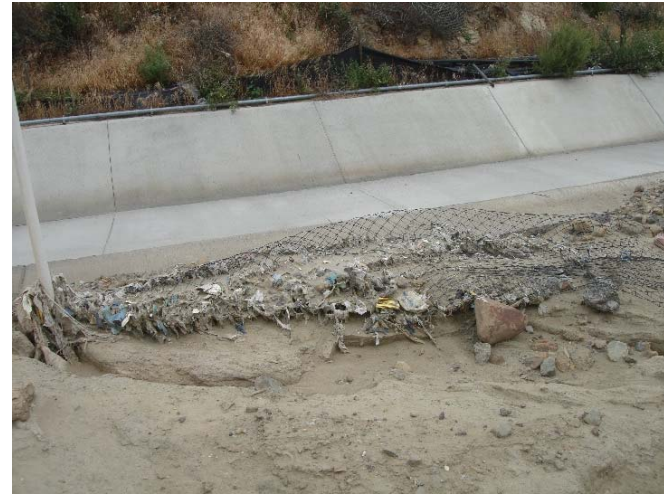
**Photo 182: Eastside Drainage Channel to Terminal Basin:  
May 9, 2017**

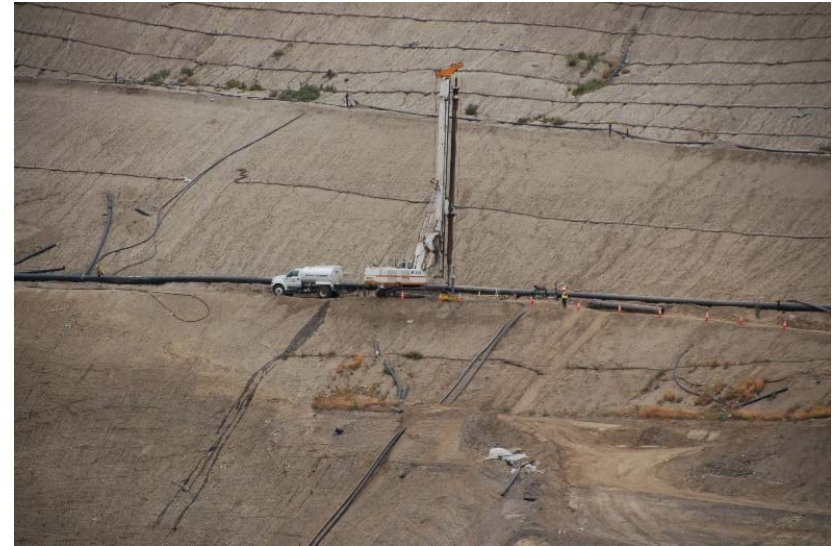
**Photo 242: Well Drilling on Slope Cell CC3B: April 18, 2017**

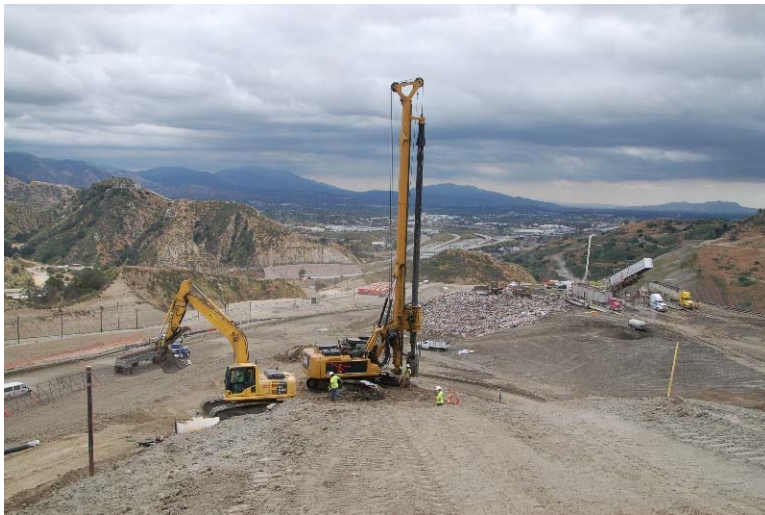
**Photo 243: Well Drilling on Deck Cell CC3B: April 18, 2017**

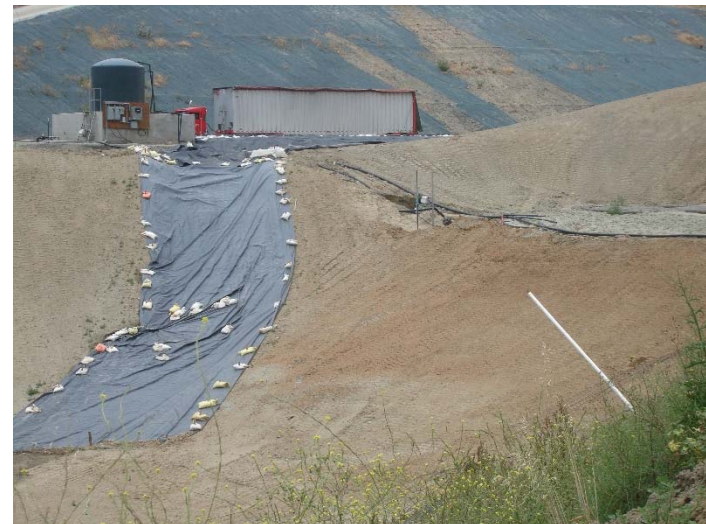
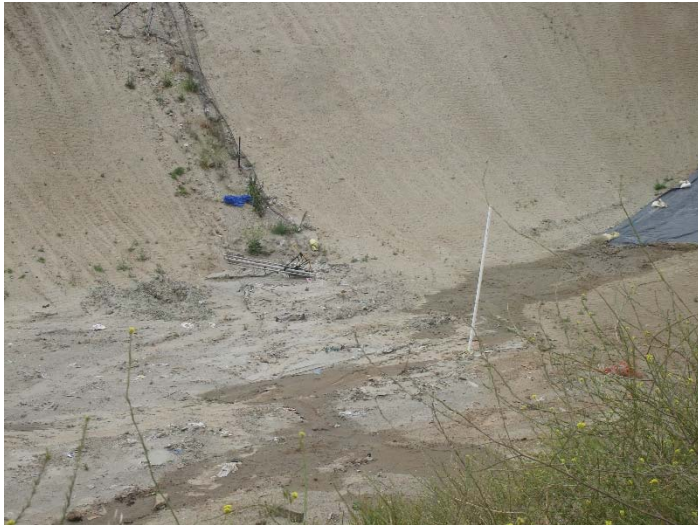
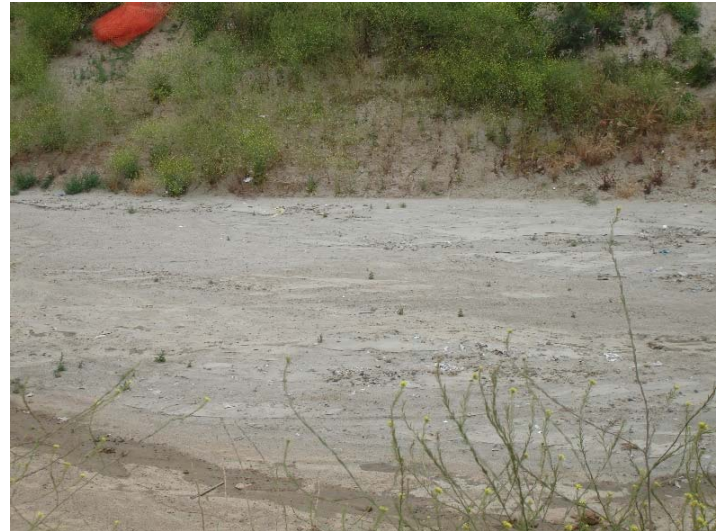
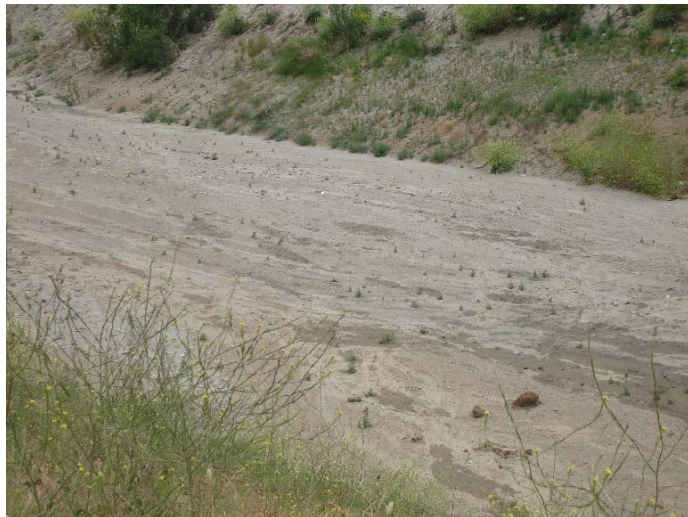
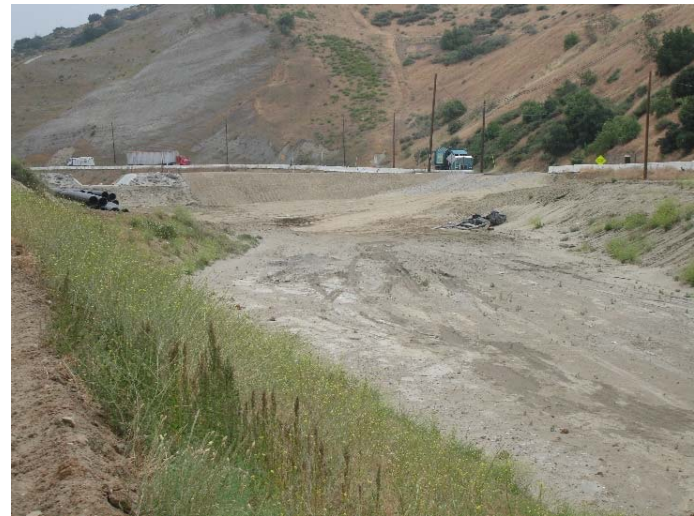
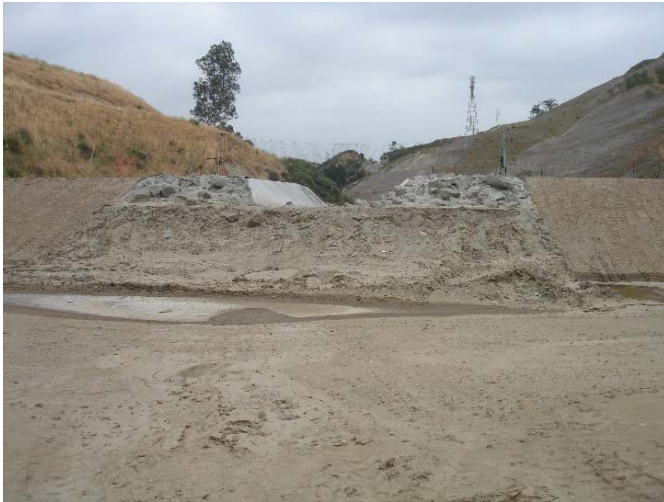
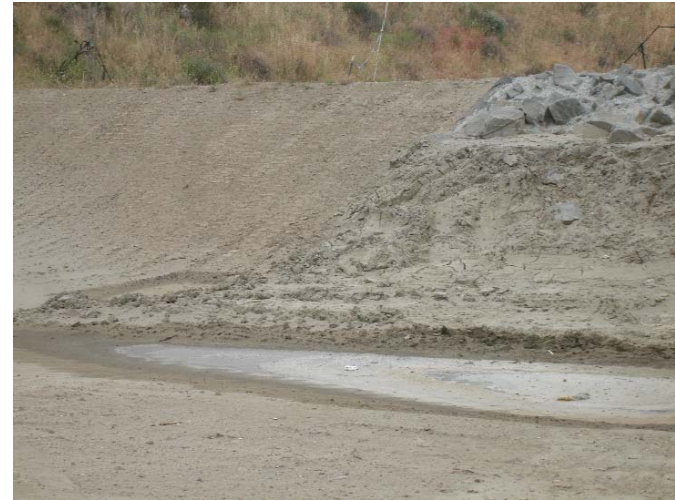
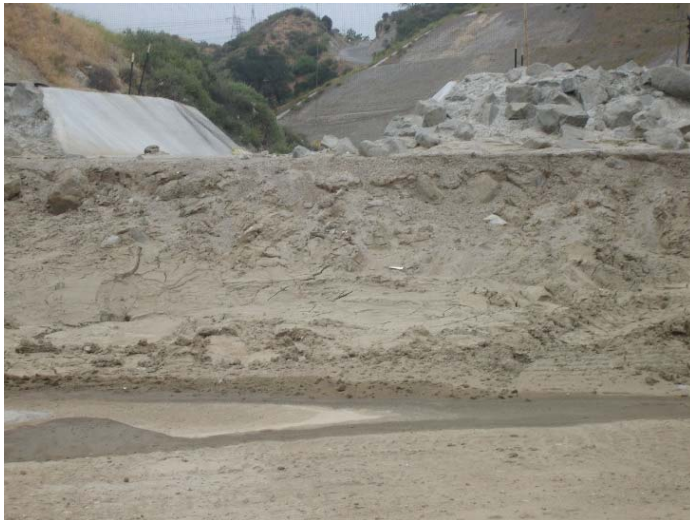
**Photo 244: Cell CC3B Temporary Basin: May 9, 2017**

**Photo 245: Cell CC3B Temporary Basin: May 9, 2017**

**Photo 246: Cell CC3B Temporary Basin: May 9, 2017**

**Photo 247: Cell CC3B Temporary Basin: May 9, 2017**

**Photo 248: Cell CC3B Temporary Basin: May 9, 2017**

**Photo 249: Cell CC3B Temporary Basin: May 9, 2017**

**Photo 250: Cell CC3B Temporary Basin: May 9, 2017**

**Photo 251: Cell CC3B Temporary Basin: May 9, 2017**

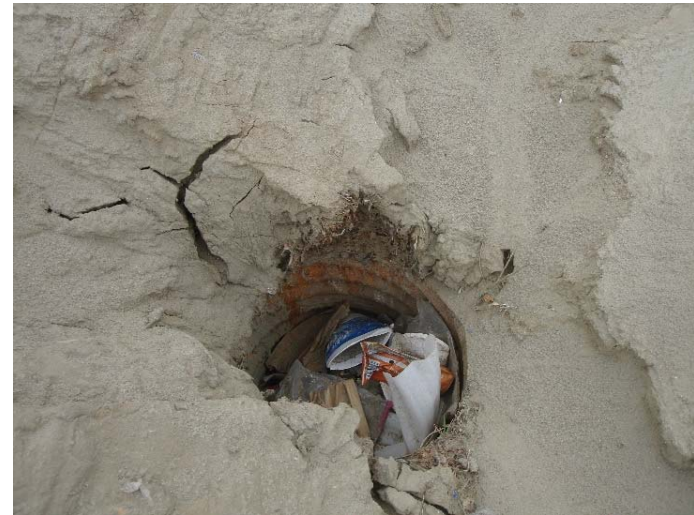
**Photo 252: CC3B Temporary Basin Plugged Low-Flow Outlet to Terminal Basin: May 9, 2017**

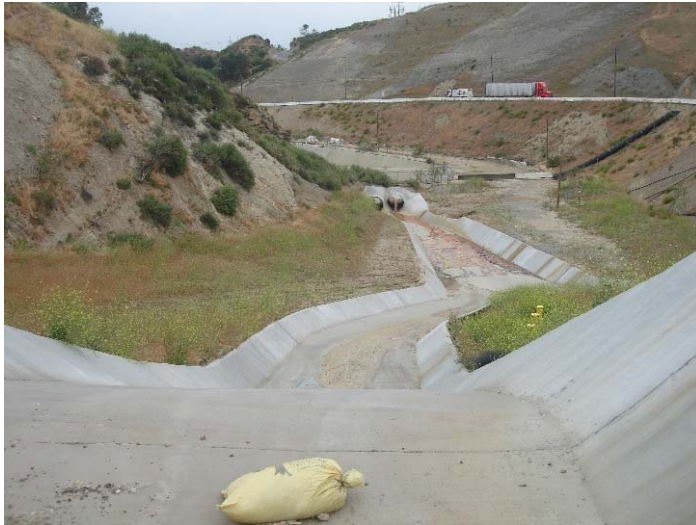
**Photo 253: CC3B Temporary Basin High-Flow Outlet to Terminal Basin: May 9, 2017**

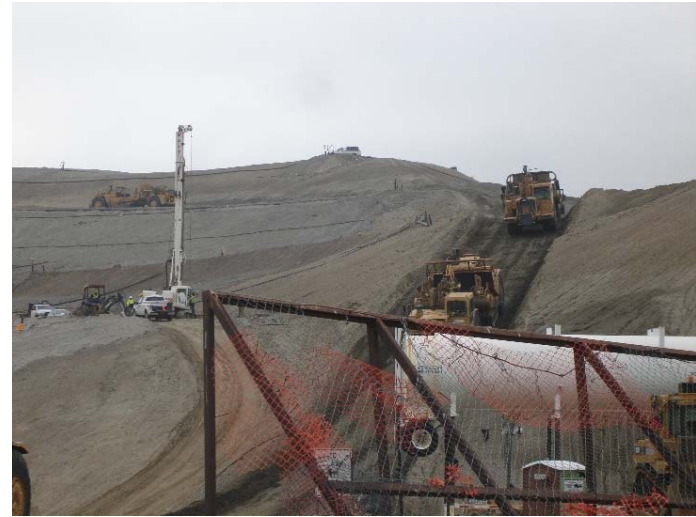
**Photo 254: CC3B Slope Well Drilling: May 9, 2017**

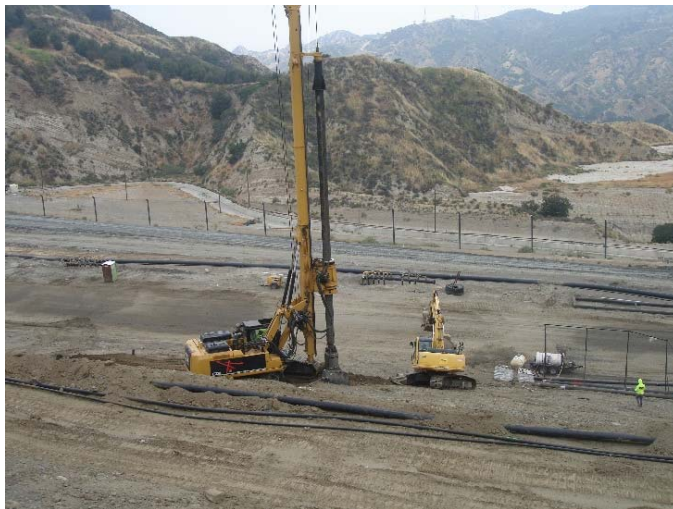
**Photo 255: CC3B Top Deck Well Drilling**

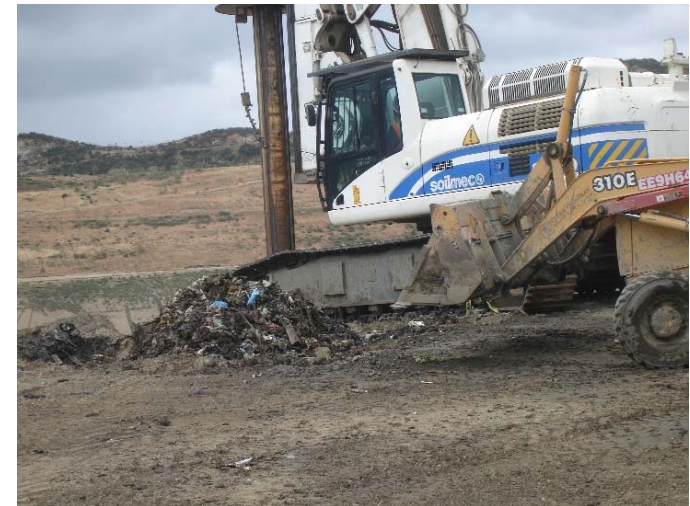
**Photo 264: Well Drilling on CC3A Top Deck: April 18, 2017**

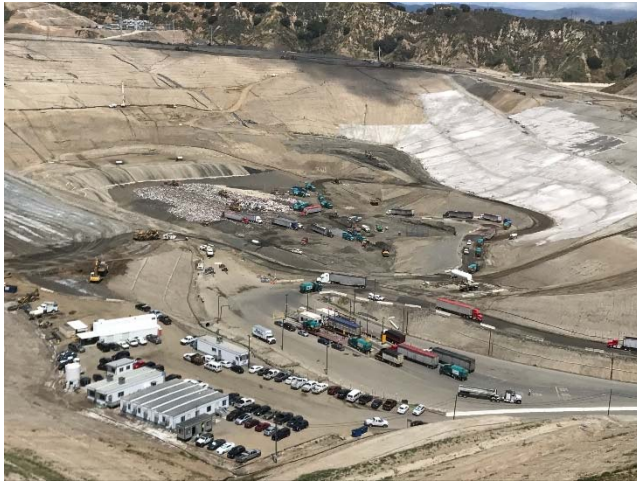
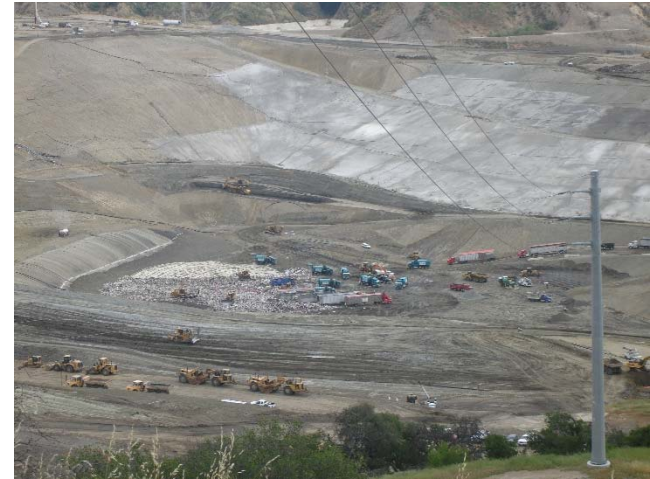
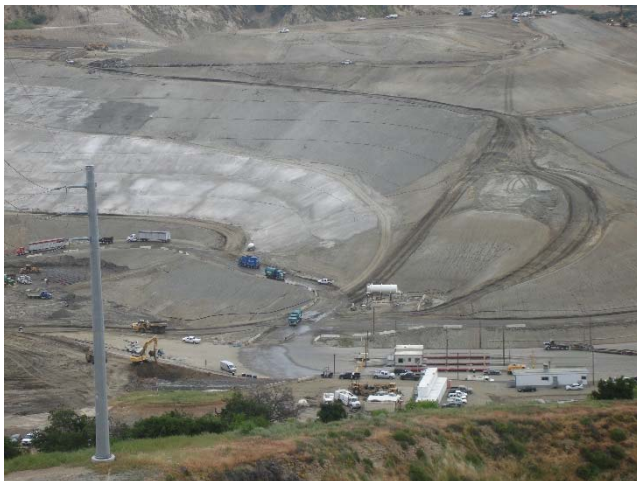
**Photo 265: CC3A Slope Posi-Shell: April 18, 2017**

**Photo 266: CC3A Slope Posi-Shell: April 18, 2017**

**Photo 267: CC3A Slope Posi-Shell: April 18, 2017**
