**Sunshine Canyon Landfill  
Independent Monitor  
Quarterly Site Monitoring Status Report  
April 1, 2017 – June 30, 2017**

**City of Los Angeles Department of City Planning**

**County of Los Angeles Department of Regional Planning**

October 10, 2017

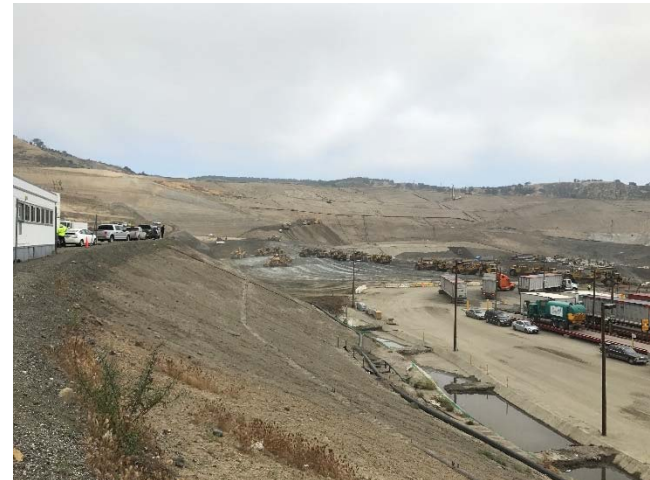
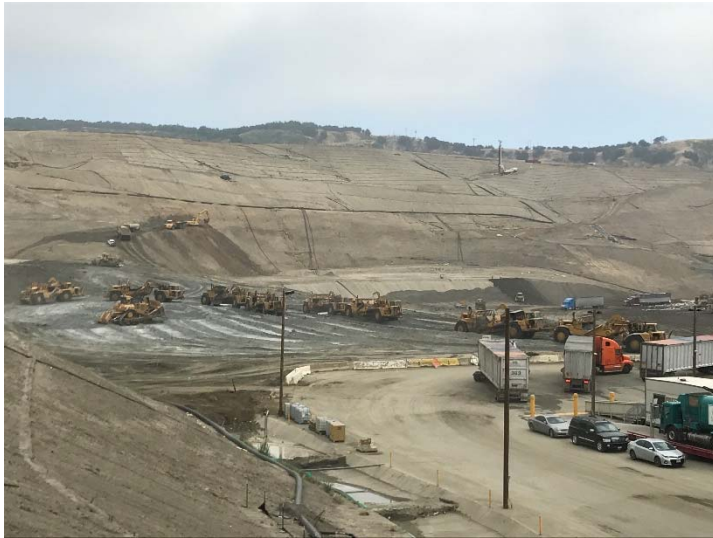
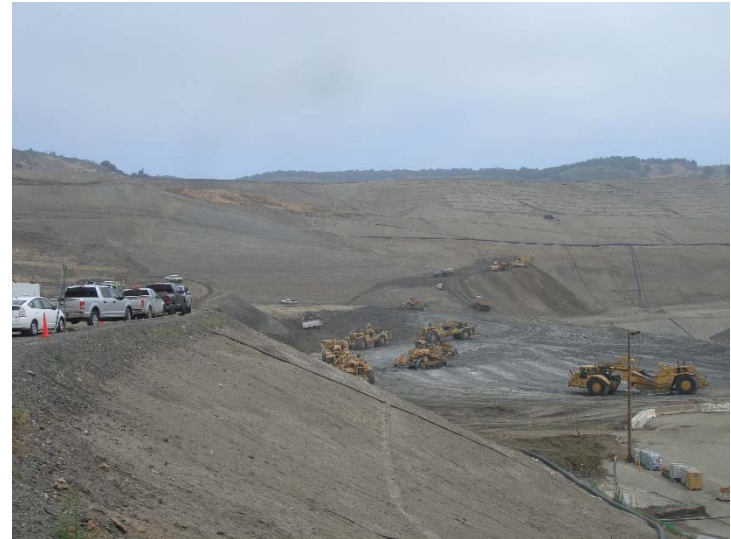
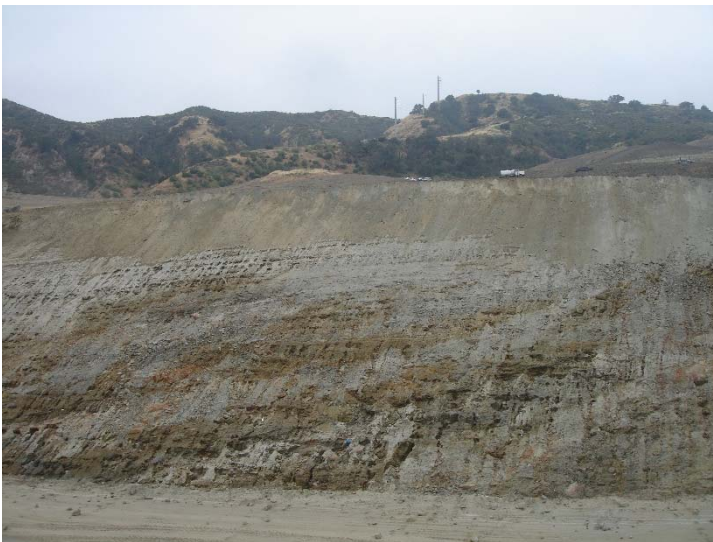
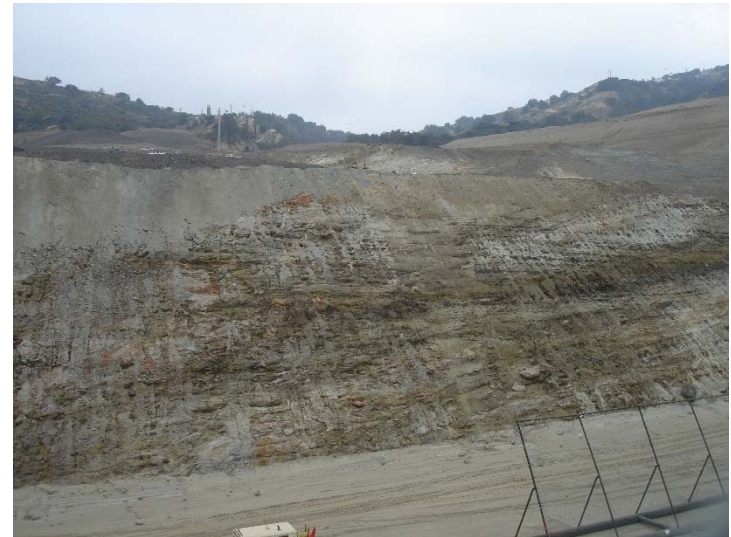
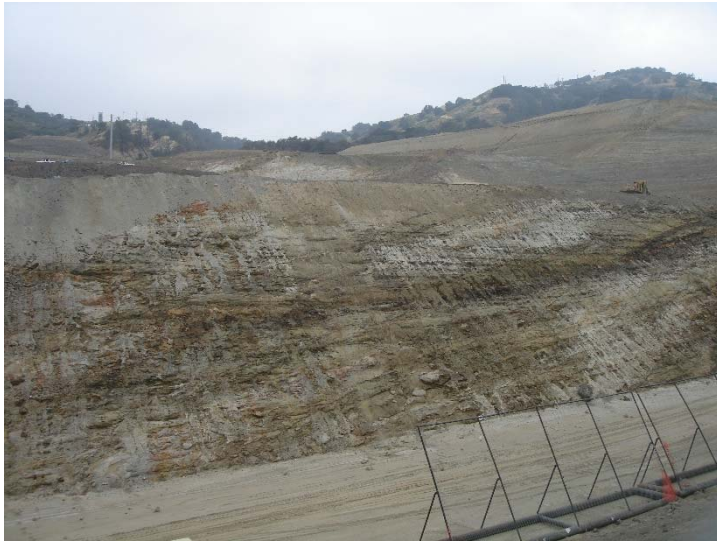
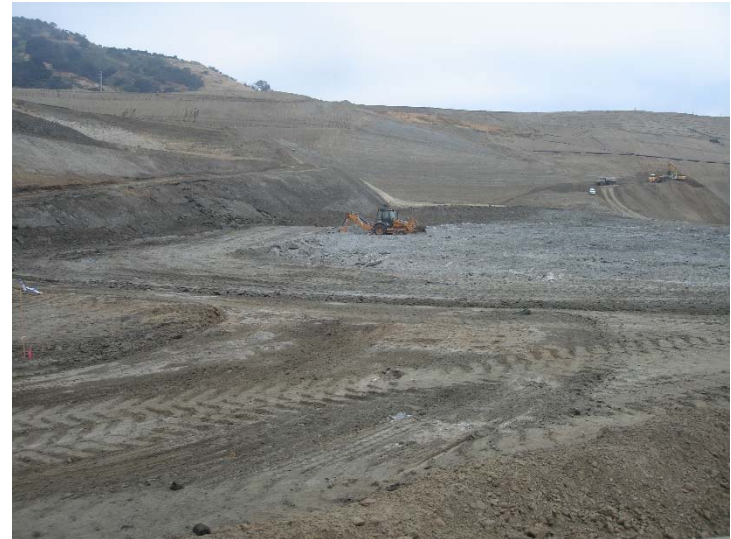
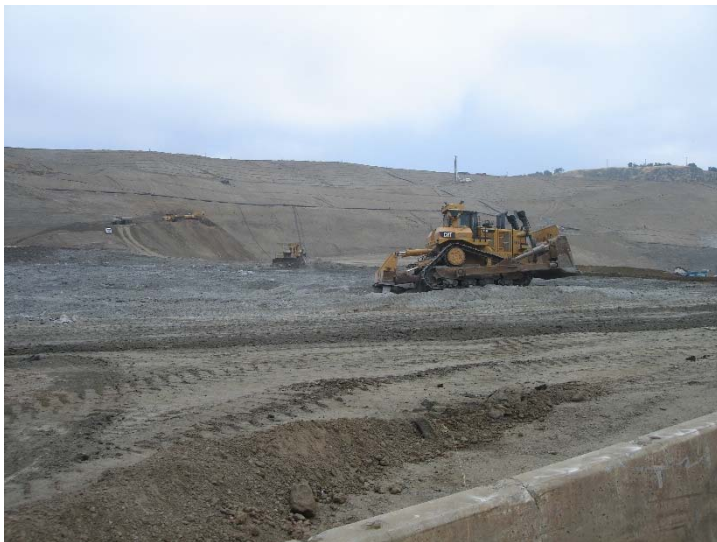
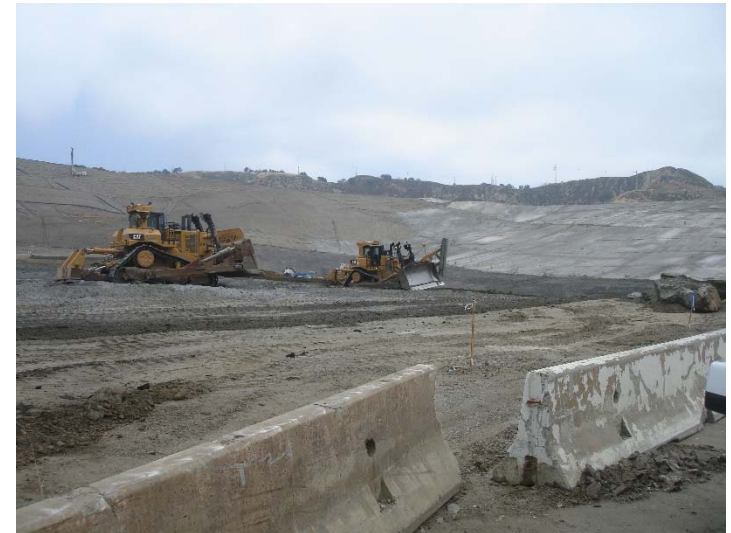
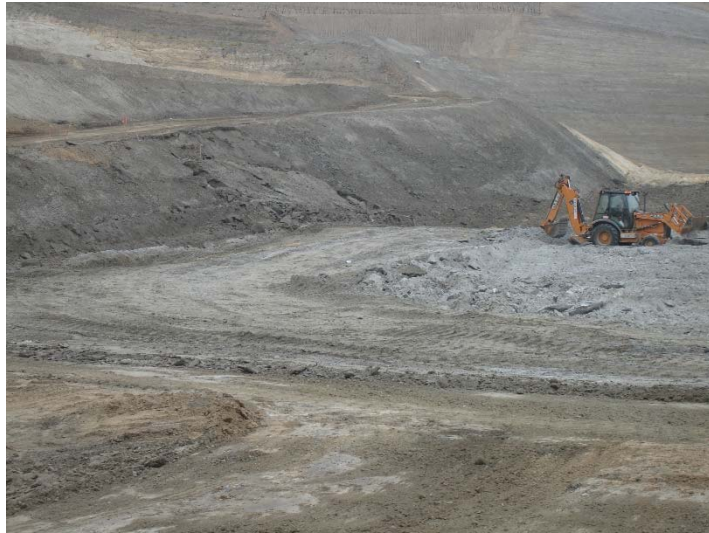
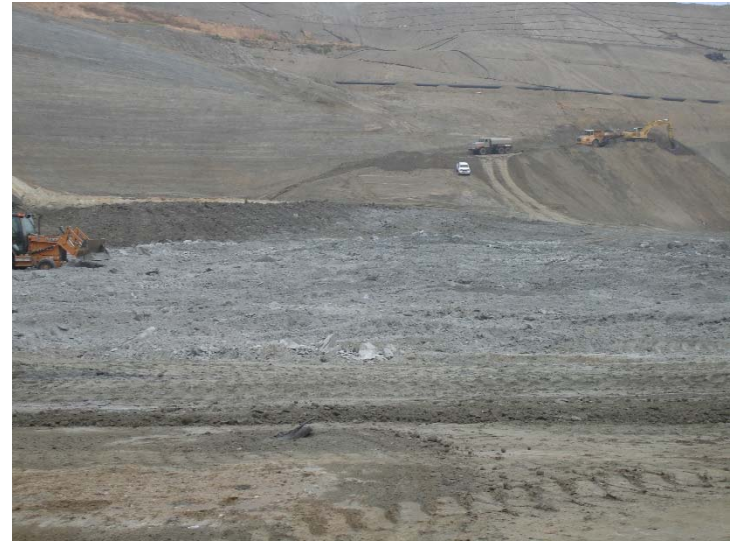
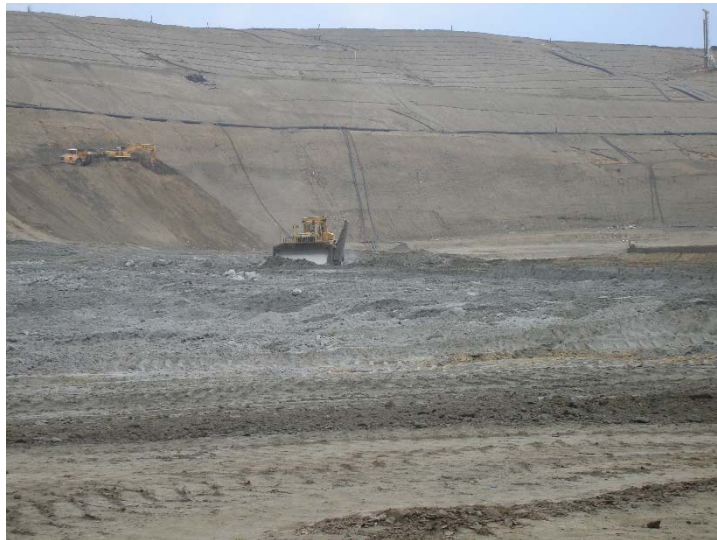
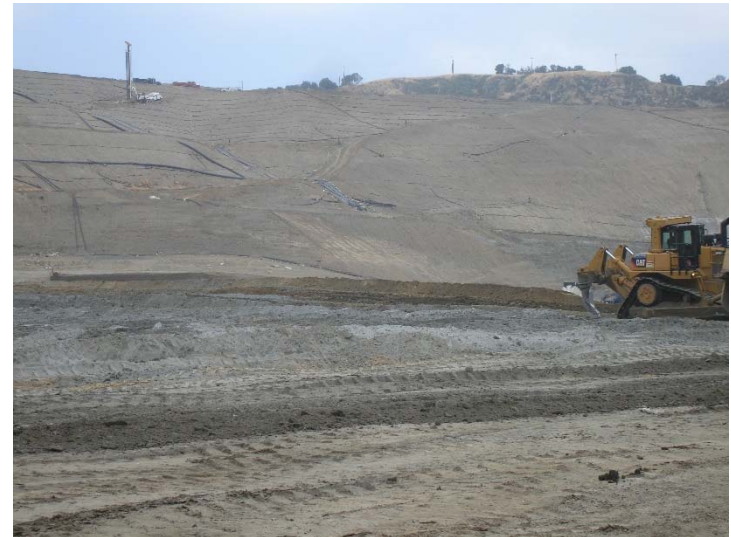
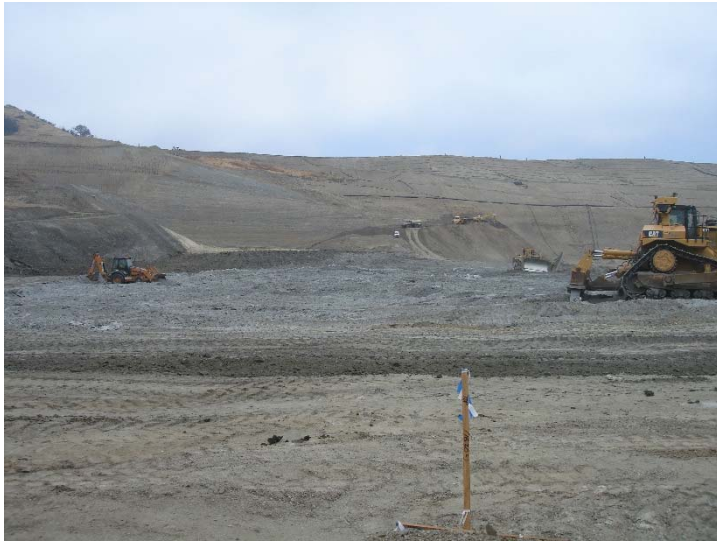
**Photo 268: CC4A Part 2 Excavation: May 9, 2017**

**Photo 269: CC4A Part 2 Excavation: May 9, 2017**

**Photo 270: CC4A Part 2 Excavation: May 9, 2017**

**Photo 271: CC4A Part 2 Excavation: May 9, 2017**

**Photo 272: CC4A Part 2 Excavation: May 9, 2017**

**Photo 273: CC4A Part 2 Excavation: May 9, 2017**

**Photo 274: CC4A Part 2 Excavation: May 9, 2017**

**Photo 275: CC4A Part 2 Excavation: May 9, 2017**

**Photo 276: CC4A Part 2 Excavation: May 9, 2017**

**Photo 277: CC4A Part 2 Excavation: May 9, 2017**

**Photo 278: CC4A Part 2 Excavation: May 9, 2017**

**Photo 279: CC4A Part 2 Excavation: May 9, 2017**

**Photo 280: CC4A Part 2 Excavation: May 9, 2017**

**Photo 281: CC4A Part 2 Excavation: May 9, 2017**

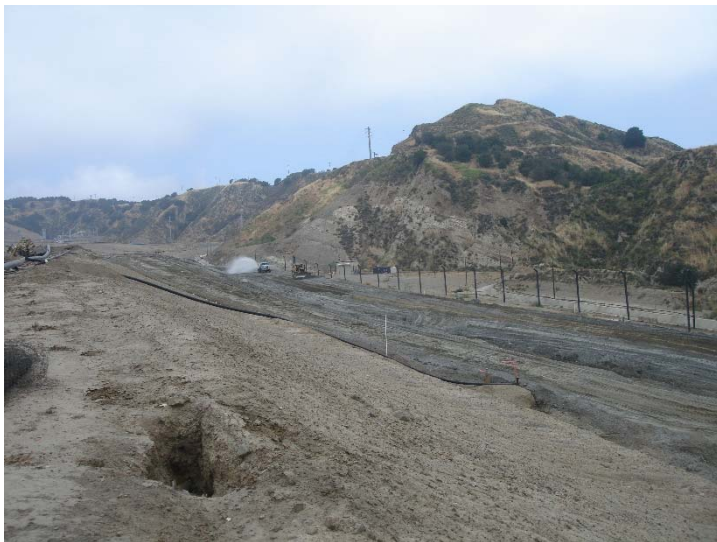
**Photo 282: CC4A Part 2 Excavation Soil Stockpile Area:  
May 9, 2017**

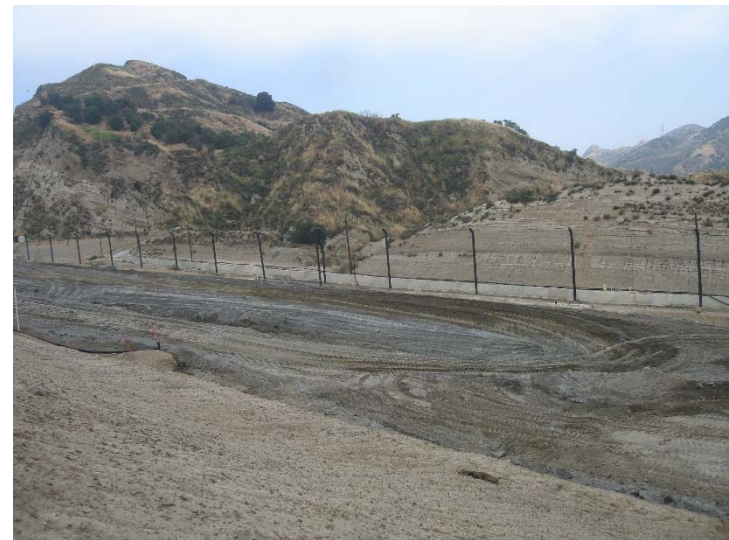
**Photo 283: CC4A Part 2 Excavation Soil Stockpile Area:  
May 9, 2017**

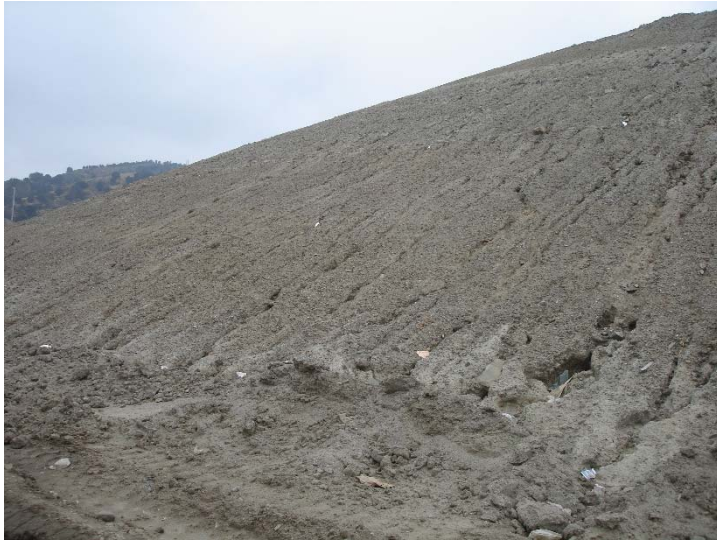
**Photo 284: CC4A Part 2 Excavation Soil Stockpile Area:  
May 9, 2017**

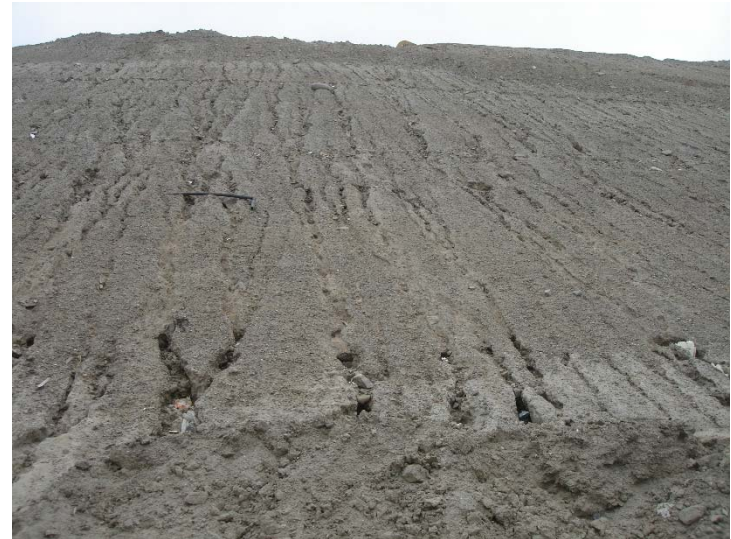
**Photo 285: CC3A Soil Stockpile Erosion: May 9, 2017**

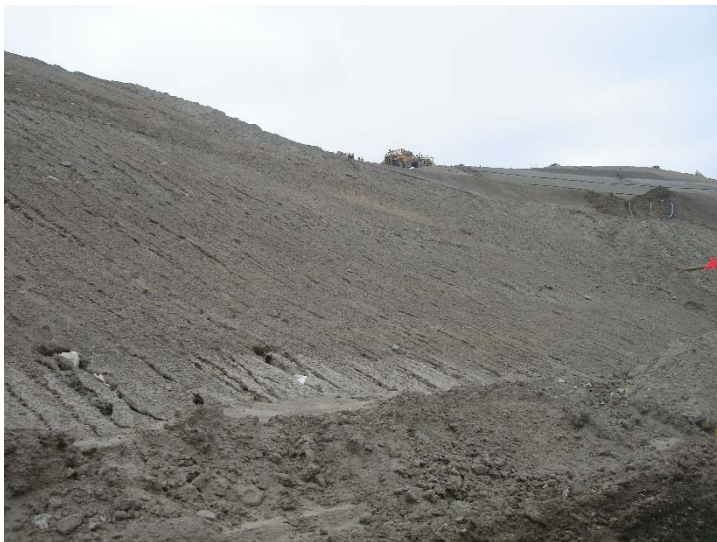
**Photo 286: CC3A Soil Stockpile Erosion: May 9, 2017**

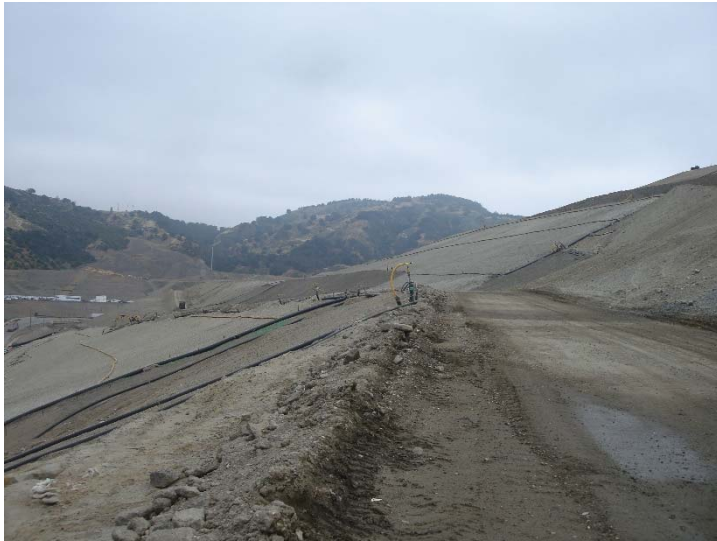
**Photo 288: CC3A Slope Repair: May 9, 2017**

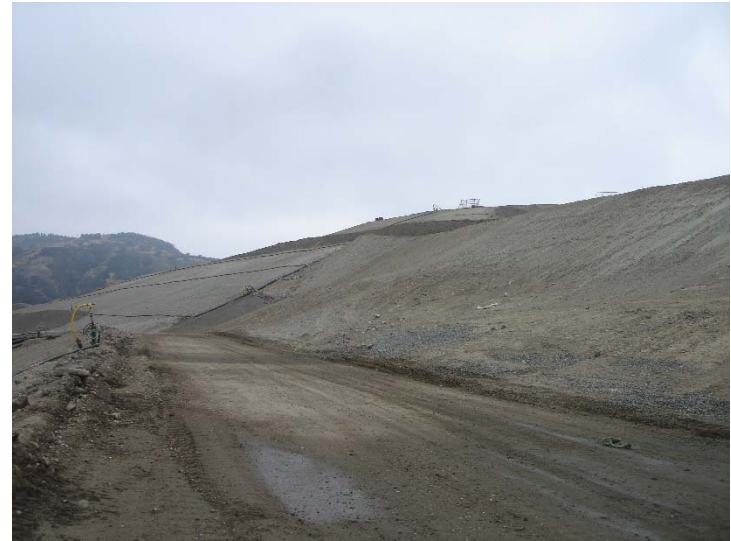
**Photo 289: CC3A Slope Repair: May 9, 2017**

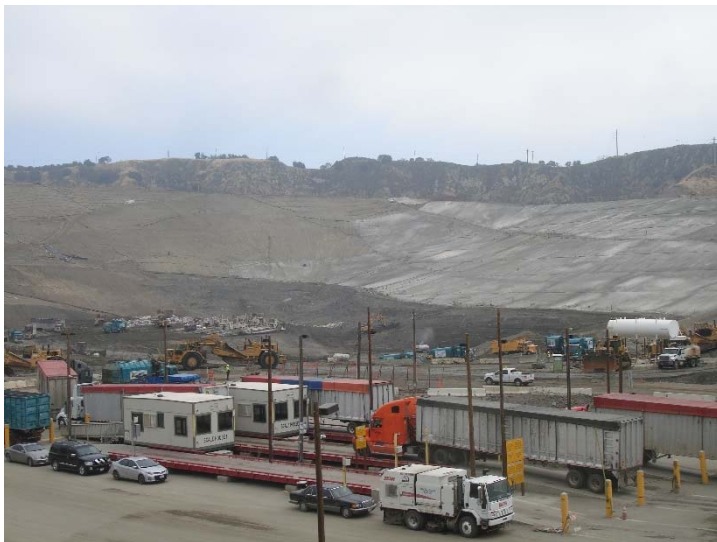
**Photo 290: CC3A Slope Repair: May 9, 2017**

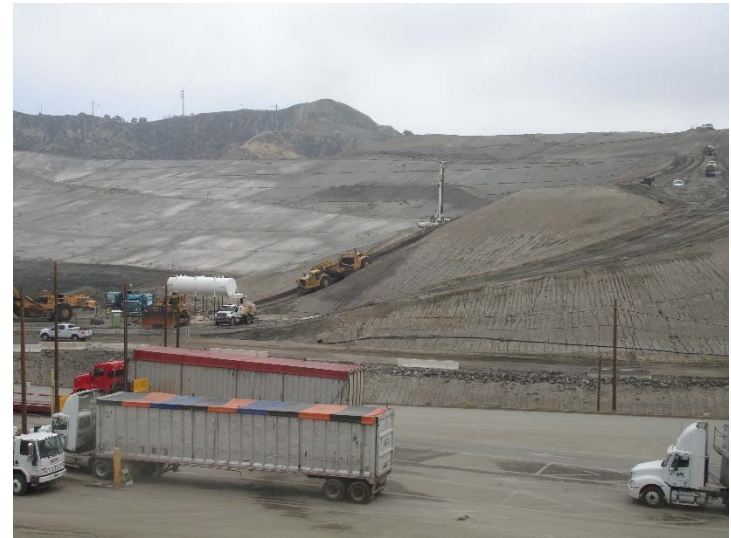
**Photo 291: CC3A Slope Posi-Shell: May 9, 2017**

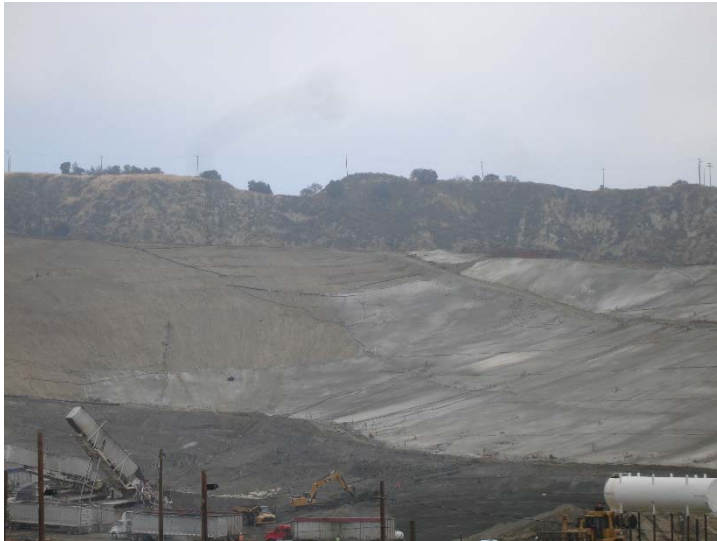
**Photo 292: CC3A Slope Posi-Shell: May 9, 2017**

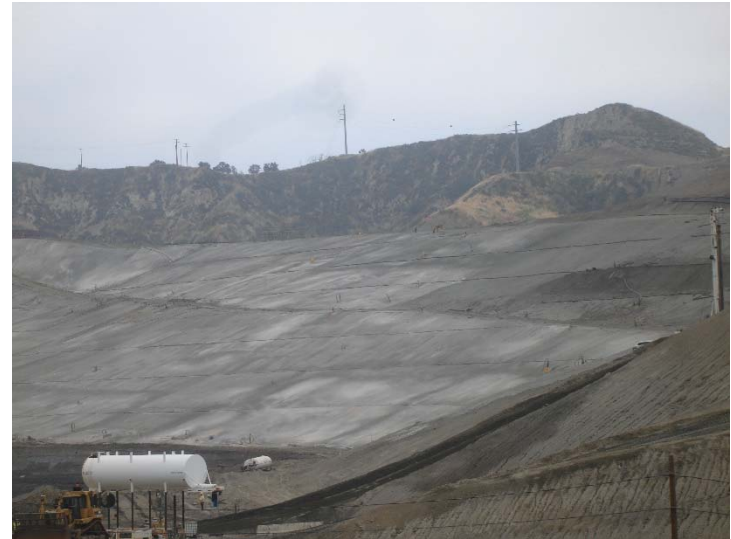
**Photo 293: CC3A Slope Posi-Shell: May 9, 2017**

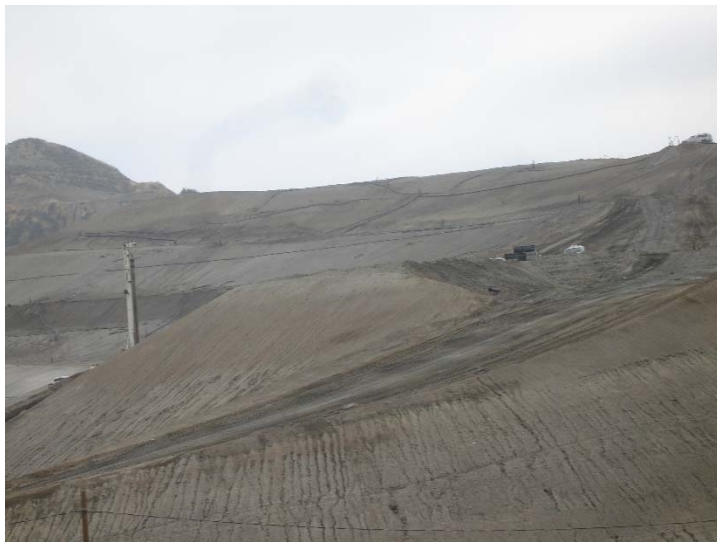
**Photo 294: CC3A Slope Posi-Shell: May 9, 2017**

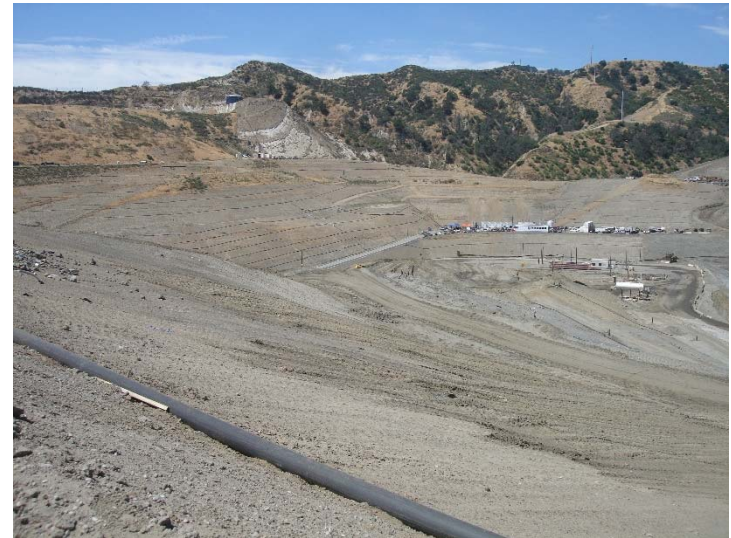
**Photo 295: CC3A Slope Posi-Shell: May 9, 2017**

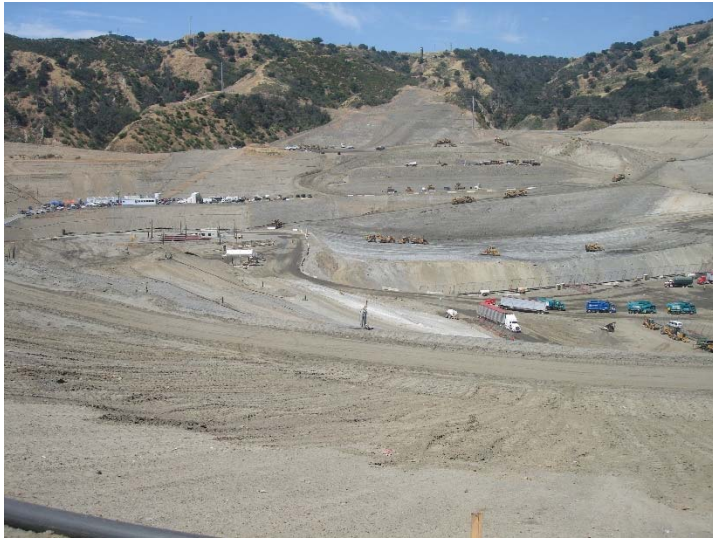
**Photo 296: CC4A Part 2 Excavation: May 23, 2017**

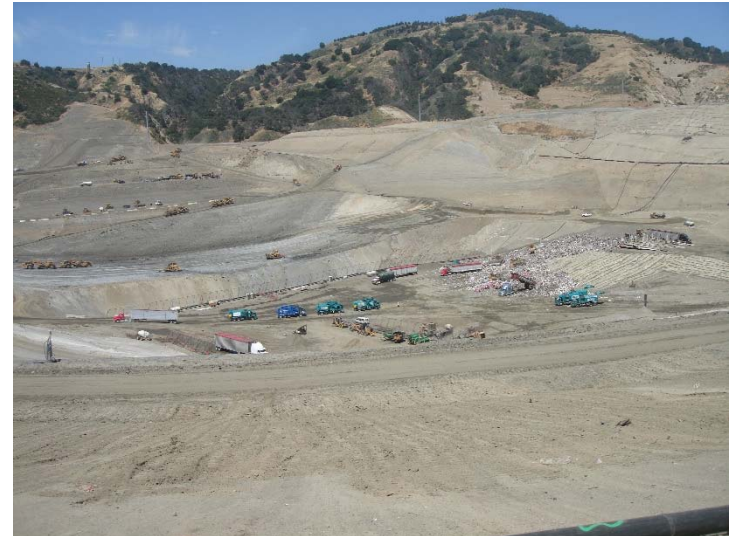
**Photo 297: CC4A Part 2 Excavation: May 23, 2017**

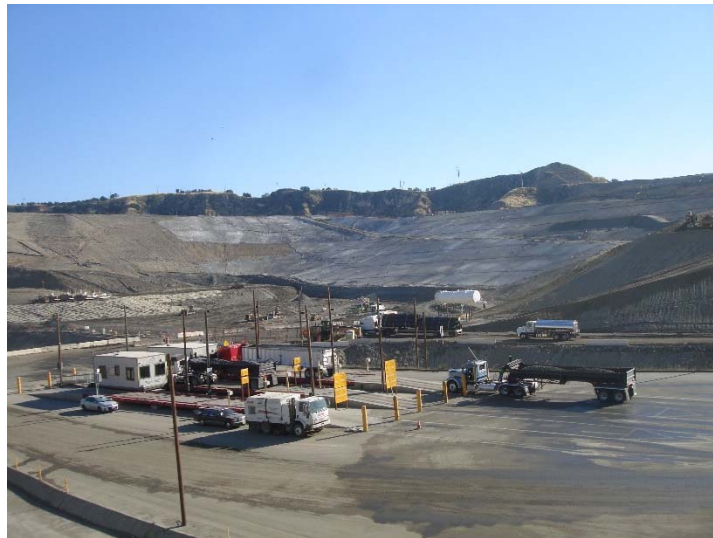
**Photo 298: CC4A Part 2 Excavation: May 23, 2017**

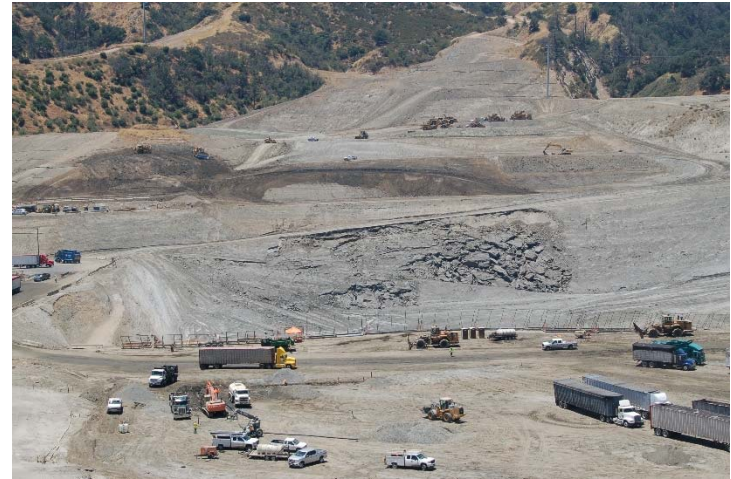
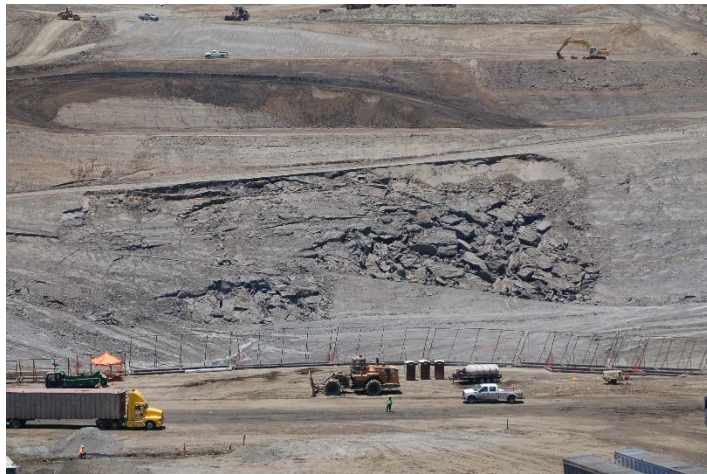
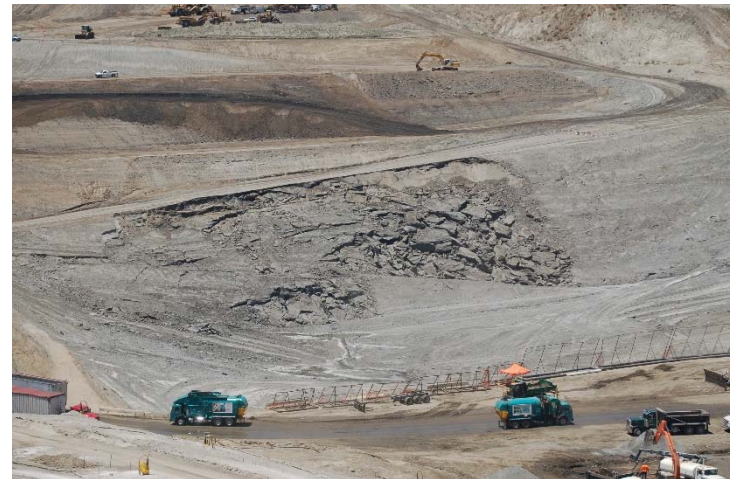
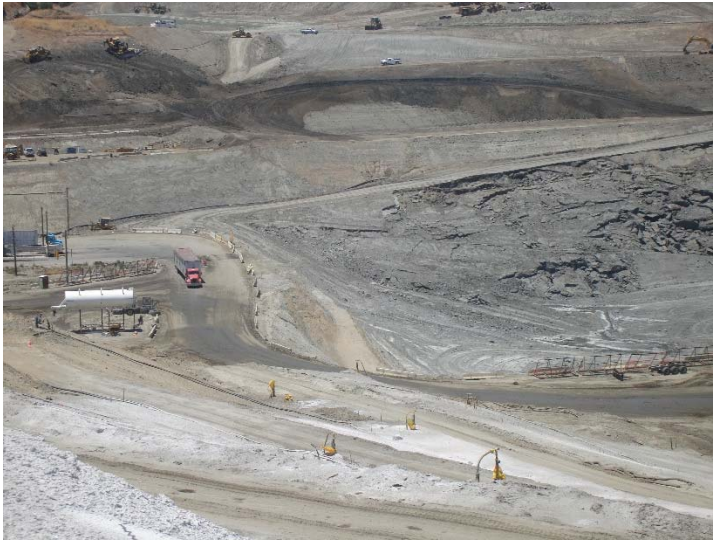
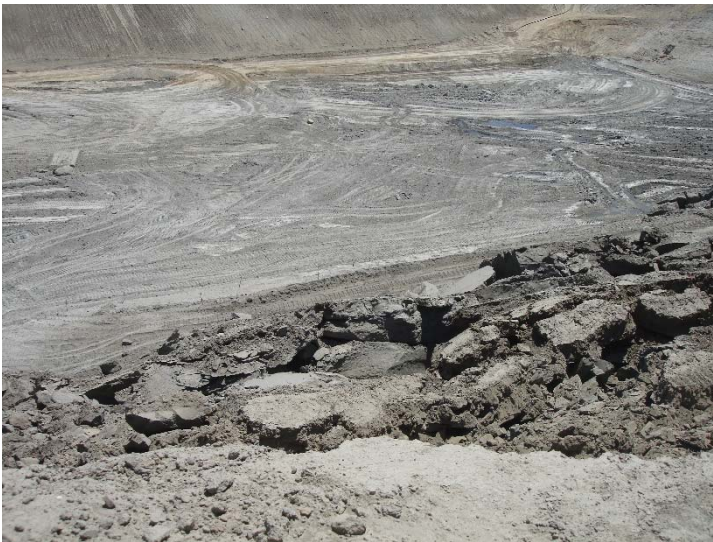
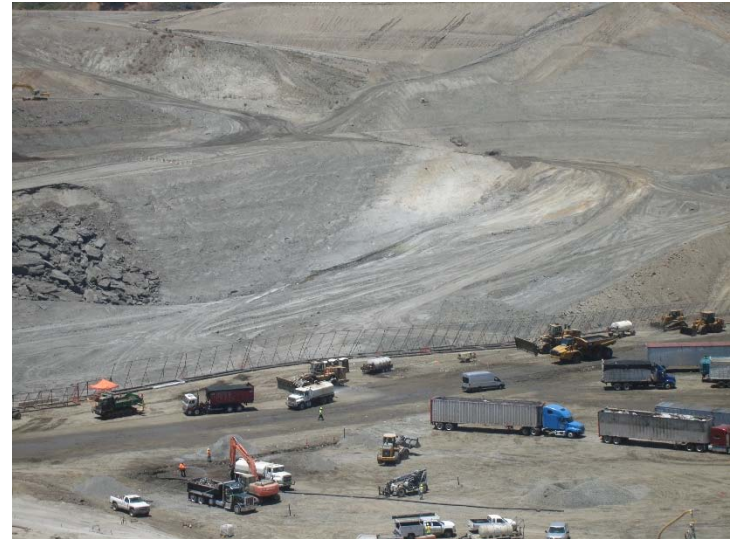
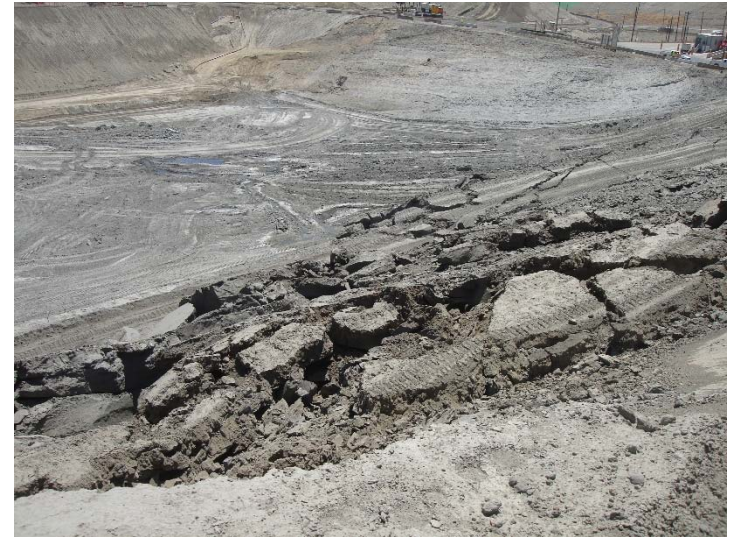
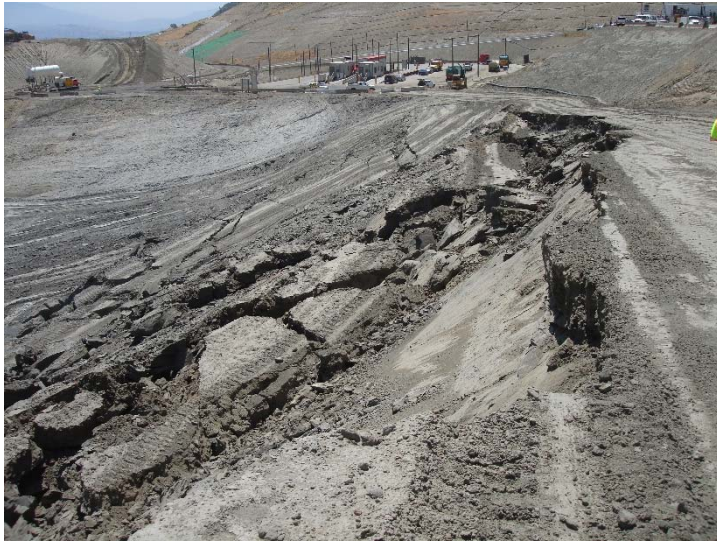
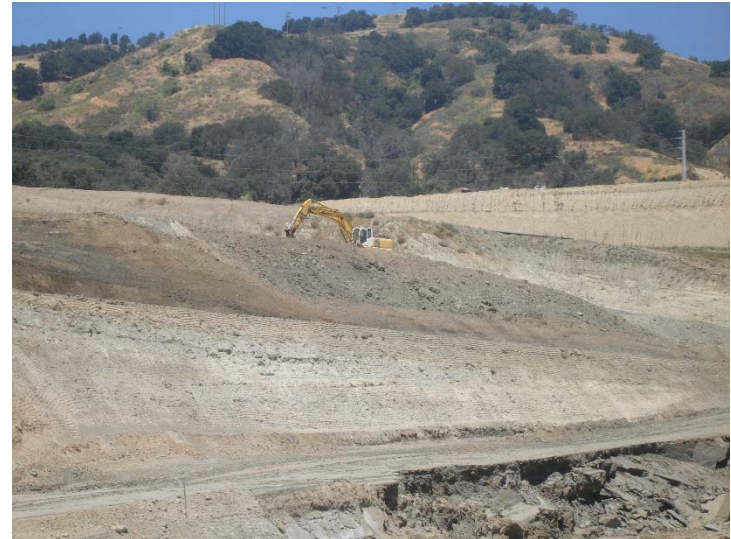
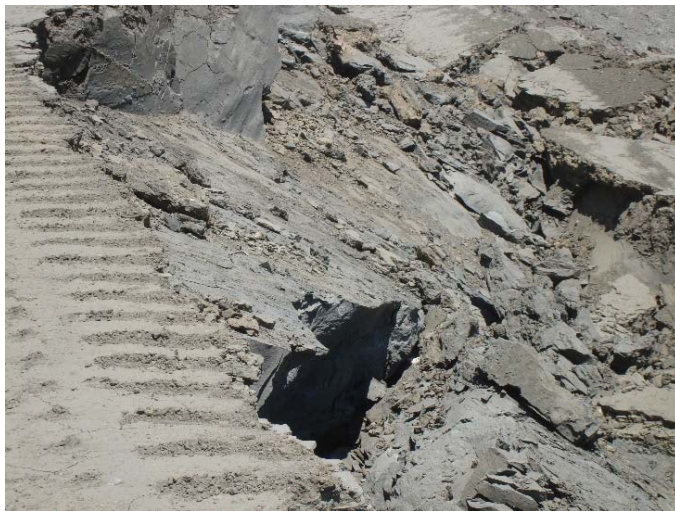
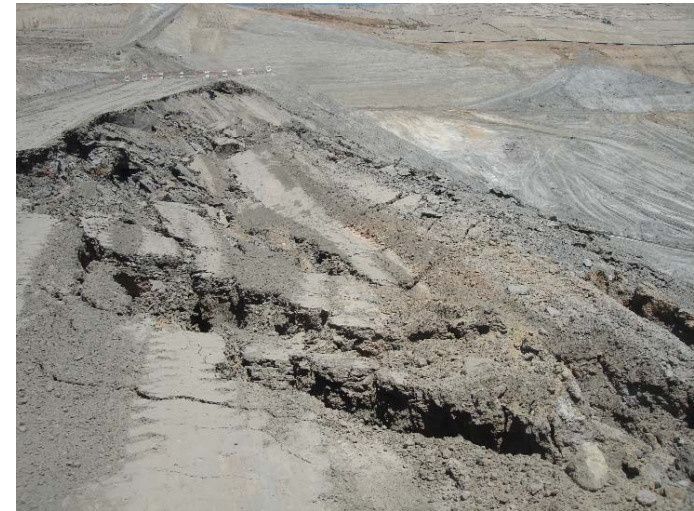
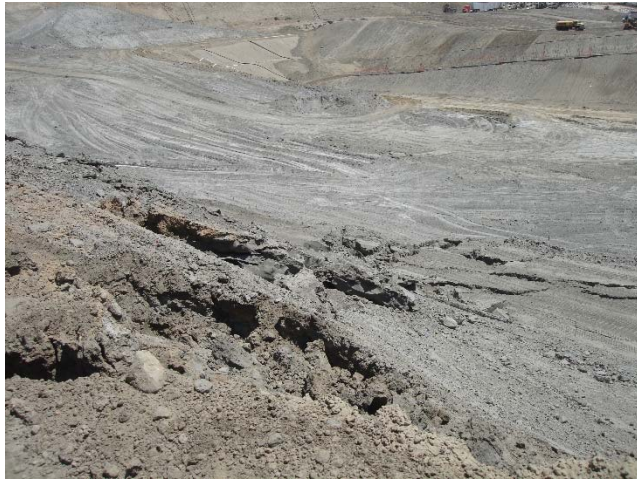
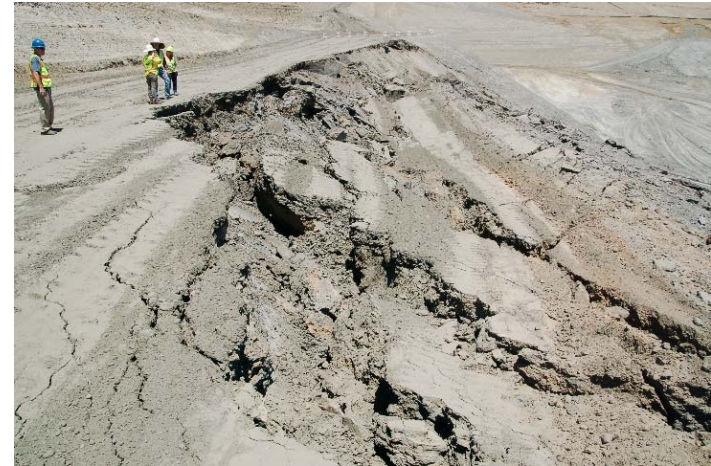
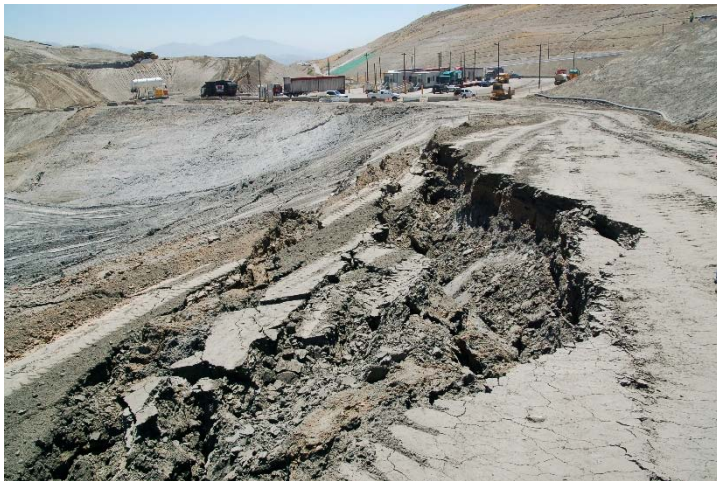
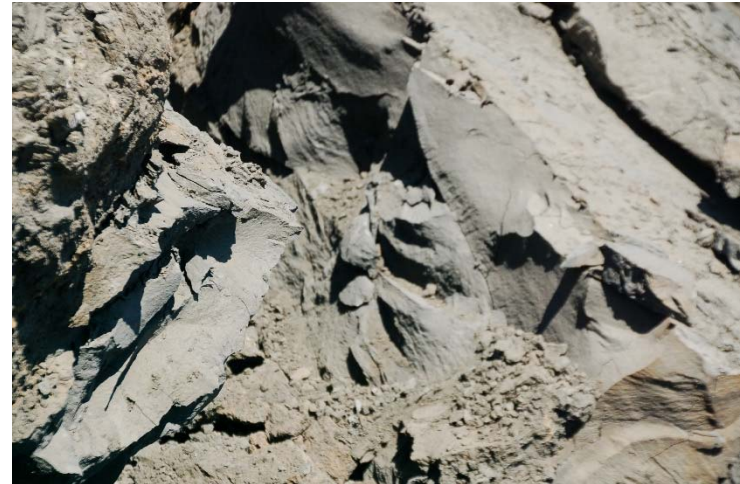
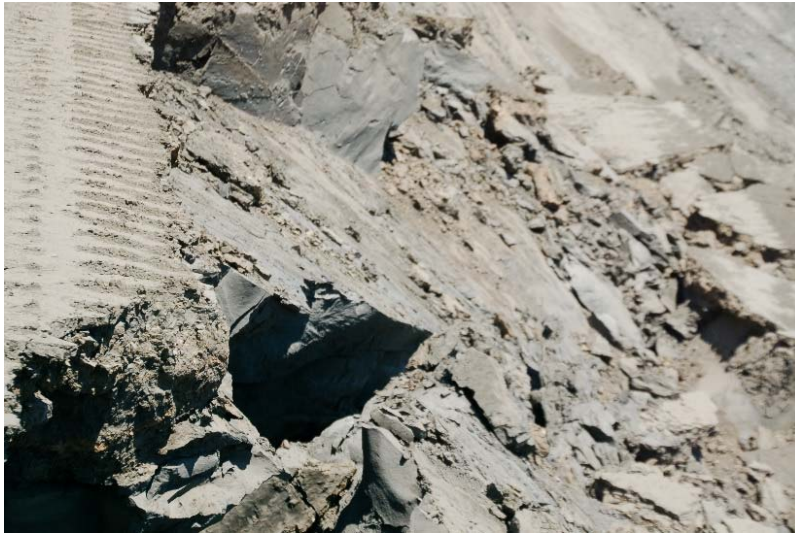
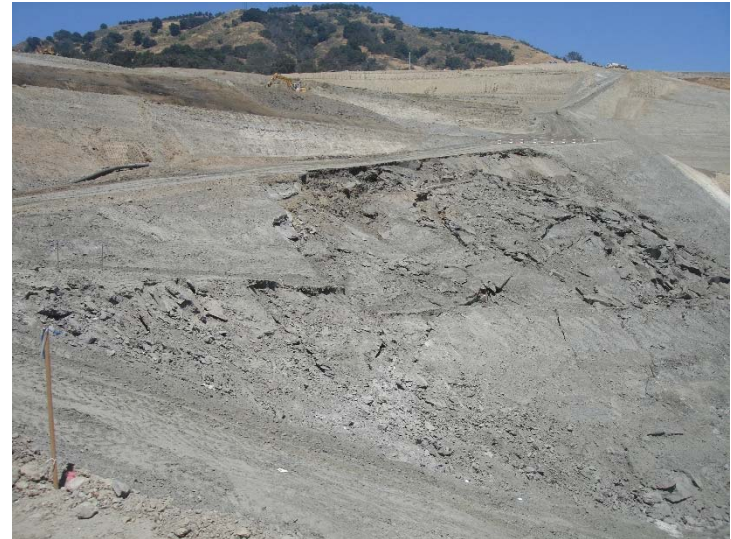
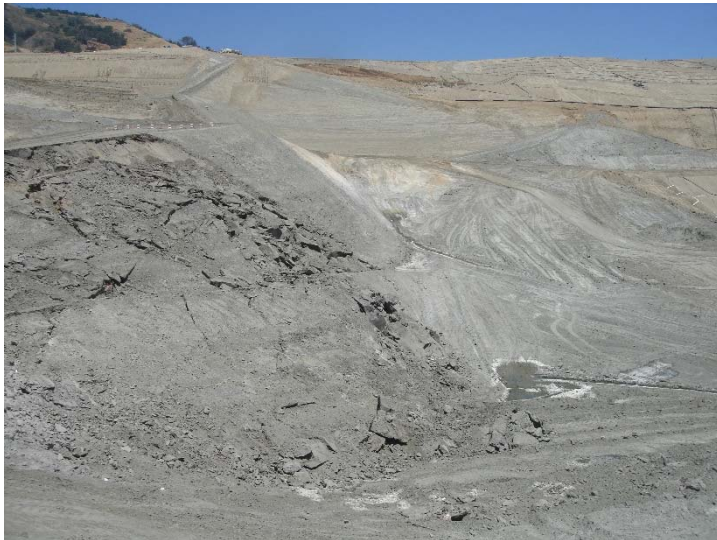
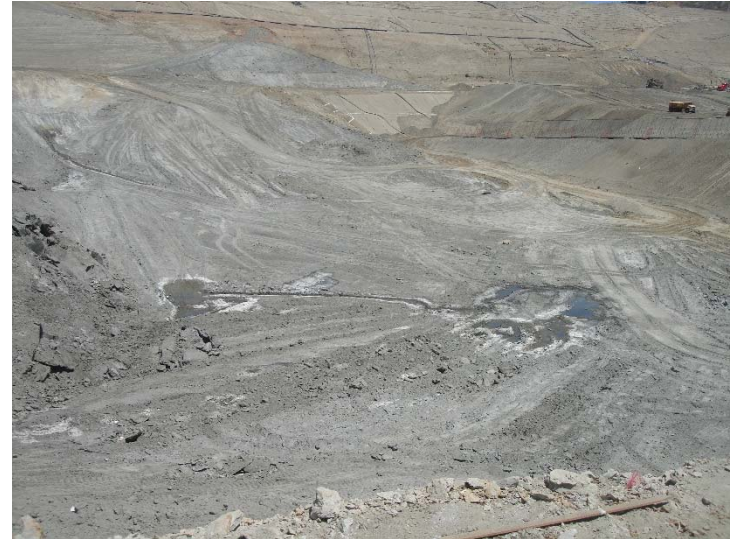
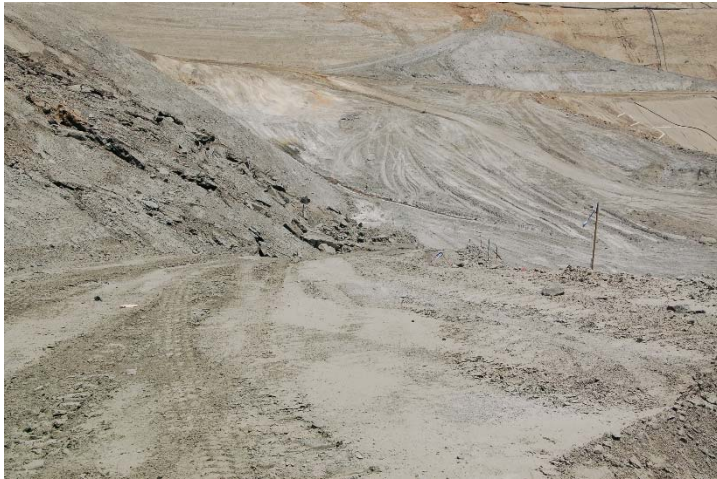
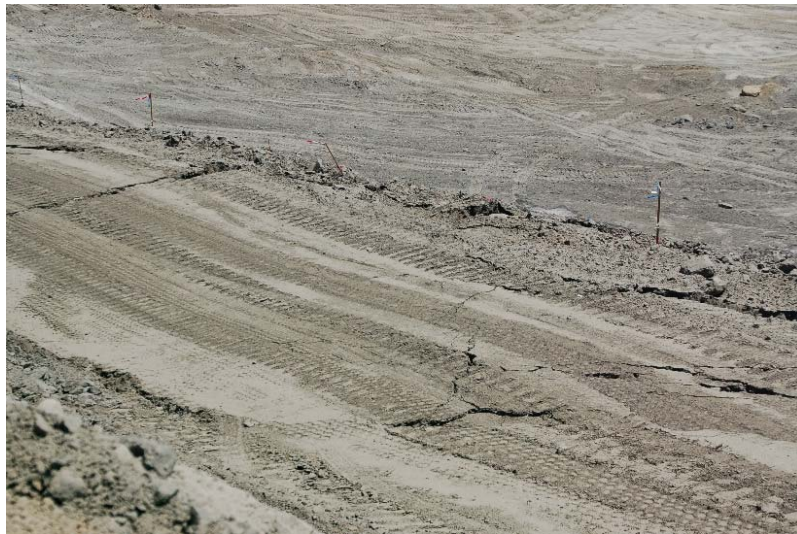
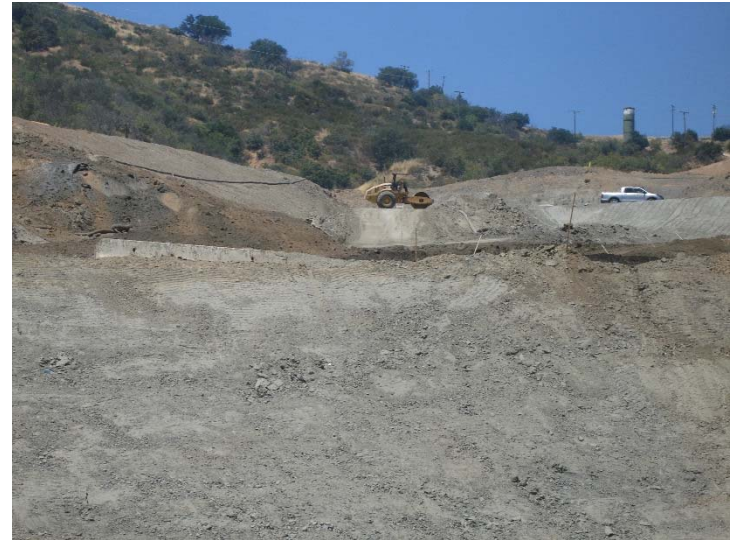
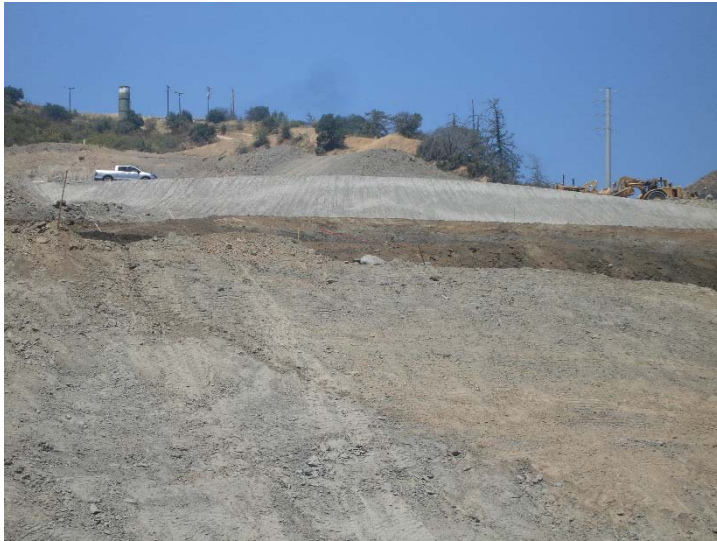
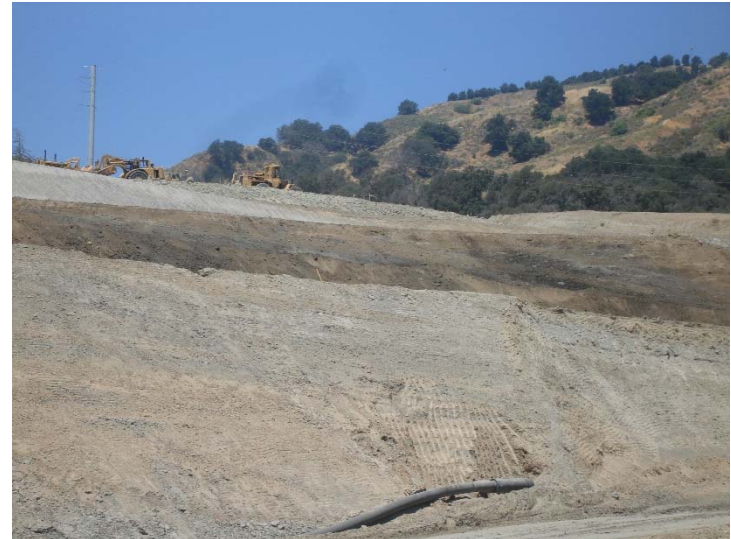
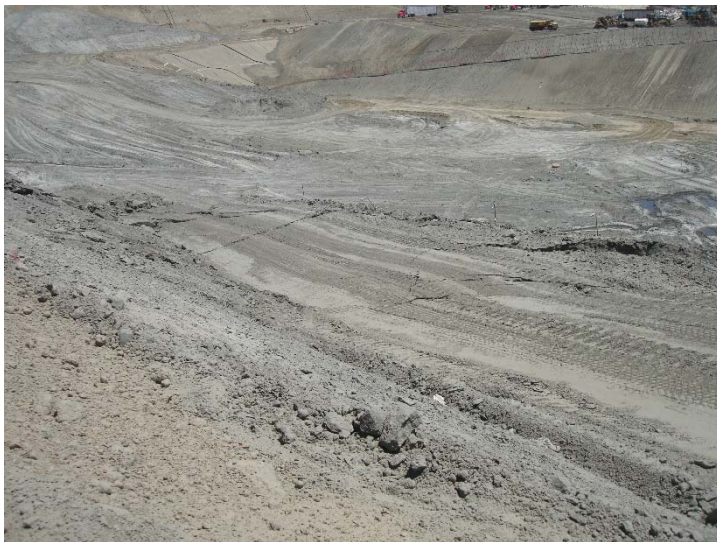
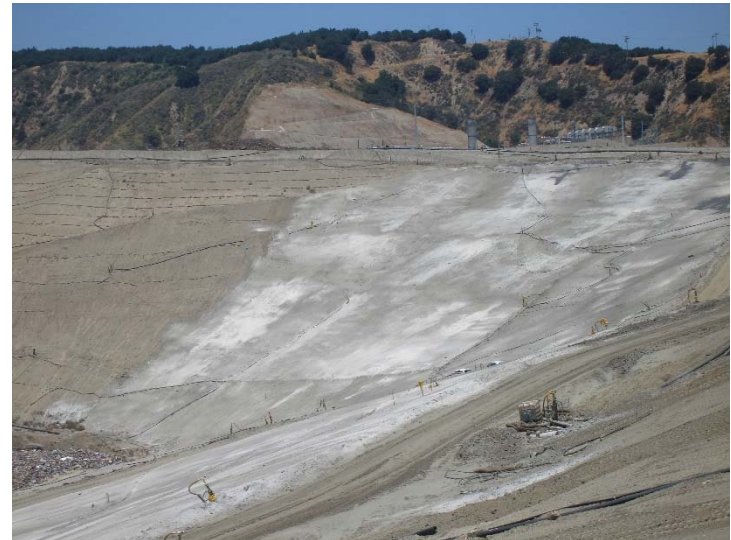
**Photo 329: CC4A Part 2 Excavation Area Slide: June 20, 2017**
