**Sunshine Canyon Landfill  
Independent Monitor  
Quarterly Site Monitoring Status Report  
April 1, 2017 – June 30, 2017**

**City of Los Angeles Department of City Planning**

**County of Los Angeles Department of Regional Planning**

October 10, 2017

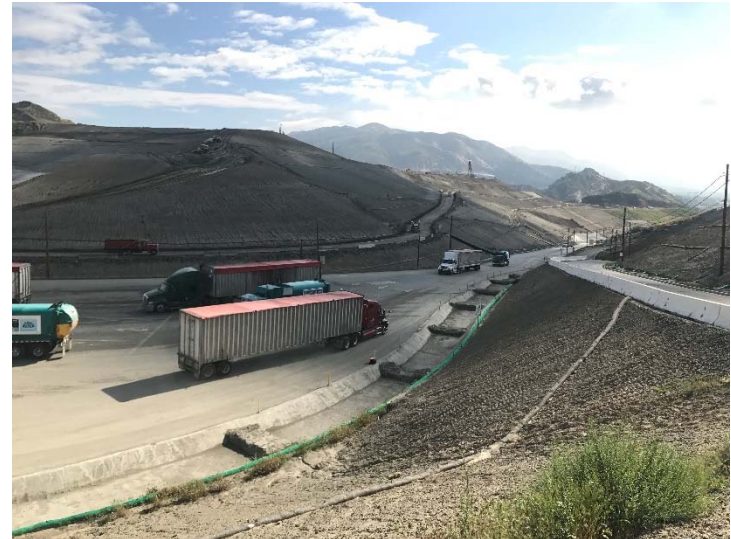
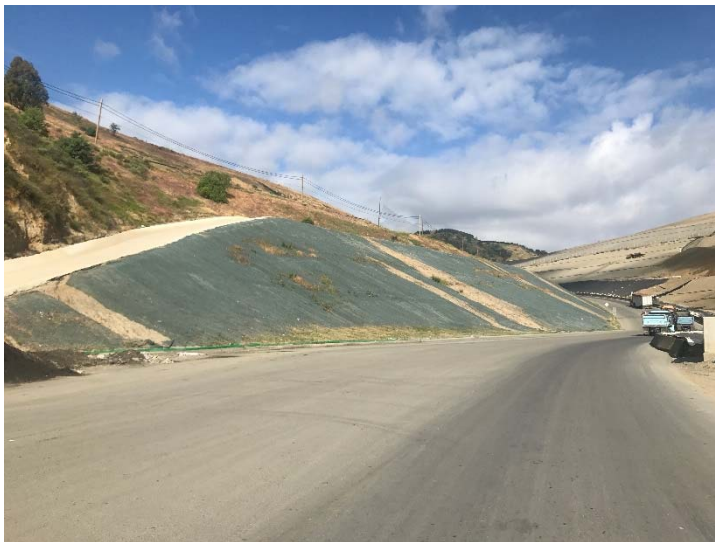
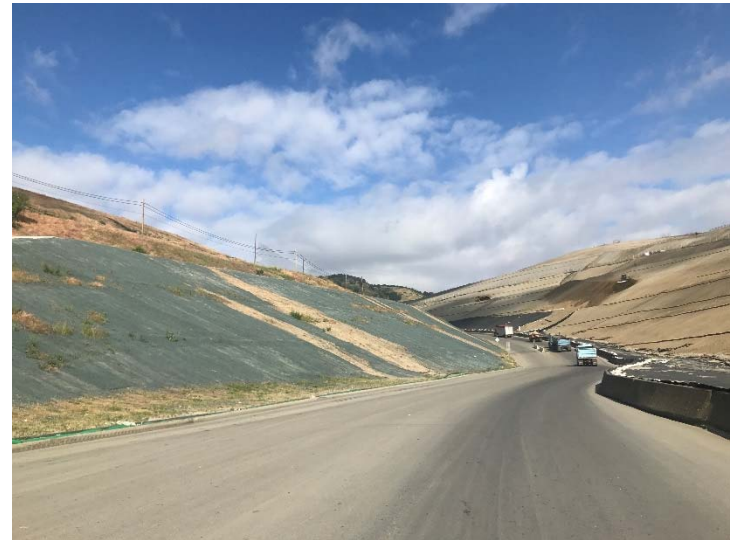
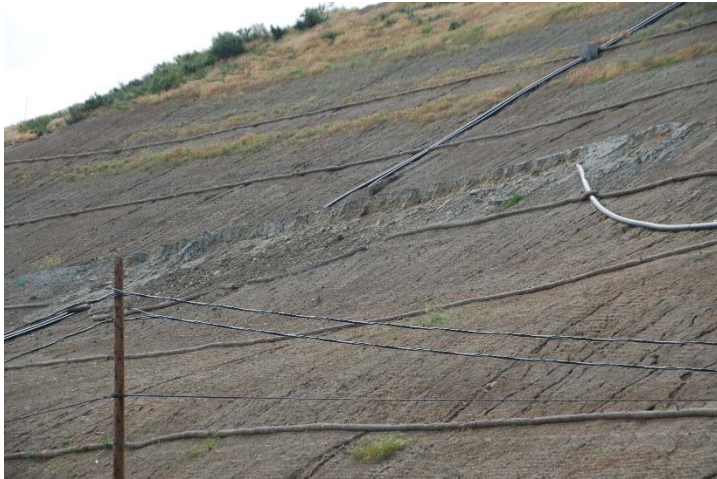
**Photo 357: Main Access Road to Scale: April 18, 2017**

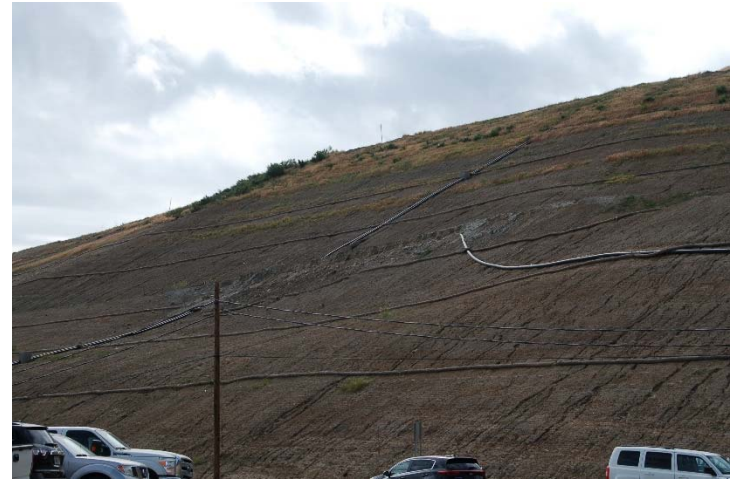
**Photo 361: Stockpile Soils Slumps on Old City Area: April 18, 2017**

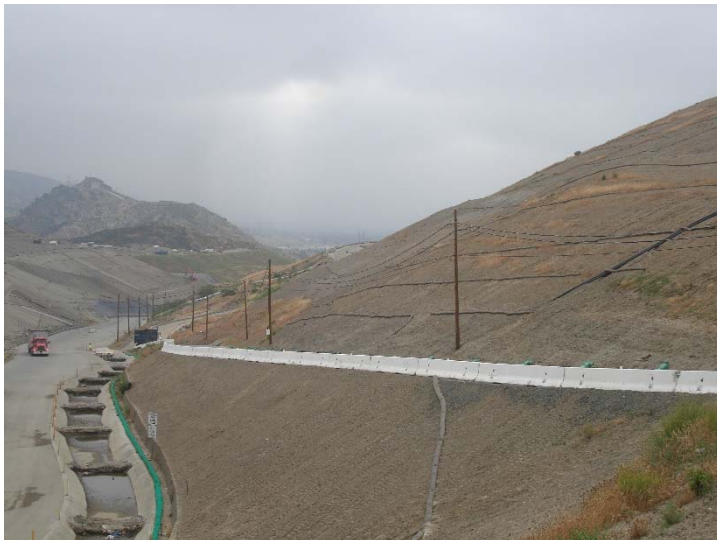
**Photo 362: Stockpile Soils Slumps on Old City Area: April 18, 2017**

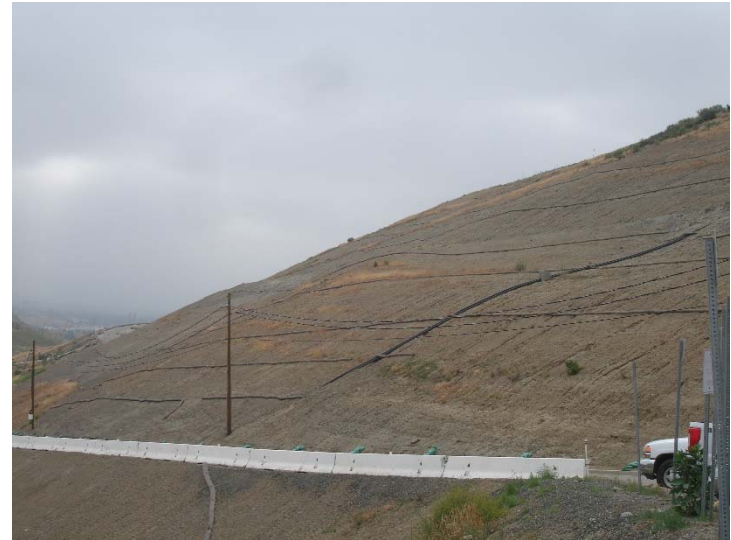
**Photo 363: Old City Landfill Soil Stockpile Near Offices: May 9, 2017**

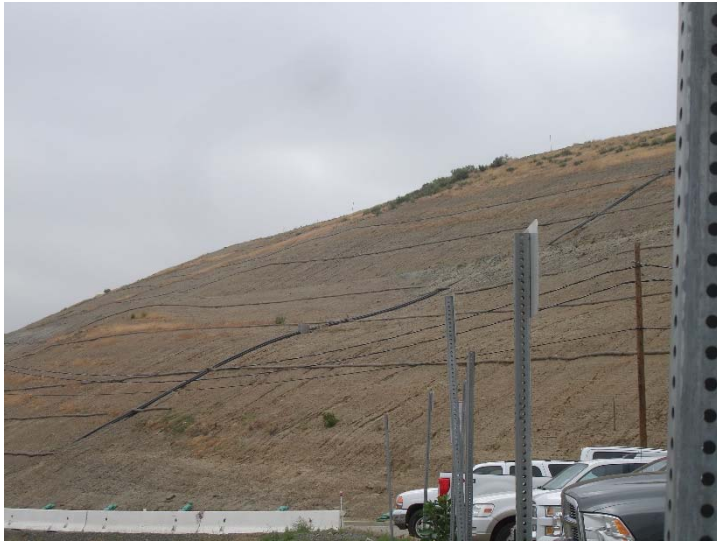
**Photo 364: Old City Landfill Soil Stockpile Near Offices: May 9, 2017**

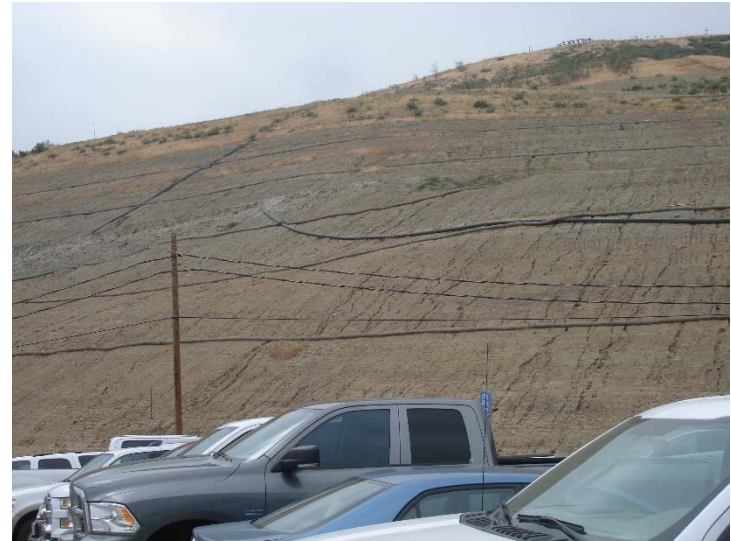
**Photo 365: Old City Landfill Soil Stockpile Near Offices: May 9, 2017**

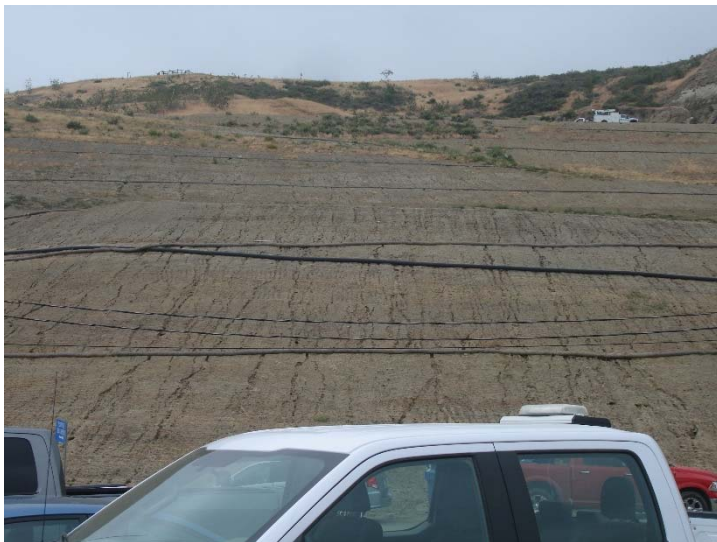
**Photo 366: Old City Landfill Soil Stockpile Near Offices: May 9, 2017**

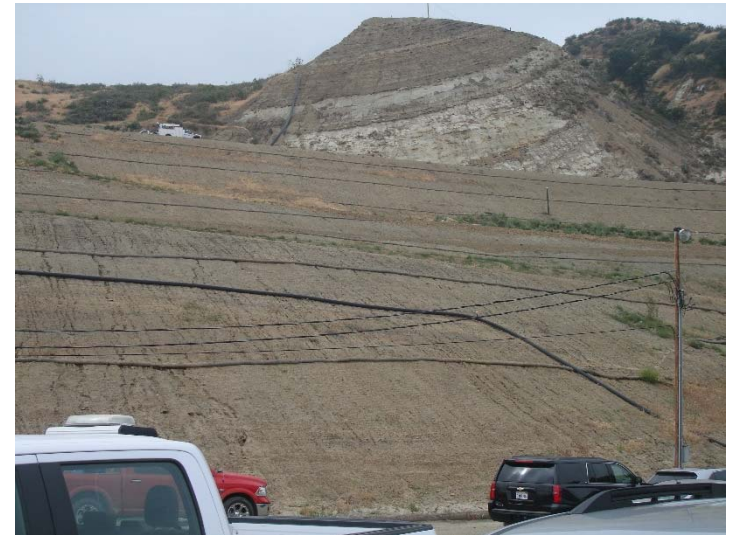
**Photo 367: Old City Landfill Soil Stockpile Near Offices: May 9, 2017**

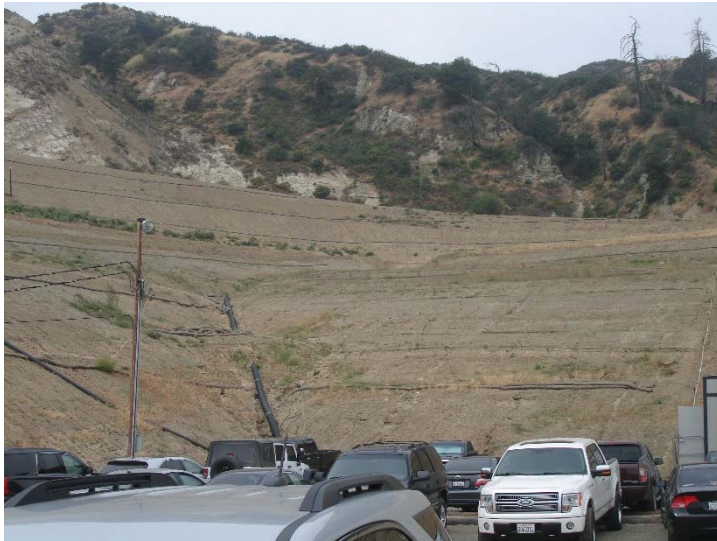
**Photo 368: Old City Landfill Soil Stockpile Near Offices: May 9, 2017**

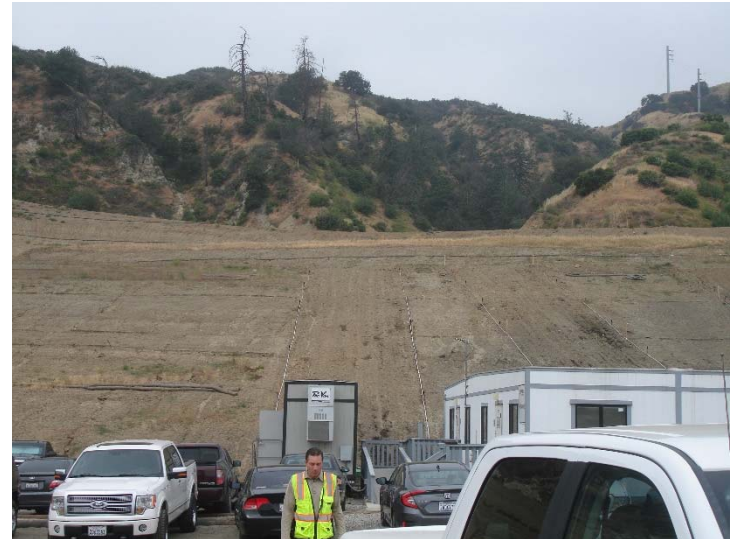
**Photo 369: Old City Landfill Soil Stockpile Near Offices: May 9, 2017**

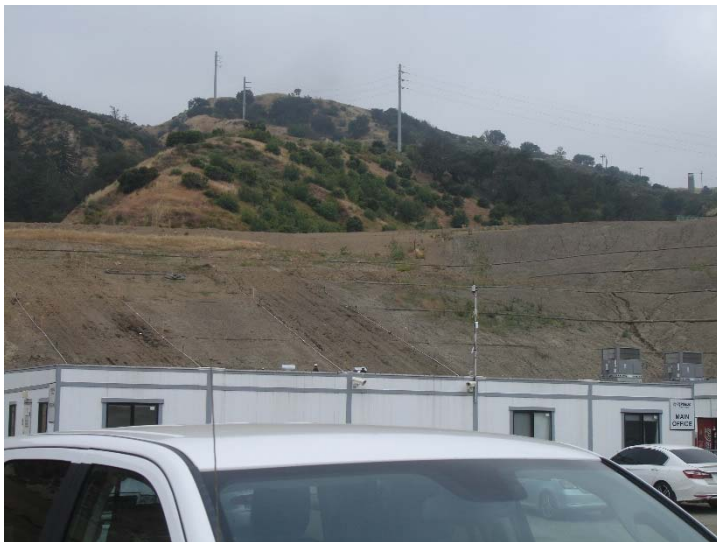
**Photo 370: Soil Stockpile Offices Back Slopes: May 9, 2017**

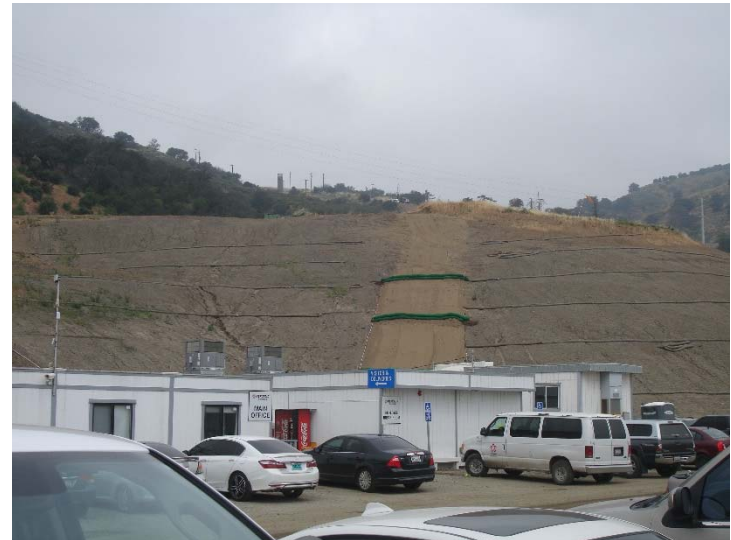
**Photo 371: Soil Stockpile Offices Back Slopes: May 9, 2017**

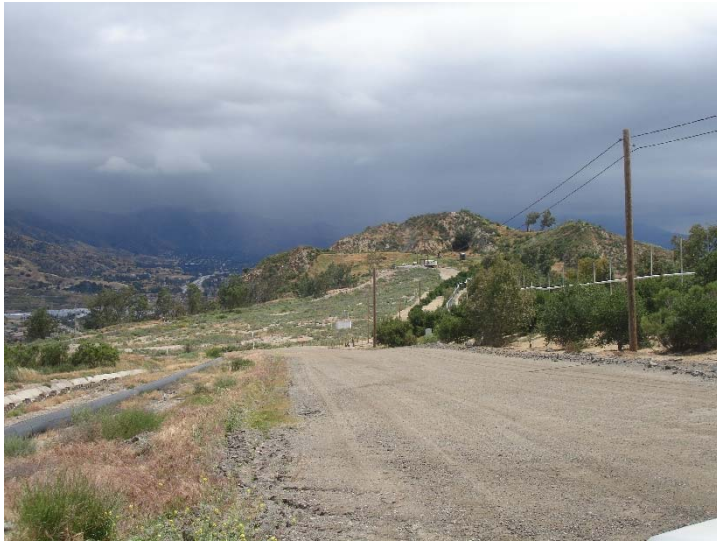
**Photo 372: Soil Stockpile Offices Back Slopes: May 9, 2017**

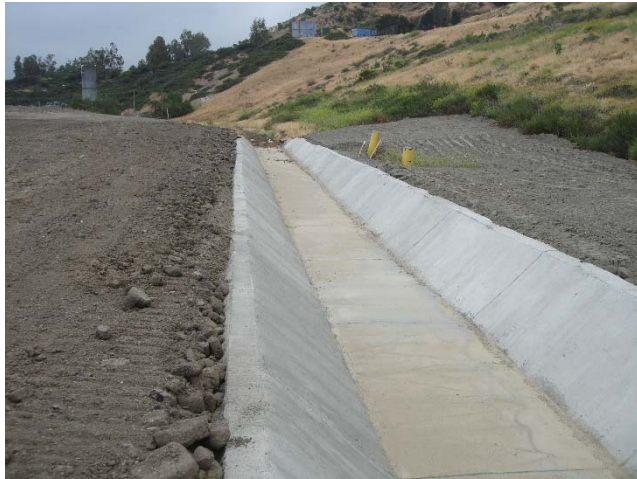
**Photo 404: Deck B Drainage Channel Repair Area: May 9, 2017**

- The City Deck A water tank foundation was backfilled and ladder access locked.
- The City Deck B concrete channel that was ponding water due to reverse flow from settlement was removed and replaced with a new concrete channel segment.

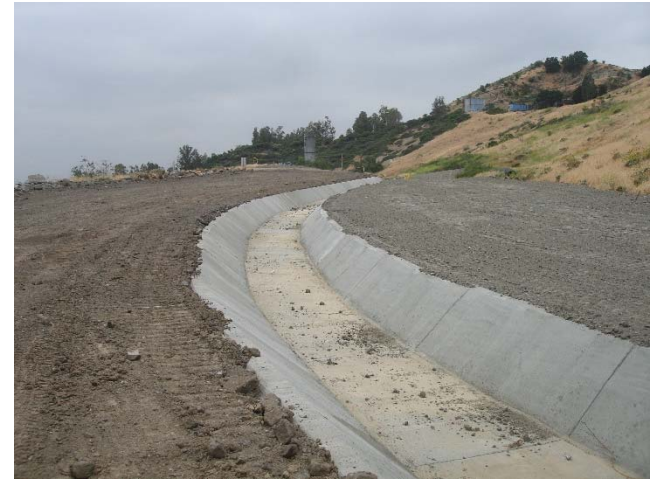
**Photo 405: Deck B Drainage Channel Repair: May 9, 2017**

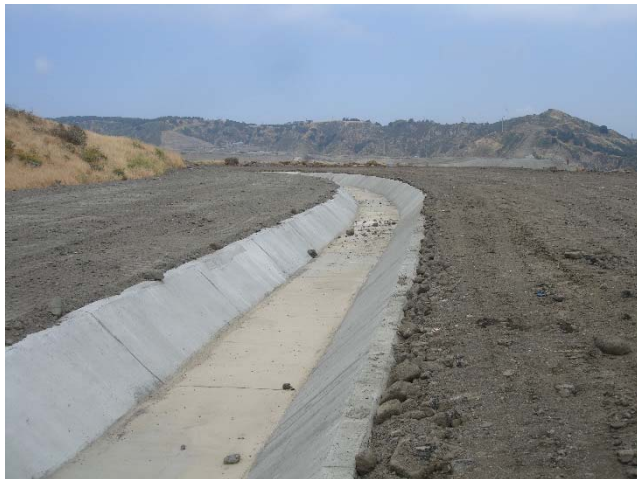
**Photo 406: Deck B Drainage Channel Repair: May 9, 2017**

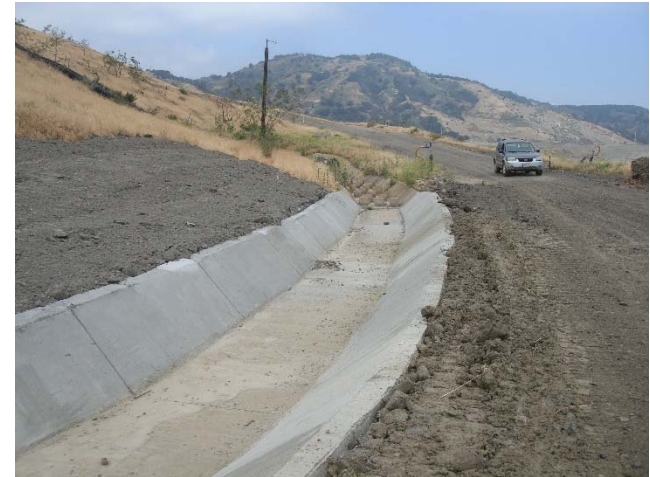
**Photo 407: Deck B Drainage Channel Repair: May 9, 2017**

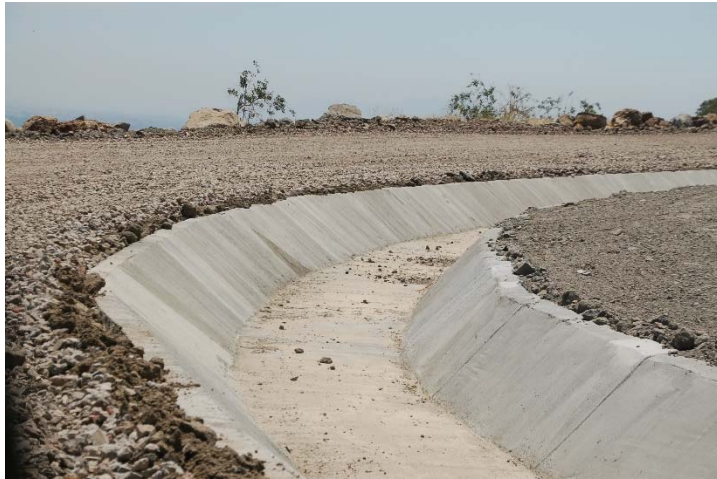
**Photo 408: Deck B Drainage Channel Repair: May 9, 2017**

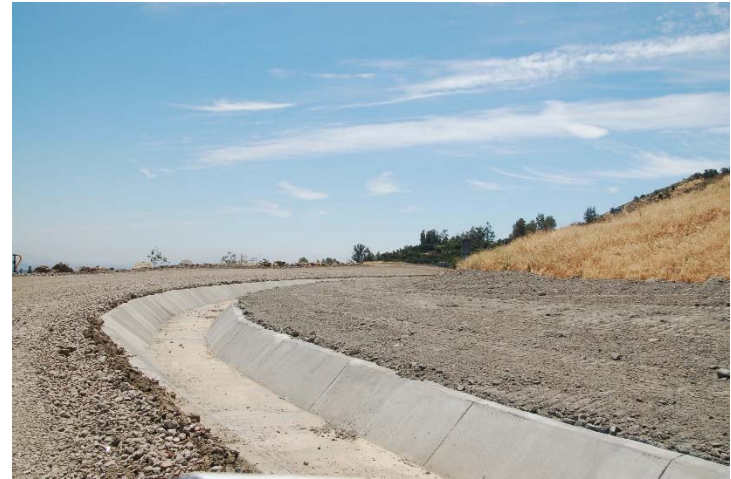
**Photo 409: Deck B Drainage Channel: May 23, 2017**

- The channel downstream of the replaced section had windblown litter and tumbleweed block any potential water flow.
- The west-facing slopes of Cell CC-3A were covered with Posi-Shell.

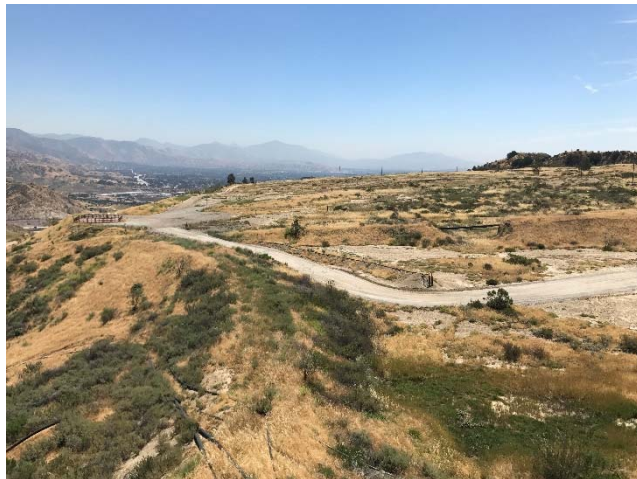
**Photo 410: Deck B Drainage Channel: May 23, 2017**

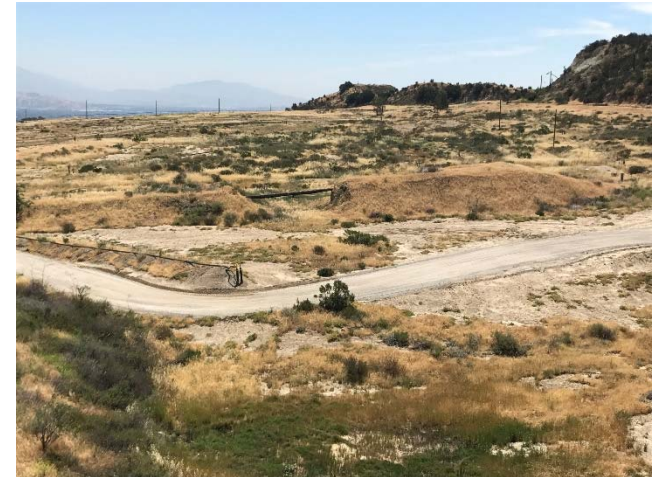
**Photo 411: Deck B Drainage Channel: May 23, 2017**

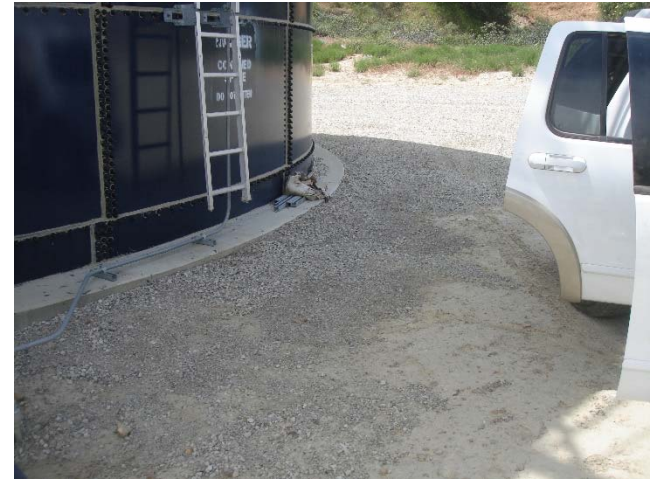
**Photo 413: Deck A Water Tank: April 18, 2017**

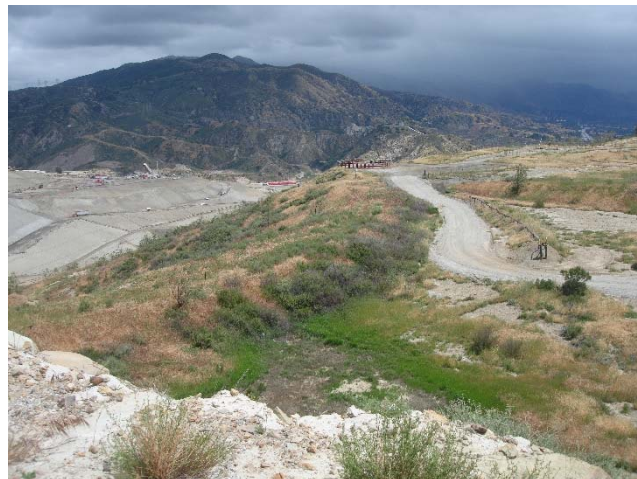
**Photo 414: Deck A Water Tank: April 18, 2017**

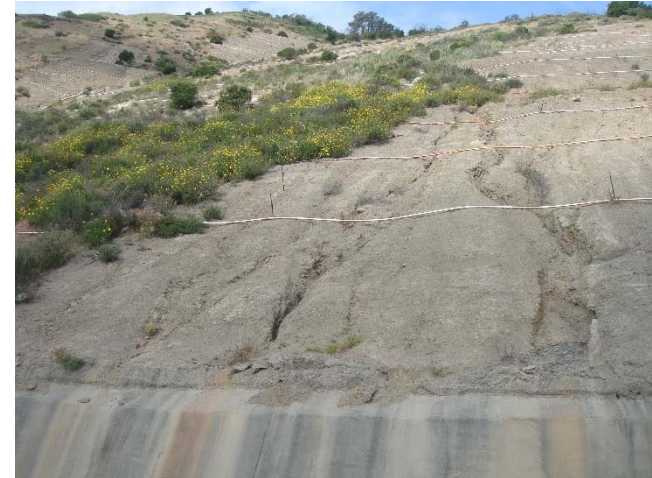
**Photo 427: County Sage Mitigation Area Slope Erosion:  
April 18, 2017**

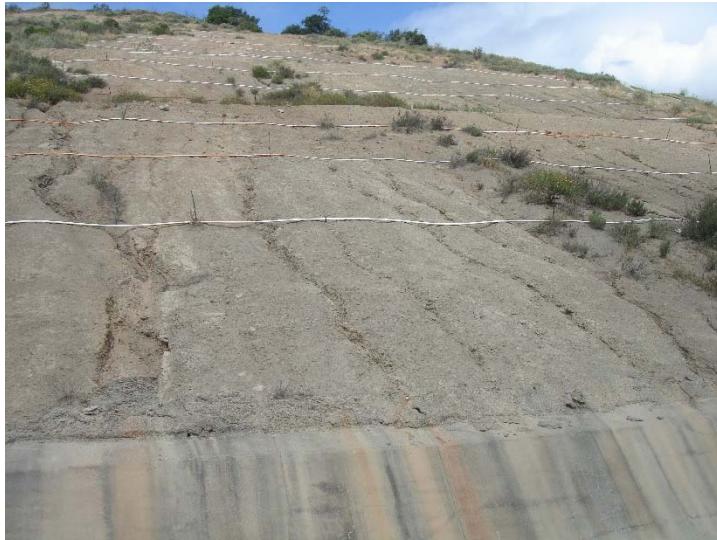
**Photo 428: County Sage Mitigation Area Slope Erosion:  
April 18, 2017**

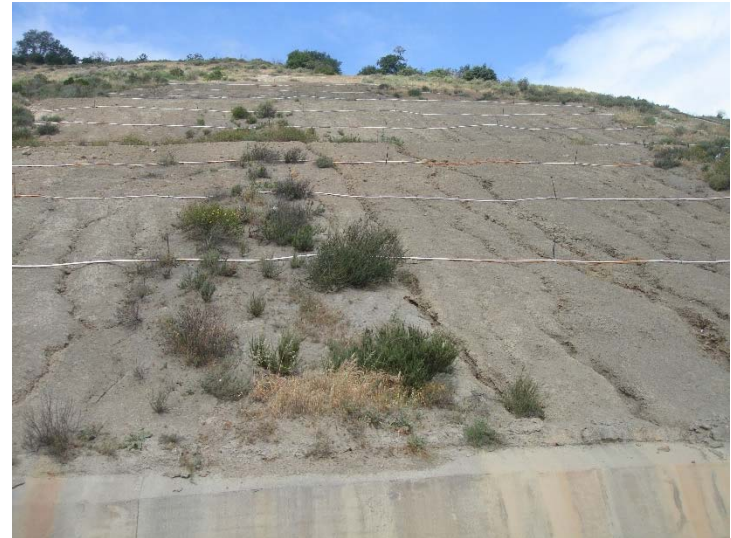
**Photo 429: County Sage Mitigation Area Slope Erosion:  
April 18, 2017**

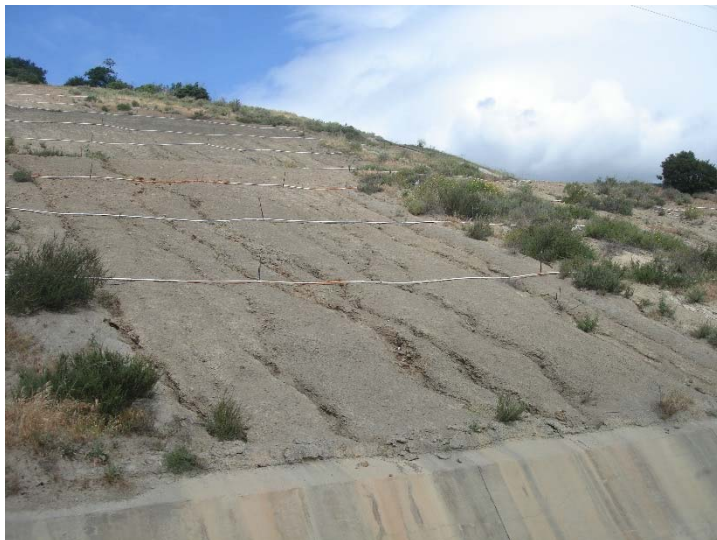
**Photo 430: County Sage Mitigation Area Slope Erosion:  
April 18, 2017**

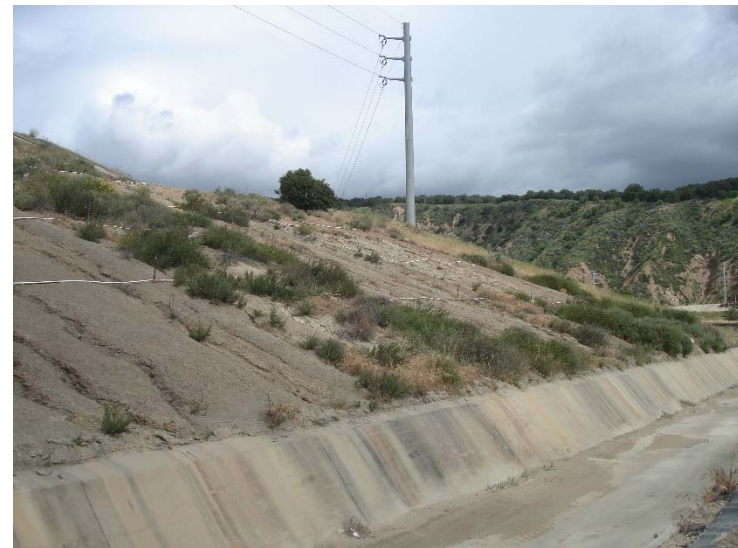
**Photo 431: County Sage Mitigation Area Slope Erosion:  
April 18, 2017**

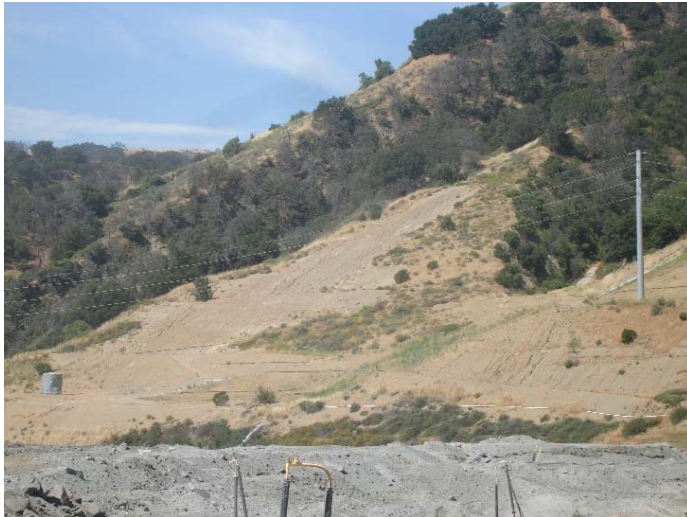
**Photo 432: County Sage Mitigation Area Slope Erosion:  
April 18, 2017**

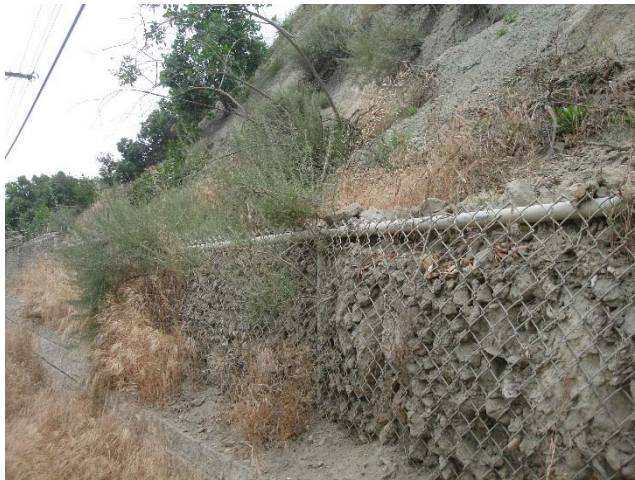
**Photo 454: Frontage Retaining Wall Slope on San Fernando Road:  
May 9, 2017**

- The potable water piping is leaking at two points.
- The San Fernando Road retaining wall had additional soil slough down onto the wall fence.

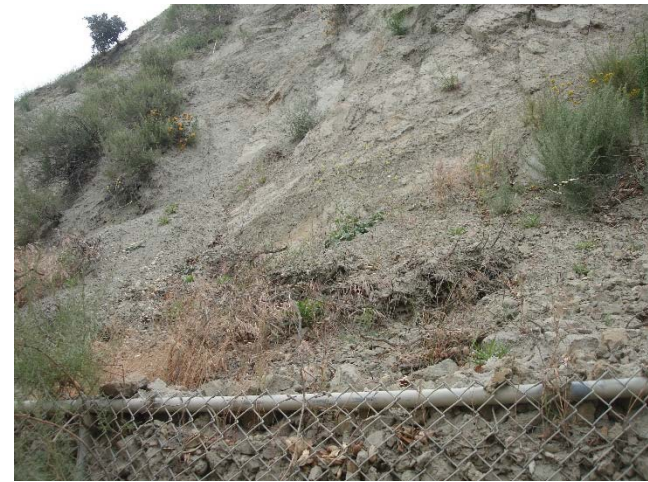
**Photo 455: Frontage Retaining Wall Slope on San Fernando Road:  
May 9, 2017**

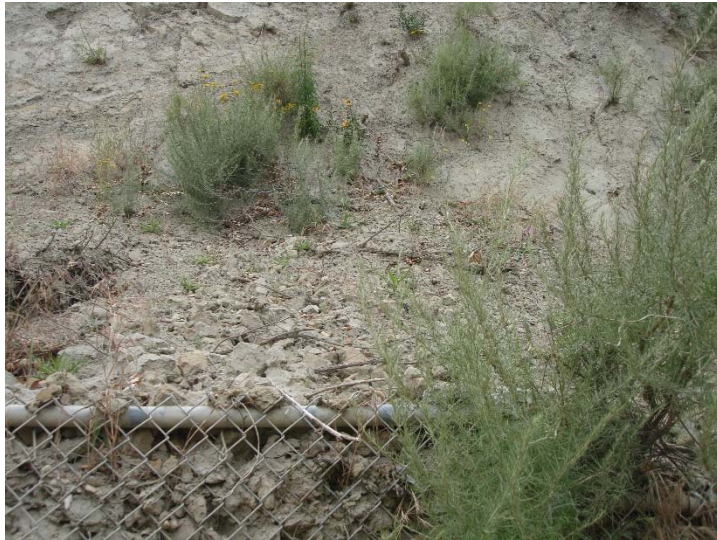
**Photo 456: Frontage Retaining Wall Slope on San Fernando Road:  
May 9, 2017**

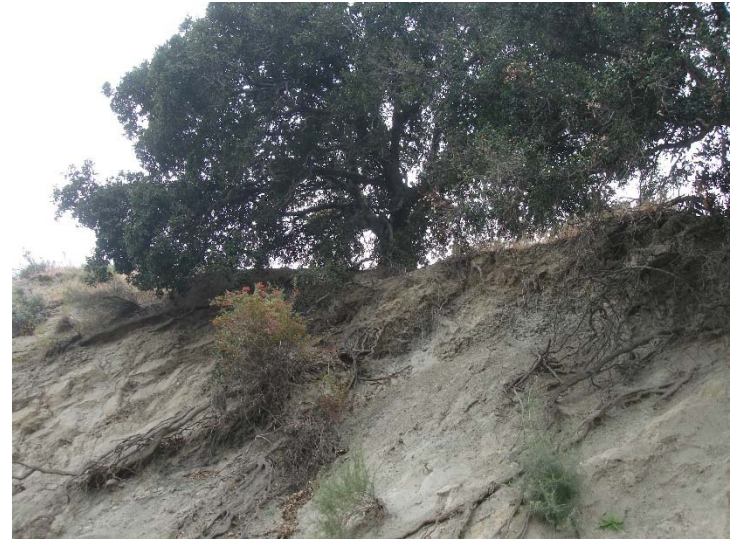
**Photo 457: Frontage Retaining Wall Slope on San Fernando Road:  
May 9, 2017**

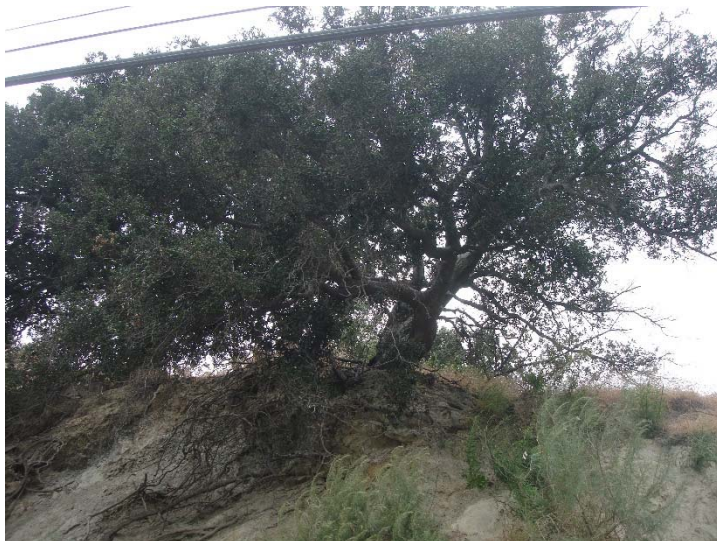
**Photo 458: Frontage Retaining Wall Slope on San Fernando Road:  
May 9, 2017**

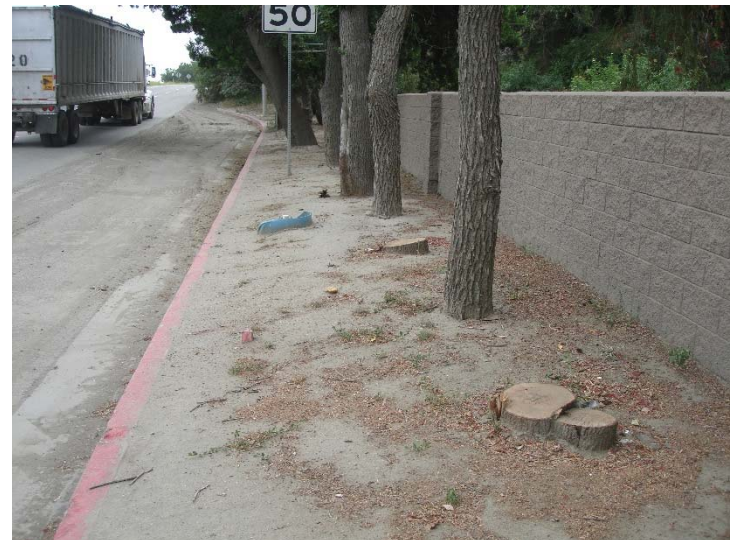
**Photo 459: Frontage Retaining Wall Slope on San Fernando Road:  
May 9, 2017**

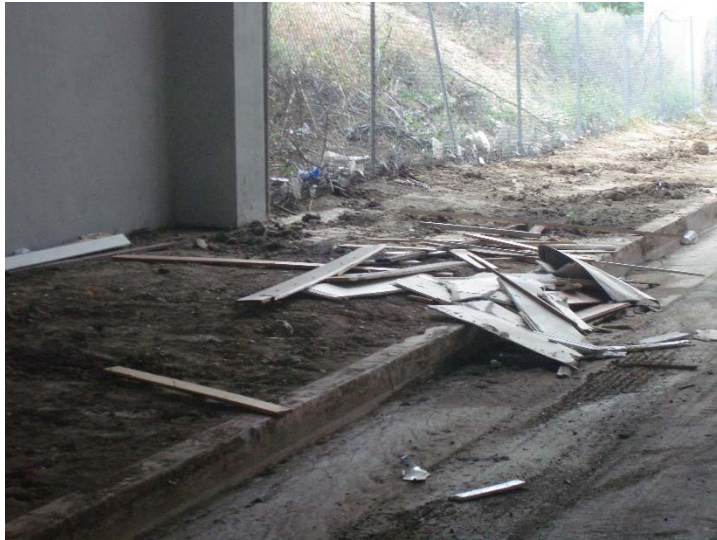
**Photo 484: San Fernando Road near I-5 Overpass: May 9, 2017**

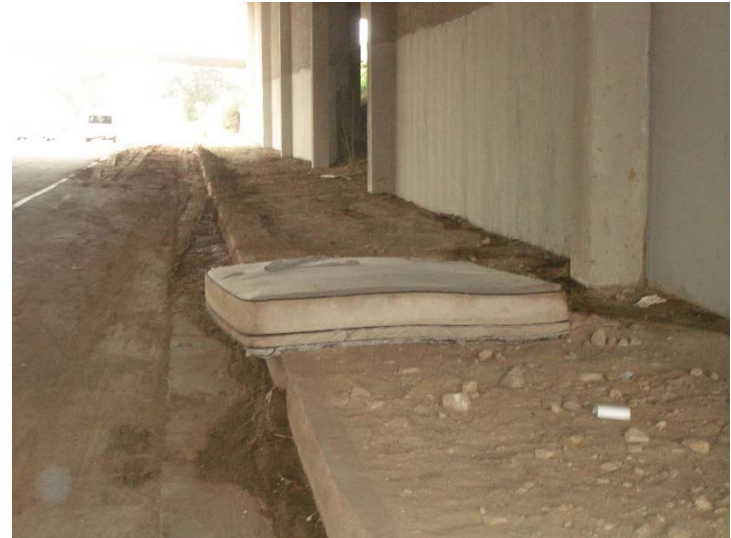
**Photo 485: San Fernando Road near I-5 Overpass: May 9, 2017**

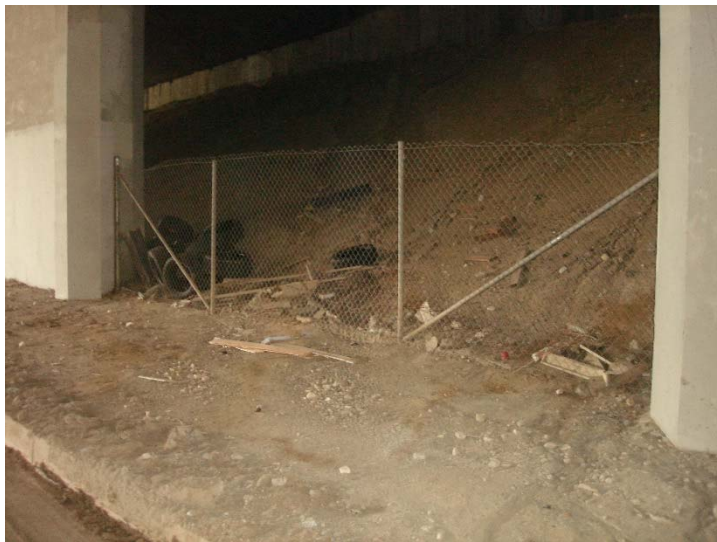
**Photo 486: San Fernando Road near I-5 Overpass: May 9, 2017**

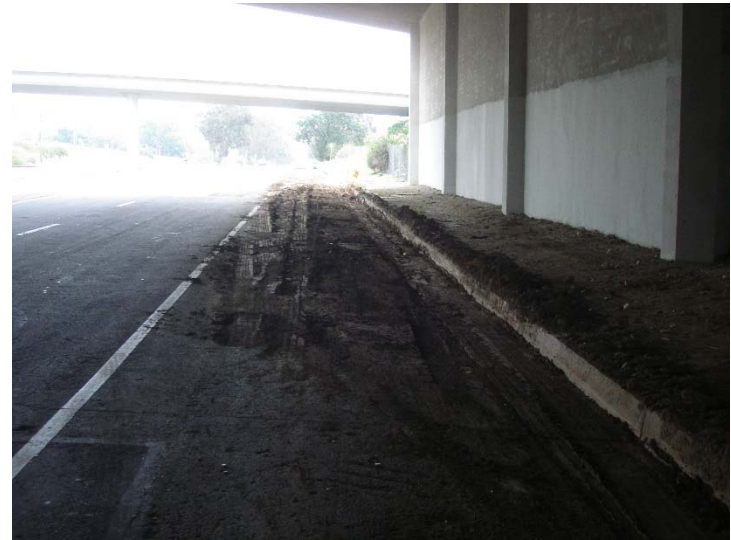
**Photo 487: San Fernando Road near I-5 Overpass: May 9, 2017**

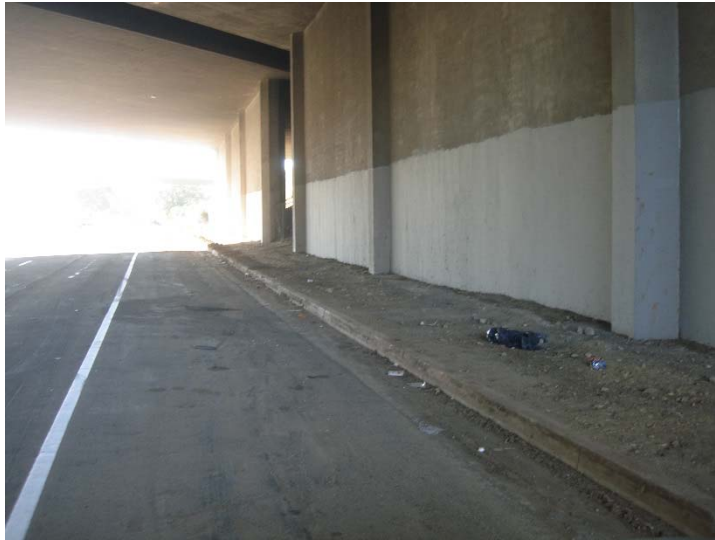
**Photo 488: San Fernando Road near I-5 Overpass: May 9, 2017**

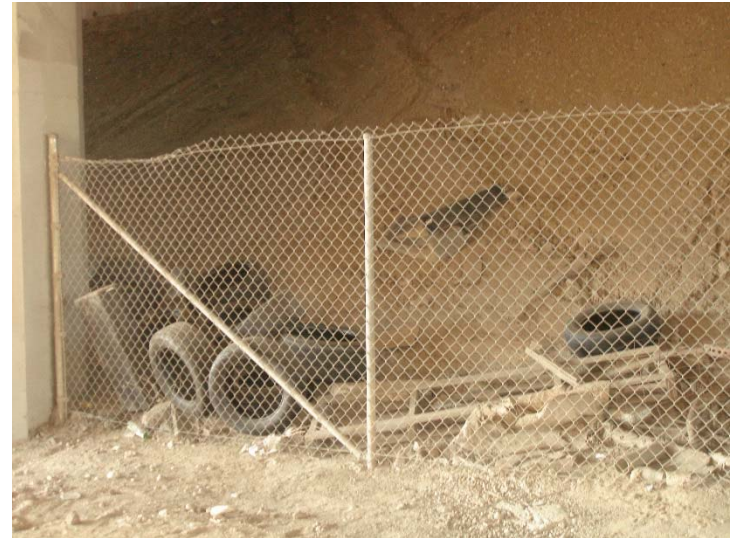
**Photo 489: San Fernando Road near I-5 Overpass: June 20, 2017**

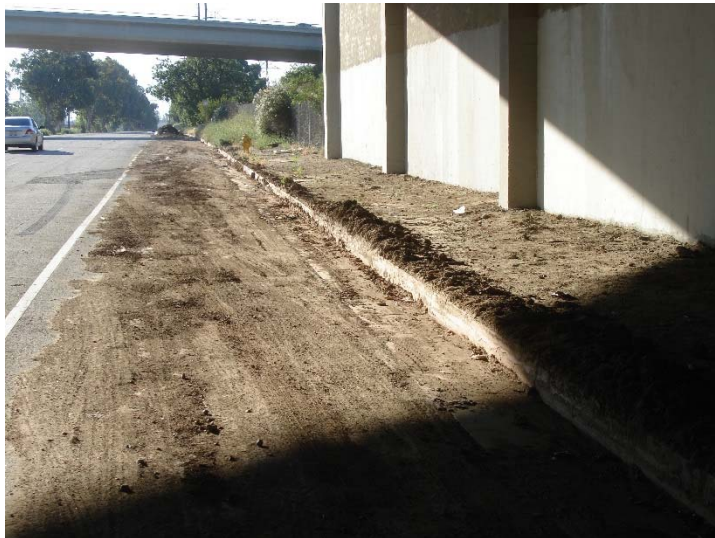
**Photo 490: San Fernando Road near I-5 Overpass: June 20, 2017**

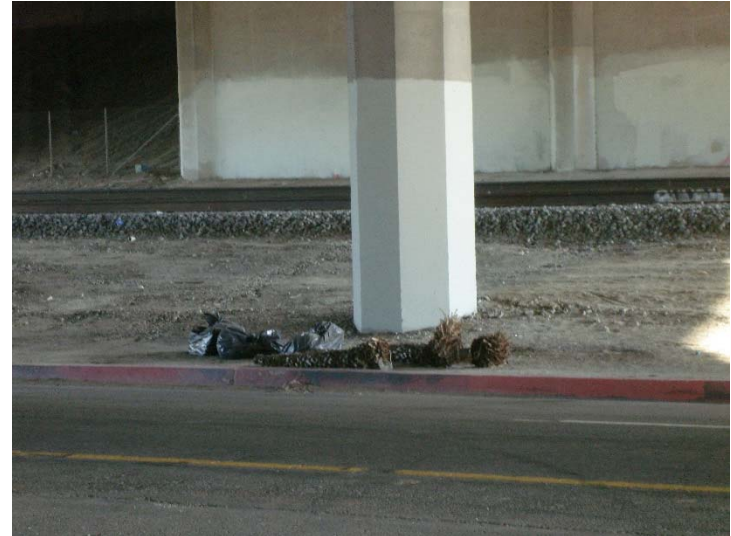
**Photo 491: San Fernando Road near I-5 Overpass: June 20, 2017**

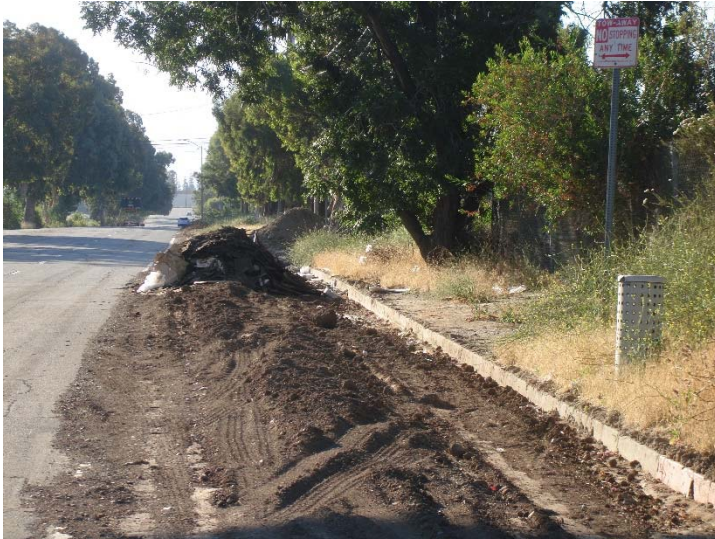
**Photo 492: San Fernando Road near I-5 Overpass: June 20, 2017**

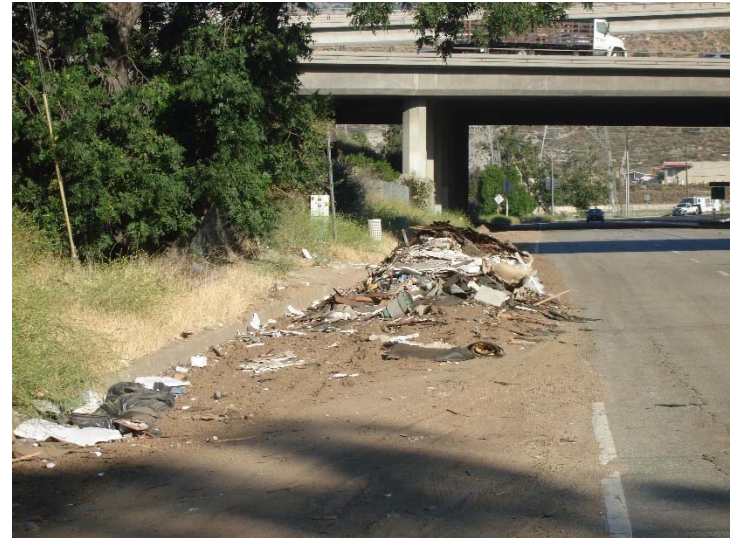
**Photo 493: San Fernando Road near I-5 Overpass: June 20, 2017**

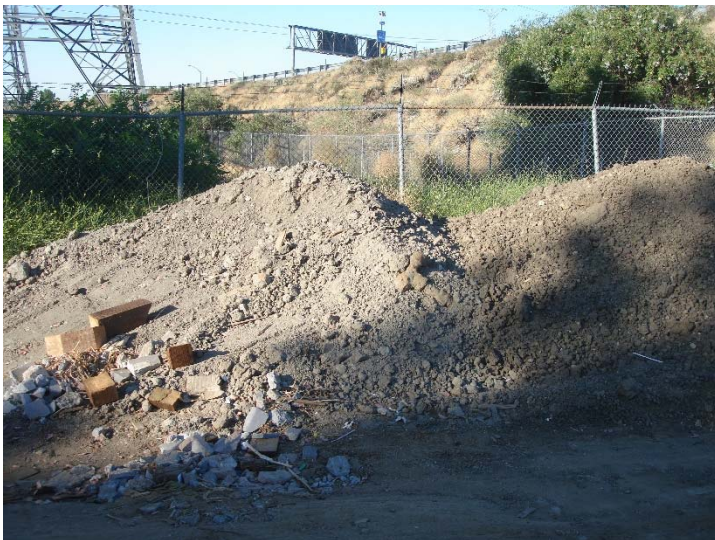
**Photo 494: San Fernando Road near I-5 Overpass: June 20, 2017**

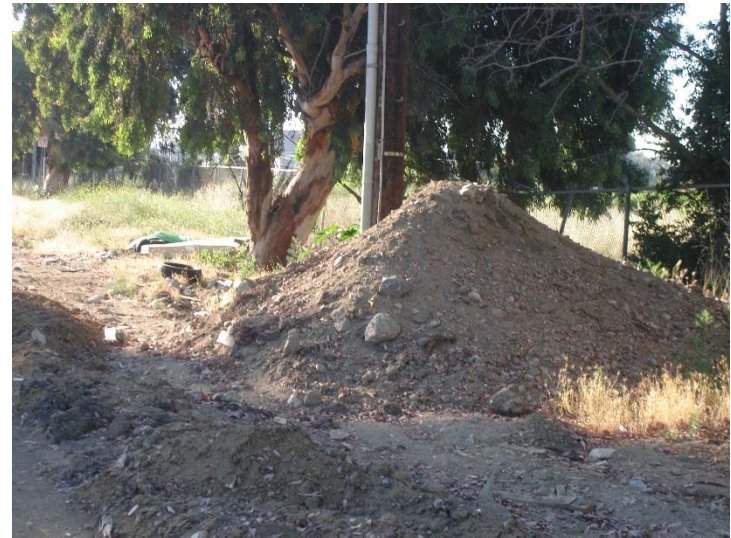
**Photo 495: San Fernando Road near I-5 Overpass: June 20, 2017**

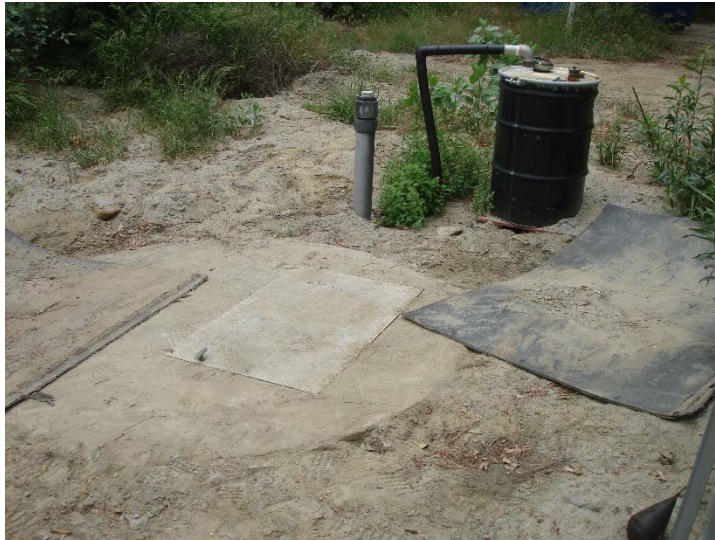
**Photo 496: San Fernando Road near I-5 Overpass: June 20, 2017**

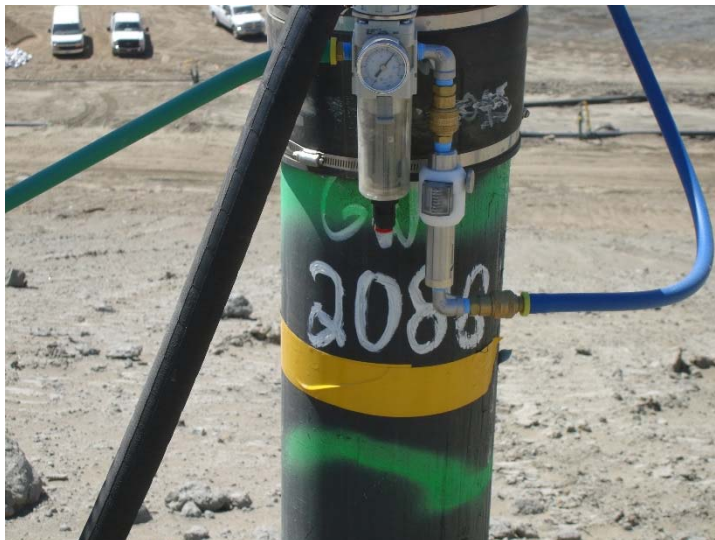
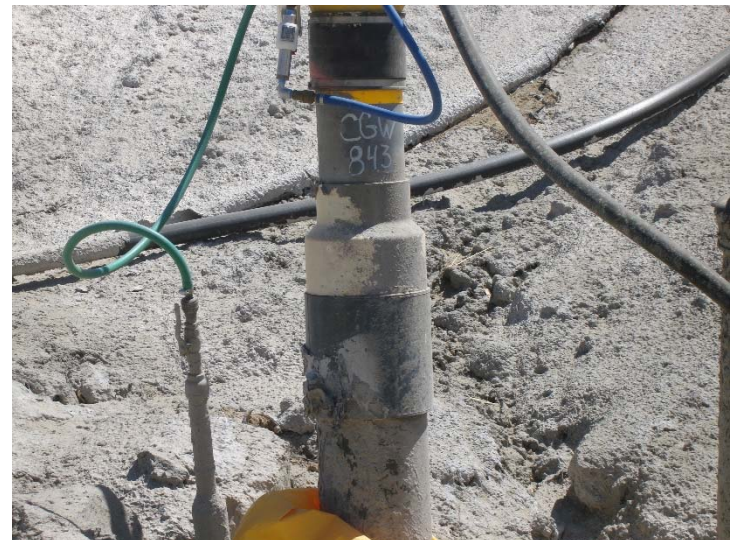
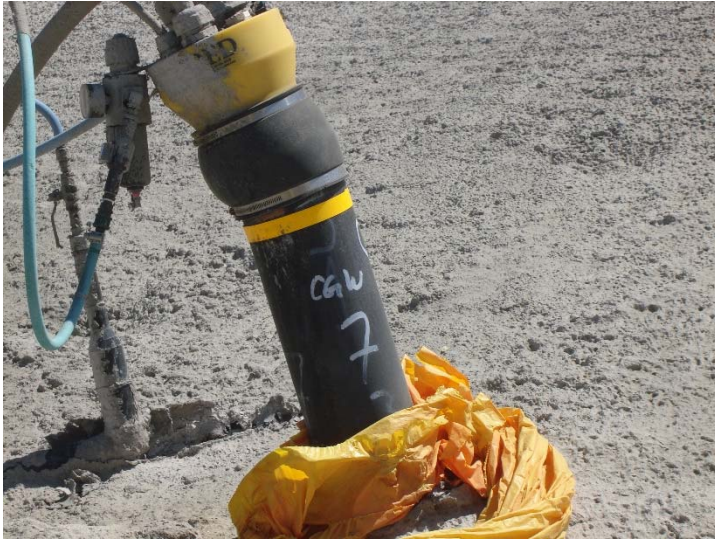
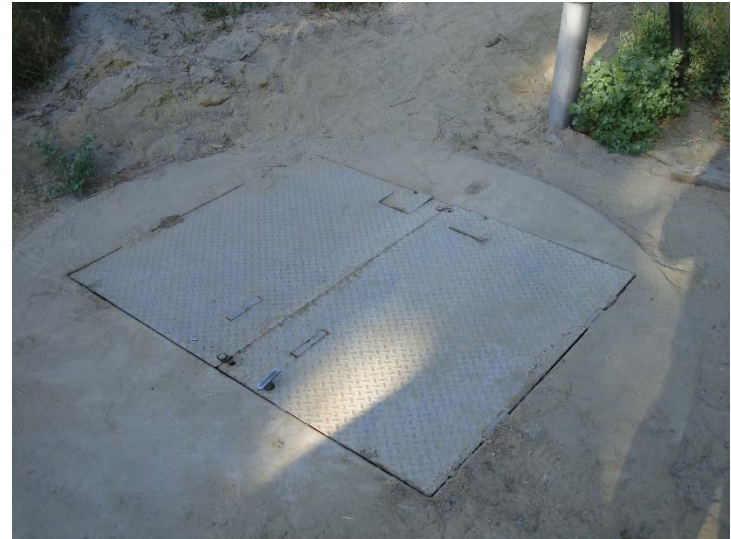
**Photo 498: Localized Odors near Well: May 23, 2017**

**Photo 499: Localized Odors near Well: May 23, 2017**

**Photo 500: Localized Odors near Well: May 23, 2017**

**Photo 501: Localized Odors near Well: May 23, 2017**

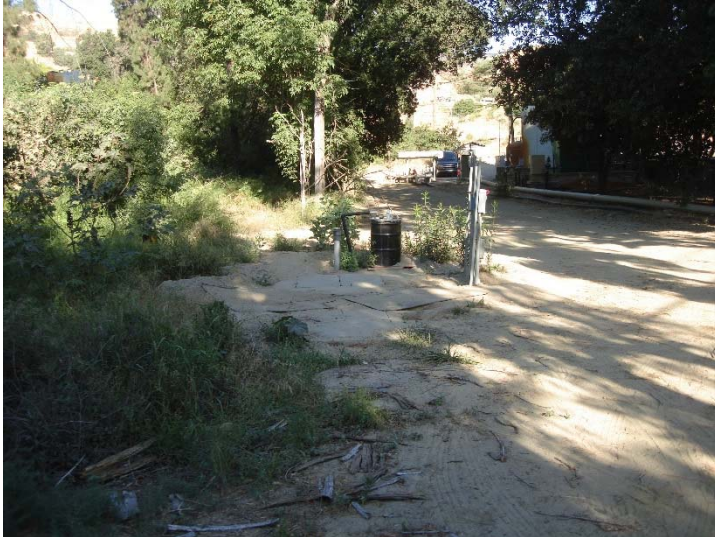
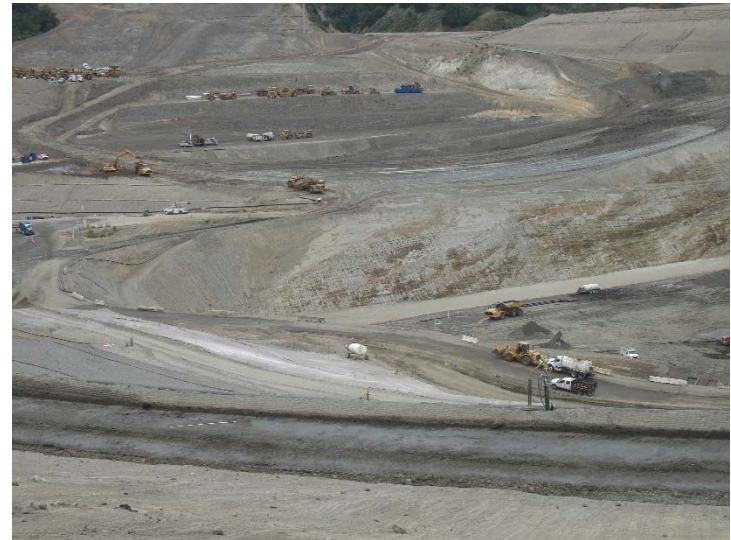
**Photo 502: Odor from Uncovered Sewer Pump Access:  
May 23, 2017**

**Photo 503: Odor from Uncovered Sewer Pump Access:  
May 23, 2017**
