**Sunshine Canyon Landfill  
Independent Monitor  
Quarterly Site Monitoring Status Report  
April 1, 2017 – June 30, 2017**

**City of Los Angeles Department of City Planning**

**County of Los Angeles Department of Regional Planning**

October 10, 2017

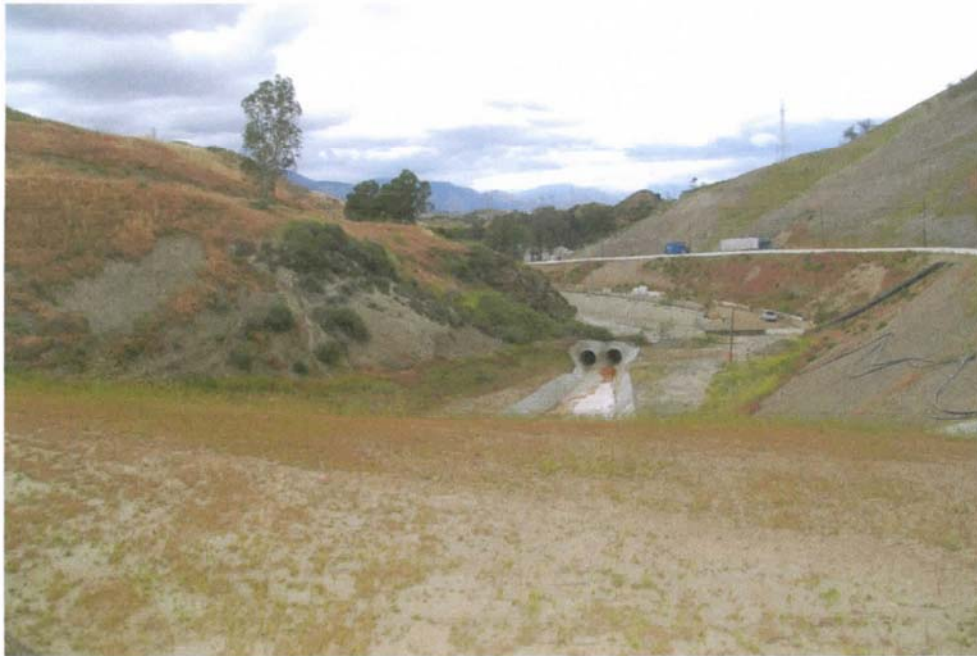
Erosion Protection <ul style="list-style-type: none"> <li>• All systems installed at site are in good shape</li> <li>• The downstream slopes of the embankment new temporary unlined earthen basin near the bottom of the canyon before the final sediment basin that suffered some damage during the rainstorm have recovered and exhibited nice vegetation growth (Photo 3).</li> </ul>	
Drainage system <ul style="list-style-type: none"> <li>• New temporary unlined earthen basin               <ul style="list-style-type: none"> <li>– basin has been partially excavated and the spillway cleared (Photo 4)</li> </ul> </li> <li>• Gabion mats installed in the channel along the access road did a great job retaining fines, minimizing the load in the Terminal basin. The fines retained that could reduce the area therefore the capacity of the channel to convey the flow of water have been cleared restoring</li> </ul>

Photo 3: Graw growing on downstream face of temporary basin

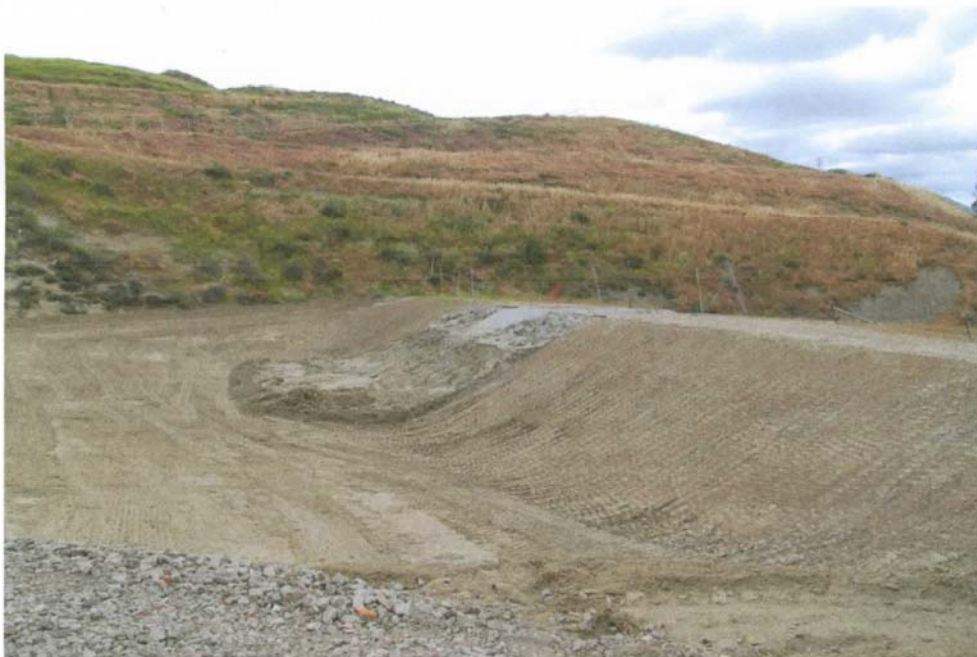
Photo 4: Temporary earthen basin near Terminal Basin cleaned up

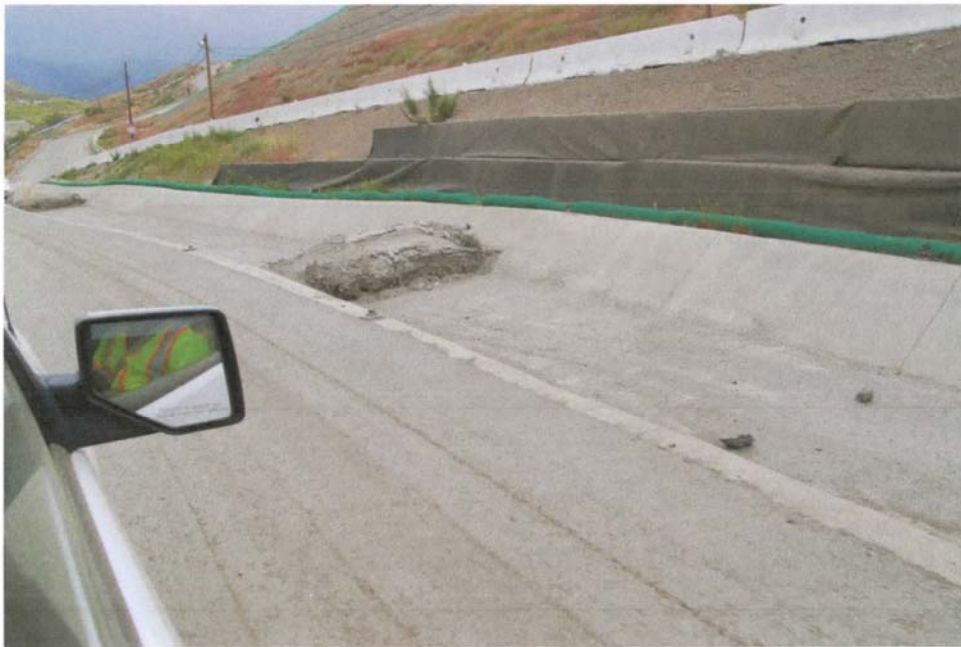
Photo 5: Fines removed from in front Gabions in Channel

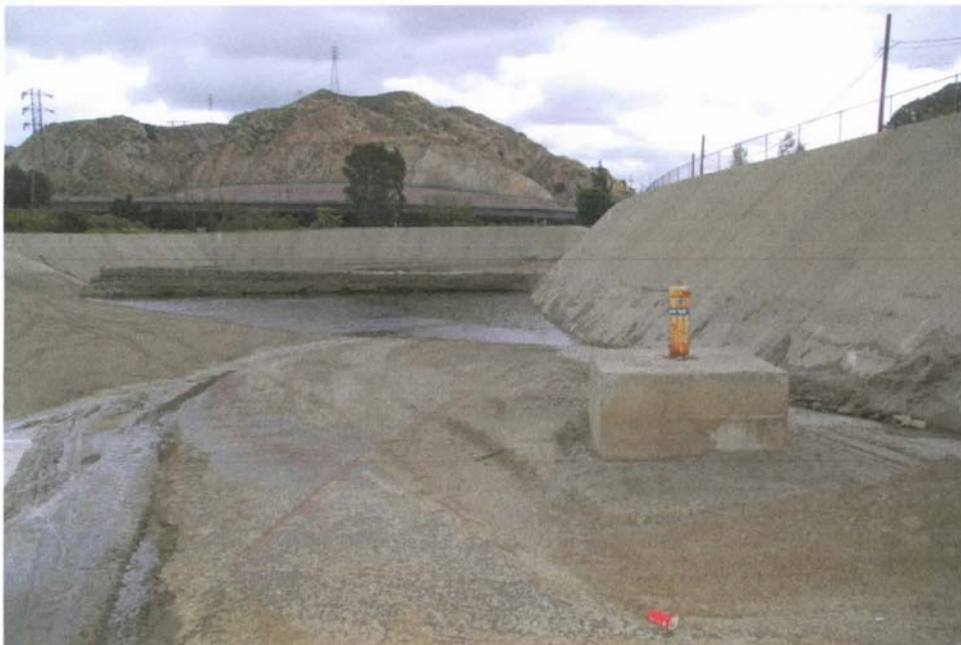
<p>full capacity (Photo 5)</p> <ul style="list-style-type: none"> <li>• Terminal Basin <ul style="list-style-type: none"> <li>– The basin has been partially cleared from sediments.</li> <li>– in particular those accumulated behind the midway now of gabions (Photo 6)</li> <li>– sediments are still accumulated between the decant towers and the midway now of gabions</li> <li>– because of the sediment, the intake area of the decant towers is reduced (Photo 7).</li> </ul> </li> <li>• Basin A <ul style="list-style-type: none"> <li>– Sediments accumulated in basin were being removed (Photo 8)</li> <li>– No additional soil has sloughed on the eastern edge where the gas line to Flare 3 is laid out</li> <li>– The seep observed on the hillside cut adjacent to the basin during the February 23, 2017 visit is not a seep, but the surface expression of erosion due to water flowing down the hill along the native terrain and the fill. Dry terrain allowed this monitor to walk up the hill and observe the area. Photos 9, 10, and 11 show that what was thought to be a seep on the hillside is in fact a gully dug by water running down along the contact between the leftover native and the fill prior to turning onto the bench and flowing on the face of the bench.</li> </ul> </li> <li>• Basin D <ul style="list-style-type: none"> <li>– Clean</li> <li>– All channels into out of the basin are clean and open.</li> </ul> </li> <li>• Basin B <ul style="list-style-type: none"> <li>– Clean</li> <li>– Some soil slid from the hill in the far corner (Photo 12)</li> </ul> </li> <li>• Channel between Basin A and D cracks, fissure, and uplift floor have been repaired with the pouring of a new slab (Photo 13)</li> <li>• The channel on the main access road on the City South Landfill deck that exhibited reverse slope and therefore ponded water was being replaced. (Photo 14)</li> <li>• Channel between Basin D and access road to Flare 9 and 10. <ul style="list-style-type: none"> <li>– The geomembrane installed in the channels has some loose at the connection with the corrugated pipe.</li> <li>– During stormwater flows, water can flow under the geomembrane and rip it (Photos 15 and 16)</li> </ul> </li> </ul>

Photo 6: Sediments removed from front half of Terminal Basin

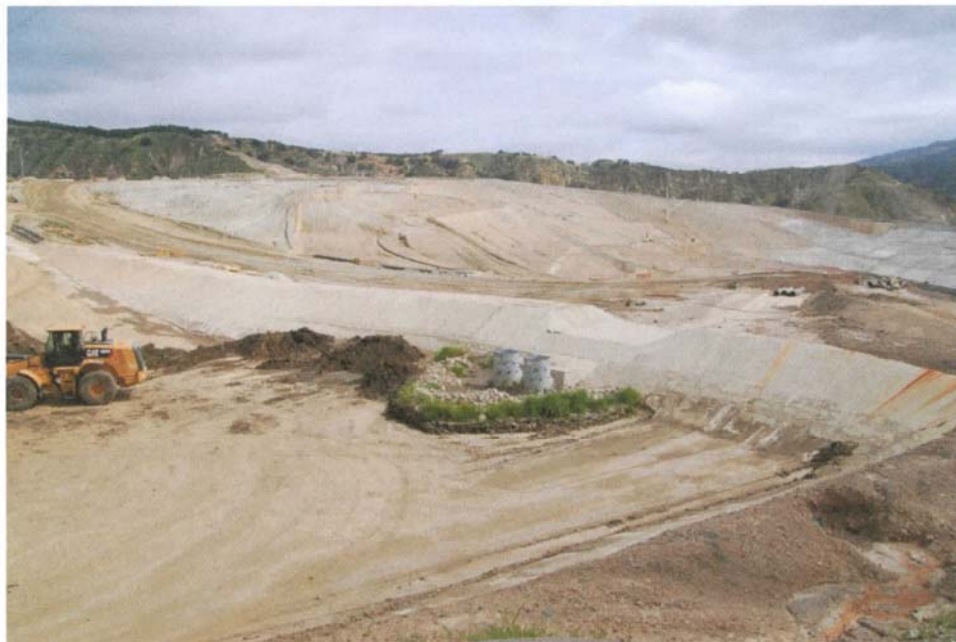
Photo 8: Removal of sediments from Basin A

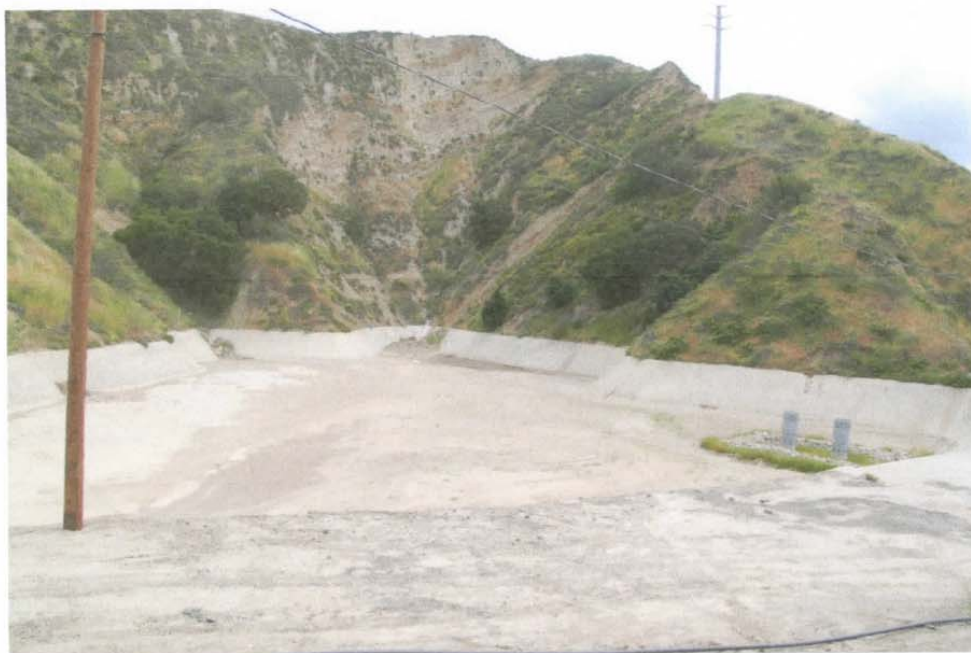
Photo 12: Basin B cleaned up

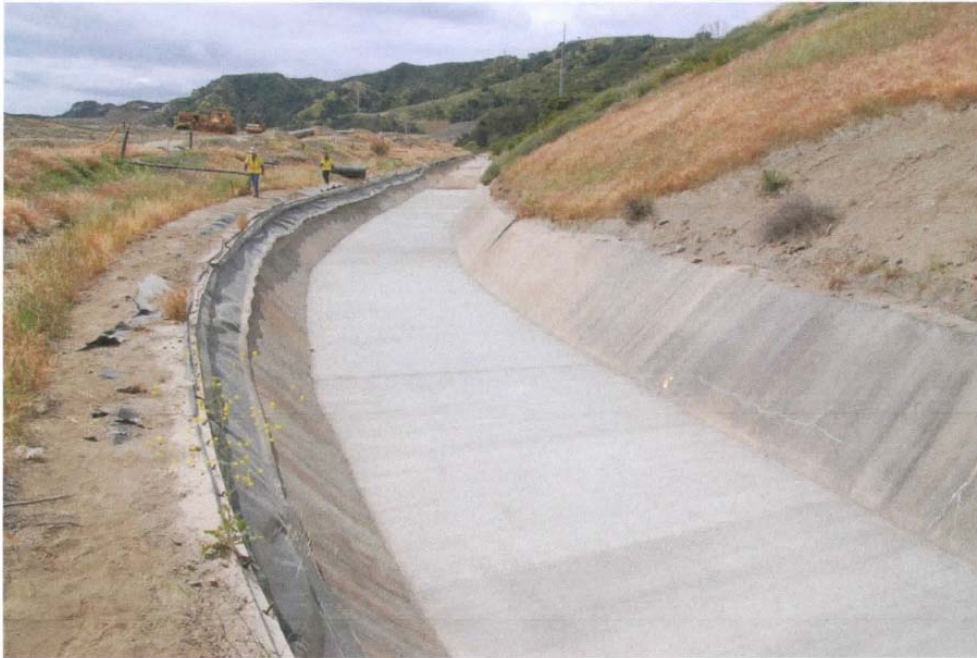
- The westside drainage channel floor that was uplifting and walls that were cracking and shifting noted on the March 9th site monitoring were repaired. The floor concrete was removed and replaced and any damaged walls fixed.

Photo 13: Repaired floor of west drainage channel

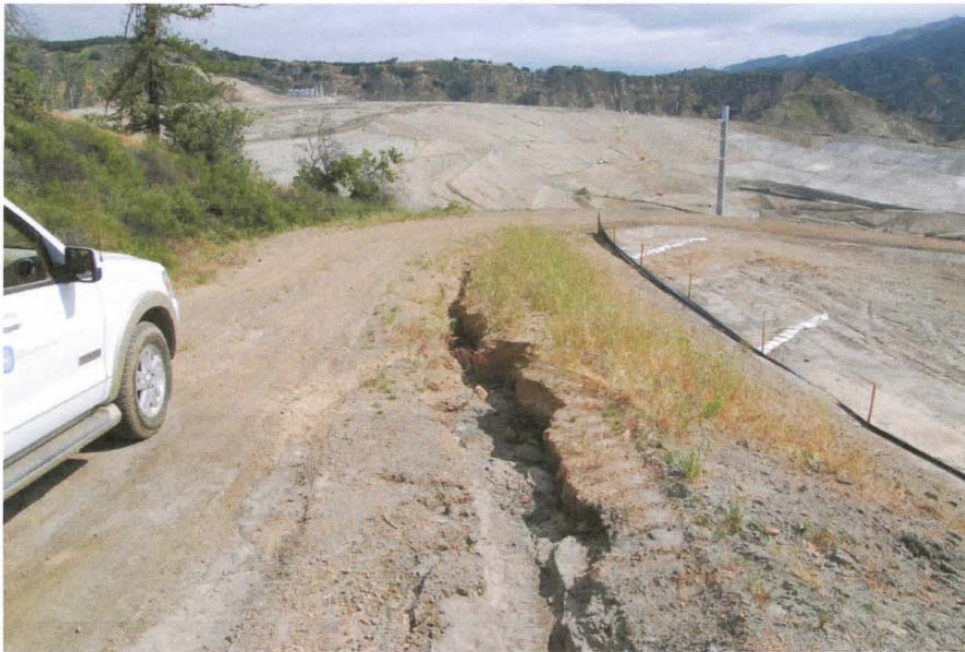
<p>Access Roads</p> <ul style="list-style-type: none"> <li>• No additional movement was observed of area on the slope rising from the access road to the administration building was observed to have experienced some sloughing.</li> <li>• Extensive, excessive erosion along the road to Flare 3 was observed (Photo 17)</li> </ul>
<p>Water tank</p> <ul style="list-style-type: none"> <li>• the gap around the ring foundation of the water tank was filled up (Photo 18)</li> </ul>
<p>Overall landfill inspection.</p> <ul style="list-style-type: none"> <li>• no geotechnical issues were observed</li> </ul>
<p>2:00-2:30 Close-out meeting with Republic Staff LADPW and GLA representative to discuss findings and retaining wall along San Fernando Road.</p> <ul style="list-style-type: none"> <li>• UltraSystems <ul style="list-style-type: none"> <li>– described the conditions of the wall namely our observations over the past few months of soil piling up against the fence component of the wall</li> </ul> </li> </ul>

Photo 17: Excessive gullies along access road to Flare 3

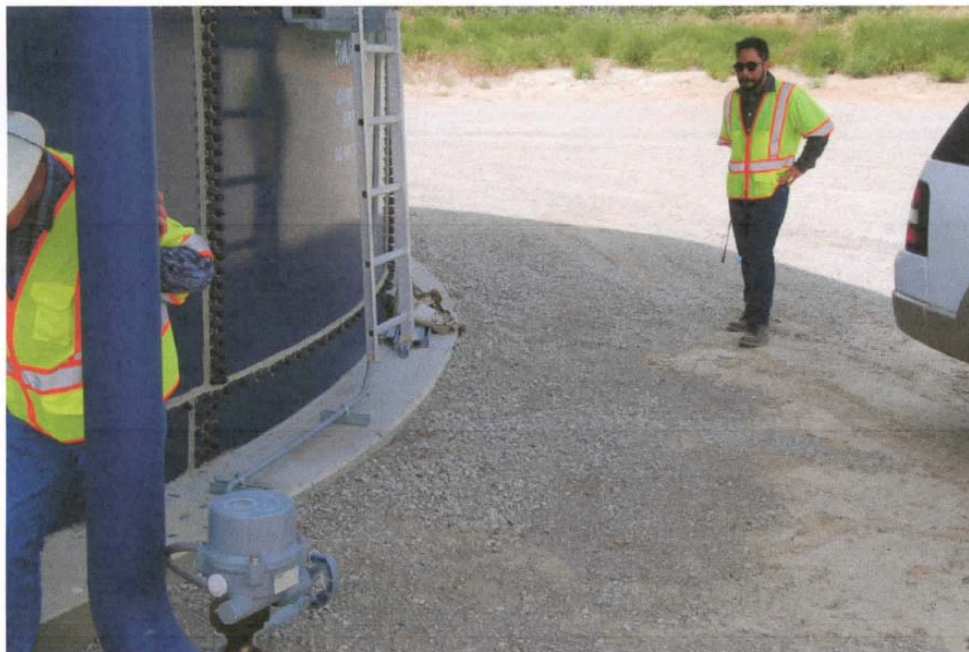
Photo 18: Foundation around water tank filled up

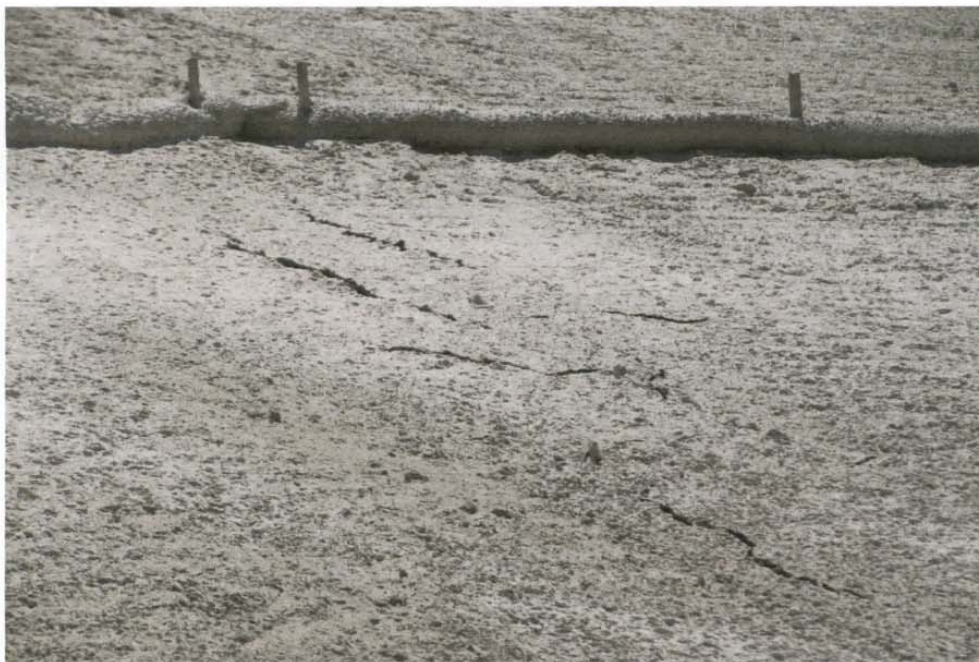
Erosion Protection <ul style="list-style-type: none"> <li>• All systems installed at site are in good shape</li> <li>• Posi shell has been applied to the slopes of cell CC3 (Photo 3). Close-up observation of Posi shell indicated some cracking (Photo 4) leading to repair by spraying over a new coat (Photo 5).</li> </ul>	
Drainage system <ul style="list-style-type: none"> <li>• New temporary unlined earthen basin <ul style="list-style-type: none"> <li>– basin had been partially excavated by April 18 and the spillway was cleared. Construction activities were ongoing so we could not observe if the intake tower has been dug out.</li> </ul> </li> <li>• Gabion mats installed in the channel along the access road have been removed (Photo 6)</li> <li>• Terminal Basin <ul style="list-style-type: none"> <li>– The basin has been cleared from sediments.</li> <li>– in particular those accumulated behind the midway now of gabions</li> <li>– some sediments are still accumulated behind the decant towers</li> </ul> </li> <li>• Basin A <ul style="list-style-type: none"> <li>– Sediments accumulated in basin have been removed</li> <li>– No additional soil has sloughed on the eastern edge where the gas line to Flare 3 is laid out <ul style="list-style-type: none"> <li>– Material that could slough off and fall in the basin was being removed (Photo 7)</li> </ul> </li> </ul> </li> </ul>

Photo 4: Cracks in Posi shell cover

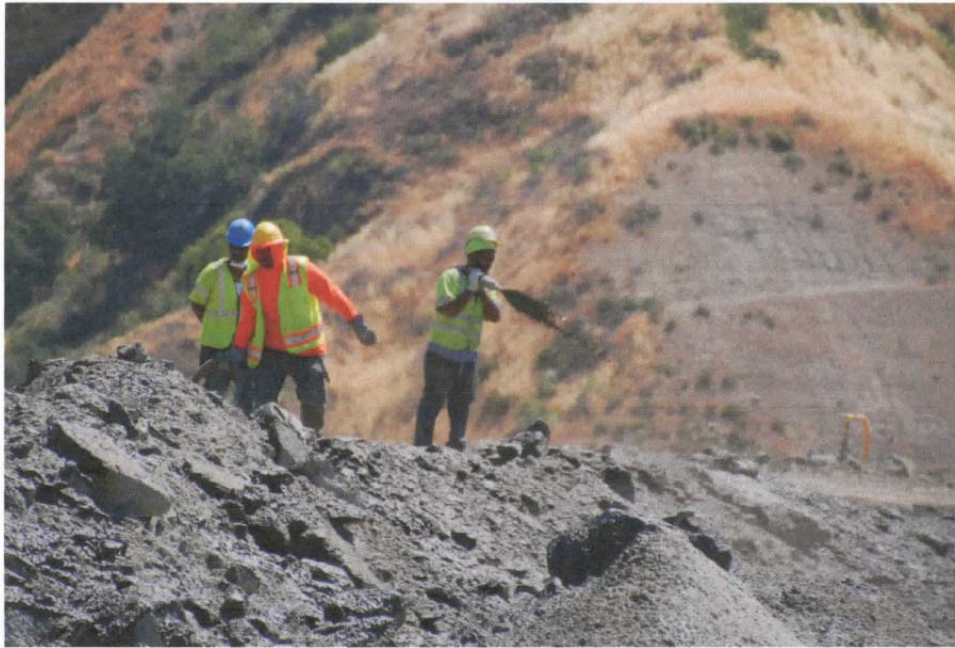
Photo 5: Spraying of Posi shell

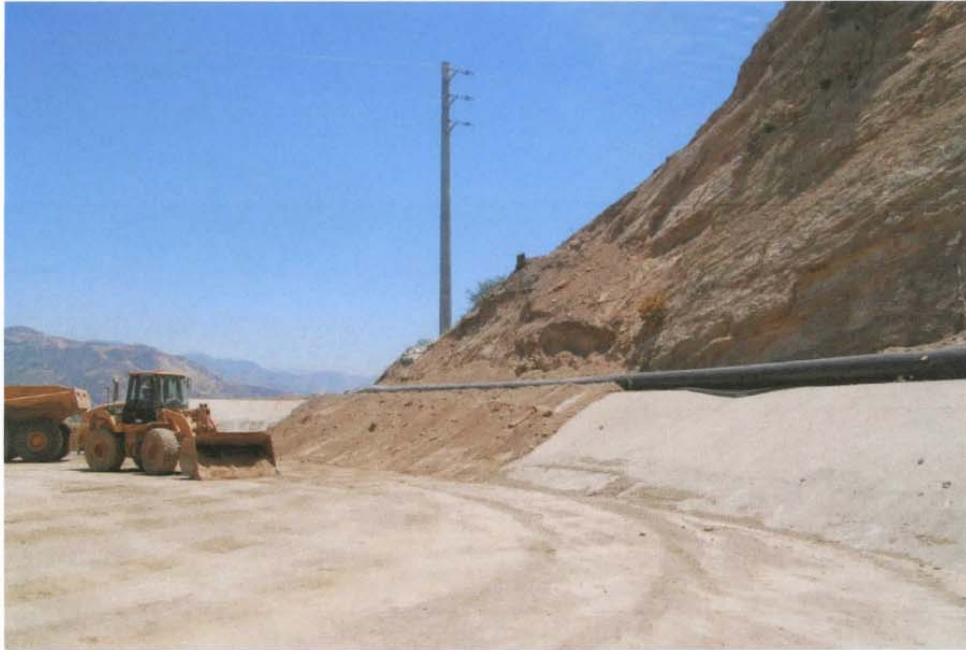
Photo 7: Removal of material from Basin A

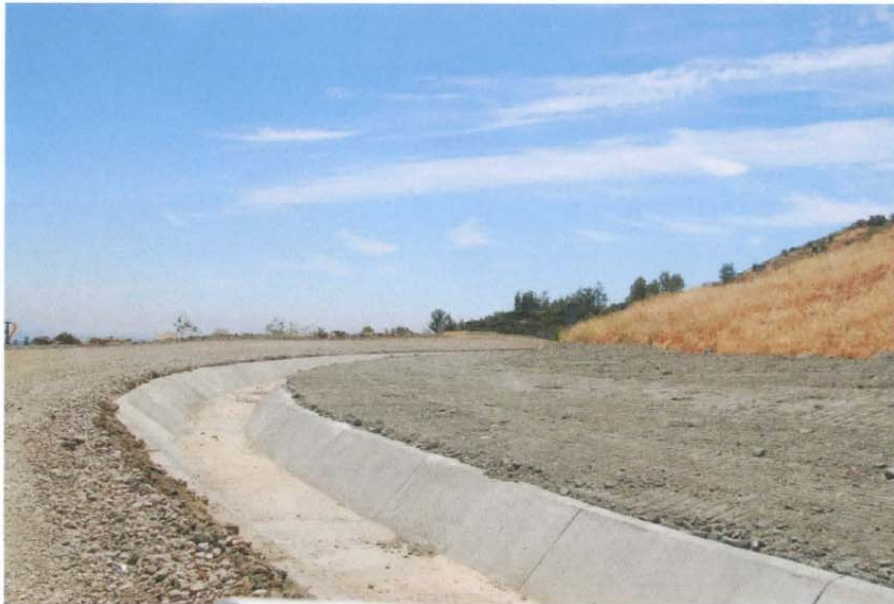
Photo 9: Repaired channel on old City Landfill Deck

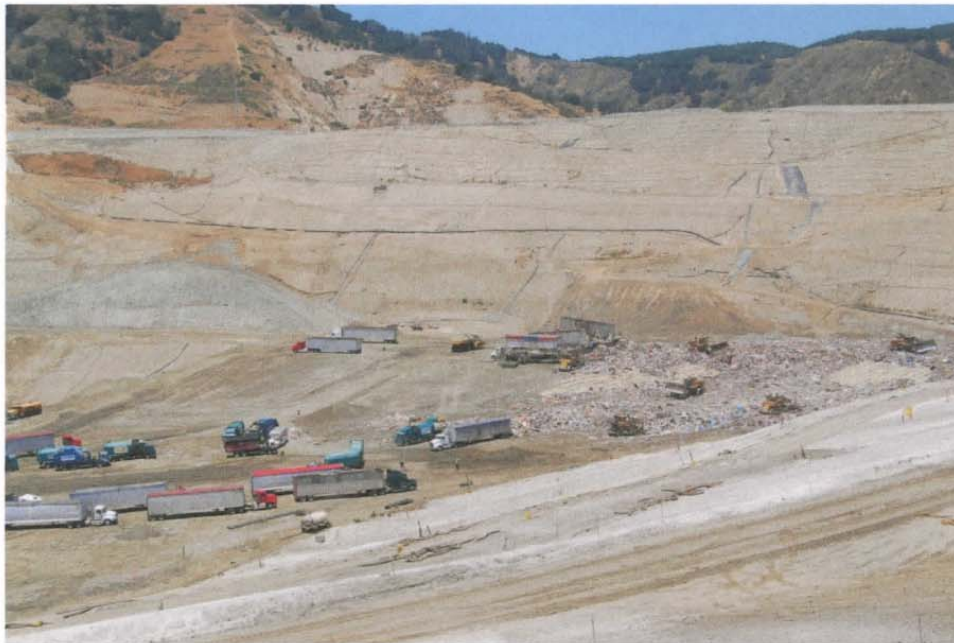
Photo 1: Filling activities in Cell CC4

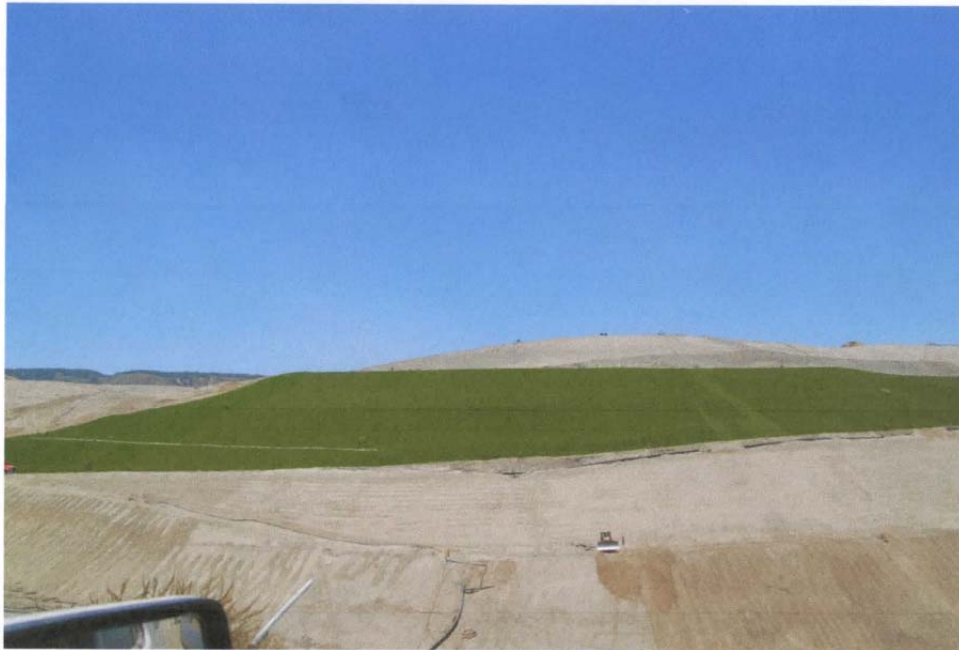
<p>Overall landfill inspection.</p> <ul style="list-style-type: none"> <li>• no geotechnical issues were observed</li> </ul>
<p>Closure Turf on slopes of CC3:</p> <ul style="list-style-type: none"> <li>• The slopes of cell CC3 were covered with Closure Turf manufactured by Watershed Geo (Photo 7)</li> <li>• It is our understanding that a horizontal gas collection system was installed under the Closure Turf as well as relief valves (Photo 8) to prevent uplift of the Closure Turf in case of landfill gas accumulation</li> <li>• Existing gas recovery wells were extended through Closure Turf (Photo 8)</li> </ul>
<p>Retaining wall on San Fernando Road:</p> <ul style="list-style-type: none"> <li>• Met with republic and LADPW representative to discuss reviews of analysis prepared by Republic consultants Geo-logic (for geology) and Dave Edwards inc. (structural integrity)</li> <li>• The new consultants addressed the concerns expressed by the compliance monitoring team proposed mitigation solutions</li> <li>• It is our understanding that the work will take place before the next rainy season</li> </ul>

Photo 7: Overview of Closure Turf on Cell CC3 slope
