**Sunshine Canyon Landfill  
Independent Monitor  
Quarterly Site Monitoring Status Report  
January 1, 2017 – March 31, 2017**

**City of Los Angeles Department of City Planning**

**County of Los Angeles Department of Regional Planning**

April 26, 2017

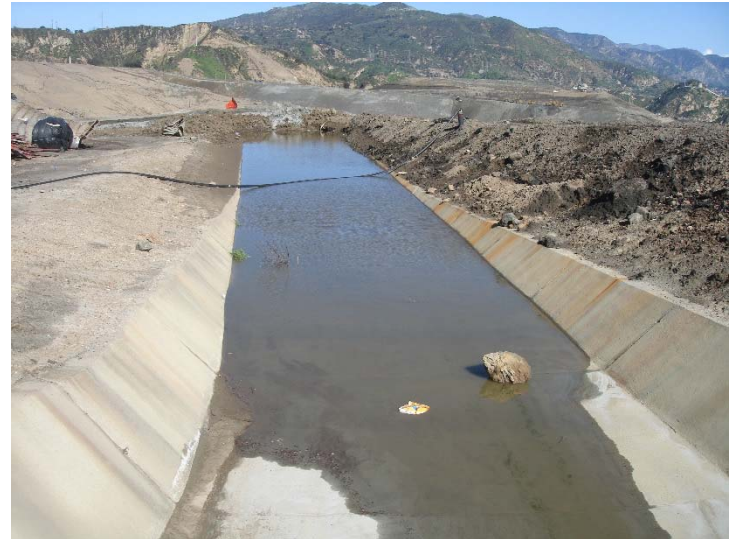
**Photo 37: Basin A Outlet: February 23, 2017**

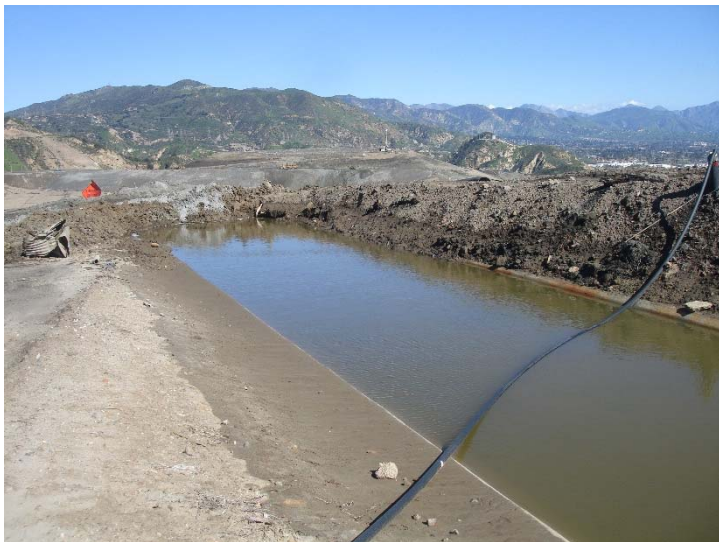
**Photo 38: Basin A Outlet: February 23, 2017**

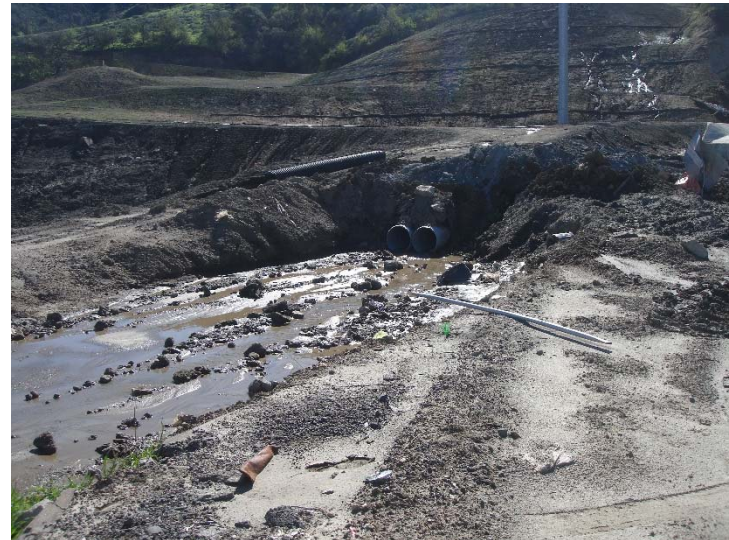
**Photo 39: Basin A Outlet: February 23, 2017**

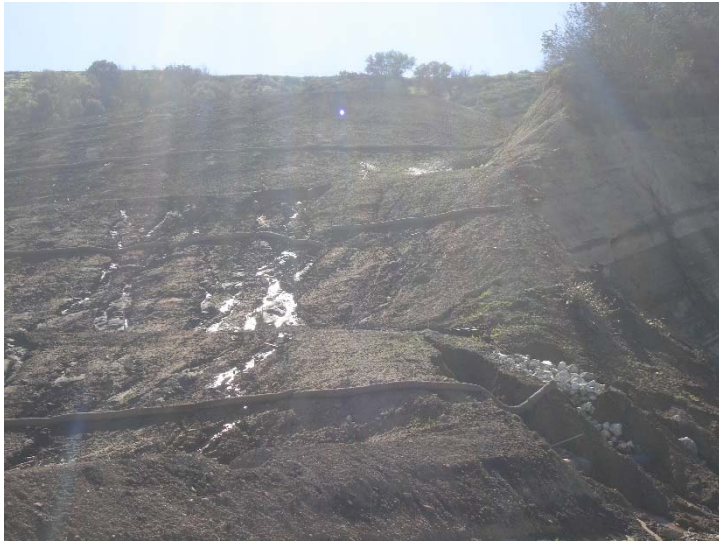
**Photo 40: Basin A Outlet: February 23, 2017**

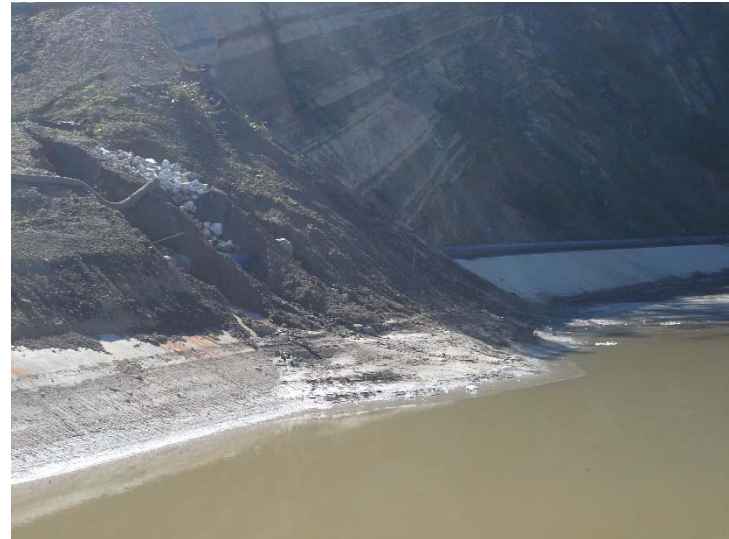
**Photo 41: Basin A Side Slope: February 23, 2017**

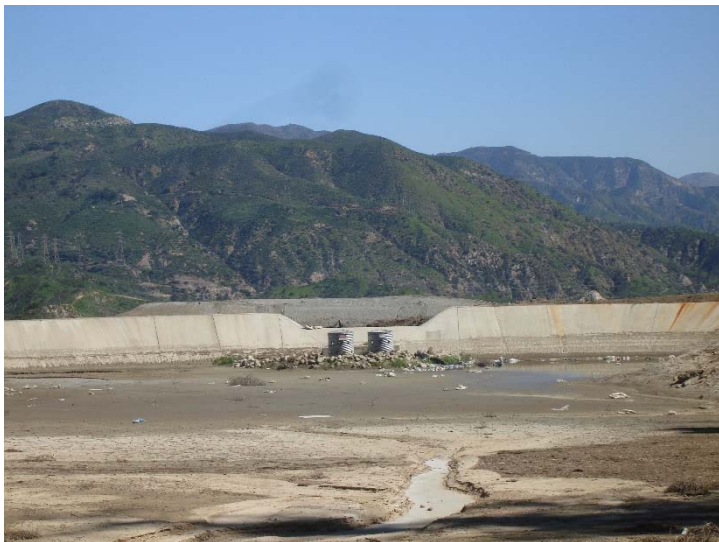
**Photo 42: Basin A Side Slope: February 23, 2017**

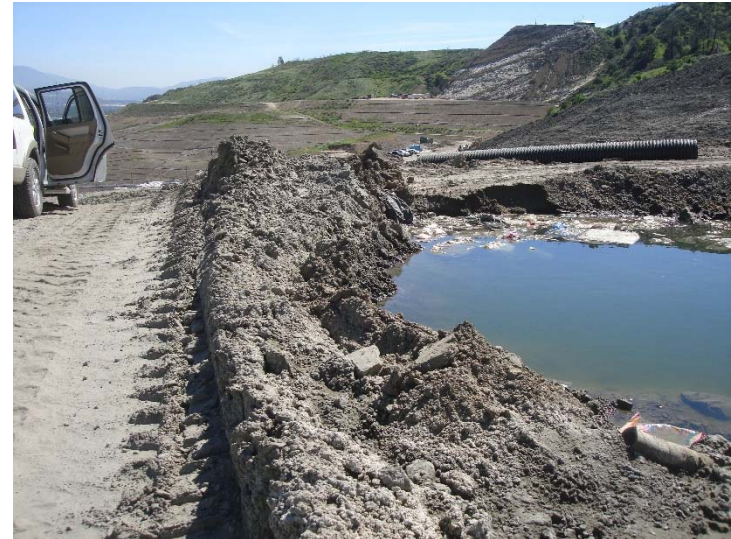
**Photo 53: Basin A Outlet Ponding Water: March 9, 2017**

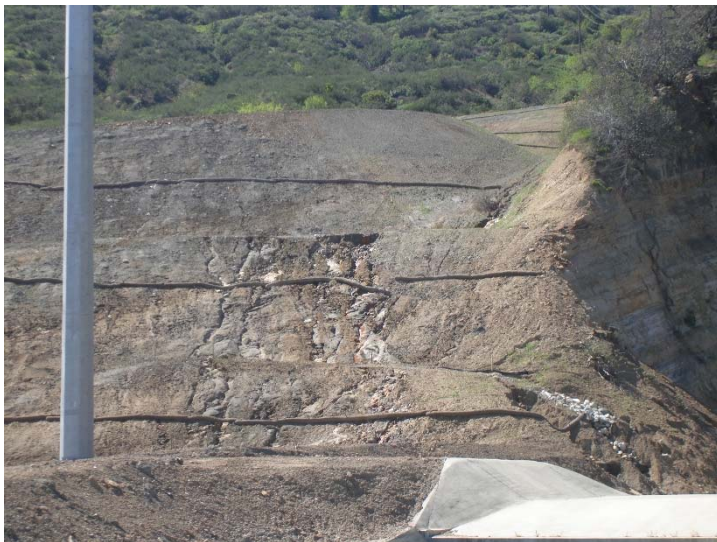
**Photo 54: Basin A Outlet Ponding Water: March 9, 2017**

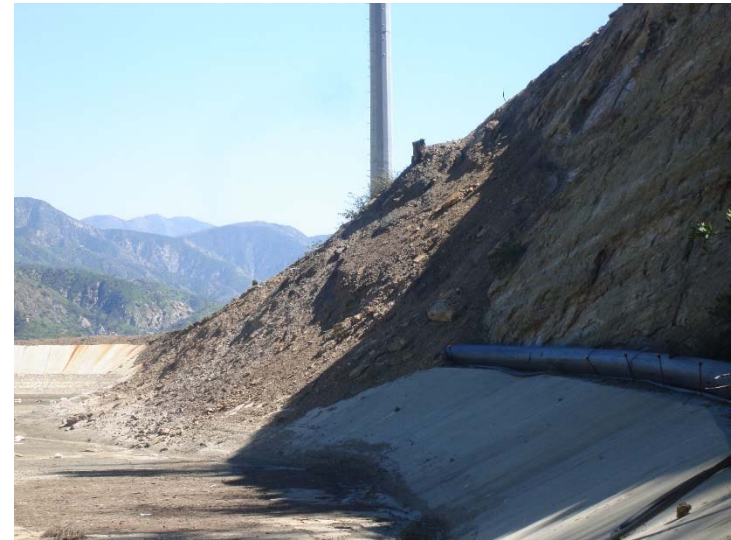
**Photo 55: Erosion in Adjacent Hillside to Basin A: March 9, 2017**

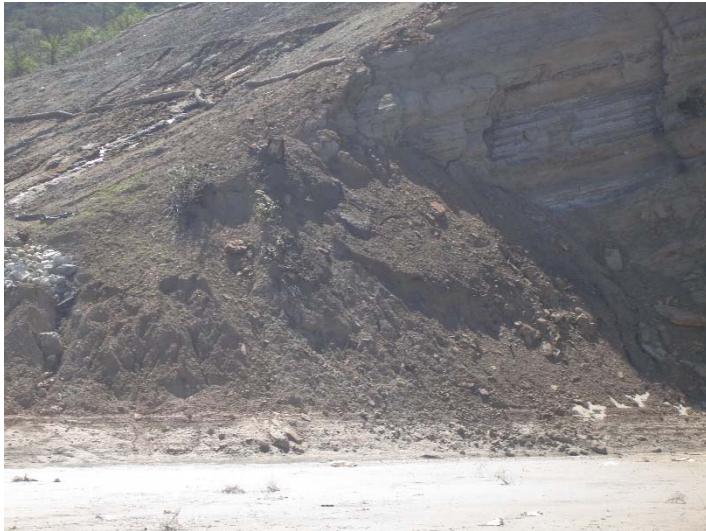
**Photo 56: Erosion in Adjacent Hillside to Basin A: March 9, 2017**

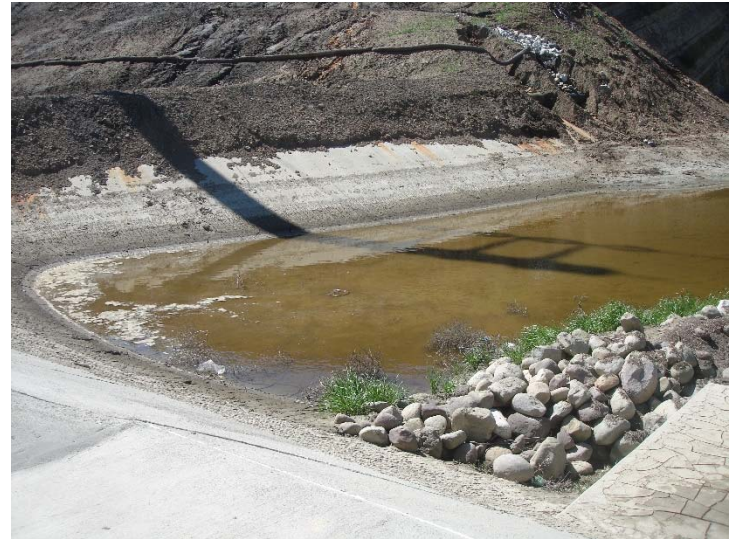
**Photo 57: Erosion in Adjacent Hillside to Basin A: March 9, 2017**

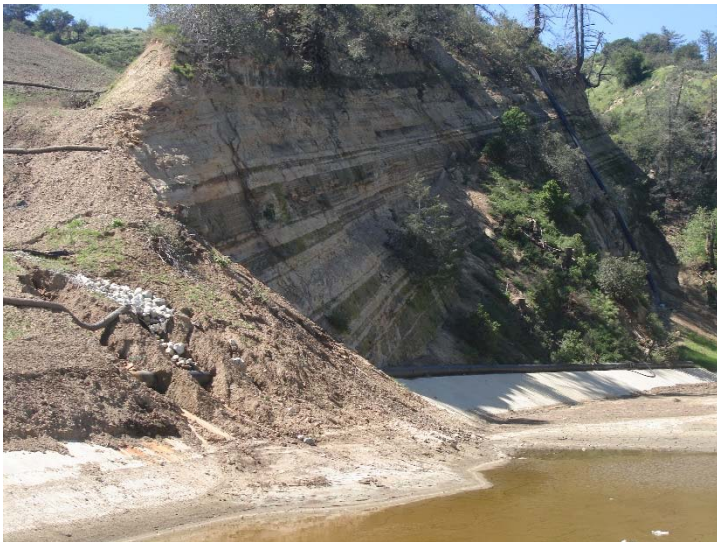
**Photo 62: Erosion in Adjacent Hillside to Basin A: March 23, 2017**

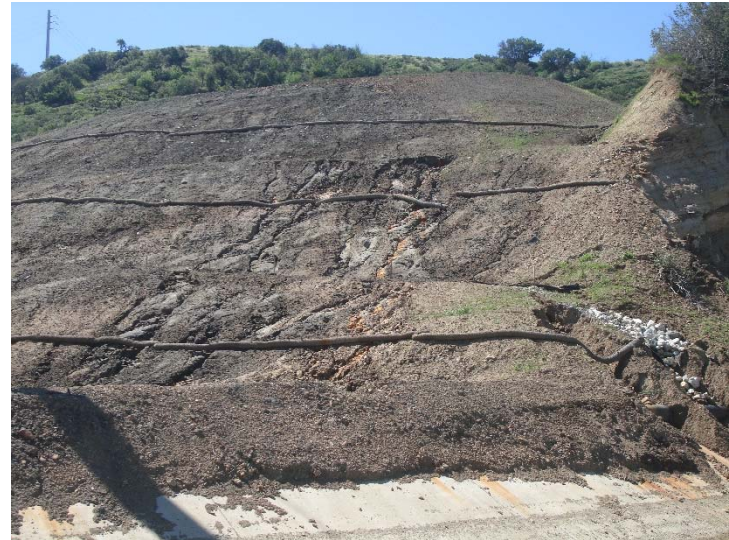
**Photo 63: Erosion in Adjacent Hillside to Basin A: March 23, 2017**

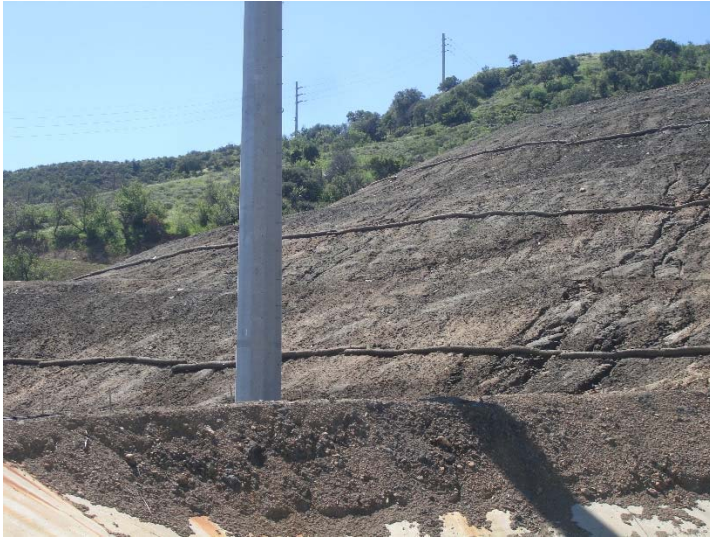
**Photo 64: Erosion in Adjacent Hillside to Basin A: March 23, 2017**

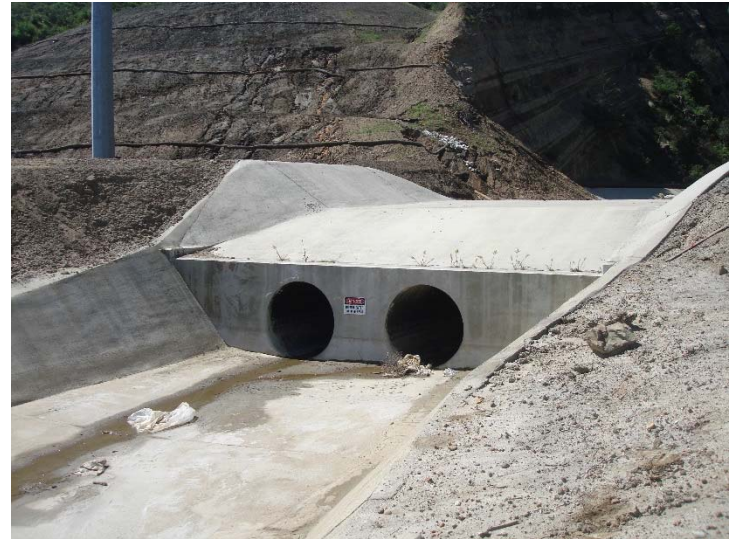
**Photo 65: Erosion in Adjacent Hillside to Basin A: March 23, 2017**

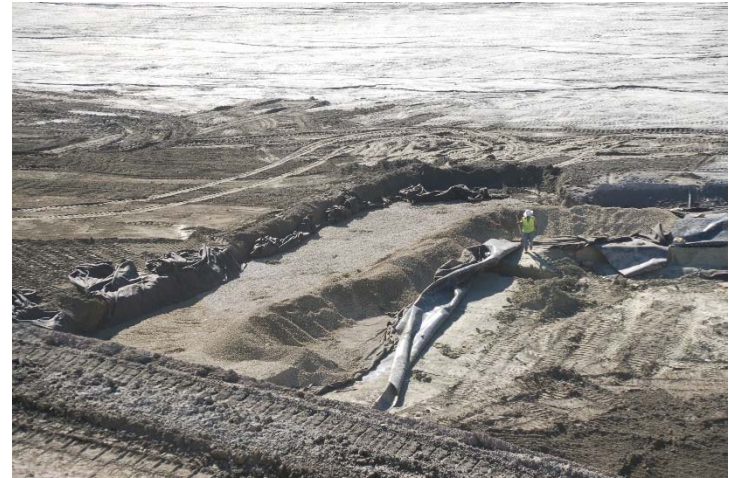
**Photo 78: CC4 Liner Area: January 17, 2017**

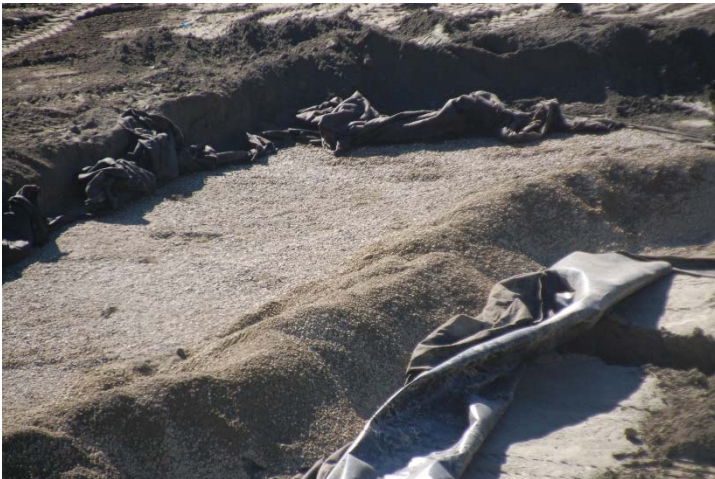
**Photo 79: CC4 Liner Area: January 17, 2017**

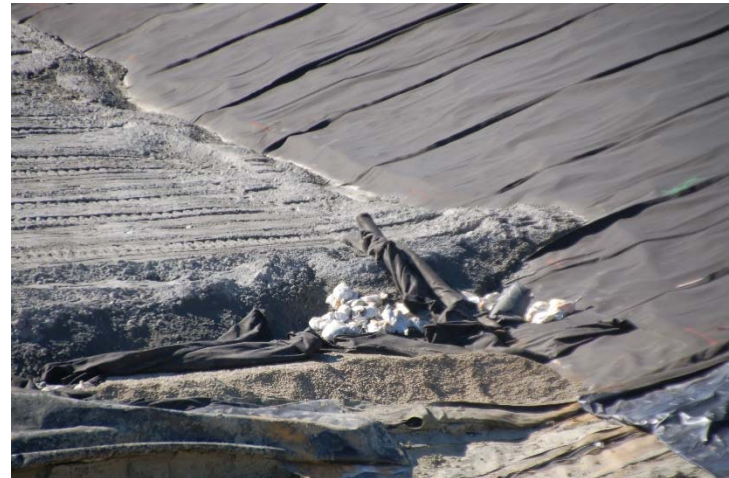
**Photo 80: CC4 Liner Area: January 17, 2017**

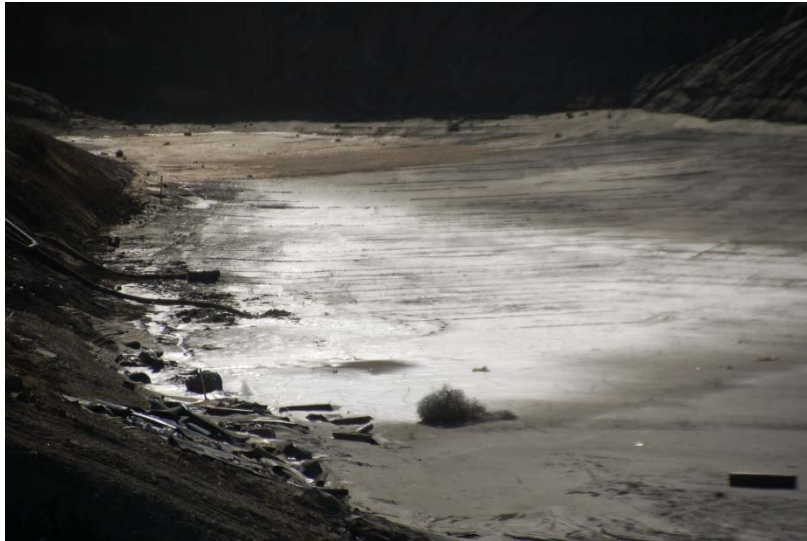
**Photo 81: CC4 Liner Area: January 17, 2017**

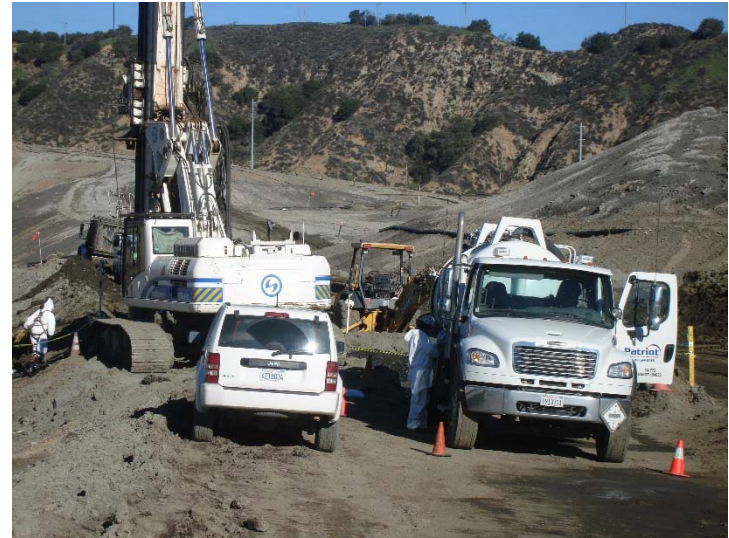
**Photo 82: Well Drilling on CC3A Bench: January 17, 2017**

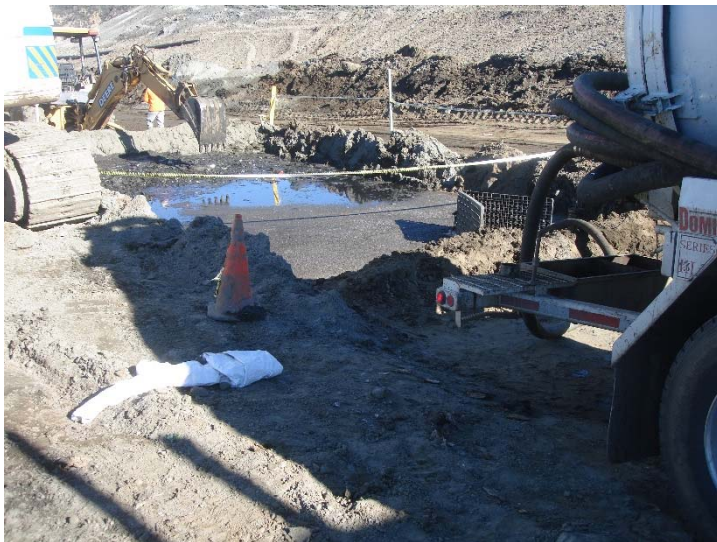
**Photo 83: Well Drilling on CC3A Bench: January 17, 2017**

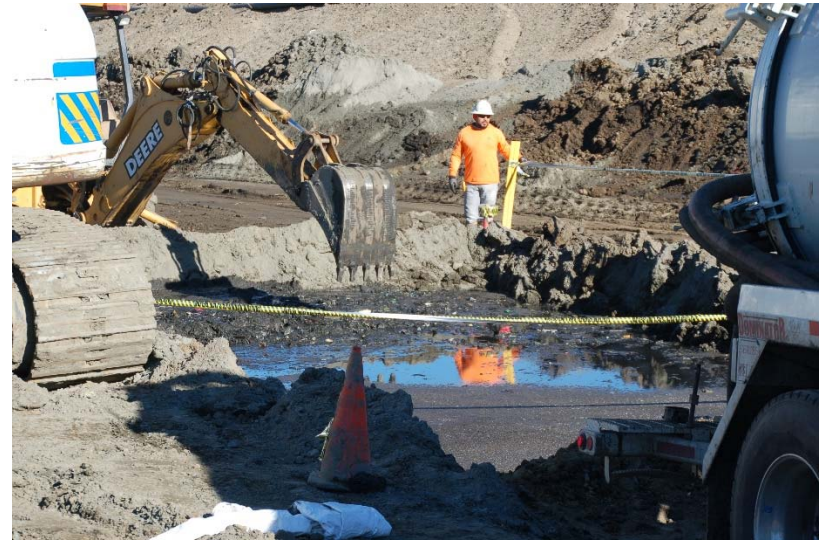
**Photo 84: Well Drilling on CC3A Bench: January 17, 2017**

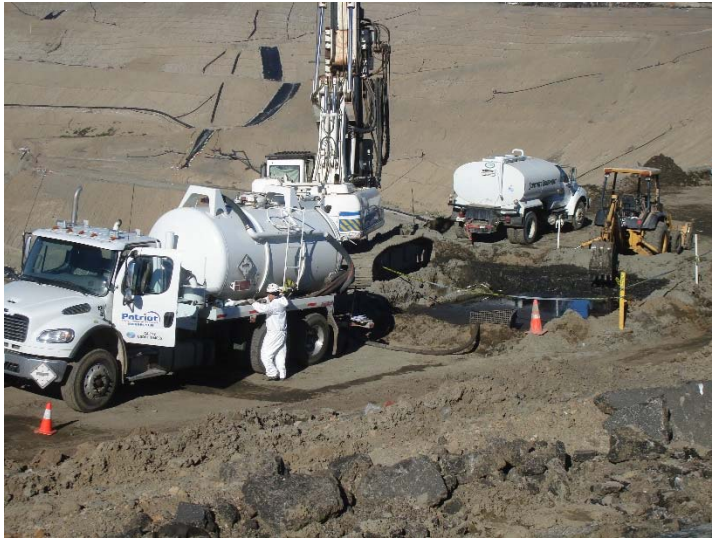
**Photo 85: Well Drilling on CC3A Bench: January 17, 2017**

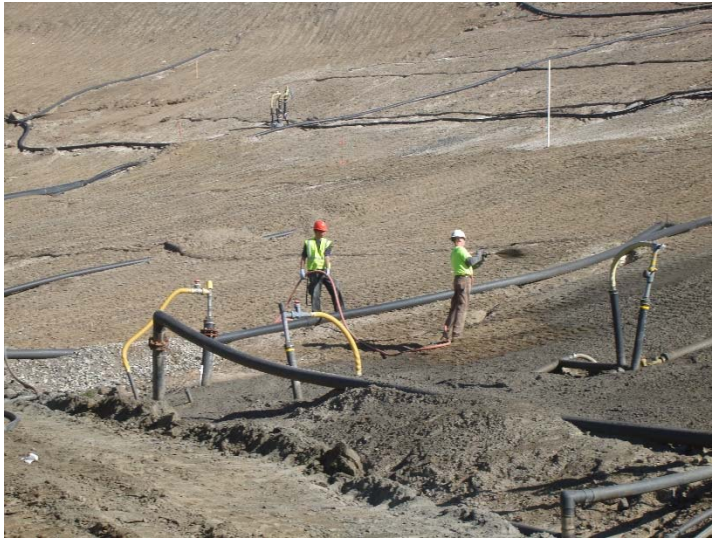
**Photo 101: Posi-Shell on Slopes above CC4 Liner Area: January 31, 2017**

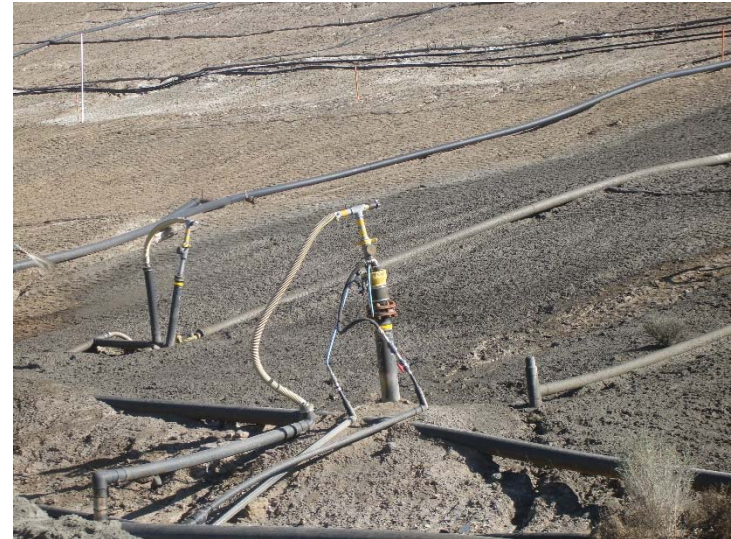
**Photo 102: Posi-Shell on Slopes above CC4 Liner Area: January 31, 2017**

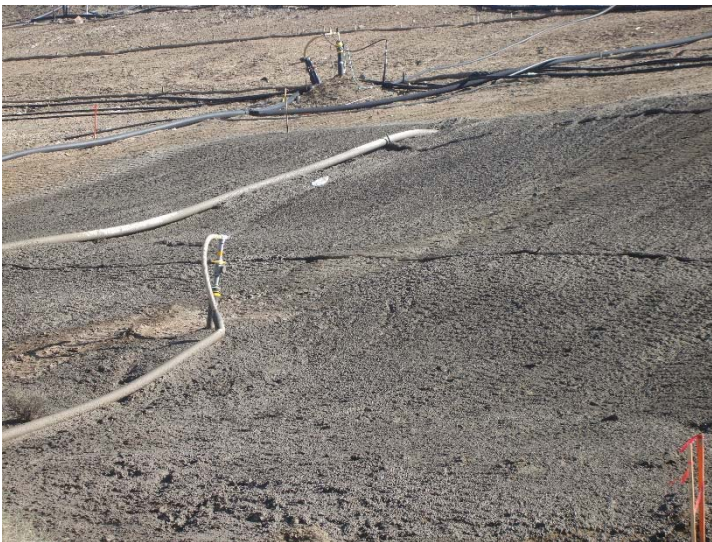
**Photo 103: Posi-Shell on Slopes above CC4 Liner Area: January 31, 2017**

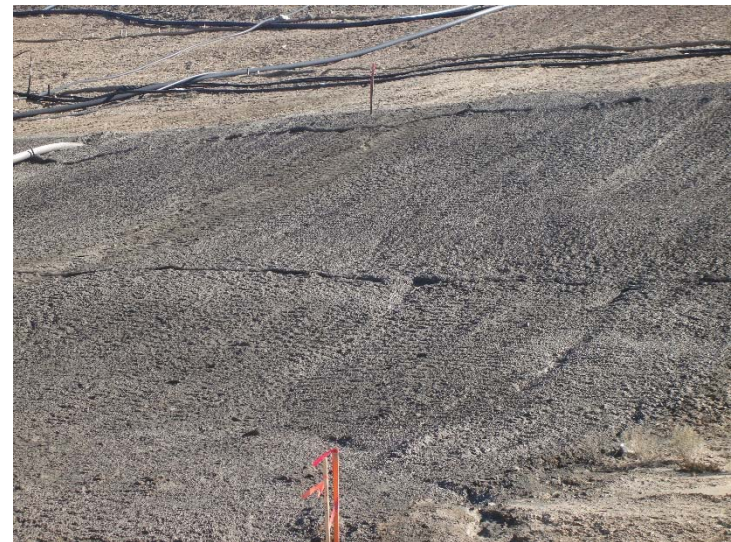
**Photo 104: Posi-Shell on Slopes above CC4 Liner Area: January 31, 2017**

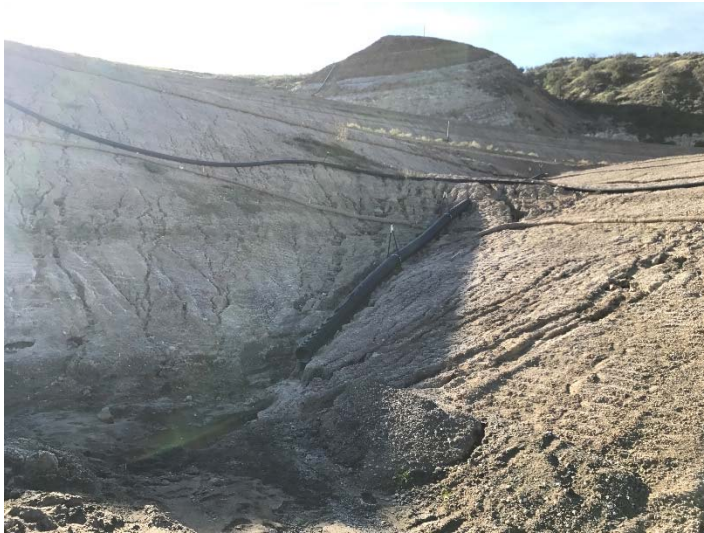
**Photo 105: CC3A Slopes Erosion: January 31, 2017**

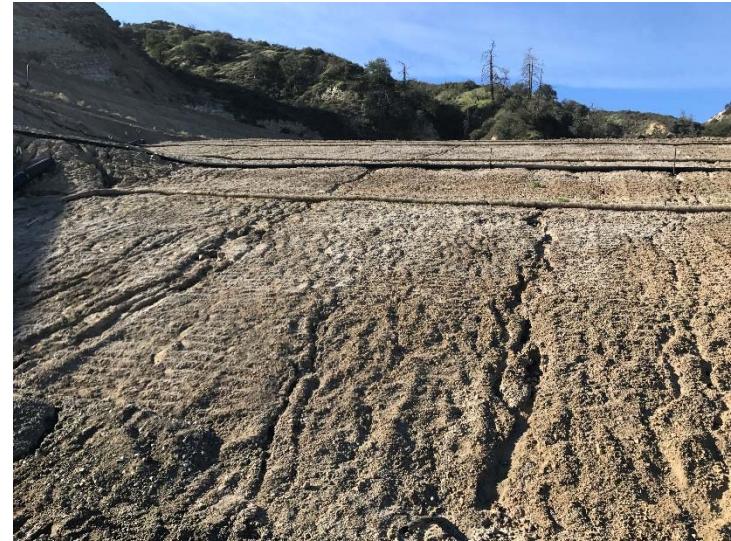
**Photo 106: CC3A Slopes Erosion: January 31, 2017**

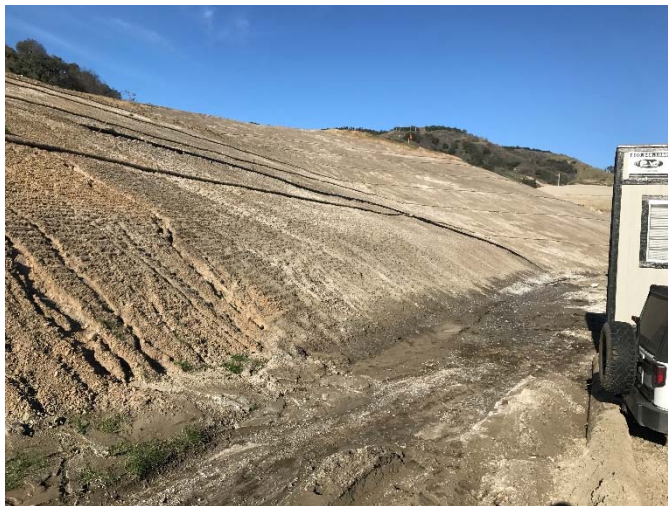
**Photo 107: CC3A Slopes Erosion: January 31, 2017**

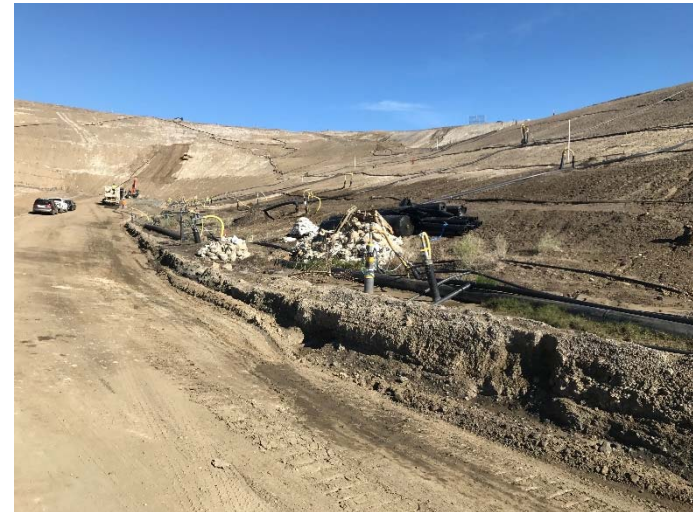
**Photo 108: CC3A Slopes Erosion: January 31, 2017**

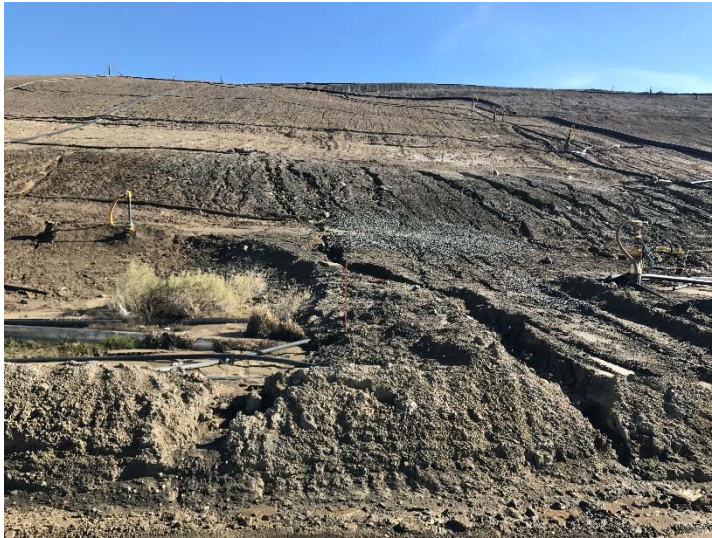
**Photo 109: CC3A Slopes Erosion: January 31, 2017**

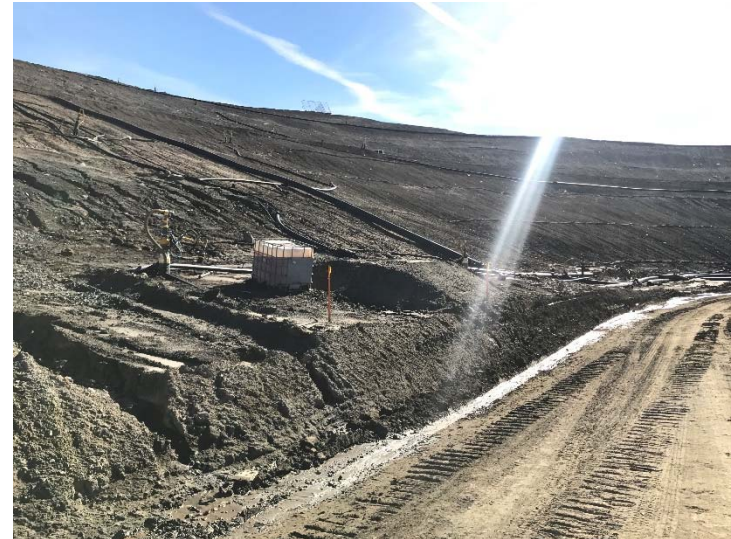
**Photo 110: CC3A Slopes Erosion: January 31, 2017**

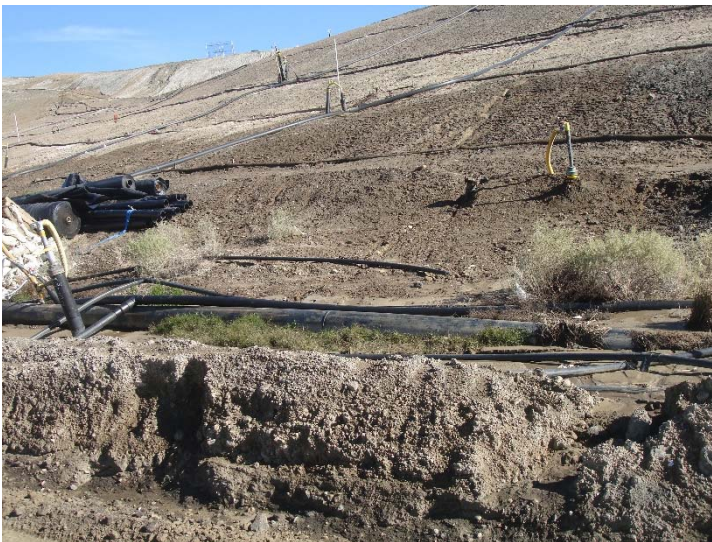
**Photo 111: CC3A Slopes Erosion: January 31, 2017**

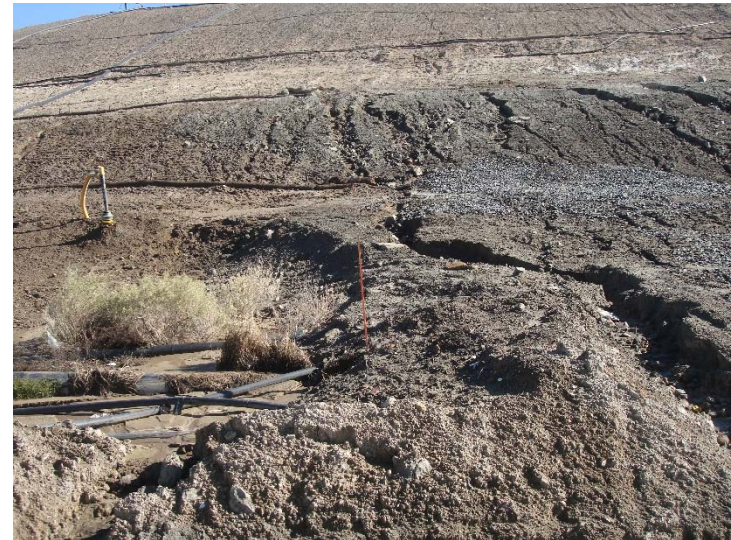
**Photo 112: CC3A Slopes Erosion: January 31, 2017**

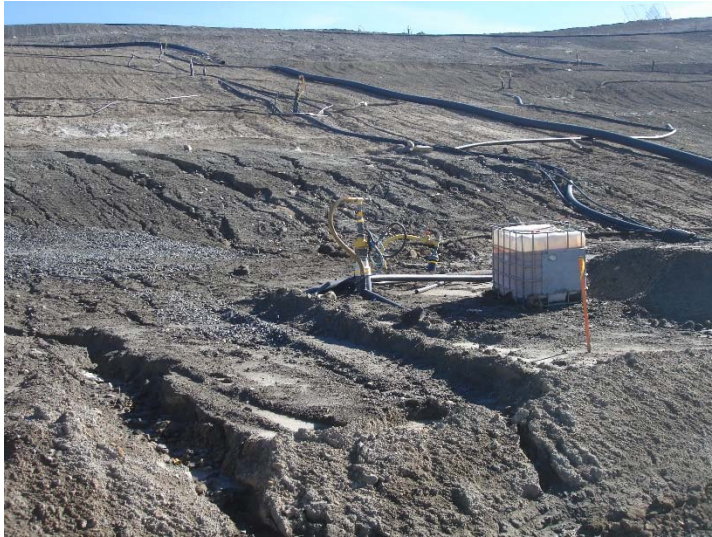
**Photo 113: CC3A Slopes Erosion: January 31, 2017**

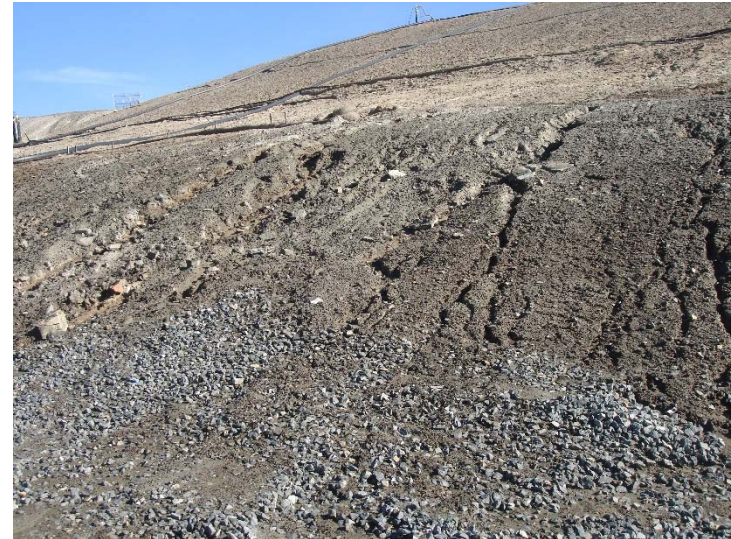
**Photo 114: CC3A Slopes Erosion: January 31, 2017**

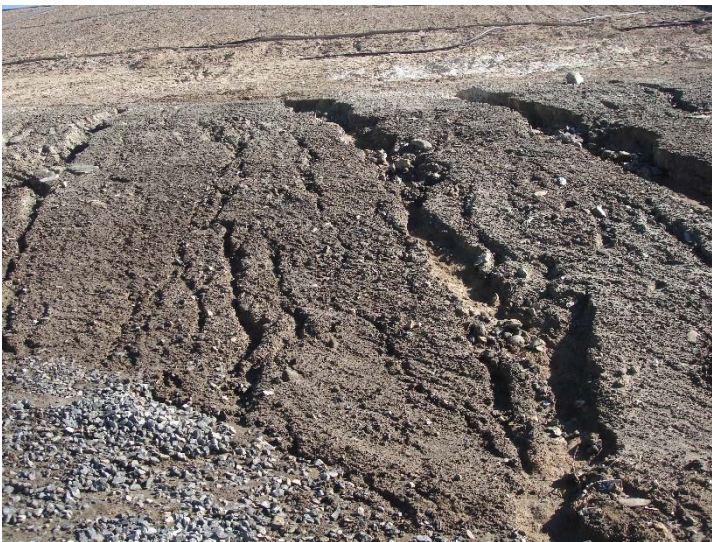
**Photo 115: CC3A Slopes Erosion: January 31, 2017**

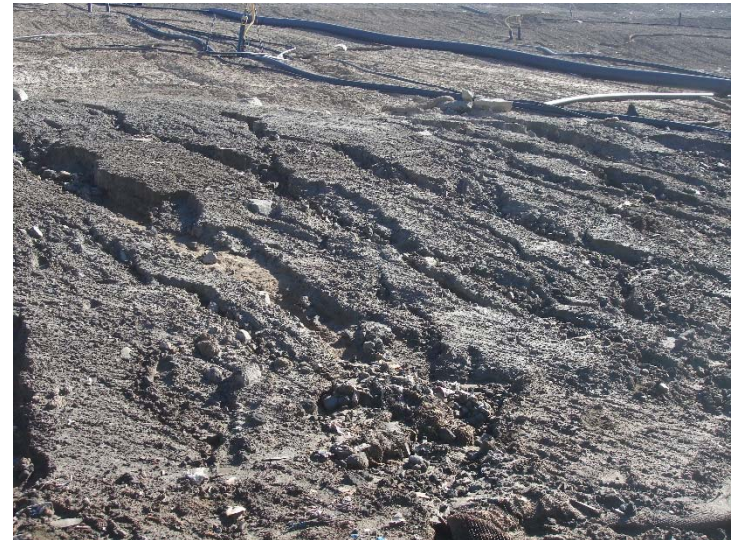
**Photo 116: CC3A Slopes Erosion: January 31, 2017**

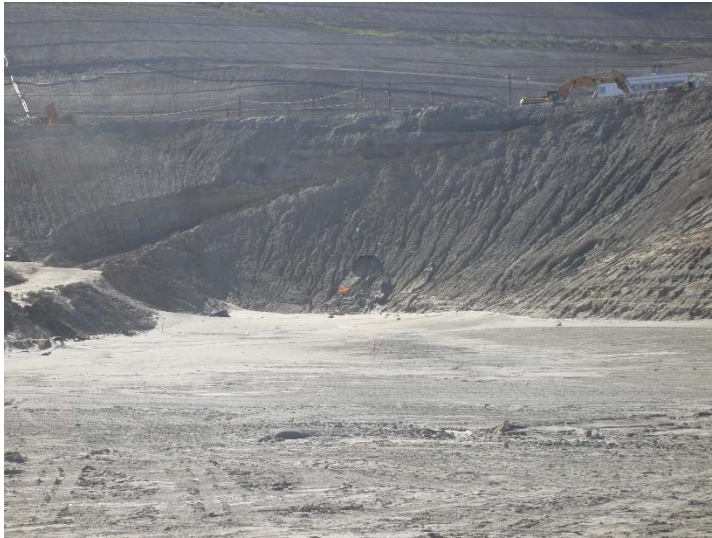
**Photo 117: CC3A Slopes Erosion: January 31, 2017**

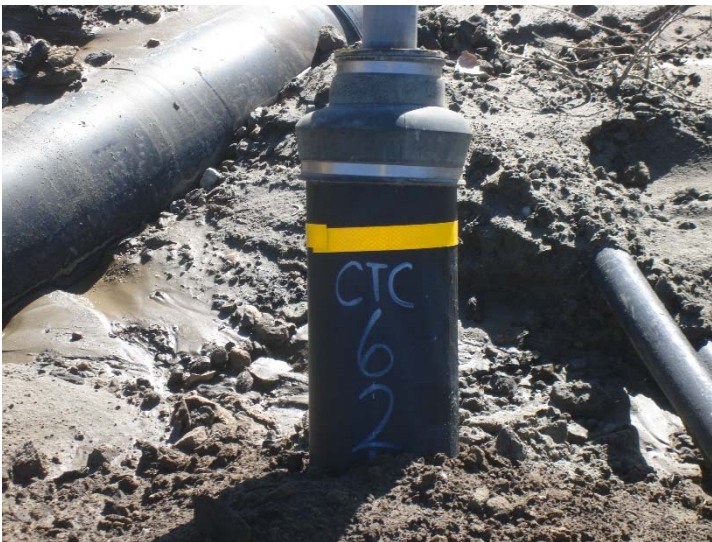
**Photo 118: CC3A Slopes Odors: January 31, 2017**

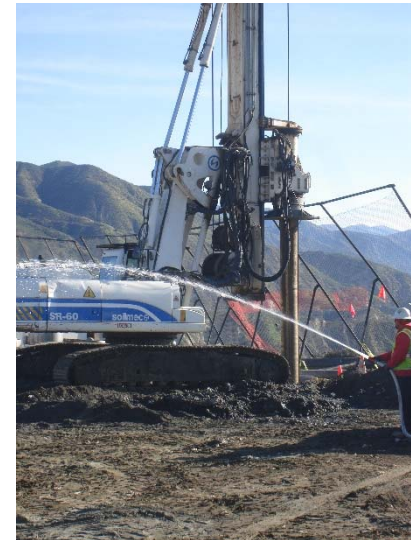
**Photo 119: CC3A Slopes Odors: January 31, 2017**

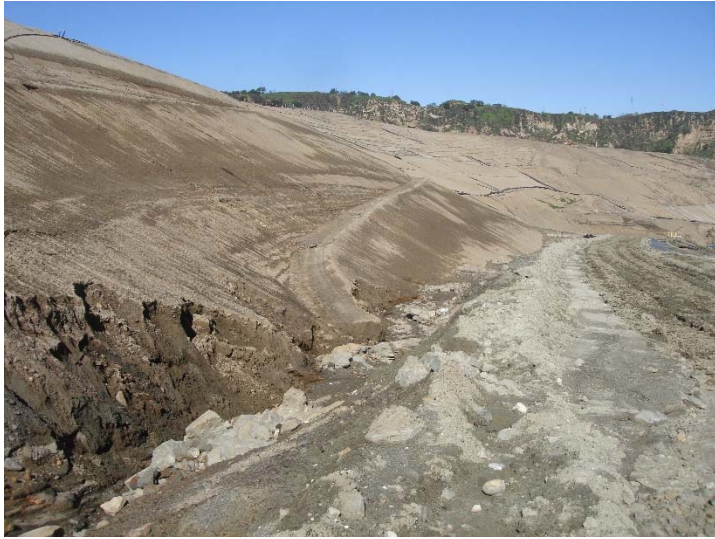
**Photo 124: Slope Erosion near CC4 Liner Area: February 23, 2017**

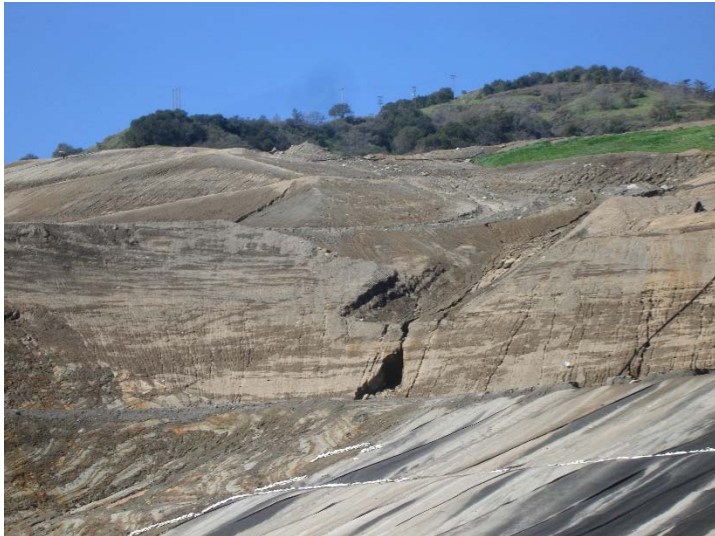
**Photo 126: Slope Erosion near CC4 Liner Area: February 23, 2017**

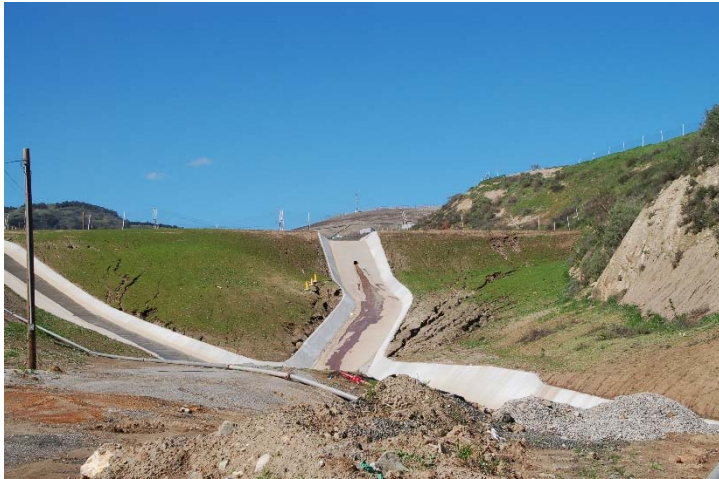
**Photo 128: Site Erosion: February 23, 2017**

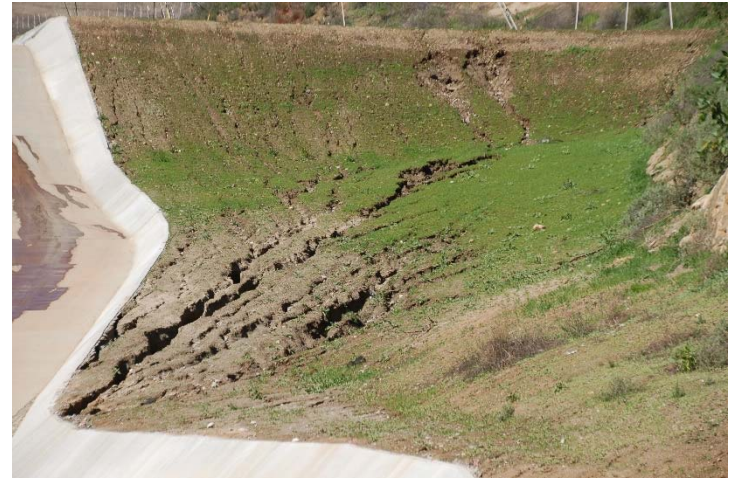
**Photo 129: Site Erosion: February 23, 2017**

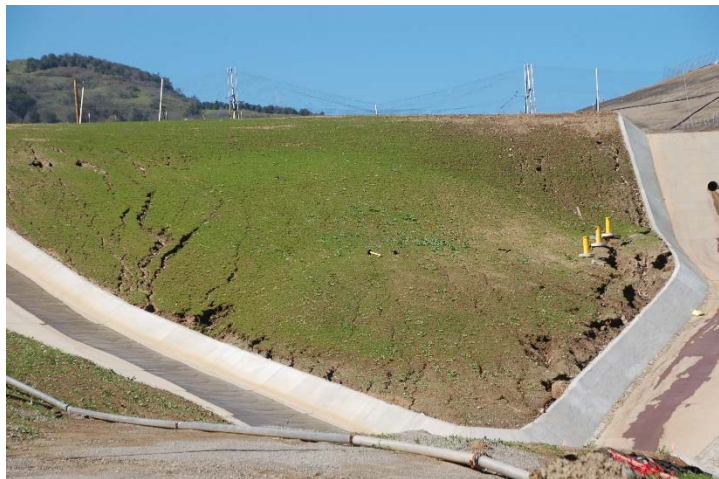
**Photo 130: Site Erosion: February 23, 2017**

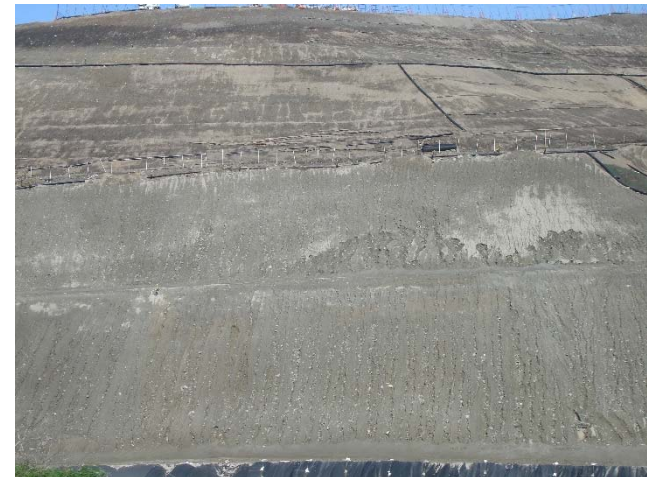
**Photo 131: Site Erosion: February 23, 2017**

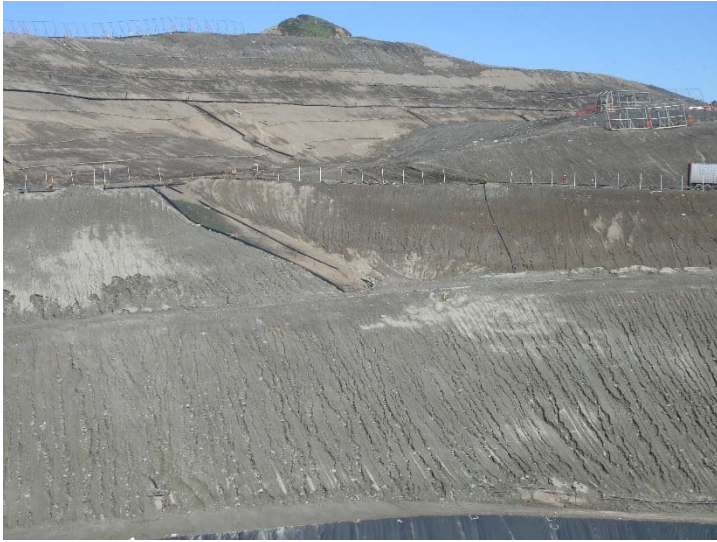
**Photo 132: Slope Erosion near CC4 Liner Area: February 23, 2017**

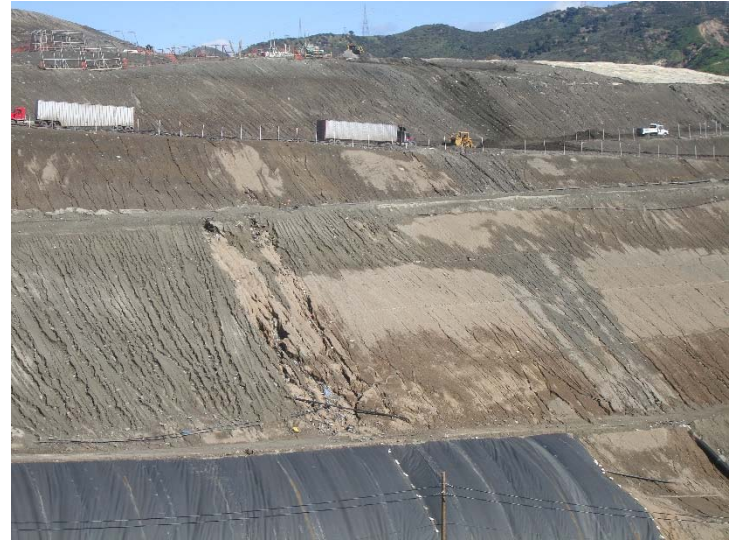
**Photo 133: Slope Erosion near CC4 Liner Area: February 23, 2017**

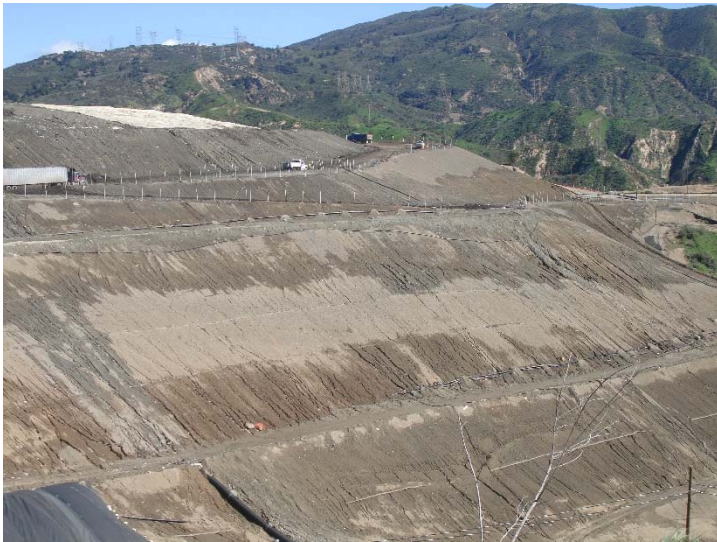
**Photo 134: Slope Erosion near CC4 Liner Area: February 23, 2017**

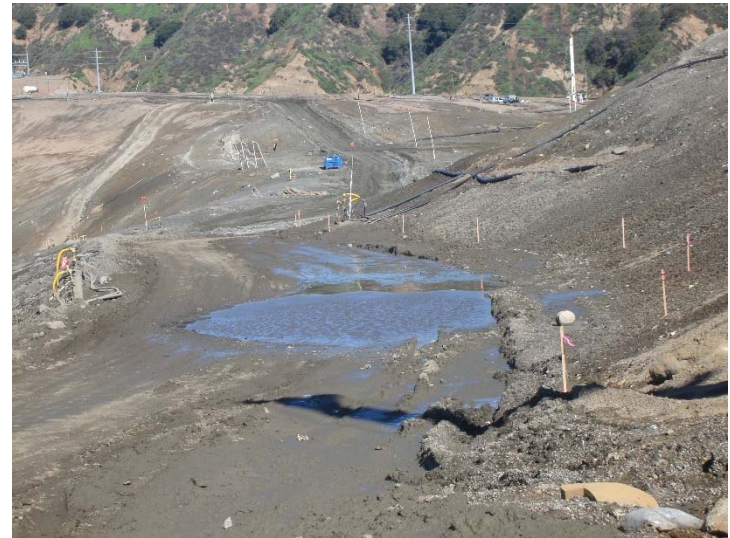
**Photo 135: Slope Erosion near CC4 Liner Area: February 23, 2017**

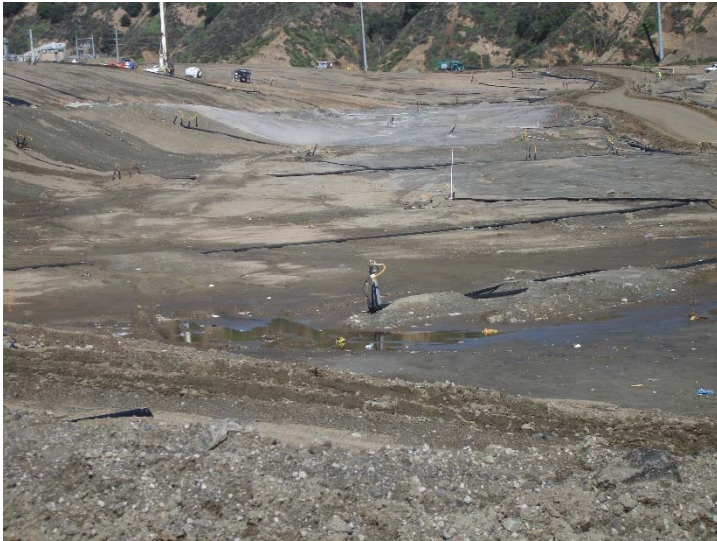
**Photo 136: Water Ponding near CC3A Access Road: February 23, 2017**

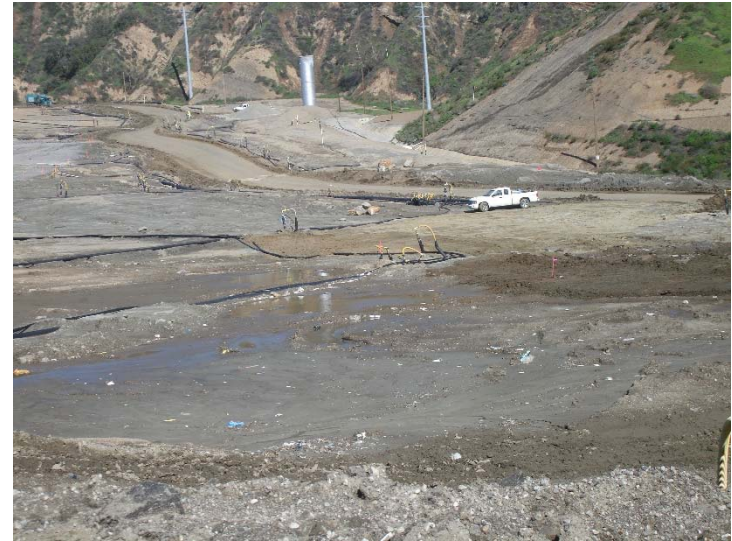
**Photo 137: Water Ponding near CC3A Access Road: February 23, 2017**

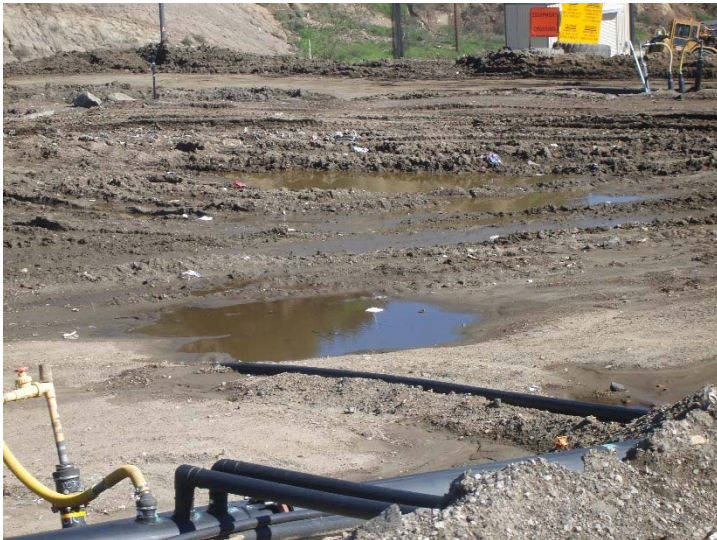
**Photo 138: Water Ponding near CC3A Access Road: February 23, 2017**

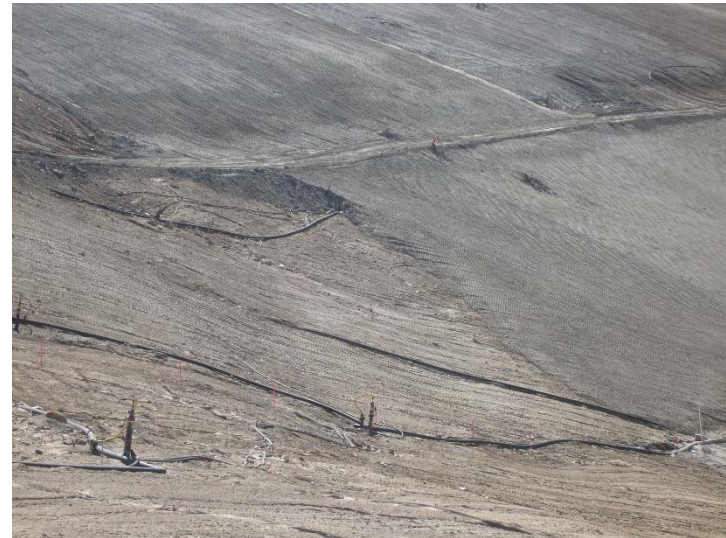
**Photo 159: Posi-Shell on Slopes above CC4 Liner Area: March 9, 2017**

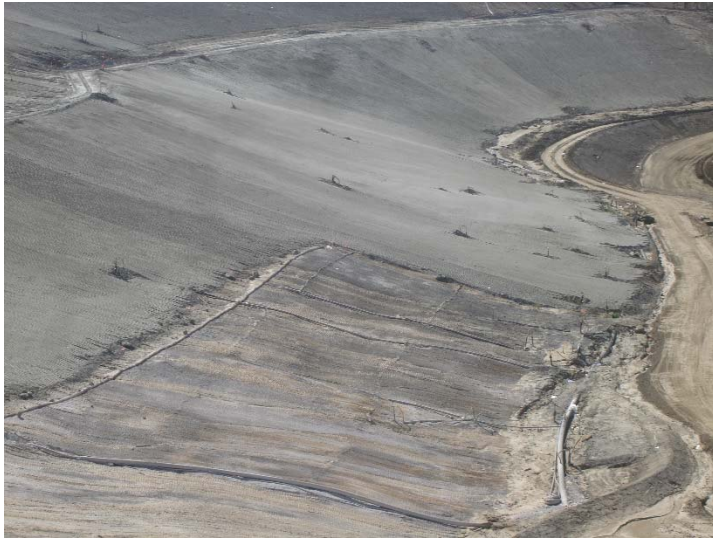
**Photo 160: Posi-Shell on Slopes above CC4 Liner Area: March 9, 2017**

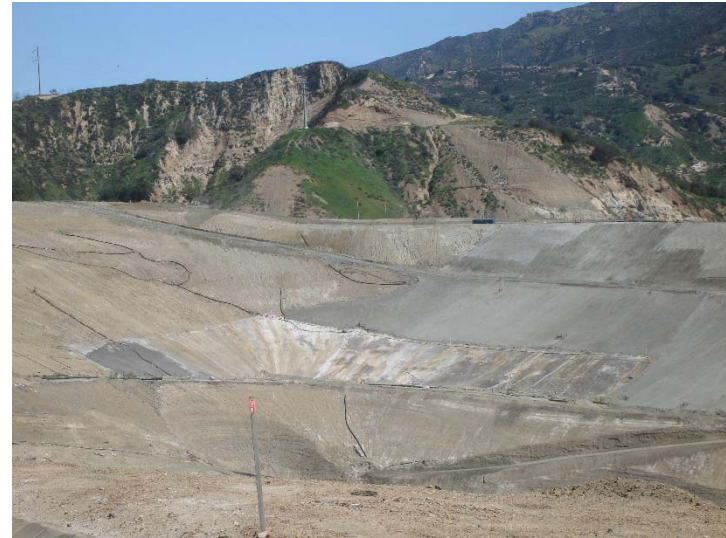
**Photo 161: Posi-Shell on Slopes above CC4 Liner Area: March 9, 2017**
