**Sunshine Canyon Landfill  
Independent Monitor  
Quarterly Site Monitoring Status Report  
January 1, 2017 – March 31, 2017**

**City of Los Angeles Department of City Planning**

**County of Los Angeles Department of Regional Planning**

April 26, 2017

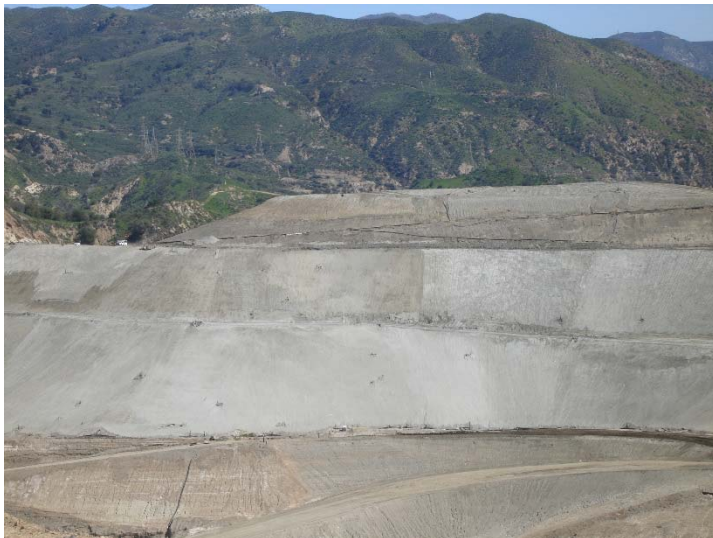
**Photo 162: Posi-Shell on Slopes above CC4 Liner Area: March 9, 2017**

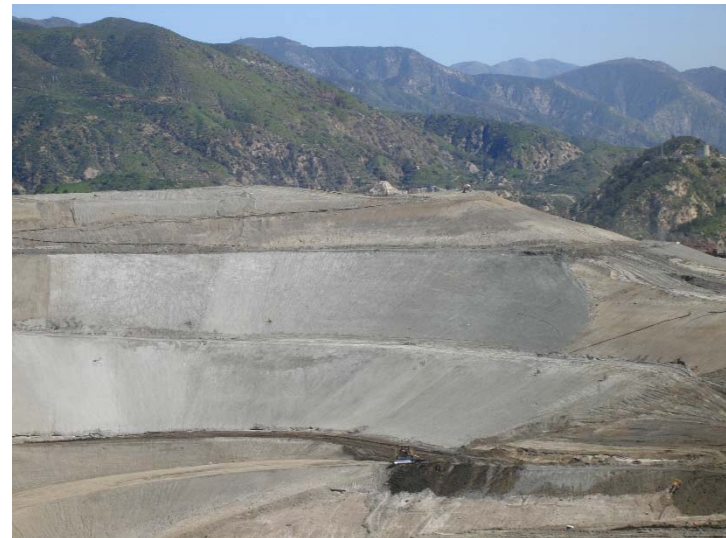
**Photo 163: Posi-Shell on Slopes above CC4 Liner Area: March 9, 2017**

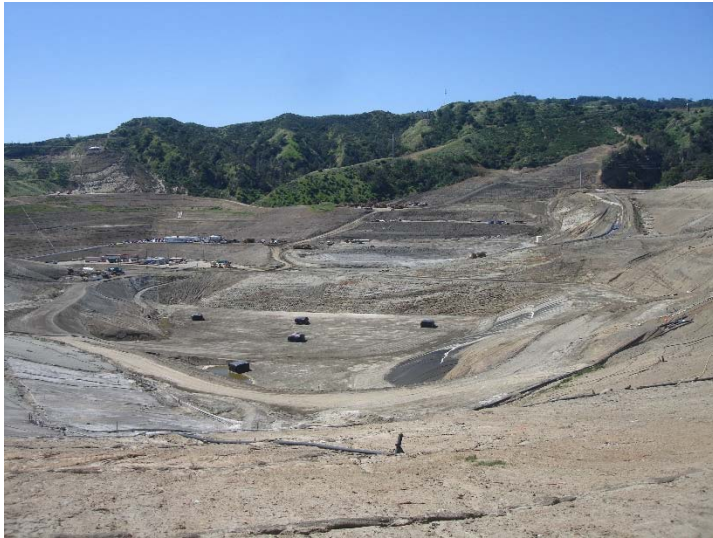
**Photo 164: Posi-Shell on Slopes above CC4 Liner Area: March 9, 2017**

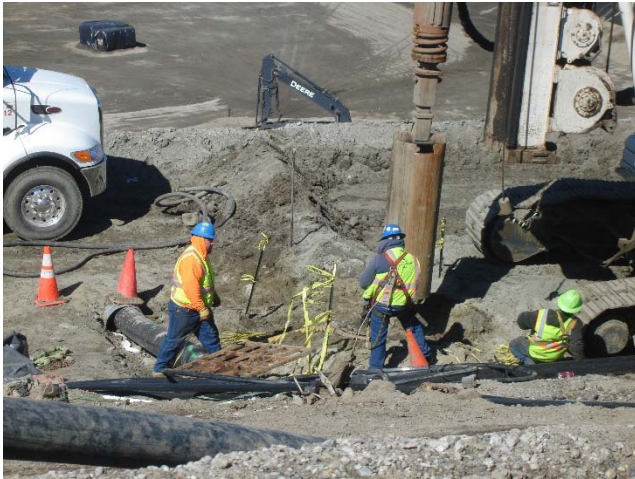
**Photo 180: Well Drilling on CC3A Bench: March 23, 2017**

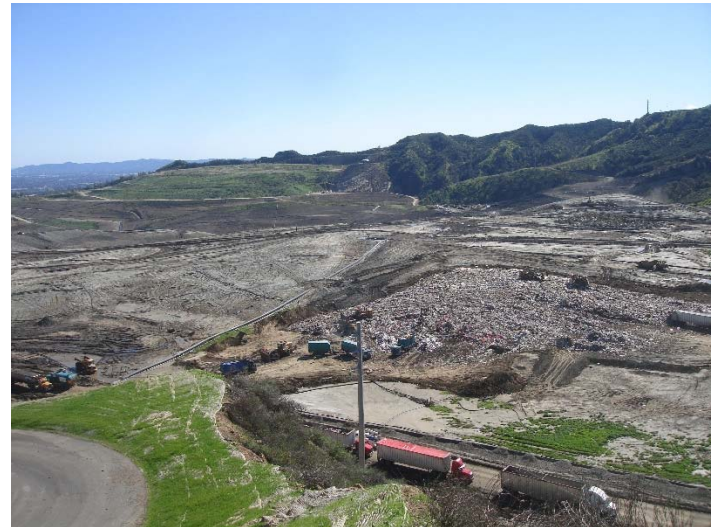
**Photo 238: County Top Deck Water Ponding: February 23, 2017**

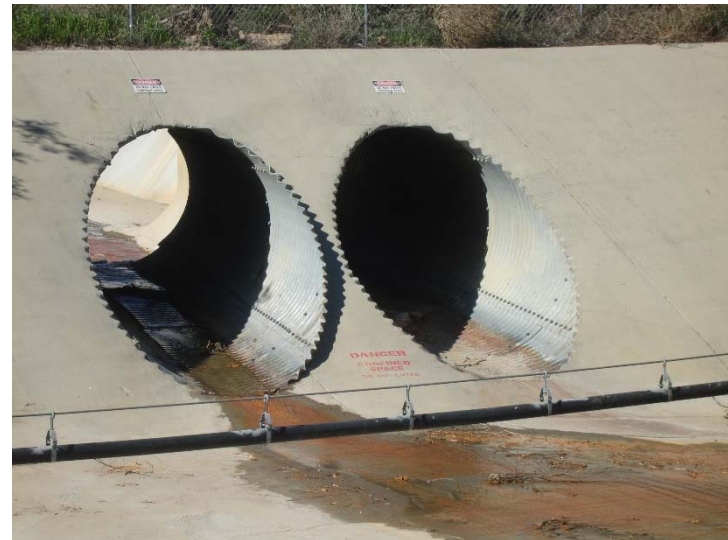
**Photo 320: Terminal Basin Inlet: January 31, 2017**

Discipline	City Condition Reference # / Mitigation #	County Condition Reference # / Mitigation #	Responsible Agency	Further Review Needed – Comments
Hydrologist				<p>I-c: There was significant amount of trash and sediment in the temporary basin below Cell CC-3B. The basin was filled with soil to the spillway level. The terminal basin had standing water and a significant amount of sediment around the outlet risers. There was approximately two feet of free board to the top of the risers. There was minimal water flow leaving the basin. There was sediment observed on the outlet side. Basin B had a minimal amount of sediment and standing water. Soil slid down from the hillside in the far eastern area of the basin. There was trash in the basin's sediment. Basin D was clean and dry. Basin A had standing water. There was sediment around the rock filter for the outlet risers. Soil from the Edison pole construction slid into the basin. The adjacent hillside had an active spring flowing water down a slope and cut ribbons into the hillside. The basin outlet channel was blocked and had approximately two feet of standing water.</p> <p>I-d: Basin D was observed to be dry and free of sediment. Basin A had standing water near the outlet risers and a significant amount of sediment. The Basin A outlet channel was blocked by a construction road and had ponding water. The cut hillsides south of Basin A had significant sloughing of soil into the basin. There was a significant amount of sediment in the terminal basin. The outlet risers were covered with trash and were significantly blocked with sediment. Sediment was observed in the outlet channel of the terminal basin.</p>

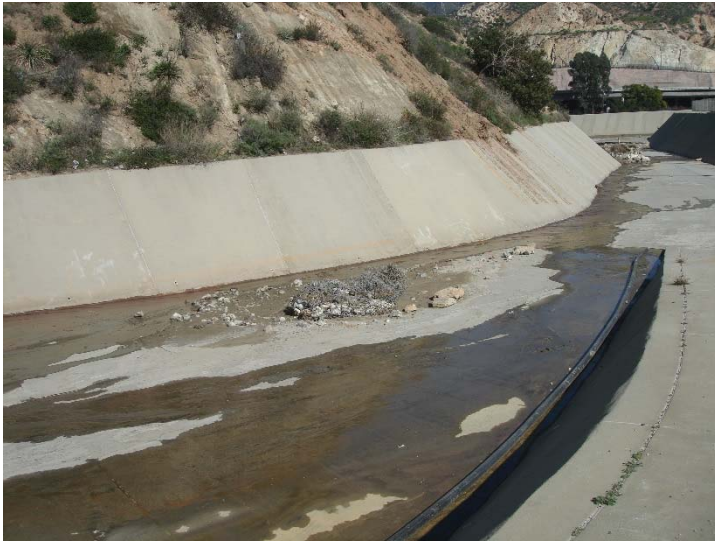
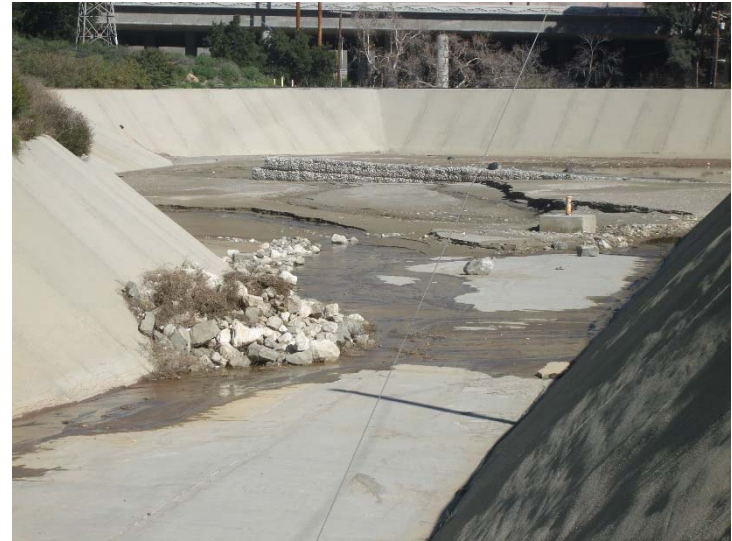
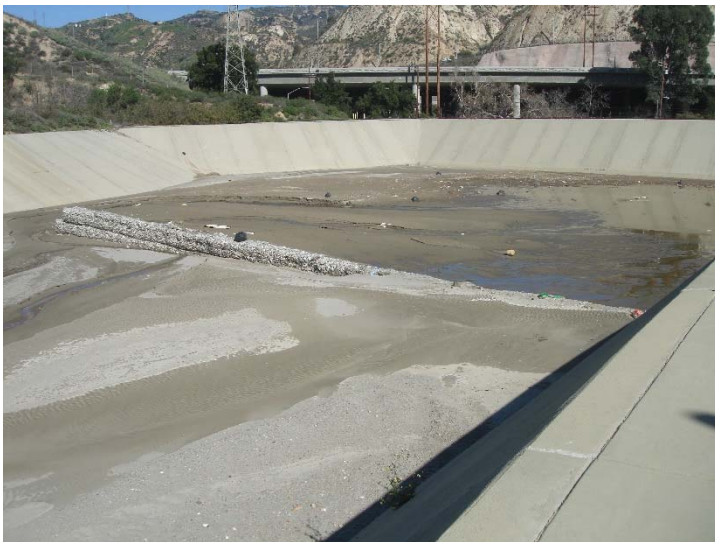
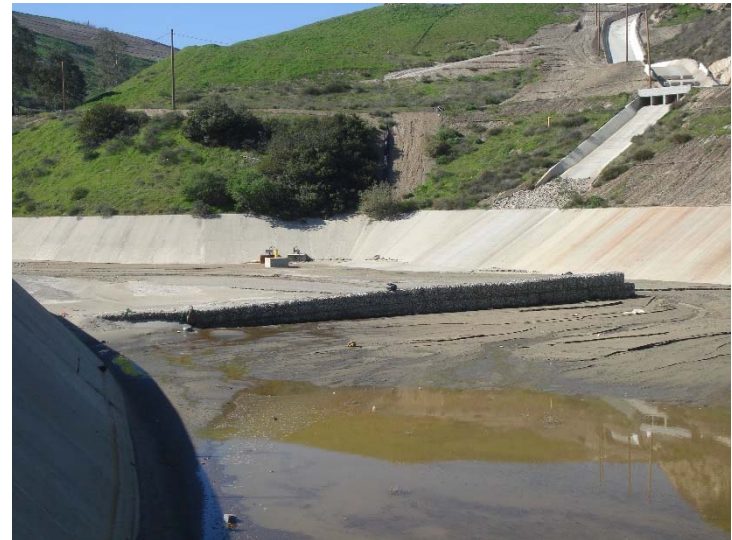
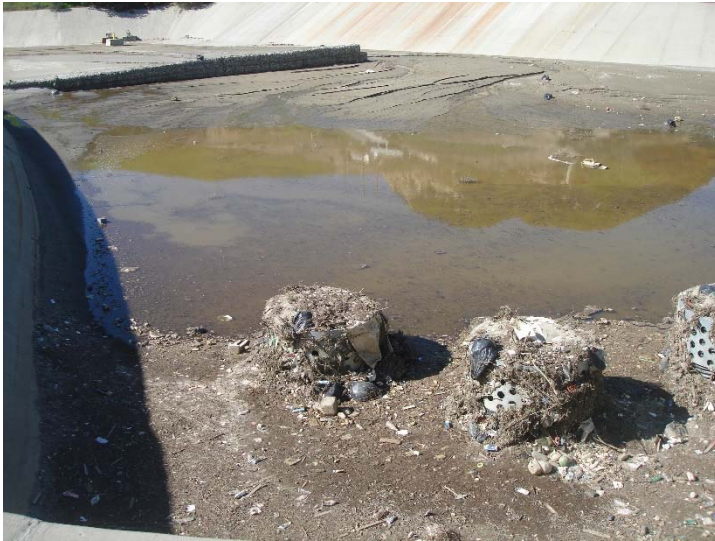
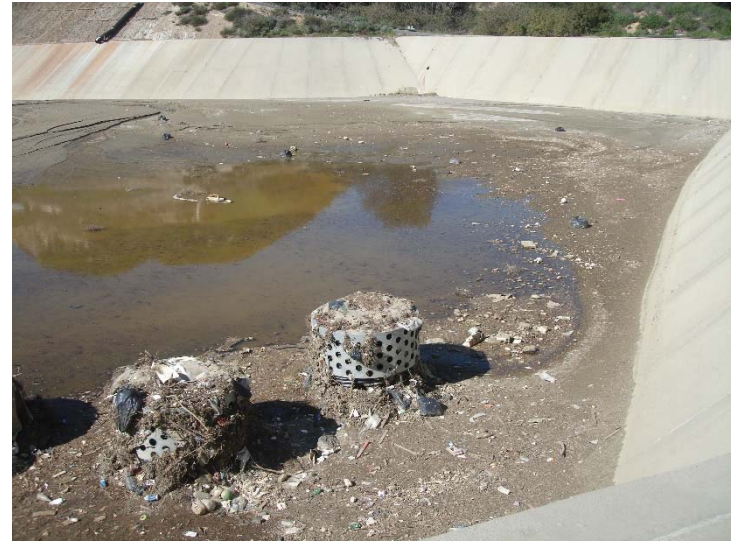
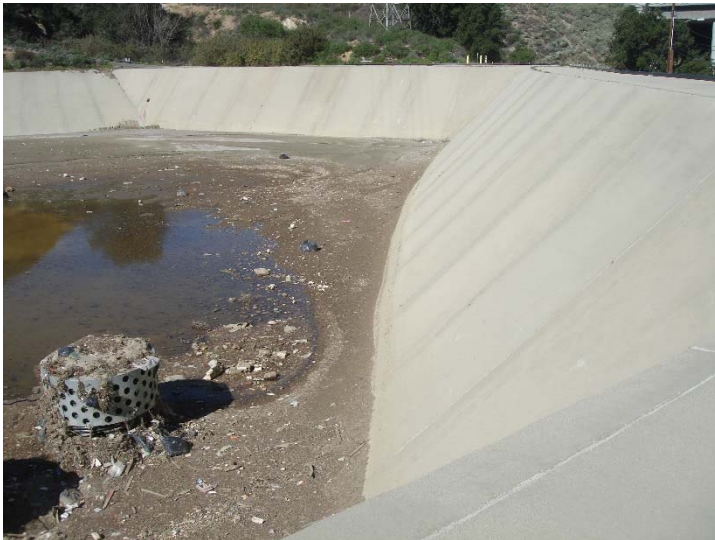
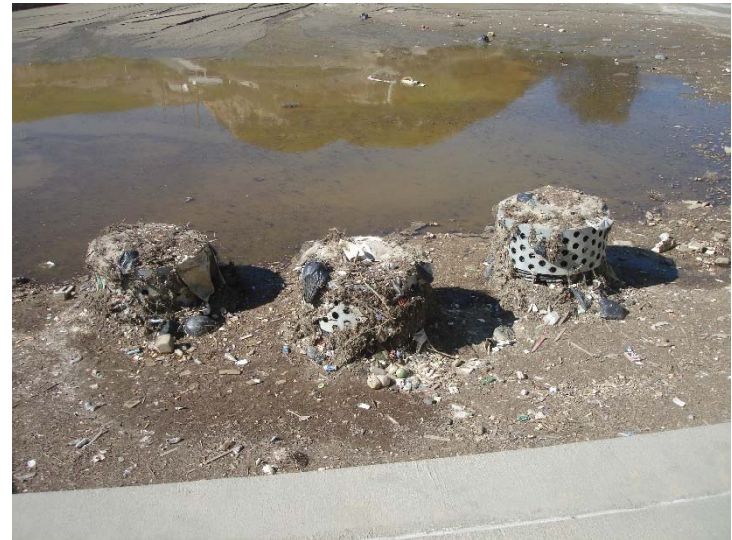
**Photo 321: Terminal Basin: January 31, 2017**

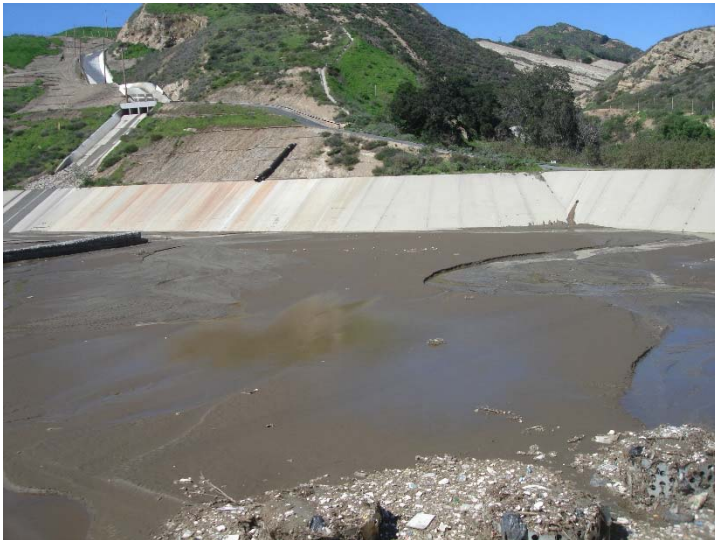
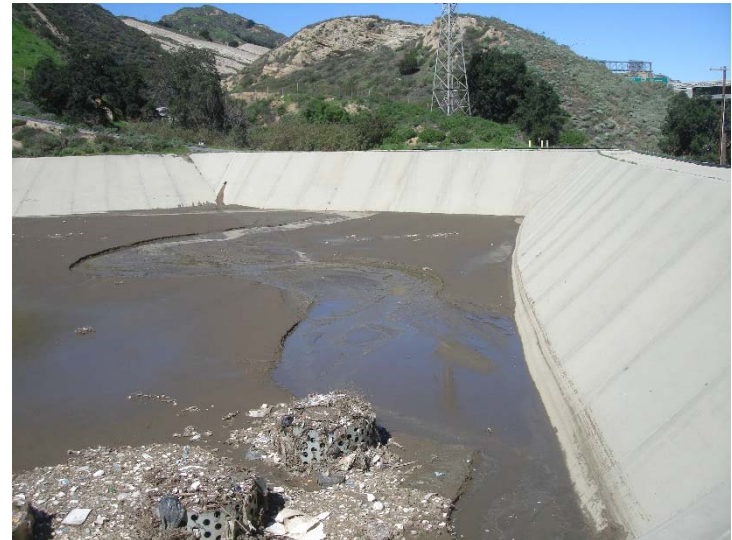
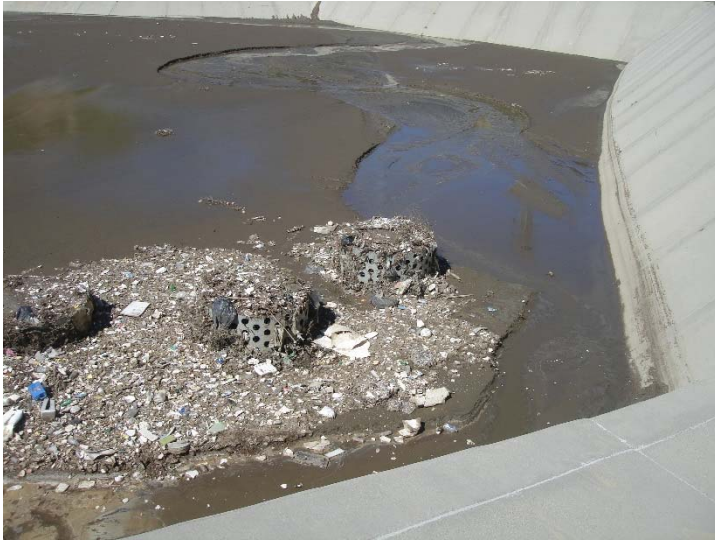
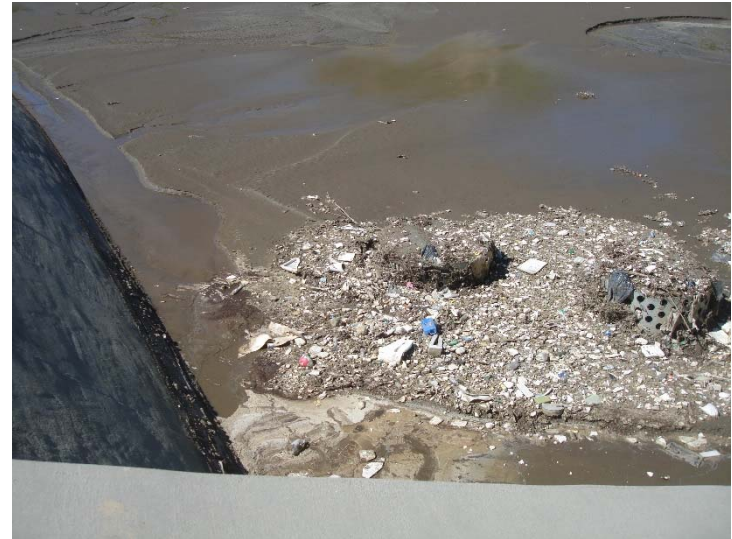
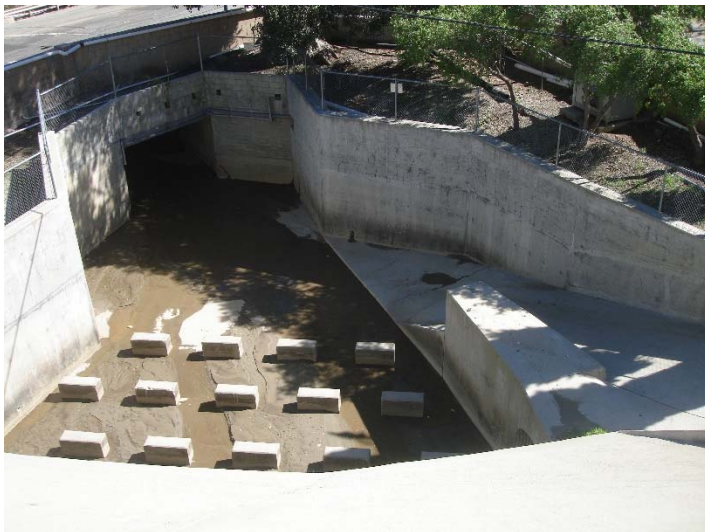
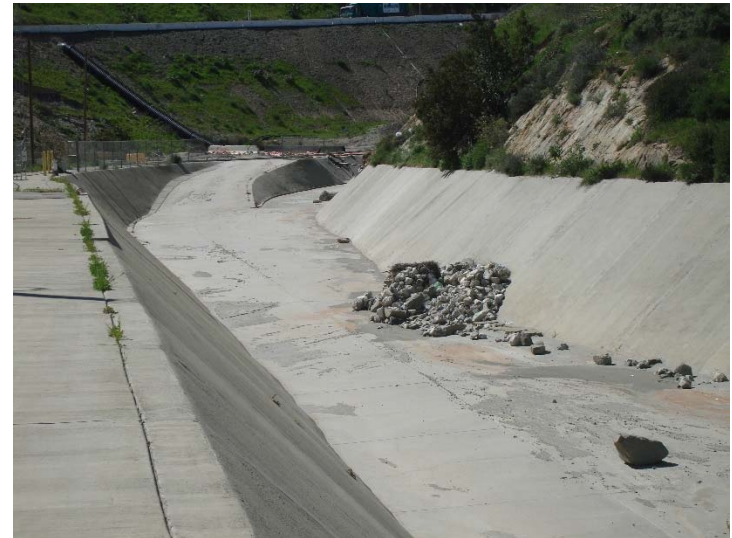
<p>I-e: The temporary basin below Cell CC3B had ponding water being pumped and sediment being removed. The prior noted trash in the basin had been removed. The terminal basin had additional sediment since the last site monitoring, with surface water ponding around the outlet risers. The risers were covered with trash and significantly blocked by sediment, restricting current capacity to handle rainwater. Portions of the basin had sediment moved to piles to drain water. Removal of sediment was in progress. Basin B had sediment with minor amounts of ponding water. The native hillside had minimal wind-blown litter.</p> <p>Basin D was dry and had no sediment from the rains. Basin A had standing water and the risers appeared to be blocked by sediment with minimal draining occurring. The outlet channel blockage had been cleared. The southern graded slopes had soil slough into the basin from the rainwater runoff.</p>

**Photo 334: Terminal Basin: February 23, 2017**

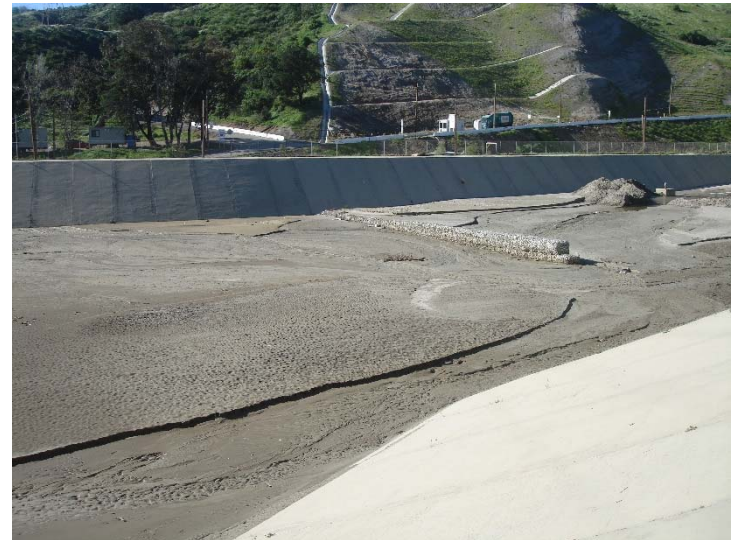
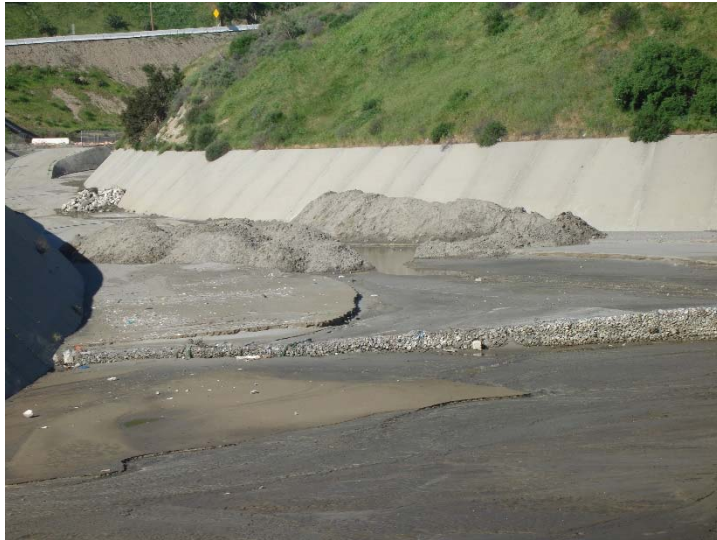
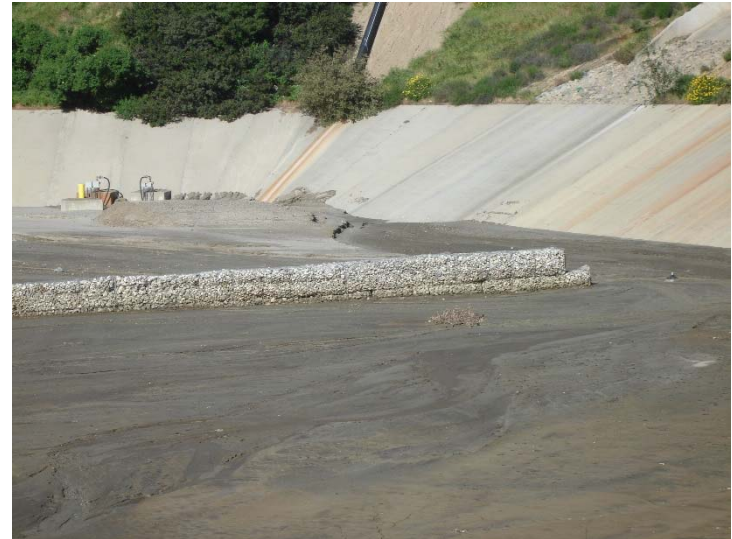
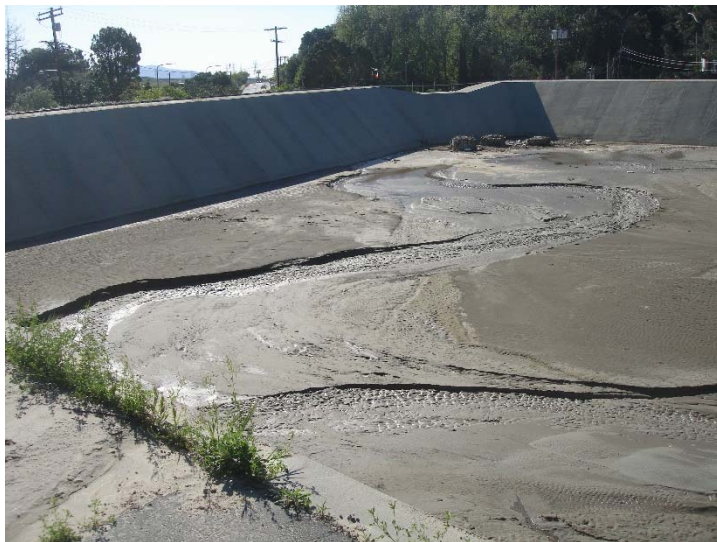
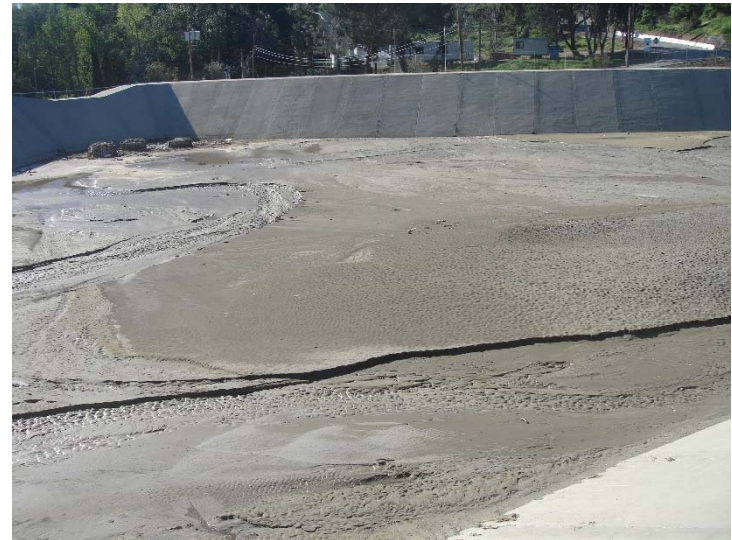
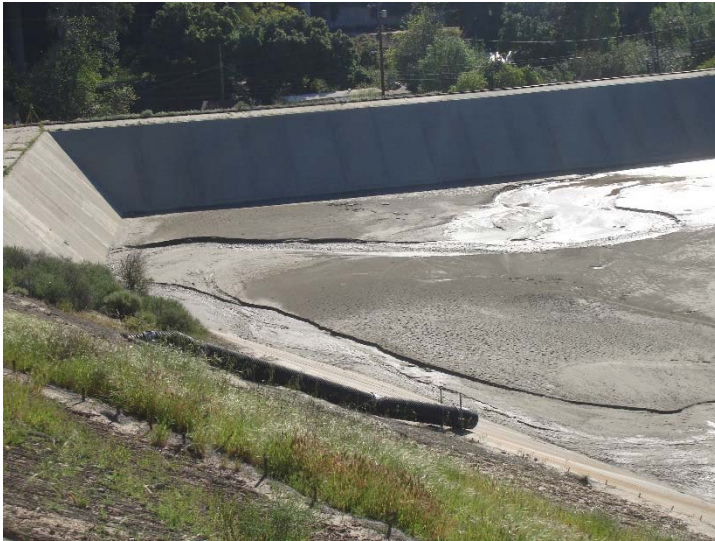
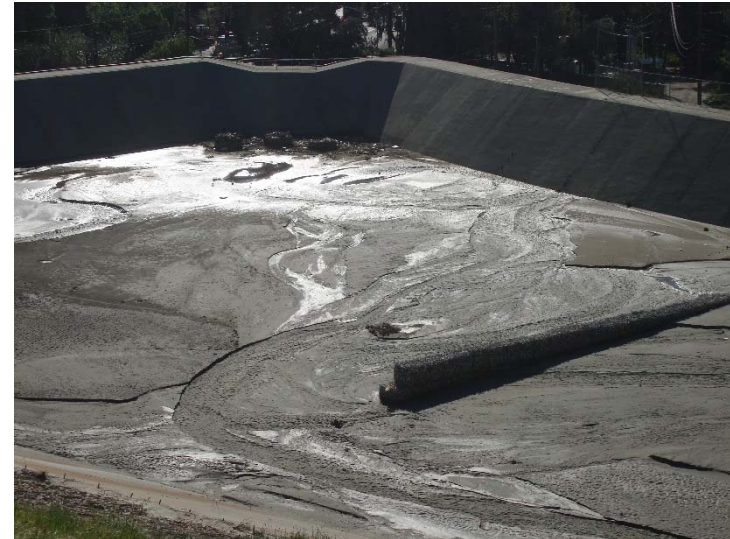
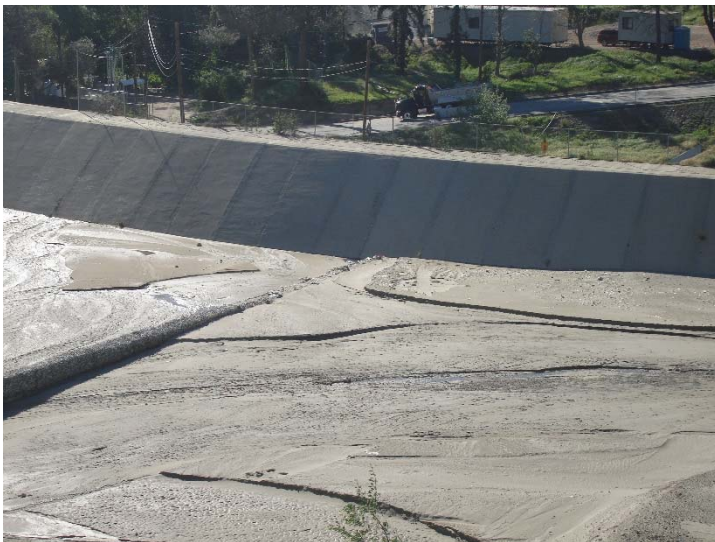
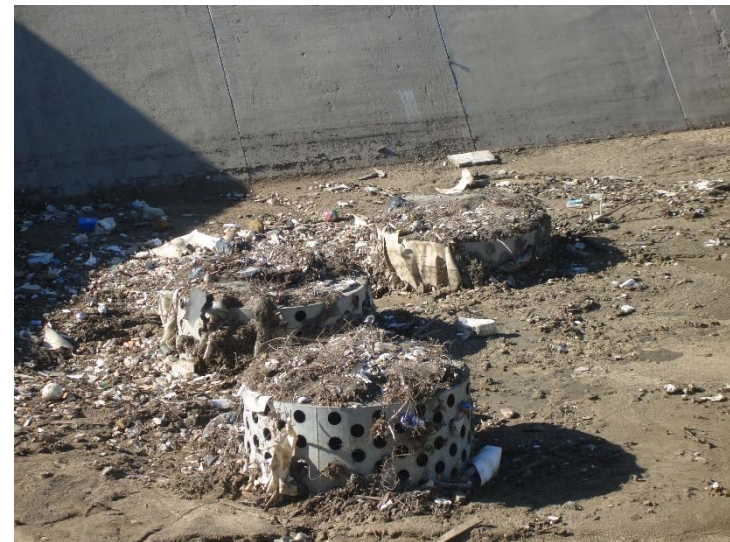
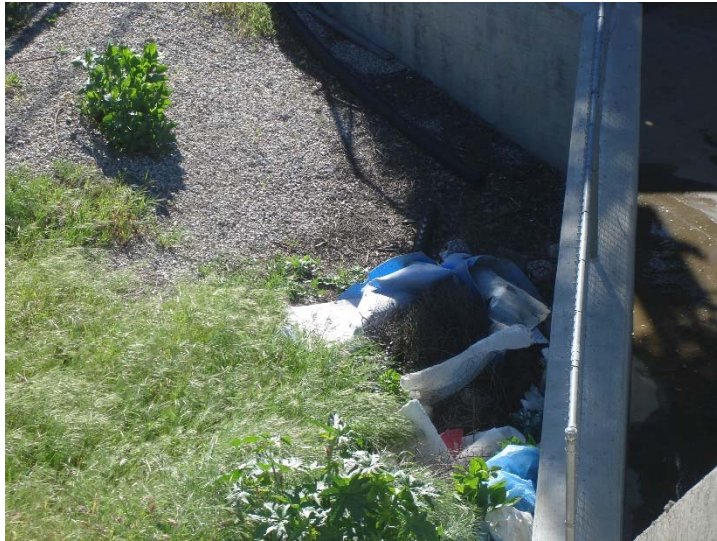
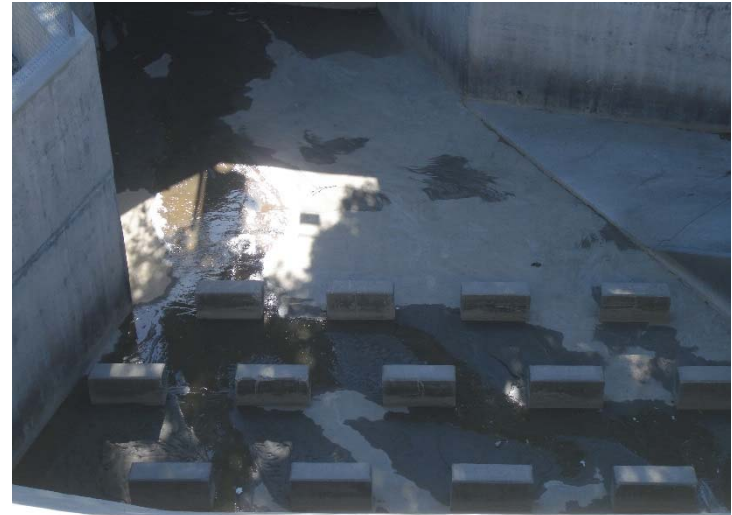
**Photo 359: Terminal Basin: March 23, 2017**

**Photo 360: Terminal Basin: March 23, 2017**

**Photo 361: Terminal Basin: March 23, 2017**

**Photo 362: Terminal Basin: March 23, 2017**

**Photo 363: Terminal Basin: March 23, 2017**

**Photo 364: Terminal Basin: March 23, 2017**

**Photo 365: Terminal Basin: March 23, 2017**

**Photo 366: Terminal Basin: March 23, 2017**

**Photo 367: Terminal Basin: March 23, 2017**

**Photo 368: Terminal Basin: March 23, 2017**

**Photo 369: Terminal Basin: March 23, 2017**

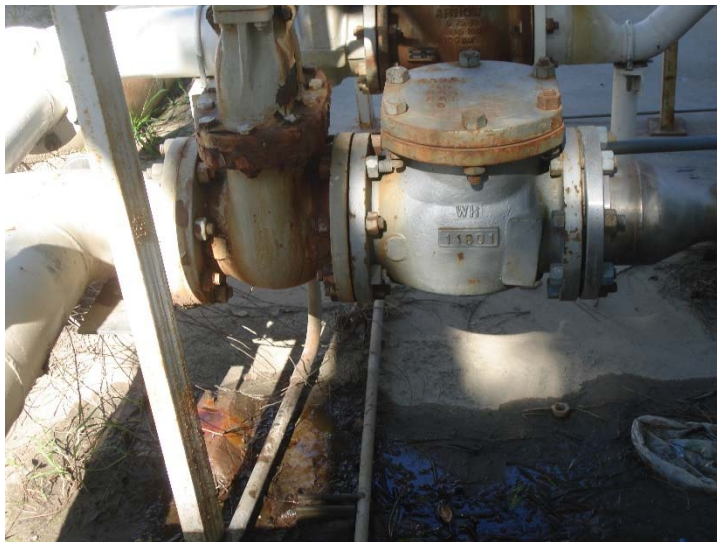
**Photo 370: Terminal Basin Outlet: March 23, 2017**

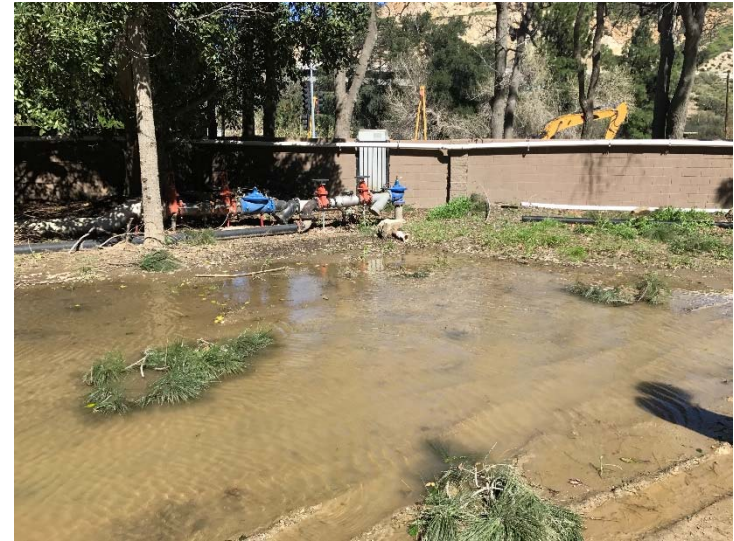
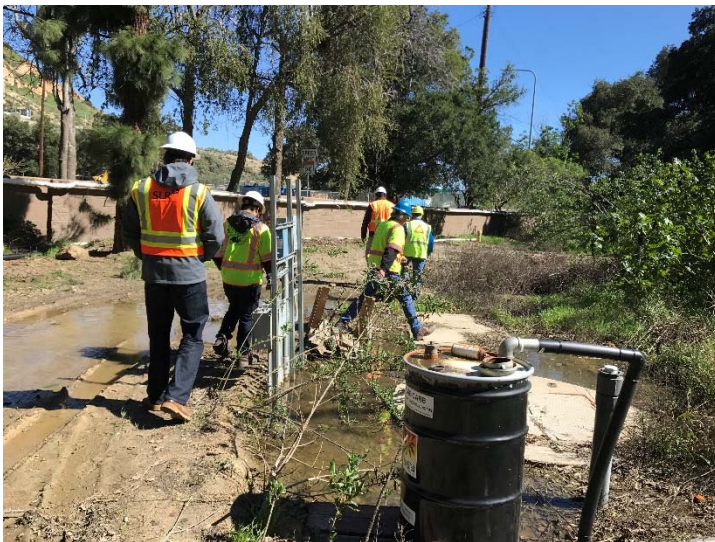
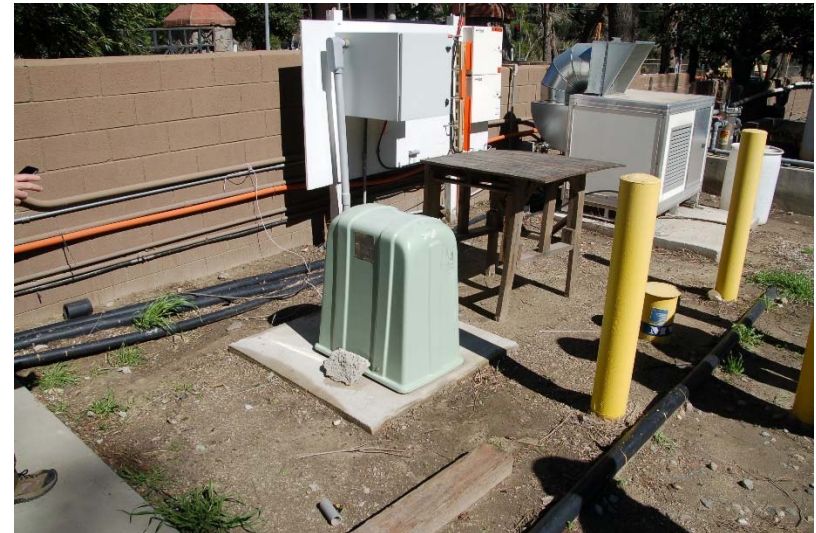
**Photo 373: Sewer Lift Pump Area: February 23, 2017**

**Photo 374: Sewer Lift Pump Area: February 23, 2017**

**Photo 375: Sewer Lift Pump Area: February 23, 2017**

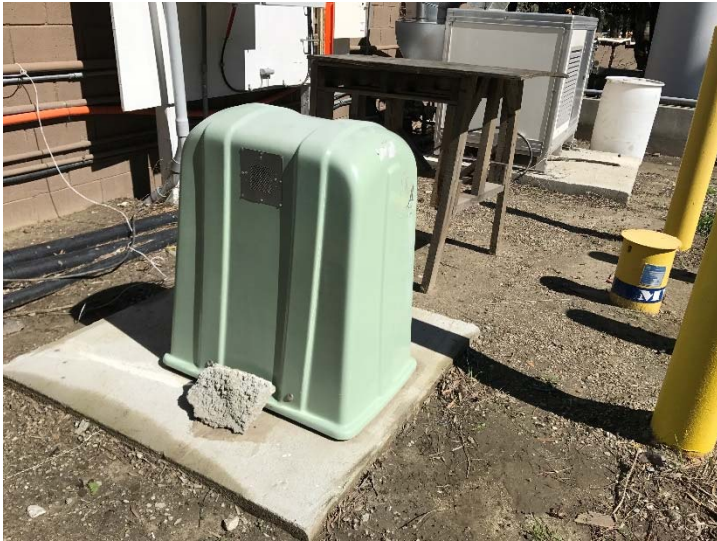
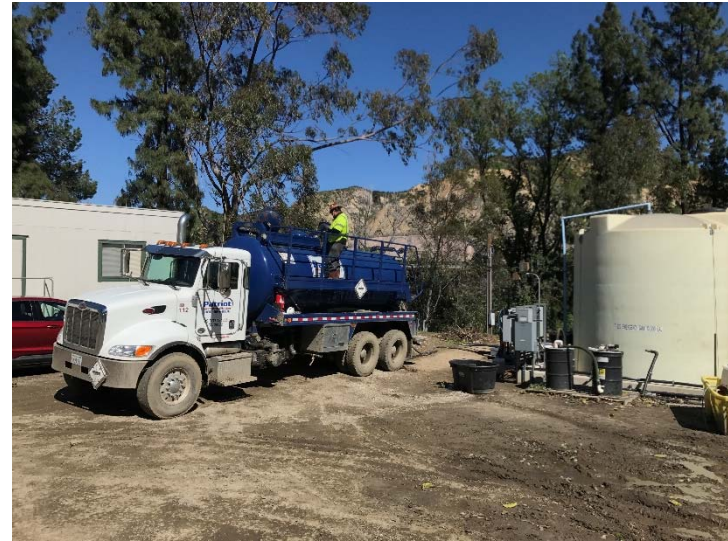
**Photo 376: Seismic Recorder: February 23, 2017**

**Photo 377: Seismic Recorder: February 23, 2017**

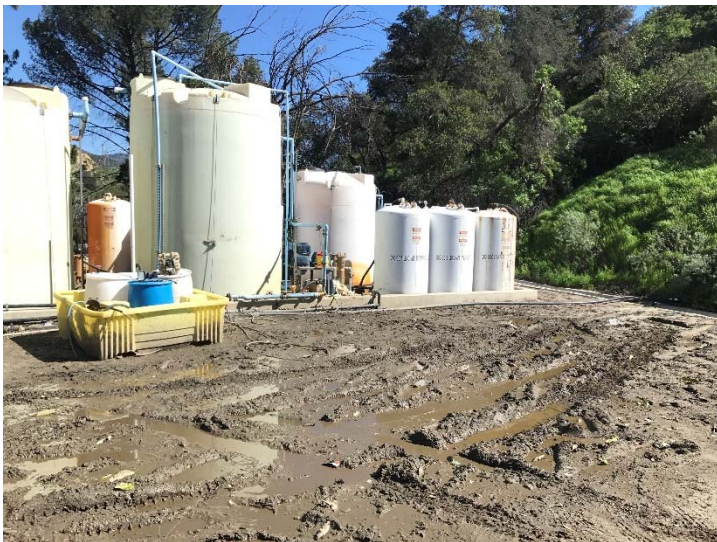
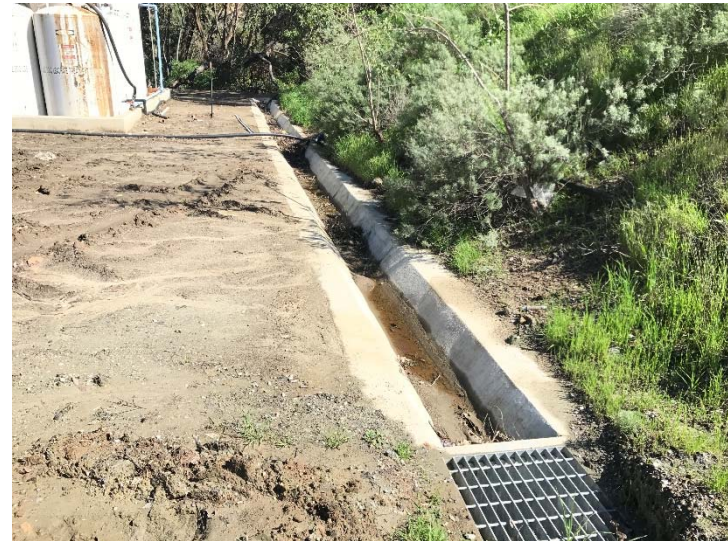
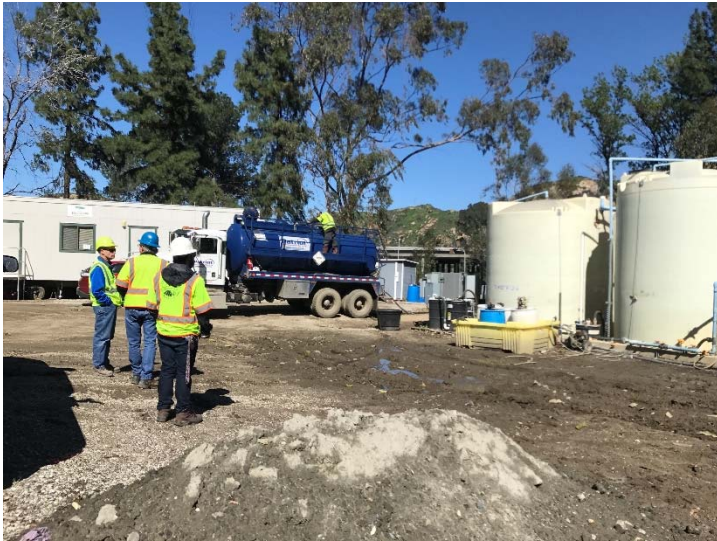
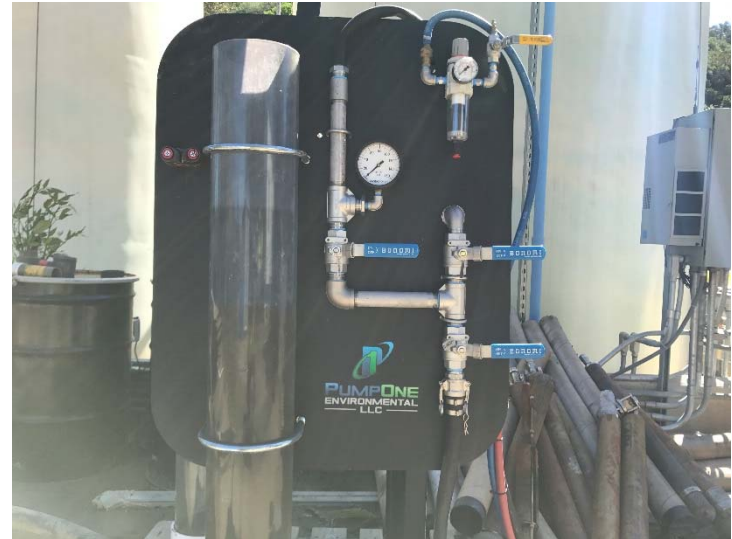
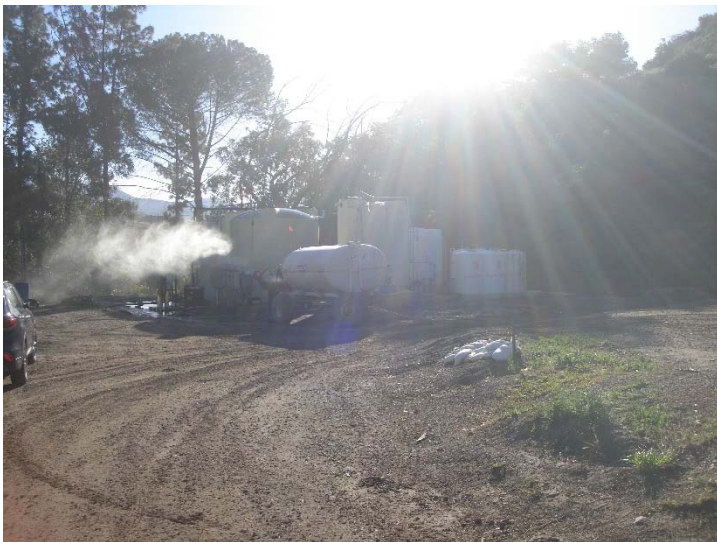
**Photo 378: Leachate Treatment Facility: February 23, 2017**

**Photo 379: Leachate Treatment Facility: February 23, 2017**

**Photo 380: Leachate Treatment Facility: February 23, 2017**

**Photo 381: Leachate Treatment Facility: February 23, 2017**

**Photo 382: Leachate Treatment Facility: February 23, 2017**

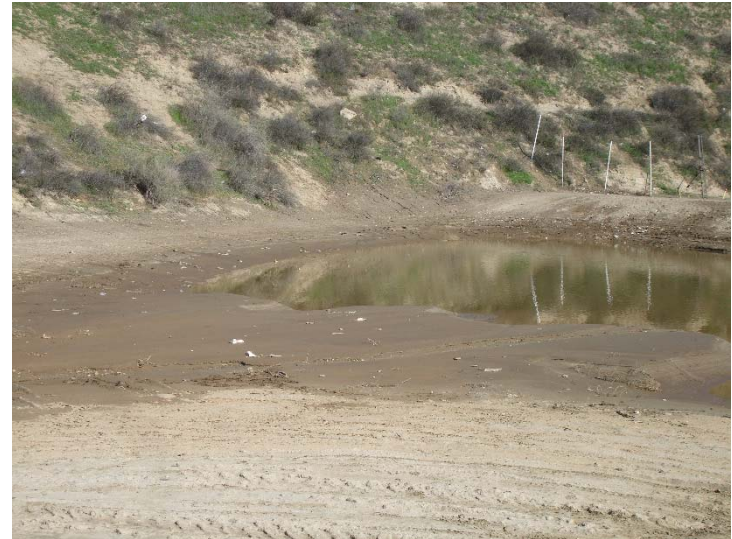
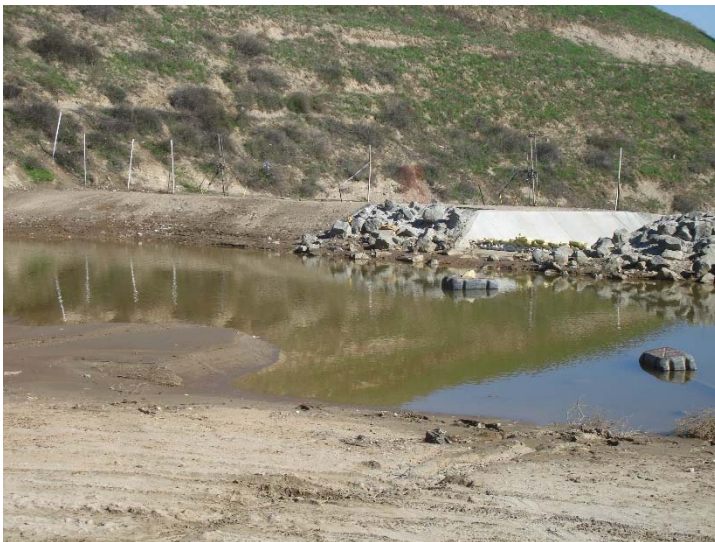
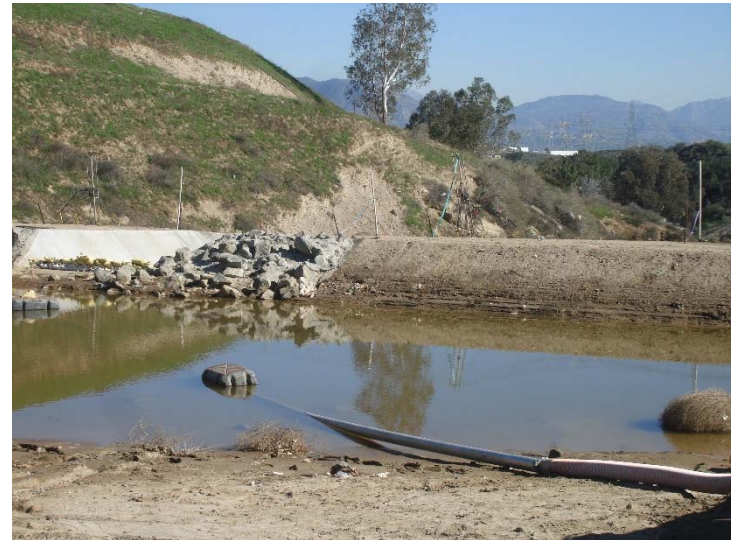
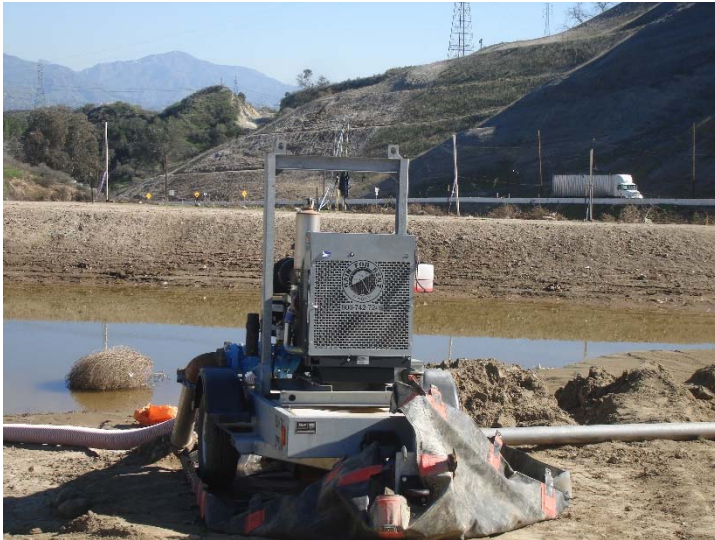
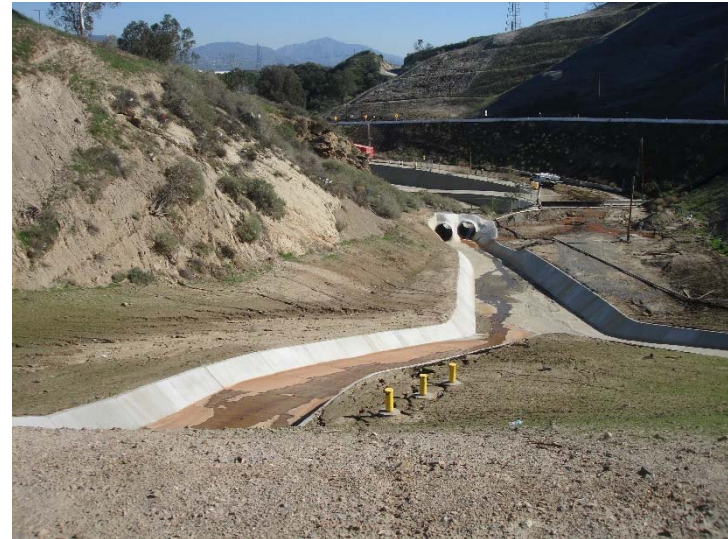
**Photo 385: CC3B Basin: January 17, 2017**

**Photo 386: CC3B Basin: January 17, 2017**

**Photo 387: CC3B Basin: January 17, 2017**

**Photo 388: CC3B Basin: January 17, 2017**

**Photo 389: CC3B Basin: January 17, 2017**

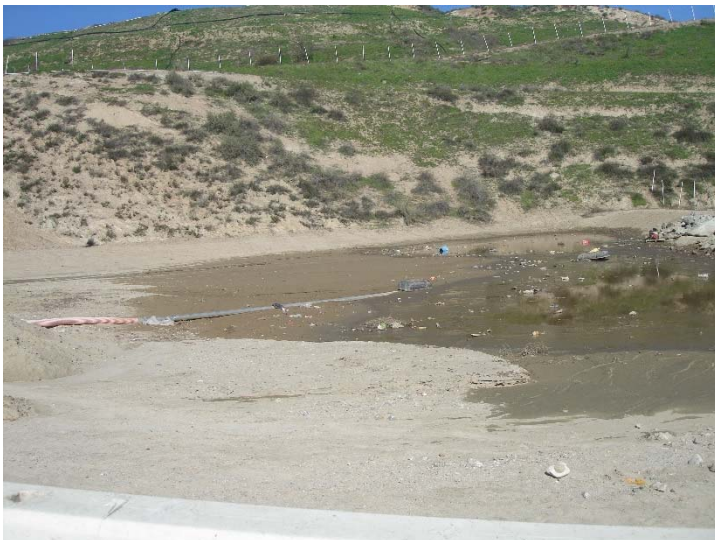
**Photo 390: CC3B Basin Drainage into Terminal Basin: January 17, 2017**

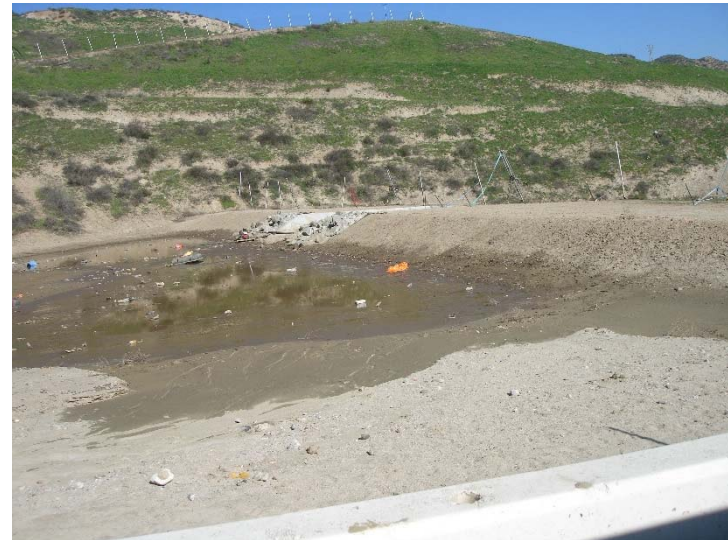
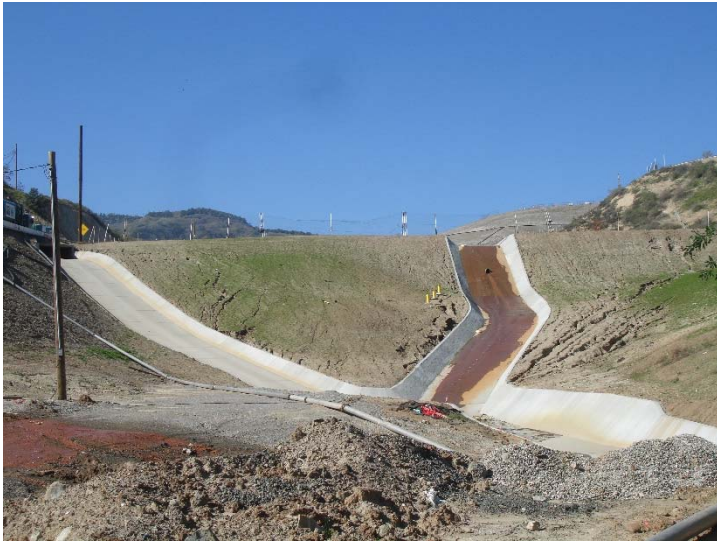
**Photo 391: CC3B Temporary Basin: January 31, 2017**

**Photo 392: CC3B Temporary Basin: January 31, 2017**

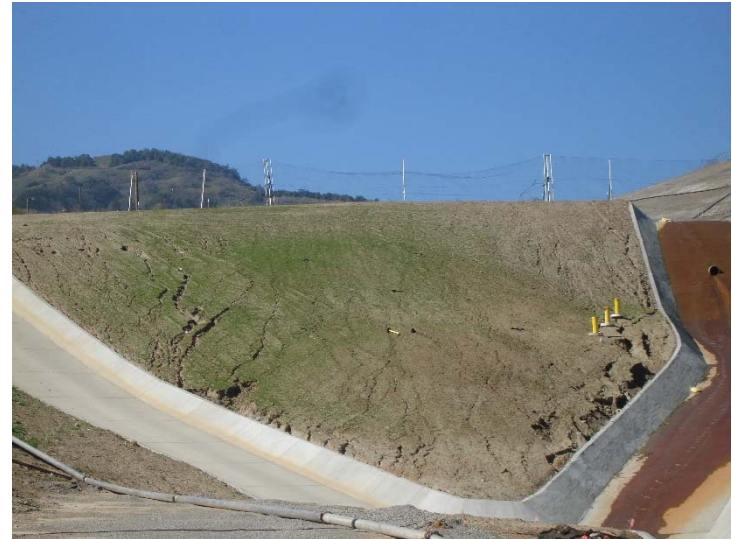
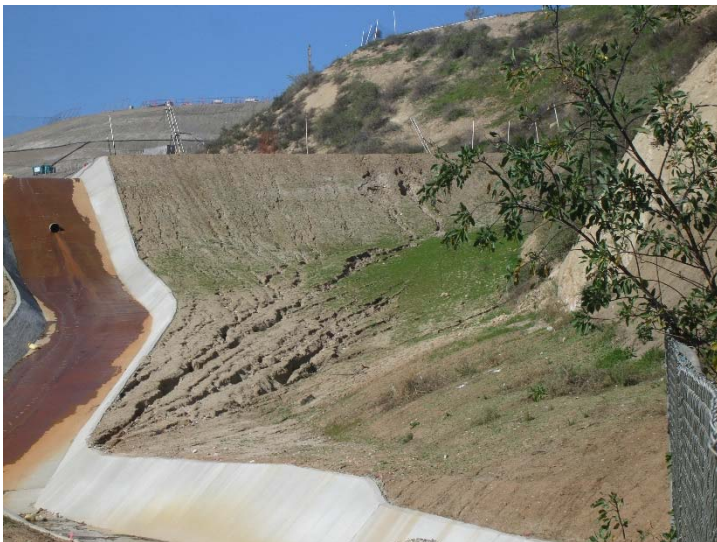
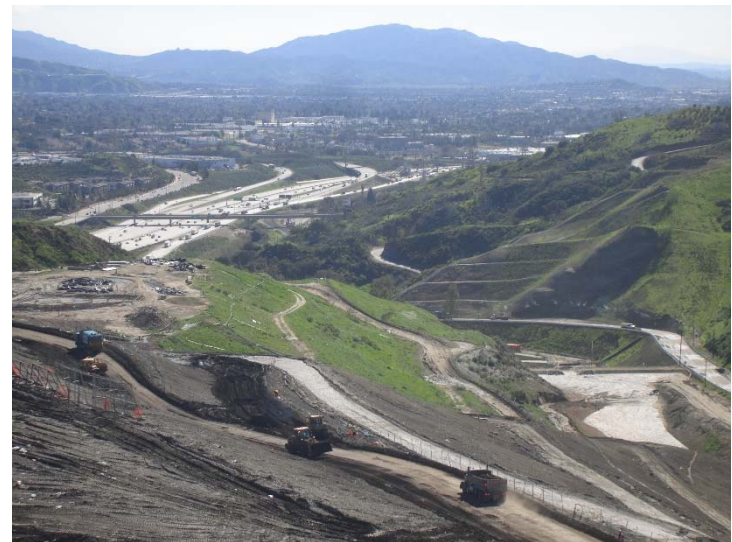
**Photo 393: CC3B Temporary Basin into Terminal Basin: January 31, 2017**

**Photo 394: CC3B Temporary Basin into Terminal Basin: January 31, 2017**

**Photo 395: CC3B Temporary Basin into Terminal Basin: January 31, 2017**
