**Sunshine Canyon Landfill  
Independent Monitor  
Quarterly Site Monitoring Status Report  
January 1, 2017 – March 31, 2017**

**City of Los Angeles Department of City Planning**

**County of Los Angeles Department of Regional Planning**

April 26, 2017

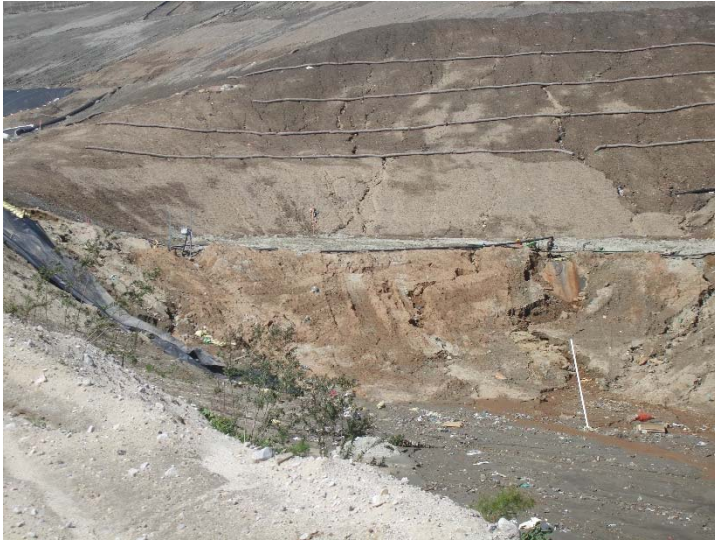
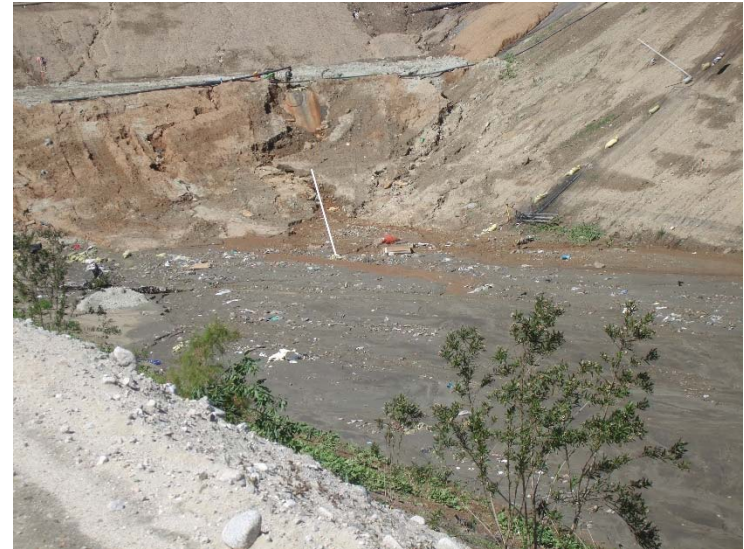
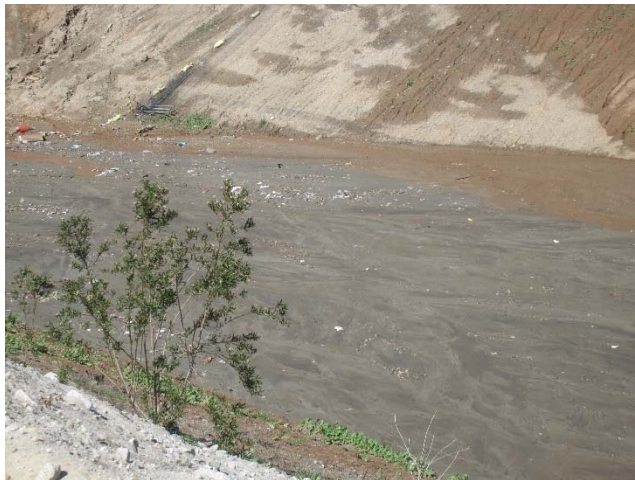
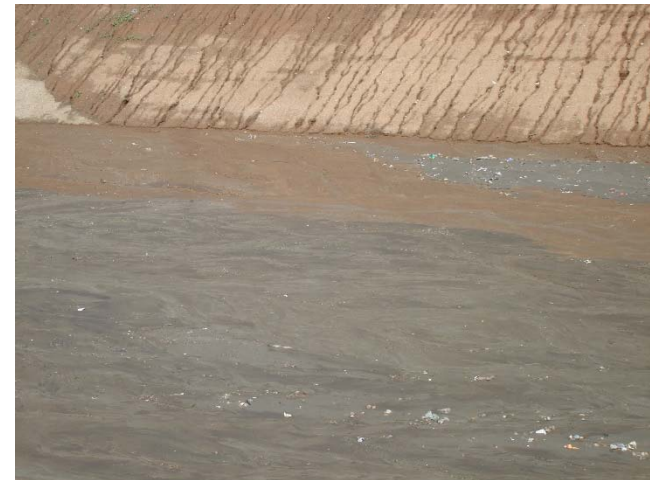
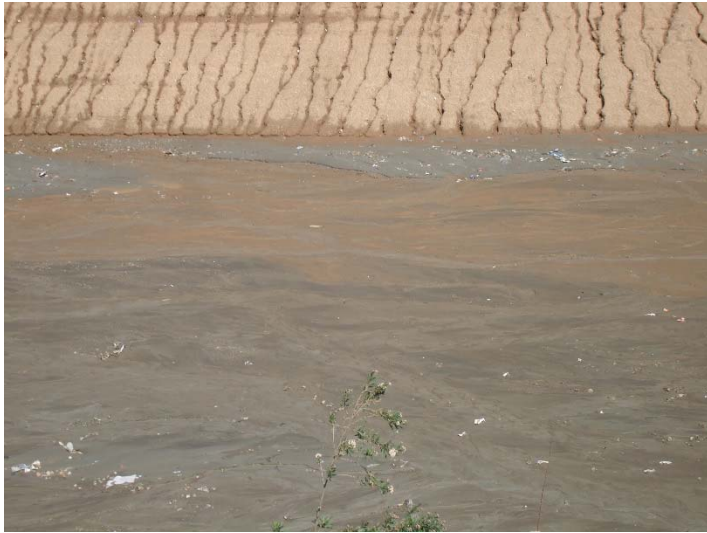
**Photo 396: CC3B Basin: February 23, 2017**

**Photo 397: CC3B Basin: February 23, 2017**

**Photo 398: CC3B Basin: February 23, 2017**

**Photo 399: CC3B Basin: February 23, 2017**

**Photo 400: CC3B Basin: February 23, 2017**

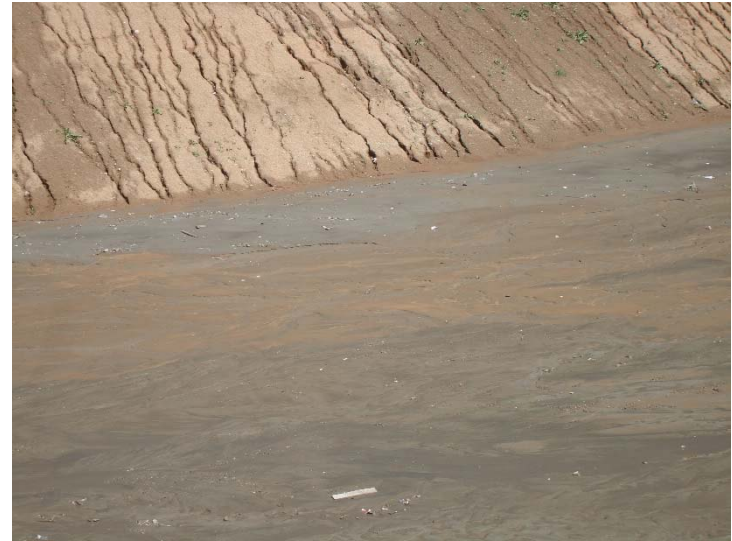
**Photo 401: CC3B Basin: February 23, 2017**

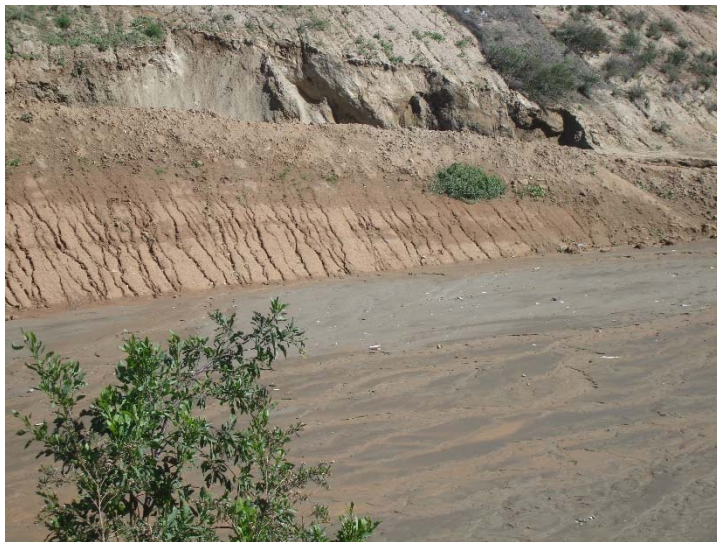
**Photo 402: CC3B Basin: February 23, 2017**

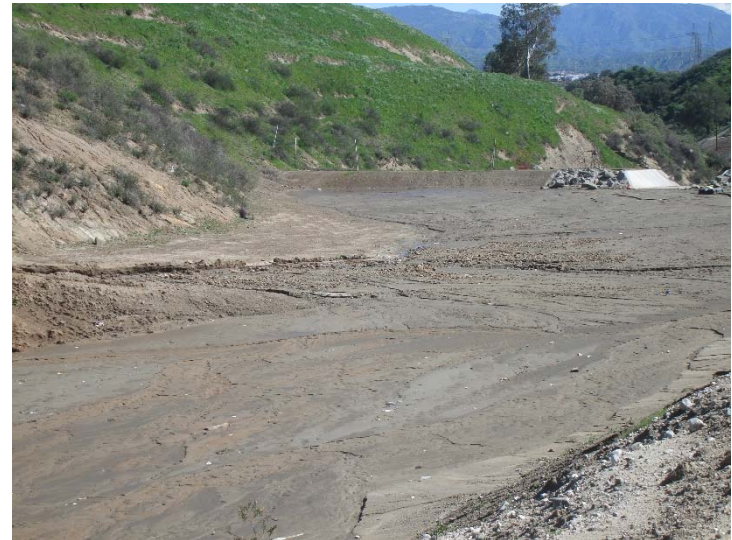
**Photo 403: CC3B Basin: February 23, 2017**

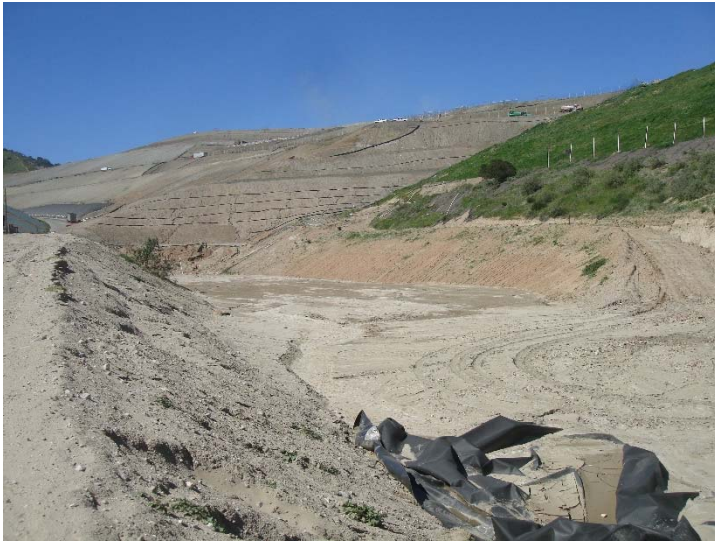
**Photo 404: CC3B Basin: February 23, 2017**

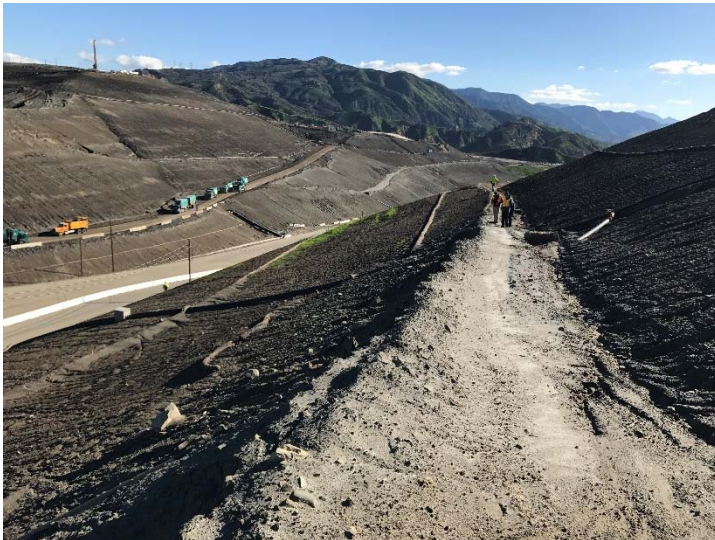
**Photo 409: CC3B Temporary Solids Removal: March 23, 2017**

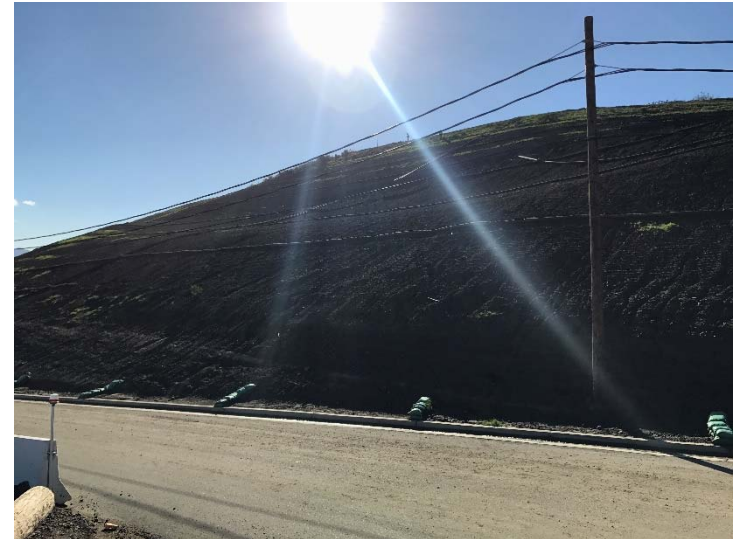
**Photo 411: City South Slope Slump: February 23, 2017**

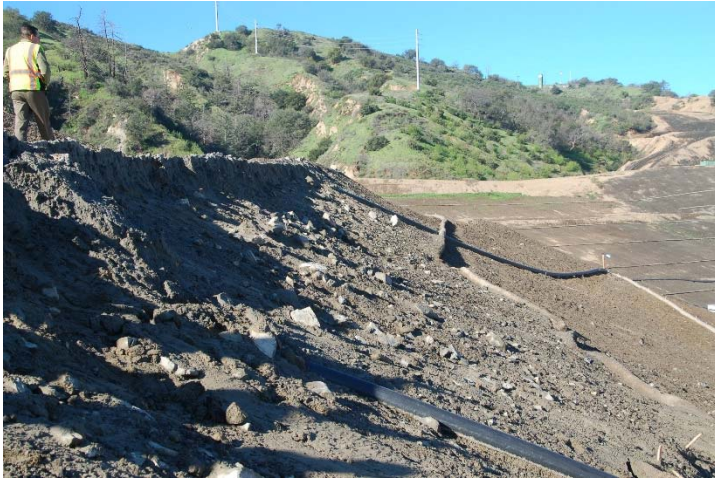
**Photo 412: City South Slope Slump: February 23, 2017**

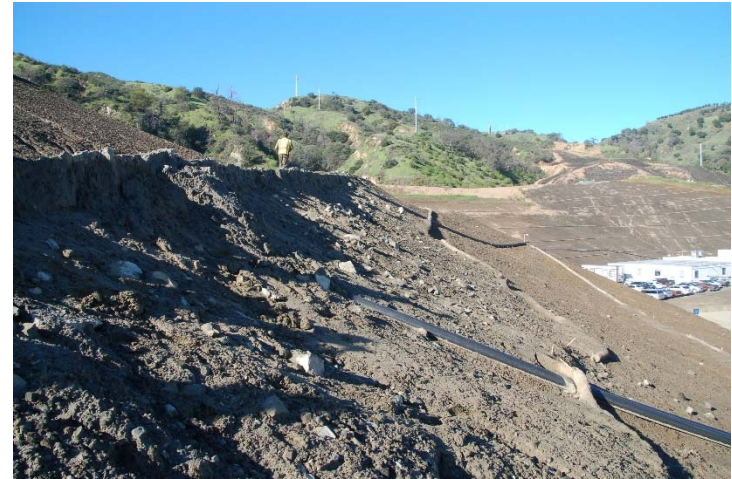
**Photo 413: City South Slope Slump: February 23, 2017**

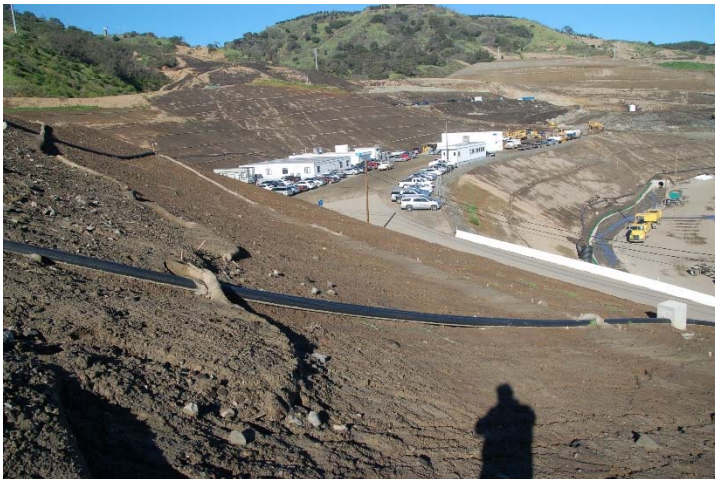
**Photo 414: City South Slope Slump: February 23, 2017**

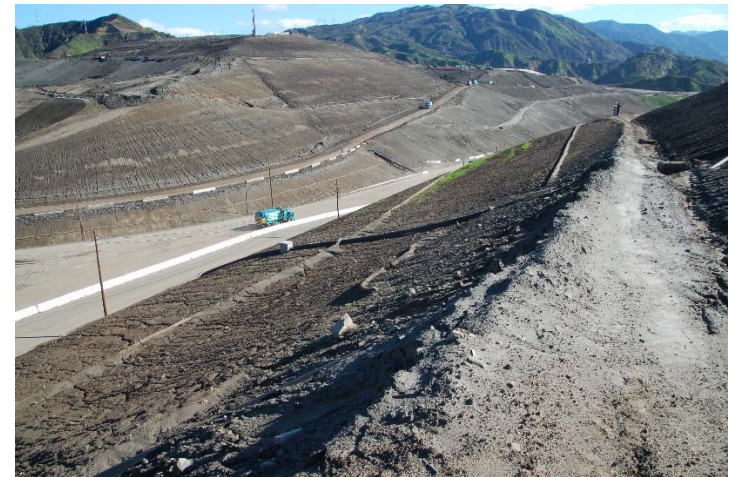
**Photo 415: City South Slope Slump: February 23, 2017**

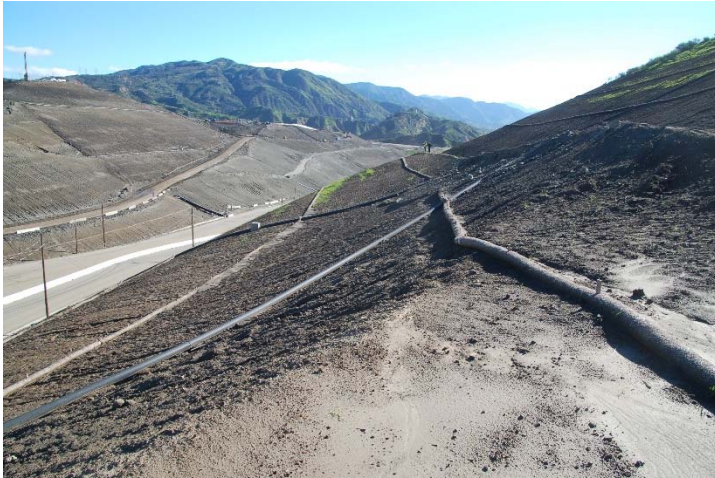
**Photo 416: City South Slope Slump: February 23, 2017**

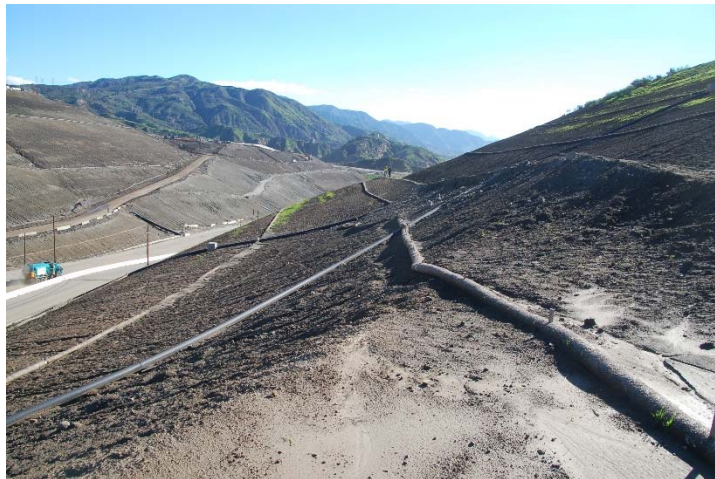
**Photo 417: City South Slope Slump: February 23, 2017**

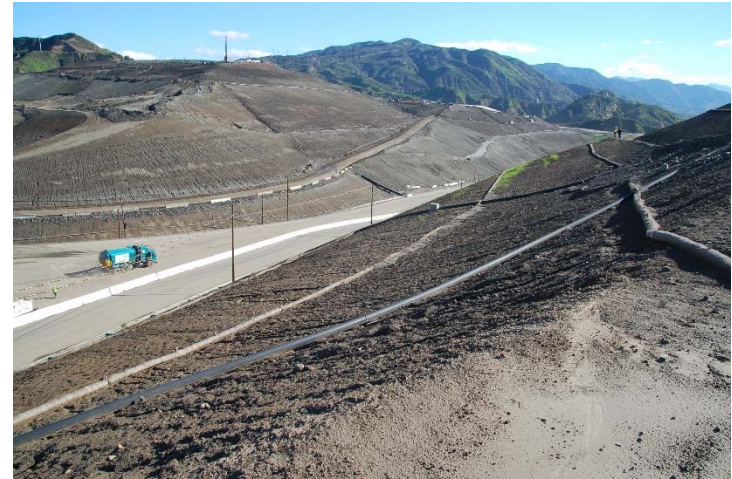
**Photo 419: City South Slope Slump: February 23, 2017**

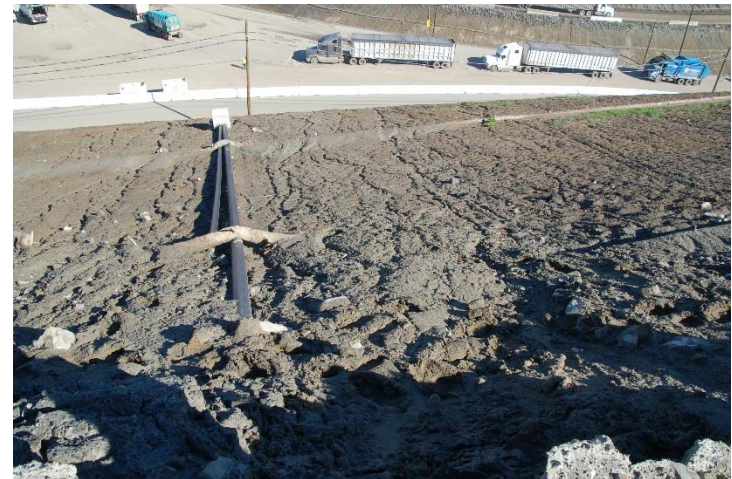
**Photo 418: City South Slope Slump: February 23, 2017**

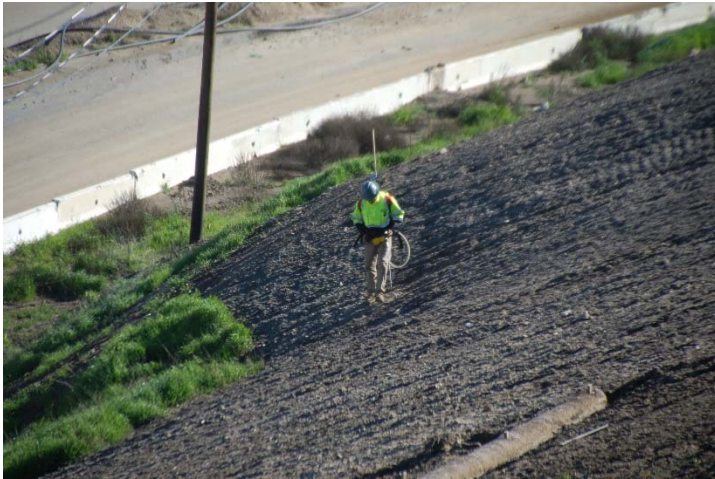
**Photo 420: City South Slope Slump: February 23, 2017**

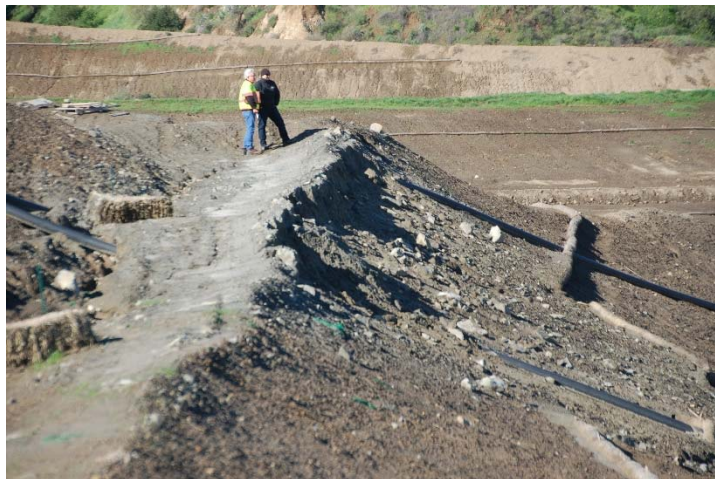
**Photo 422: City South Slope Slump: February 23, 2017**

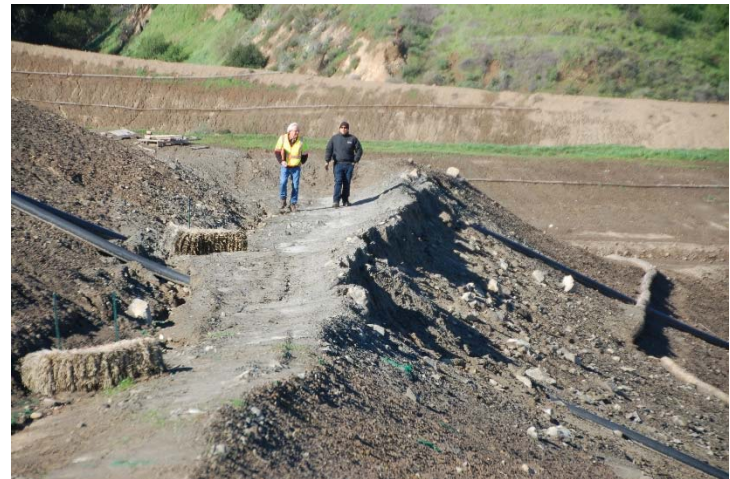
**Photo 423: City South Slope Slump: February 23, 2017**

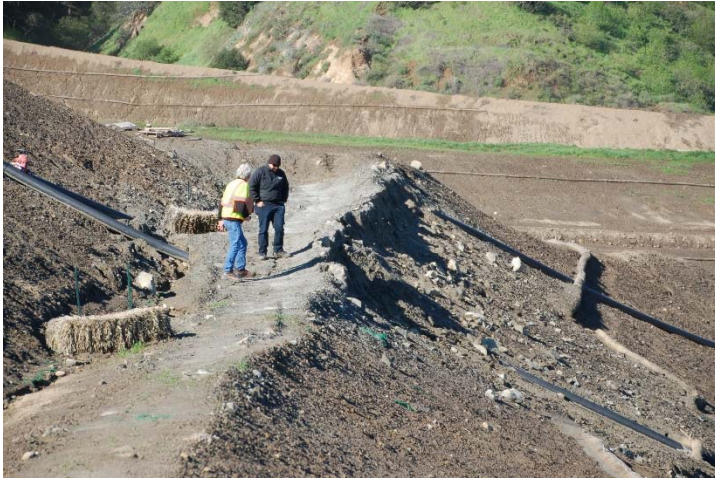
**Photo 424: City South Slope Slump: February 23, 2017**

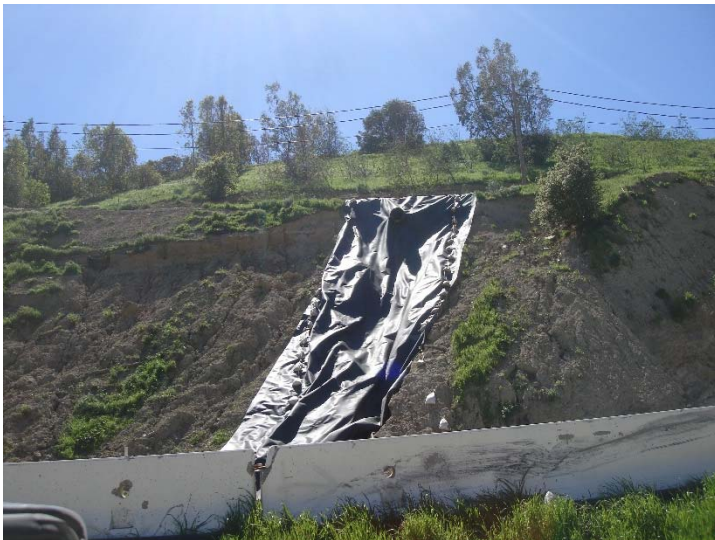
**Photo 426: City South Drainage Water Ponding: February 23, 2017**

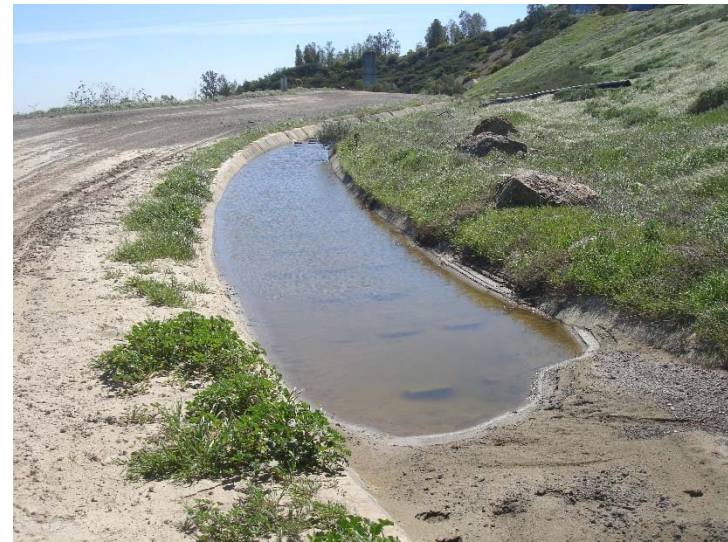
**Photo 427: City South Drainage to Westside Drainage Channel: March 9, 2017**

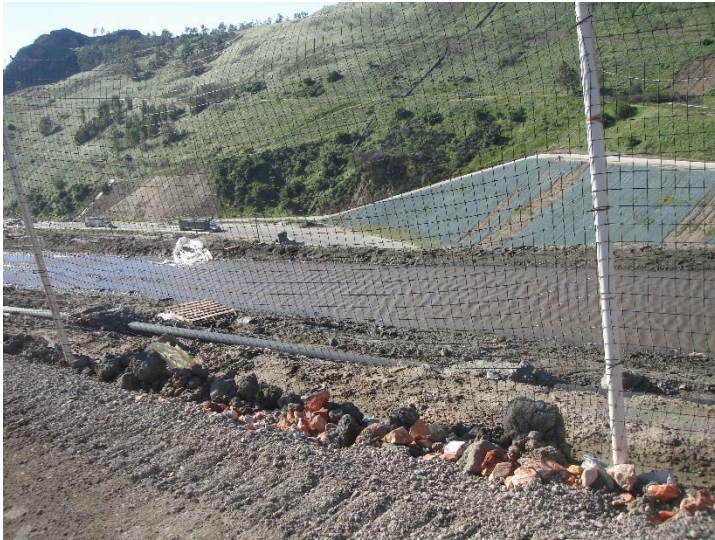
**Photo 428: City South Drainage Channel Ponding Water: March 9, 2017**

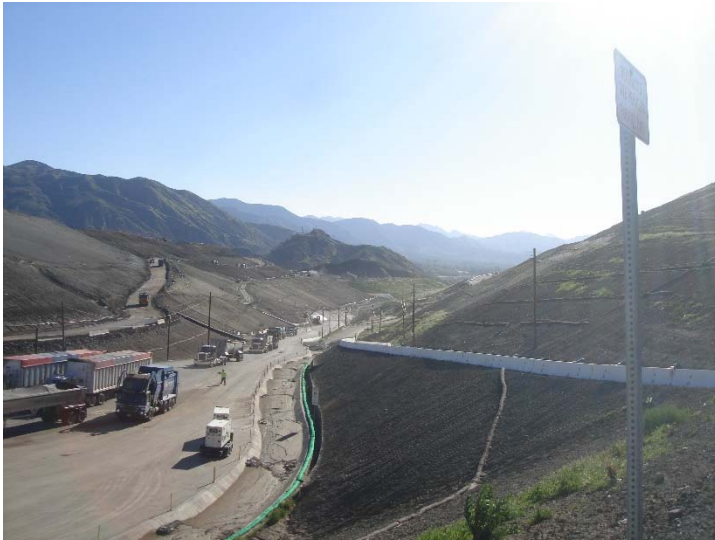
**Photo 432: City South Slopes Slump Area: March 23, 2017**

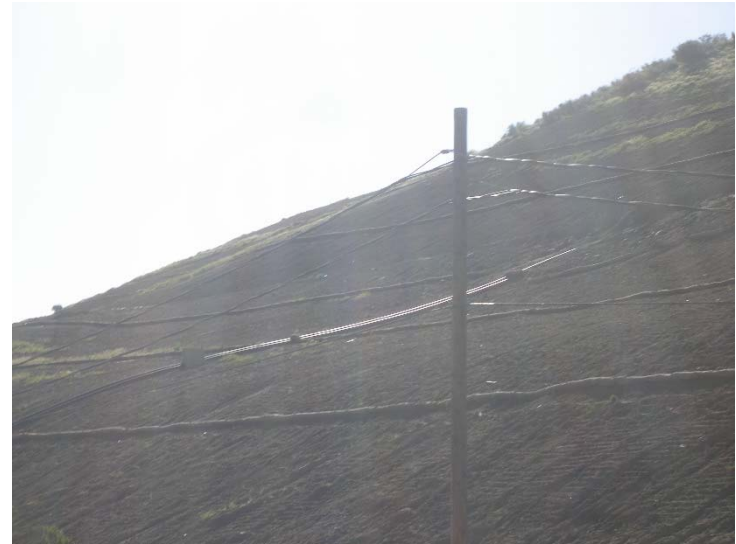
**Photo 433: City South Slopes Slump Area: March 23, 2017**

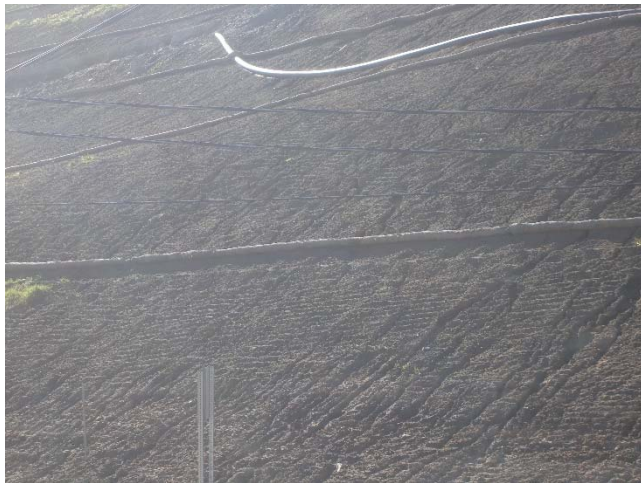
**Photo 434: City South Slopes Slump Area: March 23, 2017**

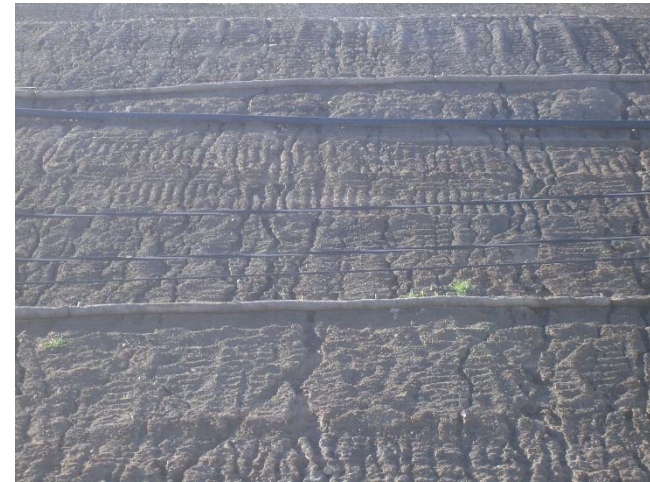
**Photo 435: City South Slopes Slump Area: March 23, 2017**

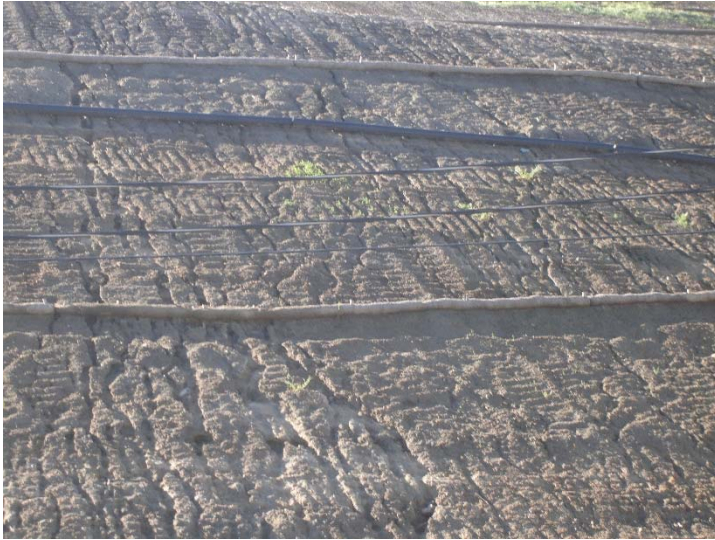
**Photo 436: City South Slopes Slump Area: March 23, 2017**

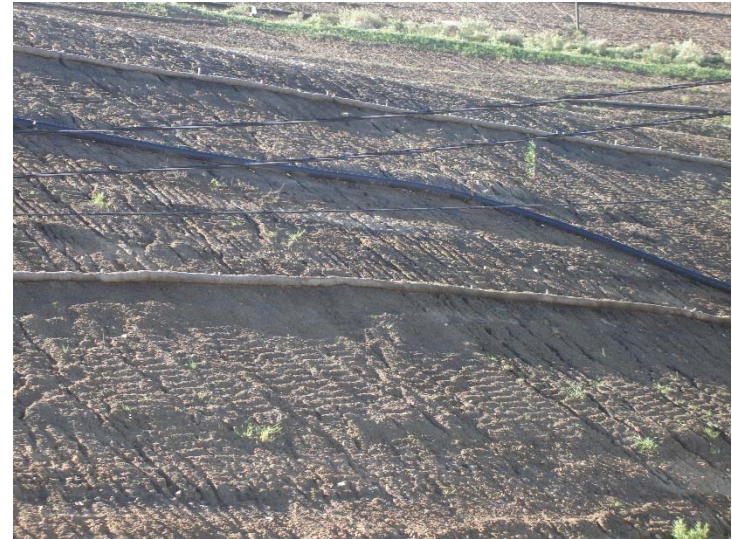
**Photo 437: City South Slopes Slump Area: March 23, 2017**

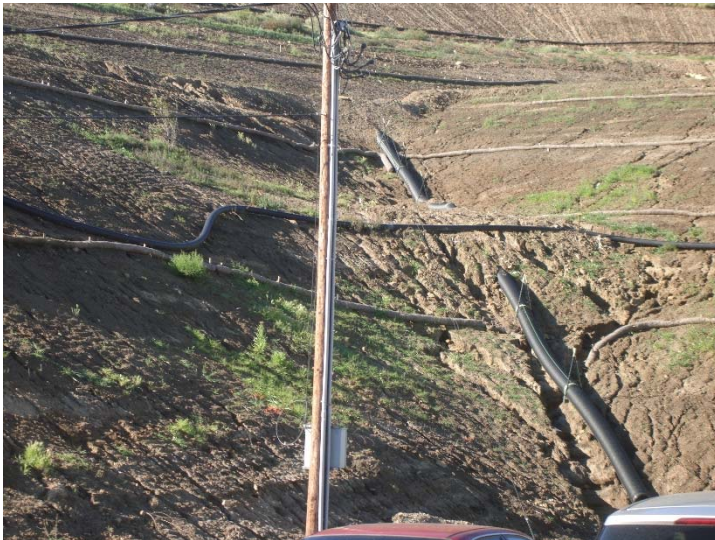
**Photo 438: City South Slopes Slump Area: March 23, 2017**

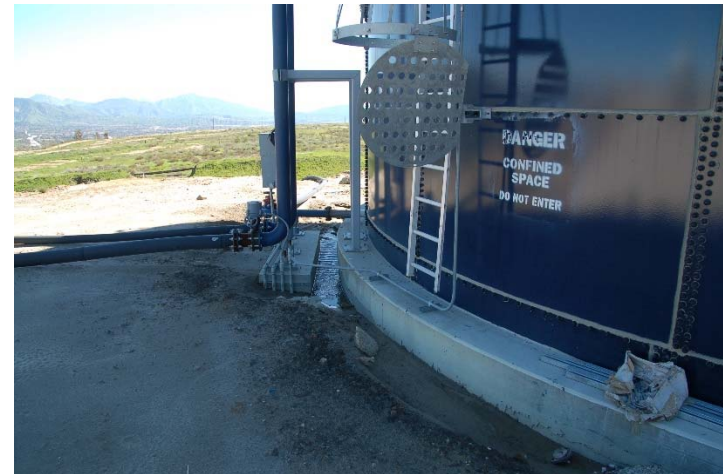
**Photo 479: Deck A Water Tank Foundation Partially Backfilled:  
February 23, 2017**

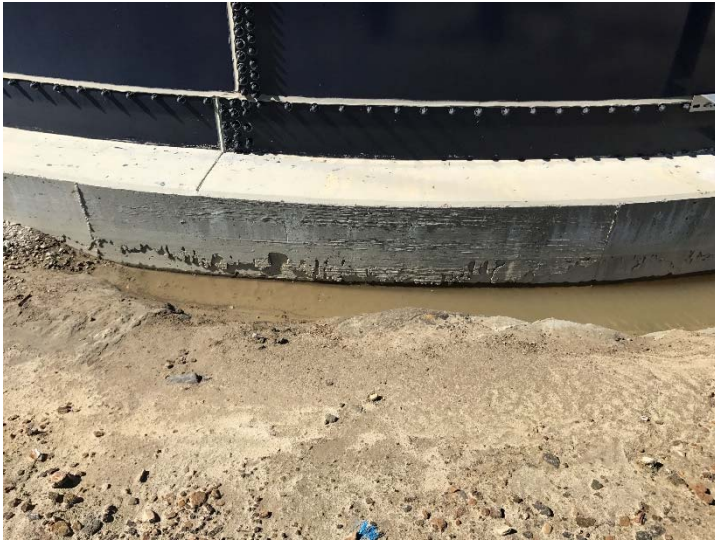
**Photo 480: Deck A Water Tank Foundation Partially Backfilled:  
February 23, 2017**

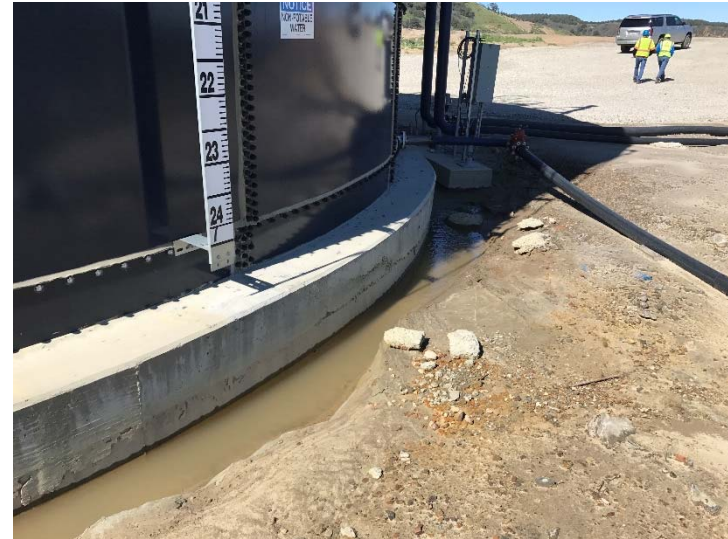
**Photo 481: Deck A Water Tank Foundation Partially Backfilled:  
February 23, 2017**

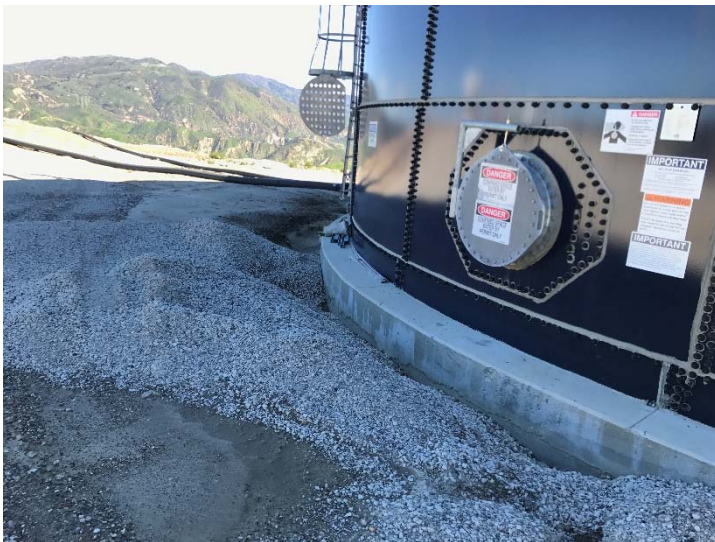
**Photo 482: Deck A Water Tank Foundation Partially Backfilled:  
February 23, 2017**

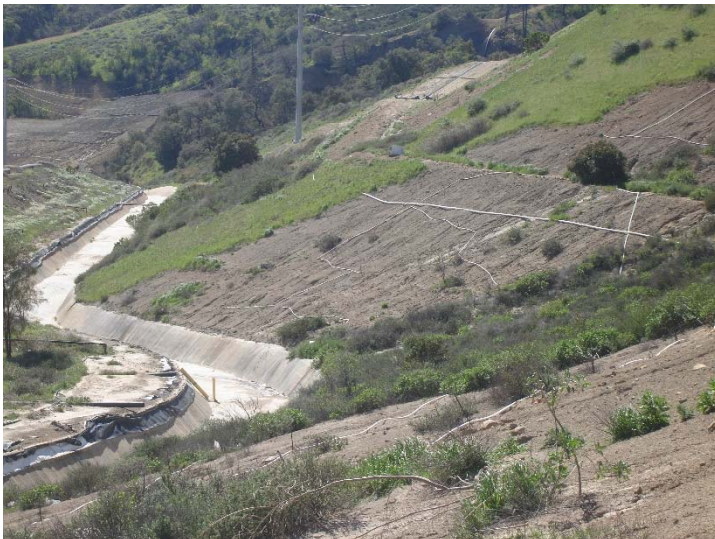
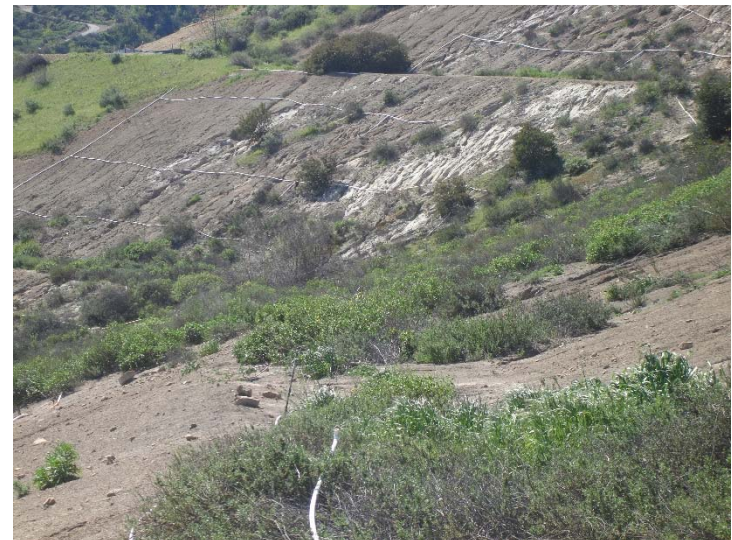
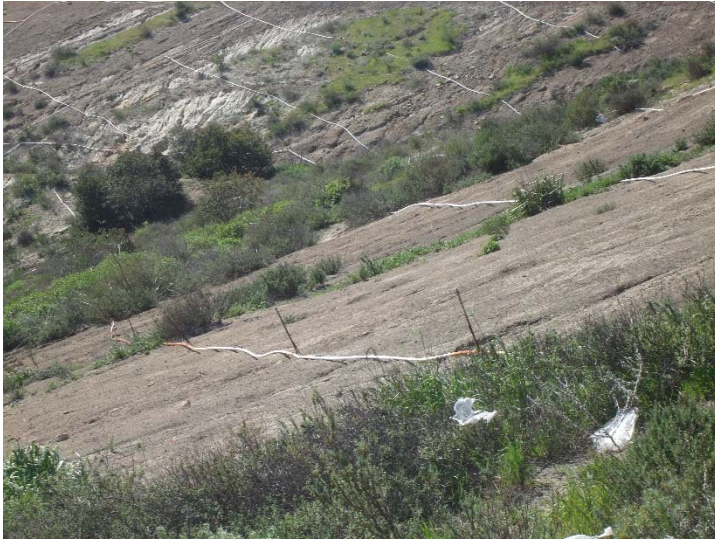
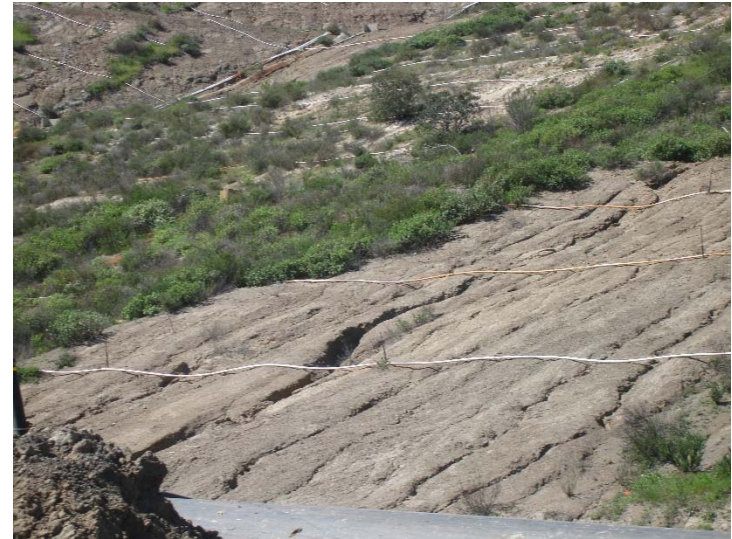
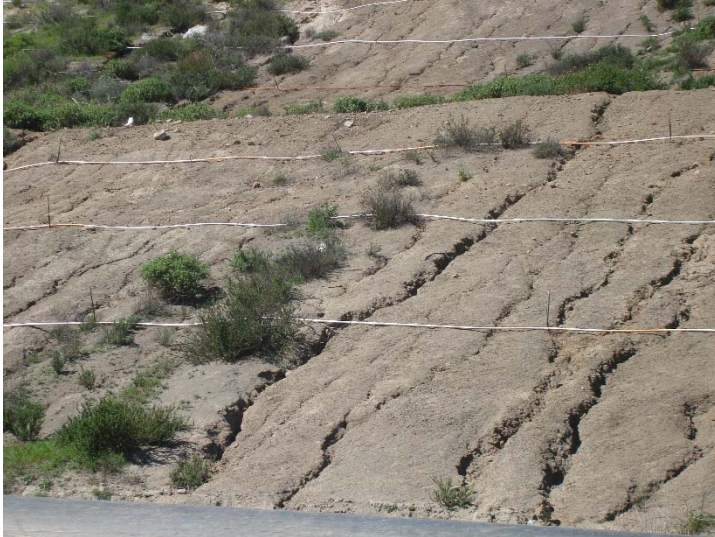
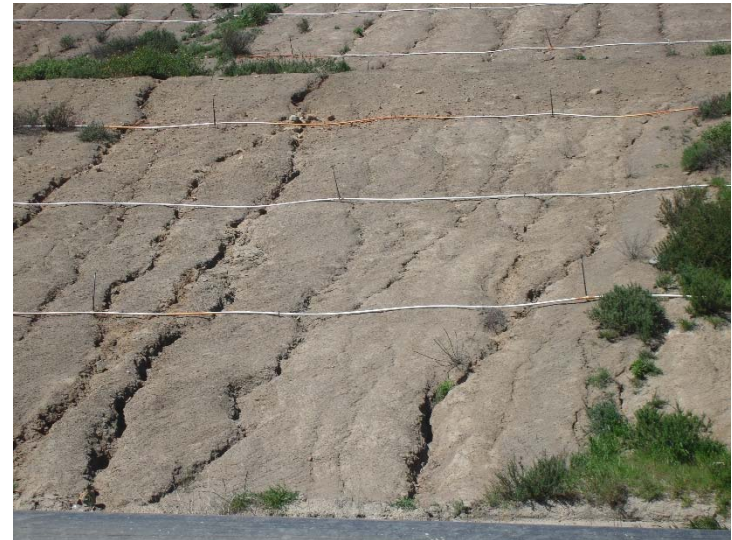
**Photo 506: County Sage Mitigation Area Slope Erosion: March 9, 2017**

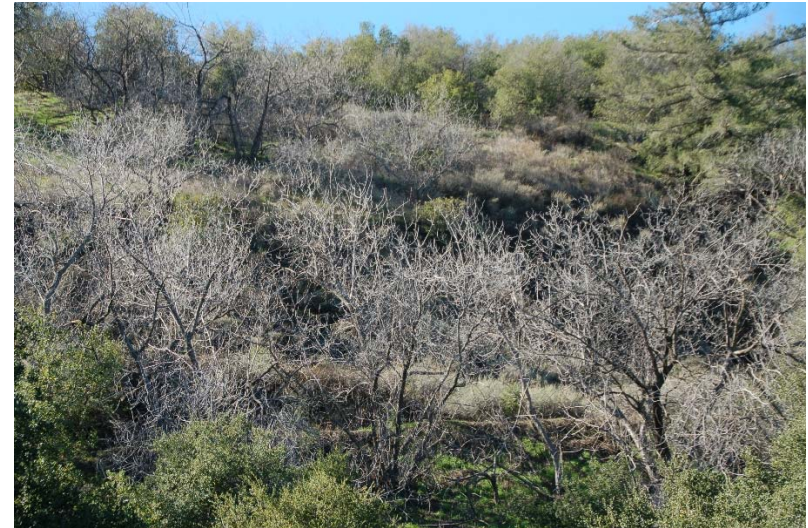
**Photo 513: County Slope near Sage Mitigation Area: March 23, 2017**

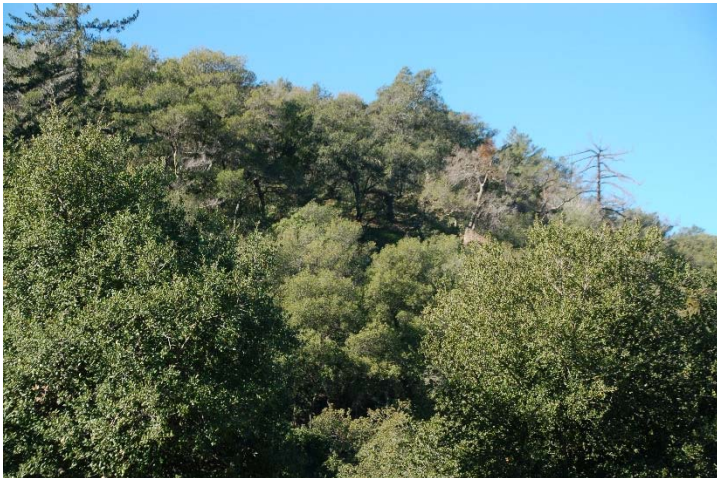
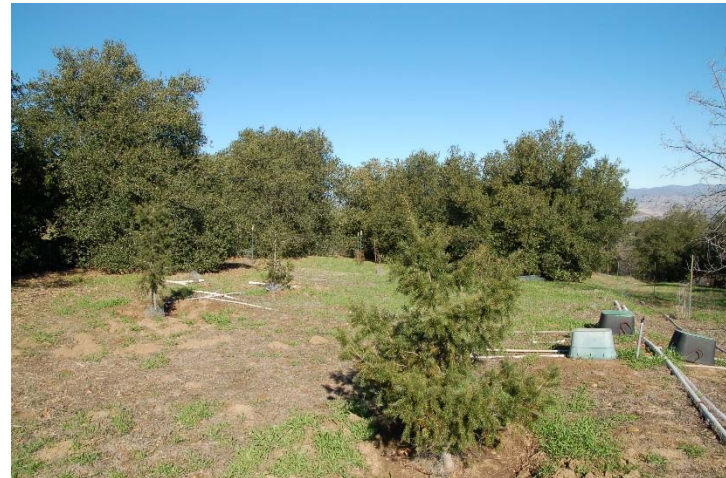
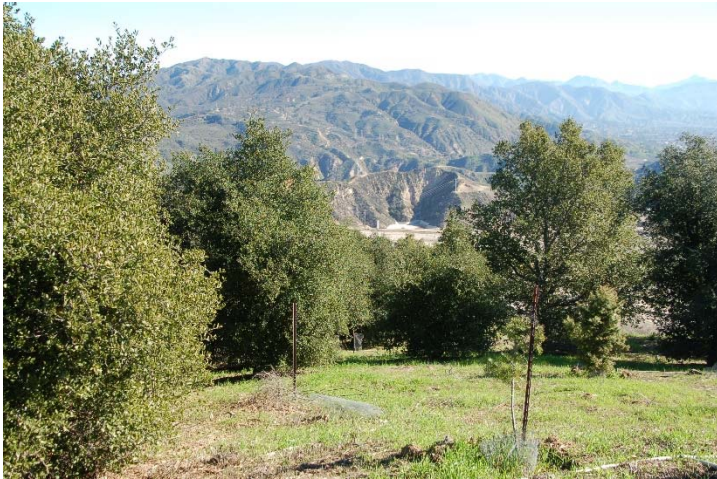
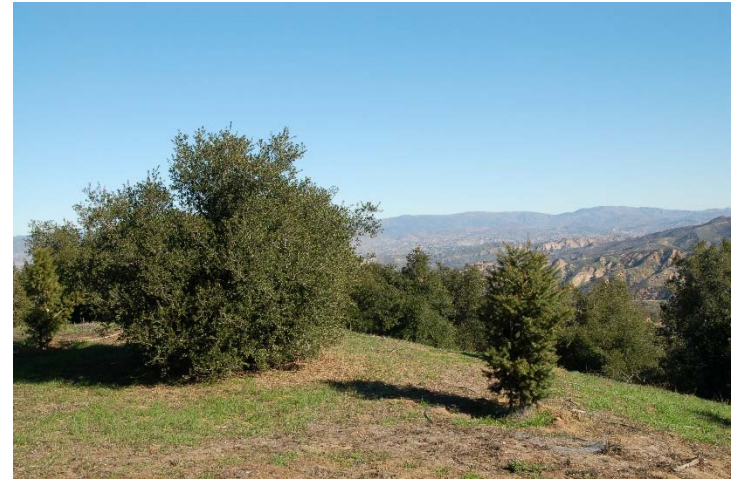
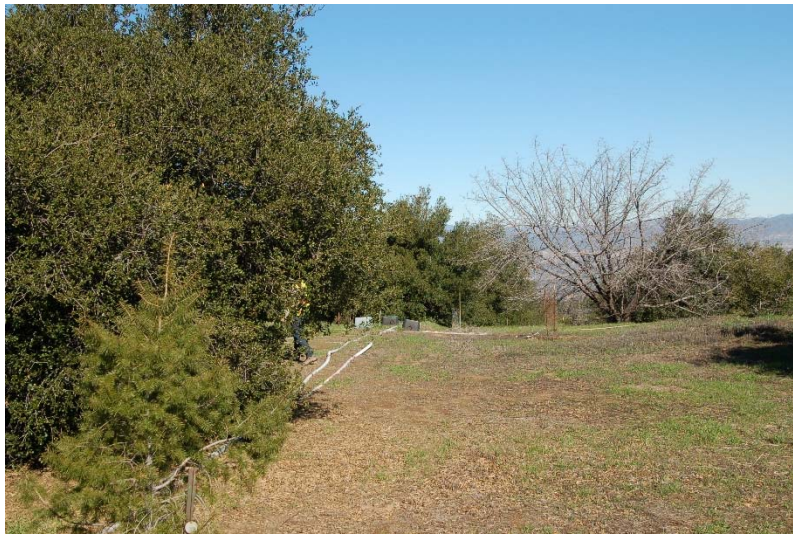
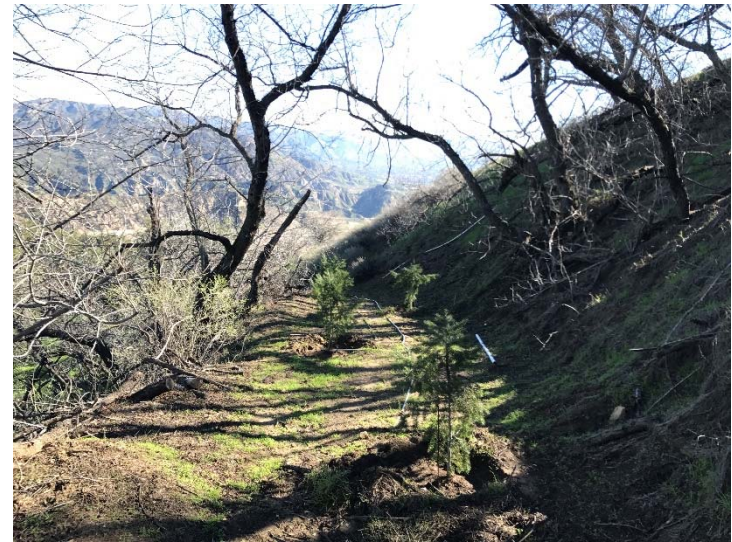
**Photo 514: Big Cone Fir Mitigation Area: January 17, 2017**

- The secondary access road from the Flare 11 pad was complete and the road from it to the I-5 was travelable.
- Observed the Big-Cone Fir mitigation trees and they were doing well with the cooler weather and rain. A current status report on the number, age, and size should be done.

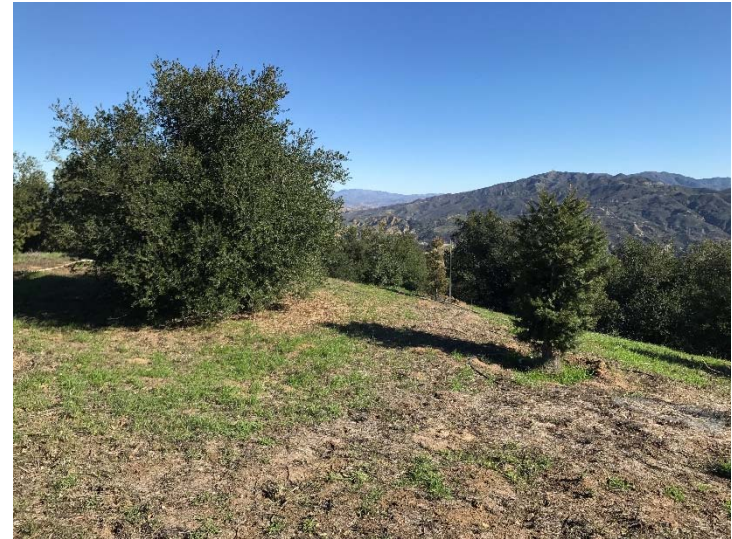
**Photo 523: Big Cone Fir Mitigation Area: January 17, 2017**

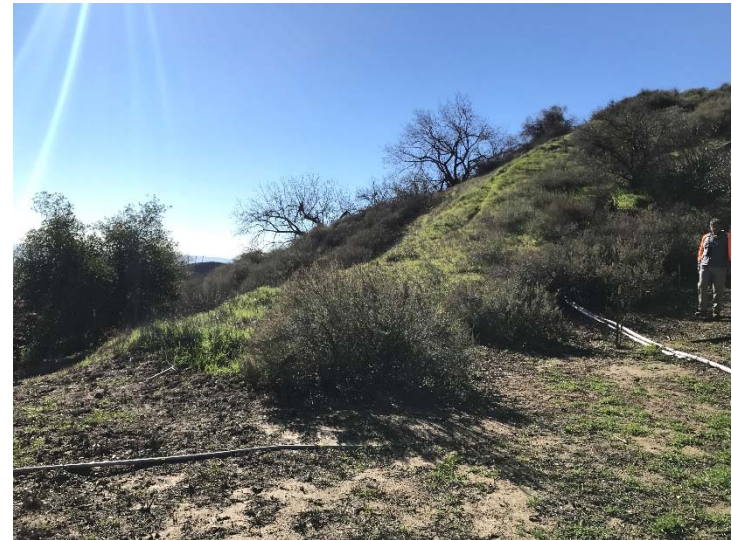
**Photo 522: Big Cone Fir Mitigation Area: January 17, 2017**

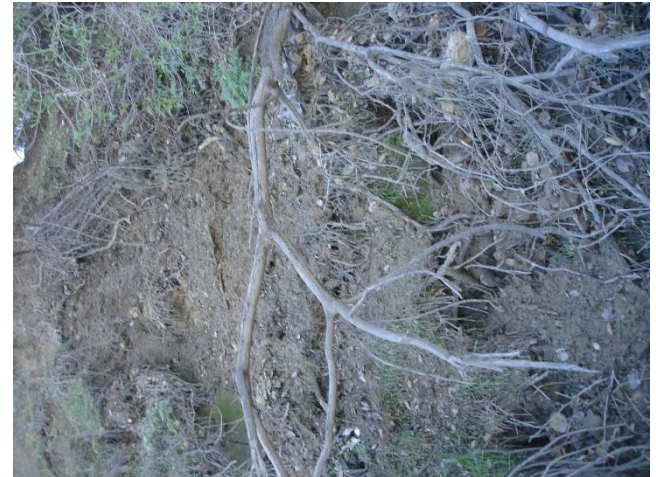
**Photo 531: Frontage Retaining Wall Slope on San Fernando Road: January 17, 2017**

<p>Overall landfill inspection.</p> <ul style="list-style-type: none"> <li>• No slope stability issues were noted during the site tour</li> <li>• Additional soil has accumulated against the fence on top of the retaining wall outside the property on San Fernando road due to sloughing off soil (Photo 16)</li> </ul>

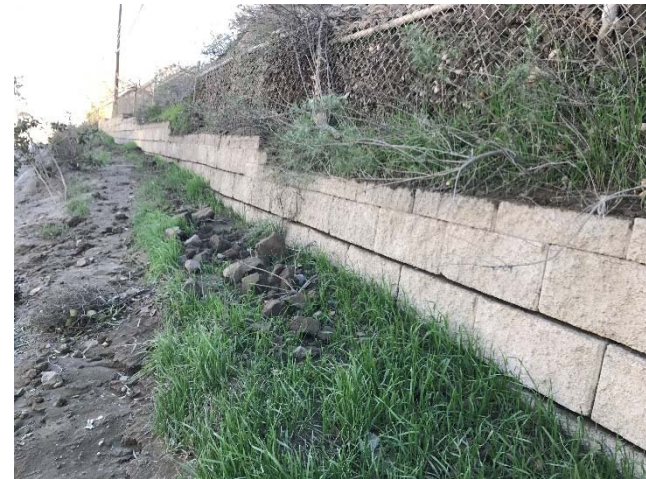
**Photo 547: Frontage Retaining Wall Slope on San Fernando Road:  
January 31, 2017**

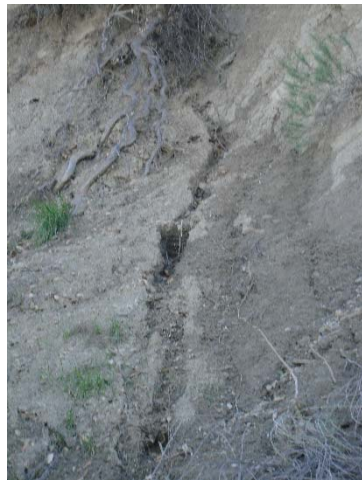
**Photo 562: Frontage Retaining Wall Slope on San Fernando  
Road: January 31, 2017**

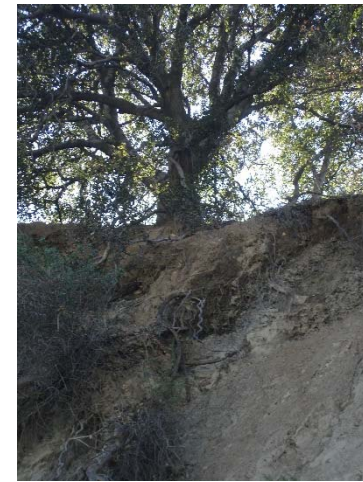
**Photo 563: Frontage Retaining Wall Slope on San Fernando Road:  
January 31, 2017**

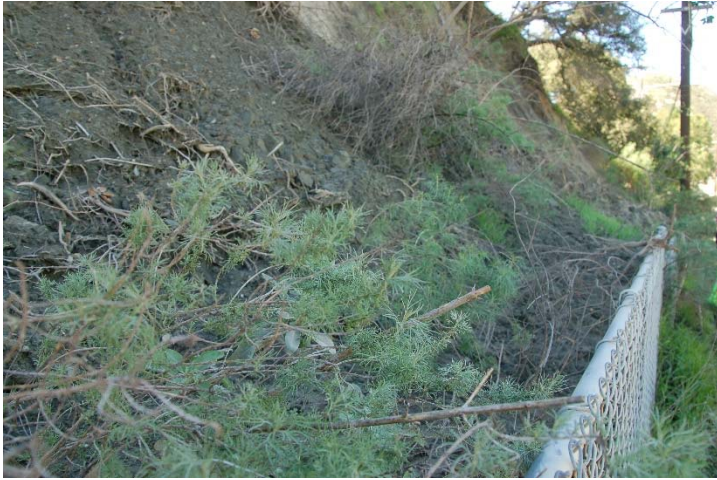
**Photo 564: Frontage Retaining Wall Slope on San Fernando  
Road: January 31, 2017**

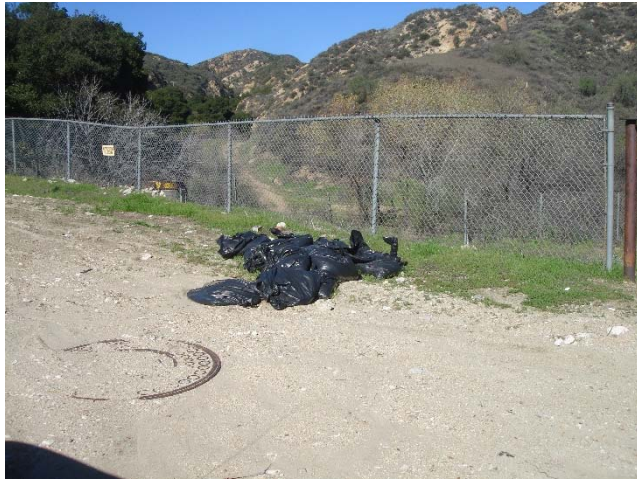
**Photo 592: Rancho Cascades Illegal Dumping: January 17, 2017**

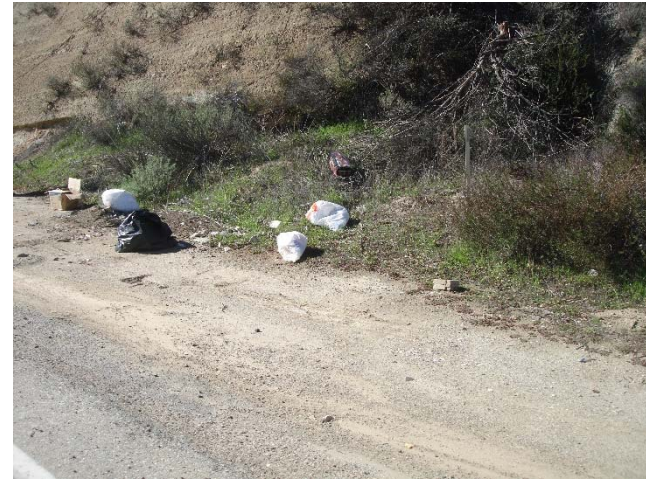
**Photo 593: Sierra High I-14 Dumping: January 17, 2017**

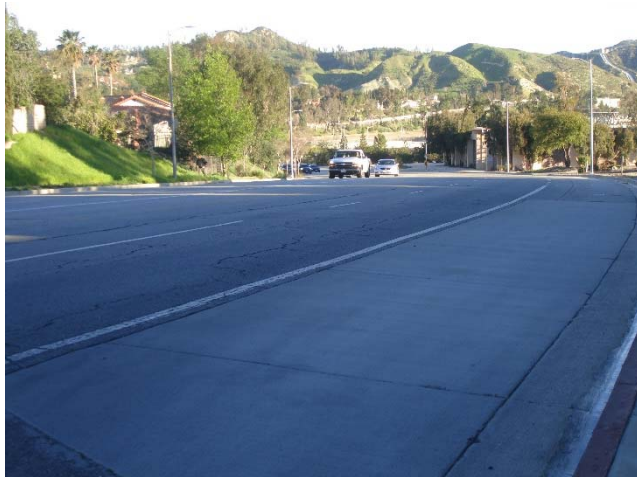
**Photo 594: Sierra High I-14 Dumping: January 17, 2017**

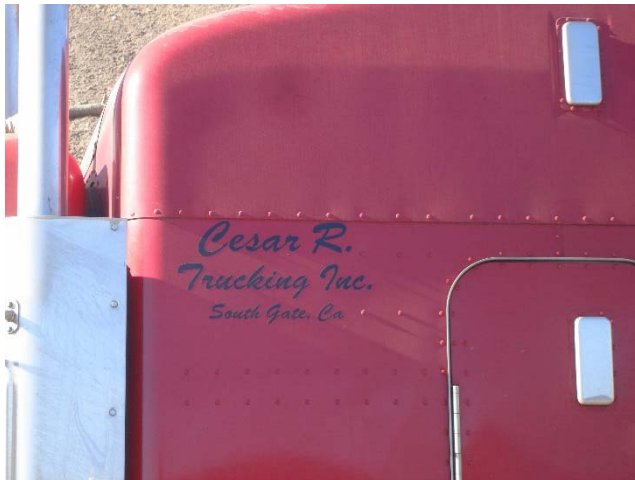
**Photo 604: Odorous Truck: January 17, 2017**

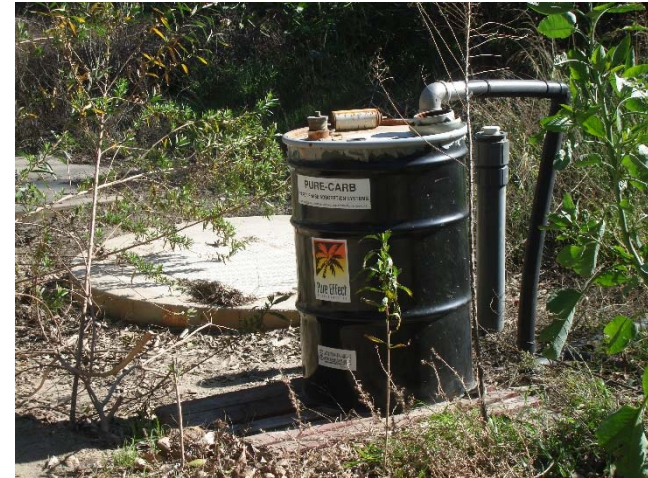
**Photo 605: Odorous Truck: January 17, 2017**
