**Sunshine Canyon Landfill  
Independent Monitor  
Quarterly Site Monitoring Status Report  
January 1, 2017 – March 31, 2017**

**City of Los Angeles Department of City Planning**

**County of Los Angeles Department of Regional Planning**

April 26, 2017

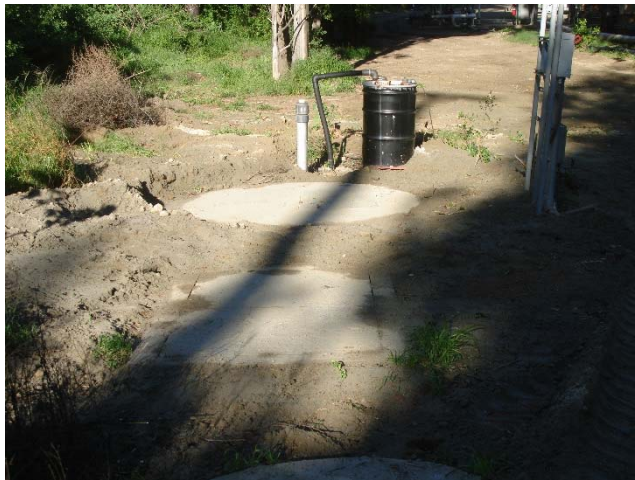
**Photo 606: Localized Odor near Sewer Lift Pump: January 31, 2017**

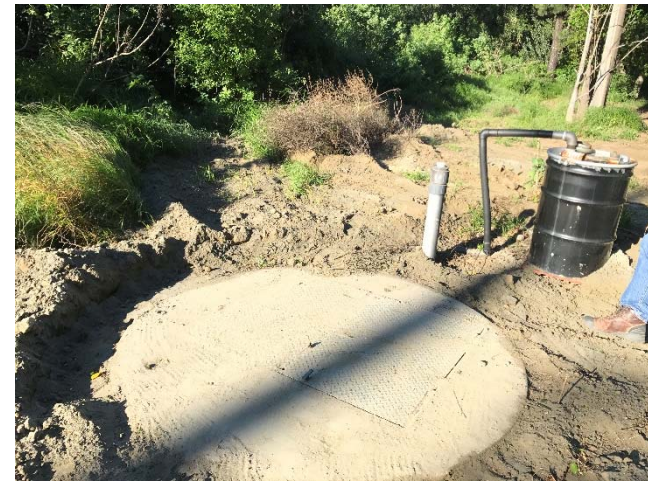
**Photo 607: Localized Odor near Sewer Lift Pump: March 23, 2017**

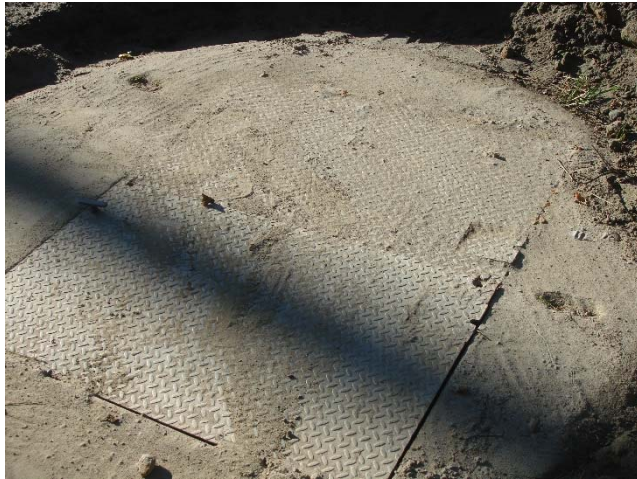
**Photo 608: Localized Odor near Sewer Lift Pump: March 23, 2017**

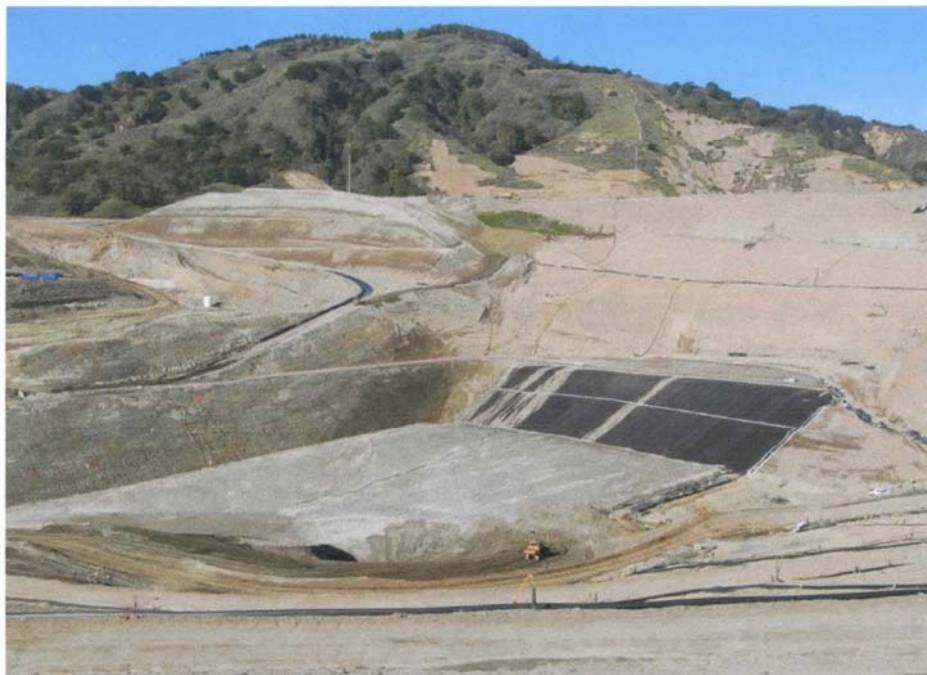
Photo 3: Construction at Cell CC4

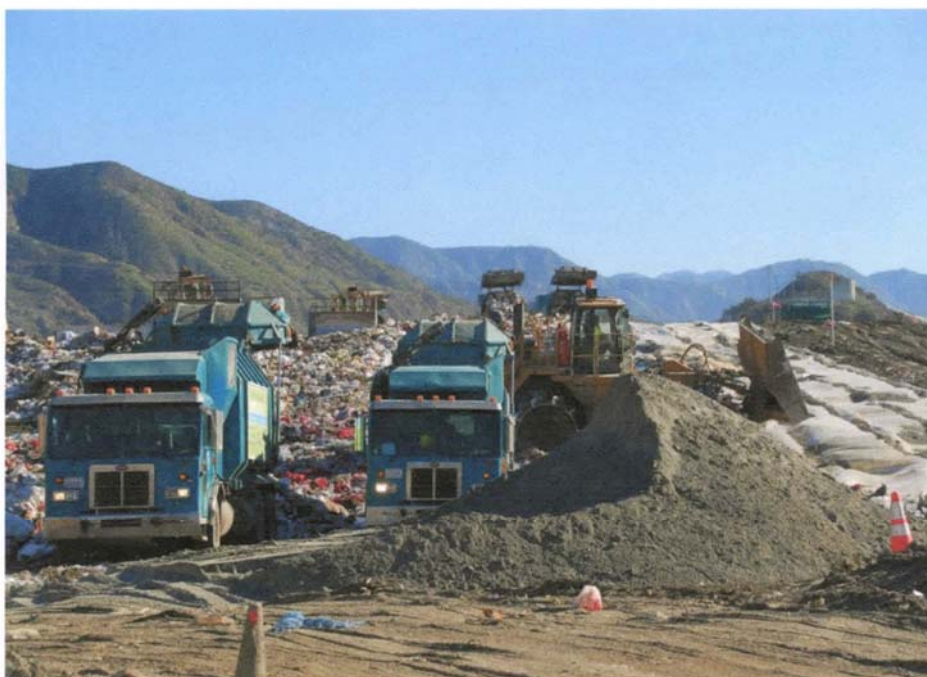
Photo 4: Placement of waste at CC3B

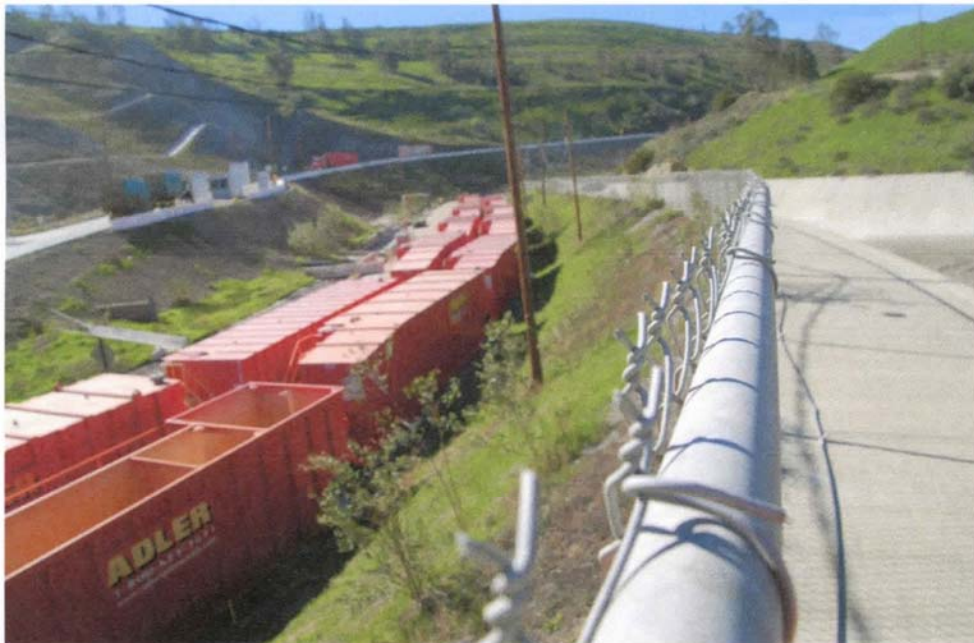
Photo 8: Storage tanks to store stormwater from new temporary unlined earthen basin

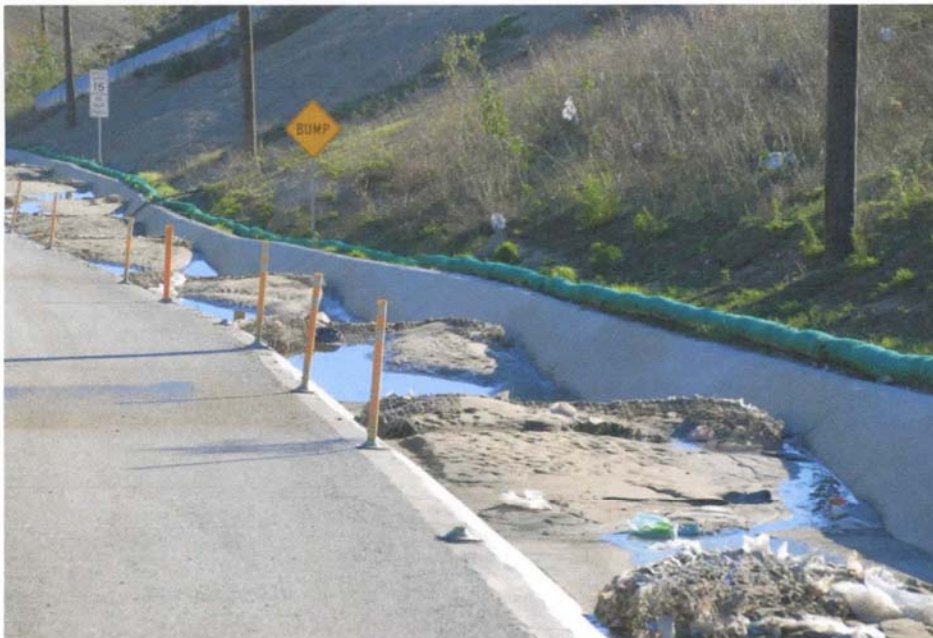
Photo 10: Gabions in main channel along access road

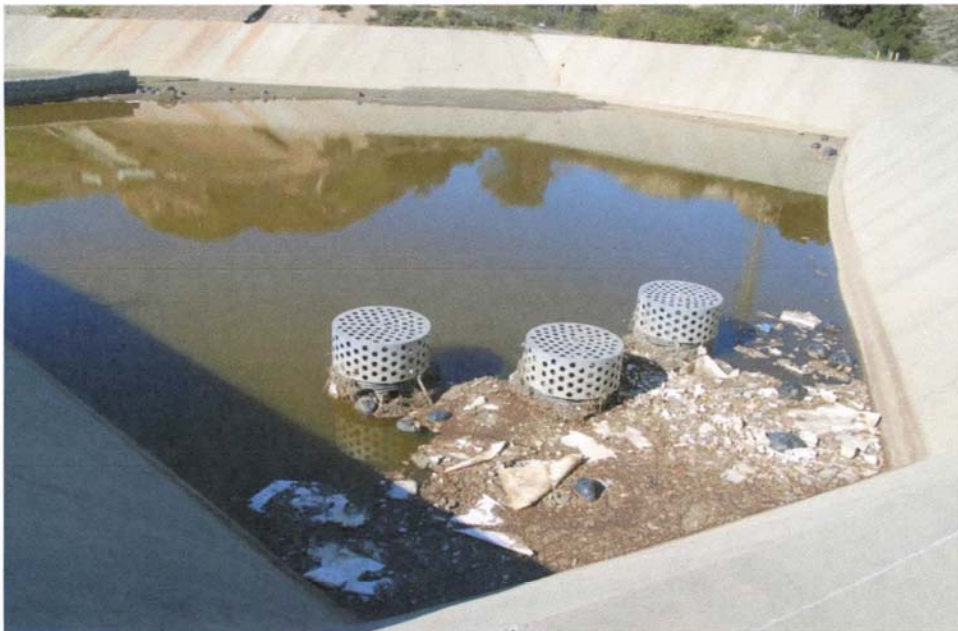
Photo 12: Water level against decant towers

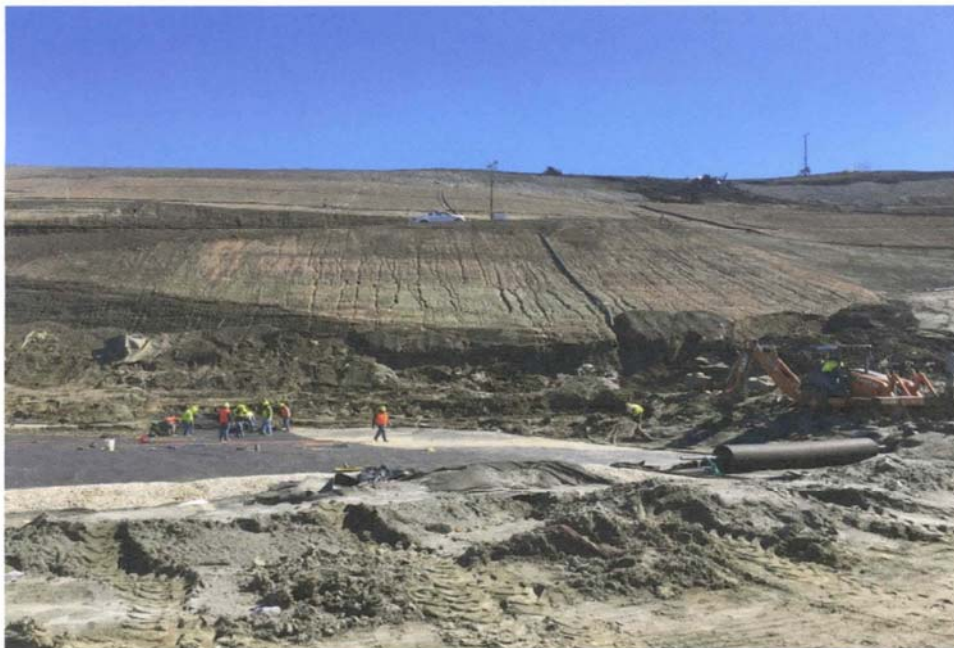
Photo 2: Installation of geosynthetics in northeast corner of cell of CC4
