**Sunshine Canyon Landfill
Independent Monitor
Quarterly Site Monitoring Status Report
April 1, 2018 – June 30, 2018**

City of Los Angeles Department of City Planning

September 26, 2018

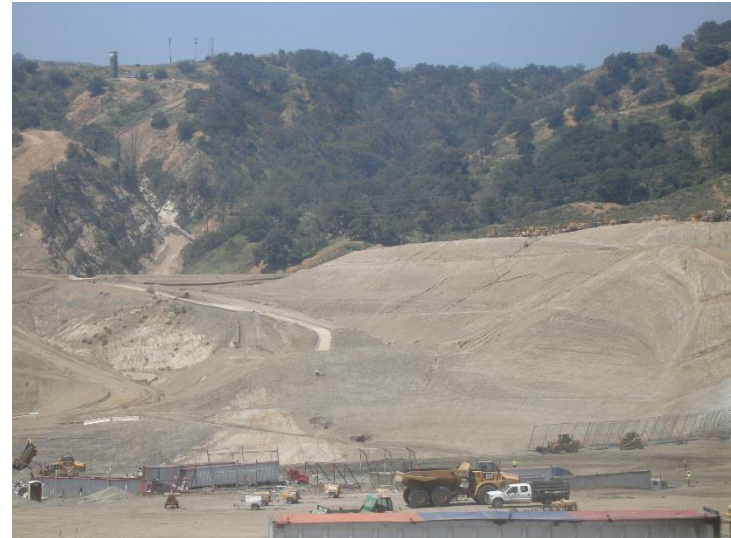
Photo 78: Site Working area CC4A Part 2: May 10, 2018

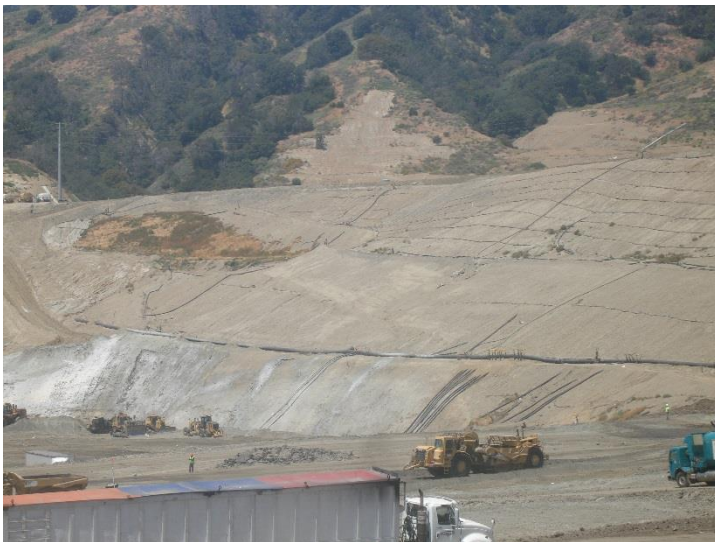
Photo 79: Inactive Area CC4A Part 1: May 10, 2018

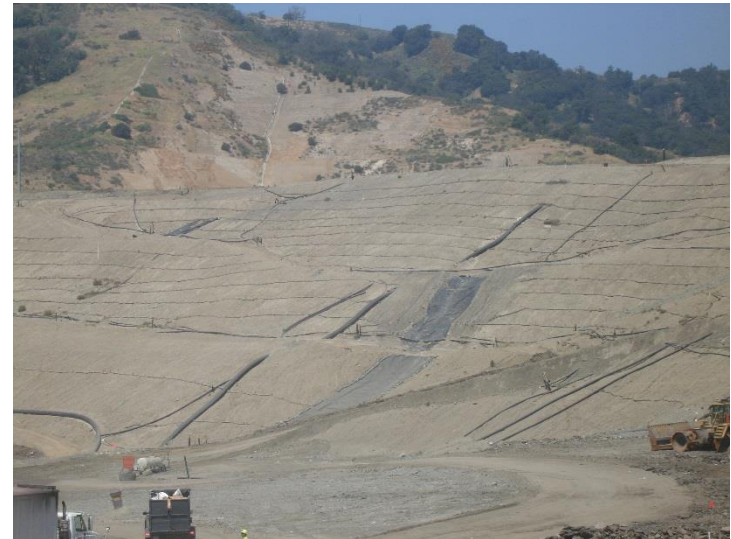
Photo 80: Inactive Area CC4A Part 1: May 10, 2018

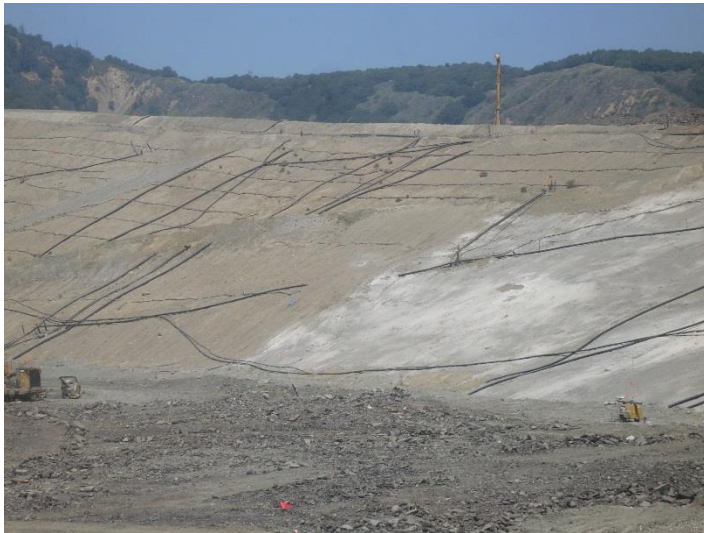
Photo 81: Inactive Area CC4A Part 1: May 10, 2018

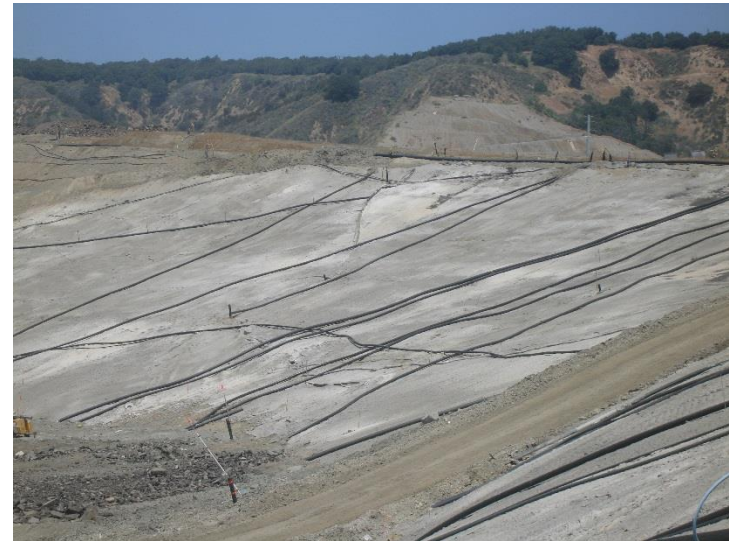
Photo 82: Inactive Area CC4A Part 1: May 10, 2018

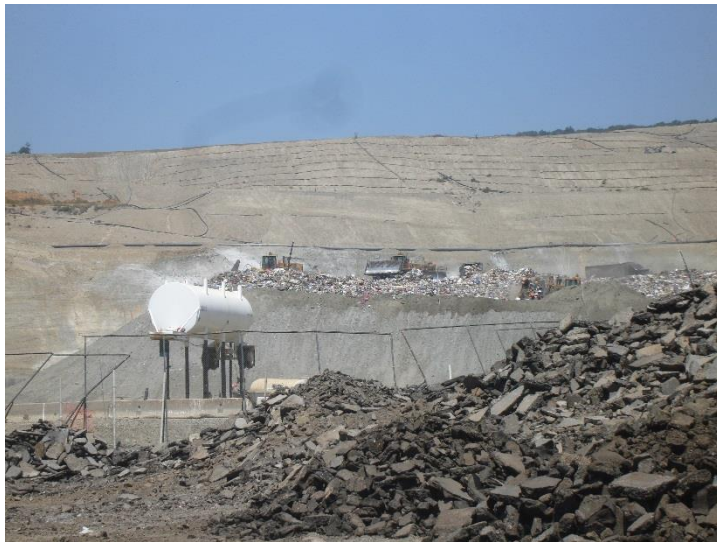
Photo 83: Site Working Area CC4A Part 2: May 10, 2018

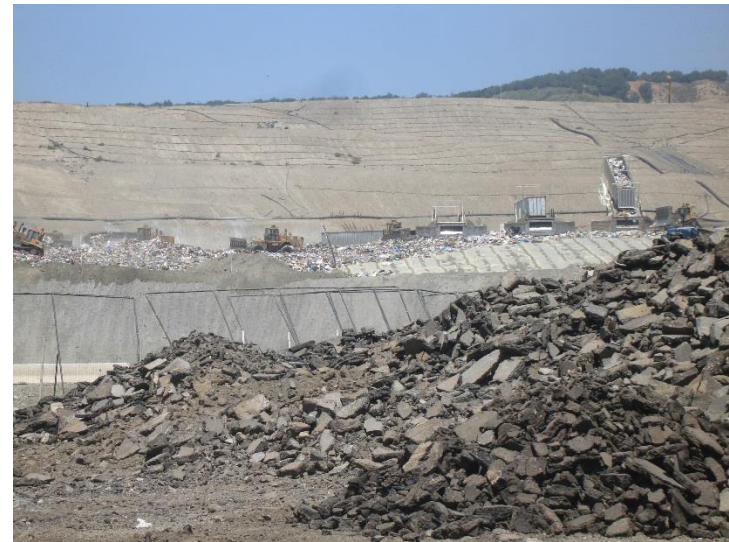
Photo 84: Site Working Area CC4A Part 2: May 10, 2018

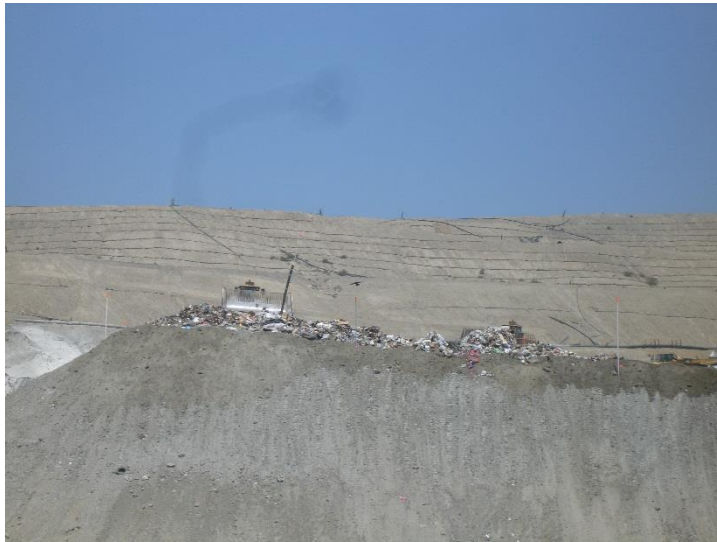
Photo 85: Site Working Area CC4A Part 2: May 10, 2018

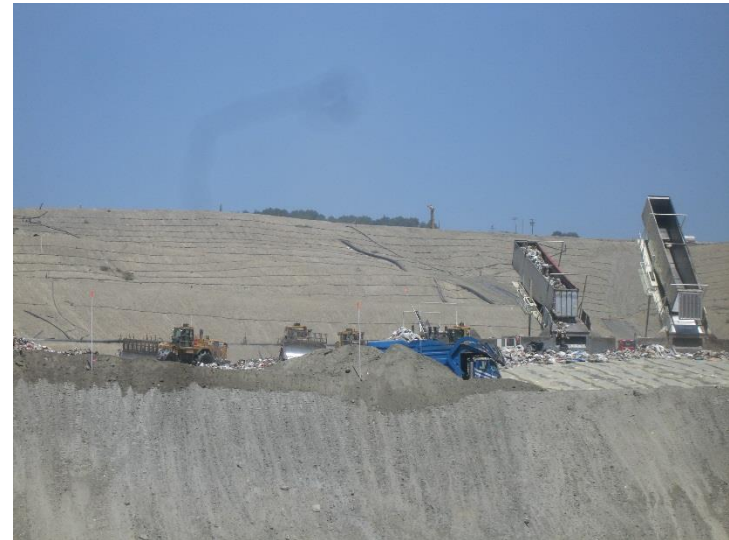
Photo 86: Site Working Area CC4A Part 2: May 10, 2018

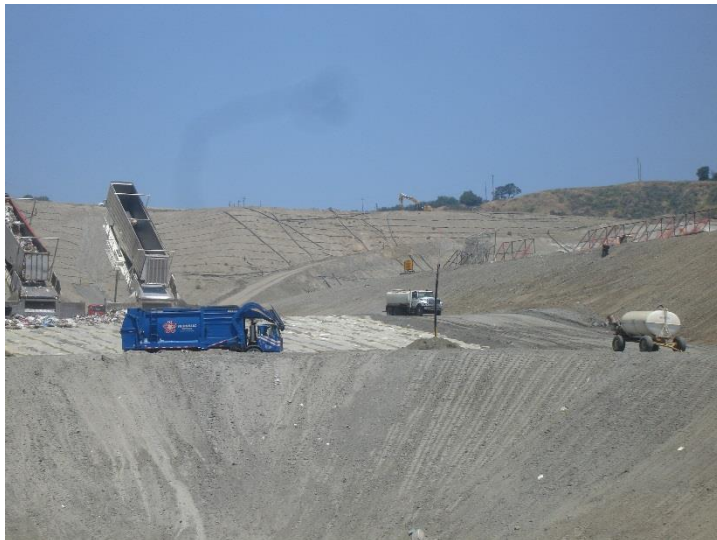
Photo 87: Site Working Area CC4A Part 2: May 10, 2018

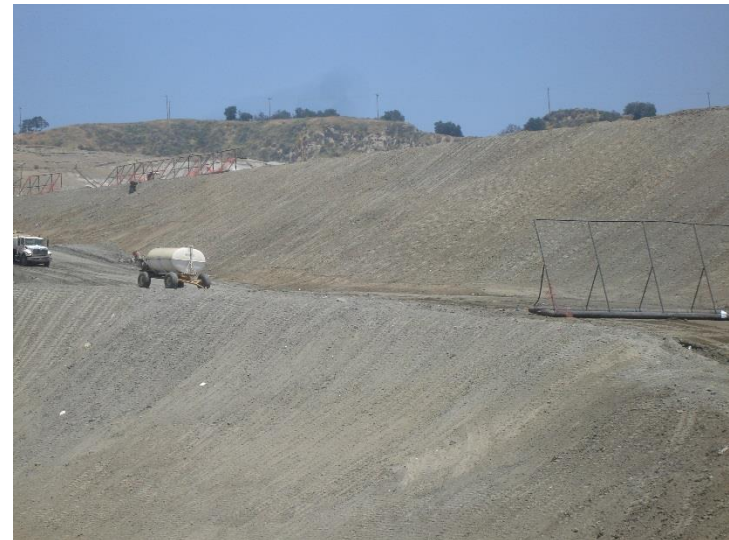
Photo 88: Site Working Area CC4A Part 2: May 10, 2018

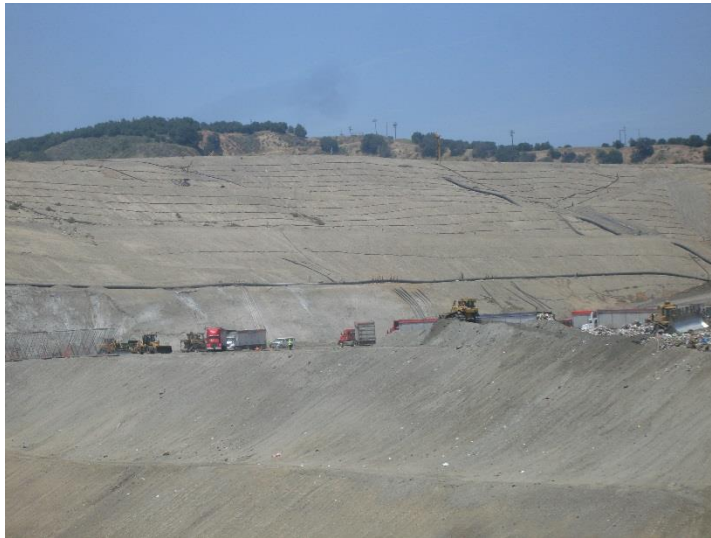
Photo 89: Site Working Area CC4A Part 2: May 10, 2018

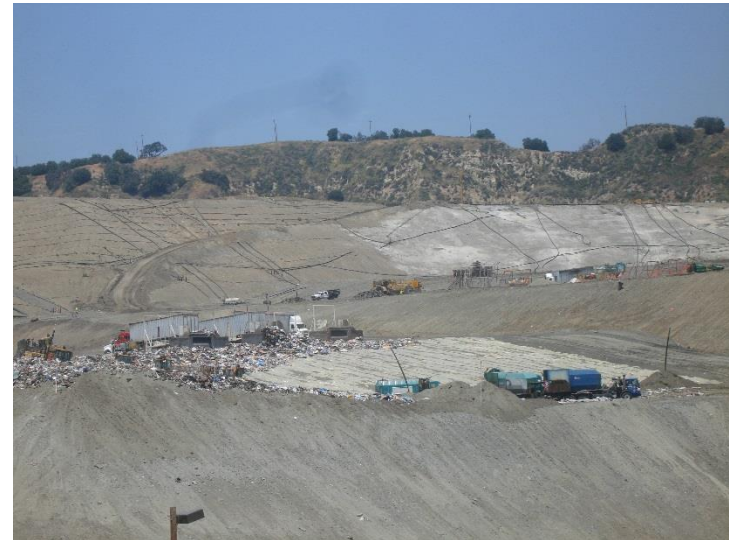
Photo 90: Site Working Area CC4A Part 2: May 10, 2018

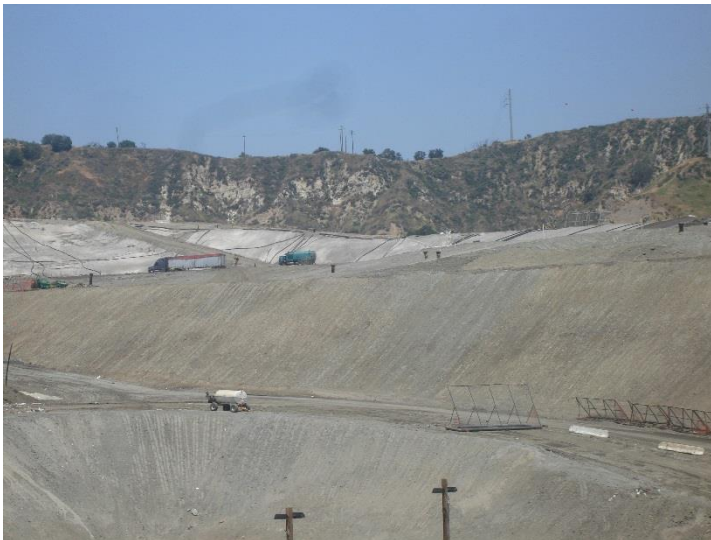
Photo 91: Site Working Area CC4A Part 2: May 10, 2018

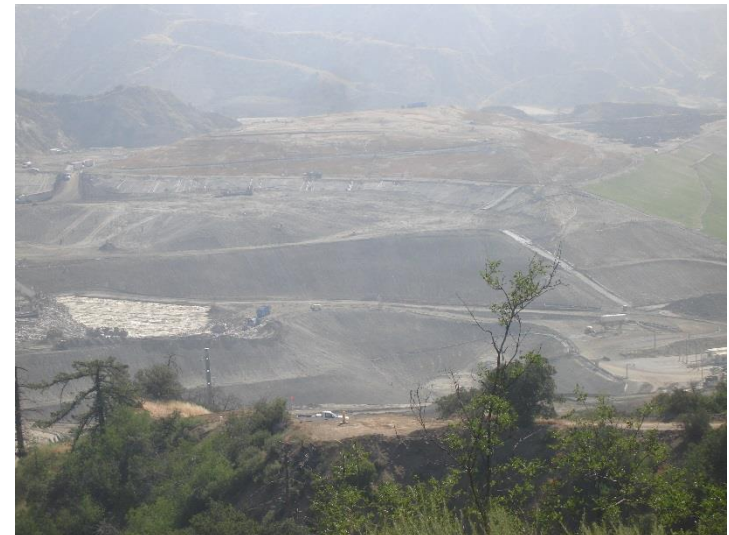
Photo 92: Site Working Area CC4A Part 2 Buttress Excavation Area Top Ridge: May 10, 2018

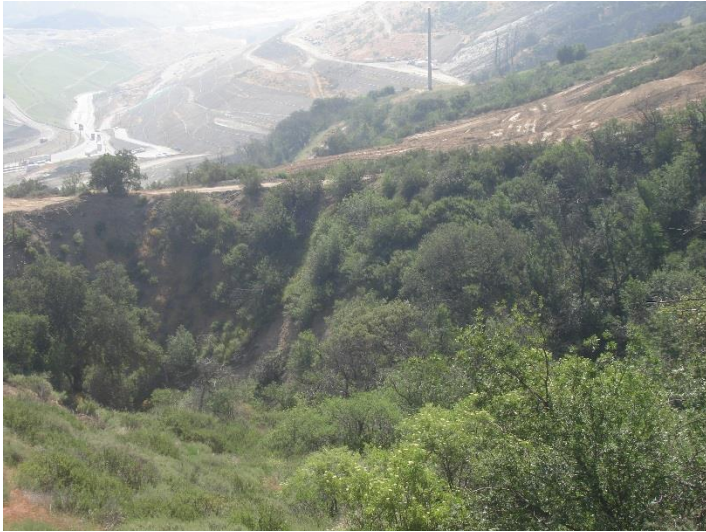
**Photo 93: Site Working Area CC4A Part 2 Buttress Excavation
Area Top Ridge: May 10, 2018**

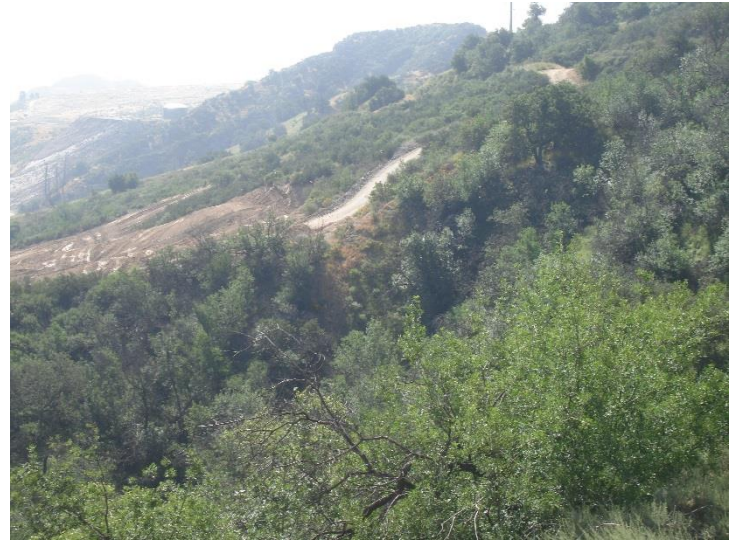
**Photo 94: Site Working Area CC4A Part 2 Buttress Excavation
Area Top Ridge: May 10, 2018**

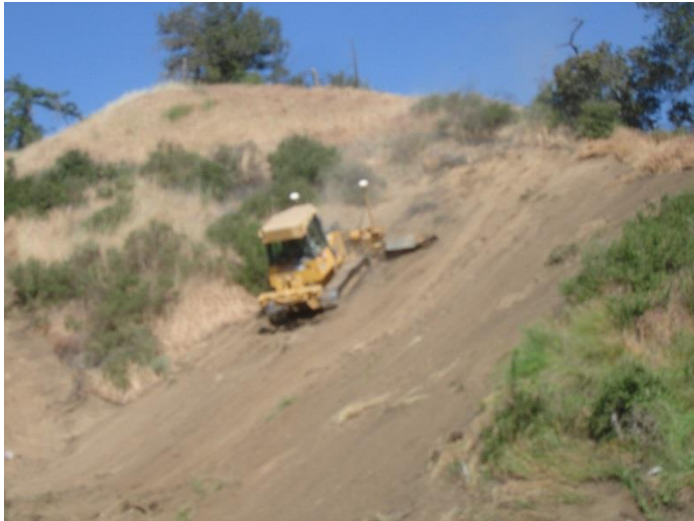
**Photo 95: Site Working Area CC4A Part 2 Buttress Excavation
Area Top Ridge: May 10, 2018**

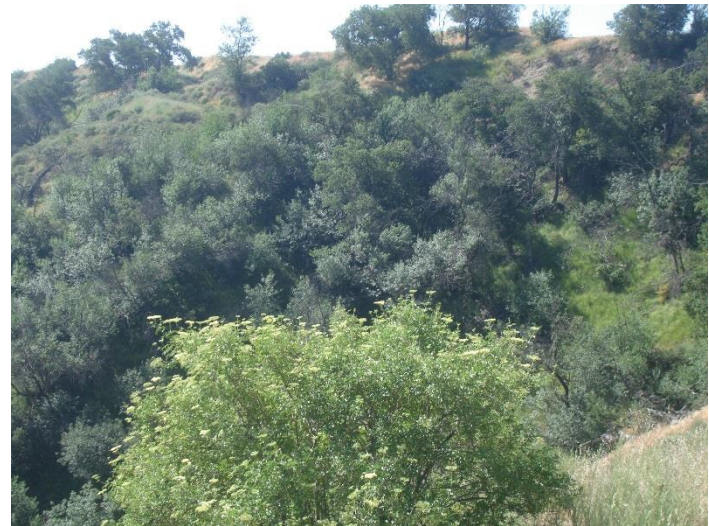
**Photo 96: Site Working Area CC4A Part 2 Buttress Excavation
Area Top Ridge: May 10, 2018**

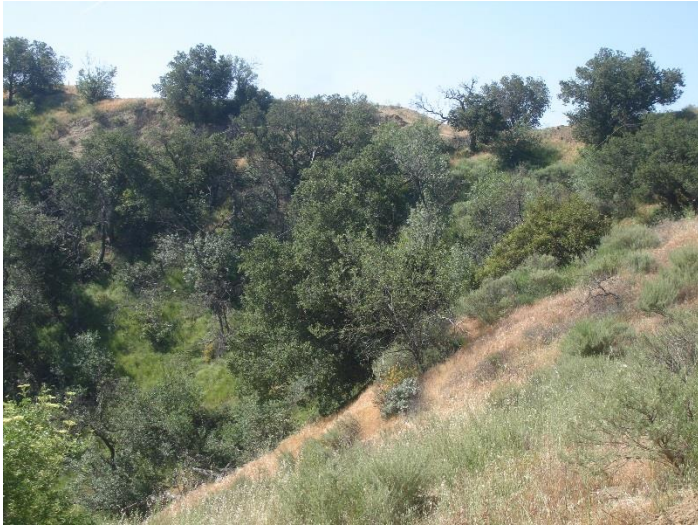
**Photo 97: Site Working Area CC4A Part 2 Buttress Excavation
Area Top Ridge: May 10, 2018**

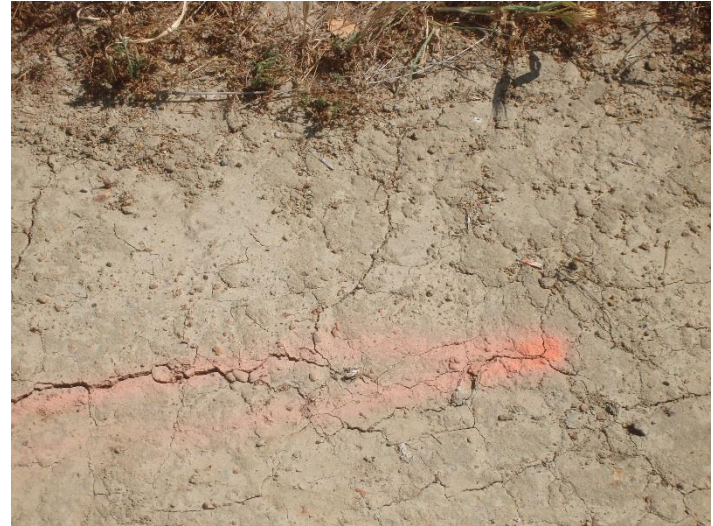
**Photo 98: Site Working Area CC4A Part 2 Buttress Excavation
Area Top Ridge: May 10, 2018**

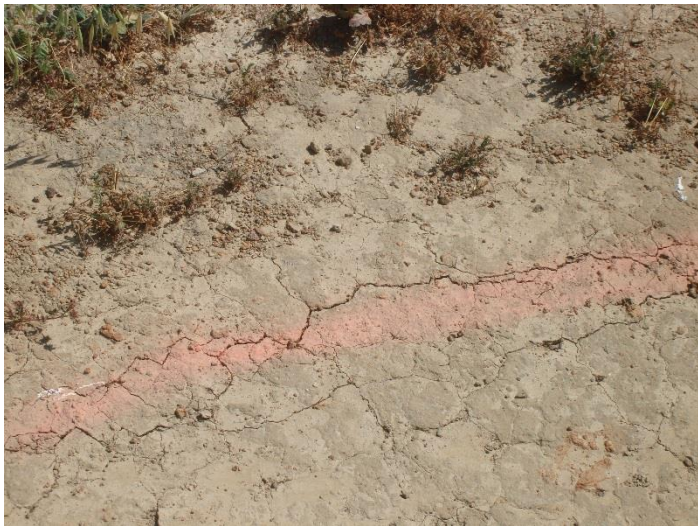
**Photo 99: Site Working Area CC4A Part 2 Buttress Excavation
Area Top Ridge: May 10, 2018**

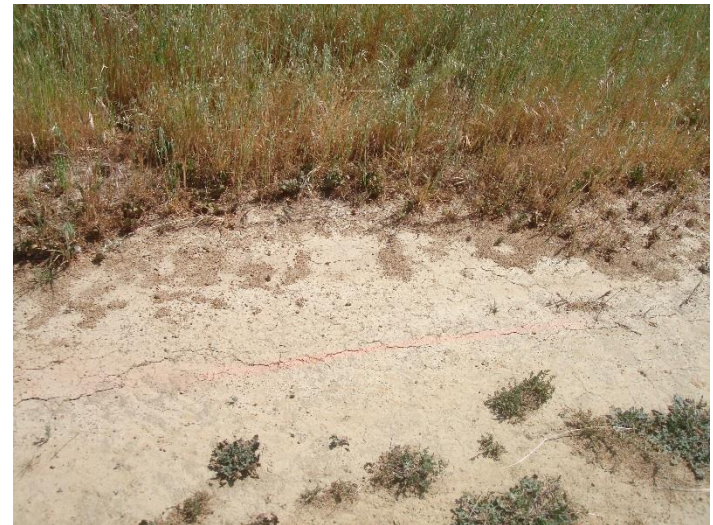
**Photo 100: Site Working Area CC4A Part 2 Buttress Excavation
Area Top Ridge: May 10, 2018**

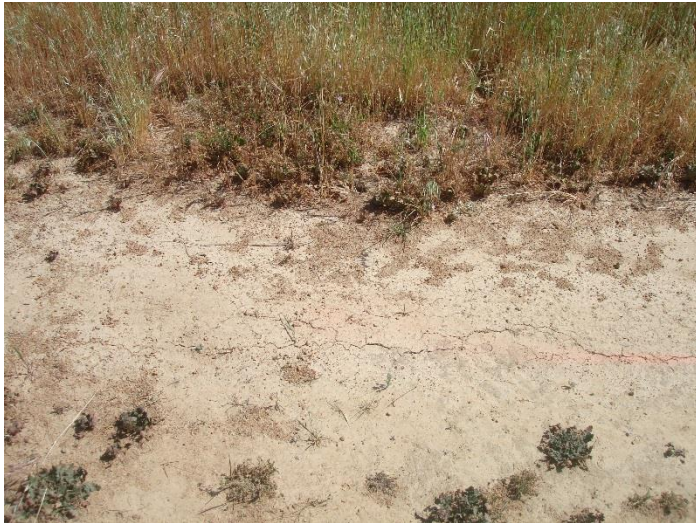
**Photo 101: Site Working Area CC4A Part 2 Buttress Excavation
Area Top Ridge: May 10, 2018**

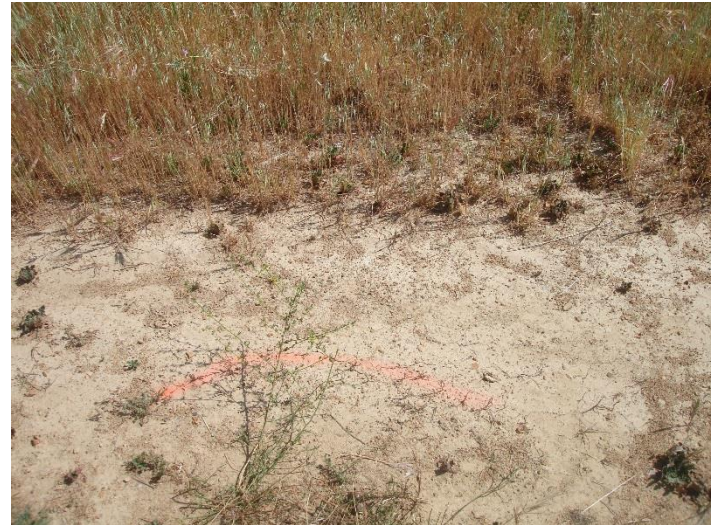
**Photo 102: Site Working Area CC4A Part 2 Buttress Excavation
Area Top Ridge: May 10, 2018**

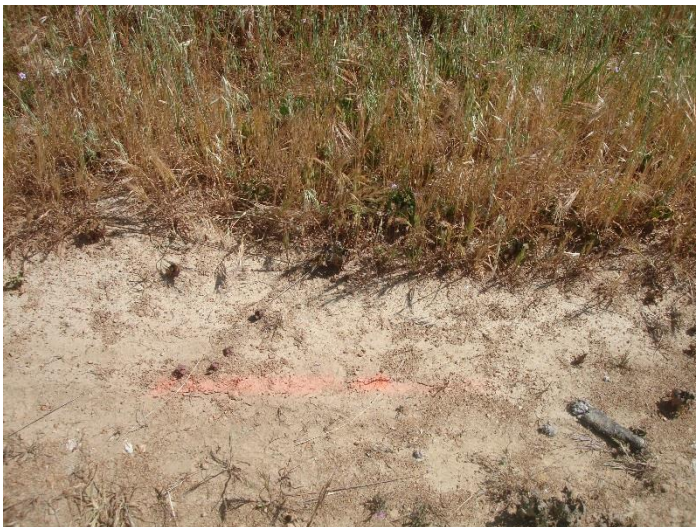
**Photo 103: Site Working Area CC4A Part 2 Buttress Excavation
Area Top Ridge: May 10, 2018**

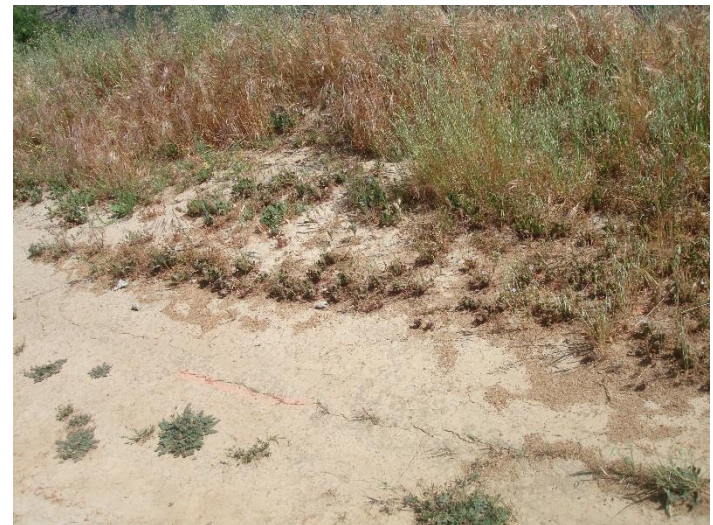
**Photo 104: Site Working Area CC4A Part 2 Buttress Excavation
Area Top Ridge: May 10, 2018**

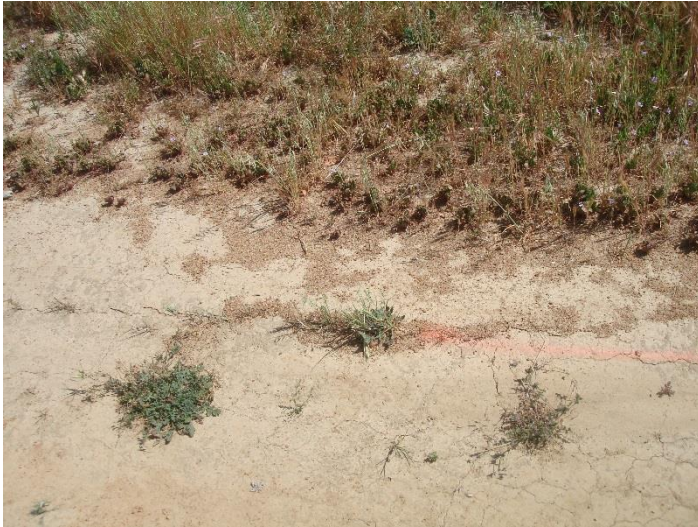
**Photo 105: Site Working Area CC4A Part 2 Buttress Excavation
Area Top Ridge: May 10, 2018**

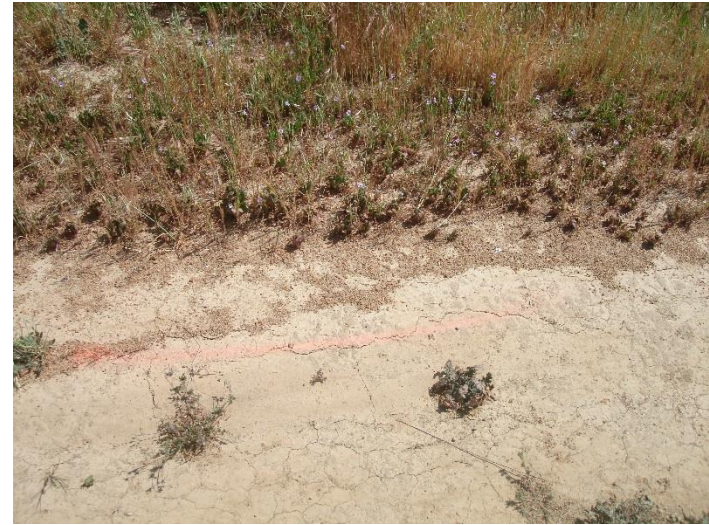
**Photo 106: Site Working Area CC4A Part 2 Buttress Excavation
Area Top Ridge: May 10, 2018**

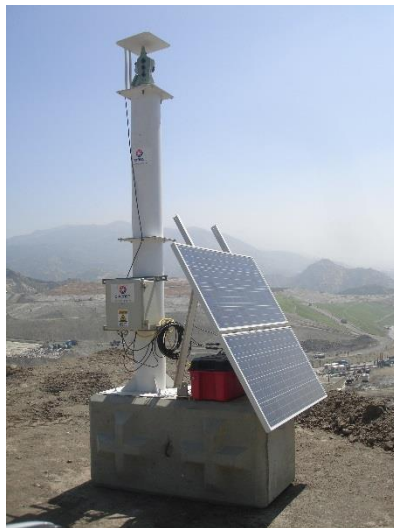
**Photo 107: Site Working Area CC4A Part 2 Buttress Excavation
Area Slope Monitor: May 10, 2018**

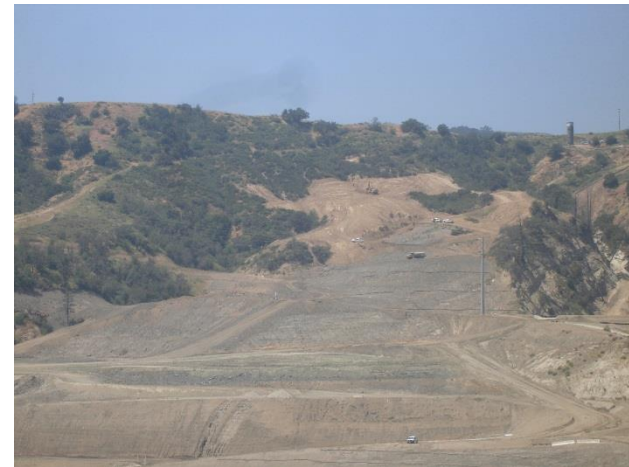
**Photo 108: Site Working Area CC4A Part 2 Buttress Excavation
Area: May 10, 2018**

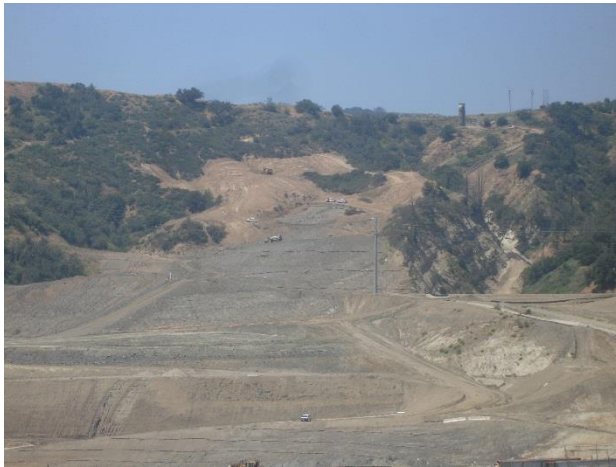
Photo 109: Site Working Area CC4A Part 2 Buttress Excavation Area: May 10, 2018

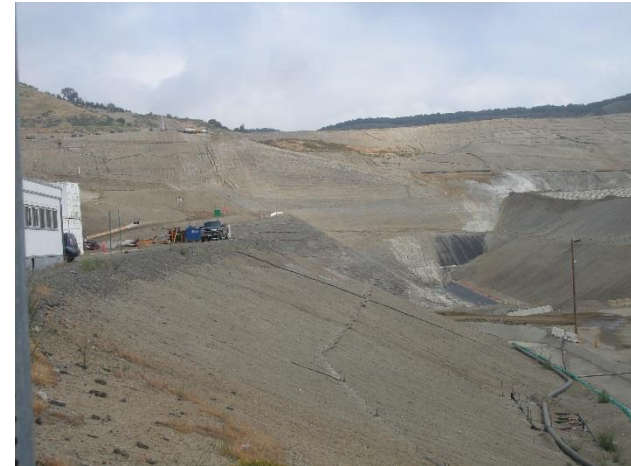
Photo 110: Site Prior to Opening CC 4A Part 1 & 2: May 22, 2018

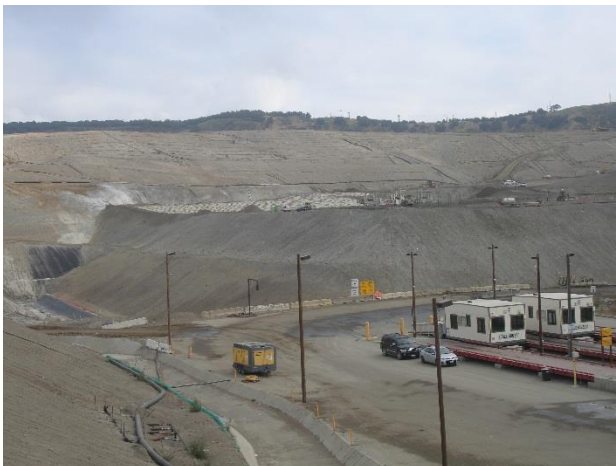
Photo 111: Site Prior to Opening CC 4A Part 1 & 2: May 22, 2018

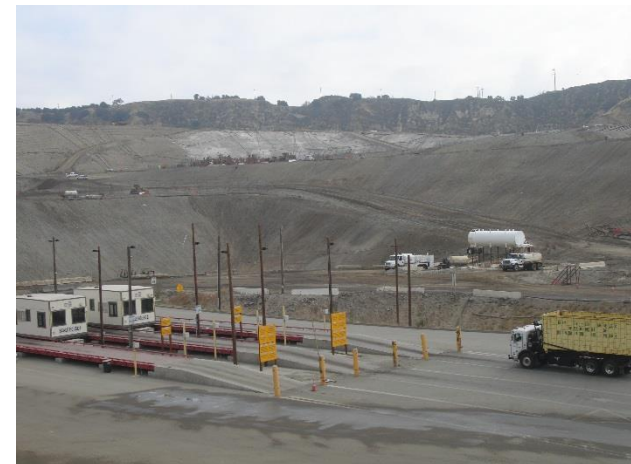
Photo 112: Site Prior to Opening CC 4A Part 1 & 2: May 22, 2018

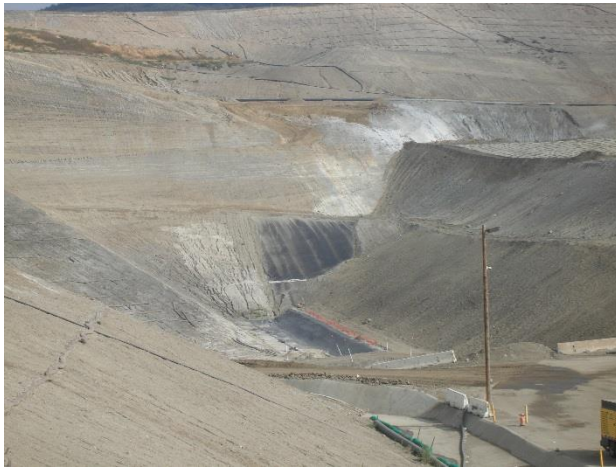
Photo 113: Site Prior to Opening CC 4A Part 1 & 2: May 22, 2018

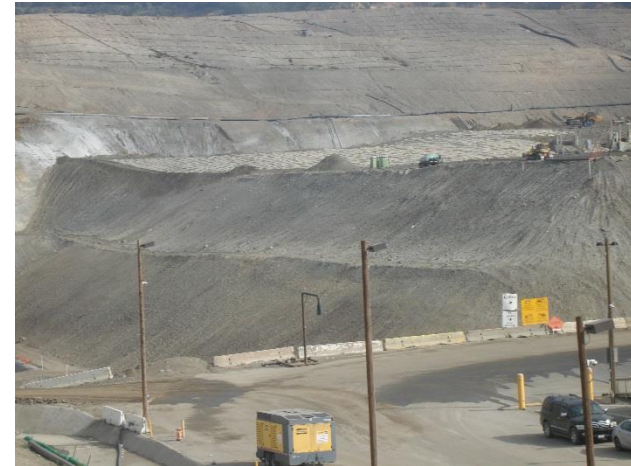
Photo 114: Site Prior to Opening CC 4A Part 1 & 2: May 22, 2018

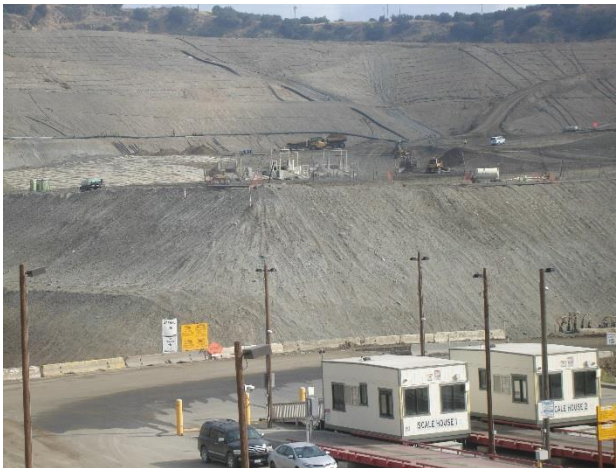
Photo 115: Site Prior to Opening CC 4A Part 1 & 2: May 22, 2018

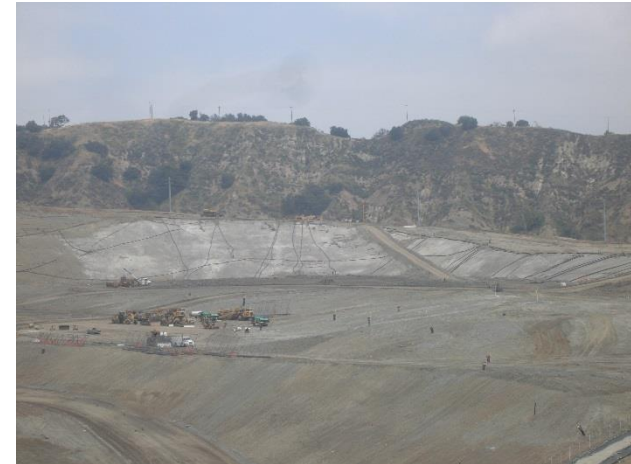
Photo 116: Site Prior to Opening CC 4A Part 1 & 2: May 22, 2018

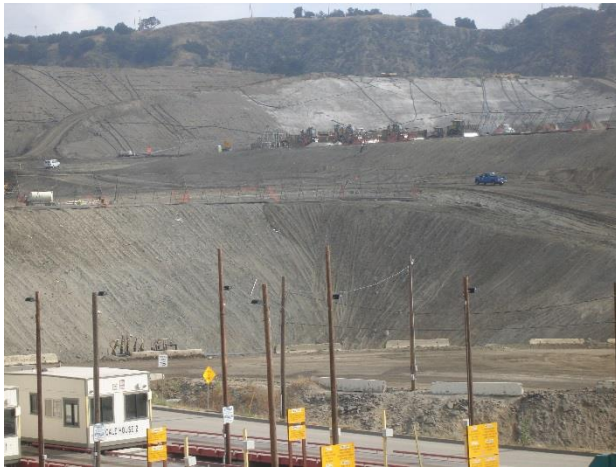
Photo 117: Site Prior to Opening CC 4A Part 1 & 2: May 22, 2018

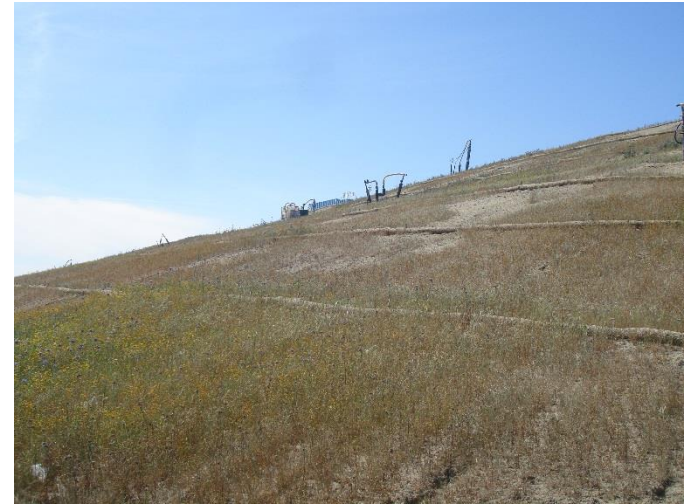
Photo 249: CC3A North Slope Well Liquids Spill: April 24, 2018

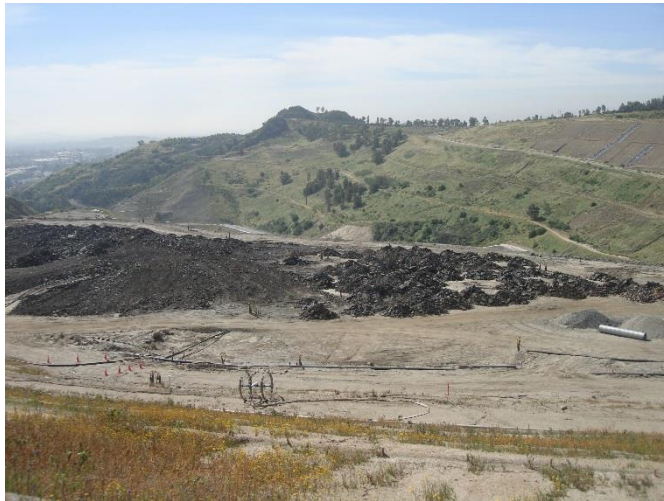
Photo 250: CC3A North Slope Well Liquids Spill: April 24, 2018

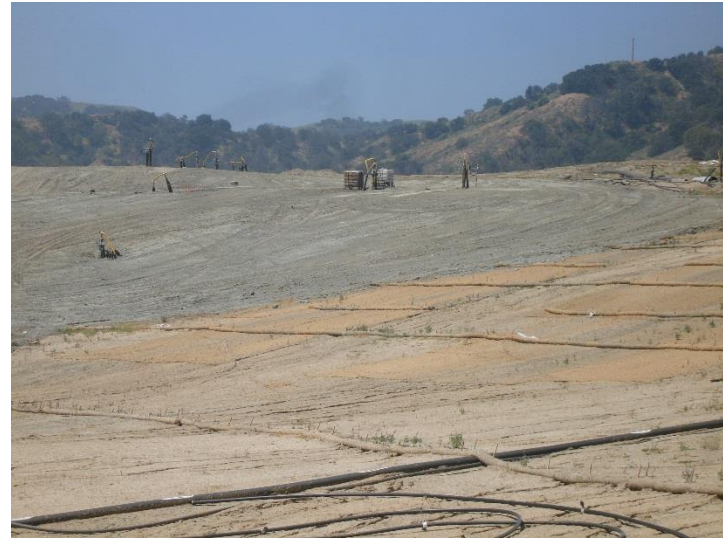
Photo 277: CC3B Top Deck (Bowl) & Slope Revegetation: May 10, 2018

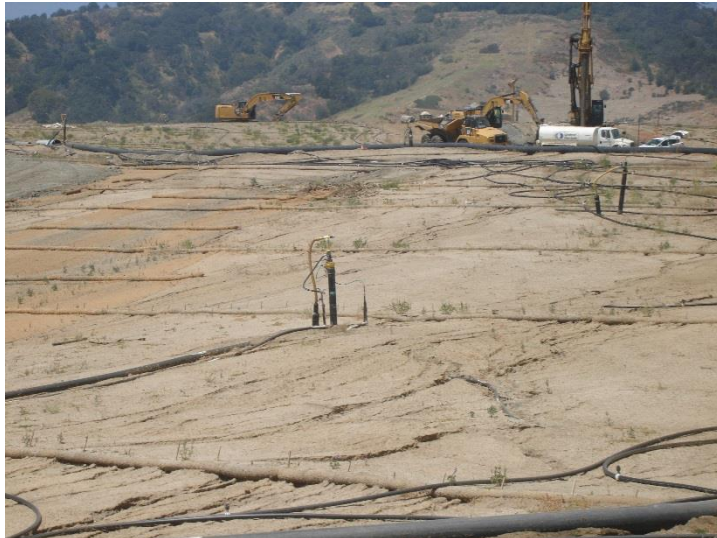
Photo 278: CC3B Top Deck (Bowl) & Slope Revegetation: May 10, 2018

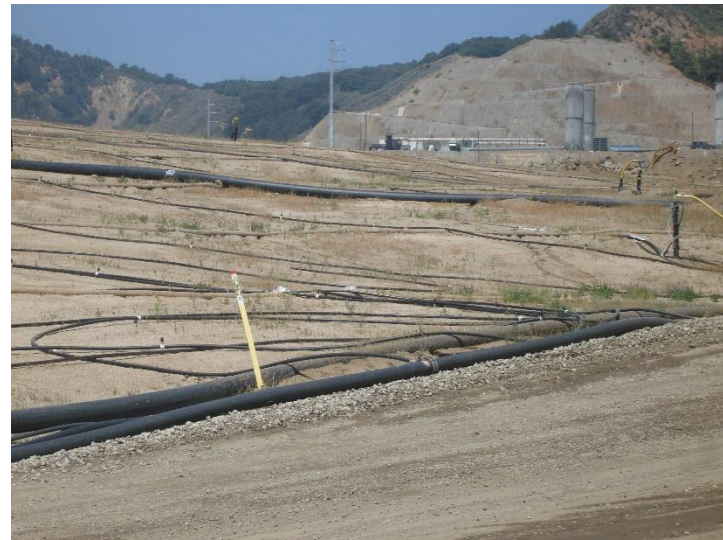
Photo 279: CC3B Top Deck (Bowl) & Slope Revegetation: May 10, 2018

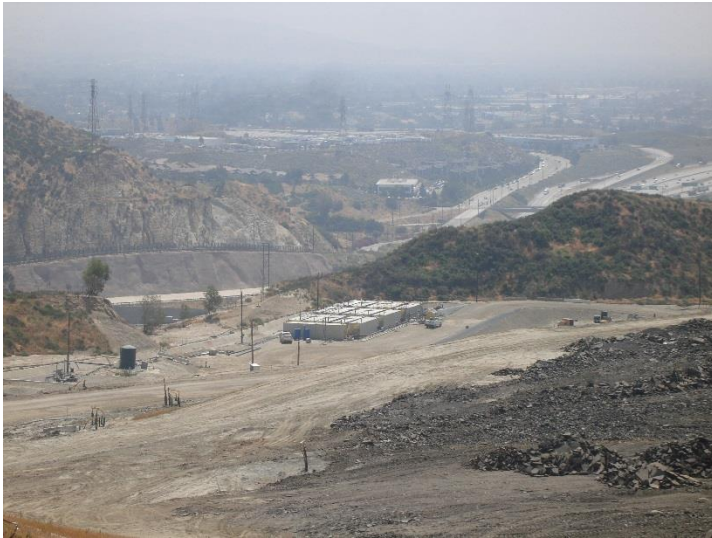
Photo 280: CC3B Top Deck (Bowl) & Slope Revegetation: May 10, 2018

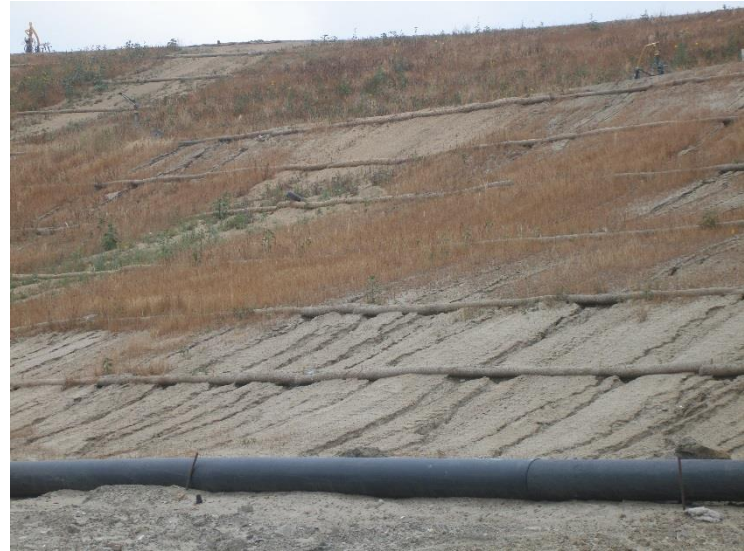
Photo 293: CC3A East Slope Revegetation: May 22, 2018

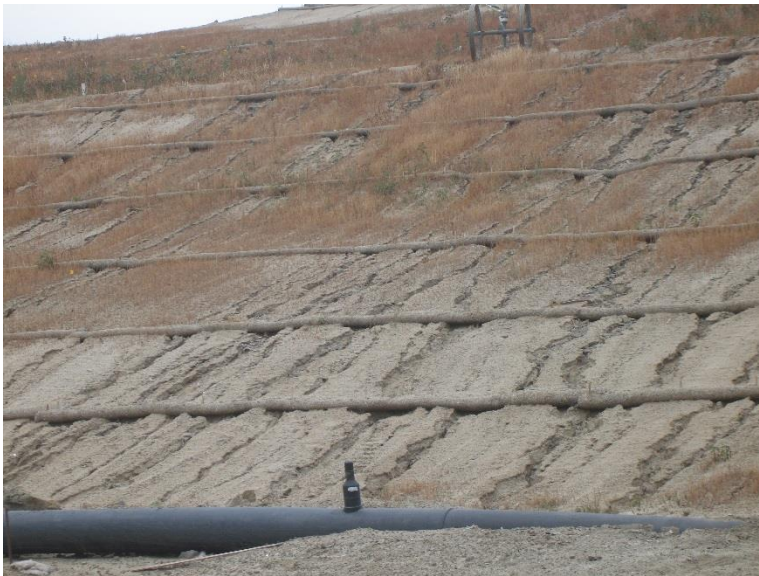
Photo 294: CC3A East Slope Revegetation: May 22, 2018

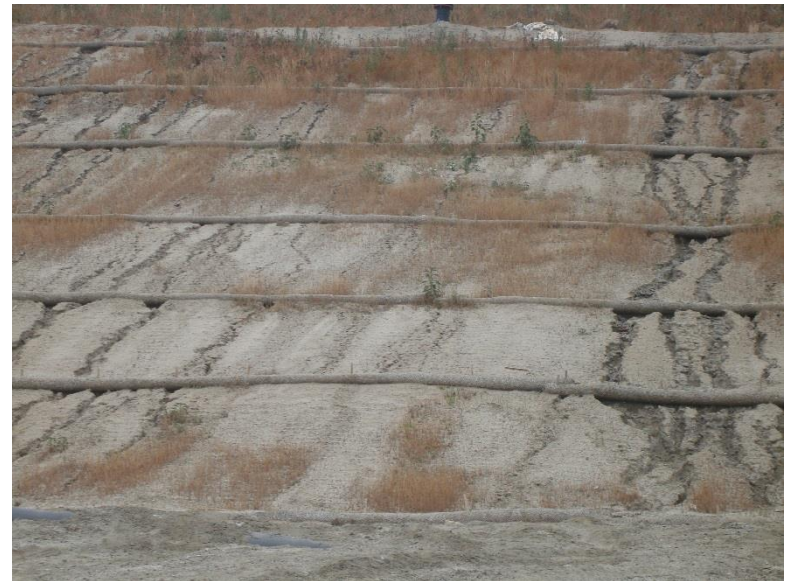
Photo 295: CC3A East Slope Revegetation: May 22, 2018

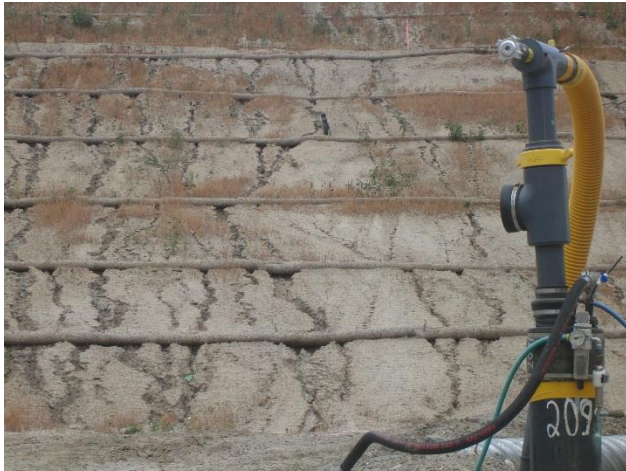
Photo 296: CC3A East Slope Revegetation: May 22, 2018

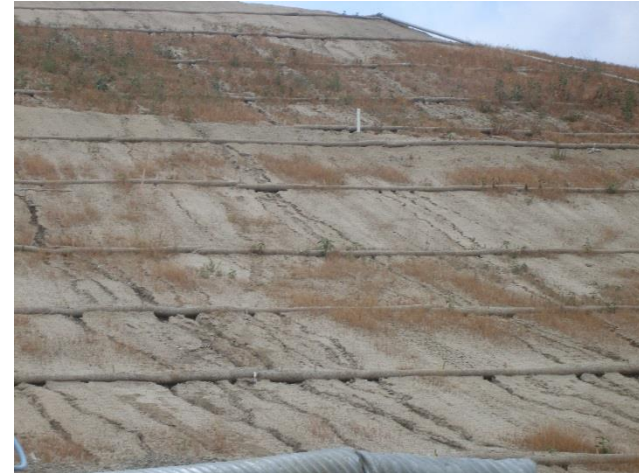
Photo 297: CC3A East Slope Revegetation: May 22, 2018

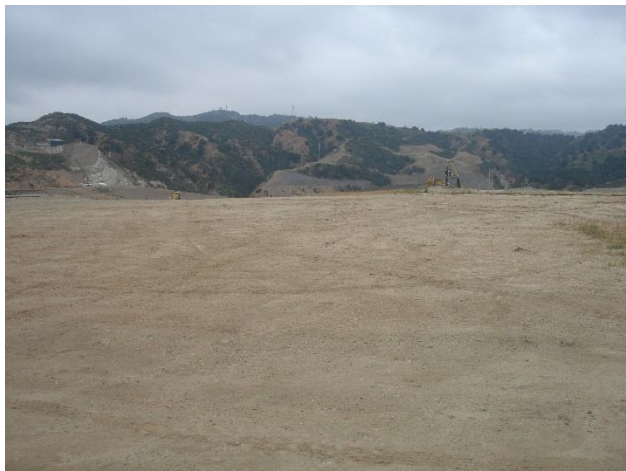
Photo 298: CC3A East Slope Revegetation: May 22, 2018

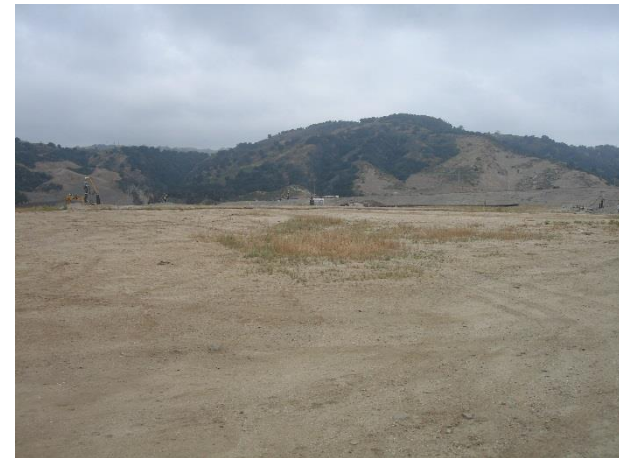
Photo 299: CC3A Top Deck Revegetation: May 22, 2018

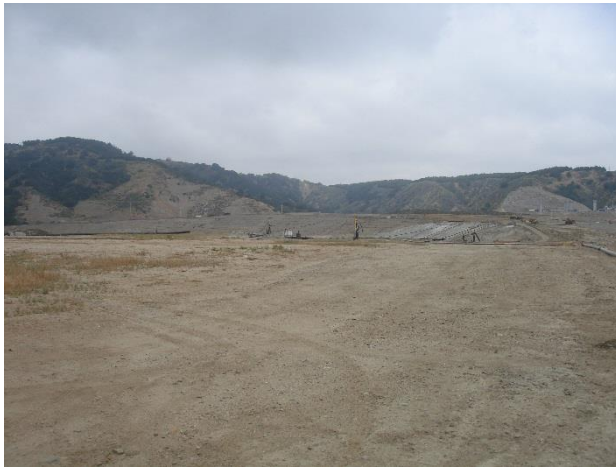
Photo 300: CC3A Top Deck Revegetation: May 22, 2018

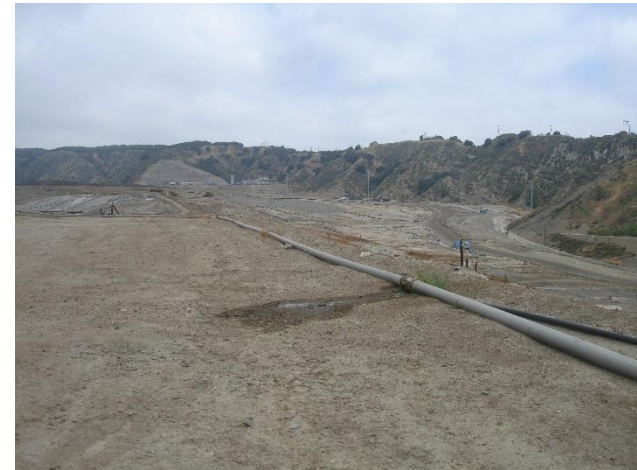
Photo 301: CC3A Top Deck Revegetation: May 22, 2018

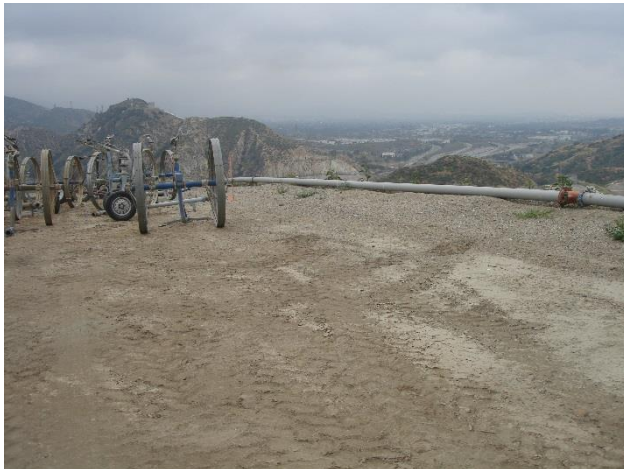
Photo 302: CC3A Top Deck Revegetation: May 22, 2018

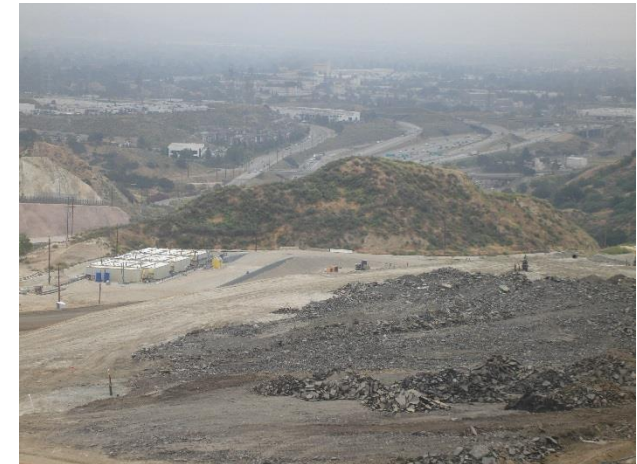
Photo 303: CC3A Top Deck Revegetation: May 22, 2018

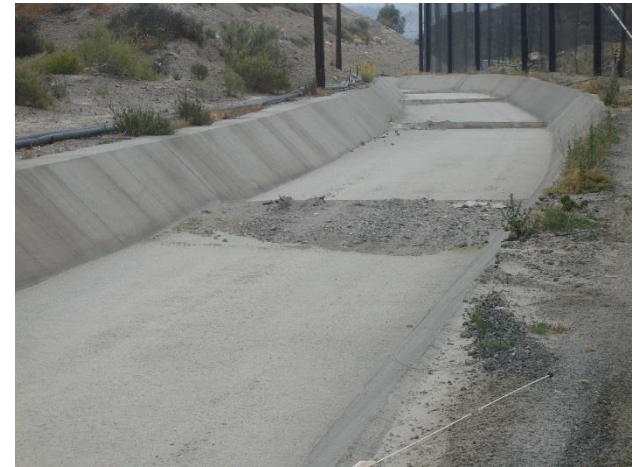
Photo 313: Basin B Slope Native Vegetation: May 22, 2018

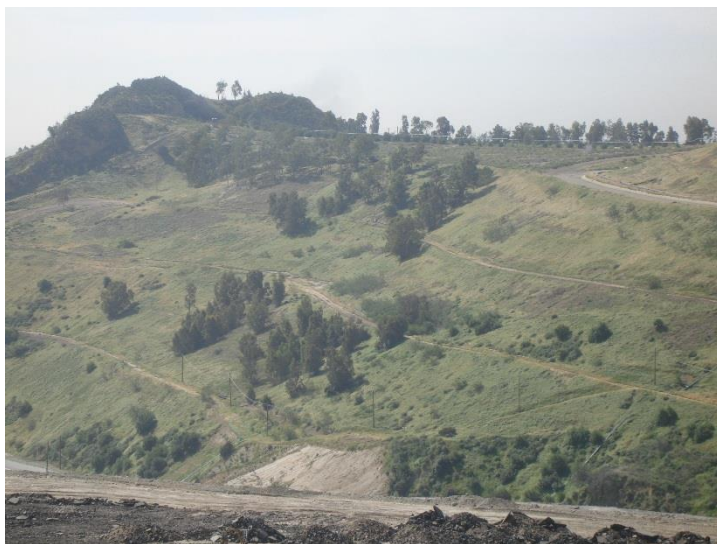
Photo 330: Old City South Slopes: April 24, 2018

Monitor: James Aidukas	Page: 1 of 2
Discipline: Project Manager	Date: 4/24/18
Site Conditions: Foggy to Clear, 65-85°F, 0-10 MPH winds	
SITE LOG	
<p>Republic General Manager - Chris Coyle</p> <p>Drove the Granada Hills neighborhood areas from 6:30 to 7:15 a.m. and there were no landfill odors detected. Met with Mike Lindsay (UltraSystems) and Tarik Hadj-Hamou (SLR) and planned the monitoring sequence. Drove the oil field and checked the hillsides for rock movement from the recent earthquake. No movement was observed. Drove to the south perimeter gate and verified that the gate was locked. The oil field operation was not operating due to a Piggings of the gas sales pipeline. Signed in and had a brief meeting with Chris Coyle. Met with Mike Harmon (LACDPW) who was joining us on the monitoring and proceeded to monitor the site and observed the following:</p> <ul style="list-style-type: none"> • Cell CC-4A Part 1 was starting operations and accepting waste. CC-4A Part 2 was not accepting waste. • Met with Dave Thompson and George Kasikarin and had a brief conversation about the operations. • Drove the access road to Cell CC-3A. The Closure Turf was observed to be functioning well with no problem areas. The stockpiled soil adjacent to the east and west Turf edges had erosion rills not yet repaired. • The eastern slopes of CC-3A that were hydroseeded had vegetation well established. There were areas with erosion rills from rainwater runoff that will need to be repaired with possible additions of temporary HDPE lined downslope drainage channels. • The slope area between well 2085 and the tote container and north of GW-3009D had a strong localized odor. This area had prior liquid spill/seep problems. SCS was working on a liquid handling pipeline and liquid wells pumps. A well was also being drilled. • The north and south facing slopes of cell CC-3A also had vegetation doing well. There was minimal vegetation seen on the top deck of CC-3A. • The liquids handling facility on the Old City North top deck was observed and operating with no odors detected. The adjacent area was dry and maintained. • Recycle asphalt was being stockpiled on the top deck of CC-3B. • The vegetation on the south facing slope above the top deck of CC-3B that was hydroseeded was doing well with 50-60% success. The temporary HDPE lined drainage downcomer was reinstalled and erosion rills repaired. • The Posi-Shell covered slopes had areas that needed repair. These areas had some cracking and movement. No odors were detected. • Sediment Basin B was dry and sediment stockpiled to dry. The back native hillside vegetation had wind-blown litter. • The County top deck and slopes (County Bowl) had minimal hydroseeding success. The slopes also had numerous and deep erosion rills.

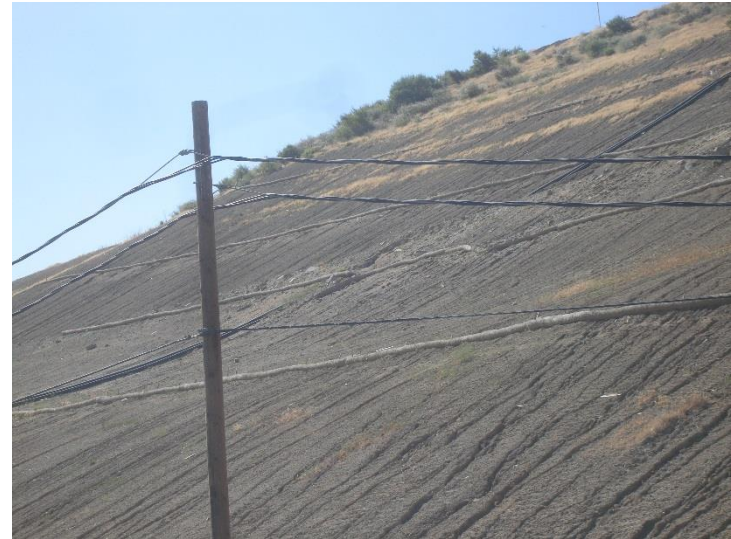
**Photo 357: Old City Landfill Slope South of Office Parking Lot:
June 12, 2018**
