**Sunshine Canyon Landfill
Independent Monitor
Quarterly Site Monitoring Status Report
April 1, 2018 – June 30, 2018**

City of Los Angeles Department of City Planning

September 26, 2018

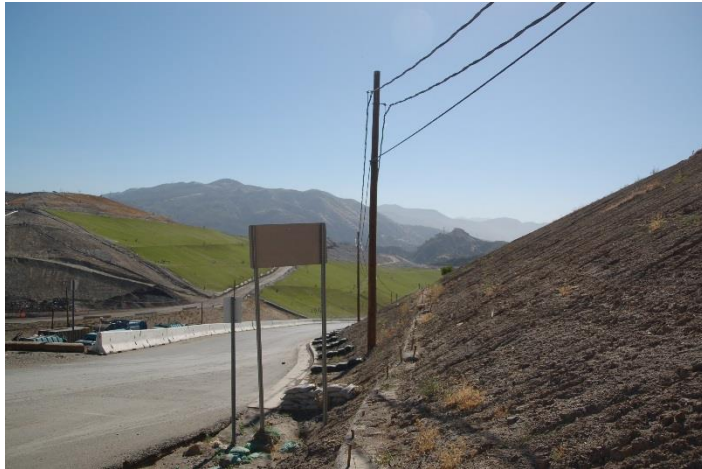
**Photo 358: Old City Landfill Slope South of Office Parking Lot:
June 12, 2018**

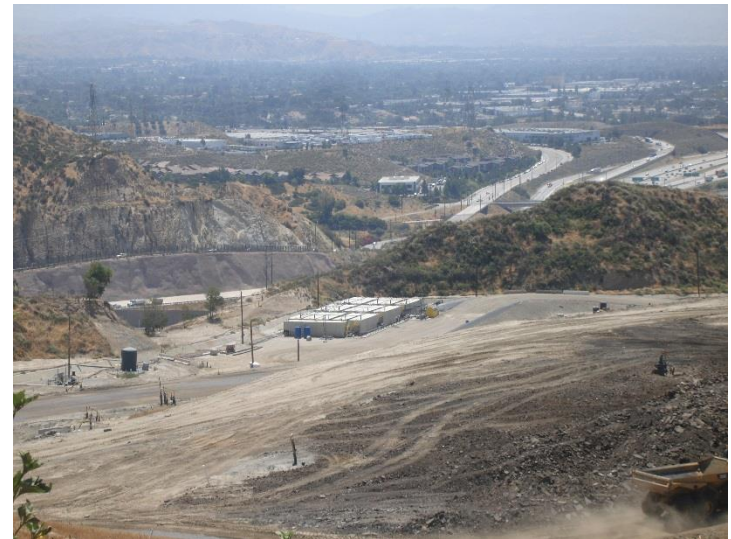
Photo 359: Old City Landfill Slope South of Office: June 12, 2018

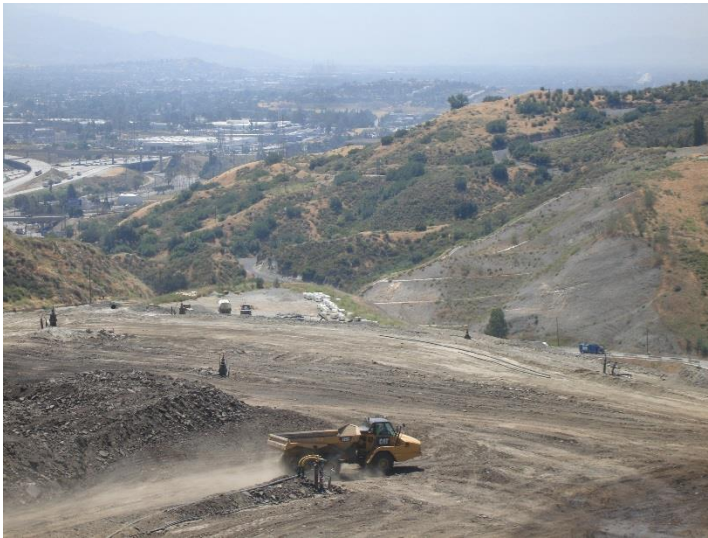
Photo 360: Old City North Top Deck: June 12, 2018

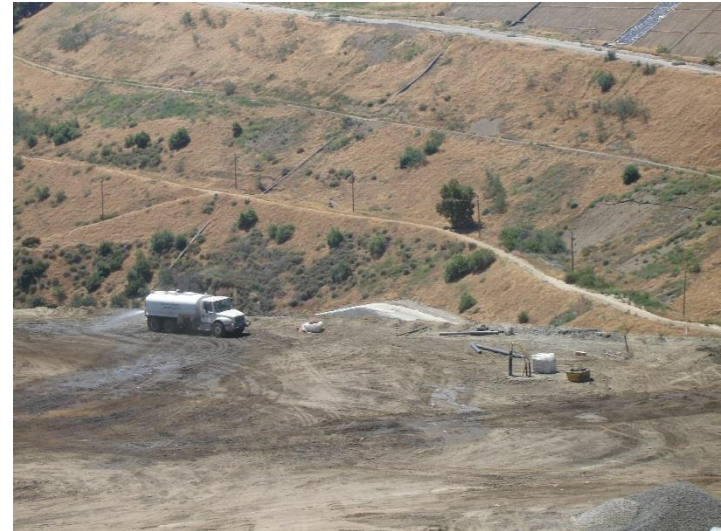
Photo 361: Old City North Top Deck: June 12, 2018

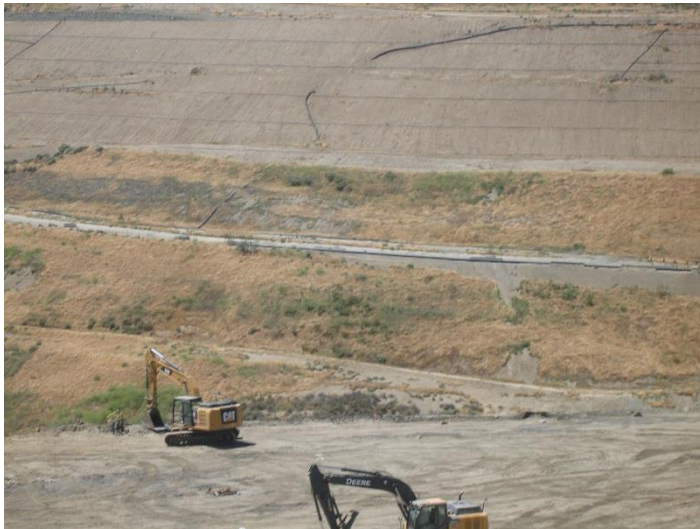
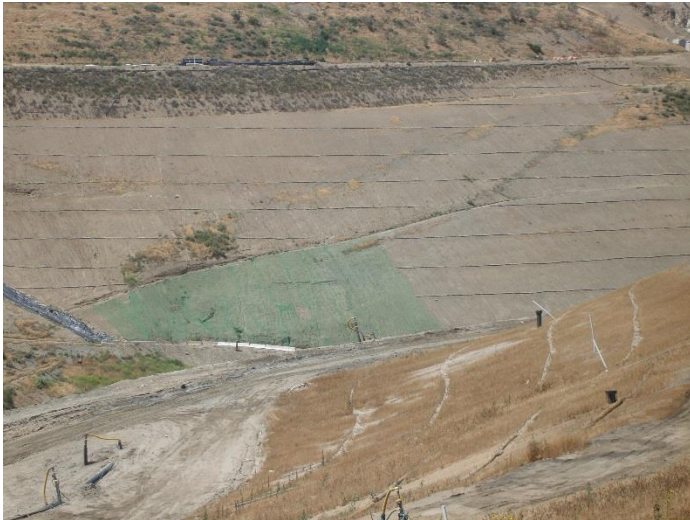
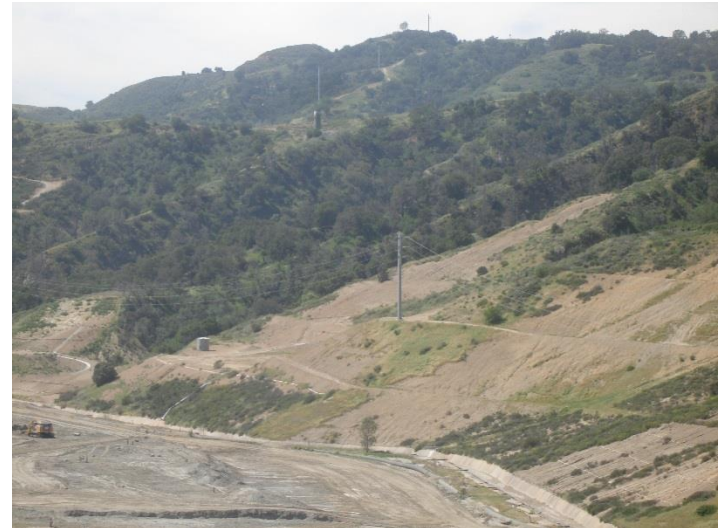
Photo 362: Old City South Slopes: June 12, 2018

Photo 363: Old City South Slopes: June 12, 2018

Photo 364: Old City South Slopes: June 12, 2018

Photo 365: Old City South Slopes: June 12, 2018

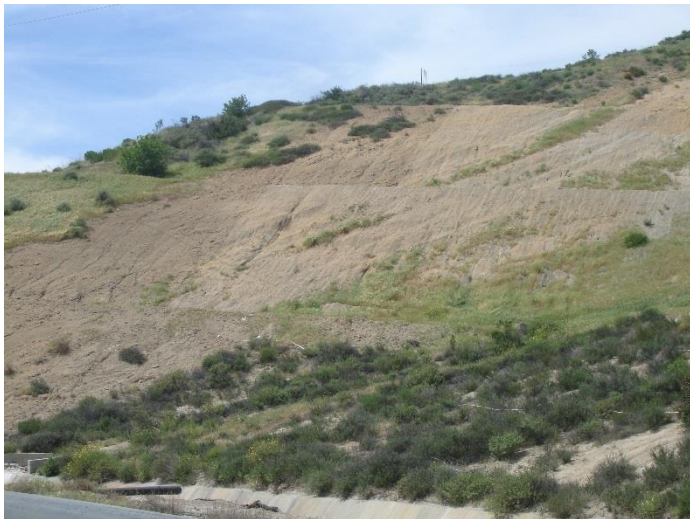
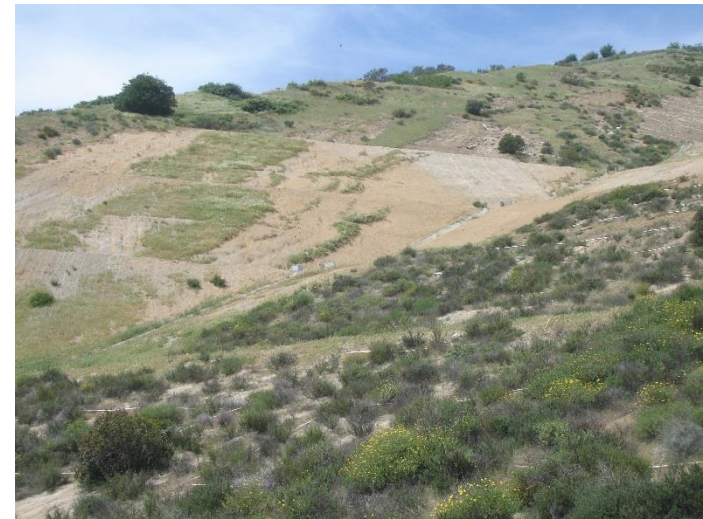
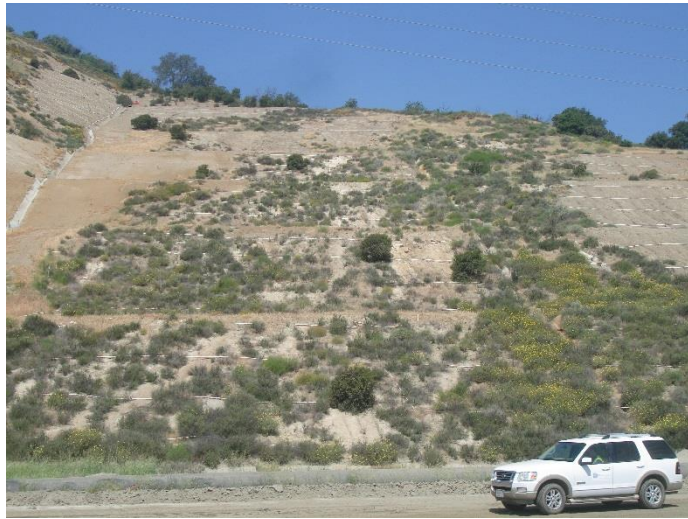
Photo 366: County Sage Mitigation Area Slope: April 24, 2018

Photo 367: County Sage Mitigation Area Slope: April 24, 2018

Photo 368: County Sage Mitigation Area Slope: April 24, 2018

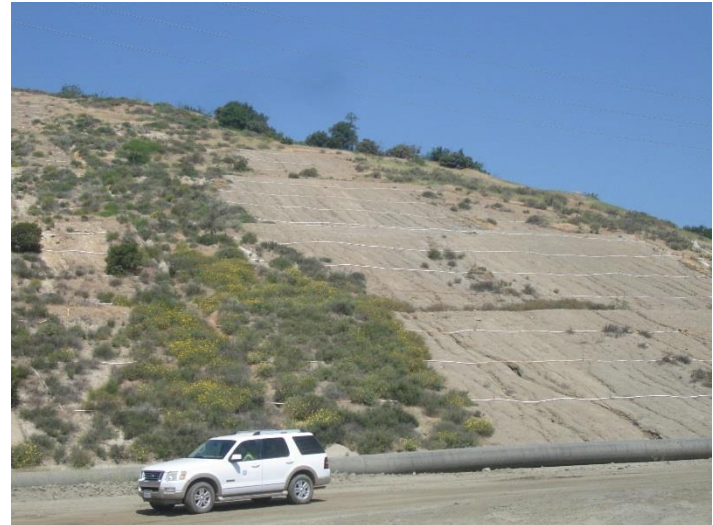
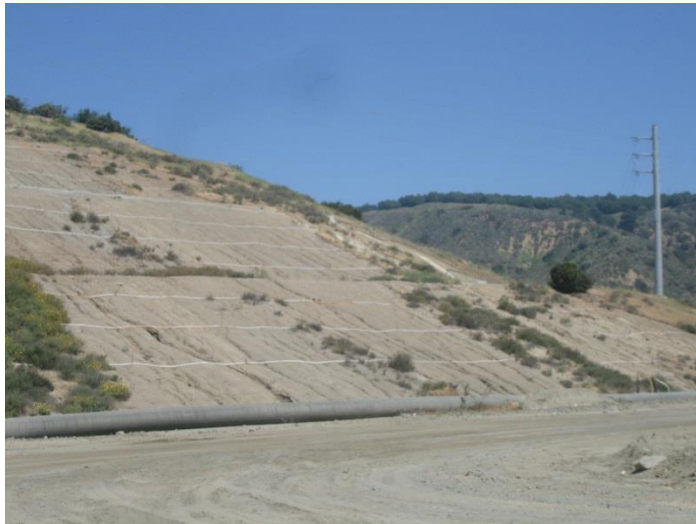
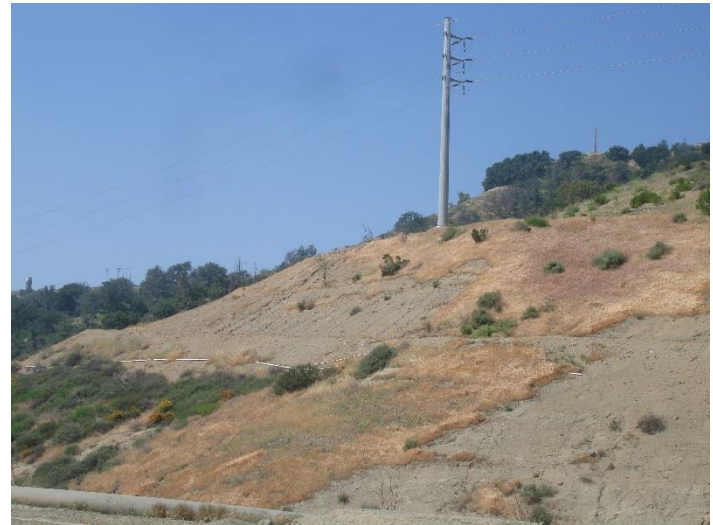
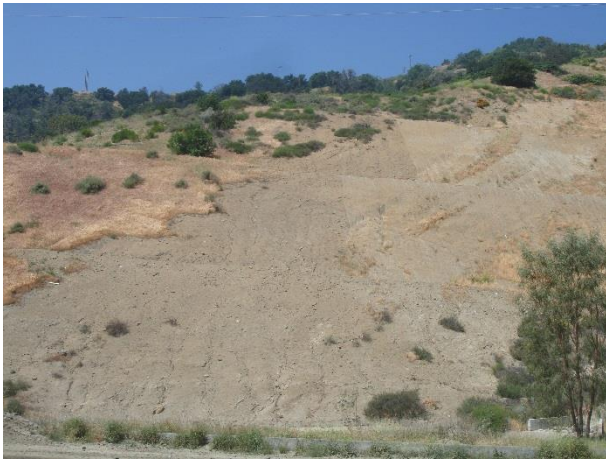
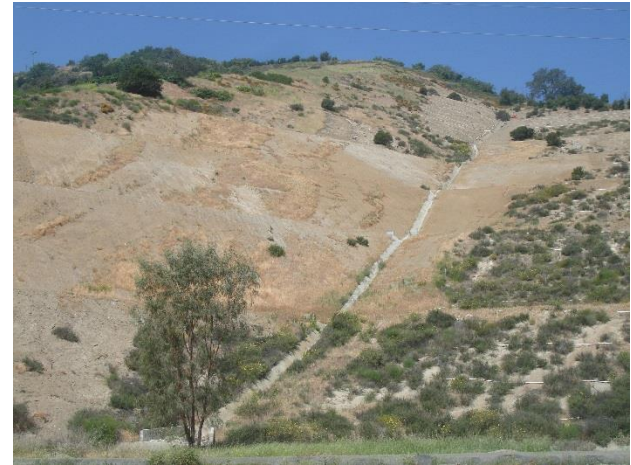
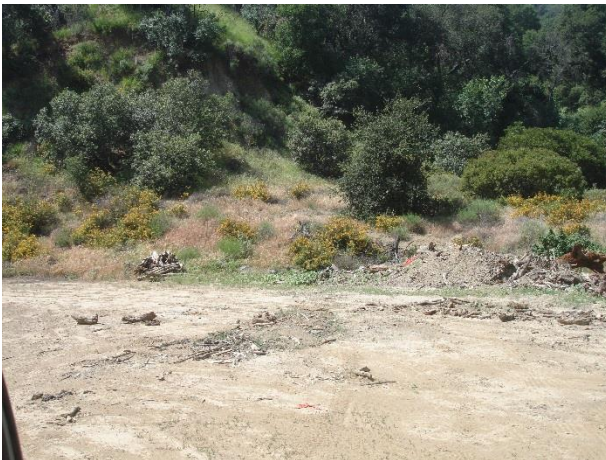
Photo 369: County Sage Mitigation Area Slope: May 10, 2018

Photo 370: County Sage Mitigation Area Slope: May 10, 2018

Photo 371: County Sage Mitigation Area Slope: May 10, 2018

Photo 372: County Sage Mitigation Area Slope: May 10, 2018

Photo 373: County Sage Mitigation Area Slope: May 10, 2018

Photo 374: County Sage Mitigation Area Slope: May 10, 2018

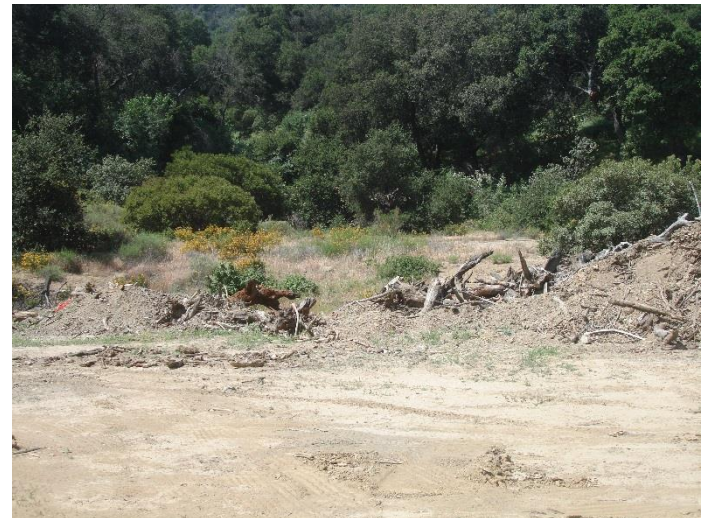
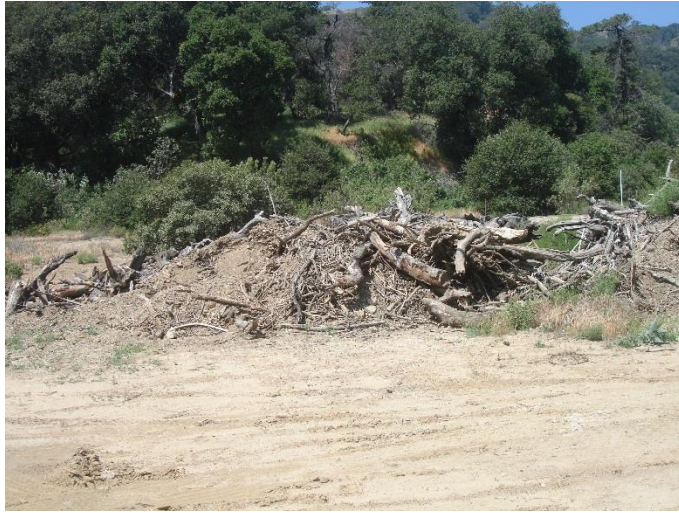
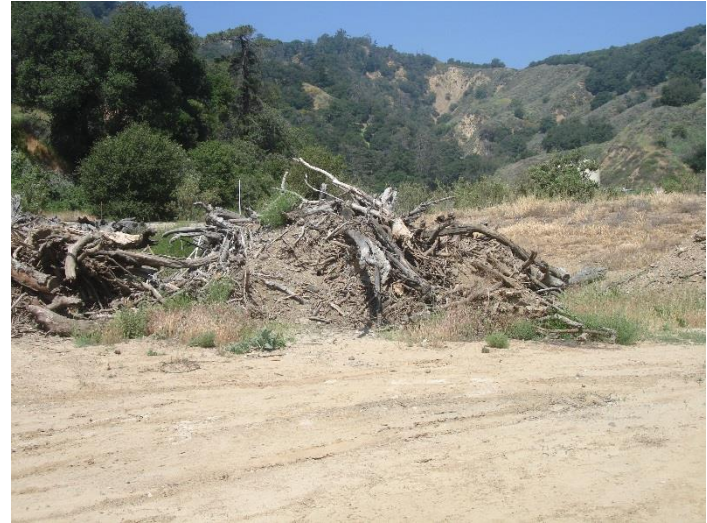
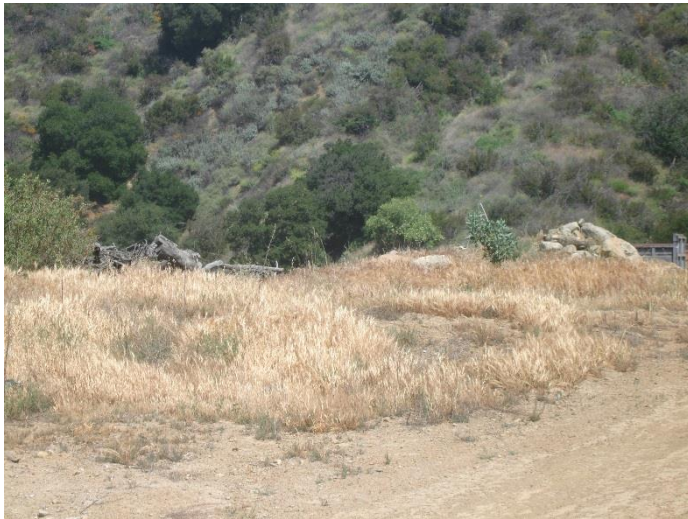
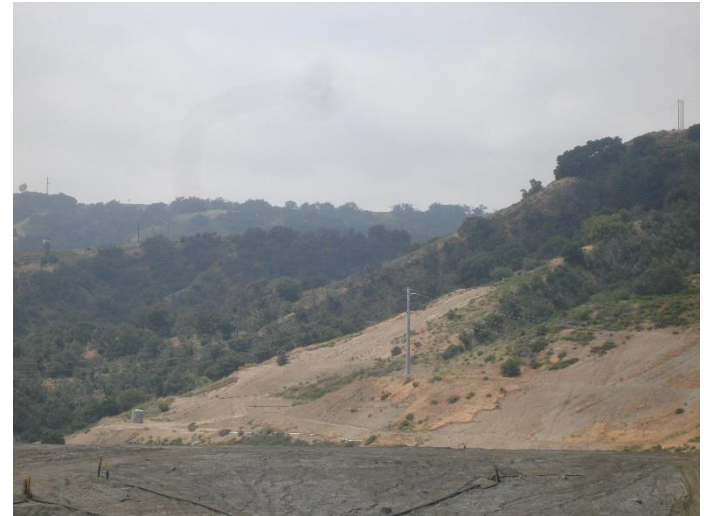
Photo 375: Basin D Deck Wood Waste Stock Pile: May 10, 2018

Photo 376: Basin D Deck Wood Waste Stock Pile: May 10, 2018

Photo 377: Basin D Deck Wood Waste Stock Pile: May 10, 2018

Photo 378: Basin D Deck Wood Waste Stock Pile: May 10, 2018

Photo 379: Basin D Deck Wood Waste Stock Pile: May 10, 2018

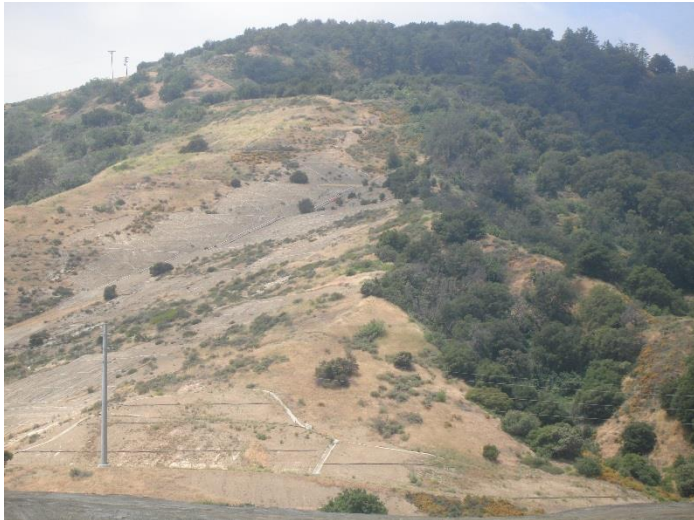
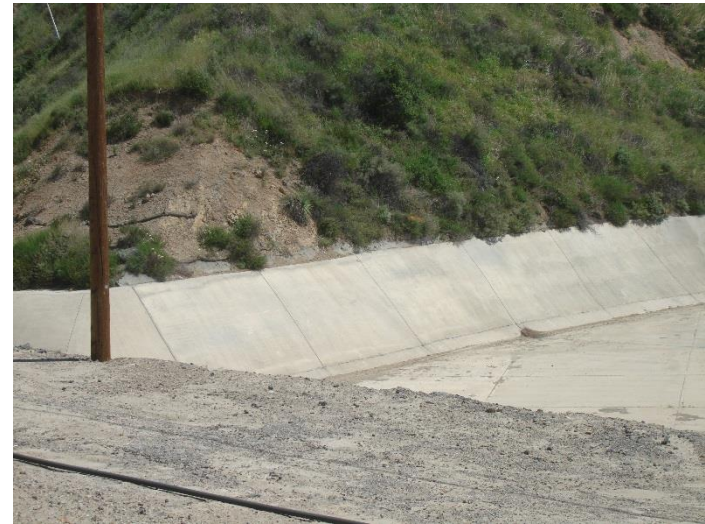
Photo 380: County Sage Mitigation Area Slope: May 22, 2018

Photo 381: County Sage Mitigation Area Slope: May 22, 2018

- A paleontologist was on site monitoring activities in the buttress area.
- Deck B sage mitigation area has planting flagging in place and appears to be ready for planting and seeding when fall weather conditions occur.

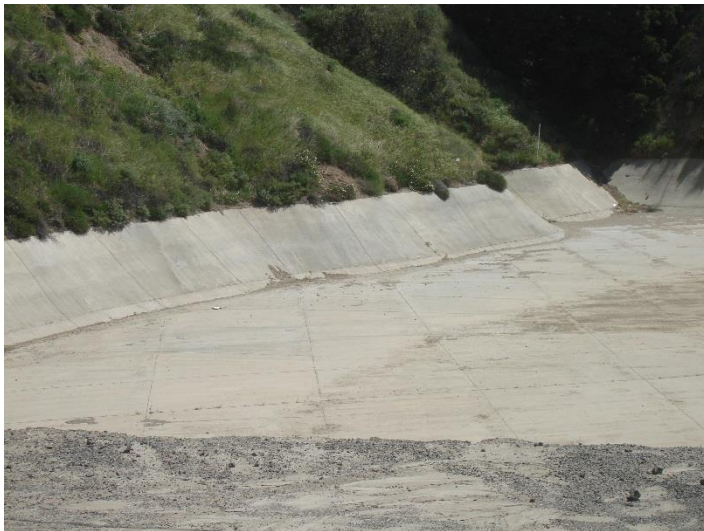
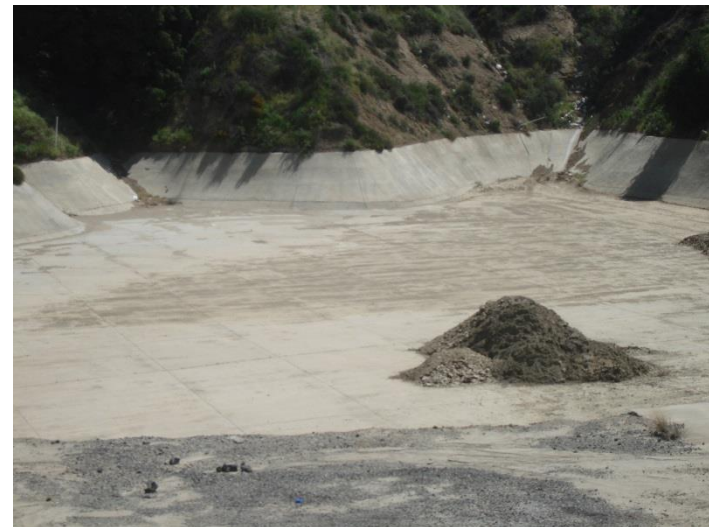
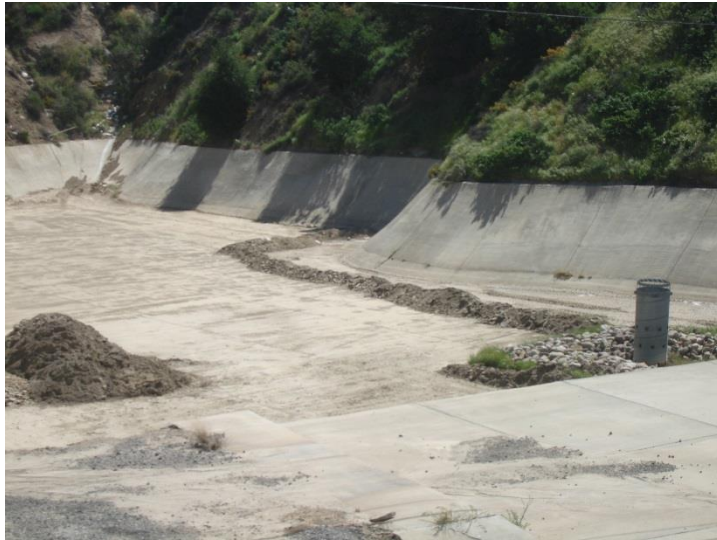
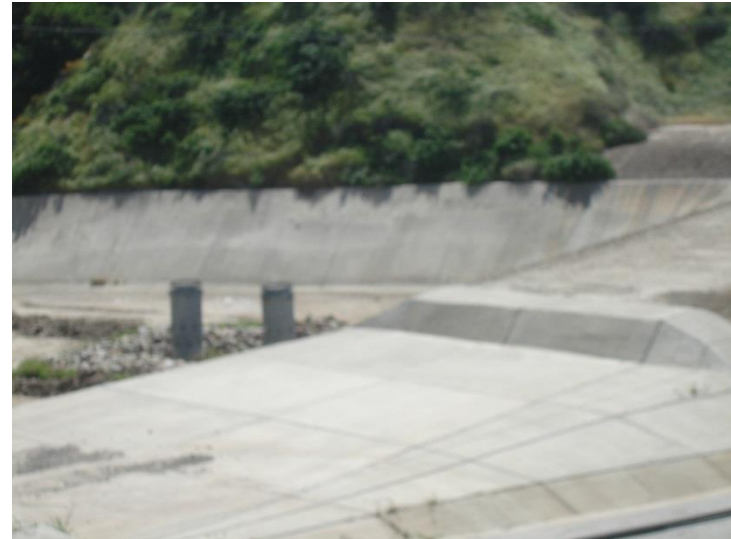
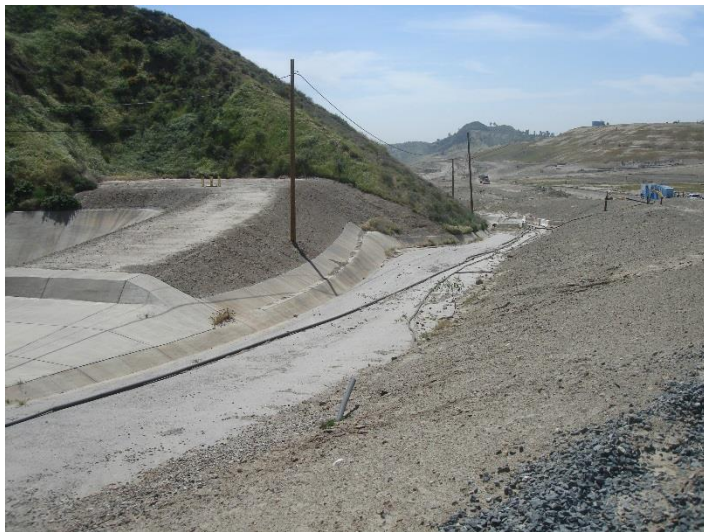
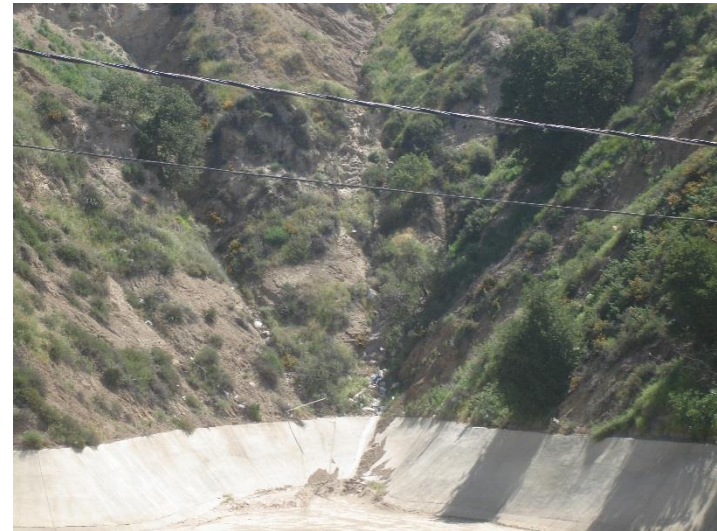
Photo 382: Basin B: April 24, 2018

Photo 383: Basin B: April 24, 2018

Photo 384: Basin B: April 24, 2018

Photo 385: Basin B: April 24, 2018

Photo 386: Basin B: April 24, 2018

Photo 387: Basin B: April 24, 2018

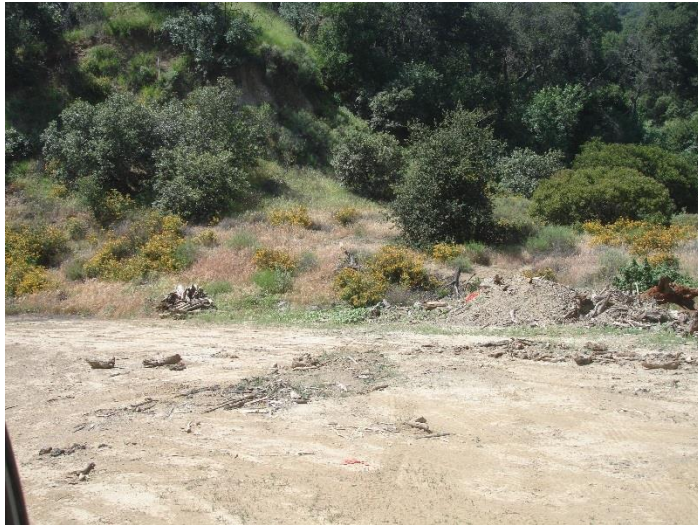
Photo 388: Basin B Windblown Litter in Native Vegetation: April 24, 2018

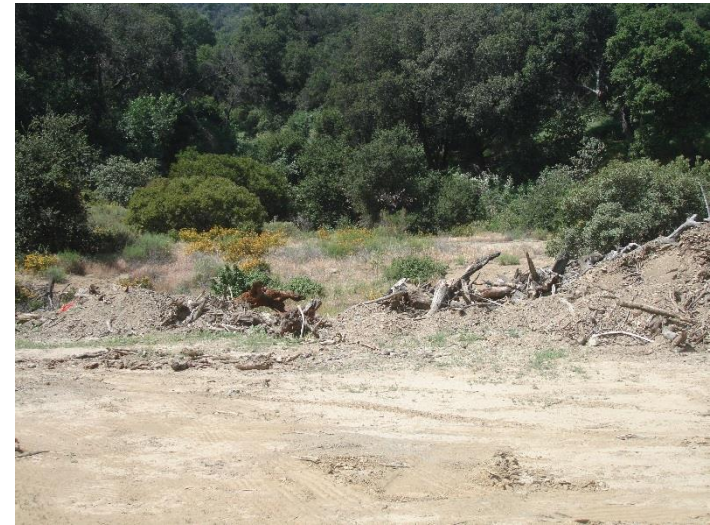
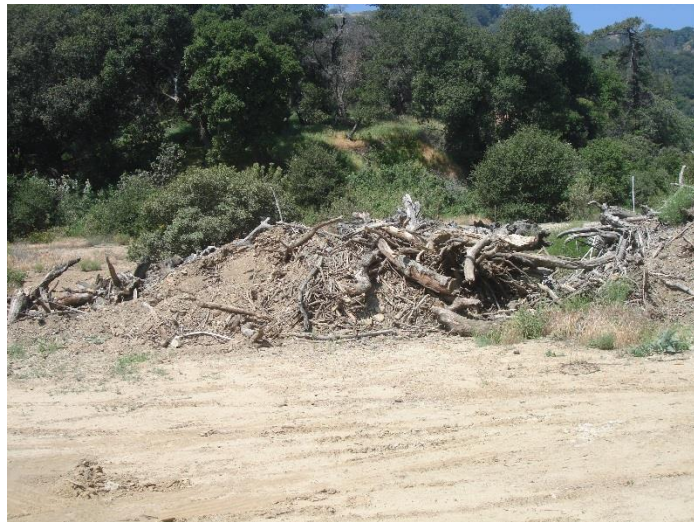
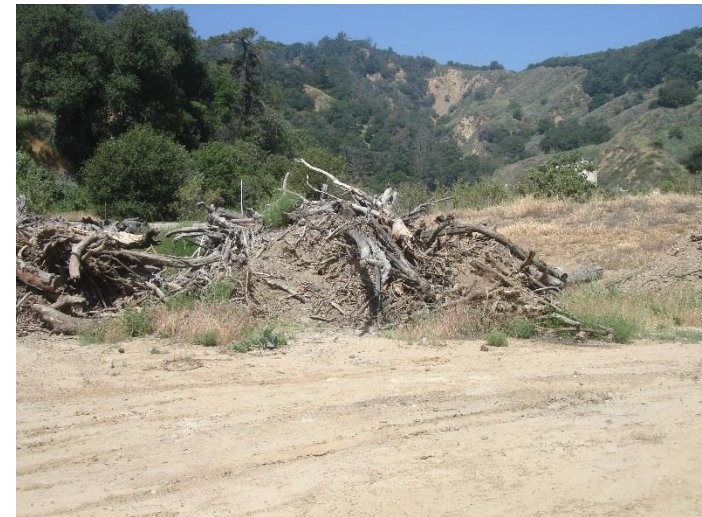
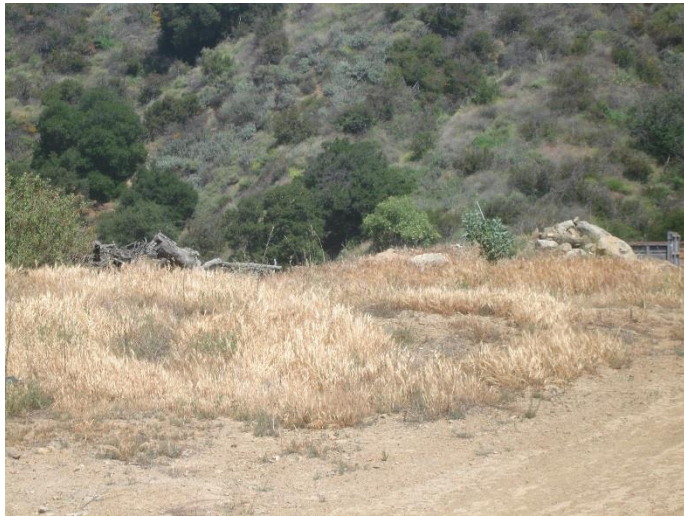
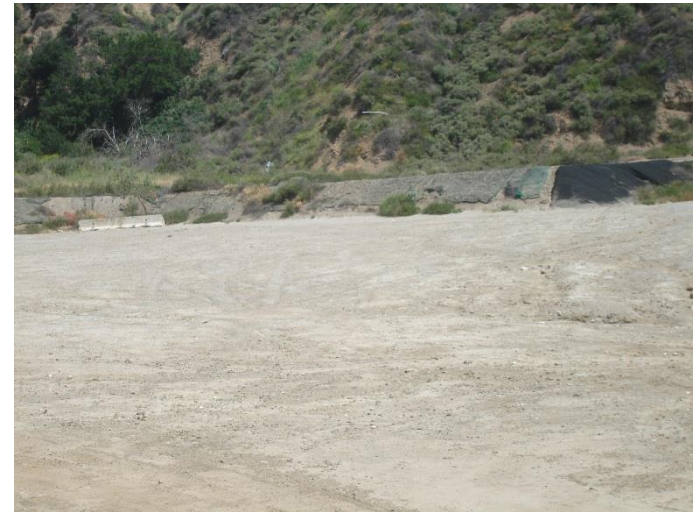
Photo 389: Basin D Deck Wood Waste Stockpile: May 10, 2018

Photo 390: Basin D Deck Wood Waste Stockpile: May 10, 2018

Photo 391: Basin D Deck Wood Waste Stockpile: May 10, 2018

Photo 392: Basin D Deck Wood Waste Stockpile: May 10, 2018

Photo 393: Basin D Deck Wood Waste Stockpile: May 10, 2018

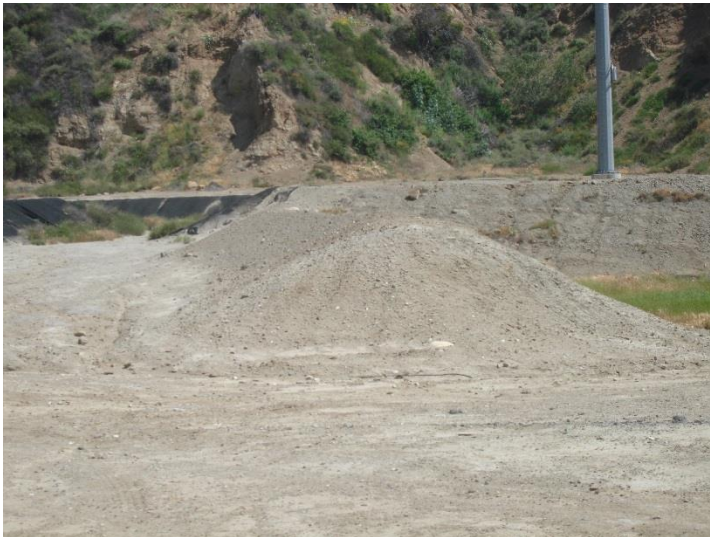
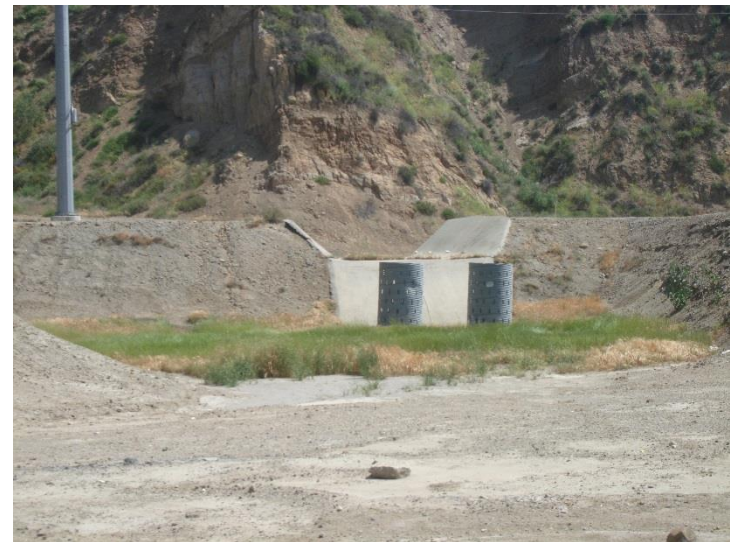
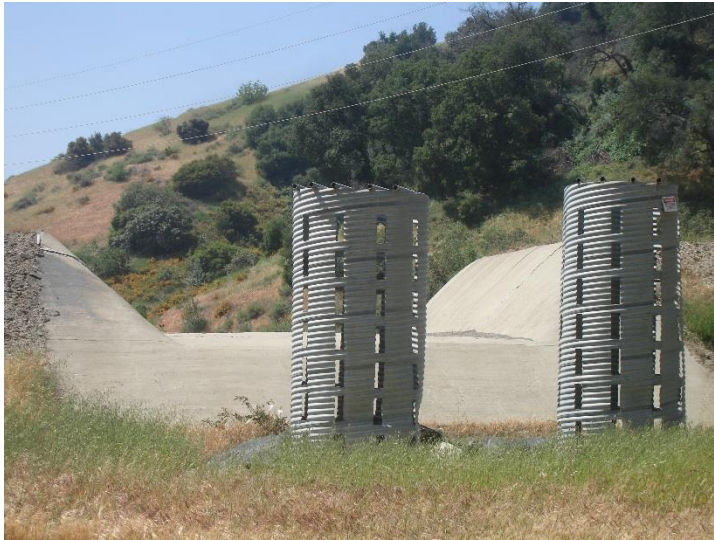
Photo 394: Basin D: May 10, 2018

Photo 395: Basin D: May 10, 2018

Photo 396: Basin D: May 10, 2018

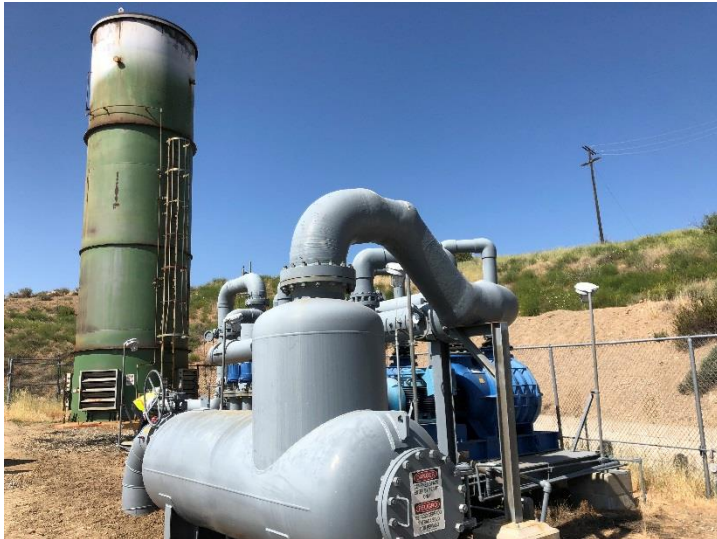
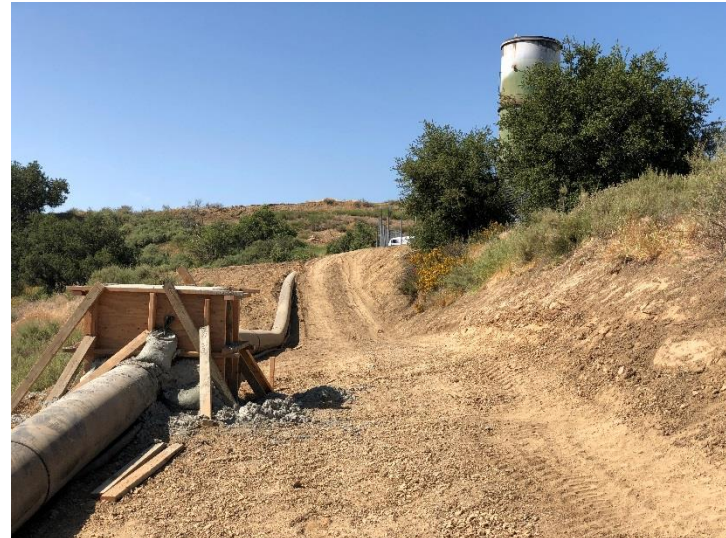
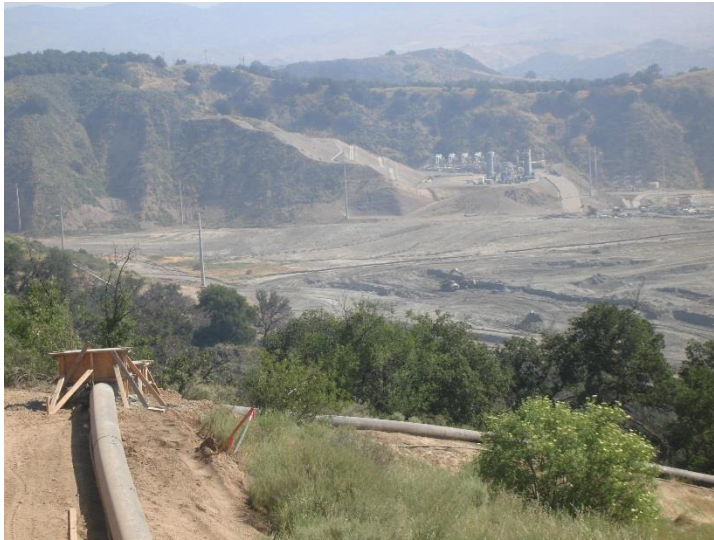
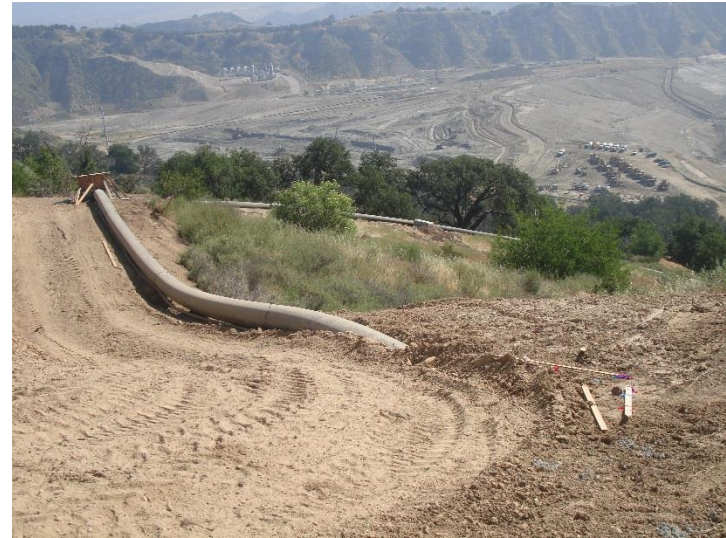
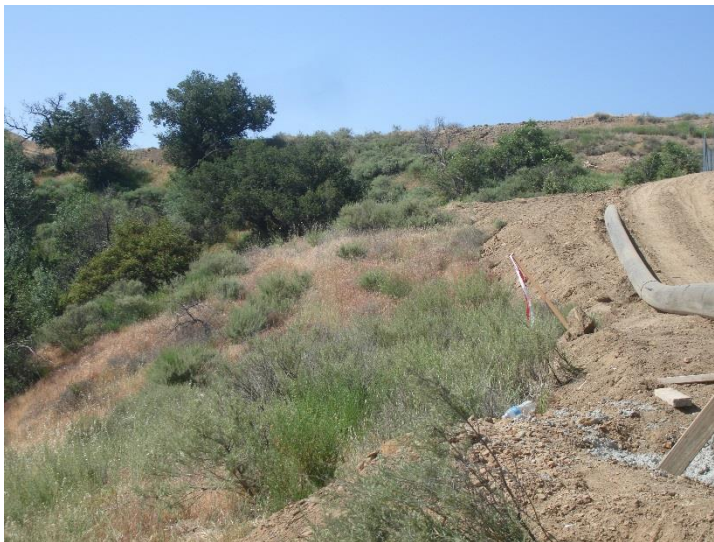
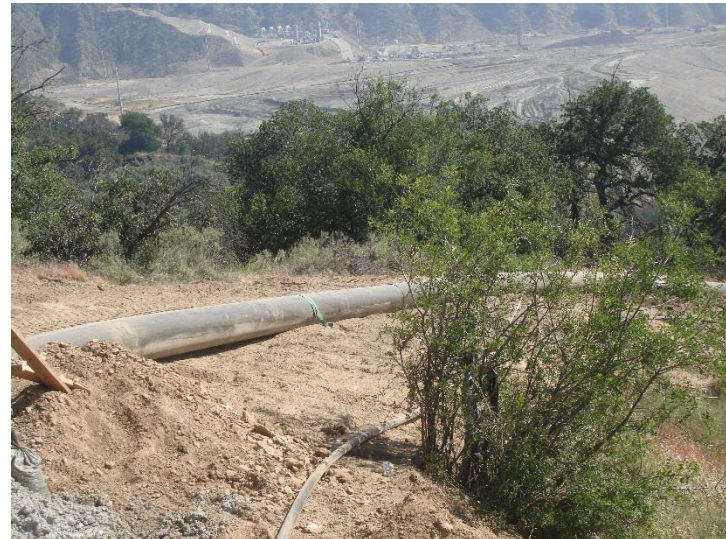
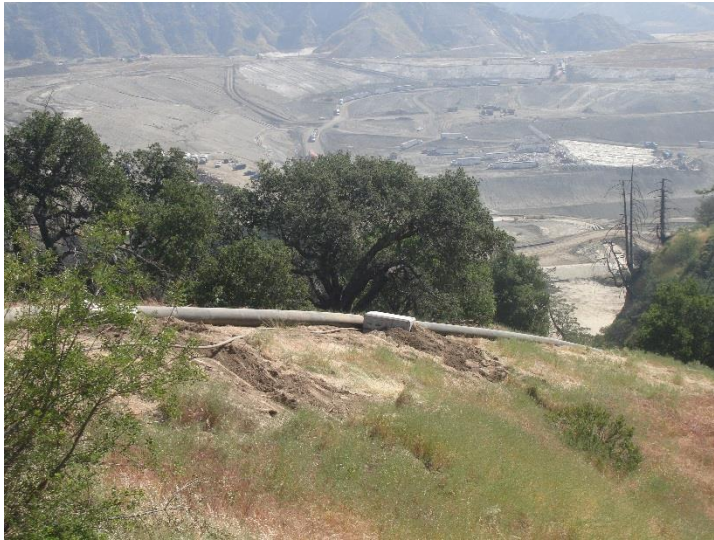
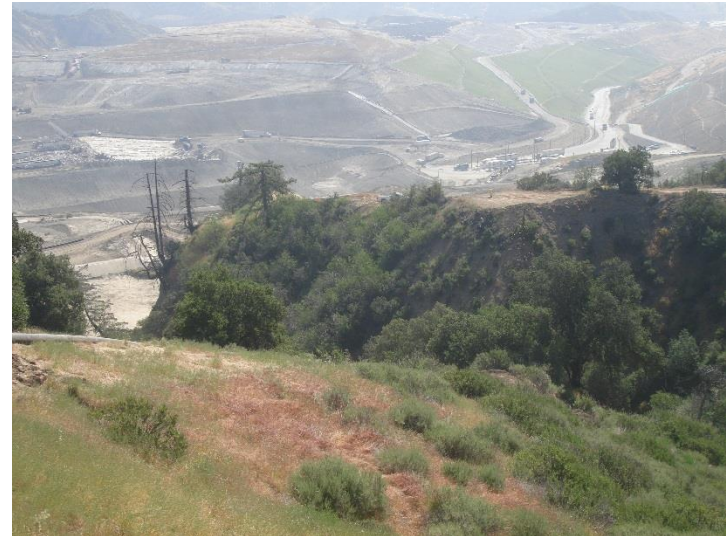
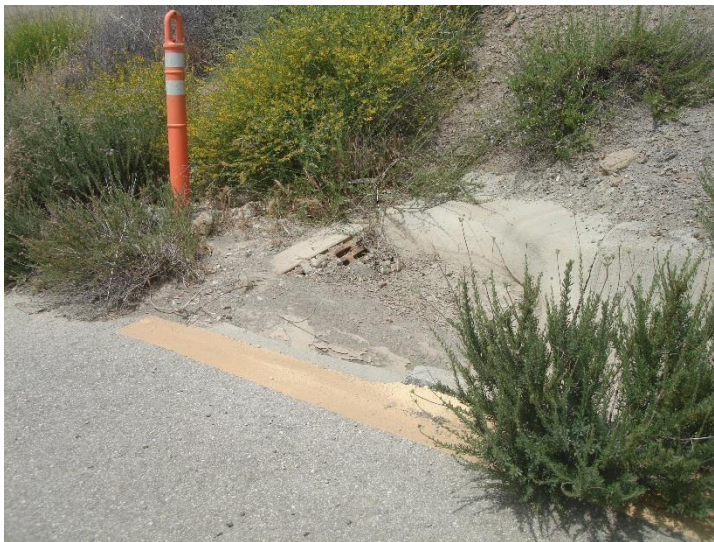
Photo 410: Flare 3 Gas Pipeline to Basin A: May 10, 2018

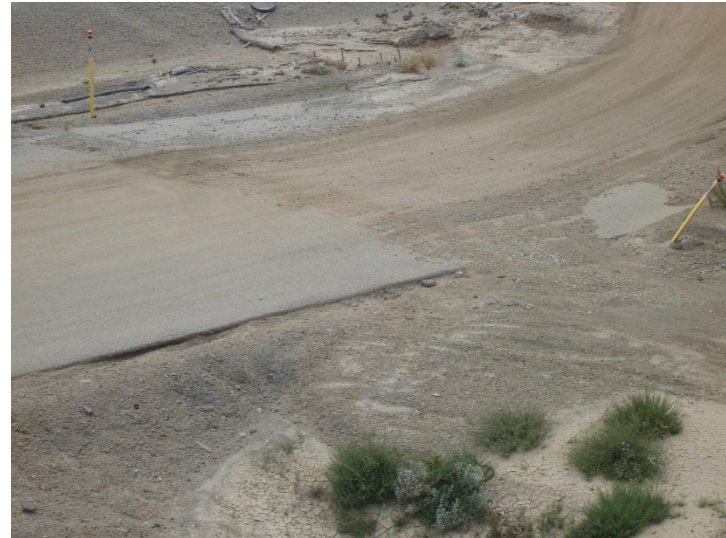
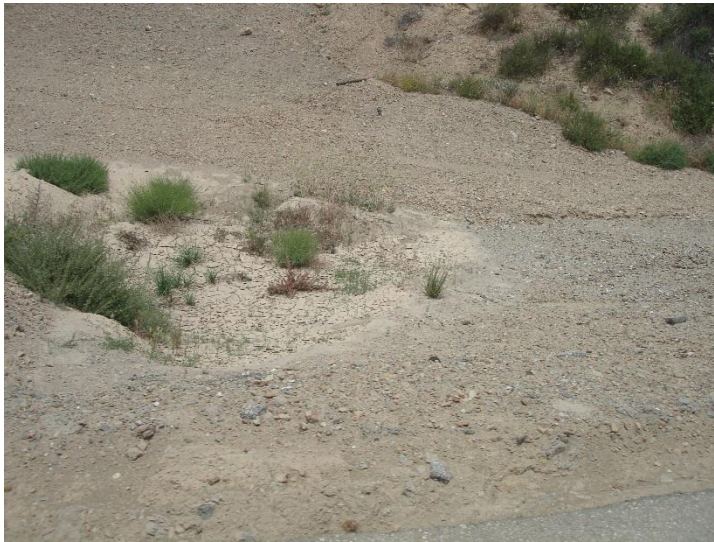
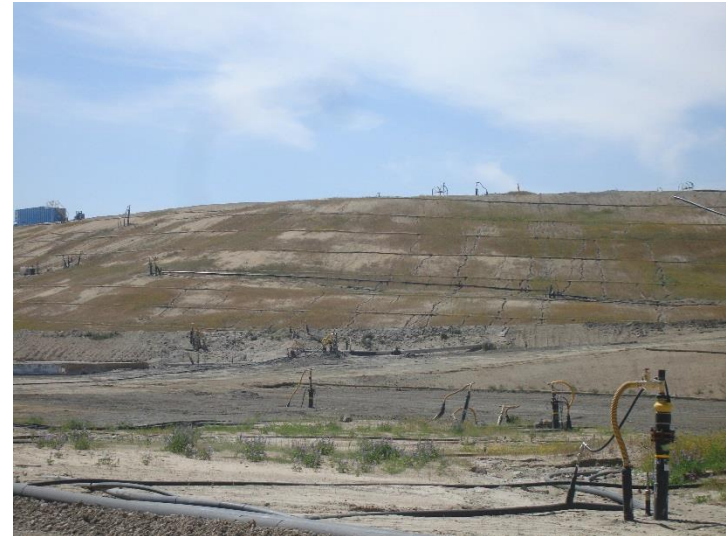
Photo 419: Buried Drain at Flare 9 Access Road: May 22, 2018

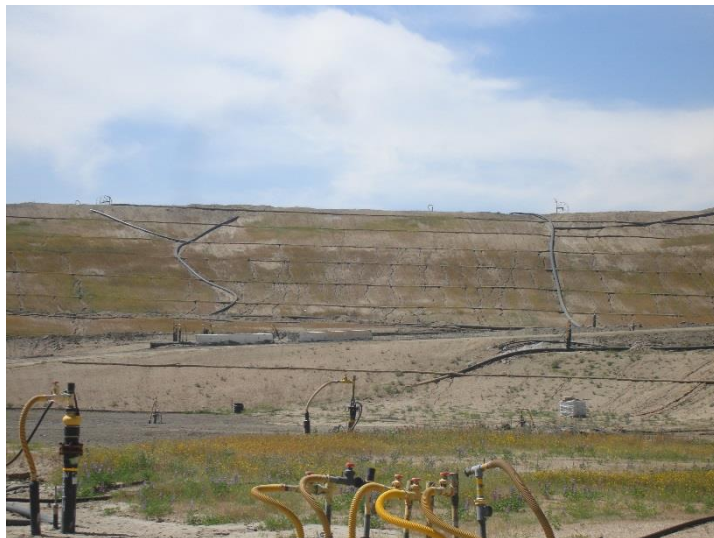
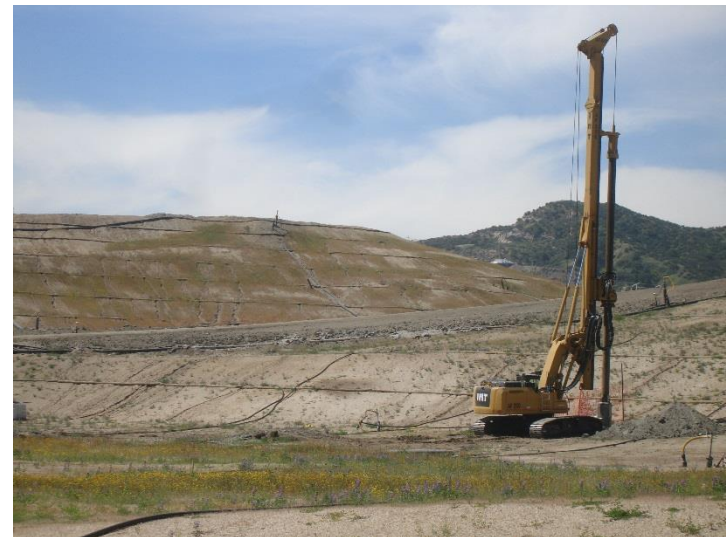
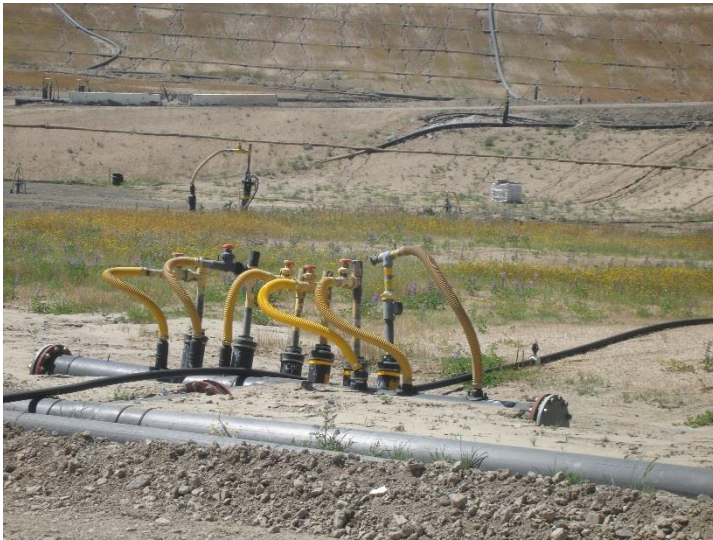
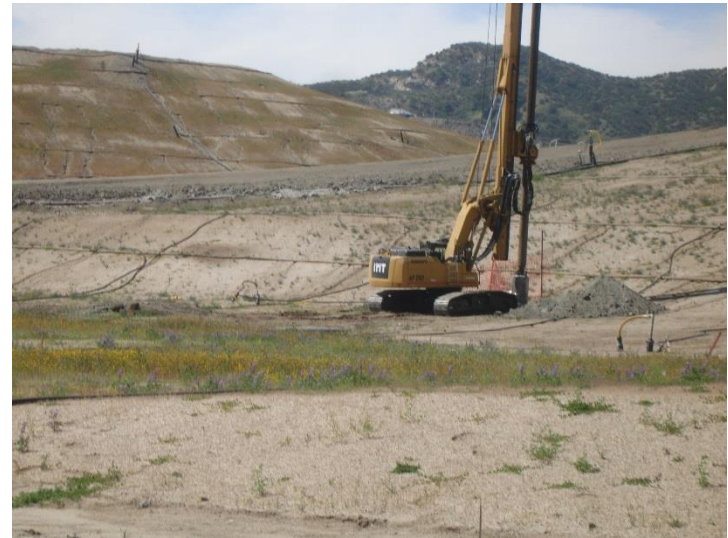
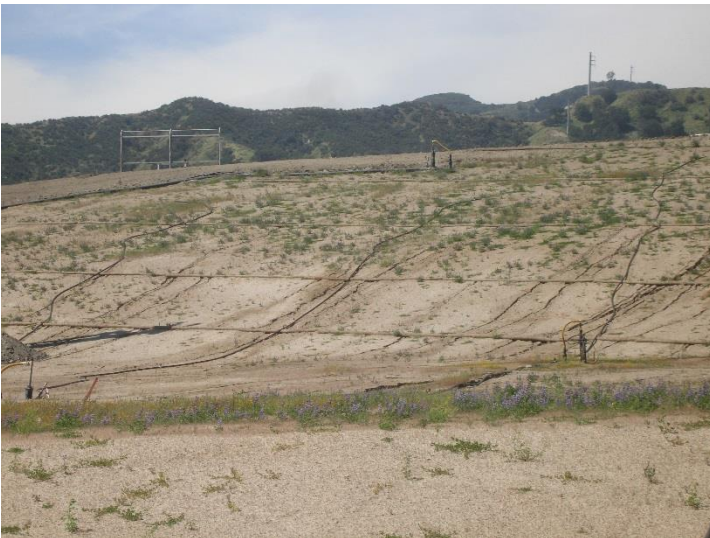
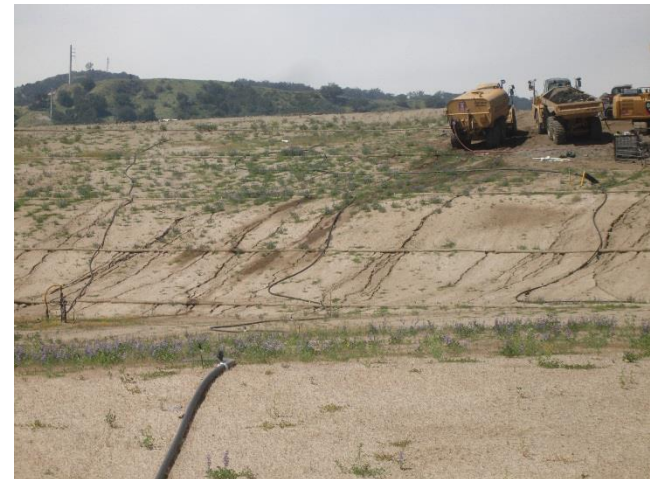
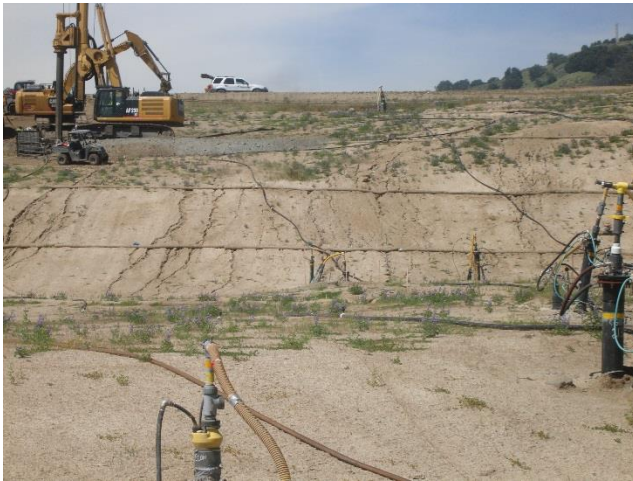
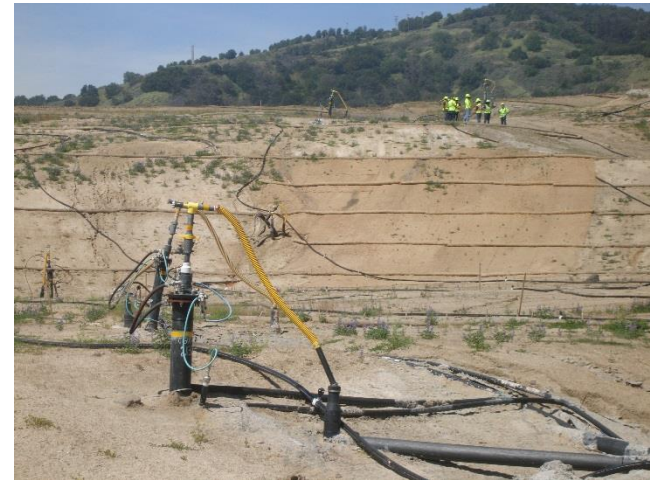
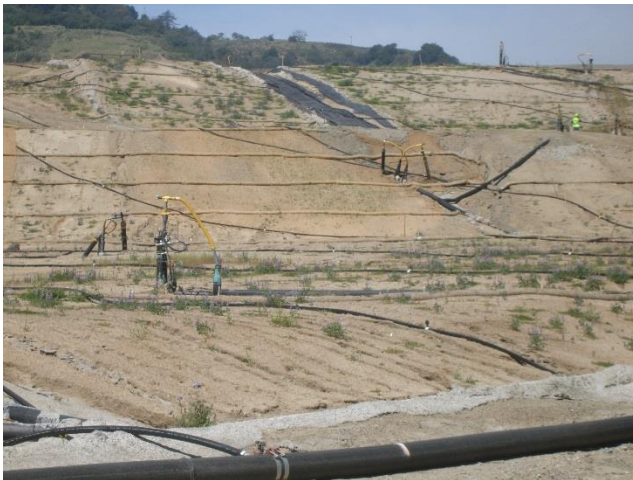
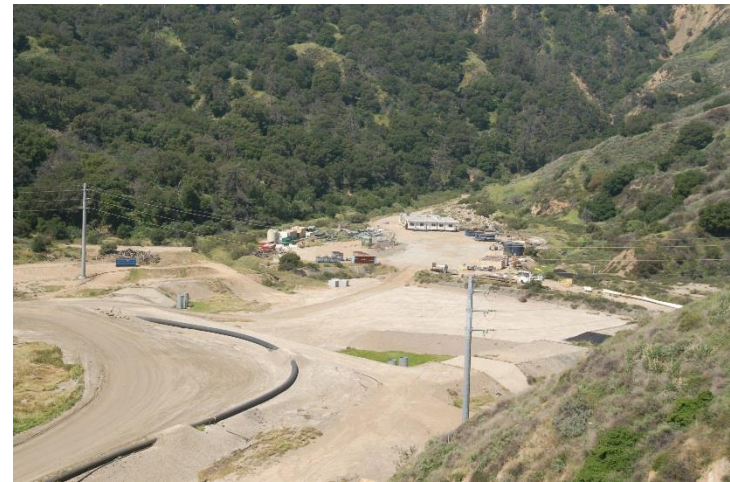
Photo 422: County Top Deck (Bowl) & Slope Revegetation: April 24, 2018
