**Sunshine Canyon Landfill
Independent Monitor
Quarterly Site Monitoring Status Report
April 1, 2018 – June 30, 2018**

City of Los Angeles Department of City Planning

September 26, 2018

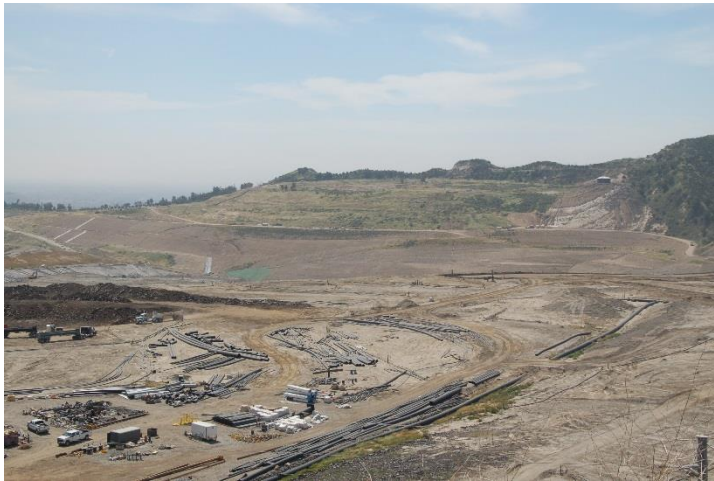
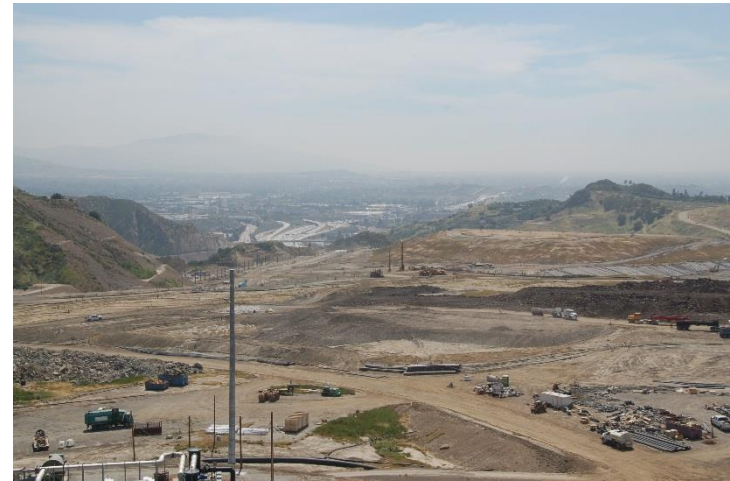
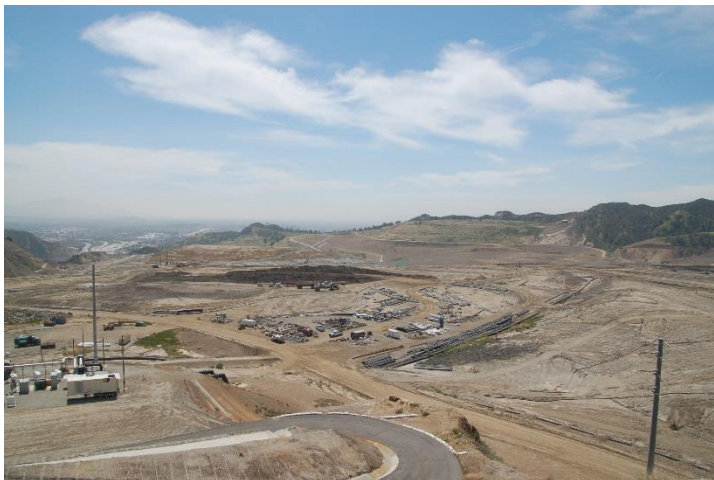
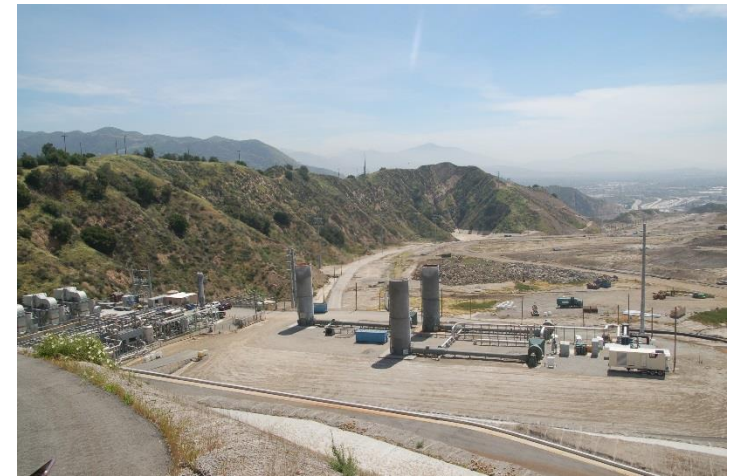
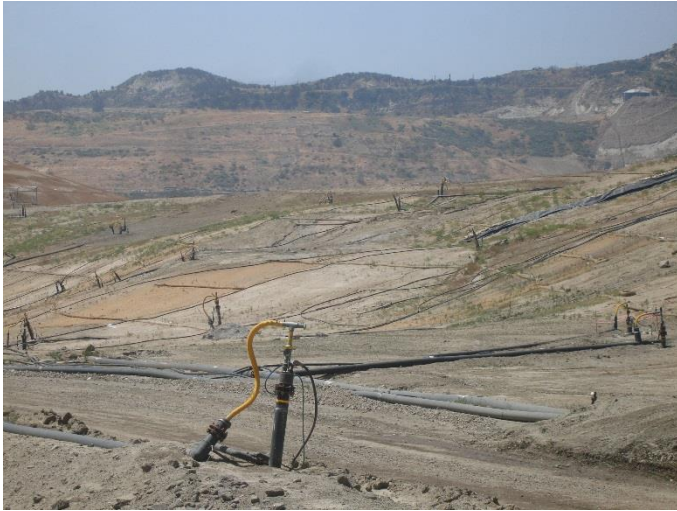
Photo 432: County Top Deck: April 24, 2018

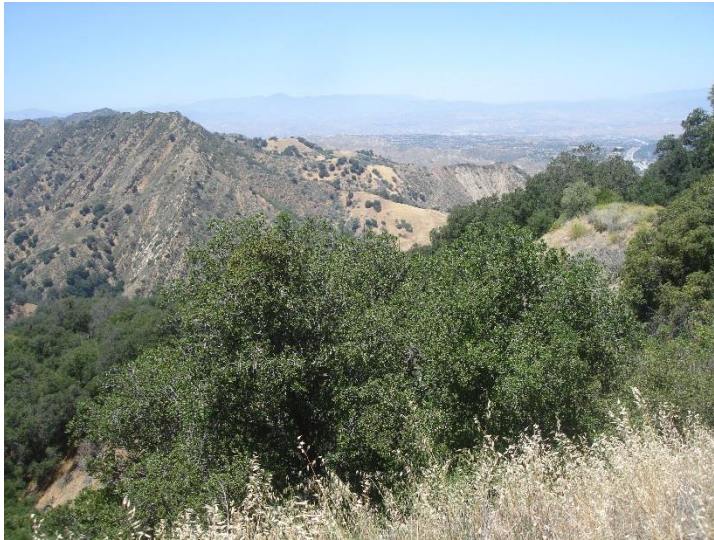
Photo 464: Oak Tree & Big Cone Fir Mitigation Area: June 12, 2018

FURTHER REVIEW NEEDED
<ol style="list-style-type: none">1. Eliminate gas odor at south slope of Cell CC-3B.2. Investigate cause of big cone fir tree die-off.
Signed:

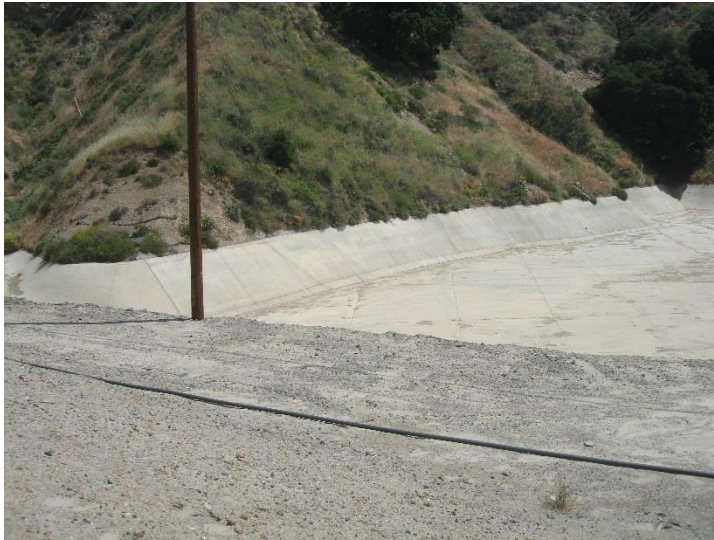
Photo 484: Basin B Windblown Litter in Native Vegetation: April 24, 2018

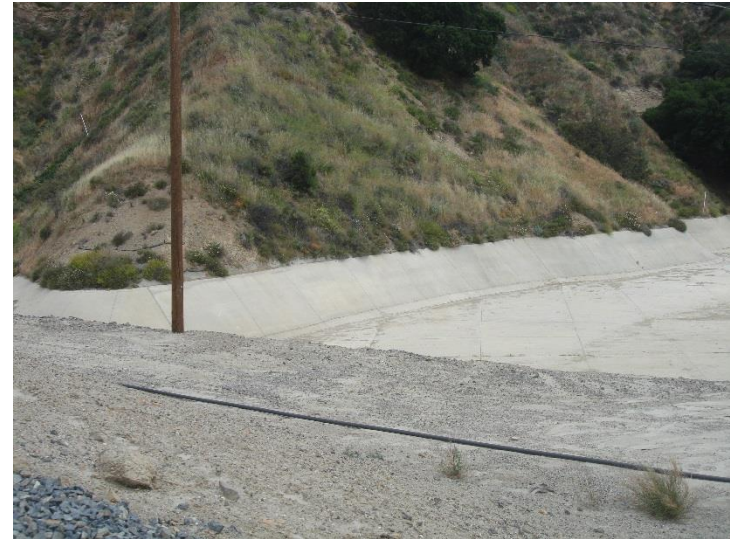
Photo 489: Basin B Windblown Litter in Native Vegetation: May 10, 2018

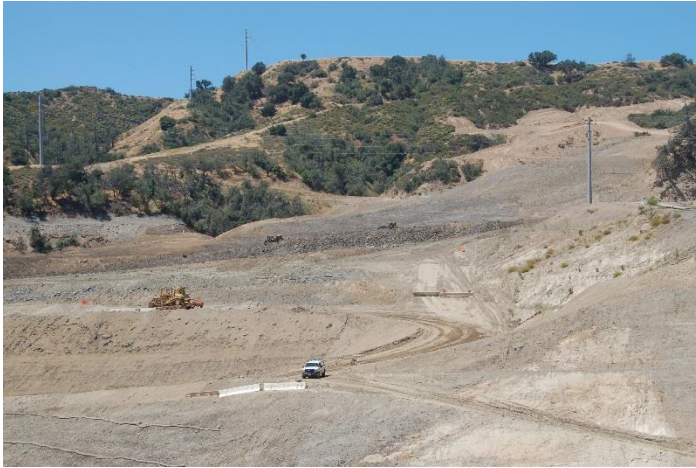
Photo 652: Sukut Fuel Storage: June 12, 2018

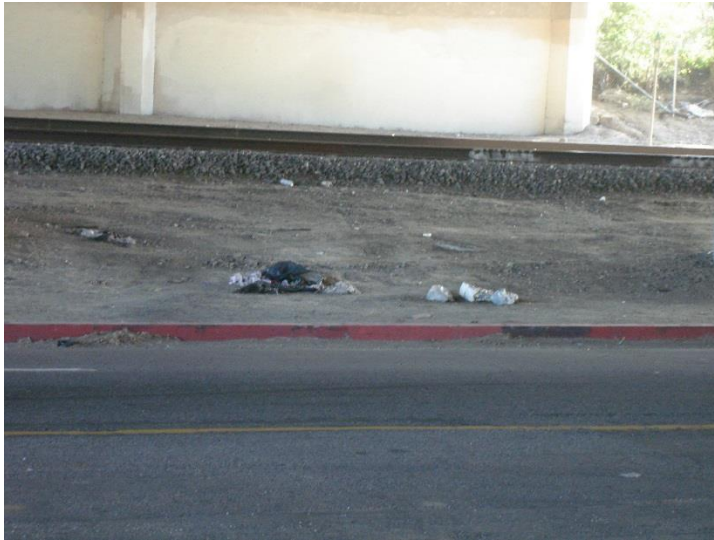
**Photo 664: Illegal Dumping San Fernando Road at I-5 Overpass:
May 22, 2018**

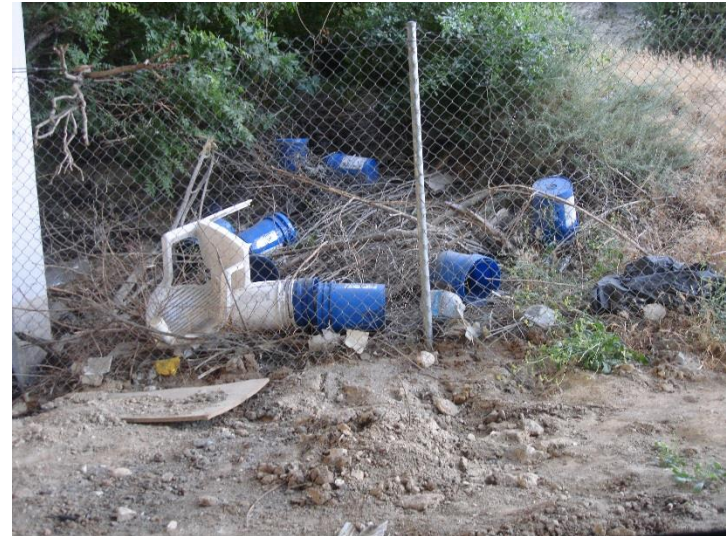
**Photo 665: Illegal Dumping San Fernando Road at I-5 Overpass:
May 22, 2018**

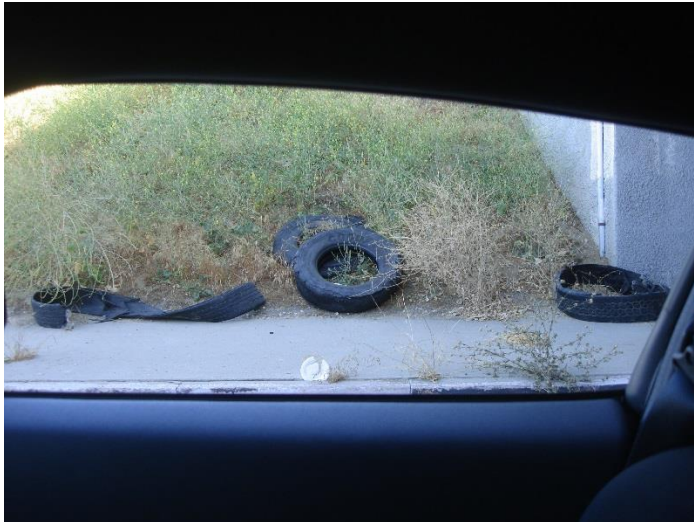
**Photo 666: Illegal Dumping San Fernando Road at I-5 Overpass:
May 22, 2018**

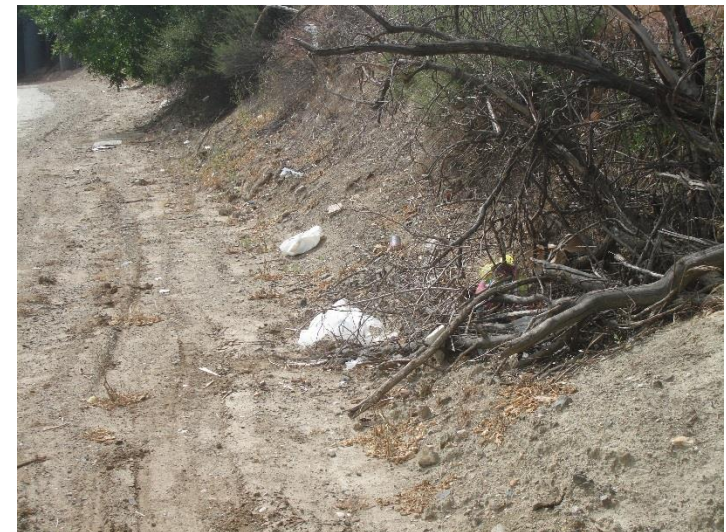
**Photo 667: Illegal Dumping San Fernando Road at I-5 Overpass:
May 22, 2018**

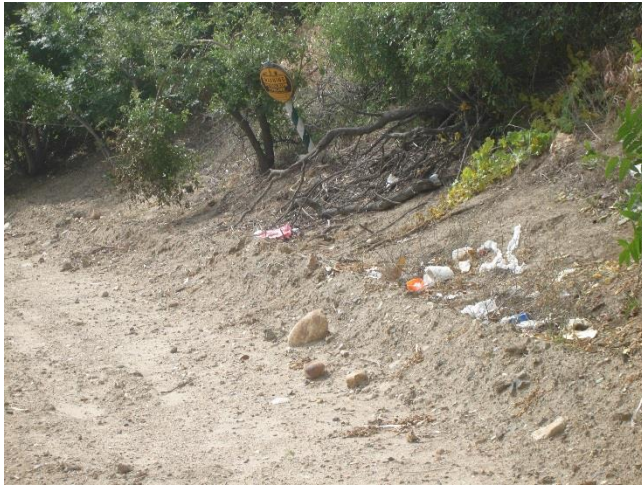
**Photo 668: Illegal Dumping San Fernando Road at I-5 Overpass:
May 22, 2018**

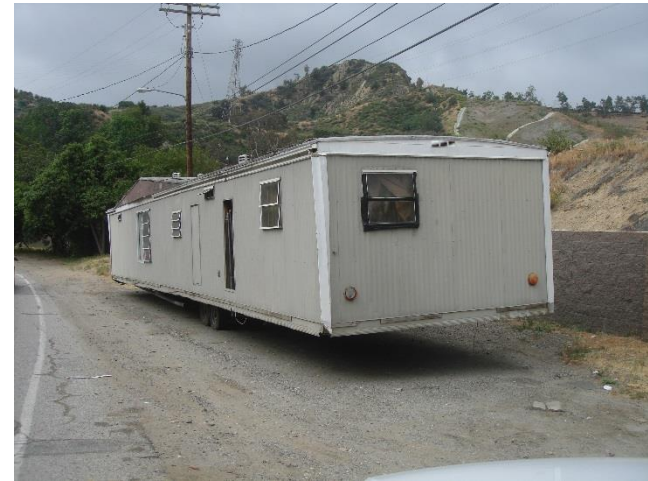
**Photo 669: Illegal Dumping San Fernando Road at I-5 Overpass:
May 22, 2018**

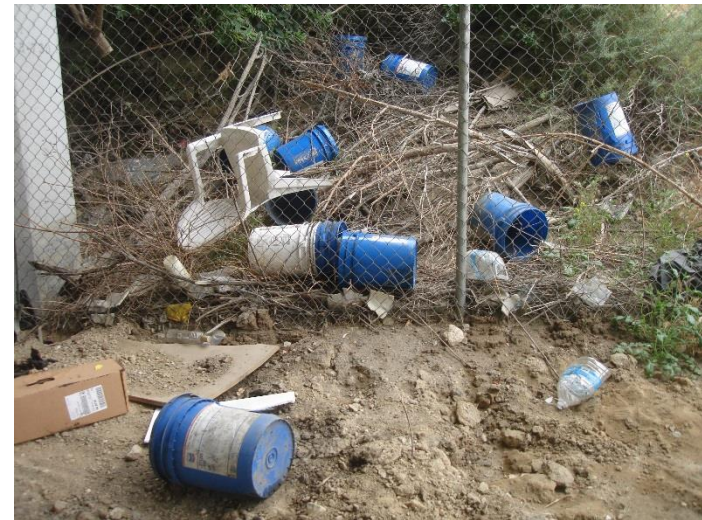
**Photo 671: Illegal Dumping San Fernando Road at I-5 Overpass:
May 22, 2018**

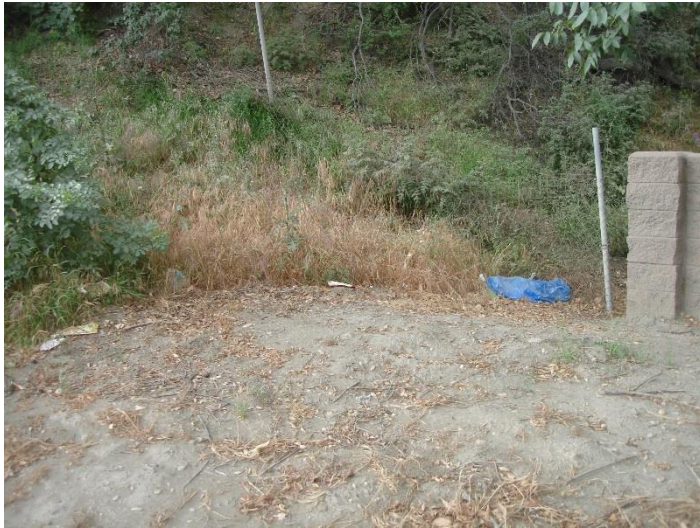
**Photo 672: Illegal Dumping San Fernando Road at I-5 Overpass:
May 22, 2018**

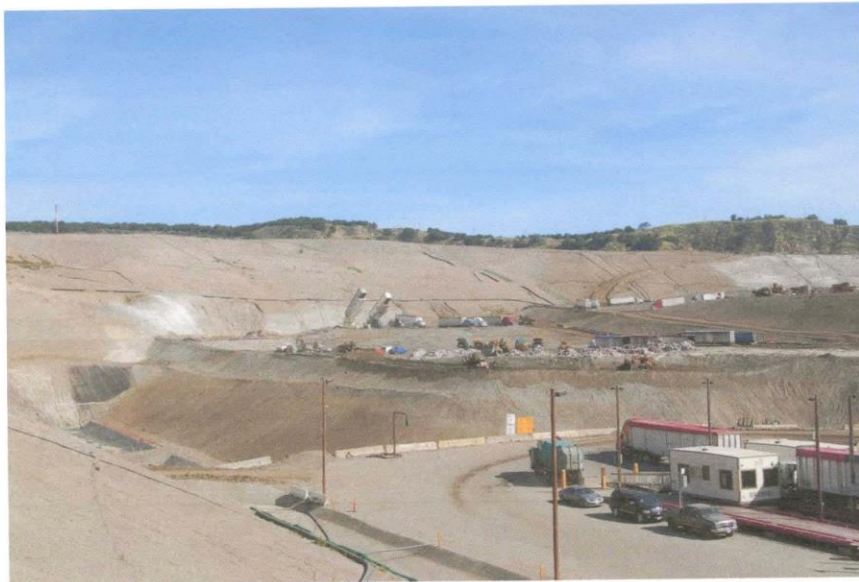
Photo 1: Waste placement at Cell CC4

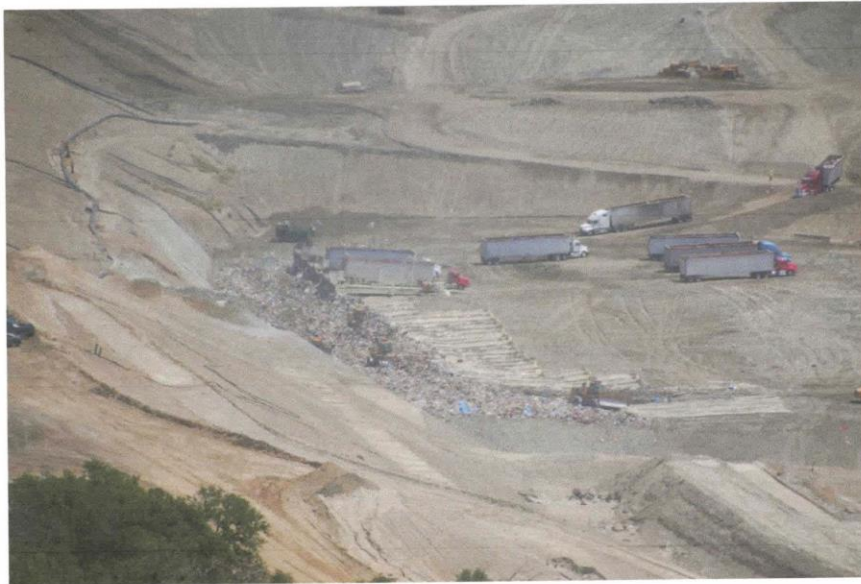
Photo 2: Alternative daily cover at Cell CC4

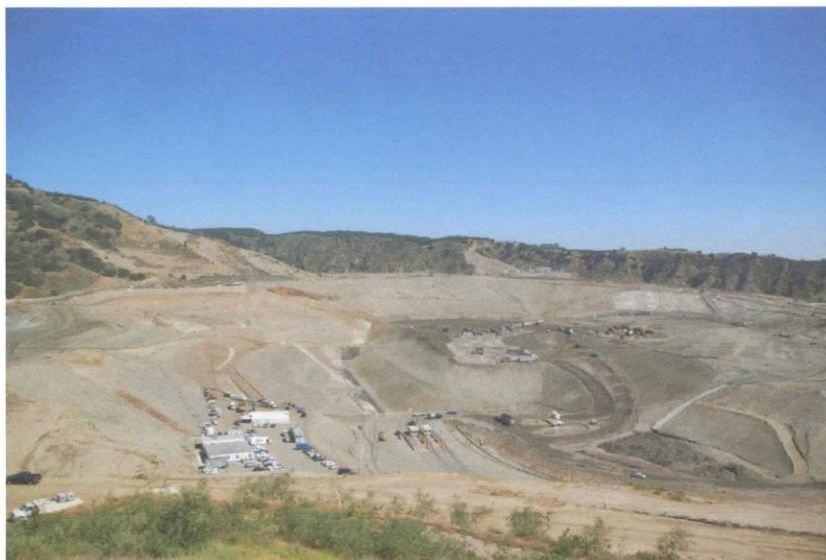
Photo 2: Landfilling ion Celle CC4

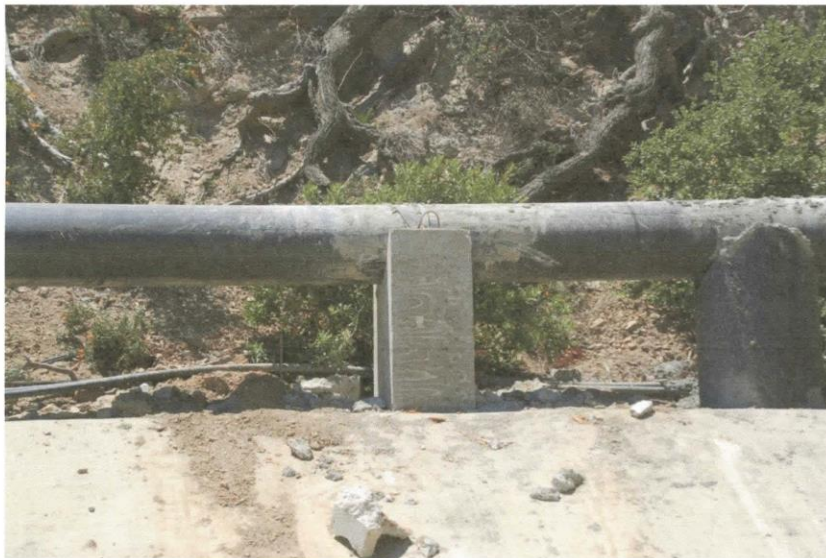
Photo 8: Concrete support for gas header to Flare 3
