**Sunshine Canyon Landfill
Independent Monitor
Quarterly Site Monitoring Status Report
July 1, 2015 – September 30, 2015**

City of Los Angeles Department of City Planning

County of Los Angeles Department of Regional Planning

February 9, 2016

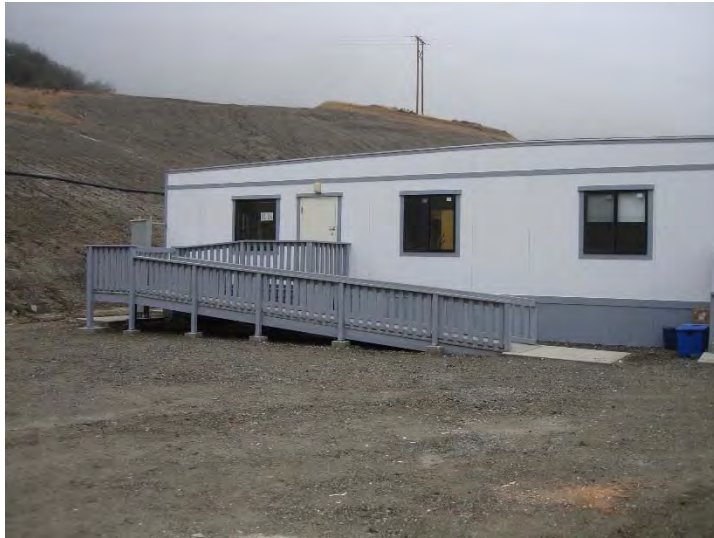
Photo 1: Relocated Landfill Offices: July 22, 2015

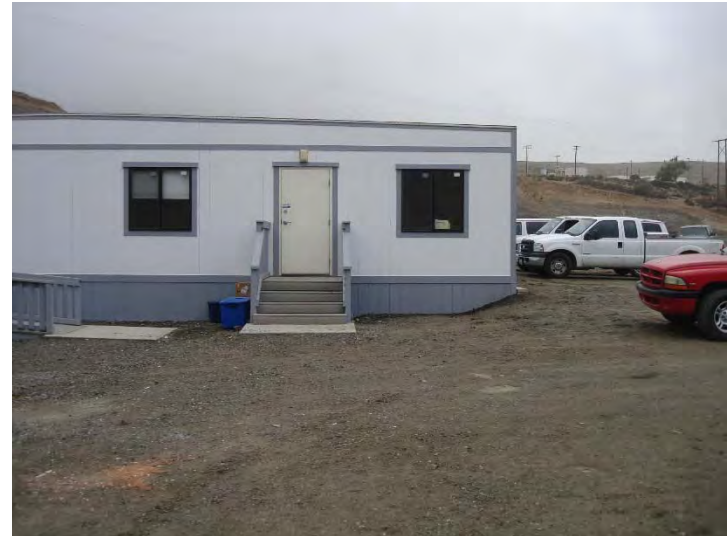
Photo 2: Relocated Landfill Offices: July 22, 2015

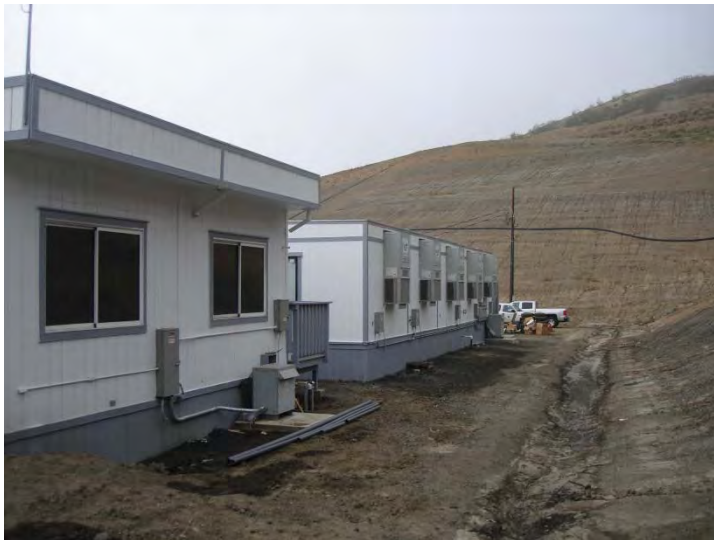
Photo 3: Relocated Landfill Offices: July 22, 2015

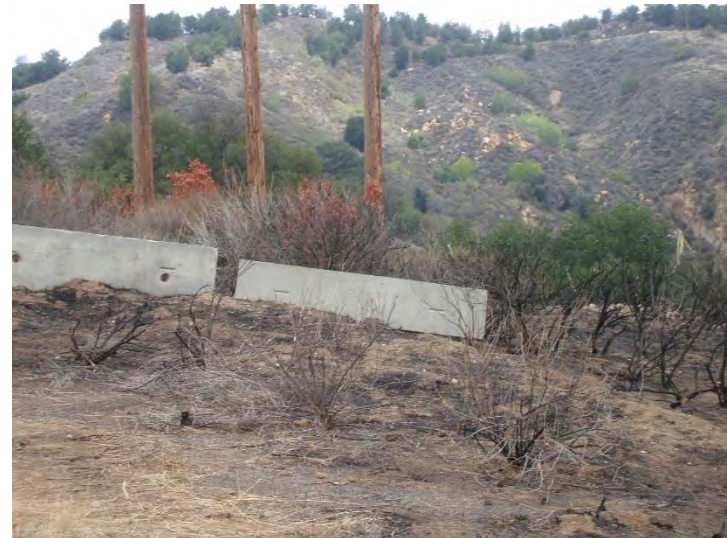
Photo 4: Prior Downed Powerline Fire Site: July 22, 2015

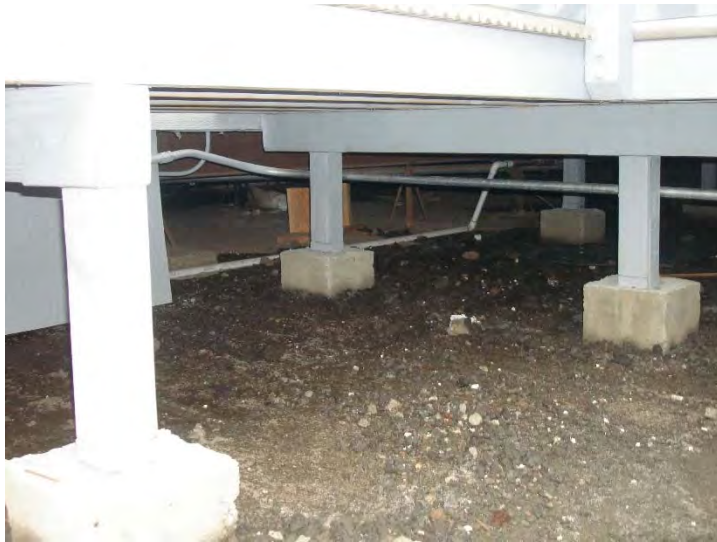
Photo 5: Relocated Landfill Offices: July 22, 2015

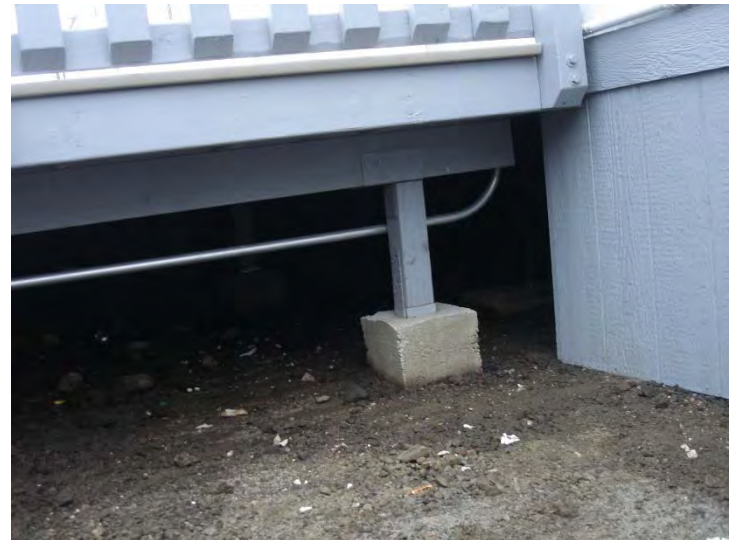
Photo 6: Relocated Landfill Offices: July 22, 2015

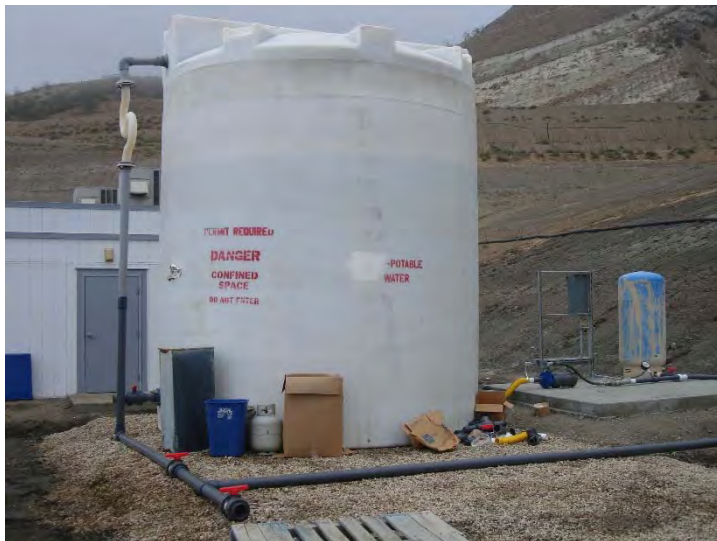
Photo 7: Relocated Landfill Offices: July 22, 2015

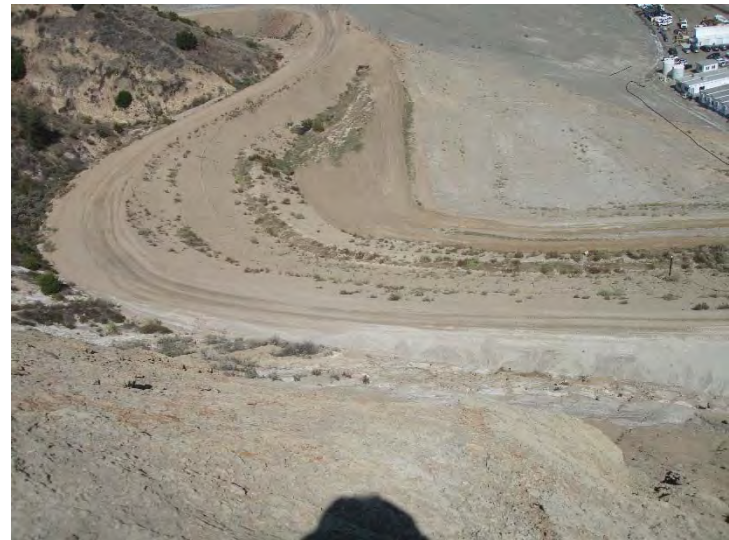
Photo 8: Drainage Above New Offices Site: September 23, 2015

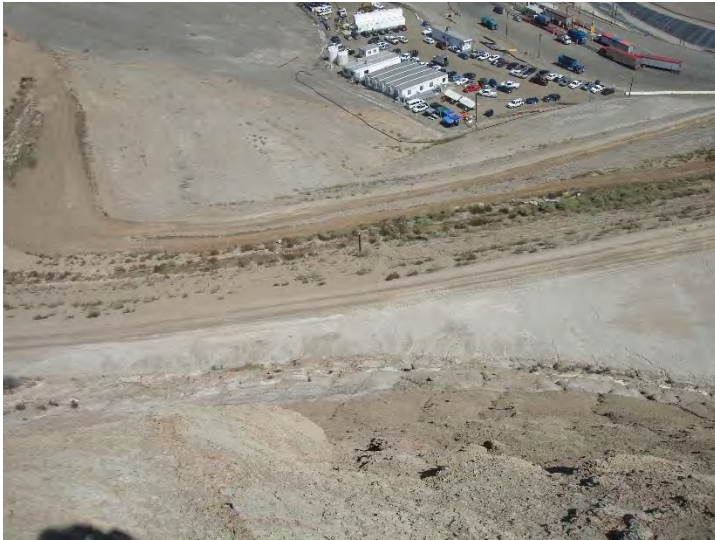
Photo 9: Drainage above New Offices Site: September 23, 2015

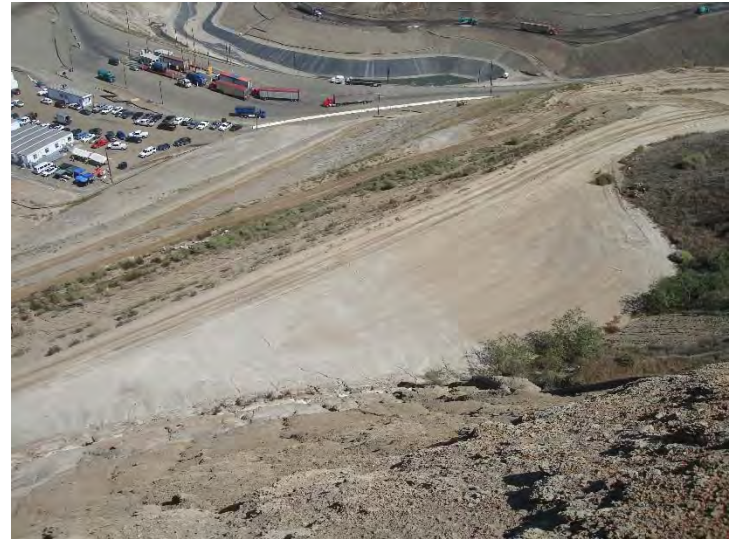
Photo 10: Drainage Above New Offices Site: September 23, 2015

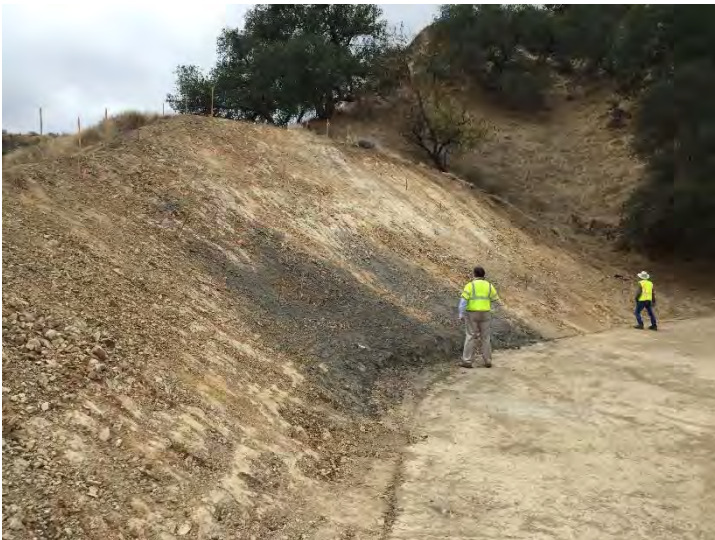
Photo 11: Grading North of Current Offices: July 22, 2015

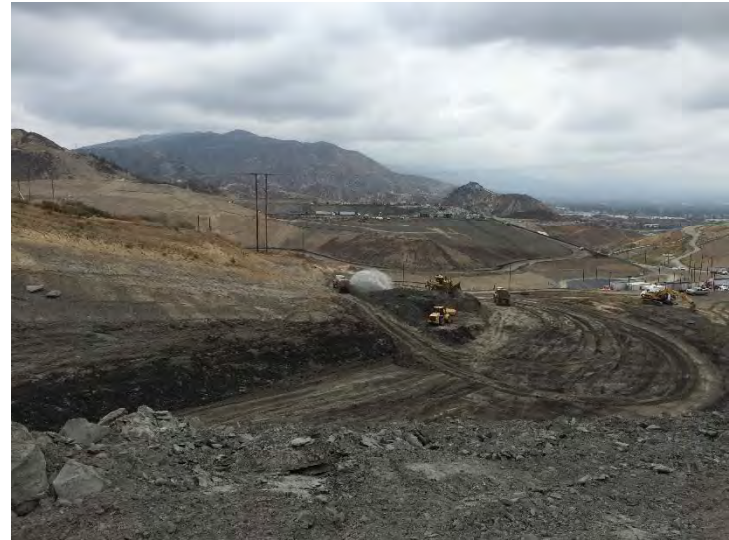
Photo 12: Grading North of Current Offices: July 22, 2015

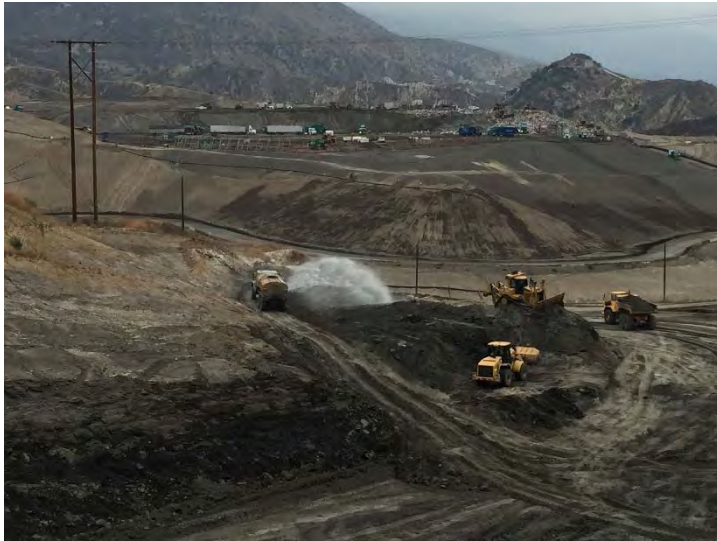
Photo 13: Grading North of Current Offices: July 22, 2015

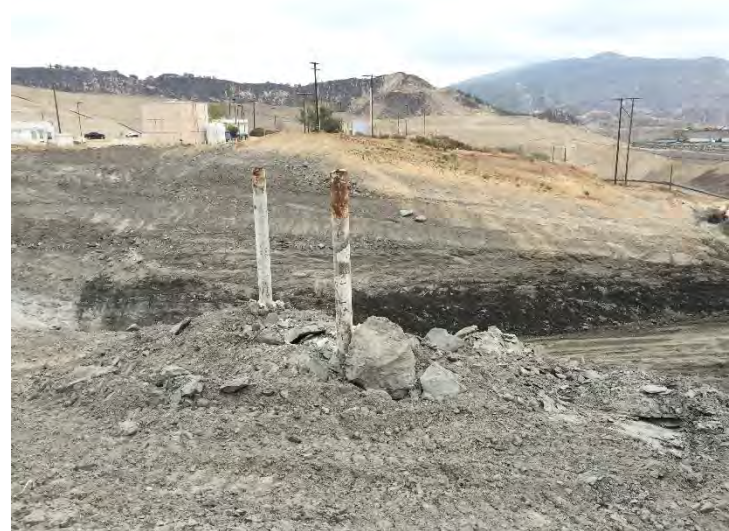
Photo 14: Grading North of Current Offices: July 22, 2015

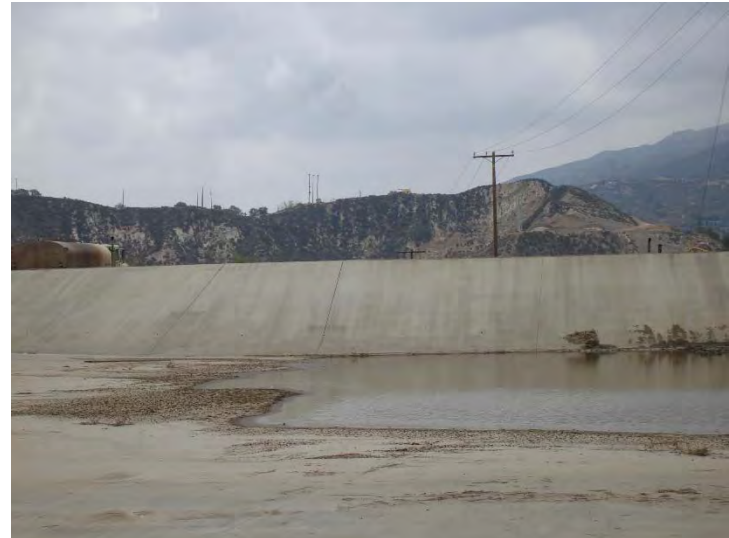
Photo 16: Basin A: July 22, 2015

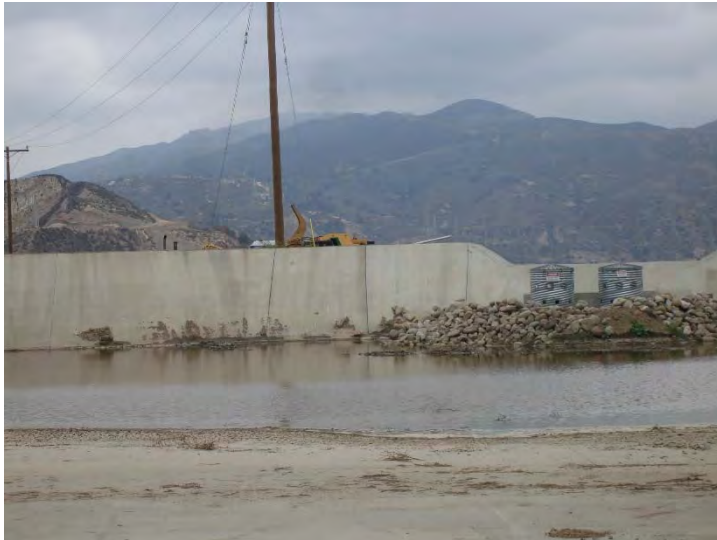
Photo 17: Basin A: July 22, 2015

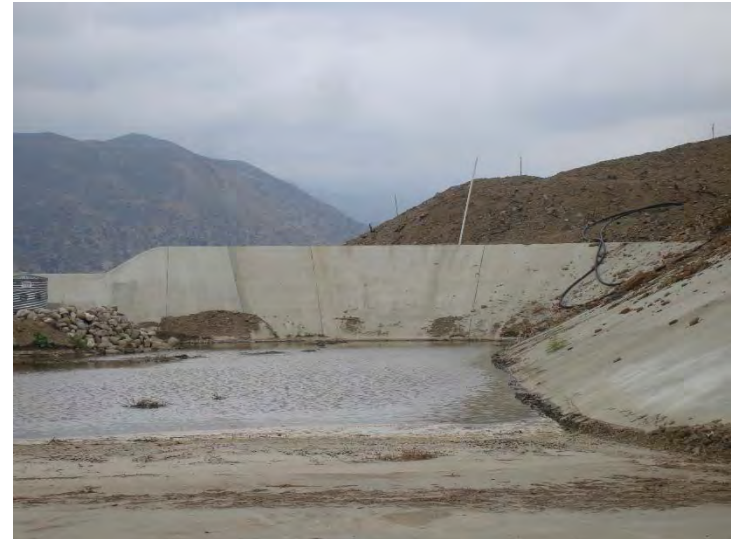
Photo 18: Basin A: July 22, 2015

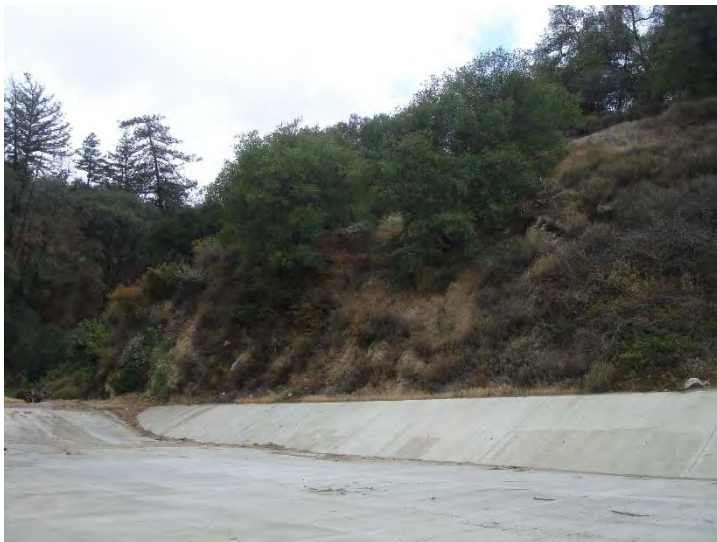
Photo 19: Basin A Native Hillside: July 22, 2015

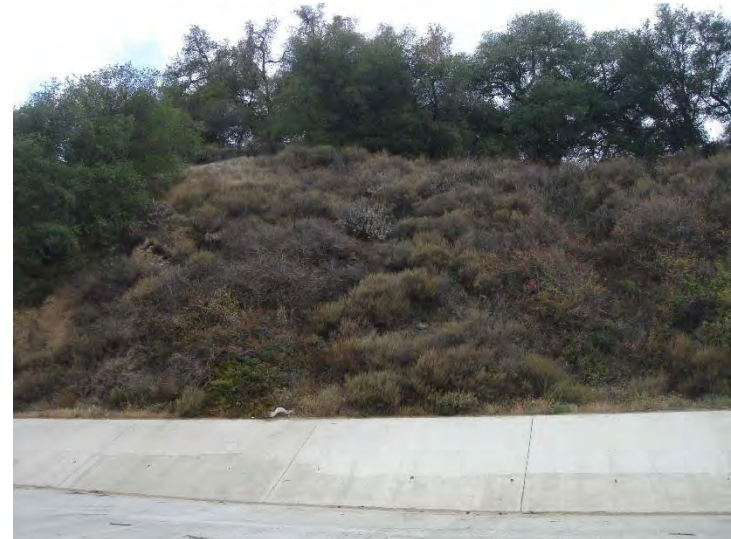
Photo 20: Basin A Native Hillside: July 22, 2015

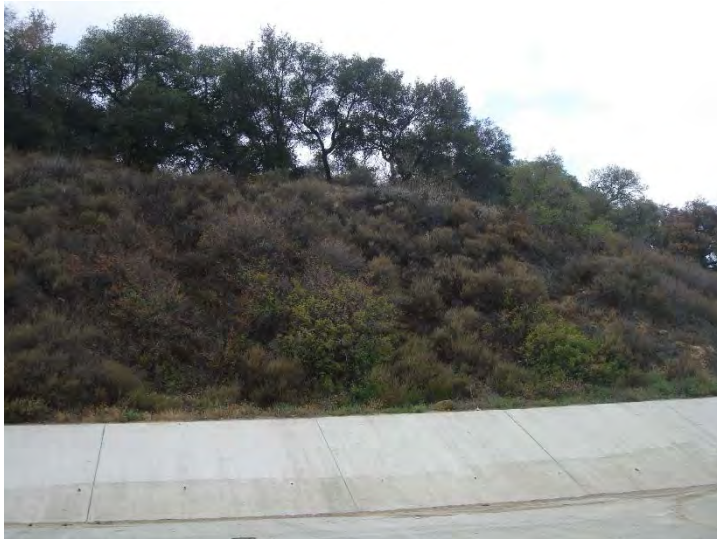
Photo 21: Basin A Native Hillside: July 22, 2015

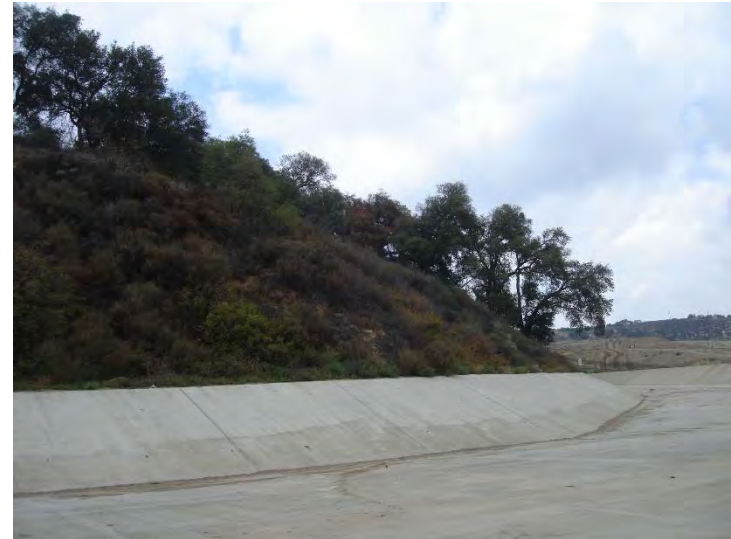
Photo 22: Basin A Native Hillside: July 22, 2015

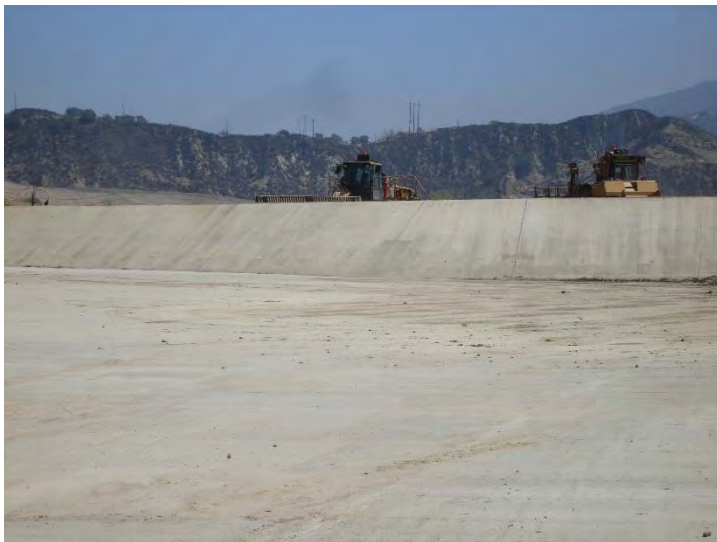
Photo 23: Basin A: August 11, 2015

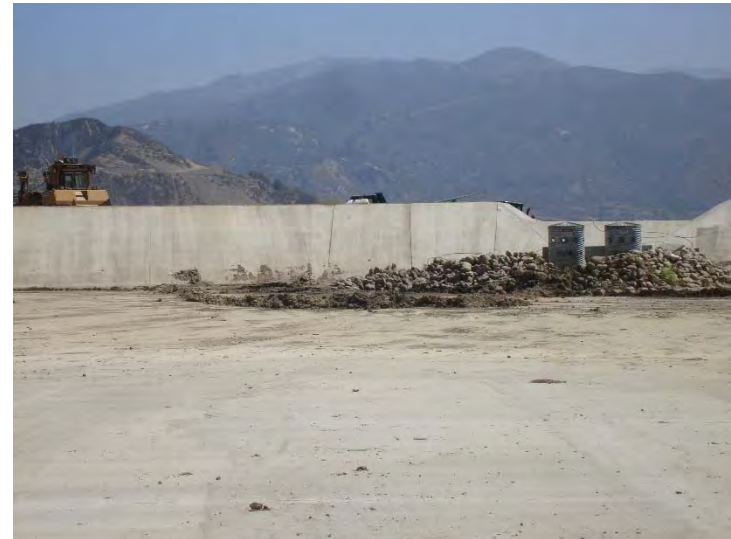
Photo 24: Basin A: August 11, 2015

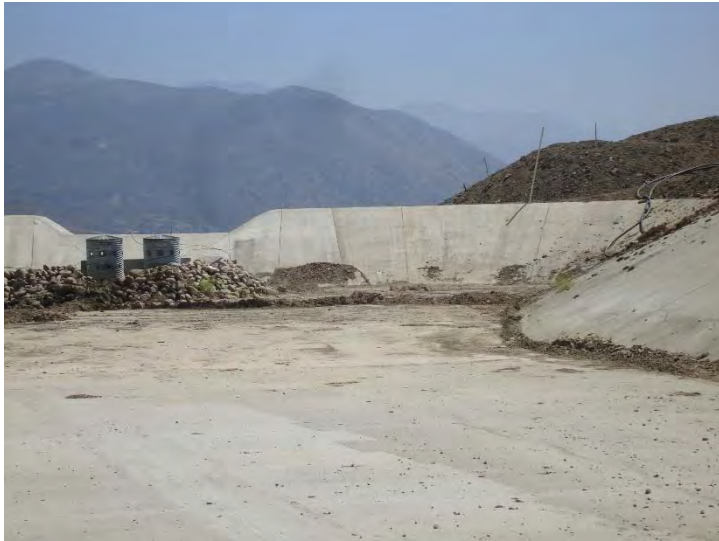
Photo 25: Basin A: August 11, 2015

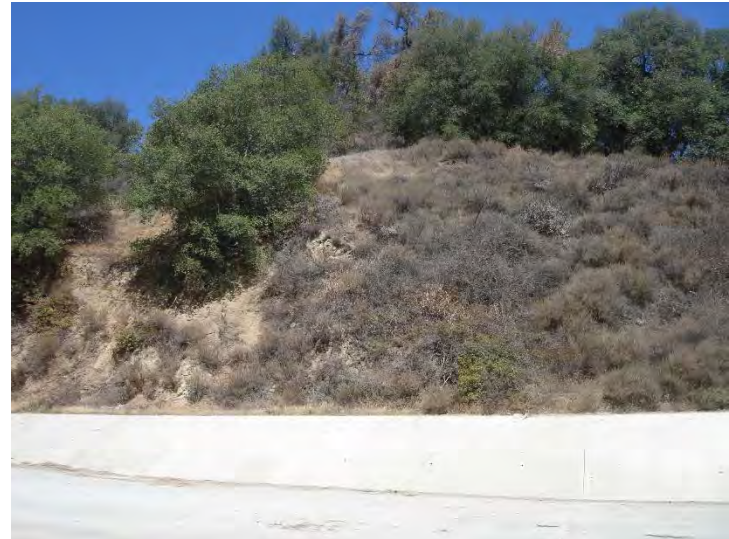
Photo 26: Basin A Native Hillside: August 11, 2015

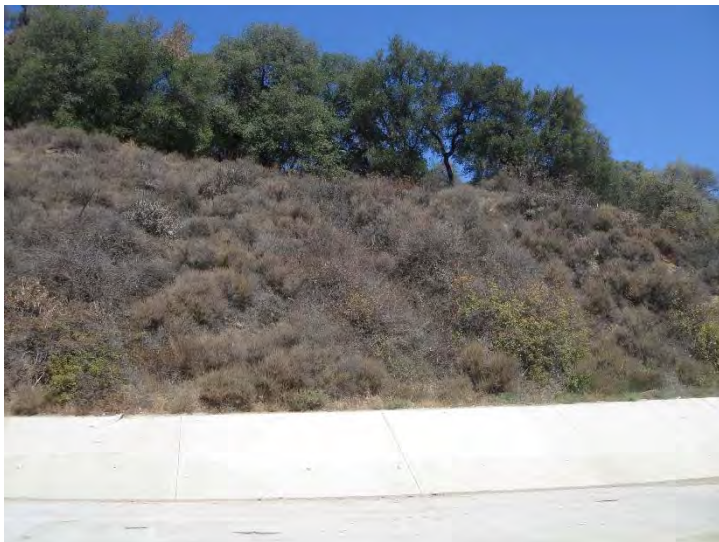
Photo 27: Basin A Native Hillside: August 11, 2015

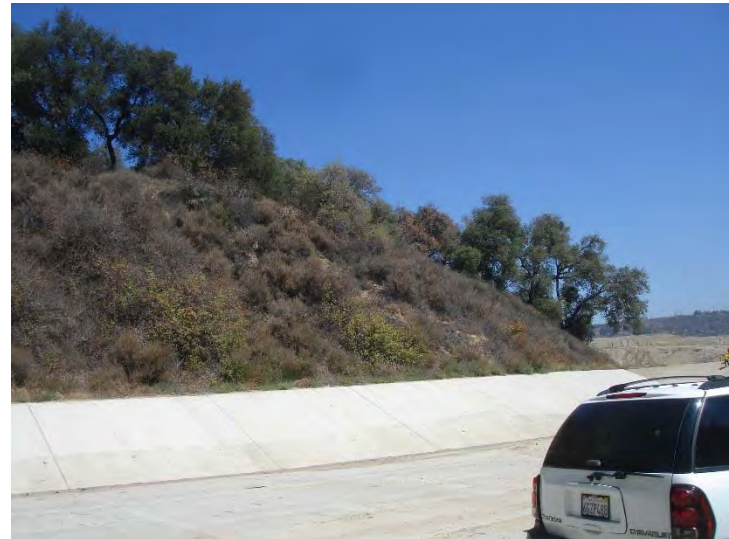
Photo 28: Basin A Native Hillside: August 11, 2015

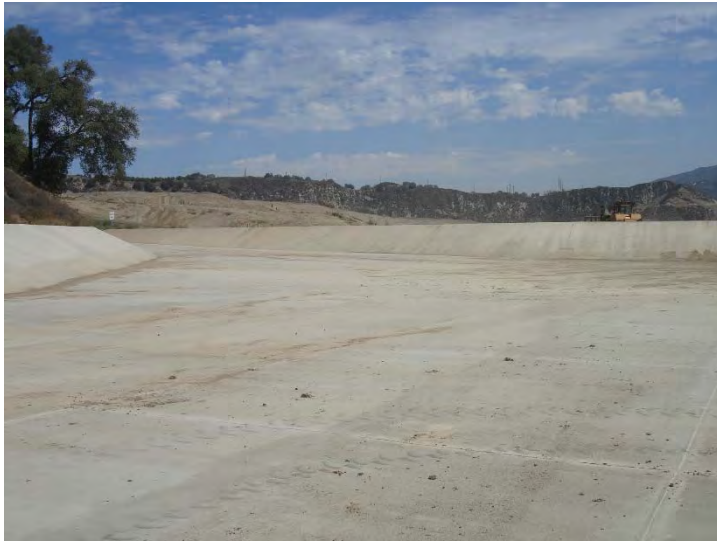
Photo 29: Basin A: August 26, 2015

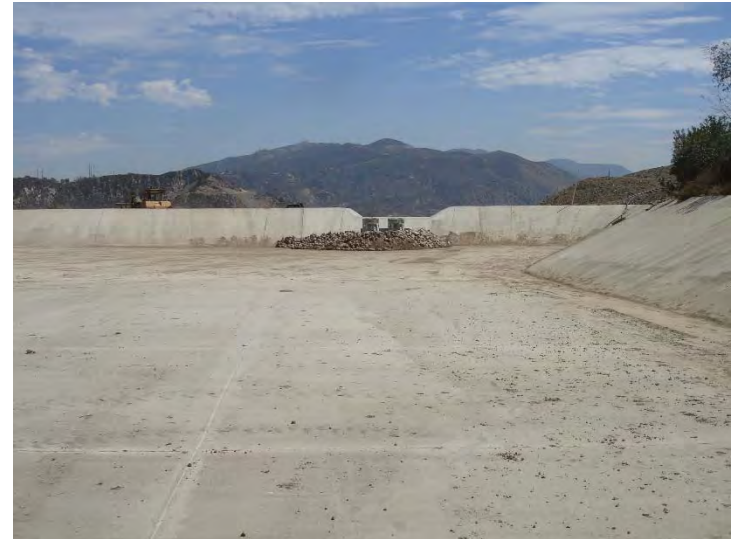
Photo 30: Basin A: August 26, 2015

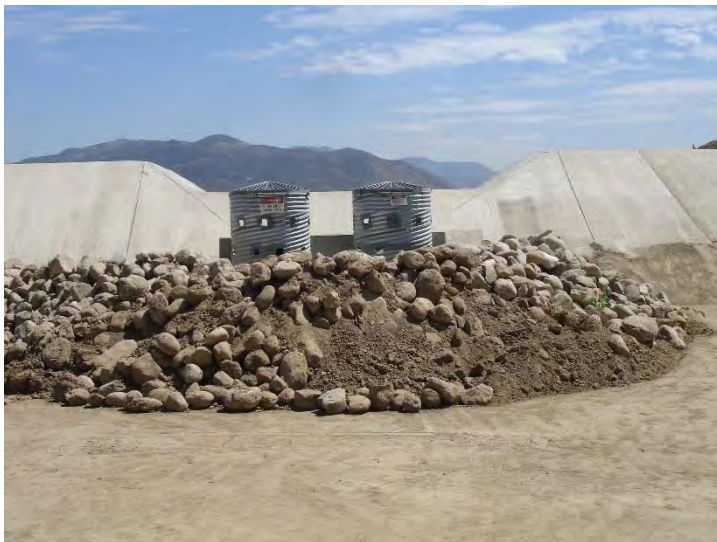
Photo 31: Basin A: August 26, 2015

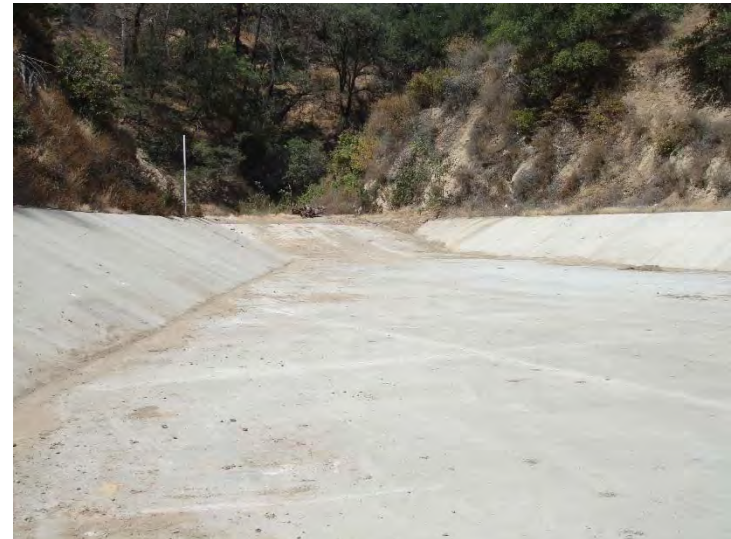
Photo 32: Basin A: August 26, 2015

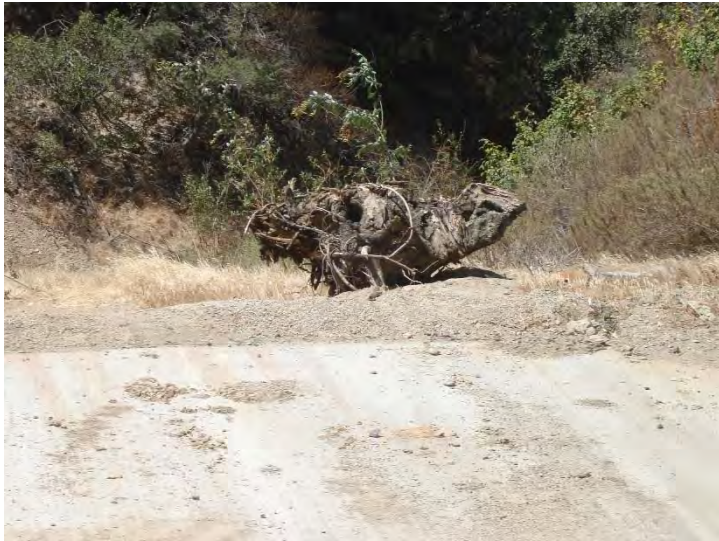
Photo 33: Basin A Native Hillside: August 26, 2015

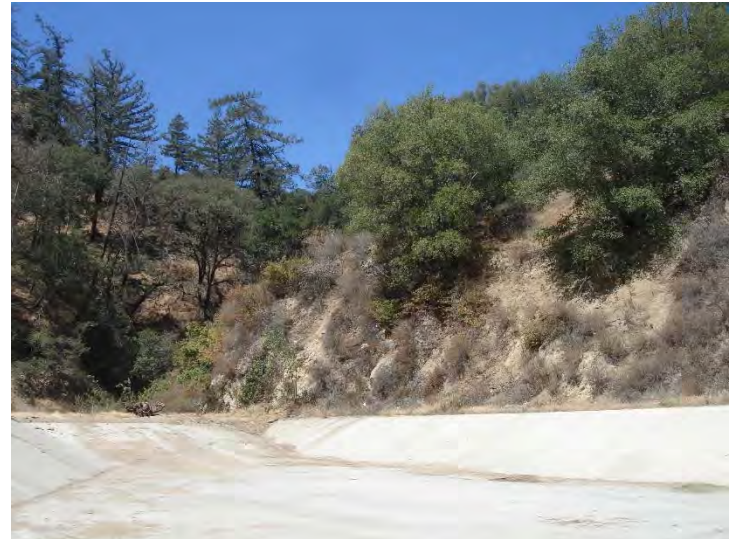
Photo 34: Basin A Native Hillside: August 26, 2015

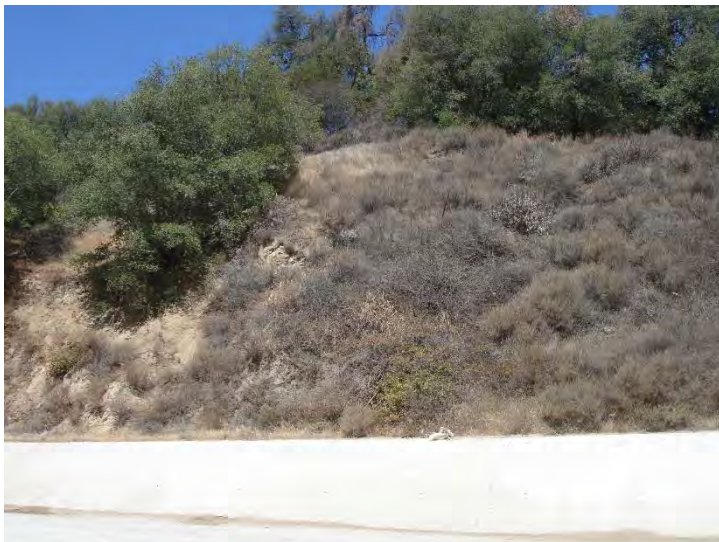
Photo 35: Basin A Native Hillside: August 26, 2015

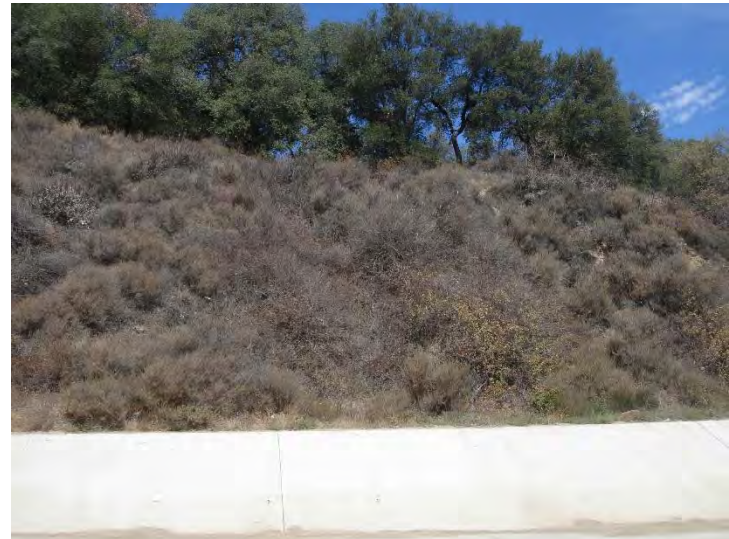
Photo 36: Basin A Native Hillside: August 26, 2015

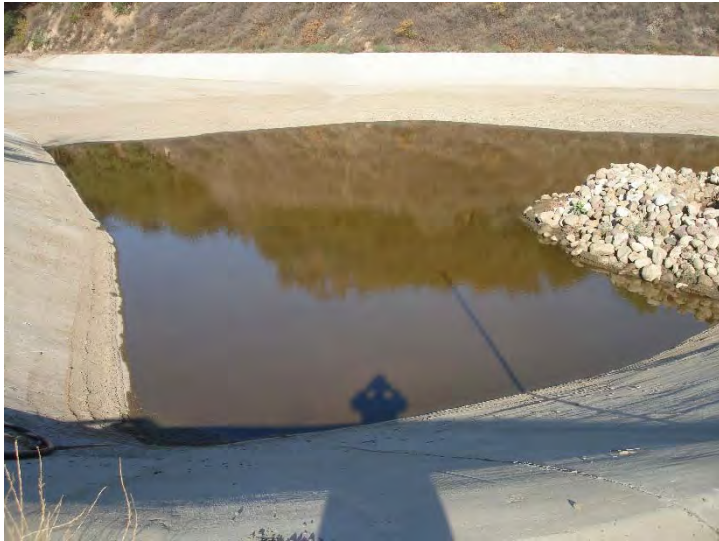
Photo 37: Basin A: September 23, 2015

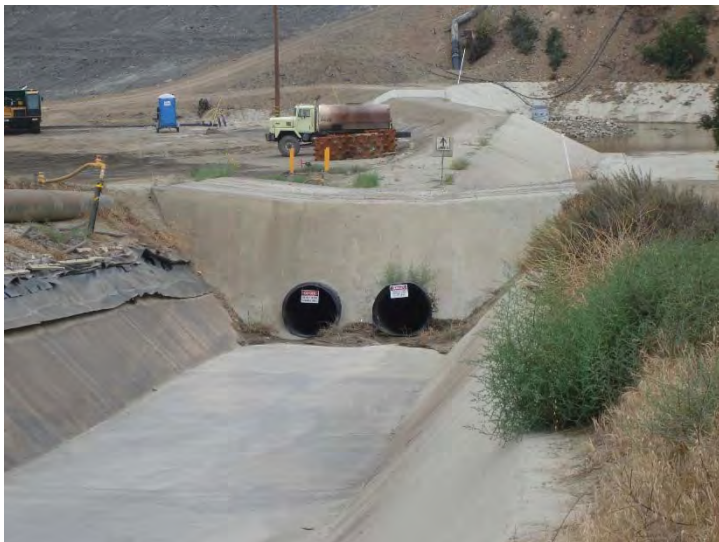
Photo 38: Basin A: September 23, 2015

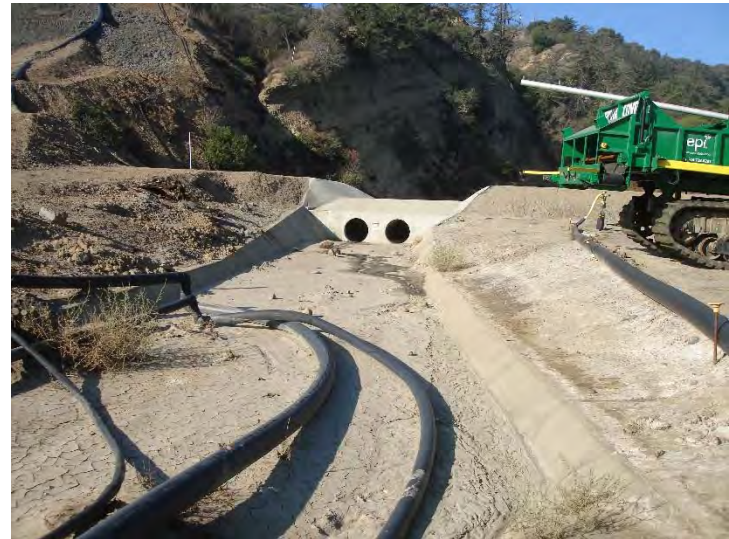
Photo 39: Basin A Westside Channel Inlet: July 22, 2015

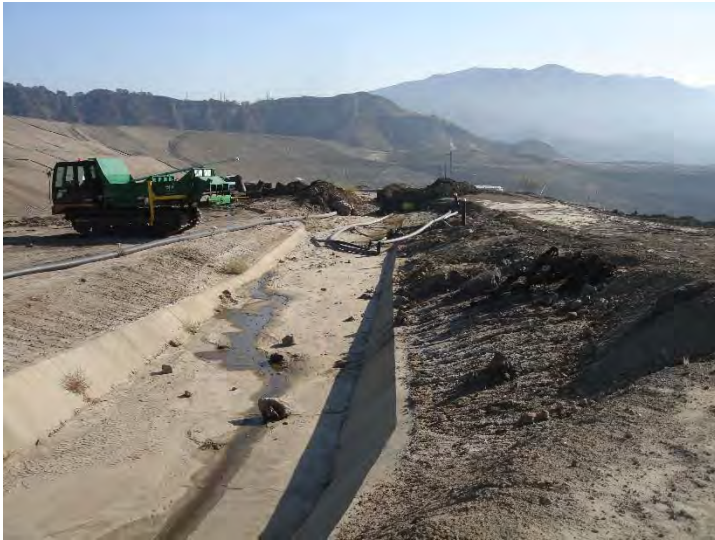
Photo 40: Basin A Outlet: September 23, 2015

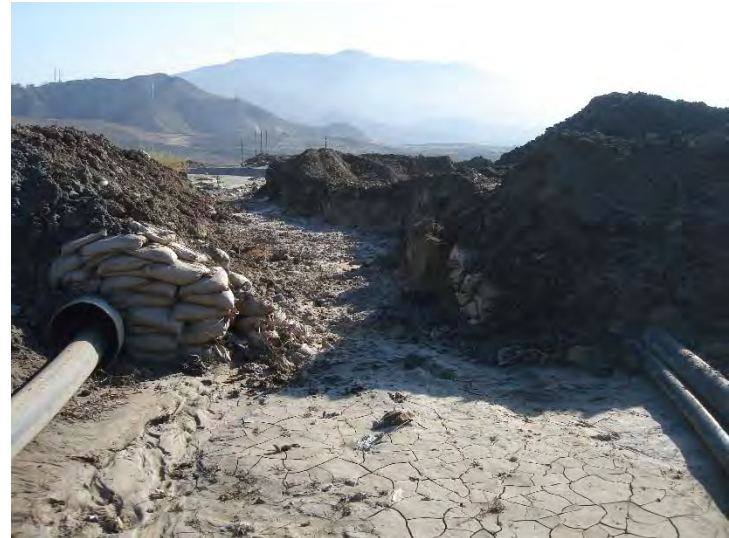
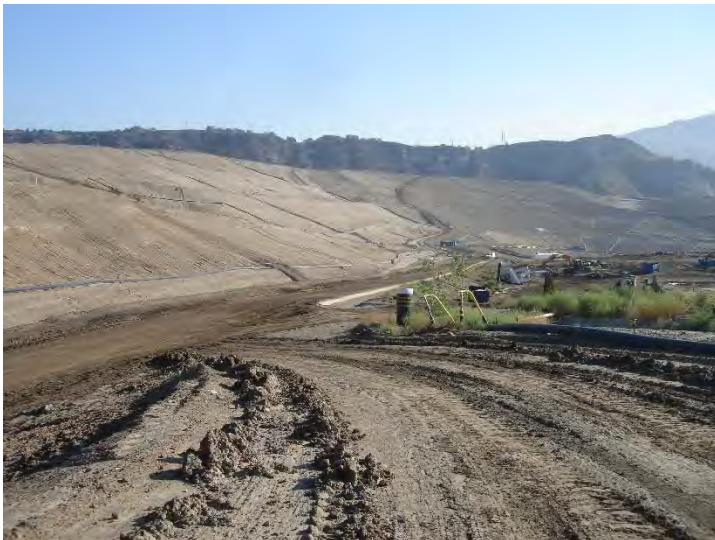
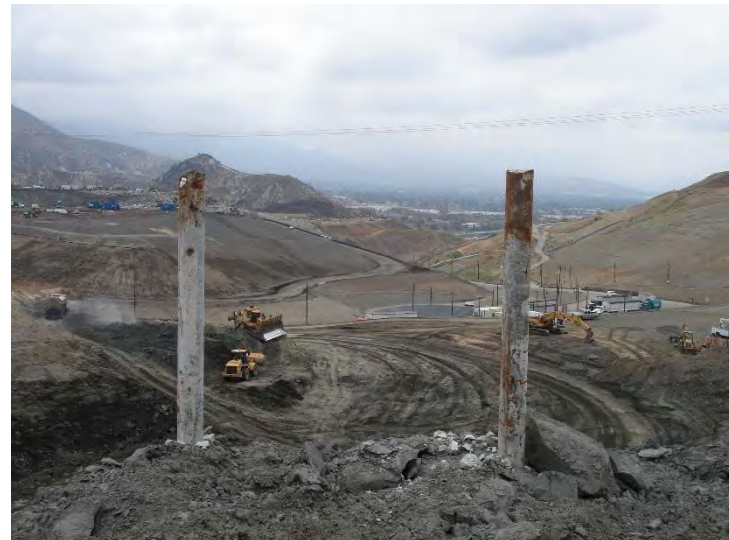
Photo 41: Basin A Outlet Channel: September 23, 2015

Photo 42: Basin A Outlet Channel: September 23, 2015

Photo 43: Basin A Outlet Channel: September 23, 2015

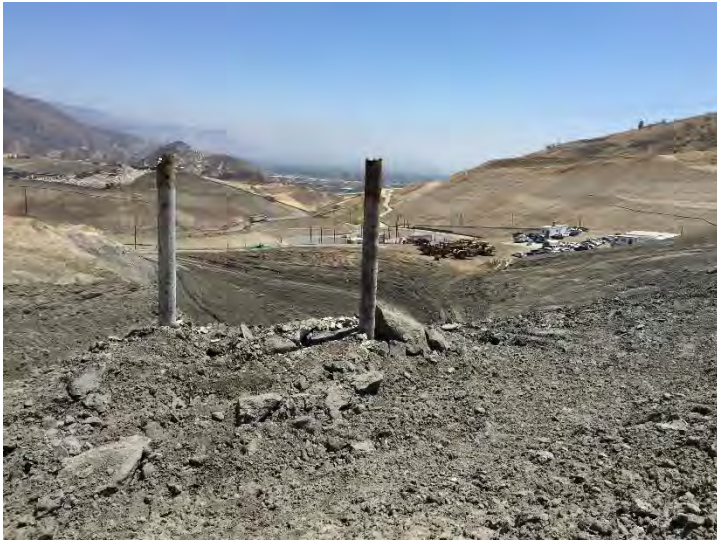
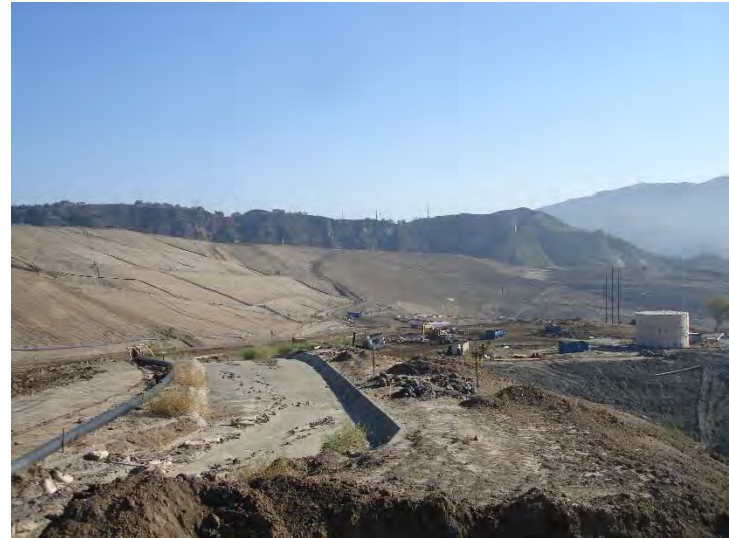
Photo 44: Old Oil Wells South of Basin A: July 22, 2015

Photo 45: Old Oil Wells: July 22, 2015

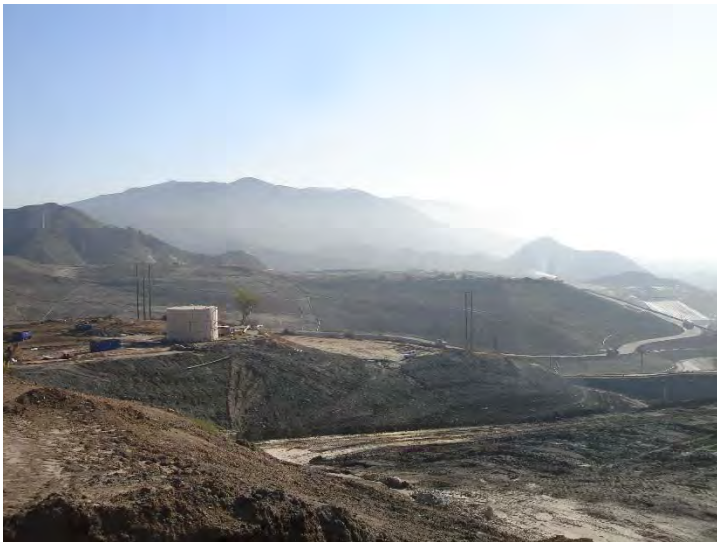
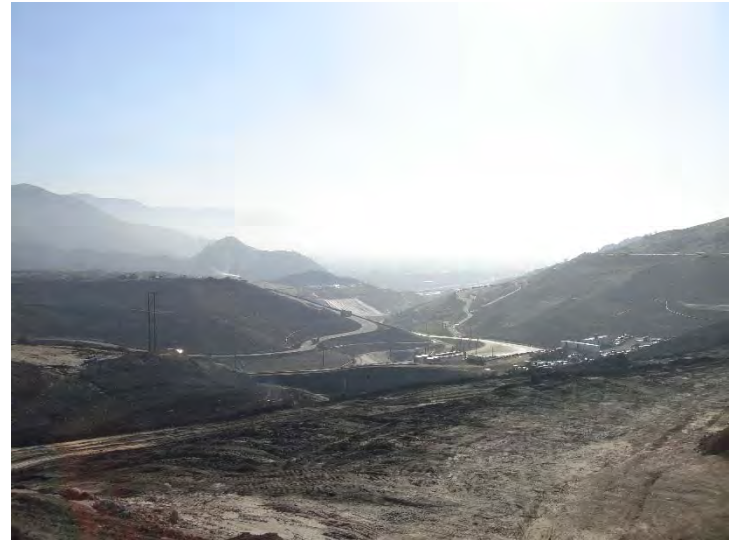
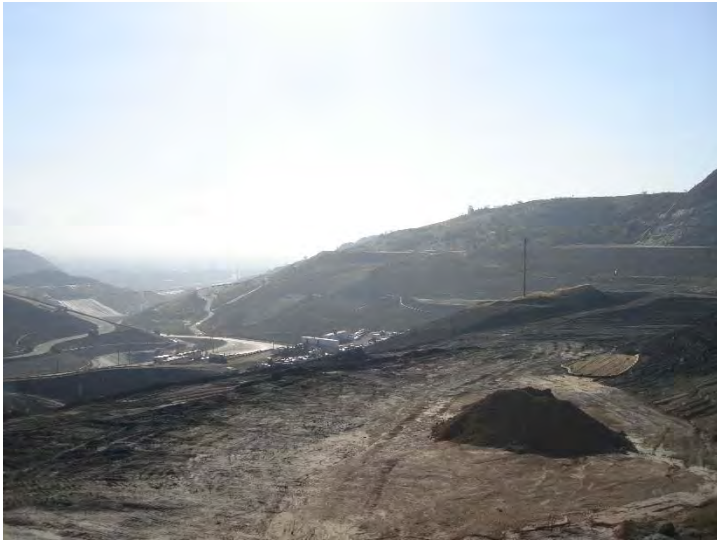
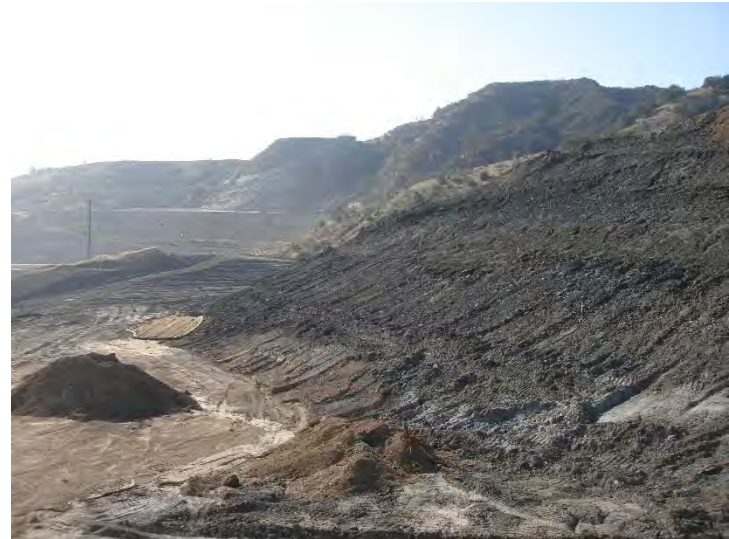
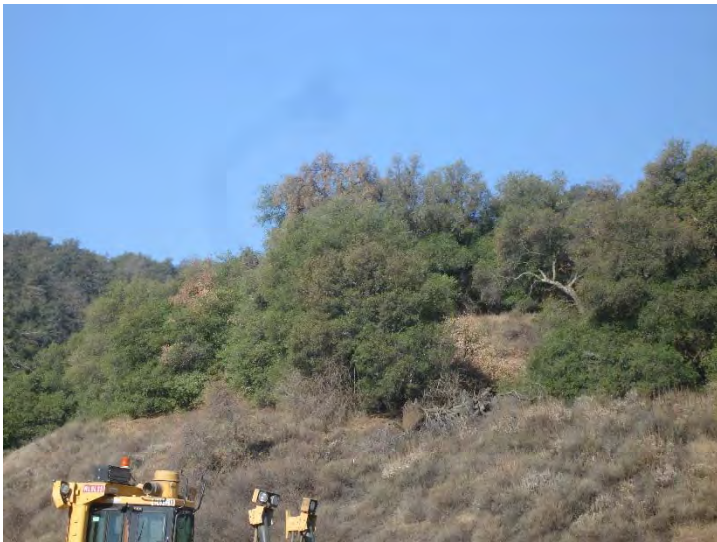
Photo 46: Grading Work near Basin A: September 23, 2015

Photo 47: Grading Work Near Basin A: September 23, 2015

Photo 48: Grading Work Near Basin A: September 23, 2015

Photo 49: Grading Work Near Basin A: September 23, 2015

Photo 50: Grading Work Near Basin A: September 23, 2015

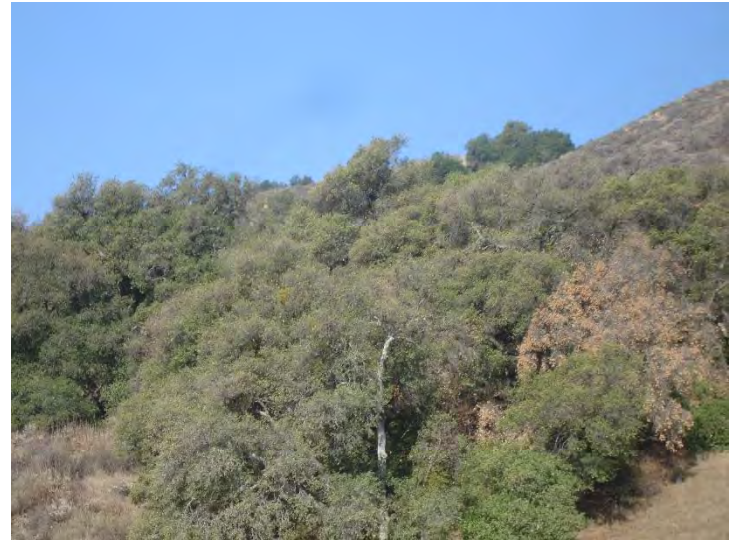
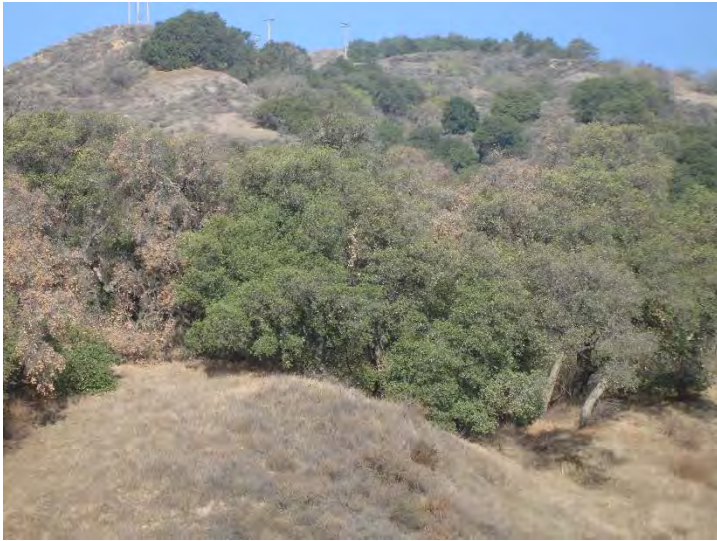
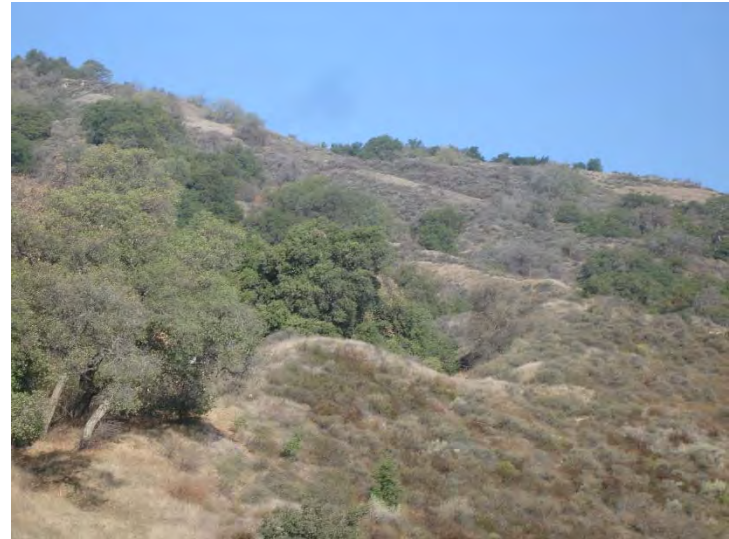
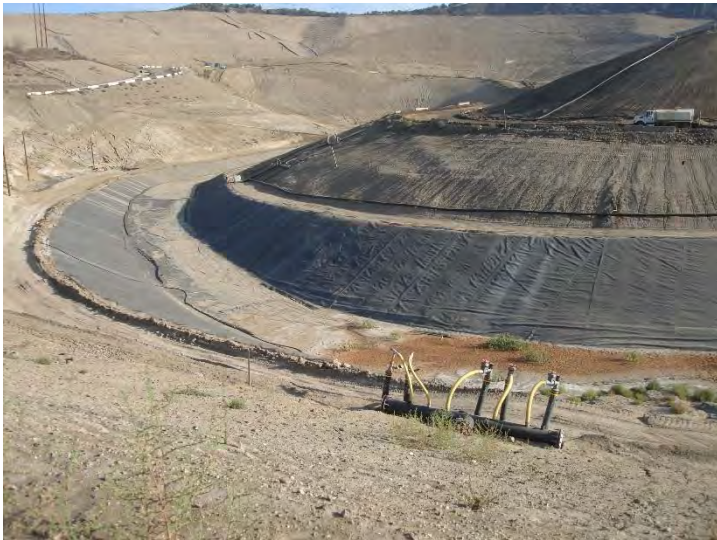
Photo 51: Native Oak Trees Dying Near Basin A: September 23, 2015

Photo 52: Native Oak Trees Dying Near Basin A: September 23, 2015

Photo 53: Native Oak Trees Dying Near Basin A: September 23, 2015

Photo 54: Native Oak Trees Dying Near Basin A: September 23, 2015

Discipline	City Condition Reference # / Mitigation #	County Condition Reference # / Mitigation #	Responsible Agency	Further Review Needed-Comments
Biologist		Visual - 10.08	County Forester	I-j, I-k, I-l, and I-m: See M - 4.1.1 / 6 above.
	M - 4.4.1 / 60		City Planning	<p>I-j: The City Deck C sage mitigation area was observed to be doing well with summer dry conditions.</p> <p>I-k: The monitors observed that the City Deck C sage mitigation was doing well. Birds were seen in the habitat area.</p> <p>I-l: The City Deck C sage mitigation was doing well with only the sage and buckwheat showing the effects of a summer dry condition. Birds were observed foraging in the area.</p> <p>I-m: The City Deck C sage mitigation was observed to be doing well. Also, the PM-10 berm oak trees were doing well in all areas except for the ridgeline saddle where the high, hot winds had stunted their growth. The understory vegetation could be planted amongst the oak trees in all areas except for the saddle.</p>
