**Sunshine Canyon Landfill
Independent Monitor
Quarterly Site Monitoring Status Report
July 1, 2015 – September 30, 2015**

City of Los Angeles Department of City Planning

County of Los Angeles Department of Regional Planning

February 9, 2016

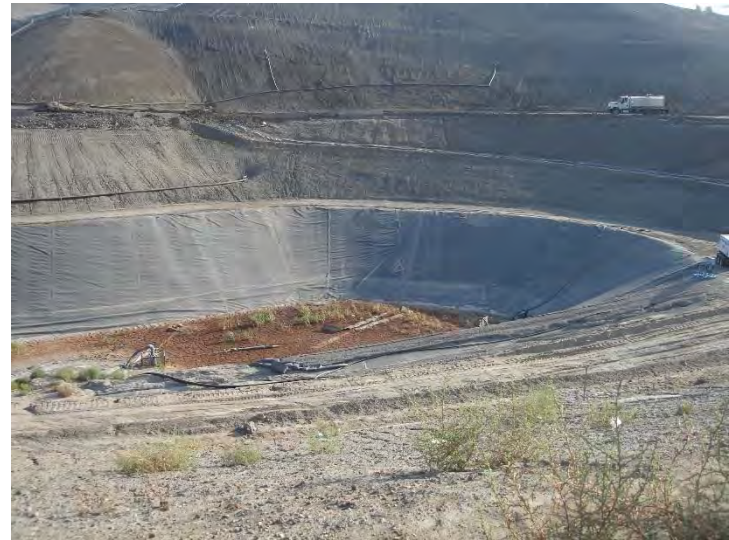
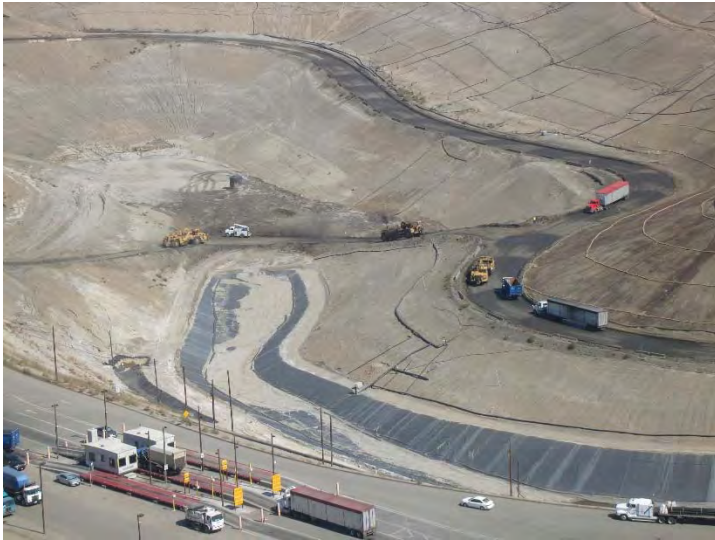
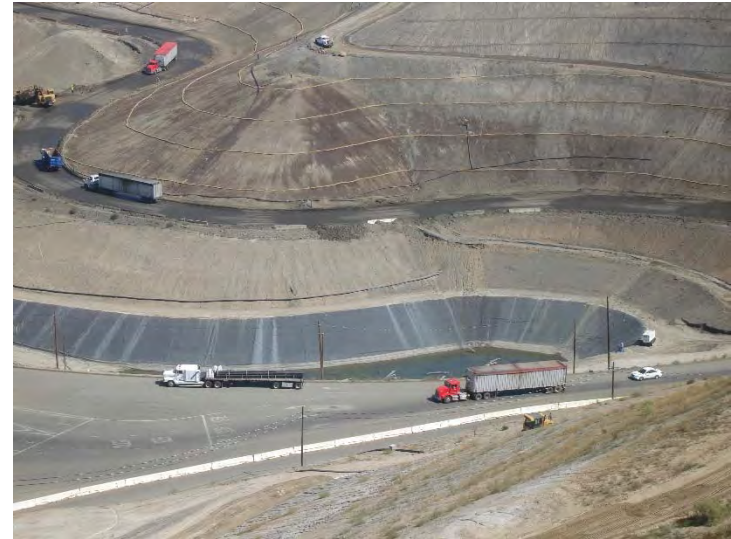
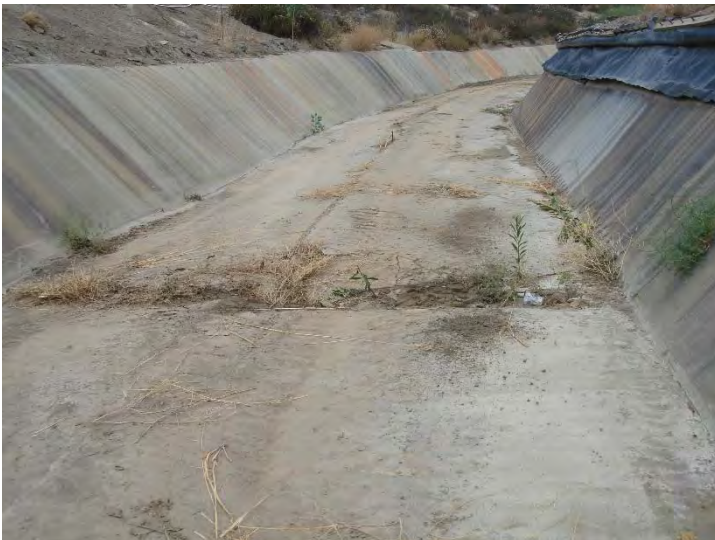
Photo 55: City Lined Drainage Lift Area: August 26, 2015

Photo 56: City Lined Drainage Lift Area: August 26, 2015

Photo 57: City Lined Drainage Lift Area: September 23, 2015

Photo 58: City Lined Drainage Lift Area: September 23, 2015

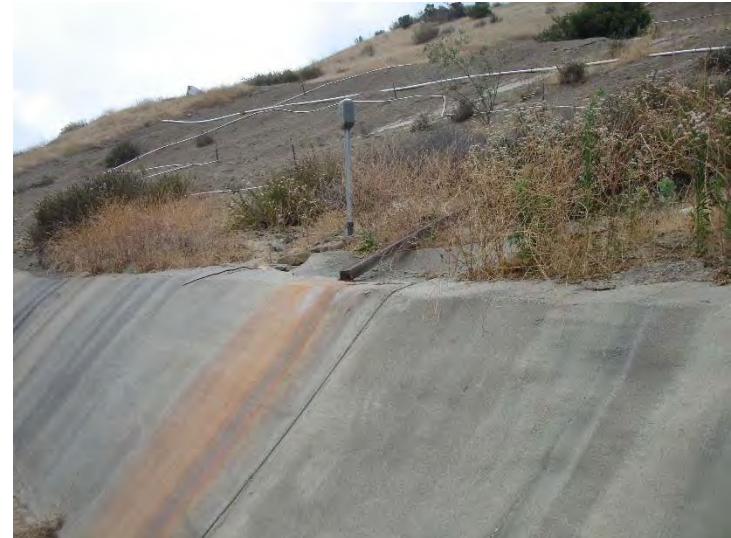
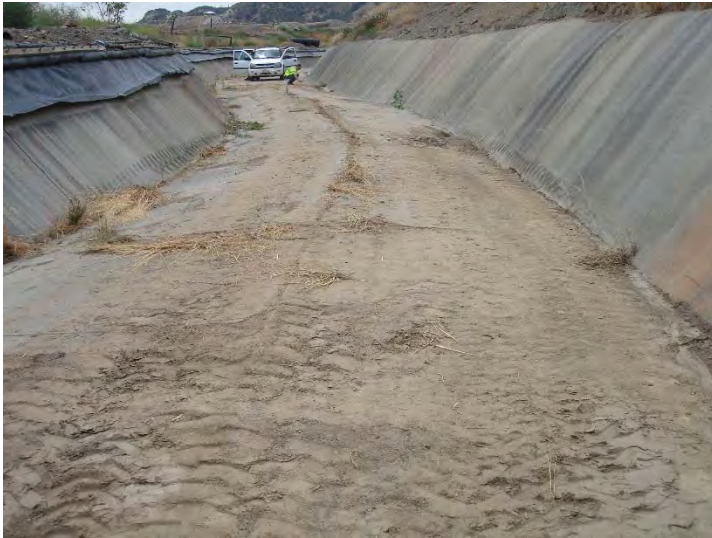
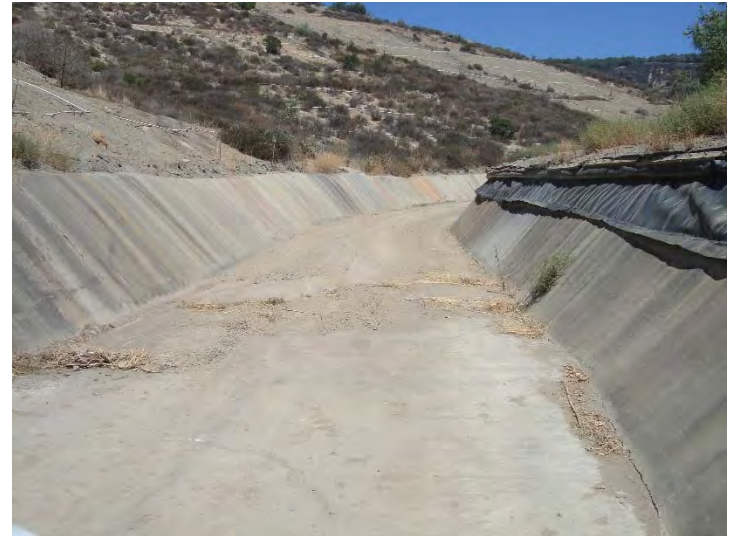
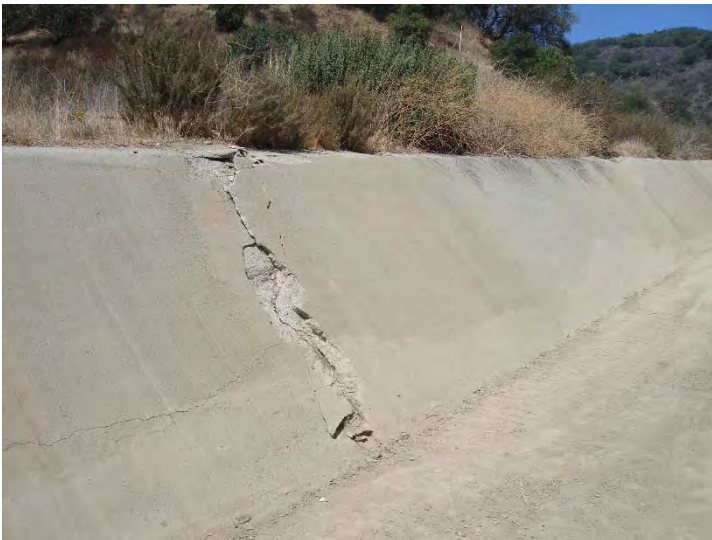
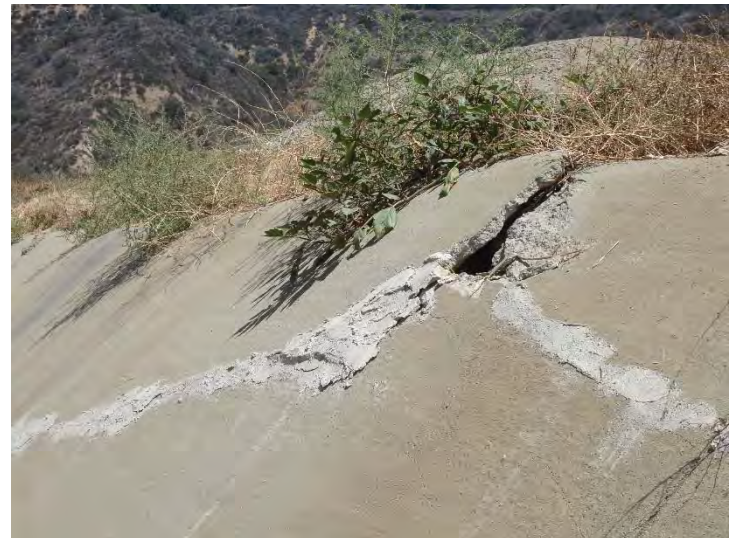
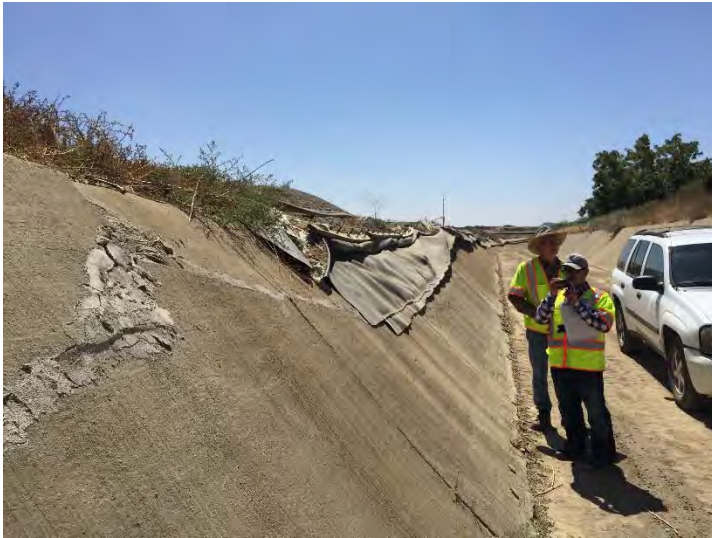
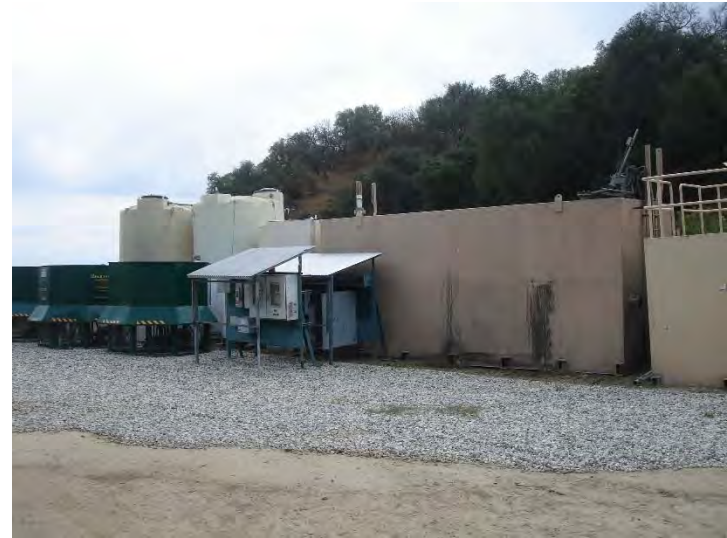
Photo 59: Westside Drainage Channel: July 22, 2015

Photo 60: Westside Drainage Channel: July 22, 2015

Photo 61: Westside Drainage Channel: July 22, 2015

Photo 62: Westside Drainage Channel: August 11, 2015

Photo 63: Westside Drainage Channel: August 11, 2015

Photo 64: Westside Drainage Channel: August 11, 2015

Photo 65: Westside Drainage Channel: August 11, 2015

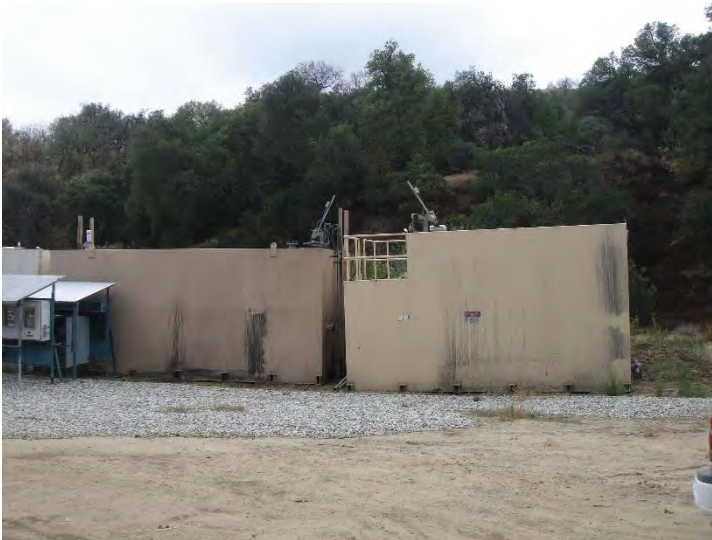
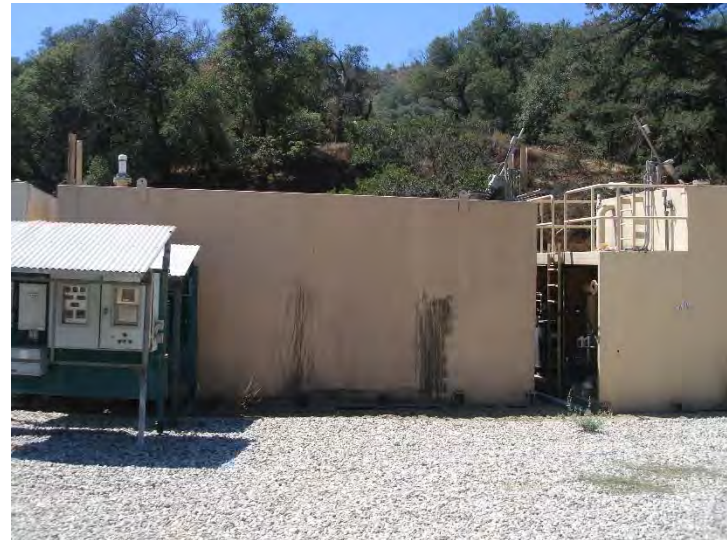
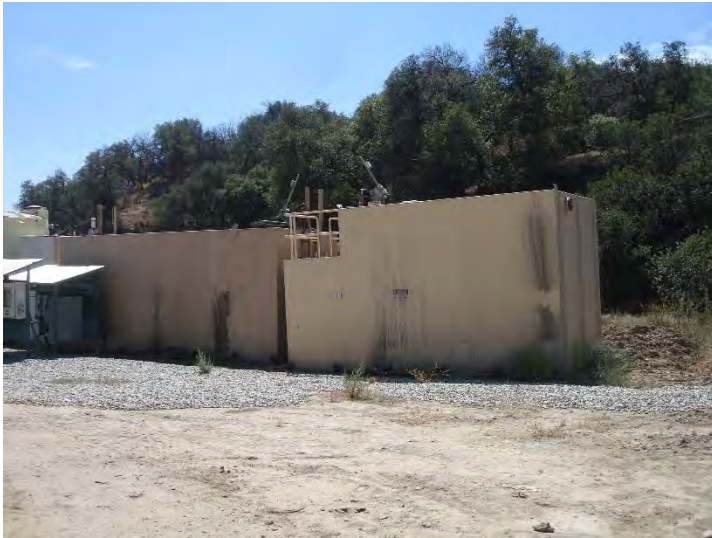
Photo 66: Condensate Equipment in Storage Yard: July 22, 2015

Photo 67: Condensate Equipment in Storage Yard: July 22, 2015

Photo 68: Condensate Equipment in Storage Yard: August 11, 2015

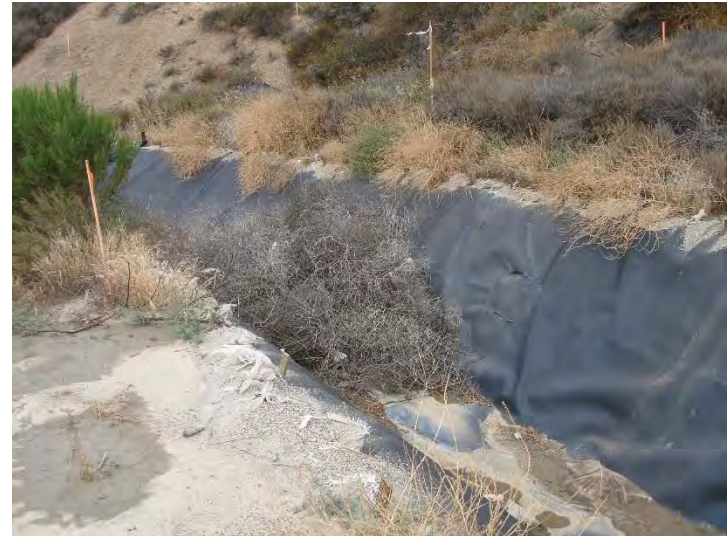
**Photo 69: Material Storage Area Old Condensate Equipment:
August 26, 2015**

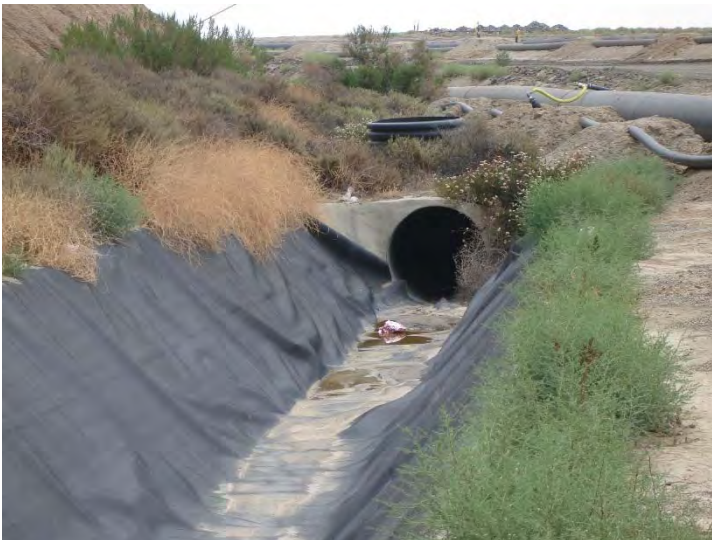
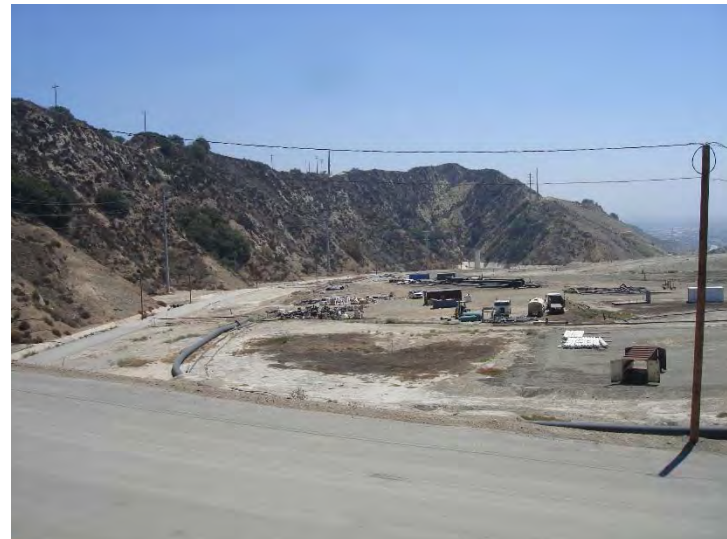
Photo 70: Basin D Outlet Channel: July 22, 2015

Photo 71: Basin D Outlet Channel: July 22, 2015

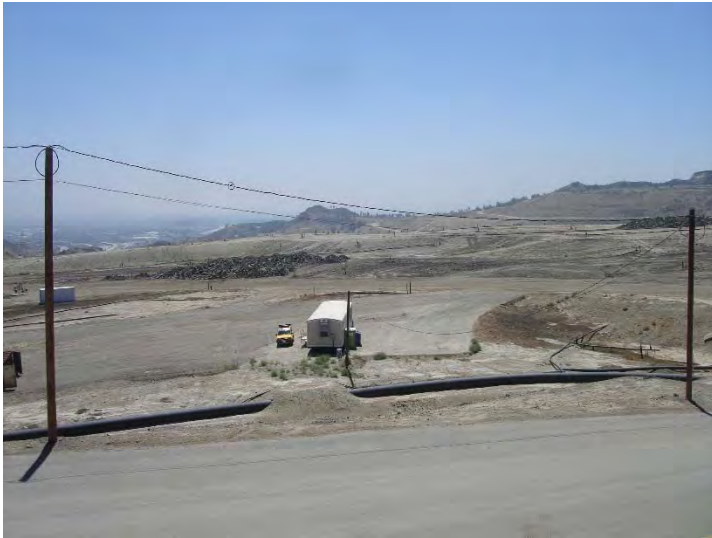
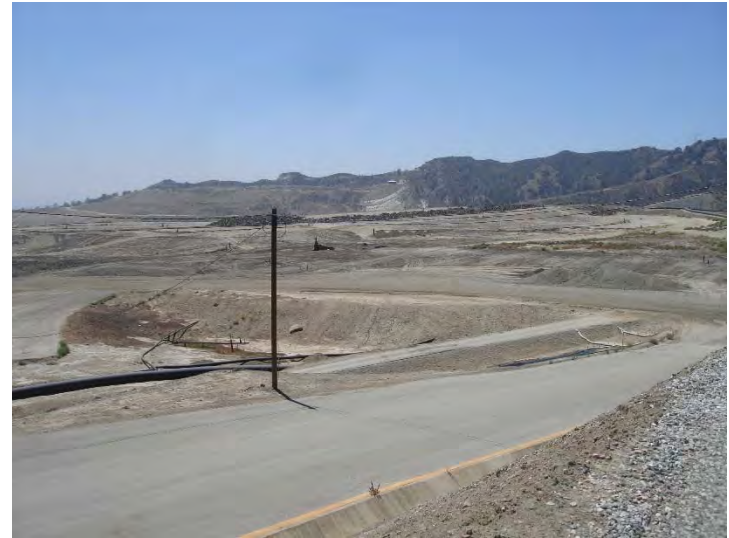
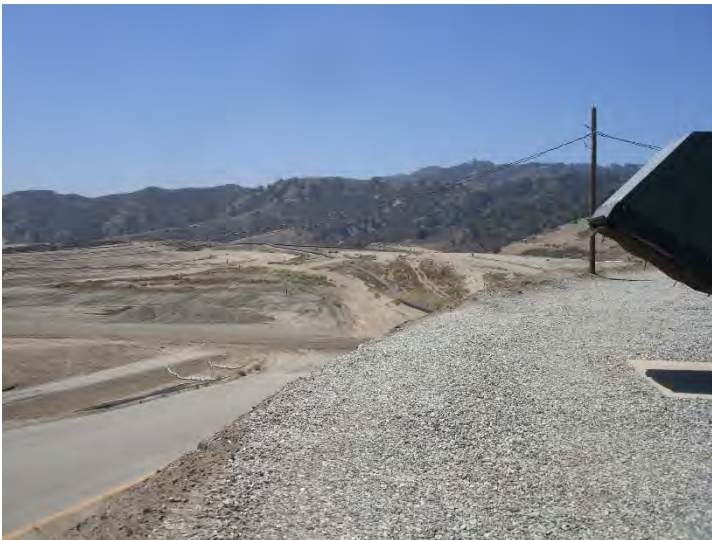
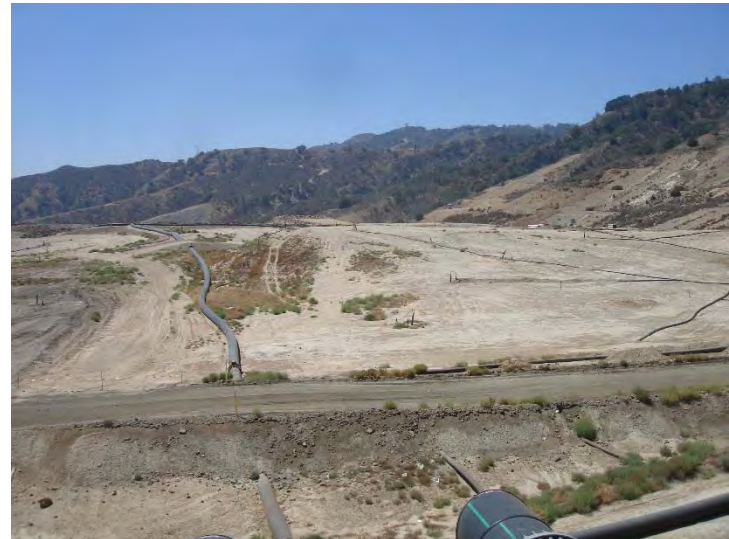
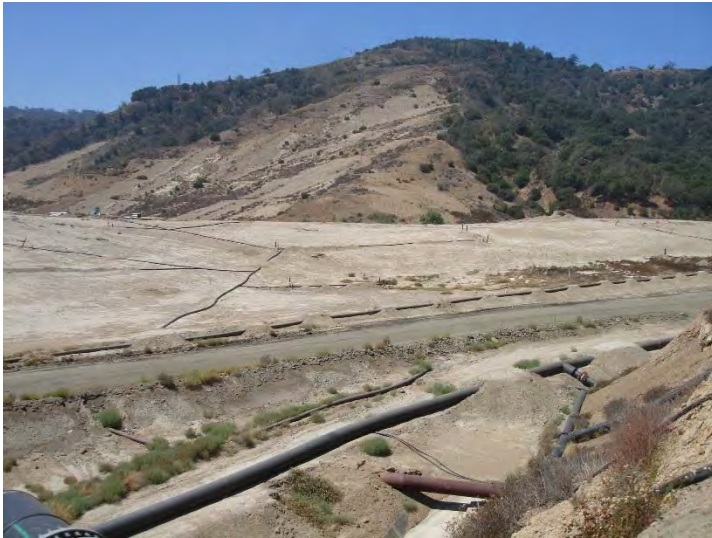
Photo 72: Site County Top Deck: August 11, 2015

Photo 73: Site County Top Deck: August 11, 2015

Photo 74: Site County Top Deck: August 11, 2015

Photo 75: Site County Top Deck: August 11, 2015

Photo 76: Site County Top Deck: August 11, 2015

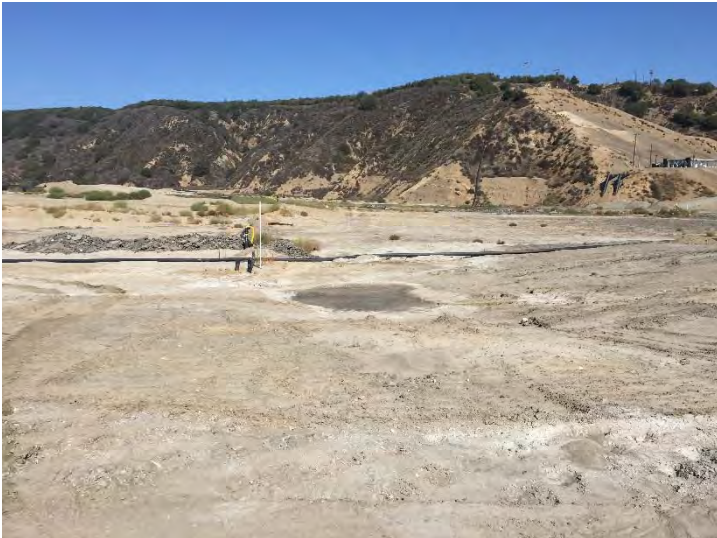
Photo 106: County Top Deck Low Point Ponding: September 23, 2015

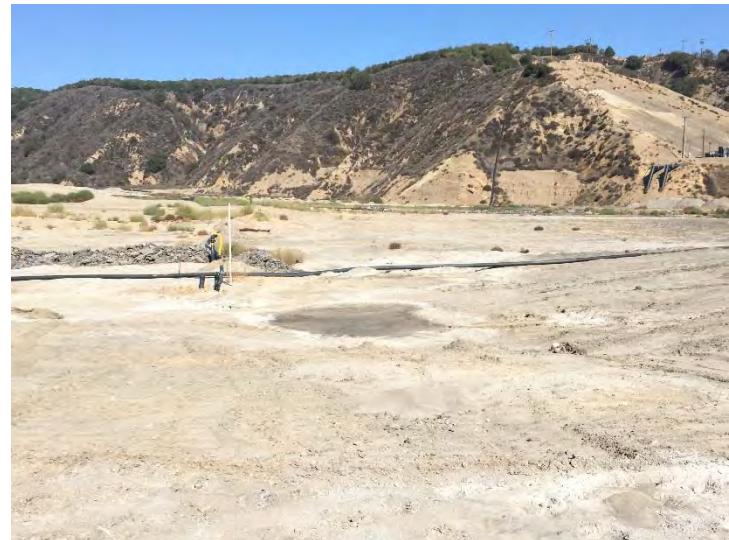
Photo 107: County Top Deck Low Point Ponding: September 23, 2015

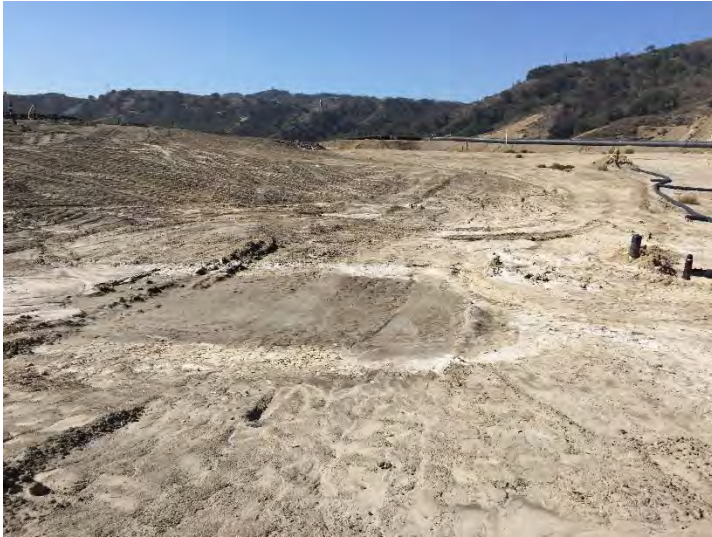
Photo 108: County Top Deck Low Point Ponding: September 23, 2015

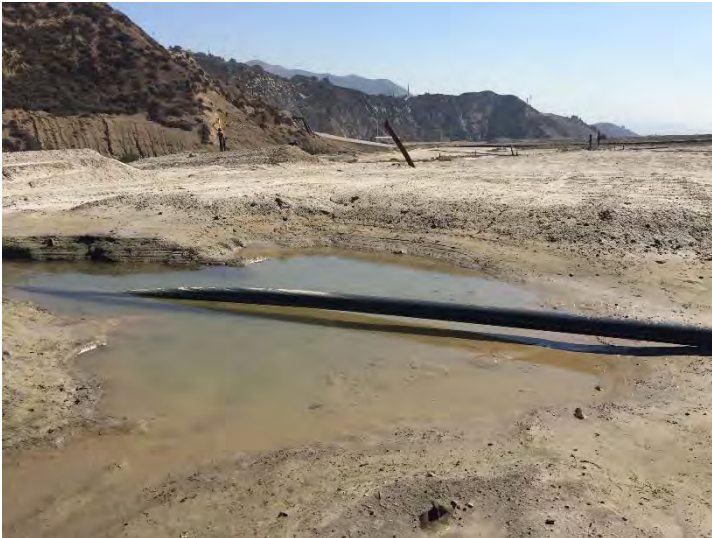
Photo 110: County Top Deck Low Point Ponding: September 23, 2015

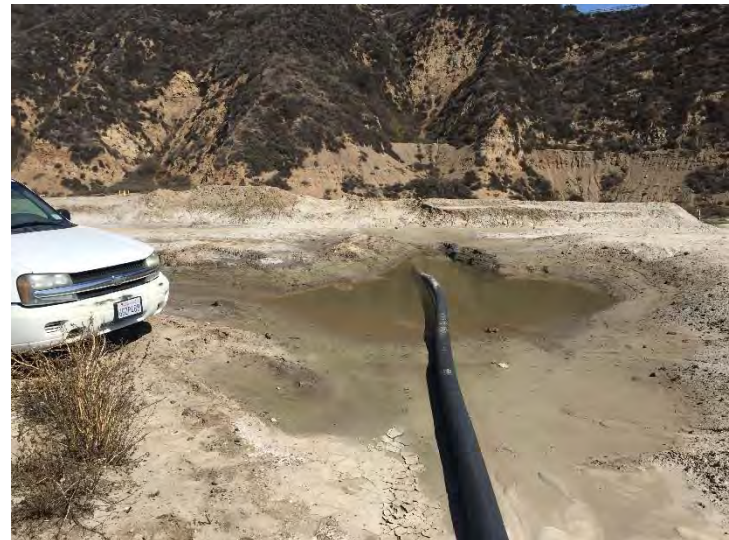
Photo 111: County Top Deck Low Point Ponding: September 23, 2015

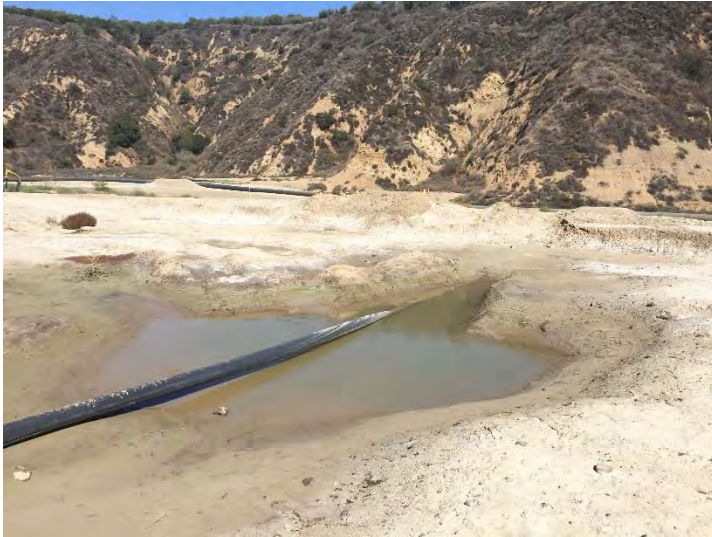
Photo 112: County Top Deck Low Point Ponding: September 23, 2015

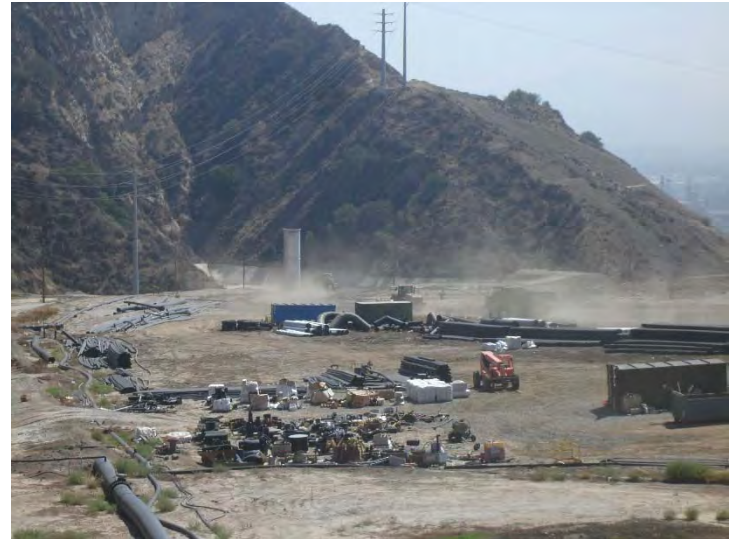
Photo 113: County Top Deck Low Point Ponding: September 23, 2015

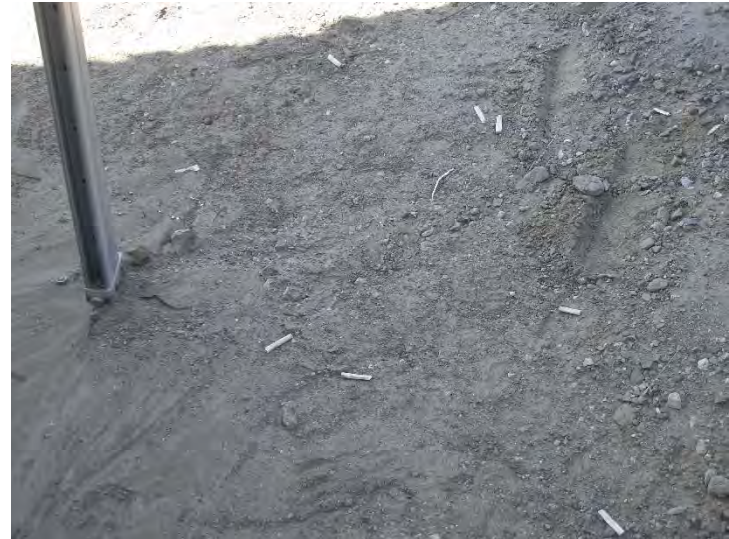
**Photo 121: Cigarette Butts at Flare 9 and 10 Control Panel:
September 23, 2015**

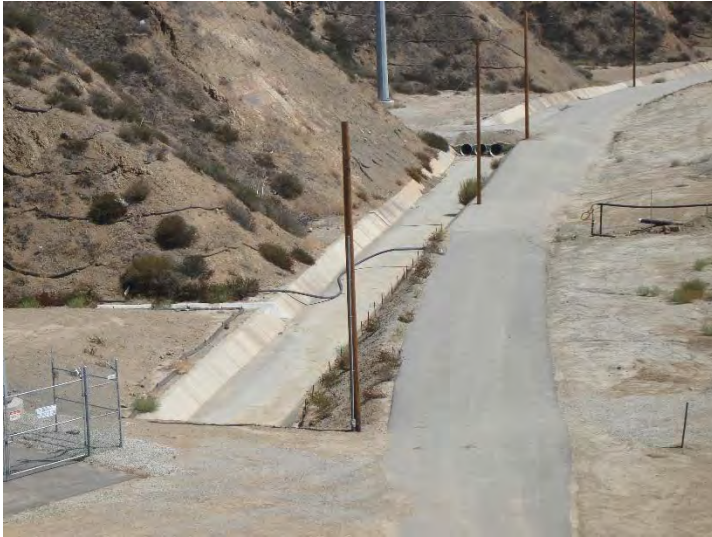
**Photo 124: Drainage Channel Below Flare 9 and 10: September
23, 2015**

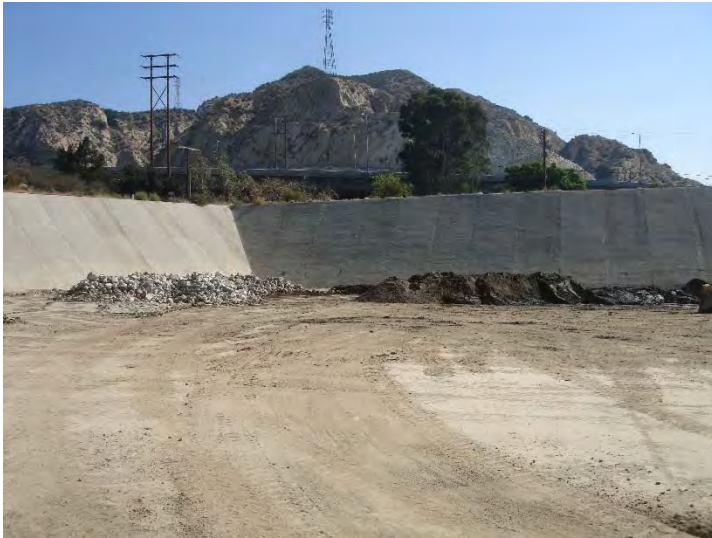
Photo 160: Terminal Basin: September 23, 2015

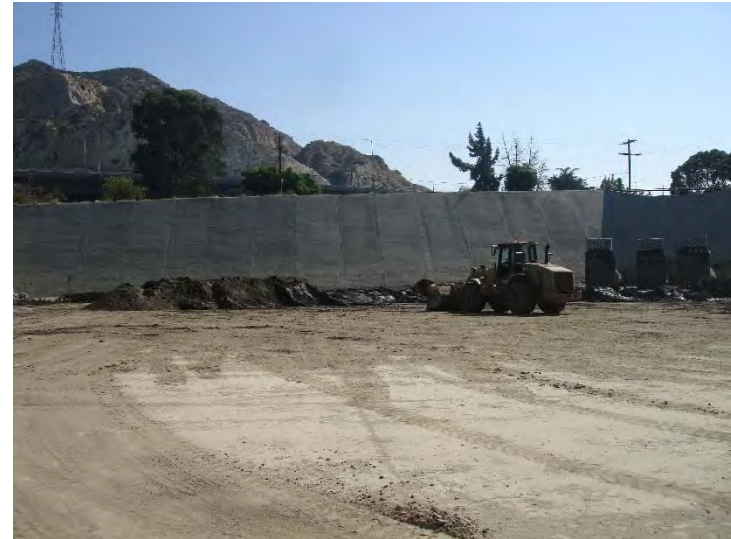
Photo 161: Terminal Basin: September 23, 2015

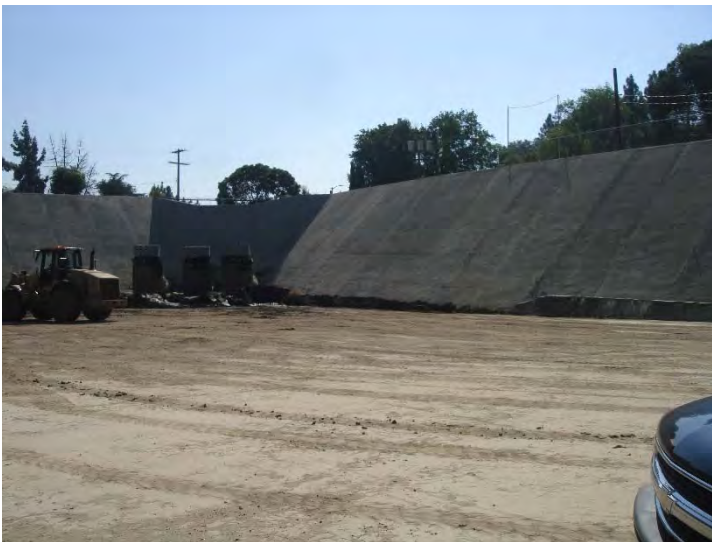
Photo 162: Terminal Basin: September 23, 2015

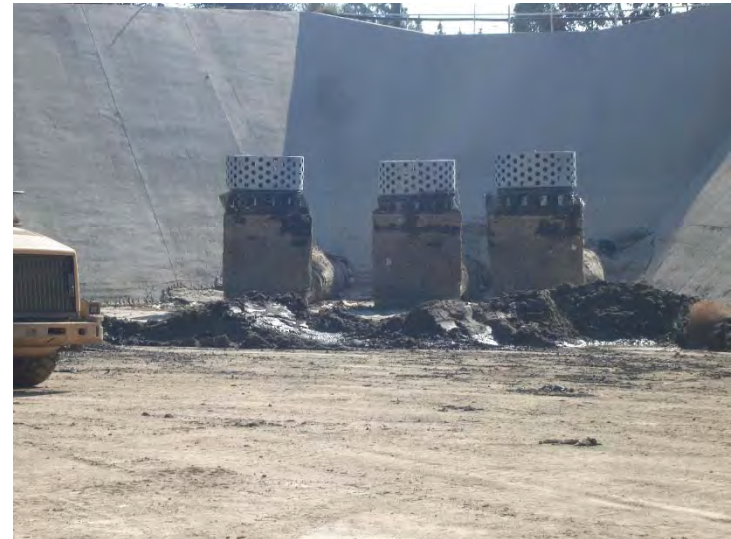
Photo 163: Terminal Basin: September 23, 2015

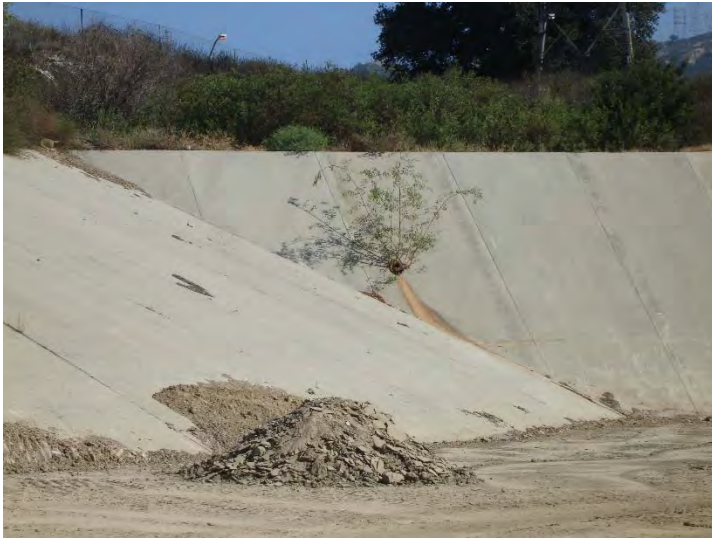
Photo 164: Terminal Basin: September 23, 2015

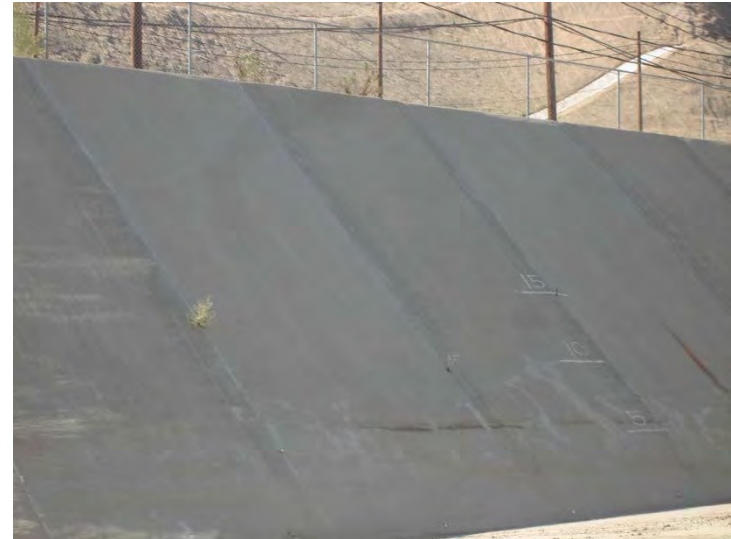
Photo 165: Terminal Basin: September 23, 2015

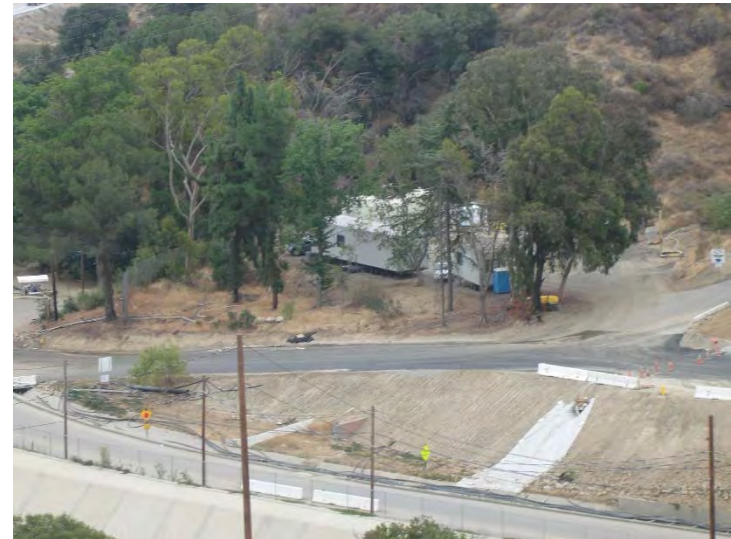
Photo 167: Terminal Basin: September 23, 2015
