**Sunshine Canyon Landfill
Independent Monitor
Quarterly Site Monitoring Status Report
July 1, 2015 – September 30, 2015**

City of Los Angeles Department of City Planning

County of Los Angeles Department of Regional Planning

February 9, 2016

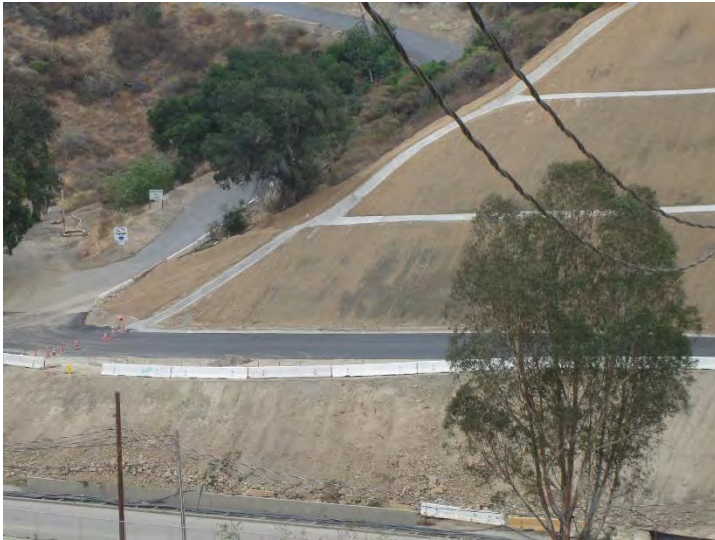
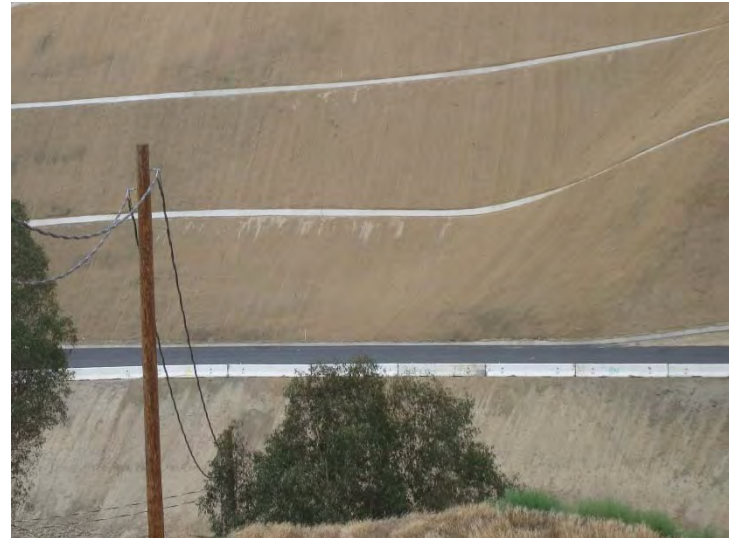
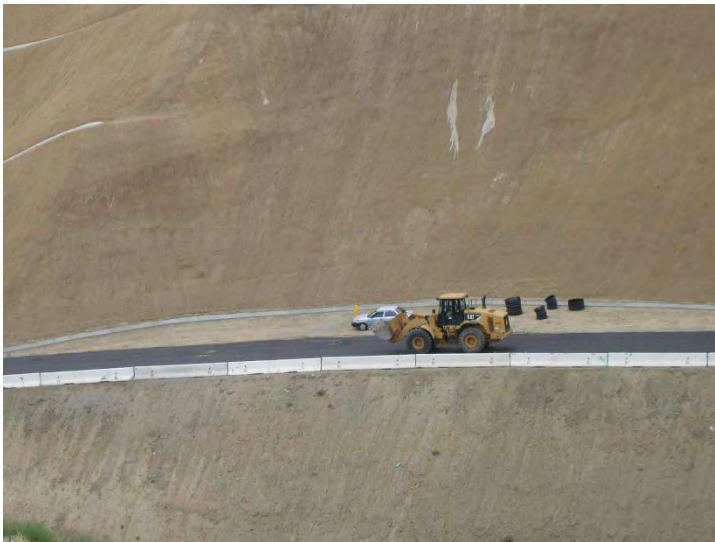
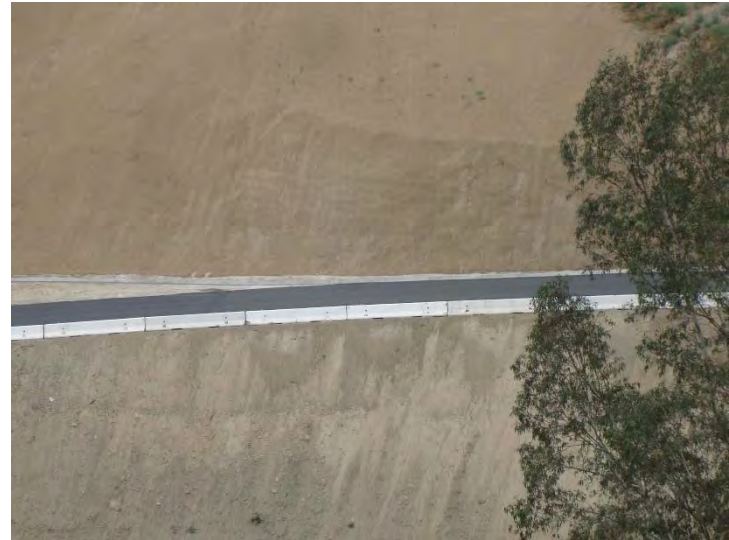
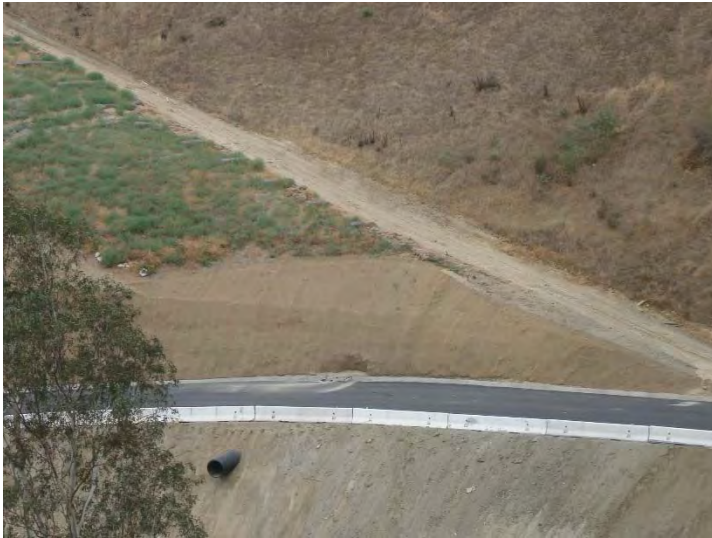
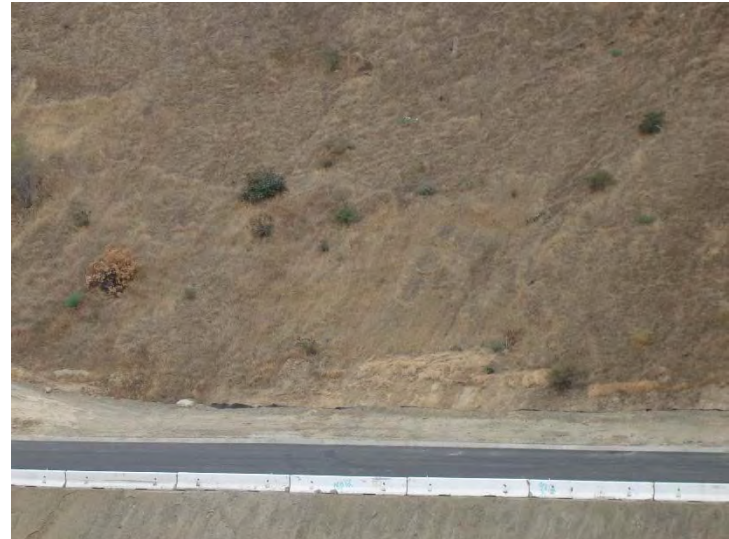
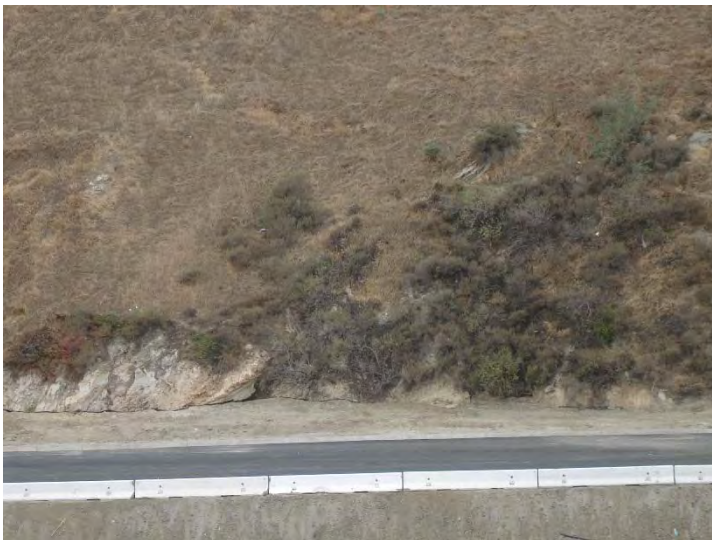
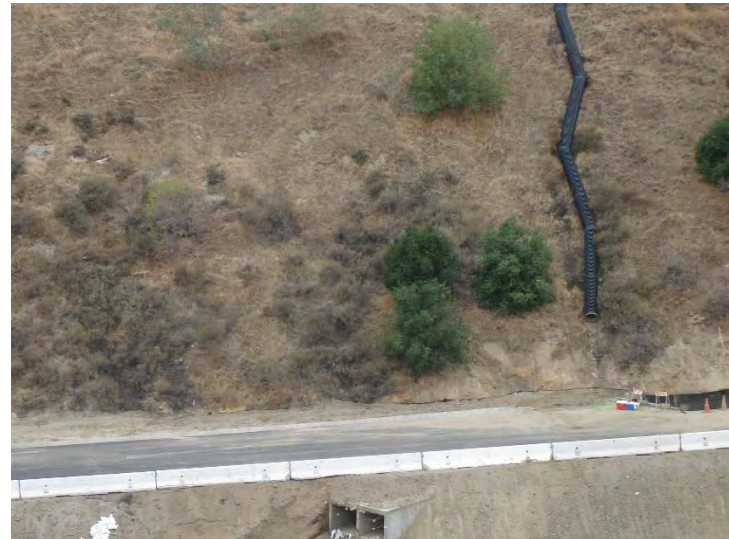
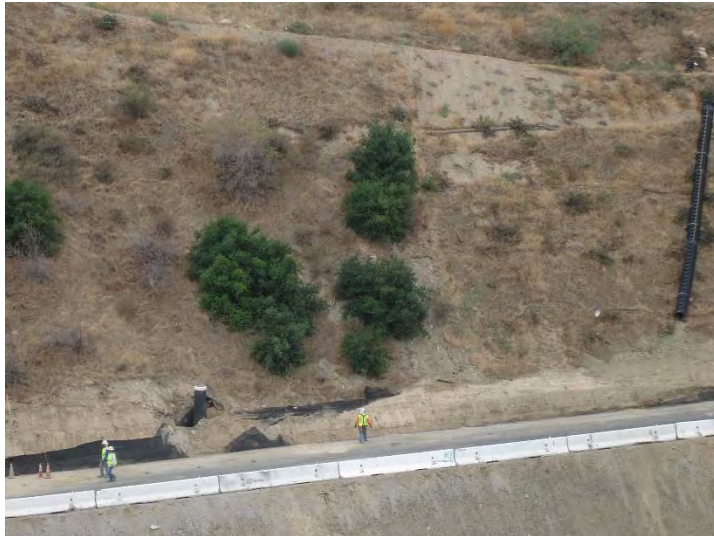
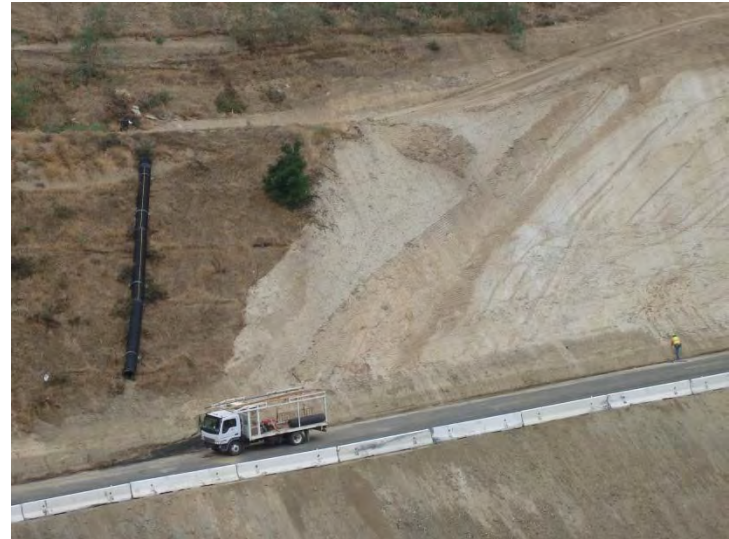
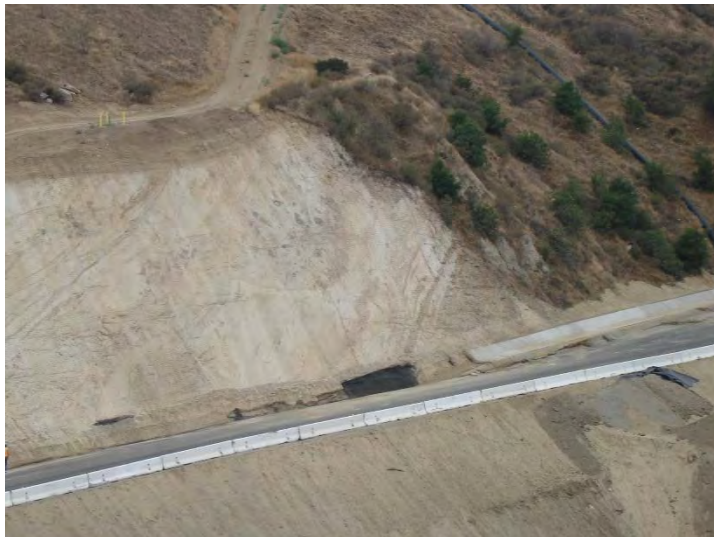
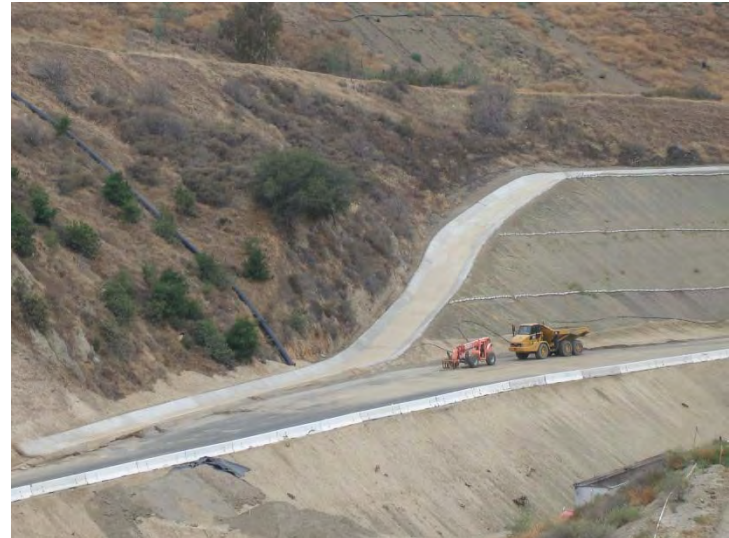
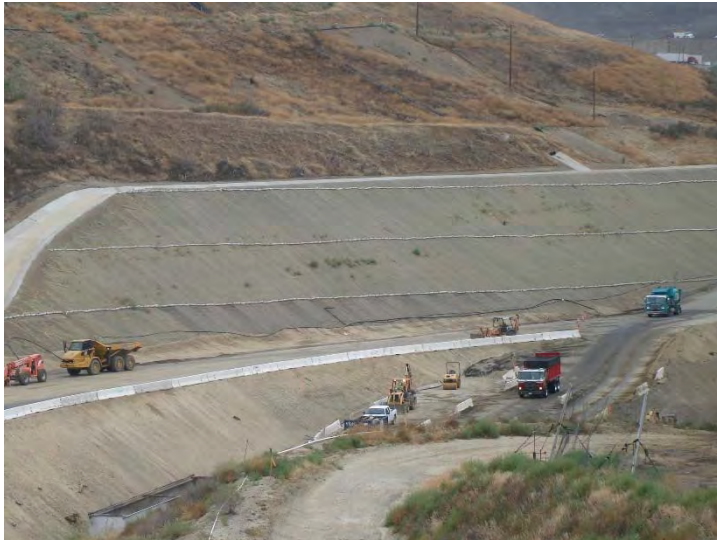
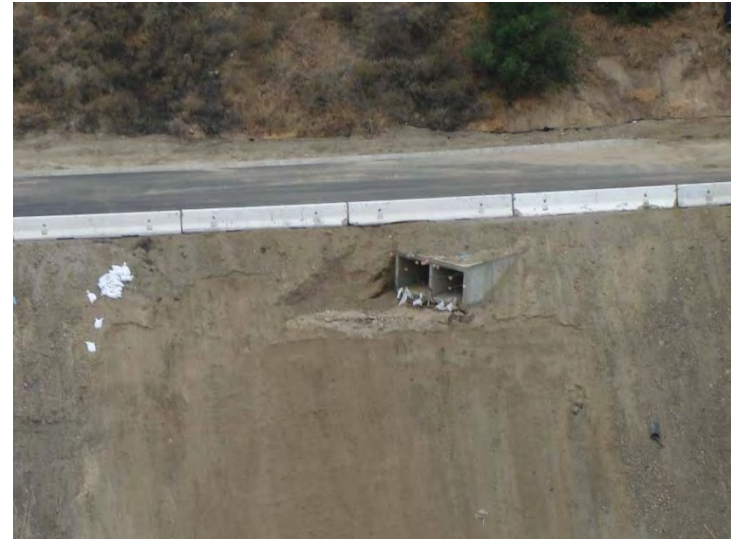
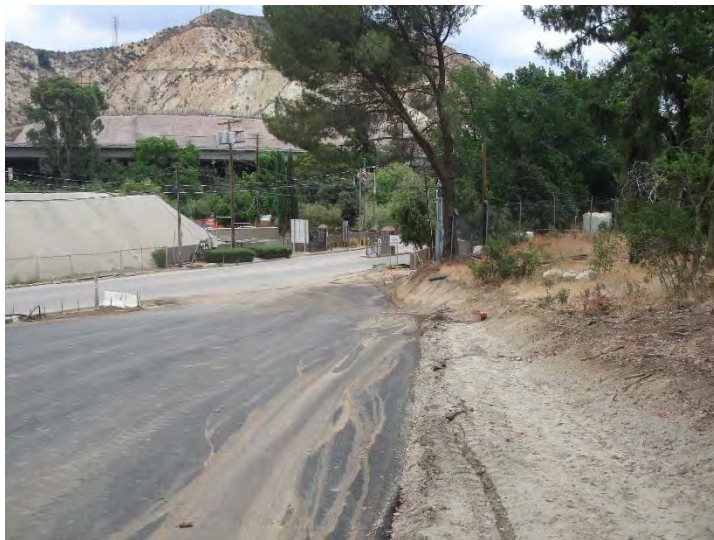
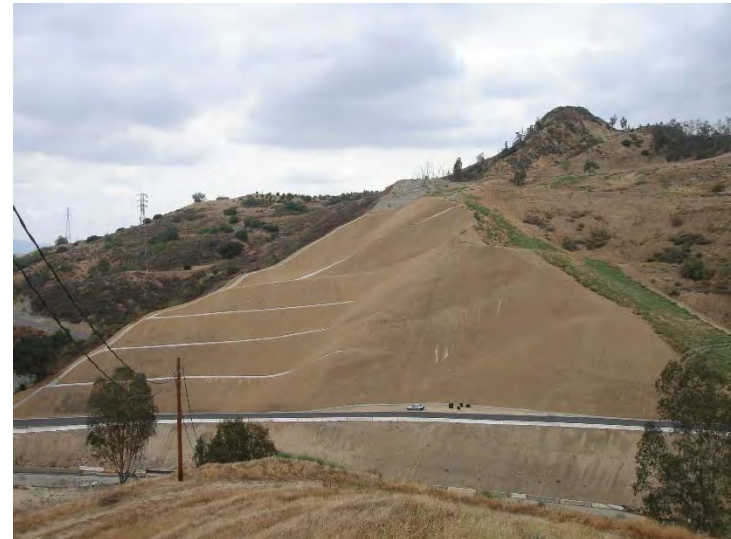
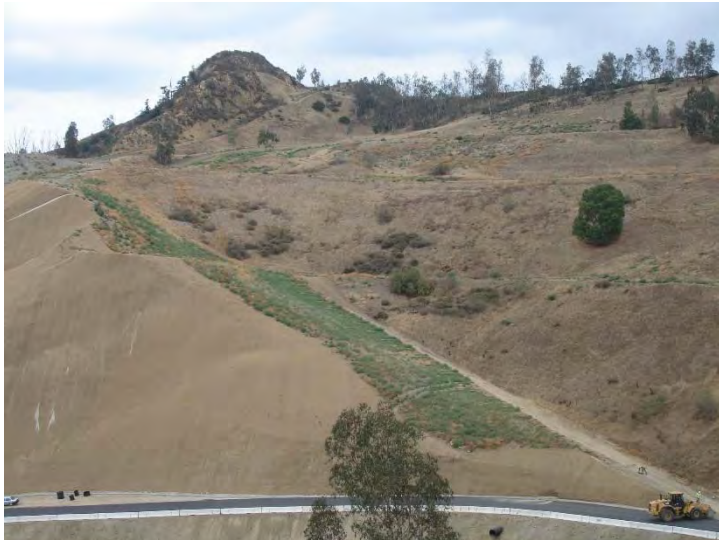
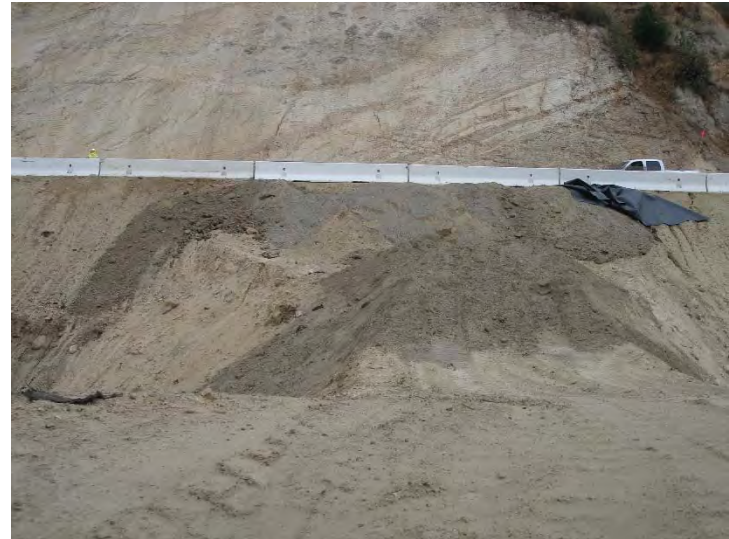
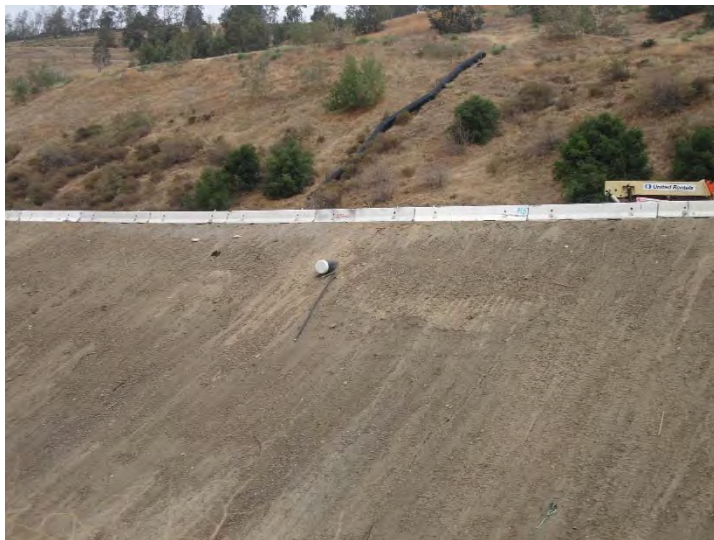
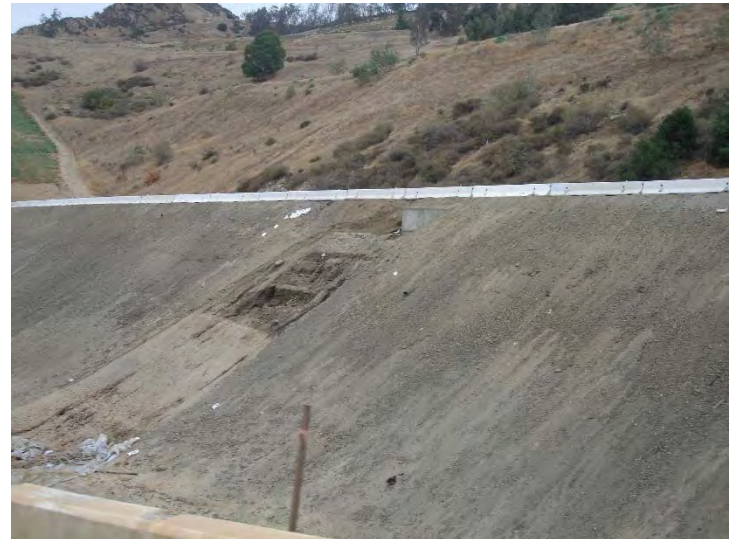
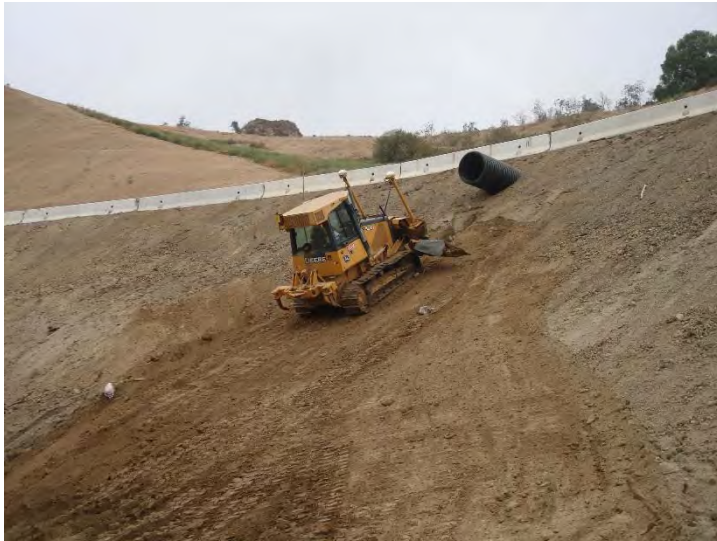
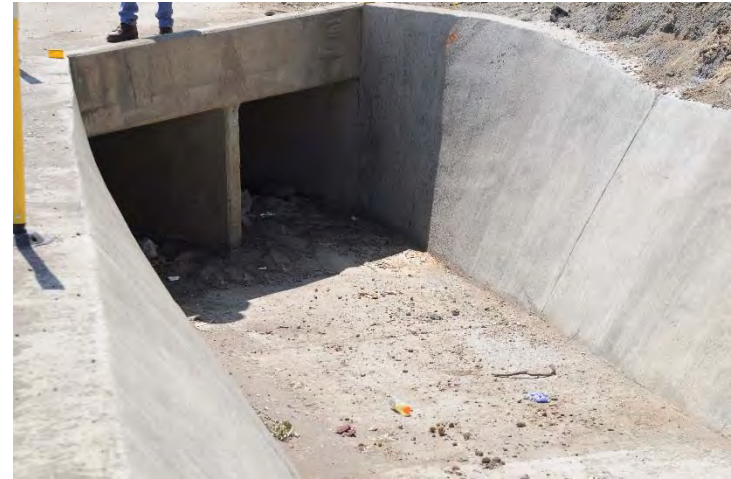
Photo 168: Access Road Realignment: July 22, 2015

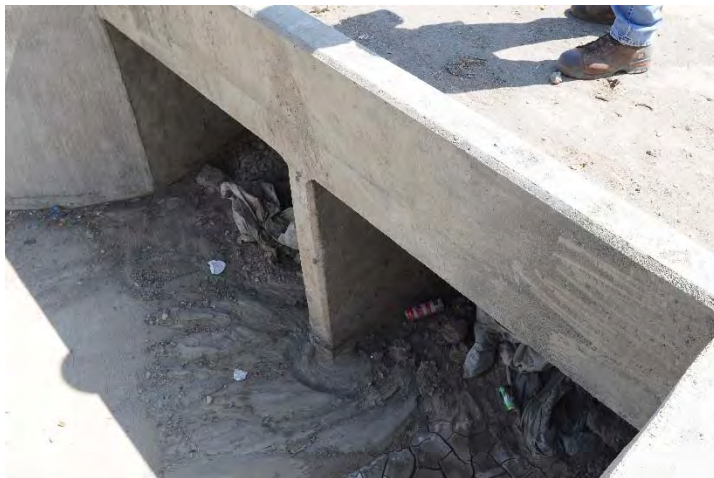
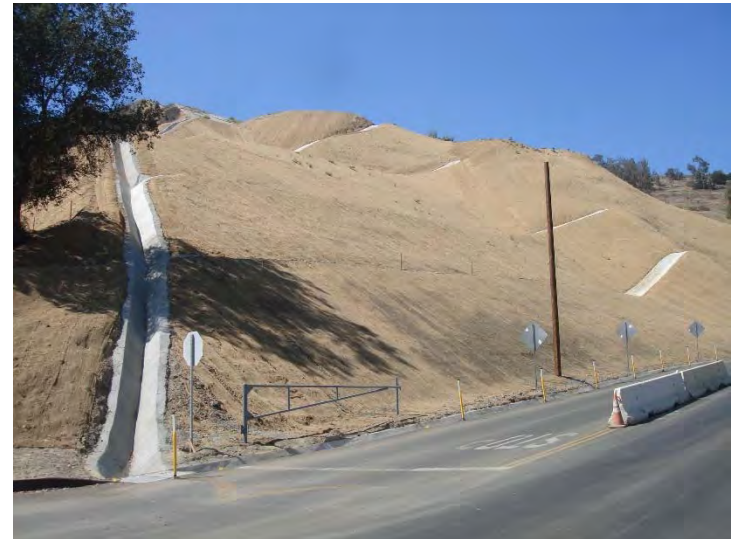
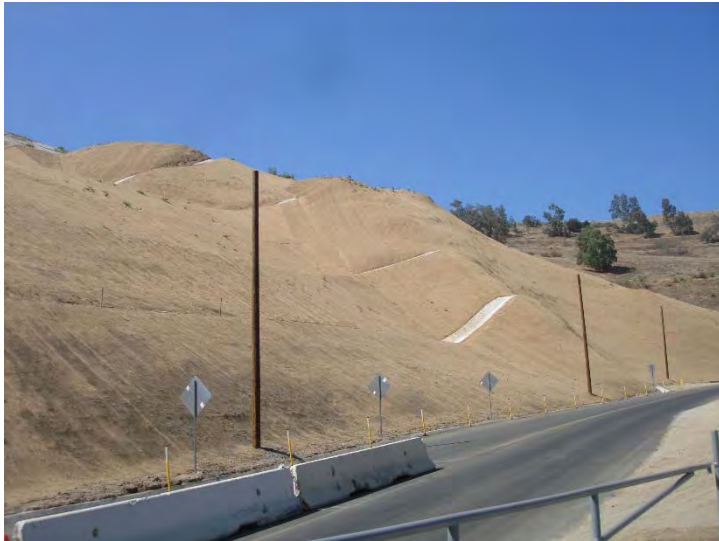
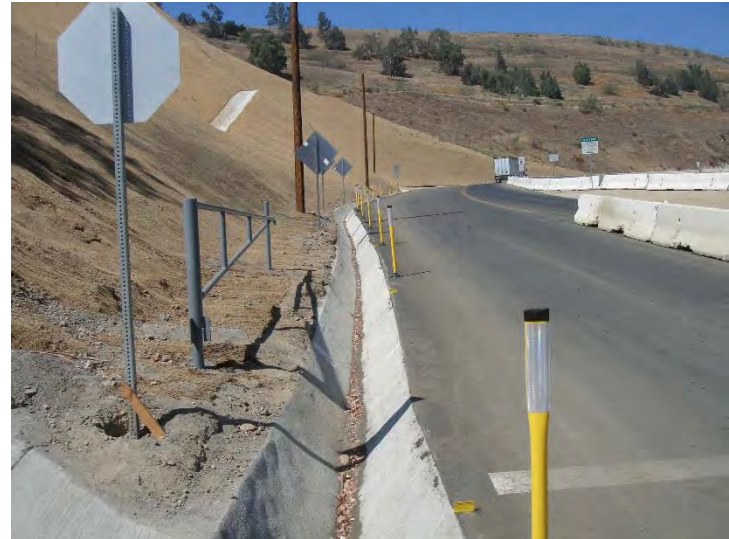
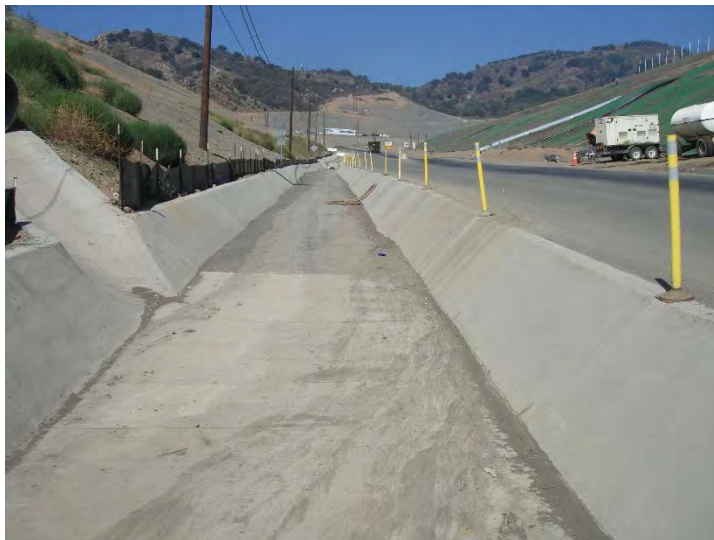
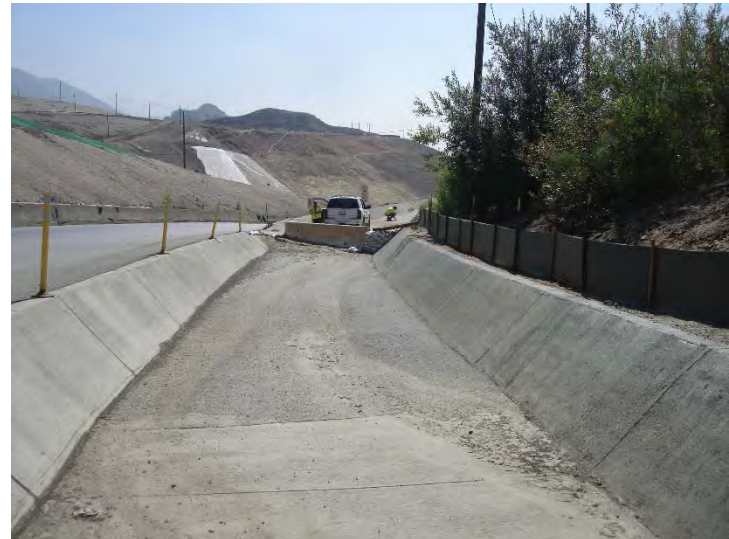
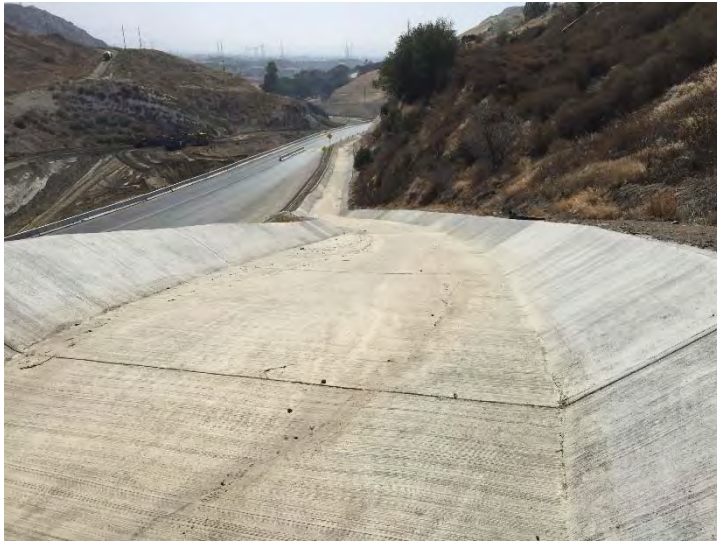
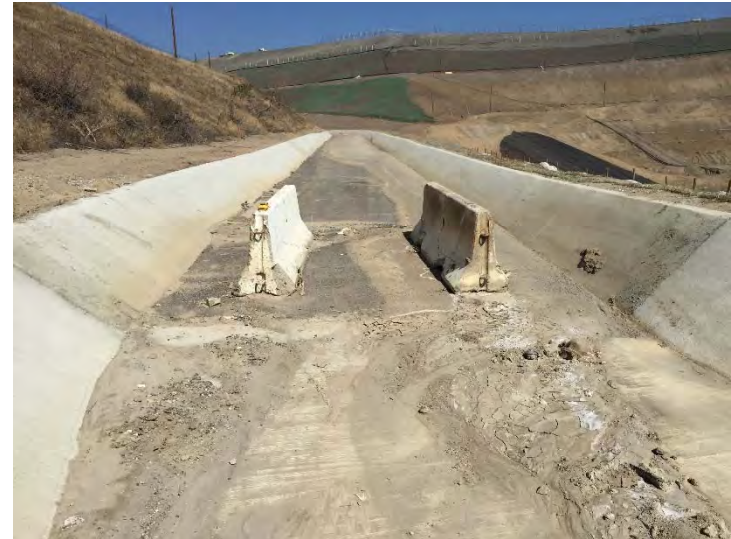
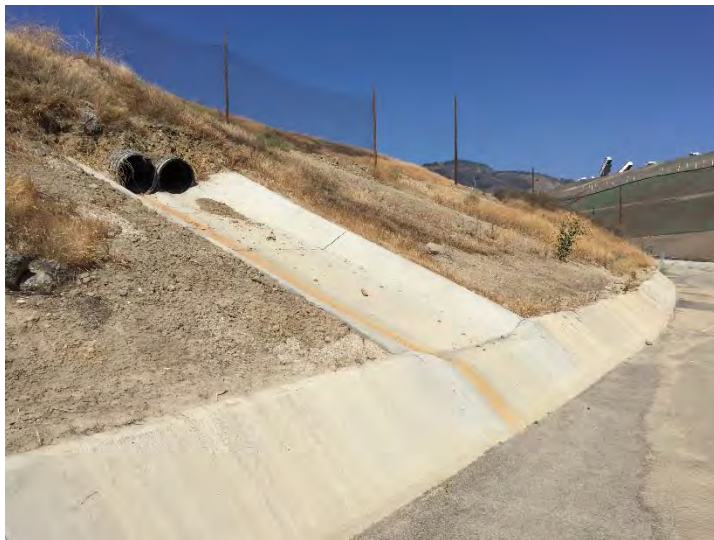
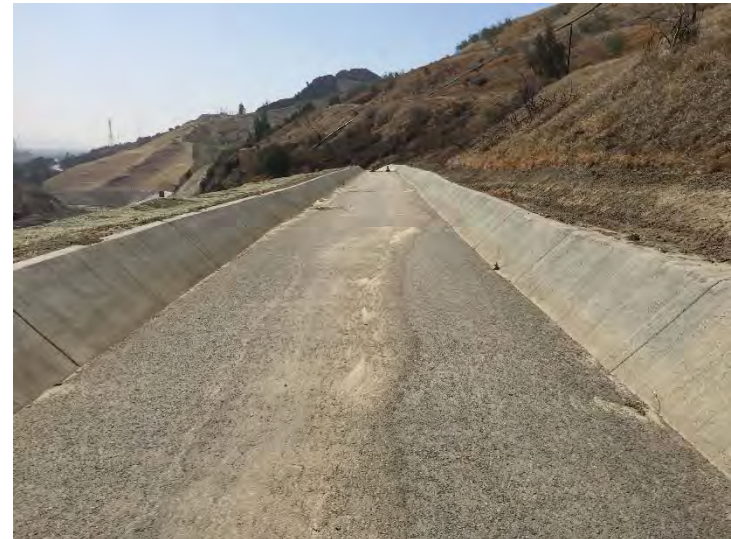
Photo 190: Access Road Drainage: August 11, 2015

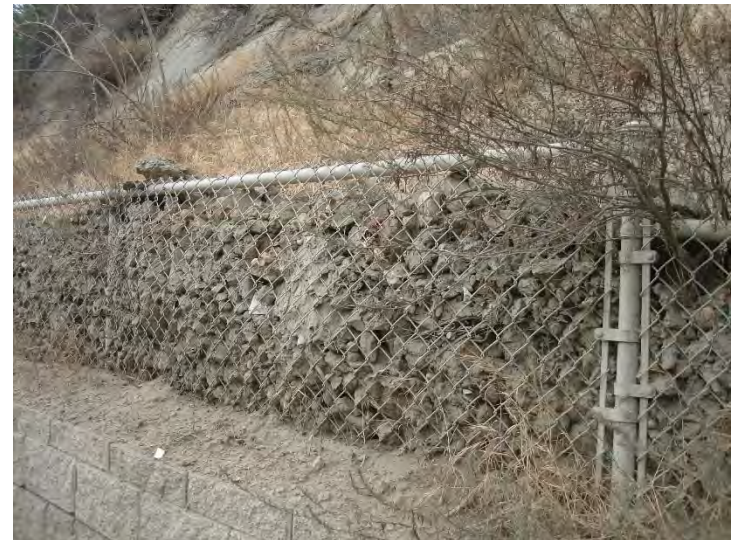
Photo 267: Retaining Wall on San Fernando Road Frontage: July 22, 2015

- Illegal dumping and litter was observed on Sierra Highway on the way to the I-14 overpass.
- The block wall hillside retaining wall along the San Fernando Road south frontage has soil and debris on top of the wall. The top drainage is blocked and the fence is nearly being topped with debris in several areas. This retaining wall was not designed for this type of loading. The two-foot wide walkway in front of the wall is piled with soil.

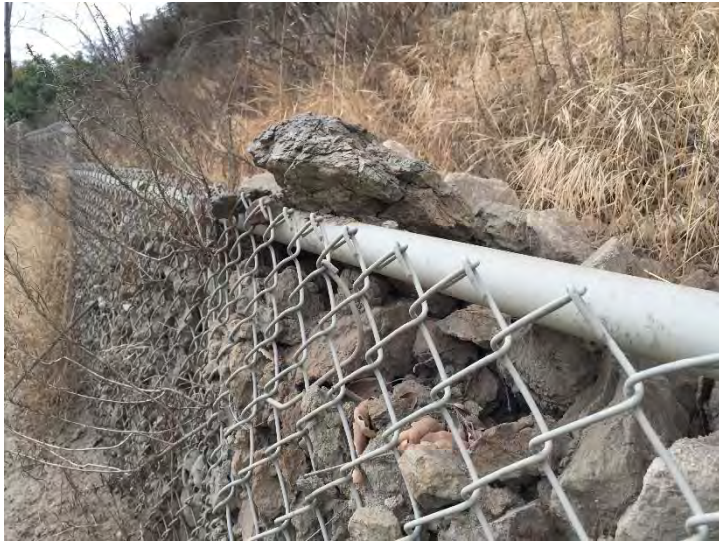
Photo 268: Retaining Wall on San Fernando Road Frontage: July 22, 2015

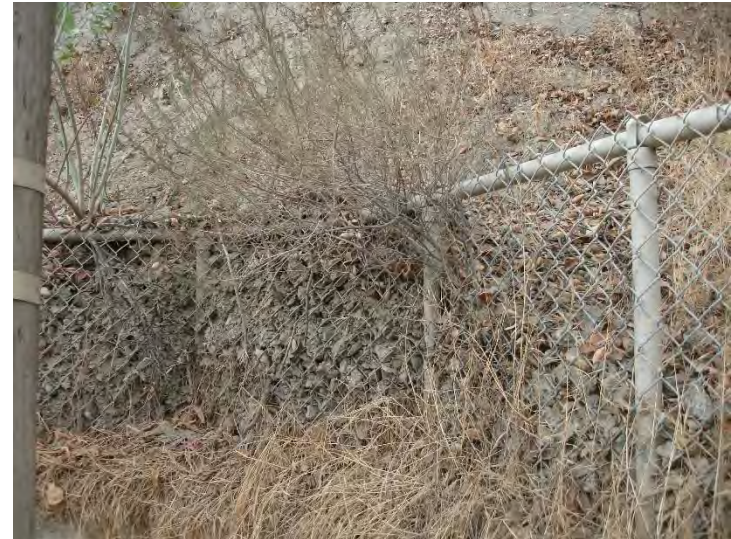
Photo 269: Retaining Wall on San Fernando Road Frontage: July 22, 2015

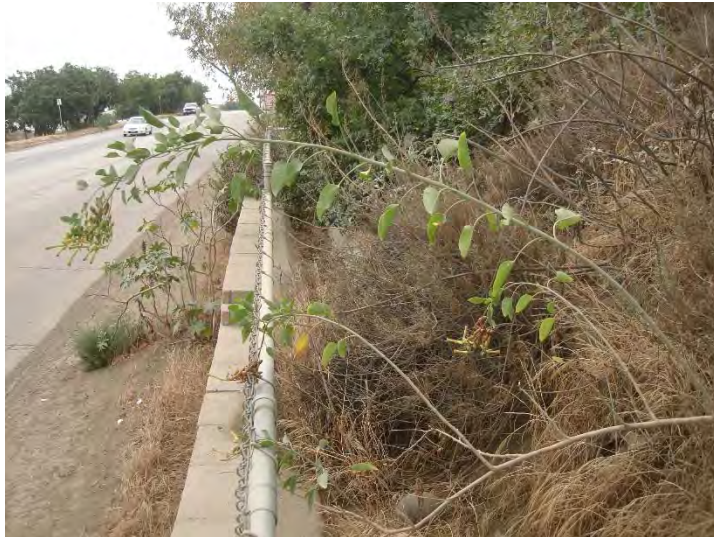
Photo 270: Retaining Wall on San Fernando Road Frontage: July 22, 2015

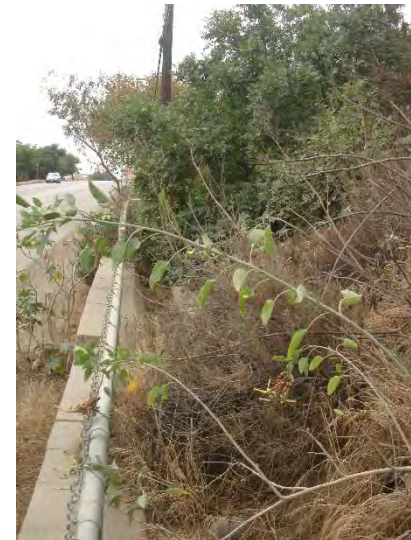
Photo 271: Retaining Wall on San Fernando Road Frontage: July 22, 2015

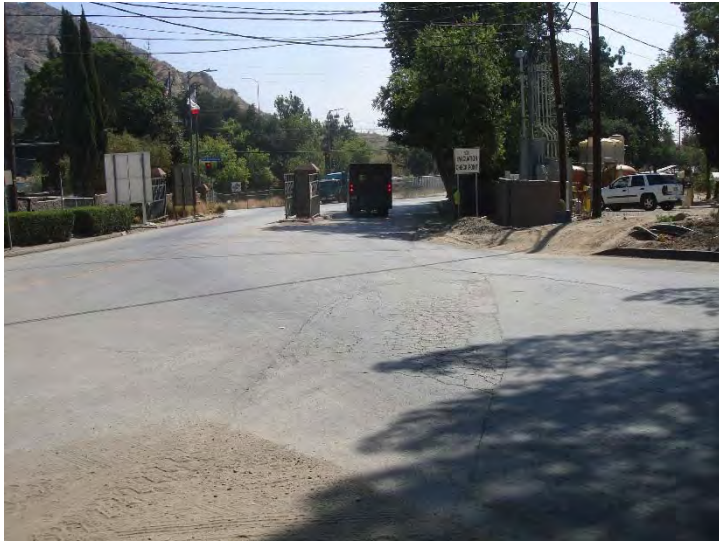
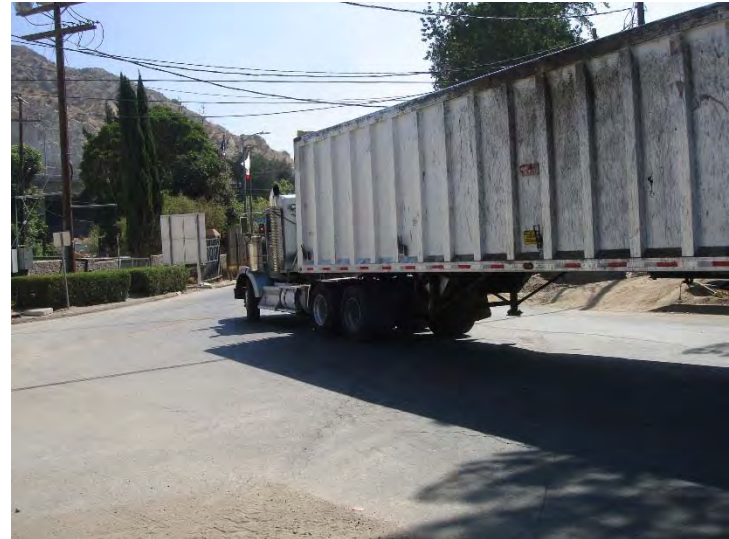
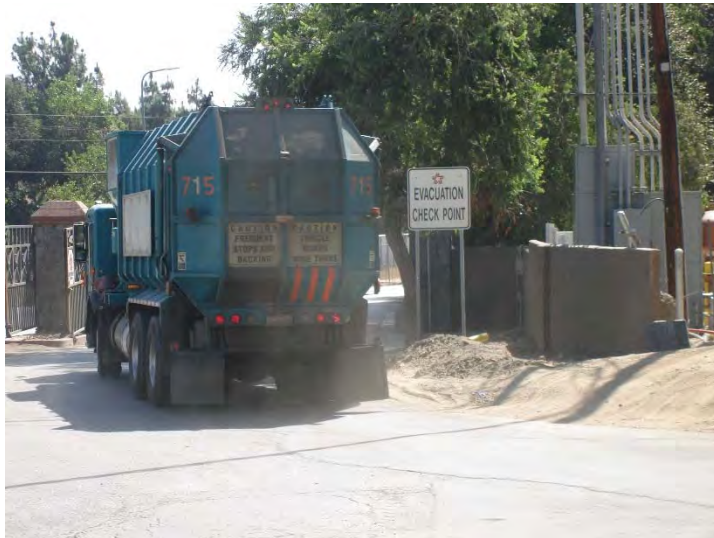
Photo 281: Exit Road Curb Encroachment: August 11, 2015

Photo 282: Exit Road Curb Encroachment: August 11, 2015

Photo 283: Exit Road Curb Encroachment: August 11, 2015

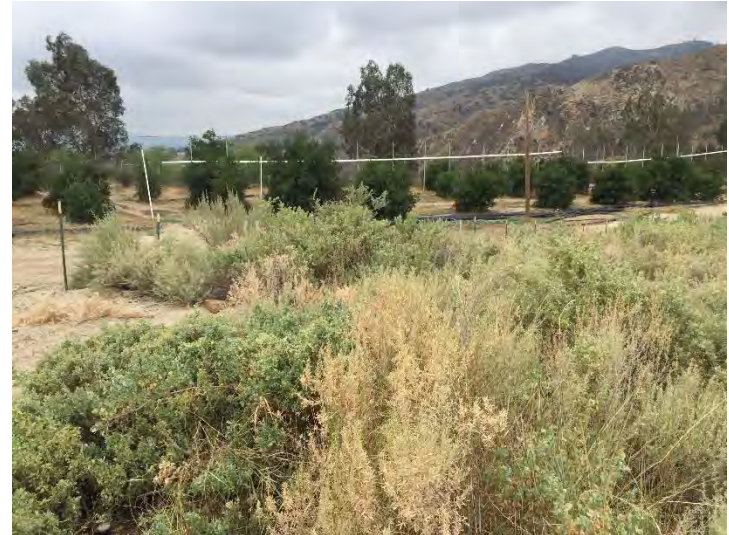
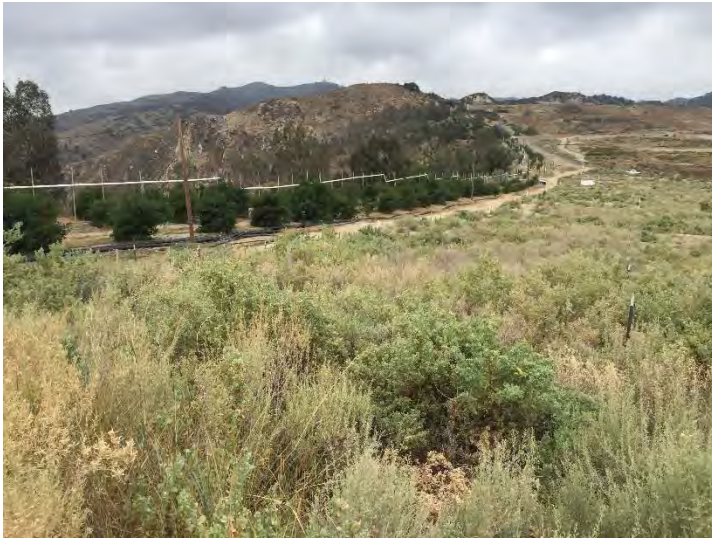
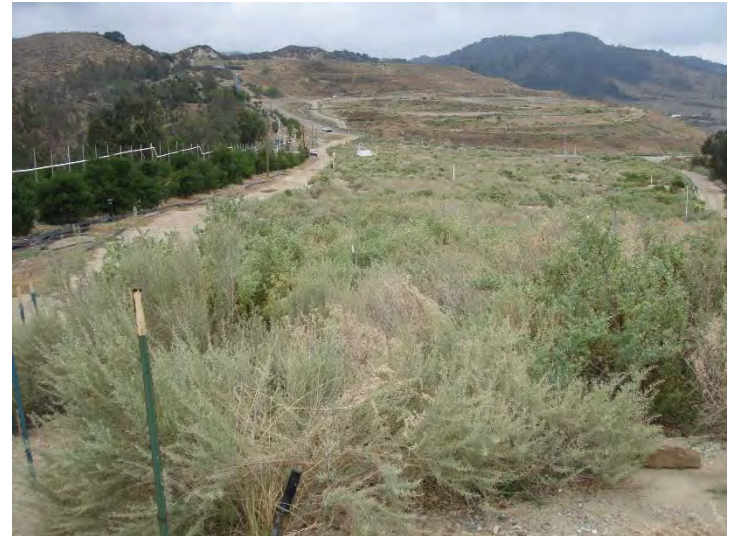
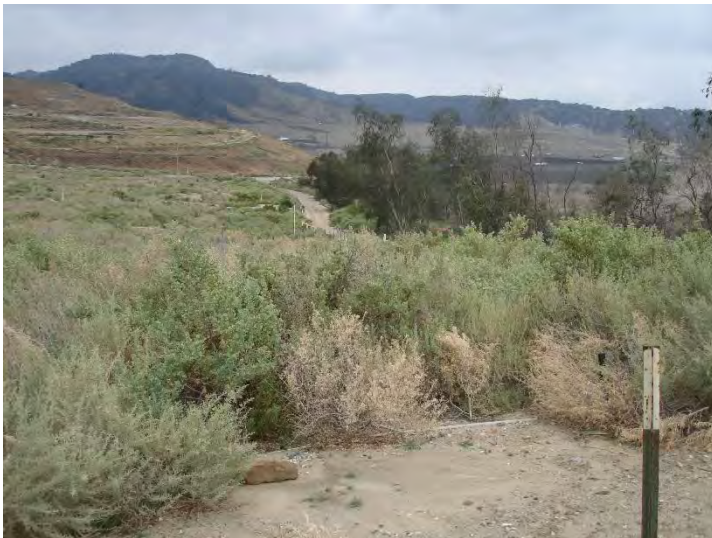
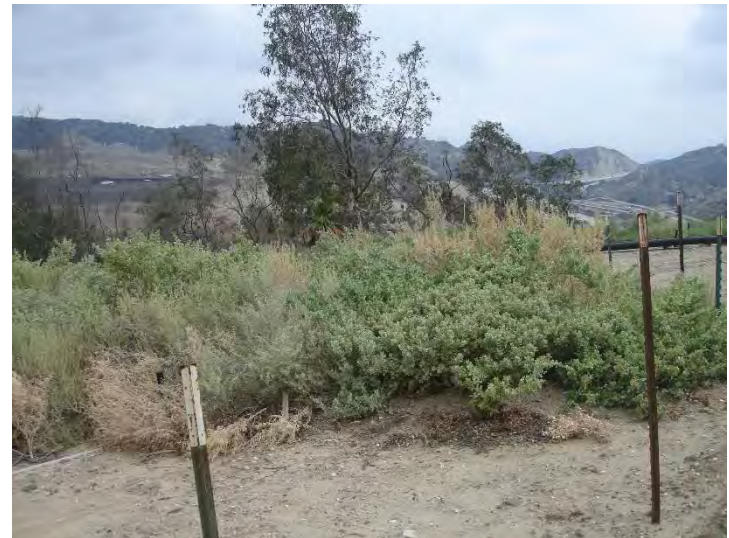
Photo 292: City Sage Mitigation Deck C: July 22, 2015

Photo 293: City Sage Mitigation Deck C: July 22, 2015

Photo 294: City Sage Mitigation Deck C: July 22, 2015

Photo 295: City Sage Mitigation Deck C: July 22, 2015

Photo 296: City Sage Mitigation Deck C: July 22, 2015

- Deck C sage mitigation area was doing well with summer dry conditions observed.
- The Deck C oil field access road had deep ruts in a small section that would make it not usable for a passenger vehicle as an emergency access road.

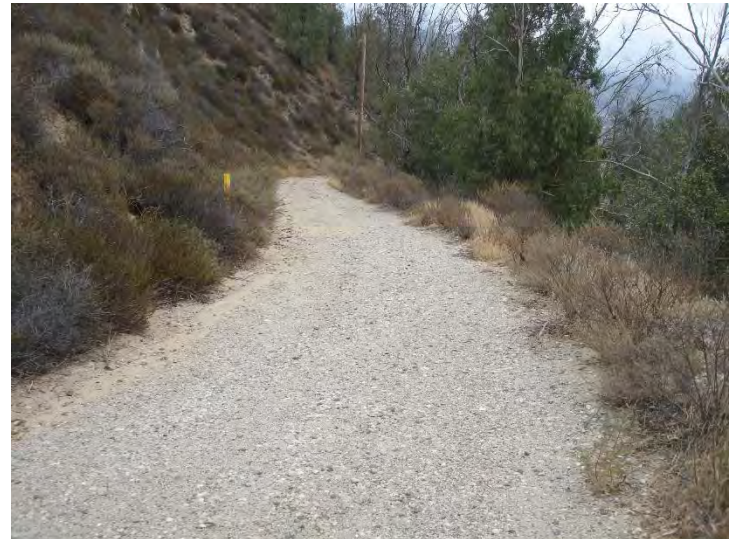
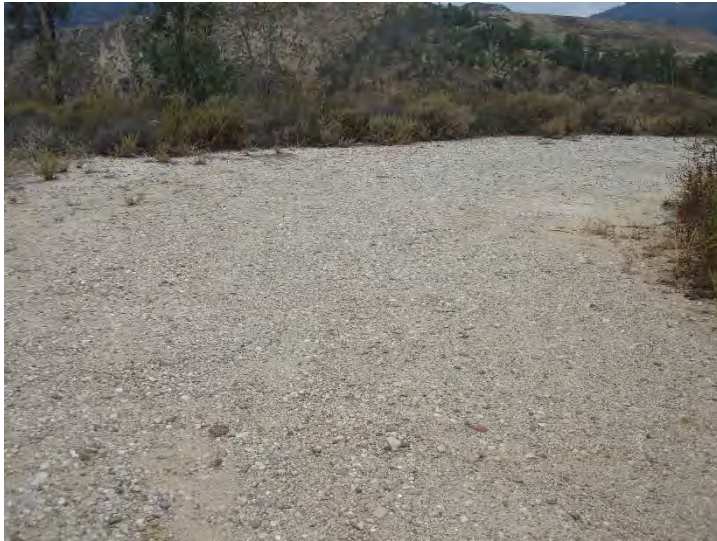
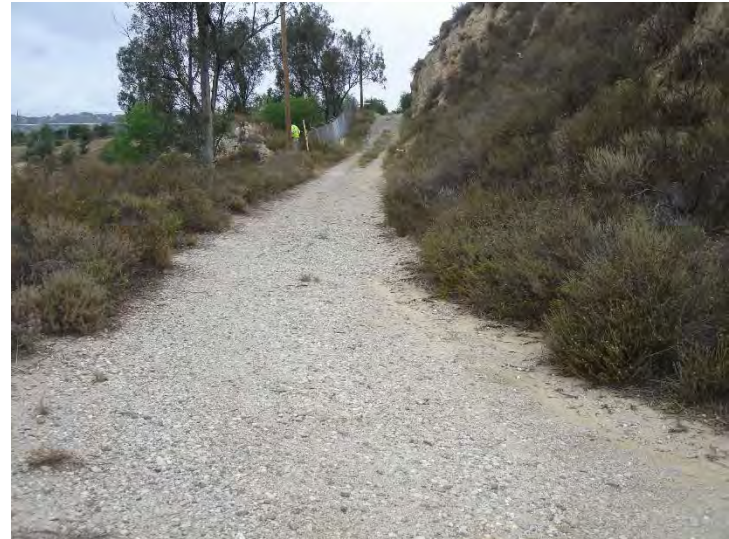
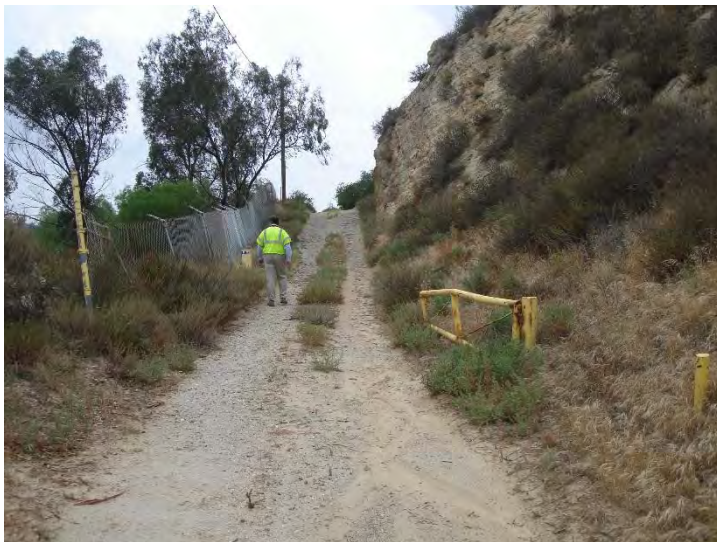
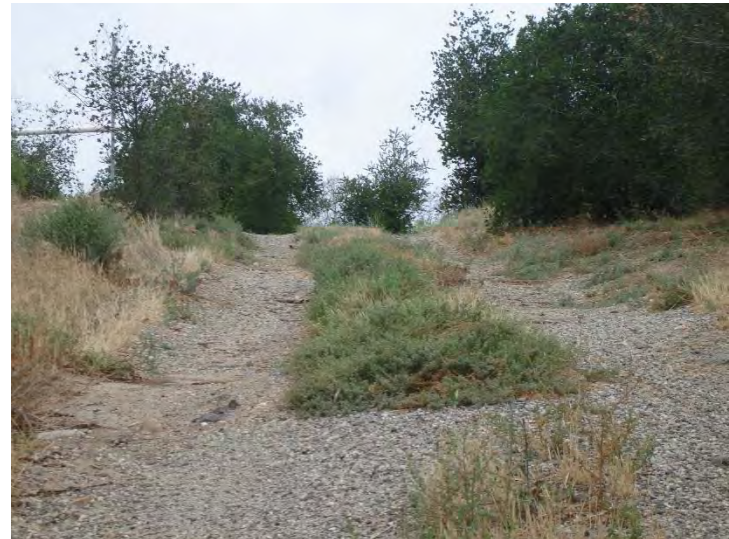
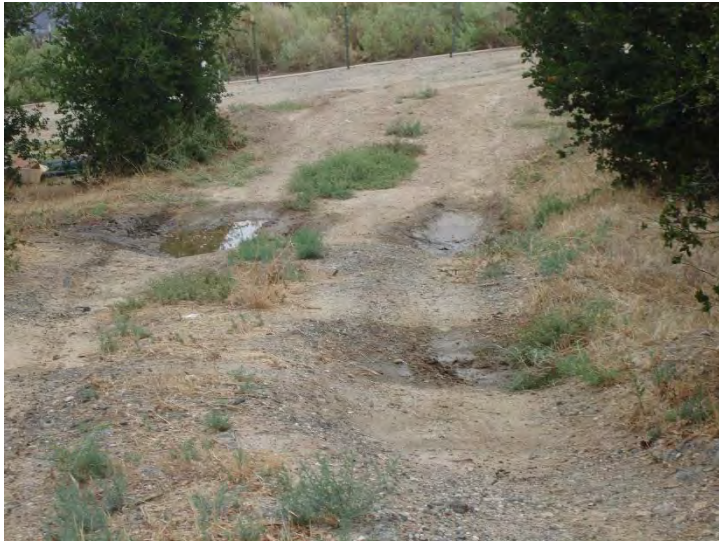
Photo 304: Secondary Access Road: July 22, 2015

Photo 305: Secondary Access Road: July 22, 2015

Photo 306: Secondary Access Road: July 22, 2015

Photo 307: Secondary Access Road: July 22, 2015

Photo 308: Secondary Access Road: July 22, 2015

Photo 309: Secondary Access Road: July 22, 2015

- Observed the realigned access road. The road was finished and asphalted. The downhill slopes had two areas that were washed away from the recent rain storm. The drainage conveyance piping was not installed on an approximately 36" corrugated HDPE drain line and two 36" box concrete drains. The slope near the corrugated pipe was being repaired.

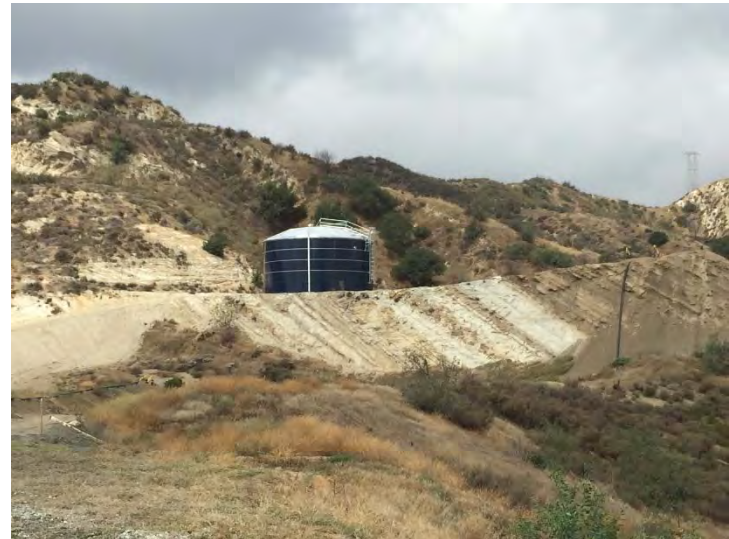
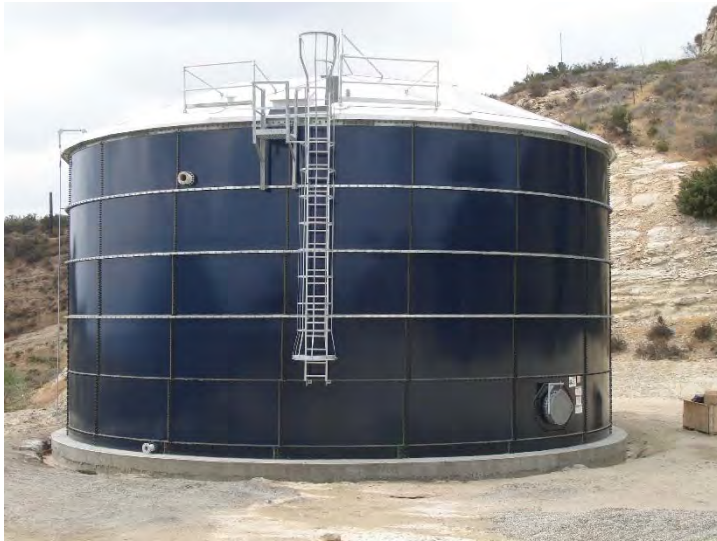
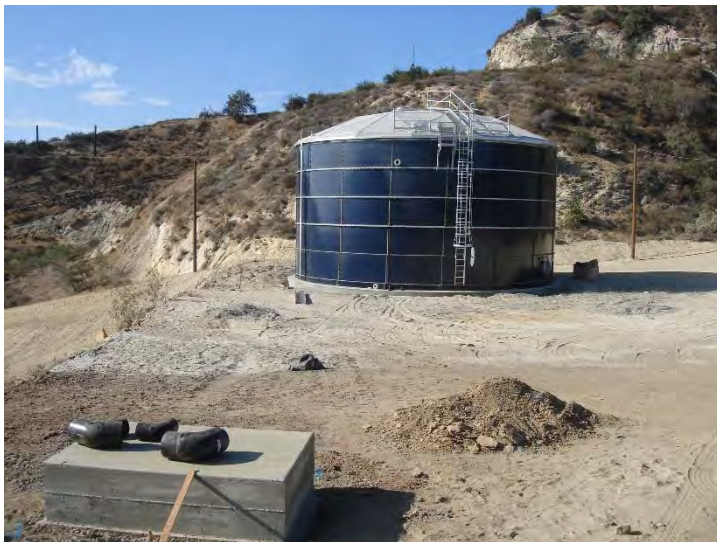
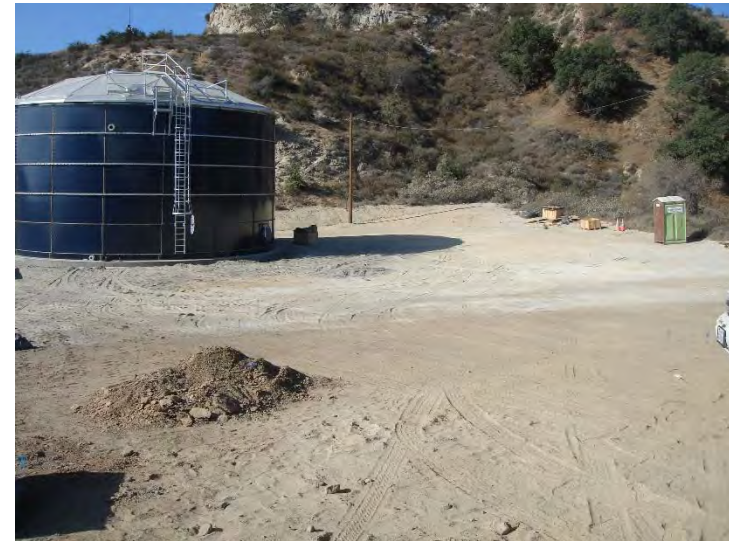
Photo 327: New City South Water Tank: July 22, 2015

- Flare 1 site had the emergency fire blanket metal case lying on the ground.
- A new 263,672 gallon water storage tank was observed on the City South Deck A. The tank appeared not to be in service.
