**Sunshine Canyon Landfill
Independent Monitor
Quarterly Site Monitoring Status Report
July 1, 2015 – September 30, 2015**

City of Los Angeles Department of City Planning

County of Los Angeles Department of Regional Planning

February 9, 2016

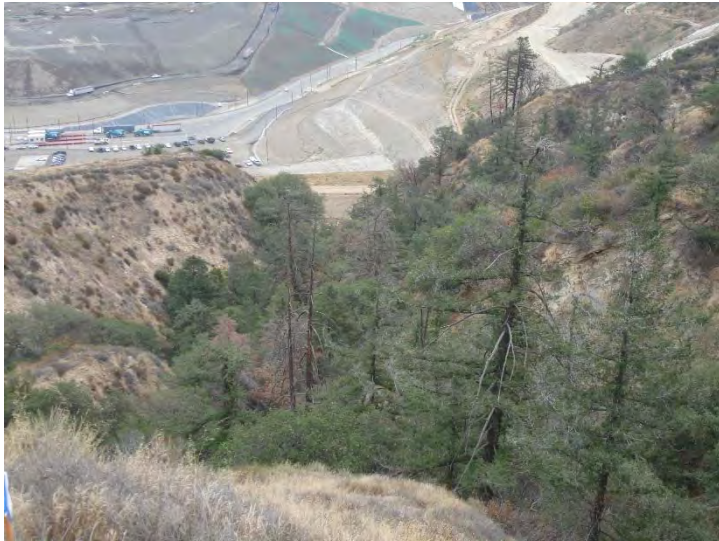
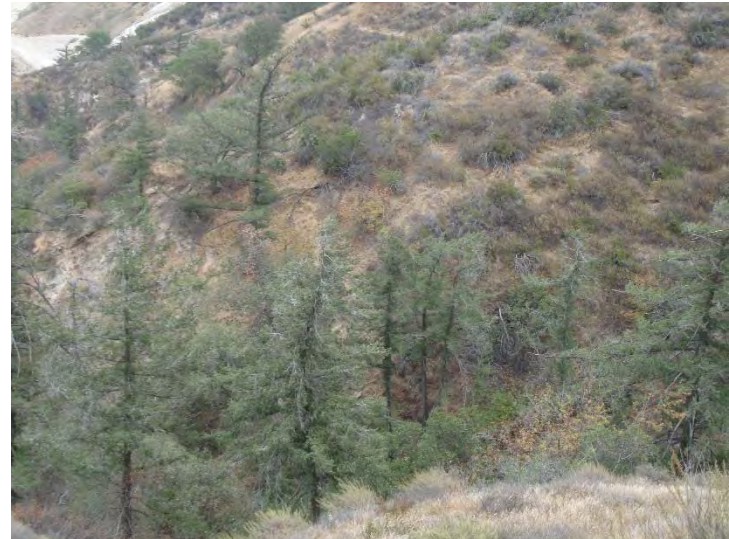
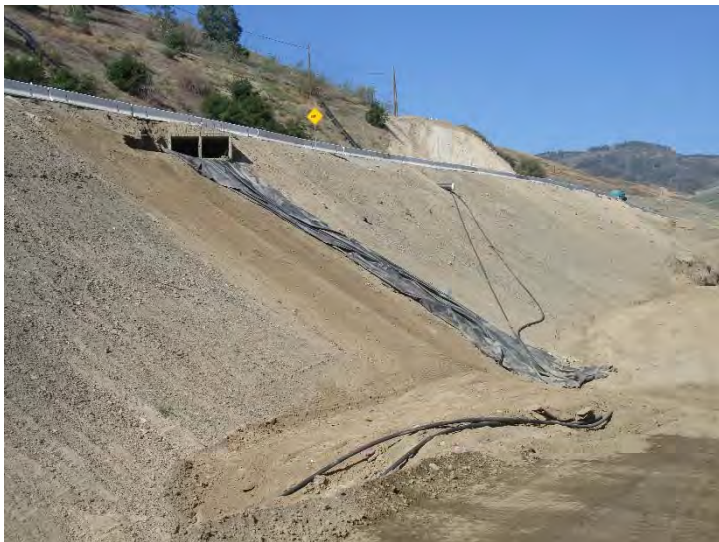
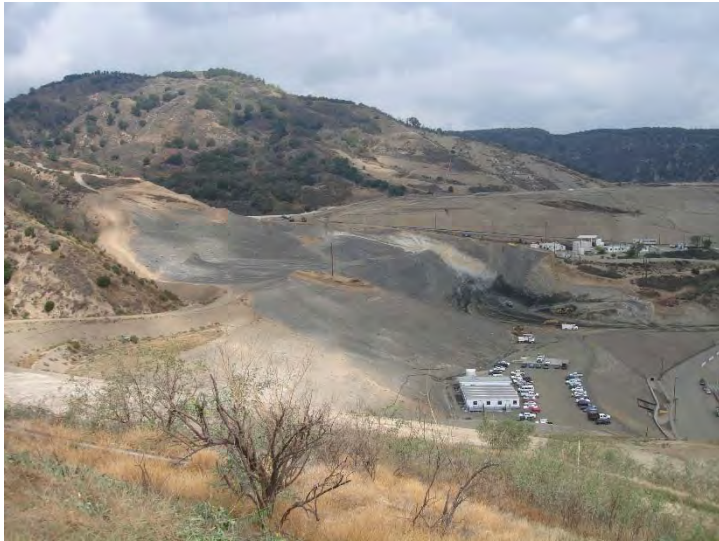
Photo 340: Edison New Powerline Site: July 11, 2015

- The prior fire area near Flare 3 was observed. There was no change in the condition of the cracked Edison wood poles.
- The construction of the new Edison high tension structures was still on hold due to the nesting birds in the native vegetation.

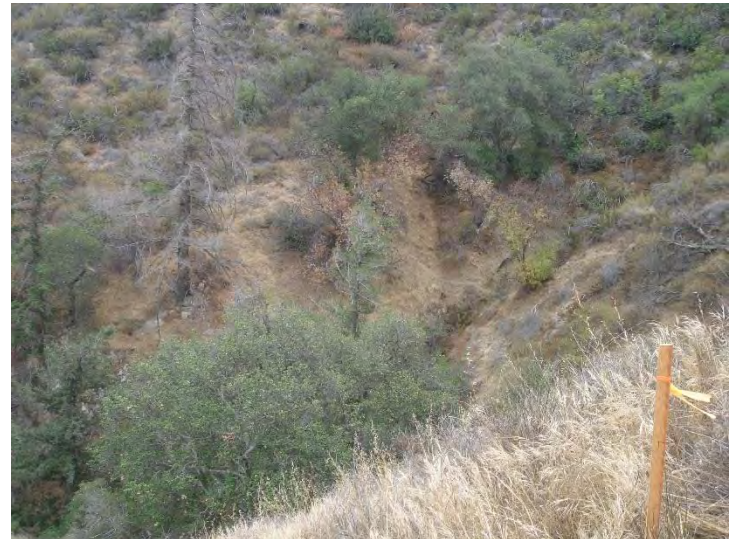
Photo 343: Access Road Drainage to Terminal Basin: July 11, 2015

- Ponding of rainwater was observed below the new re-aligned road. This unimproved channel did not drain into the terminal basin. Positive divergence and drainage needs to be established before fall 2015 rains start.

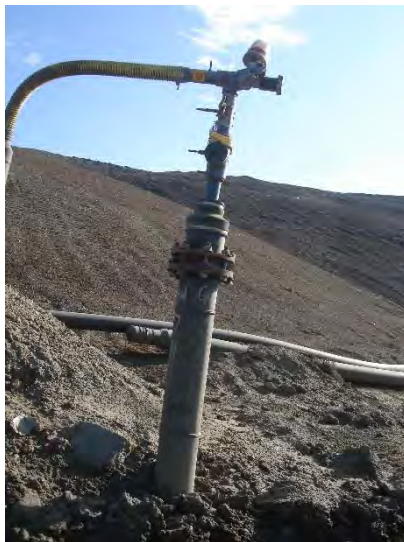
Photo 379: Condensate on Road near Gas Well: August 26, 2015

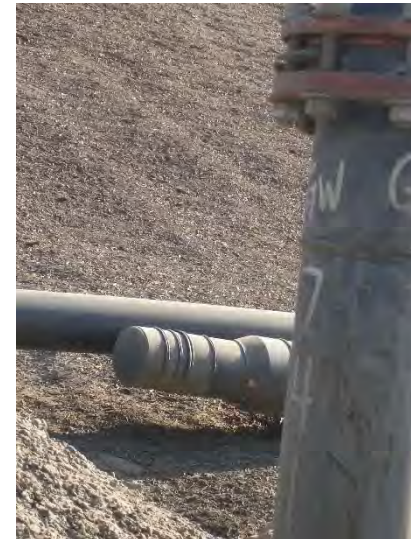
Photo 380: Condensate on Road near Gas Well: August 26, 2015

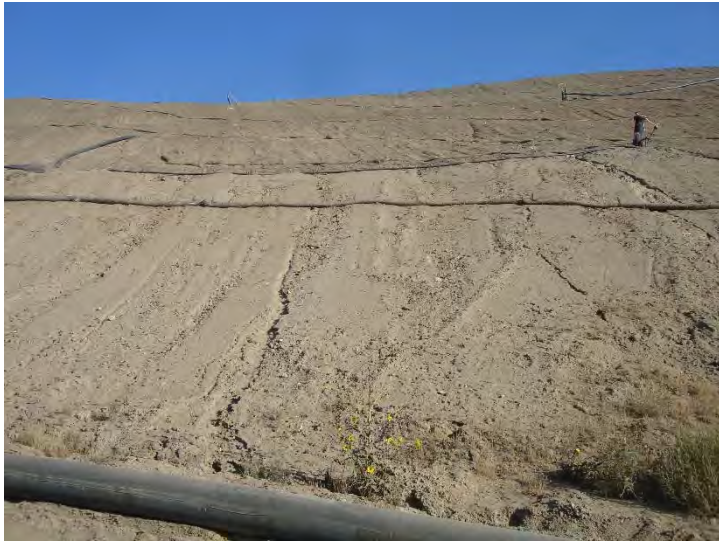
Photo 381: City Slope with no Erosion Control: August 26, 2015

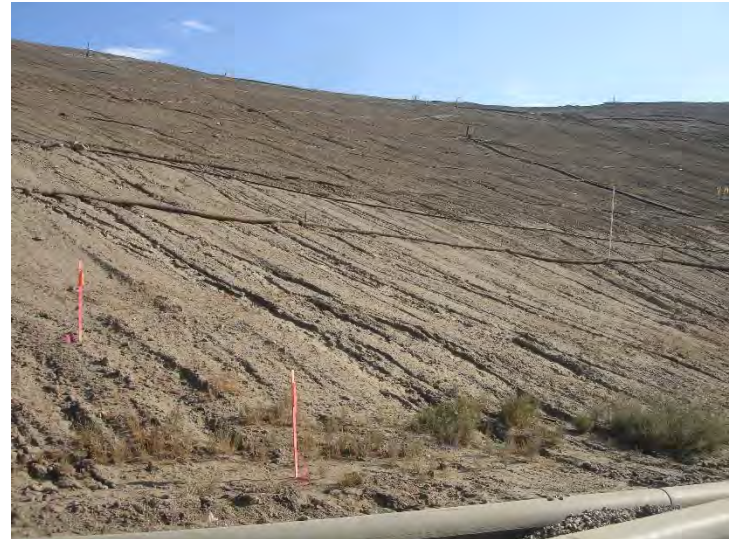
Photo 382: City Slope with no Erosion Control: August 26, 2015

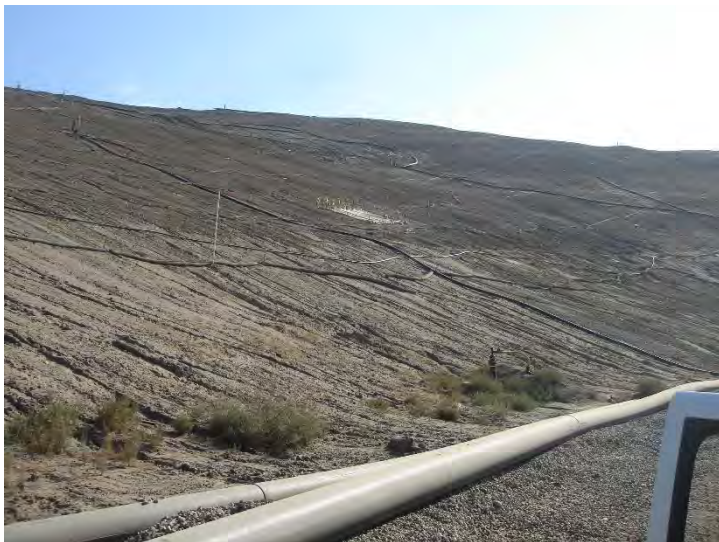
Photo 383: City Slope with no Erosion Control: August 26, 2015

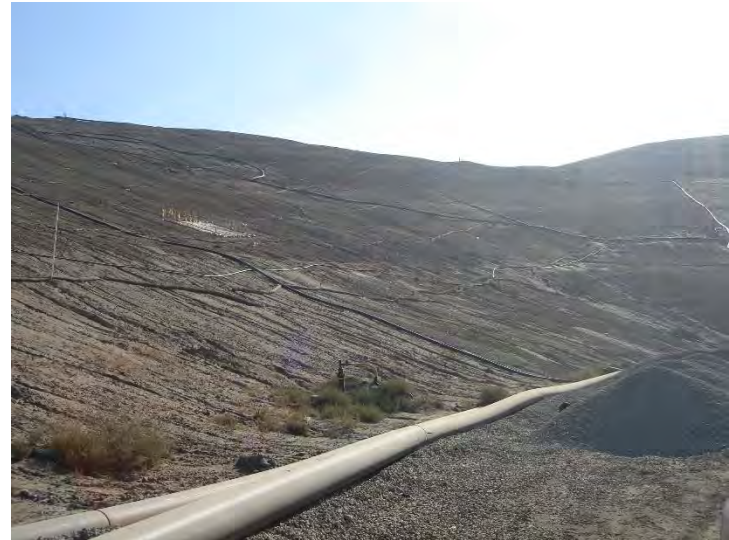
Photo 384: City Slope with no Erosion Control: August 26, 2015

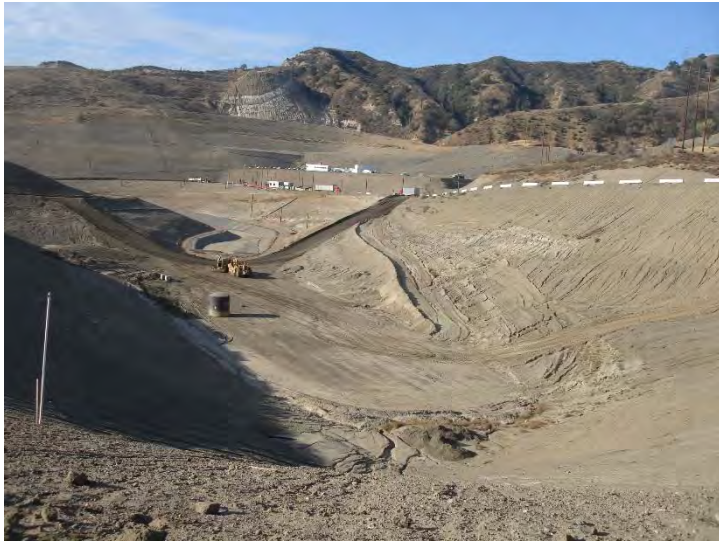
Photo 385: City Slope with no Erosion Control: August 26, 2015

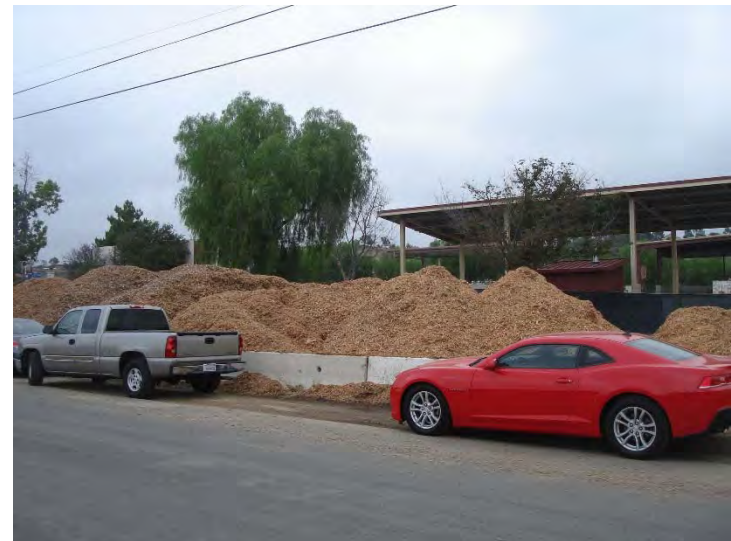
Photo 388: Greenwaste Odor Source: July 22, 2015

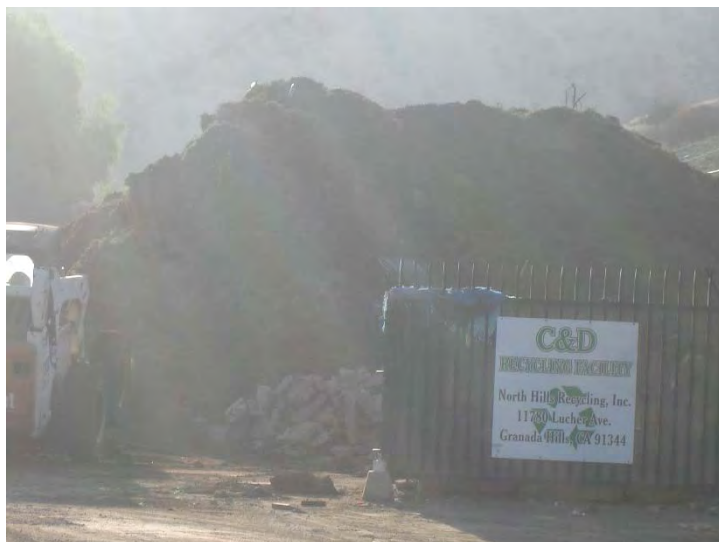
Photo 391: Greenwaste Odor Source: September 23, 2015

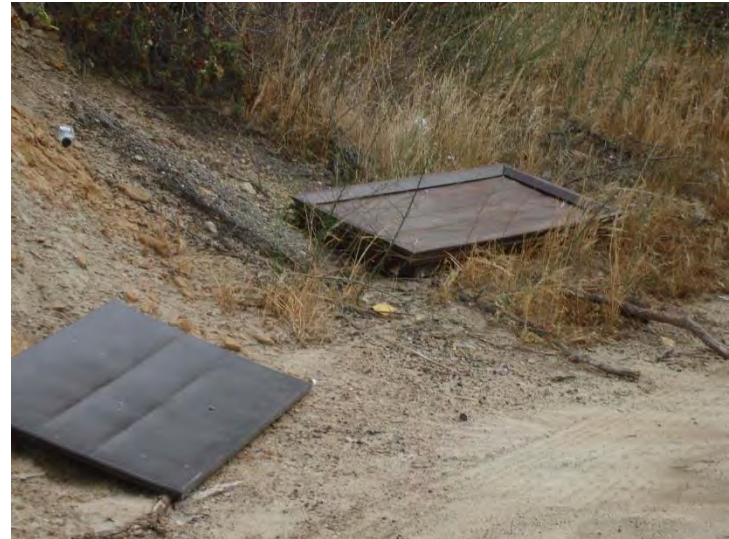
Photo 394: Sierra Highway Near I-14 Overpass: July 22, 2015

- Illegal dumping and litter was observed on Sierra Highway on the way to the I-14 overpass.
- The block wall hillside retaining wall along the San Fernando Road south frontage has soil and debris on top of the wall. The top drainage is blocked and the fence is nearly being topped with debris in several areas. This retaining wall was not designed for this type of loading. The two-foot wide walkway in front of the wall is piled with soil.

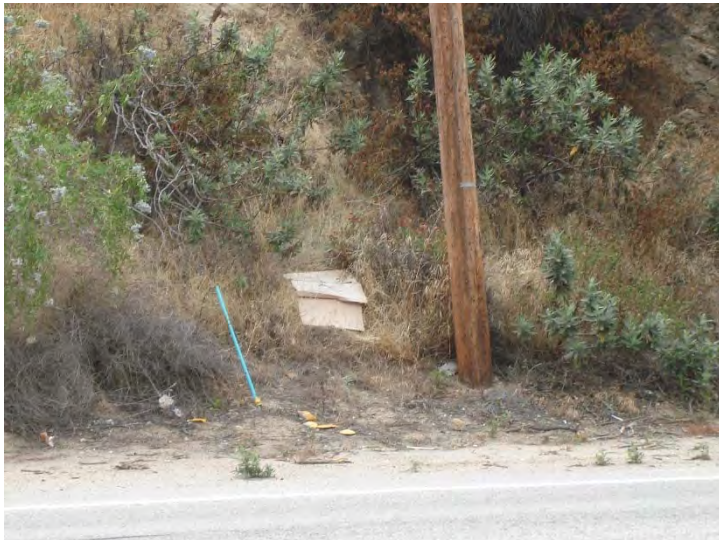
Photo 395: Sierra Highway Near I-14 Overpass: July 22, 2015

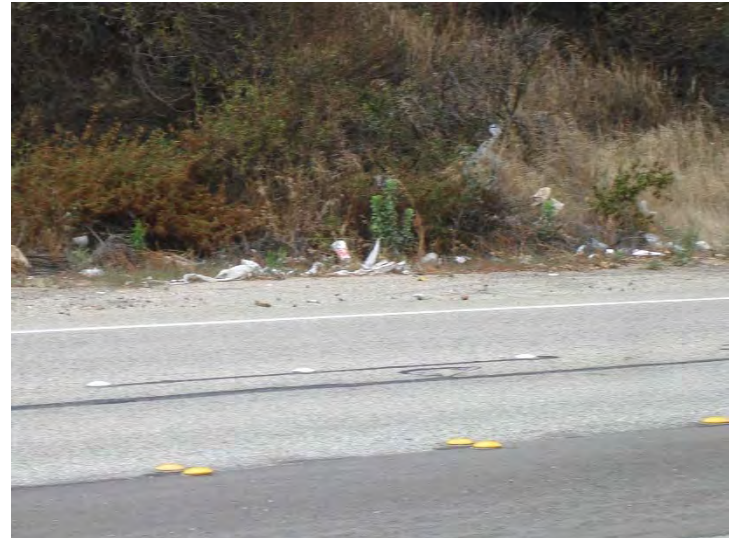
Photo 396: Sierra Highway Near I-14 Overpass: July 22, 2015

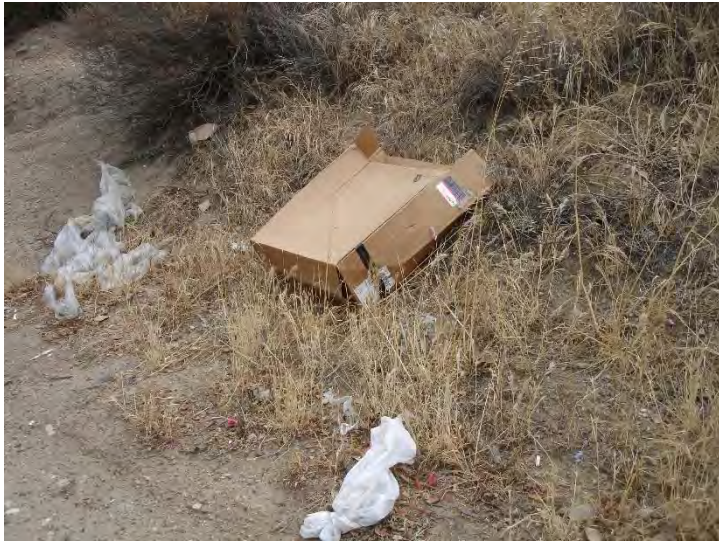
Photo 397: Sierra Highway Near I-14 Overpass: July 22, 2015

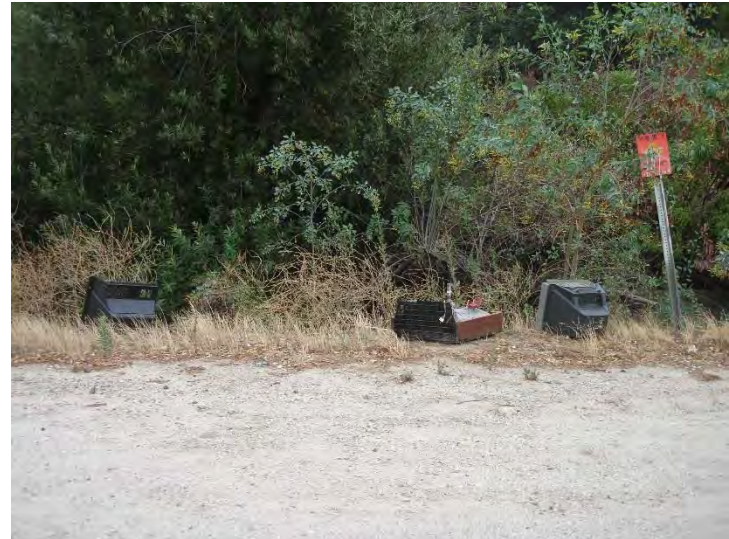
Photo 398: Sierra Highway Near I-14 Overpass: July 22, 2015

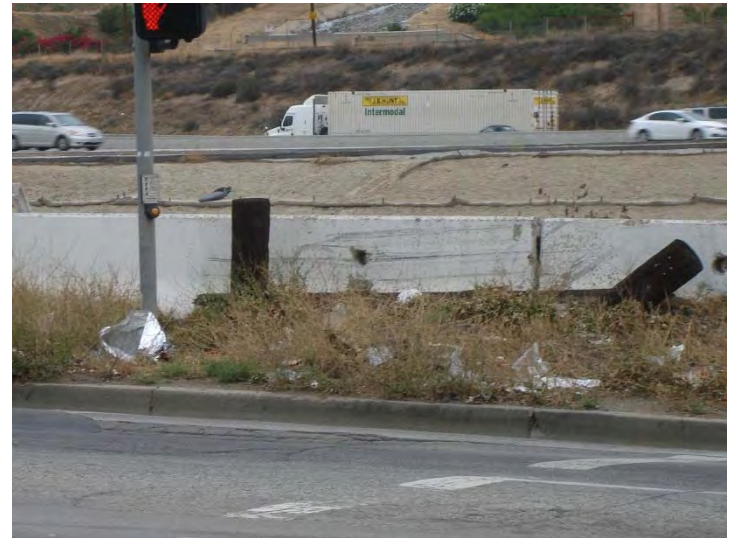
Photo 400: San Fernando Road Near Balboa: July 22, 2015

- Wind-blown litter was observed along the railroad side of San Fernando Road. Republic staff stated that the Metro staff directed them not to clean that side of the road due to safety issues with rail tracks.

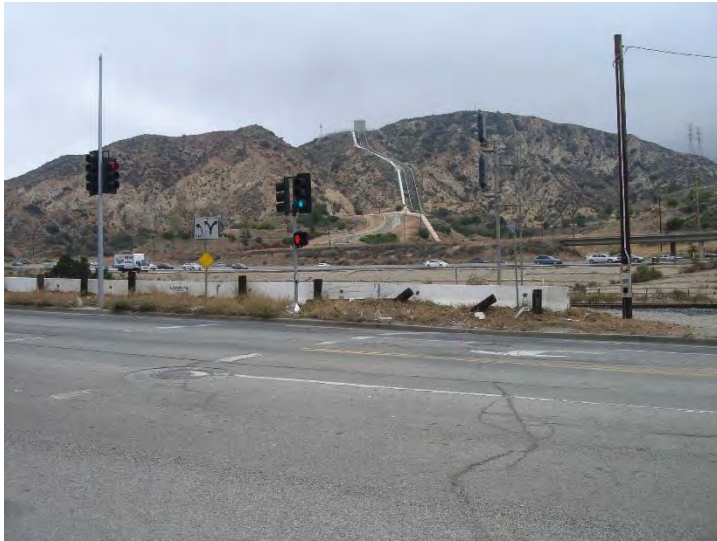
Photo 401: San Fernando Road Near Balboa: July 22, 2015

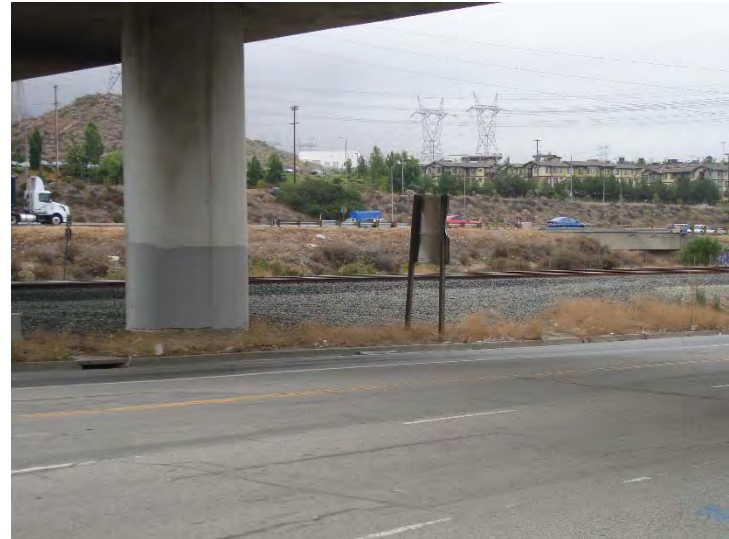
Photo 402: San Fernando Road Near Balboa: July 22, 2015

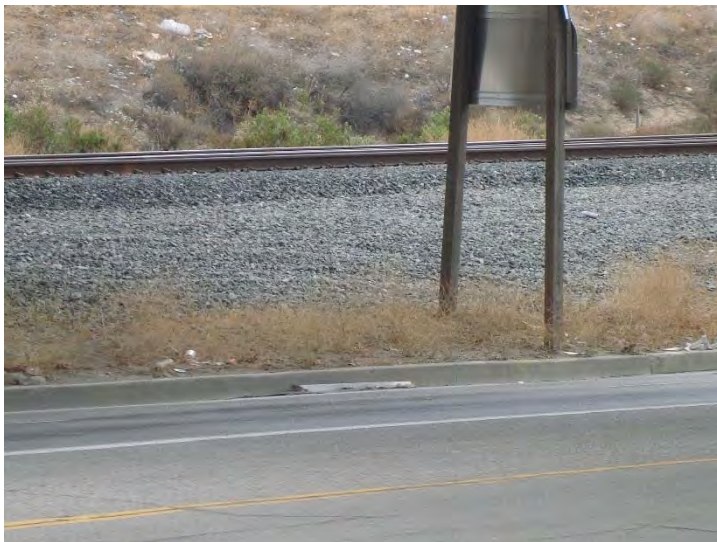
Photo 403: San Fernando Road Near Balboa: July 22, 2015

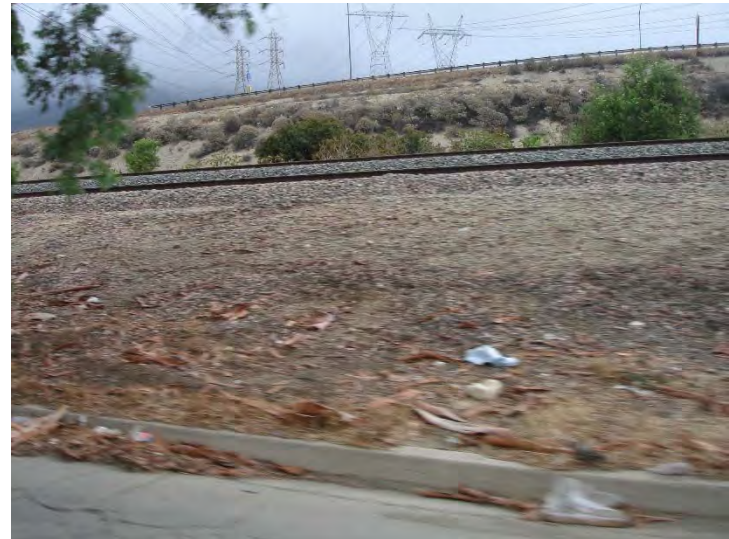
Photo 404: San Fernando Road Near Balboa: July 22, 2015

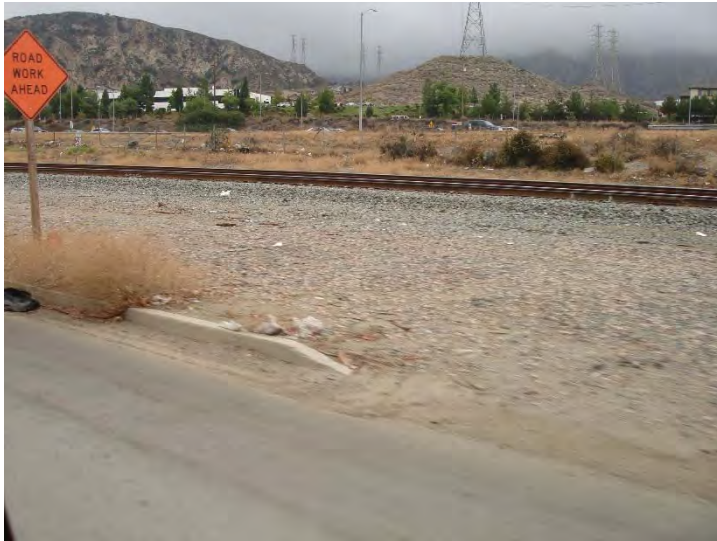
Photo 405: San Fernando Road Near Balboa: July 22, 2015

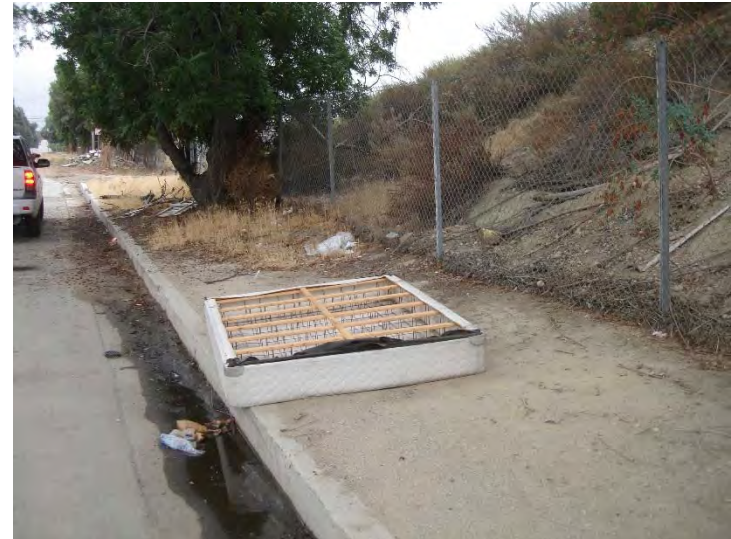
Photo 406: San Fernando Road Near Balboa: July 22, 2015

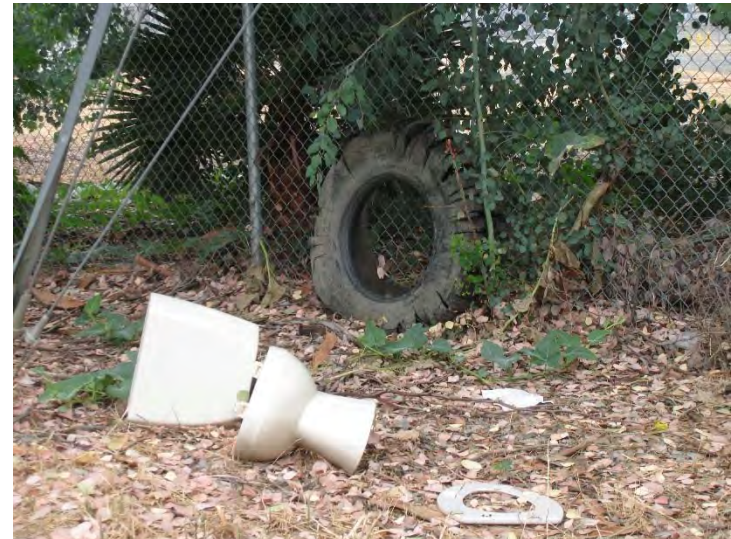
Photo 408: San Fernando Road Highway Near I-5 Overpass: July 22, 2015

- Illegal dumping was observed on San Fernando Road south of the I-5 overpass. This area is outside of Republic's designated clean-up area. The LEA was notified.

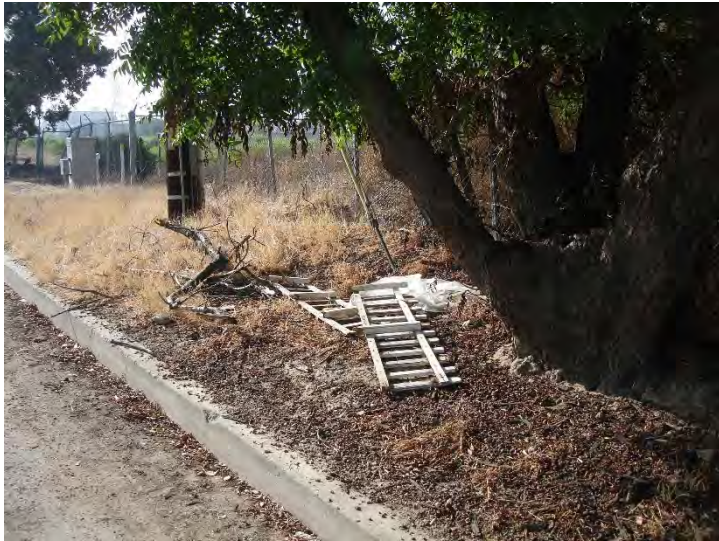
**Photo 409: San Fernando Road Highway Near I-5 Overpass:
August 11, 2015**

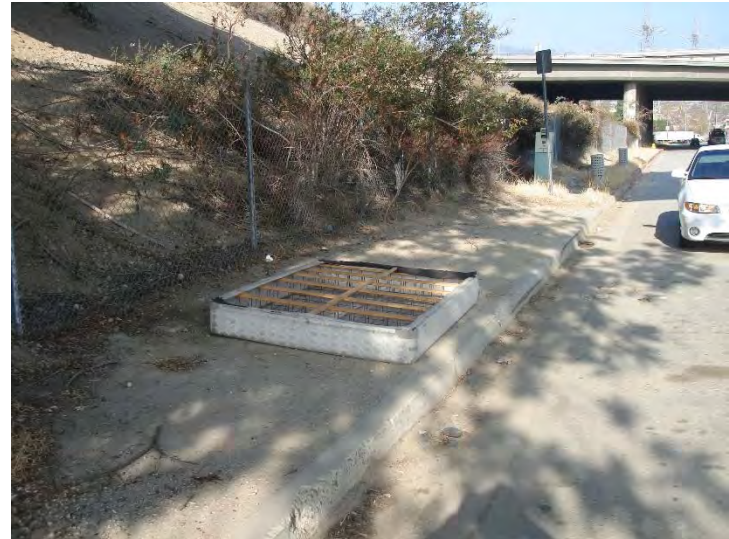
**Photo 410: San Fernando Road Highway Near I-5 Overpass:
August 11, 2015**

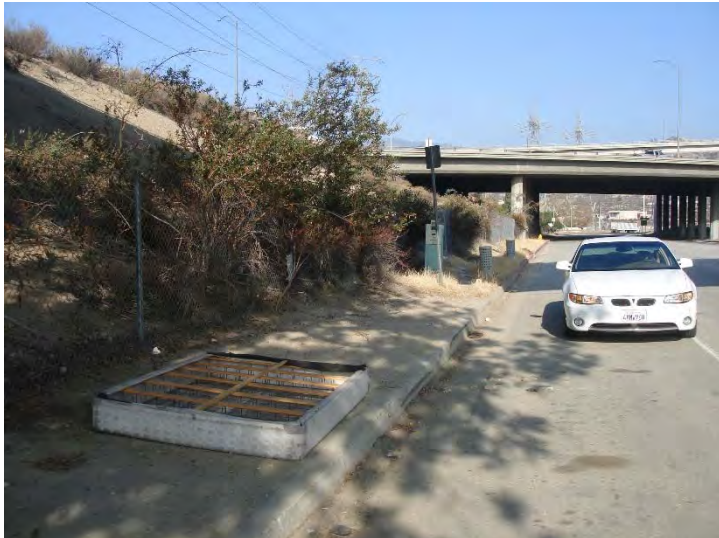
**Photo 411: San Fernando Road Highway Near I-5 Overpass:
August 11, 2015**

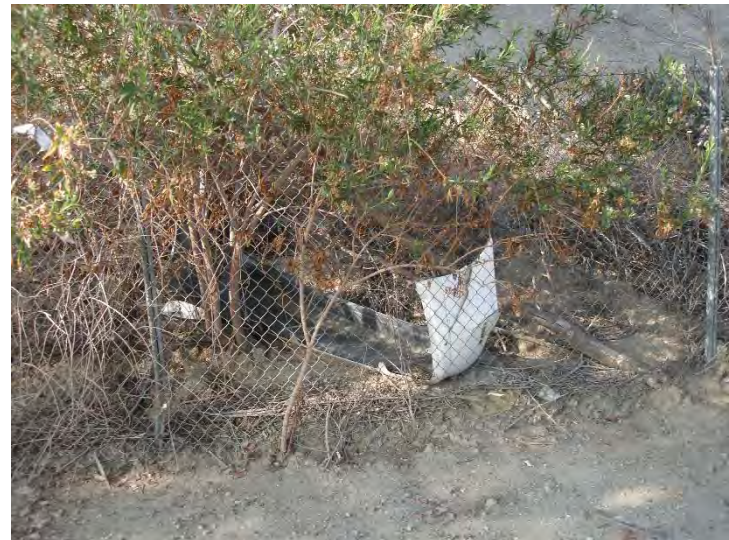
**Photo 412: San Fernando Road Highway Near I-5 Overpass:
August 11, 2015**

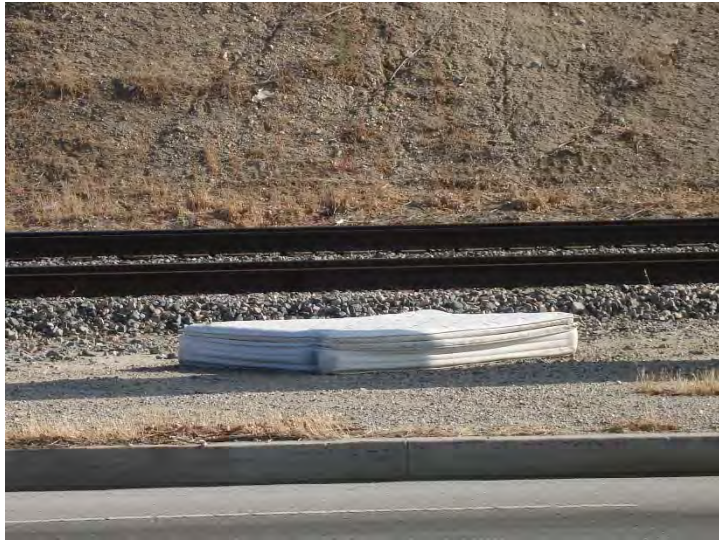
**Photo 413: San Fernando Road Highway Near I-5 Overpass:
August 11, 2015**

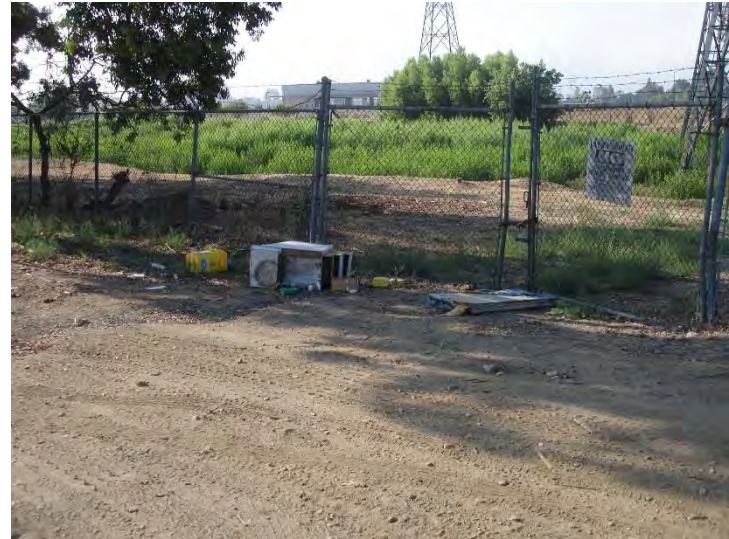
**Photo 414: San Fernando Road Highway Near I-5 Overpass:
August 11, 2015**

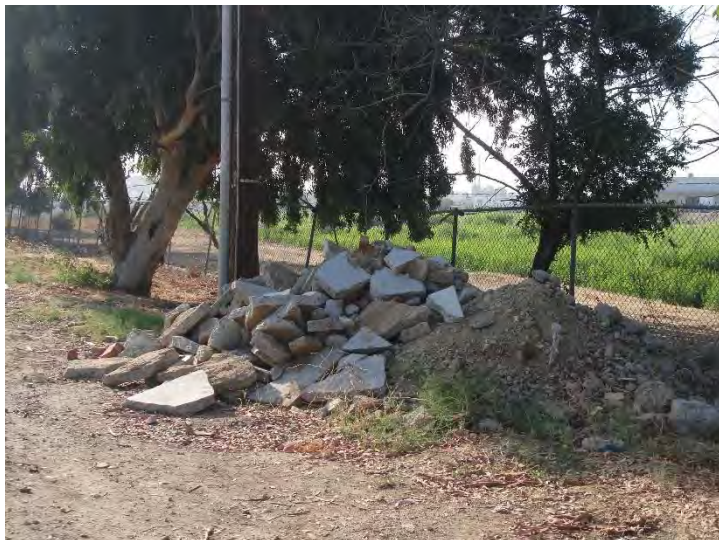
**Photo 415: San Fernando Road Highway Near I-5 Overpass:
August 11, 2015**
