**Sunshine Canyon Landfill  
Independent Monitor  
Quarterly Site Monitoring Status Report  
April 1, 2015 – June 30, 2015**

**City of Los Angeles Department of City Planning**

**County of Los Angeles Department of Regional Planning**

August 5, 2015

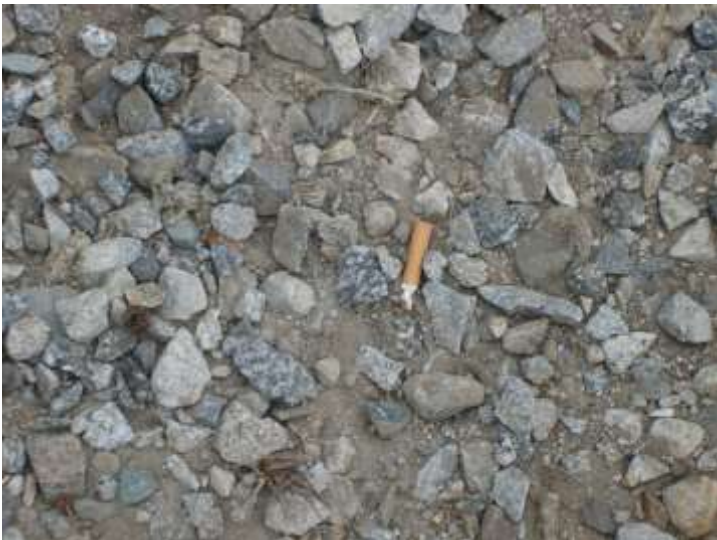
**Photo 122: Cigarette Butts at Flare 9 & 10 Blower Skid: April 23, 2015**

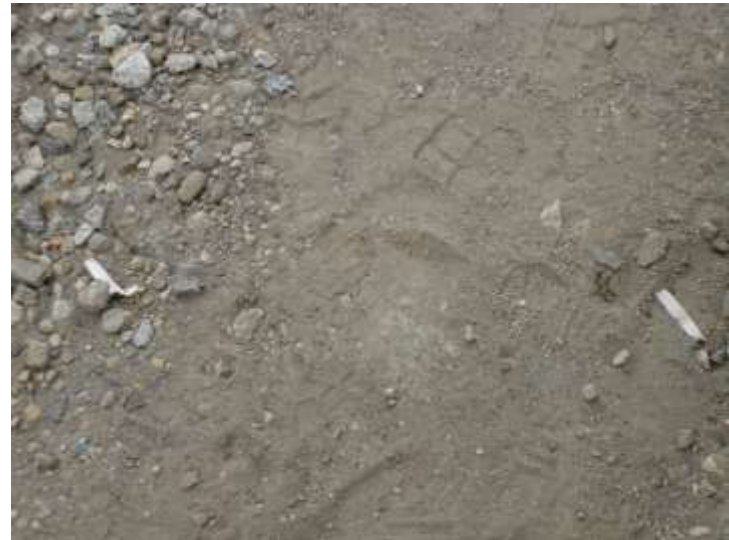
**Photo 123: Cigarette Butts at Flare 9 & 10 Blower Skid: April 23, 2015**

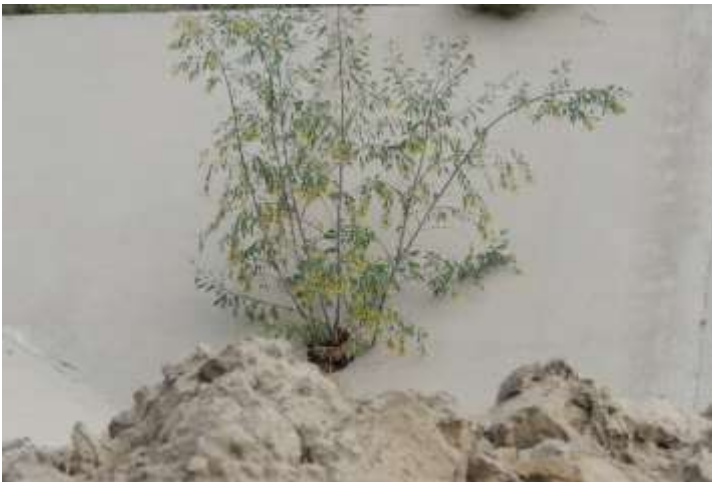
**Photo 170: Plants Growing in Terminal Basin Walls: May 27, 2015**

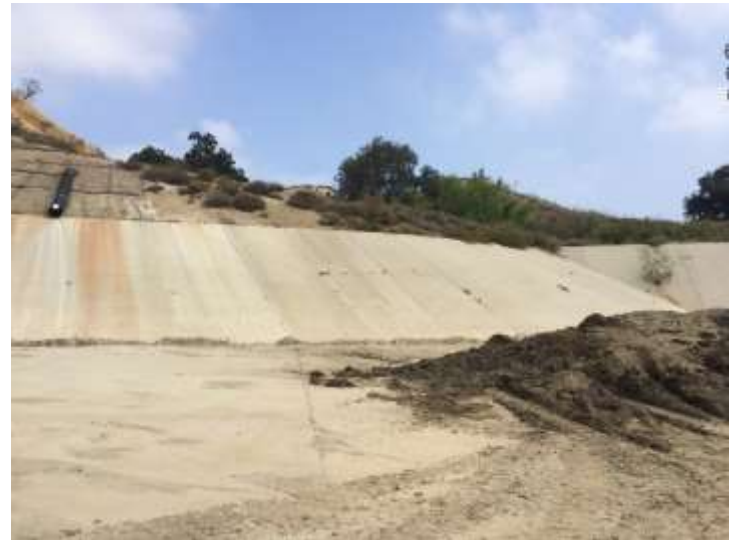
**Photo 171: Plants Growing in Terminal Basin Walls: May 27, 2015**

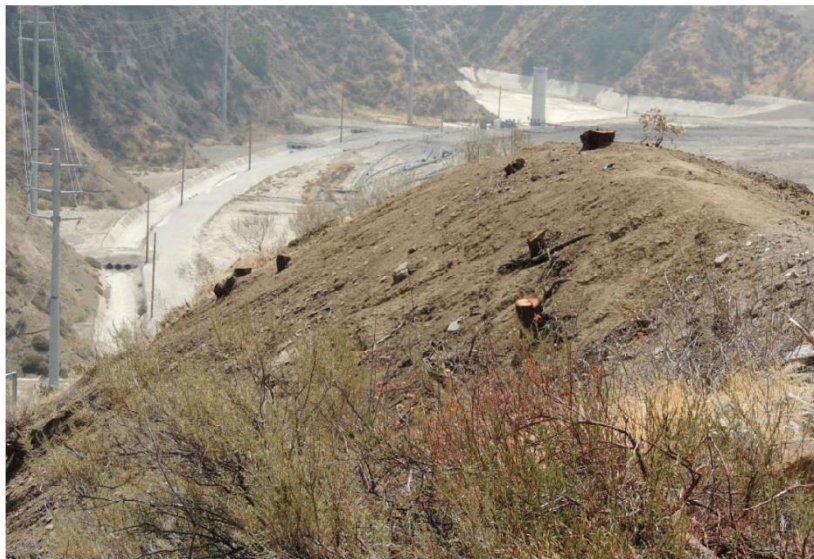
Photo 1: Construction of New Access Road
