**Sunshine Canyon Landfill
Independent Monitor
Quarterly Site Monitoring Status Report
October 1, 2017 – December 31, 2017**

March 6, 2018

The attached Quarterly Site Monitoring Status Report for the Sunshine Canyon Landfill dated March 6, 2018 is the Fourth Quarterly Report for 2017, issued by UltraSystems. This report covers the monitoring period from October 1, 2017 through December 31, 2017 and is prepared for the City of Los Angeles Department of City Planning and the County of Los Angeles Department of Regional Planning.

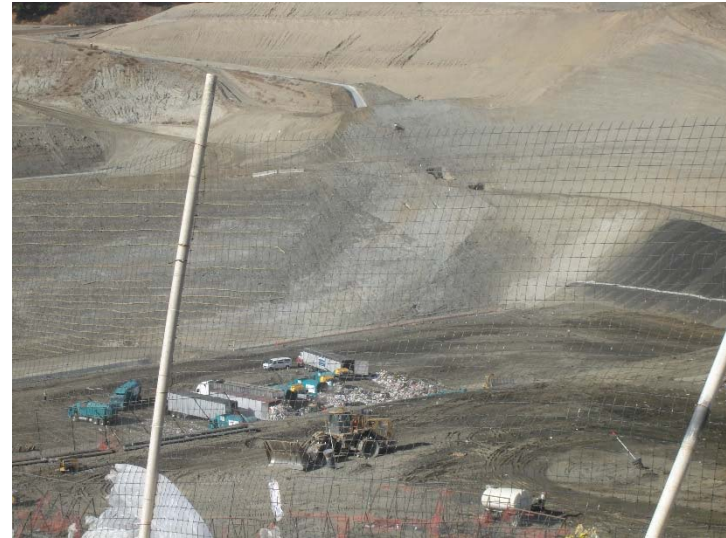
Photo 158: Site Working Area CC4 Part 2 1100AM: November 21, 2017

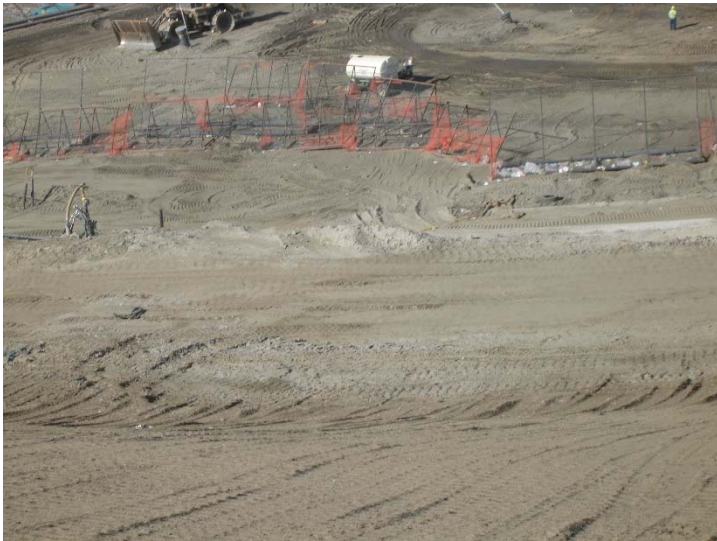
Photo 159: Site Working Area CC4 Part 2 1100AM: November 21, 2017

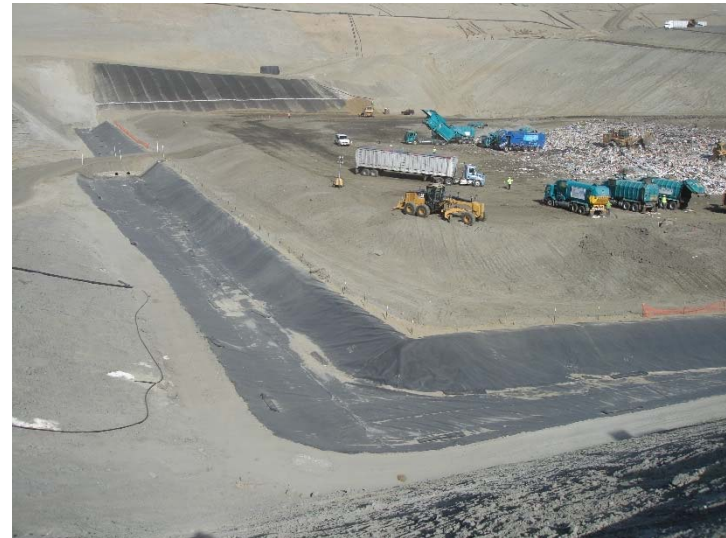
Photo 160: Site Working Area CC4 Part 2 1100AM: November 21, 2017

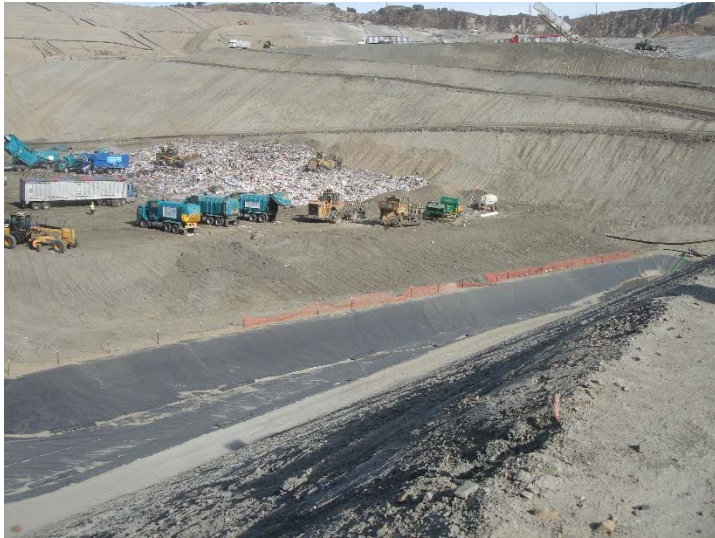
Photo 161: Site Working Area CC4 Part 2 1100AM: November 21, 2017

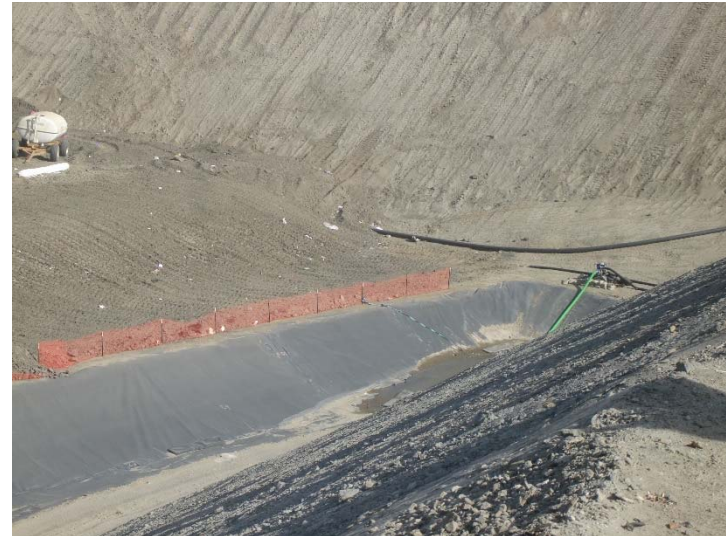
Photo 162: Site Working Area CC4 Part 2 1100AM: November 21, 2017

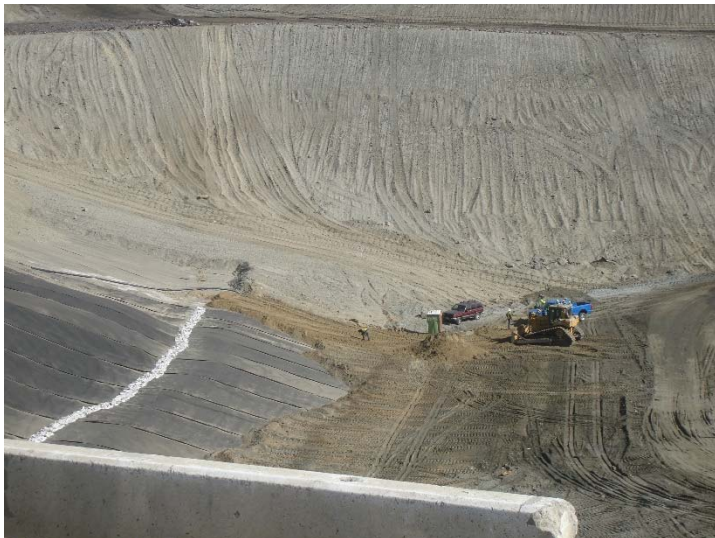
Photo 163: Site Working Area CC4 Part 2 1100AM: November 21, 2017

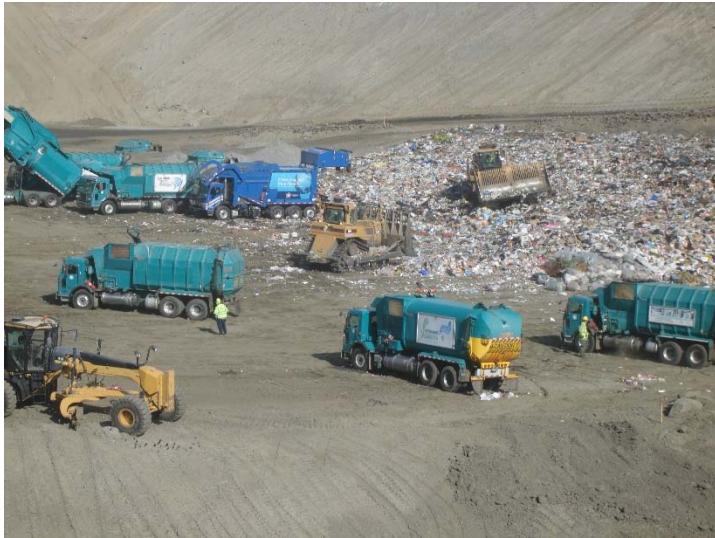
Photo 165: Site Working Area CC4 Part 2 1100AM: November 21, 2017

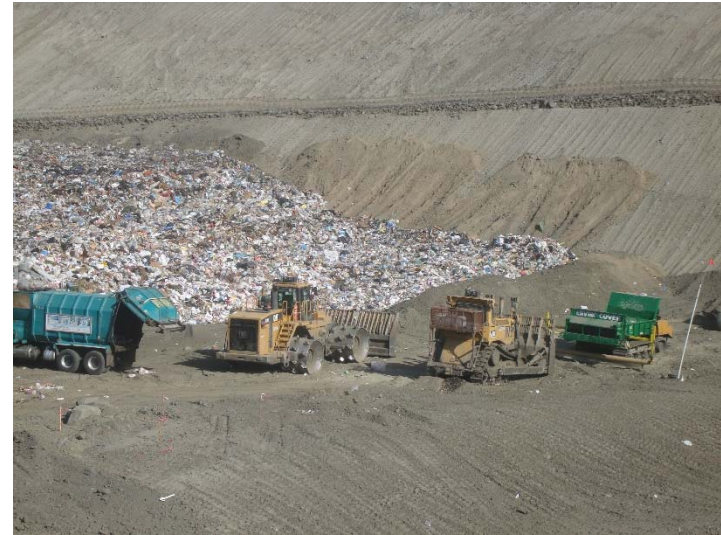
Photo 166: Site Working Area CC4 Part 2 1100AM: November 21, 2017

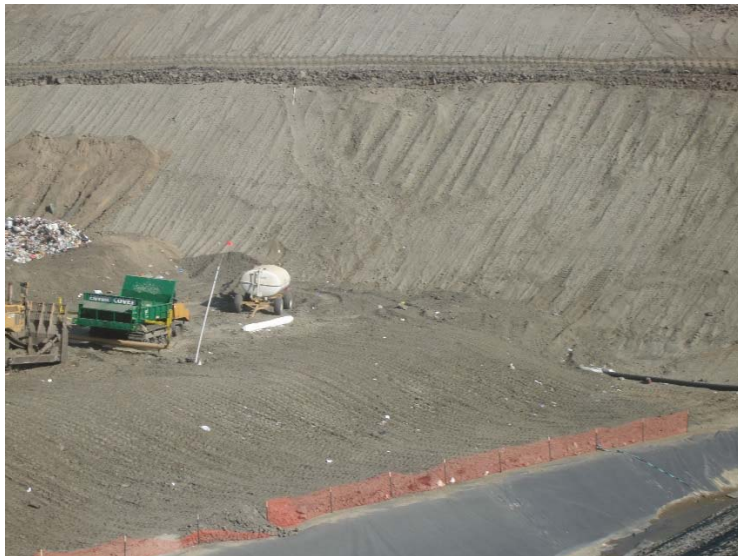
Photo 167: Site Working Area CC4 Part 2 1100AM: November 21, 2017

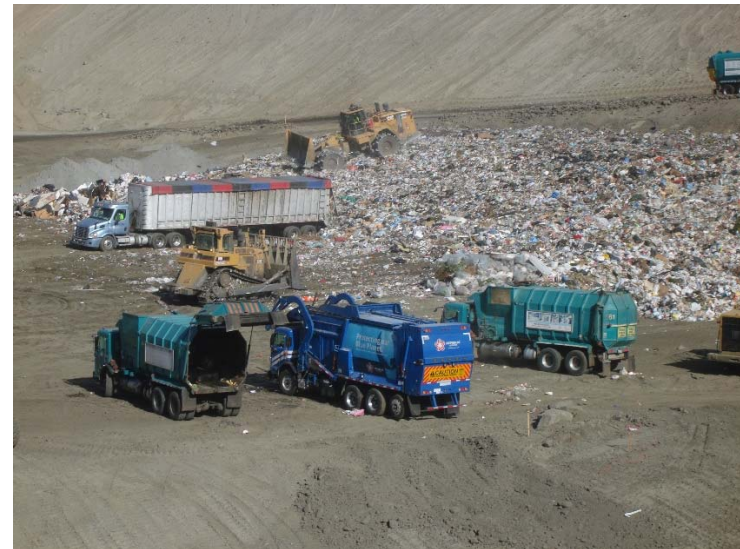
Photo 168: Site Working Area CC4 Part 2 1100AM: November 21, 2017

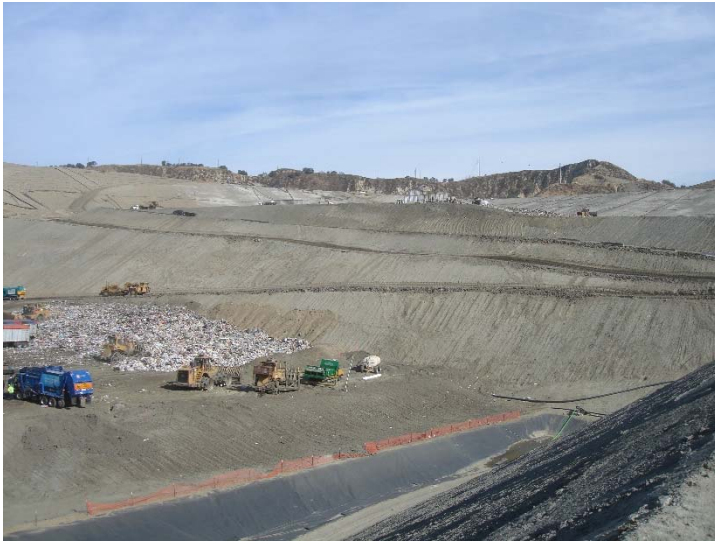
Photo 169: Site Working Area CC4 Part 2 1100AM: November 21, 2017

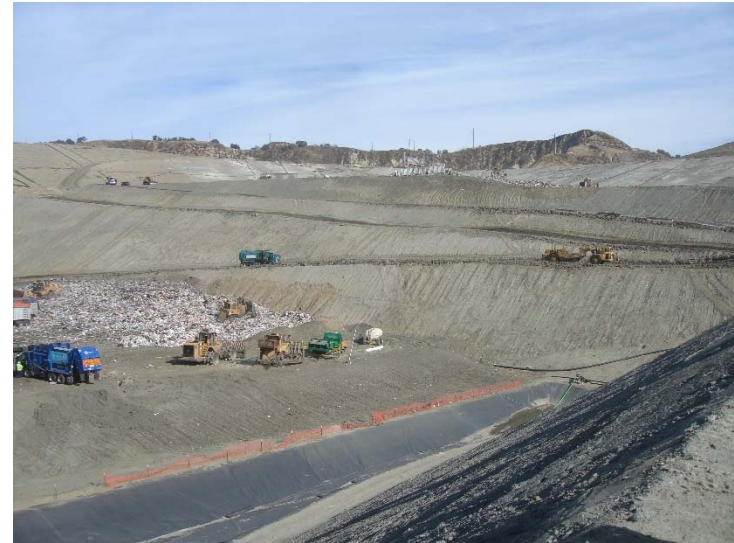
Photo 170: Site Working Area CC4 Part 2 1100AM: November 21, 2017

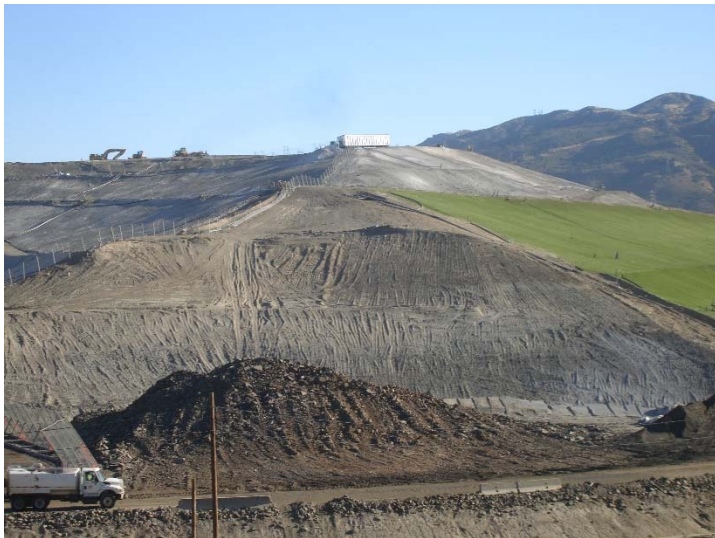
Photo 171: CC3A Stockpile Removal 900AM: October 26, 2017

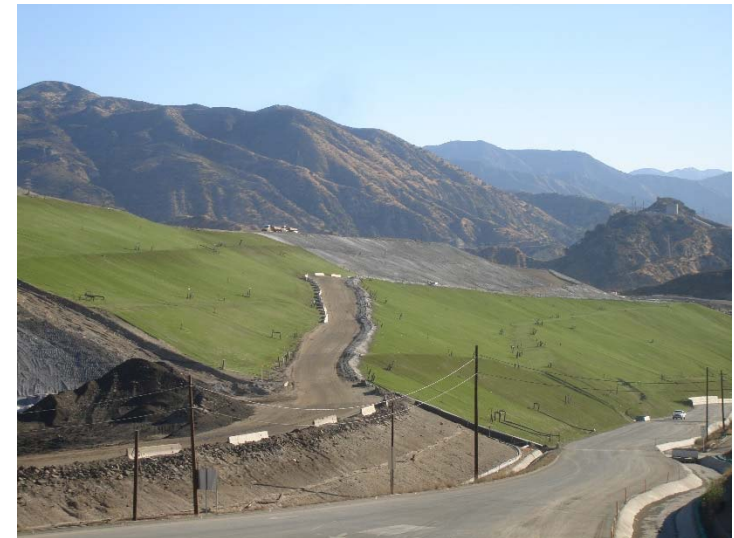
Photo 172: Cell CC3A Liquid Break-Out Area: October 26, 2017

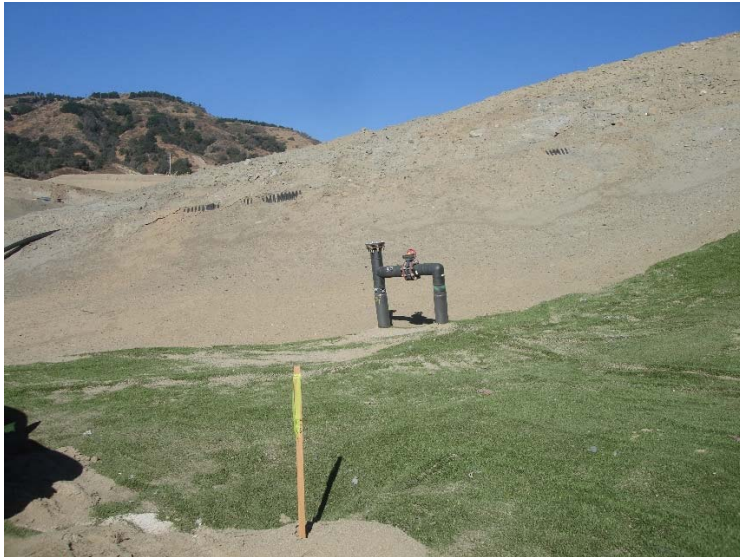
Photo 173: Cell CC3A Liquid Break-Out Area: October 26, 2017

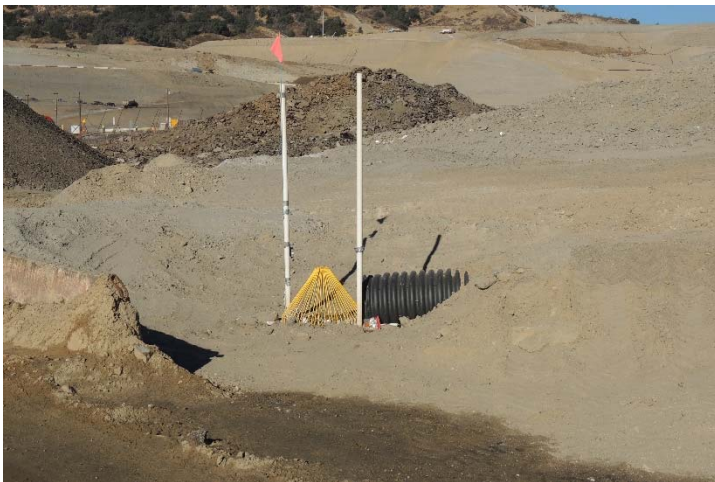
Photo 175: Cell CC3A Liquid Break-Out Area: October 26, 2017

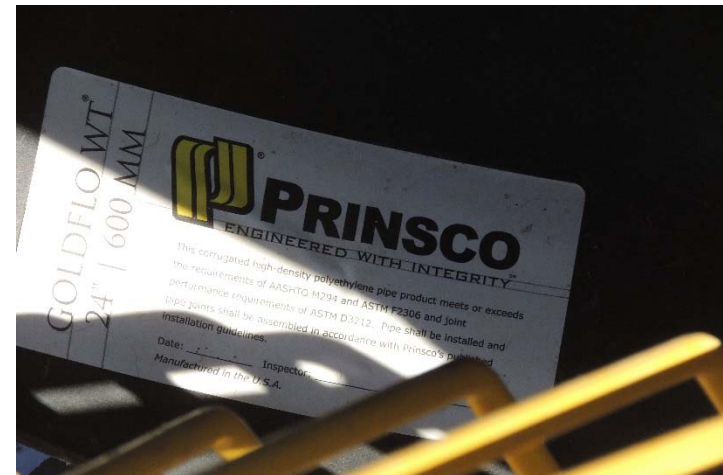
Photo 176: Cell CC3A Liquid Break-Out Area: October 26, 2017

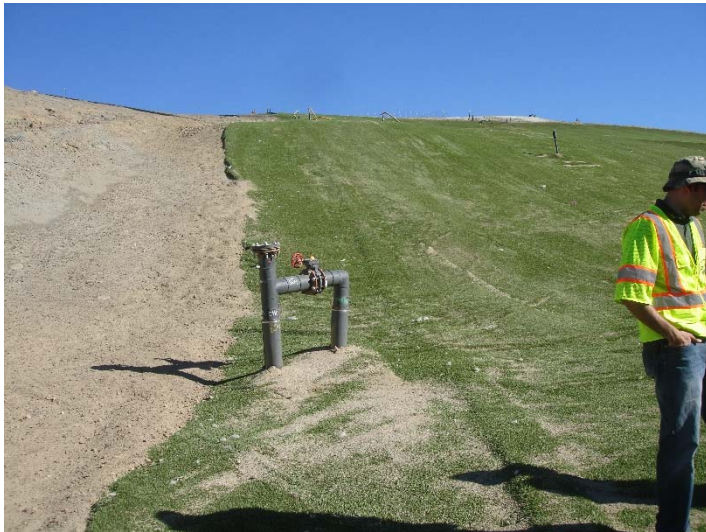
Photo 177: Cell CC3A Liquid Break-Out Area: October 26, 2017

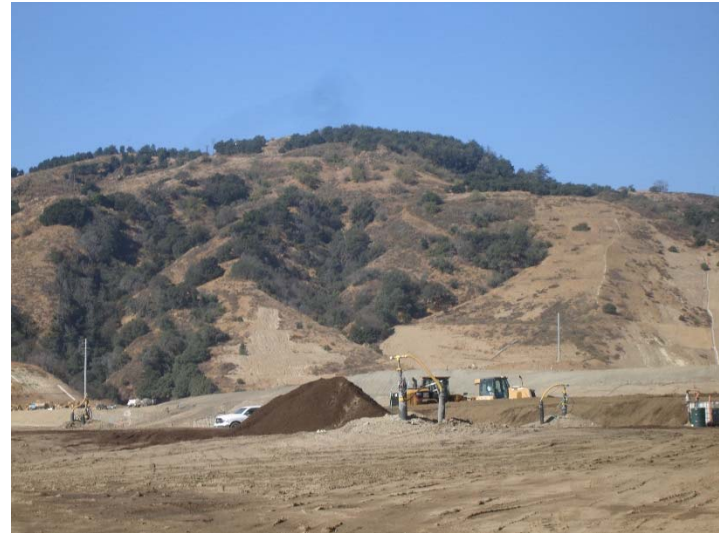
Photo 178: CC3A Top Deck Soil Amending: October 26, 2017

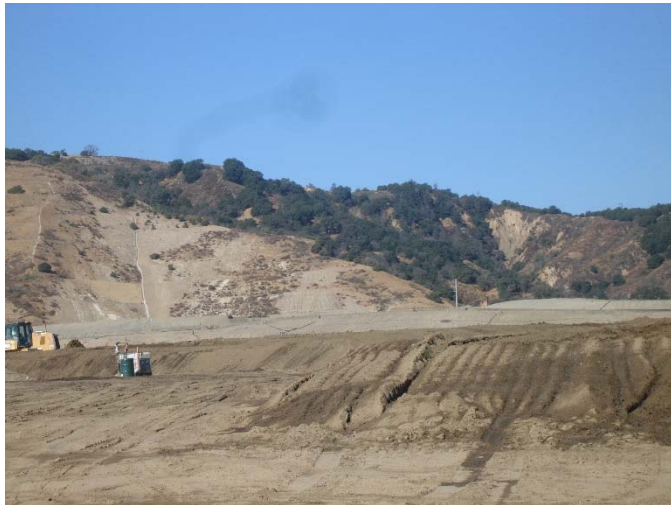
Photo 179: CC3A Top Deck Soil Amending: October 26, 2017

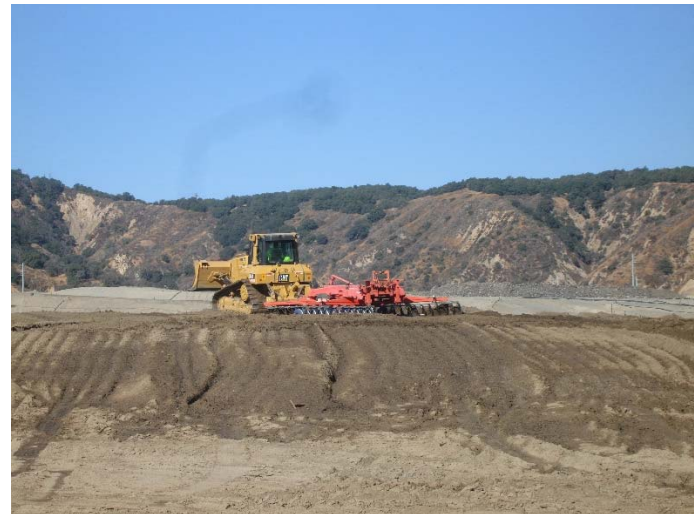
Photo 180: CC3A Top Deck Soil Amending: October 26, 2017

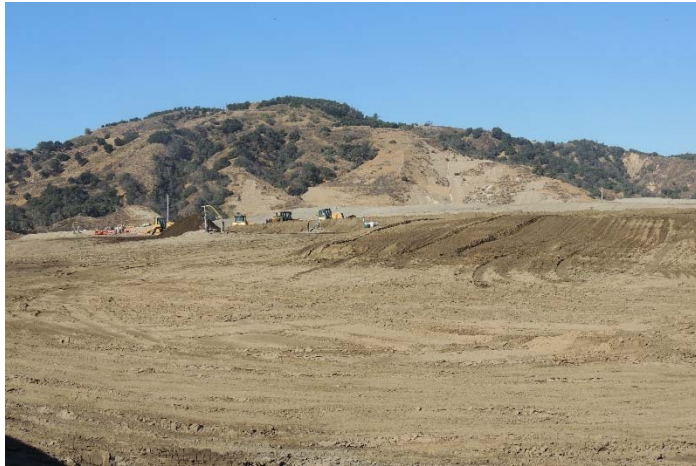
Photo 181: CC3A Top Deck Soil Amending: October 26, 2017

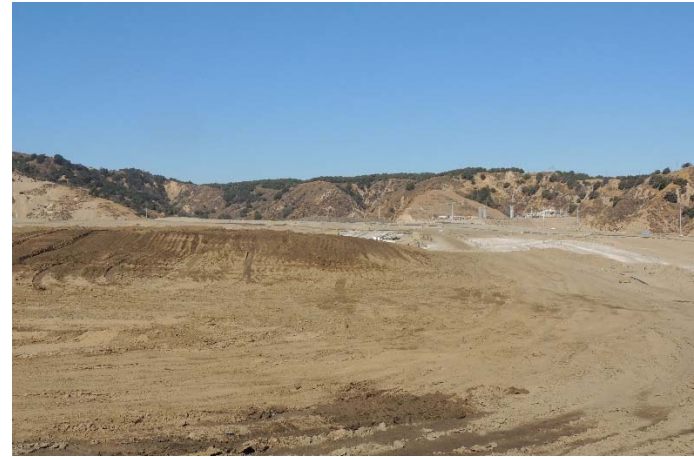
Photo 182: CC3A Top Deck Soil Amending: October 26, 2017

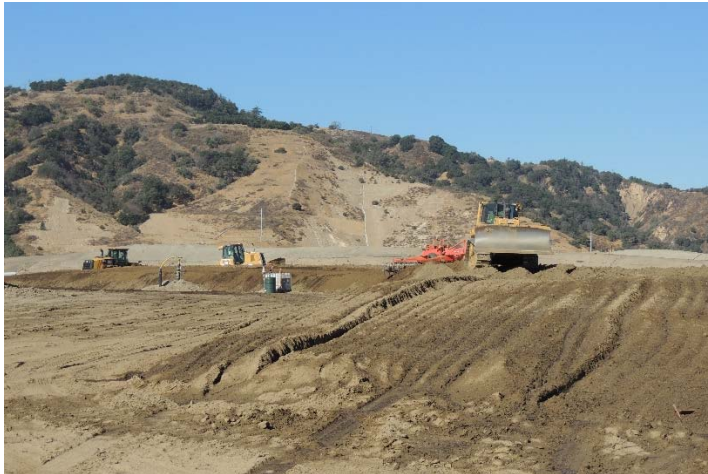
Photo 183: CC3A Top Deck Soil Amending: October 26, 2017

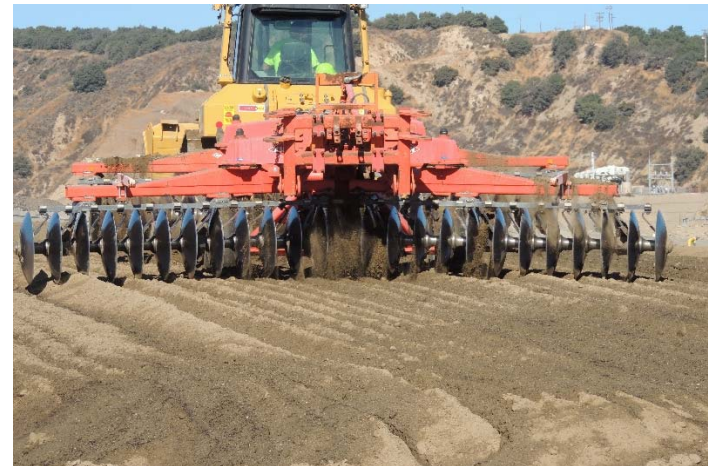
Photo 184: CC3A Top Deck Soil Amending: October 26, 2017

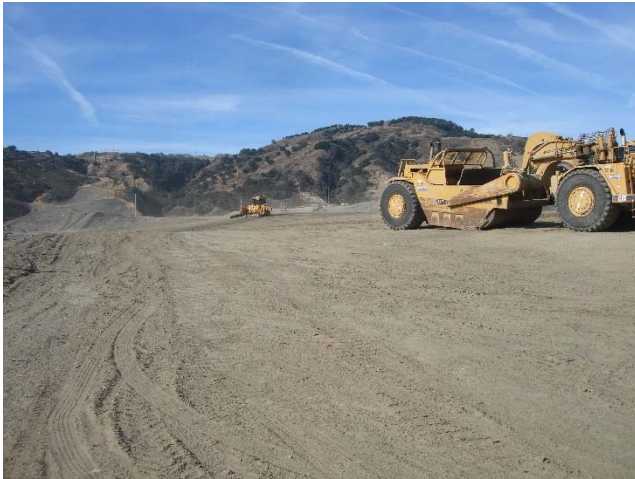
Photo 185: CC3A Top Deck Soil Amending: November 21, 2017

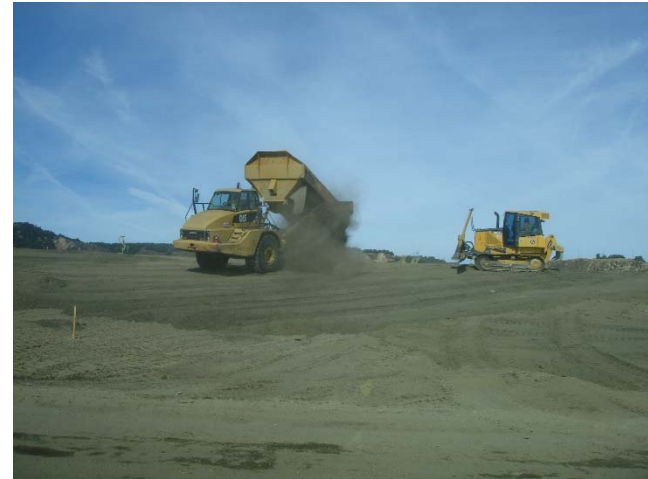
Photo 186: CC3A Top Deck Soil Amending: November 21, 2017

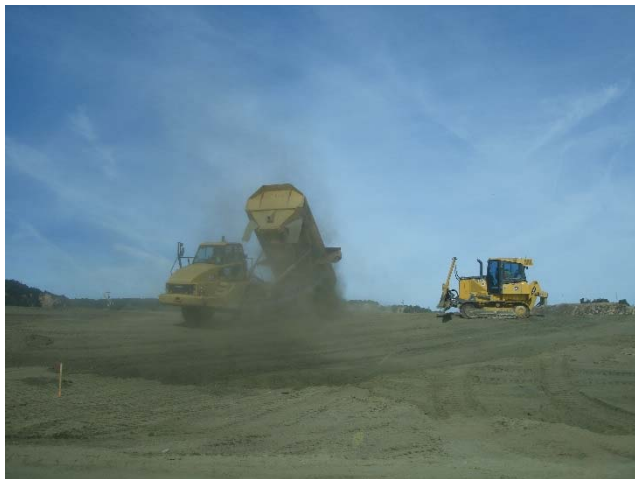
Photo 187: CC3A Top Deck Soil Amending: November 21, 2017

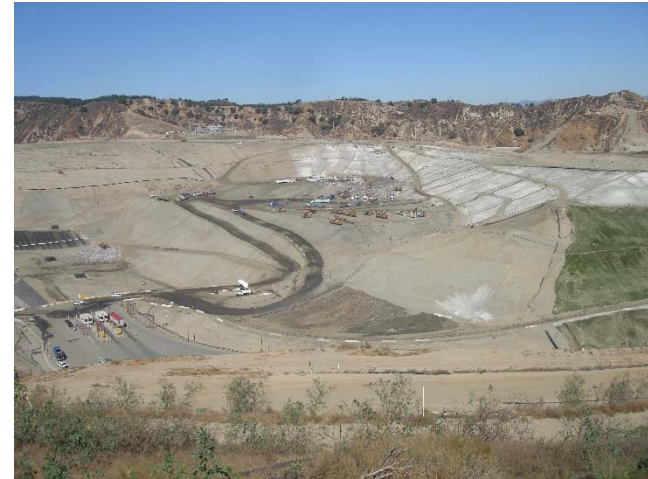
Photo 188: Closure Turf & Posi-Shell: October 26, 2017

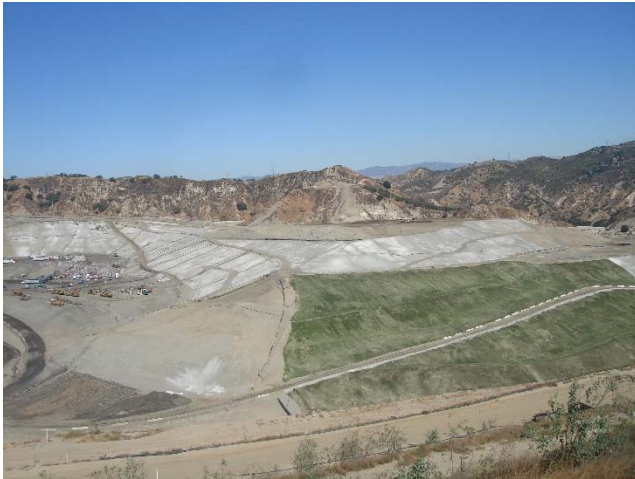
Photo 189: Closure Turf & Posi-Shell: October 26, 2017

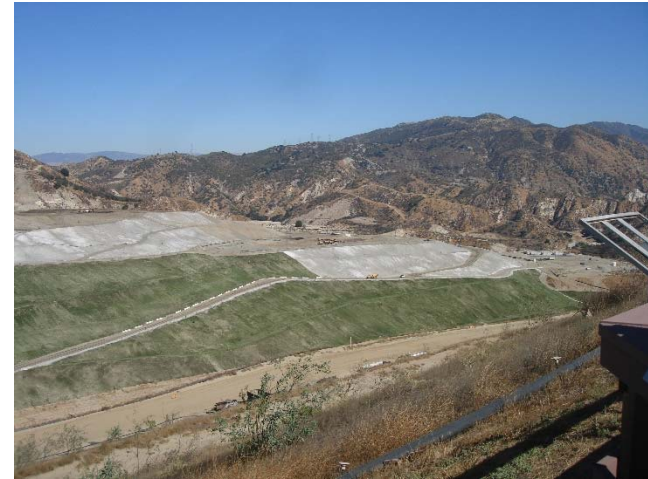
Photo 190: Closure Turf & Posi-Shell: October 26, 2017

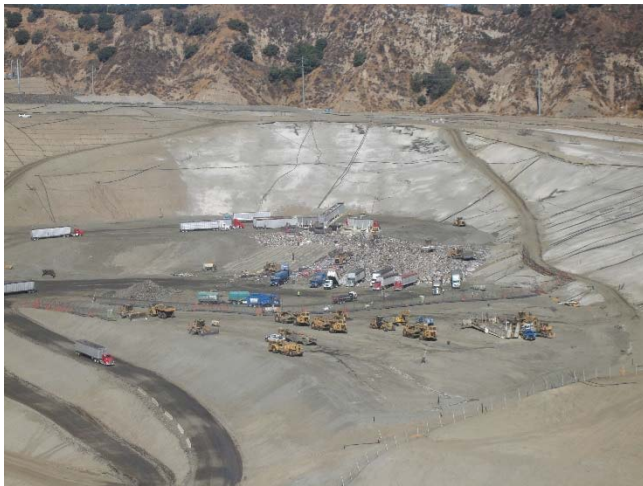
Photo 191: Closure Turf & Posi-Shell: October 26, 2017

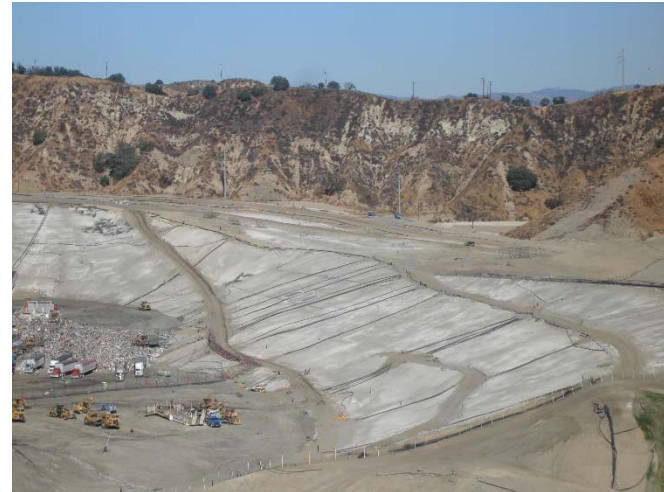
Photo 192: Closure Turf & Posi-Shell: October 26, 2017

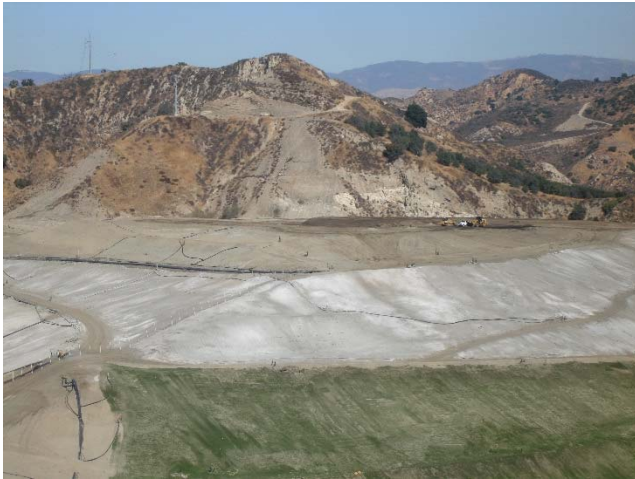
Photo 193: Closure Turf & Posi-Shell: October 26, 2017

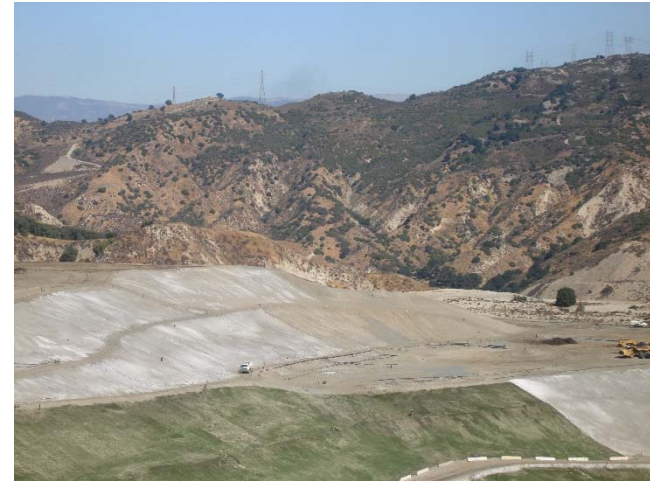
Photo 194: Closure Turf & Posi-Shell: October 26, 2017

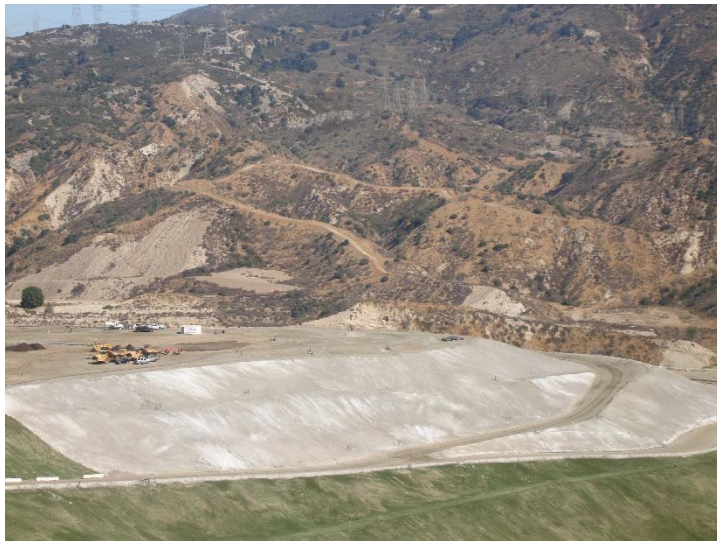
Photo 195: Closure Turf & Posi-Shell: October 26, 2017

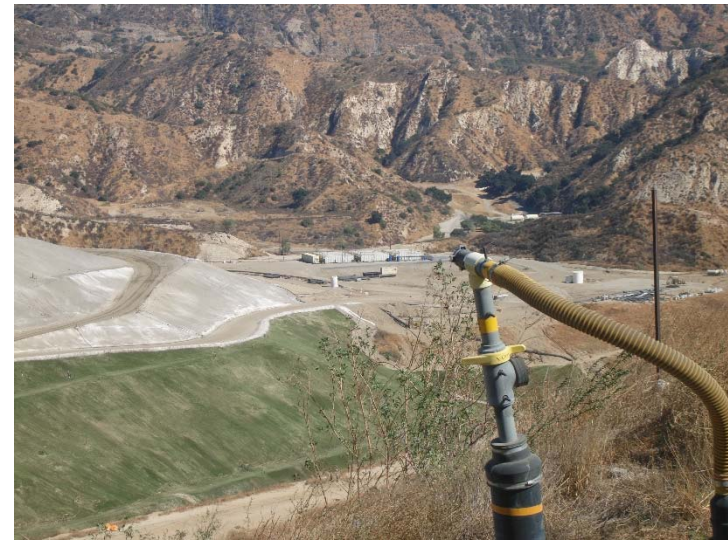
Photo 196: Closure Turf & Posi-Shell: October 26, 2017

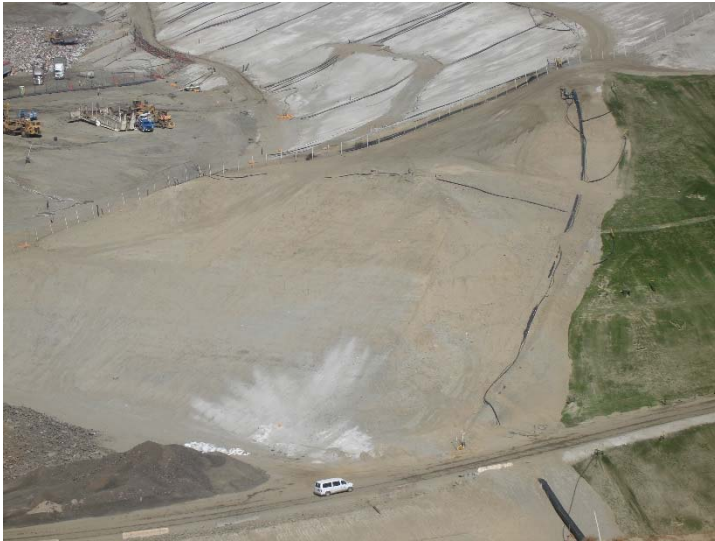
Photo 197: Closure Turf & Posi-Shell: October 26, 2017

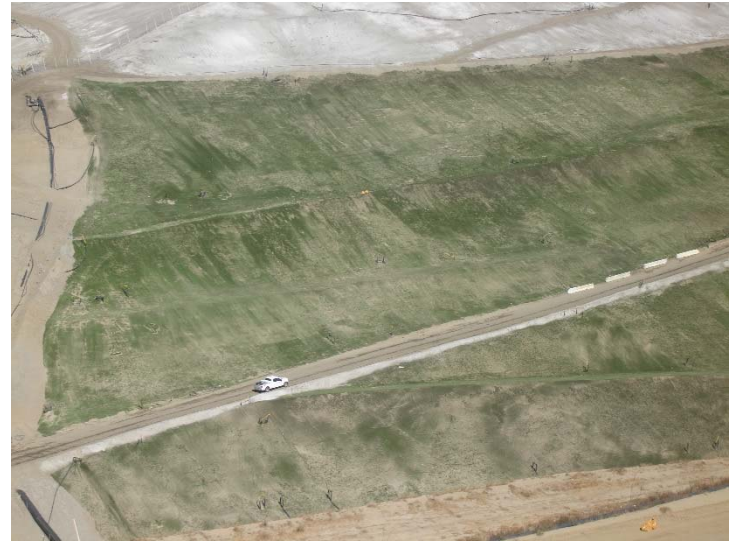
Photo 198: Closure Turf & Posi-Shell: October 26, 2017

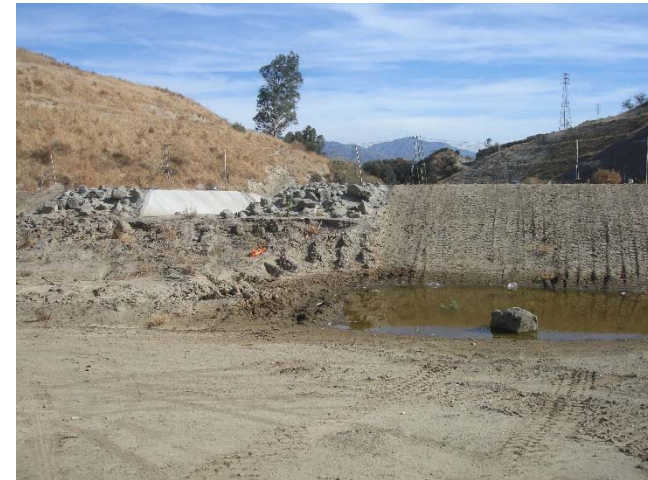
Photo 263: Basin CC3B Plugged Low Flow-Outlet: November 21, 2017

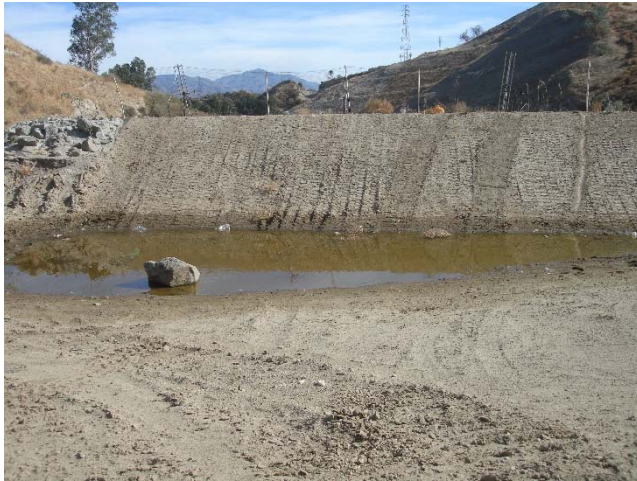
Photo 264: Basin CC3B Plugged Low Flow-Outlet: November 21, 2017

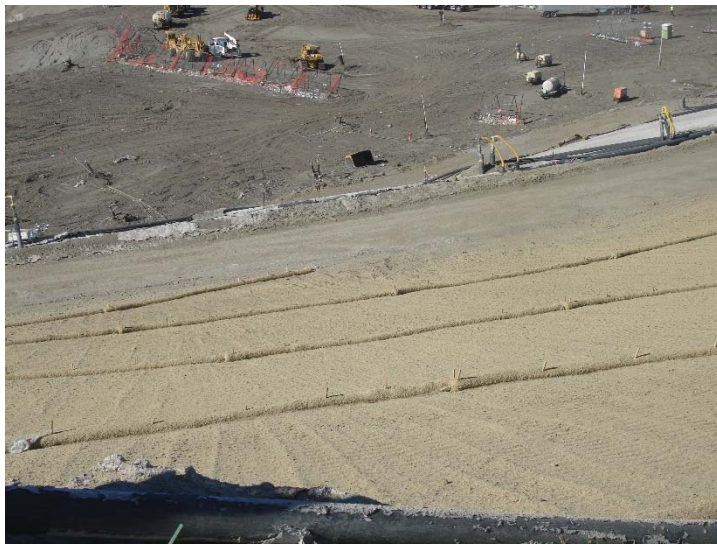
Photo 278: Top Deck & Slope Revegetation: December 12, 2017

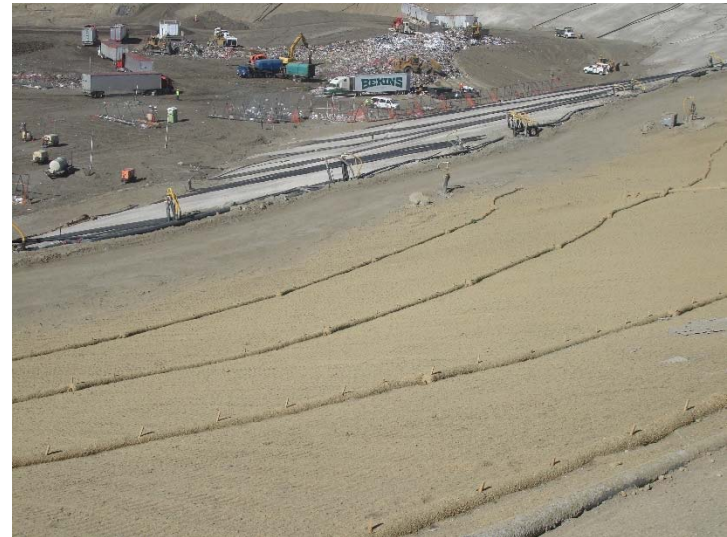
Photo 279: Top Deck & Slope Revegetation: December 12, 2017

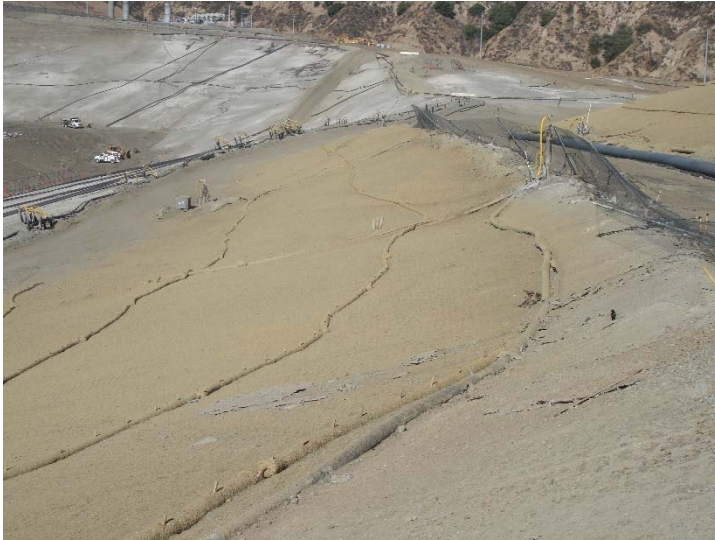
Photo 280: Top Deck & Slope Revegetation: December 12, 2017

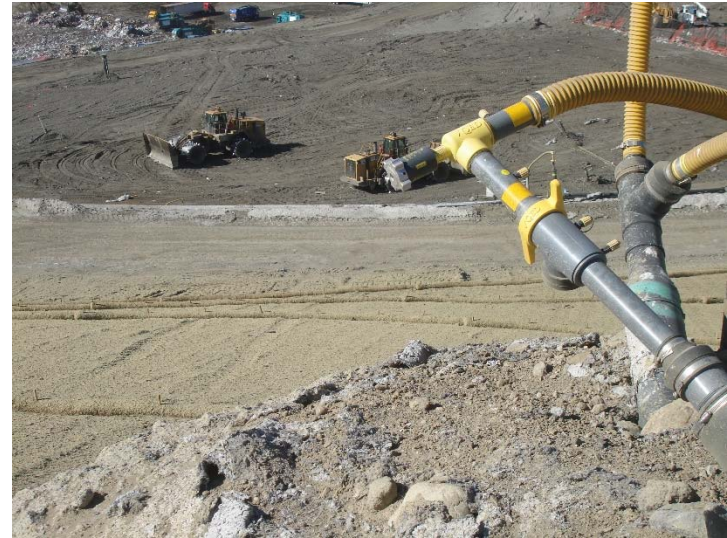
Photo 281: Top Deck & Slope Revegetation: December 12, 2017

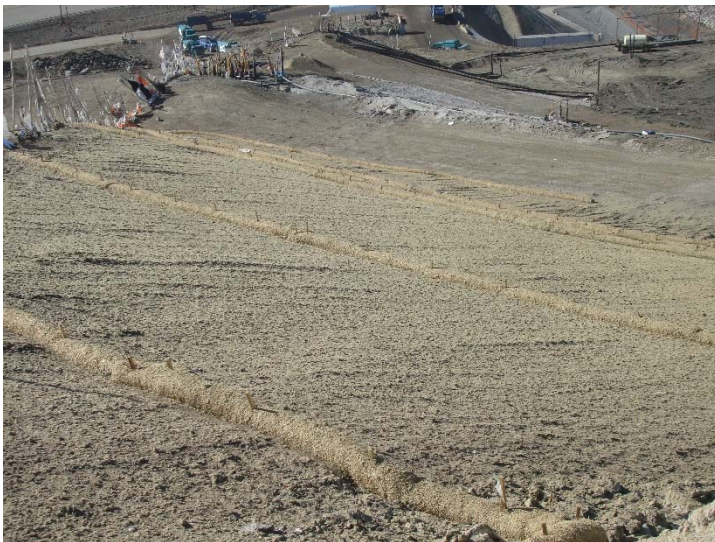
Photo 282: Top Deck & Slope Revegetation: December 12, 2017

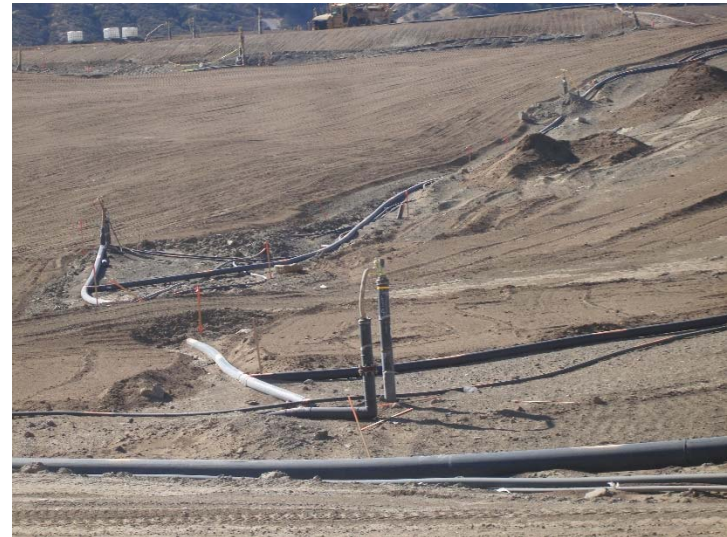
Photo 283: Top Deck & Slope Revegetation: December 12, 2017

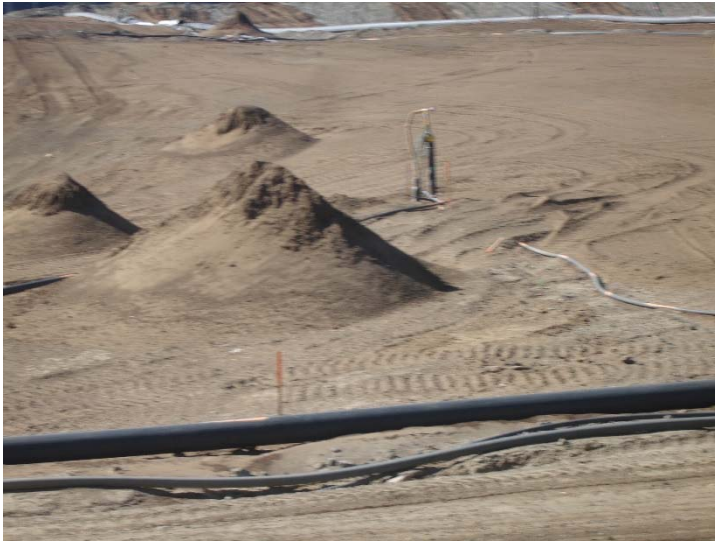
Photo 284: Top Deck & Slope Revegetation: December 12, 2017

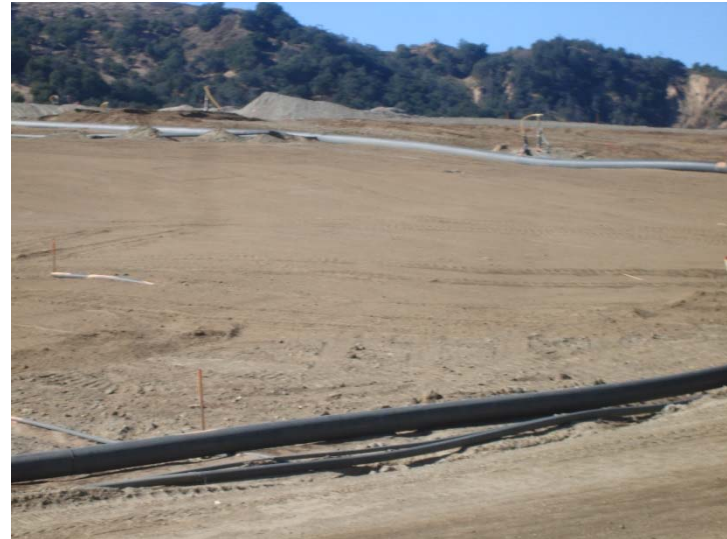
Photo 285: Top Deck & Slope Revegetation: December 12, 2017

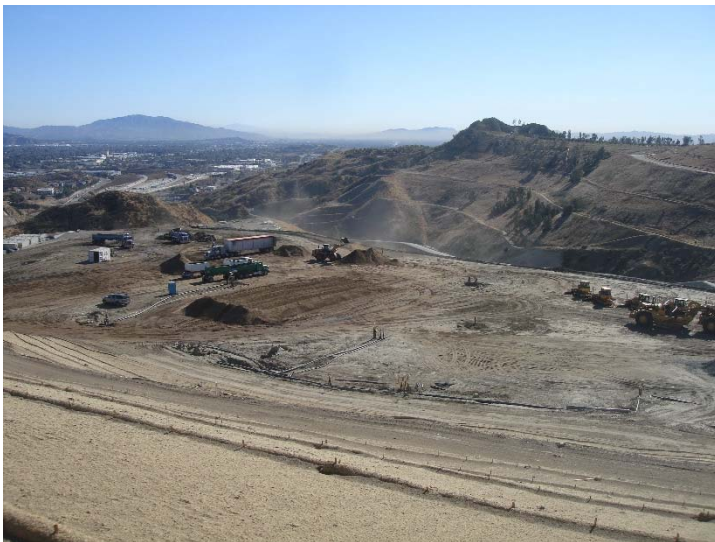
Photo 286: Top Deck & Slope Revegetation: December 12, 2017

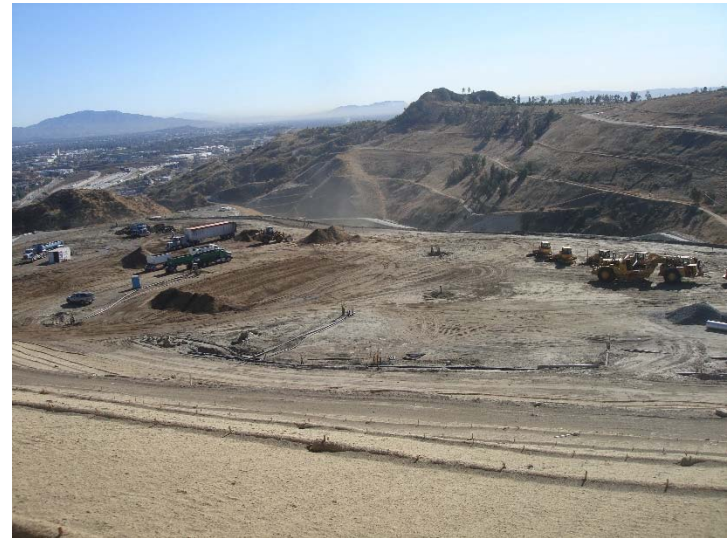
Photo 287: Old City North-Eastern and CC3B Top Decks: December 12, 2017

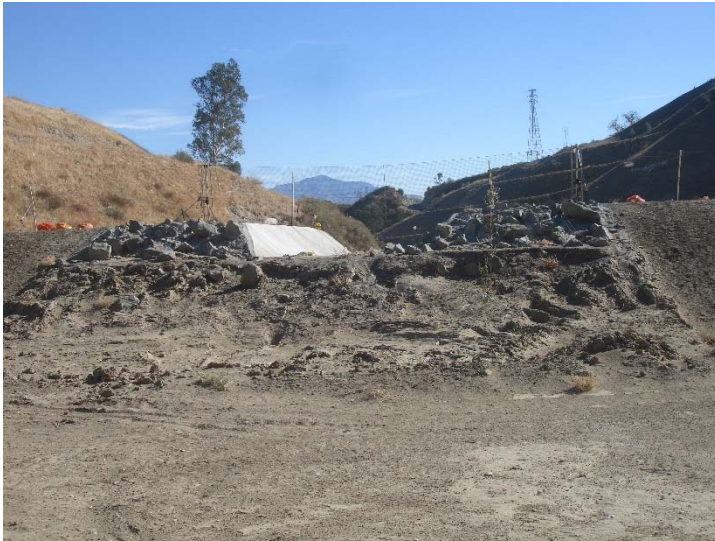
Photo 288: CC3B Top Deck: December 12, 2017

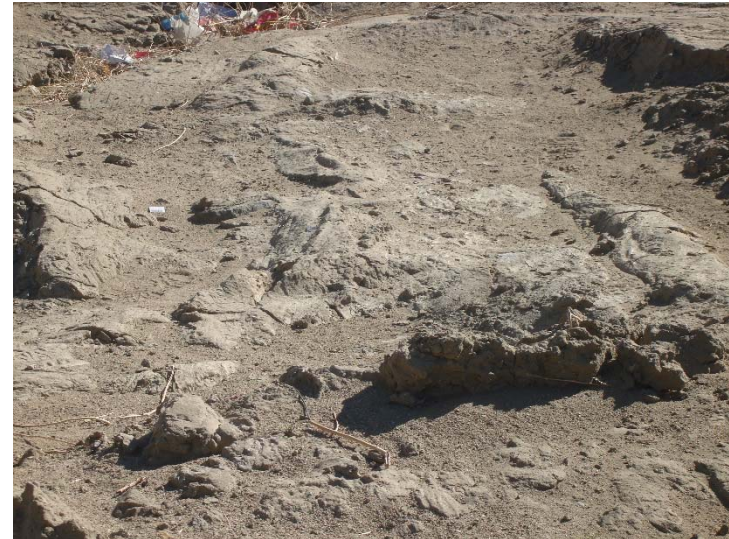
Photo 289: Basin CC3B Low & High Flow Outlet: December 12, 2017

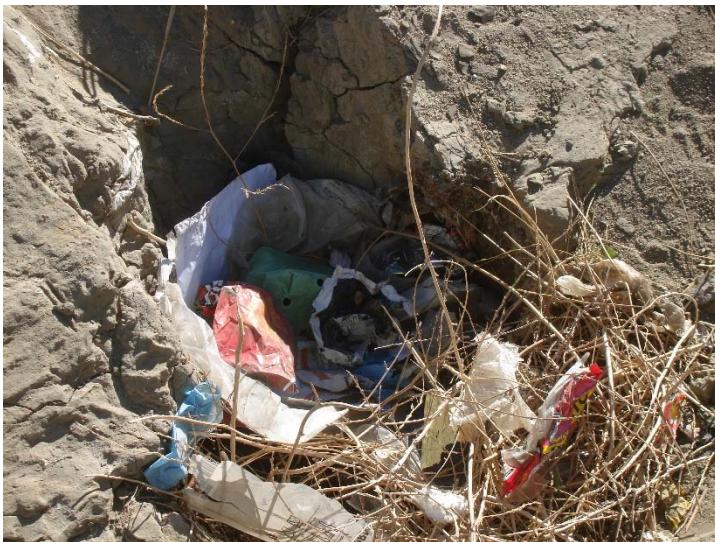
Photo 290: Basin CC3B Low & High Flow Outlet: December 12, 2017

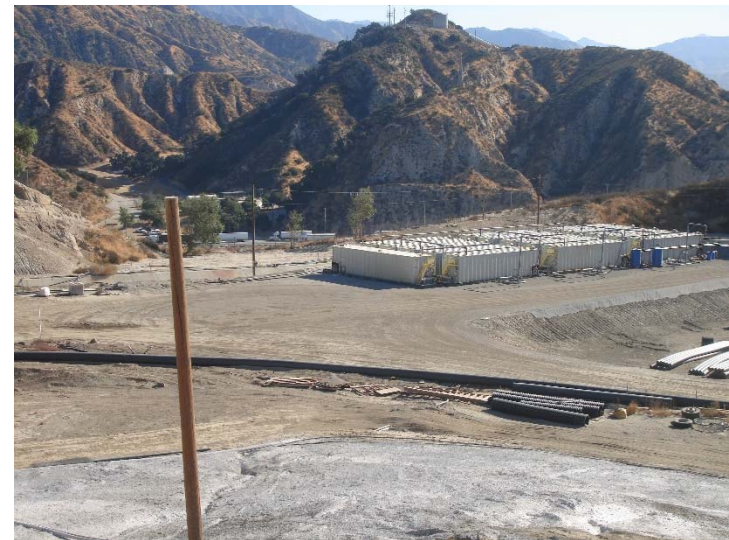
Photo 291: Basin CC3B Low & High Flow Outlet: December 12, 2017

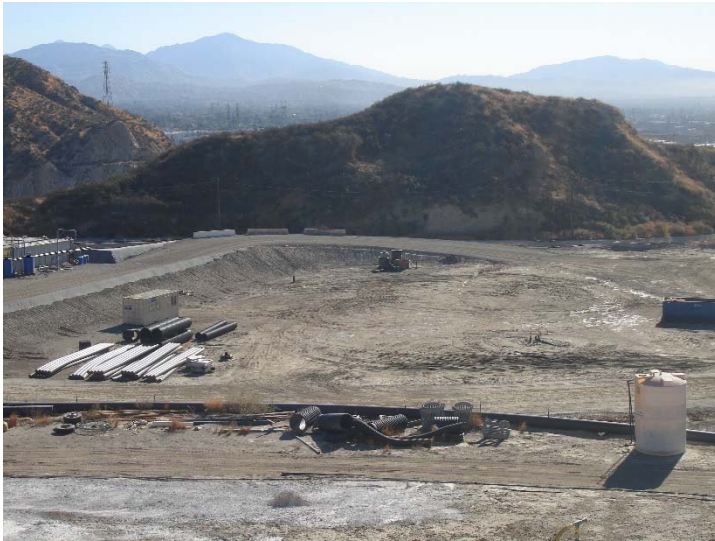
Photo 292: Old City North-Eastern Top Deck: Oct 26, 2017

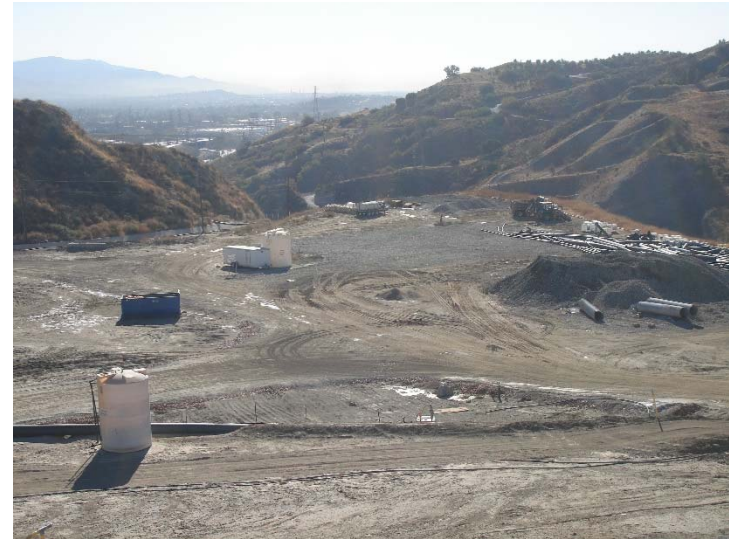
Photo 293: Old City North-Eastern Top Deck: Oct 26, 2017

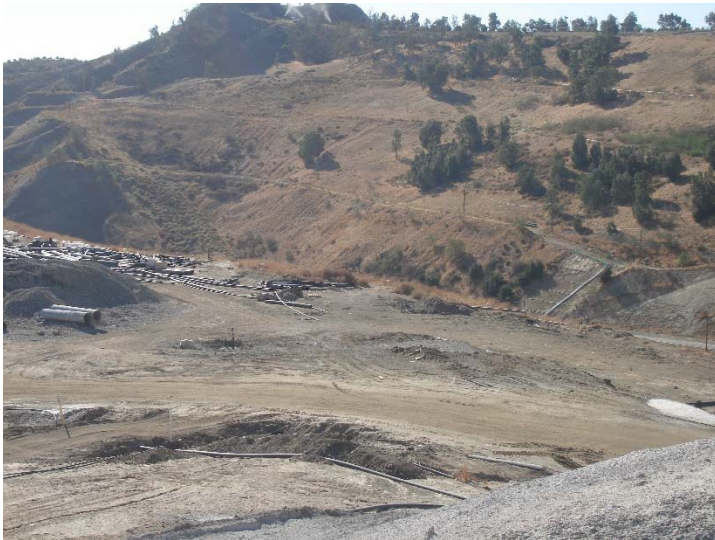
Photo 294: Old City North-Eastern Top Deck: Oct 26, 2017

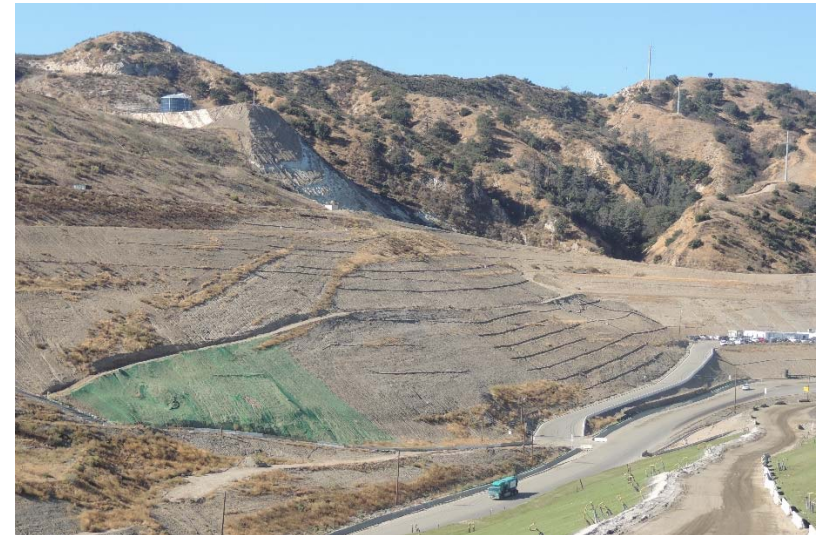
Photo 295: Old City North-Eastern Top Deck: Oct 26, 2017

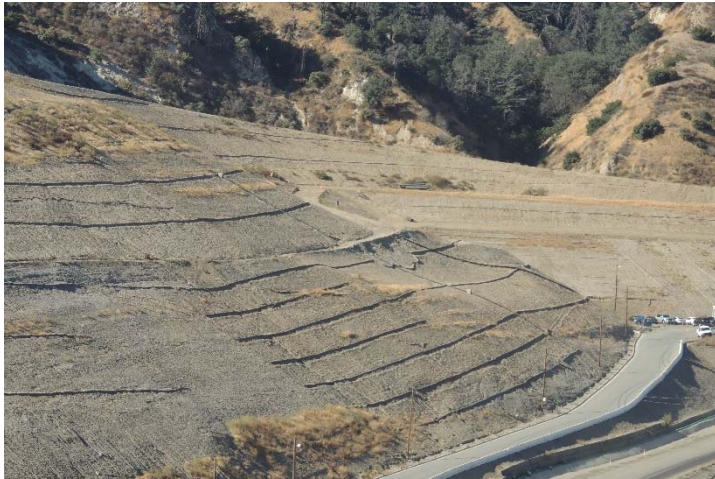
Photo 296: Old City Slope South of Office Flares 3: October 26, 2017
