**Sunshine Canyon Landfill
Independent Monitor
Quarterly Site Monitoring Status Report
October 1, 2017 – December 31, 2017**

March 6, 2018

The attached Quarterly Site Monitoring Status Report for the Sunshine Canyon Landfill dated March 6, 2018 is the Fourth Quarterly Report for 2017, issued by UltraSystems. This report covers the monitoring period from October 1, 2017 through December 31, 2017 and is prepared for the City of Los Angeles Department of City Planning and the County of Los Angeles Department of Regional Planning.

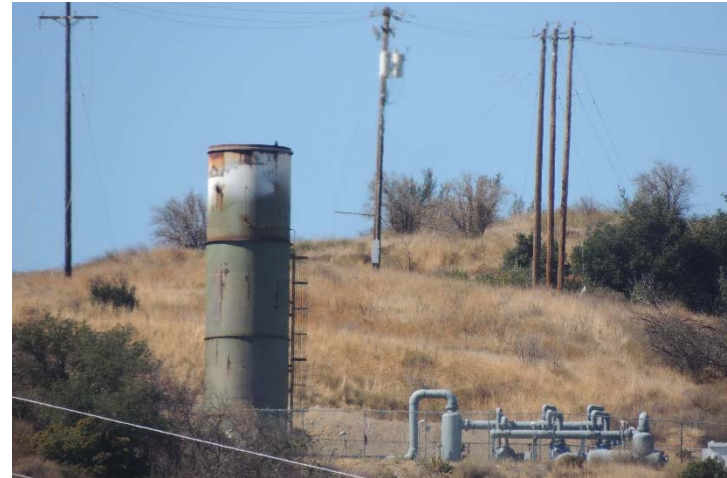
Photo 297: Old City Slope South of Office Flares 3: October 26, 2017

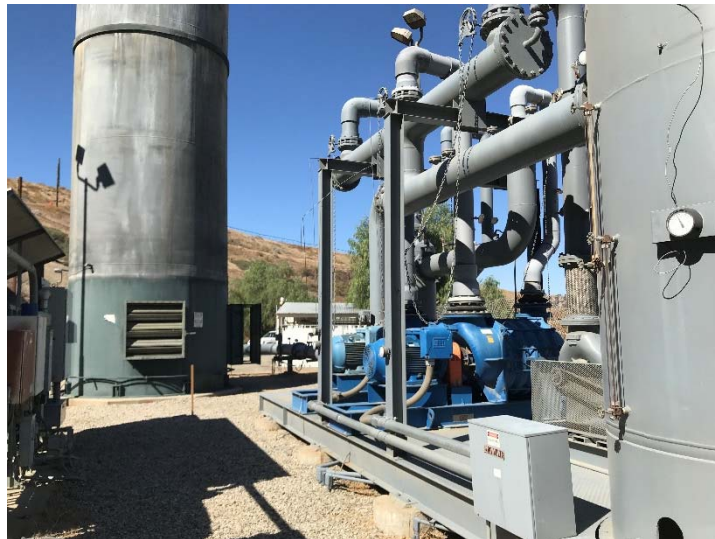
Photo 298: Old City Slope South of Office Flares 3: October 26, 2017

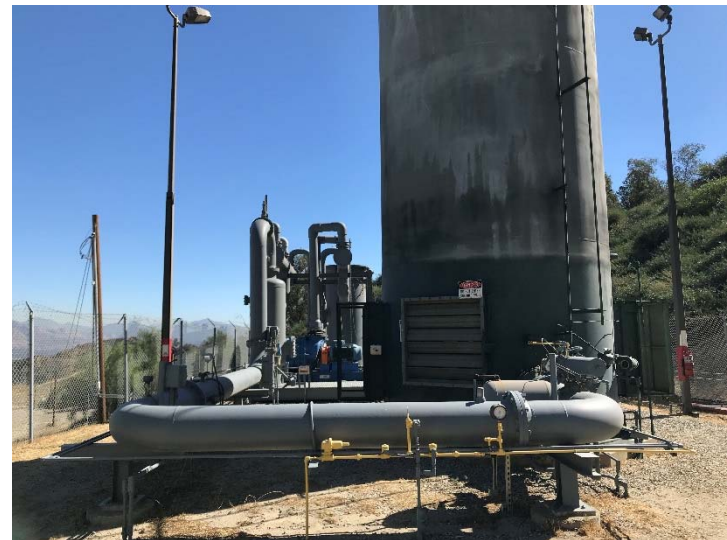
Photo 299: Old City Slope South of Office Flares 3: October 26, 2017

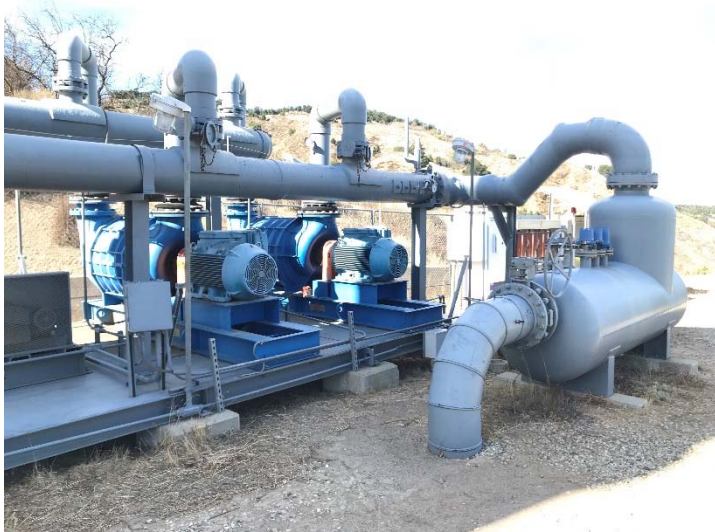
Photo 300: Old City Slope South of Office Flares 3: October 26, 2017

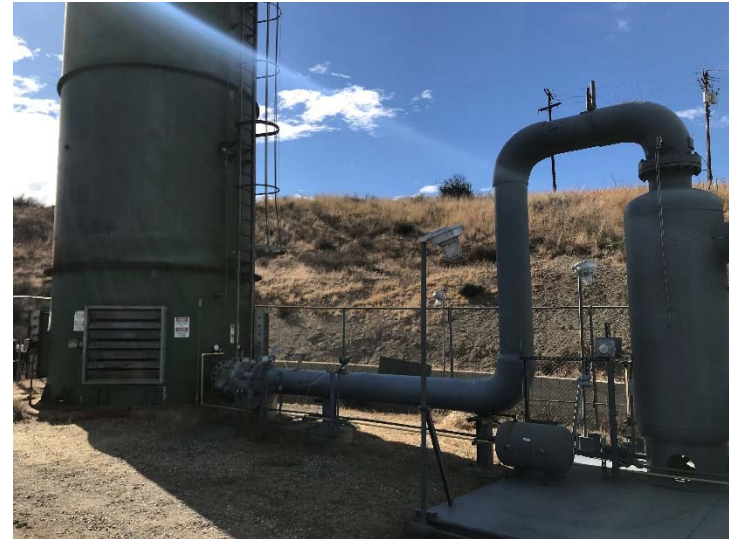
Photo 301: Flare 3: November 7, 2017

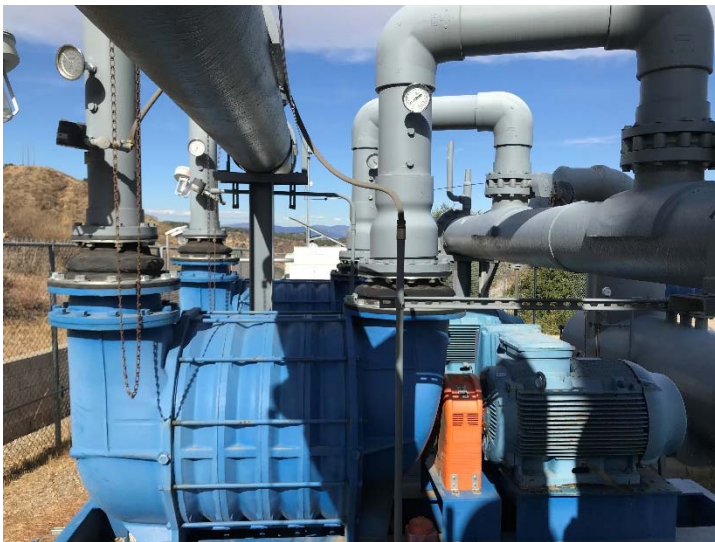
Photo 302: Flare 3: November 7, 2017

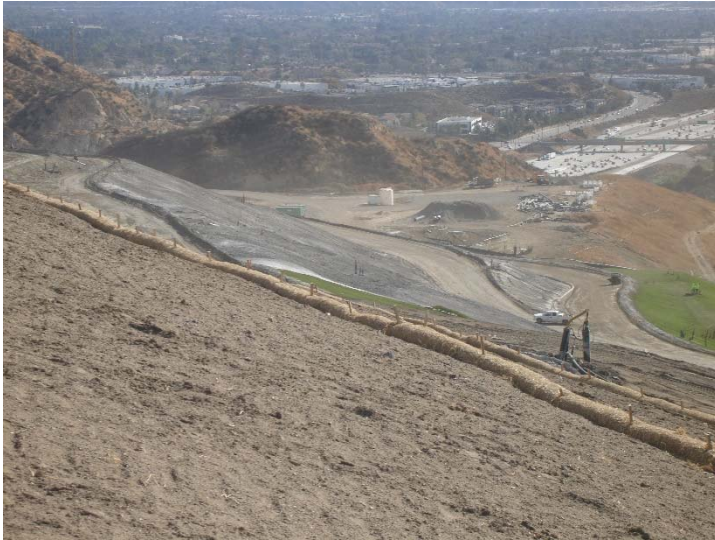
Photo 304: Old City North-Eastern and CC3B Top Decks: November 21, 2017

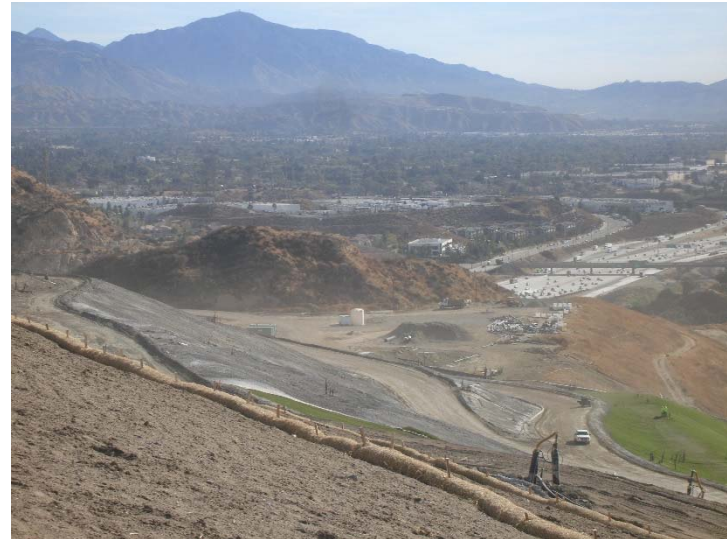
Photo 305: Old City North-Eastern Top Deck: November 21, 2017

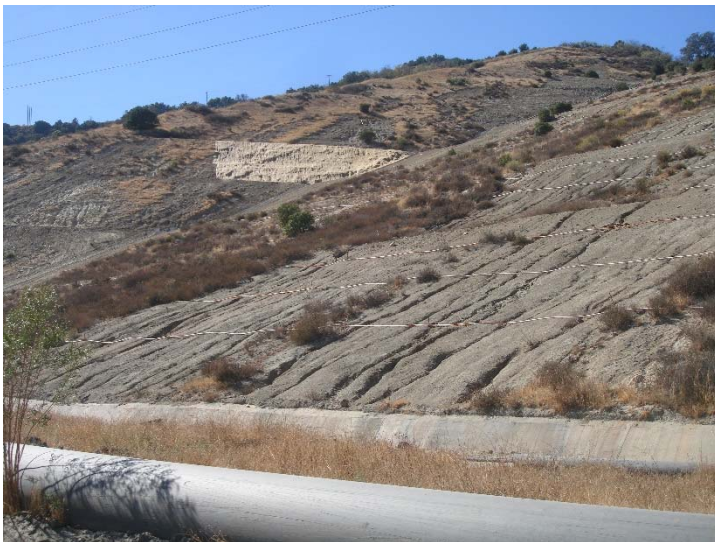
Photo 306: Old City North-Eastern Top Deck: November 21, 2017

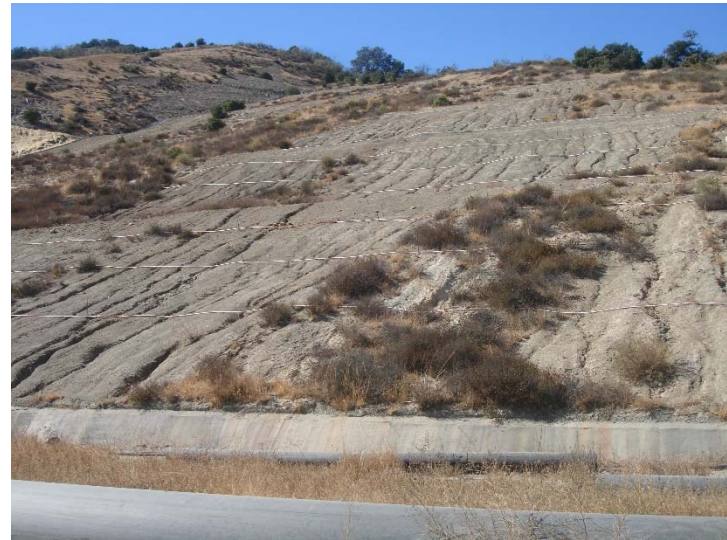
Photo 307: County Sage Mitigation Area Slope: October 26, 2017

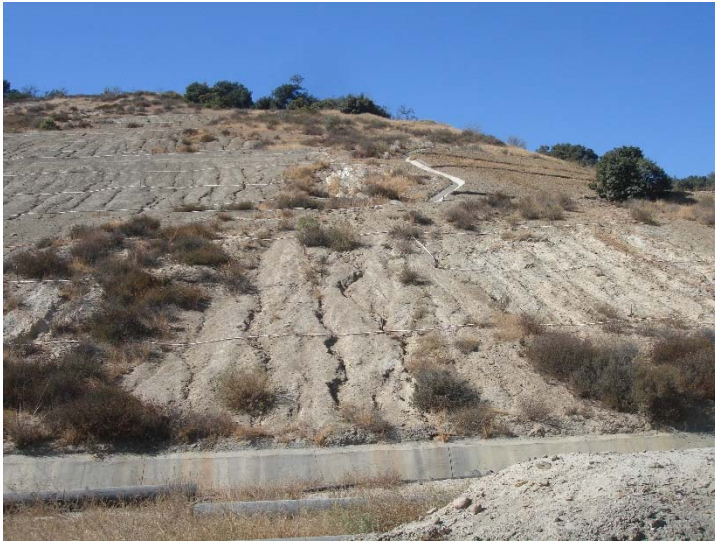
Photo 308: County Sage Mitigation Area Slope: October 26, 2017

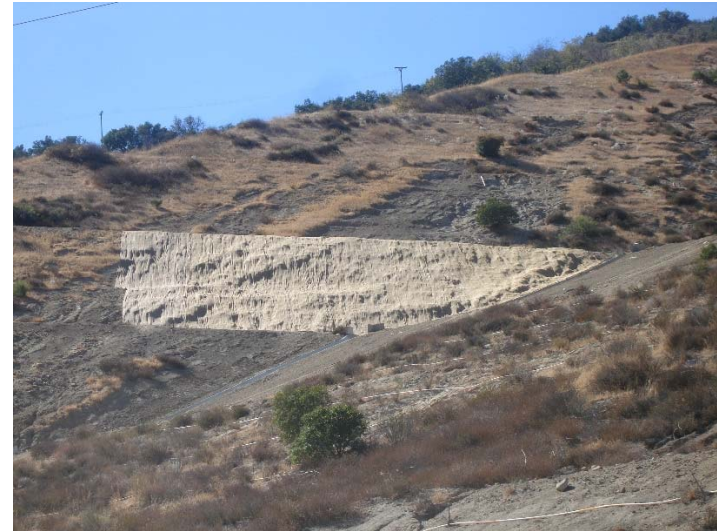
Photo 309: County Sage Mitigation Area Slope: October 26, 2017

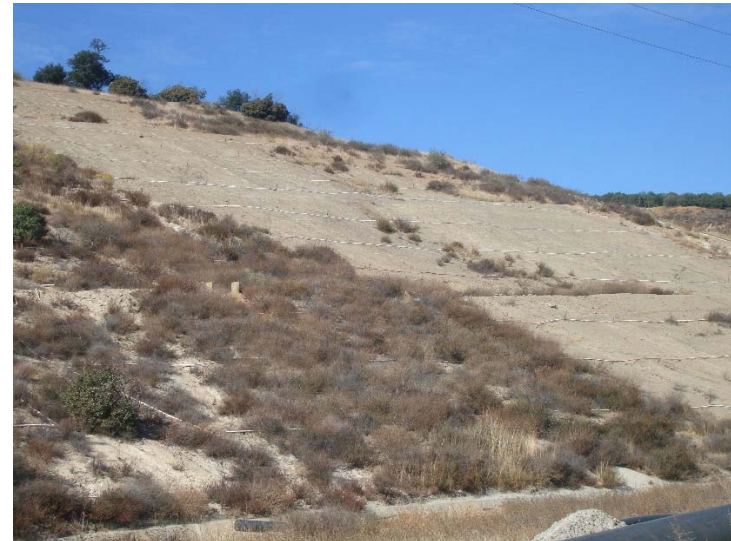
Photo 311: County Sage Mitigation Area Slope: November 7, 2017

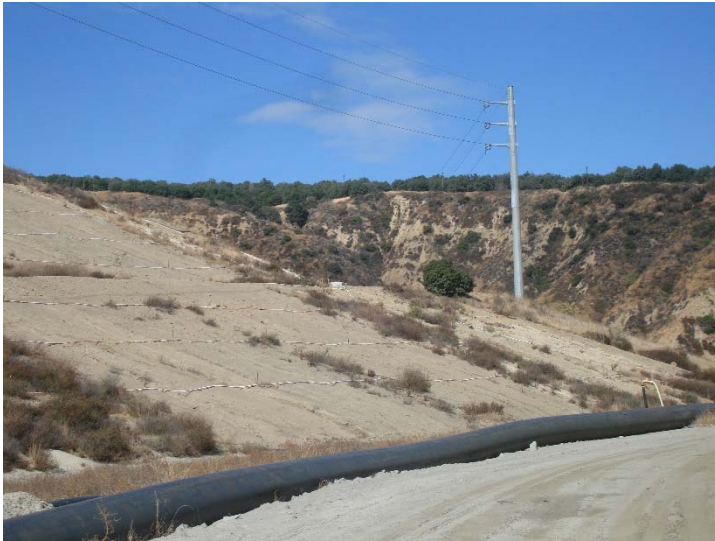
Photo 312: County Sage Mitigation Area Slope: November 7, 2017

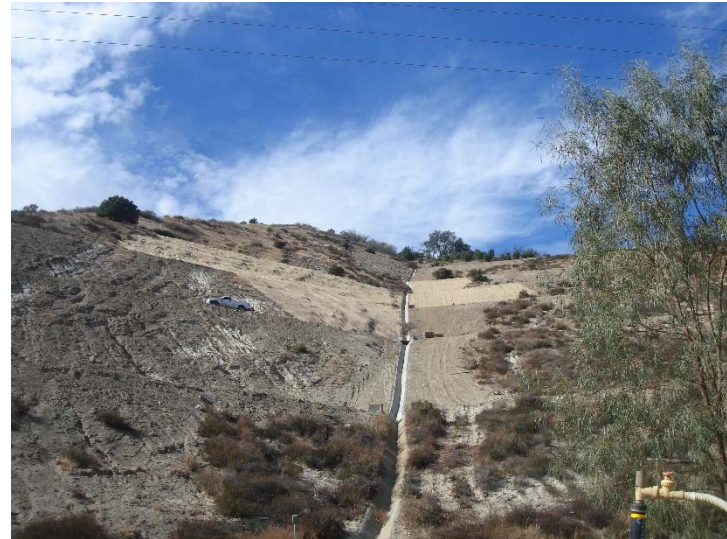
Photo 313: County Sage Mitigation Area Slope: November 7, 2017

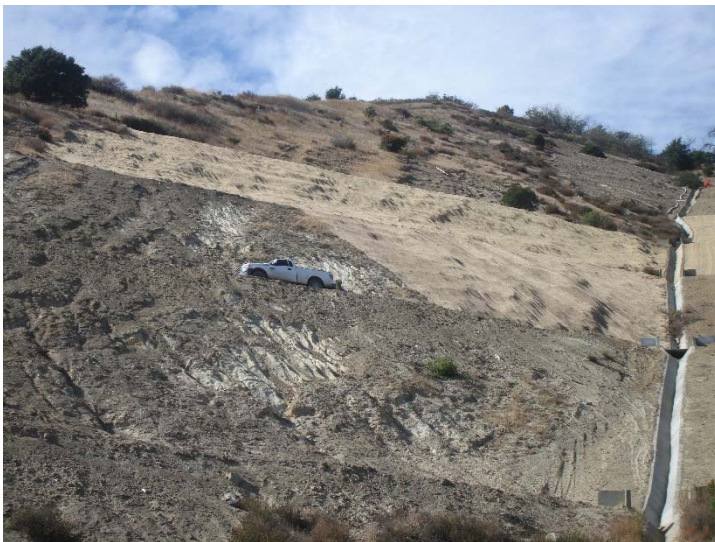
Photo 314: County Sage Mitigation Area Slope: November 7, 2017

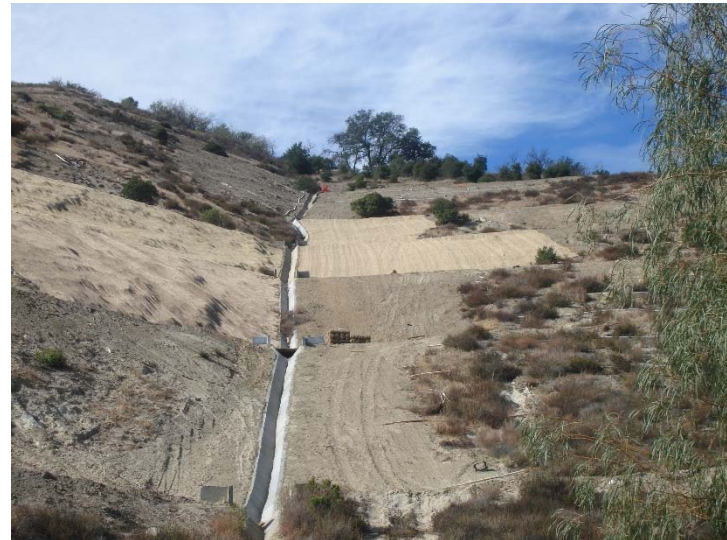
Photo 315: County Sage Mitigation Area Slope: November 7, 2017

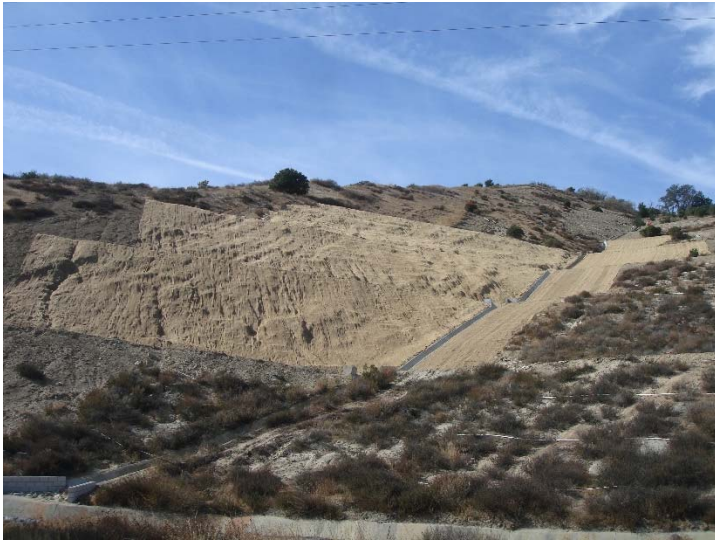
Photo 316: County Sage Mitigation Area Slope: November 7, 2017

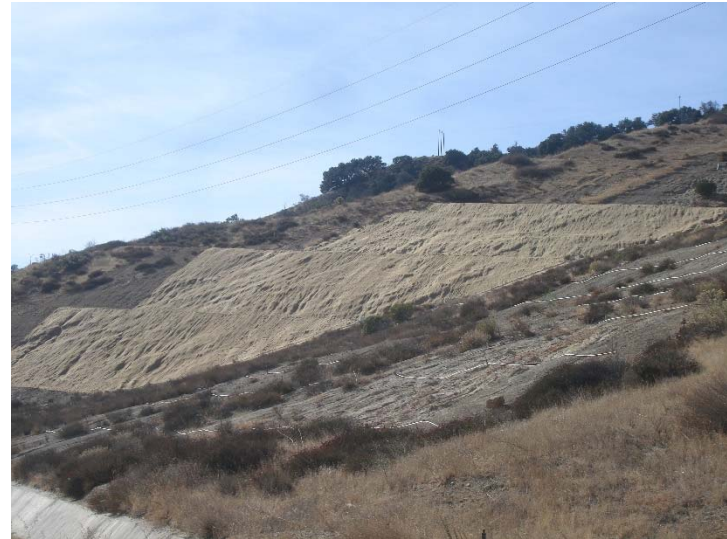
Photo 317: County Sage Mitigation Area Slope: November 21, 2017

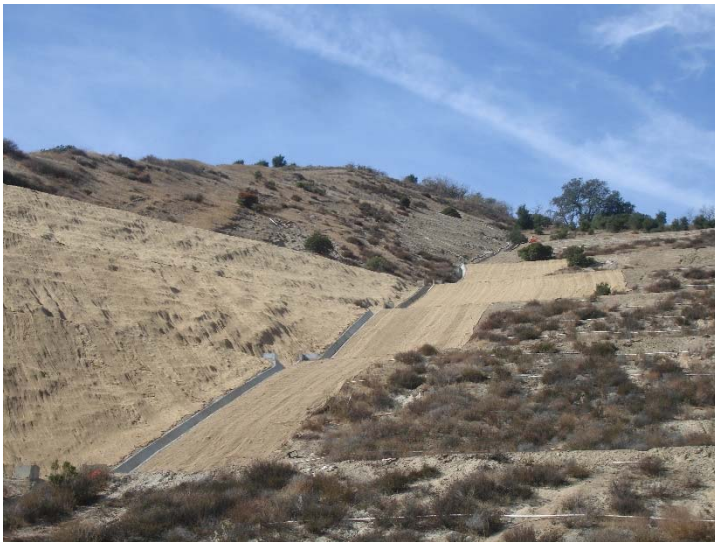
Photo 319: County Sage Mitigation Area Slope: November 21, 2017

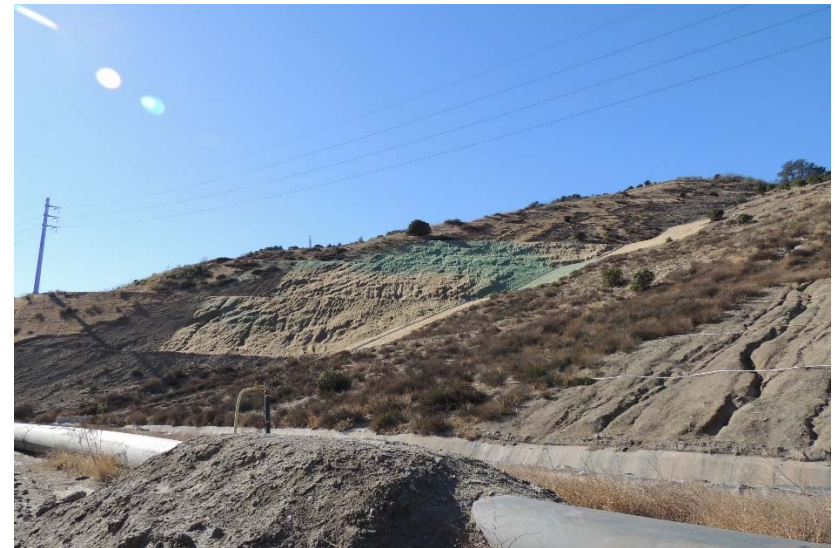
Photo 320: County Sage Mitigation Area Slope: December 12, 2017

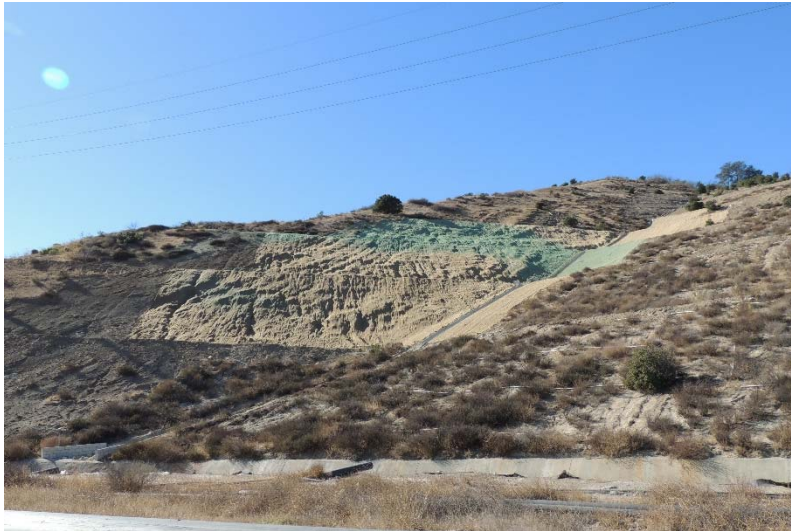
Photo 321: County Sage Mitigation Area Slope: December 12, 2017

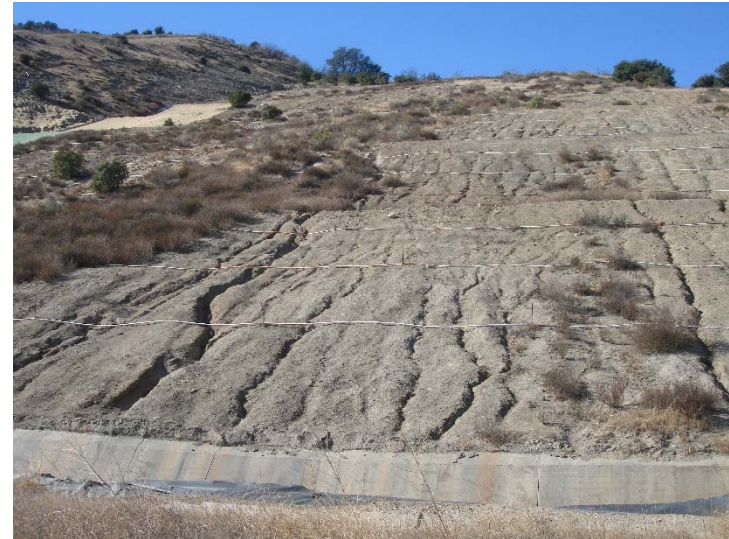
Photo 322: County Sage Mitigation Area Slope: December 12, 2017

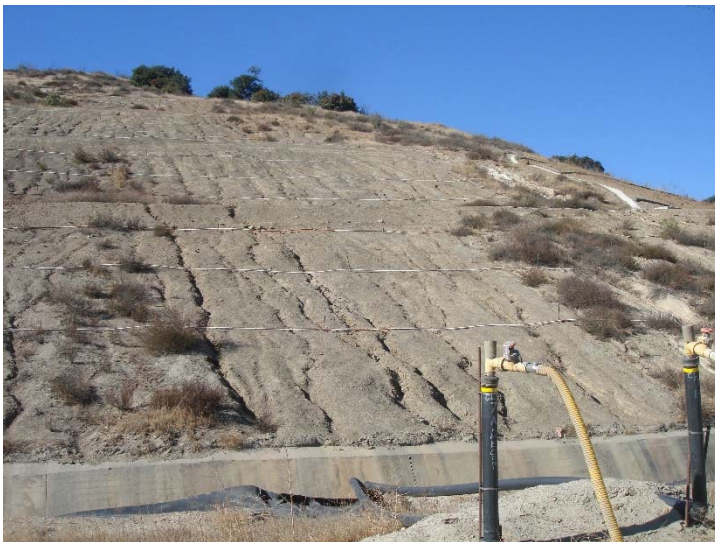
Photo 323: County Sage Mitigation Area Slope: December 12, 2017

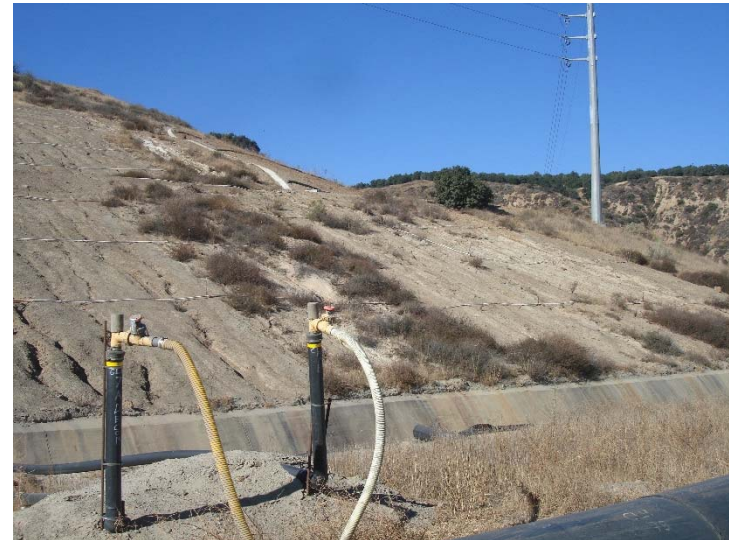
Photo 324: County Sage Mitigation Area Slope: December 12, 2017

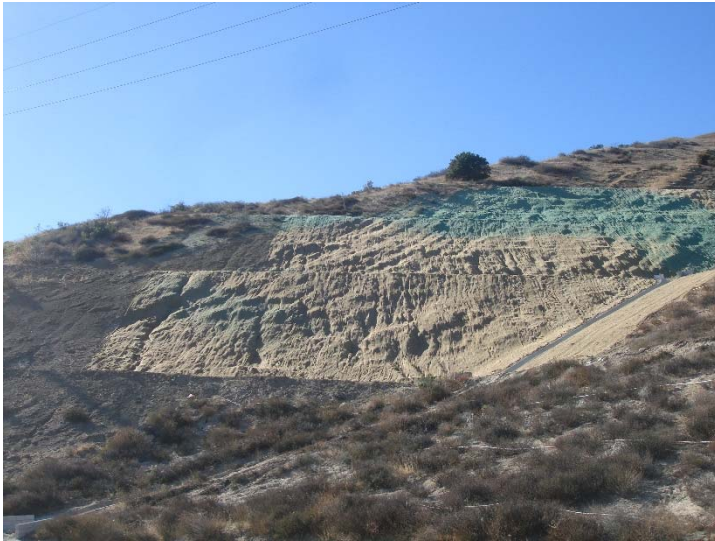
Photo 325: County Sage Mitigation Area Slope: December 12, 2017

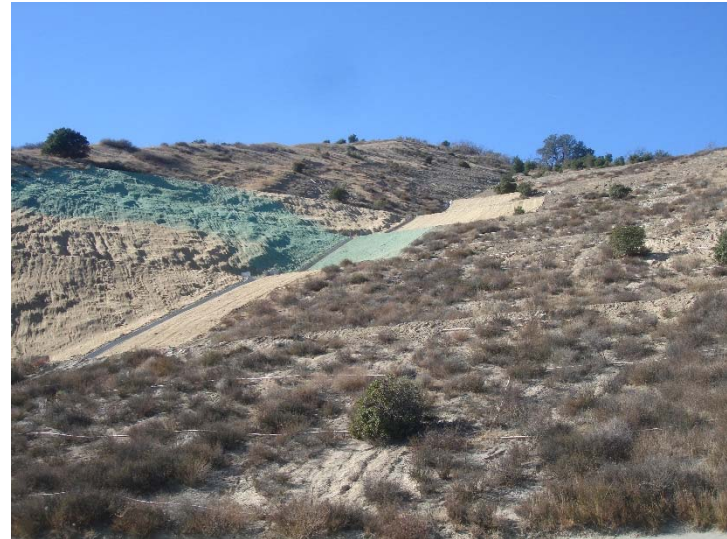
Photo 326: County Sage Mitigation Area Slope: December 12, 2017

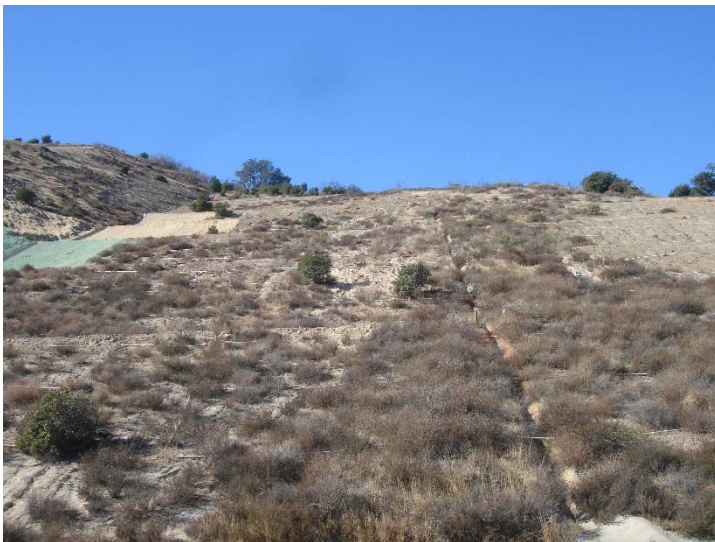
Photo 327: County Sage Mitigation Area Slope: December 12, 2017

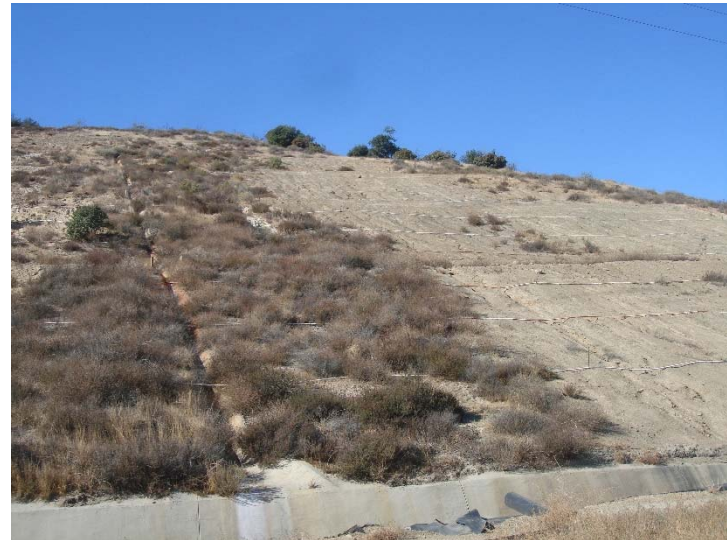
Photo 328: County Sage Mitigation Area Slope: December 12, 2017

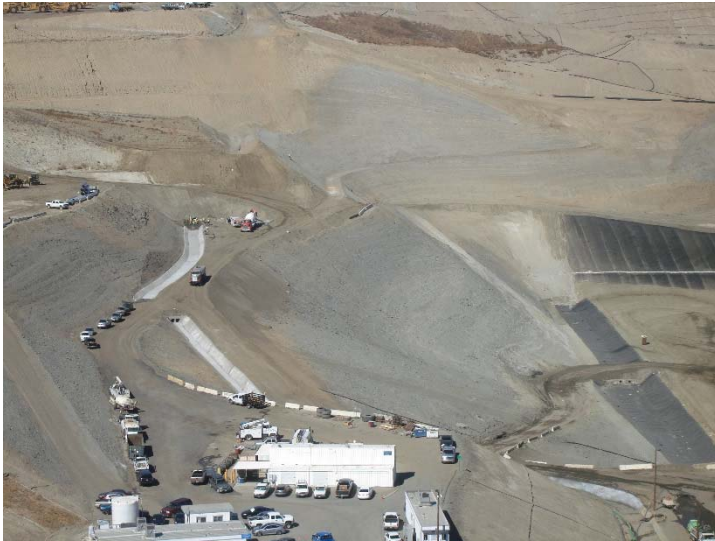
Photo 329: New Concrete Westside Drainage Channel: October 26, 2017

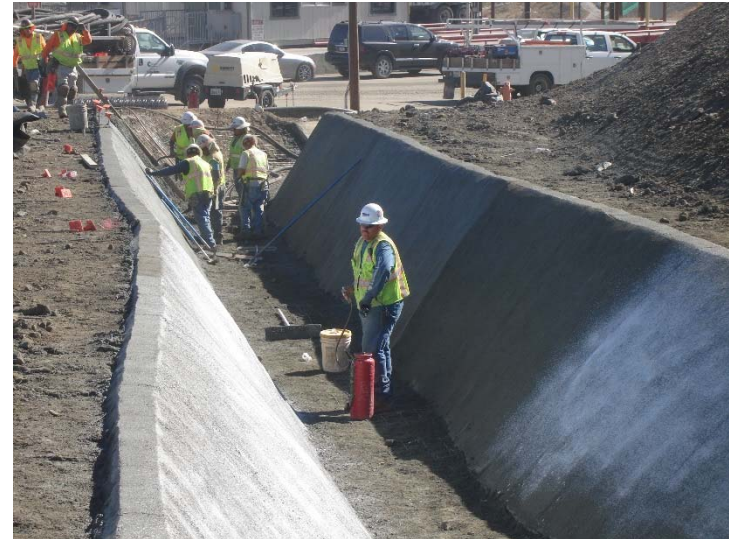
Photo 330: New Concrete Westside Drainage Channel: October 26, 2017

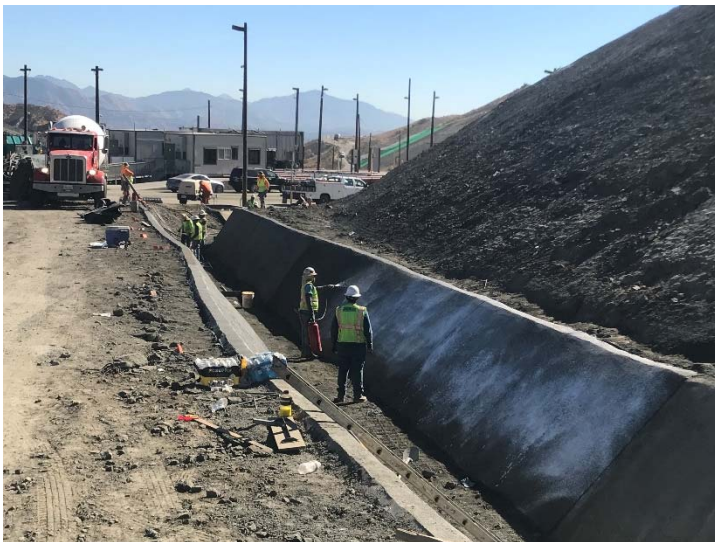
Photo 331: New Concrete Westside Drainage Channel: October 26, 2017

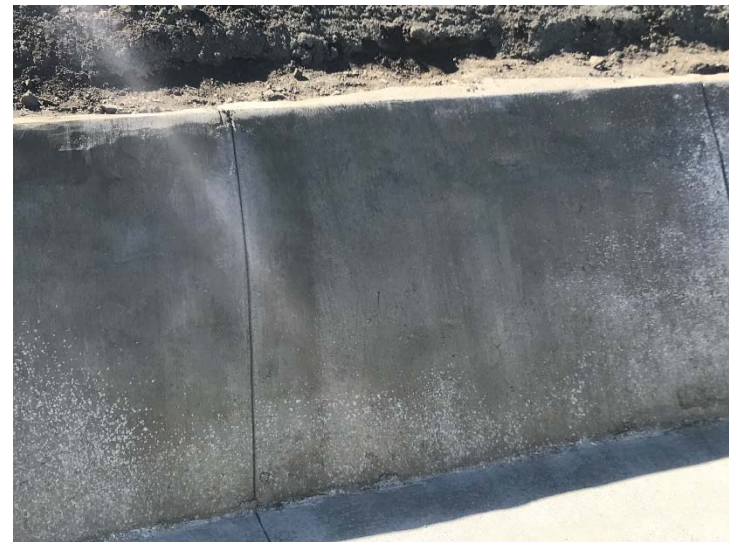
Photo 332: New Concrete Westside Drainage Channel: October 26, 2017

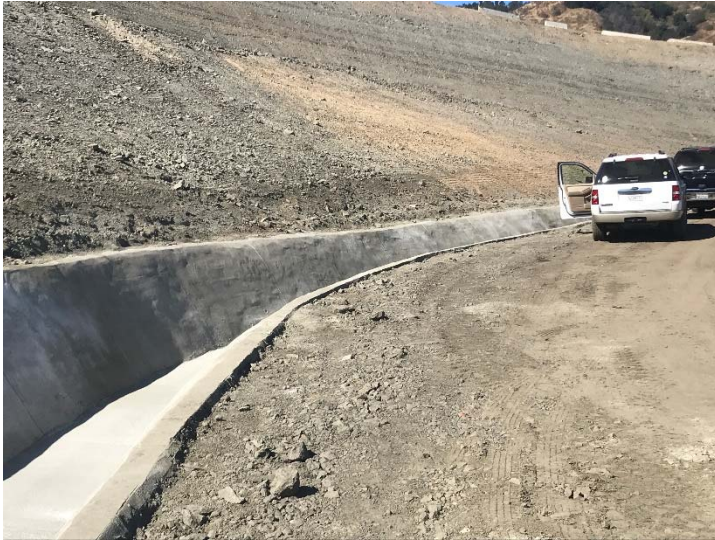
Photo 333: New Concrete Westside Drainage Channel: October 26, 2017

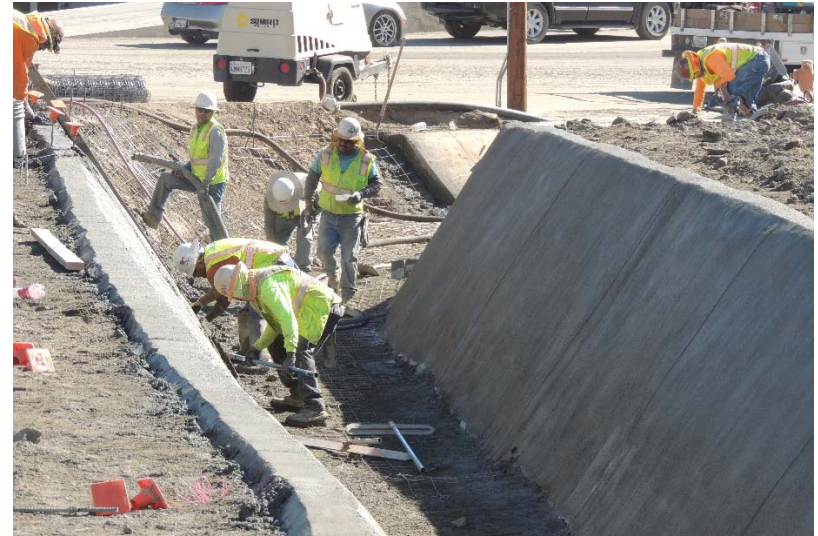
Photo 334: New Concrete Westside Drainage Channel: October 26, 2017

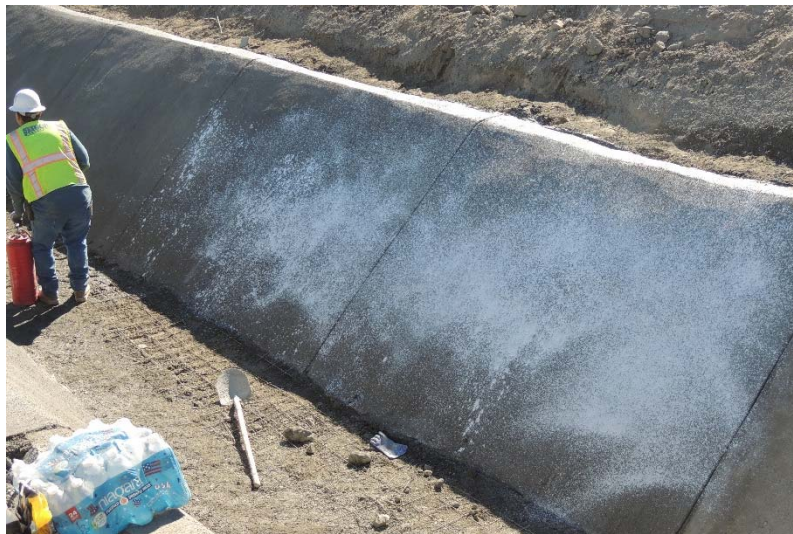
Photo 335: New Concrete Westside Drainage Channel: October 26, 2017

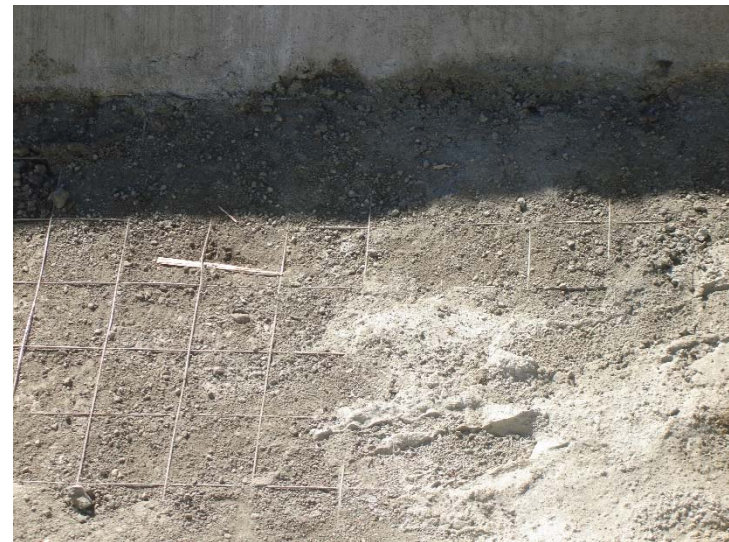
Photo 336: New Concrete Westside Drainage Channel: October 26, 2017

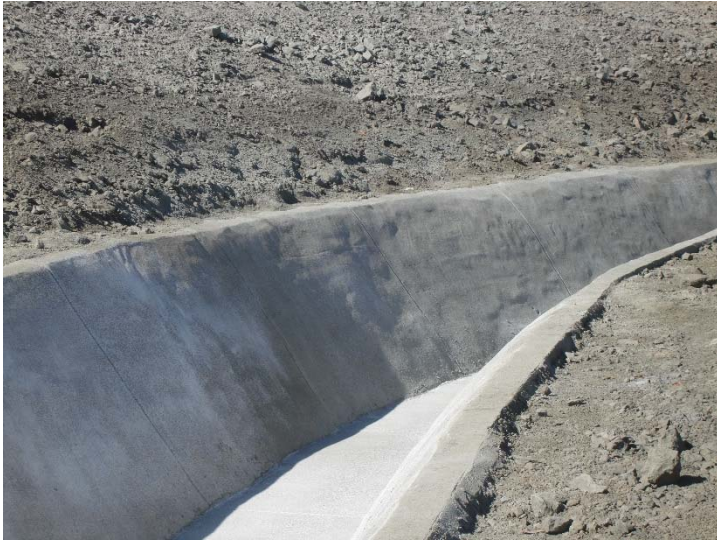
Photo 337: New Concrete Westside Drainage Channel: October 26, 2017

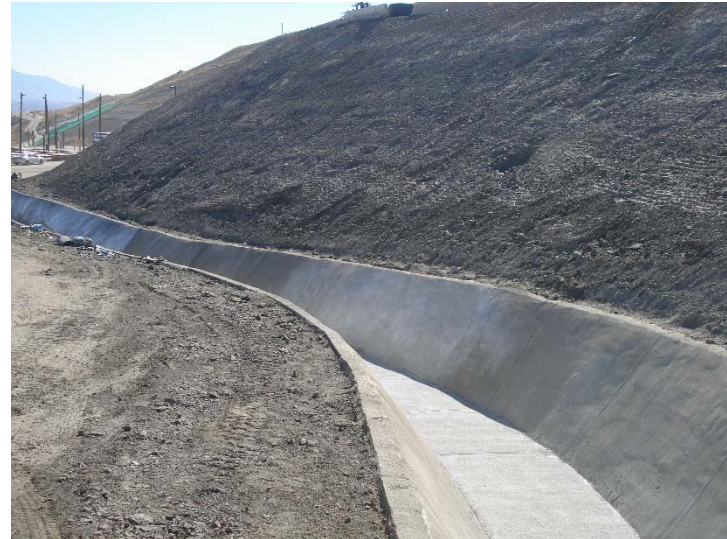
Photo 338: New Concrete Westside Drainage Channel: October 26, 2017

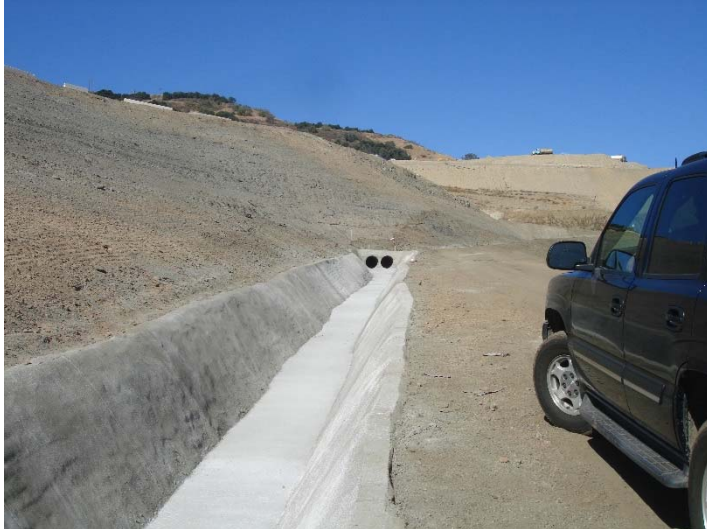
Photo 339: New Concrete Westside Drainage Channel: October 26, 2017

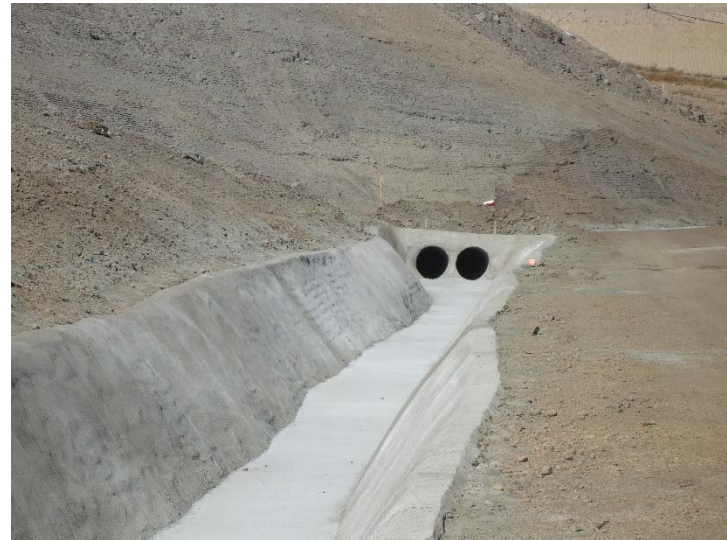
Photo 340: New Concrete Westside Drainage Channel: October 26, 2017

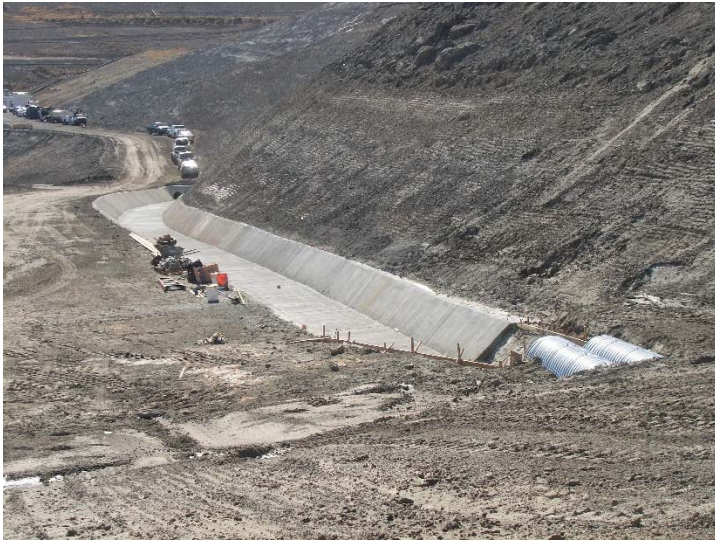
Photo 341: New Concrete Westside Drainage Channel: October 26, 2017

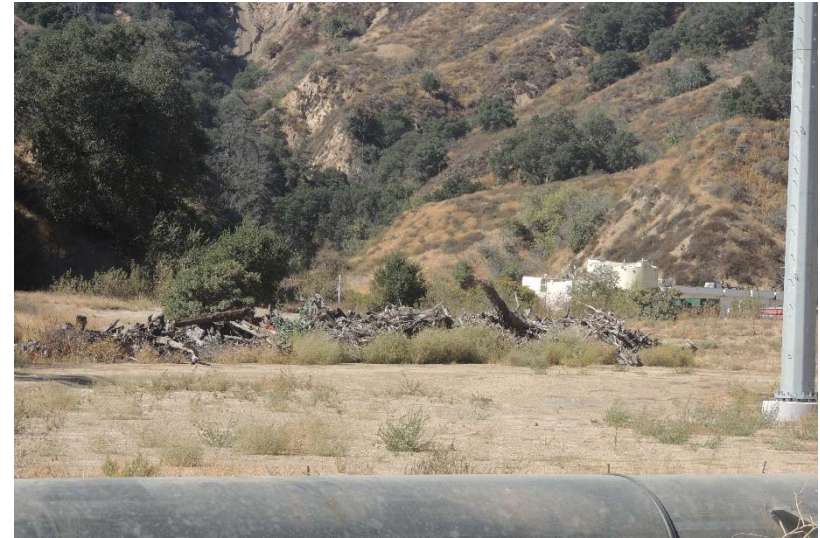
Photo 342: Waste Material near Basin D Storage Area: Oct 26, 2017

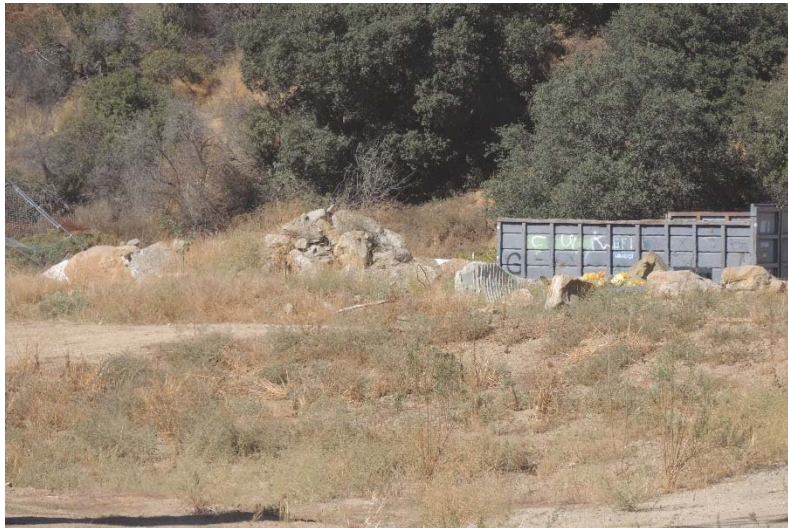
Photo 343: Waste Material near Basin D Storage Area: Oct 26, 2017

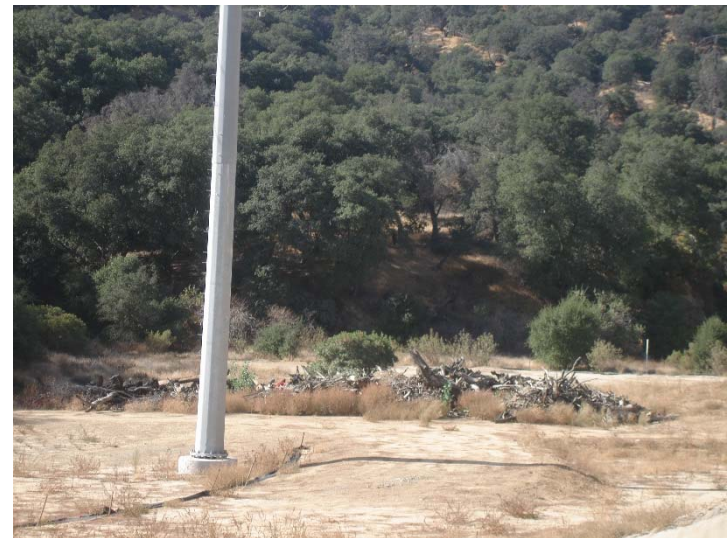
Photo 344: Waste Material near Basin D Storage Area: November 21, 2017

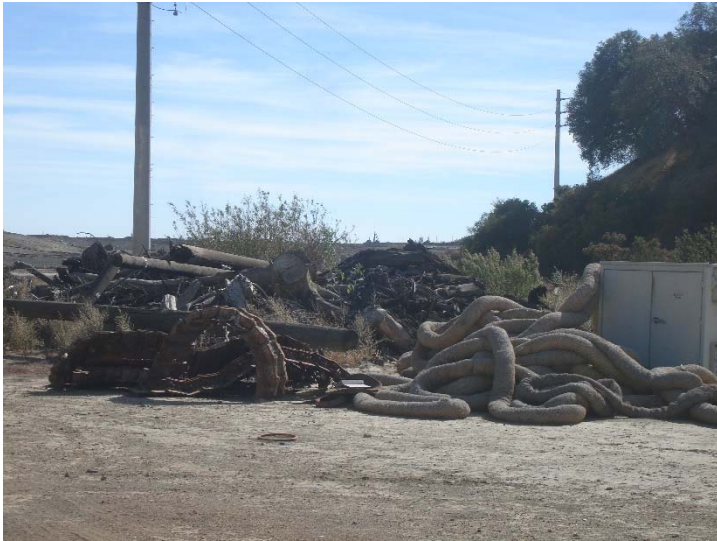
Photo 345: Waste Material near Basin D Storage Area: November 21, 2017

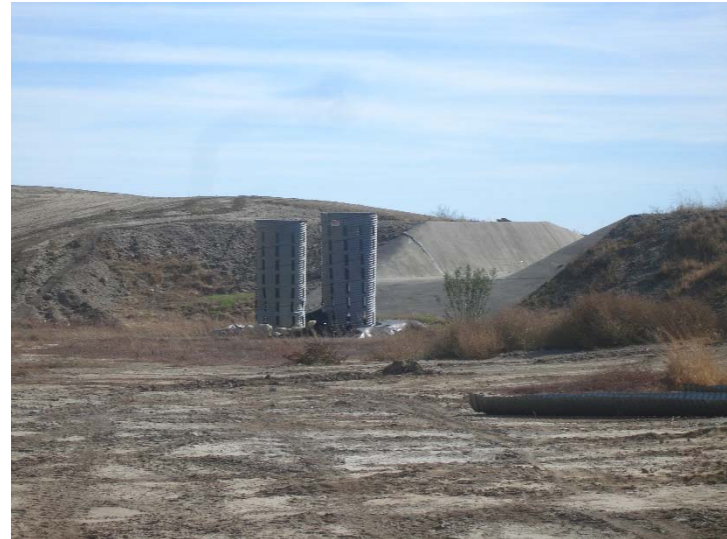
Photo 346: Basin D: November 21, 2017

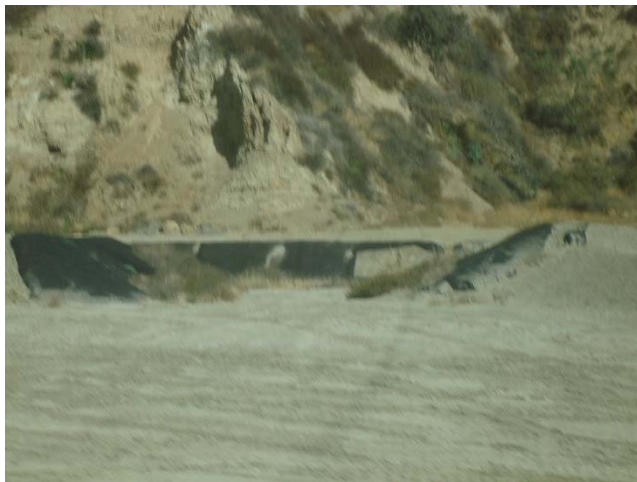
Photo 347: Basin D: November 21, 2017

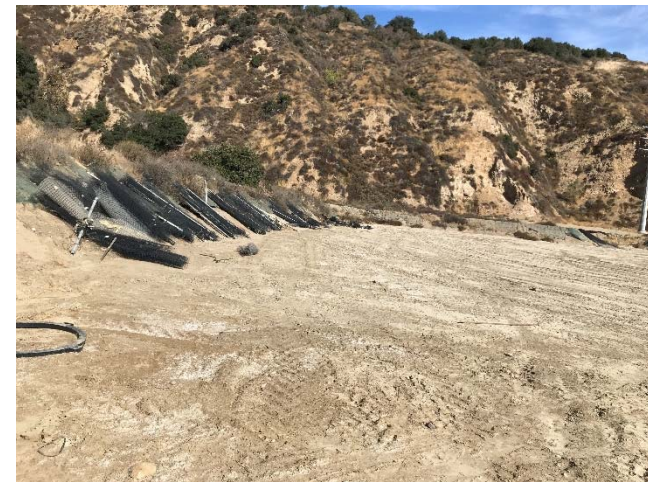
Photo 348: Basin D: November 21, 2017

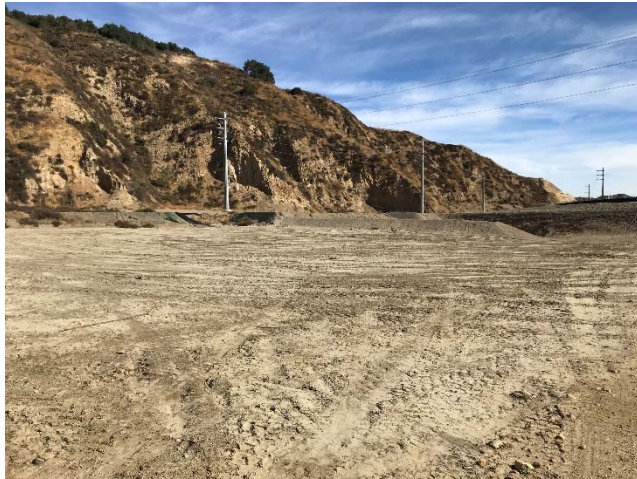
Photo 349: Basin D: November 21, 2017

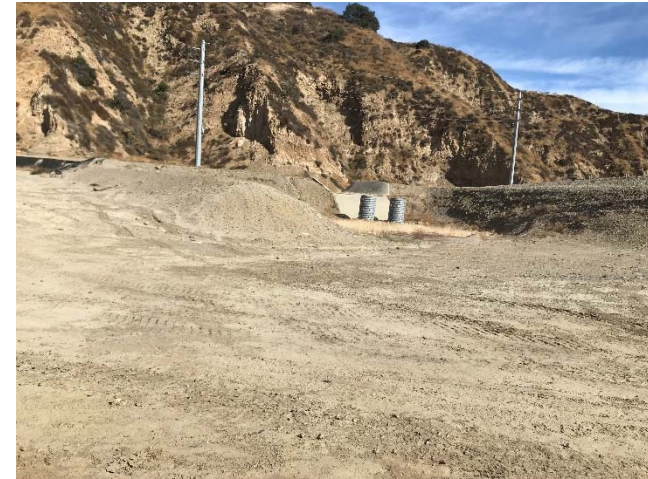
Photo 350: Basin D: November 21, 2017

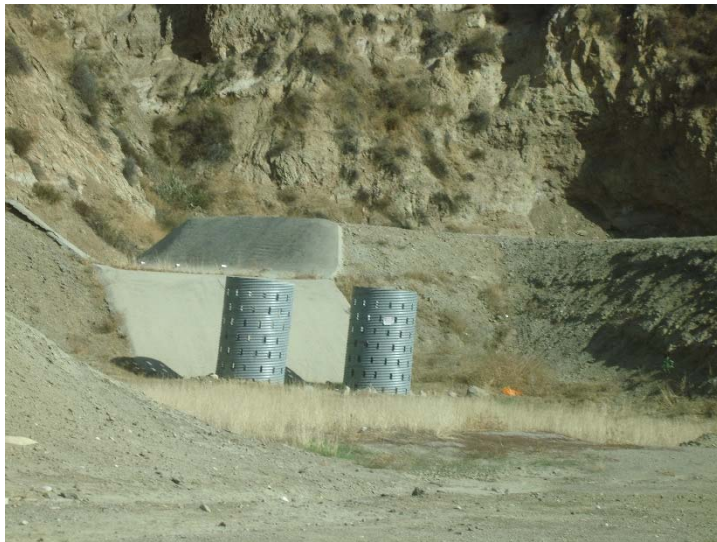
Photo 351: Basin D: November 21, 2017

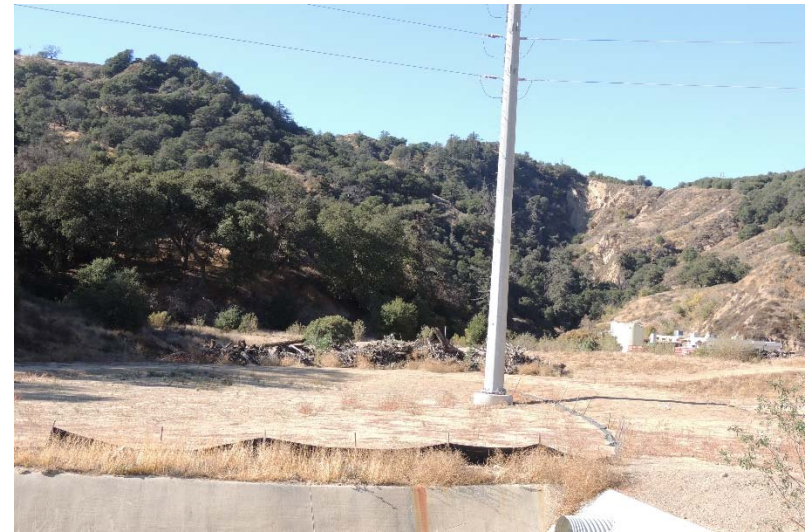
Photo 352: Waste Material near Basin D Storage Area: December 12, 2017

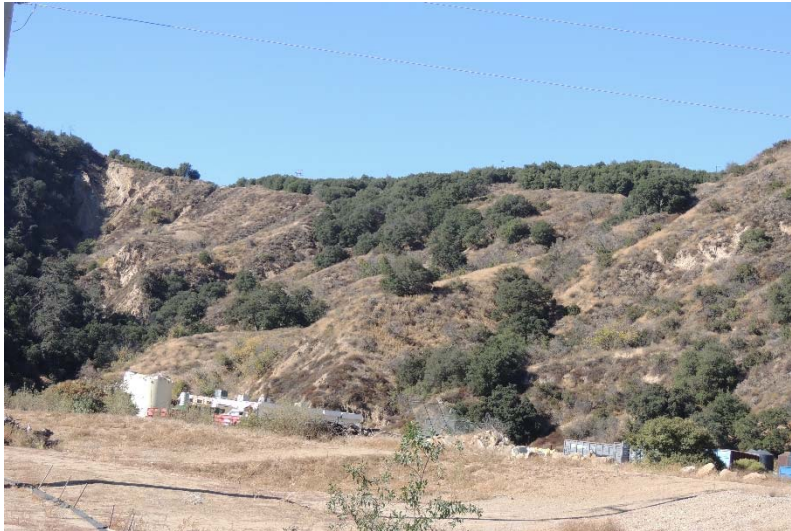
Photo 353: Waste Material near Basin D Storage Area: December 12, 2017

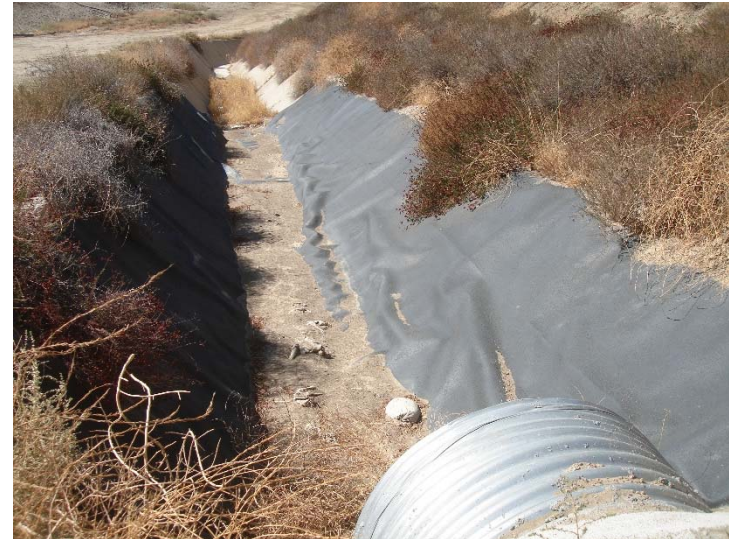
Photo 354: Basin D Outlet Channel: Oct 26, 2017

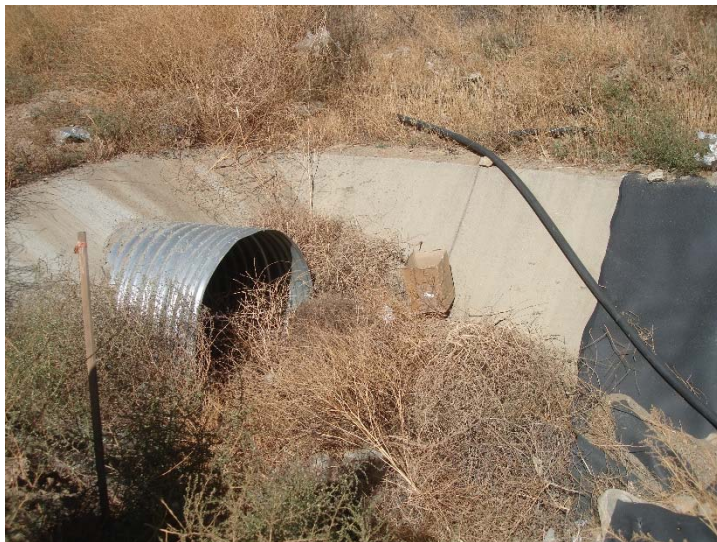
Photo 355: Basin D Outlet Channel: Oct 26, 2017

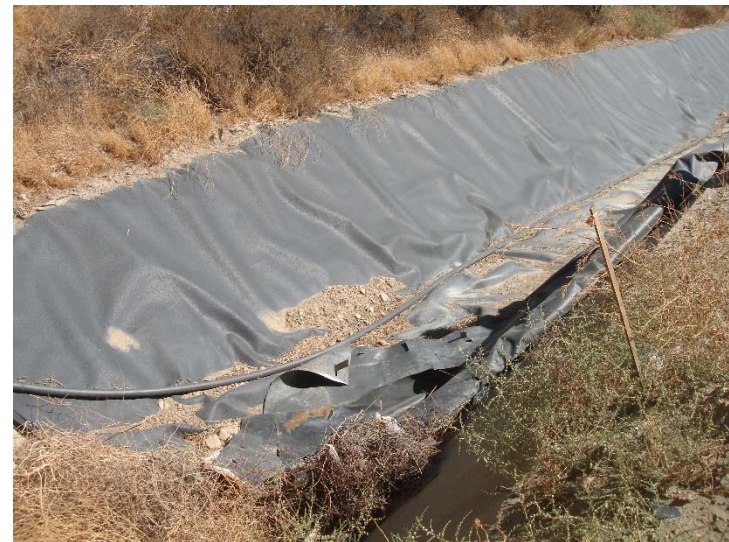
Photo 356: Basin D Outlet Channel: Oct 26, 2017
