**Sunshine Canyon Landfill
Independent Monitor
Quarterly Site Monitoring Status Report
October 1, 2017 – December 31, 2017**

March 6, 2018

The attached Quarterly Site Monitoring Status Report for the Sunshine Canyon Landfill dated March 6, 2018 is the Fourth Quarterly Report for 2017, issued by UltraSystems. This report covers the monitoring period from October 1, 2017 through December 31, 2017 and is prepared for the City of Los Angeles Department of City Planning and the County of Los Angeles Department of Regional Planning.

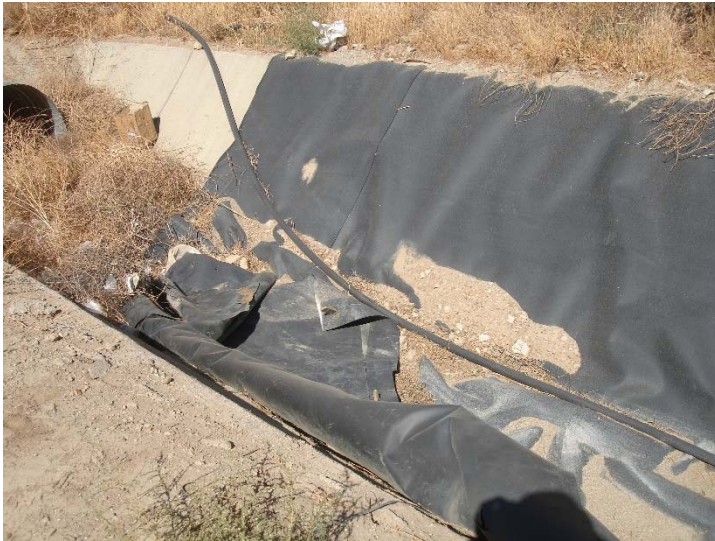
Photo 357: Basin D Outlet Channel: Oct 26, 2017

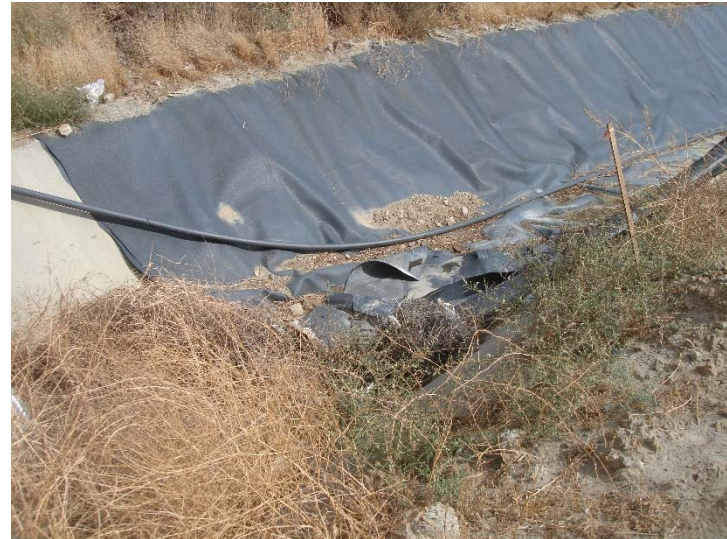
Photo 358: Basin D Outlet Channel: November 7, 2017

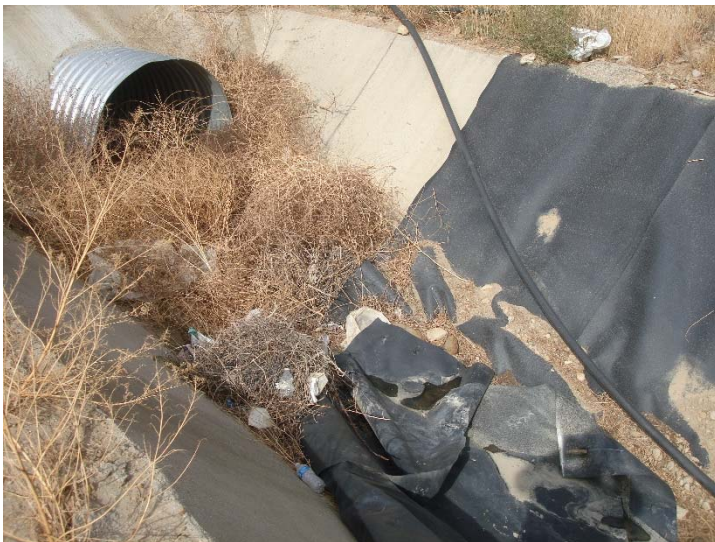
- Flare 11 equipment was being installed. Flares 9 and 10 were not running due to equipment tie-ins for Flare 11.
- Basin D outlet channel has the HDPE liner material torn, lifted, and could block stormwater flow. Debris and tumbleweed was observed in multiple areas and could block flow.

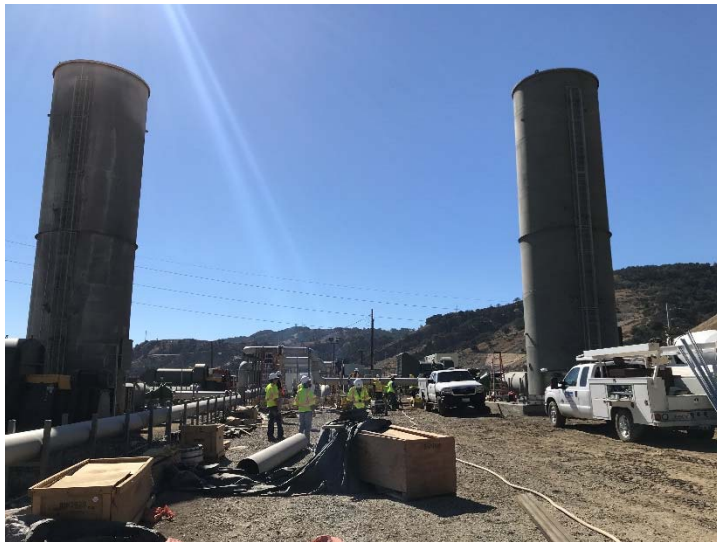
Photo 368: Flare 11 Construction: October 26, 2017

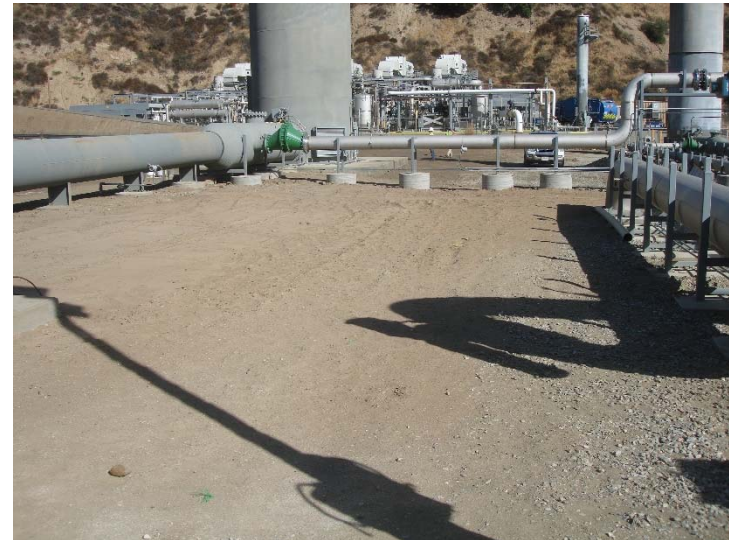
Photo 395: Flares 9, 10 & 11 Blower Knock-Out Liquids: November 21, 2017

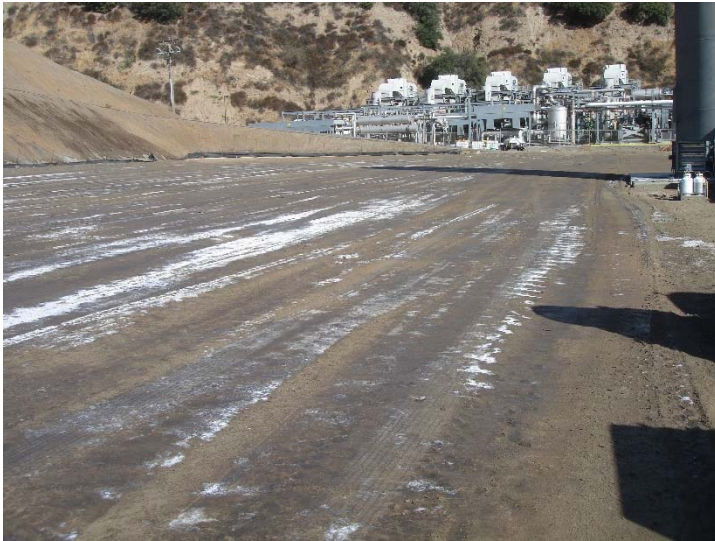
Photo 396: Flares 9, 10 & 11 Unsealed Dirt Pad Area: November 21, 2017

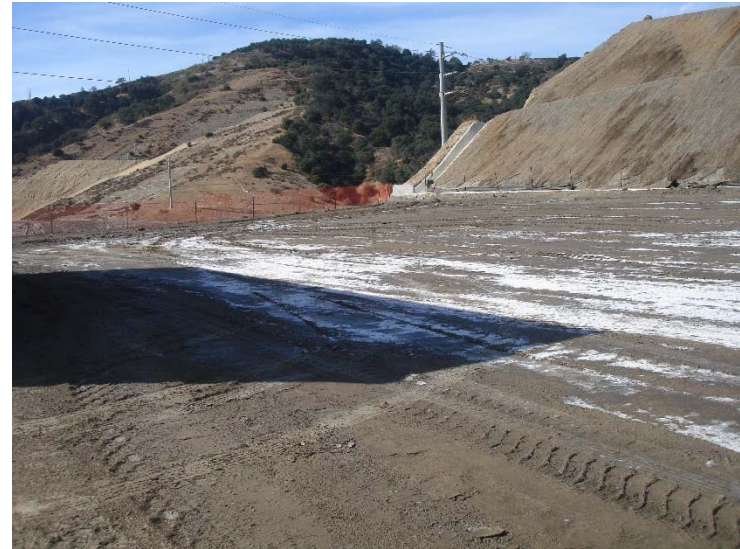
Photo 397: Flares 9, 10 & 11 Sealed Dirt Pad Area: November 21, 2017

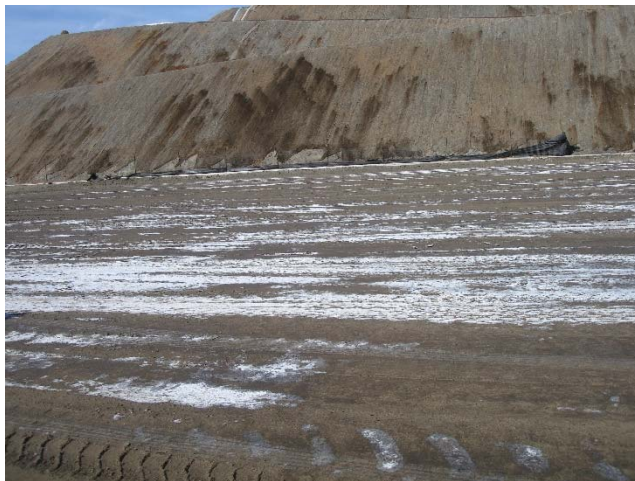
Photo 398: Flares 9, 10 & 11 Sealed Dirt Pad Area: November 21, 2017

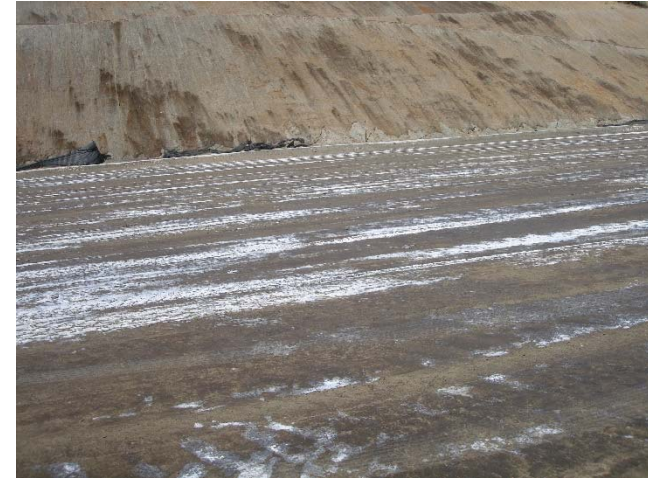
Photo 399: Flares 9, 10 & 11 Sealed Dirt Pad Area: November 21, 2017

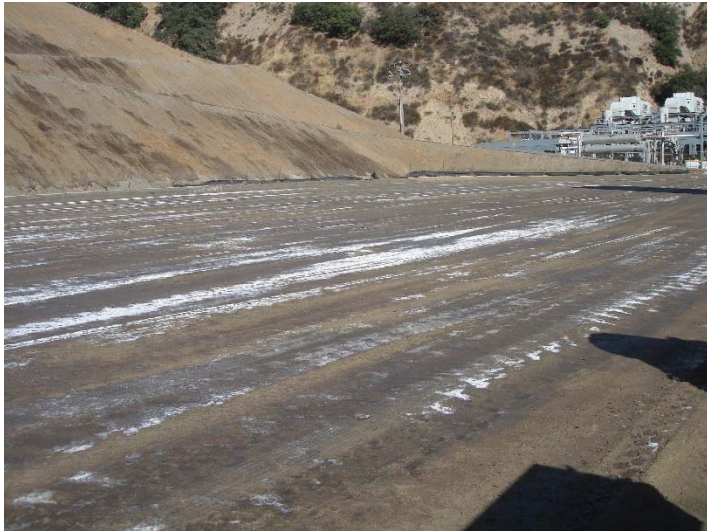
Photo 400: Flares 9, 10 & 11 Sealed Dirt Pad Area: November 21, 2017

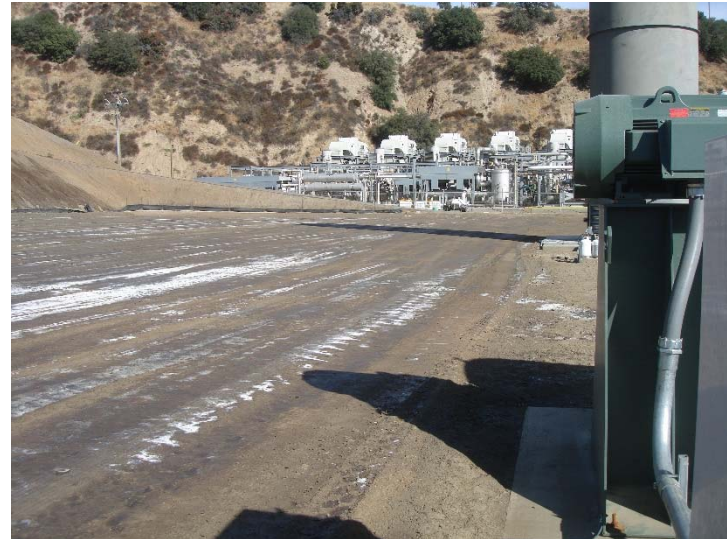
Photo 401: Flares 9, 10 & 11 Sealed Dirt Pad Area: November 21, 2017

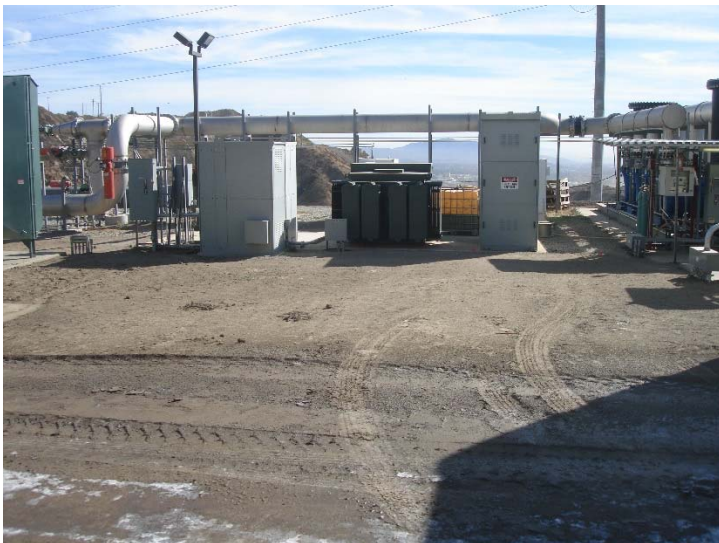
Photo 402: Flares 9, 10 & 11 Sealed Dirt Pad Area: November 21, 2017

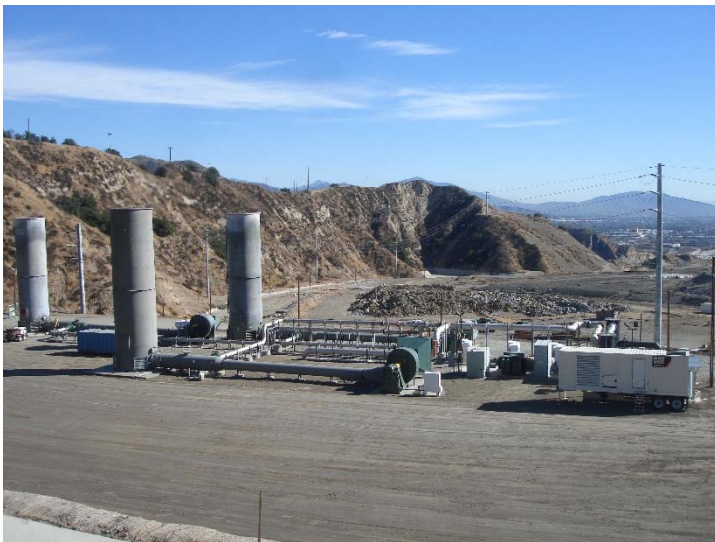
Photo 406: Flare 8 Pad Site Debris: November 21, 2017

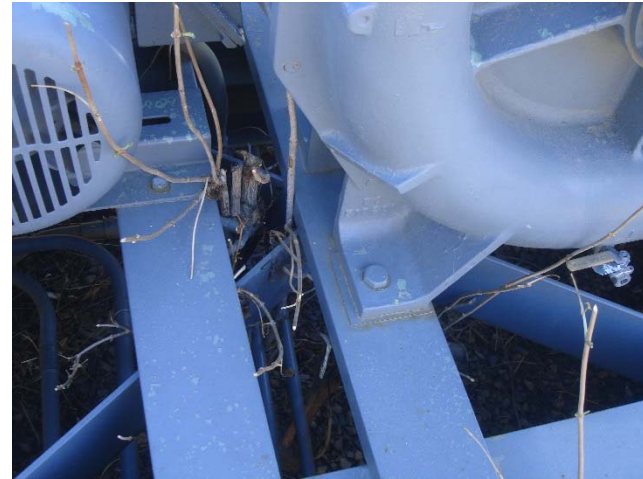
Photo 413: Flare 8 Pad Site Debris: December 12, 2017

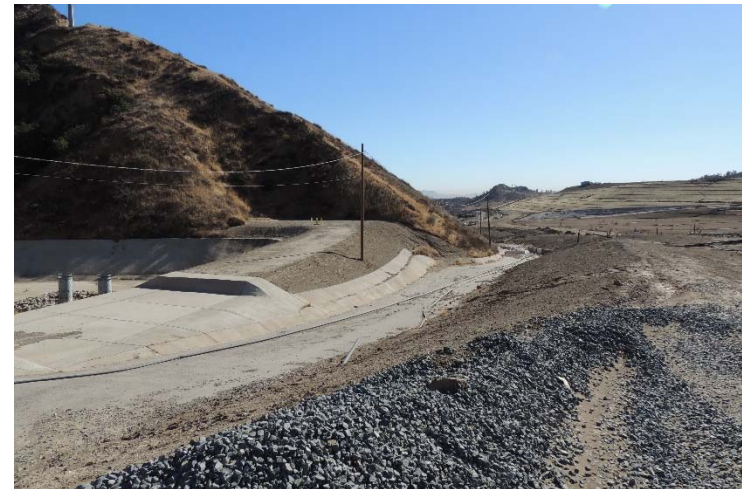
Photo 444: Basin B Outlet Channel: December 12, 2017

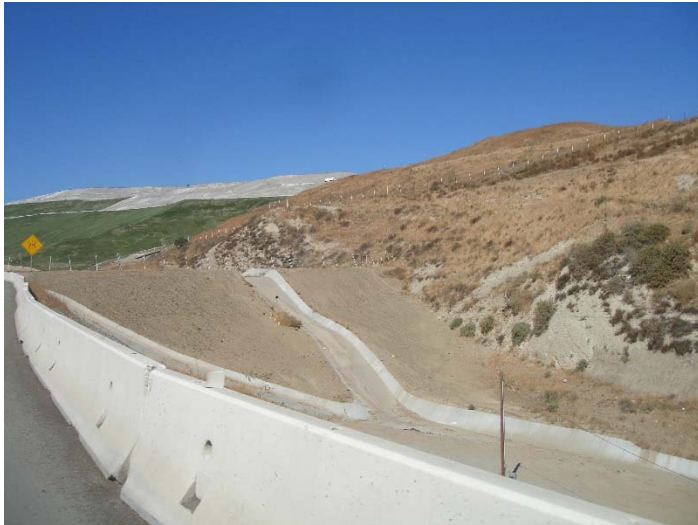
Photo 445: Terminal Basin Inlet Channel: October 26, 2017

- Vegetation was growing out of cracks in the top deck and on the sides of the terminal basin.
- The inlet channels into the terminal basin were clean and ready for winter rains.

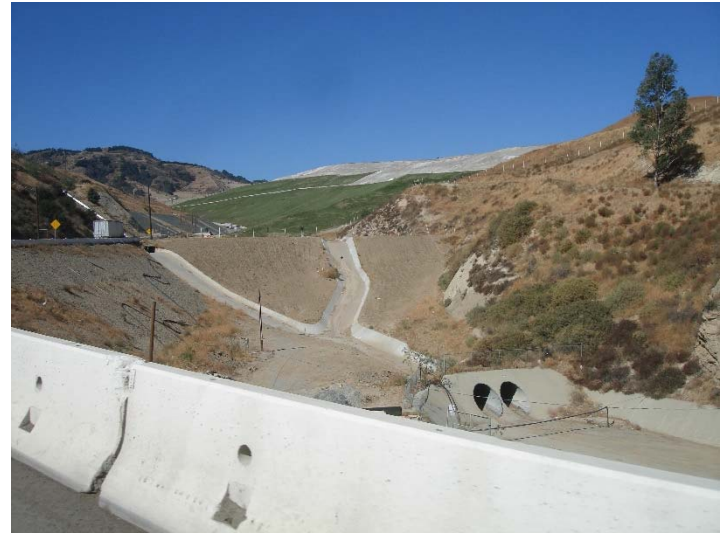
Photo 446: Terminal Basin Inlet Channel: October 26, 2017

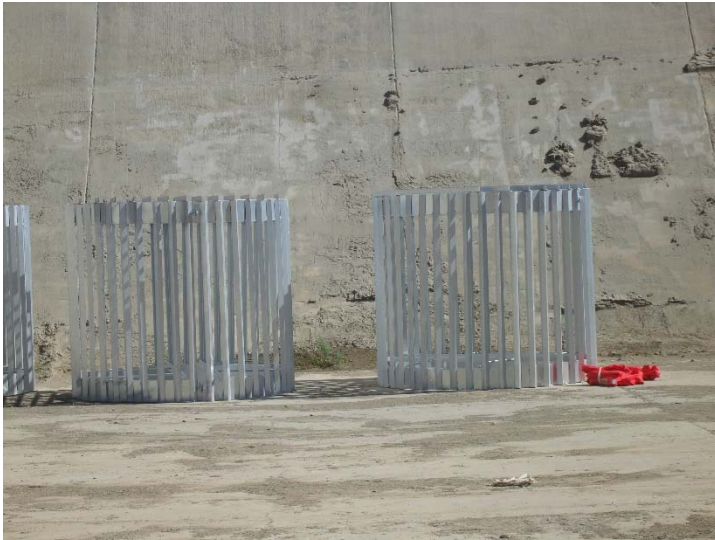
Photo 454: Terminal Basin: October 26, 2017

- New concrete drainage channels were being installed connecting the upper westside surface water drainage to the lower concrete channel.
- The terminal basin had a skimmer system being installed on the outlet risers. No underdrain system to drain sediment was observed.

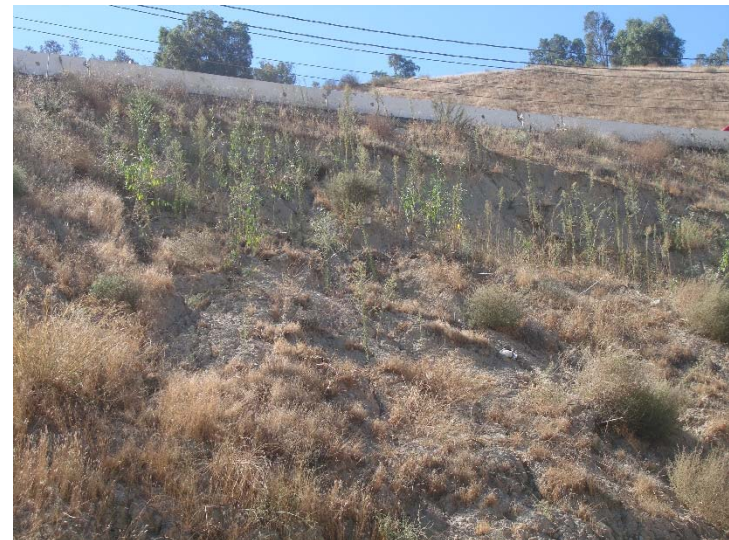
Photo 468: Access Road Prior Slope Wet Area near Terminal Basin: October 26, 2017

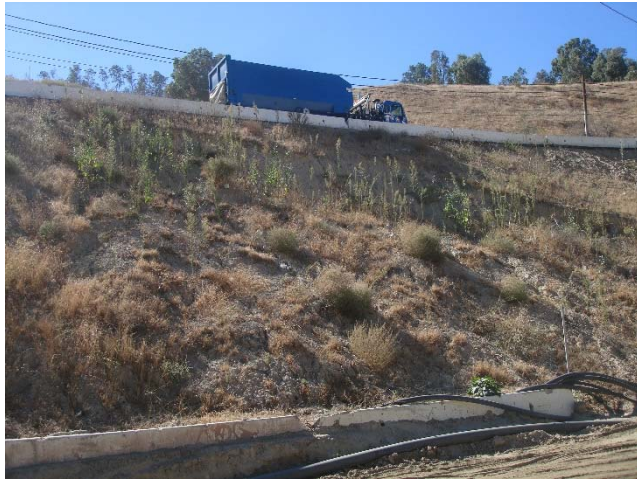
Photo 469: Access Road Prior Slope Wet Area near Terminal Basin: October 26, 2017

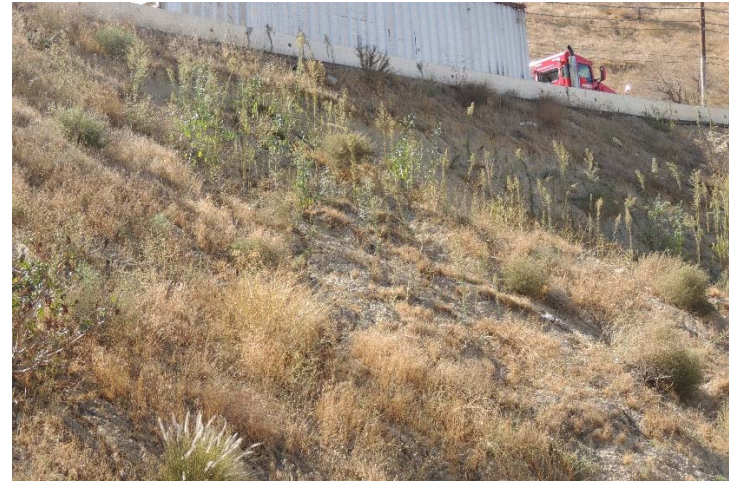
Photo 470: Access Road Prior Slope Wet Area near Terminal Basin: October 26, 2017

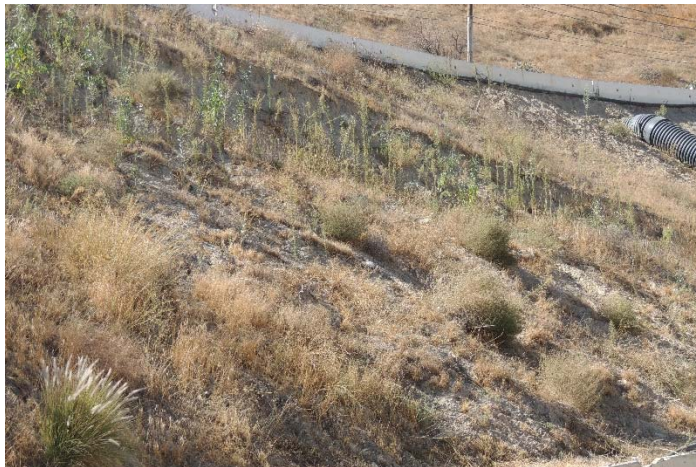
Photo 471: Access Road Prior Slope Wet Area near Terminal Basin: October 26, 2017

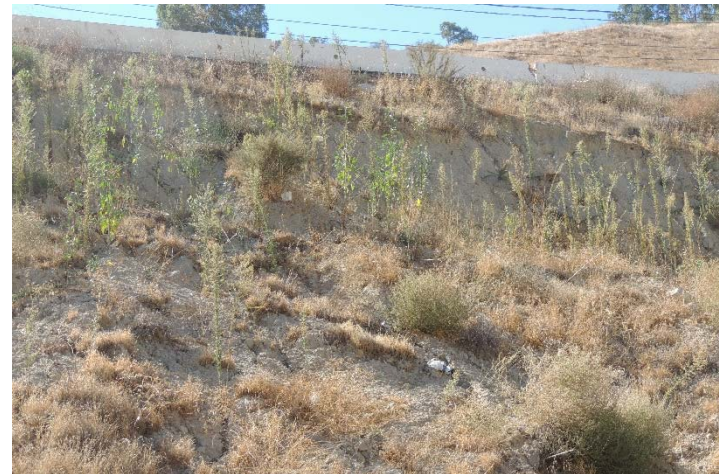
Photo 472: Access Road Prior Slope Wet Area near Terminal Basin: October 26, 2017

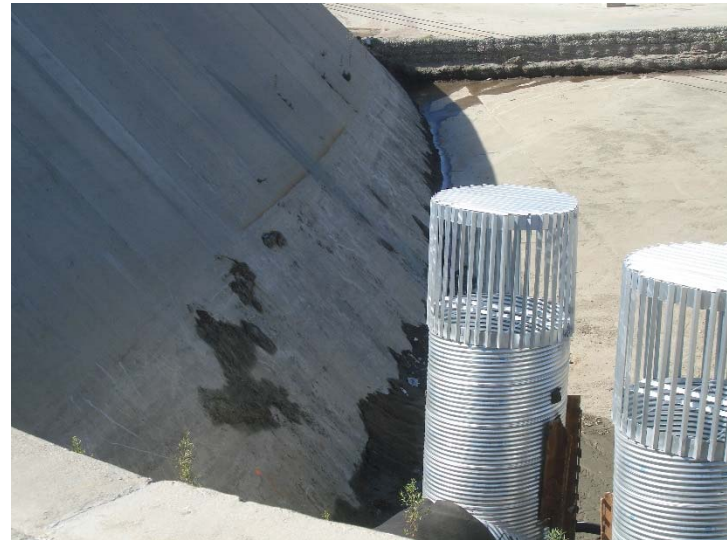
Photo 483: Terminal Basin New Skimmer Risers: November 7, 2017

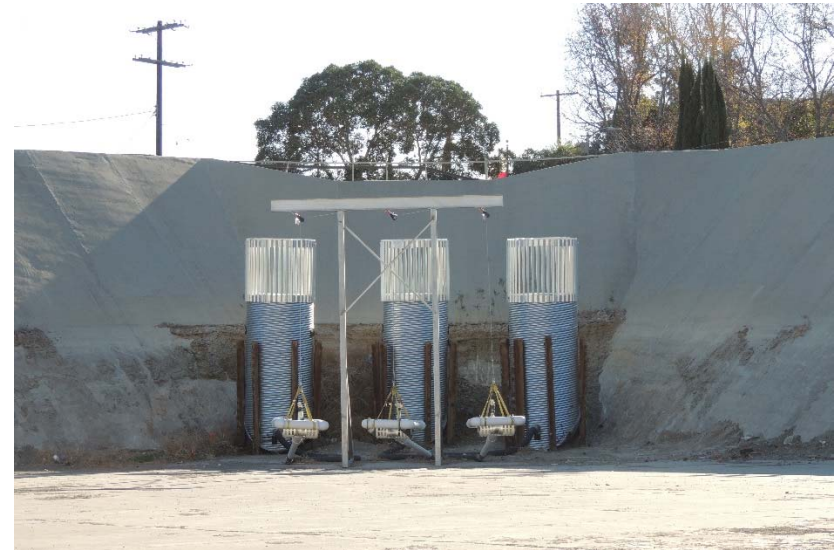
**Photo 509: Terminal Basin New Skimmer Risers Outlet System:
December 12, 2017**

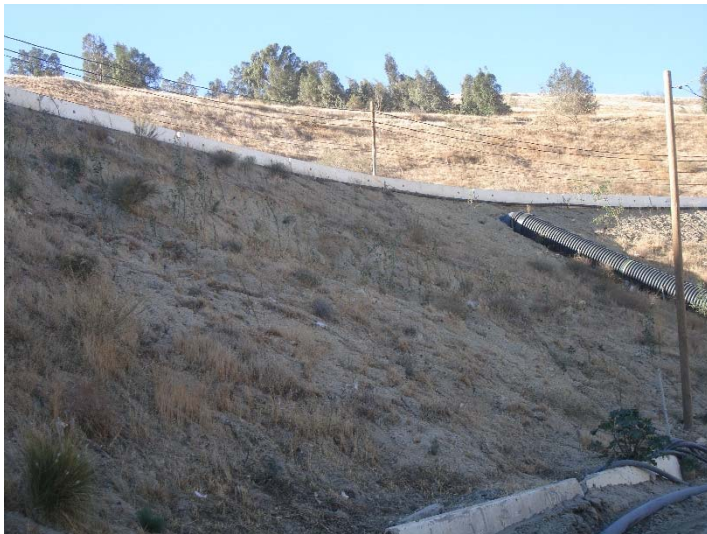
**Photo 518: Access Road Slope Movement Area near Terminal
Basin: December 12, 2017**

<p>Access roads.</p> <ul style="list-style-type: none"> • Main access roads • Some sloughing has occurred on the embankment of the new access road (Photo 15) near the Apex of the road. The sloughing can be noted from the entrance to the Terminal Basin.
<p>Closure Turf on slopes of CC3:</p> <ul style="list-style-type: none"> • a break-out that occurred at access road to the deck of cell CC3 in an area covered with Closure Turf has been repaired (Photo 16)
<p>Retaining wall on San Fernando Road:</p> <ul style="list-style-type: none"> • cleaning operation were on-going (Photo 17) <ul style="list-style-type: none"> – the sidewalk has been totally cleared of sloughed soil (Photo 18) – the drain at end of drainage swale has been cleared (Photo 19)
<p>Overall landfill inspection.</p> <ul style="list-style-type: none"> • no other geotechnical issues than that noted at access road were observed

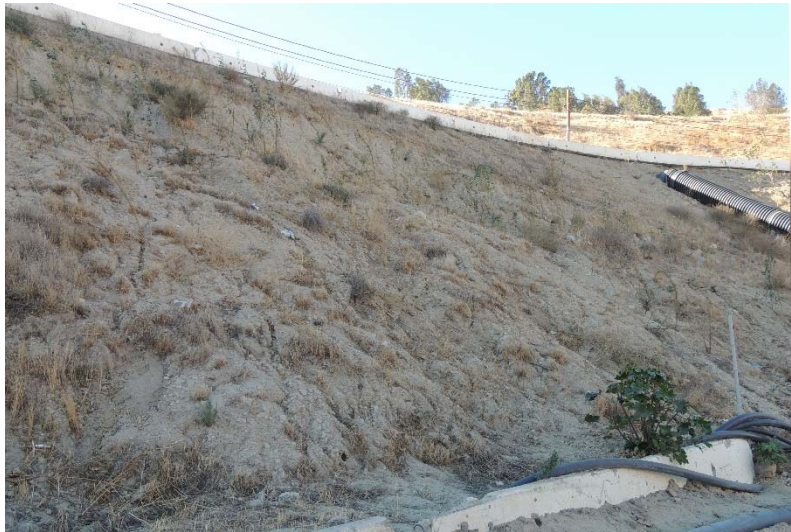
**Photo 520: Access Road Slope Movement Area near Terminal
Basin: December 12, 2017**

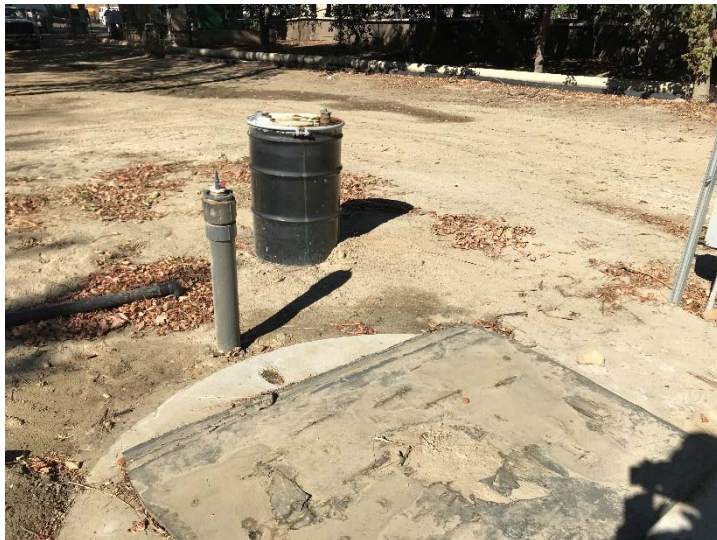
Photo 523: Sewer Lift Pump Area: November 7, 2017

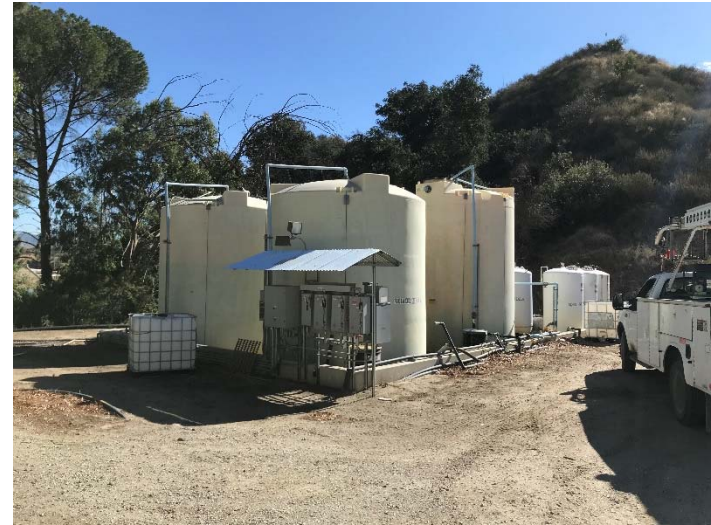
Photo 522: Leachate Treatment Systems: November 7, 2017

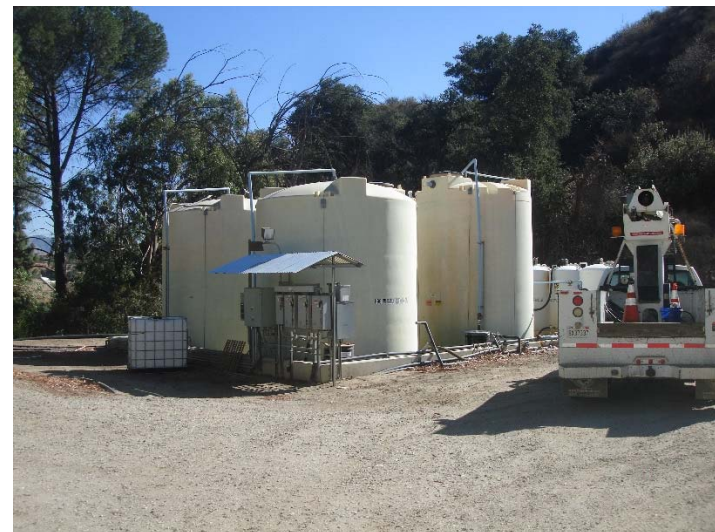
Photo 524: Leachate Treatment Systems Temporary Strong Localized Odor: November 7, 2017

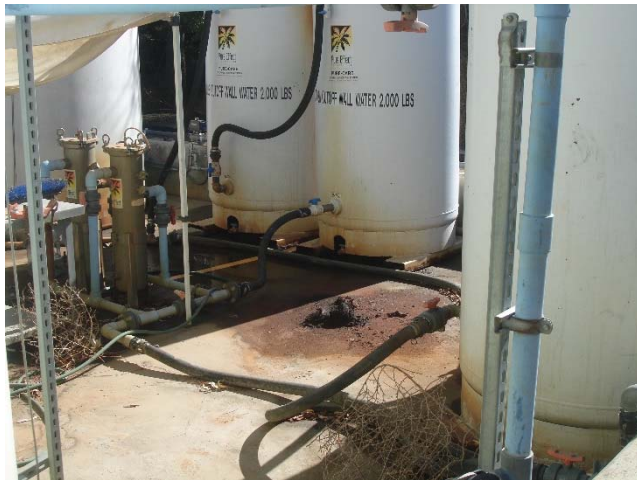
Photo 525: Leachate Treatment Systems Temporary Strong Localized Odor: November 7, 2017

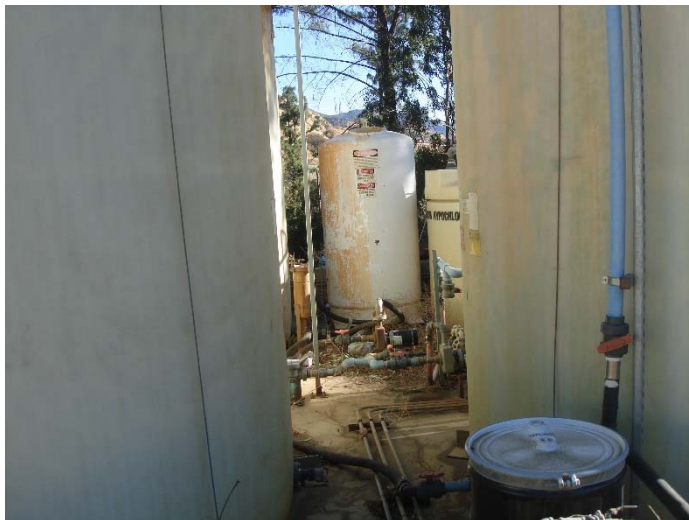
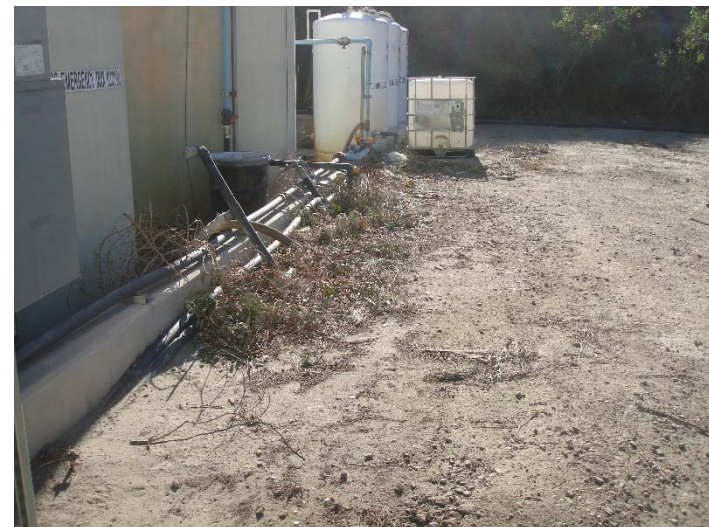
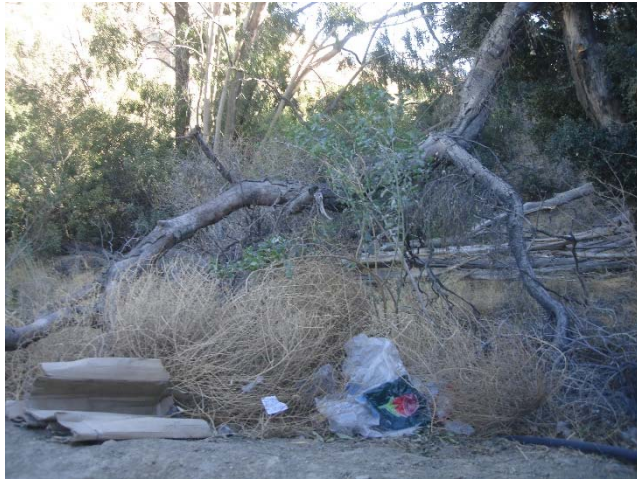
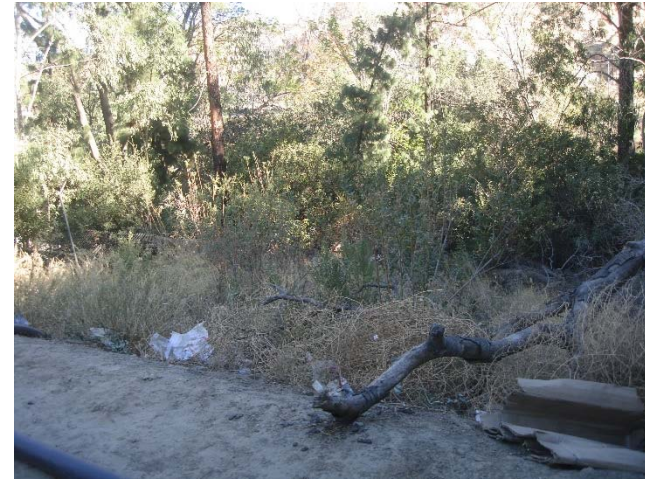
Photo 526: Debris In & Around Leachate Treatment Systems: December 12, 2017

Photo 527: Debris In & Around Leachate Treatment Systems: December 12, 2017

Photo 528: Debris In & Around Leachate Treatment Systems: December 12, 2017

**Photo 529: Debris In & Around Leachate Treatment Systems:
December 12, 2017**

**Photo 530: Debris In & Around Leachate Treatment Systems:
December 12, 2017**

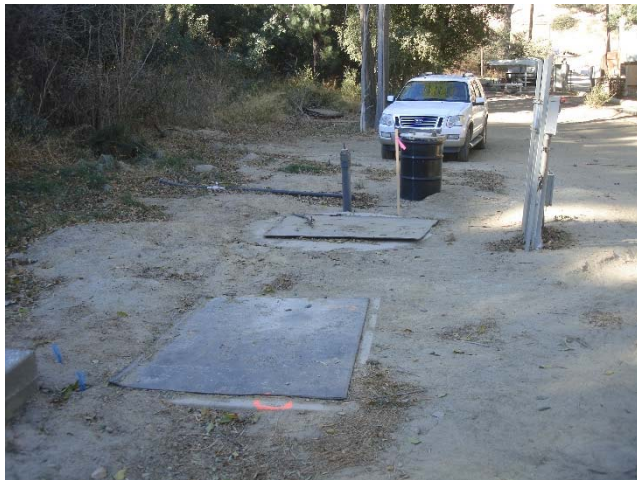
**Photo 531: Localized odor near Sewer Connection Pump:
December 12, 2017**

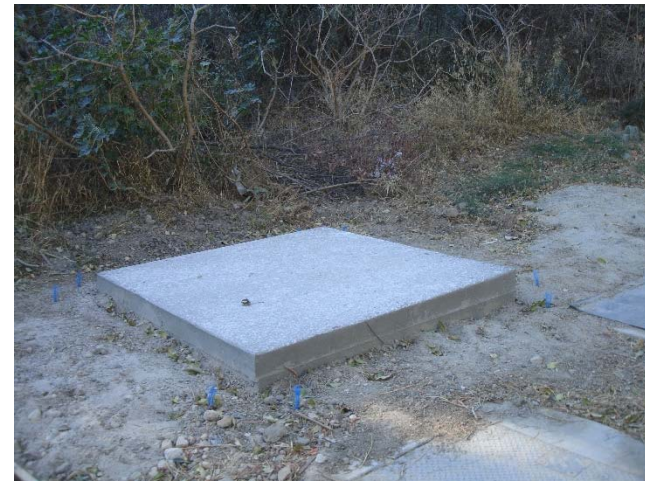
**Photo 532: New Equipment Foundation near Sewer Connection:
December 12, 2017**

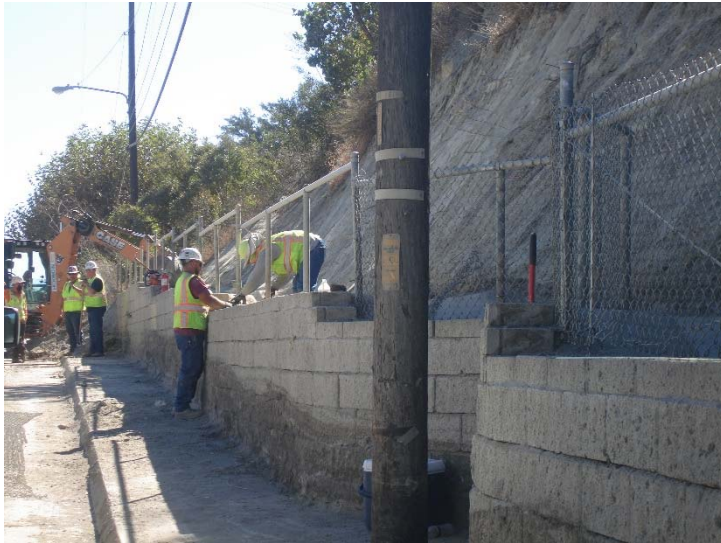
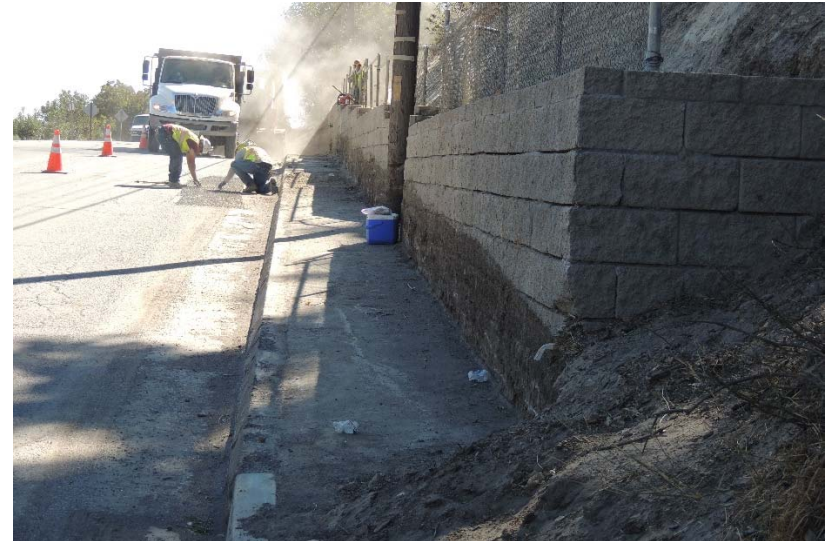
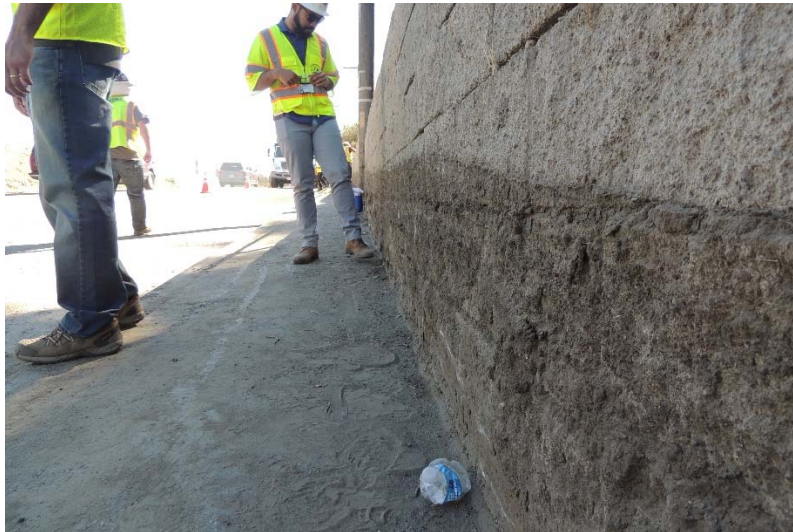
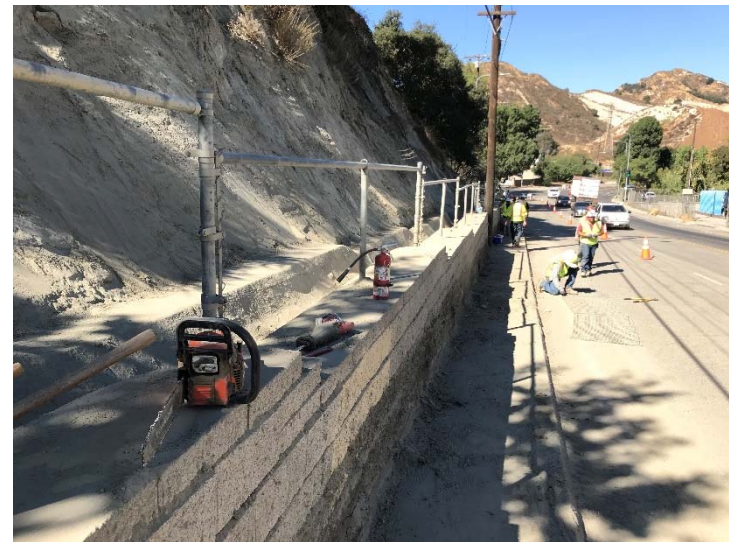
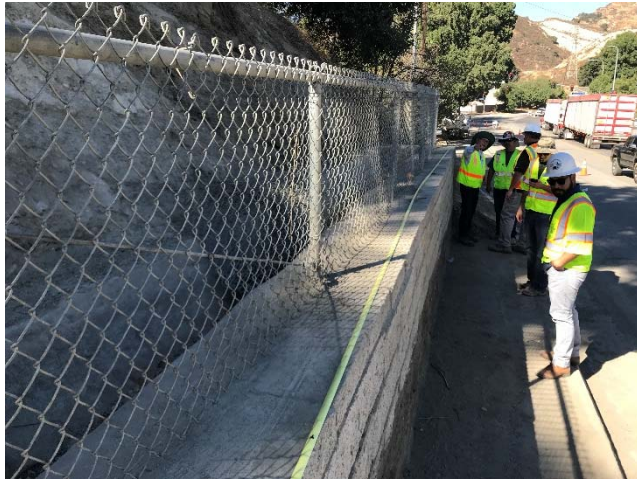
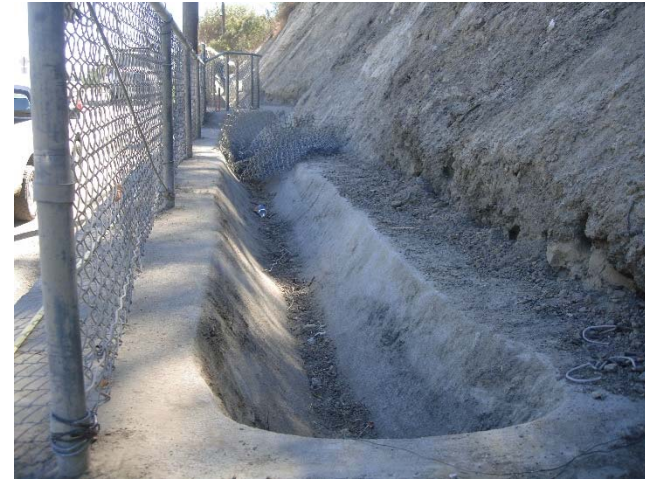
**Photo 533: Frontage Retaining Wall on San Fernando Road:
October 26, 2017**

- The San Fernando Road retaining wall was being cleared of soil and rock against the fence and in front of the wall. The slope above the wall was graded to remove loose material and one oak tree was removed. The wall top drainage channel was cleaned and re-established.

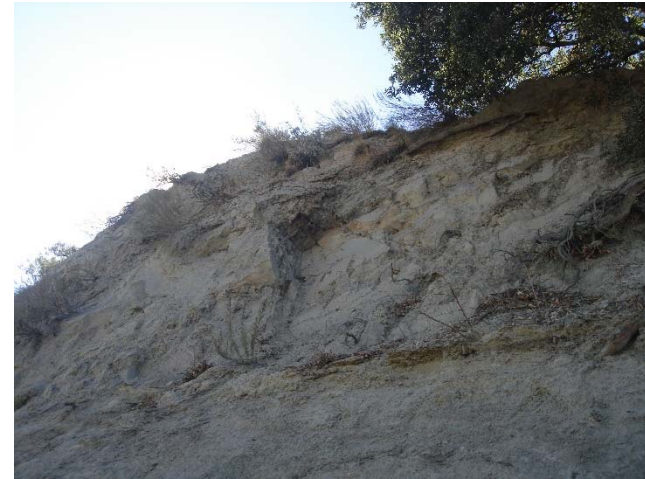
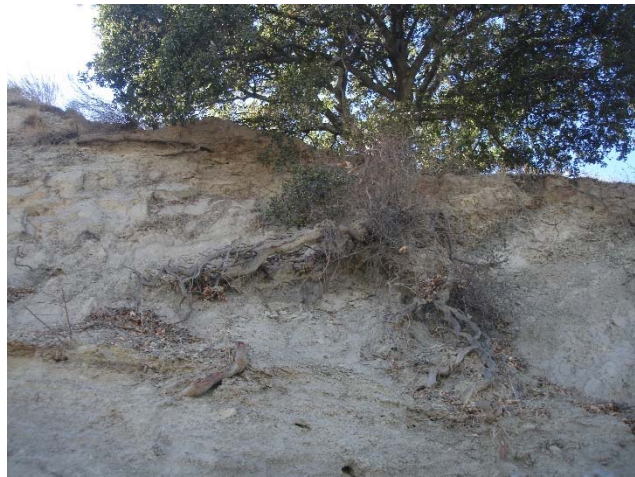
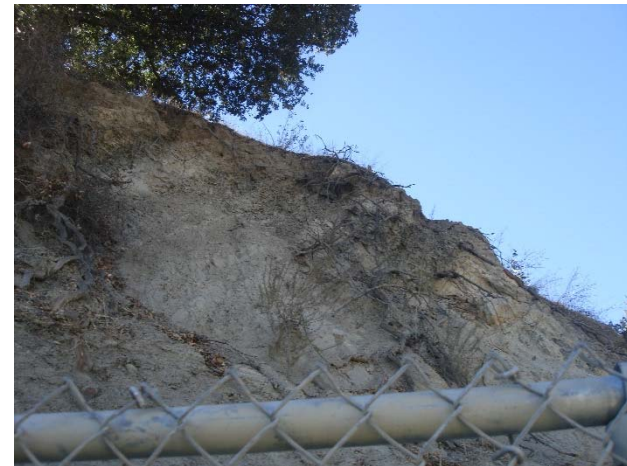
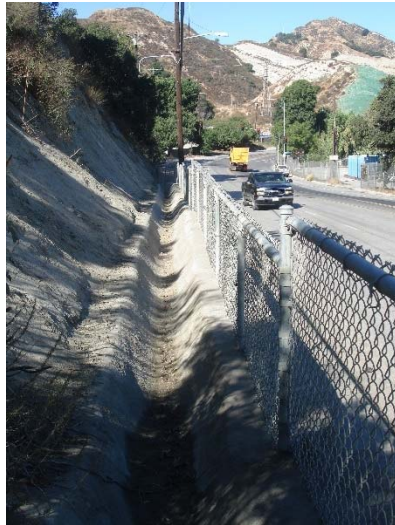
**Photo 561: Frontage Retaining Wall on San Fernando Road:
November 7, 2017**

**Photo 562: Frontage Retaining Wall on San Fernando Road:
November 7, 2017**

**Photo 563: Frontage Retaining Wall on San Fernando Road:
November 7, 2017**

**Photo 564: Frontage Retaining Wall on San Fernando Road:
November 7, 2017**

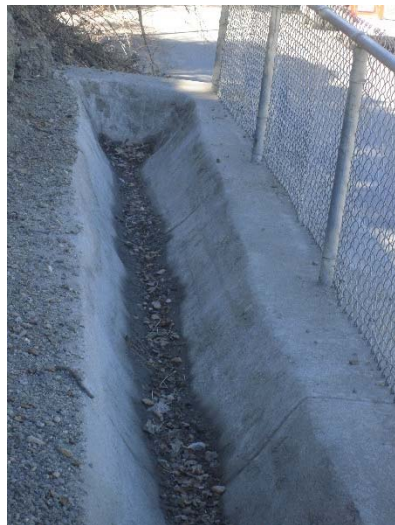
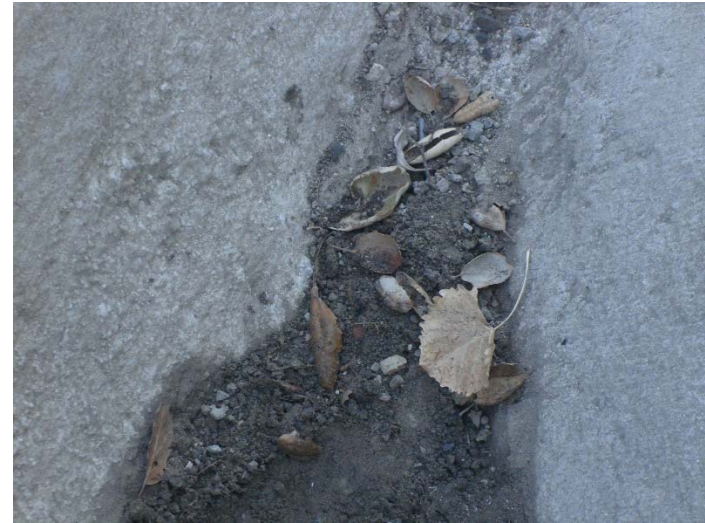
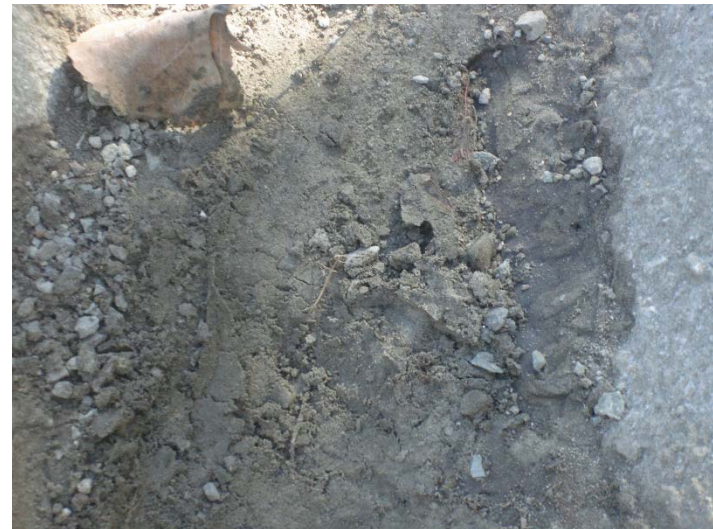
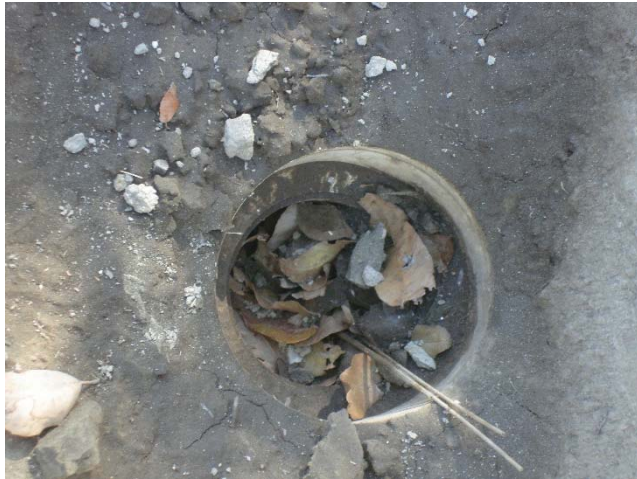
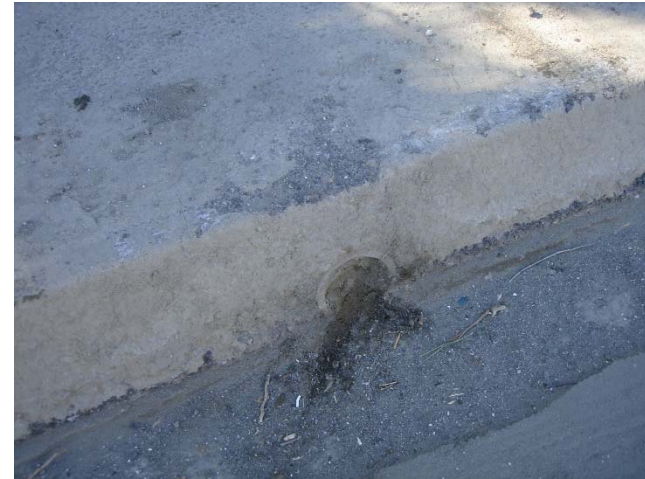
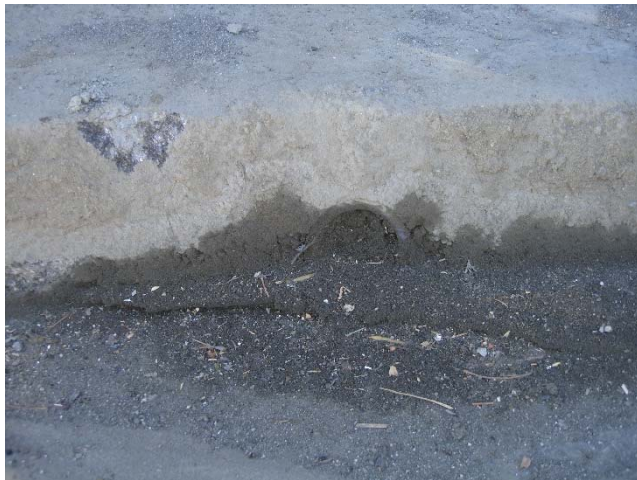
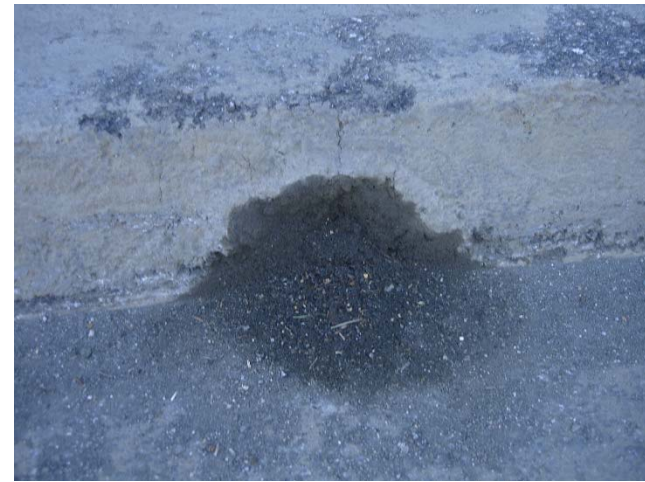
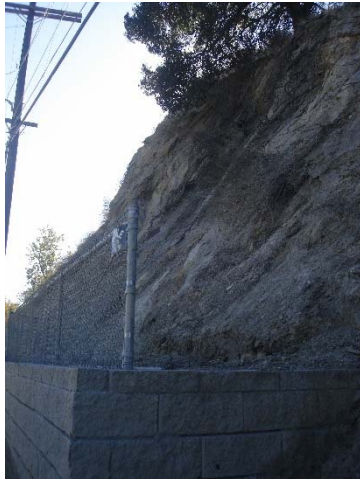
**Photo 565: Frontage Retaining Wall on San Fernando Road
Plugged Drainage: November 7, 2017**

**Photo 567: Frontage Retaining Wall on San Fernando Road
Plugged Drainage: November 7, 2017**

**Photo 566: Frontage Retaining Wall on San Fernando Road
Plugged Drainage: November 7, 2017**

**Photo 568: Frontage Retaining Wall on San Fernando Road
Plugged Drainage: November 7, 2017**

**Photo 569: Frontage Retaining Wall on San Fernando Road
Plugged Drainage: November 7, 2017**

**Photo 570: Frontage Retaining Wall on San Fernando Road
Plugged Drainage: November 7, 2017**

**Photo 571: Frontage Retaining Wall on San Fernando Road
Plugged Drainage: November 7, 2017**

**Photo 572: Frontage Retaining Wall on San Fernando Road
Plugged Drainage: November 7, 2017**
