**Sunshine Canyon Landfill
Independent Monitor
Quarterly Site Monitoring Status Report
October 1, 2017 – December 31, 2017**

March 6, 2018

The attached Quarterly Site Monitoring Status Report for the Sunshine Canyon Landfill dated March 6, 2018 is the Fourth Quarterly Report for 2017, issued by UltraSystems. This report covers the monitoring period from October 1, 2017 through December 31, 2017 and is prepared for the City of Los Angeles Department of City Planning and the County of Los Angeles Department of Regional Planning.

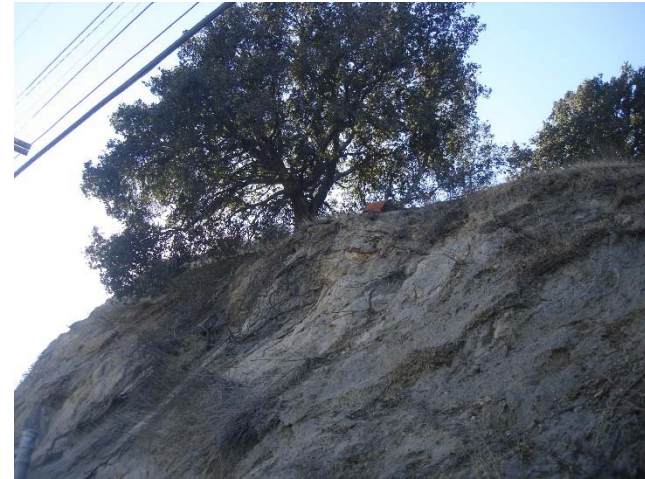
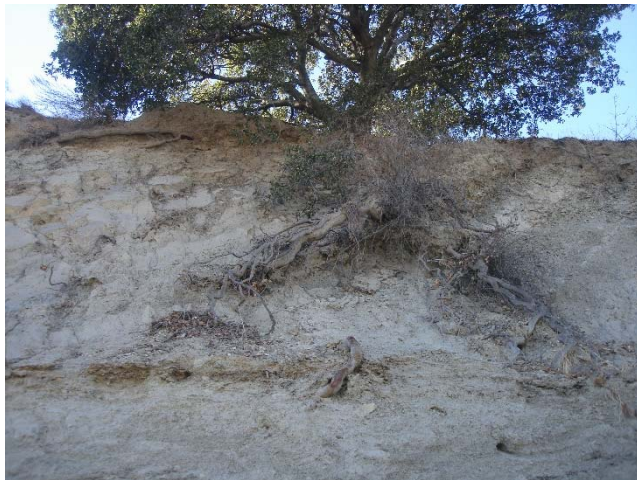
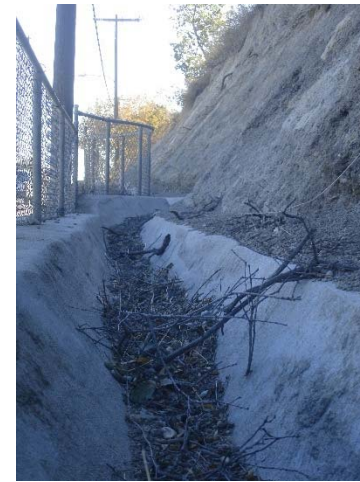
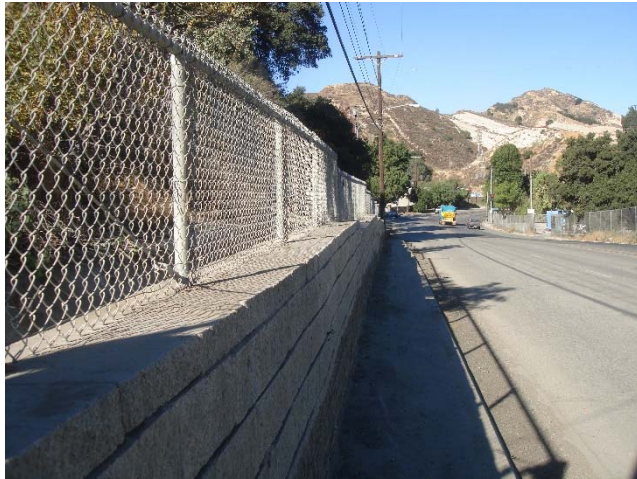
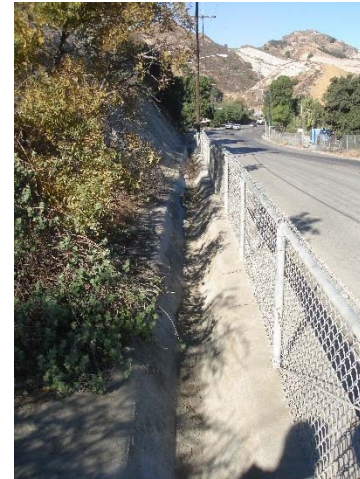
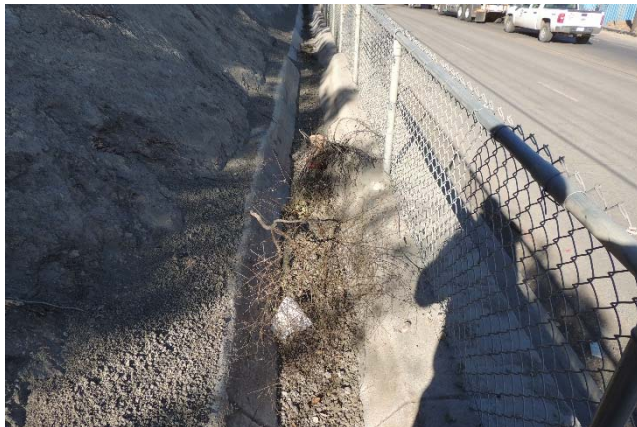
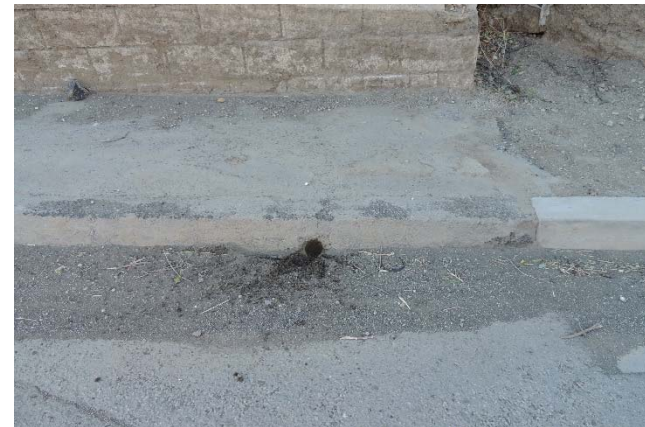
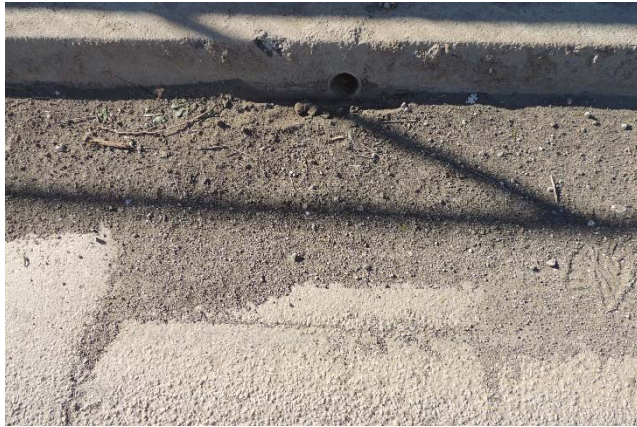
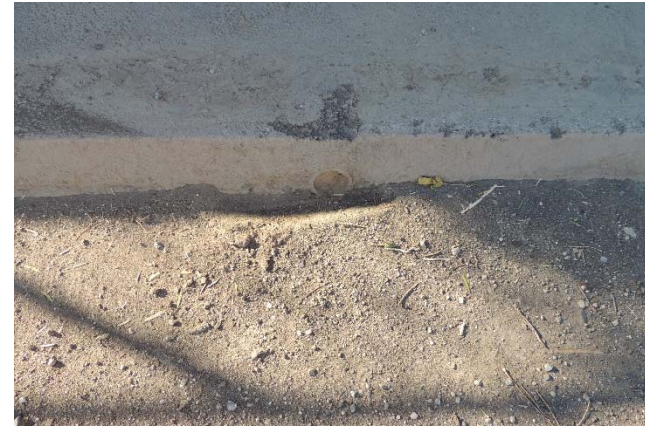
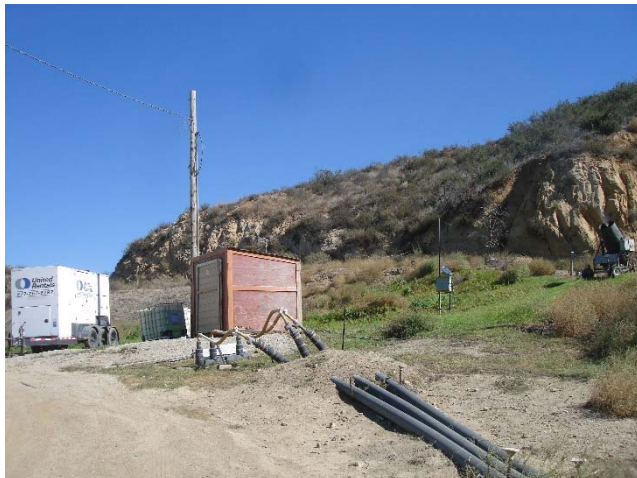
**Photo 573: Frontage Retaining Wall on San Fernando Road:
December 12, 2017**

- The San Fernando Road retaining wall was being cleared of soil and rock against the fence and in front of the wall. The slope above the wall was graded to remove loose material and one oak tree was removed. The wall top drainage channel was cleaned and re-established.

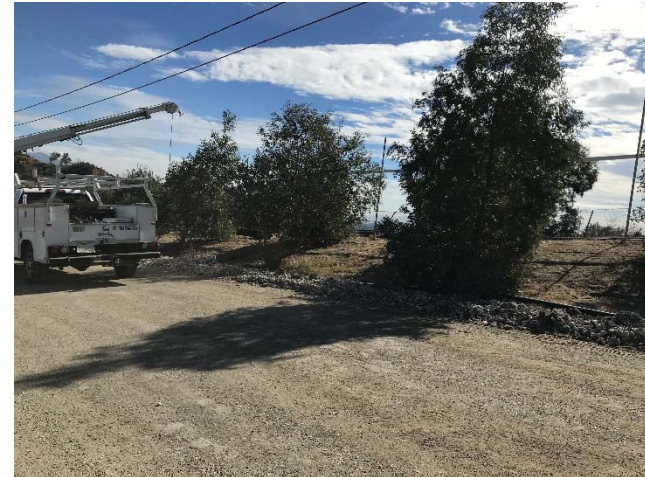
**Photo 615: New Power Pole & Power Supply to City Deck C & B:
November 7, 2017**

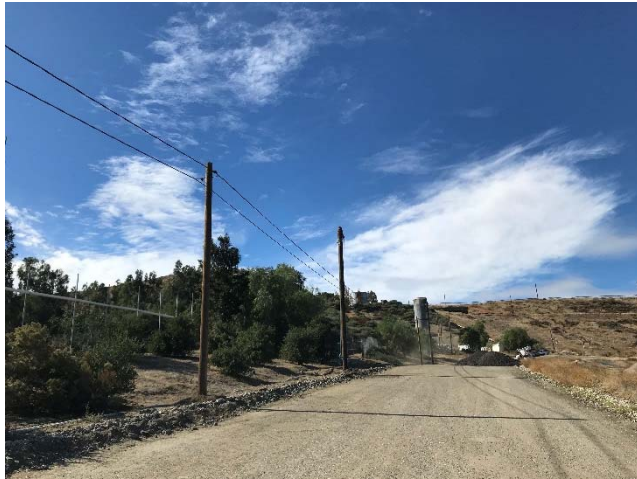
**Photo 616: New Power Pole & Power Supply to City Deck C & B:
November 7, 2017**

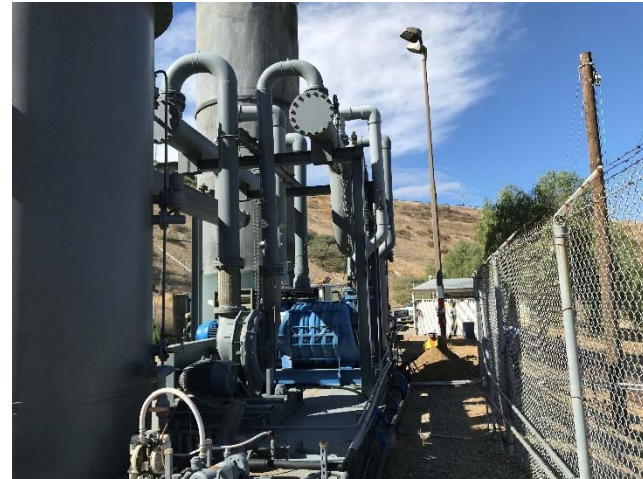
**Photo 617: New Power Pole & Power Supply to City Deck C & B:
November 7, 2017**

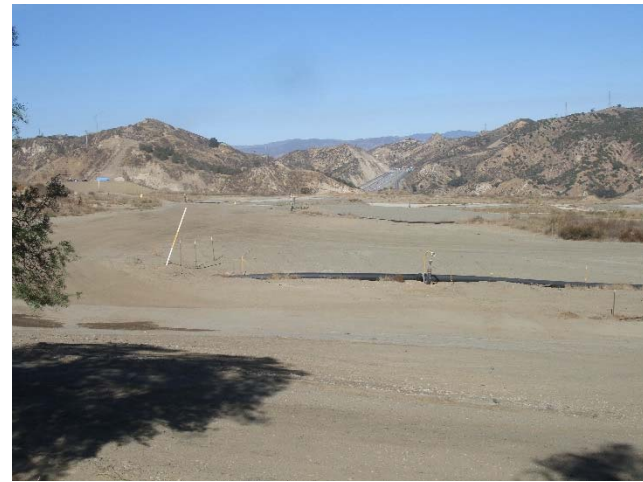
**Photo 619: Deck B Slope Drainage Channel near Flare 1: November
7, 2017**

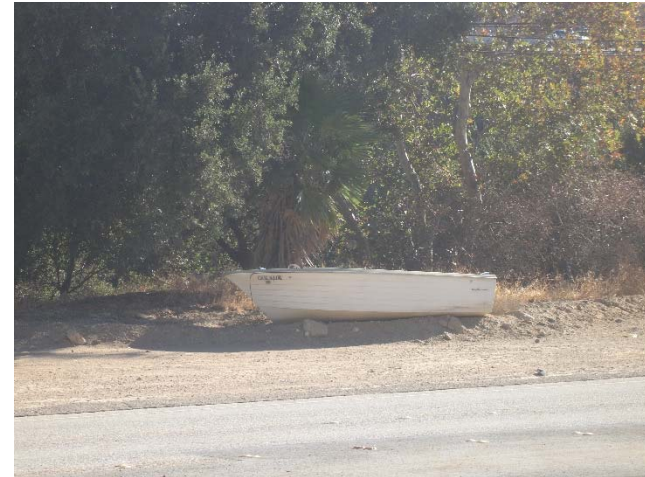
**Photo 623: Illegal Dumping at Sierra Highway near I-14 Overpass:
October 26, 2017**

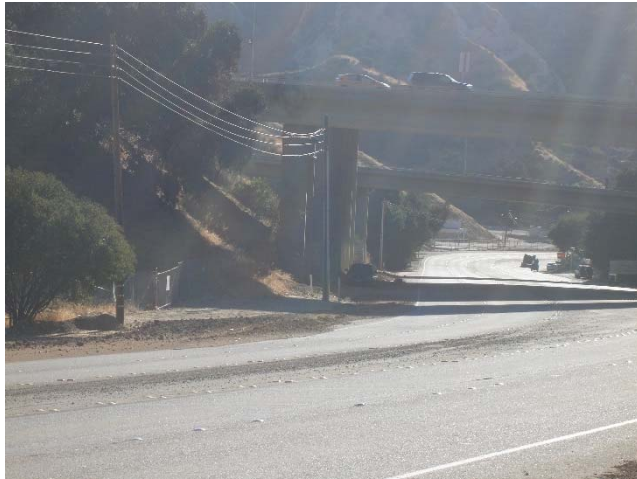
**Photo 624: Illegal Dumping at Sierra Highway near I-14 Overpass:
October 26, 2017**

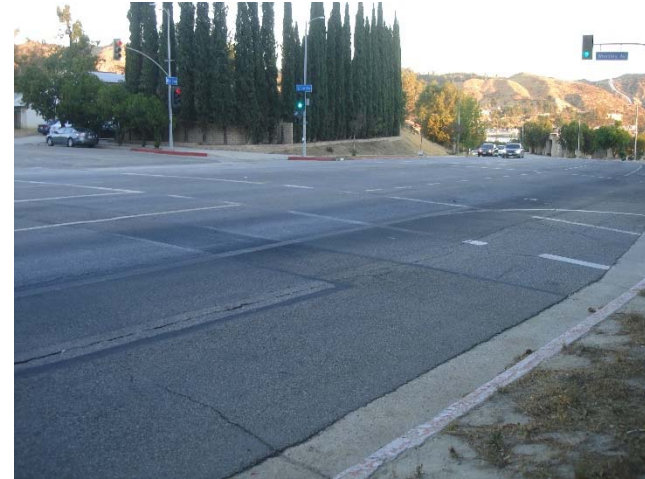
**Photo 625: Illegal Dumping at Sierra Highway near I-14 Overpass:
October 26, 2017**

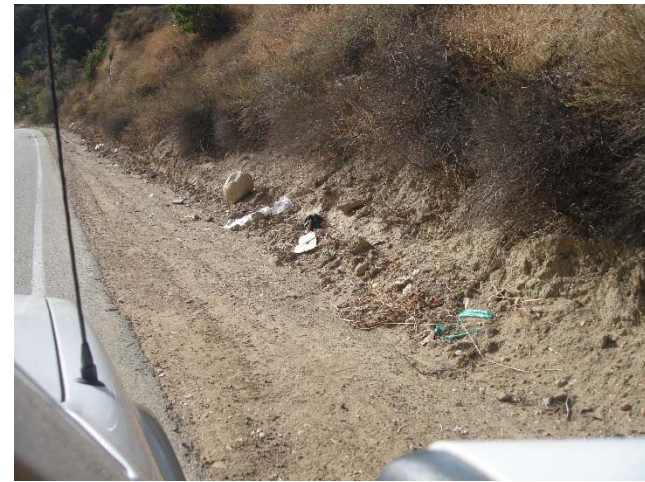
**Photo 627: Illegal Dumping at Sierra Highway near I-14 Overpass:
November 7, 2017**

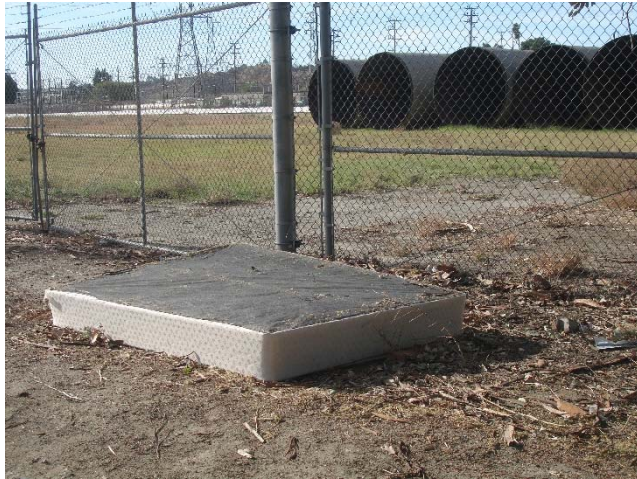
**Photo 628: Illegal Dumping at Sierra Highway near I-14 Overpass:
November 21, 2017**

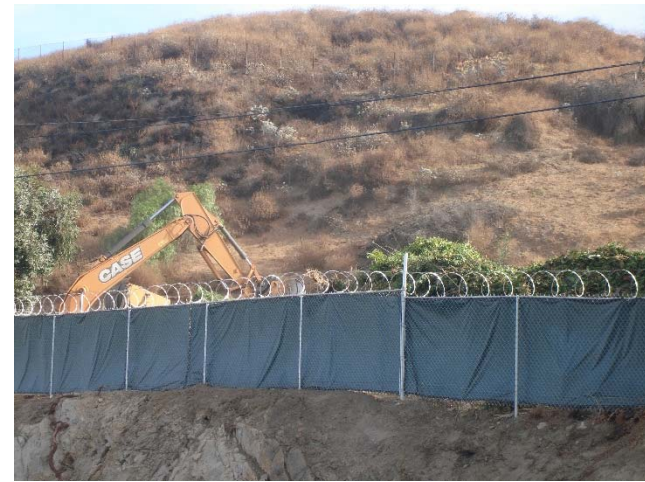
**Photo 639: Greenwaste and Smoldering Greenwaste Odor near
North Hills Recycling: November 21, 2017**

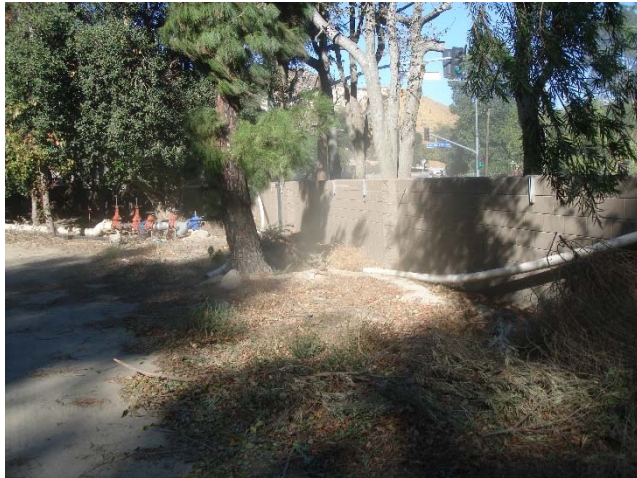
**Photo 640: Greenwaste and Smoldering Greenwaste Odor near
North Hills Recycling: November 21, 2017**

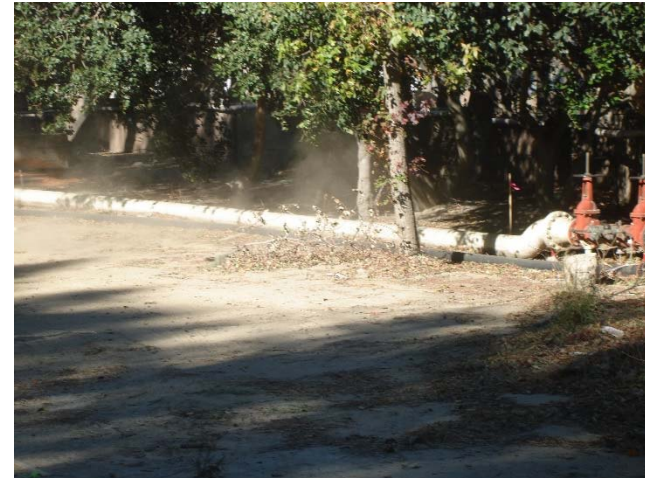
**Photo 641: Localized Odor near Front Wall from Sewer Connection
Area: December 12, 2017**

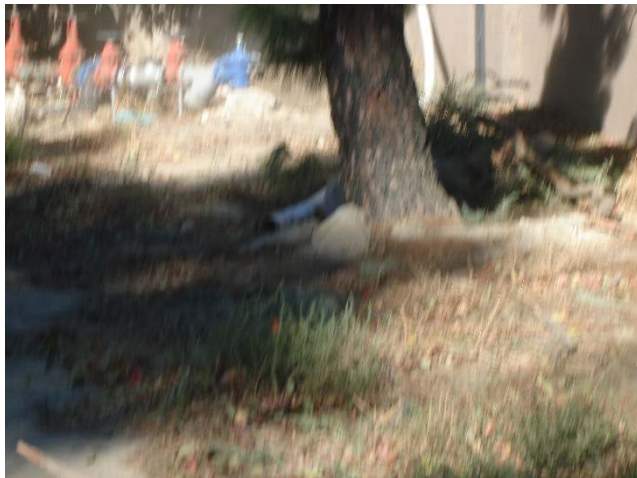
**Photo 642: Localized Odor near Front Wall from Sewer Connection
Area: December 12, 2017**

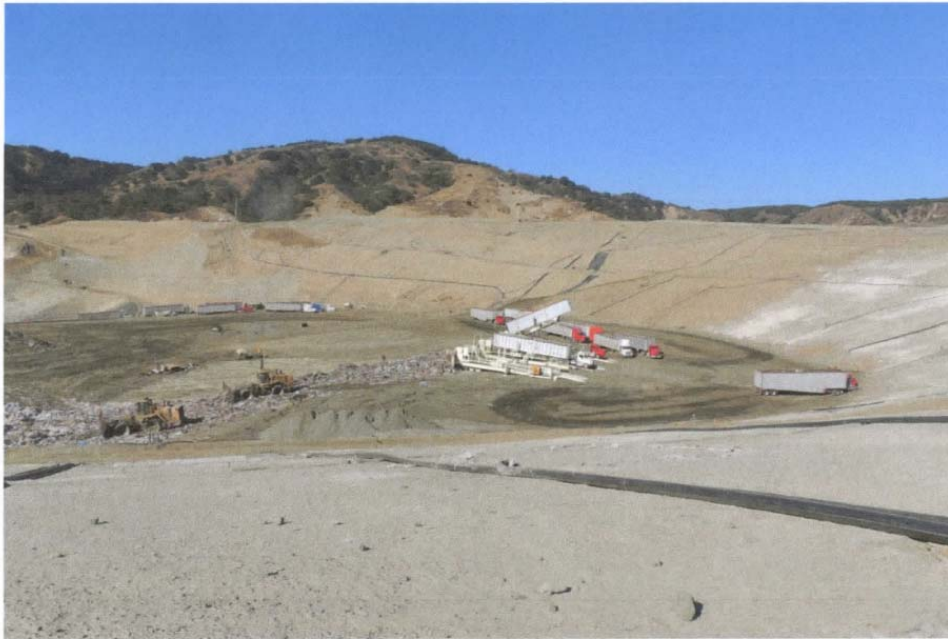
Photo 1: Waste disposal in Cell CC4 Phase 1

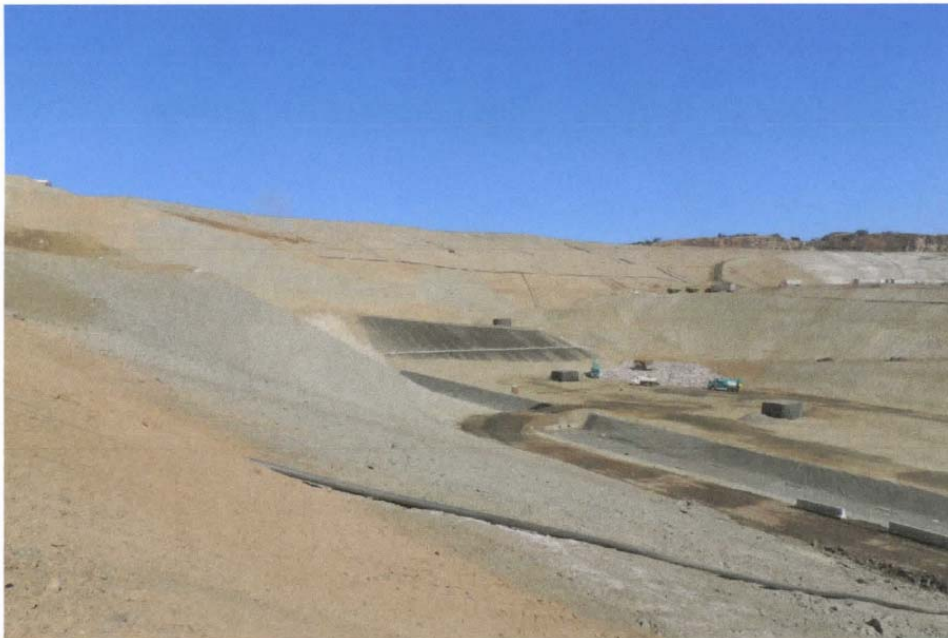
Photo 2: Waste disposal in Cell CC4 Phase 2

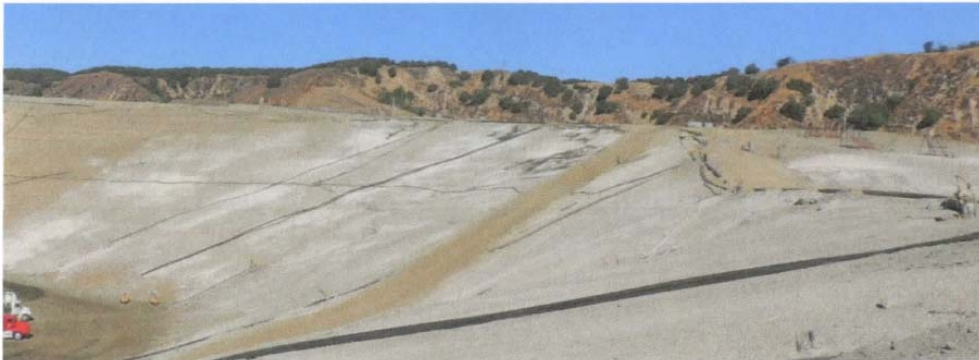
Photo 3: Posi-shell on slope of Cell CC3b

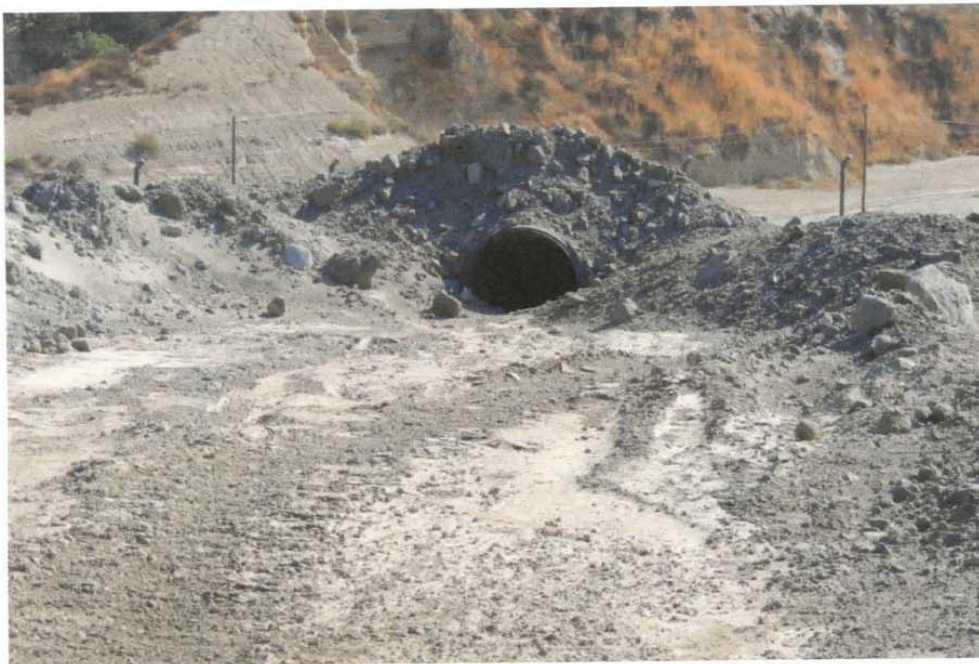
<ul style="list-style-type: none"> – a pipe has been installed to drain water off the deck (Photo 6) – there is no measure to control large amount of soil and from entering pipe to flow into the pipe – no protection on side were installed (e.g. sand bag wing walls, K-rails) and erosion could occur on sides • Basin A <ul style="list-style-type: none"> – Sediments accumulated in basin have been removed – the gas header is supported on pedestal made with V-notched pieces of HDPE pipe (Photo 7) – the gas header in the area near the toe of the slope that has in in past (see report dated 17 January 2017) is retained by few steel bars driven into the ground (Photo 8) which may not be sufficient in case of a subsequent slide – Downstream channel is used as access road with pipes under earth fill (Photo 9). The capacity of pipes to accept design flow should be checked and flow capacity restored if needed (removal of soil, additional pipes, ...) • Basin D <ul style="list-style-type: none"> – Clean • Basin B <ul style="list-style-type: none"> – Clean • Channel between Basin D and access road to Flare 9 and 10. <ul style="list-style-type: none"> – The geomembrane installed in the channel is totally loose at the connections with the corrugated pipe (Photo 10) – There were tumbleweeds and soil in channel • Terminal Basin <ul style="list-style-type: none"> – all sediments have been removed – Sukut was installing the three skimmers. They should be operational in 2 weeks (i.e. around November 15th) – there are plants growing through concrete cracks (Photo 11) • V-ditch on the west slope (remediation area) have been replaced (Photo 12) <ul style="list-style-type: none"> – A new shotcrete ditch has been installed on the access road on west side of Cell CC4 (Photo 13) • Cell CC4 Phase 2 <ul style="list-style-type: none"> – The cell is bordered on west and south by a lined basin with no outlet. It is our understanding from republic that the water will be pumped out. (Photo 14)

Photo 6: Drain pipe on deck of Cell CC3b

1:45-2:15 Close-out meeting with Republic Staff representative to discuss findings of visit
FURTHER REVIEW NEEDED
None
COMMENTS
<ul style="list-style-type: none">• Drain pipe on deck of Cell CC3b may need protection such as sand bag to direct water into pipe and minimize risk of erosion on sides• It was explained to the team how the water removed from ten lined basin at Cell CC4 Phase 2 was going to be managed – some of it will have been in contact with waste
Signed:

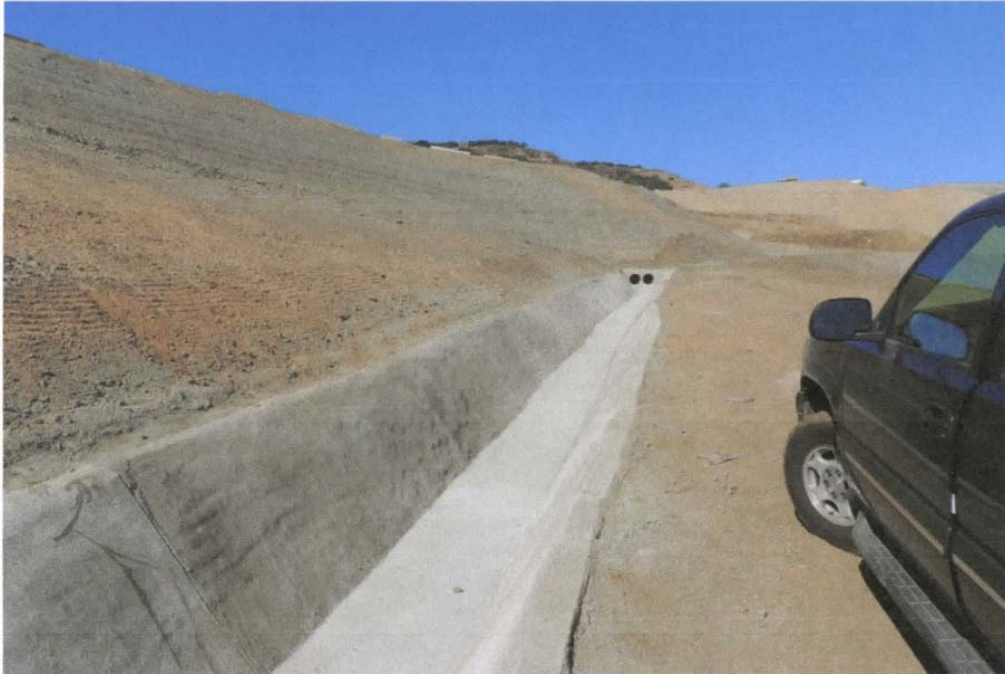
Photo 13: New V-ditch along access road bordering cell CC4 Phase 2

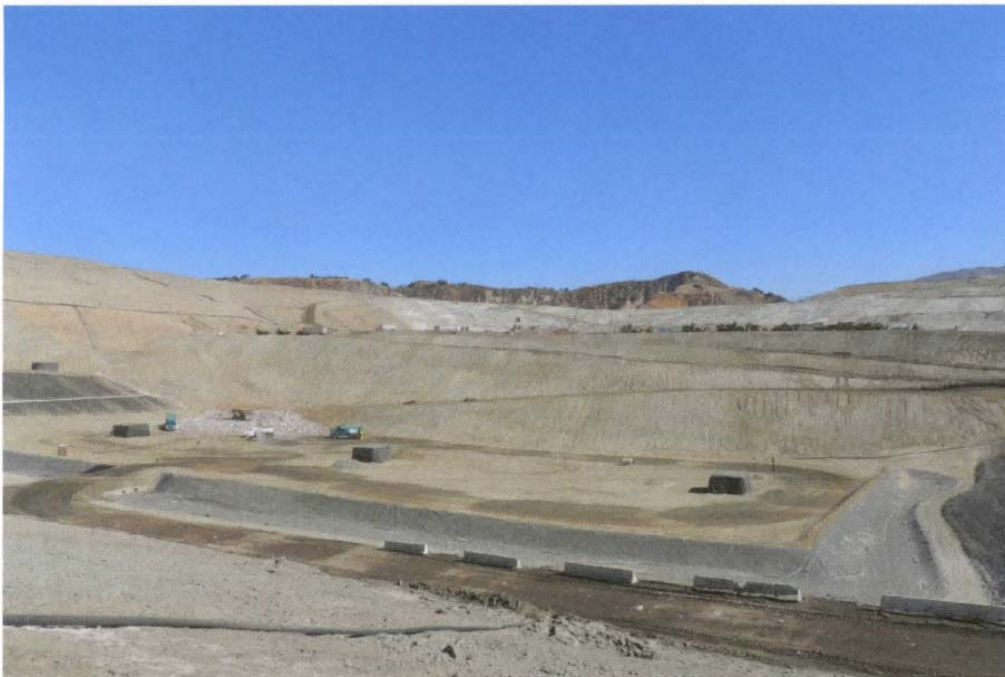
Photo 14: Lined water storage basin at Cell CC4 Phase 2

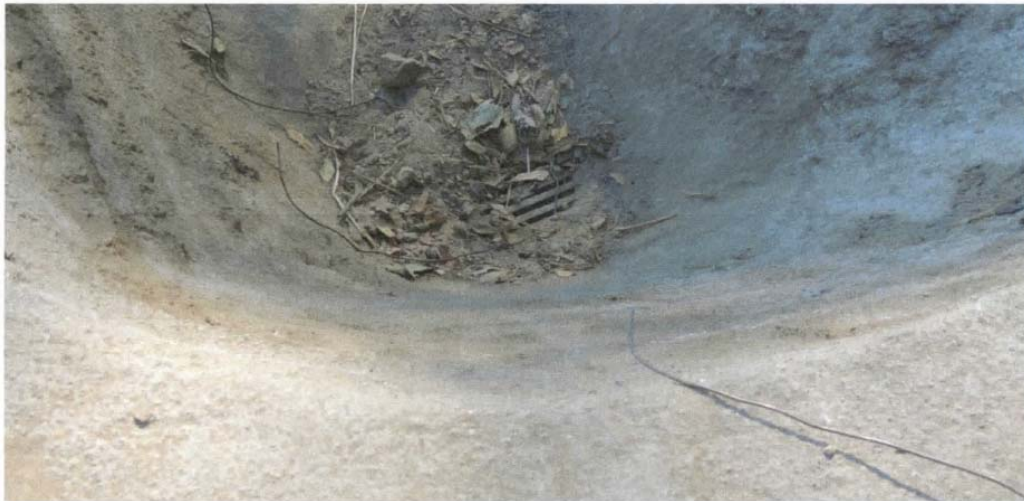
Photo 19: Cleaning operations at wall on San Fernando Road – Cleared drain intake at swale

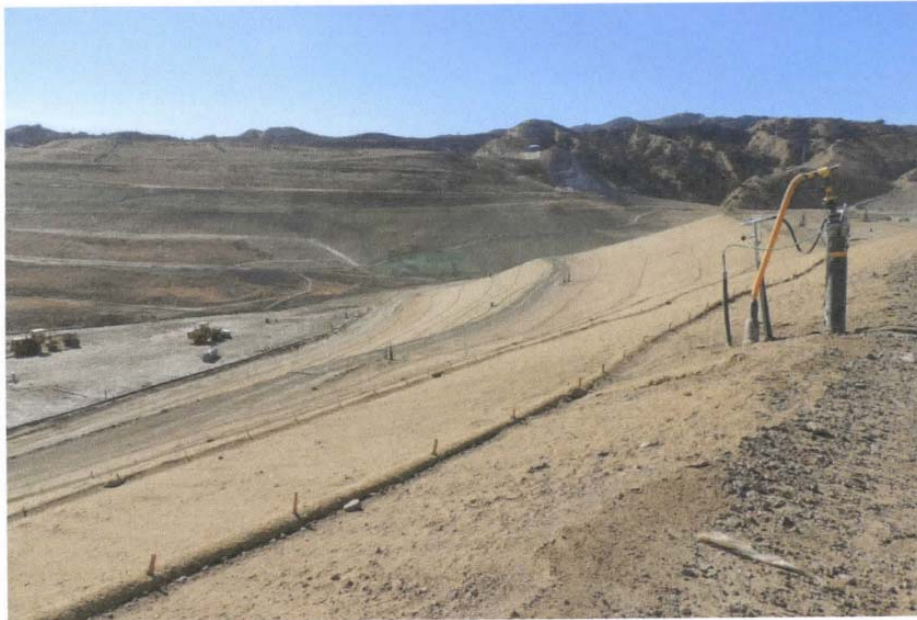
Erosion Protection <ul style="list-style-type: none"> • All systems installed at site are in good shape • Posi-shell applied to the slopes of Cell CC3 is holding out. we did not notice any new cracks • Wattles have been deployed on numerous slopes at the landfill such as the east facing slopes of Cell CC3A (Photo 3) 	
Drainage system <ul style="list-style-type: none"> • New temporary unlined earthen basin above Terminal basin <ul style="list-style-type: none"> – Basin is fully excavated and the spillway was cleared. Inlet of intake low flow pipe that daylight on the concrete spillway was covered and therefore useless (Photo 4) • Basin A <ul style="list-style-type: none"> – Sediments accumulated in basin have been removed – The gas header is supported on pedestal made with V-notched pieces of HDPE pipe. Some of these pedestals have moved slightly out of alignment probably because of expansion/contraction of the pipe leading to ‘snaking’ (Photo 5). The gas head could end up being unstable – Outlets from Basin A are blocked by tumbleweeds (Photo 6) – Downstream channel is still used as access road with pipes under earth fill (Photo 7). The

Photo 3: Wattles on East facing Slope of Cell CC3

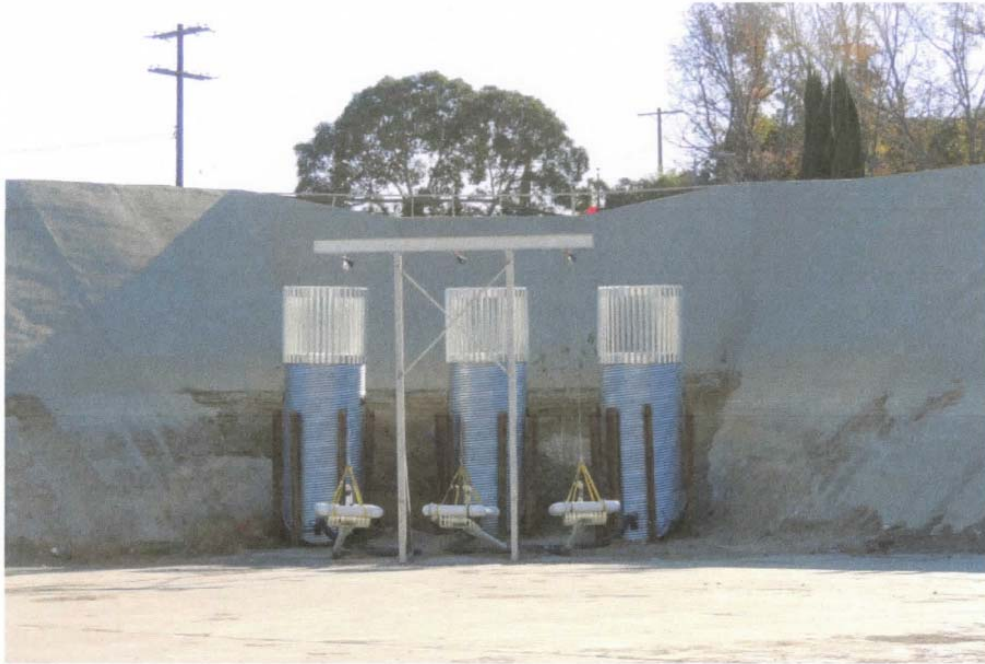
Photo 9: Skimmers in Terminal Basin

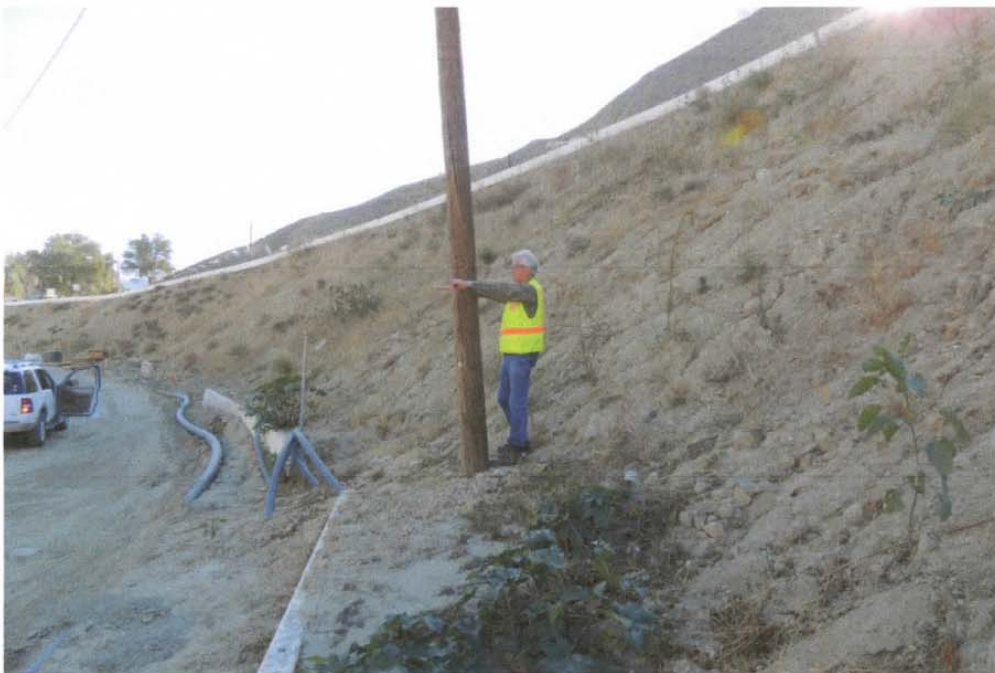
<p>Access roads.</p> <ul style="list-style-type: none"> • Main access roads • Some sloughing has occurred on the embankment of the new access road (Photo 13) near the Apex of the road. The sloughing can be noted from the entrance to the Terminal Basin. • sloughed earth has pushed the utility pole out of verticality (Photo 14)
<p>Closure Turf on slopes of CC3:</p> <ul style="list-style-type: none"> • The leachate break-out that occurred at access road to the deck of cell CC3 in an area covered with Closure Turf has been repaired
<p>Retaining wall on San Fernando Road:</p> <ul style="list-style-type: none"> • cleaning operations are finished <ul style="list-style-type: none"> – the sidewalk has been totally cleared of sloughed soil • Drains from top of wall concrete channel daylighting a sheet level have not been cleared and are still plugged with soil (Photo 15) • Soil was already accumulating in drainage swale on top of wall (Photo 16)

Photo 14: Tiller Utility Pole near entrance of Terminal Basin
