**Sunshine Canyon Landfill
Independent Monitor
Quarterly Site Monitoring Status Report
October 1, 2018 – December 31, 2018**

January 9, 2019

CERTIFICATION STATEMENT

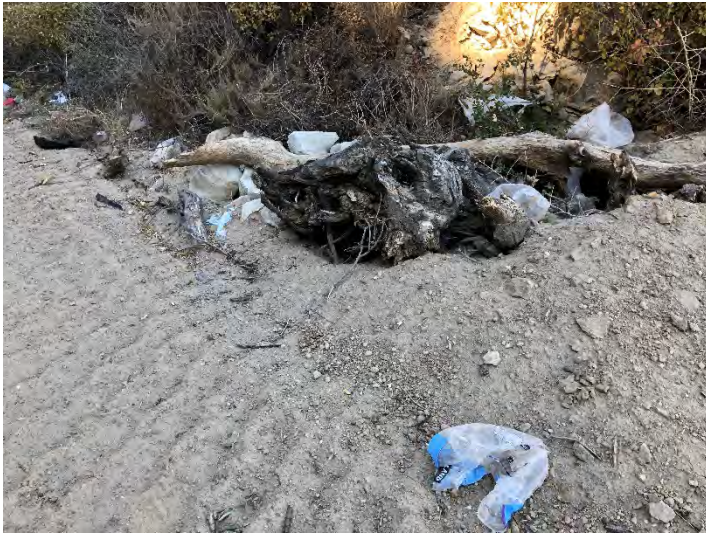
Photo 5: Basin A Hillside Litter: October 23, 2018

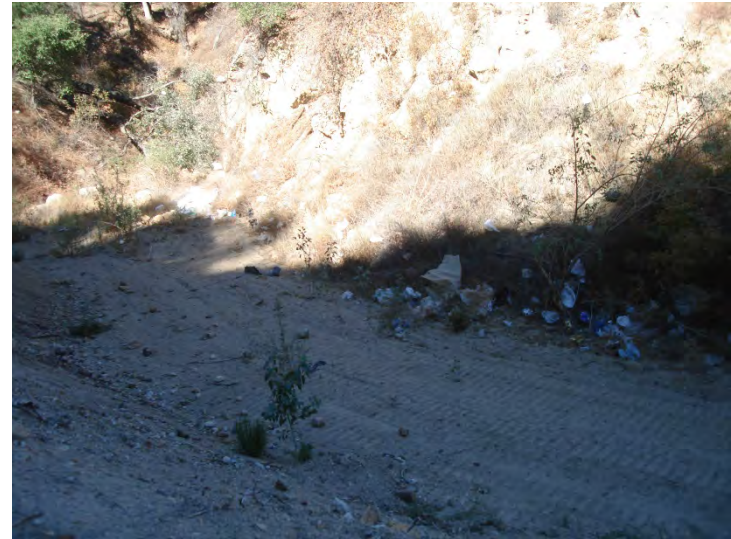
Photo 6: Basin A Hillside Litter: October 23, 2018

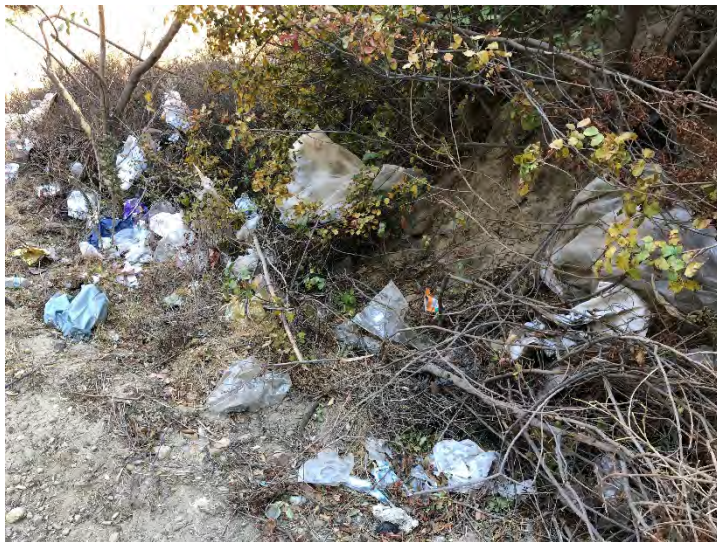
Photo 7: Basin A Hillside Litter: October 23, 2018

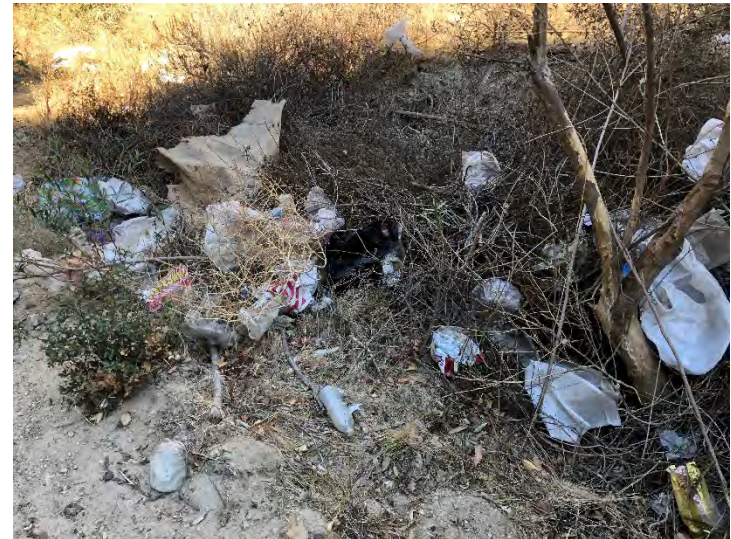
Photo 8: Basin A Hillside Litter: October 23, 2018

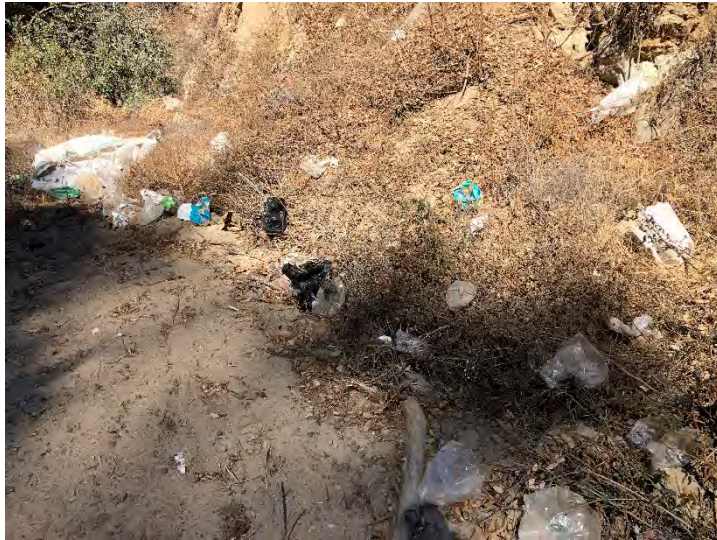
Photo 9: Basin A Hillside Litter: October 23, 2018

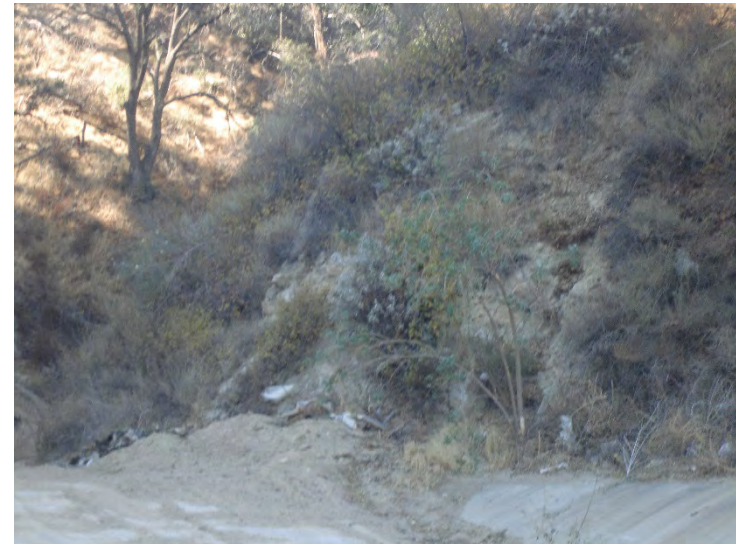
Photo 20: Basin A Native Hillside Windblown Litter: November 20, 2018

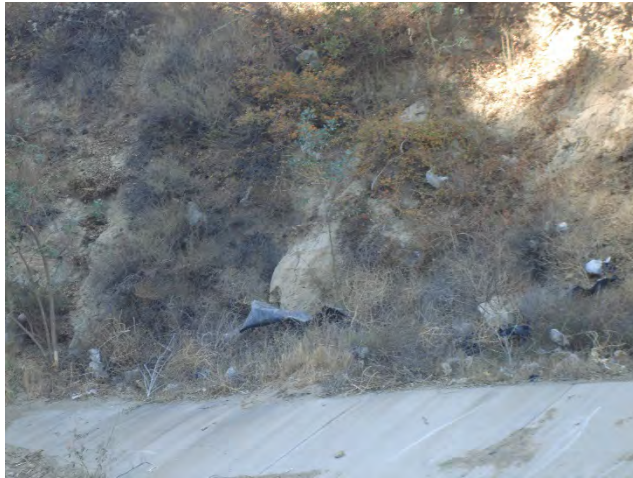
Photo 21: Basin A Native Hillside Windblown Litter: November 20, 2018

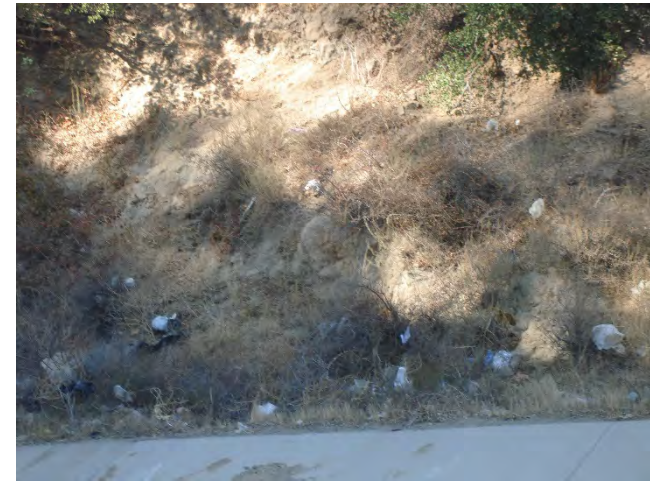
Photo 22: Basin A Native Hillside Windblown Litter: November 20, 2018

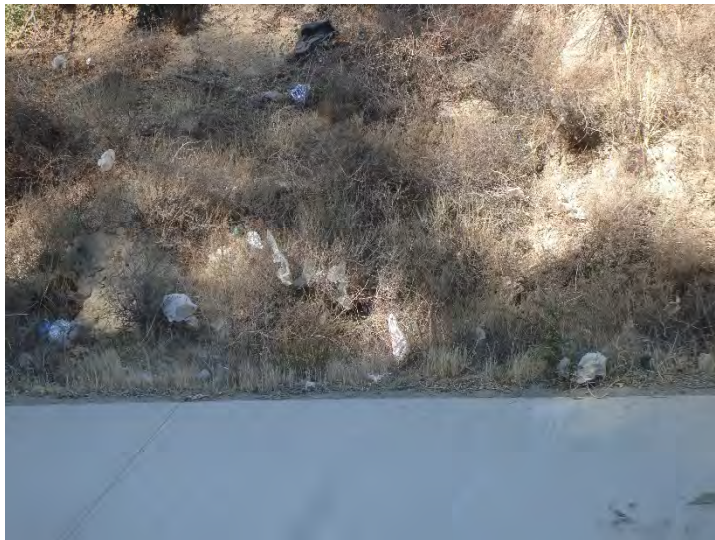
Photo 23: Basin A Native Hillside Windblown Litter: November 20, 2018

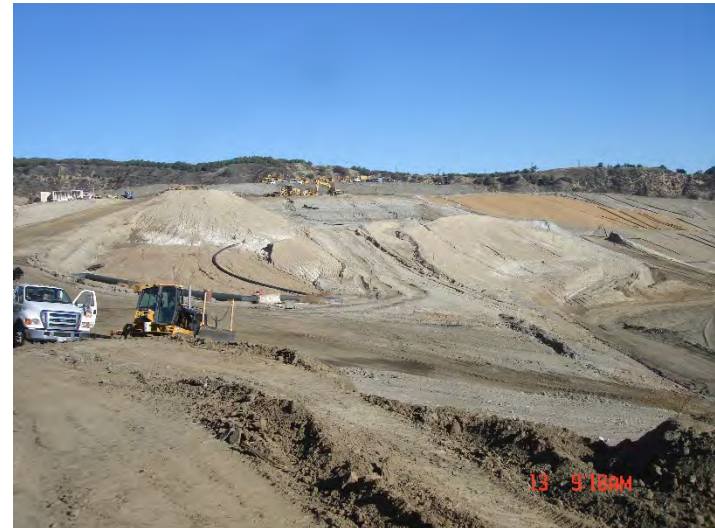
**Photo 72: County Soil Stockpile Erosion Near CC-4 Parts 1&2:
December 13, 2018**

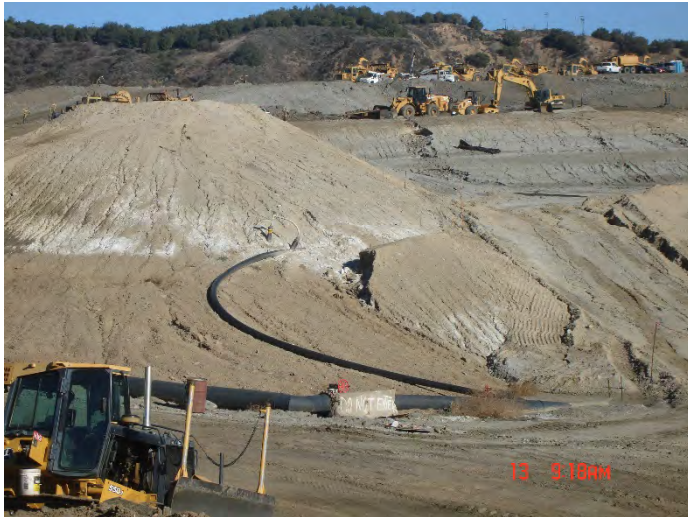
**Photo 73: County Soil Stockpile Erosion Near CC-4 Parts 1&2:
December 13, 2018**

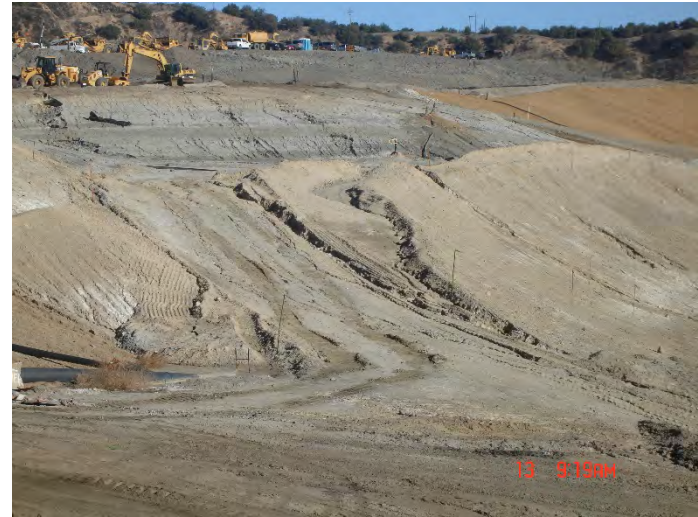
**Photo 74: County Soil Stockpile Erosion Near CC-4 Parts 1&2:
December 13, 2018**

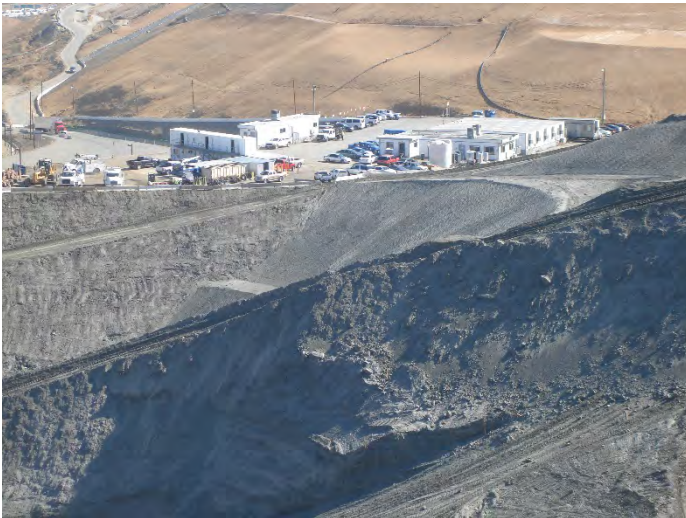
Photo 119: CC4 Part 3 Buttress Excavation Area: November 20, 2018

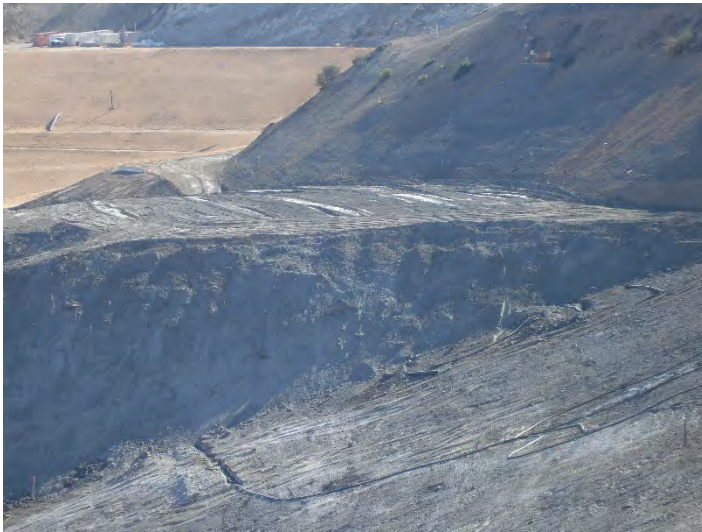
Photo 121: CC4 Part 3 Buttress Excavation Area: November 20, 2018

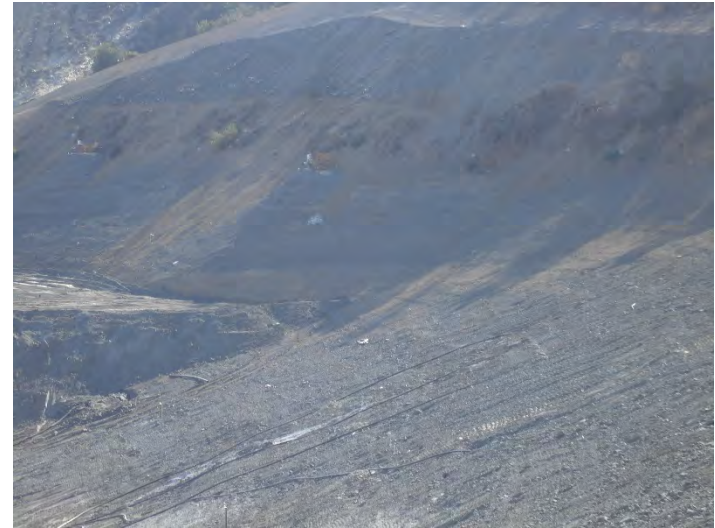
Photo 122: CC4 Part 3 Buttress Excavation Area: November 20, 2018

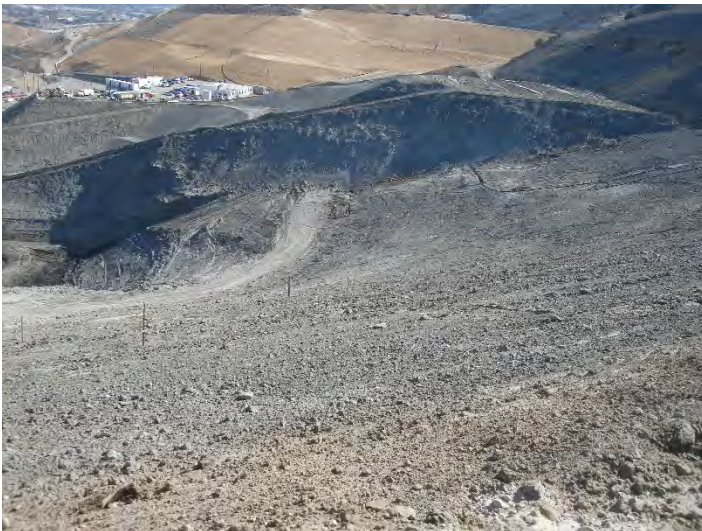
Photo 123: CC4 Part 3 Buttress Excavation Area: November 20, 2018

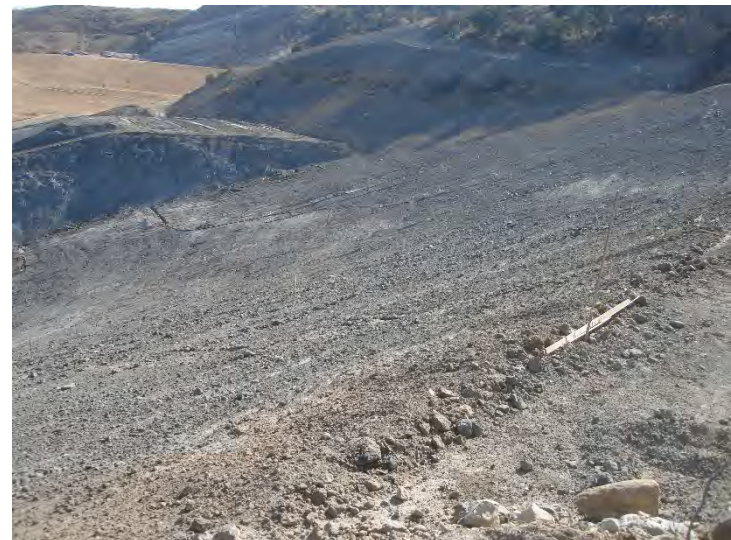
Photo 124: CC4 Part 3 Buttress Excavation Area: November 20, 2018

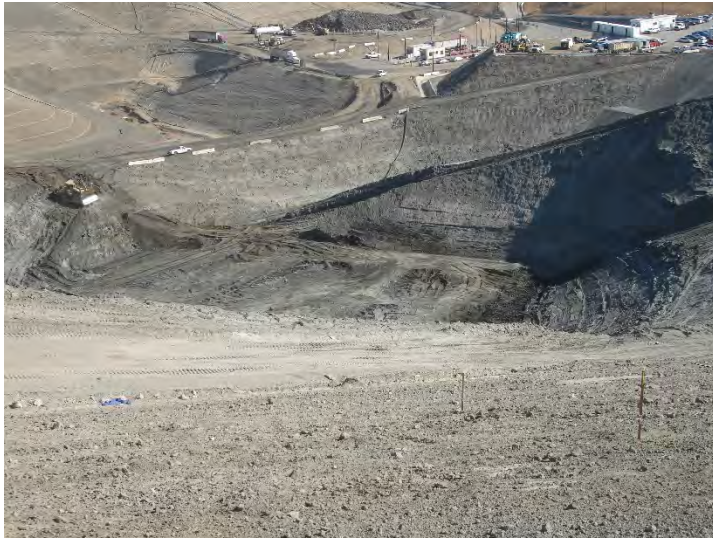
Photo 125: CC4 Part 3 Buttress Excavation Area: November 20, 2018

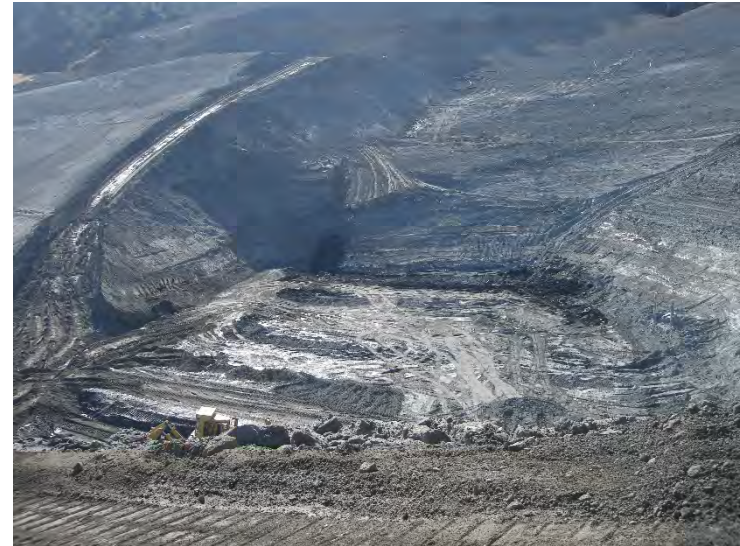
Photo 126: CC4 Part 3 Buttress Excavation Area: November 20, 2018

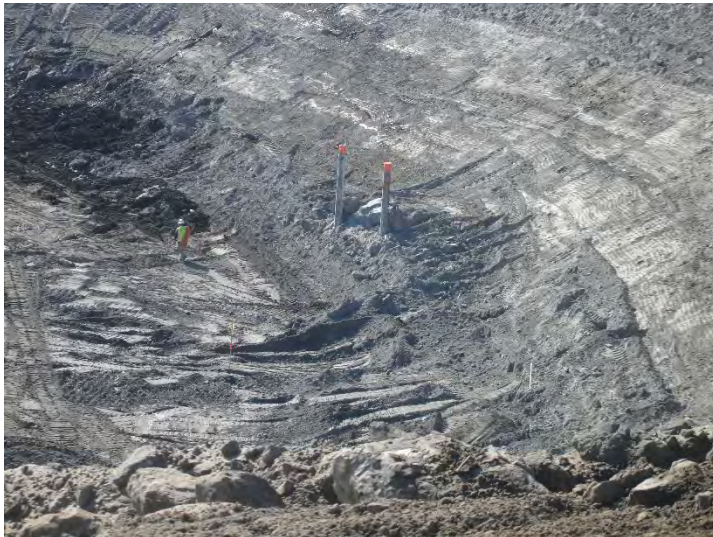
Photo 127: CC4 Part 3 Buttress Excavation Area: November 20, 2018

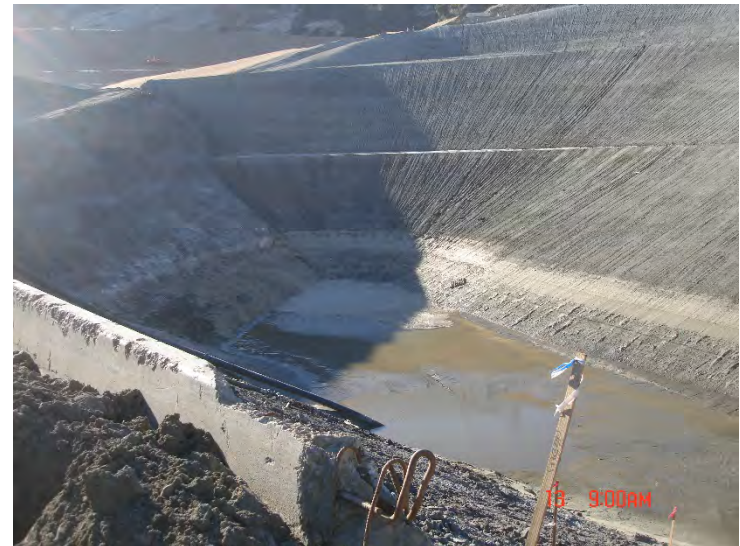
Photo 128: CC4 Part 3 Buttress Excavation Area: December 13, 2018

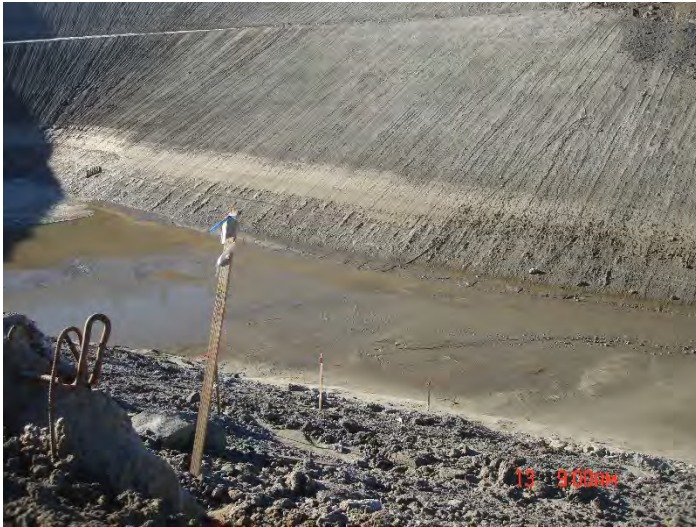
Photo 129: CC4 Part 3 Buttress Excavation Area: December 13, 2018

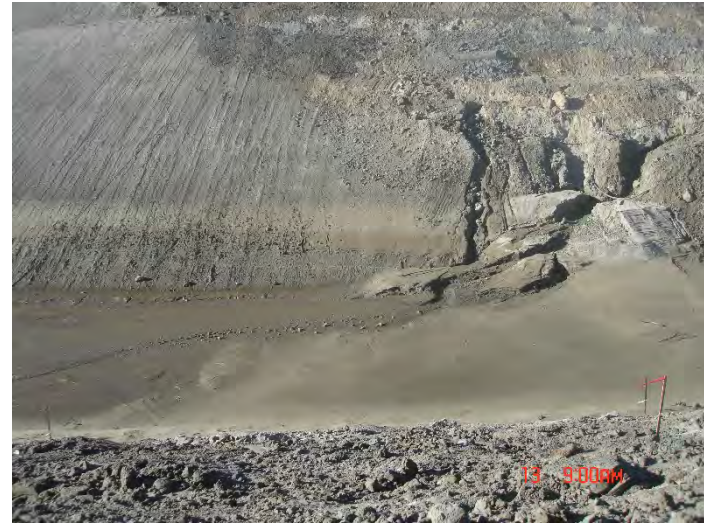
Photo 130: CC4 Part 3 Buttress Excavation Area: December 13, 2018

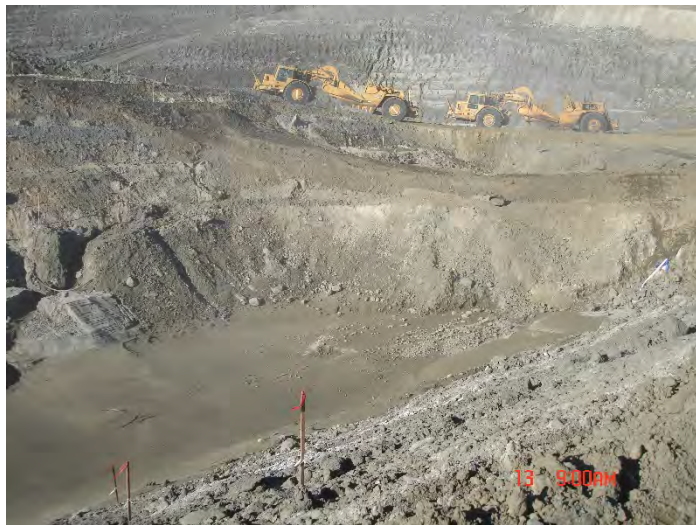
Photo 131: CC4 Part 3 Buttress Excavation Area: December 13, 2018

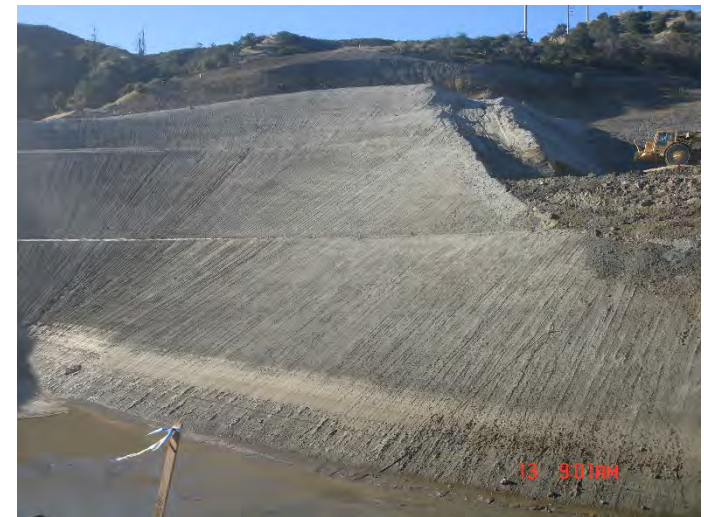
Photo 132: CC4 Part 3 Buttress Excavation Area: December 13, 2018

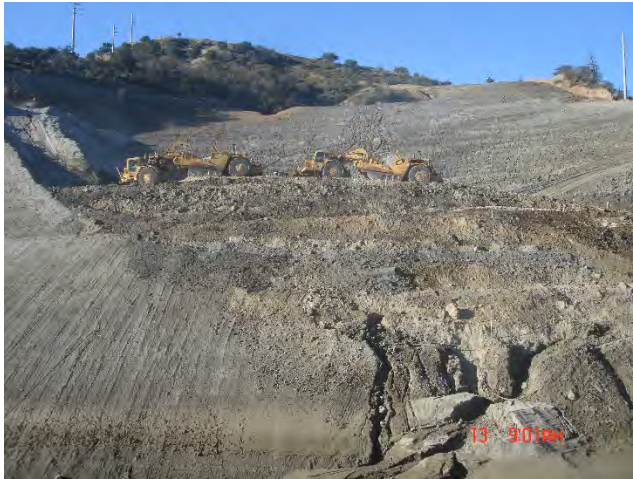
Photo 133: CC4 Part 3 Buttress Excavation Area: December 13, 2018

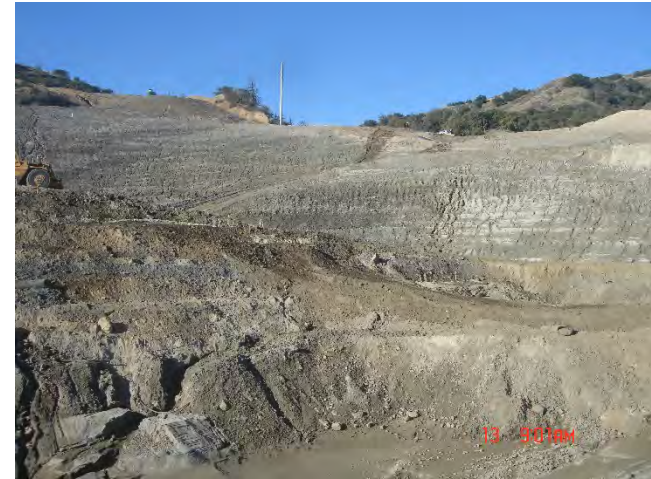
Photo 134: CC4 Part 3 Buttress Excavation Area: December 13, 2018

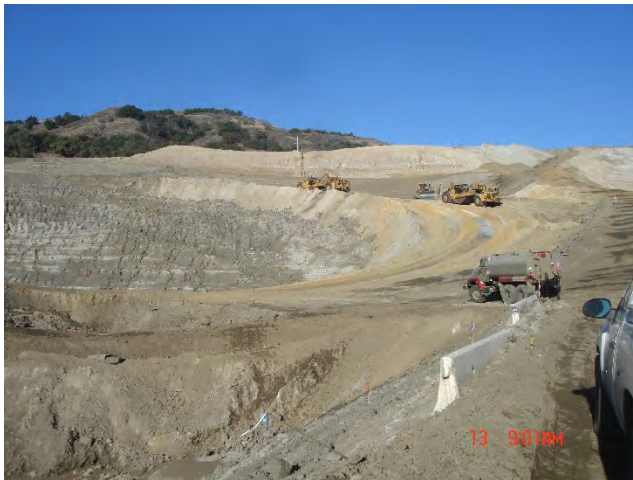
Photo 135: CC4 Part 3 Buttress Excavation Area: December 13, 2018

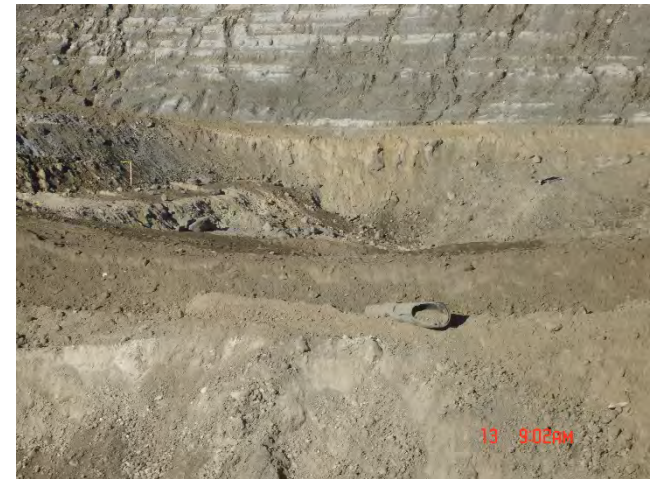
Photo 136: CC4 Part 3 Buttress Excavation Area: December 13, 2018

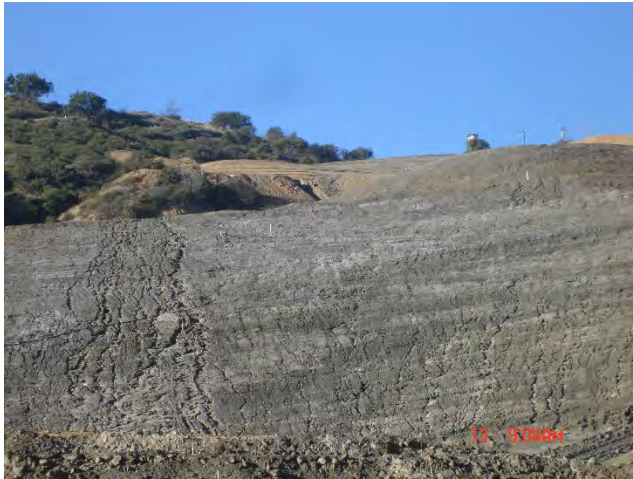
Photo 137: CC4 Part 3 Buttress Excavation Area: December 13, 2018

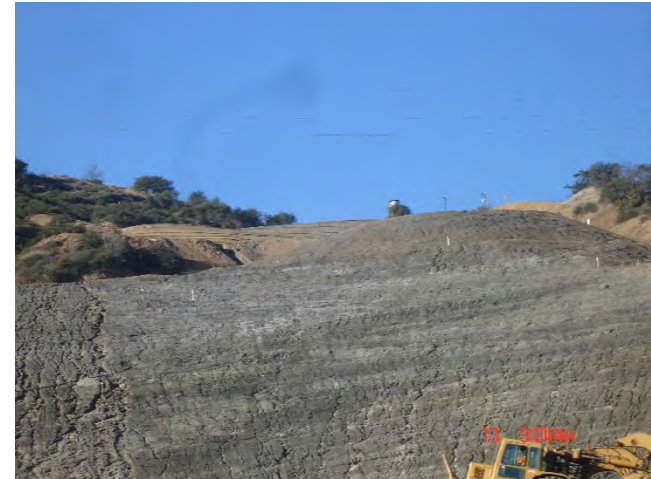
Photo 138: CC4 Part 3 Buttress Excavation Area: December 13, 2018

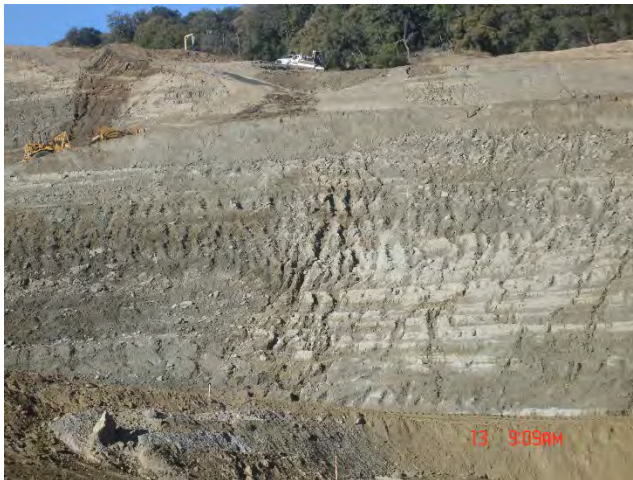
Photo 139: CC4 Part 3 Buttress Excavation Area: December 13, 2018

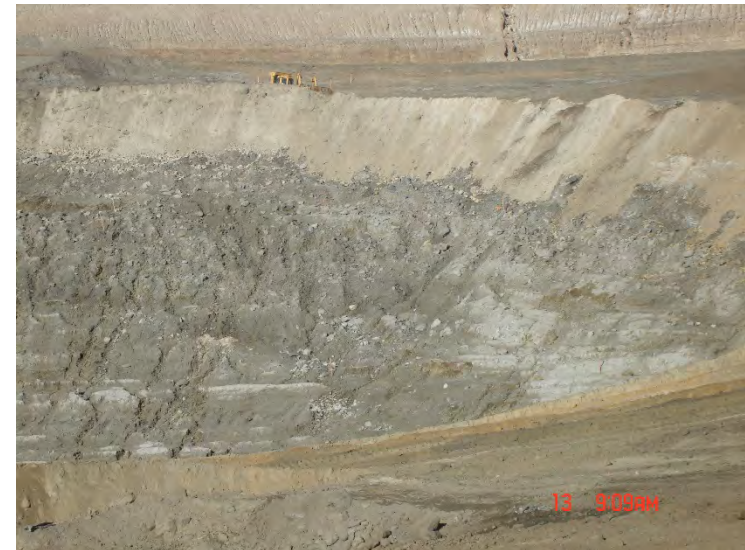
Photo 140: CC4 Part 3 Buttress Excavation Area: December 13, 2018

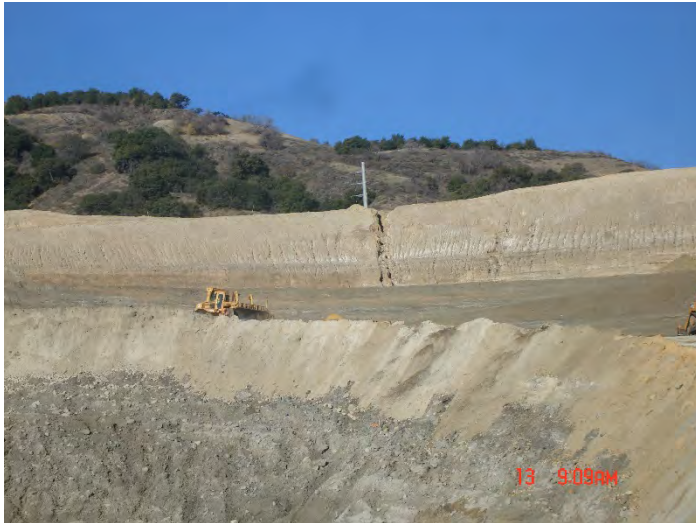
Photo 141: CC4 Part 3 Buttress Excavation Area: December 13, 2018

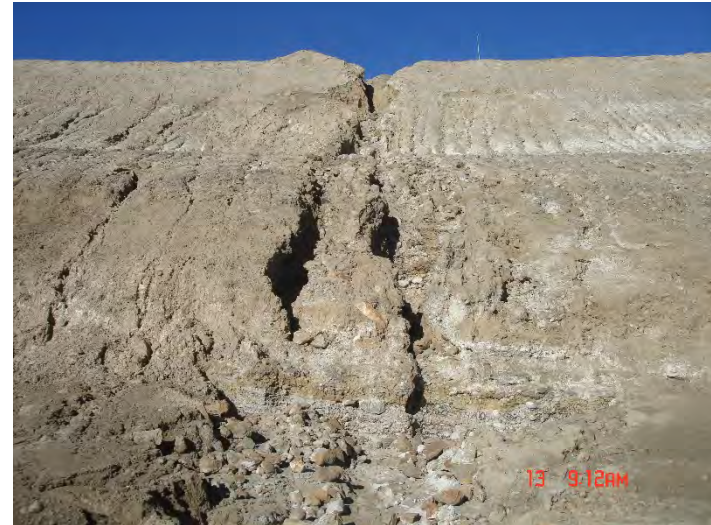
Photo 142: CC4 Part 3 Buttress Excavation Area: December 13, 2018

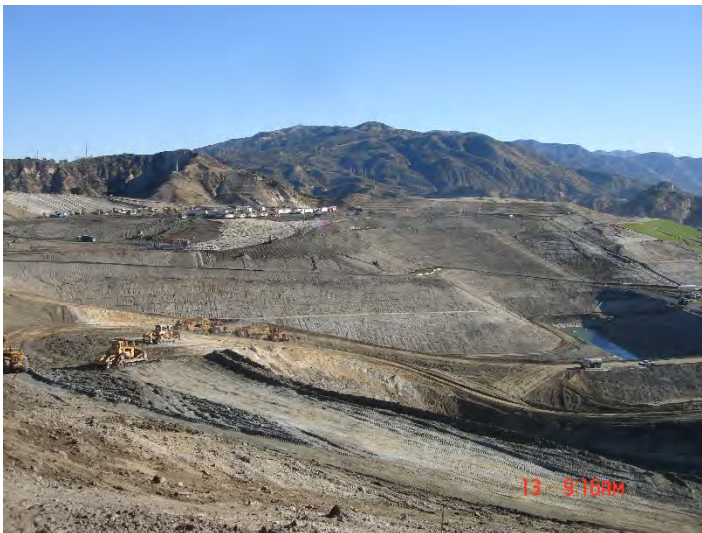
Photo 143: CC4 Part 3 Buttress Excavation Area: December 13, 2018

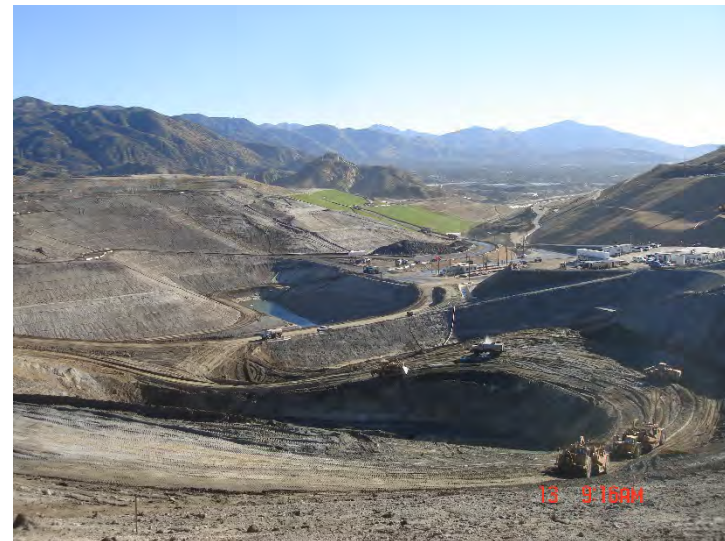
Photo 144: CC4 Part 3 Buttress Excavation Area: December 13, 2018

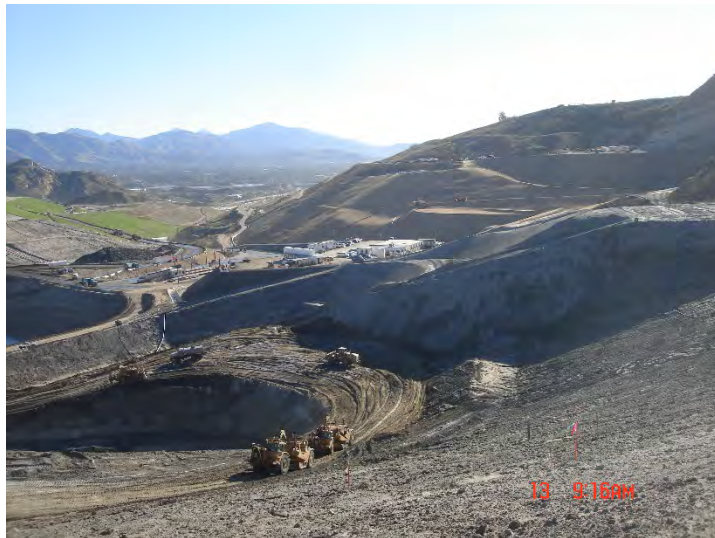
Photo 145: CC4 Part 3 Buttress Excavation Area: December 13, 2018

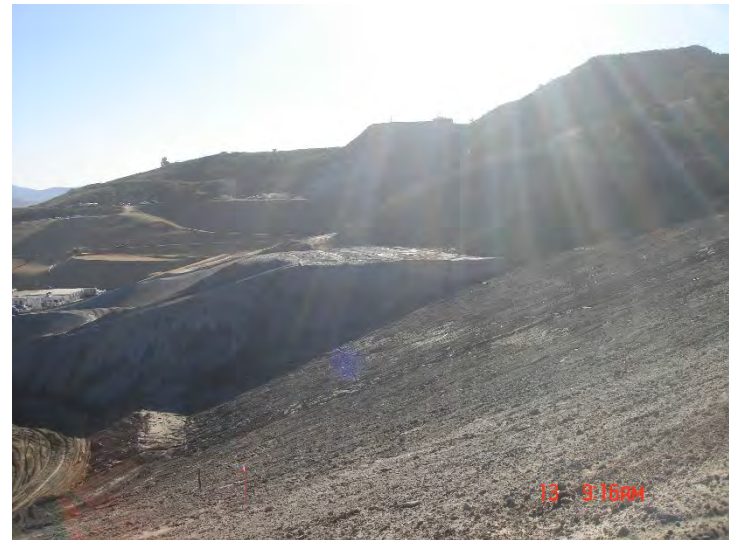
Photo 146: CC4 Part 3 Buttress Excavation Area: December 13, 2018

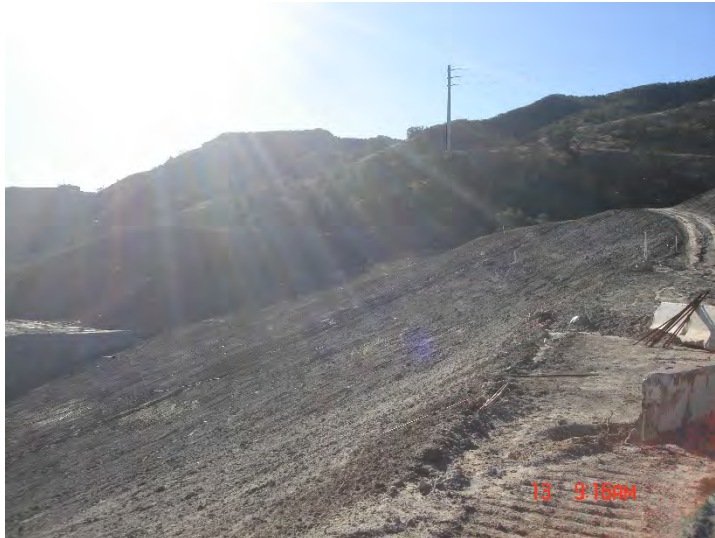
Photo 147: CC4 Part 3 Buttress Excavation Area: December 13, 2018

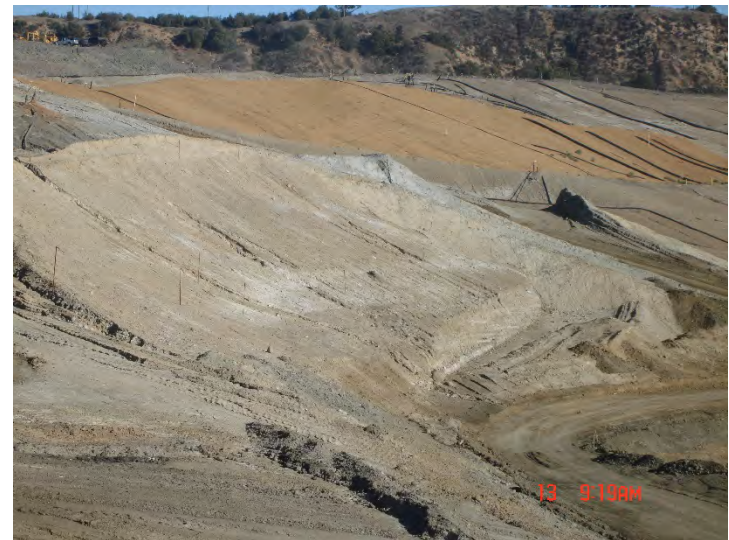
Photo 148: CC4 Part 3 Buttress Excavation Area: December 13, 2018

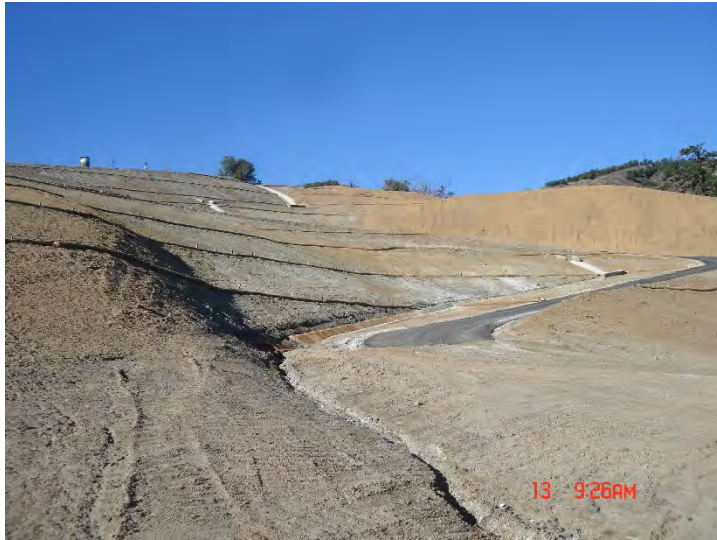
Photo 149: CC4 Part 3 Buttress Excavation Area: December 13, 2018

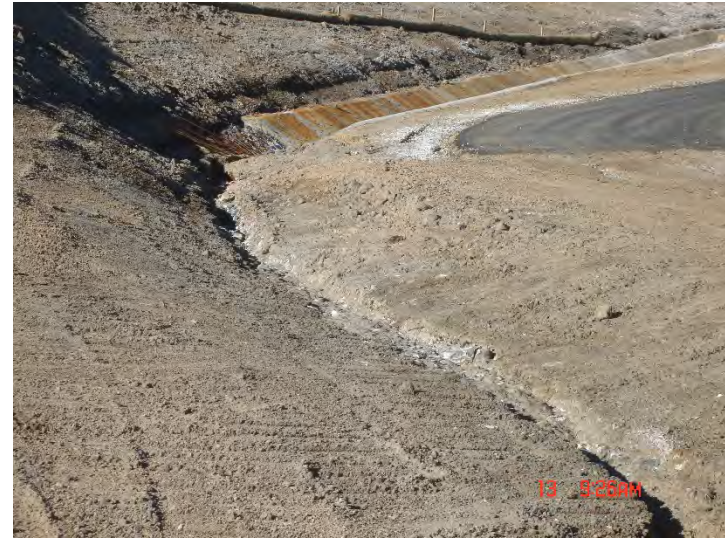
Photo 150: CC4 Part 3 Buttress Excavation Area: December 13, 2018

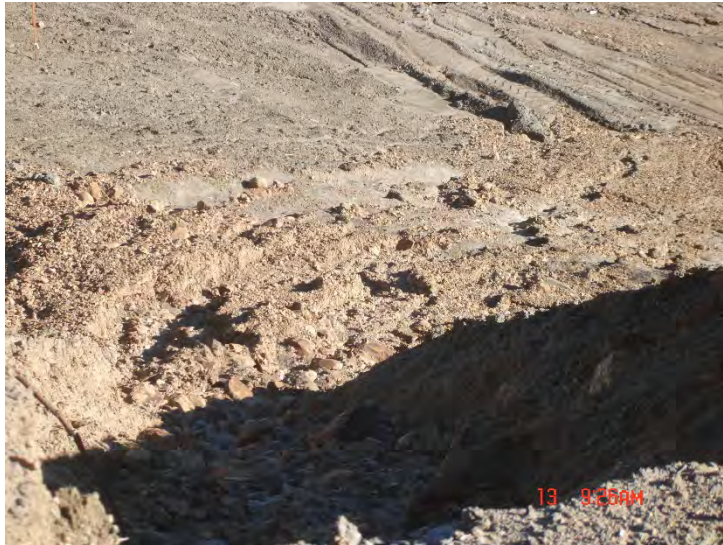
Photo 151: CC4 Part 3 Buttress Excavation Area: December 13, 2018

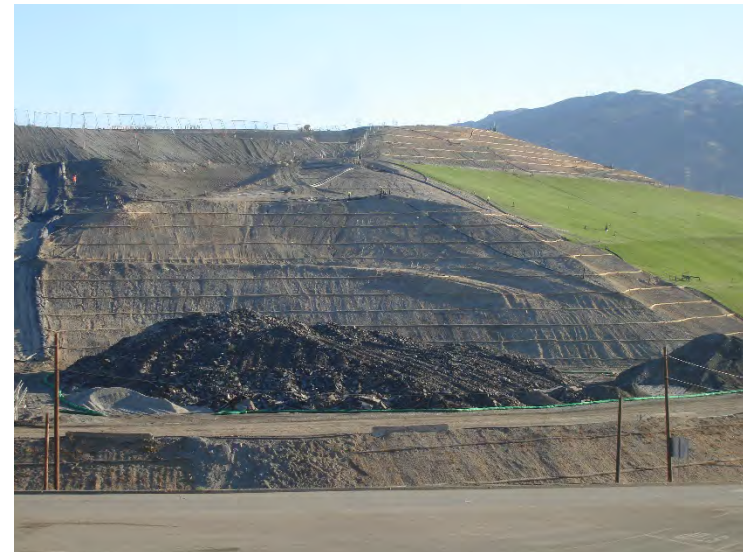
Photo 152: Posi-Shell and Closure Turf: October 23, 2018

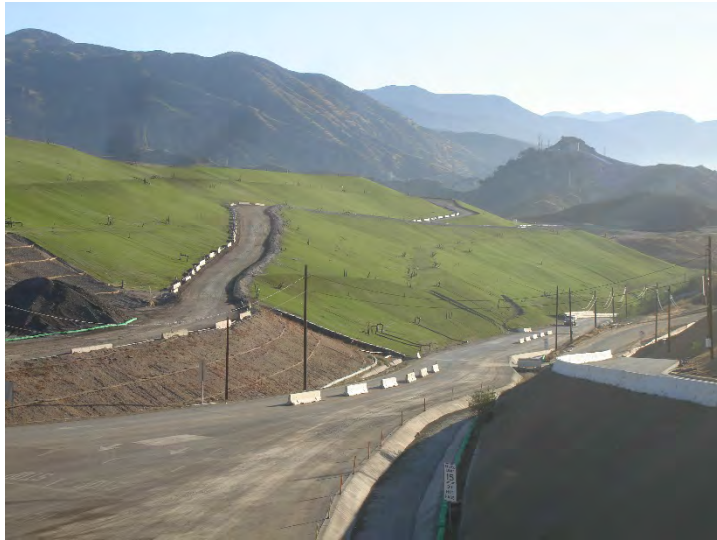
Photo 153: Posi-Shell and Closure Turf: October 23, 2018

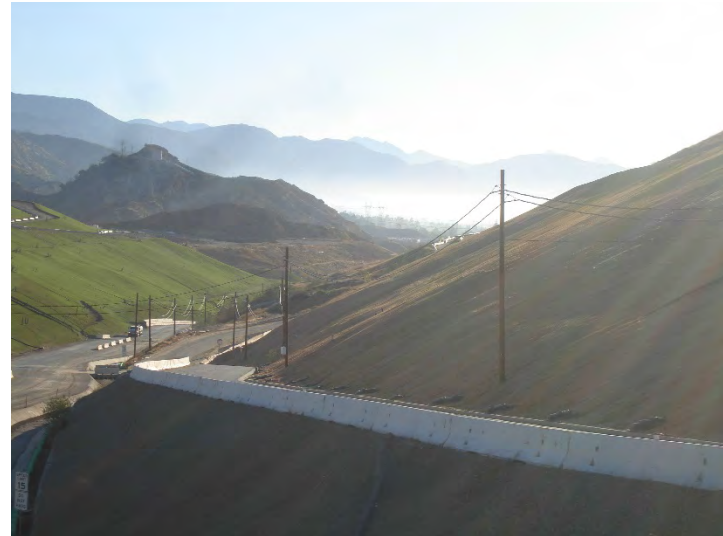
Photo 154: Posi-Shell and Closure Turf: October 23, 2018

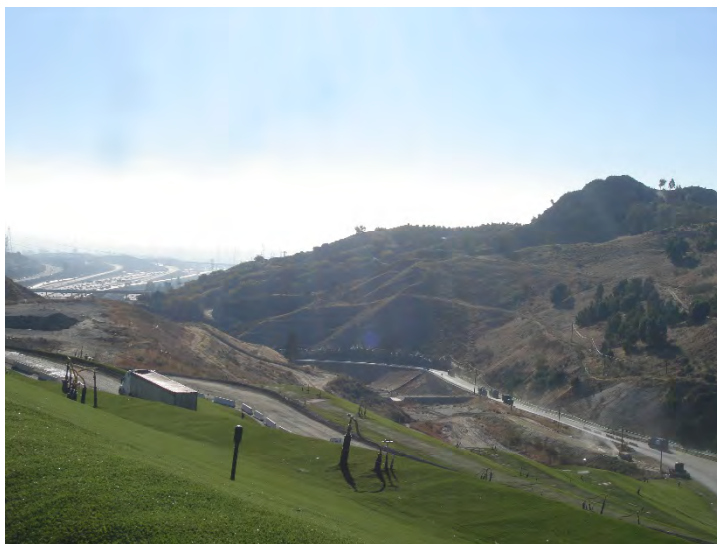
Photo 155: Posi-Shell and Closure Turf: October 23, 2018

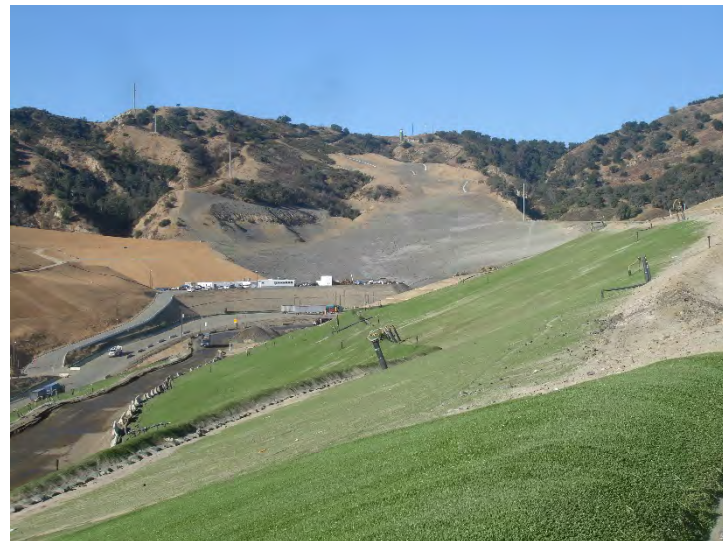
Photo 156: Posi-Shell and Closure Turf: October 23, 2018

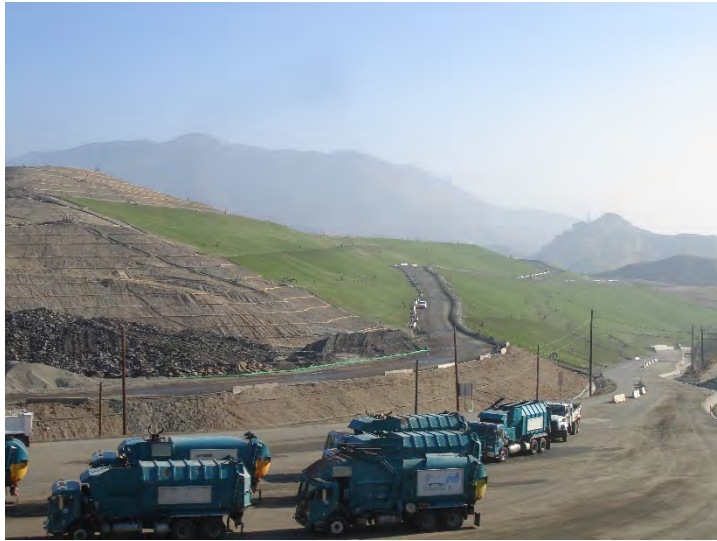
Photo 157: Posi-Shell and Closure Turf: November 6, 2018

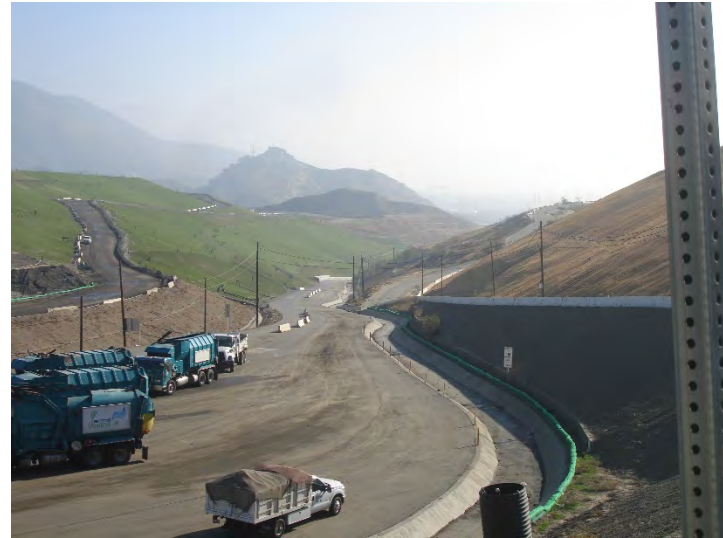
Photo 158: Posi-Shell and Closure Turf: November 6, 2018

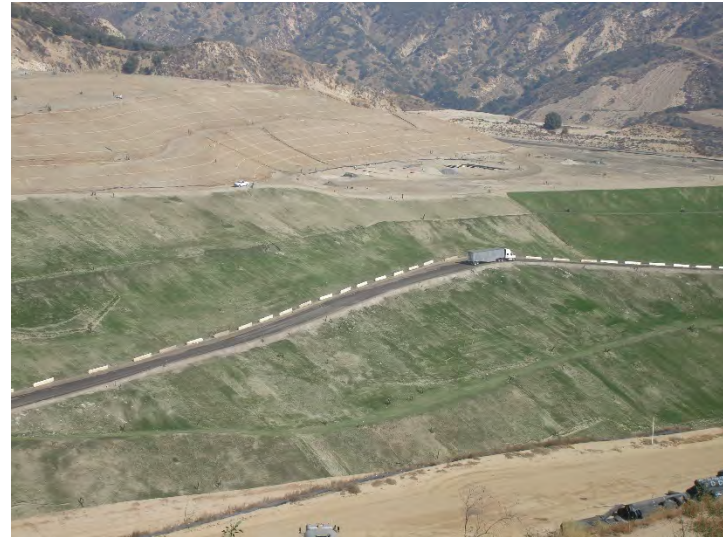
Photo 159: Posi-Shell and Closure Turf: November 6, 2018

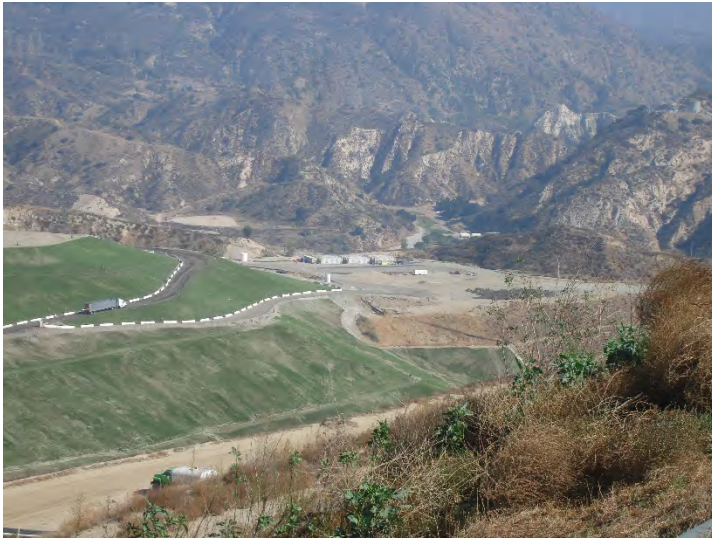
Photo 160: Posi-Shell and Closure Turf: November 6, 2018

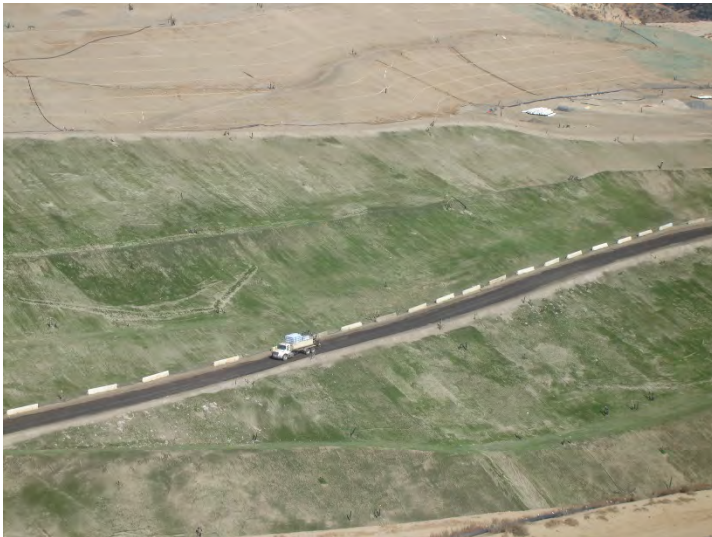
Photo 161: Posi-Shell and Closure Turf: November 6, 2018

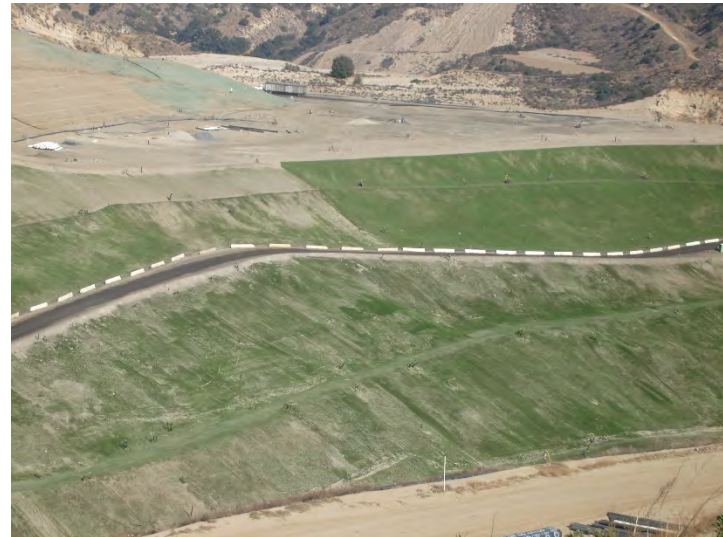
Photo 162: Posi-Shell and Closure Turf: November 20, 2018

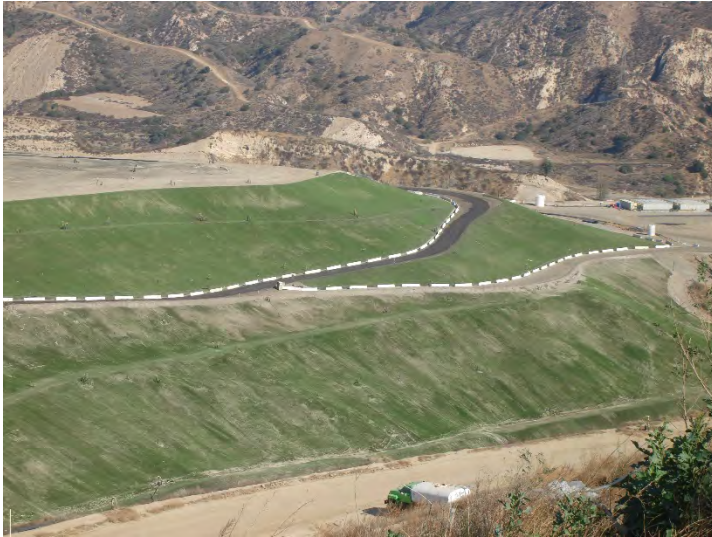
Photo 164: Posi-Shell and Closure Turf: November 20, 2018

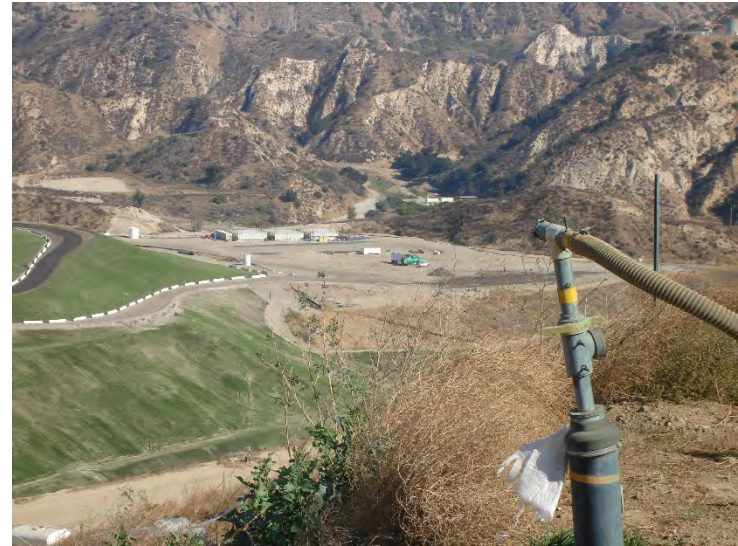
Photo 165: Posi-Shell and Closure Turf: November 20, 2018

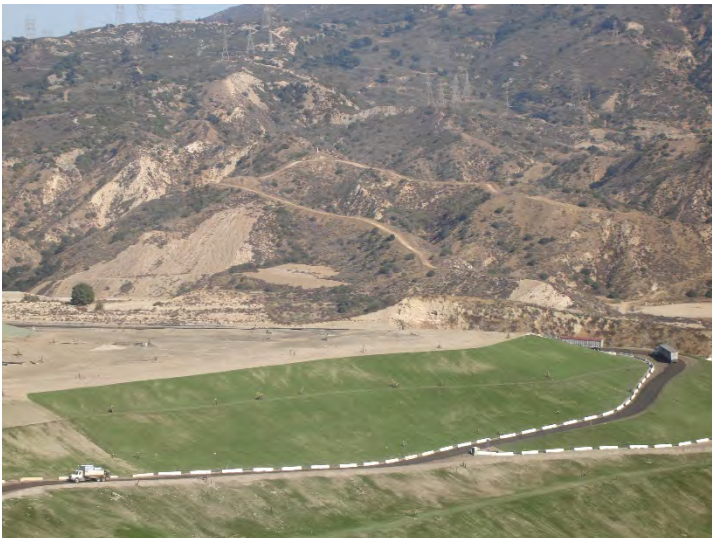
Photo 166: Posi-Shell and Closure Turf: November 20, 2018

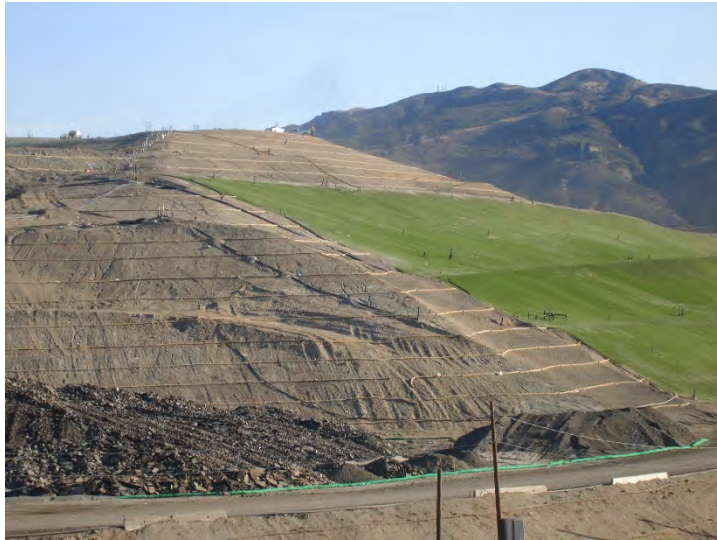
Photo 168: Posi-Shell and Closure Turf: November 20, 2018
