**Sunshine Canyon Landfill
Independent Monitor
Quarterly Site Monitoring Status Report
October 1, 2018 – December 31, 2018**

January 9, 2019

CERTIFICATION STATEMENT

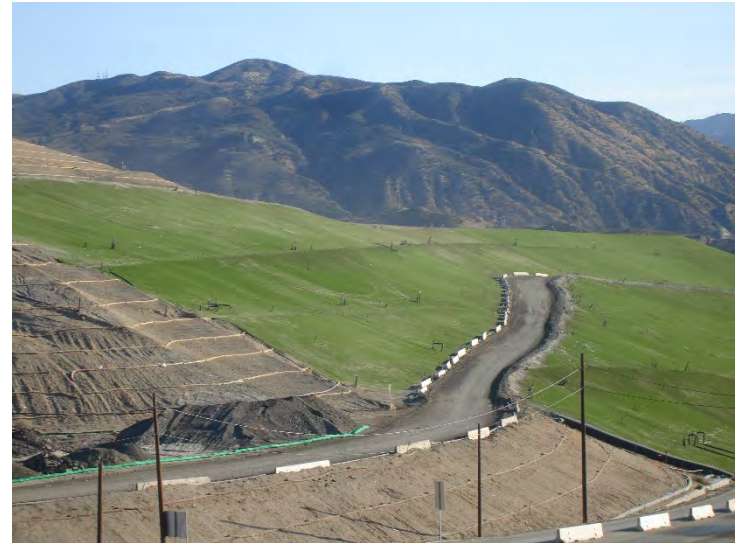
Photo 169: Posi-Shell and Closure Turf: November 20, 2018

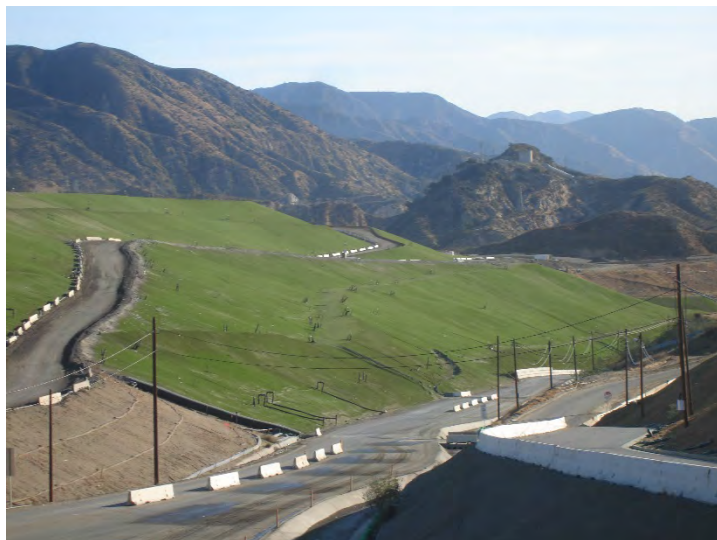
Photo 170: Posi-Shell and Closure Turf: November 20, 2018

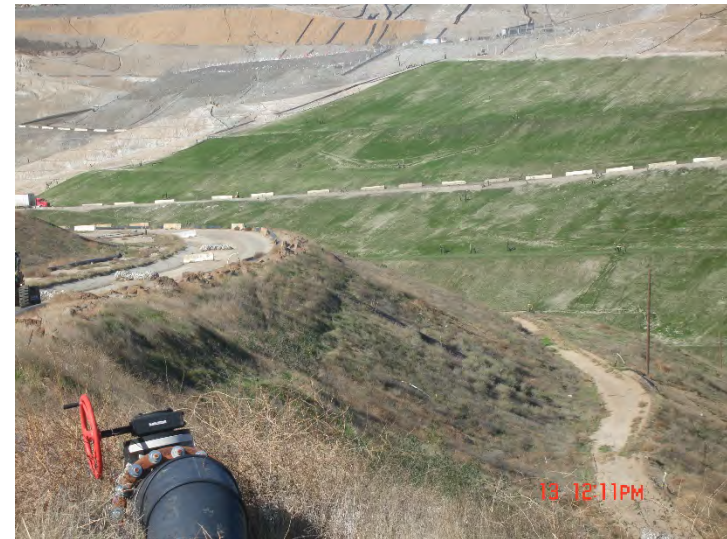
Photo 171: Posi-Shell and Closure Turf: November 20, 2018

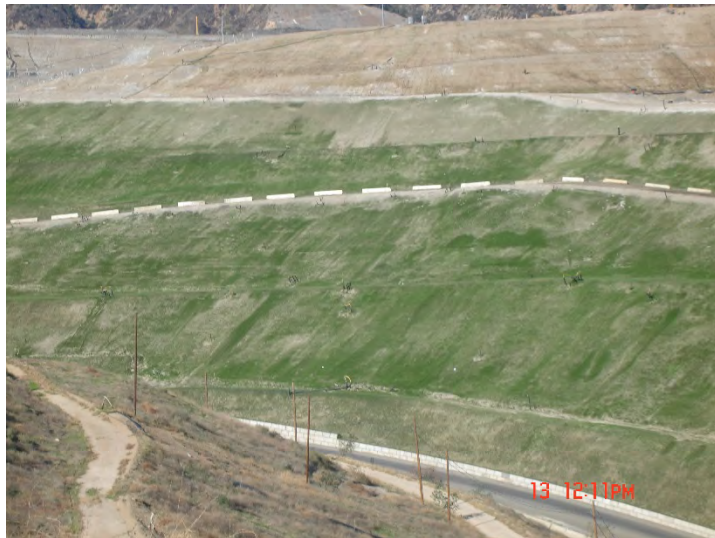
Photo 172: Posi-Shell and Closure Turf: December 13, 2018

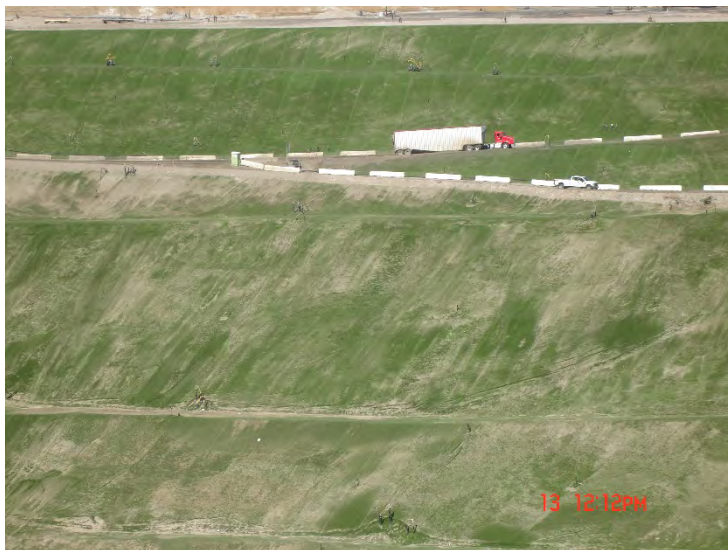
Photo 173: Posi-Shell and Closure Turf: December 13, 2018

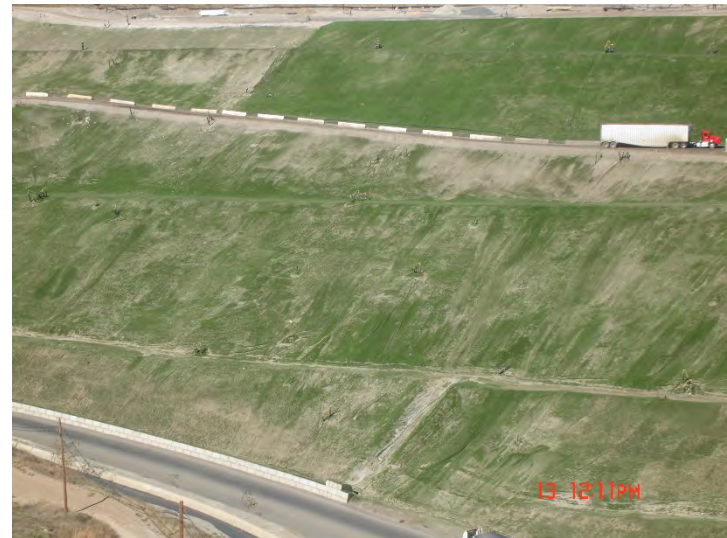
Photo 175: Posi-Shell and Closure Turf: December 13, 2018

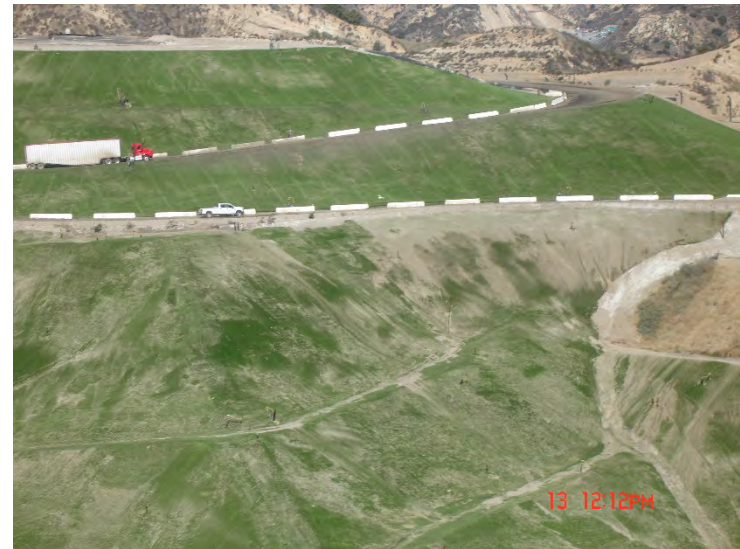
Photo 174: Posi-Shell and Closure Turf: December 13, 2018

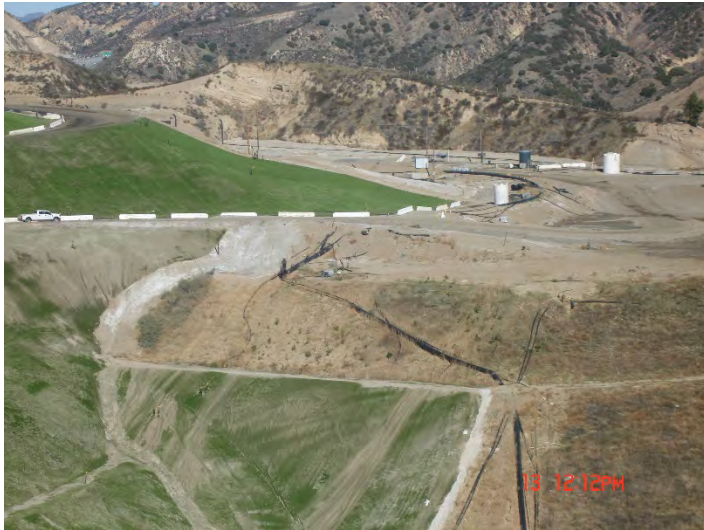
Photo 176: Posi-Shell and Closure Turf: December 13, 2018

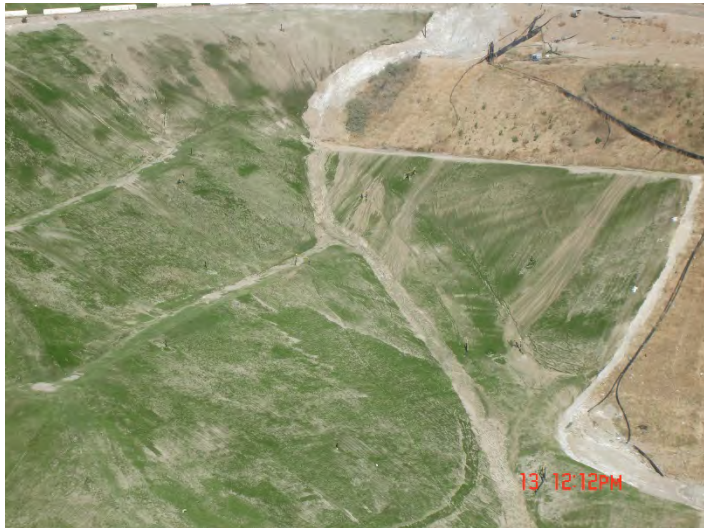
Photo 177: Posi-Shell and Closure Turf: December 13, 2018

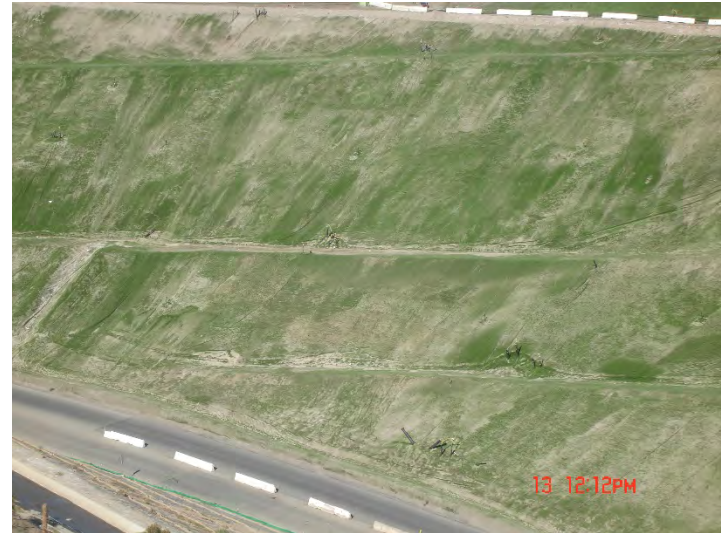
Photo 179: Posi-Shell and Closure Turf: December 13, 2018

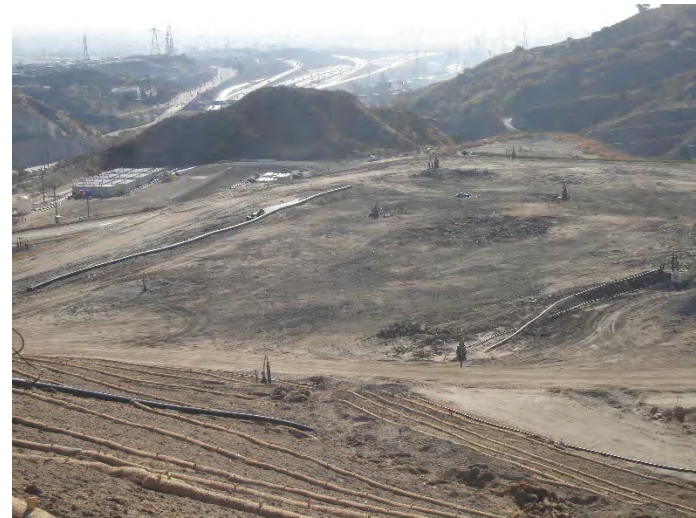
Photo 178: Posi-Shell and Closure Turf: December 13, 2018

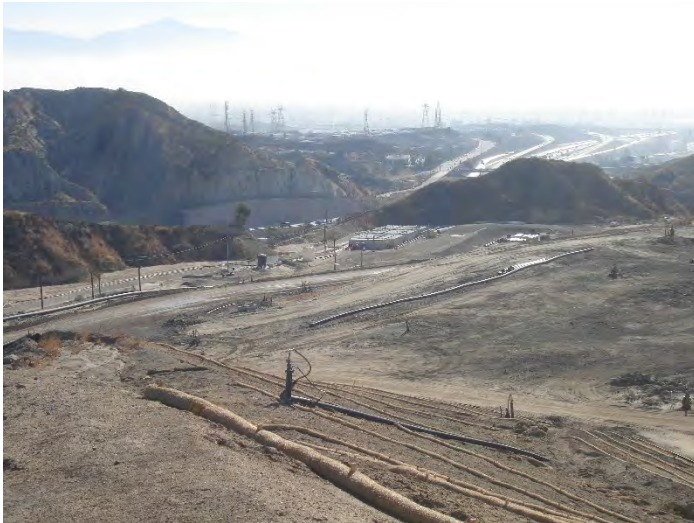
**Photo 180: Old City North Top Deck Liquids Handling Facility:
October 23, 2018**

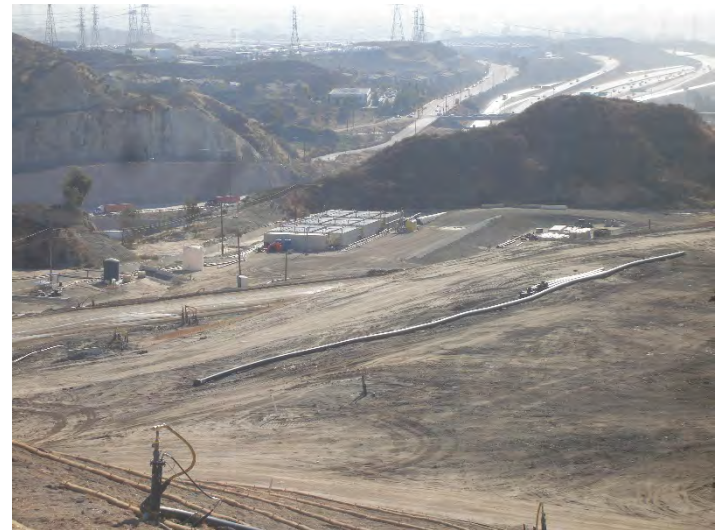
**Photo 181: Old City North Top Deck Liquids Handling Facility:
October 23, 2018**

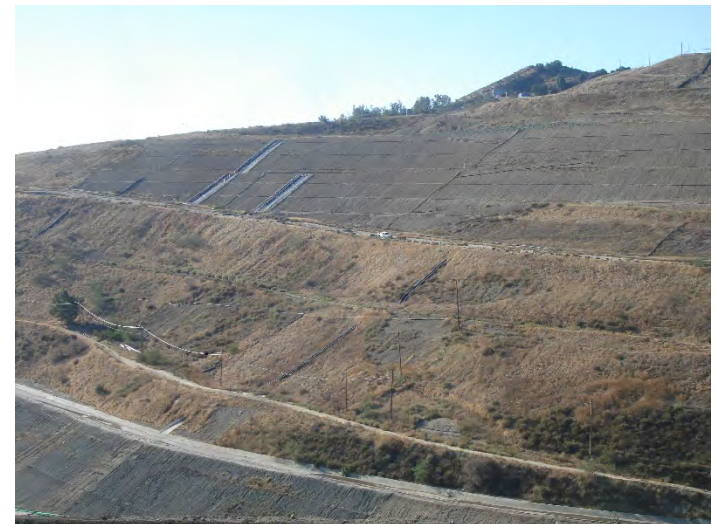
Photo 183: Old City South Slopes: October 23, 2018

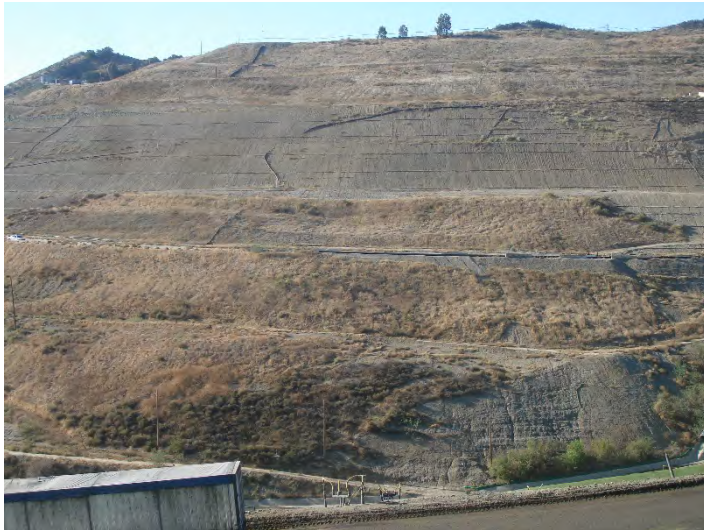
Photo 184: Old City South Slopes: October 23, 2018

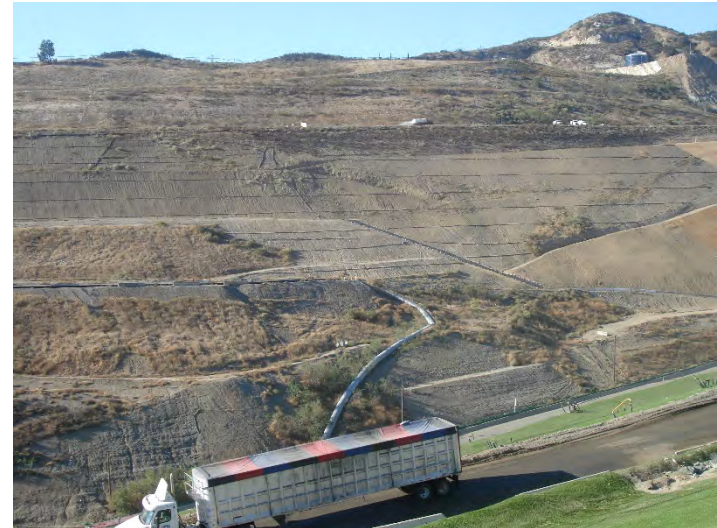
Photo 185: Old City South Slopes: October 23, 2018

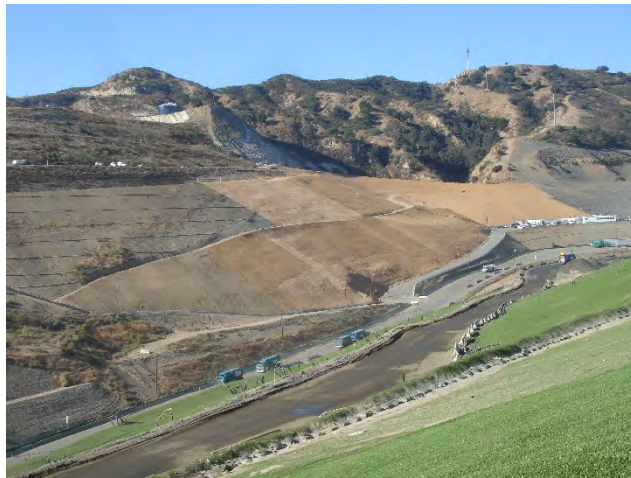
Photo 186: Old City South Slopes: October 23, 2018

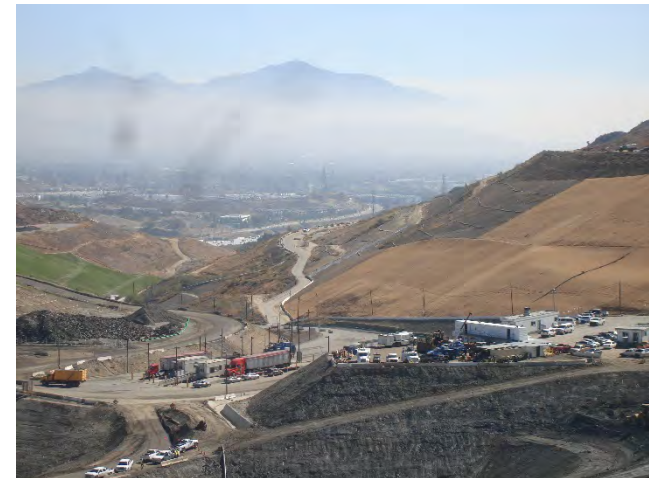
Photo 187: Old City South Slopes: October 23, 2018

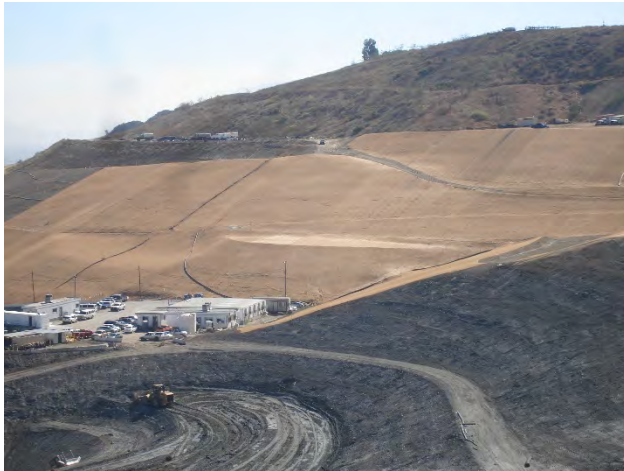
Photo 188: Old City South Slopes: October 23, 2018

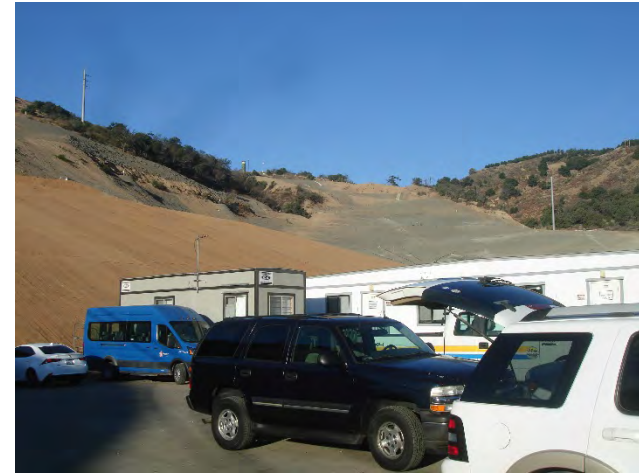
Photo 189: Old City South Slopes: October 23, 2018

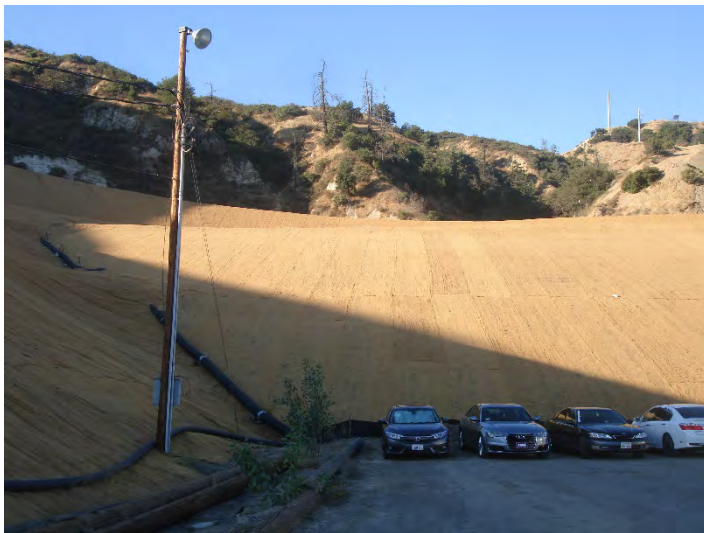
Photo 190: Old City South Slopes: October 23, 2018

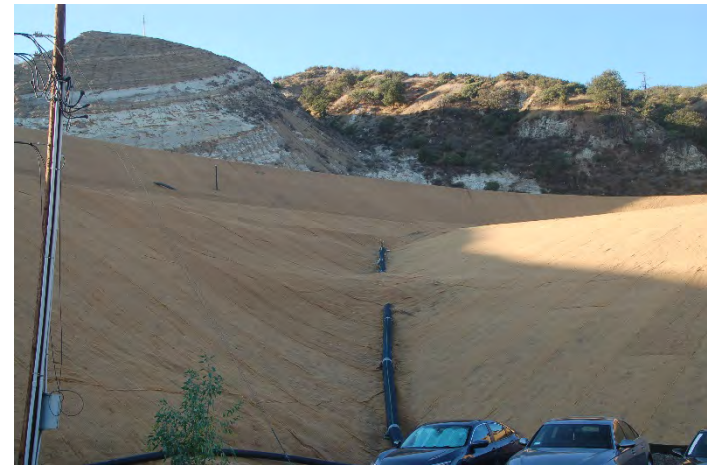
Photo 191: Old City South Slopes: October 23, 2018

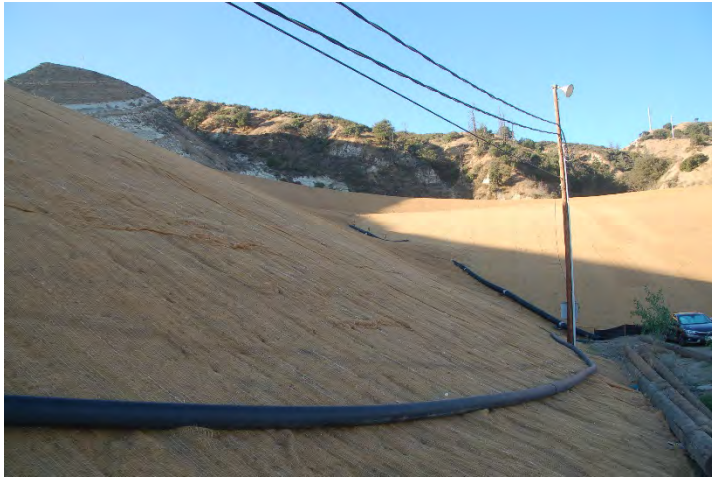
Photo 192: Old City South Slopes: October 23, 2018

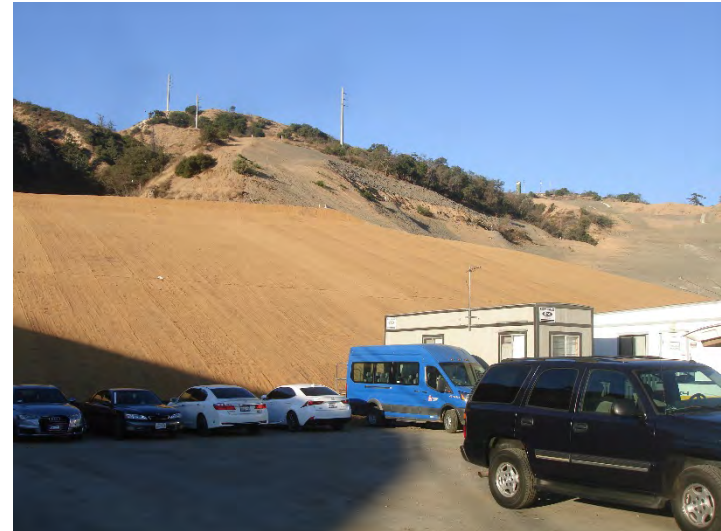
Photo 193: Old City South Slopes: October 23, 2018

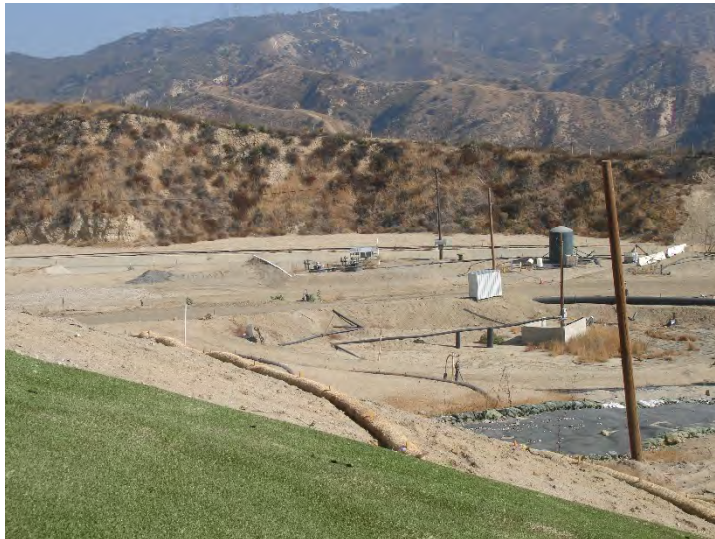
Photo 194: Old City South Slopes: October 23, 2018

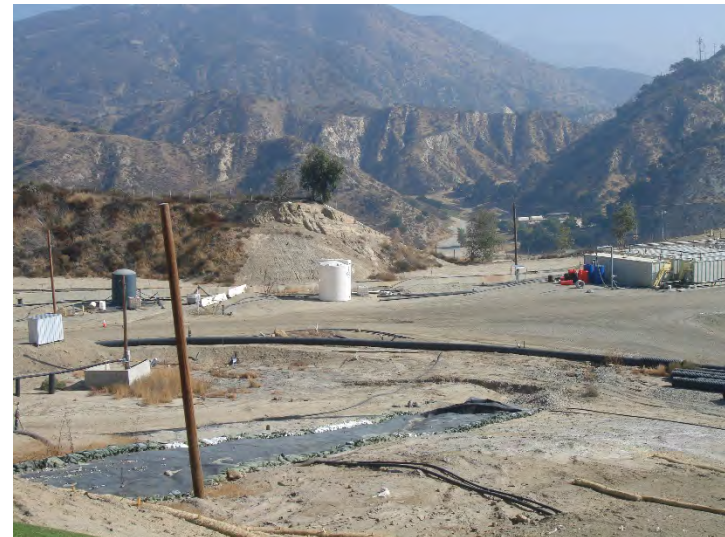
**Photo 195: Old City North Top Deck Liquids Handling Facility:
November 6, 2018**

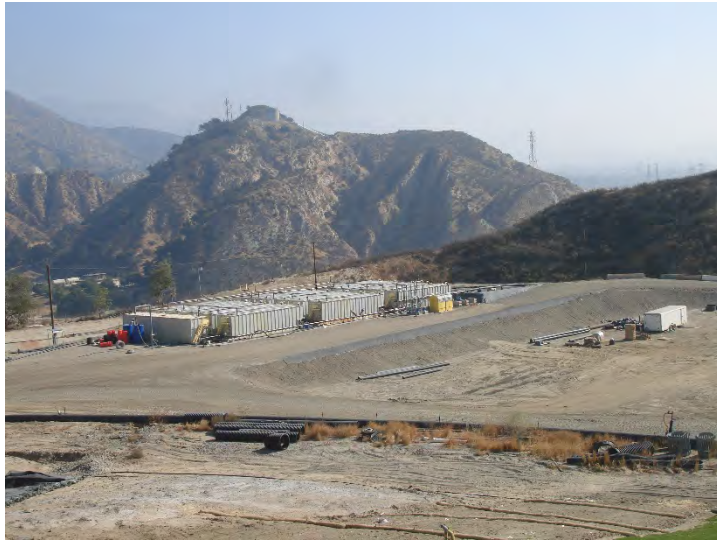
**Photo 196: Old City North Top Deck Liquids Handling Facility:
November 6, 2018**

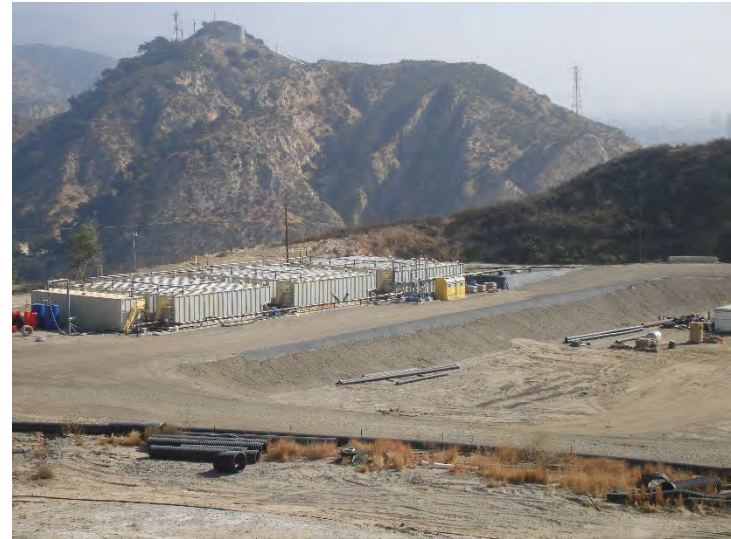
**Photo 197: Old City North Top Deck Liquids Handling Facility:
November 6, 2018**

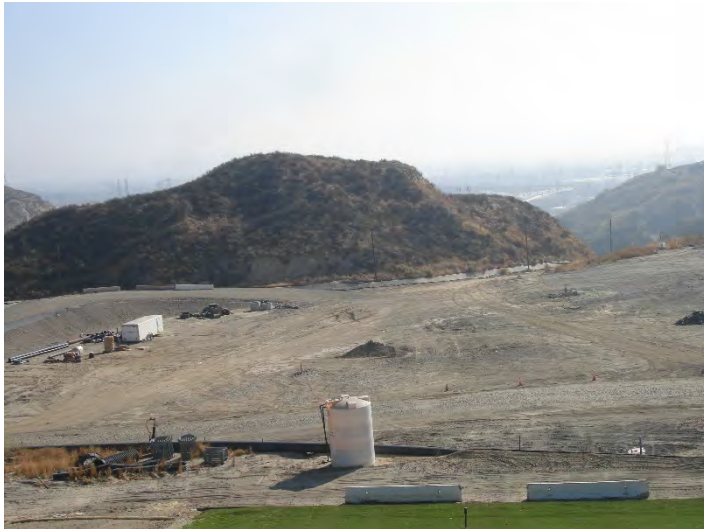
Photo 199: Old City North Top Deck: November 6, 2018

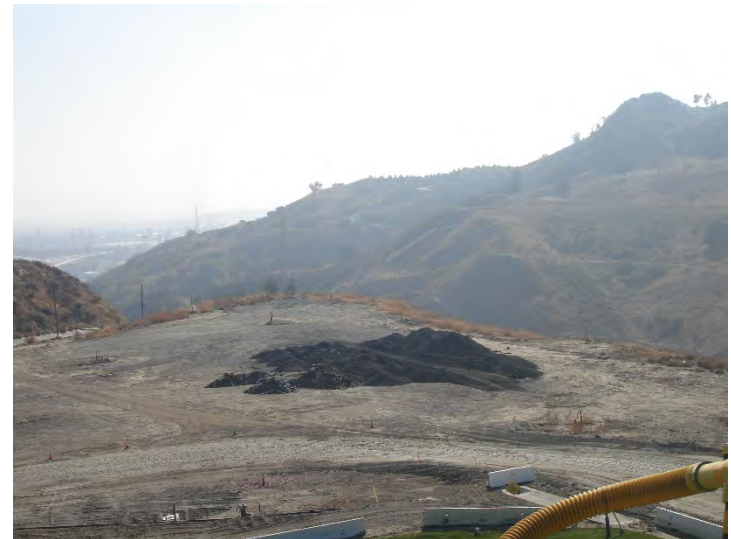
Photo 200: Old City North Top Deck: November 6, 2018

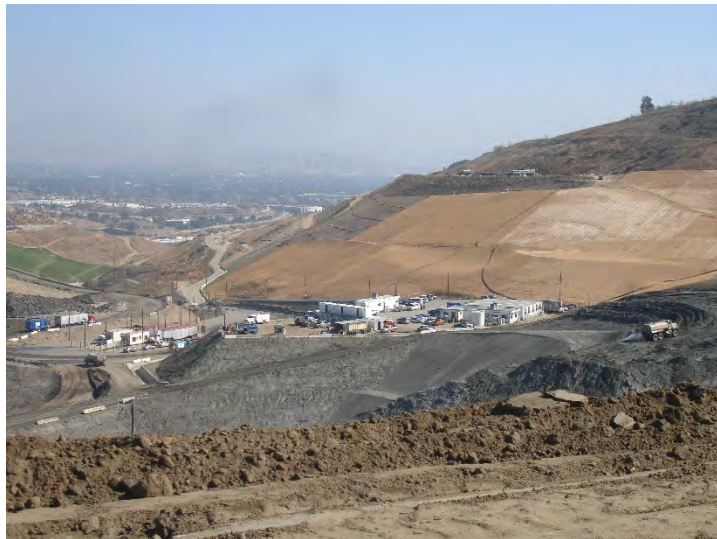
Photo 211: Old City South Soil Stockpile Slump: November 6, 2018

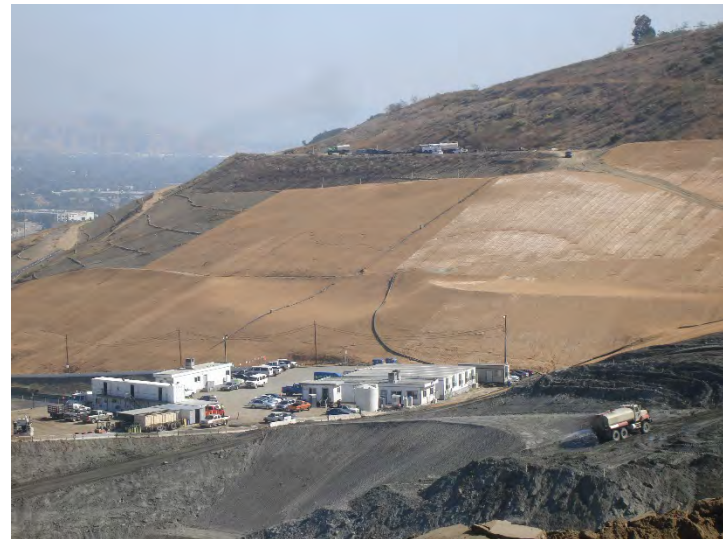
Photo 212: Old City South Soil Stockpile Slump: November 6, 2018

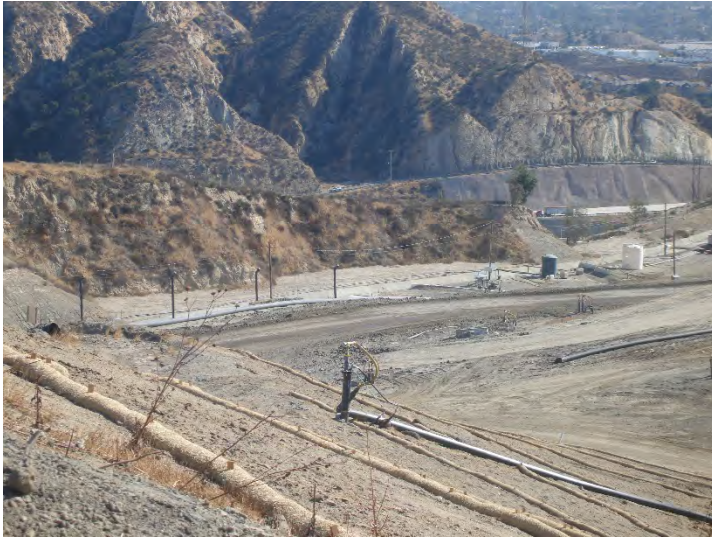
**Photo 213: Old City North Top Deck Liquids Handling Facility:
November 20, 2018**

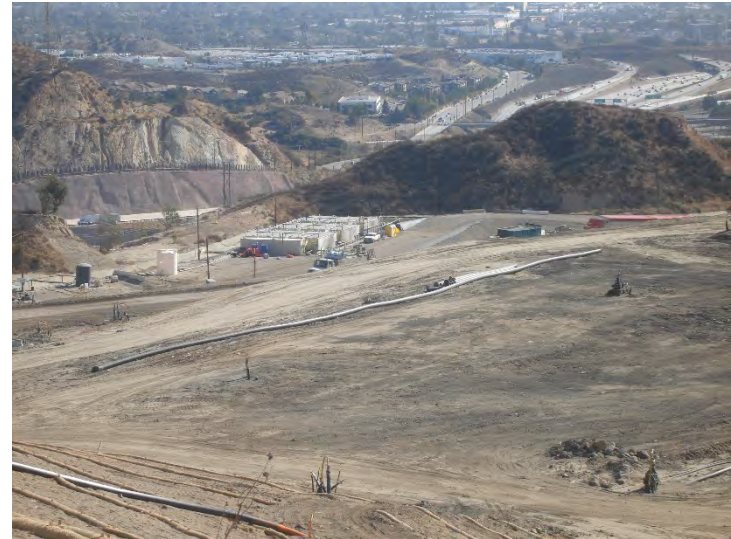
**Photo 214: Old City North Top Deck Liquids Handling Facility:
November 20, 2018**

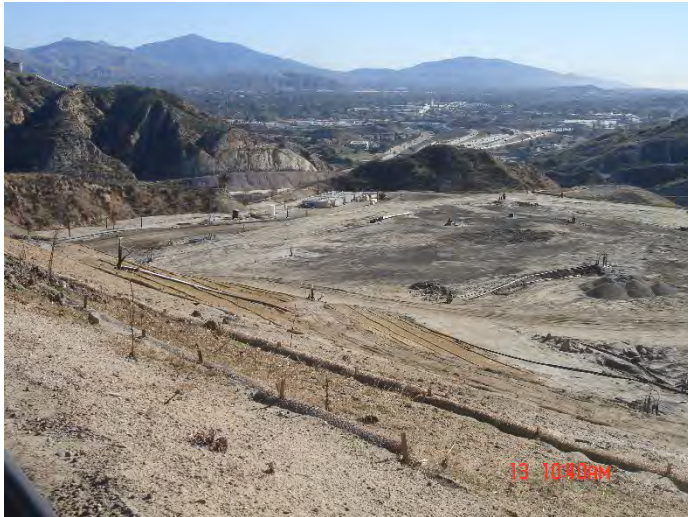
**Photo 225: Old City North Top Deck Liquids Handling Facility:
December 13, 2018**

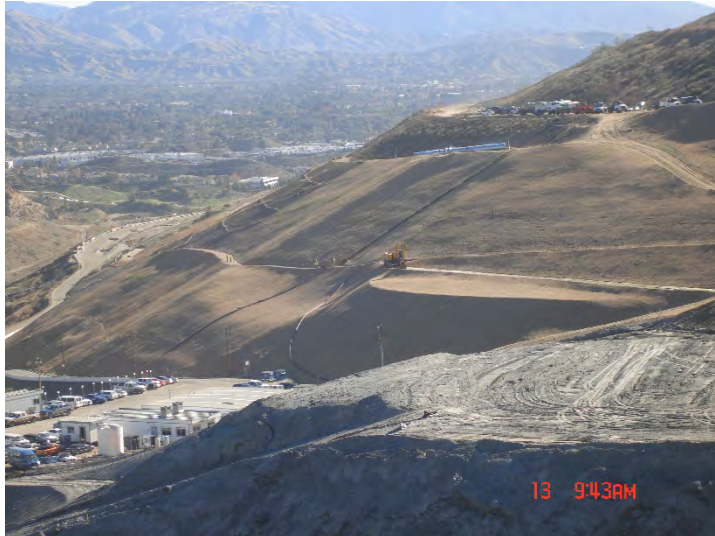
Photo 231: Old City South Soil Stockpile Slump: December 13, 2018

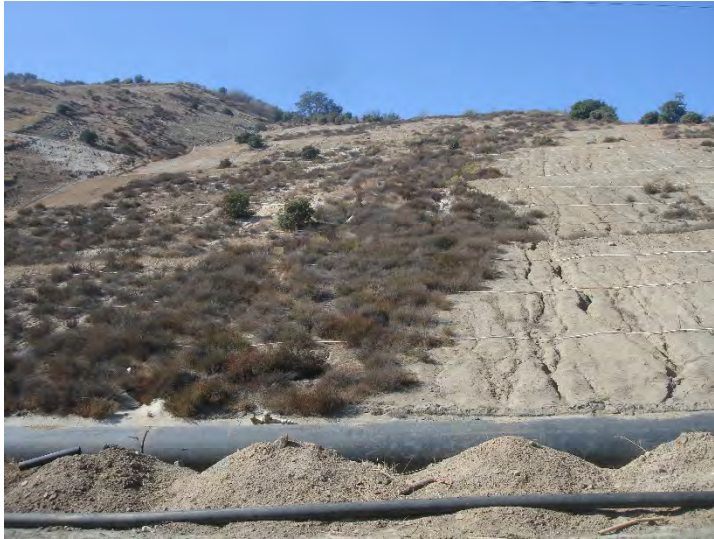
Photo 288: County Sage Mitigation Area Slope: November 6, 2018

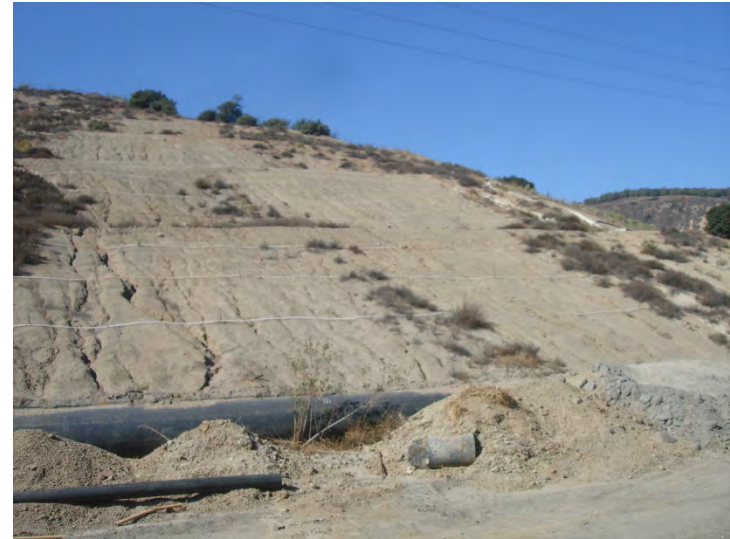
Photo 289: County Sage Mitigation Area Slope: November 6, 2018

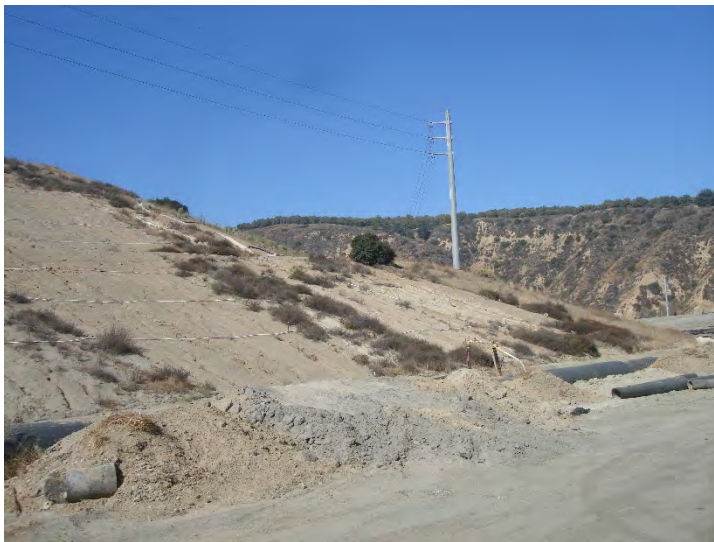
Photo 290: County Sage Mitigation Area Slope: November 6, 2018

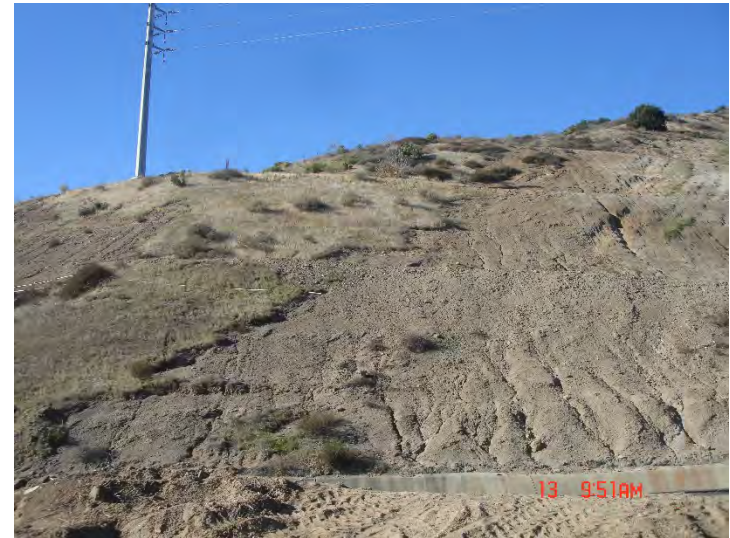
Photo 291: County Sage Mitigation Area Slope: November 6, 2018

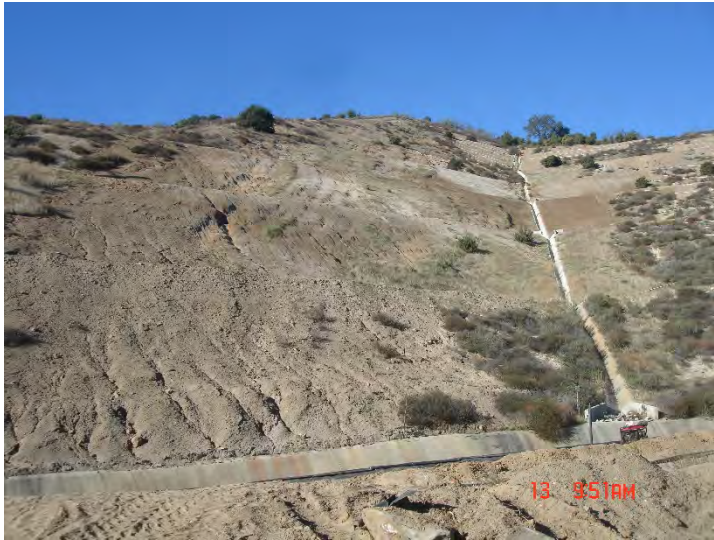
Photo 292: County Sage Mitigation Area Slope: December 13, 2018

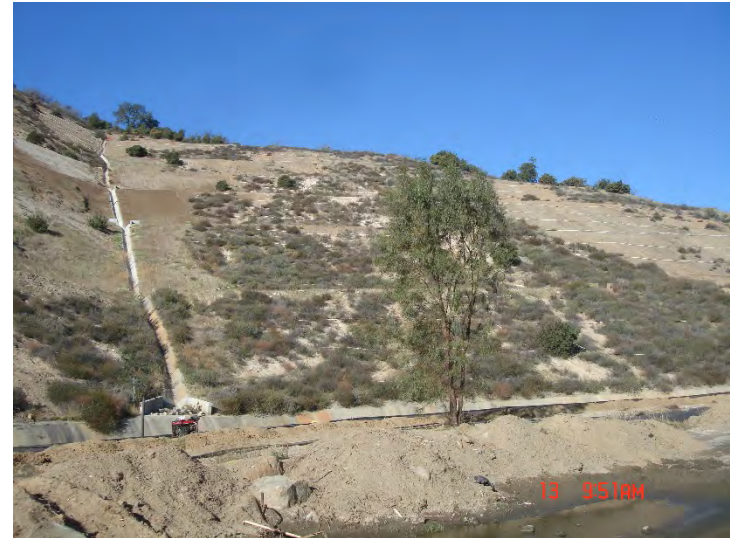
Photo 293: County Sage Mitigation Area Slope: December 13, 2018

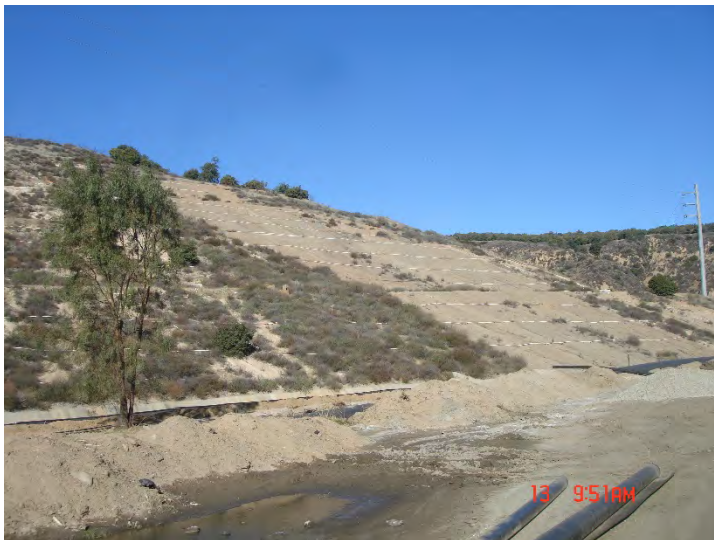
Photo 294: County Sage Mitigation Area Slope: December 13, 2018

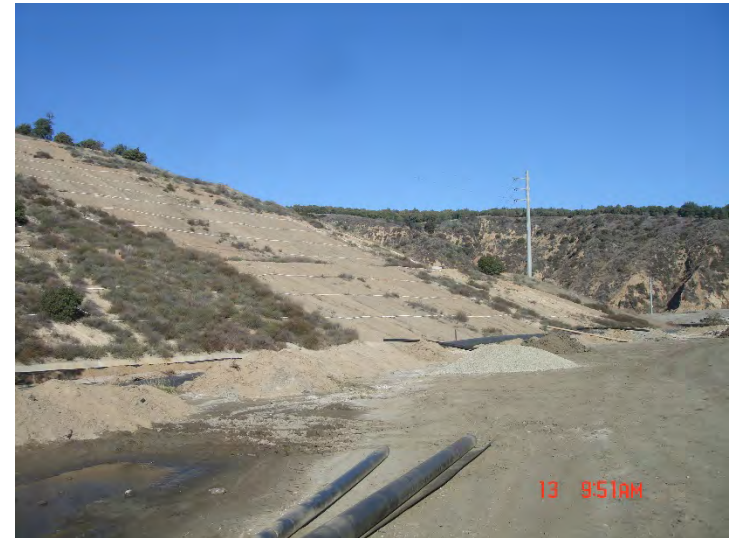
Photo 295: County Sage Mitigation Area Slope: December 13, 2018

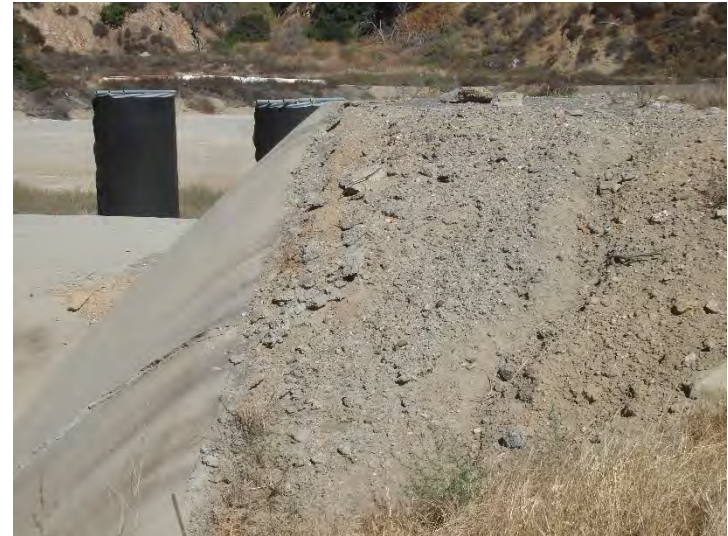
Photo 297: Basin D Westside Channel High Flow Outlet: October 23, 2018

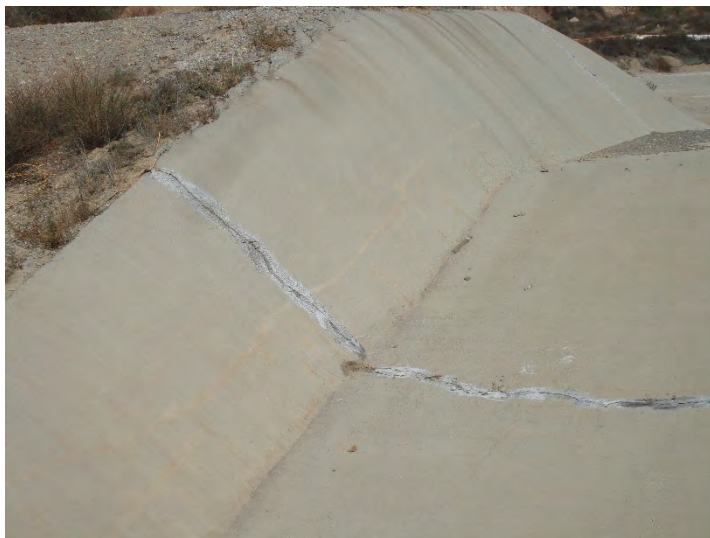
Photo 298: Basin D Westside Channel High Flow Outlet: October 23, 2018

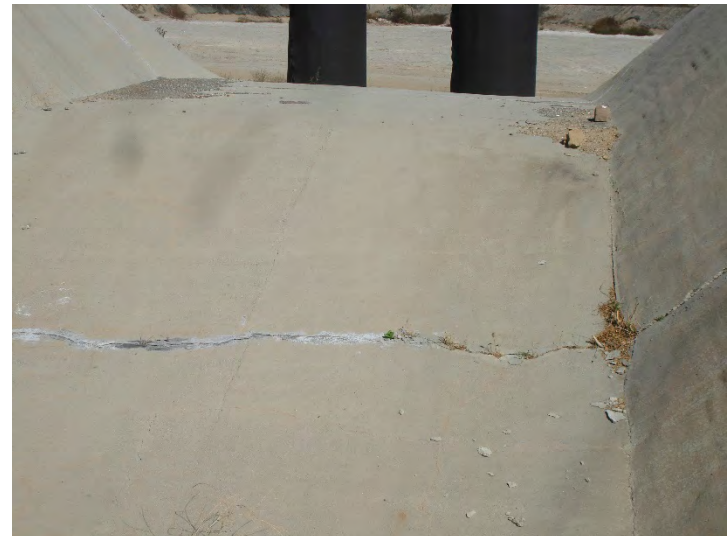
Photo 299: Basin D Westside Channel High Flow Outlet: October 23, 2018

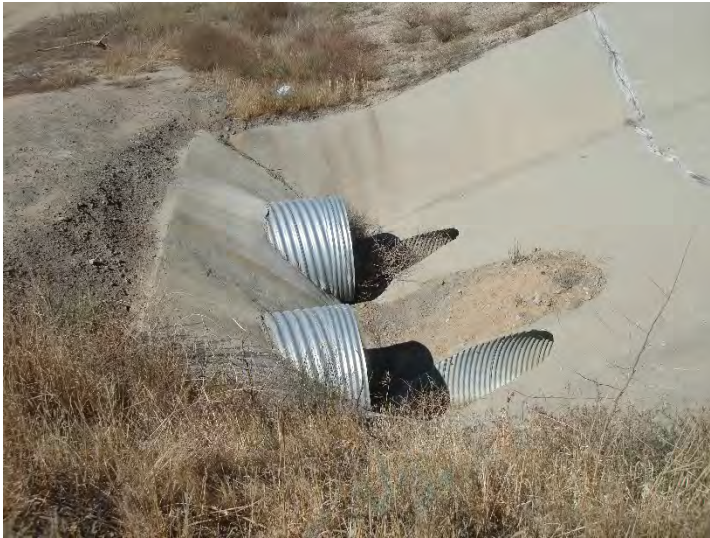
Photo 300: Basin D Westside Channel High Flow Outlet: October 23, 2018

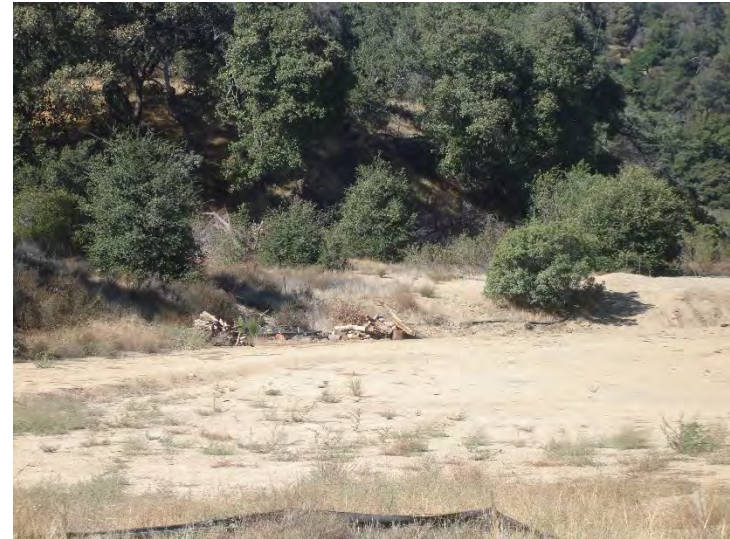
Photo 301: Basin D Westside Channel High Flow Outlet: October 23, 2018

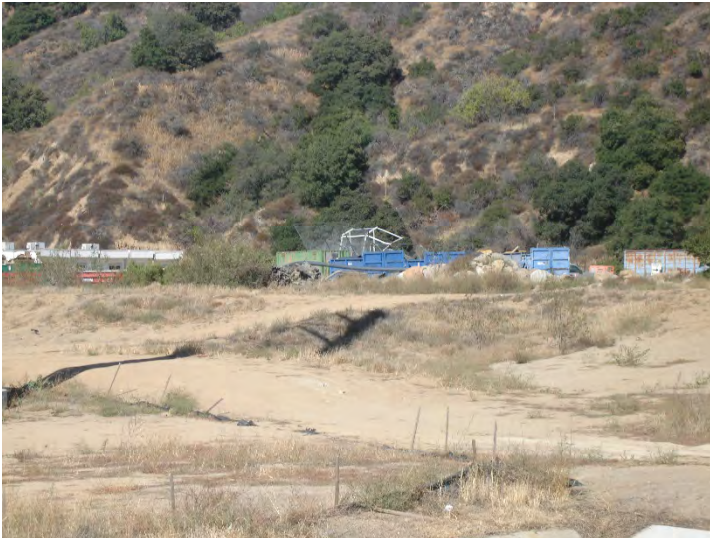
Photo 302: Basin D Adjacent Wood Stockpile: October 23, 2018

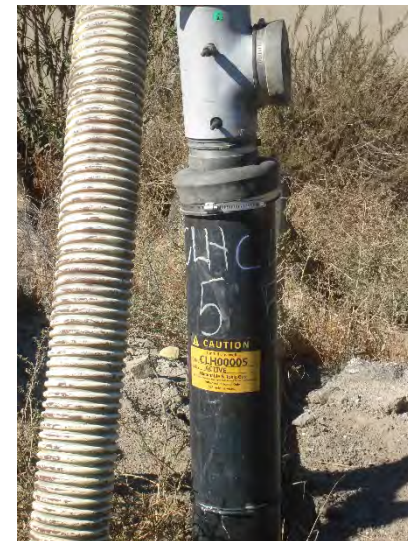
Photo 303: Basin D Adjacent Wood Stockpile: October 23, 2018

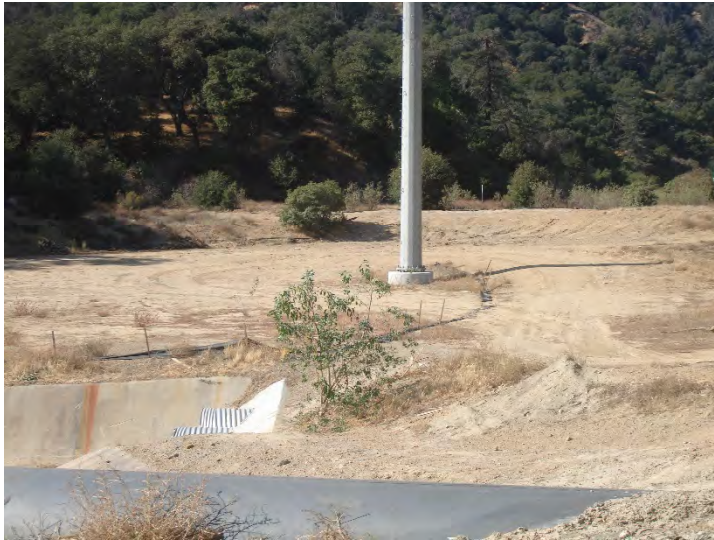
Photo 304: Basin D Adjacent Well with Localized Odors: October 23, 2018

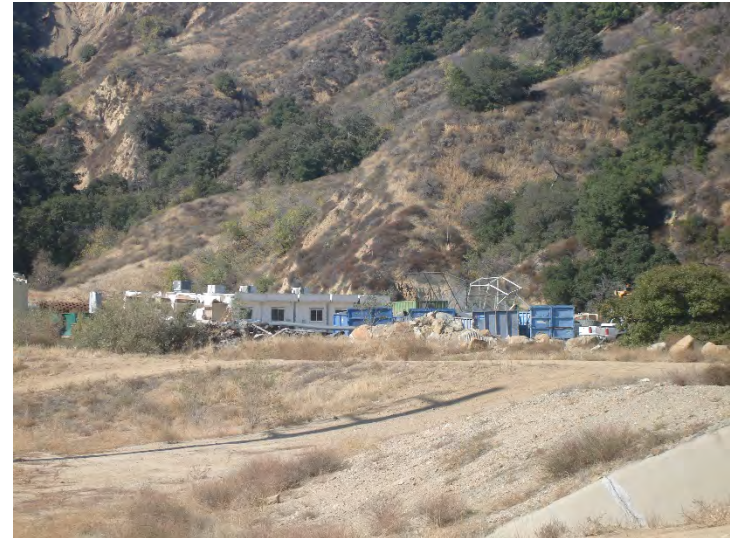
Photo 305: Basin D Wood Stockpile Removed: November 20, 2018

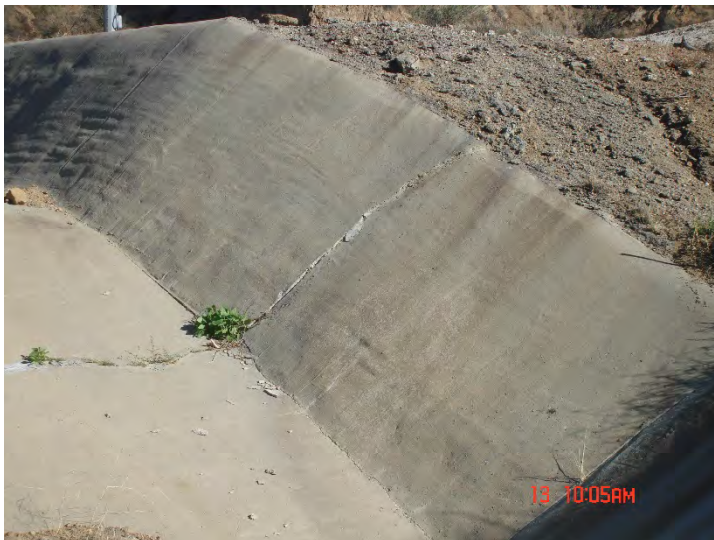
Photo 306: Basin D Wood Stockpile Removed: November 20, 2018

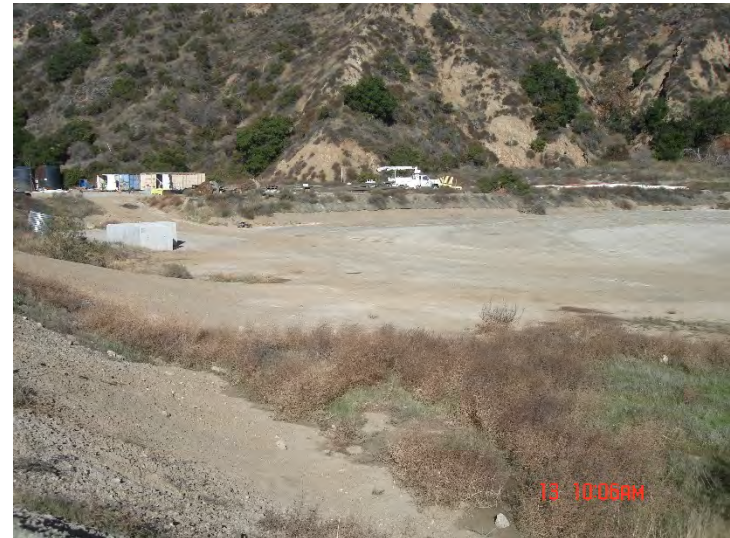
Photo 307: Basin D Westside Channel High Flow Outlet: December 13, 2018

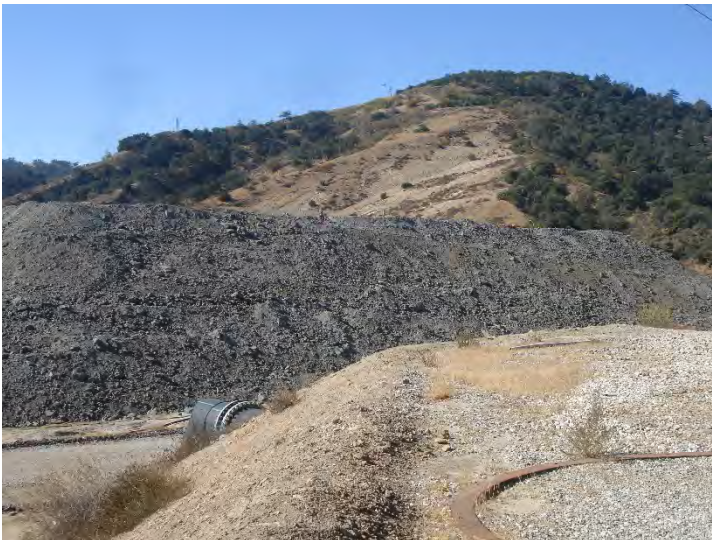
Photo 318: County Top Deck Buttress Soils Stockpile: October 23, 2018

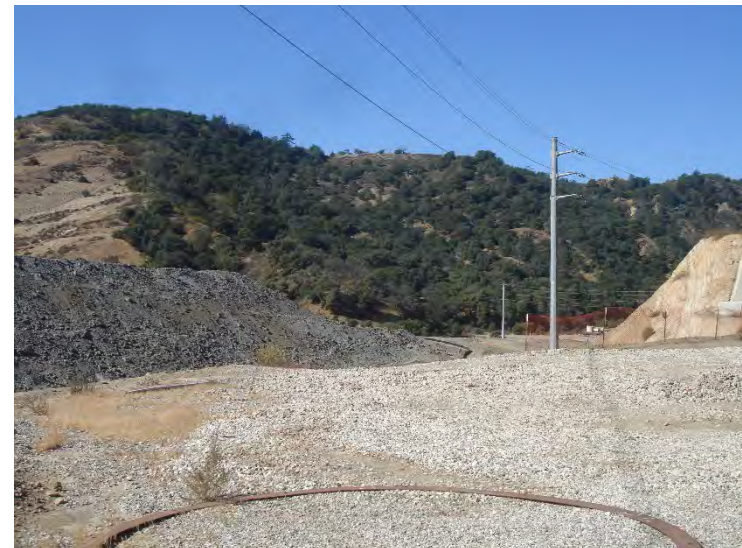
Photo 319: County Top Deck Buttress Soils Stockpile: October 23, 2018

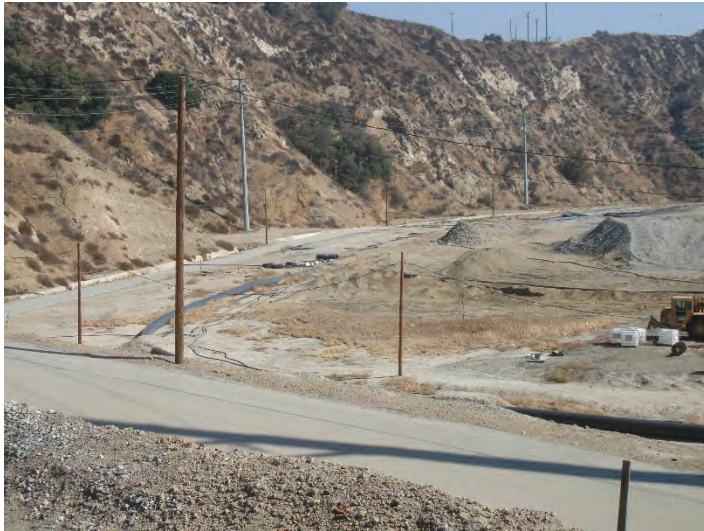
Photo 320: County Top Deck Buttress Soils Stockpile: October 23, 2018
