**Sunshine Canyon Landfill
Independent Monitor
Quarterly Site Monitoring Status Report
October 1, 2018 – December 31, 2018**

January 9, 2019

CERTIFICATION STATEMENT

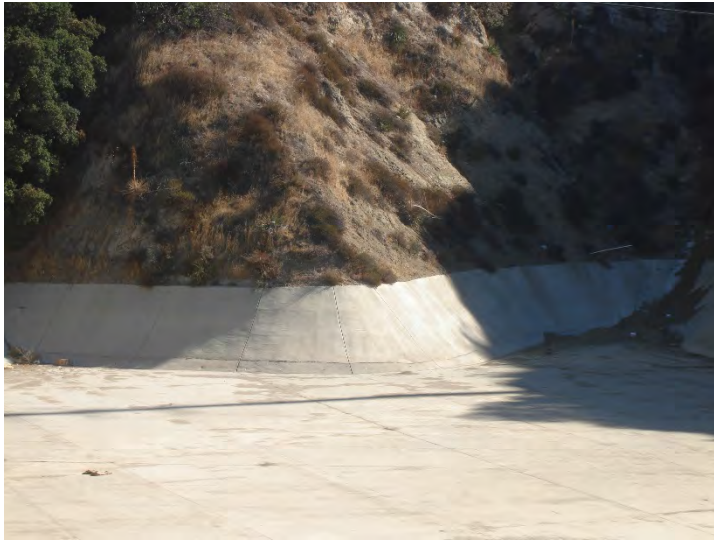
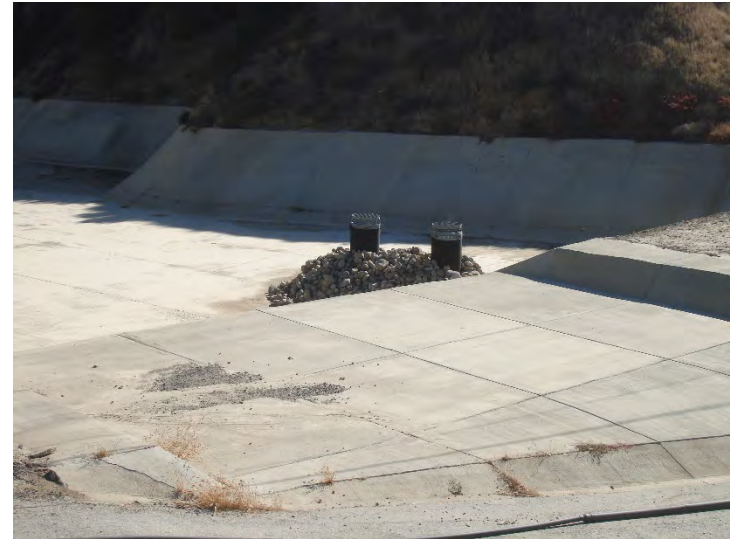
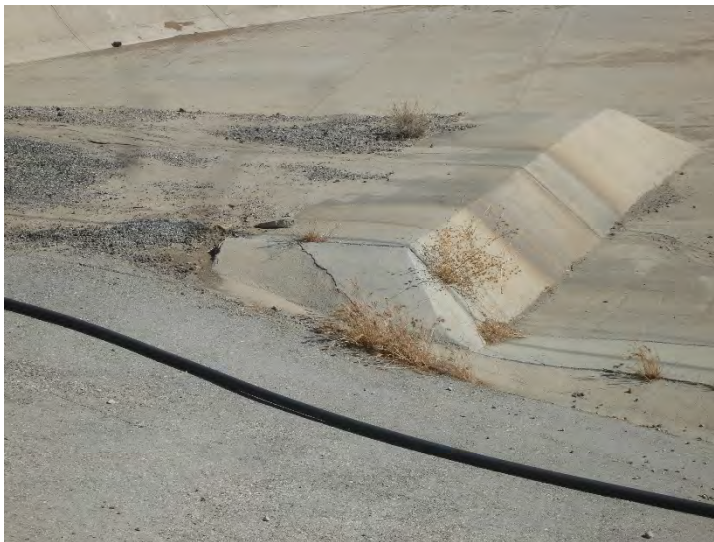
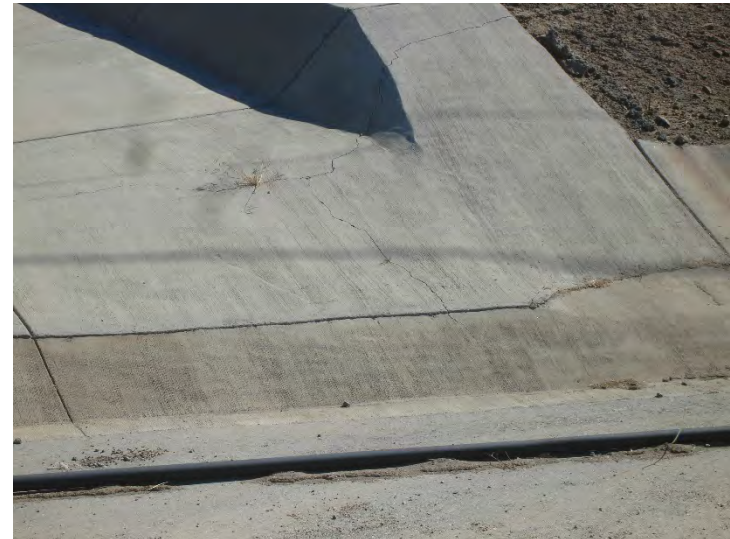
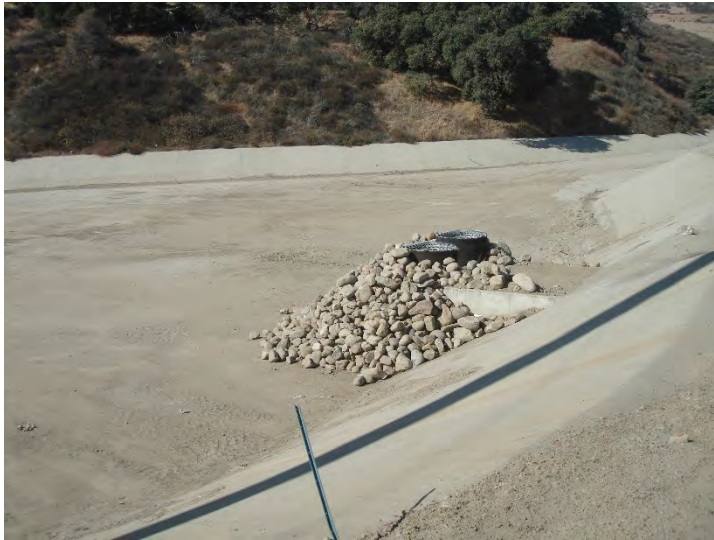
Photo 368: Basin B: October 23, 2018

<p>results. Their plan is to direct the water toward the toe of the buttress where a retention basin currently exists (Photo 10) and pump the water out.</p> <ul style="list-style-type: none"> • Basin B <ul style="list-style-type: none"> – Basin is clean • Basin D <ul style="list-style-type: none"> – Basin is clean – Vegetation including a small bush growing through the crack observed in previous visits has been removed • Channels <ul style="list-style-type: none"> – all clean • Moat around Cell CC3 Part 2 <ul style="list-style-type: none"> – a fair amount of sediment has accumulated and could cause problem to the pump slated to empty the moat during/after a storm (Photo 11)
<p>Excavation for Cell 4 Phase 3</p> <ul style="list-style-type: none"> • Excavation was ongoing with scrapper and dozers • Compaction provided scrapers and dozers traffic, no rollers are used to compact the material • In place density and moisture control are monitored by nuclear gauge testing (Photo 12) • no sign of potential geotechnical issues – the different geologic formations in the area can be clearly seen <ul style="list-style-type: none"> – Horizontal drains are in place – Prism system in use to monitor movement

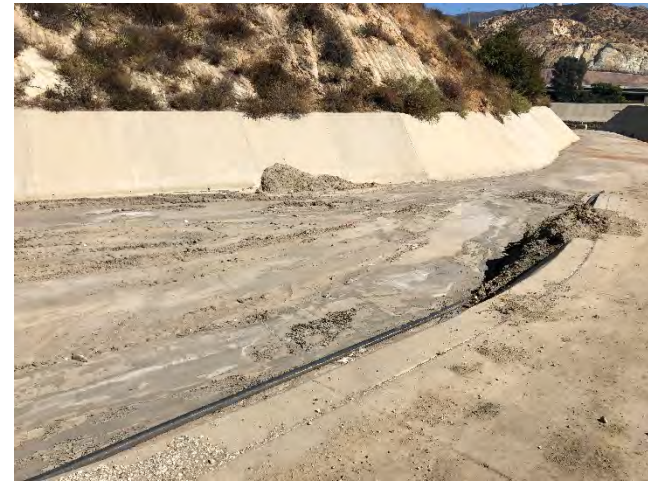
Photo 383: Terminal Basin Westside Drainage Channel: October 23, 2018

- Well 3013D was hot to the touch and had a burnt odor.
- The dirt slopes adjacent to the westside inlet channel into the terminal basin were graded and repaired.
- The terminal basin had ponding water around the outlet risers. The slopes below the main access road were graded and covered with jute netting.
- Sage mitigation Deck B was being irrigated to condition the soil to raise the pH.
- The prior Deck A subsurface oxidation near PCW 224 was extinguished.

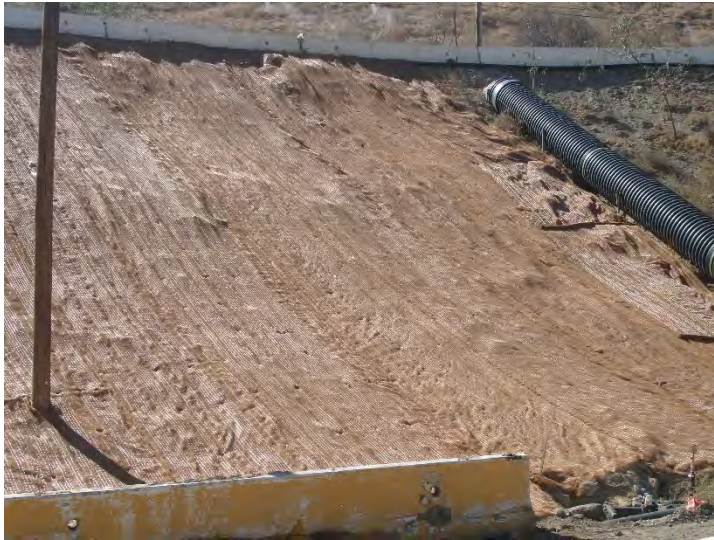
Photo 448: Main Access Road Slopes Near Terminal Basin: October 23, 2018

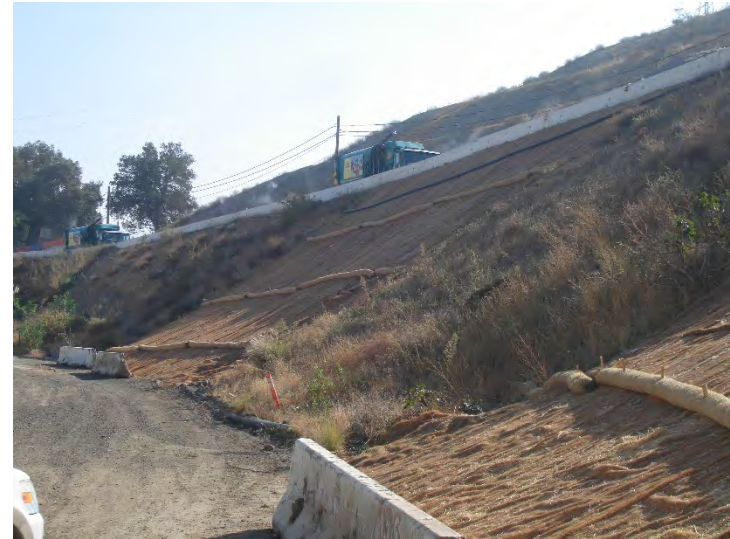
Photo 449: Main Access Road Slopes Near Terminal Basin: October 23, 2018

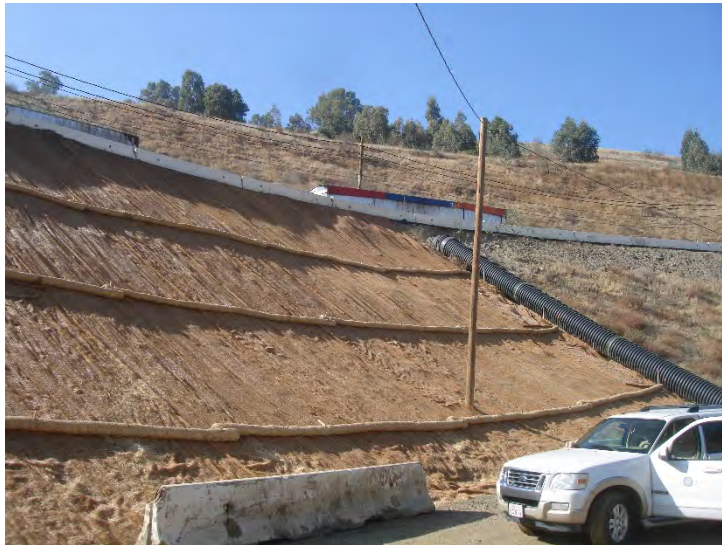
Photo 450: Main Access Road Slopes Near Terminal Basin: November 6, 2018

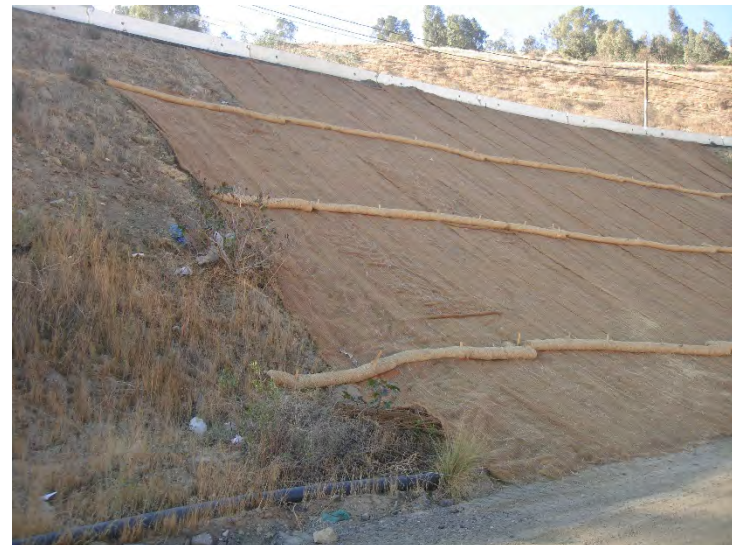
Photo 451: Main Access Road Slopes Near Terminal Basin: November 6, 2018

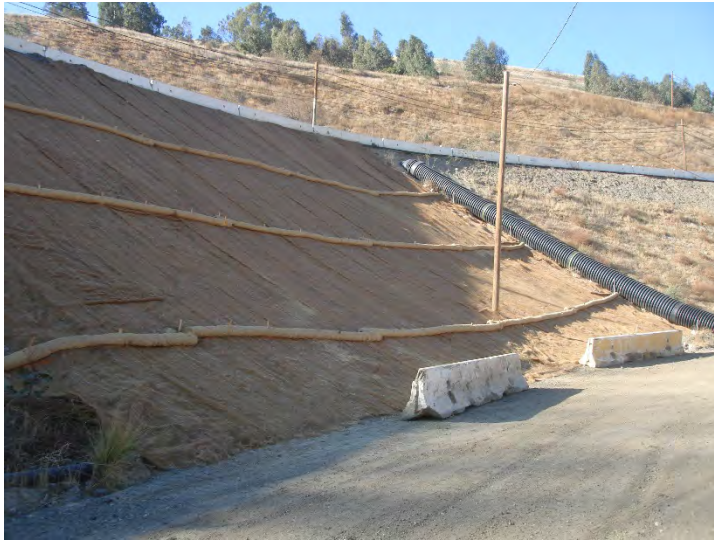
Photo 452: Main Access Road Slopes Near Terminal Basin: November 20, 2018

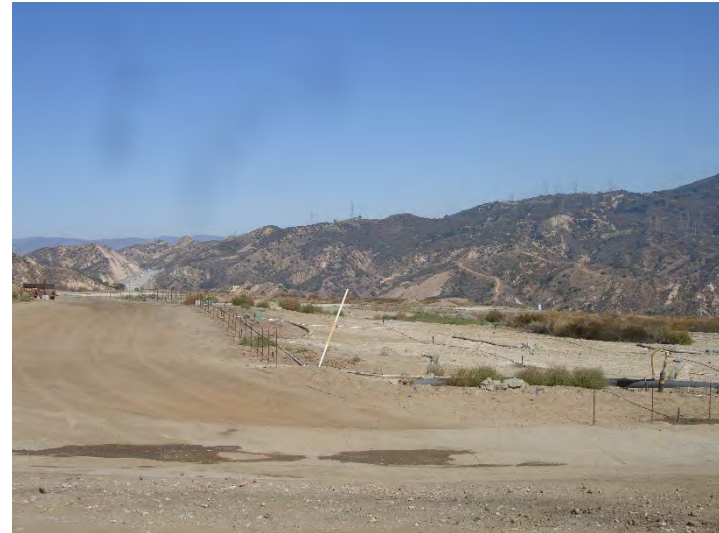
**Photo 453: Main Access Road Slopes Near Terminal Basin:
November 20, 2018**

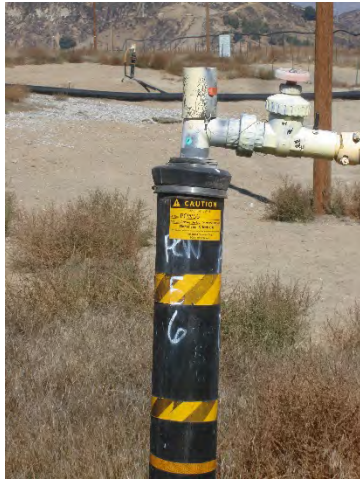
**Photo 460: Deck A Sage Mitigation Area High Level CO Wells:
October 23, 2018**

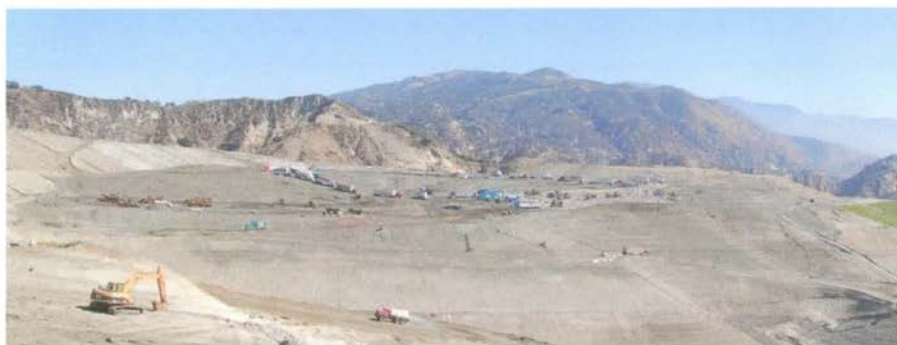
Photo 2: Waste placement at Cell CC4 – Part 1

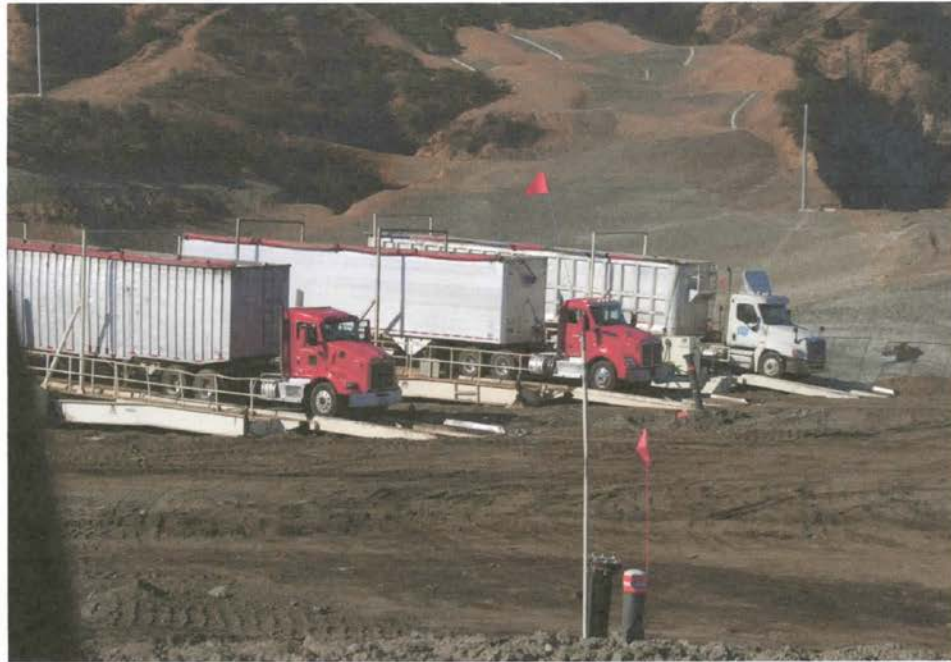
Photo 3: Tilters in use at waste face on Cell CC4 Part 1

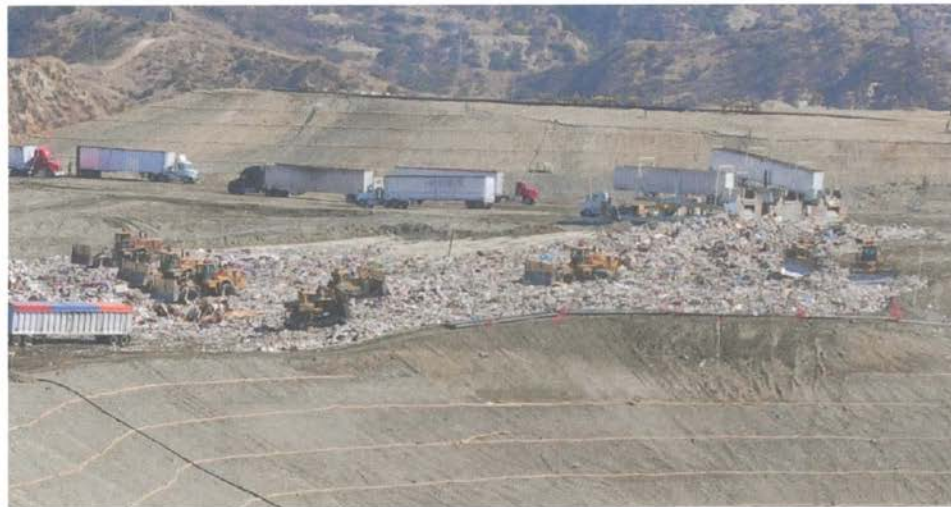
Photo 4: Interim over in use at Cell CC4 Part 1

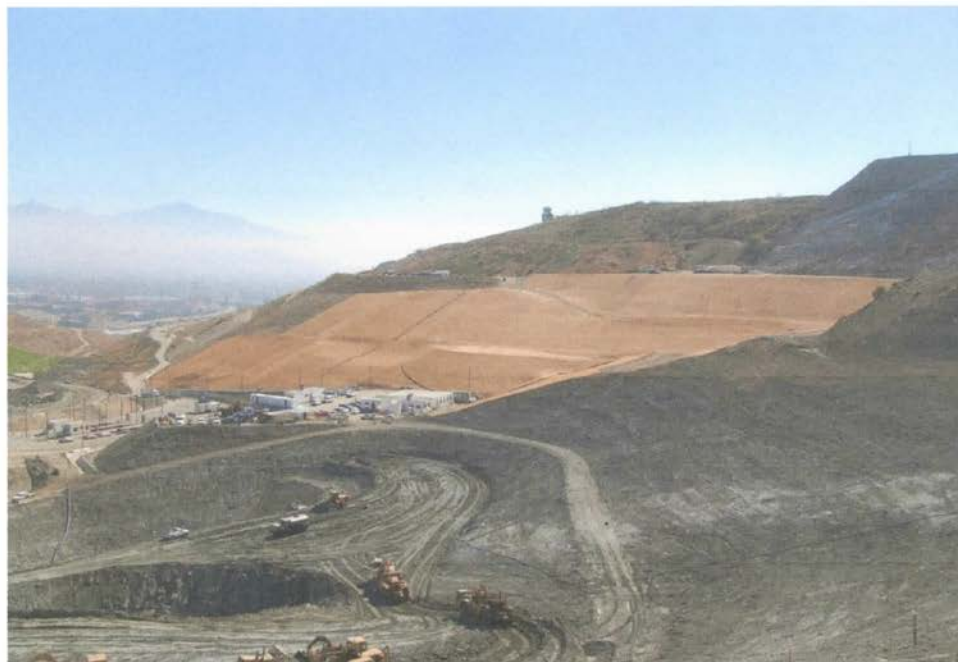
Figure 10: Potential retention basin at toe of buttress for Cell CC4 part 3

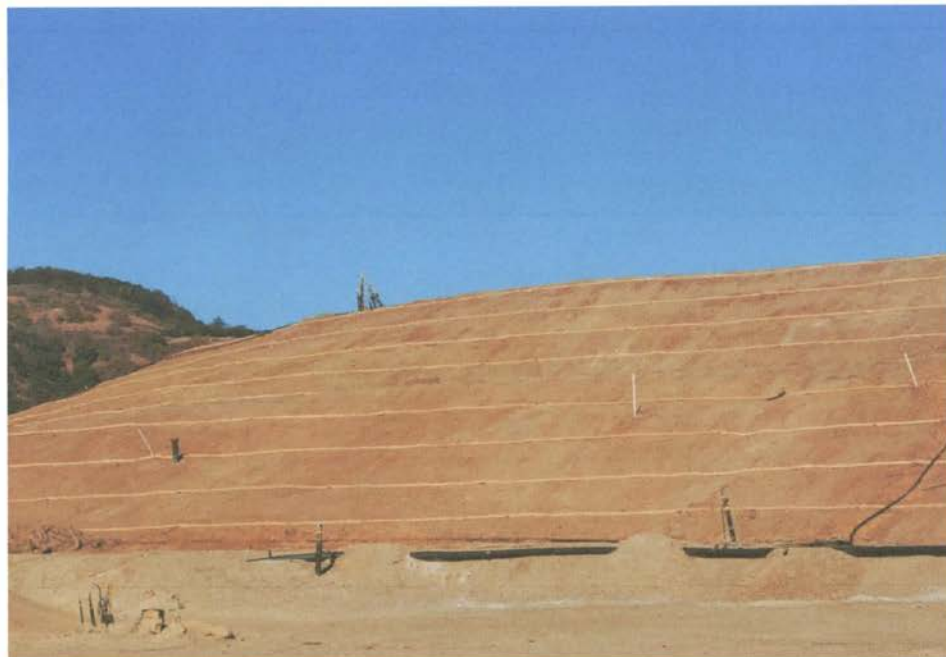
<p>Erosion Protection Systems</p> <ul style="list-style-type: none"> • erosion protection blankets and wattles have been placed on numerous slopes: cell CC3 (Photo 13), behind the administration pad (Photo 14) • Surfaces of slopes that were observed to present signs of erosion (gullies, ruts) have been groomed • shotcrete ditches have been built on the slope below Flare 3 (Photo 15)
<p>Access road embankment at Terminal basin</p> <ul style="list-style-type: none"> • the areas that had sloughed and mentioned over the course of past visits have been reworked and are protected by erosion control blankets (Photo 16)
<p>Landfill for geotechnical and hydrological issues</p> <ul style="list-style-type: none"> • no other geotechnical issues than that noted at access roads were observed during the visit
<p>Miscellaneous</p> <ul style="list-style-type: none"> • it is our understand that ground motions were recorded at the site seismograph station during the channel island earthquake of 04/05/2018. Following on our request of September 12, 2018 Republic should look into getting the information.

Photo 14: Erosion protection BMPs on the slopes of Cell CC3

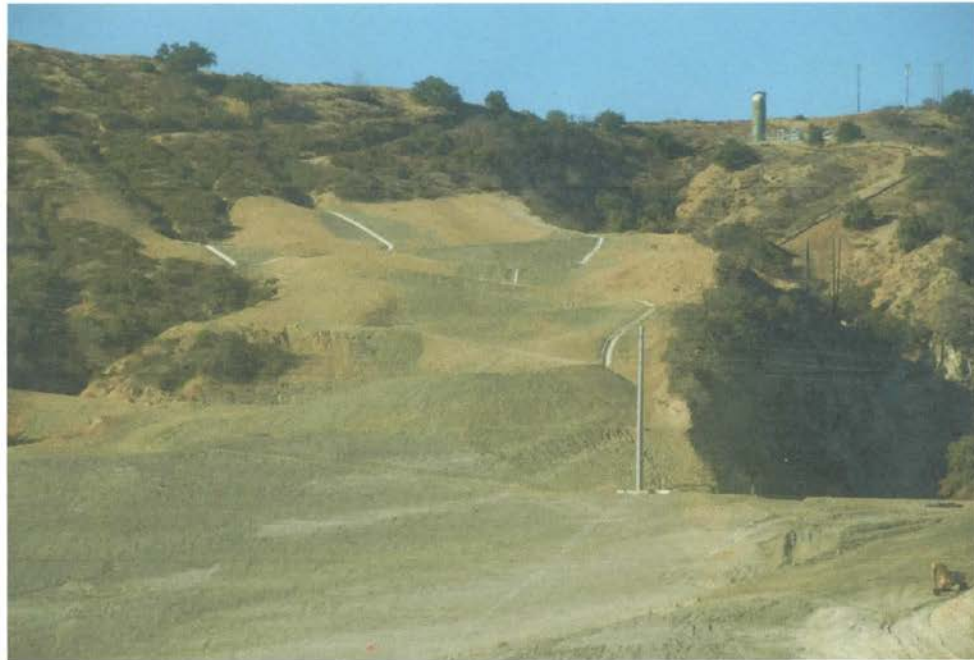
Photo 15: Shotcrete ditches on slope beneath Flare 3

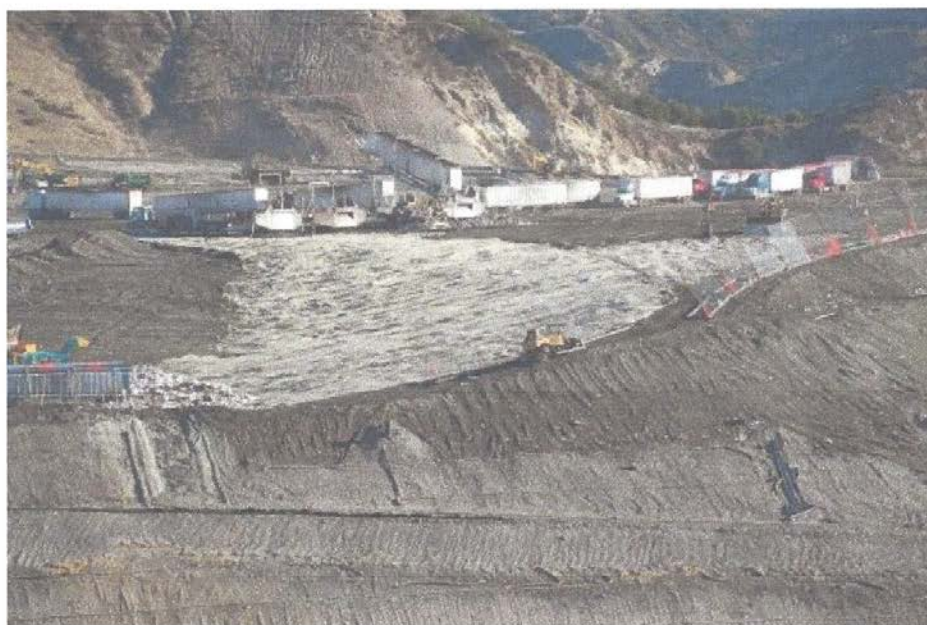
Photo 2: Waste placement at Cell CC4 with Interim over

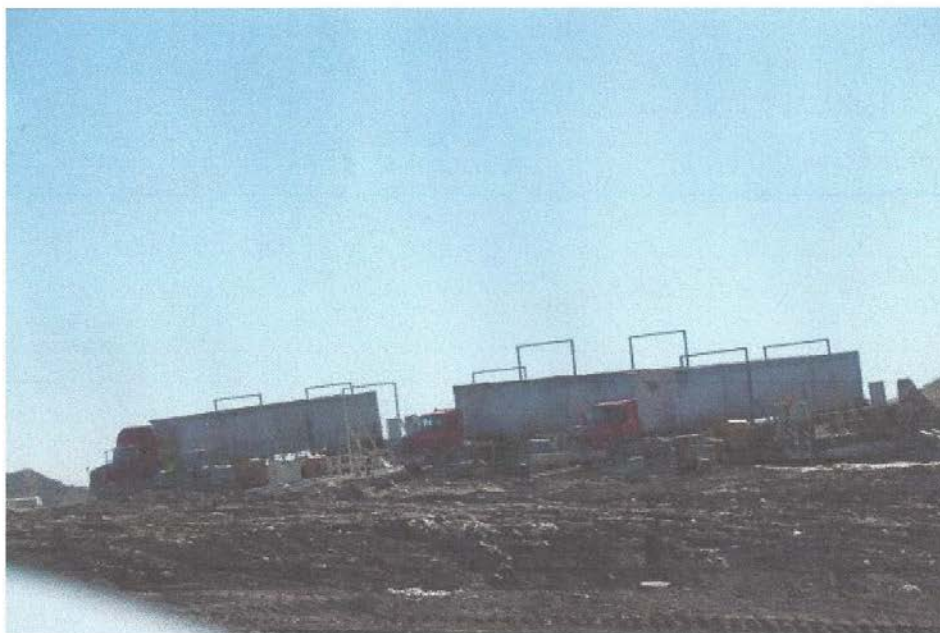
Photo 3: Filters in use at waste face on Cell CC4

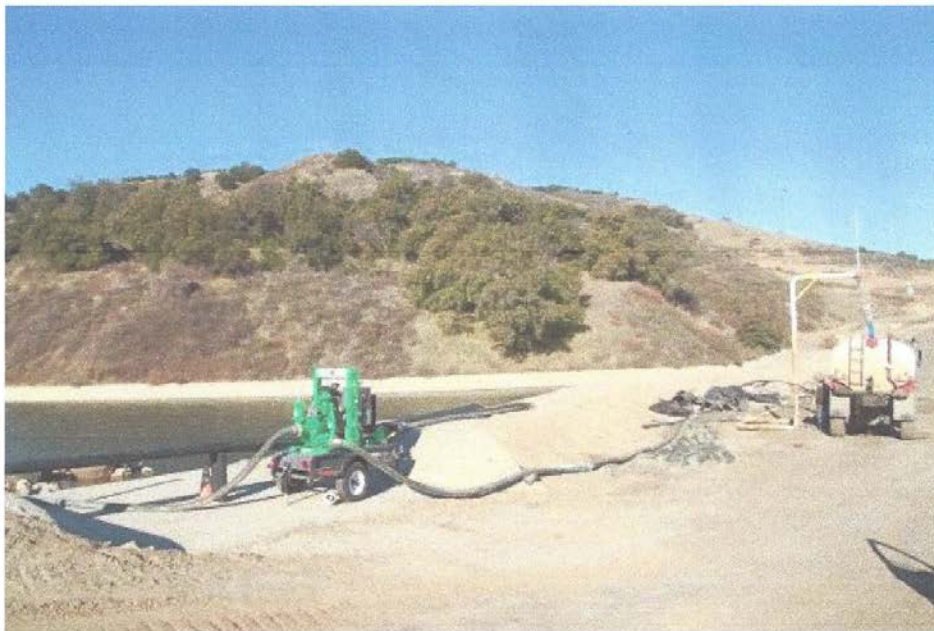
Photo 8: Water form basin A is used for construction by Sukut

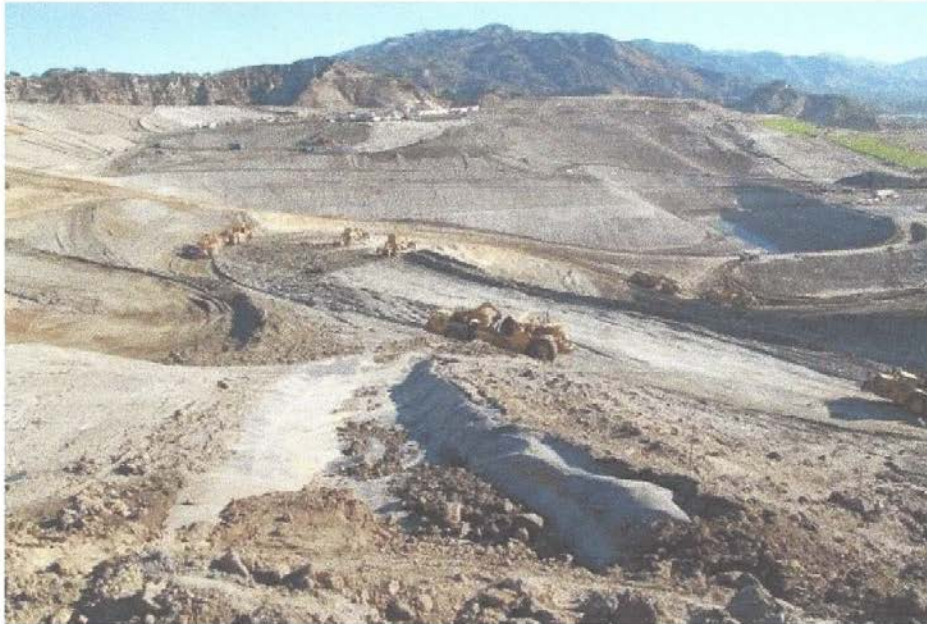
<p>responsible for managing the stormwater and whatever erosion results. Their plan is to direct the water toward through a lined swale (Photo 9) the toe of the buttress where a retention basin currently exists and pump the water out into the main concrete channel connected to the terminal basin. The plan worked well during the earlier storm.</p> <ul style="list-style-type: none"> • Basin D <p>Basin is clean</p> <ul style="list-style-type: none"> • Basin B <p>Basin is essentially clean with a small amount of sediment near the intake towers (Photo 10)</p> <ul style="list-style-type: none"> • Channels <p>Main channels are clean</p> <ul style="list-style-type: none"> • Outlet of concrete ditch along the access road to Flare 9-11 and the energy recovery plant is blocked by sediment (Photo 11) • Moat around Cell CC3 Part 2 <p>Moat around Cell CC4 Part 2</p> <ul style="list-style-type: none"> • water accumulated and was pumped out (Photo 12) <p>Access road to Flare 3</p> <ul style="list-style-type: none"> • A large erosion gully has formed on the fill at the end of the unfinished roadway and ditch (Photo 13) leading to a large erosion feature on the fill slope (Photo 14) leading

Photo 9: Lined swale to drain Basin A towards temporary basin at toe of buttress

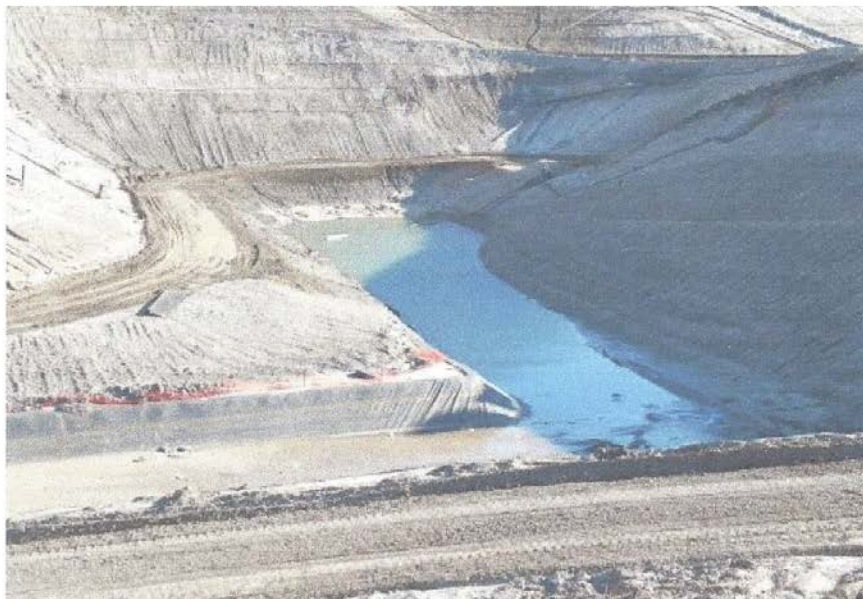
Photo 12: Pumping of water out of moat around Cell CC4 Part 2
