Corporate Office – Orange County 16431 Scientific Way Irvine, CA 92618-4355 Telephone: 949.788.4900 Facsimile: 949.788.4901 Sunshine Canyon Landfill Independent Monitor Quarterly Site Monitoring Status Report January1, 2013 – March 31, 2013

May 6, 2013

Appendix II Relevant Site Photos

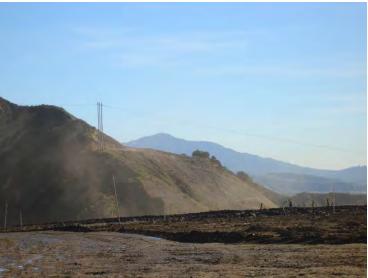
Photo 36: County Top Deck Blowing Dust: January 16, 2013

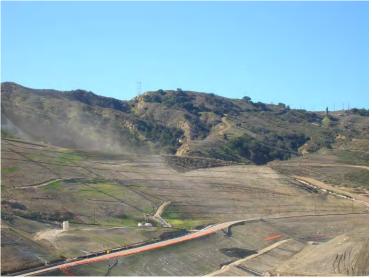
Photo 37: County Top Deck Blowing Dust: January 16, 2013

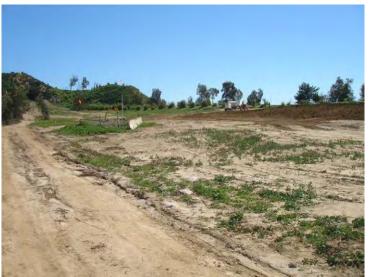
Photo 128: City Top Deck C: March 13, 2013

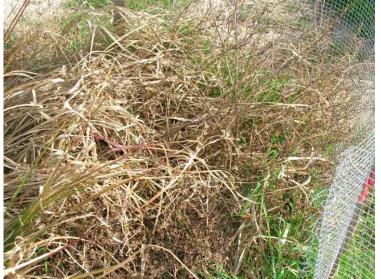
Photo 133: City Top Deck C Vegetation: February 1, 2013

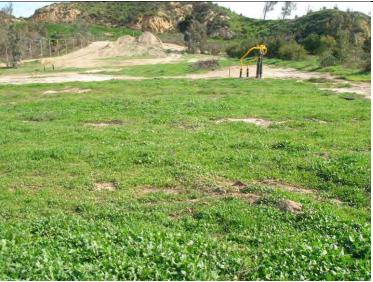
Photo 134: City Top Deck C Vegetation: February 1, 2013

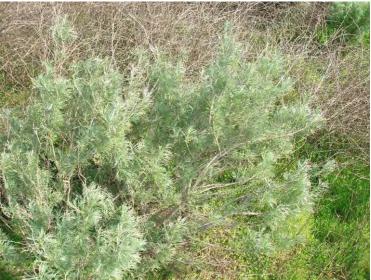
Photo 141: City Top Deck B Vegetation: February 1, 2013

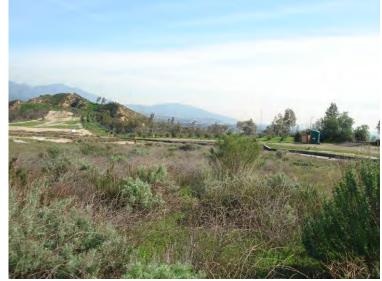
Photo 142: City Top Deck B Vegetation: February 1, 2013

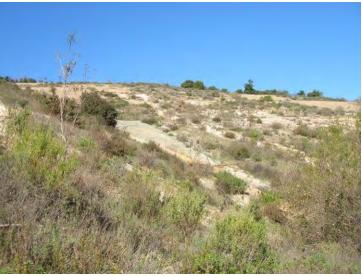
Photo 153: County Sage Mitigation Area: February 13, 2013

- Spot check County top deck elevations
- Observe the County Sage Mitigation Area. Minimal growth has occurred this year with further erosion from the rains.
- The active fill area had debris mixed in with cover soils. This could have been from prior windy days.
- The City South top decks were walked and photos were taken of the existing condition of vegetation

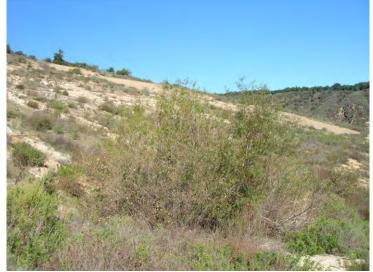
Photo 155: County Sage Mitigation Area: February 13, 2013

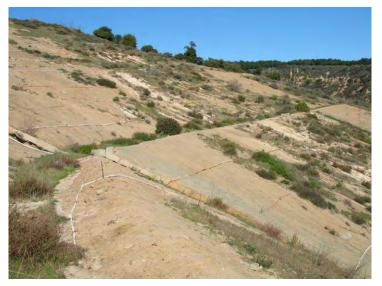
Photo 154: County Sage Mitigation Area: February 13, 2013

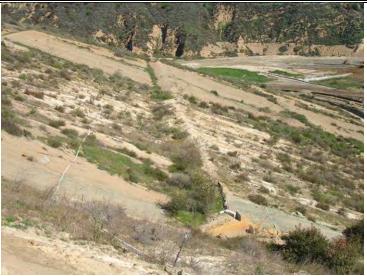
Photo 156: County Sage Mitigation Area: February 13, 2013

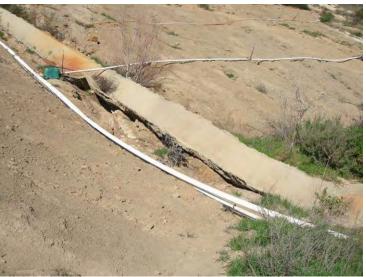
Photo 157: County Sage Mitigation Area: February 13, 2013

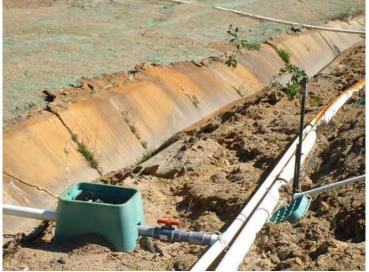
Photo 159: County Sage Mitigation Area: March 13, 2013

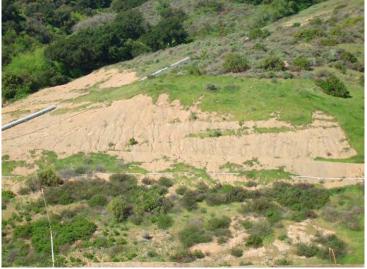
Photo 158: County Sage Mitigation Area: February 13, 2013

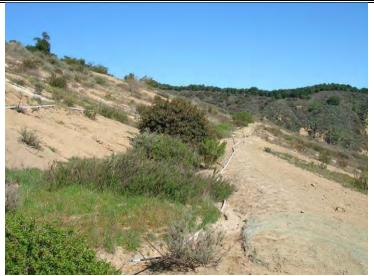
Photo 160: County Sage Mitigation Area: March 13, 2013

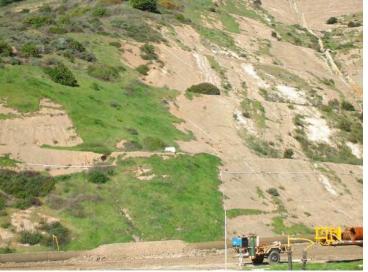
Photo 161: County Sage Mitigation Area: March 13, 2013
