January 23, 2014

**Sunshine Canyon Landfill
Independent Monitor
Quarterly Site Monitoring Status Report
October 1, 2013 – December 31, 2013**

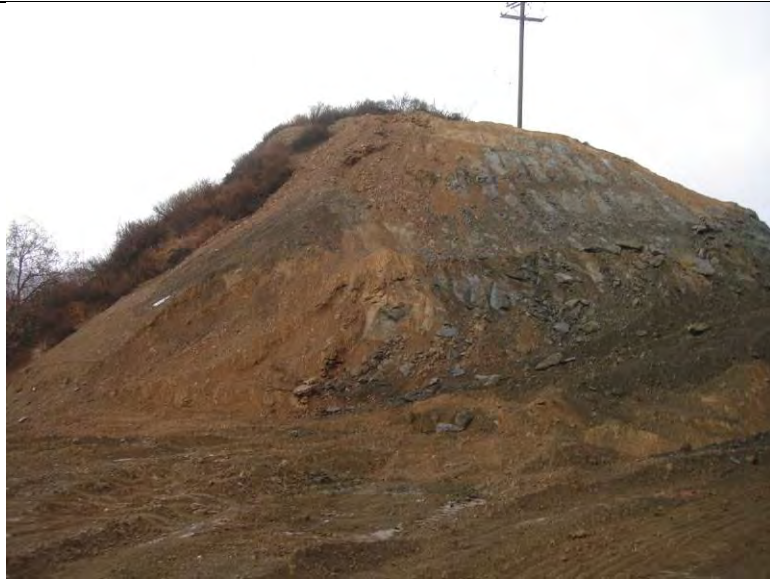
Photo 1: Scraper Access Road Grading: October 9, 2013

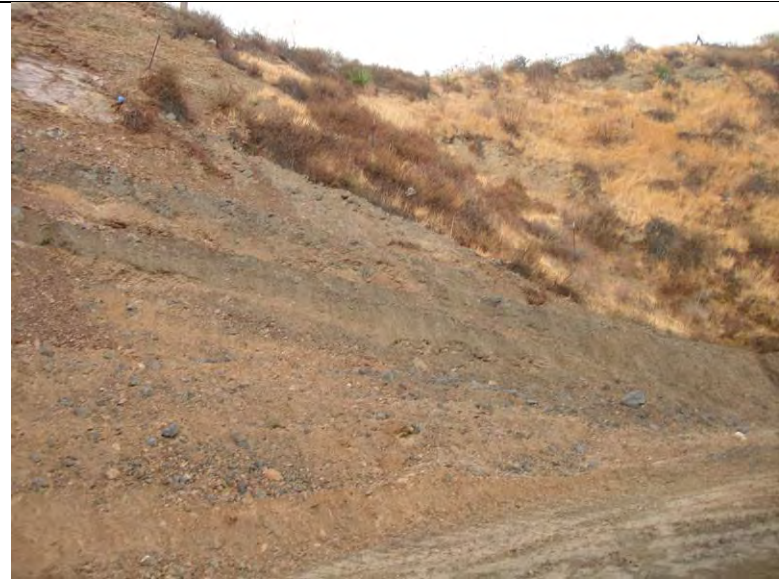
Photo 2: Scraper Access Road Grading: October 9, 2013

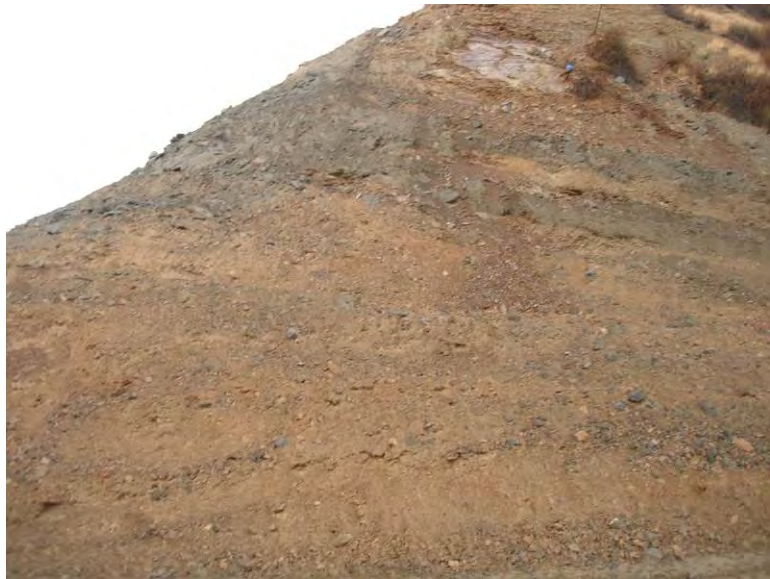
Photo 3: Scraper Access Road Grading: October 9, 2013

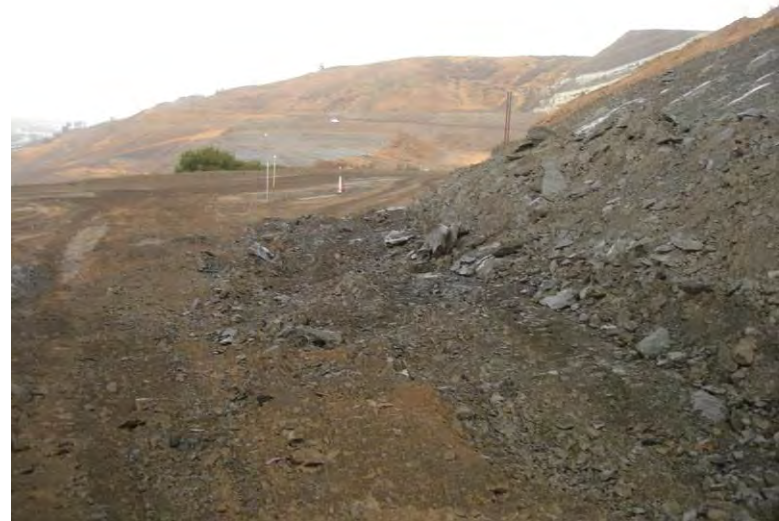
Photo 4: Scraper Access Road Grading: October 9, 2013

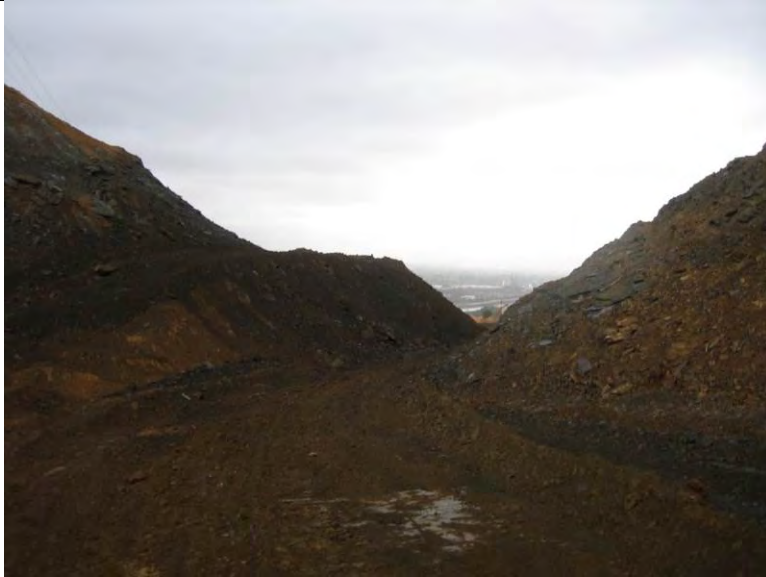
Photo 5: Scrapper Access Road Grading: October 9, 2013

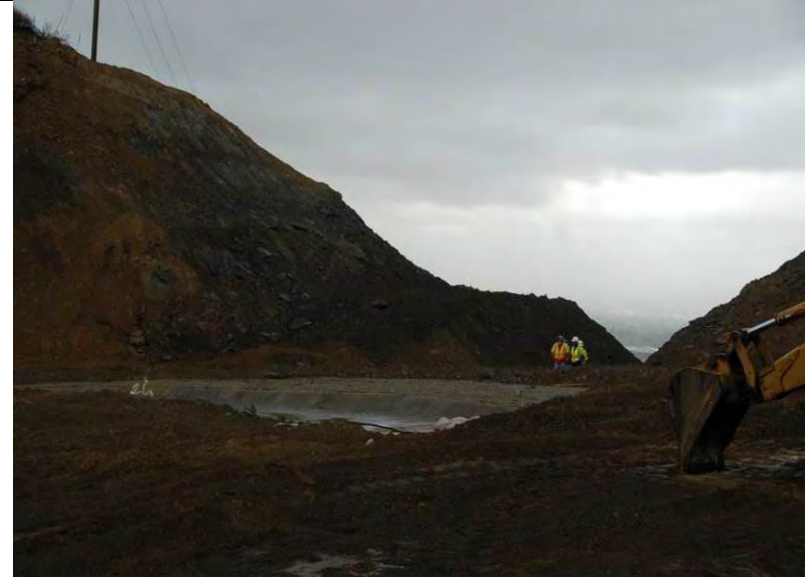
Photo 6: Scrapper Access Road Grading: October 9, 2013

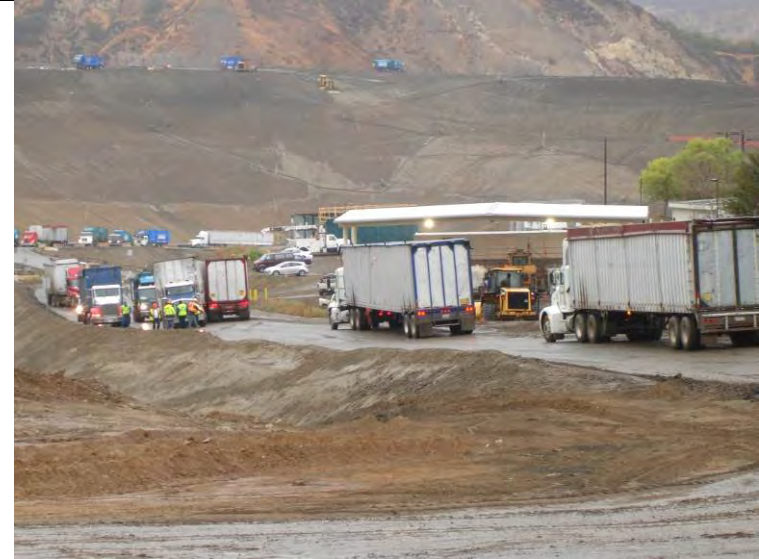
Photo 18: Wet Slick Roadway: October 9, 2013

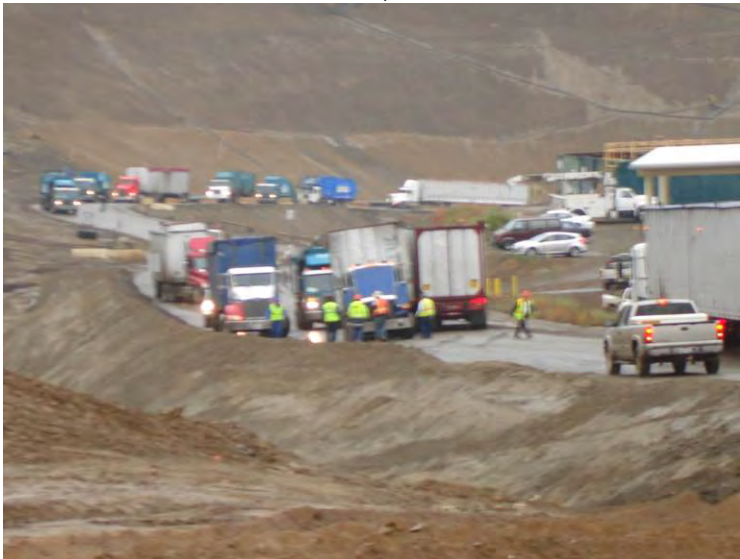
Photo 19: Wet Slick Roadway: October 9, 2013

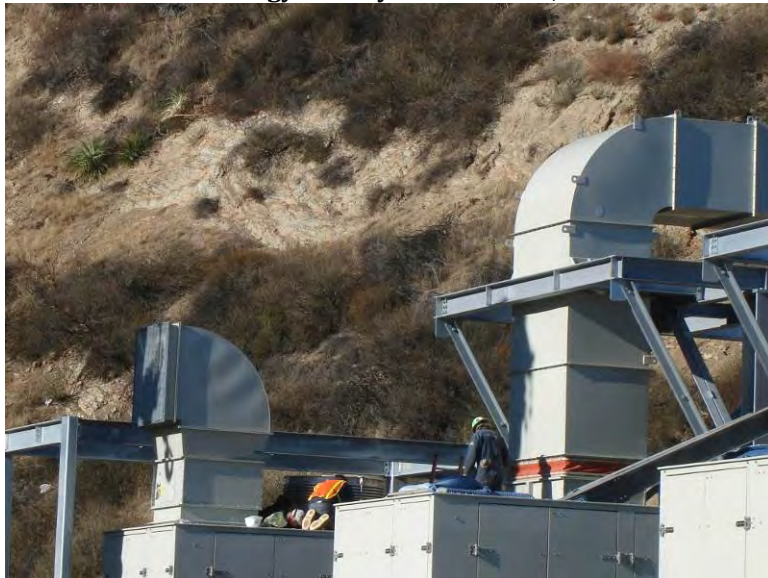
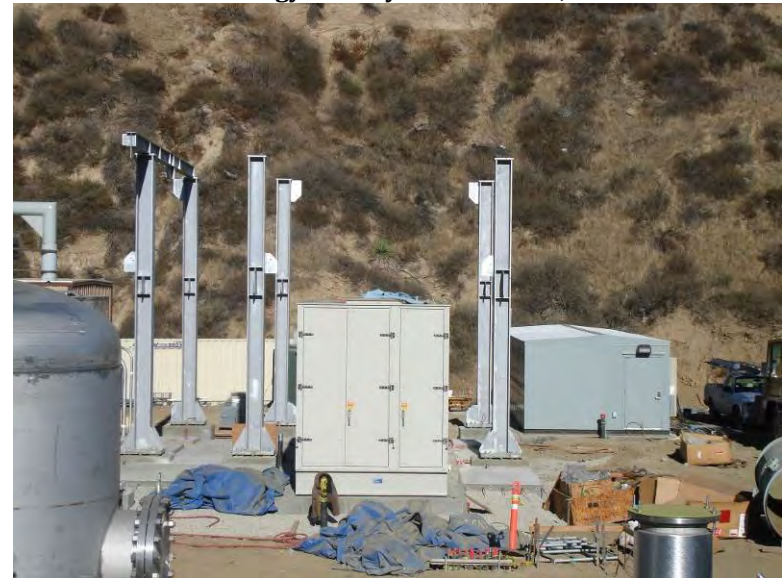
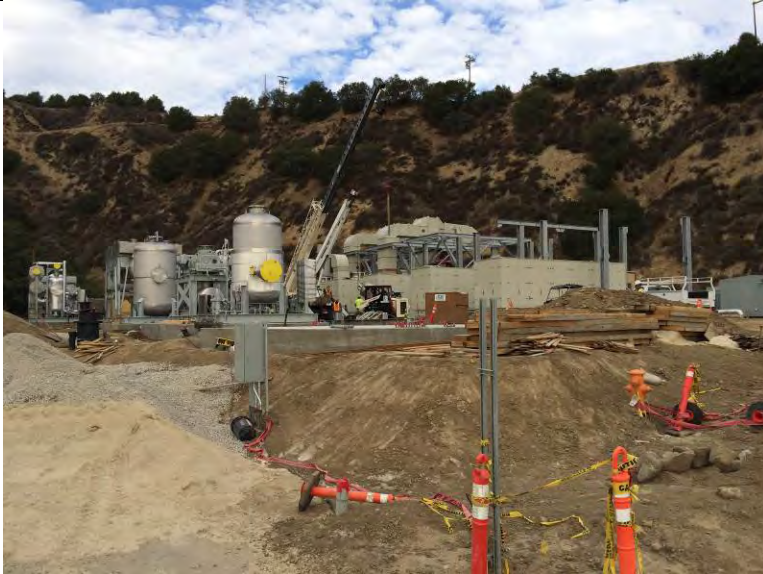
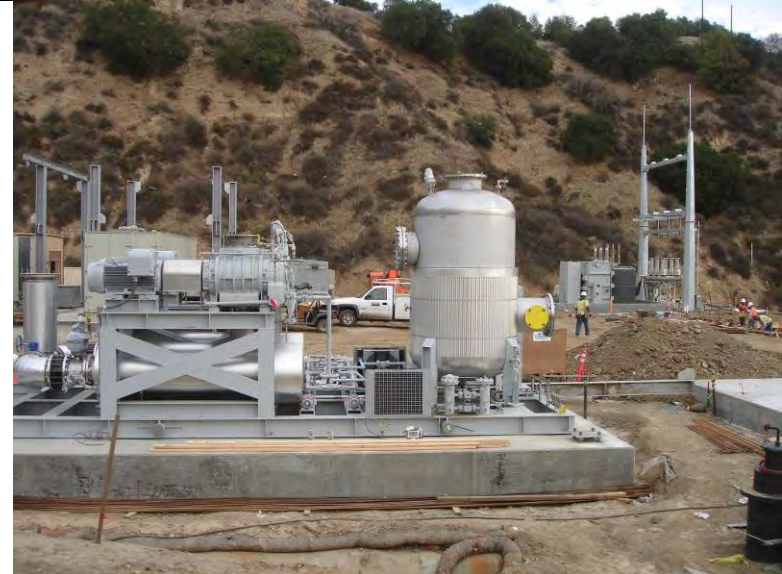
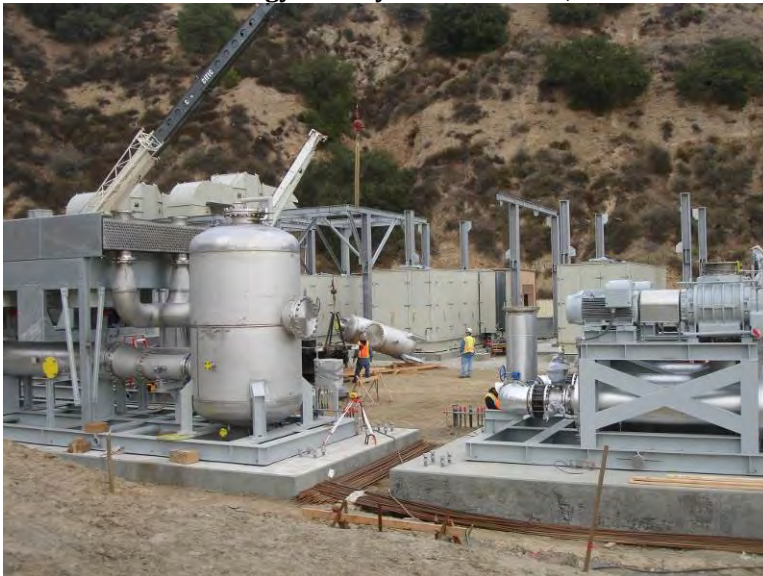
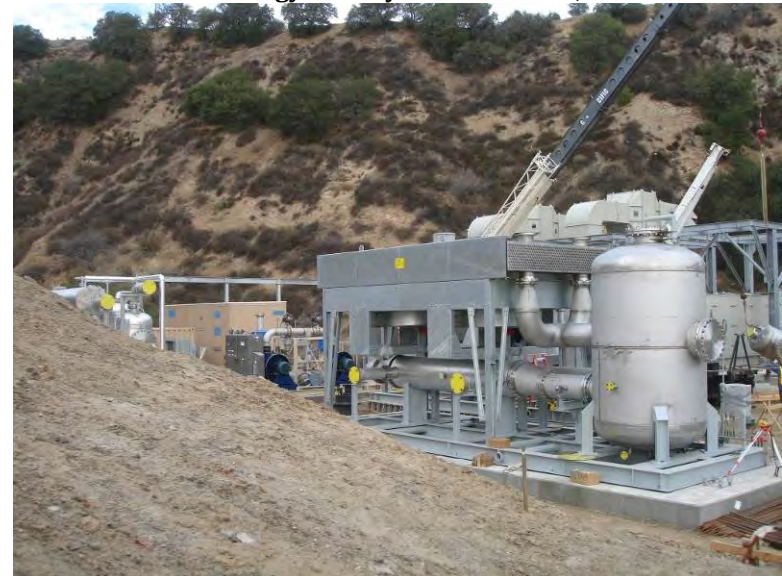
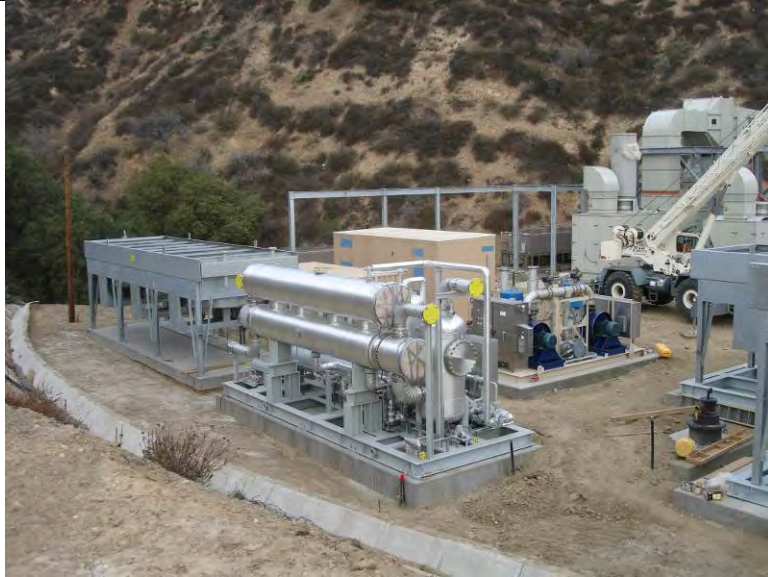
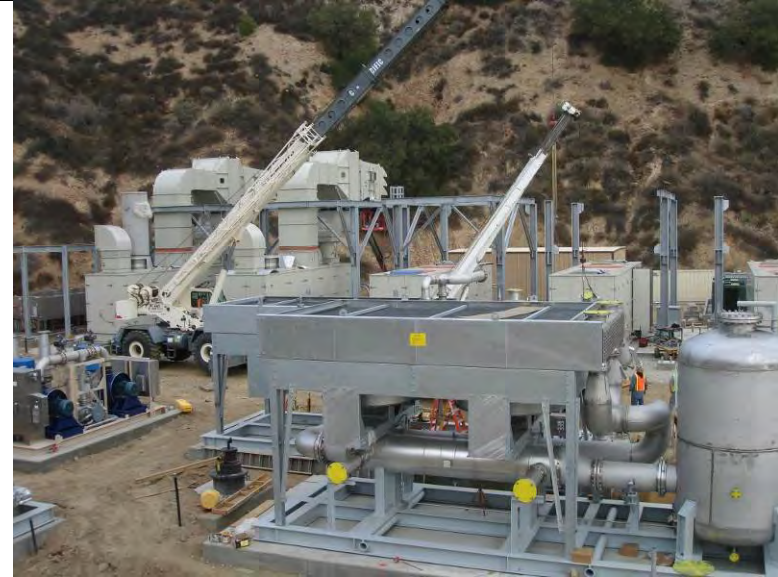
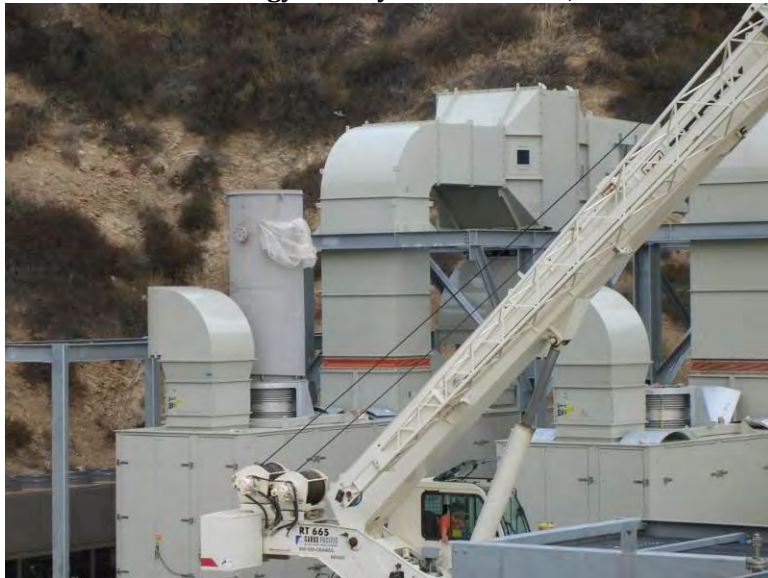
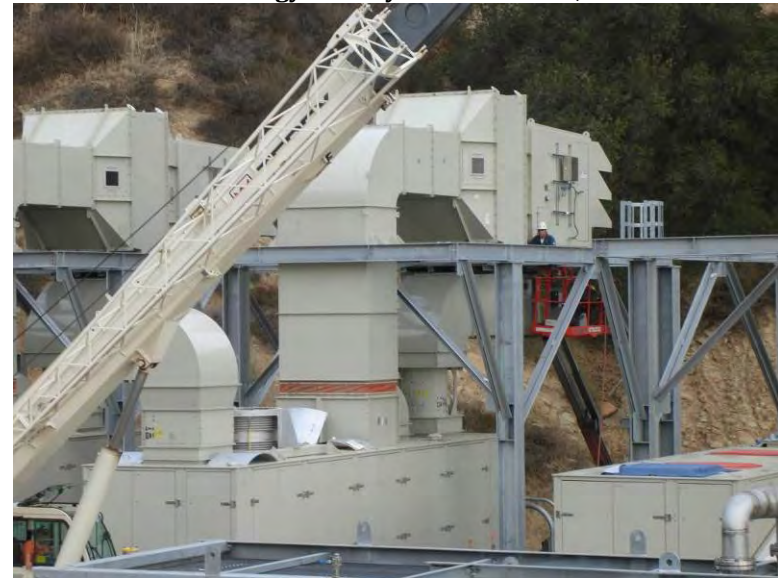
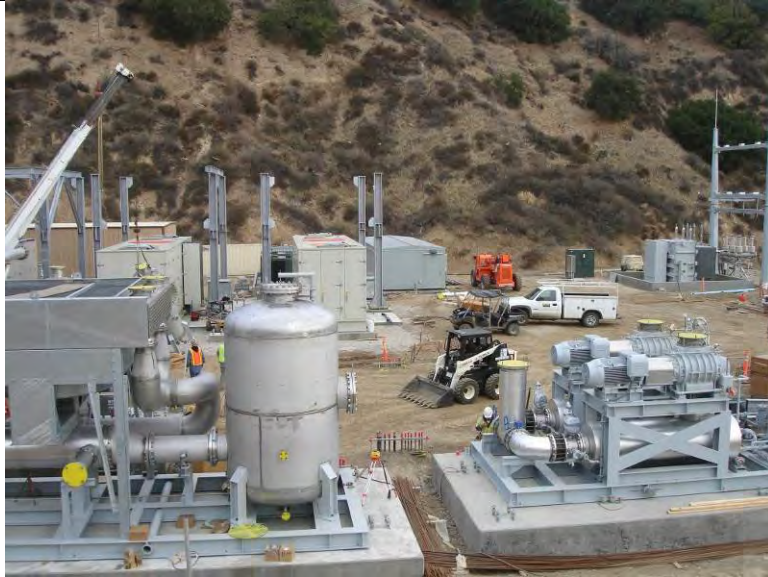
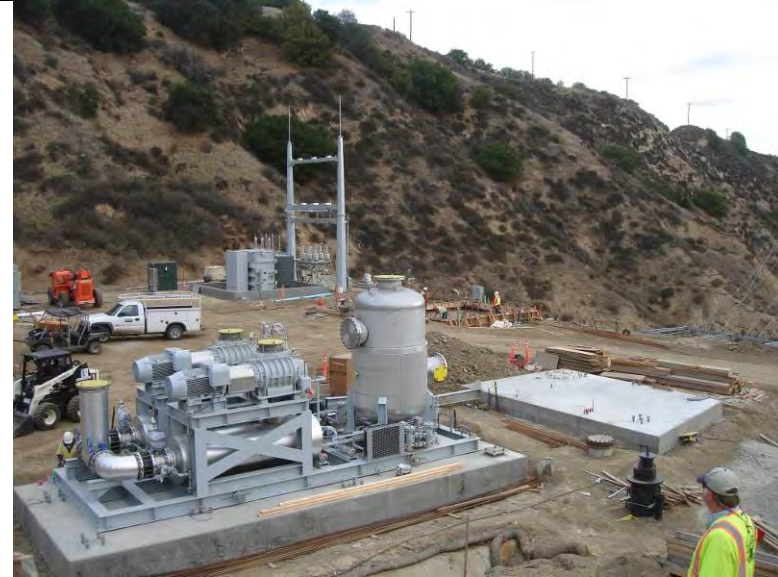
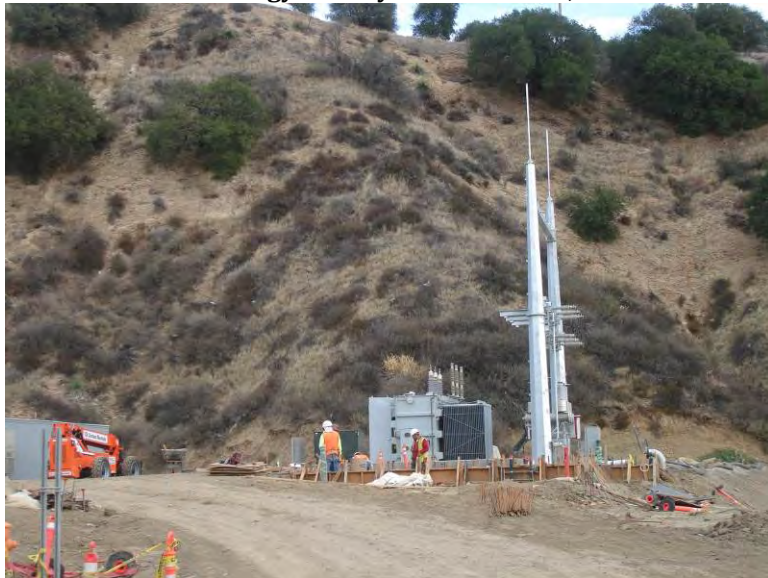
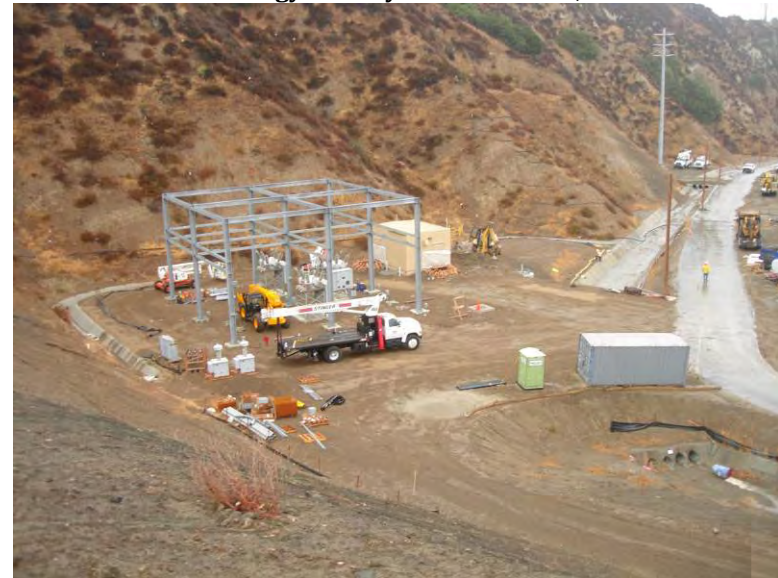
Q - C.10.c		City Planning	I-p through I-t: The gas-to-energy and Edison facilities were observed during this quarter. Progress can be seen by the photos taken. The Edison facility appeared complete and ready for commissioning on December 4, 2013. On December 18th, the gas-to-energy facility still had work to be accomplished. The expected schedule for commissioning of both facilities is the end of the 1st Quarter or early 2nd Quarter of 2014.

Photo 82: Gas to Energy Facility: December 4, 2013

Photo 83: Gas to Energy Facility: December 4, 2013

Photo 84: Gas to Energy Facility: December 4, 2013

Photo 85: Gas to Energy Facility: December 18, 2013

Photo 86: Gas to Energy Facility: December 18, 2013

Photo 87: Gas to Energy Facility: December 18, 2013

Photo 88: Gas to Energy Facility: December 18, 2013

Photo 89: Gas to Energy Facility: December 18, 2013

Photo 90: Gas to Energy Facility: December 18, 2013

Photo 91: Gas to Energy Facility: December 18, 2013

Photo 92: Gas to Energy Facility: December 18, 2013

Photo 93: Gas to Energy Facility: December 18, 2013

Photo 94: Gas to Energy Facility: December 18, 2013

Photo 95: Gas to Energy Facility: December 18, 2013

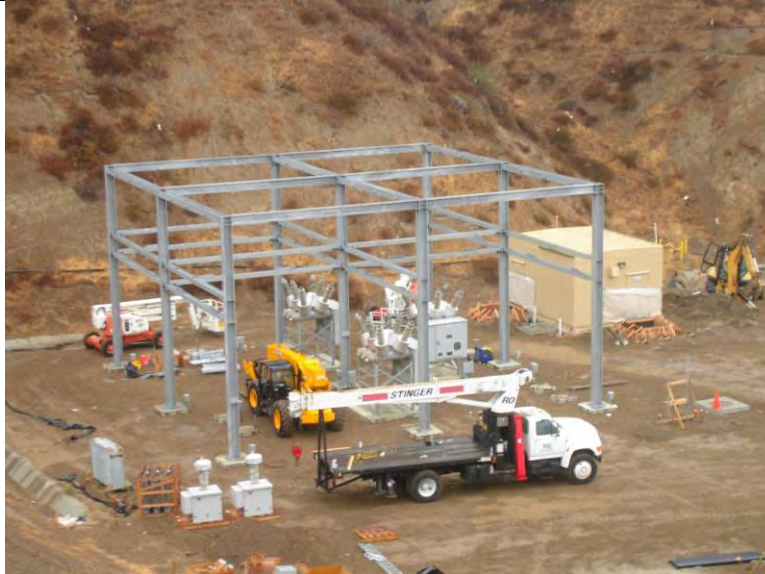
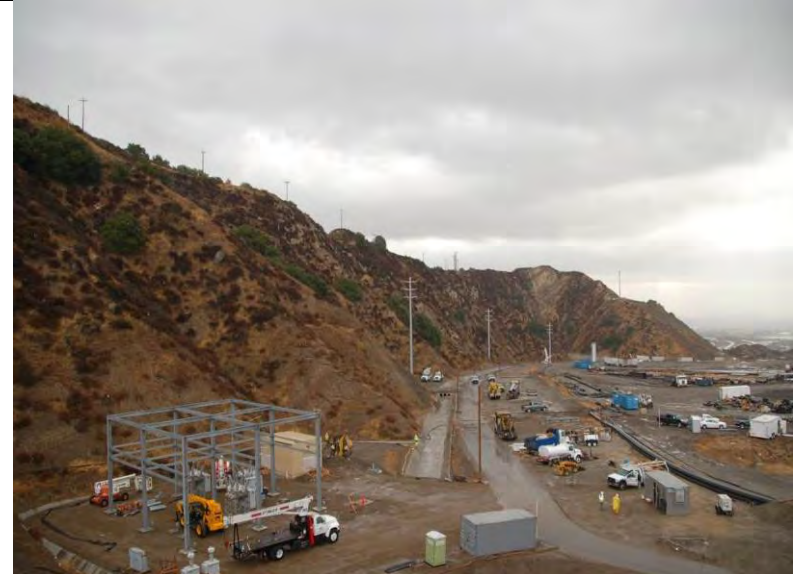
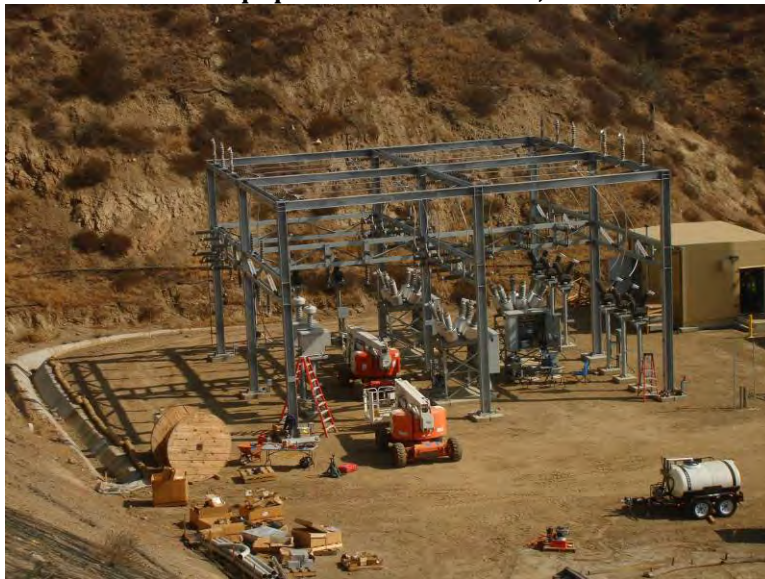
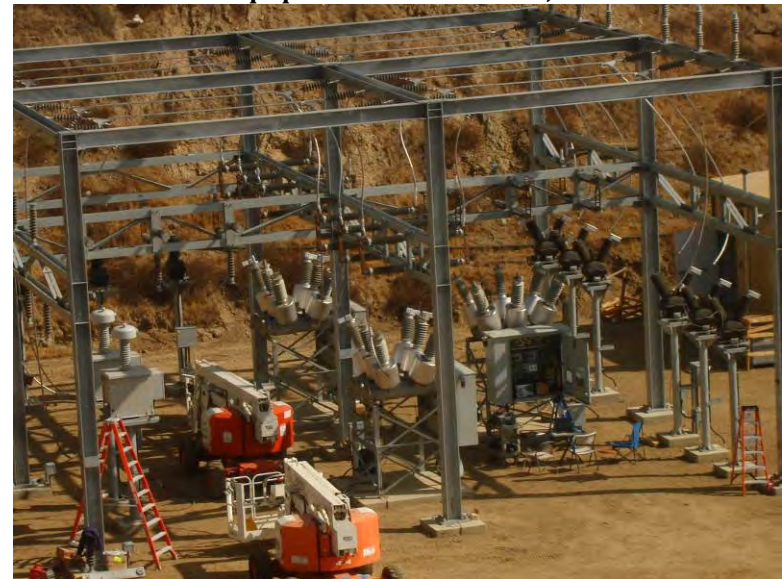
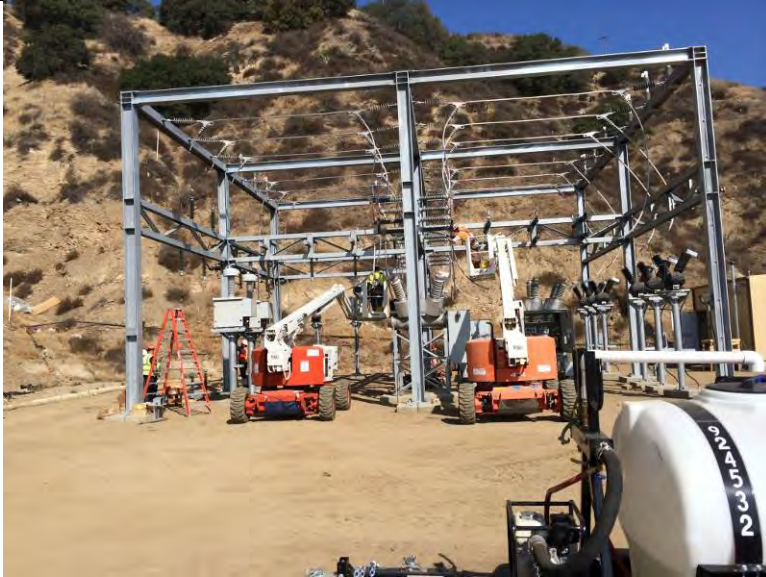
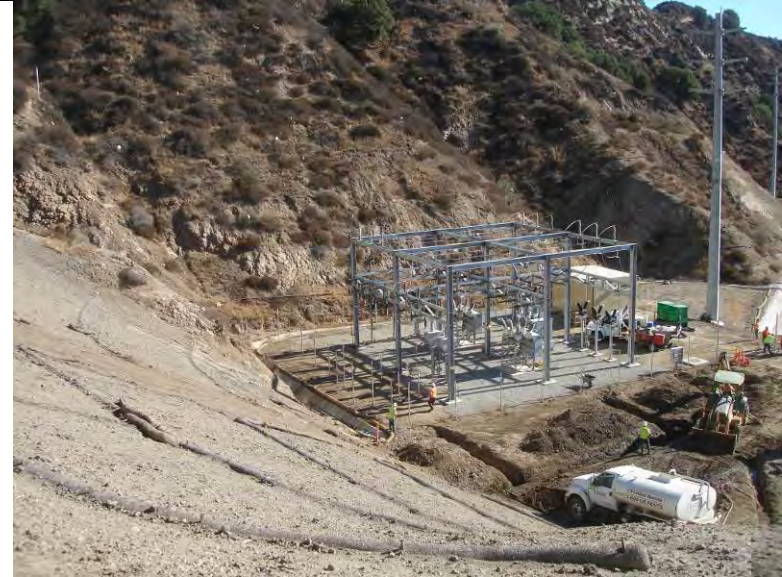
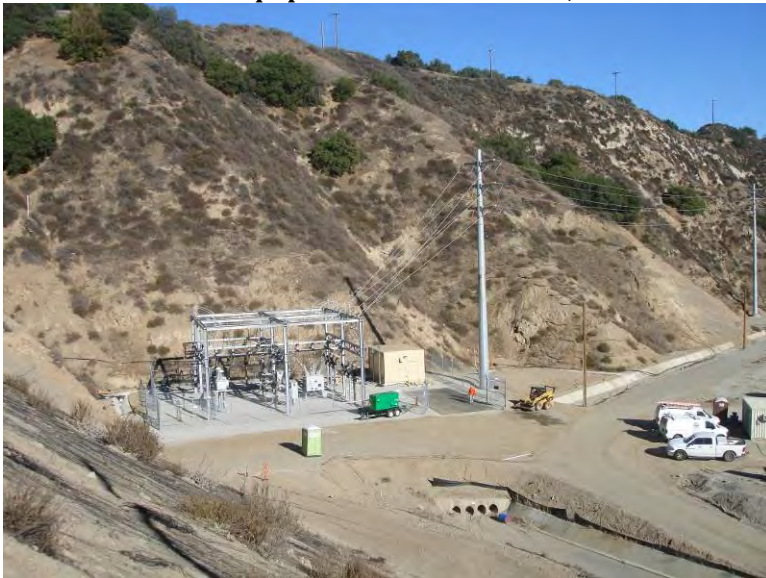
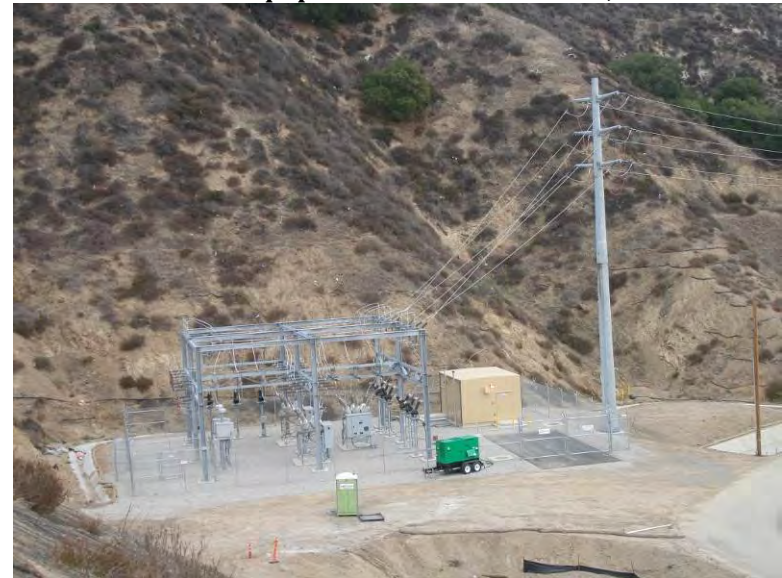
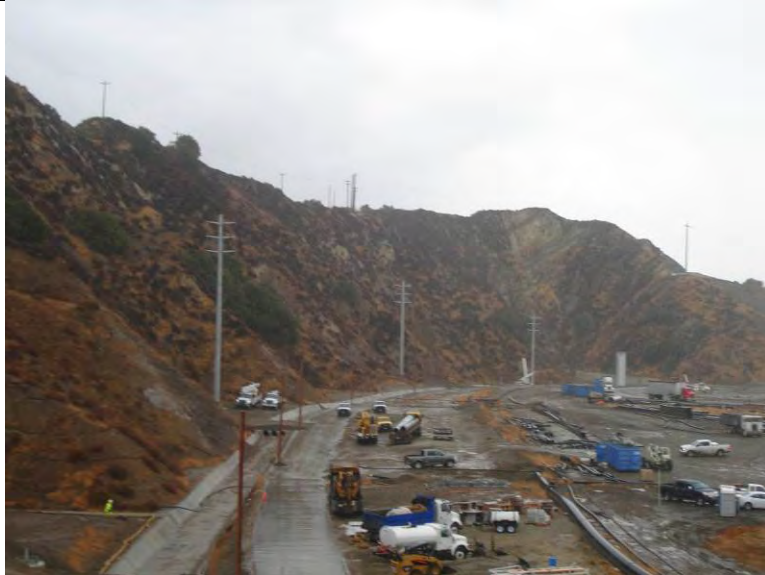
Photo 96: Edison Equipment Site: October 9, 2013

Photo 97: Edison Equipment Site: October 9, 2013

Photo 98: Edison Equipment Site: October 9, 2013

Photo 99: Edison Equipment Site: October 23, 2013

Photo 100: Edison Equipment Site: October 23, 2013

Photo 101: Edison Equipment Site: October 23, 2013

Photo 102: Edison Equipment Site: November 13, 2013

Photo 103: Edison Equipment Site: December 4, 2013

Photo 104: Edison Equipment Site: December 18, 2013

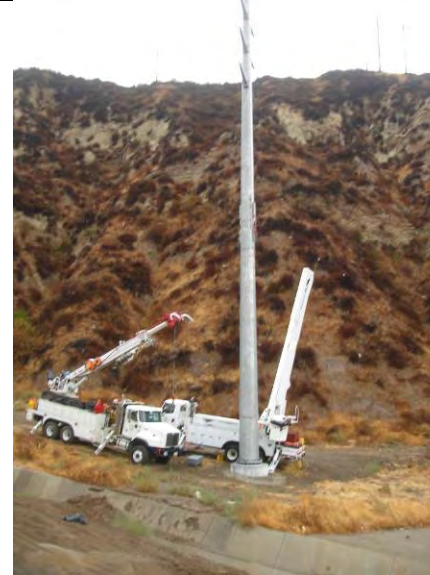
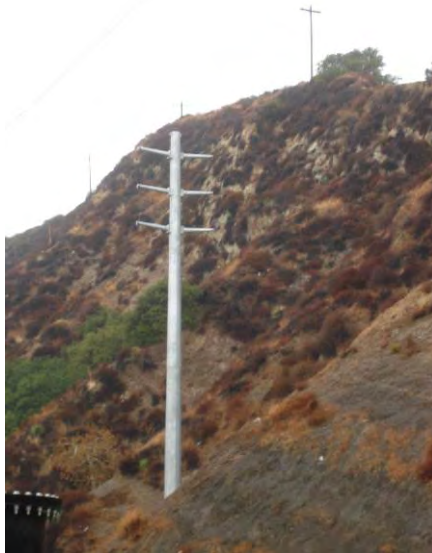
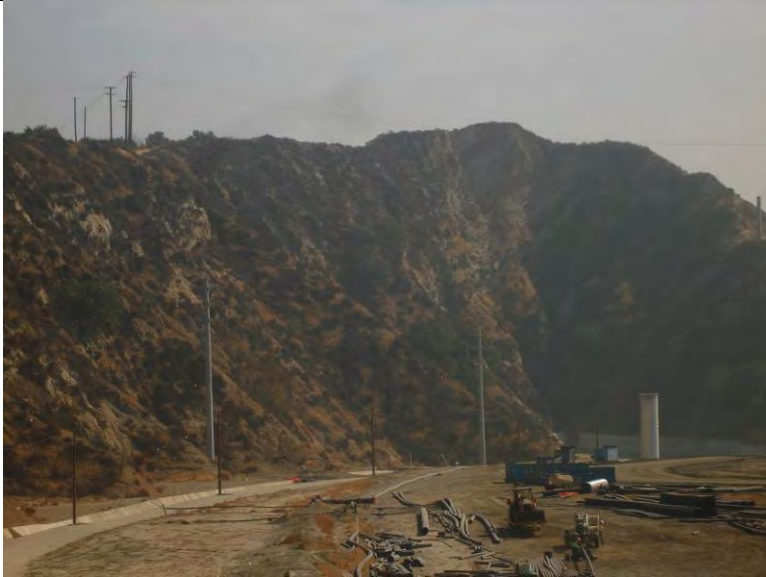
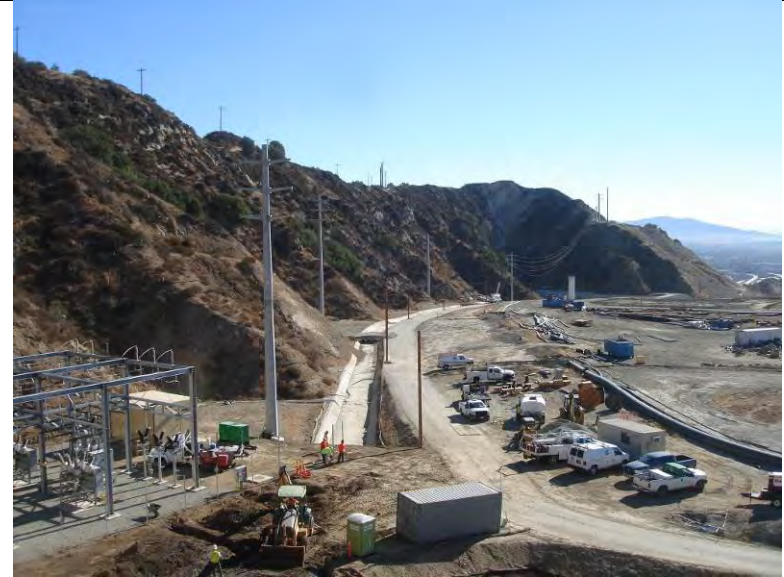
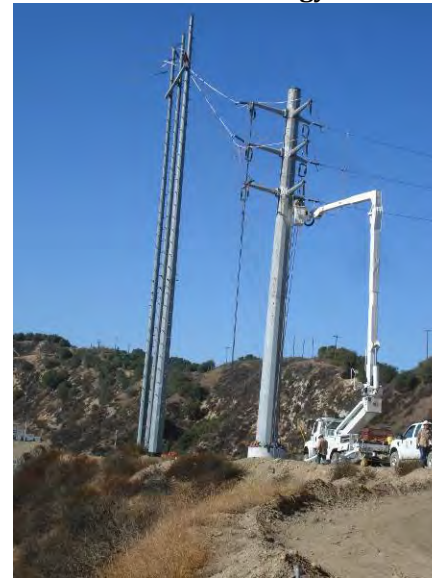
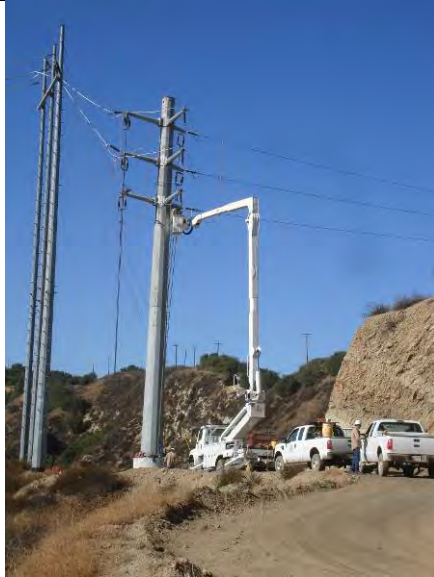
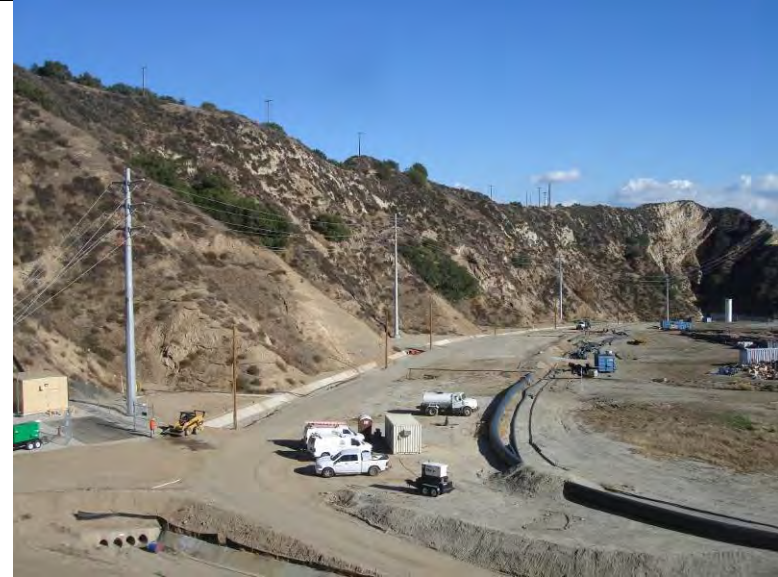
Photo 105: Edison Energy Sales New Poles: October 9, 2013

Photo 106: Edison Energy Sales New Poles: October 9, 2013

Photo 107: Edison Energy Sales New Poles: October 9, 2013

Photo 108: Edison Energy Sales New Poles: October 23, 2013

Photo 109: Edison Energy Sales New Poles: October 23, 2013

Photo 110: Edison Energy Sales New Poles: November 13, 2013

Photo 111: Edison Energy Sales New Poles: November 13, 2013

Photo 112: Edison Energy Sales New Poles: November 13, 2013

Photo 113: Edison Energy Sales New Poles: November 13, 2013

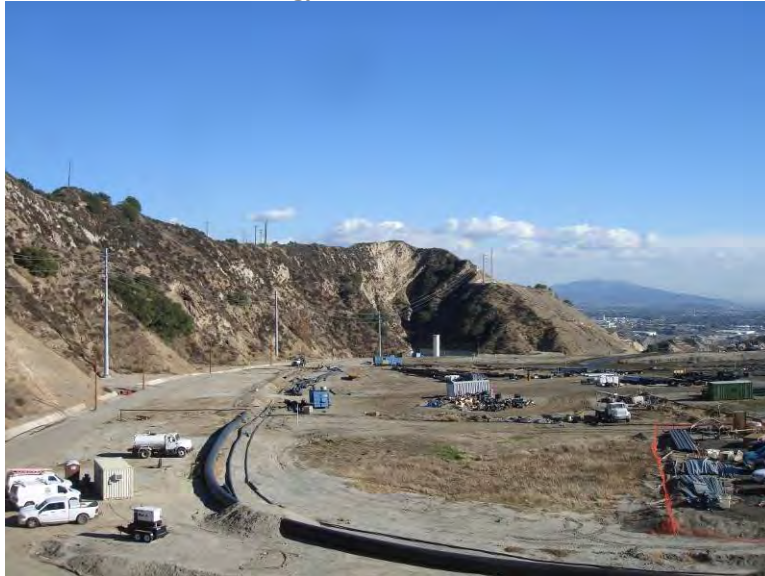
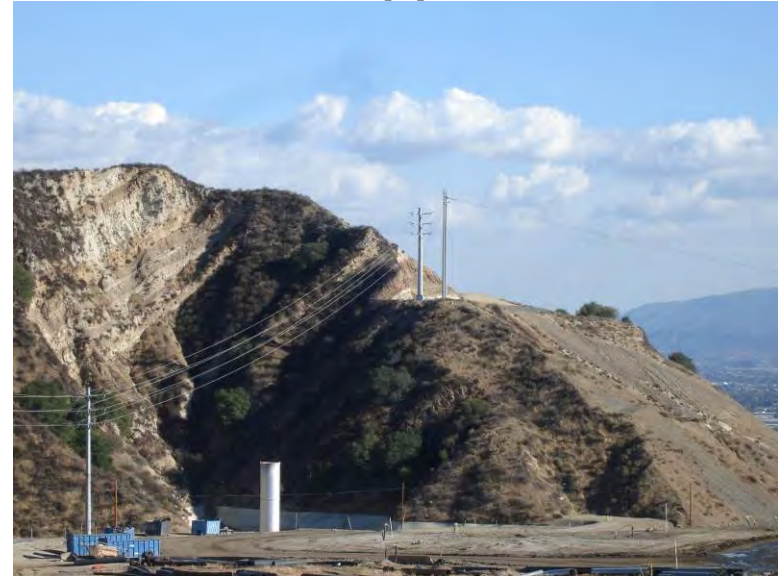
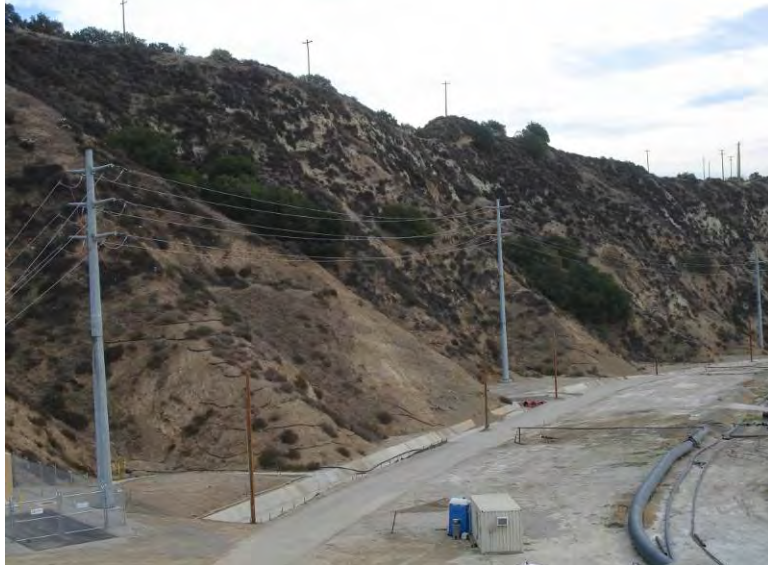
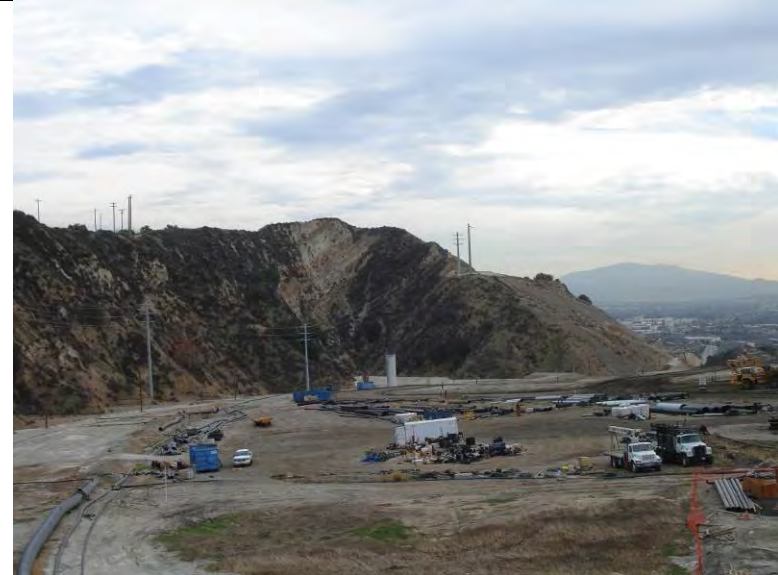
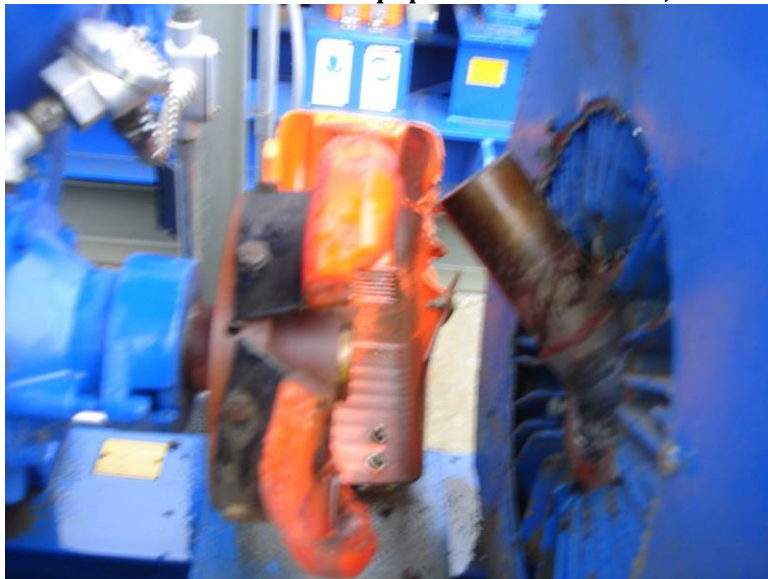
Photo 114: Edison Pole Line Equipment: December 4, 2013

Photo 115: Edison Pole Line Equipment: December 4, 2013

Photo 116: Edison Pole Line Equipment: December 4, 2013

Photo 117: Edison Pole Line Equipment: December 18, 2013

Photo 118: Edison Pole Line Equipment: December 18, 2013

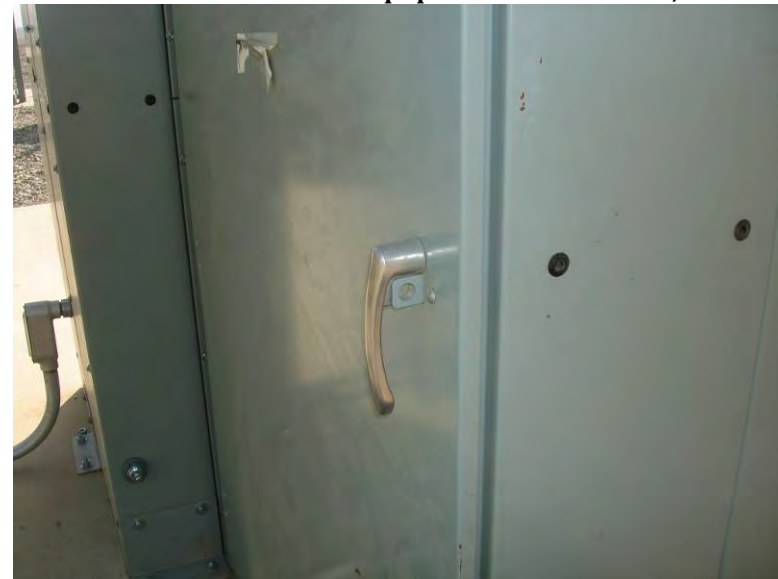
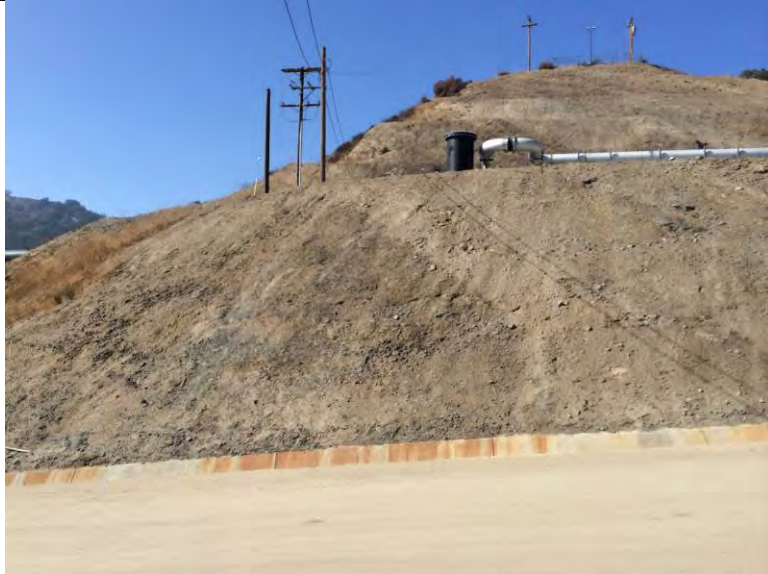
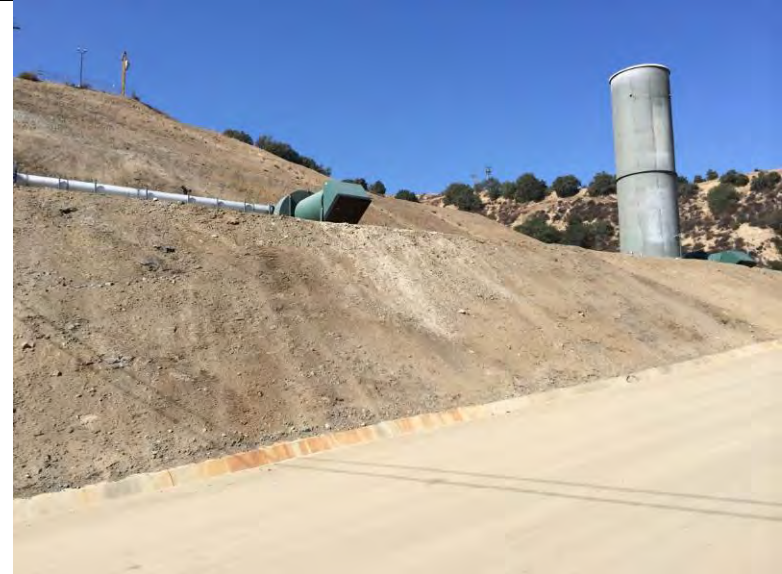
Photo 119: Flare 9 & 10 Facility Sites: October 9, 2013

Photo 120: Flare 9 & 10 Facility Sites: October 23, 2013

Photo 121: Flare 9 and 10 Facility Sites: October 23, 2013

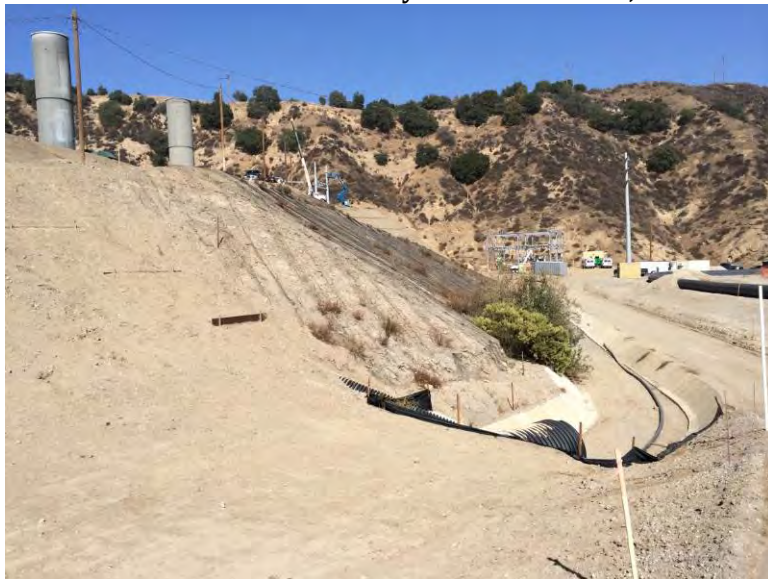
Photo 122: Flare 9 and 10 Facility Sites: October 23, 2013

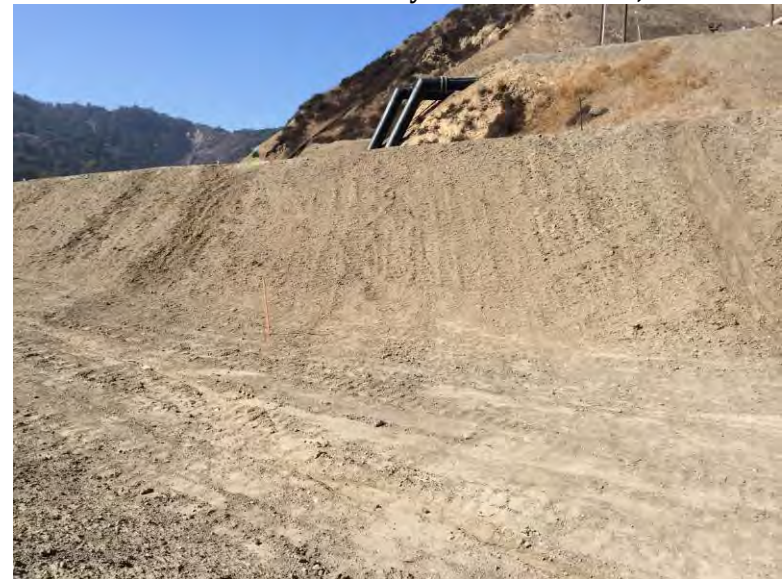
Photo 123: Flare 9 and 10 Facility Sites: October 23, 2013

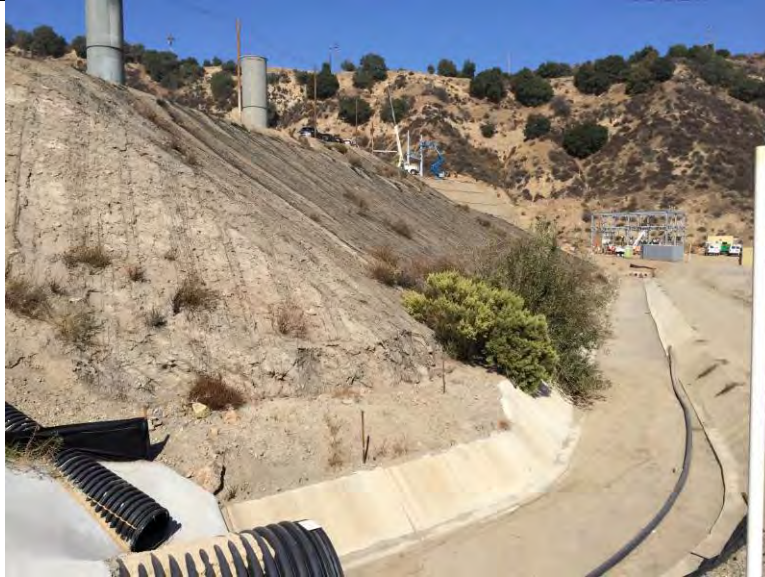
Photo 124: Flare 9 and 10 Facility Sites: October 23, 2013

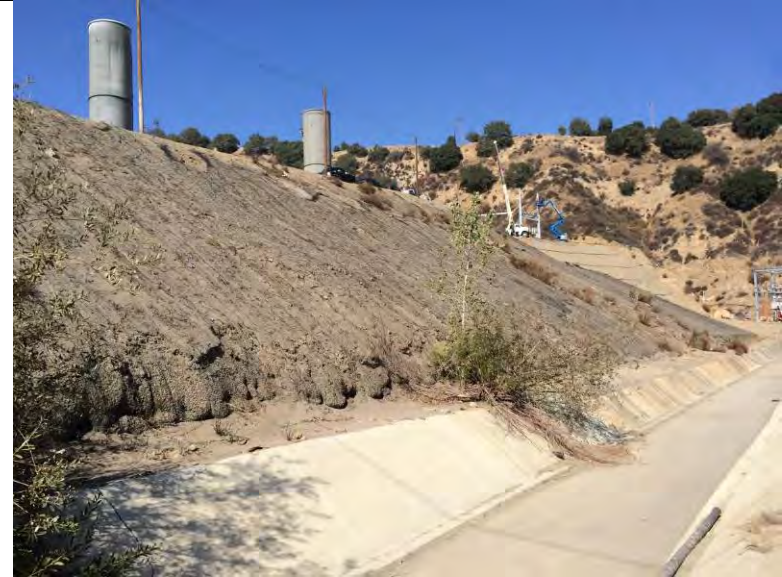
Photo 125: Flare 9 and 10 Facility Sites: October 23, 2013

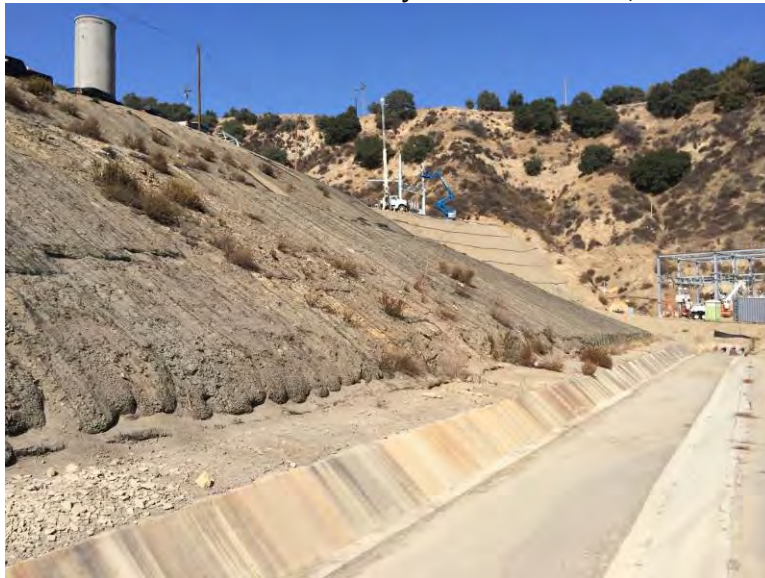
Photo 126: Flare 9 and 10 Facility Sites: October 23, 2013

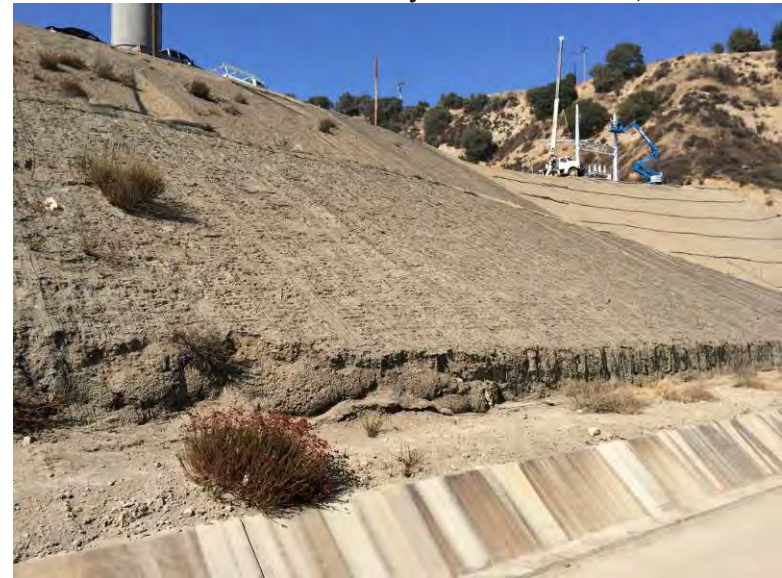
Photo 127: Flare 9 and 10 Facility Sites: October 23, 2013
