January 23, 2014

**Sunshine Canyon Landfill
Independent Monitor
Quarterly Site Monitoring Status Report
October 1, 2013 – December 31, 2013**

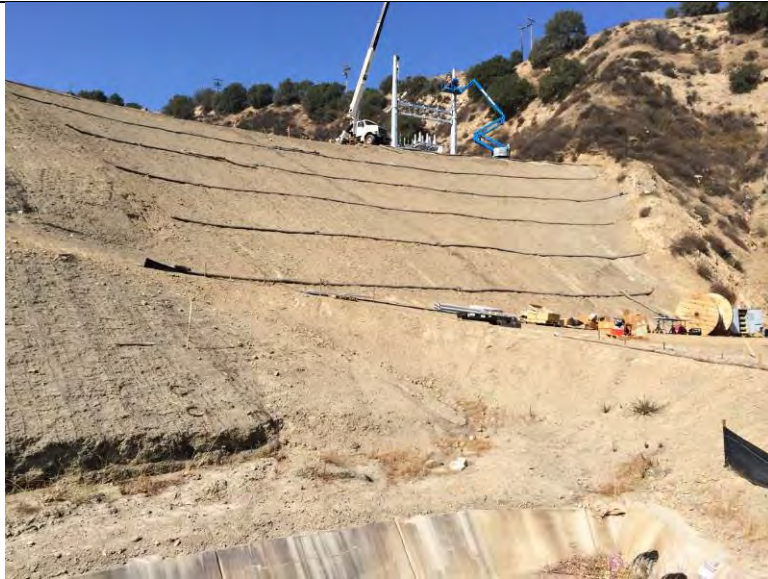
Photo 128: Slopes Below Flares 9 and 10: October 23, 2013

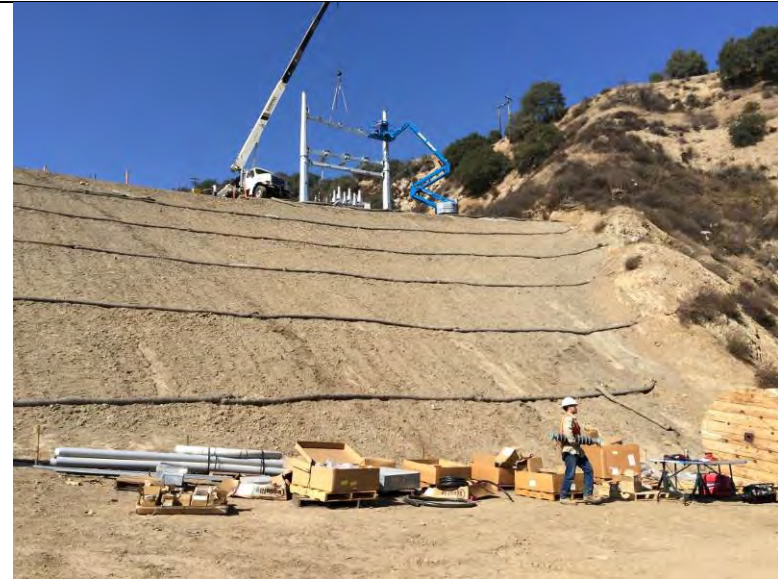
Photo 129: Slopes Below Flares 9 and 10: October 23, 2013

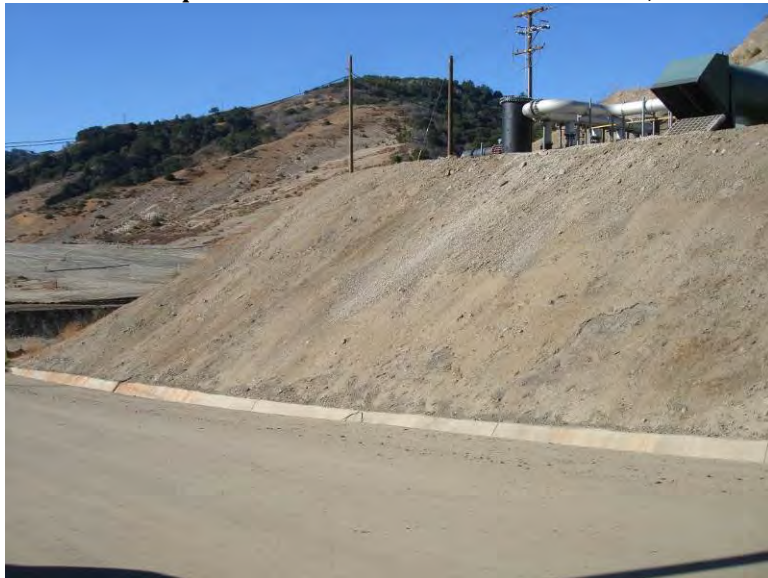
Photo 130: Slopes Below Flares 9 and 10: October 23, 2013

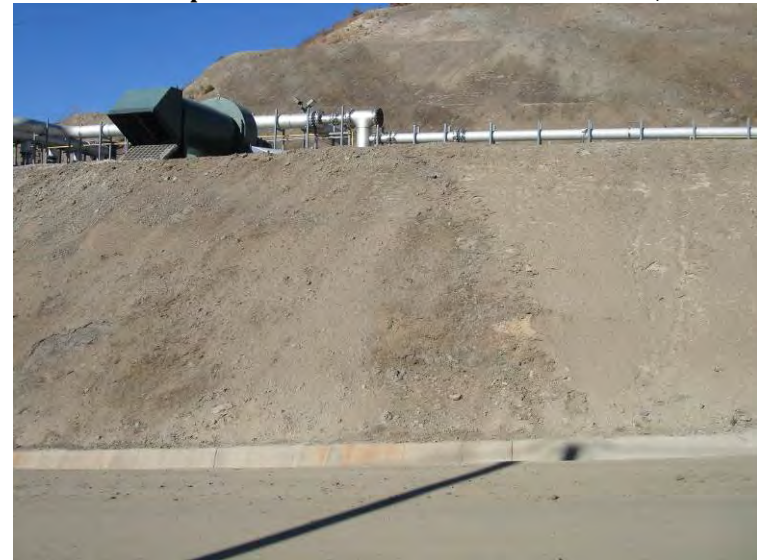
Photo 131: Slopes Below Flares 9 and 10: November 13, 2013

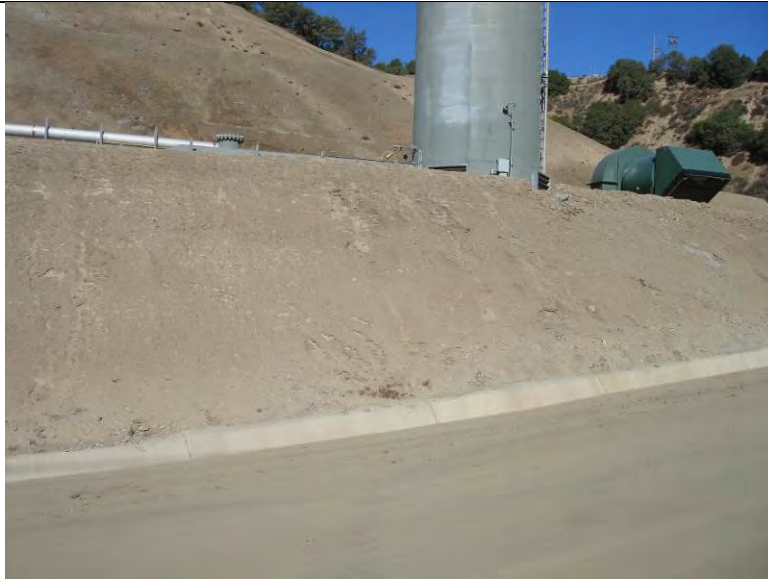
Photo 132: Slopes Below Flares 9 and 10: November 13, 2013

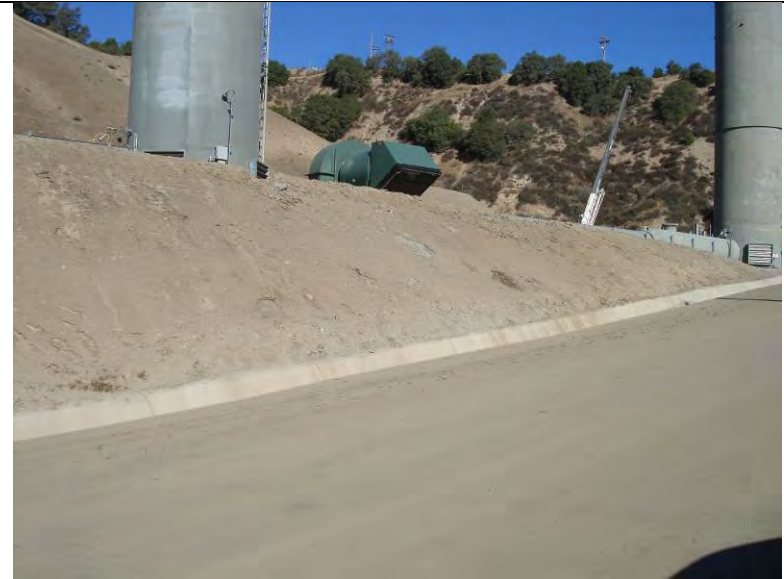
Photo 133: Slopes Below Flares 9 and 10: November 13, 2013

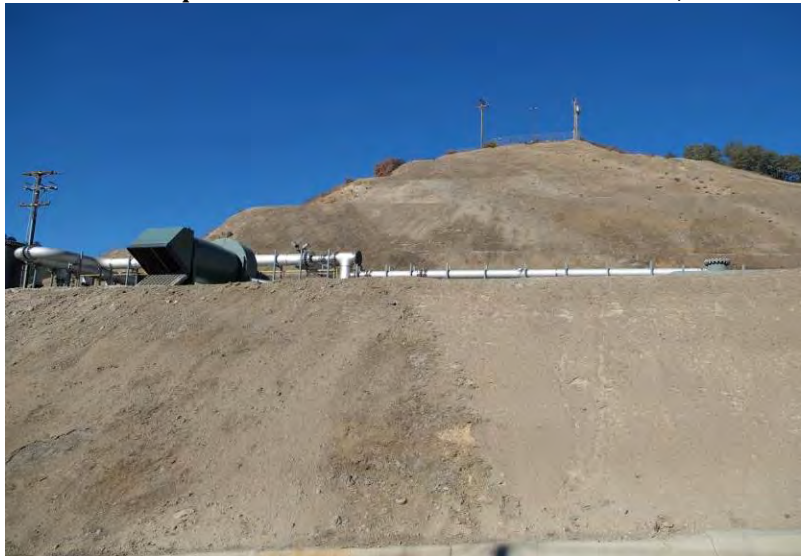
Photo 134: Slopes Below Flares 9 and 10: November 13, 2013

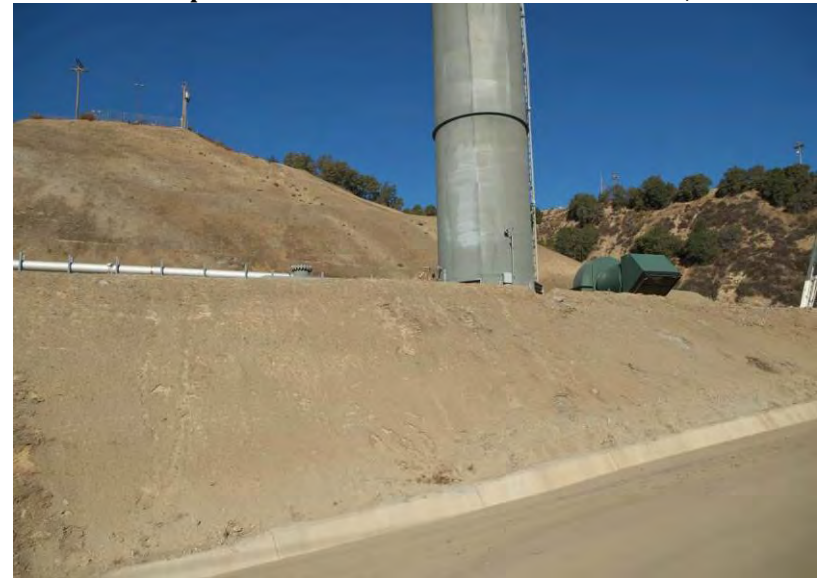
Photo 135: Slopes Below Flares 9 and 10: November 13, 2013

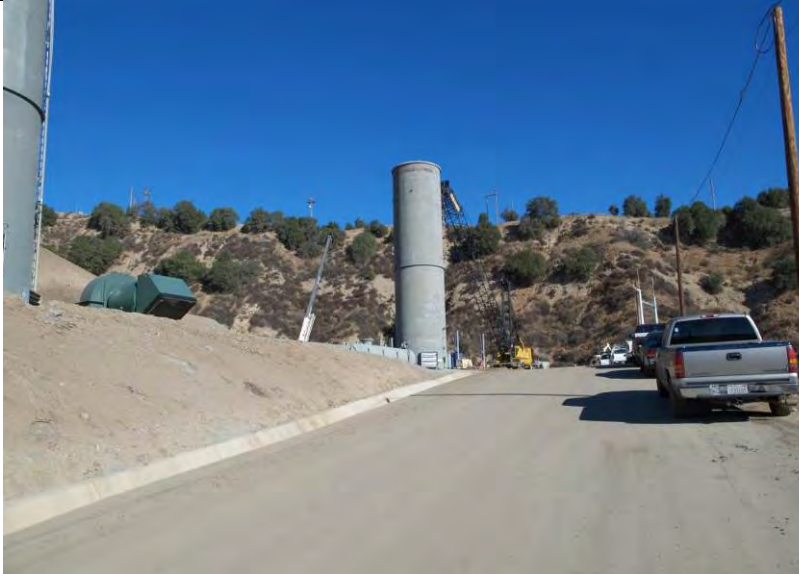
Photo 136: Slopes Below Flares 9 and 10: November 13, 2013

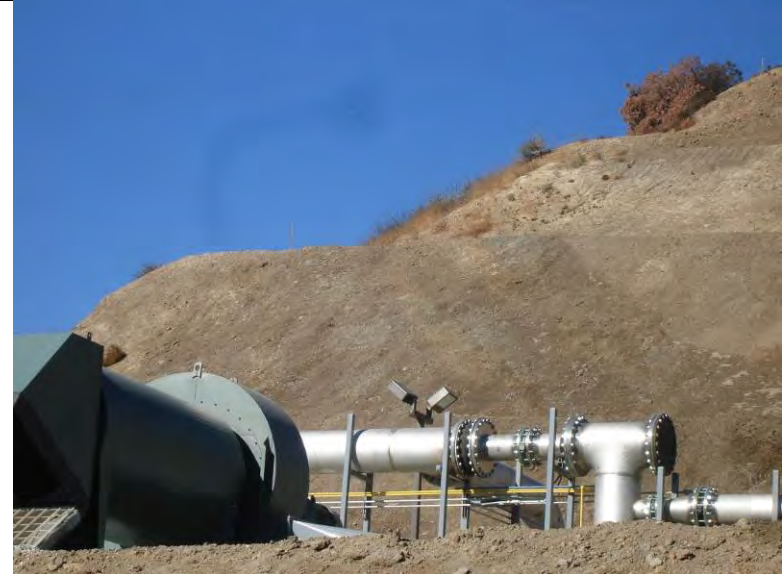
Photo 137: Slopes Below Flares 9 and 10: November 13, 2013

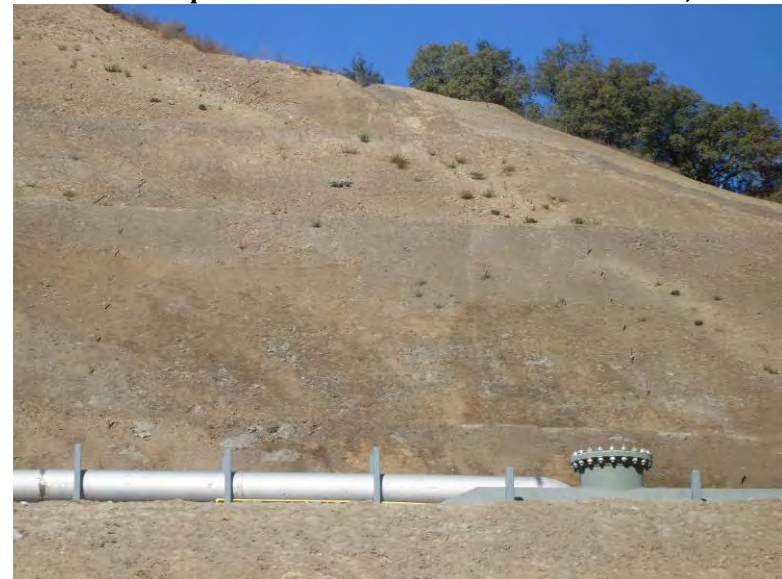
Photo 139: Hillside Behind Flares 9 & 10: November 13, 2013

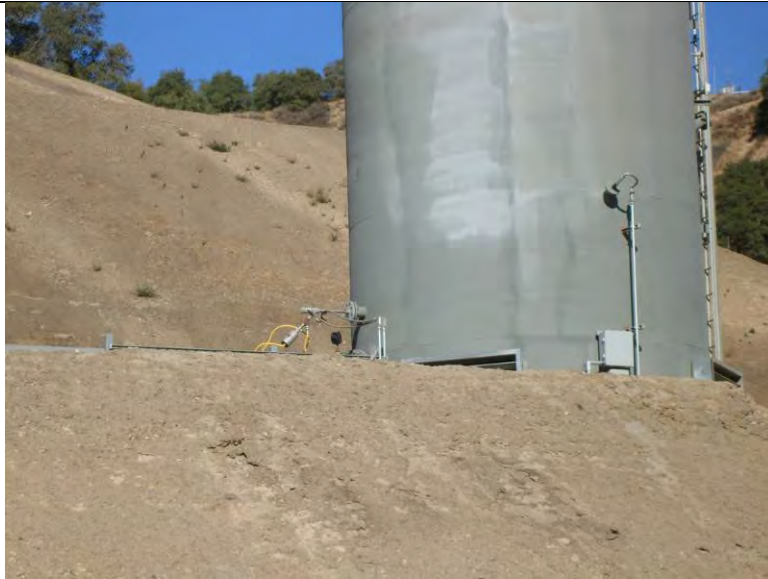
Photo 140: Hillside Behind Flares 9 & 10: November 13, 2013

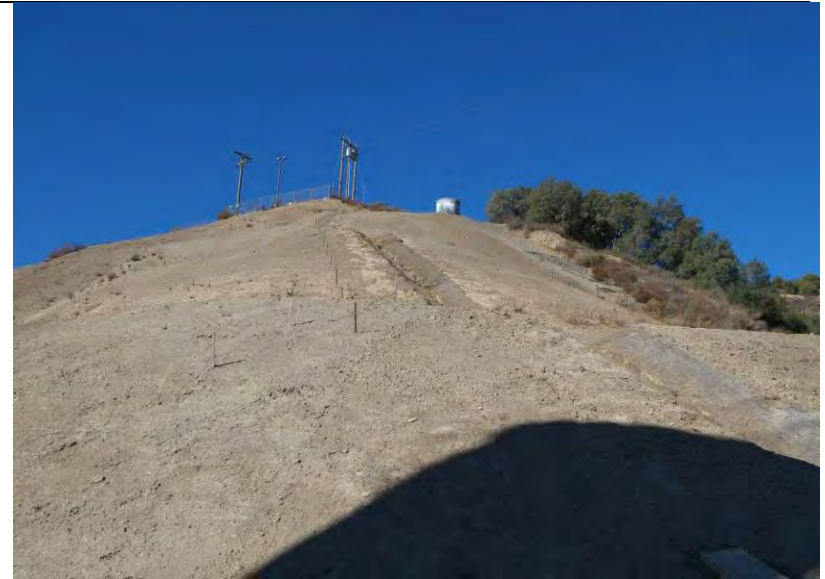
Photo 141: Hillside Behind Flares 9 & 10: November 13, 2013

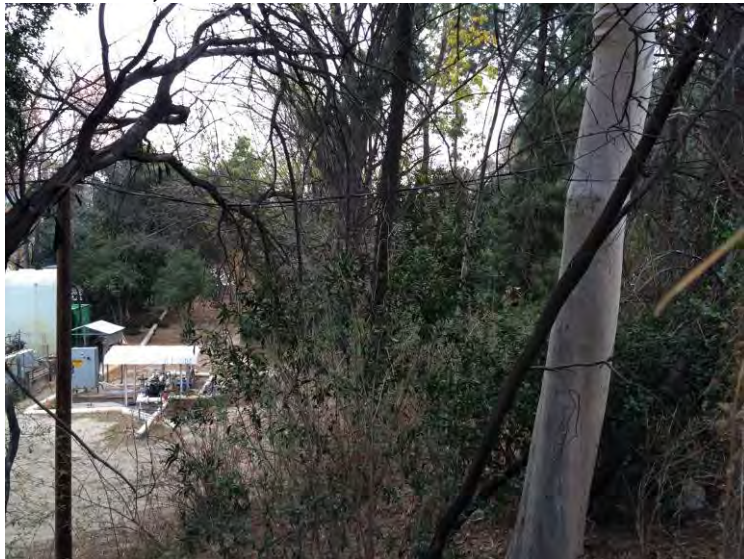
**Photo 250: Leachate Treatment Facility Electrical Lines:
December 4, 2013**

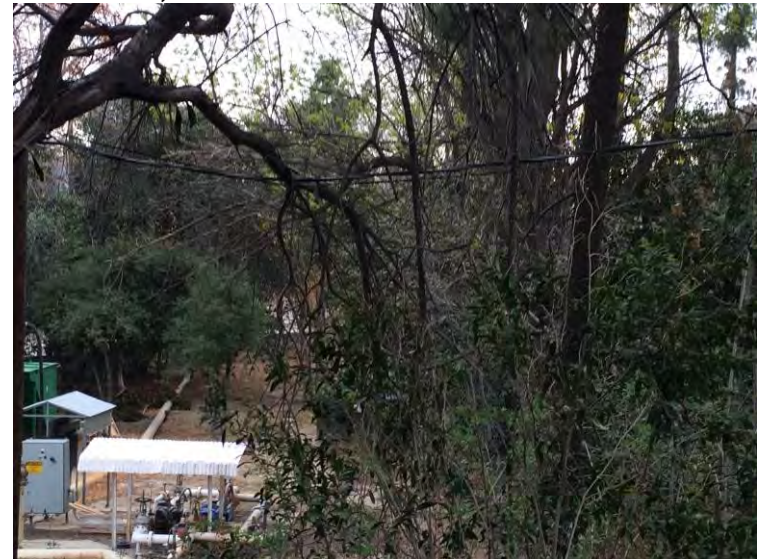
**Photo 251: Leachate Treatment Facility Electrical Lines:
December 18, 2013**

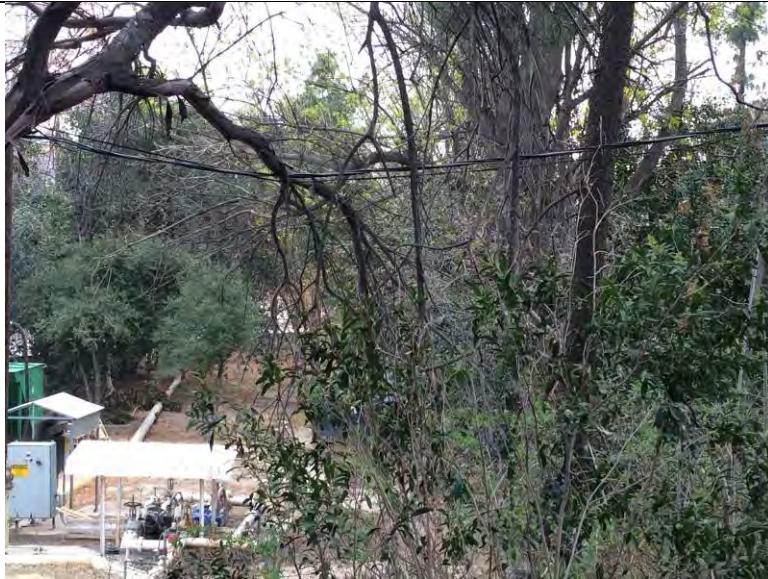
**Photo 252: Leachate Treatment Facility Electrical Lines:
December 18, 2013**

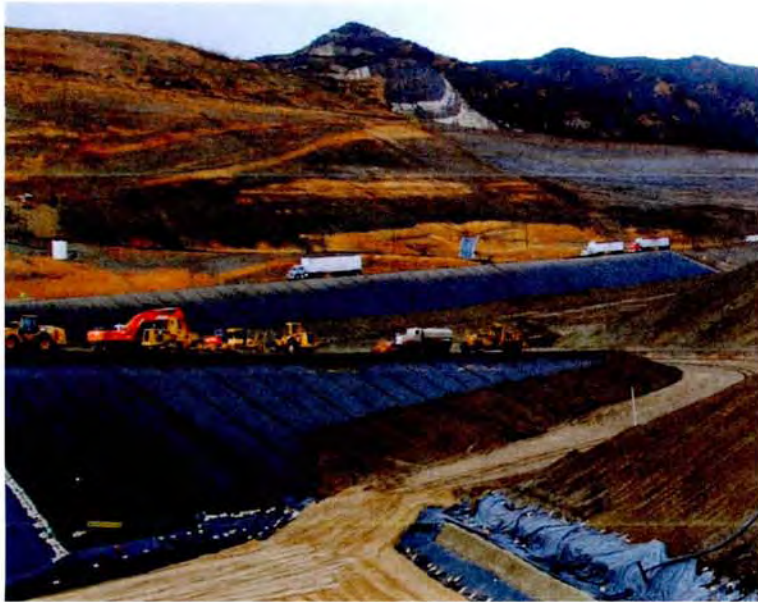
Photo 3: Operation layer over geosynthetics in Cell CC3a Part 1
