**Sunshine Canyon Landfill
Independent Monitor
Quarterly Site Monitoring Status Report
October 1, 2015 – December 31, 2015**

February 12, 2016

The attached Quarterly Site Monitoring Status Report for the Sunshine Canyon Landfill dated February 12, 2016 is the Fourth Quarterly Report for 2015, issued by UltraSystems. This report covers the monitoring period from October 1, 2015 through December 31, 2015 and is prepared for the City of Los Angeles Department of City Planning and the County of Los Angeles Department of Regional Planning.

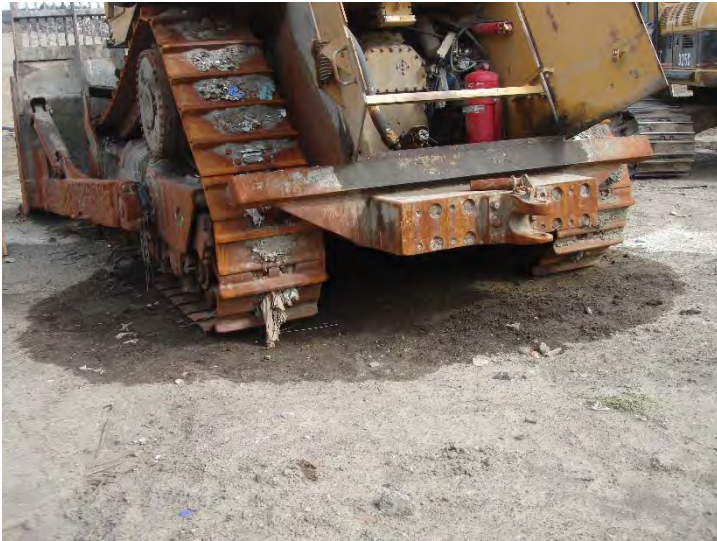
Photo 37: Equipment Leaking Oil Near Basin A: October 28, 2015

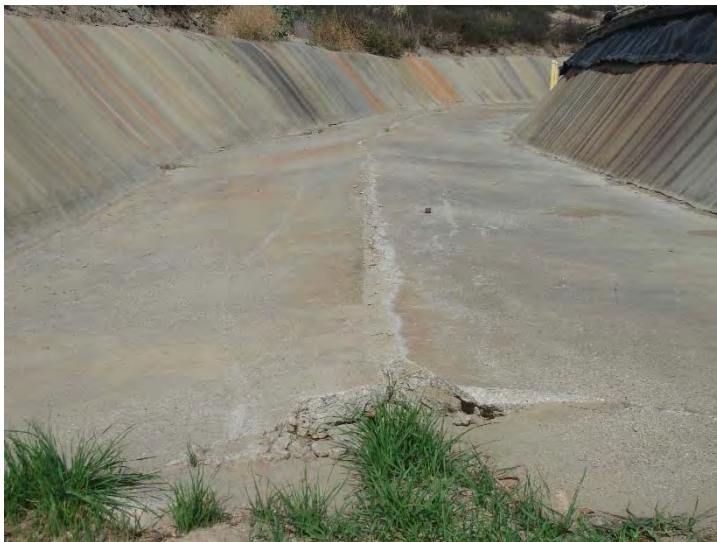
Photo 43: Westside Drainage Channel: October 14, 2015

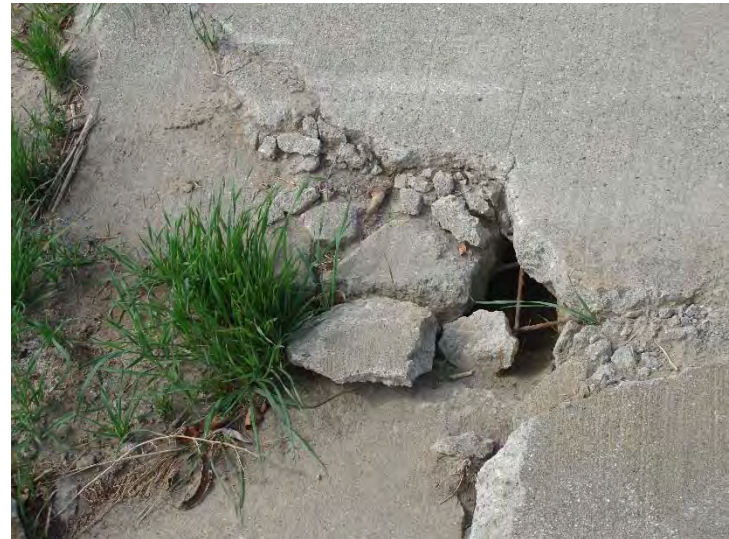
Photo 44: Westside Drainage Channel: October 14, 2015

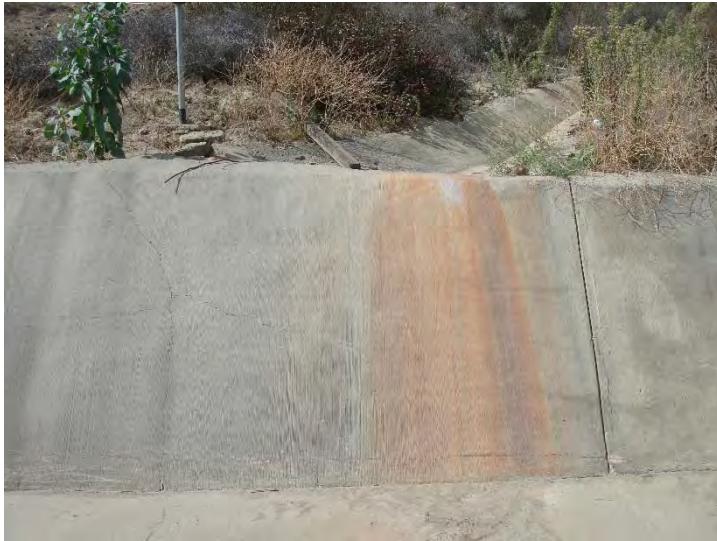
Photo 45: Westside Drainage Channel: October 14, 2015

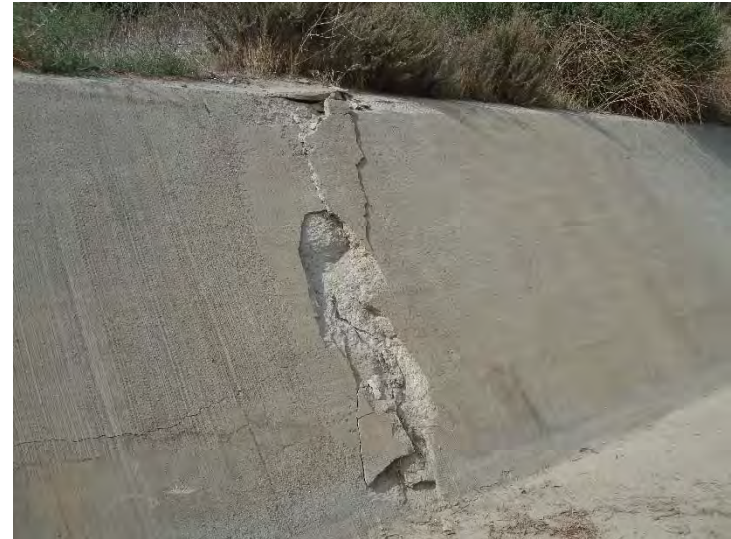
Photo 46: Westside Drainage Channel: October 14, 2015

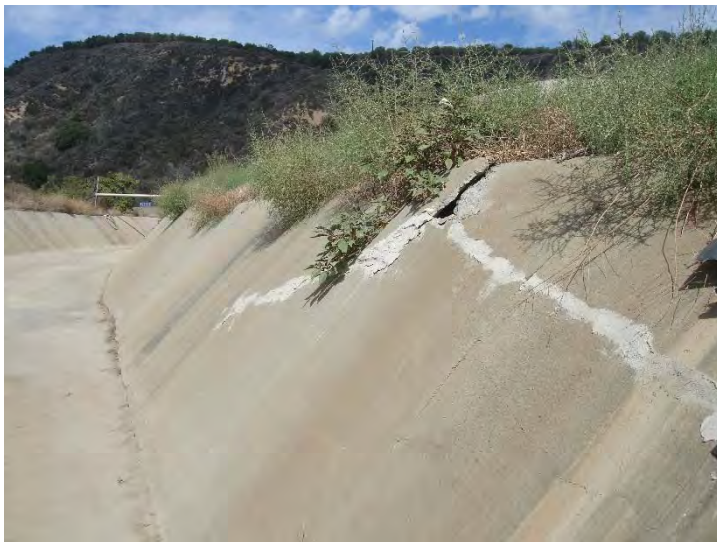
Photo 47: Westside Drainage Channel: October 14, 2015

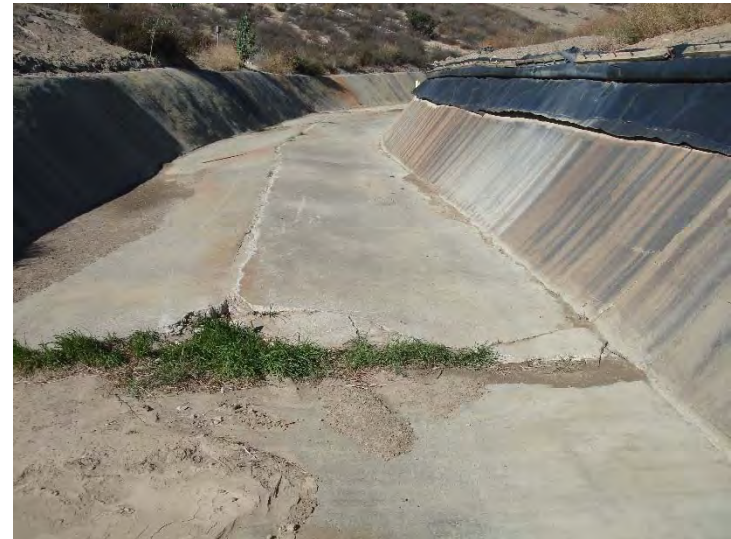
Photo 48: Westside Drainage Channel: November 16, 2015

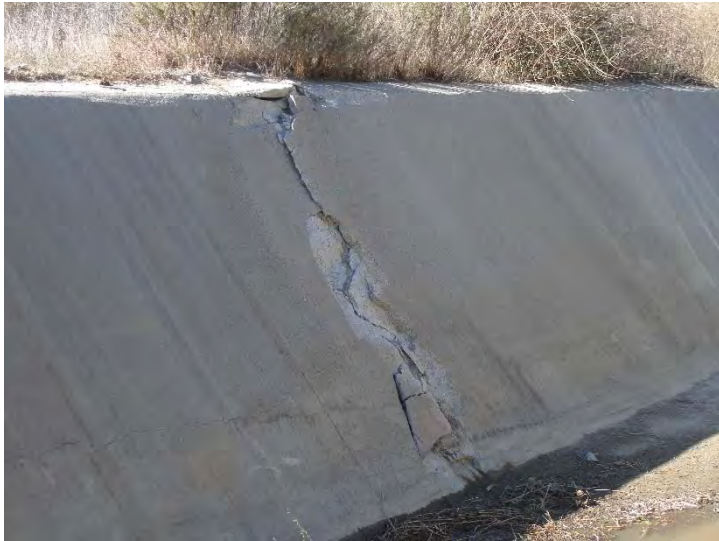
Photo 49: Westside Drainage Channel: November 16, 2015

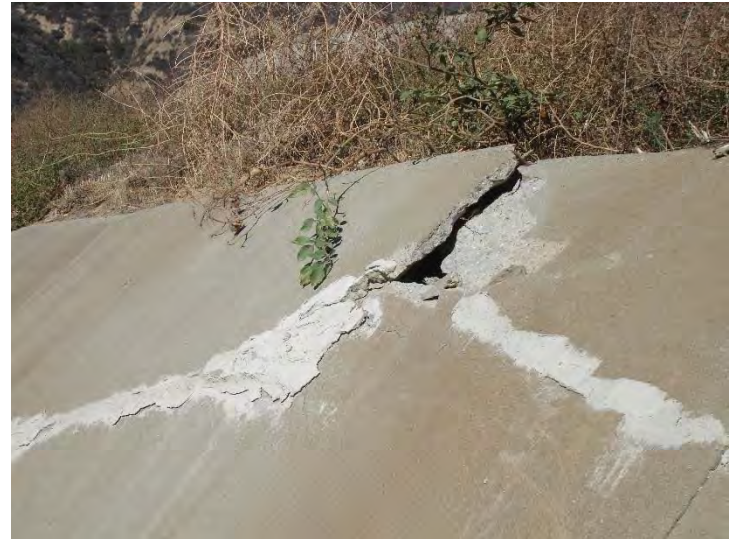
Photo 50: Westside Drainage Channel: November 16, 2015

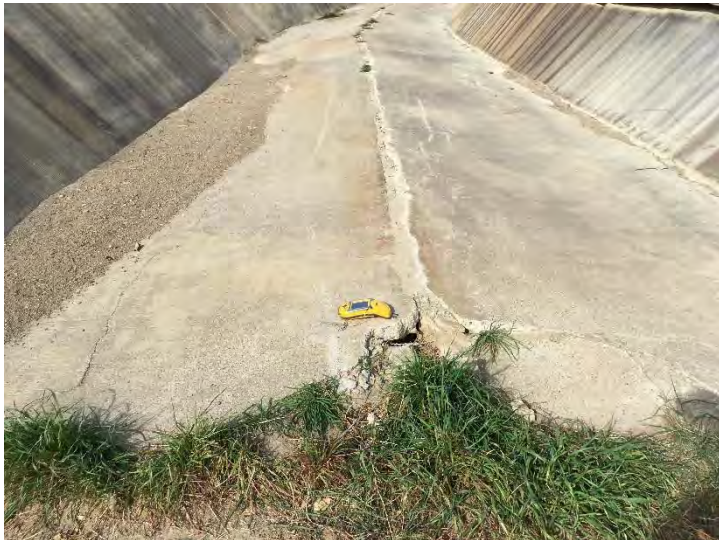
Photo 51: Westside Drainage Channel: December 9, 2015

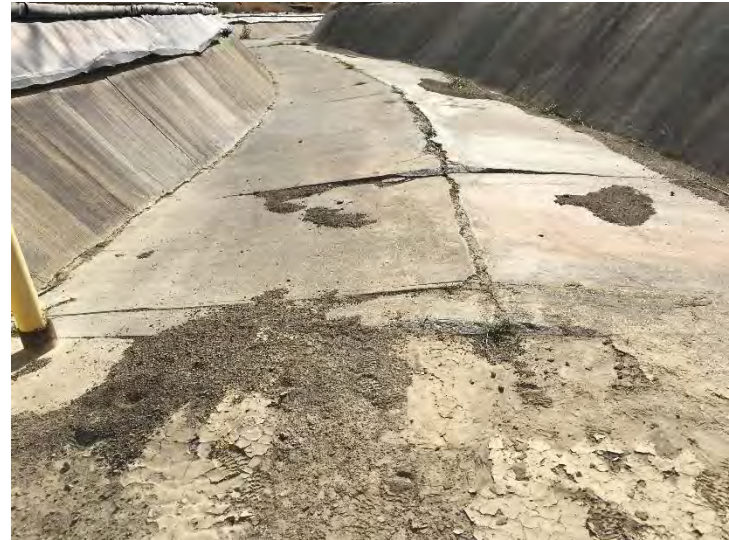
Photo 52: Westside Drainage Channel: December 9, 2015

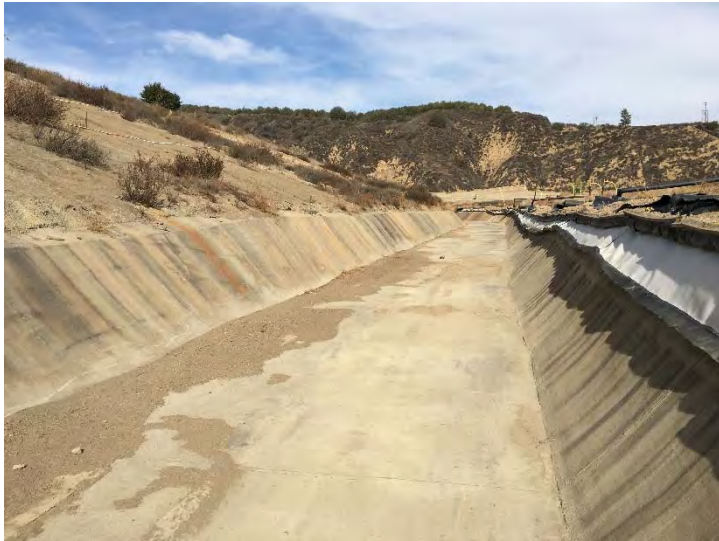
Photo 53: Westside Drainage Channel: December 9, 2015

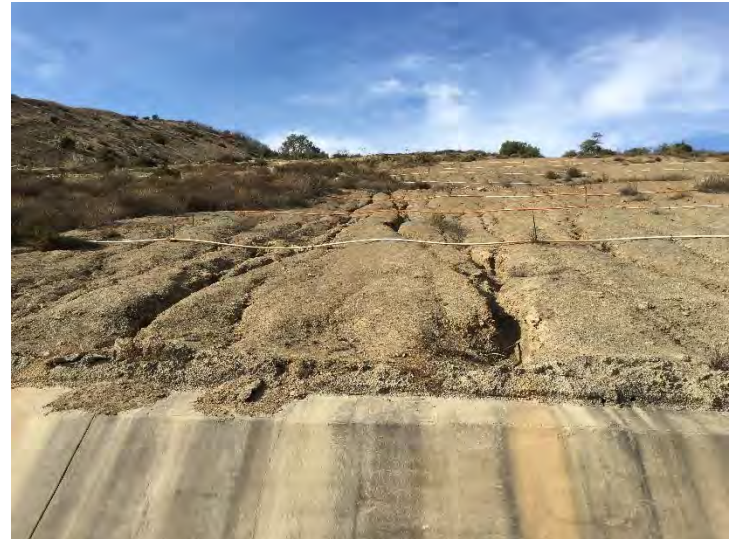
Photo 54: County Sage Area: December 9, 2015

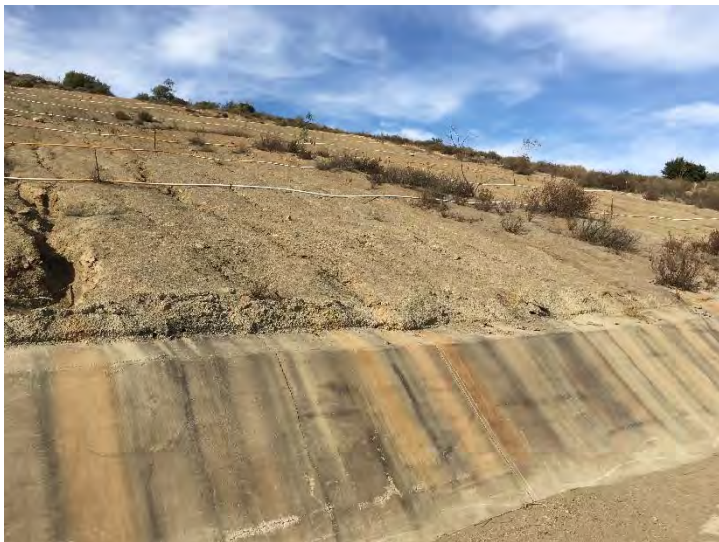
Photo 55: County Sage Area: December 9, 2015

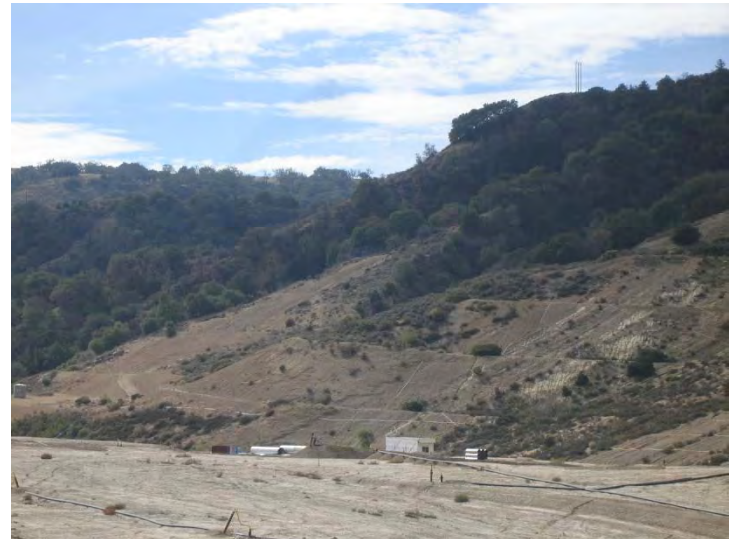
Photo 56: County Sage Mitigation Area: October 28, 2015

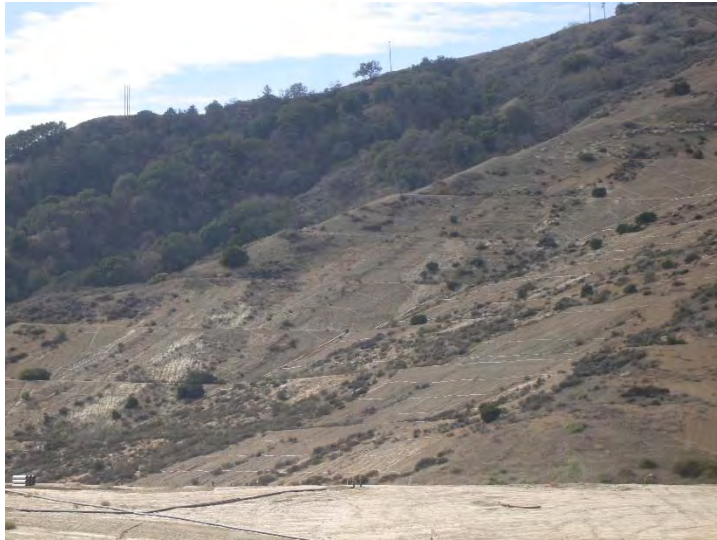
Photo 57: County Sage Mitigation Area: October 28, 2015

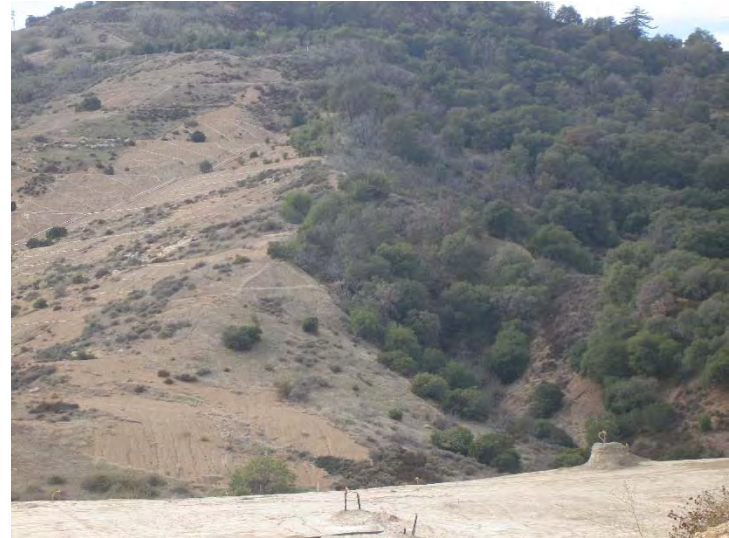
Photo 58: County Sage Mitigation Area: October 28, 2015

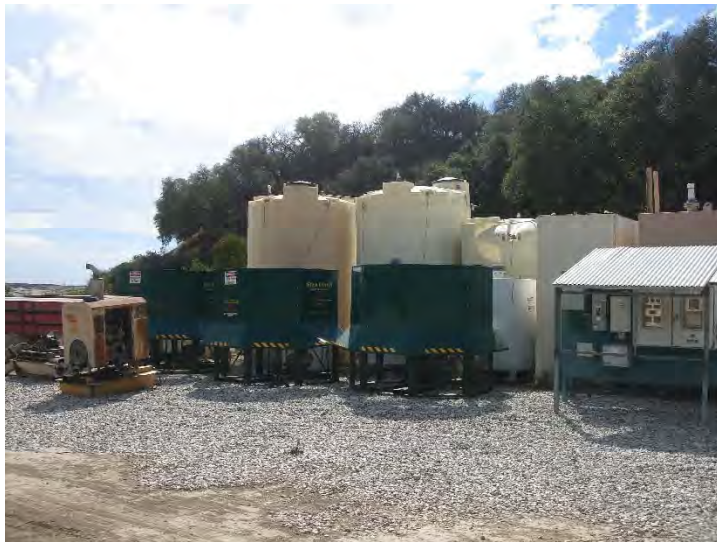
Photo 59: Condensate Equipment in Storage Yard: October 14, 2015

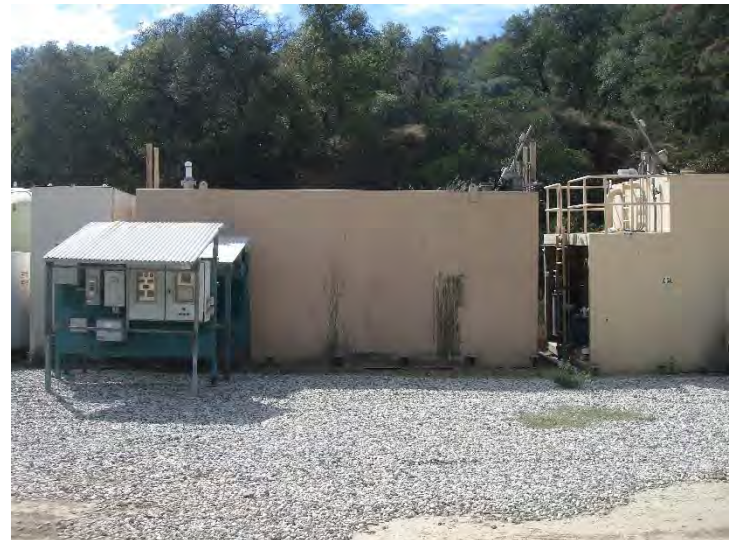
Photo 60: Condensate Equipment in Storage Yard: October 14, 2015

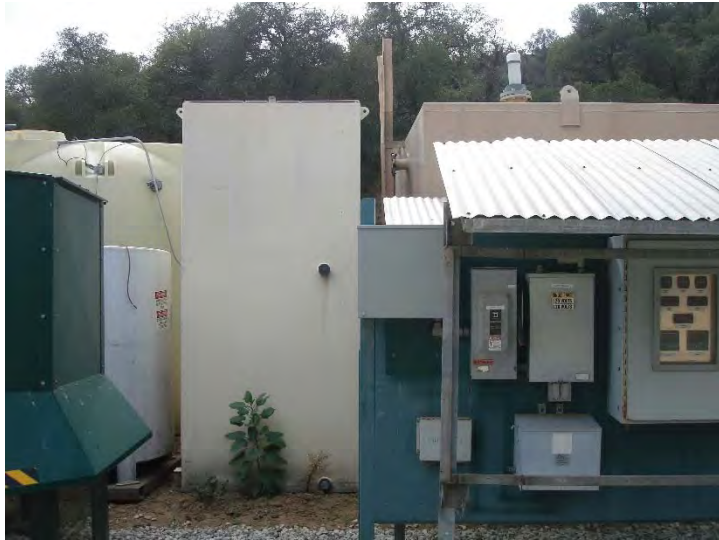
Photo 61: Condensate Equipment in Storage Yard: October 28, 2015

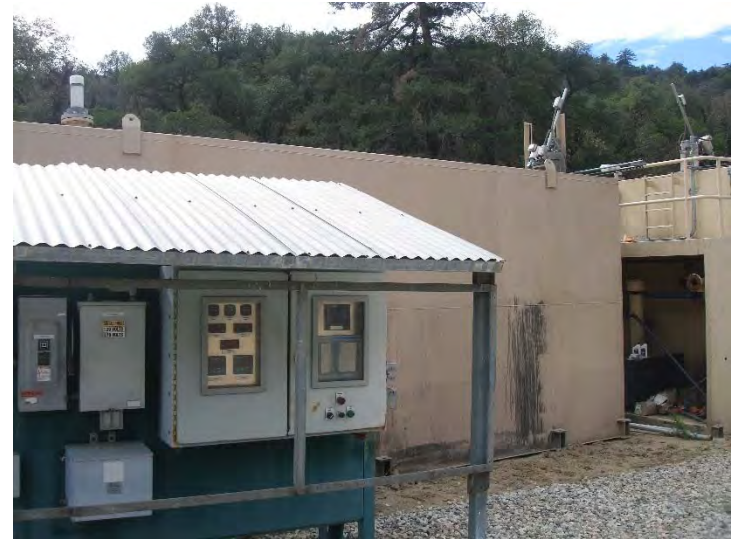
Photo 62: Condensate Equipment in Storage Yard: October 28, 2015

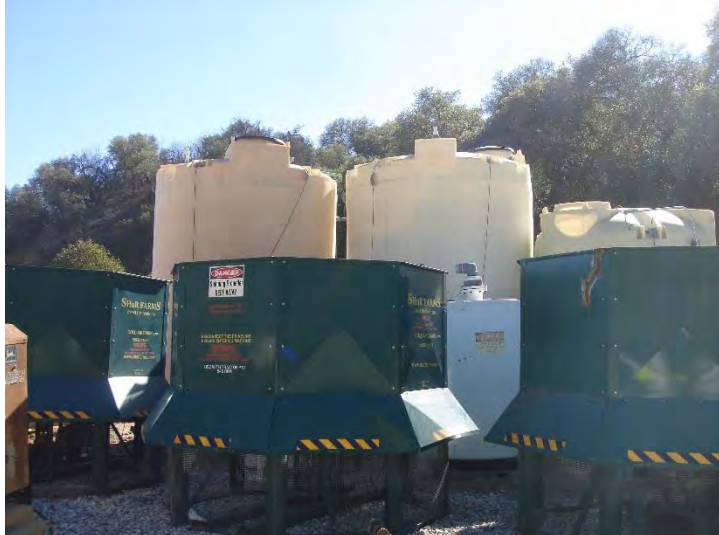
Photo 63: Condensate Equipment in Storage Yard: November 11, 2015

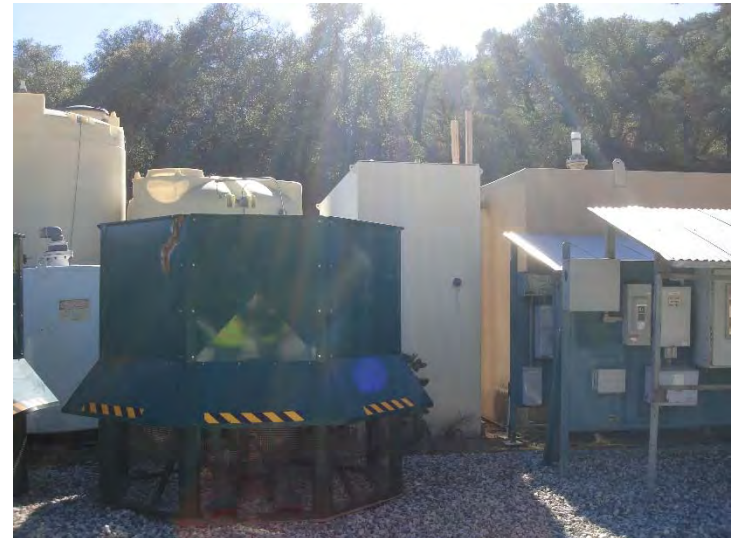
Photo 64: Condensate Equipment in Storage Yard: November 11, 2015

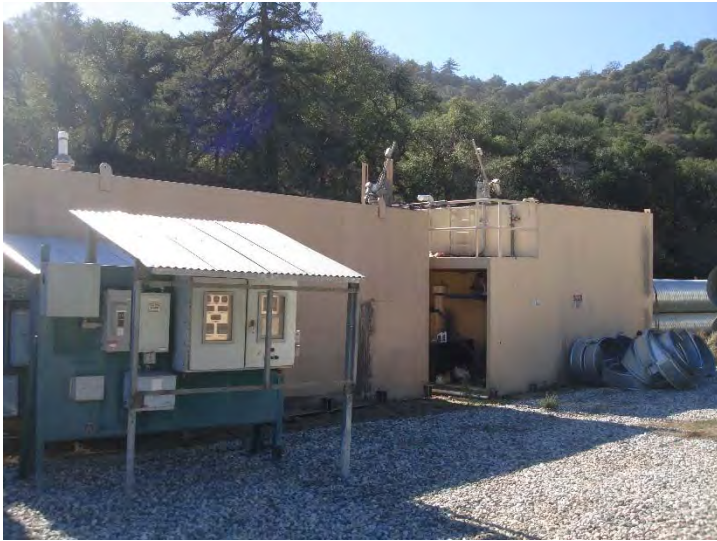
Photo 65: Condensate Equipment in Storage Yard: November 11, 2015

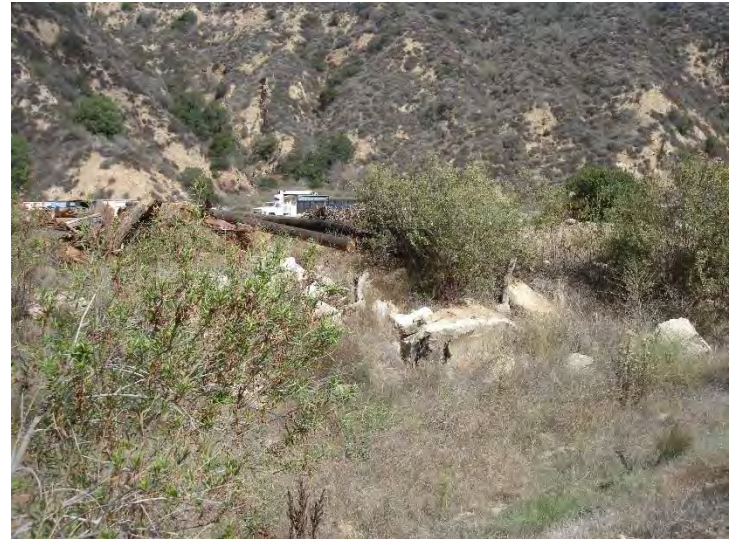
Photo 66: Native Hillside Drainage into Basin D: October 14, 2015

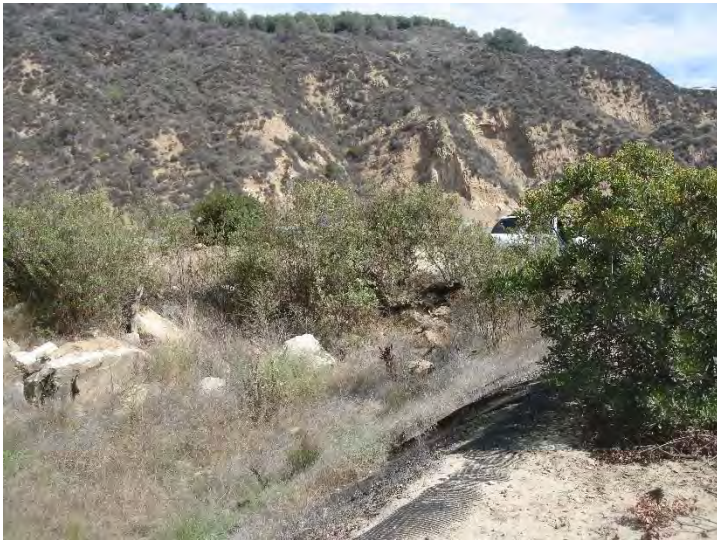
Photo 67: Native Hillside Drainage into Basin D: October 14, 2015

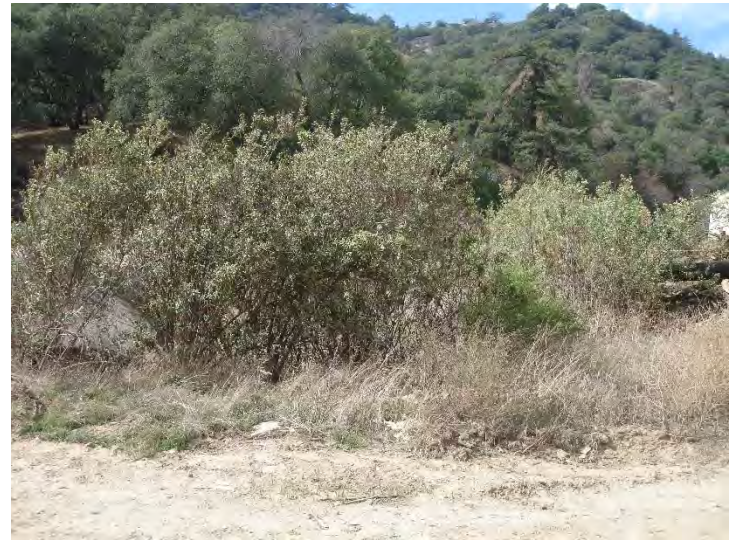
Photo 68: Native Hillside Drainage into Basin D: October 14, 2015

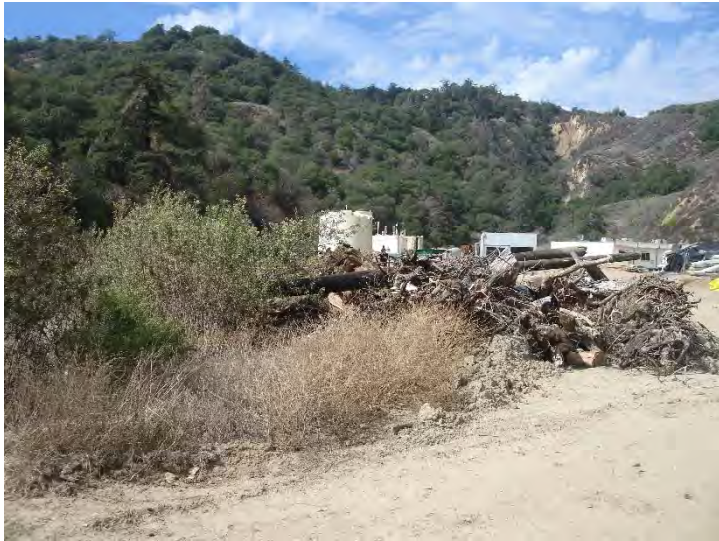
Photo 69: Native Hillside Drainage into Basin D: October 14, 2015

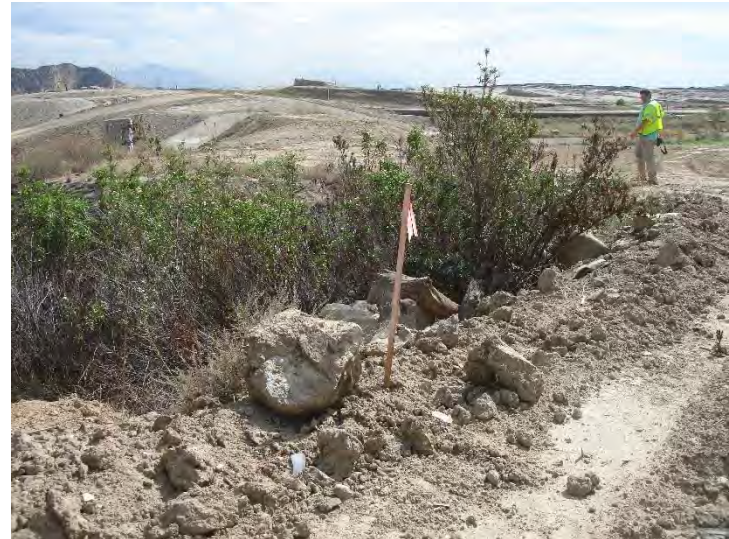
Photo 70: Native Hillside Drainage into Basin D: October 14, 2015

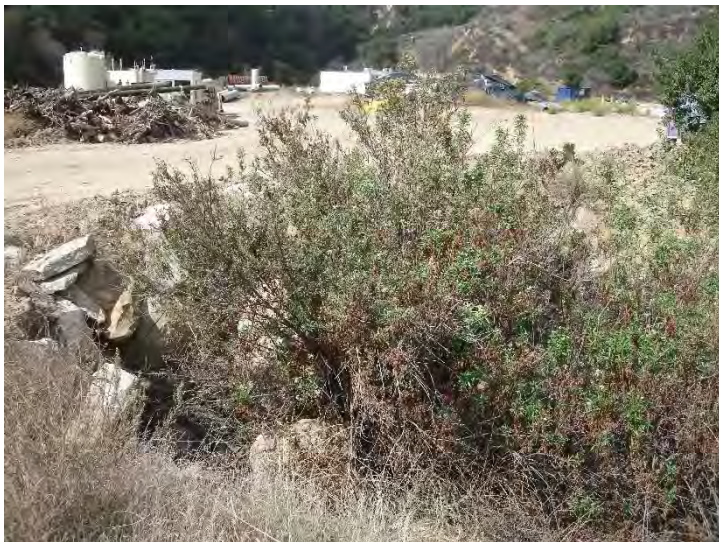
Photo 71: Native Hillside Drainage into Basin D: October 14, 2015

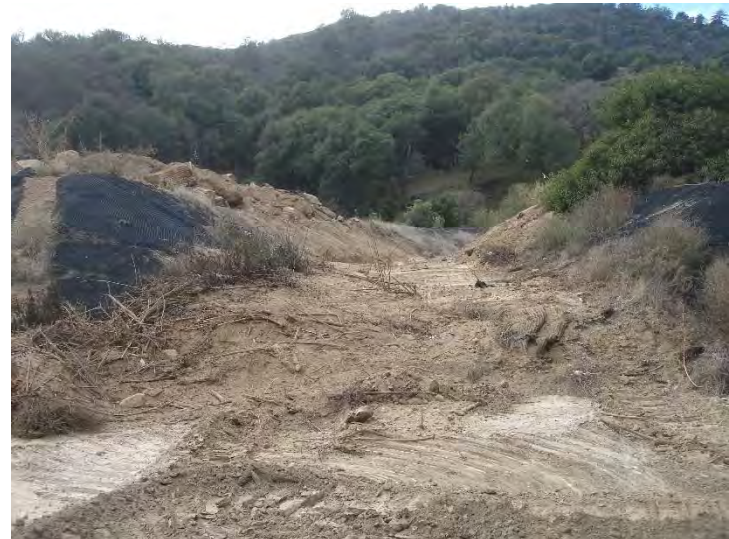
Photo 72: Native Hillside Drainage into Basin D: October 28, 2015

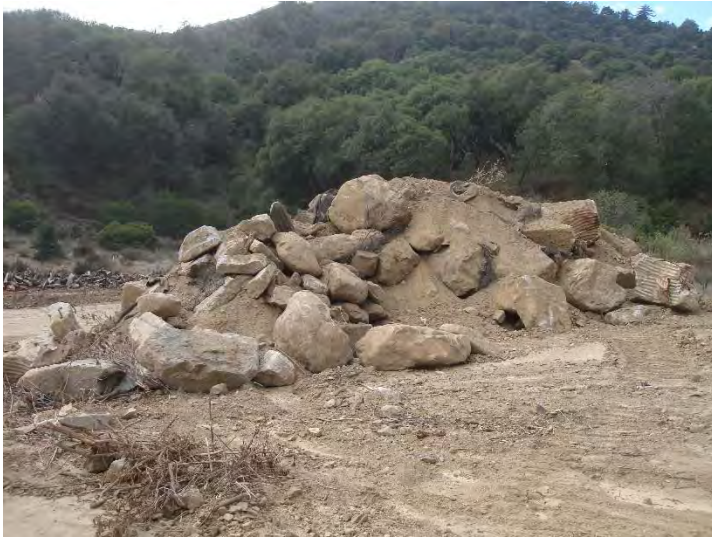
Photo 73: Native Hillside Drainage into Basin D: October 28, 2015

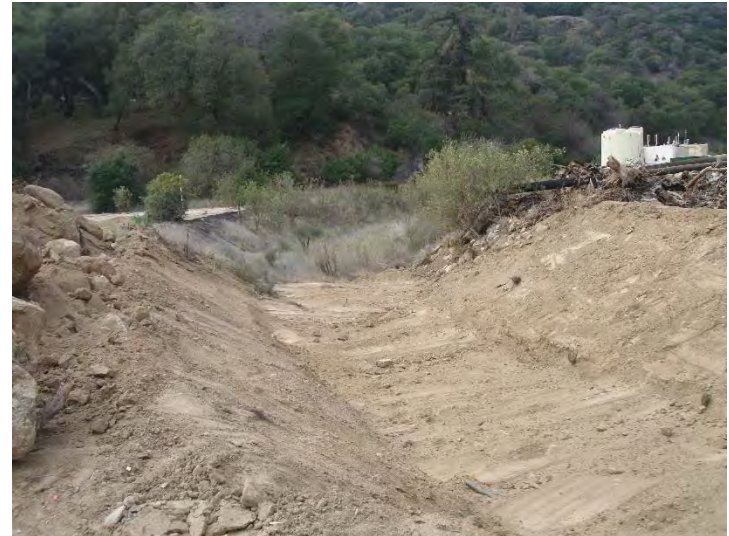
Photo 74: Native Hillside Drainage into Basin D: October 28, 2015

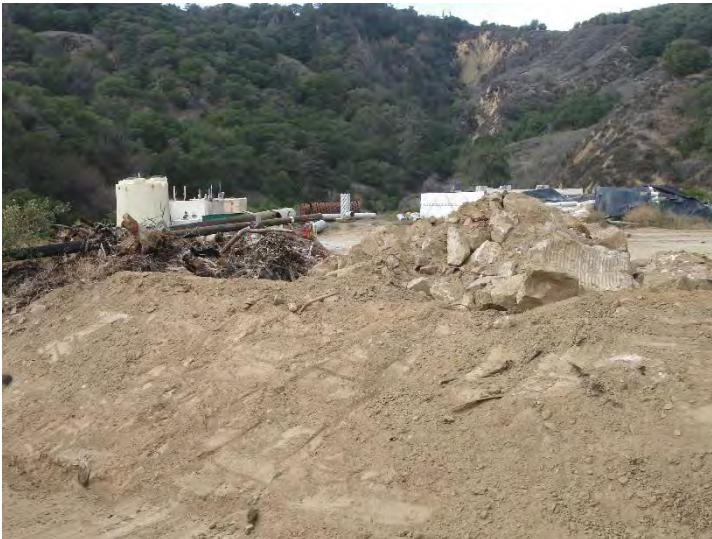
Photo 75: Native Hillside Drainage into Basin D: October 28, 2015

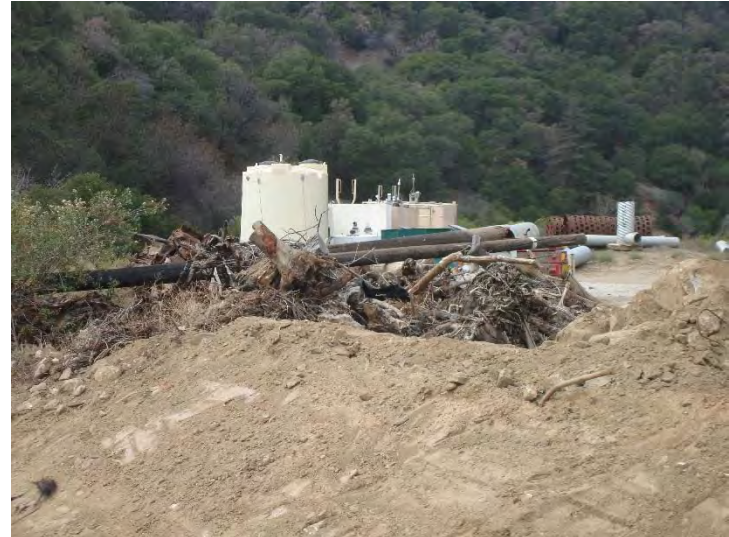
Photo 76: Native Hillside Drainage into Basin D: October 28, 2015

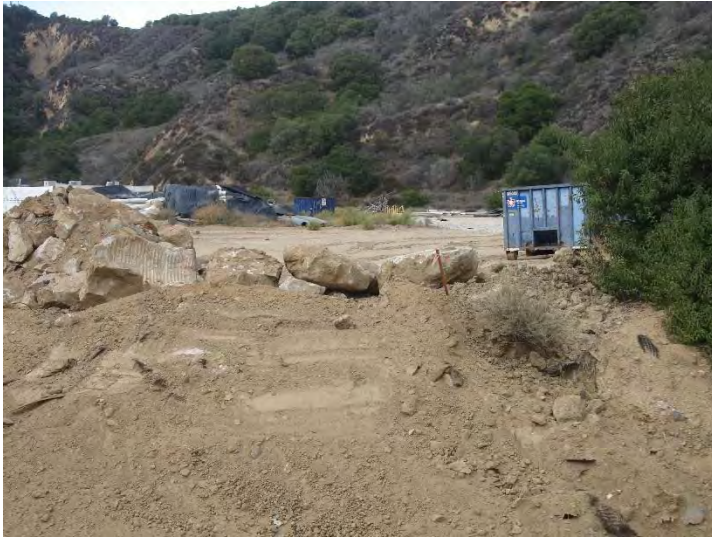
Photo 77: Native Hillside Drainage into Basin D: October 28, 2015

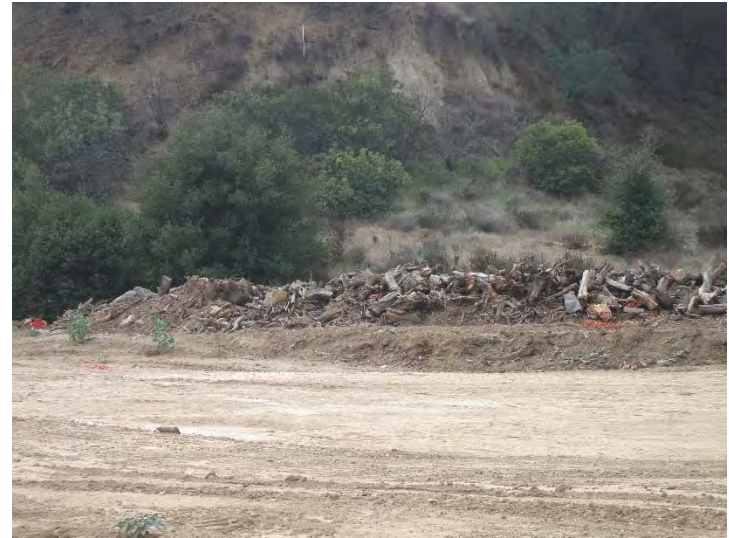
Photo 78: Native Hillside Drainage into Basin D: October 28, 2015

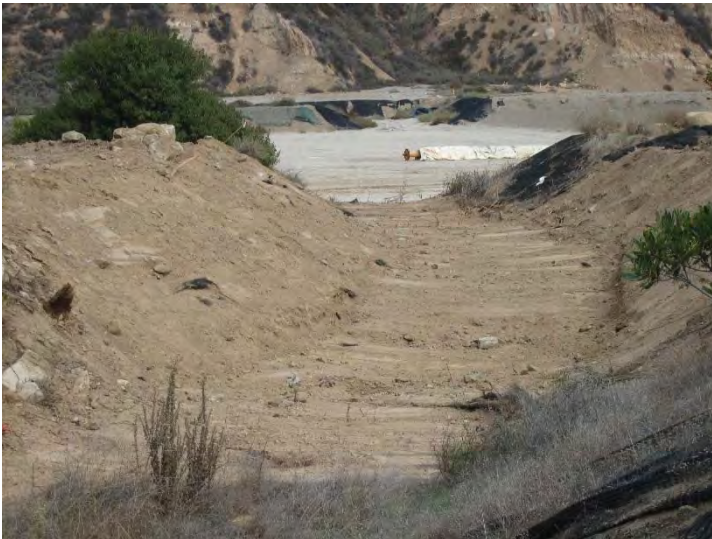
Photo 79: Native Hillside Drainage into Basin D: October 28, 2015

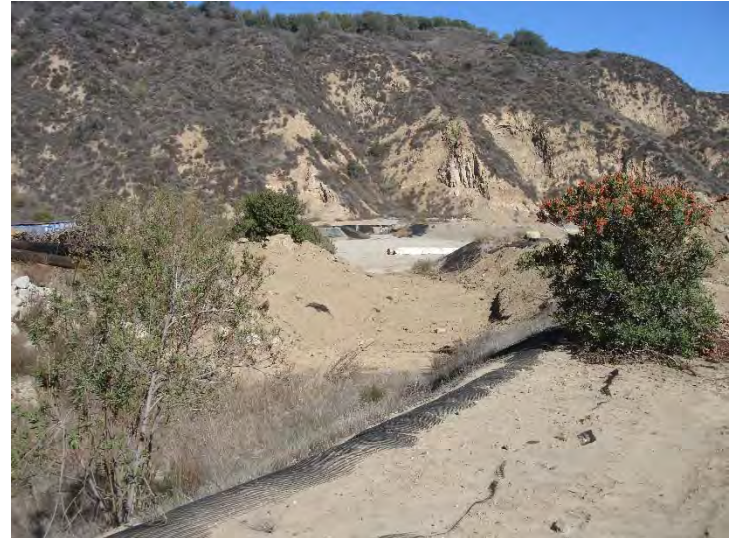
Photo 80: Native Hillside Drainage into Basin D: November 16, 2015

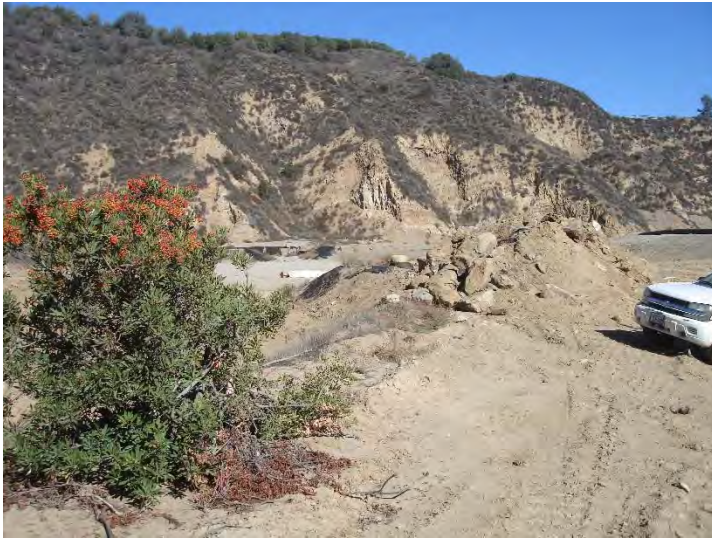
Photo 81: Native Hillside Drainage into Basin D: November 16, 2015

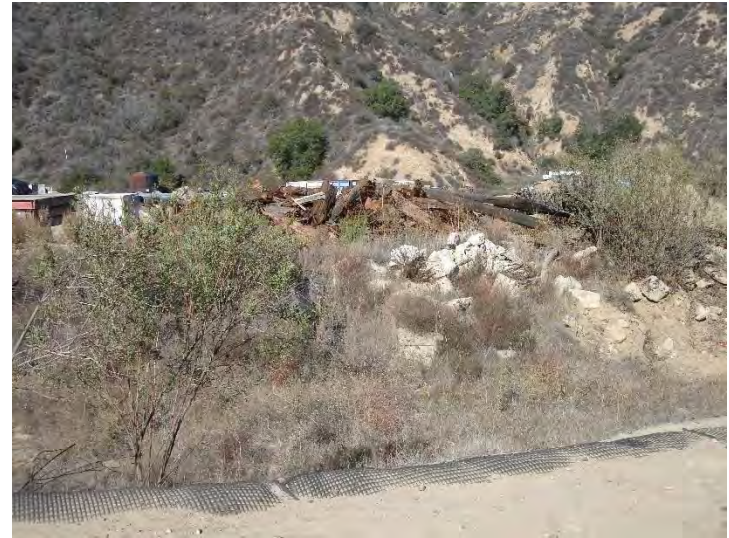
Photo 82: Native Hillside Drainage into Basin D: November 16, 2015

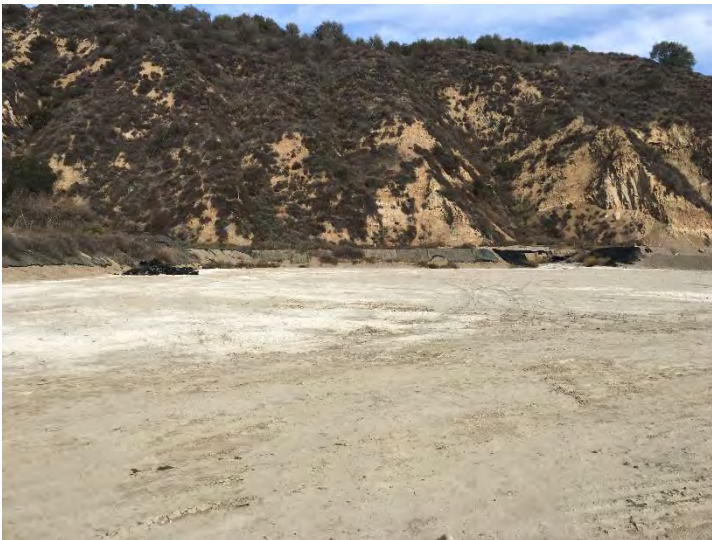
Photo 83: Basin D: December 9, 2015

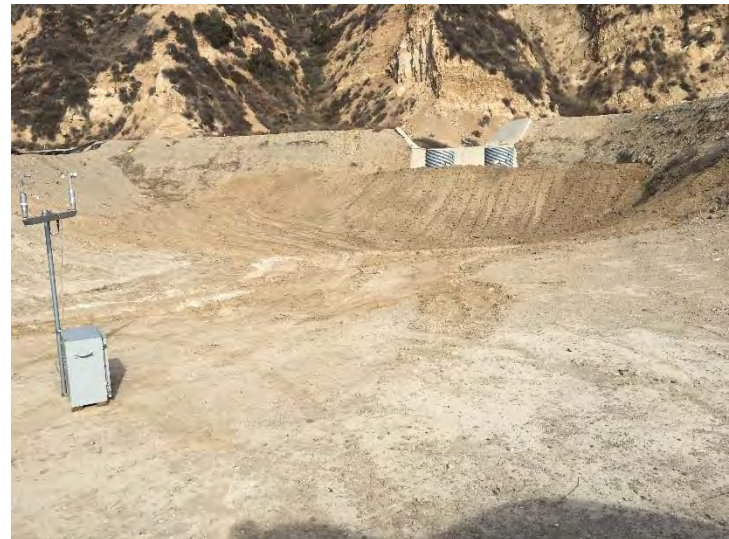
Photo 84: Basin D: December 9, 2015

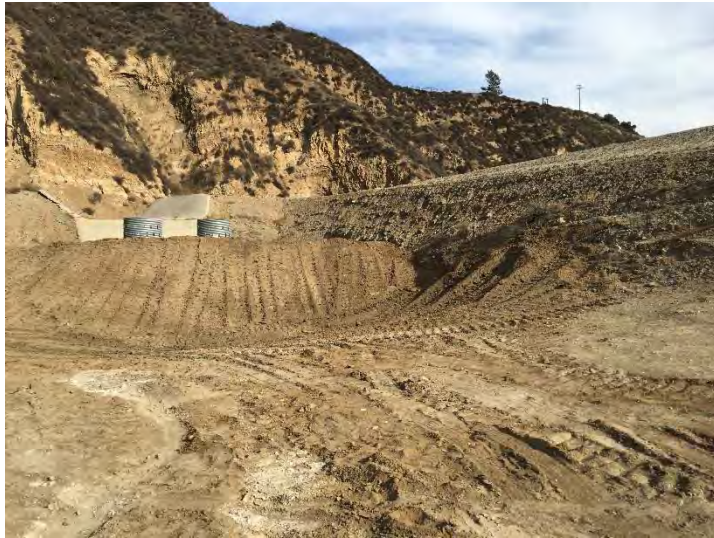
Photo 85: Basin D: December 9, 2015

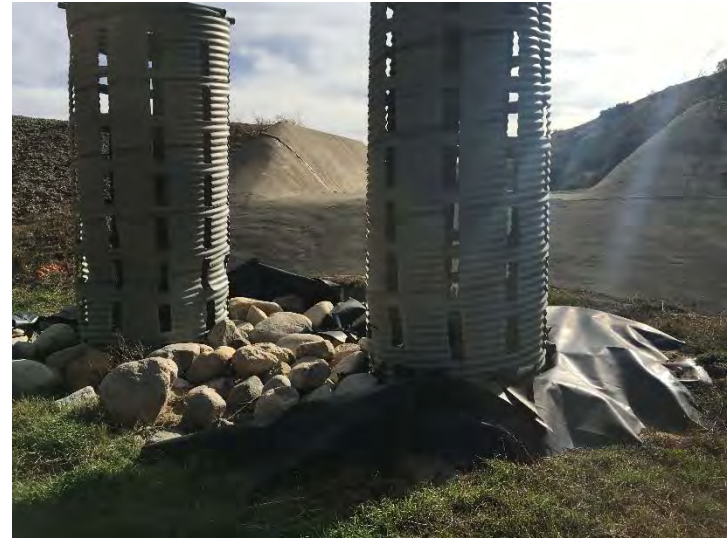
Photo 86: Basin D: December 9, 2015

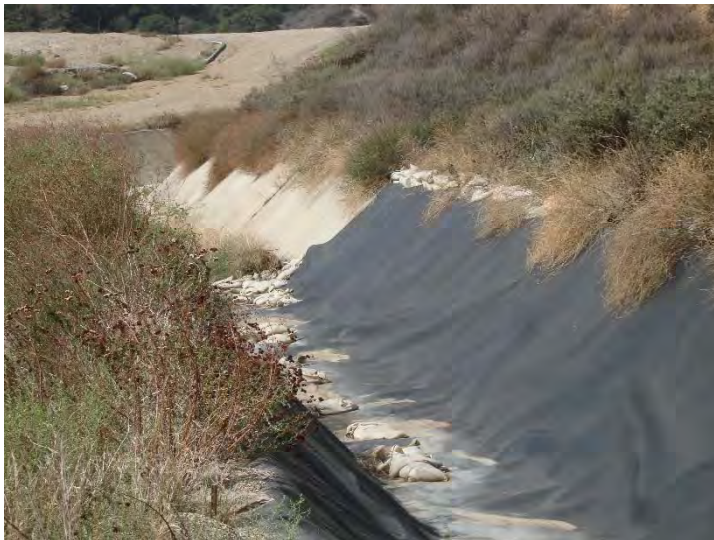
Photo 87: Basin D Outlet Channel: October 14, 2015

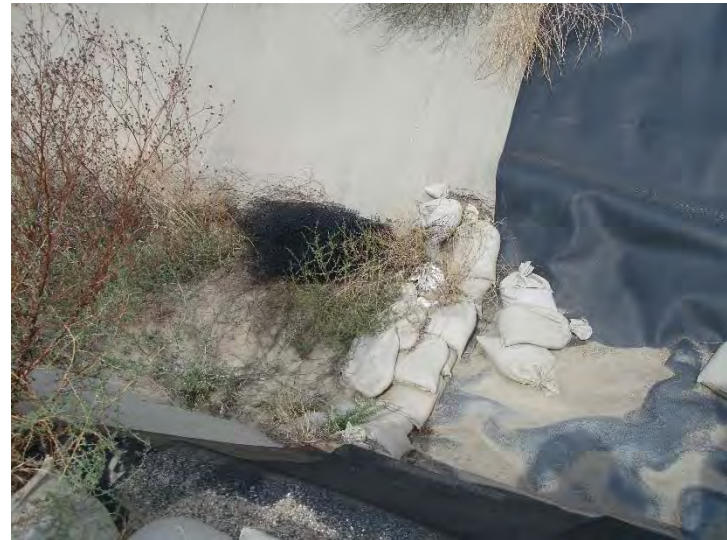
Photo 88: Basin D Outlet Channel: October 14, 2015

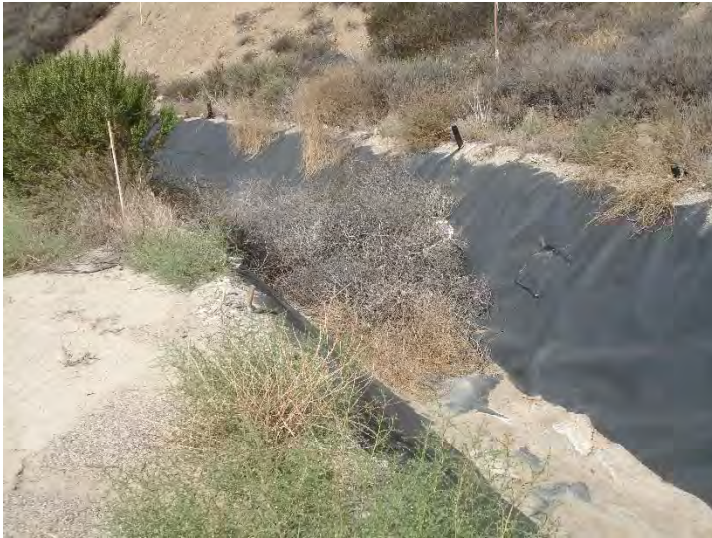
Photo 89: Basin D Outlet Channel: October 14, 2015

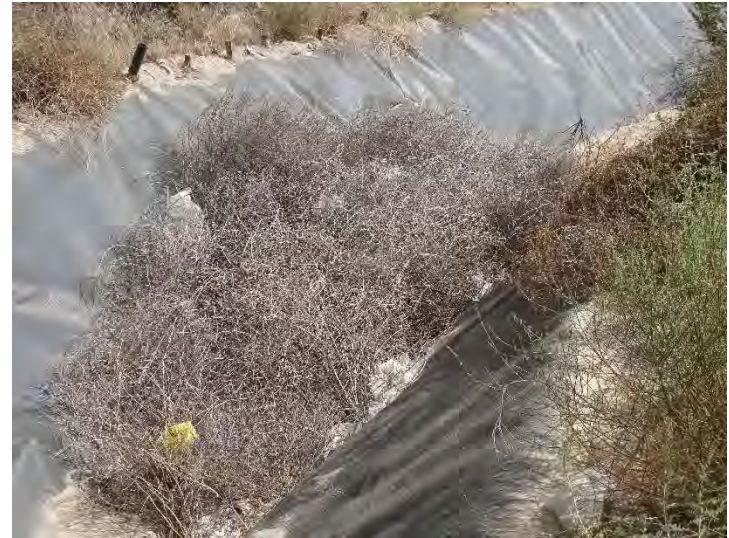
Photo 90: Basin D Outlet Channel: October 14, 2015

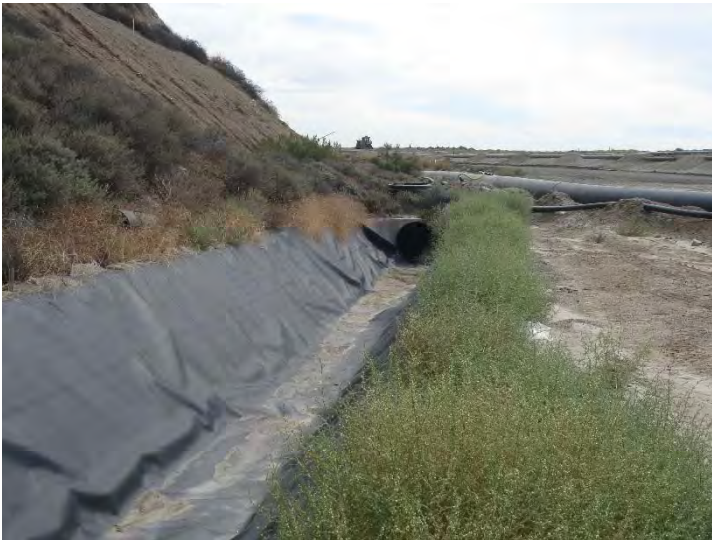
Photo 91: Basin D Outlet Channel: October 14, 2015

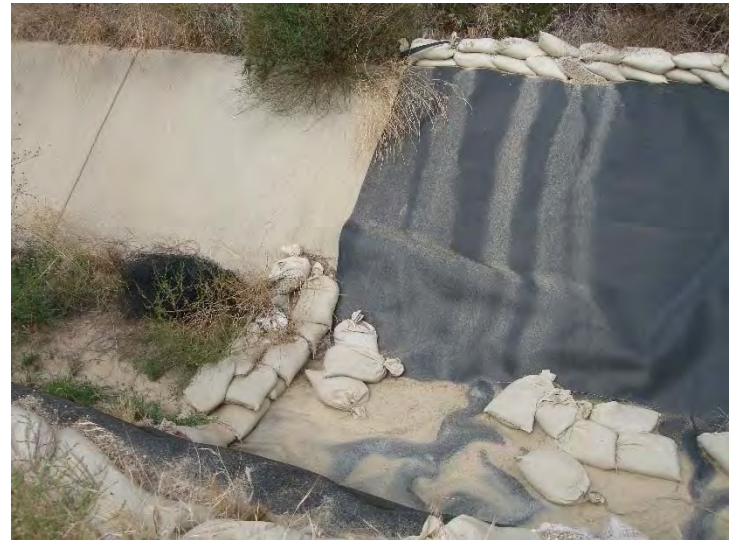
Photo 92: Basin D Outlet Channel: October 28, 2015

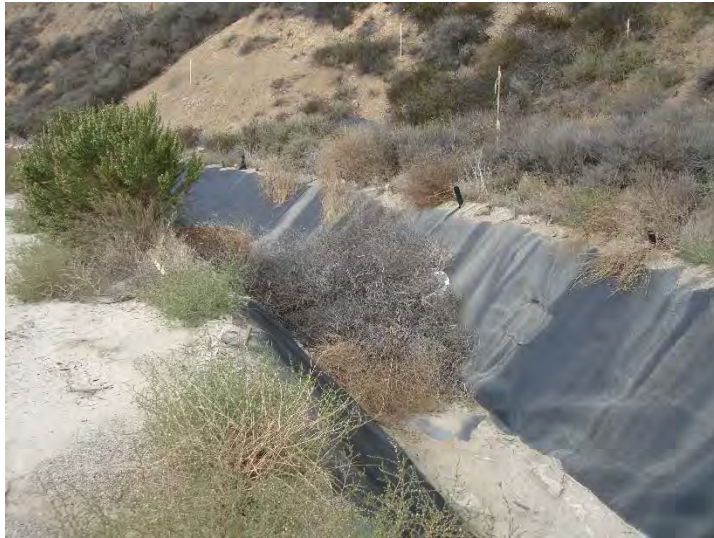
Photo 93: Basin D Outlet Channel: October 28, 2015

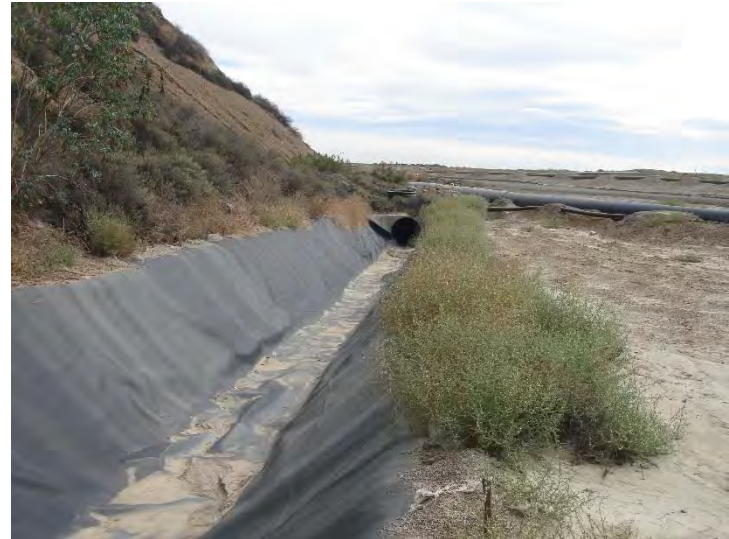
Photo 94: Basin D Outlet Channel: October 28, 2015

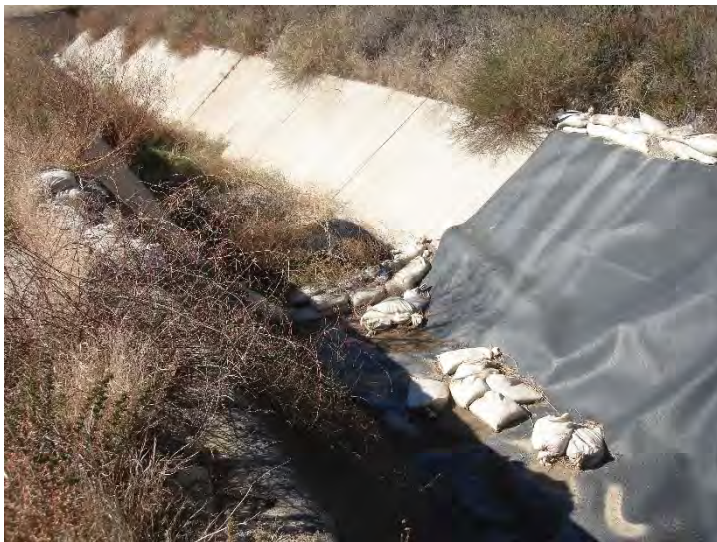
Photo 95: Basin D Outlet Channel: November 16, 2015

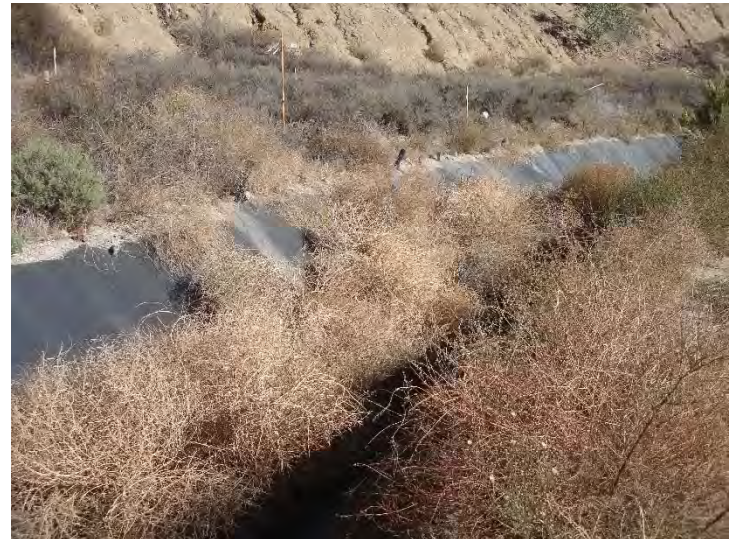
Photo 96: Basin D Outlet Channel: November 16, 2015

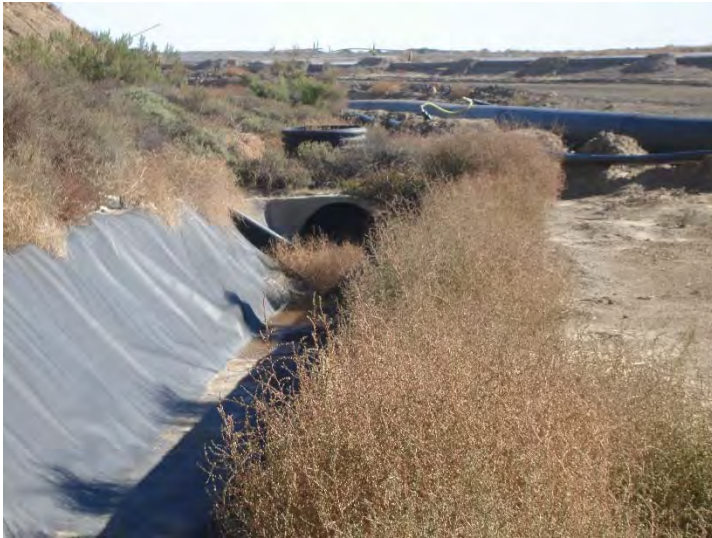
Photo 97: Basin D Outlet Channel: November 16, 2015

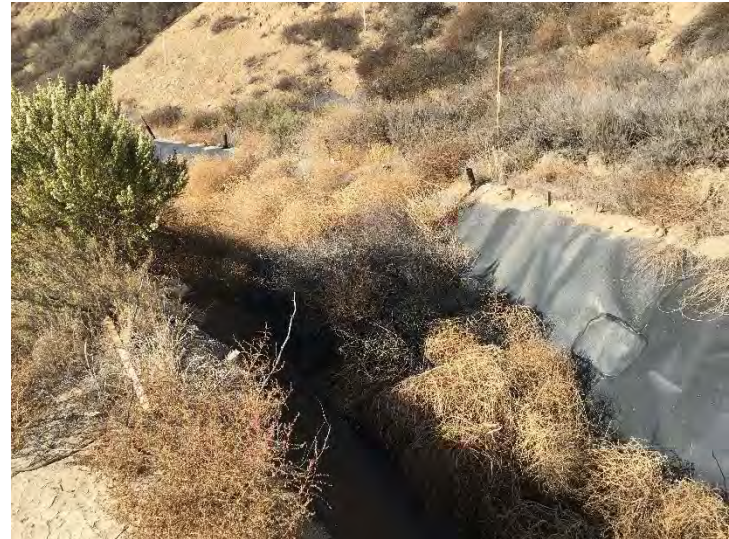
Photo 98: Basin D Outlet Channel: December 9, 2015
