**Sunshine Canyon Landfill
Independent Monitor
Quarterly Site Monitoring Status Report
October 1, 2015 – December 31, 2015**

February 12, 2016

The attached Quarterly Site Monitoring Status Report for the Sunshine Canyon Landfill dated February 12, 2016 is the Fourth Quarterly Report for 2015, issued by UltraSystems. This report covers the monitoring period from October 1, 2015 through December 31, 2015 and is prepared for the City of Los Angeles Department of City Planning and the County of Los Angeles Department of Regional Planning.

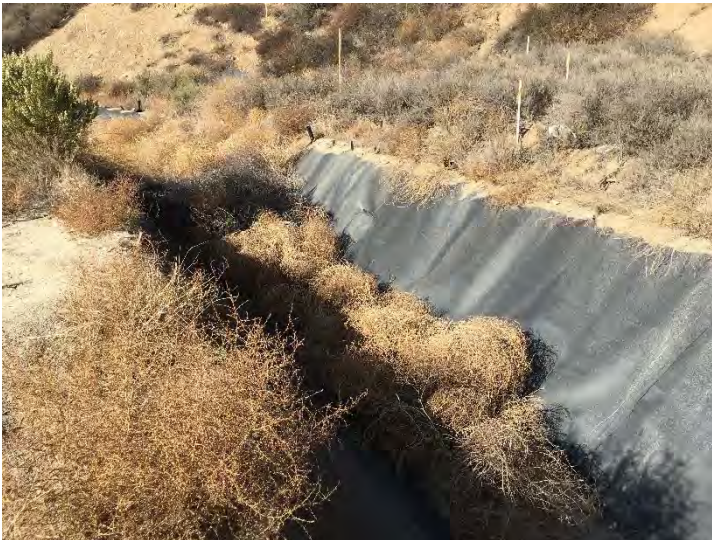
Photo 99: Basin D Outlet Channel: December 9, 2015

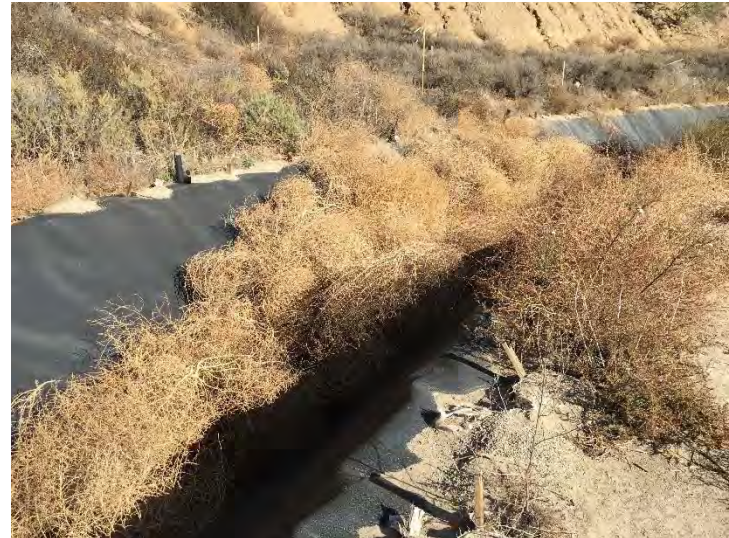
Photo 100: Basin D Outlet Channel: December 9, 2015

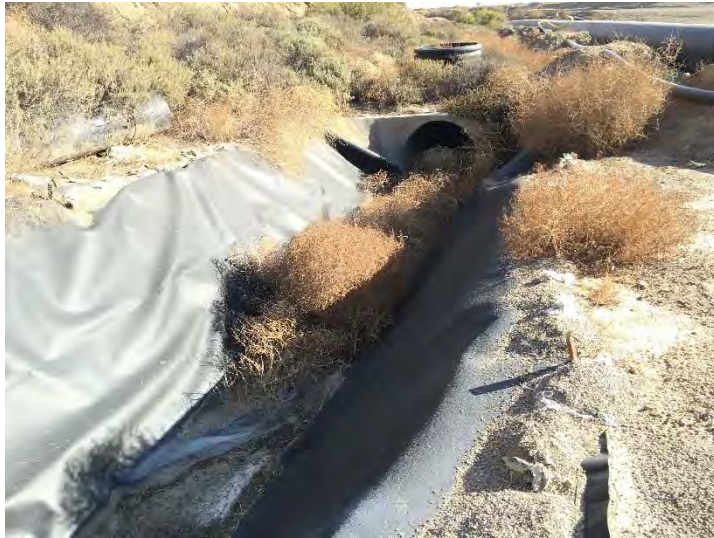
Photo 101: Basin D Outlet Channel: December 9, 2015

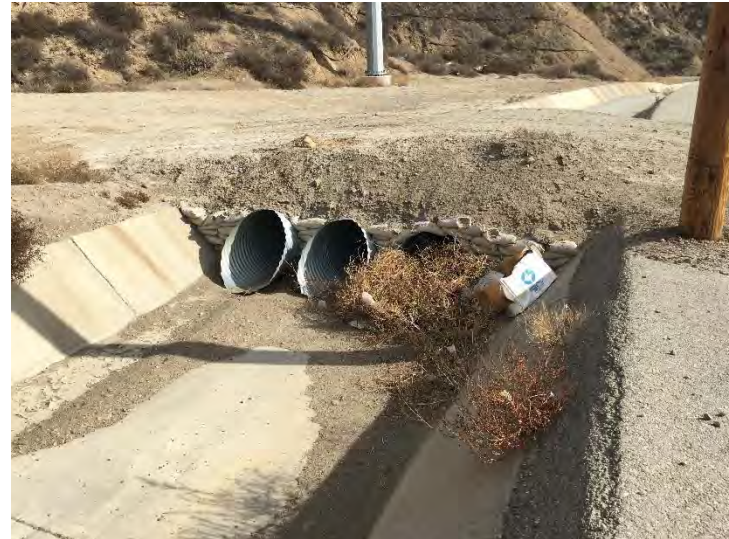
Photo 102: Basin D Outlet Channel: December 9, 2015

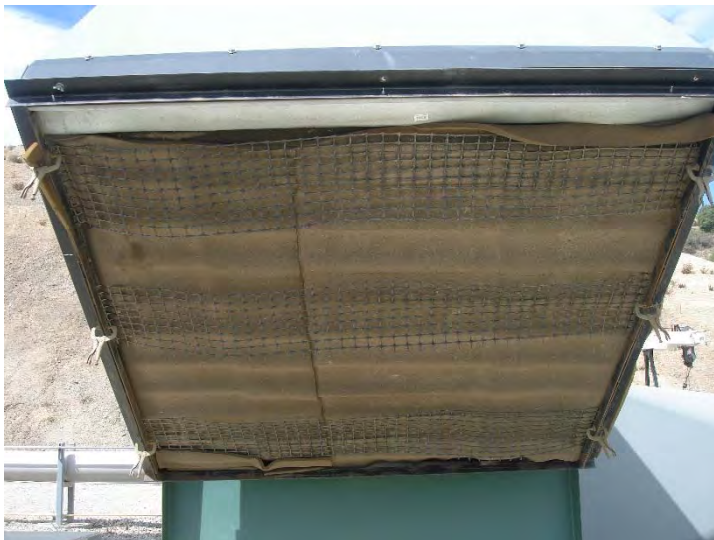
Photo 103: New Flare 9 Air Blower Filter October 14, 2015

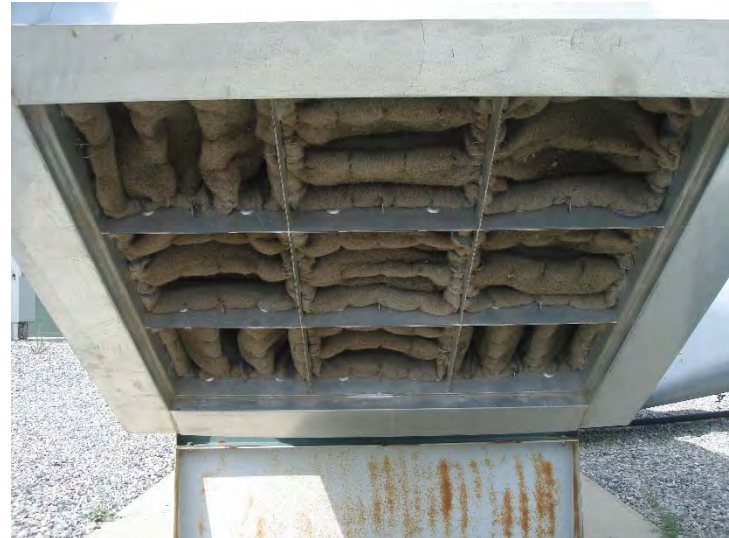
Photo 104: Old Flare 10 Air Blower Filter: October 14, 2015

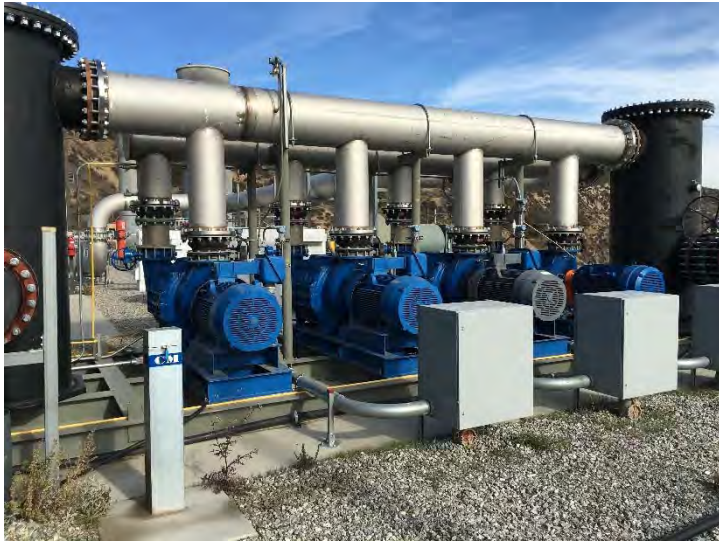
Photo 105: Flare 9 and 10: December 9, 2015

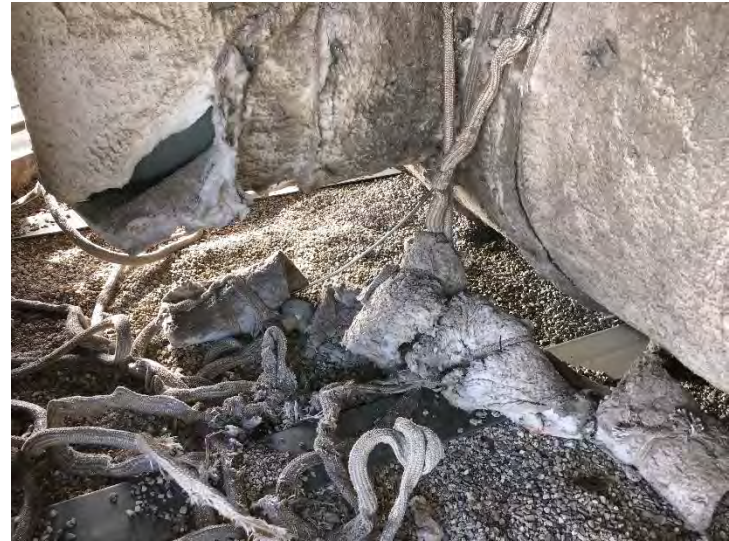
Photo 106: Flare 9: December 9, 2015

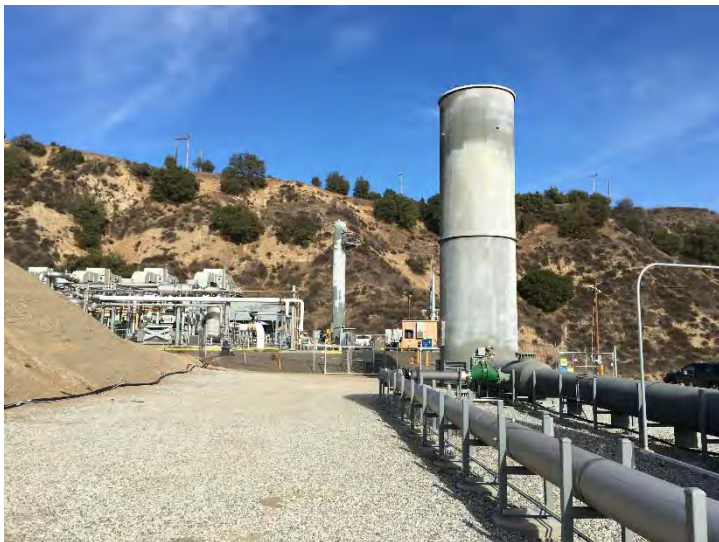
Photo 107: Flare 10: December 9, 2015

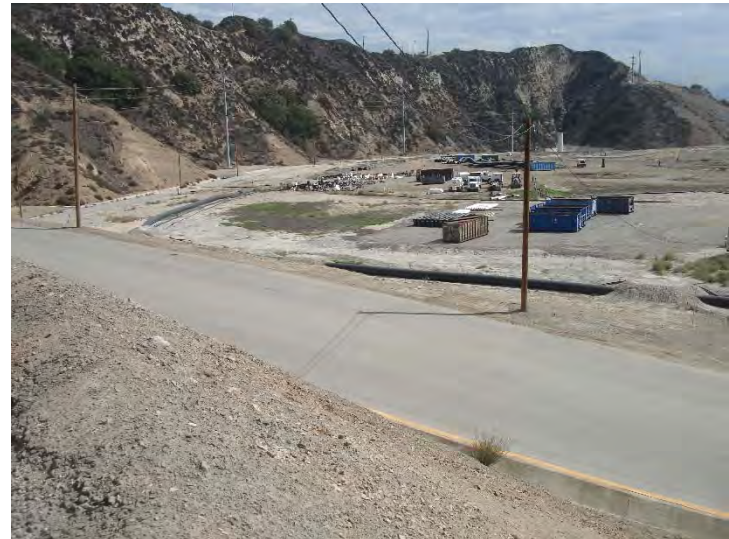
Photo 108: County Top Deck: October 14, 2015

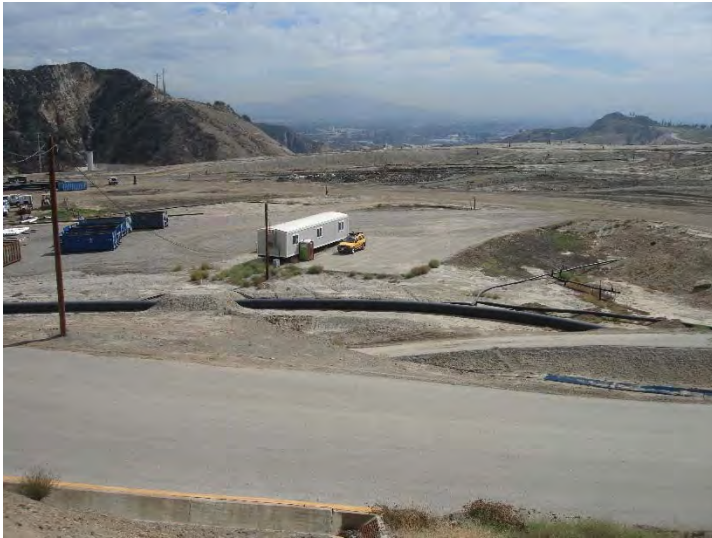
Photo 109: County Top Deck: October 14, 2015

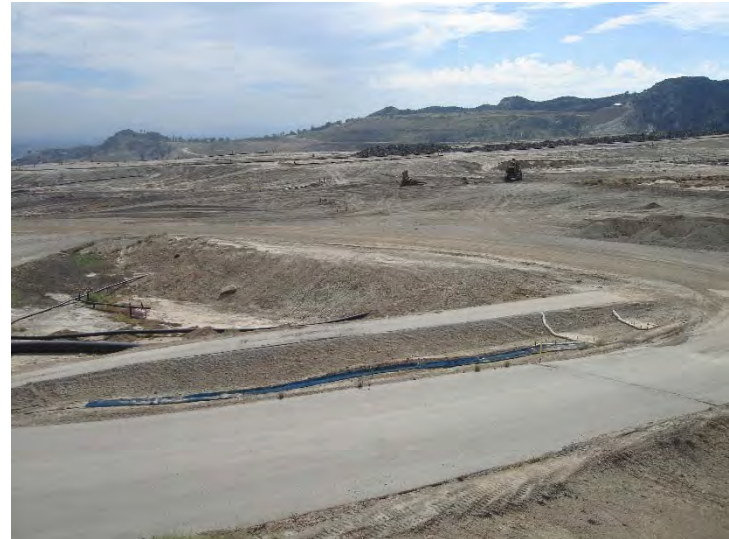
Photo 110: County Top Deck: October 14, 2015

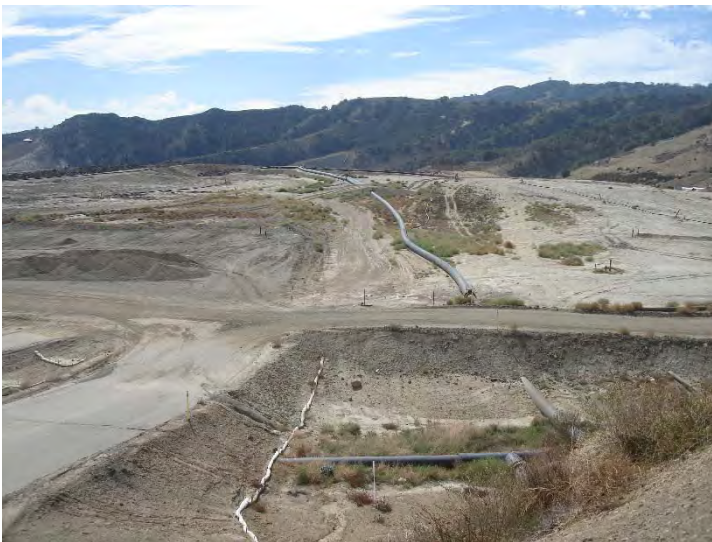
Photo 111: County Top Deck: October 14, 2015

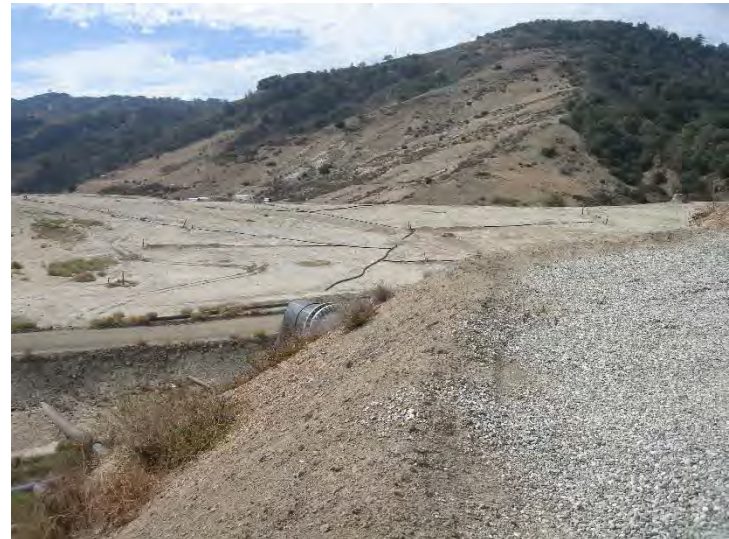
Photo 112: County Top Deck: October 14, 2015

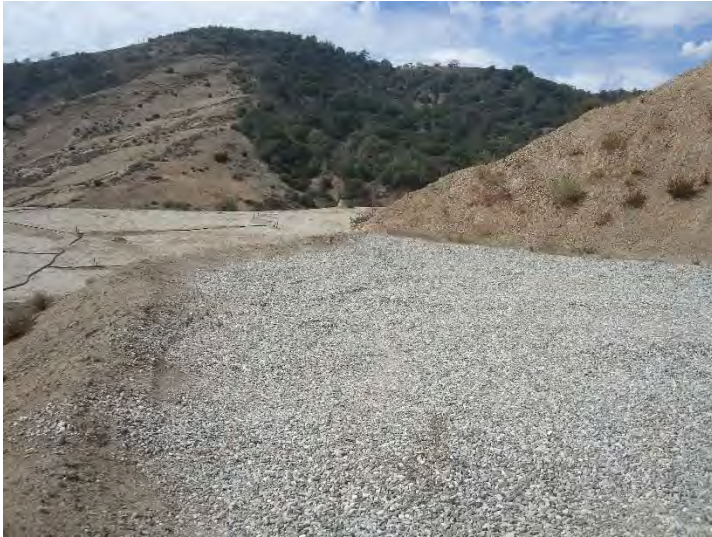
Photo 113: County Top Deck: October 14, 2015

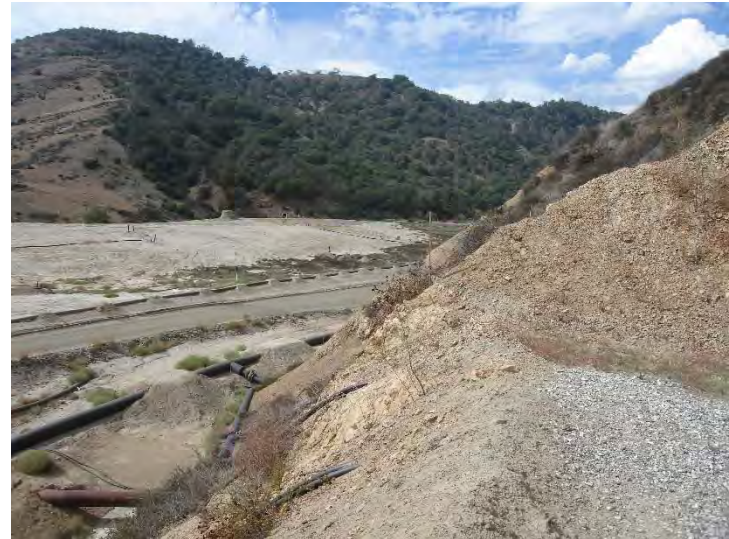
Photo 114: County Top Deck: October 14, 2015

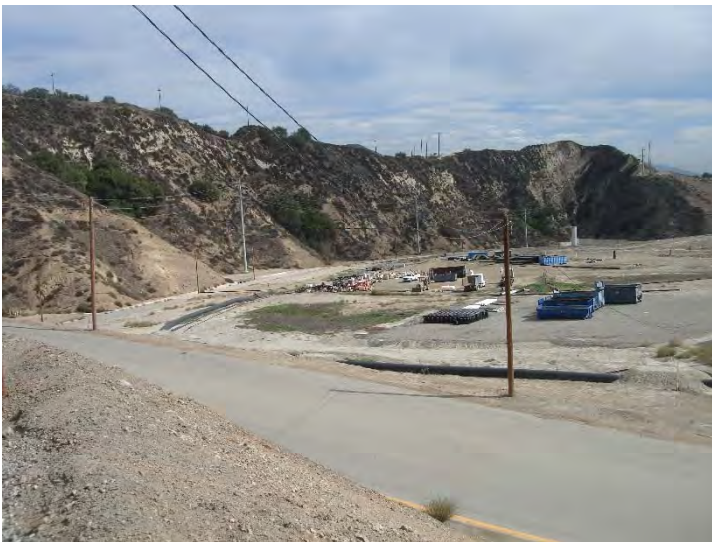
Photo 115: County Top Deck: October 28, 2015

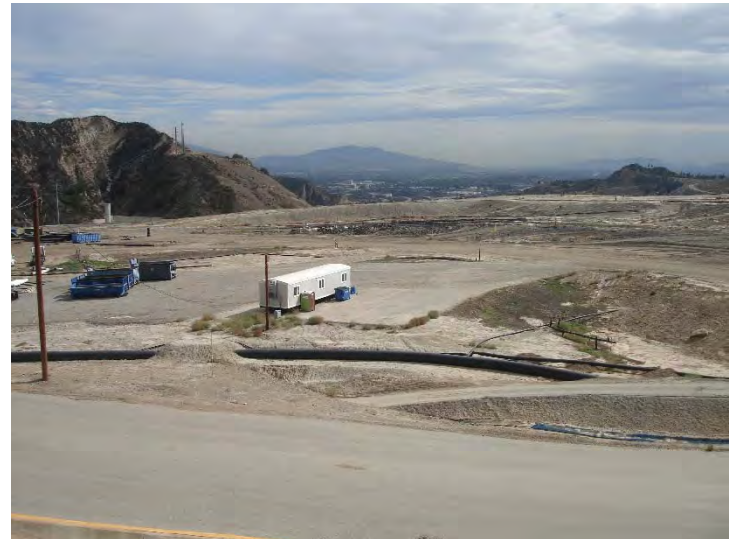
Photo 116: County Top Deck: October 28, 2015

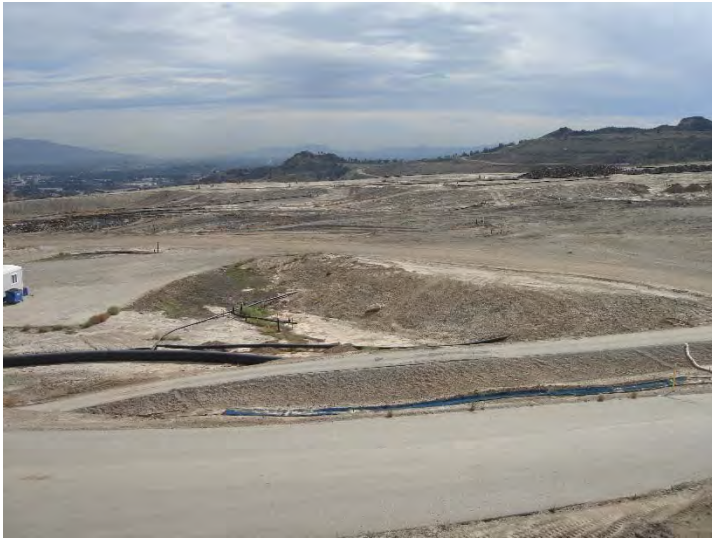
Photo 117: County Top Deck: October 28, 2015

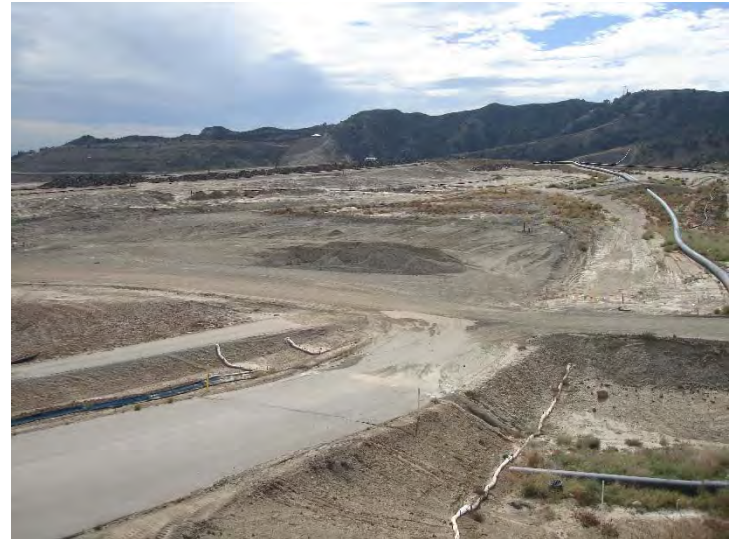
Photo 118: County Top Deck: October 28, 2015

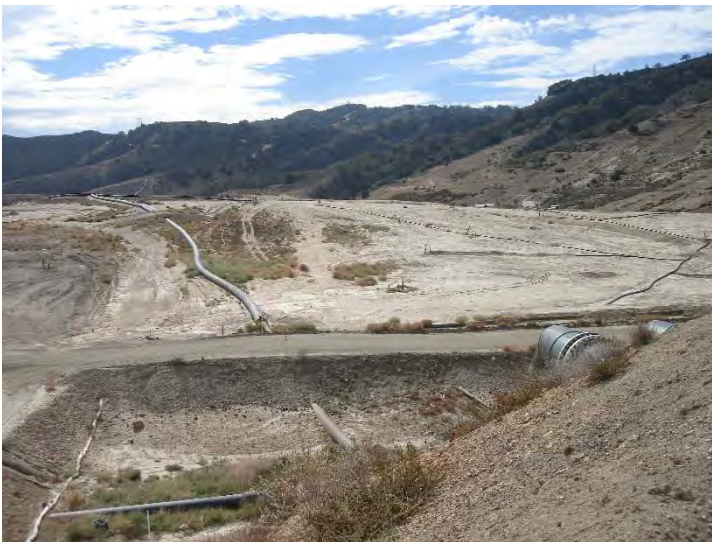
Photo 119: County Top Deck: October 28, 2015

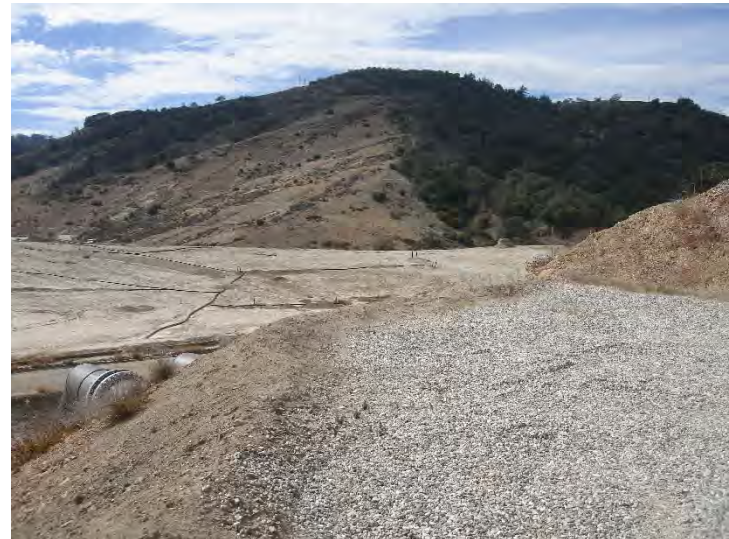
Photo 120: County Top Deck: October 28, 2015

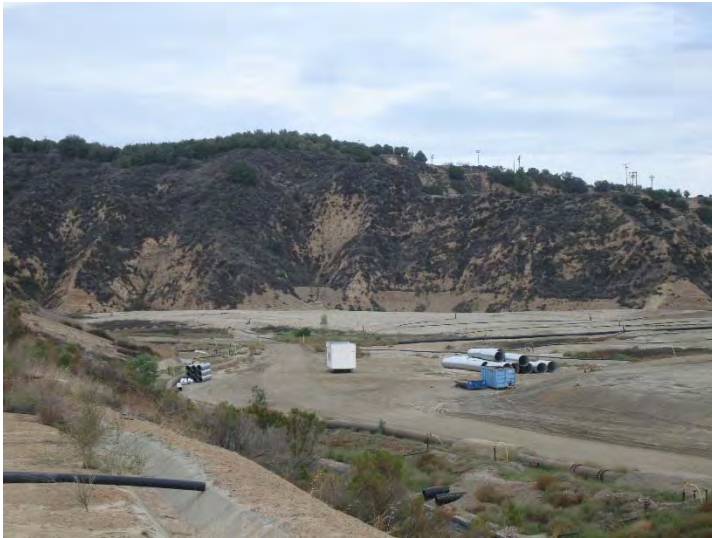
Photo 121: County Top Deck: October 28, 2015

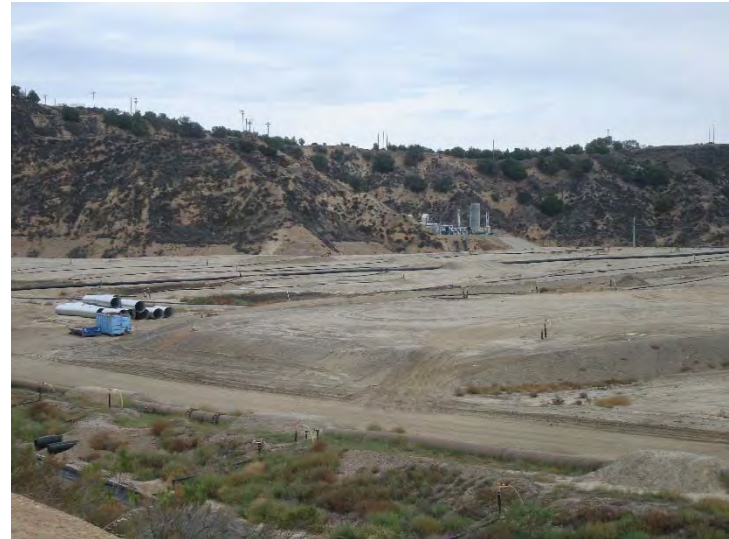
Photo 122: County Top Deck: October 28, 2015

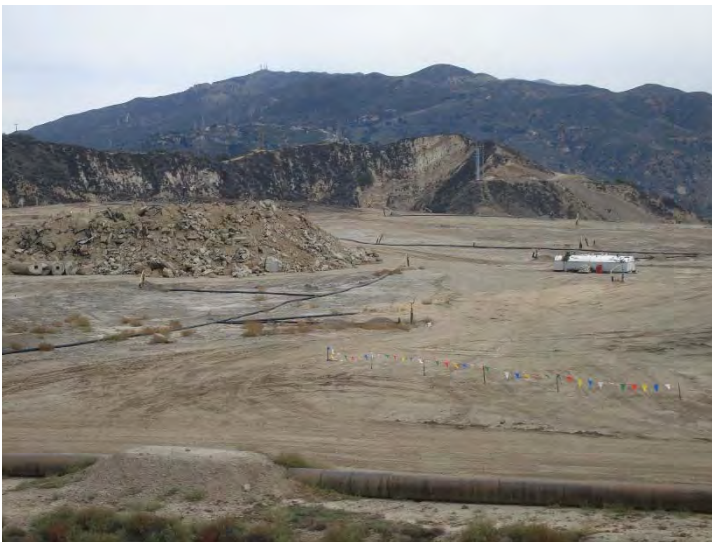
Photo 123: County Top Deck: October 28, 2015

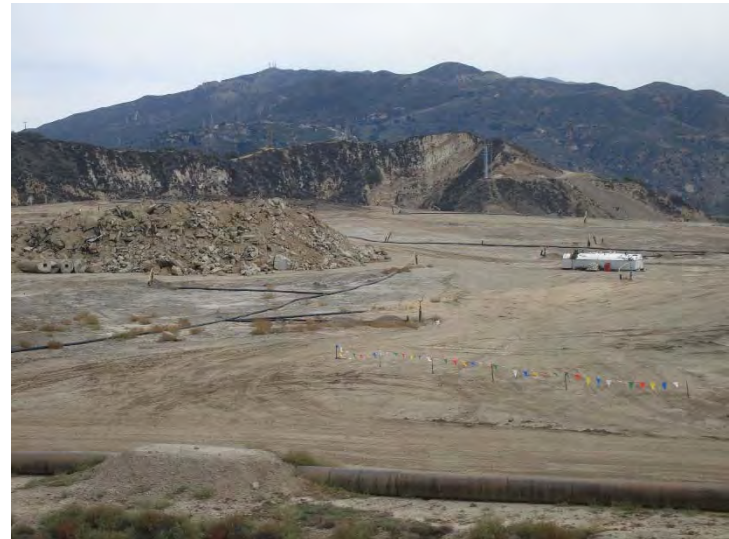
Photo 124: County Top Deck: October 28, 2015

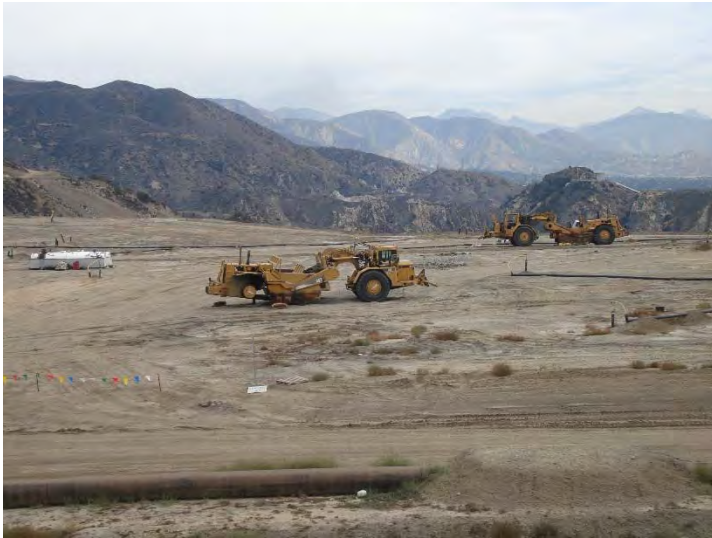
Photo 125: County Top Deck: October 28, 2015

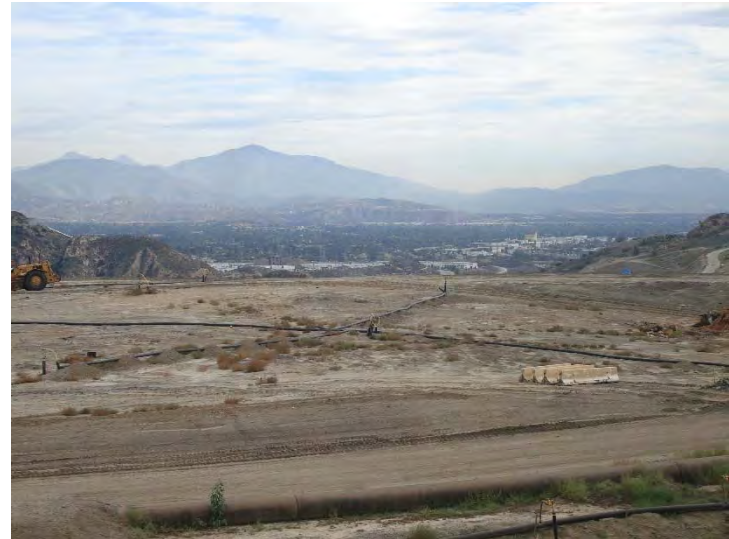
Photo 126: County Top Deck: October 28, 2015

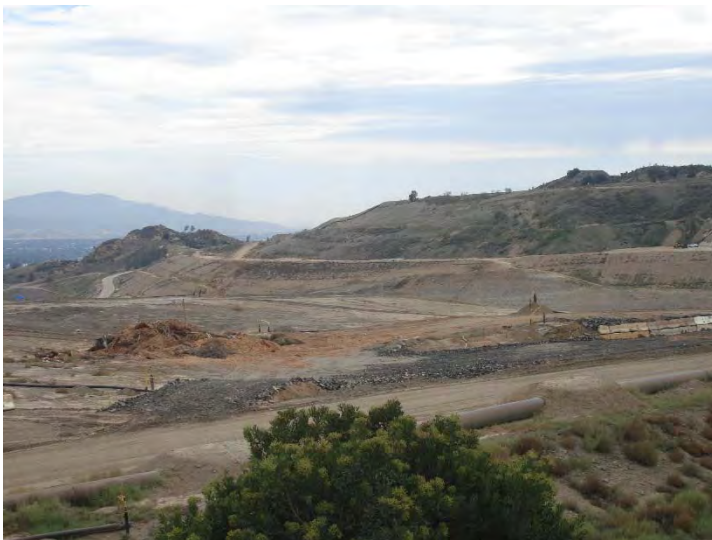
Photo 127: County Top Deck: October 28, 2015

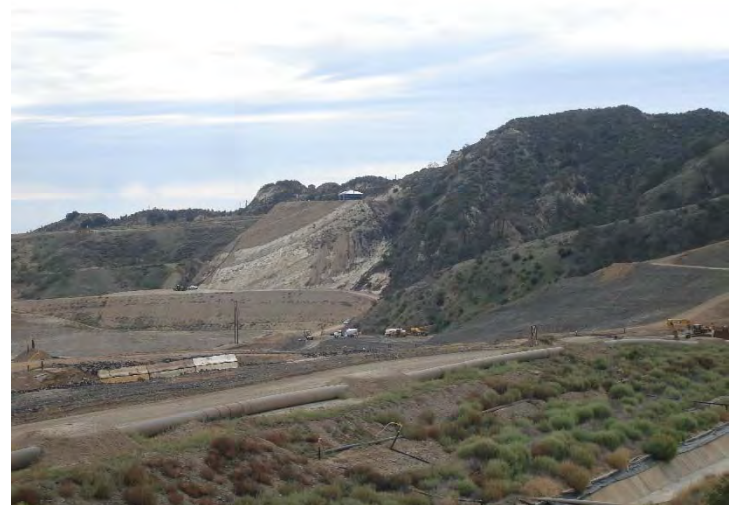
Photo 128: County Top Deck: October 28, 2015

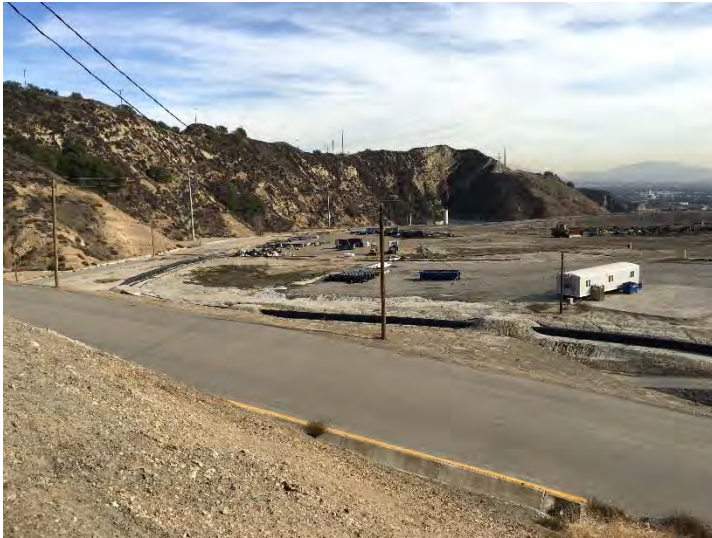
Photo 129: County Top Deck: December 9, 2015

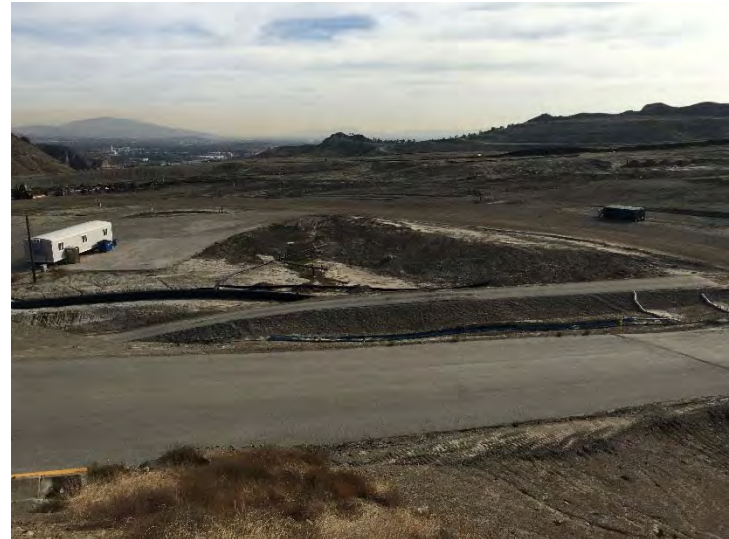
Photo 130: County Top Deck: December 9, 2015

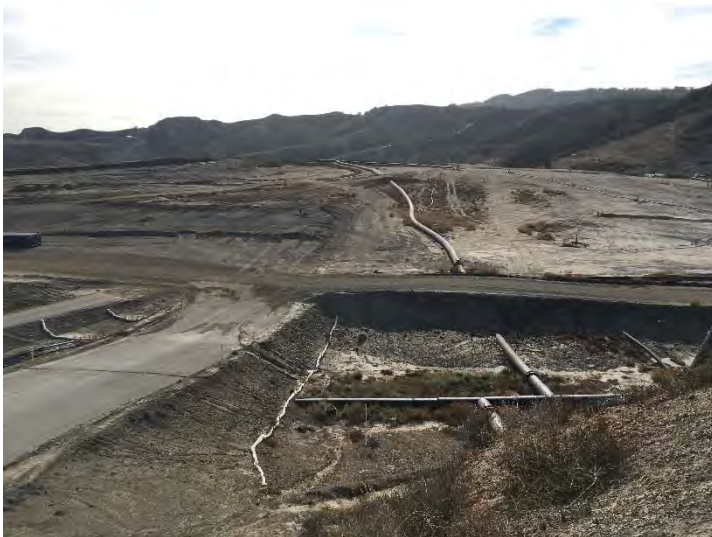
Photo 131: County Top Deck: December 9, 2015

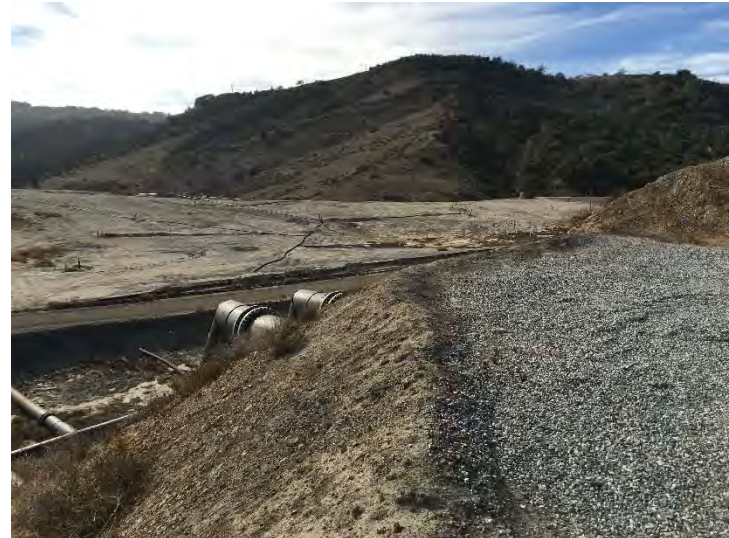
Photo 132: County Top Deck: December 9, 2015

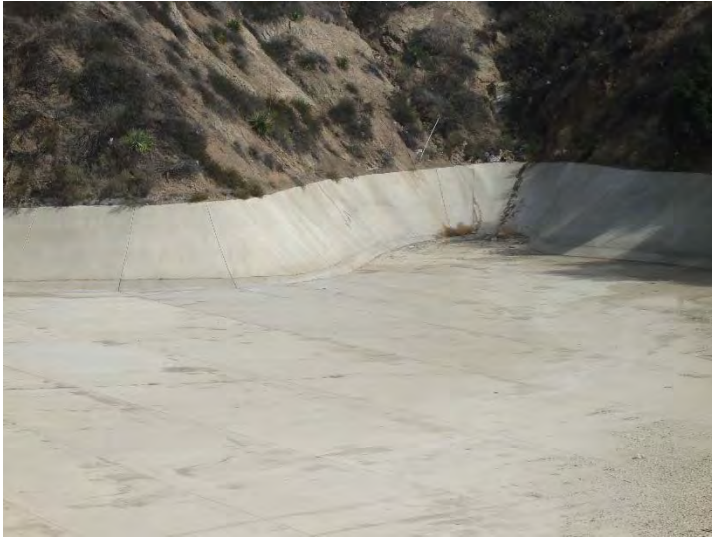
Discipline	City Condition Reference # / Mitigation #	County Condition Reference # / Mitigation #	Responsible Agency	Further Review Needed-Comments
Project Manager				<p>The native canyons above the office facilities drain into two shallow dirt basins. Each basin has two 24-inch corrugated HDPE drain lines draining them onto a sloping deck that drains to the slope uphill from the offices. These drains could flood the offices with mud and water during a heavy rain. There is a hazard to the facilities. Basin A had approximately one foot of standing water that was not draining through the rock into the outlet risers. The drainage channel out of Basin A was blocked with soil with a 20-inch HDPE pipe being the only flow to the westside channel. The blocked native drainage channel south of the material storage area noted on the October 14 monitoring visit had the road and rock removed, and now drains into Basin D. The Basin D outlet channel has tumbleweed blocking a portion of the channel. Additional sandbags were placed on the leading edge of the channel's HDPE liner to prevent the liner from uplifting. Basin B was clean with minor water puddles.</p> <p>I-p: The monitors observed that the Basin A outlet channel was blocked with dirt and sand bags except for a 12-inch HDPE line. There was a temporary road crossing at this location.</p> <p>I-q: The monitors noted that the removal of the soil on the top of the retaining wall along San Fernando Road south of the entrance had not been scheduled. The wall had the top drainage channel blocked, and the soil and rock topped the wall's fence in some locations. Also, two oak trees above the retaining wall were losing soil around their roots, and if they slide it would impact San Fernando Road and the powerlines. An arborist should look at the condition of these trees.</p> <p>Basin A was clean and free of sediment. The westside concrete drainage channel had not been scheduled for repair. Portions of one section of the floor continue to lift and sidewall cracks were worsening. Basin D had grading done to build berms to direct stormwater flow into the northern outlet; before, flow would go to the westside channel. This basin was ready for winter storms. The Basin D outlet channel had sections of it blocked with tumbleweed.</p> <p>Basin B was clean and free of sediment and ready for winter storms.</p>

Photo 133: Basin B: October 28, 2015

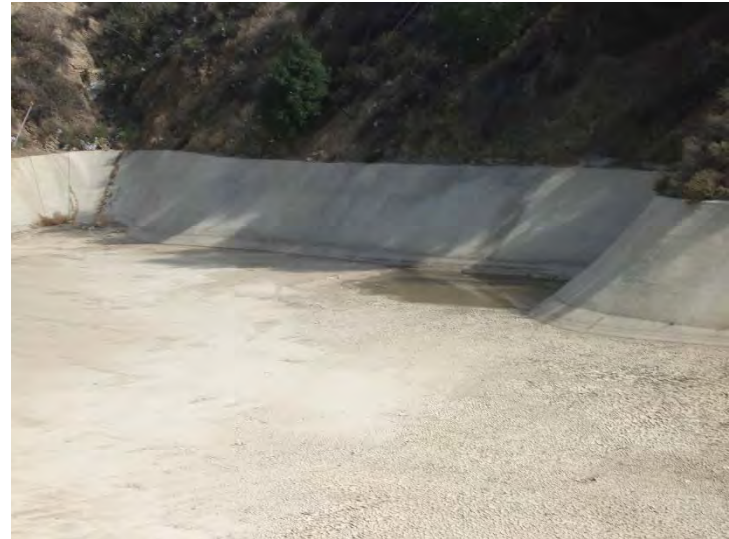
Photo 134: Basin B: October 28, 2015

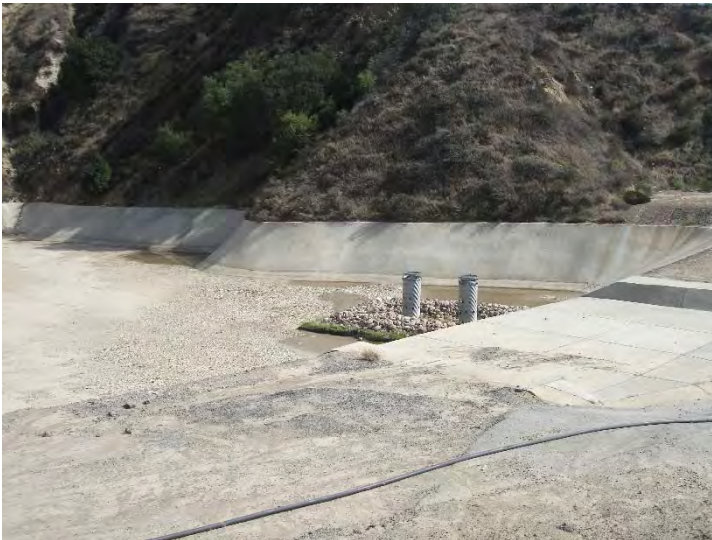
Photo 135: Basin B: October 28, 2015

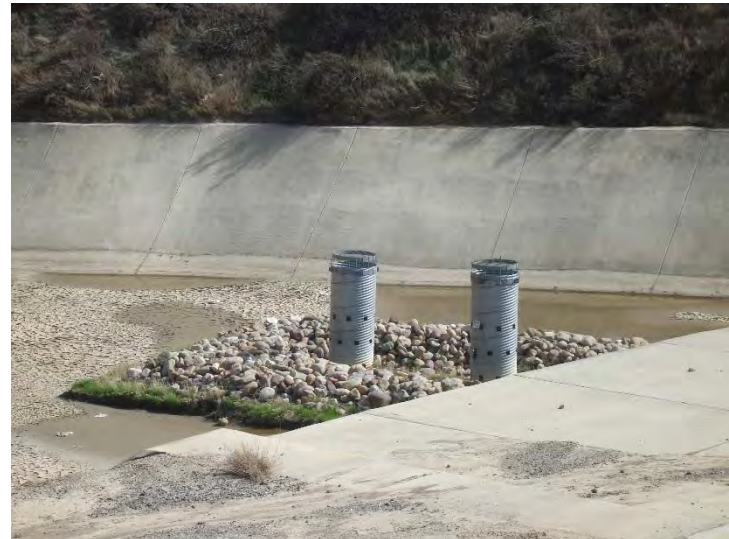
Photo 136: Basin B: October 28, 2015

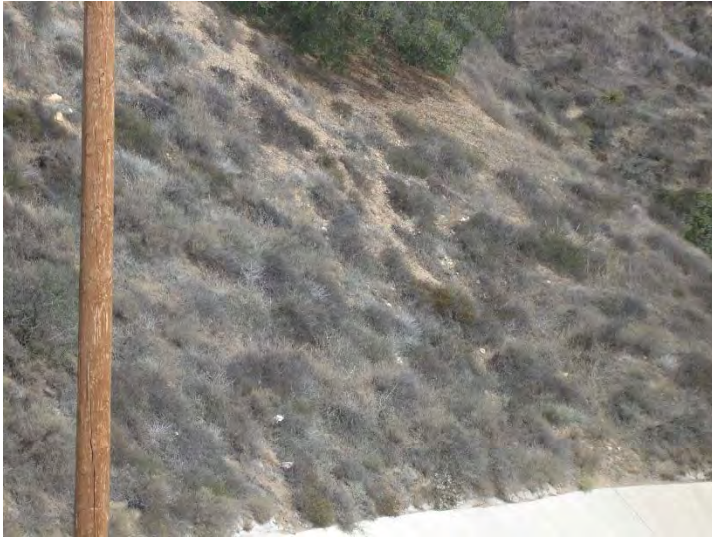
Photo 137: Basin B Native Hillside: October 28, 2015

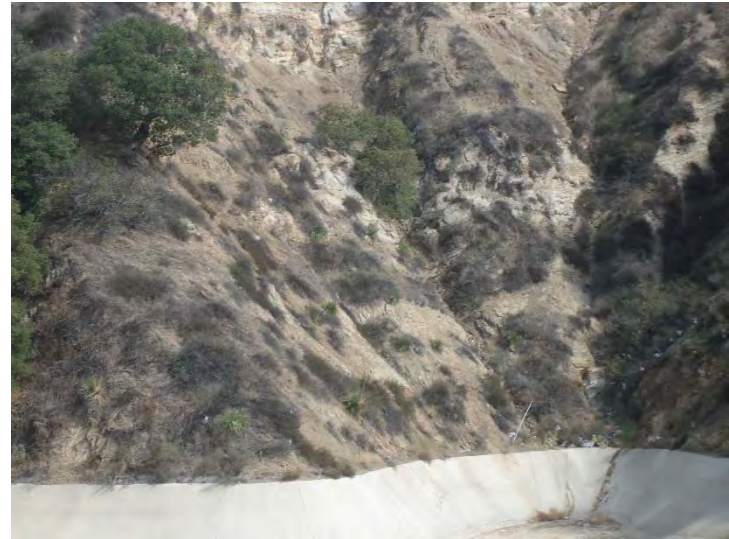
Photo 138: Basin B Native Hillside: October 28, 2015

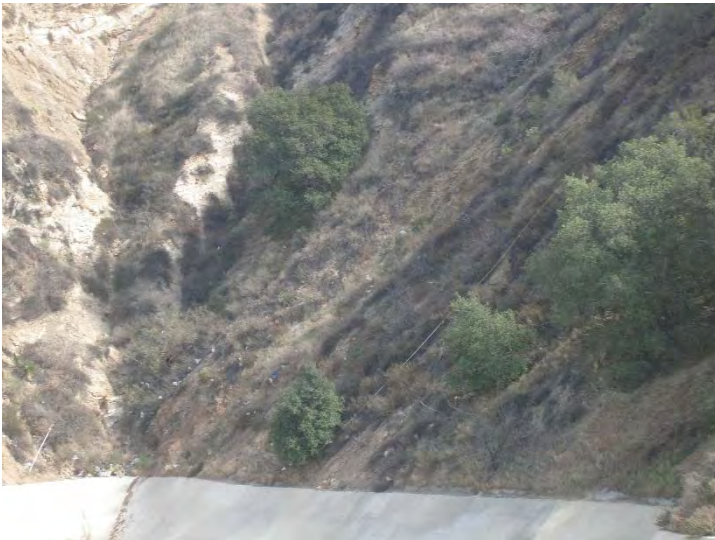
Photo 139: Basin B Native Hillside: October 28, 2015

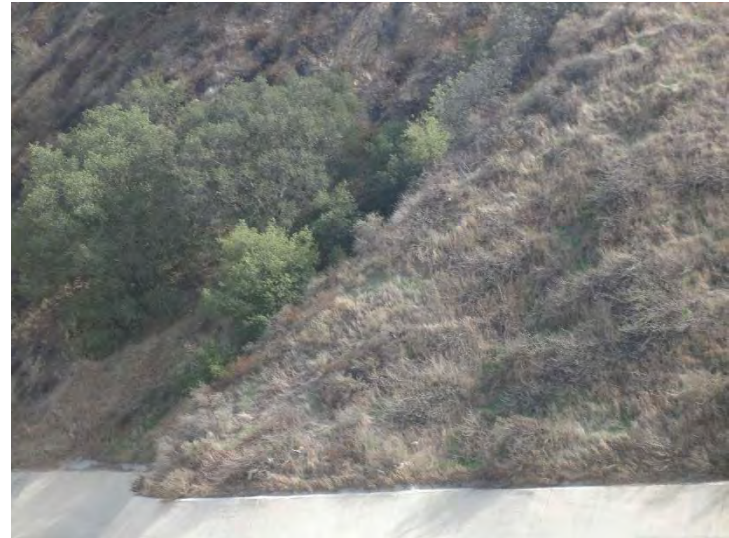
Photo 140: Basin B Native Hillside: October 28, 2015

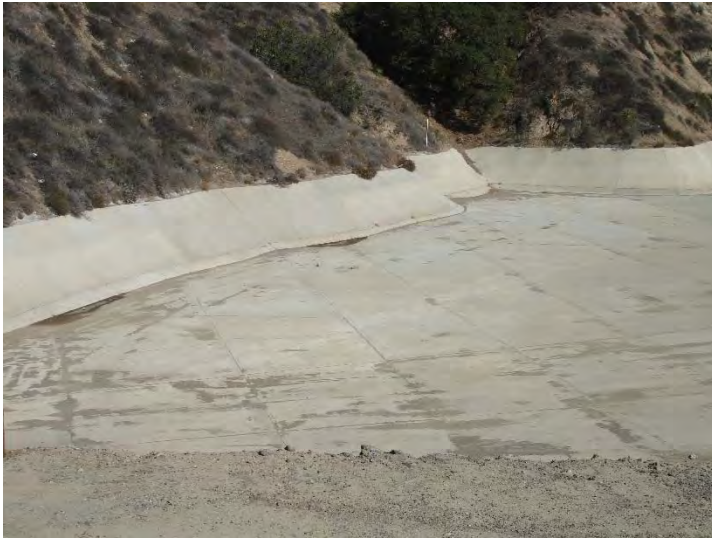
Photo 141: Basin B: November 16, 2015

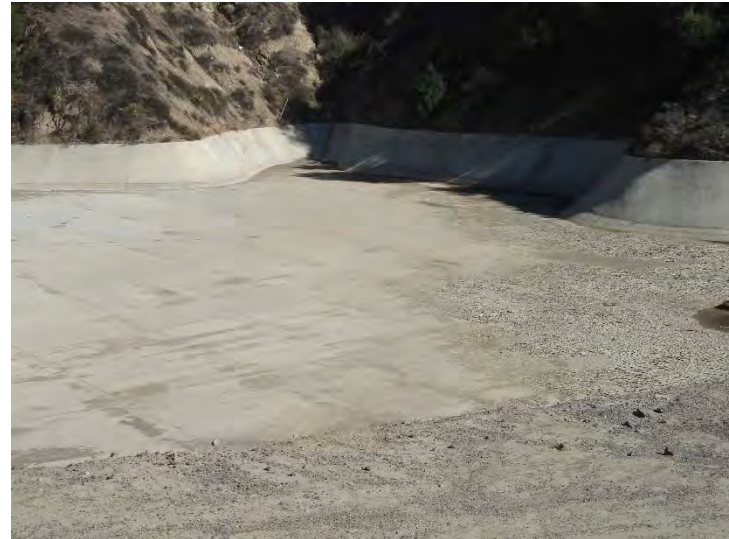
Photo 142: Basin B: November 16, 2015

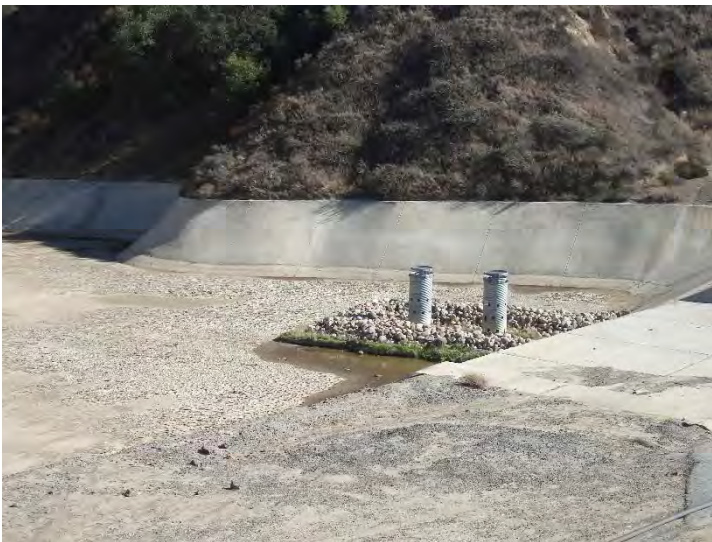
Photo 143: Basin B: November 16, 2015

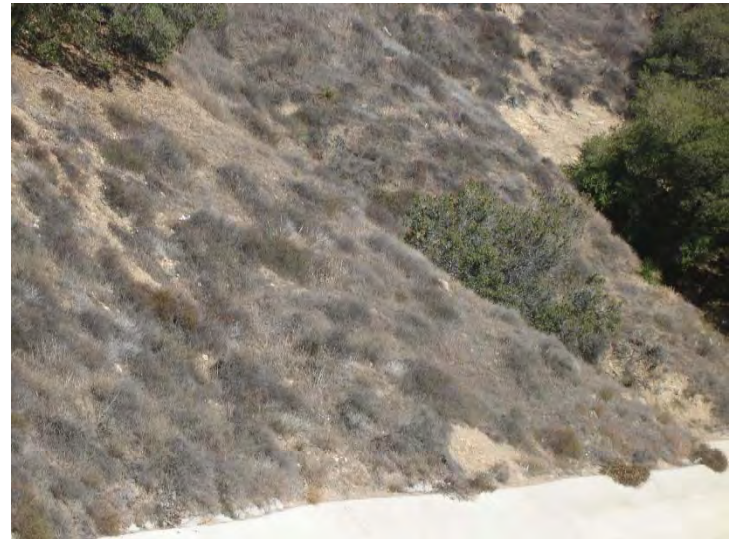
Photo 144: Basin B Native Hillside: November 16, 2015

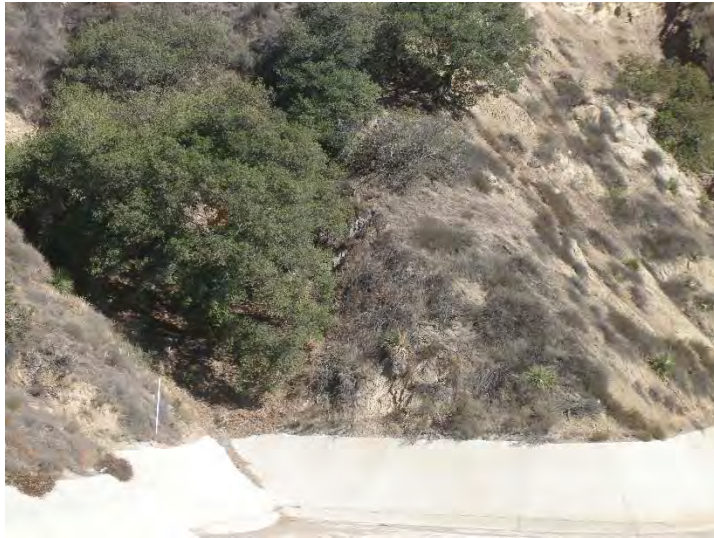
Photo 145: Basin B Native Hillside: November 16, 2015

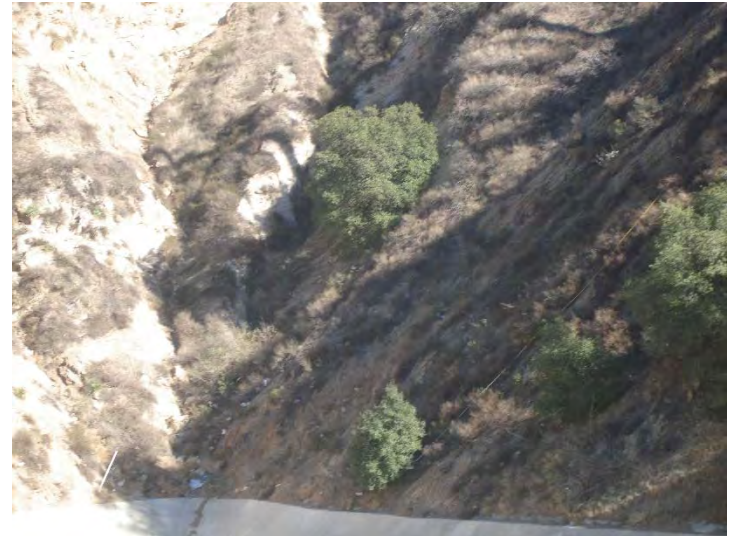
Photo 146: Basin B Native Hillside: November 16, 2015

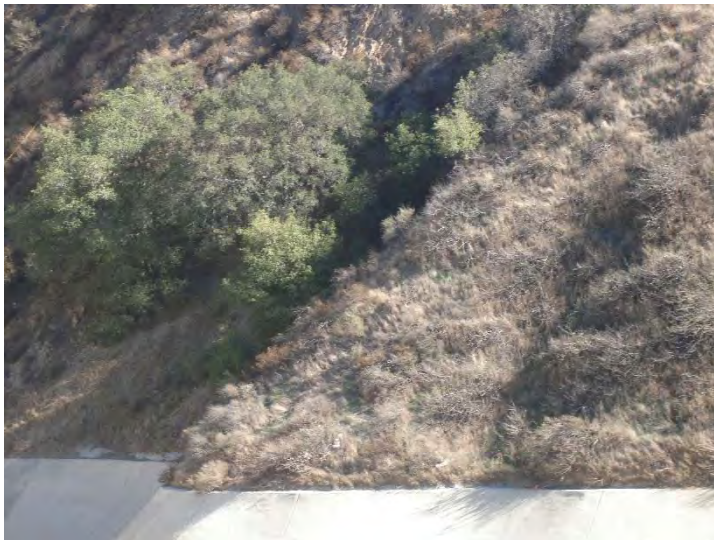
Photo 147: Basin B Native Hillside: November 16, 2015

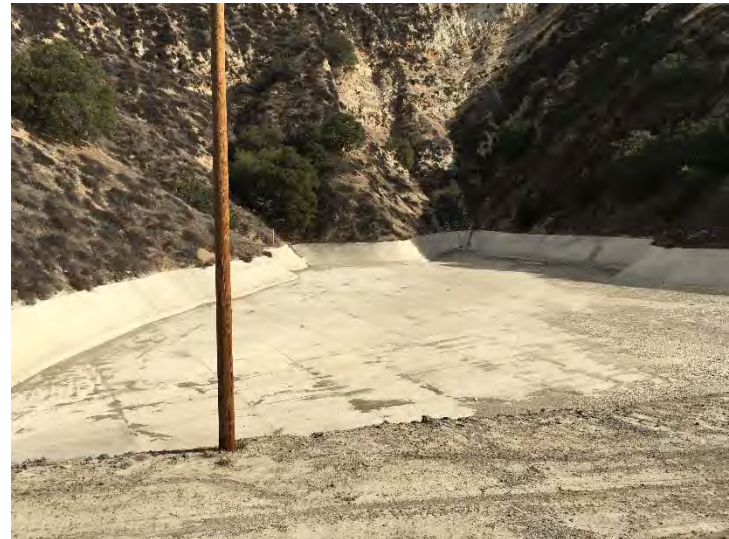
Photo 148: Basin B: December 9, 2015

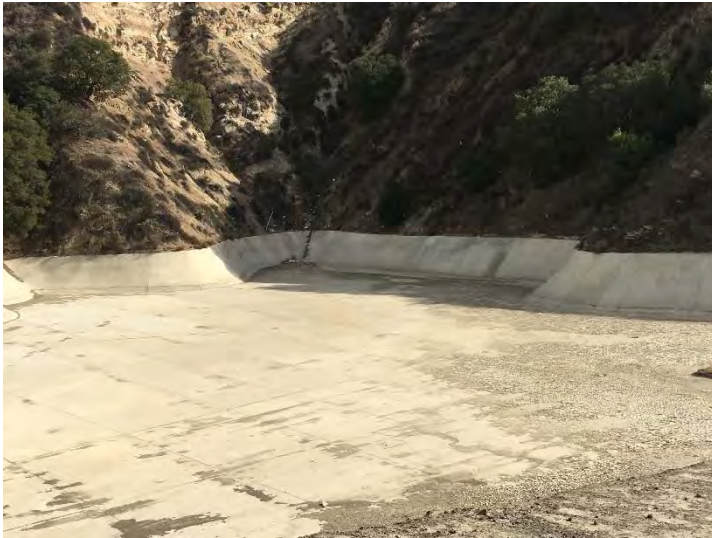
Photo 149: Basin B: December 9, 2015

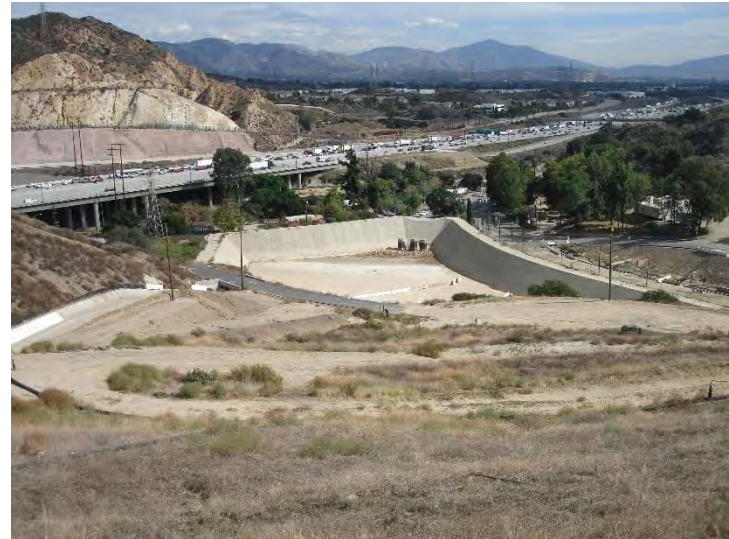
Photo 150: Terminal Basin: October 28, 2015

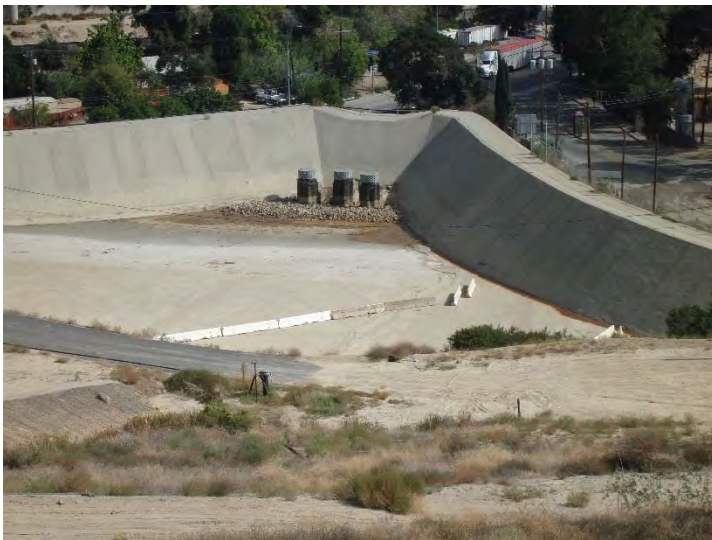
Photo 151: Terminal Basin: October 28, 2015

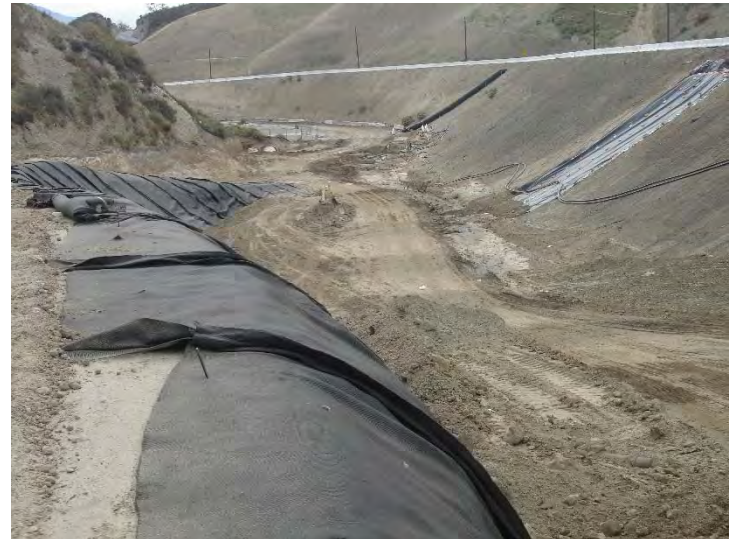
Photo 152: Terminal Basin Inlet: October 28, 2015

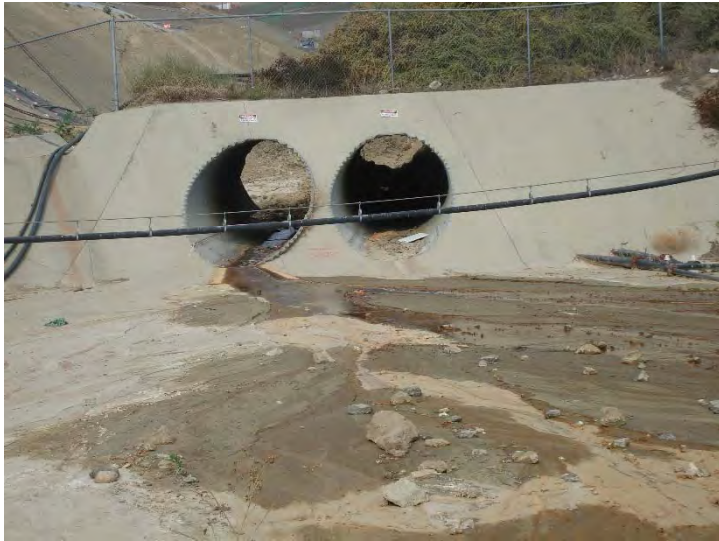
Photo 153: Terminal Basin Inlet: October 28, 2015

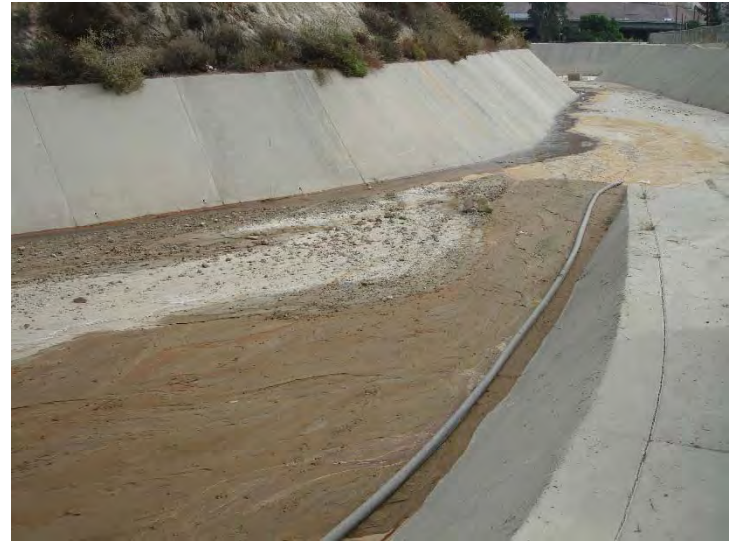
Photo 154: Terminal Basin: October 28, 2015
