**Sunshine Canyon Landfill
Independent Monitor
Quarterly Site Monitoring Status Report
October 1, 2015 – December 31, 2015**

February 12, 2016

The attached Quarterly Site Monitoring Status Report for the Sunshine Canyon Landfill dated February 12, 2016 is the Fourth Quarterly Report for 2015, issued by UltraSystems. This report covers the monitoring period from October 1, 2015 through December 31, 2015 and is prepared for the City of Los Angeles Department of City Planning and the County of Los Angeles Department of Regional Planning.

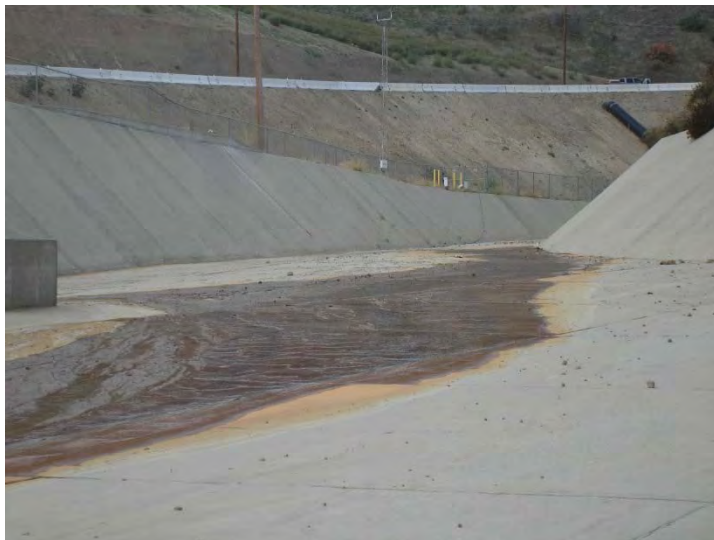
Photo 155: Terminal Basin: October 28, 2015

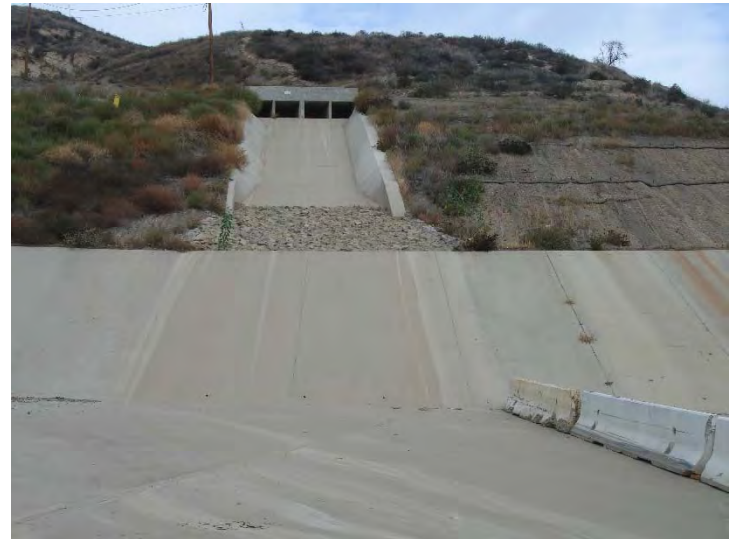
Photo 156: Terminal Basin: October 28, 2015

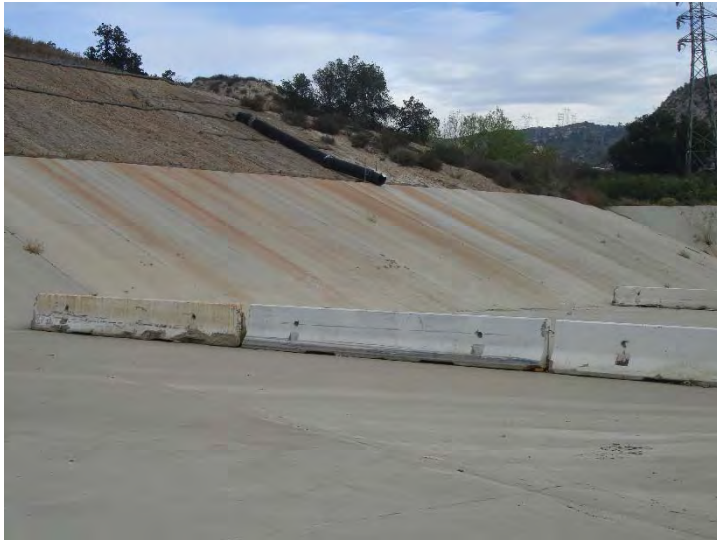
Photo 157: Terminal Basin: October 28, 2015

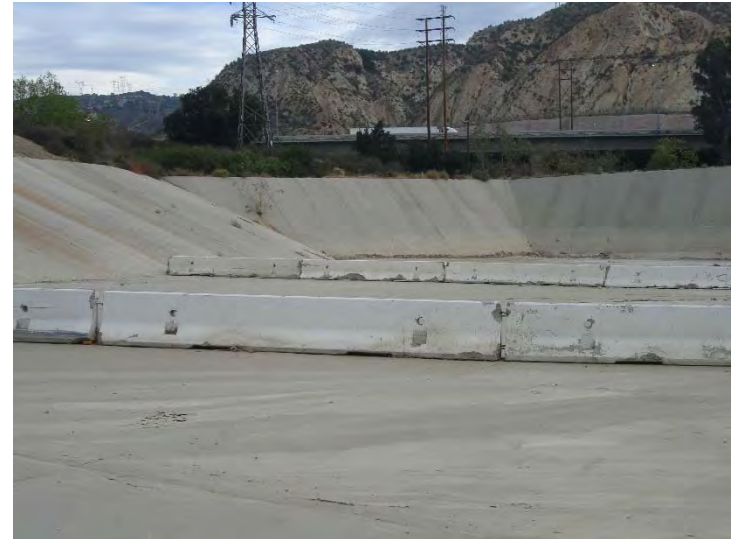
Photo 158: Terminal Basin: October 28, 2015

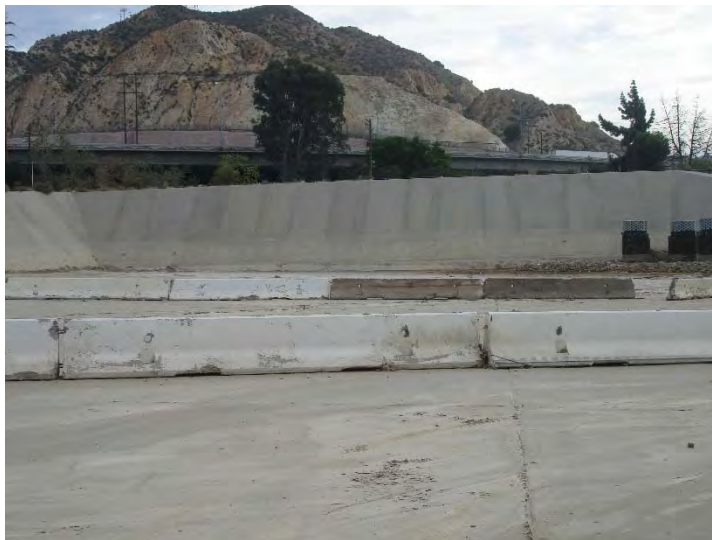
Photo 159: Terminal Basin: October 28, 2015

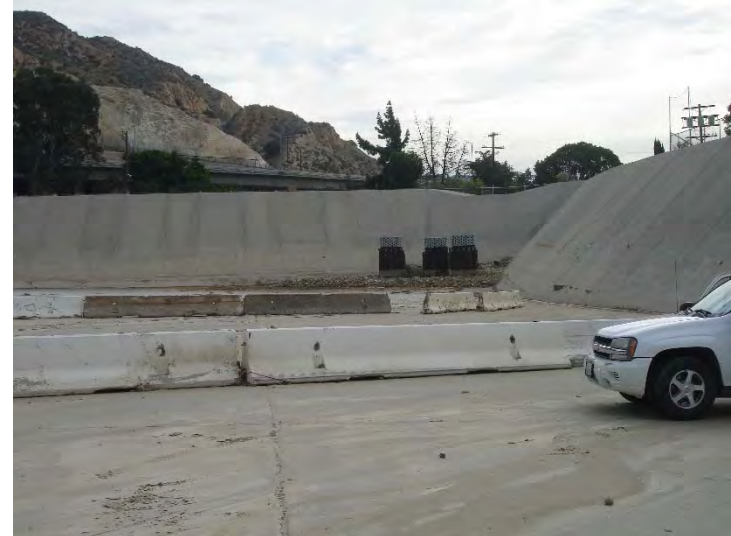
Photo 160: Terminal Basin: October 28, 2015

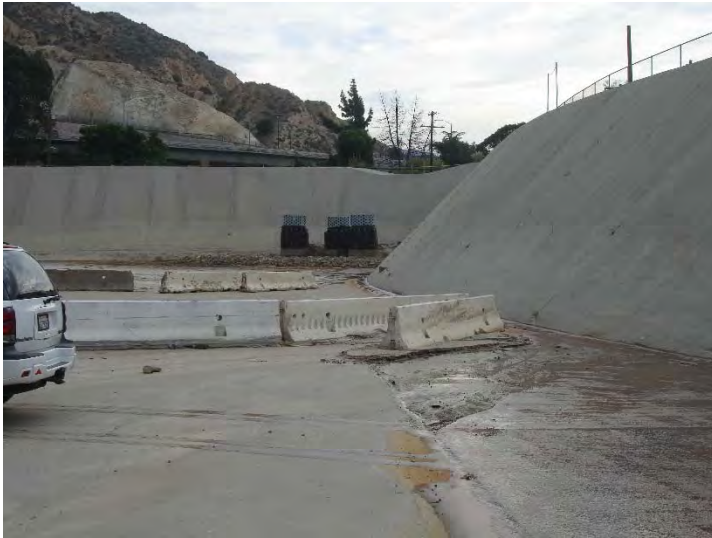
Photo 161: Terminal Basin: October 28, 2015

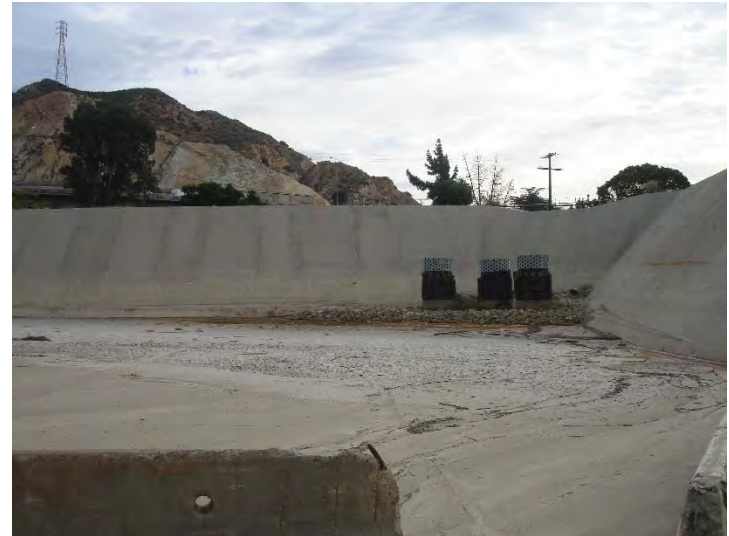
Photo 162: Terminal Basin: October 28, 2015

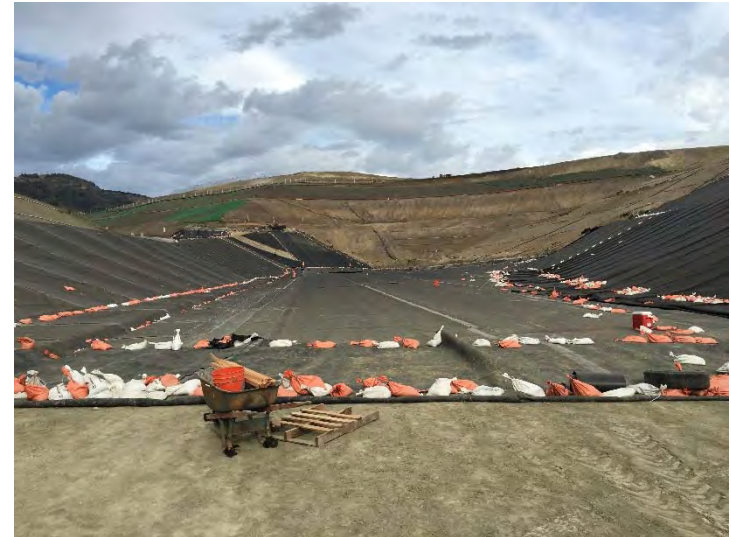
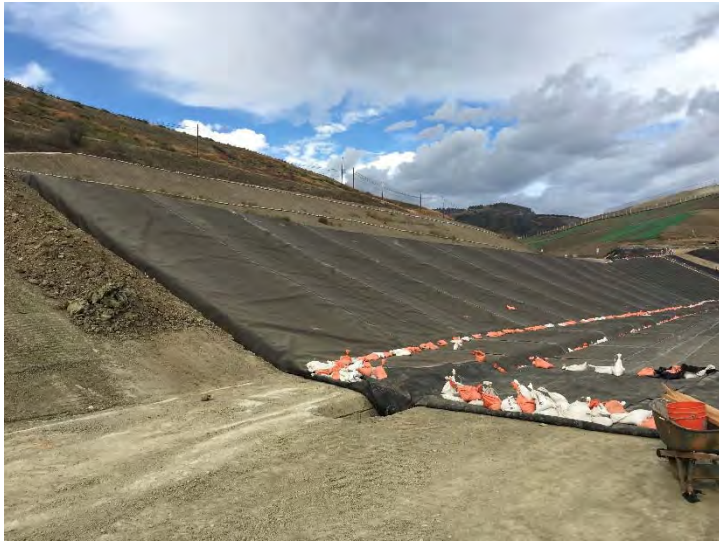
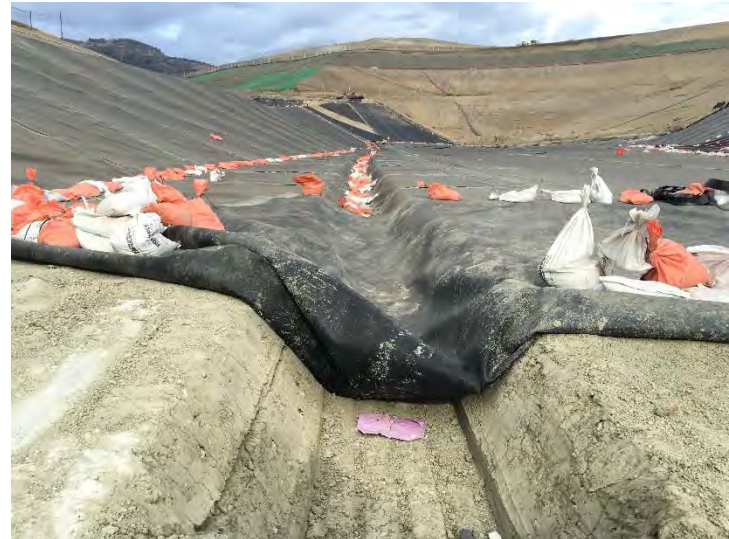
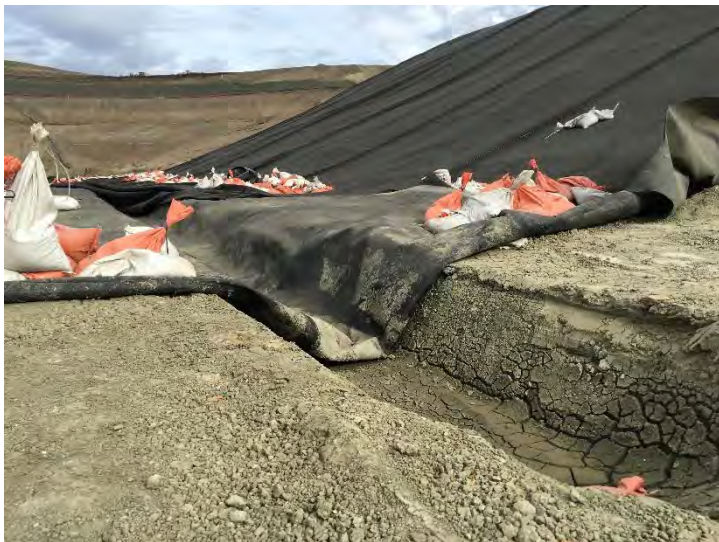
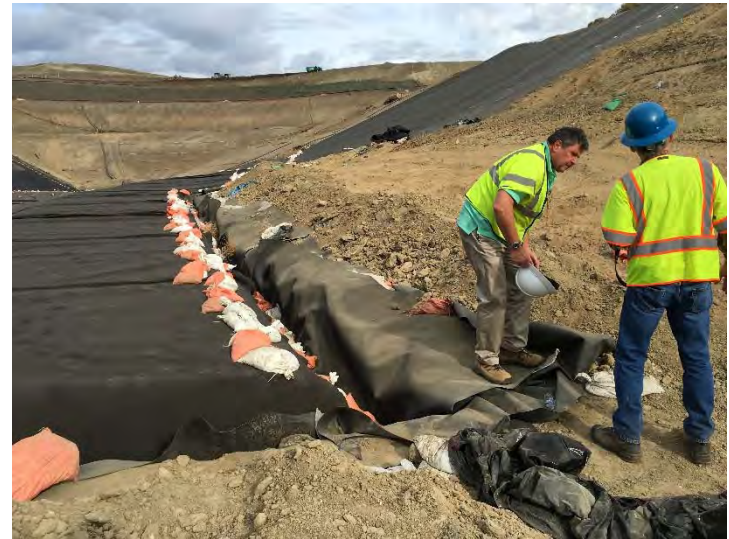
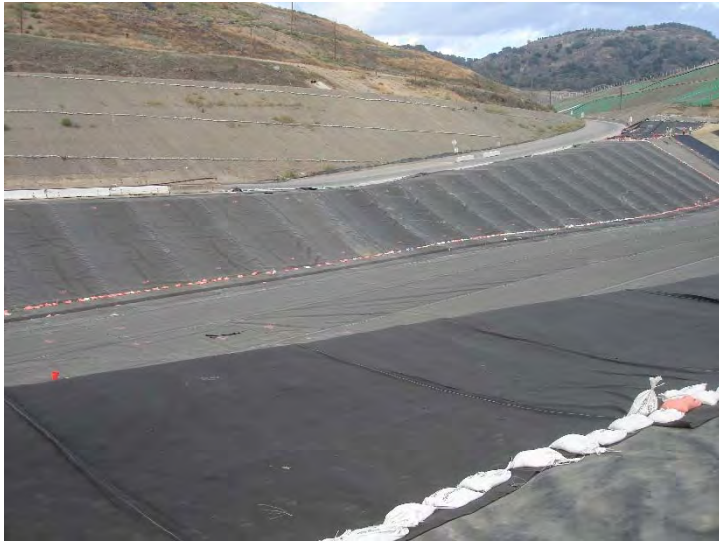
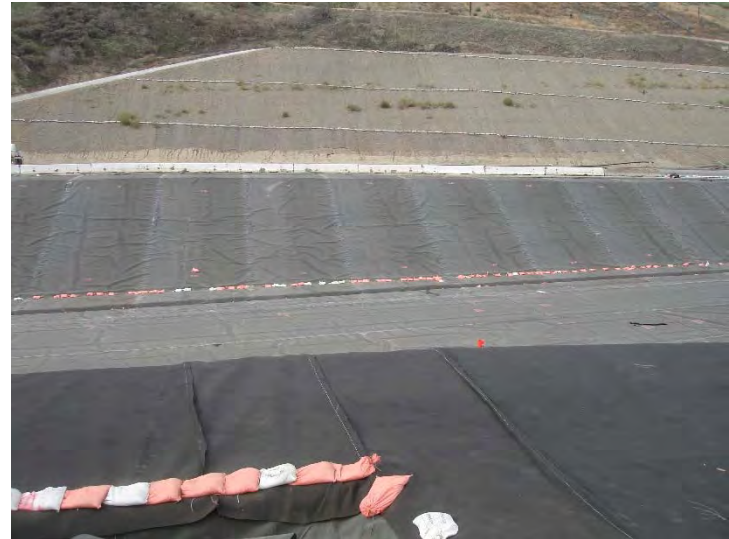
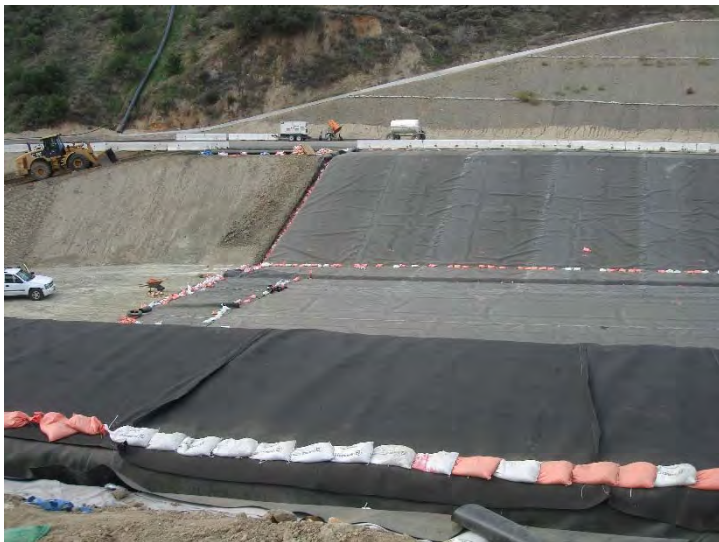
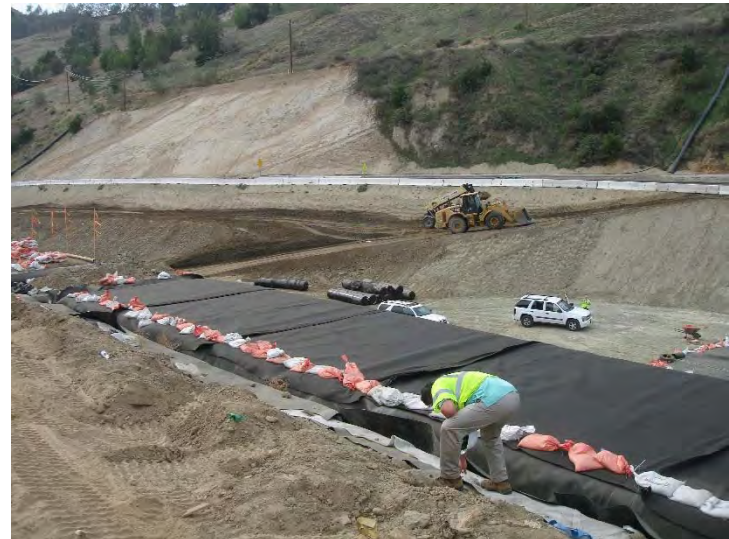
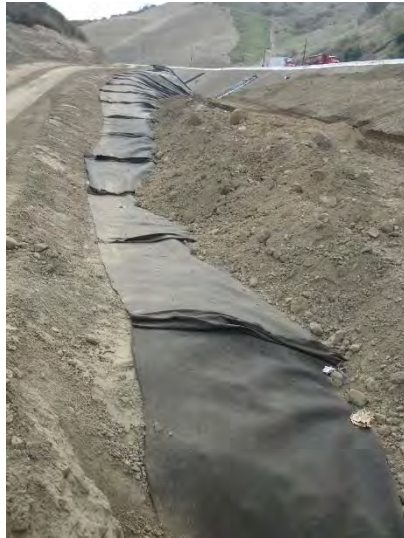
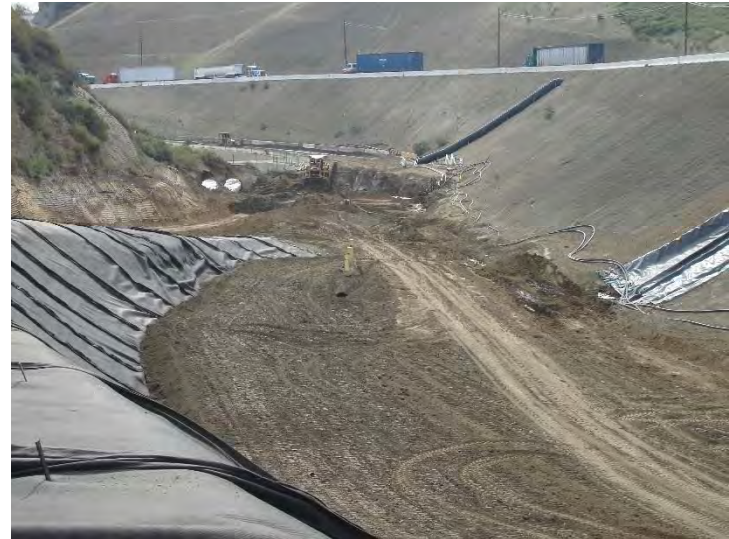
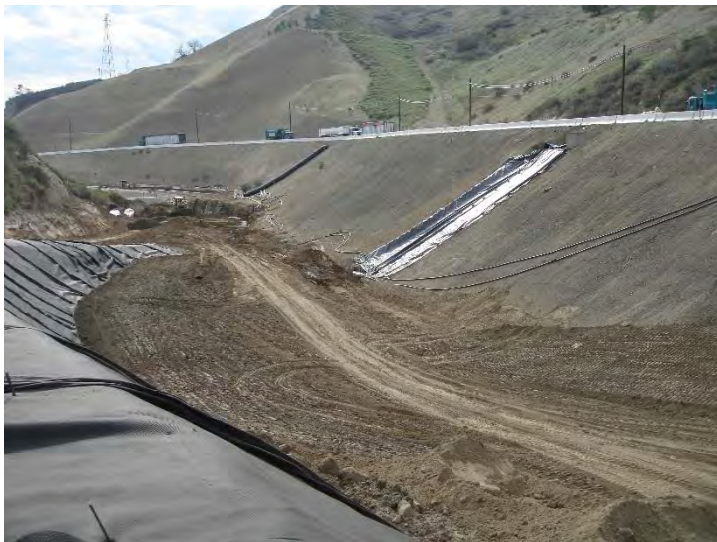
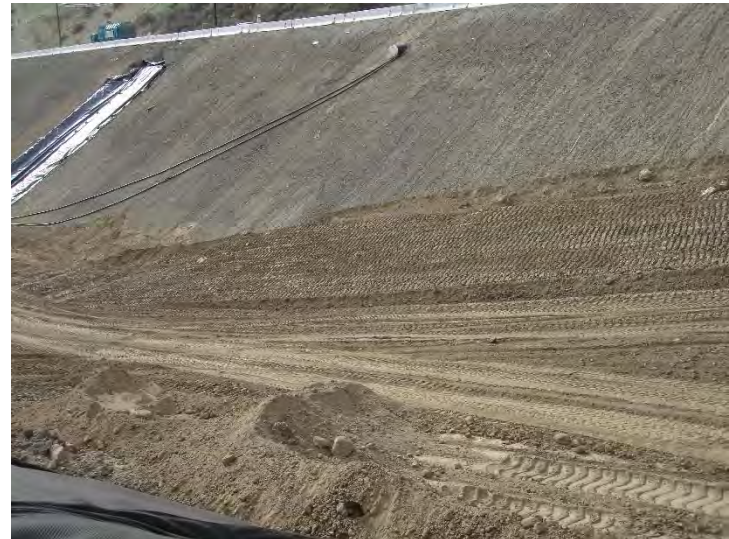
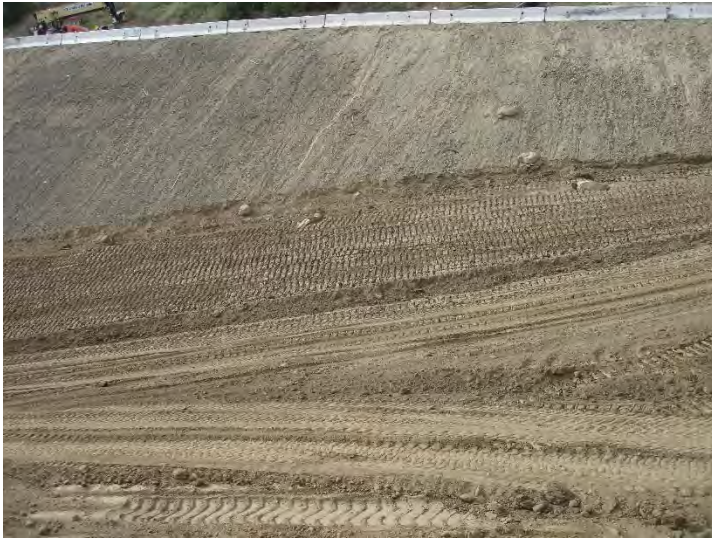
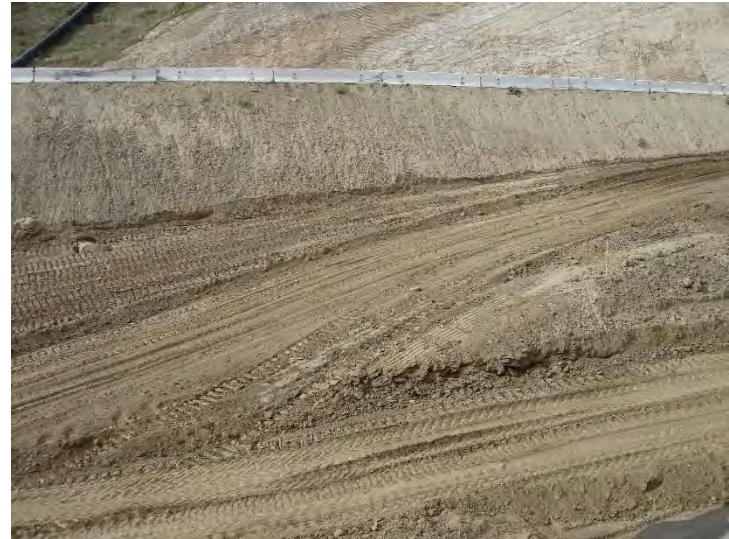
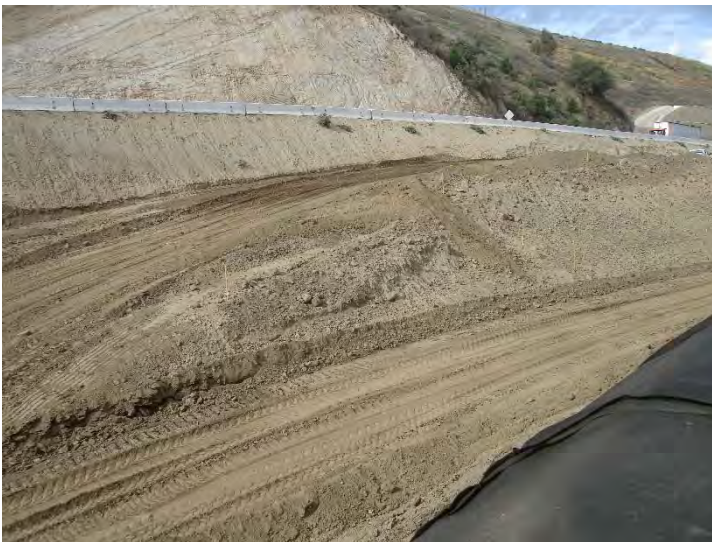
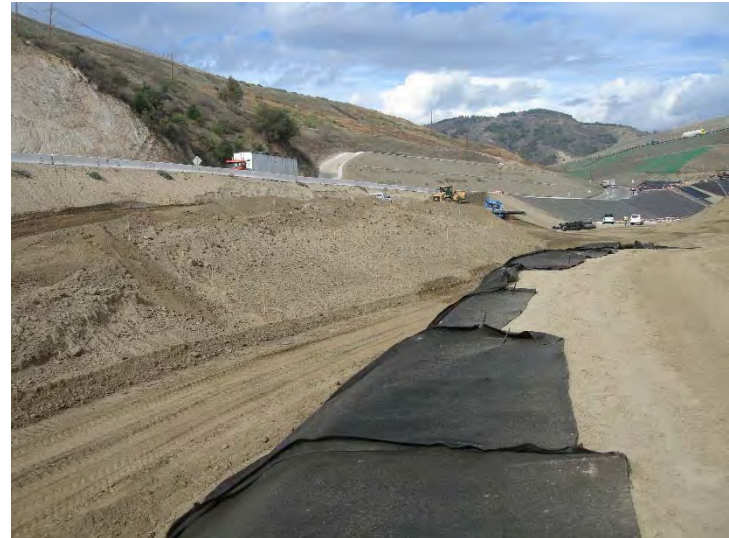
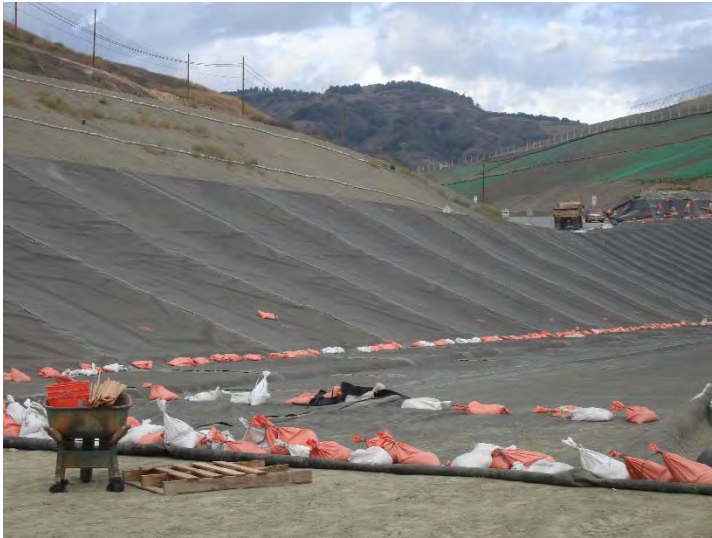
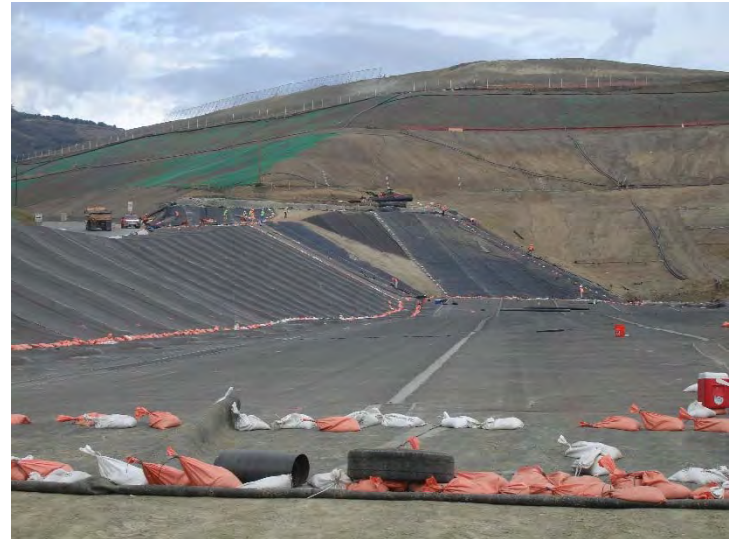
Discipline	City Condition Reference # / Mitigation #	County Condition Reference # / Mitigation #	Responsible Agency	Further Review Needed-Comments
Project Manager	Q – B.2.c		City Planning	<p>I-n: The liner was being placed in the Cell CC-3B area and on the lower slopes of the old City North landfill. Activities observed included liner installation of geosynthetic material on side slopes and excavation of anchor trenches. Quality control (CQA) monitoring was ongoing as evidenced by markings on the geosynthetic material. Liner on slopes was observed to meet design approved by the Regional Water Quality Control Board (RWQCB) and consists of, from bottom to top of prepared soil foundation, high-density polyethylene (HDPE) geomembrane, geosynthetic clay liner (GCL) and HDPE geomembrane. In the area where the liner overlies the inactive landfill, a geocomposite material to act as a gas collection layer was installed in accordance with County Condition Groundwater 3.13. Additionally, grading was occurring south of Basin A, removing the hill where the old offices were located.</p> <p>I-o: Cell CC-3B was nearing liner completion with clay being placed on top of the liner. Grading continued south of Basin A.</p> <p>I-p: Work on Cell CC-3B stopped for the day that the monitor was onsite because of high wind conditions. The cell construction was still in progress, however.</p> <p>I-q: Cell CC-3B was having final liner cover being placed on top of the lined area. Construction of temporary stormwater basins and HDPE-lined drainage ditches were being constructed. Grading continued south of Basin A.</p>

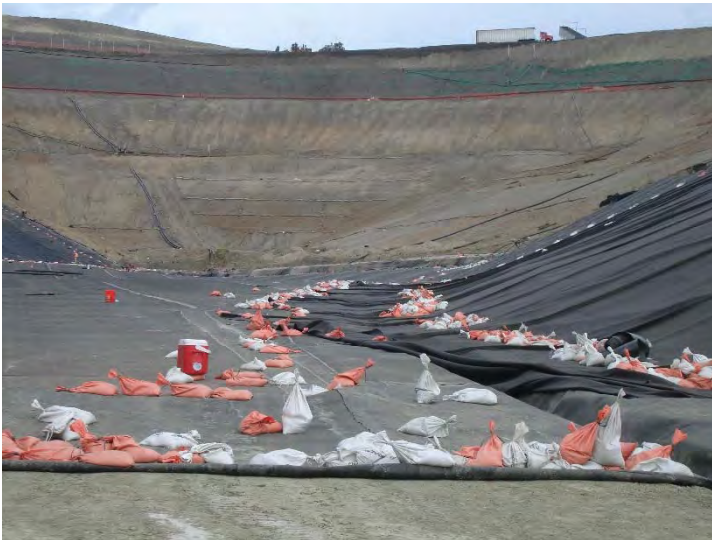
Photo 203: City Cell CC3B Construction: October 14 2015

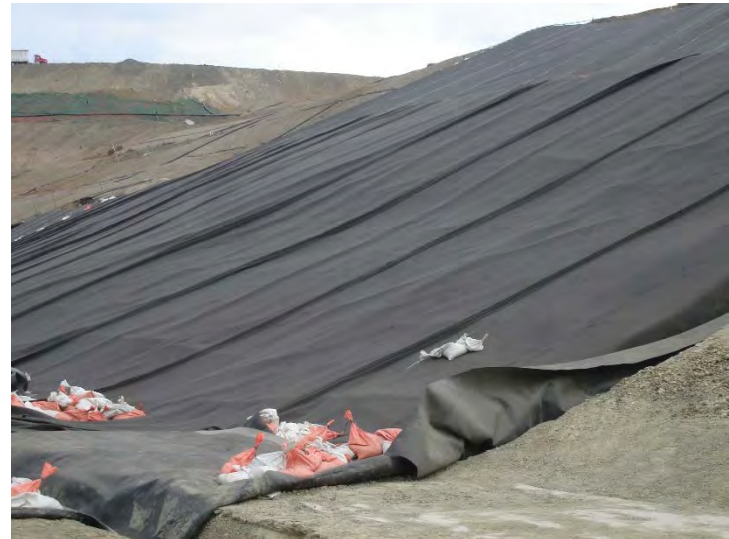
Photo 204: City Cell CC3B Construction: October 14 2015

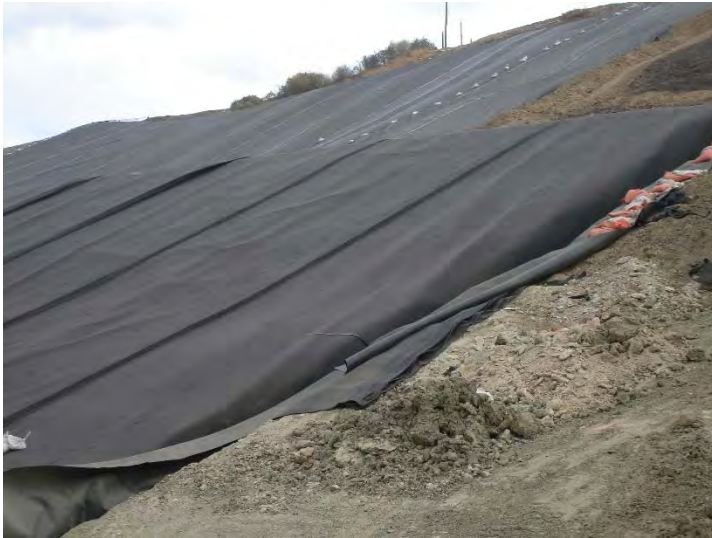
Photo 205: City Cell CC3B Construction: October 14 2015

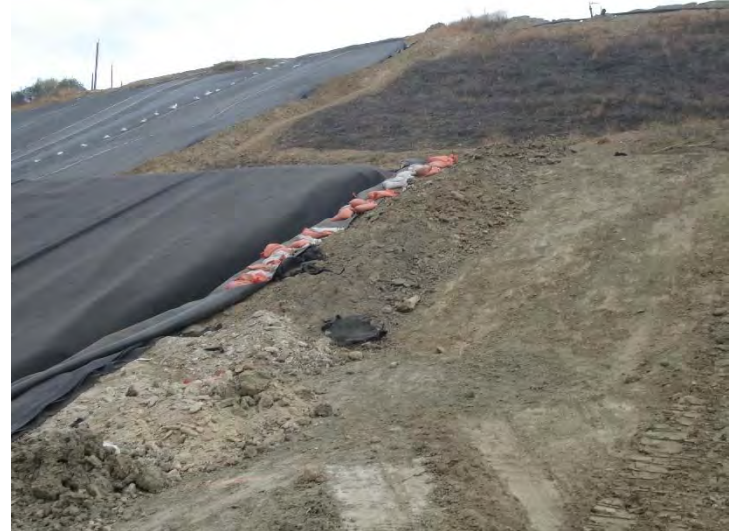
Photo 206: City Cell CC3B Construction: October 14 2015

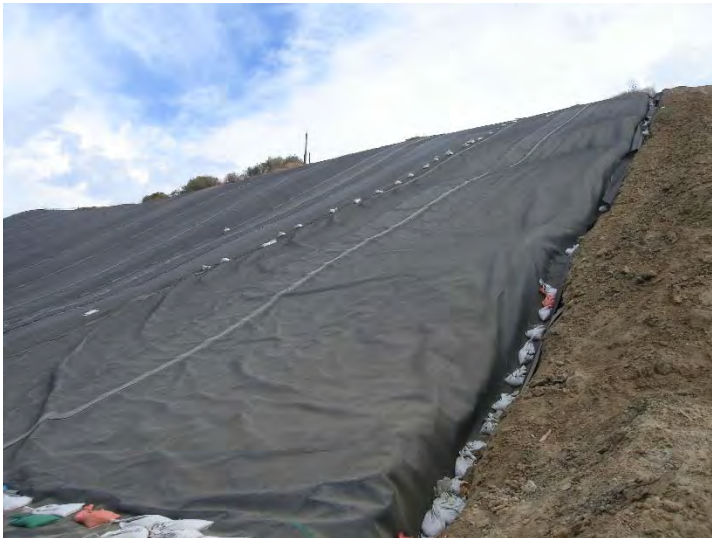
Photo 207: City Cell CC3B Construction: October 14 2015

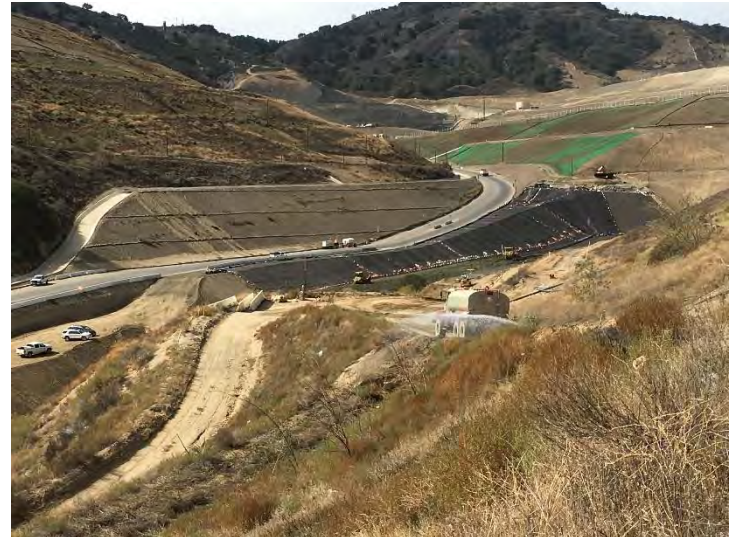
Photo 208: City Cell CC3B Construction: October 28, 2015

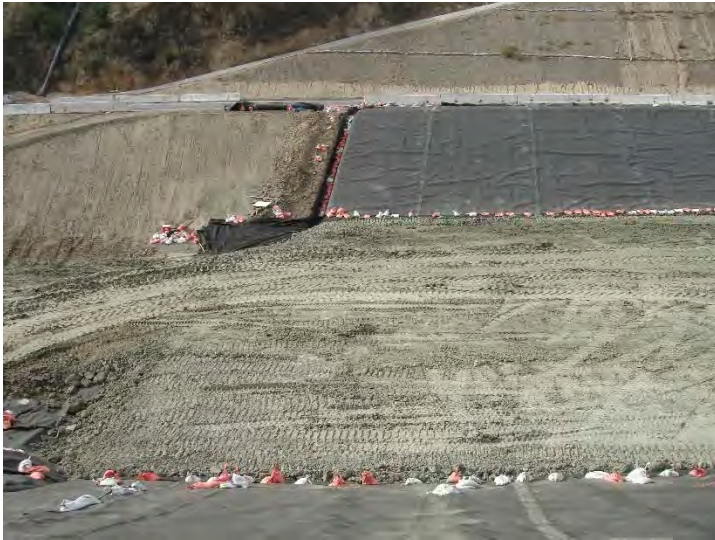
Photo 209: City Cell CC3B Construction: October 28, 2015

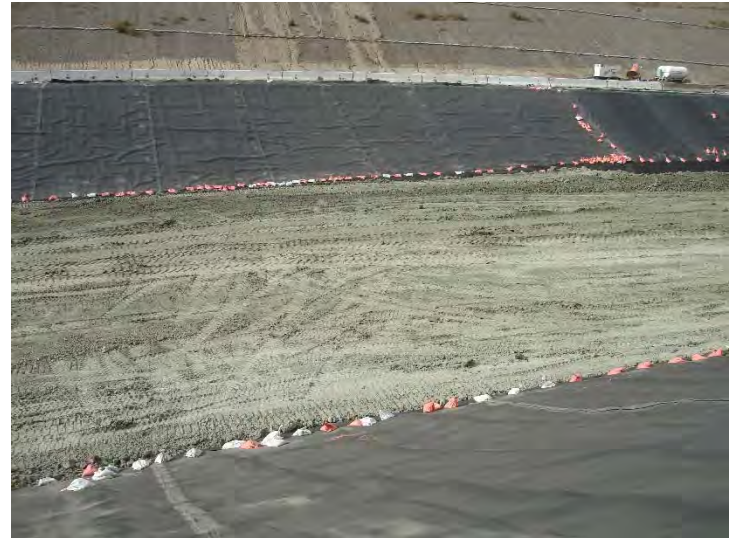
Photo 210: City Cell CC3B Construction: October 28, 2015

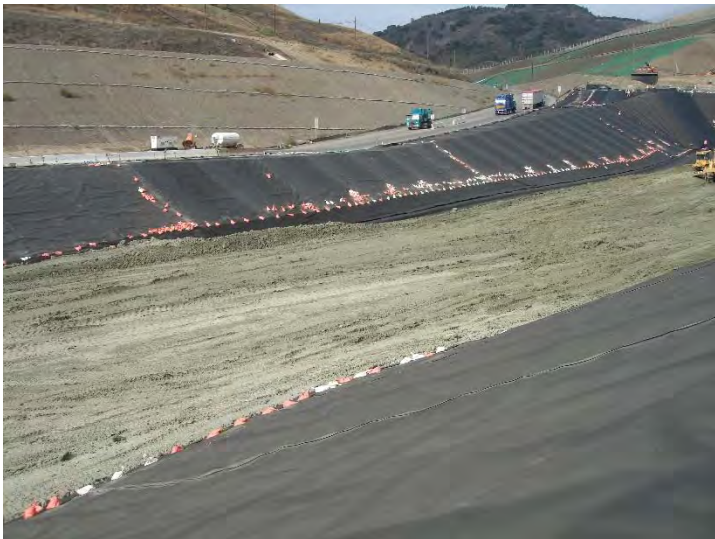
Photo 211: City Cell CC3B Construction: October 28, 2015

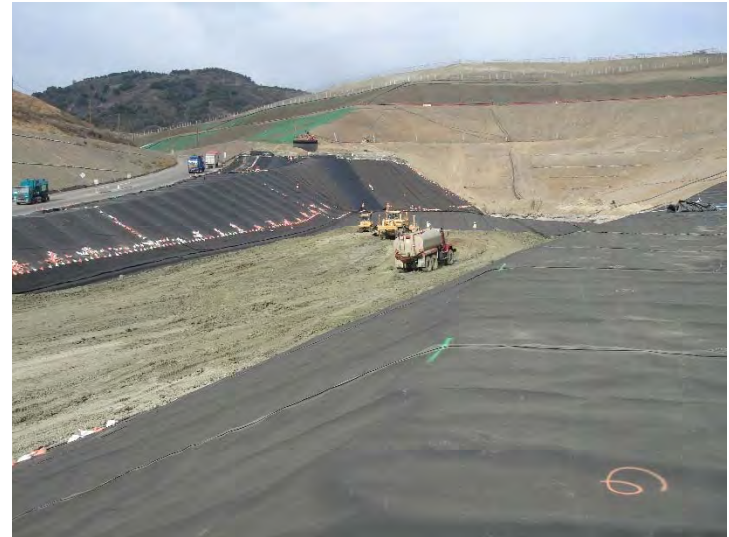
Photo 212: City Cell CC3B Construction: October 28, 2015

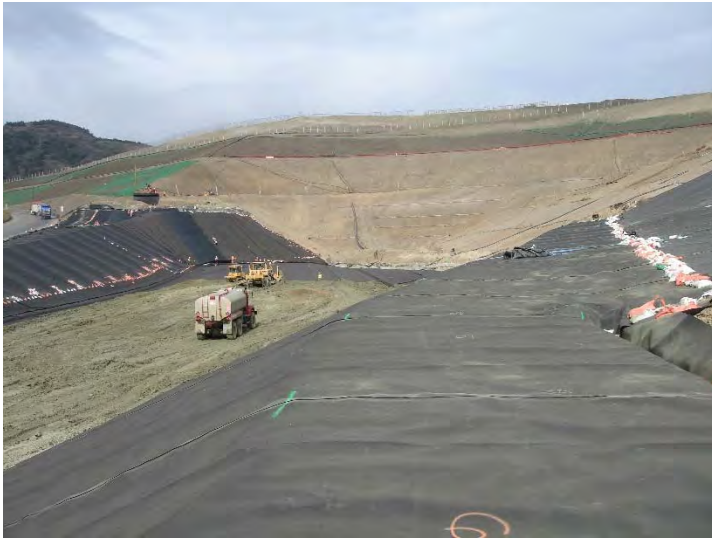
Photo 213: City Cell CC3B Construction: October 28, 2015

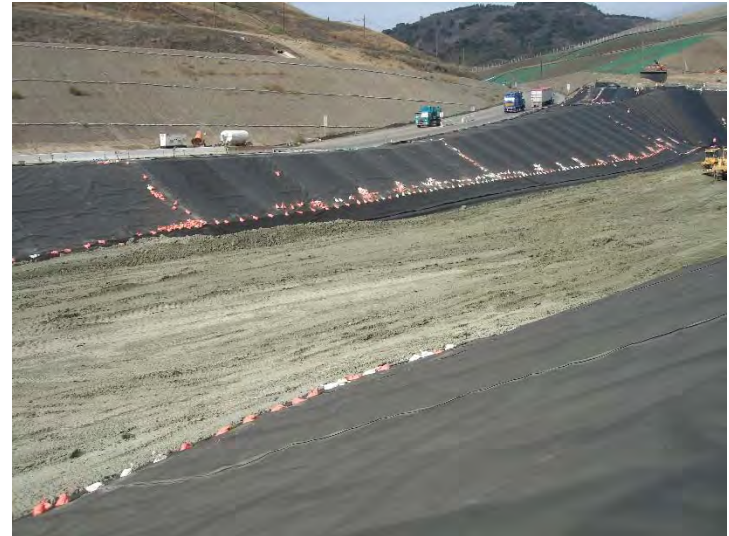
Photo 214: City Cell CC3B Construction: October 28, 2015

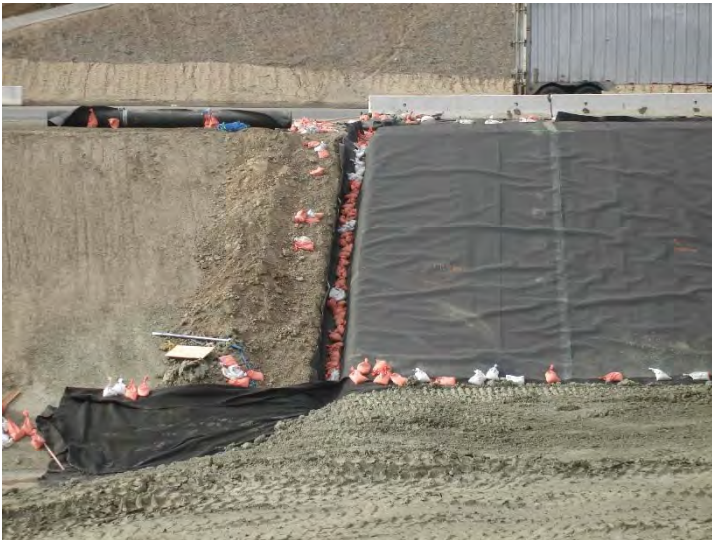
Photo 215: City Cell CC3B Construction: October 28, 2015

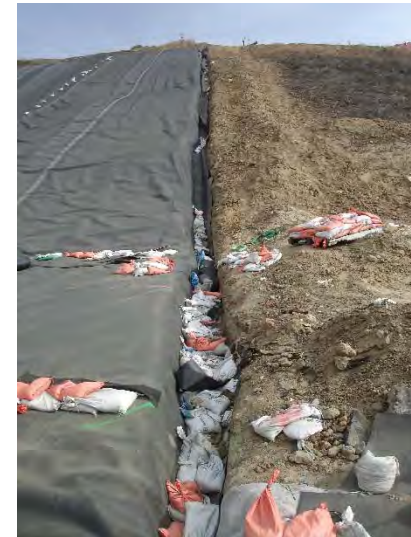
Photo 216: City Cell CC3B Construction: October 28, 2015

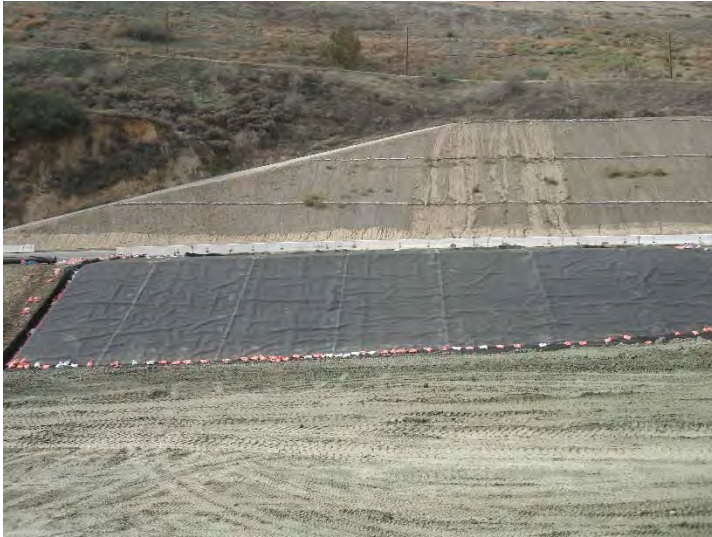
Photo 217: City Cell CC3B Construction: October 28, 2015

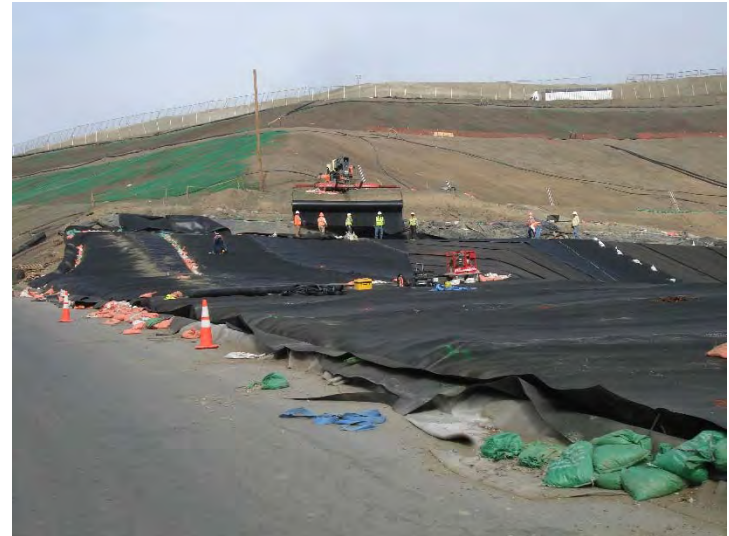
Photo 218: City Cell CC3B Construction: October 28, 2015

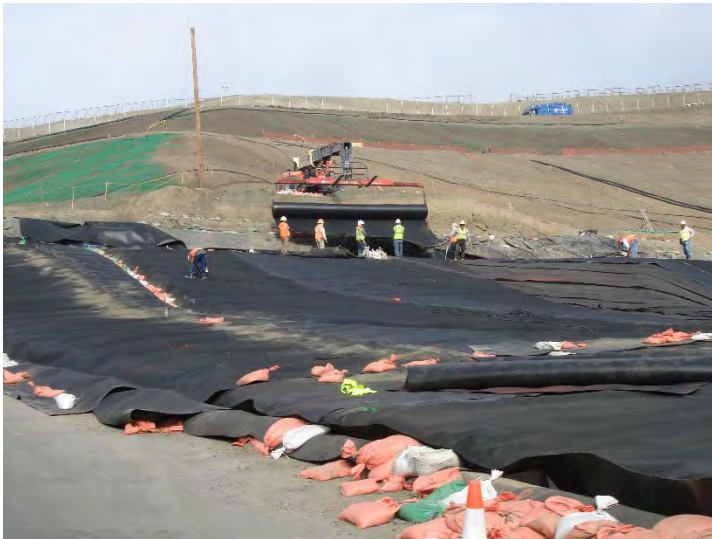
Photo 219: City Cell CC3B Construction: October 28, 2015

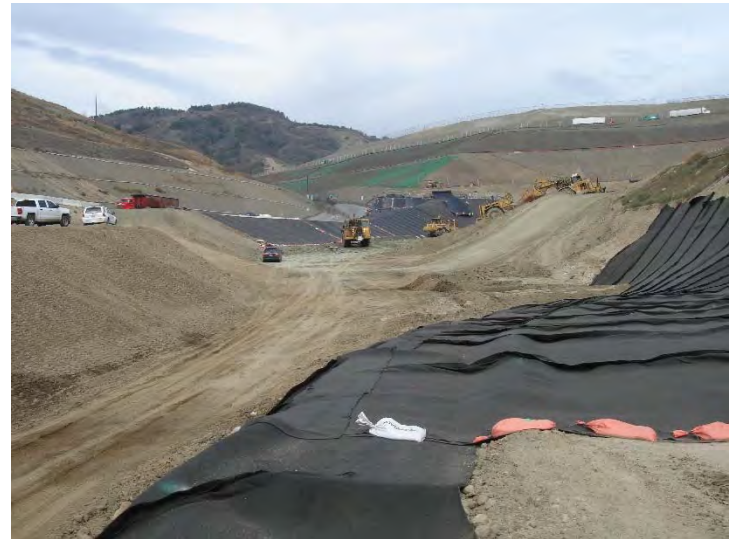
Photo 220: City Cell CC3B Construction: October 28, 2015

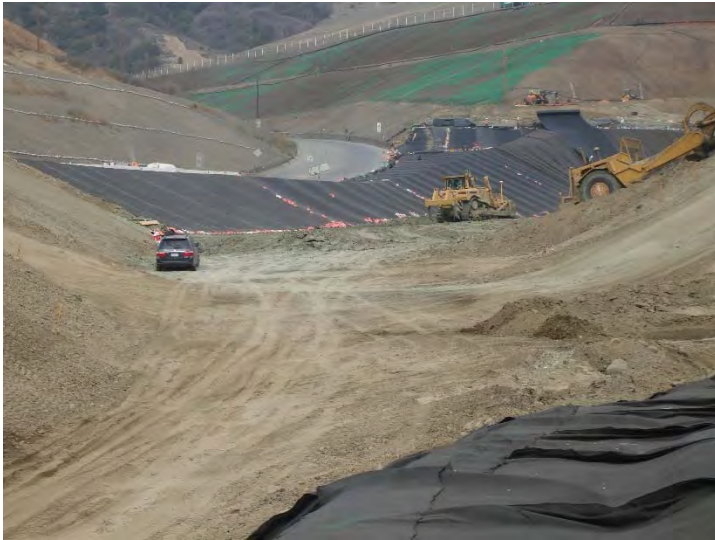
Photo 221 City Cell CC3B Construction: October 28, 2015

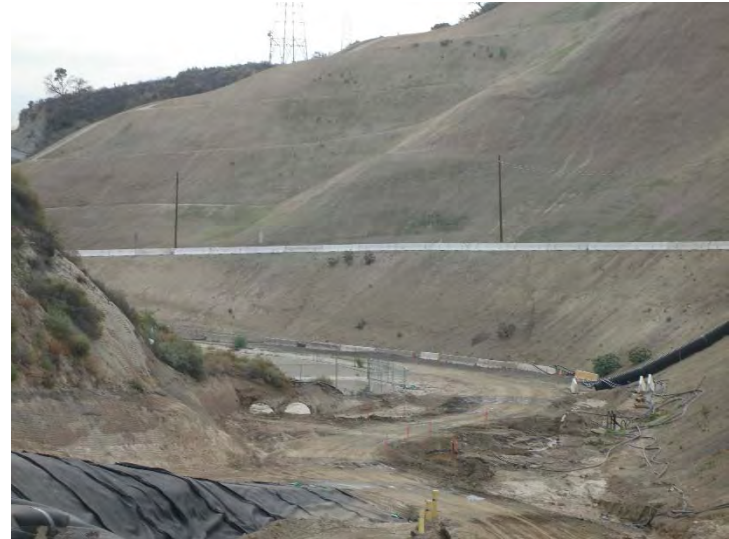
Photo 222: City Cell CC3B Construction: October 28, 2015

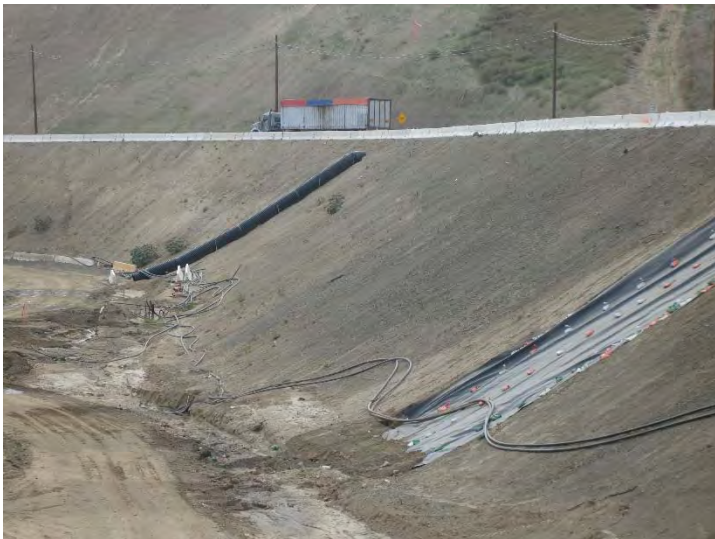
Photo 223: Main Access Road Slope: October 28, 2015

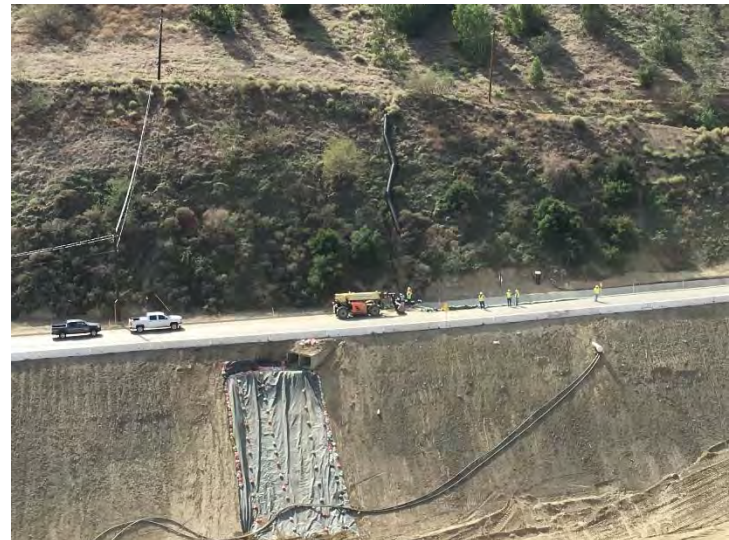
Photo 224: Main Access Road Slope: October 28, 2015

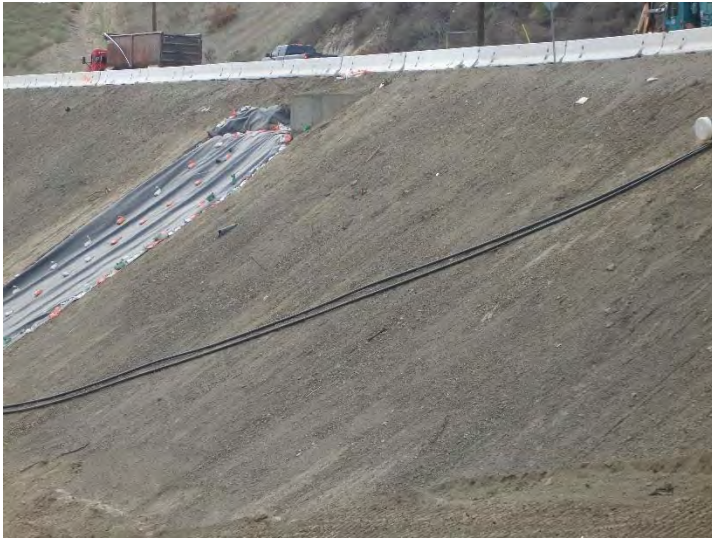
Photo 225: Main Access Road Slope: October 28, 2015

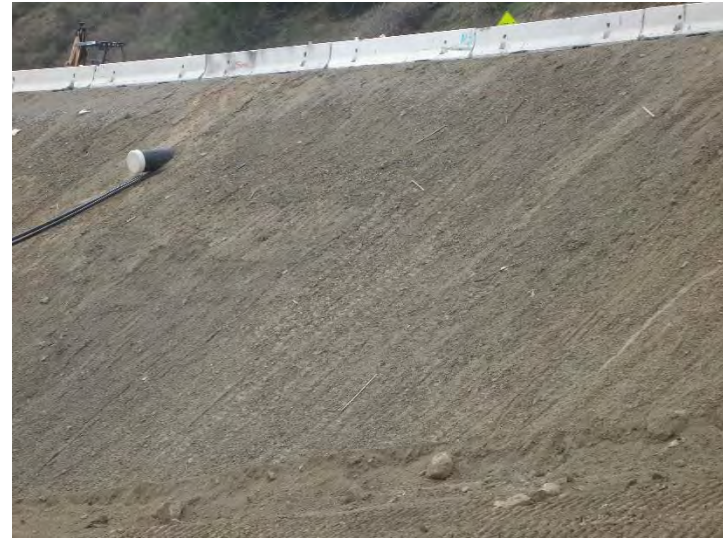
Photo 226: Main Access Road Slope: October 28, 2015

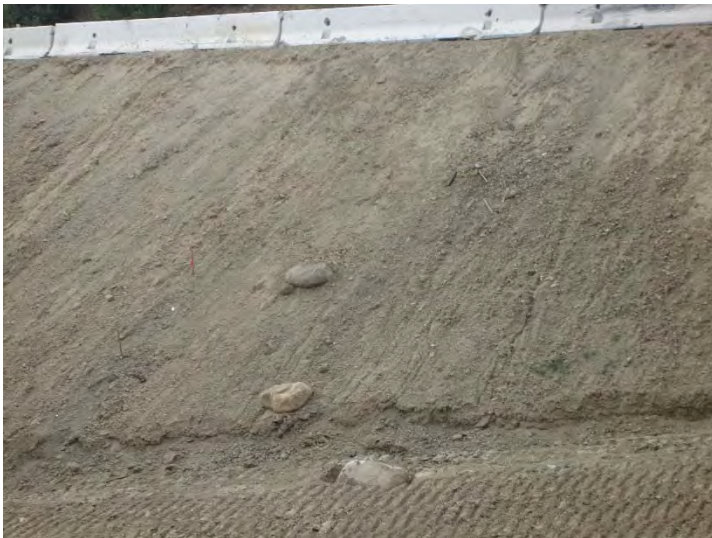
Photo 227: Main Access Road Slope: October 28, 2015

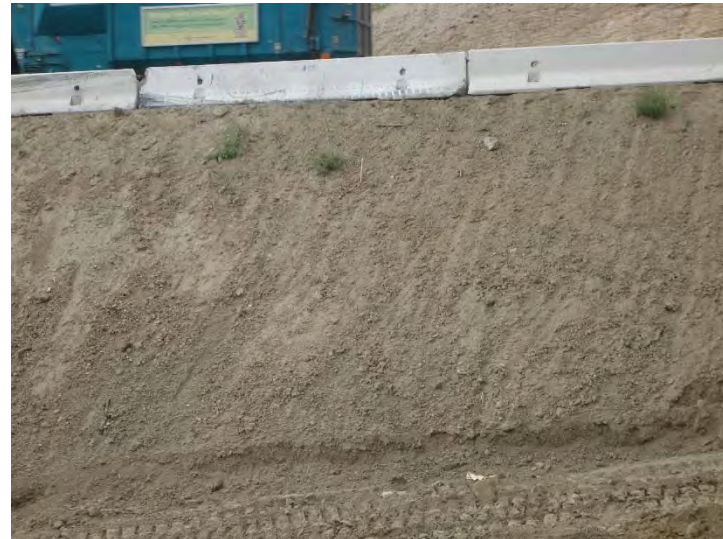
Photo 228: Main Access Road Slope: October 28, 2015

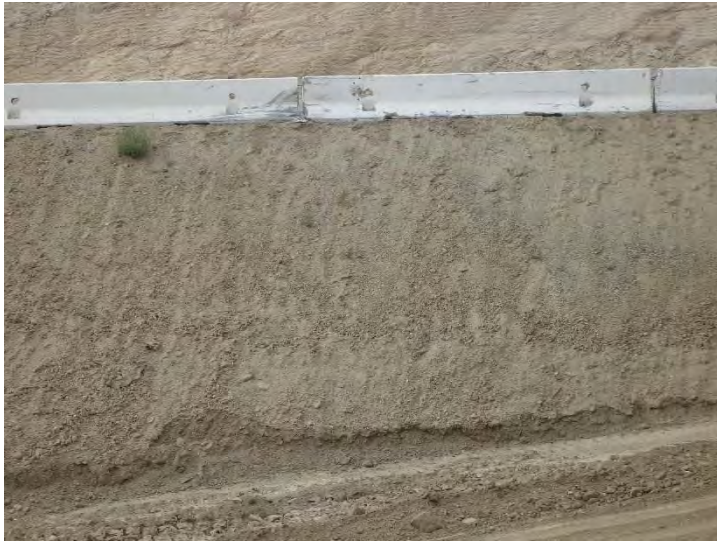
Photo 229: Main Access Road Slope: October 28, 2015

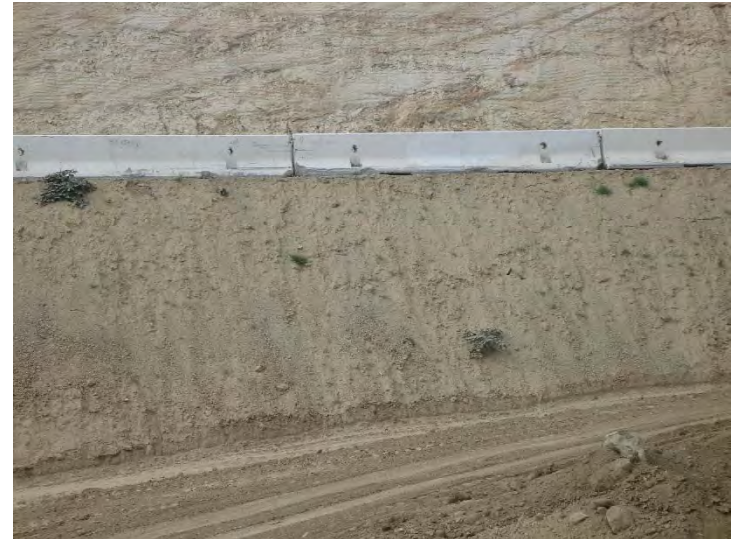
Photo 230: Main Access Road Slope: October 28, 2015

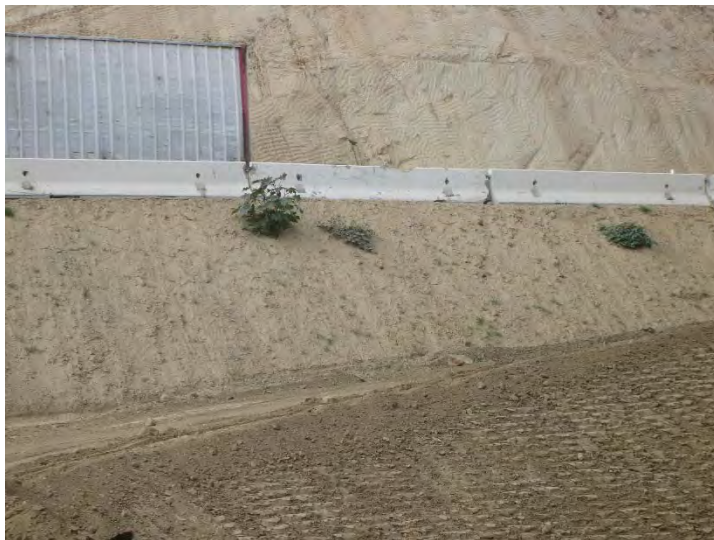
Photo 231: Main Access Road Slope: October 28, 2015

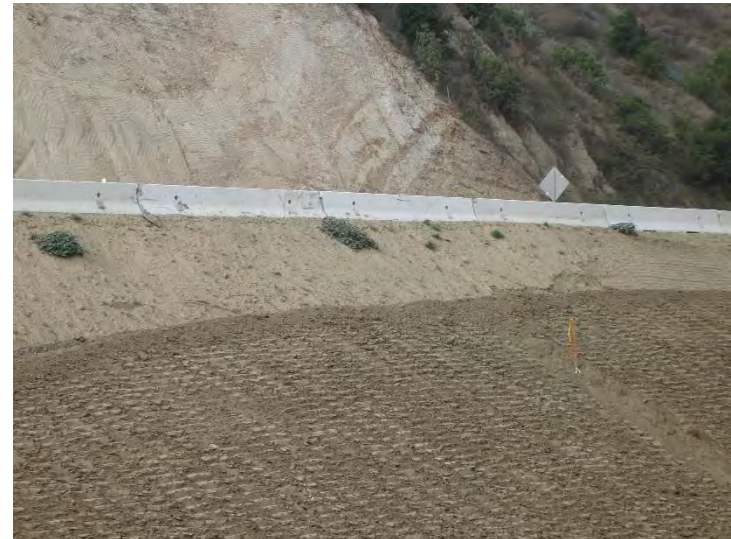
Photo 232: Main Access Road Slope: October 28, 2015
