**Sunshine Canyon Landfill
Independent Monitor
Quarterly Site Monitoring Status Report
October 1, 2015 – December 31, 2015**

February 12, 2016

The attached Quarterly Site Monitoring Status Report for the Sunshine Canyon Landfill dated February 12, 2016 is the Fourth Quarterly Report for 2015, issued by UltraSystems. This report covers the monitoring period from October 1, 2015 through December 31, 2015 and is prepared for the City of Los Angeles Department of City Planning and the County of Los Angeles Department of Regional Planning.

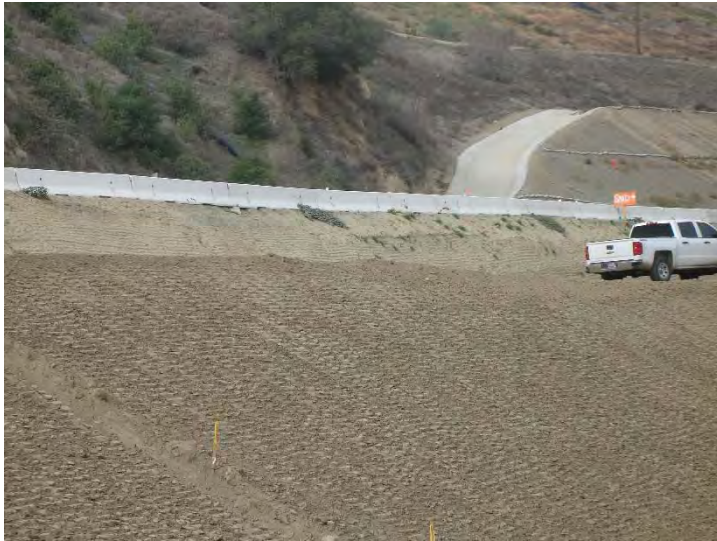
Photo 233: Main Access Road Slope: October 28, 2015

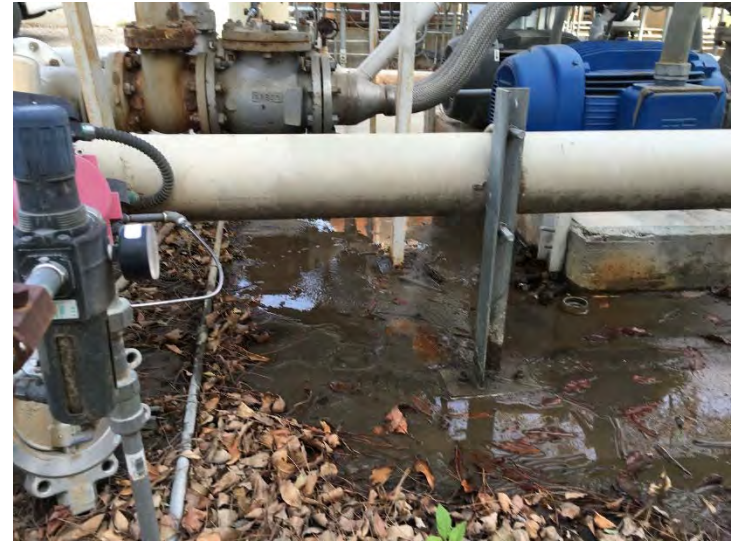
Photo 234: Water Pipe Leak at Treatment Plant: December 9, 2015

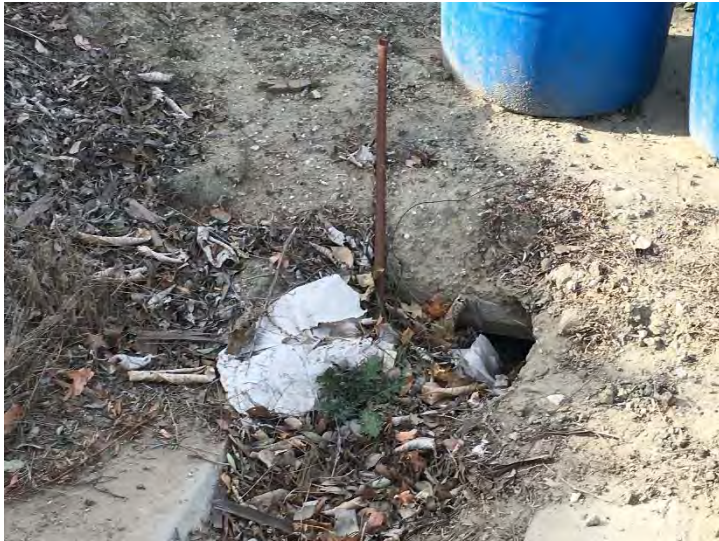
Photo 237: Drain Clogged at Leachate Facility: December 9, 2015

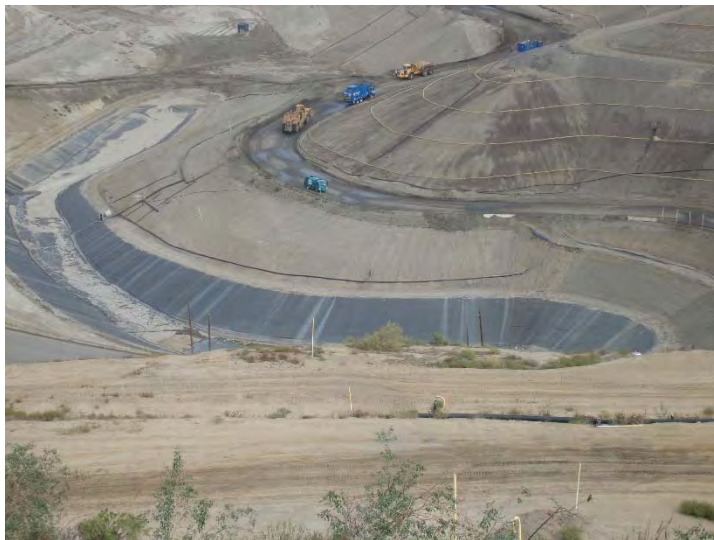
Photo 239: City Lined Drainage Lift Area: October 14, 2015

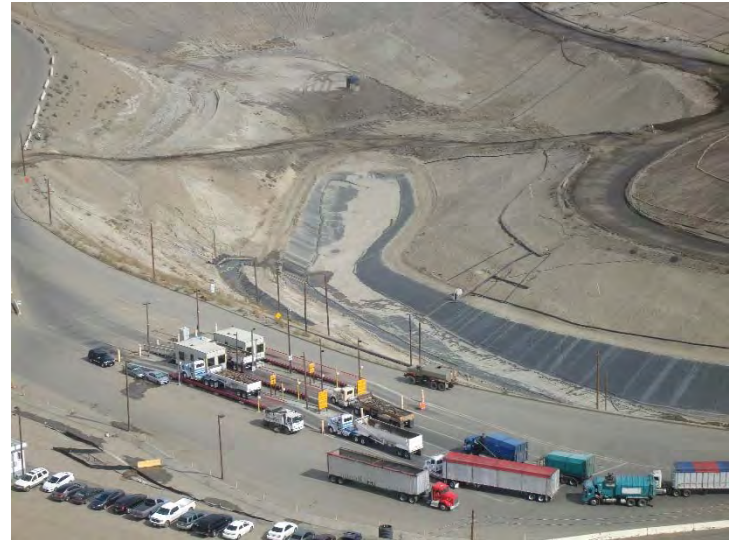
Photo 240: City Lined Drainage Lift Area: October 14, 2015

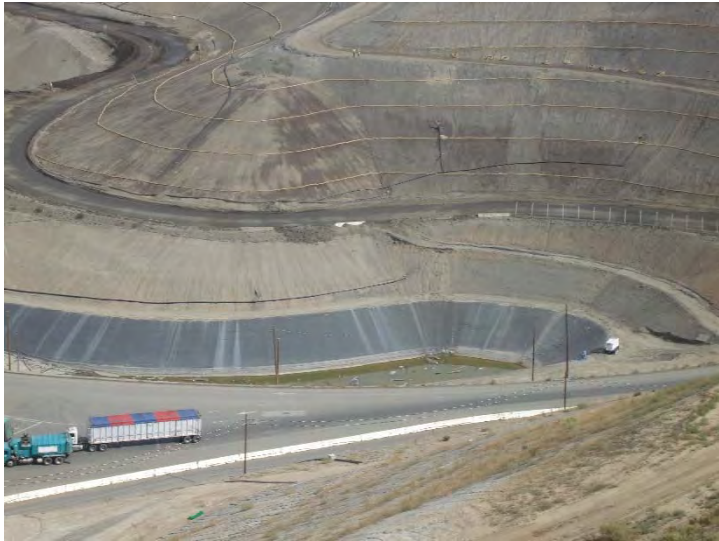
Photo 241: City Lined Drainage Lift Area: October 14, 2015

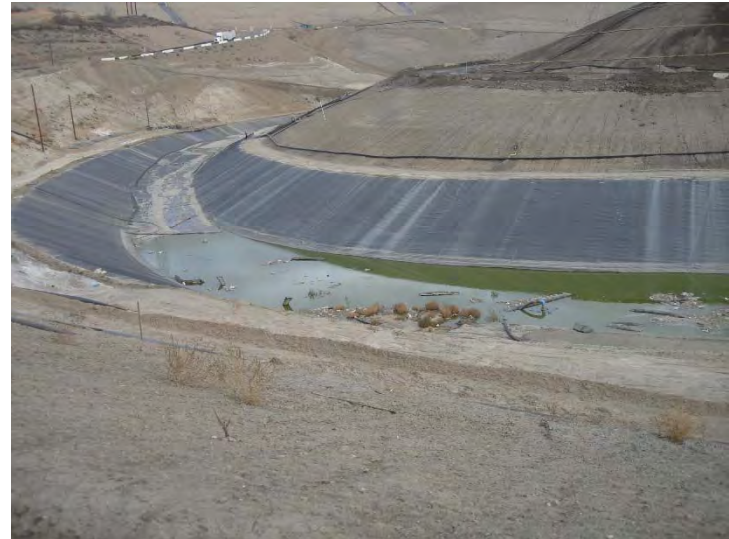
Photo 242: City Lined Drainage Lift Area: October 28, 2015

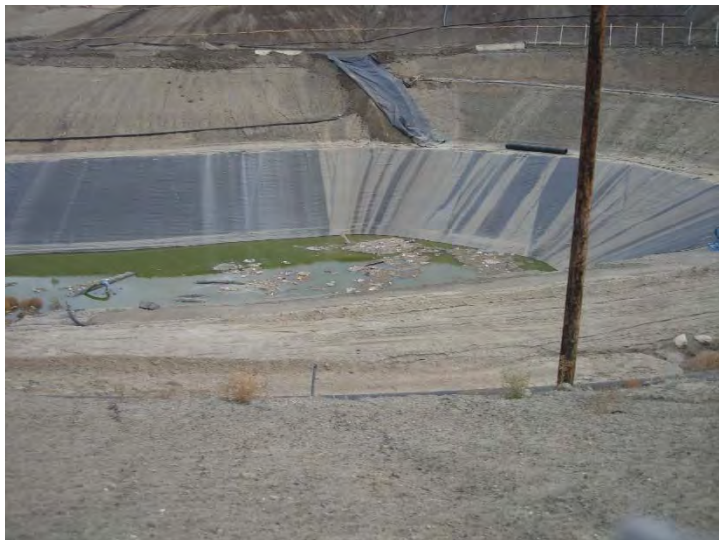
Photo 243: City Lined Drainage Lift Area: October 28, 2015

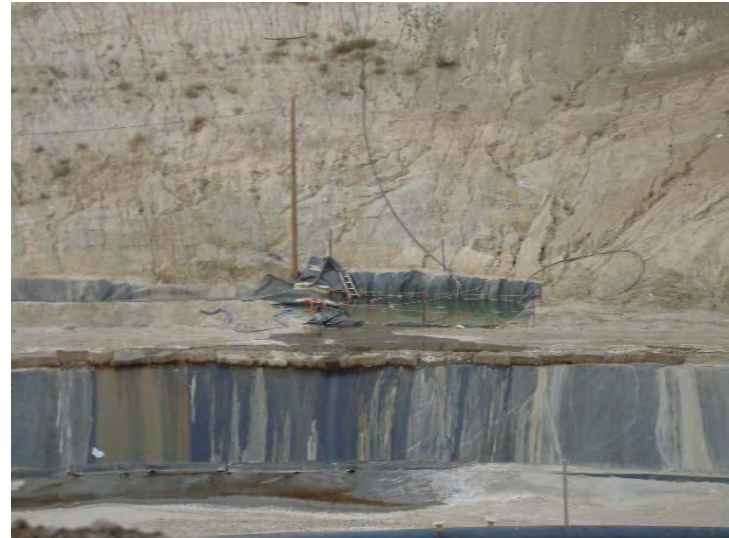
Photo 244: City Lined Drainage Lift Area: October 28, 2015

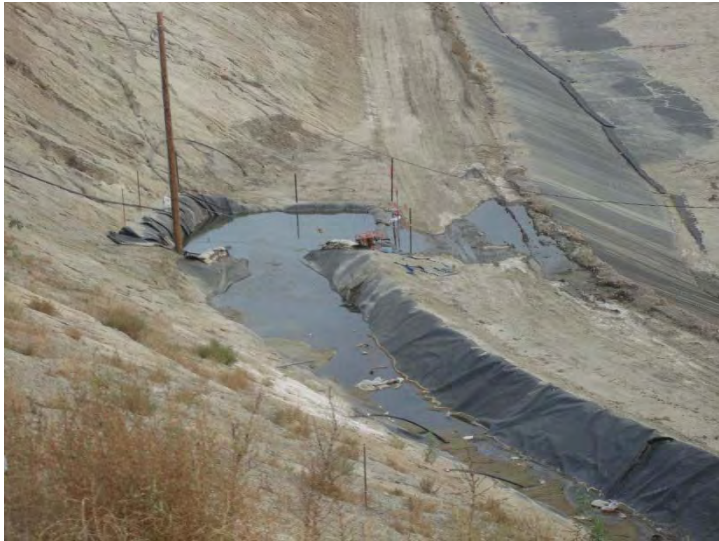
Photo 245: City Lined Drainage Lift Area: October 28, 2015

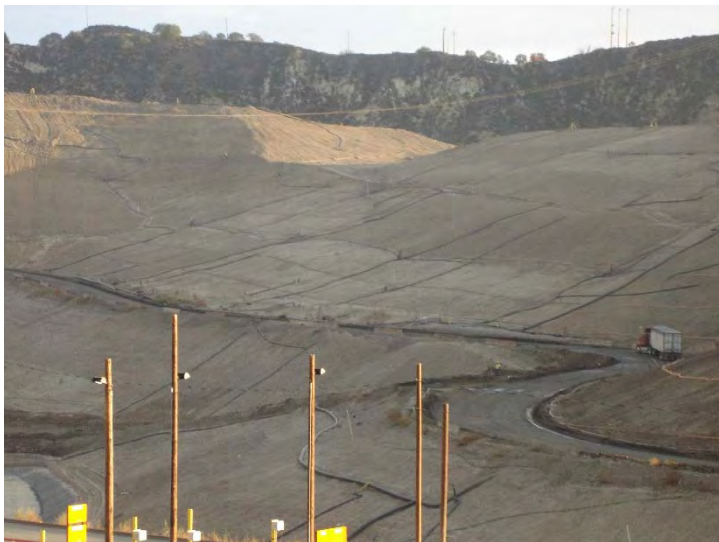
Photo 247: City Slope Erosion Control: October 14, 2015

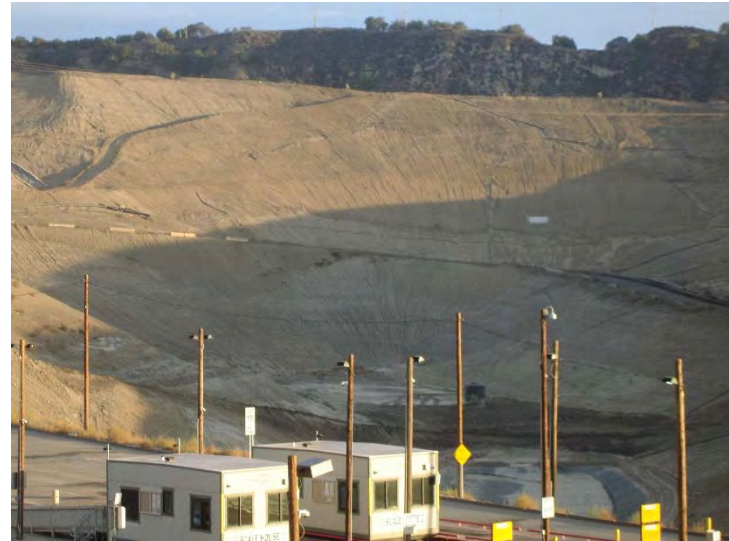
Photo 246: City Slope Erosion Control: October 14, 2015

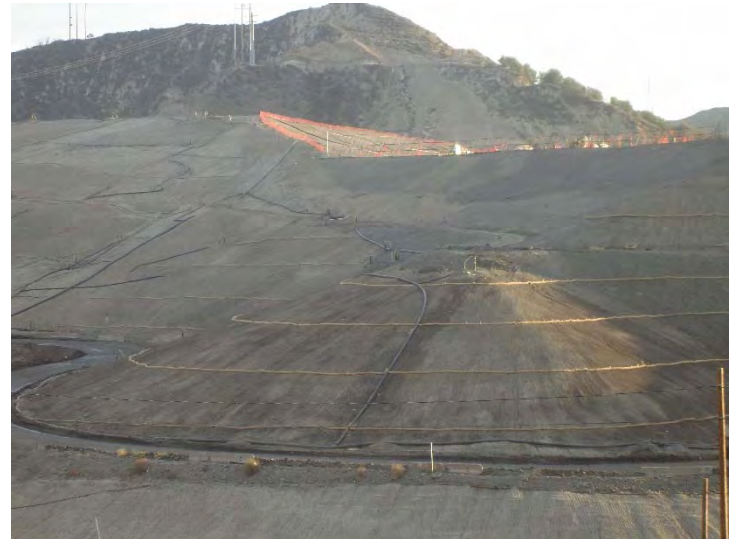
Photo 248: City Slope Erosion Control: October 14, 2015

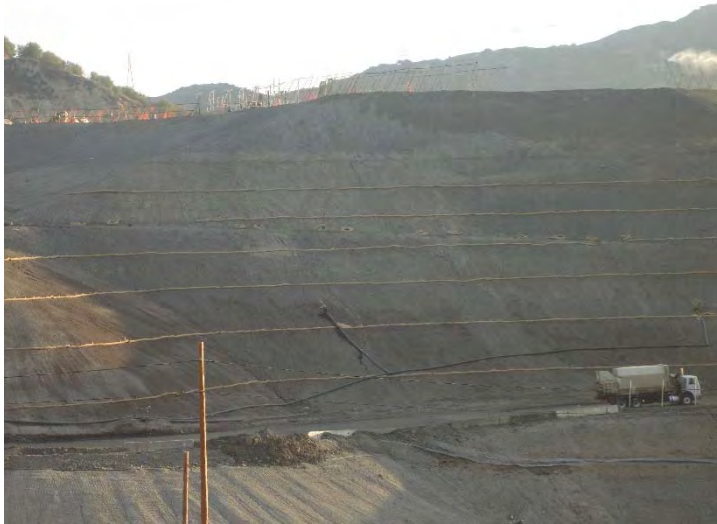
Photo 249: City Slope Erosion Control: October 14, 2015

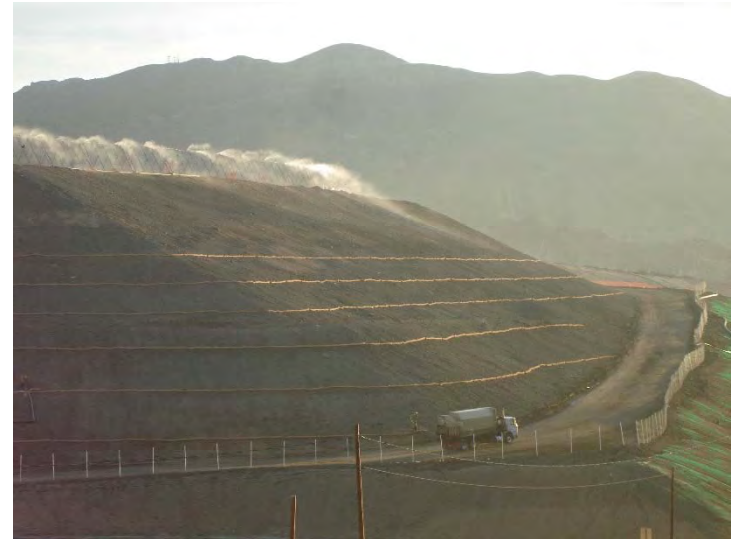
Photo 250: City Slope Erosion Control: October 14, 2015

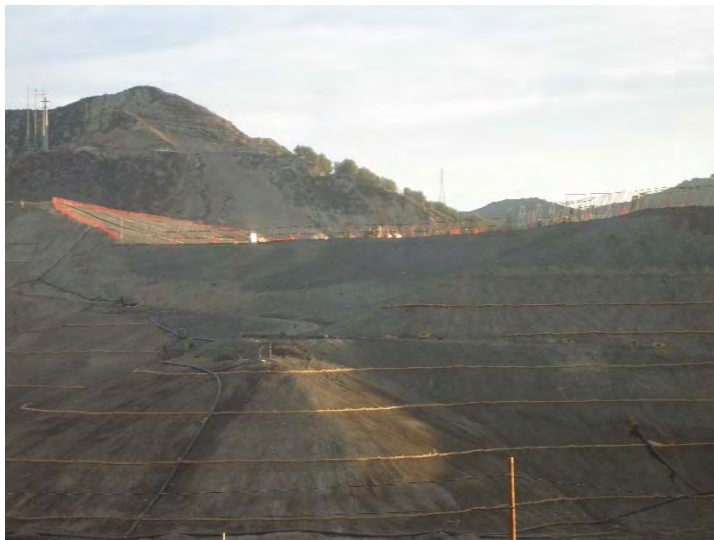
Photo 251: City Slope Erosion Control: October 14, 2015

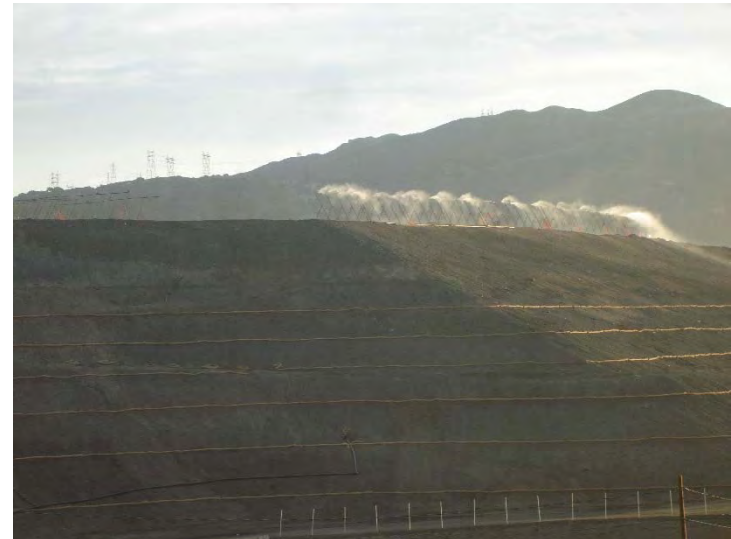
Photo 252: City Slope Erosion Control: October 14, 2015

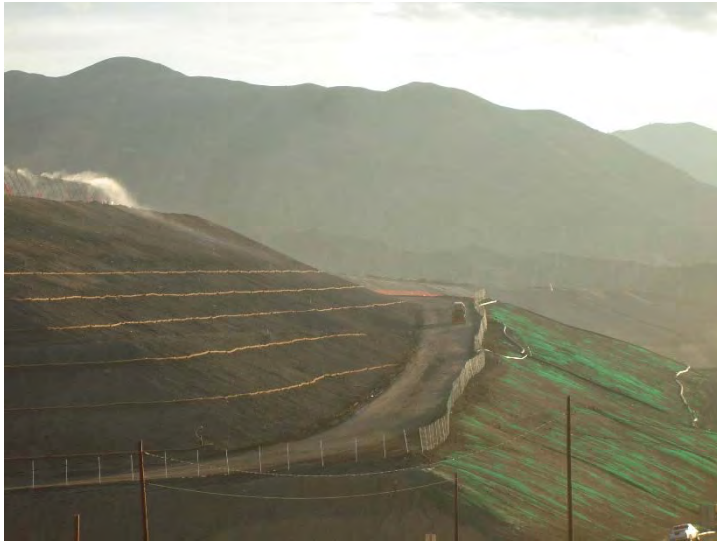
Photo 253: City Slope Erosion Control: October 14, 2015

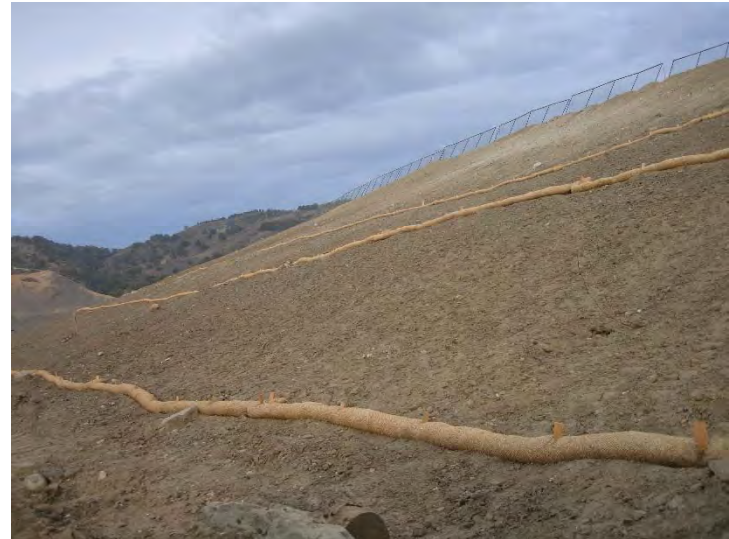
Photo 254: City Slope Erosion Control: October 28, 2015

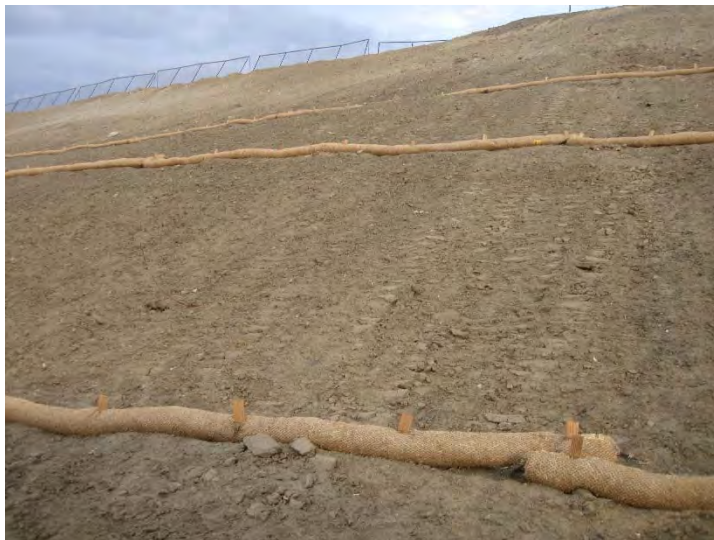
Photo 255: City Slope Erosion Control: October 28, 2015

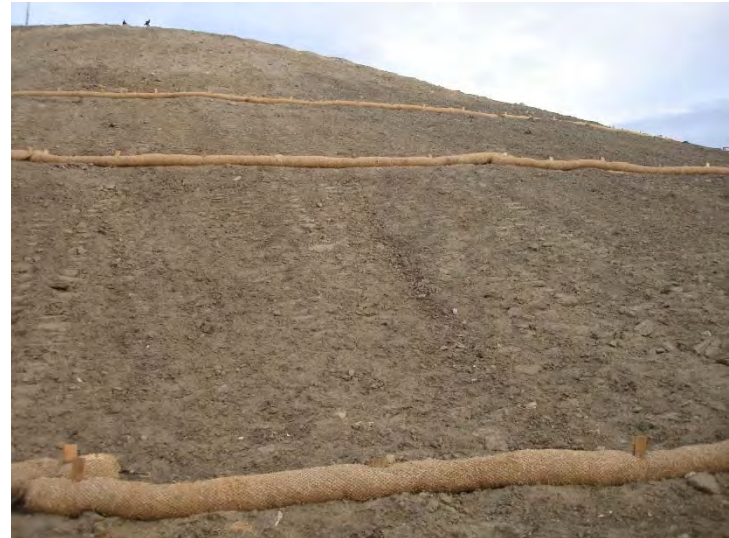
Photo 256: City Slope Erosion Control: October 28, 2015

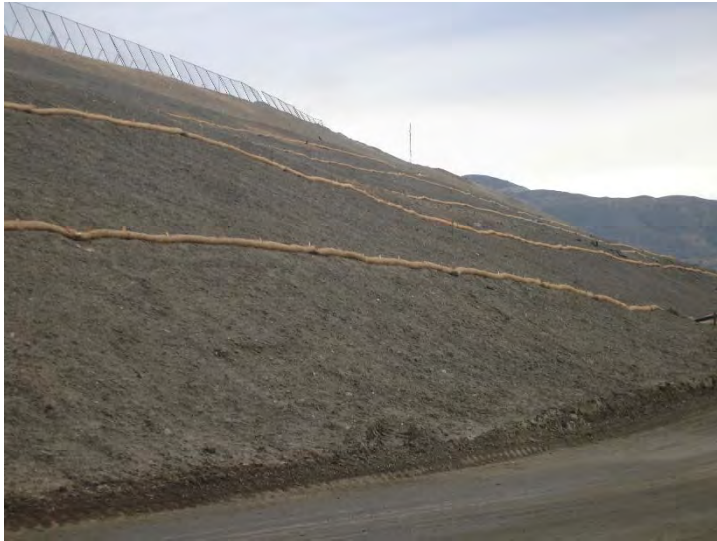
Photo 257: City Slope Erosion Control: October 28, 2015

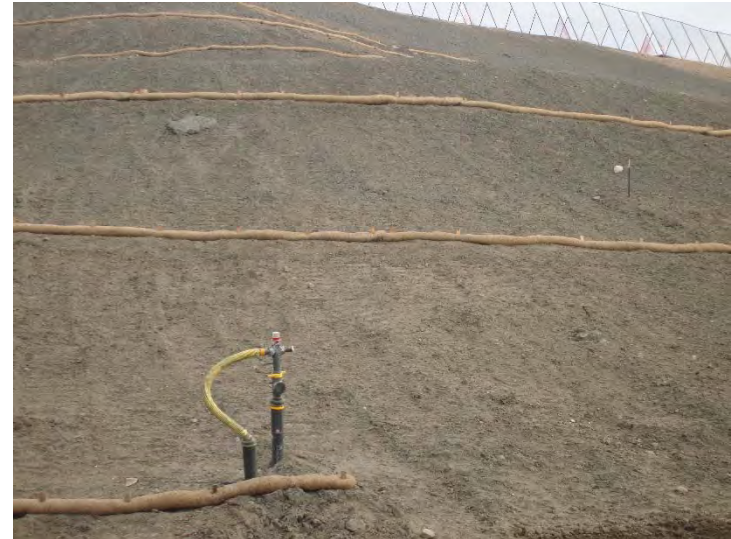
Photo 258: City Slope Erosion Control: October 28, 2015

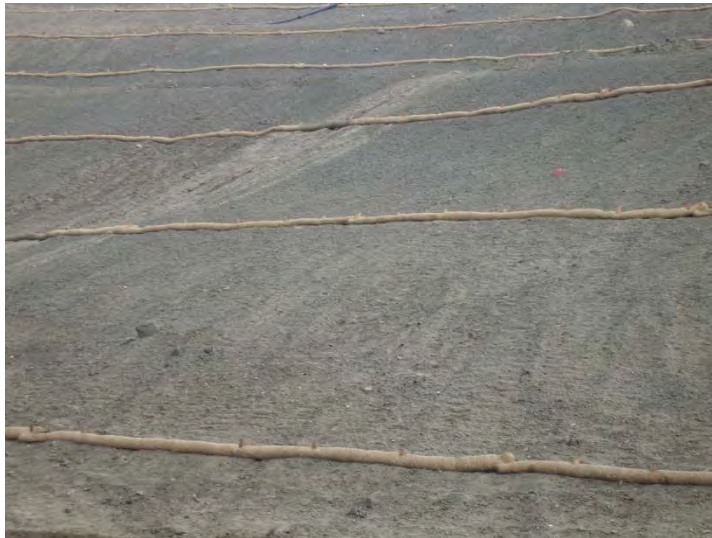
Photo 259: City Slope Erosion Control: October 28, 2015

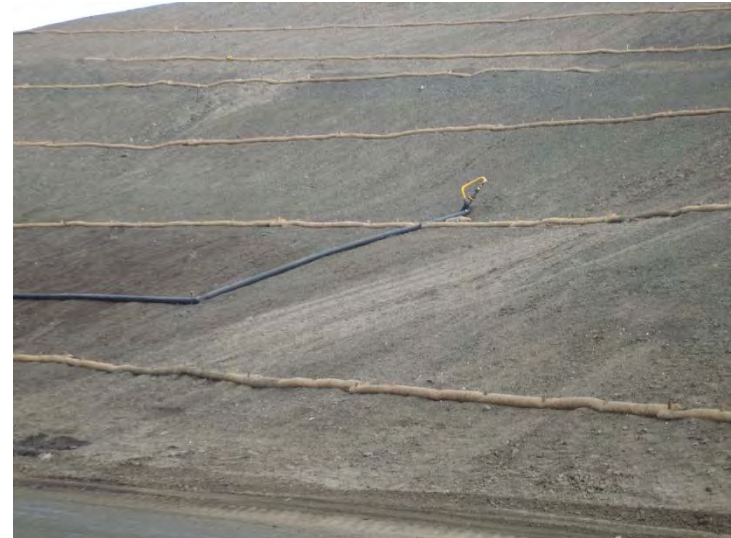
Photo 260: City Slope Erosion Control: October 28, 2015

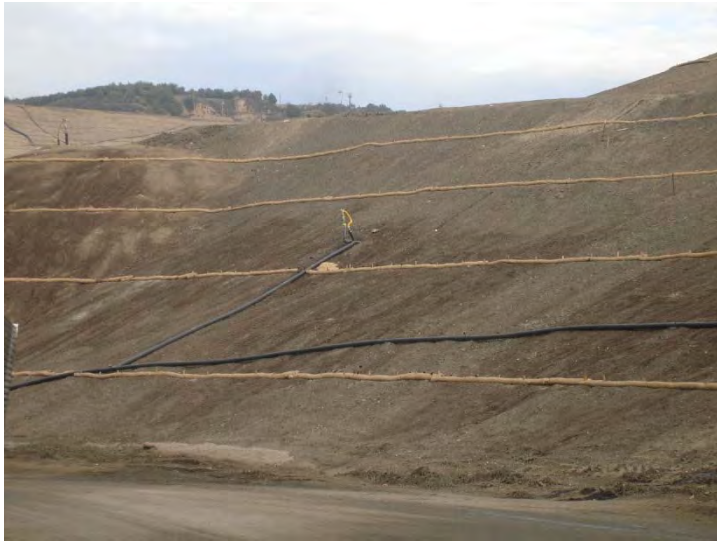
Photo 261: City Slope Erosion Control: October 28, 2015

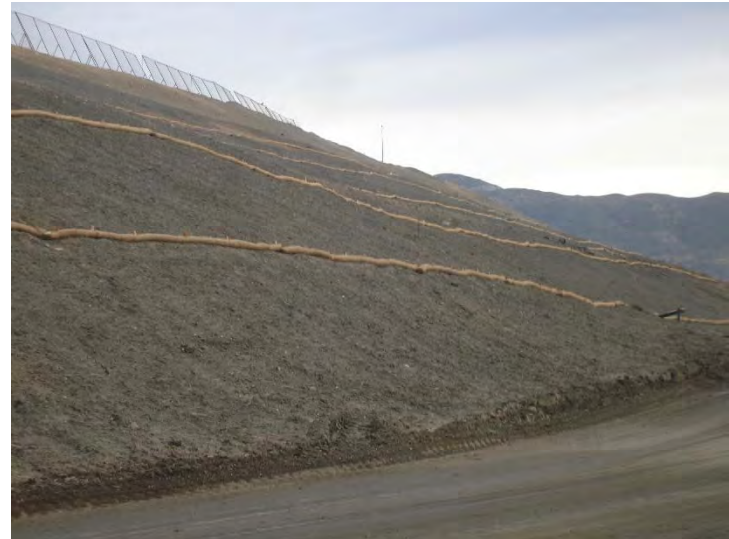
Photo 262: City Slope Erosion Control: October 28, 2015

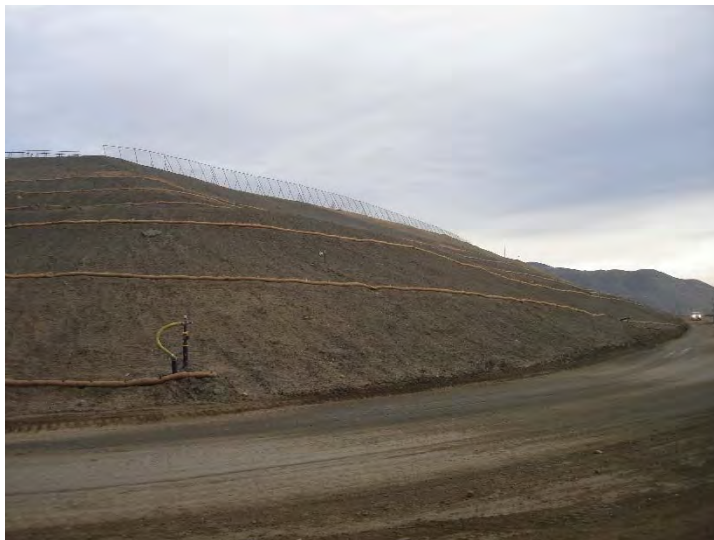
Photo 263: City Slope Erosion Control: October 28, 2015

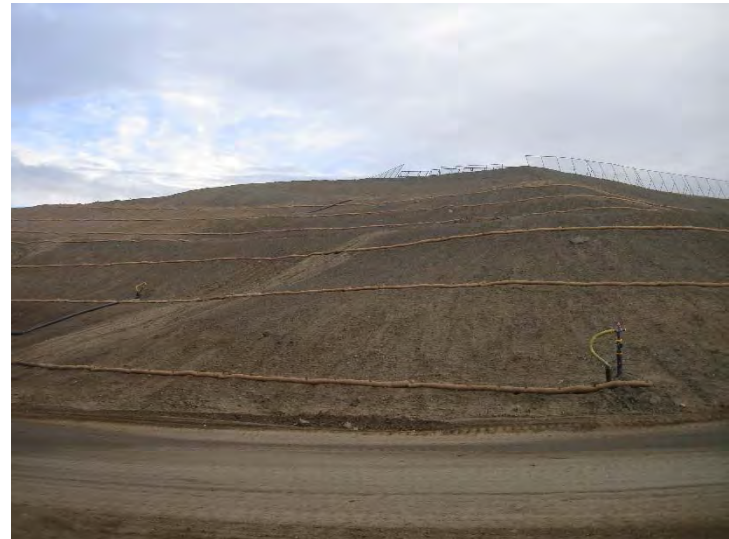
Photo 264: City Slope Erosion Control: October 28, 2015

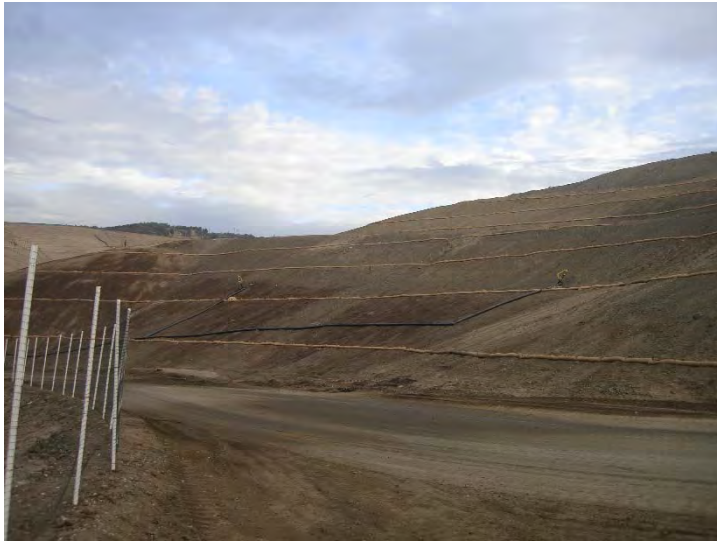
Photo 265: City Slope Erosion Control: October 28, 2015

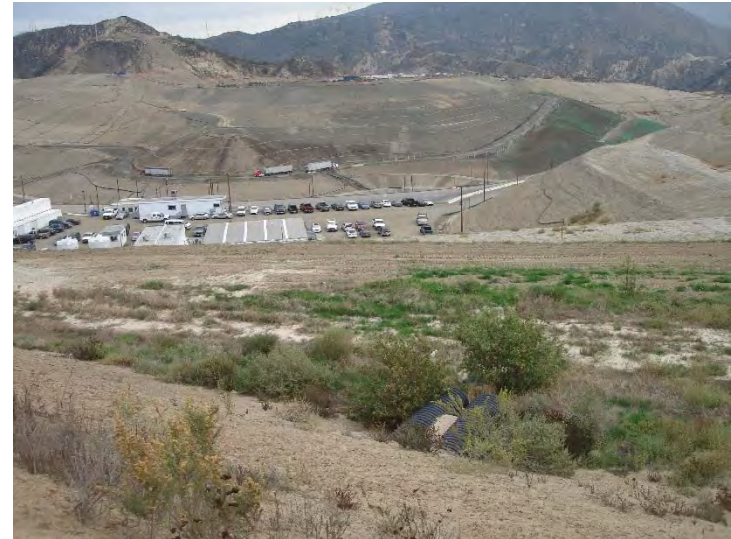
**Photo 266: Native Slope Drainage to Bench Above Offices:
October 28, 2015**

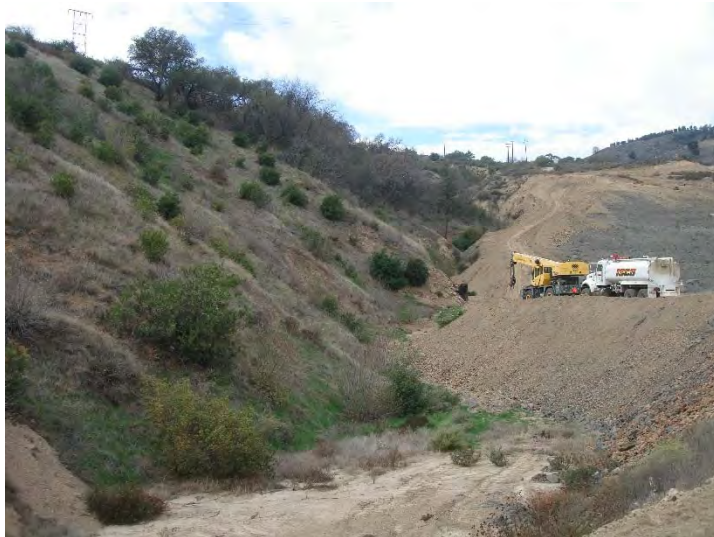
**Photo 267: Native Slope Drainage to Bench Above Offices:
October 28, 2015**

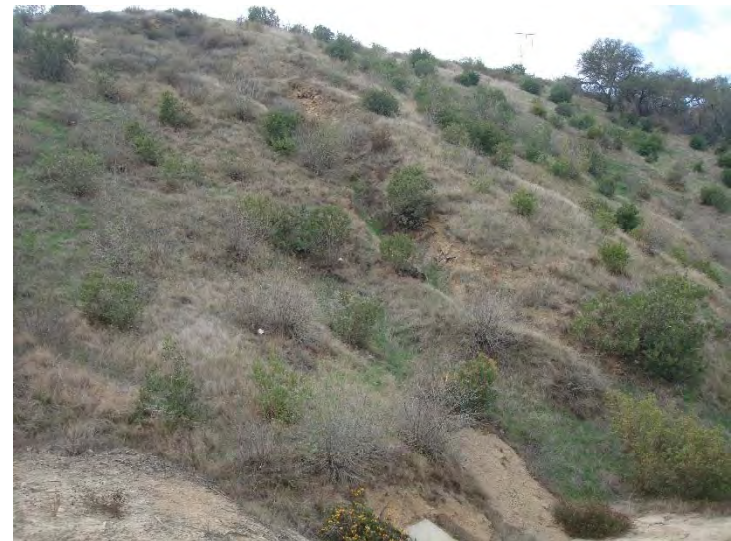
**Photo 268: Native Slope Drainage to Bench Above Offices:
October 28, 2015**

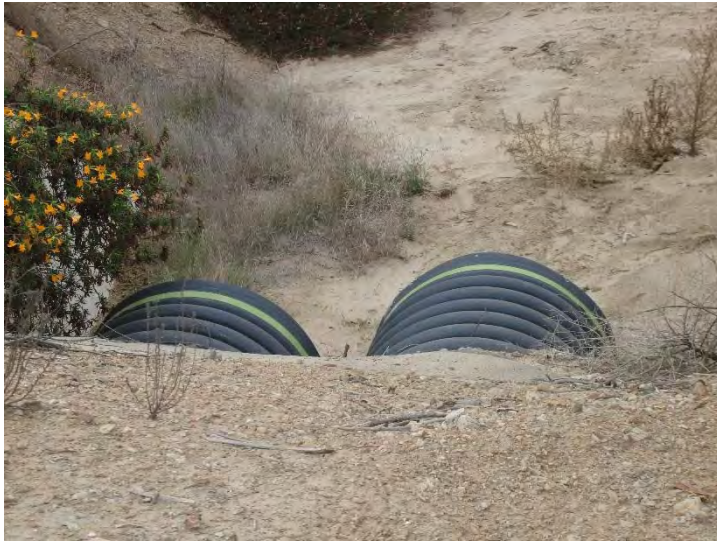
**Photo 269: Native Slope Drainage to Bench Above Offices:
October 28, 2015**

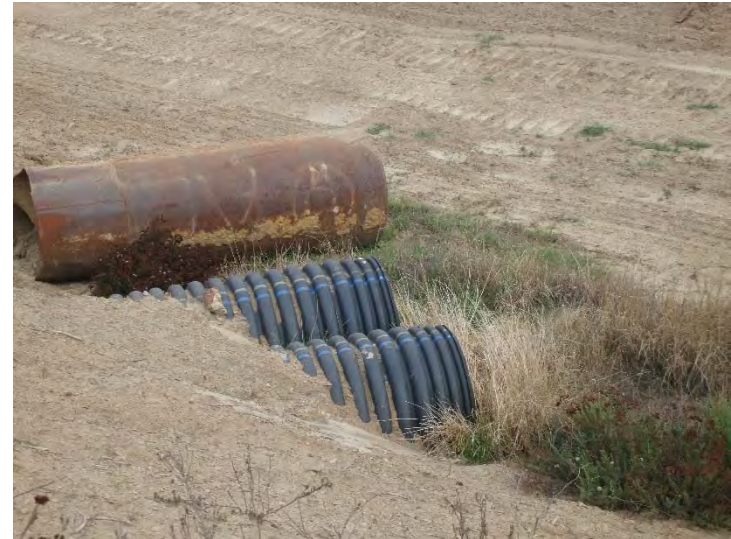
**Photo 270: Native Slope Drainage to Bench Above Offices:
October 28, 2015**

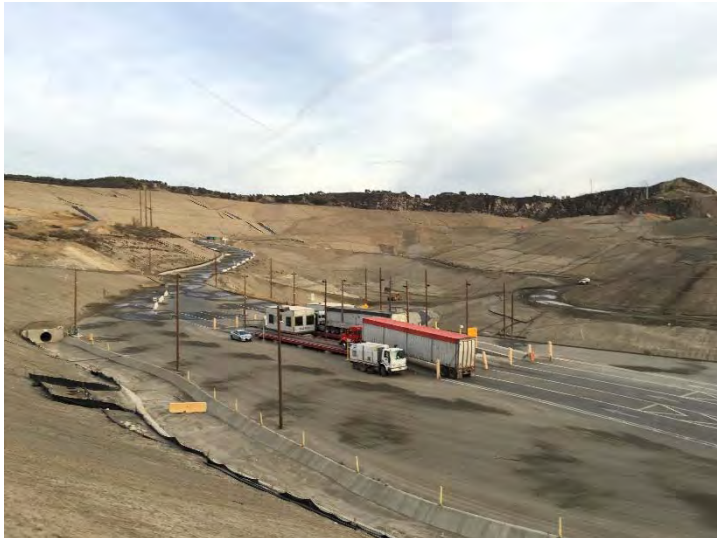
Photo 271: City Slope Erosion Control: December 9, 2015

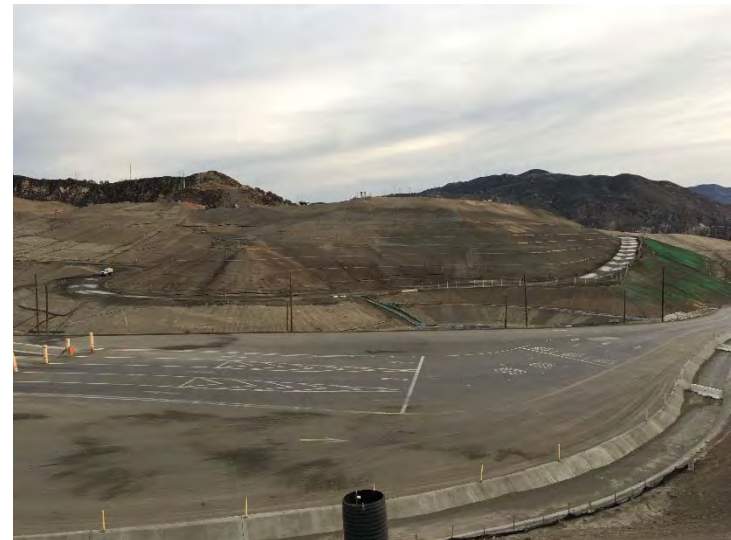
Photo 272: City Slope Erosion Control: December 9, 2015

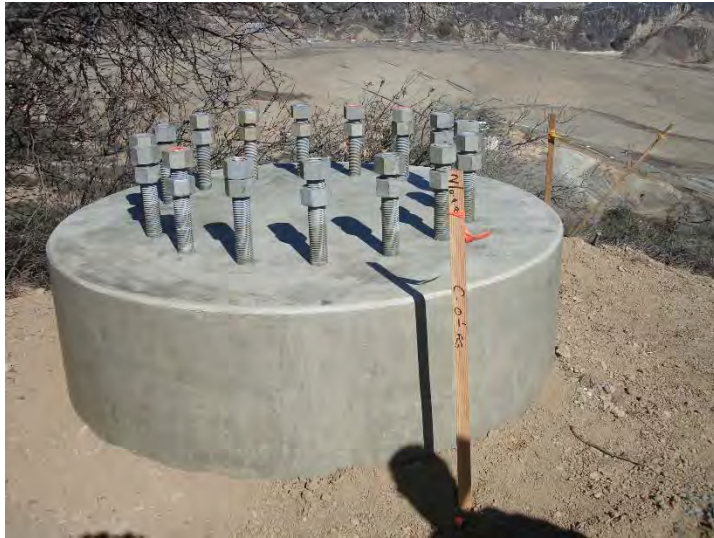
Photo 273: Edison Westside Ridge New Pole Foundation: October 28, 2015

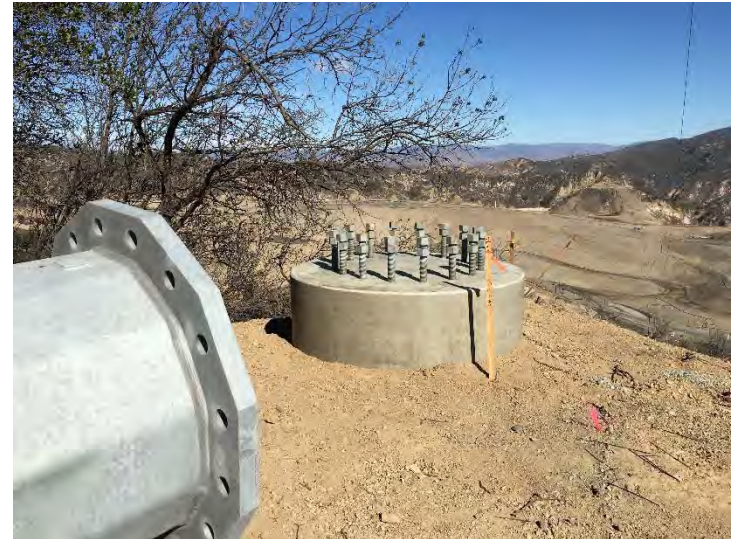
Photo 274: Edison Westside Ridge New Pole: November 16, 2015

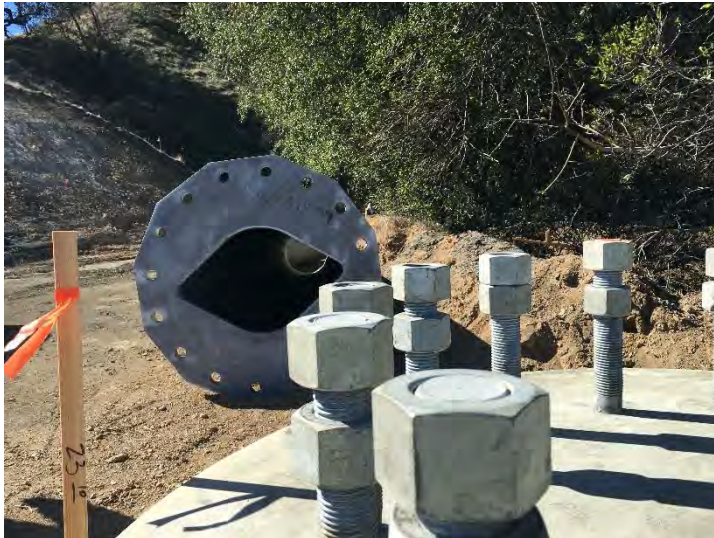
Photo 275: Edison Westside Ridge New Pole

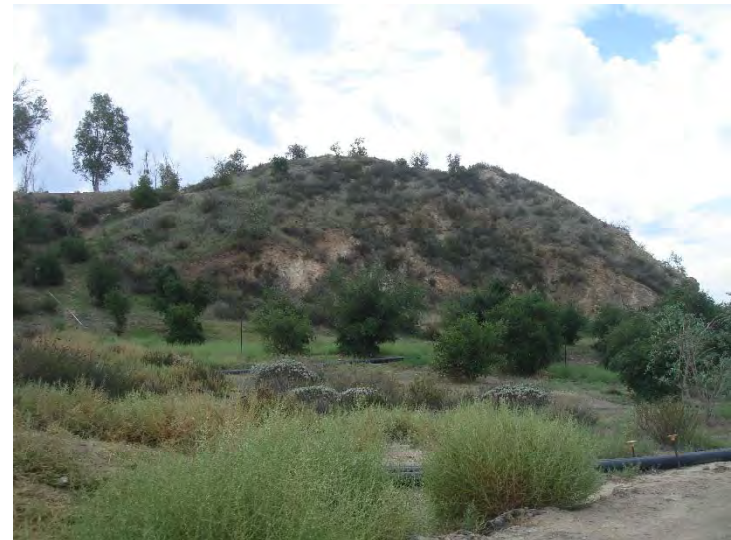
Photo 276: City Sage Mitigation Deck C: October 14, 2015

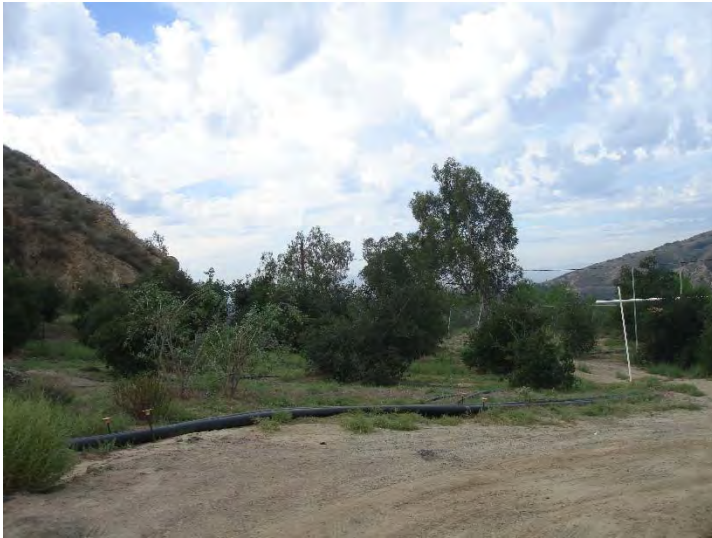
Photo 277: City Sage Mitigation Deck C: October 14, 2015

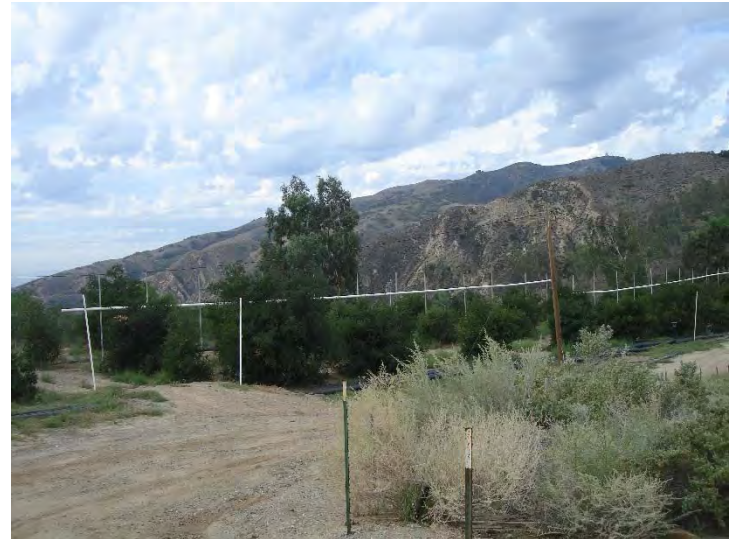
Photo 278: City Sage Mitigation Deck C: October 14, 2015

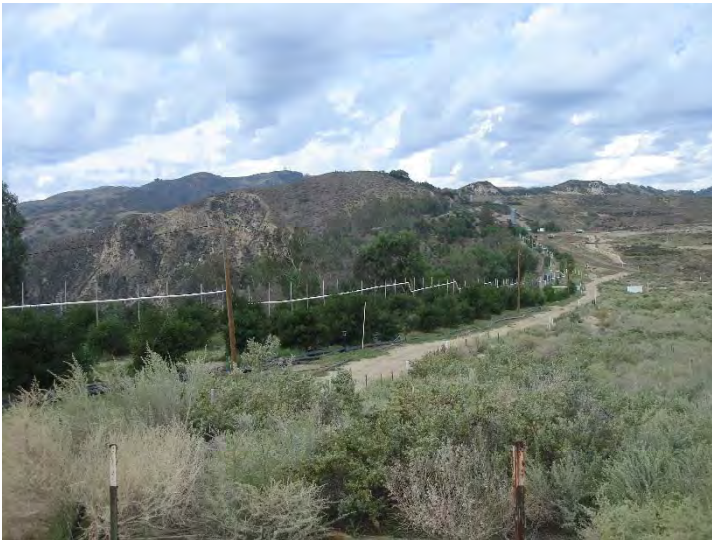
Photo 279: City Sage Mitigation Deck C: October 14, 2015

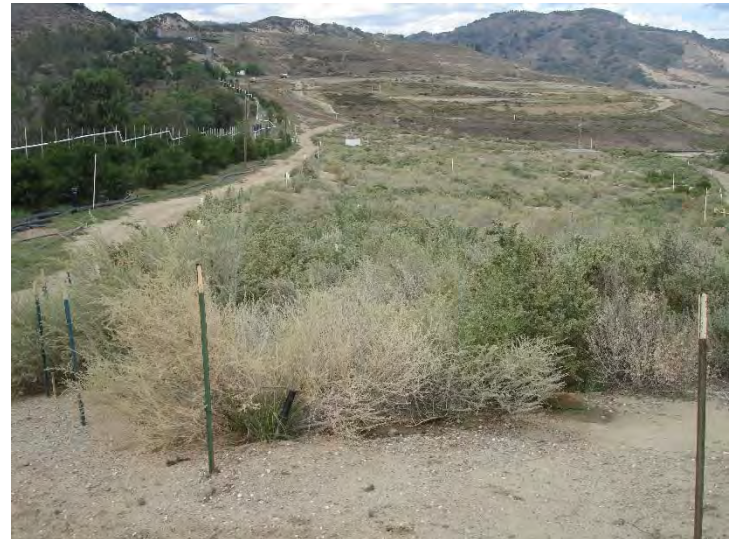
Photo 280: City Sage Mitigation Deck C: October 14, 2015

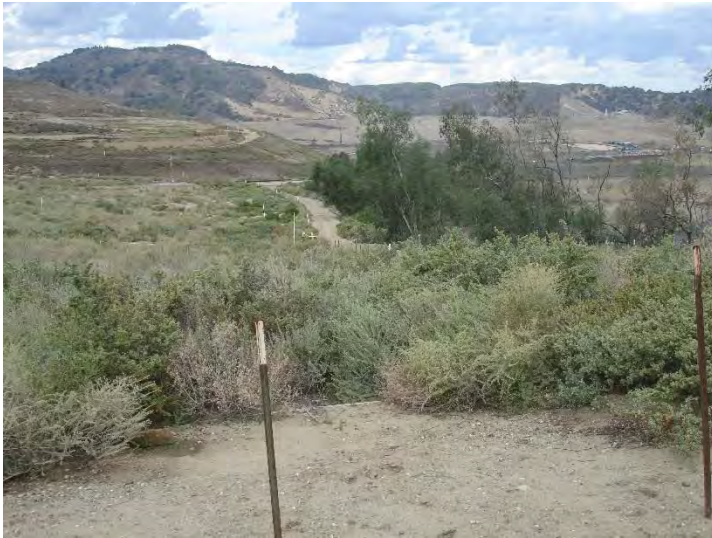
Photo 281: City Sage Mitigation Deck C: October 14, 2015

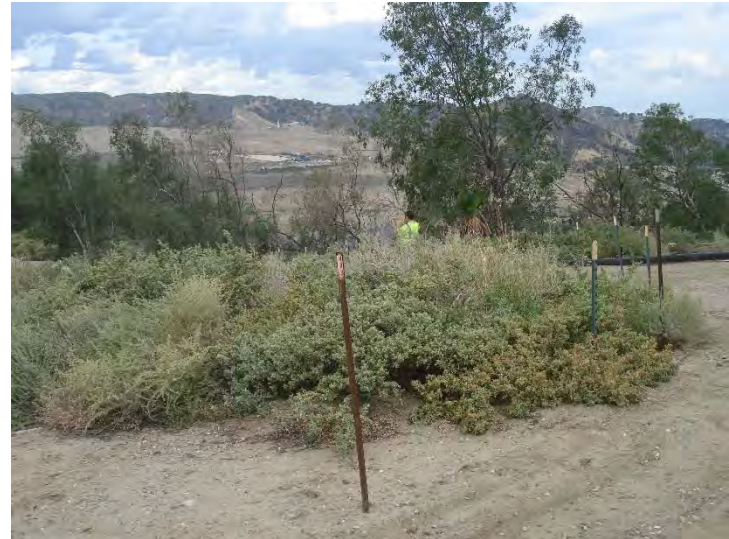
Photo 282: City Sage Mitigation Deck C: October 14, 2015

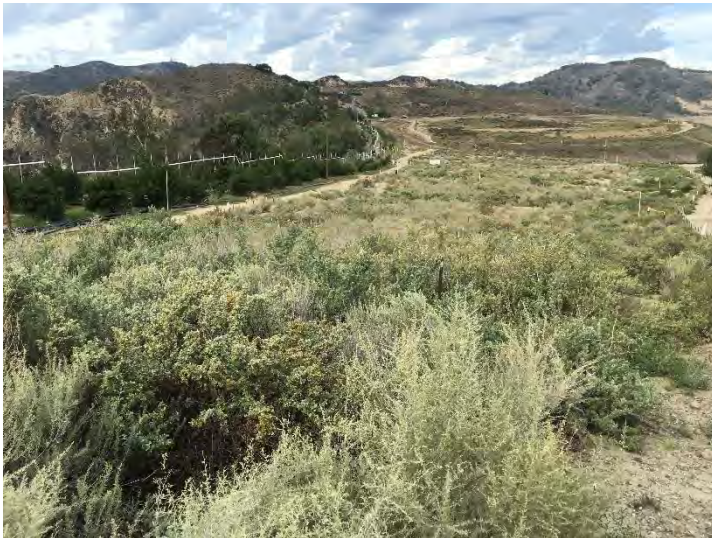
Photo 283: City Sage Mitigation Deck C: October 14, 2015

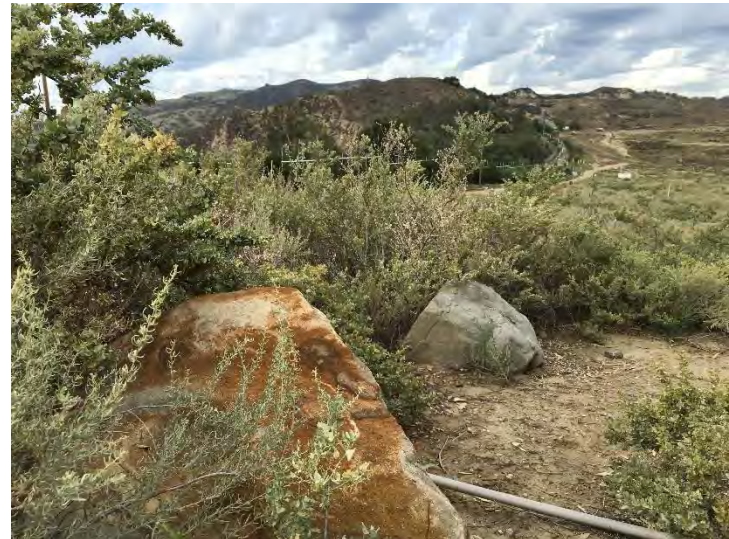
Photo 284: City Sage Mitigation Deck C: October 14, 2015

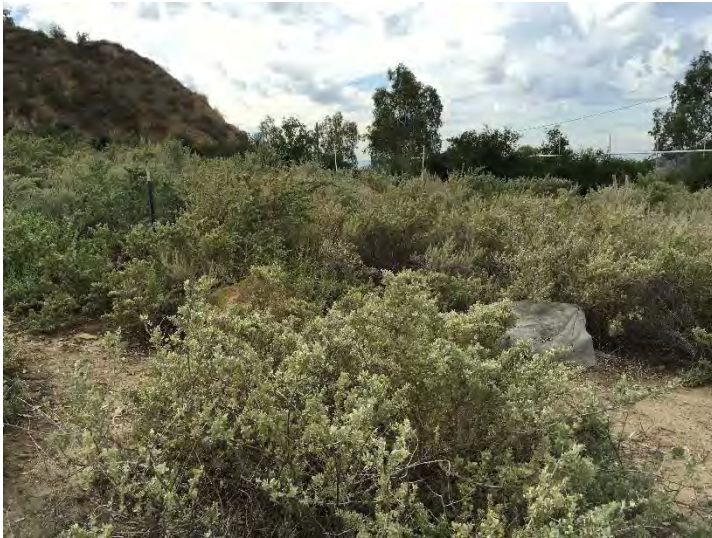
Photo 285: City Sage Mitigation Deck C: October 14, 2015

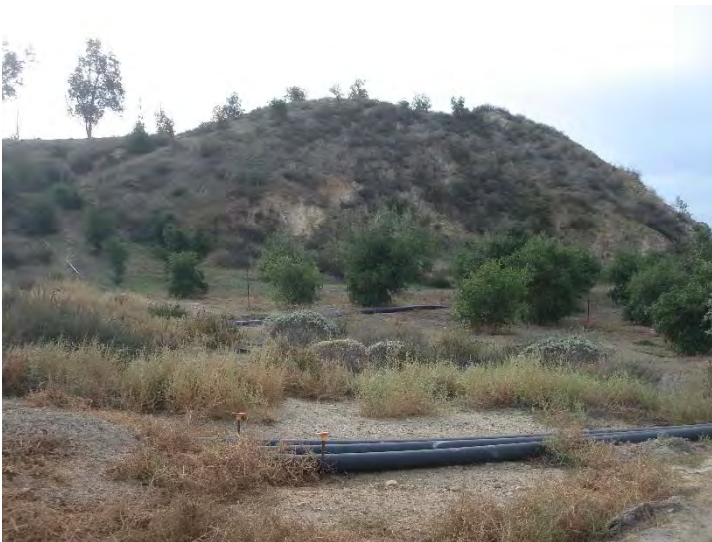
Photo 286: City Sage Mitigation Deck C: October 14, 2015
