**Sunshine Canyon Landfill
Independent Monitor
Quarterly Site Monitoring Status Report
October 1, 2015 – December 31, 2015**

February 12, 2016

The attached Quarterly Site Monitoring Status Report for the Sunshine Canyon Landfill dated February 12, 2016 is the Fourth Quarterly Report for 2015, issued by UltraSystems. This report covers the monitoring period from October 1, 2015 through December 31, 2015 and is prepared for the City of Los Angeles Department of City Planning and the County of Los Angeles Department of Regional Planning.

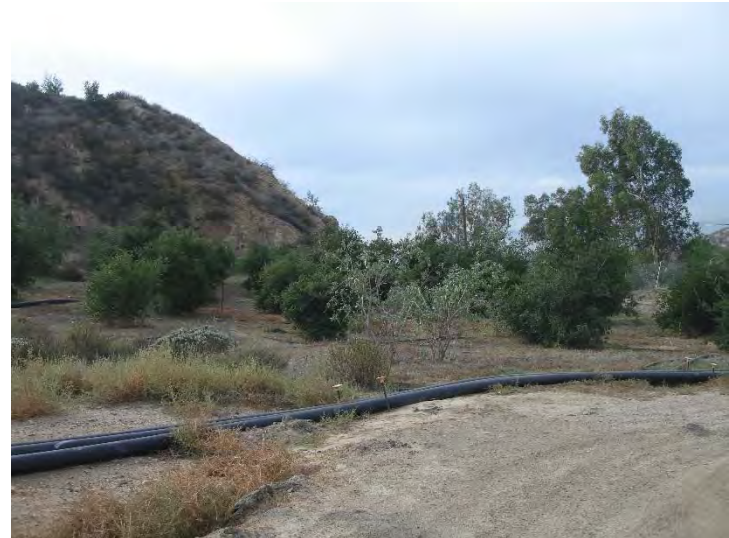
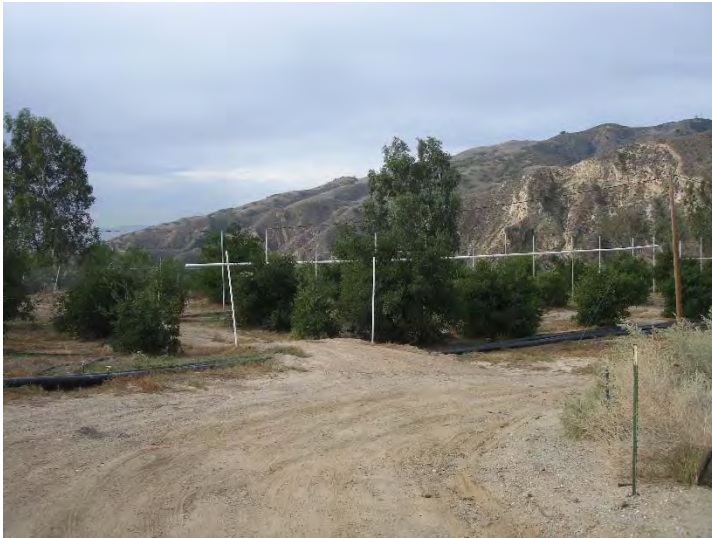
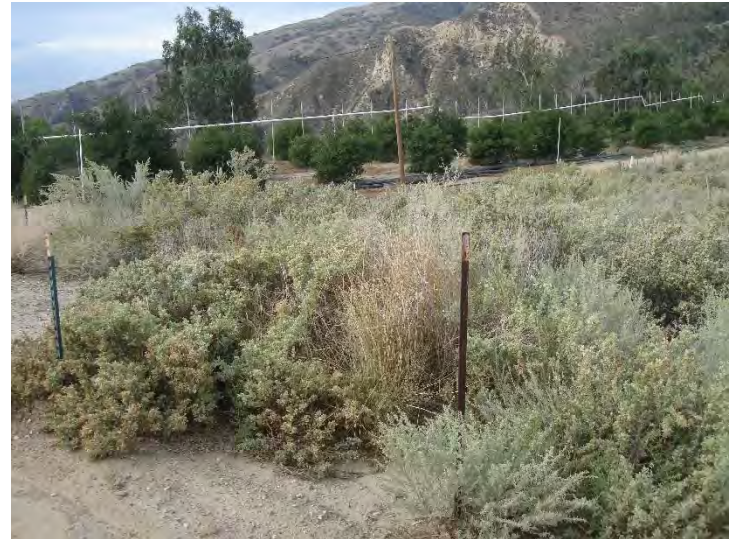
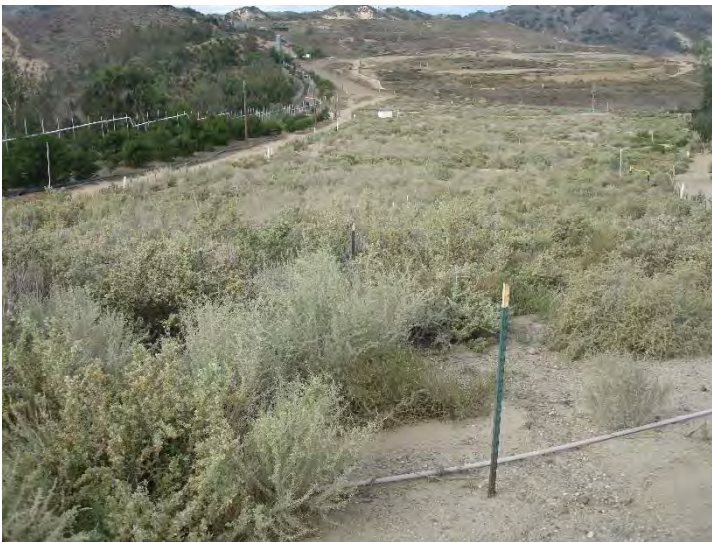
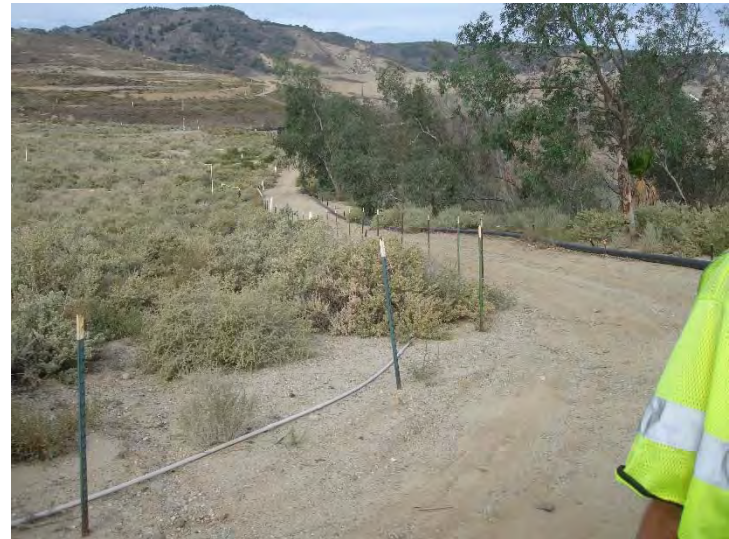
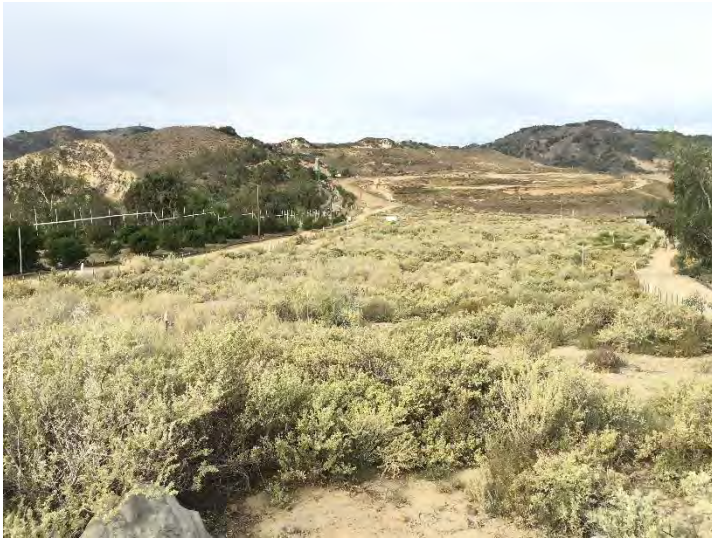
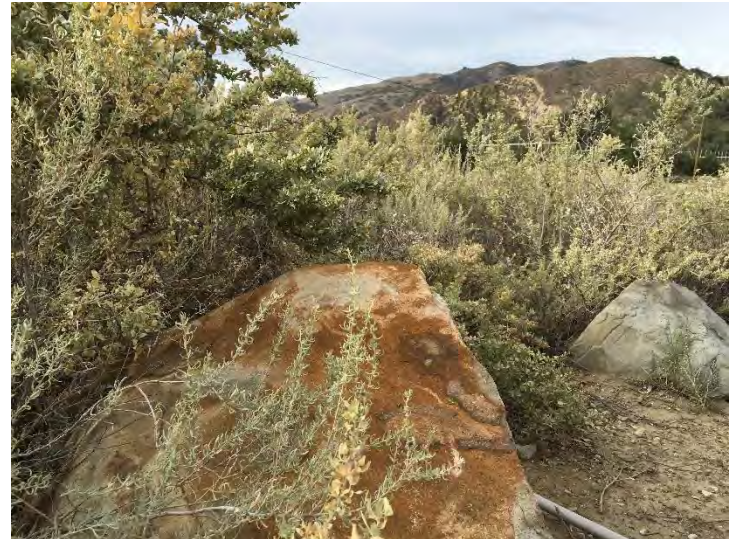
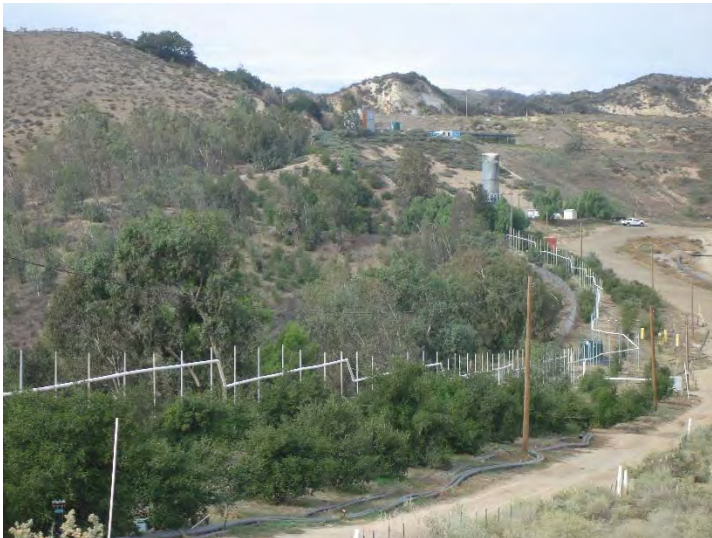
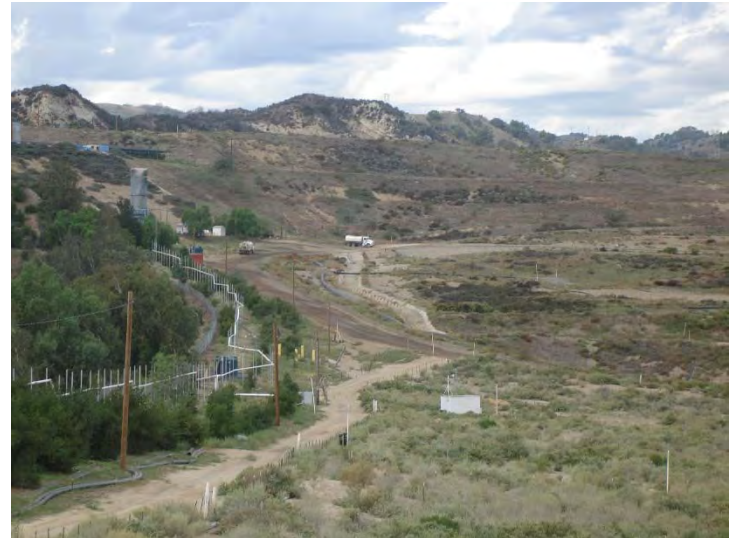
Photo 287: City Sage Mitigation Deck C: October 28, 2015

- There was no sage mitigation activity on Decks A or B.
- The new water tank foundation has not been backfilled with soil. The soil on the deck adjacent to the tank is powder-like soil and should be treated with sealant.

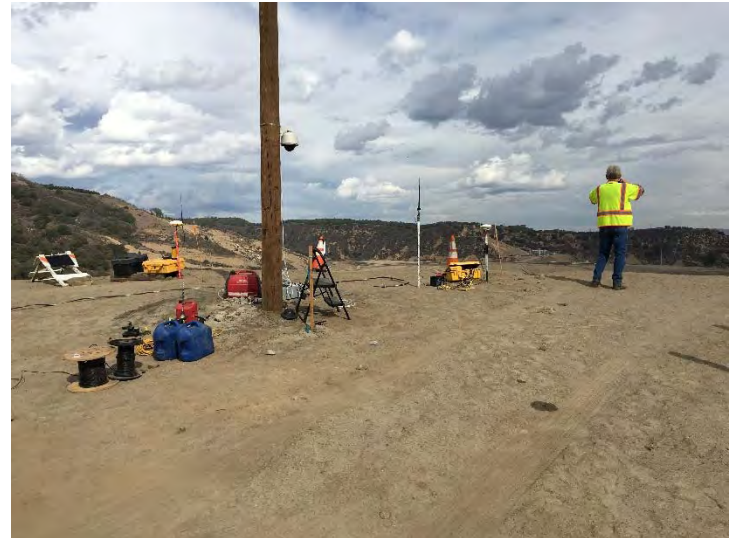
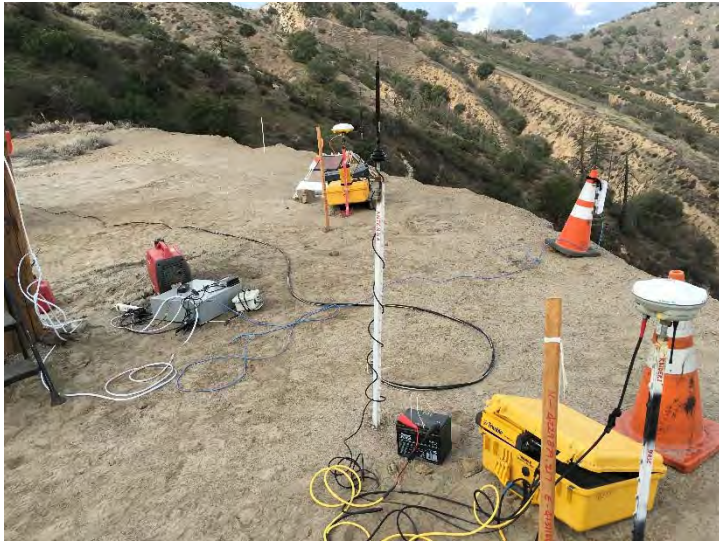
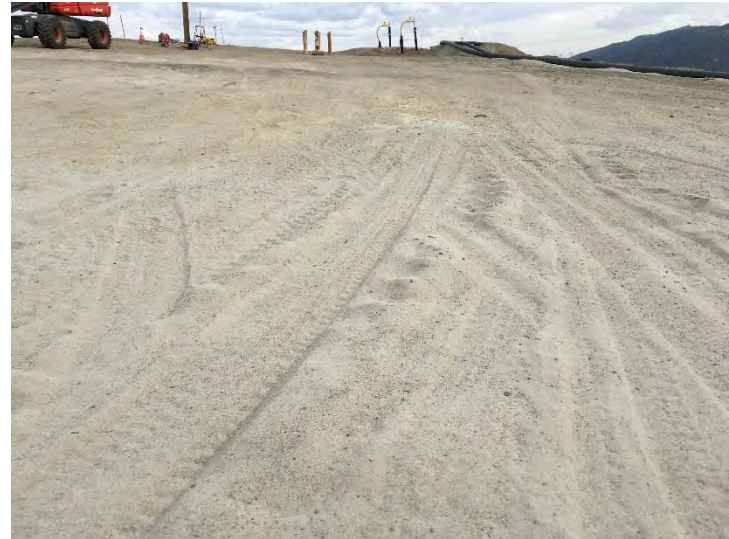
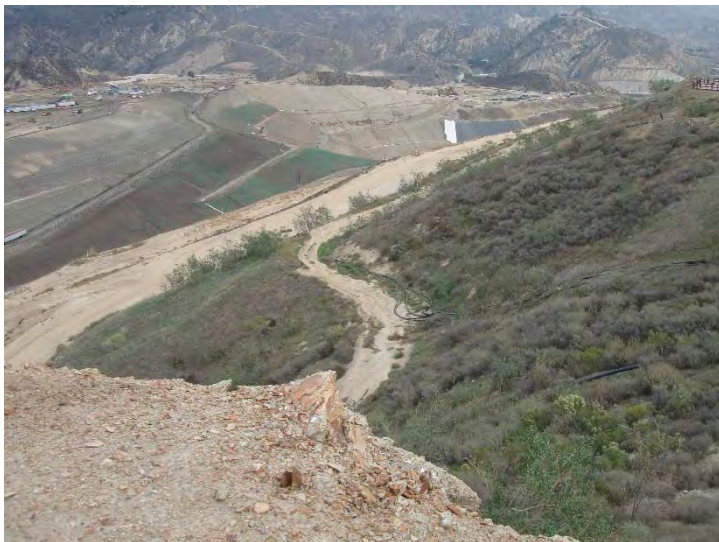
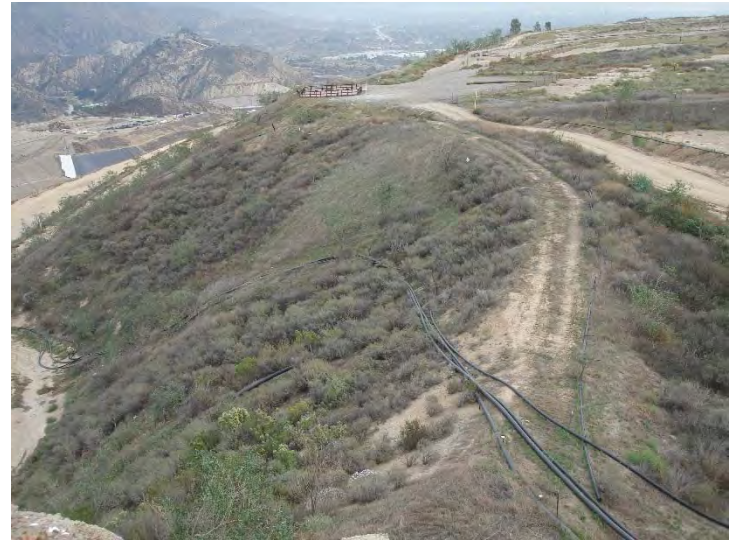
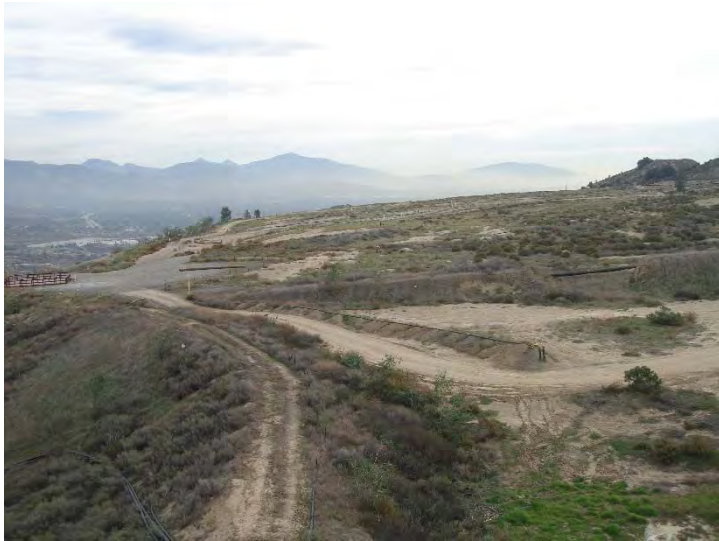
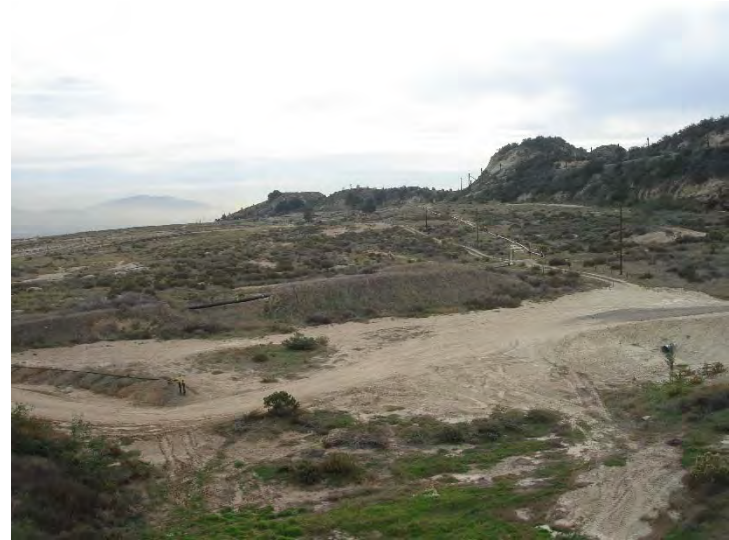
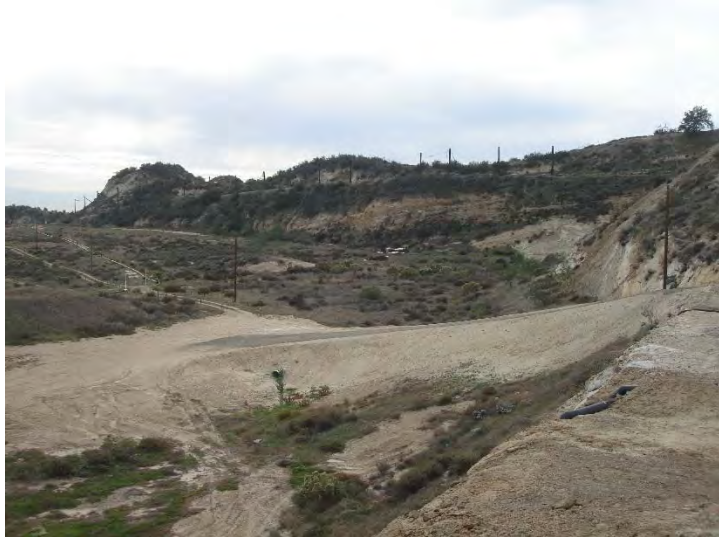
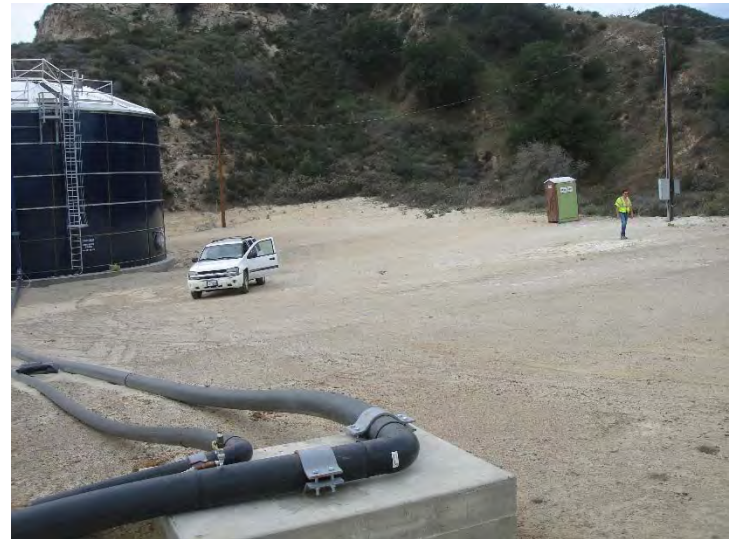
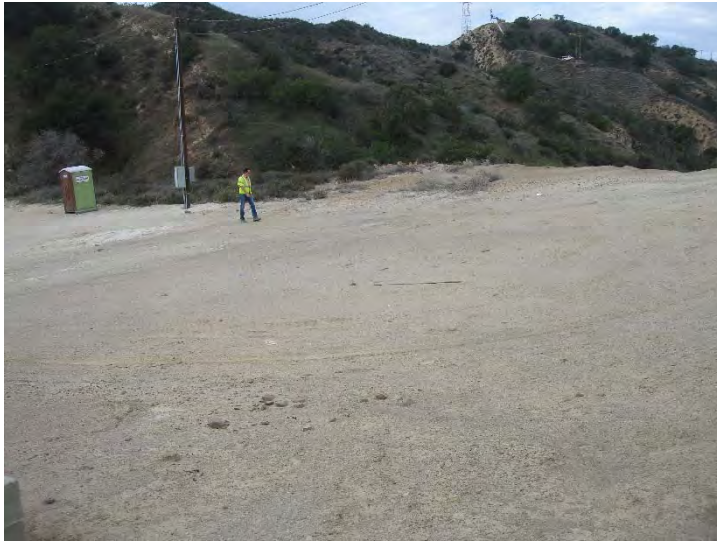
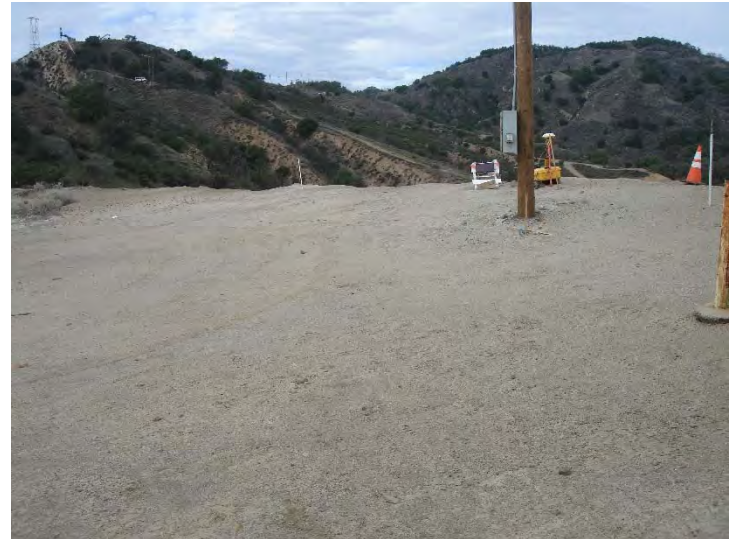
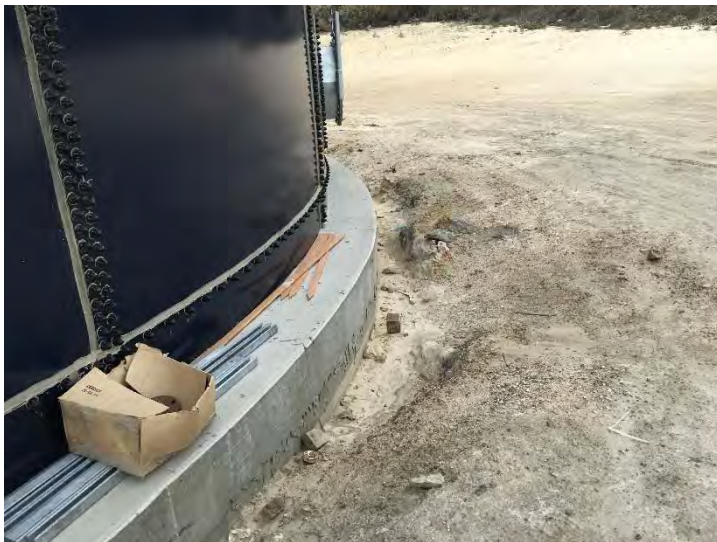
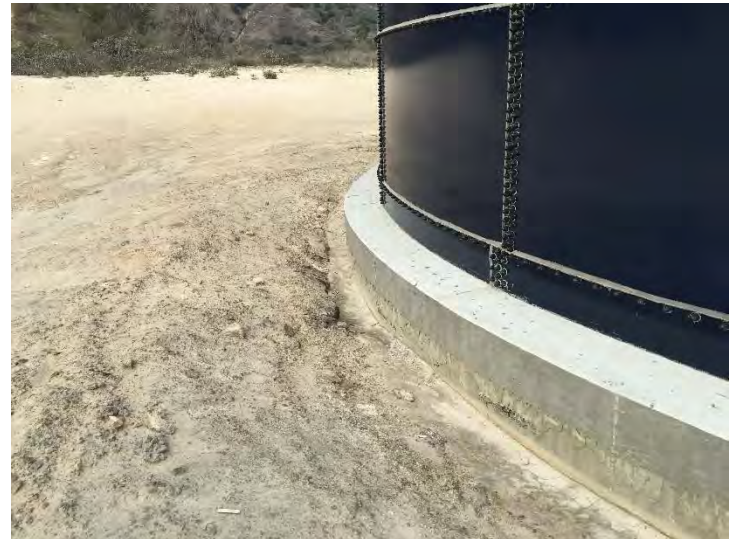
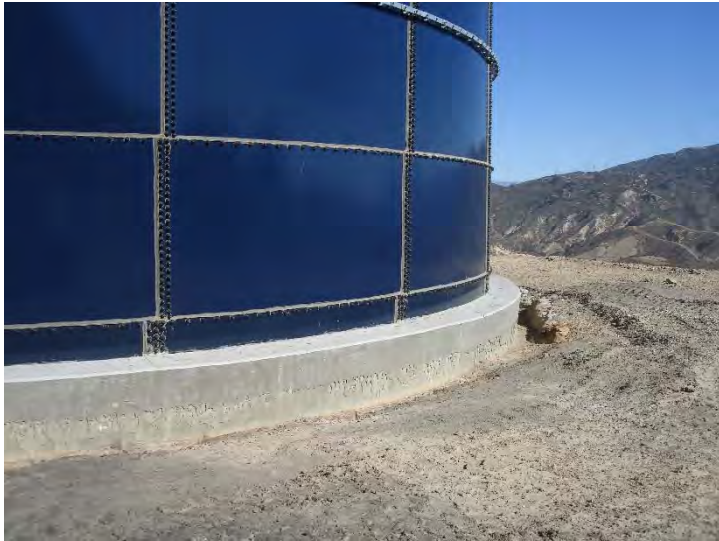
Photo 312: New City South Water Tank Deck A: October 28, 2015

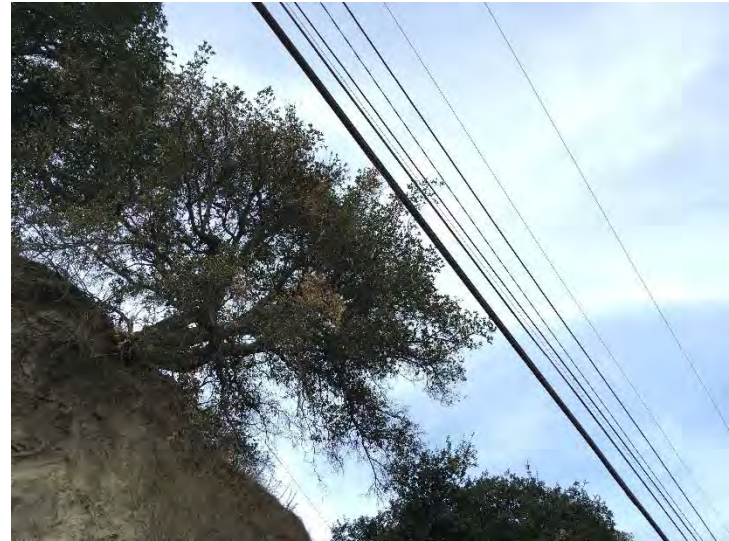
Photo 342: Tree over Powerline: December 16, 2015

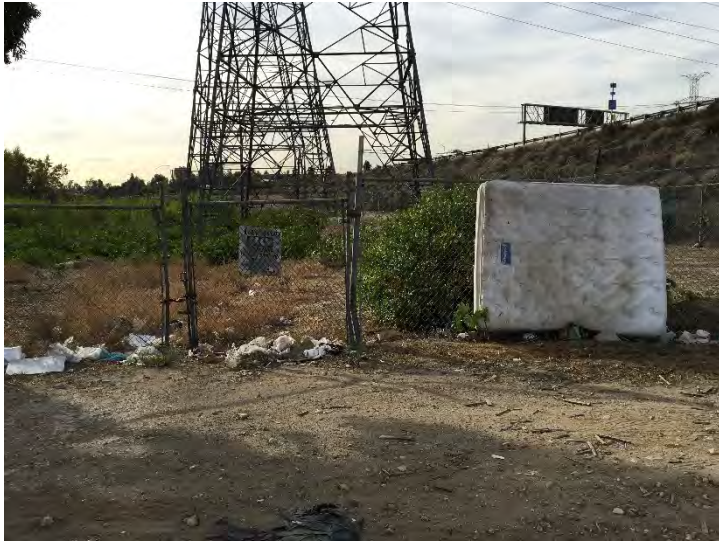
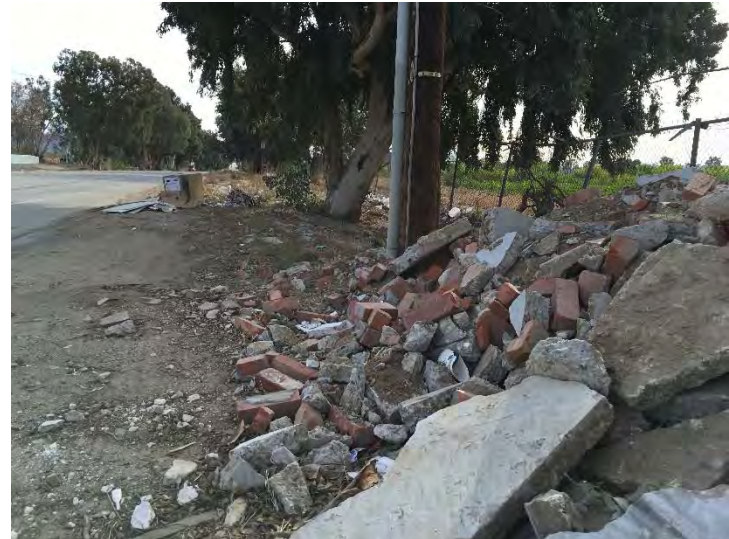
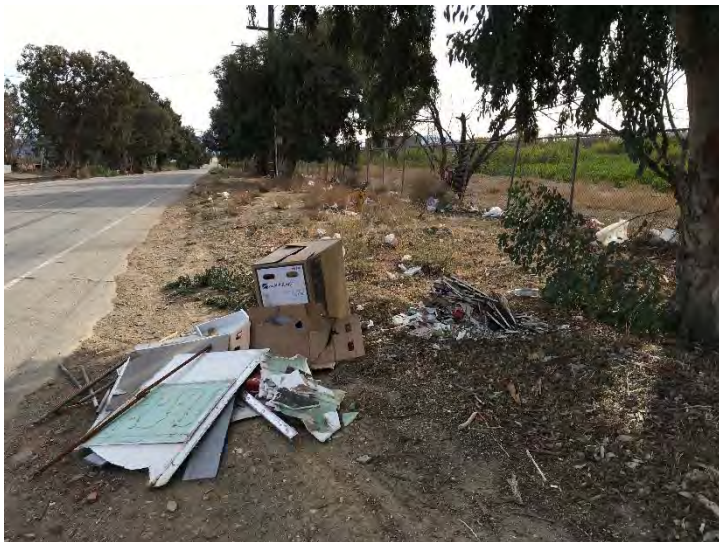
Photo 357: Illegal Dumping: December 9, 2015

Photo 358: Illegal Dumping: December 9, 2015

Photo 359: Illegal Dumping: December 9, 2015

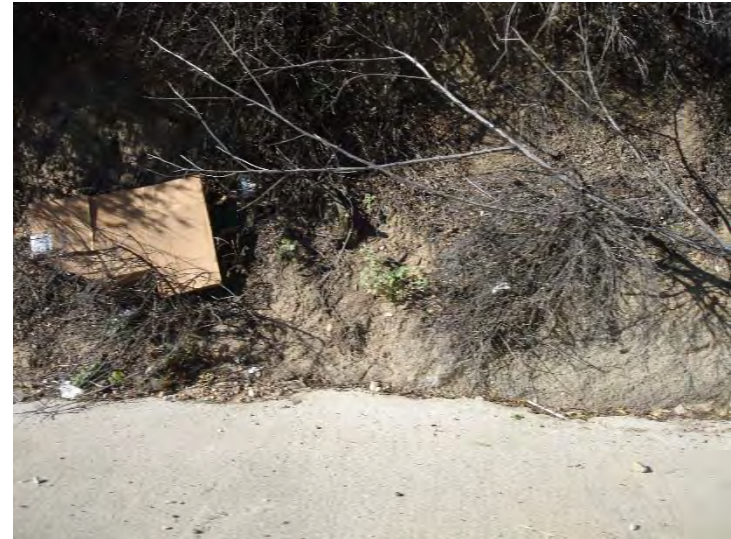
Photo 365: Sierra Highway Near I-14 Overpass: October 28, 2015

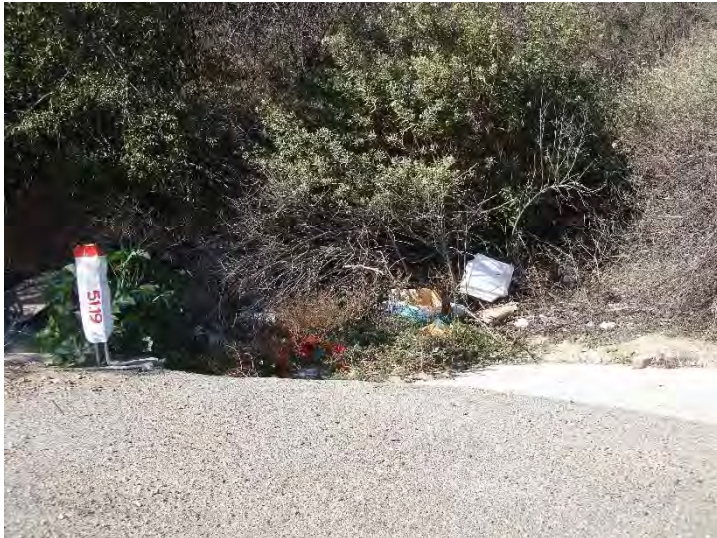
Photo 366: Sierra Highway Near I-14 Overpass: November 16, 2015

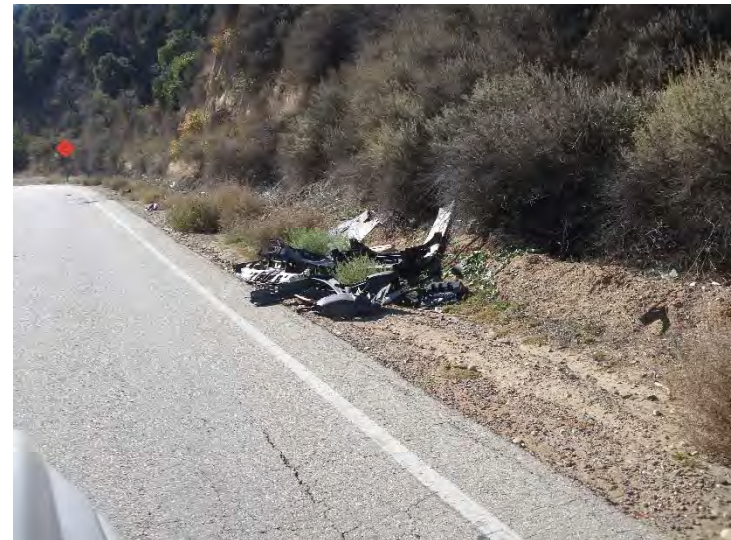
Photo 367: Sierra Highway Near I-14 Overpass: November 16, 2015

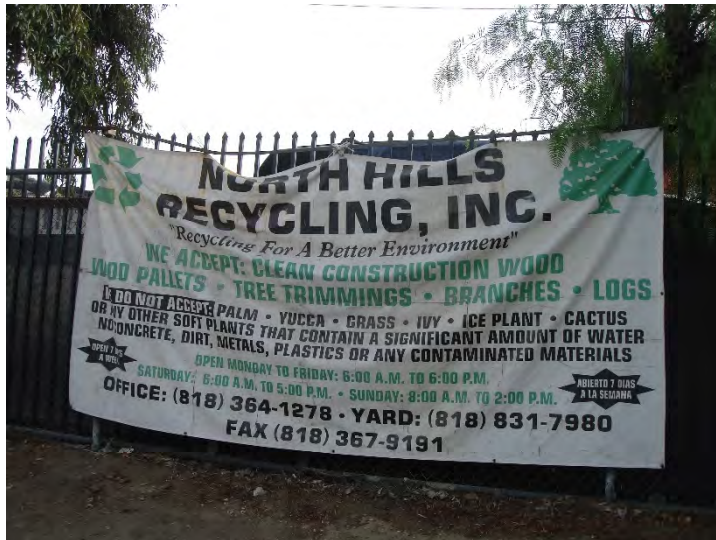
Photo 368: Sierra Highway Near I-14 Overpass: November 16, 2015

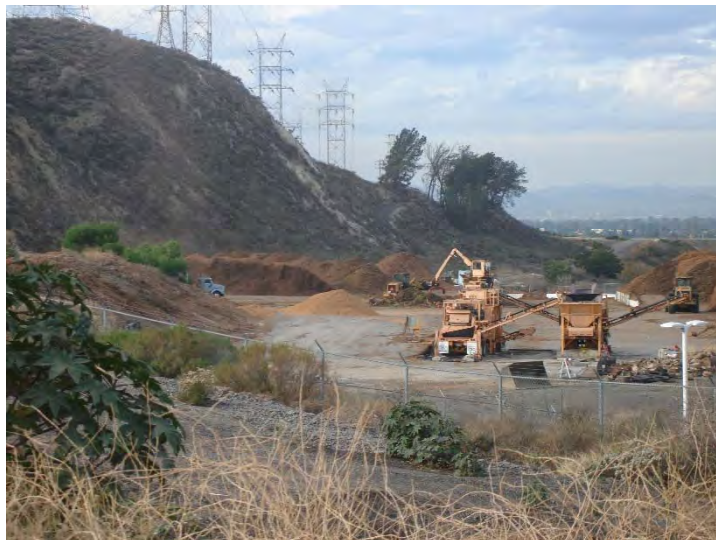
Photo 370: Greenwaste Odor Source: October 14, 2015

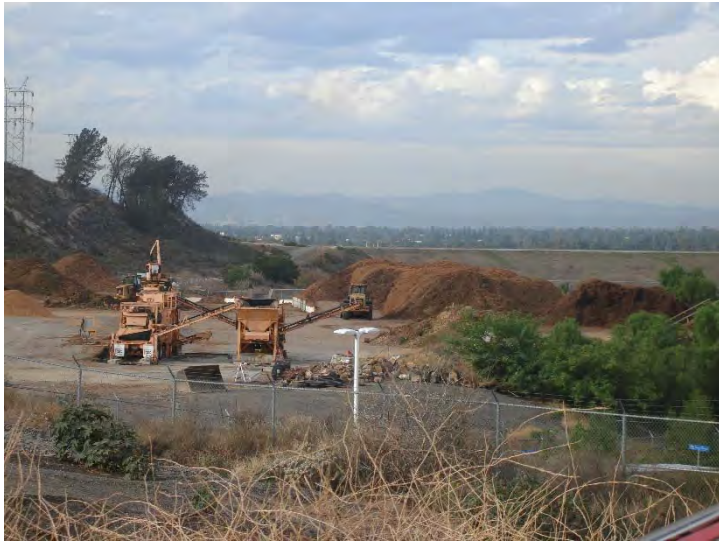
Photo 372: Greenwaste Odor Source: October 14, 2015

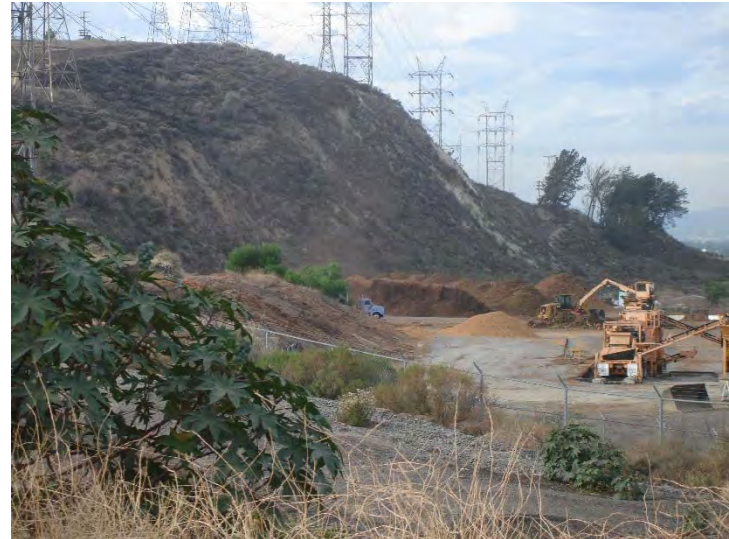
Photo 373: Greenwaste Odor Source: October 14, 2015

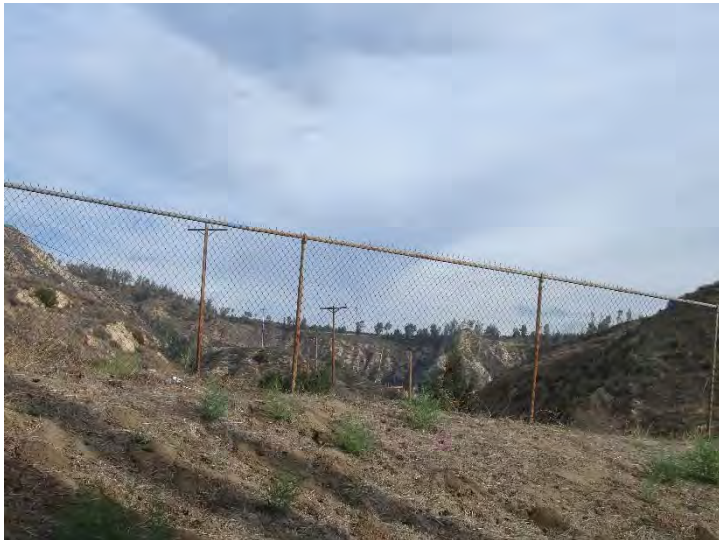
Photo 374: Greenwaste Odor Source: October 14, 2015

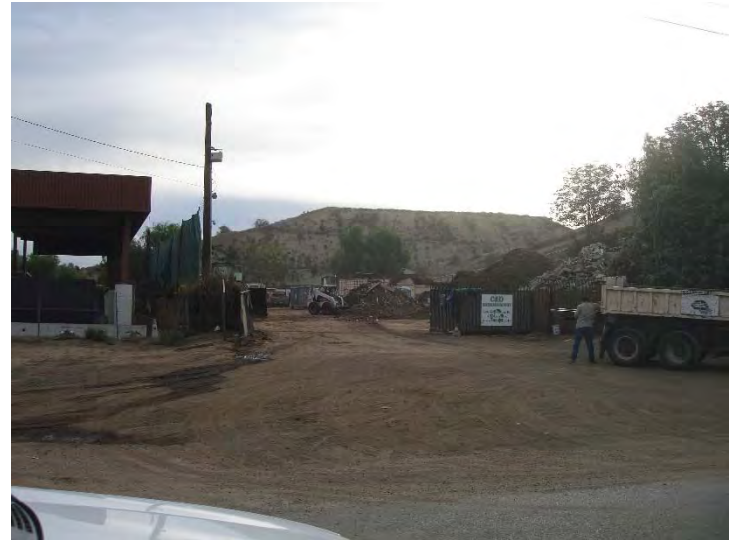
Photo 375: Operations Face Odor Source: October 14, 2015

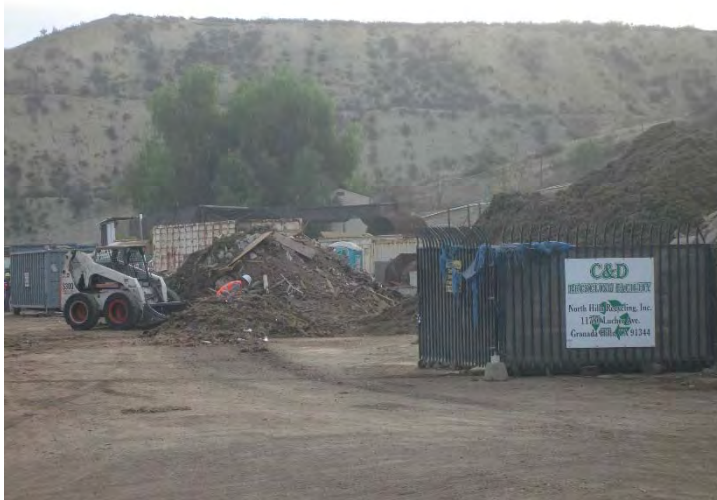
Photo 376: Greenwaste Odor Source: October 28, 2015

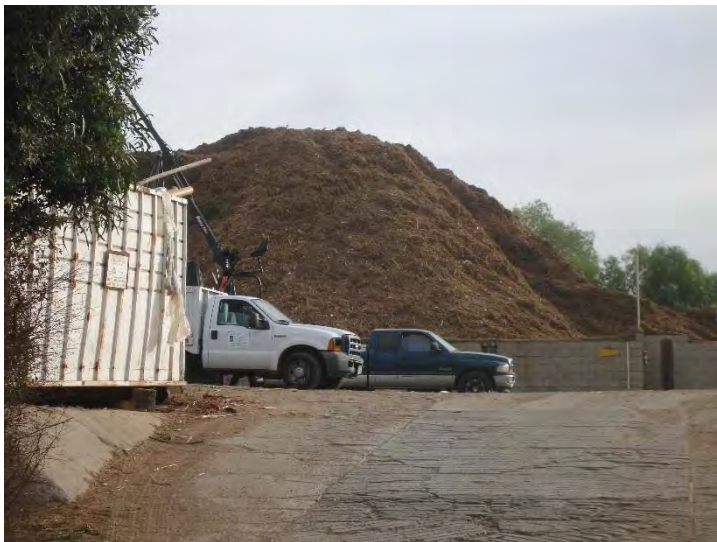
Photo 378: Greenwaste Odor Source: October 28, 2015

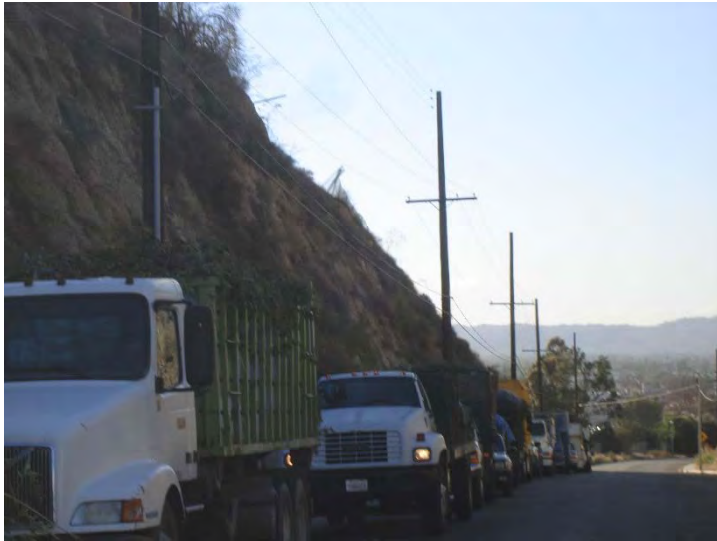
Photo 380: Greenwaste Odor Source: October 28, 2015

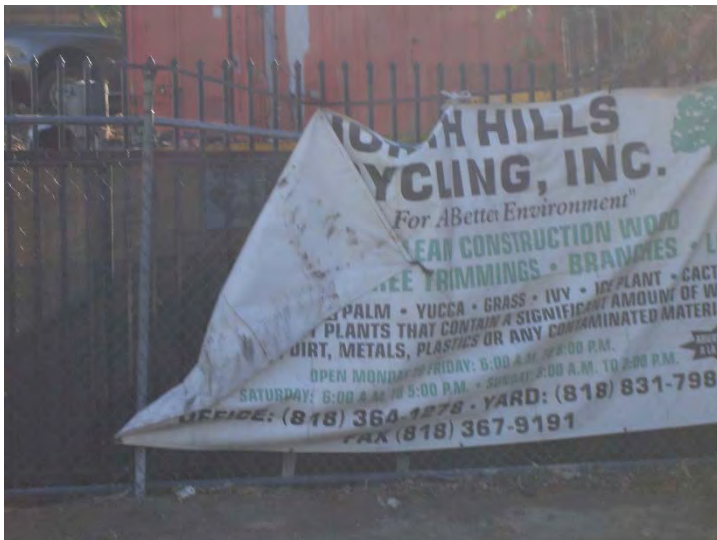
Photo 382: Greenwaste Odor Source: November 16, 2015

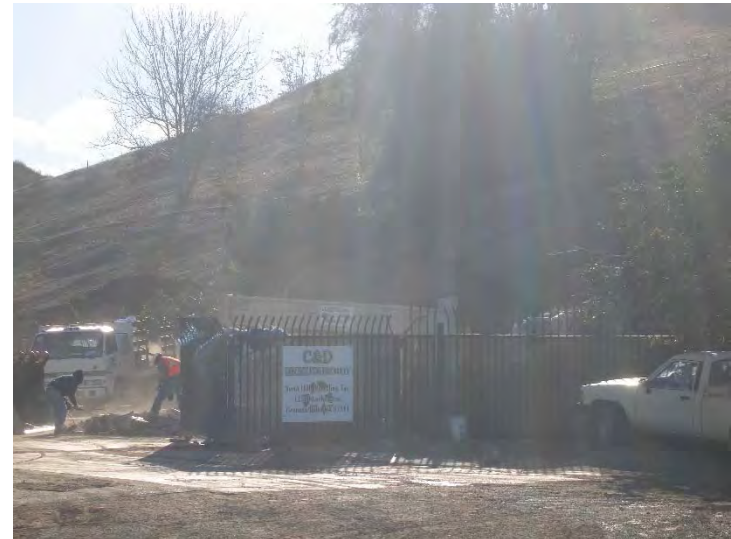
Photo 383: Greenwaste Odor Source: November 16, 2015

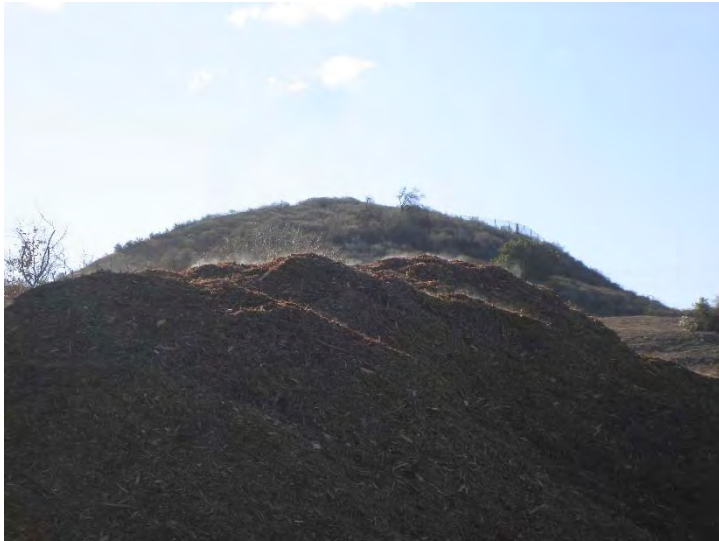
Photo 384: Greenwaste Odor Source: November 16, 2015

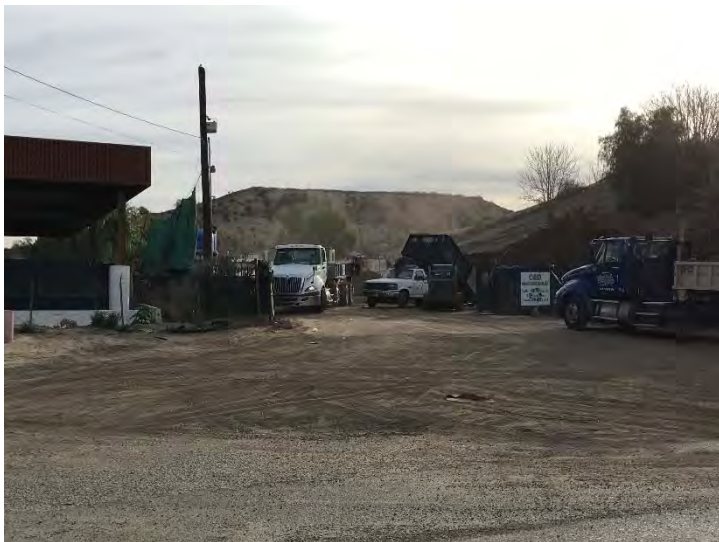
Photo 386: Greenwaste Odor Source: December 9, 2015

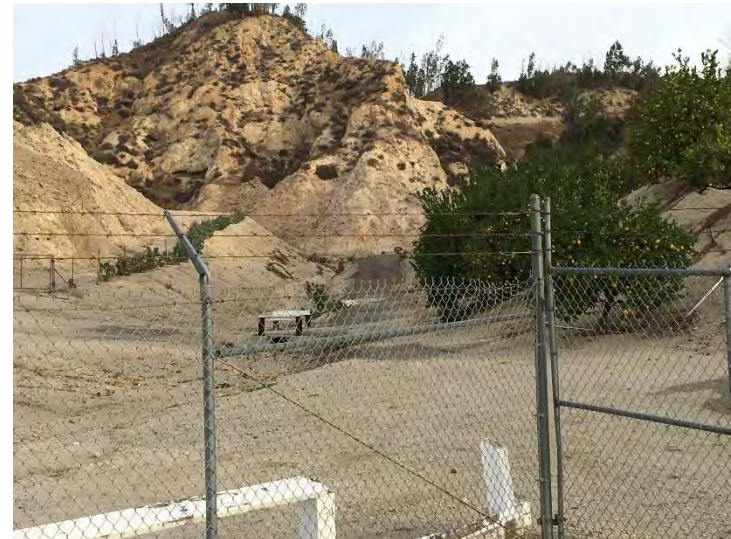
Photo 387: Greenwaste Odor Source: December 9, 2015

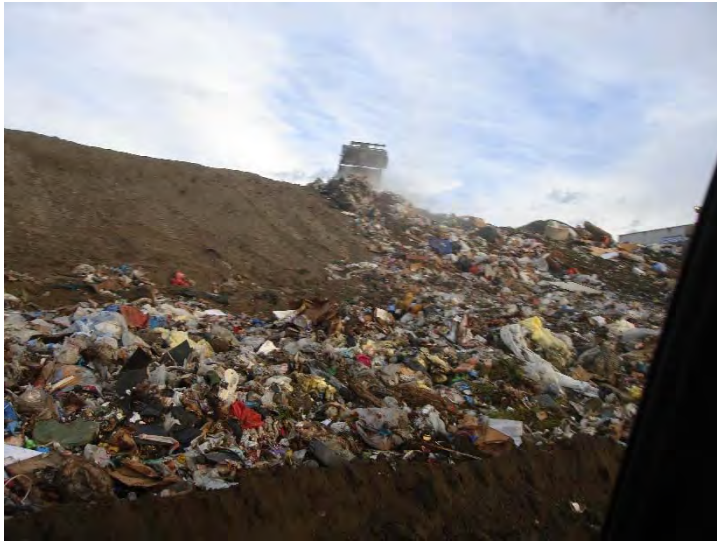
Photo 388: Operations Face Odor Source: December 9, 2015

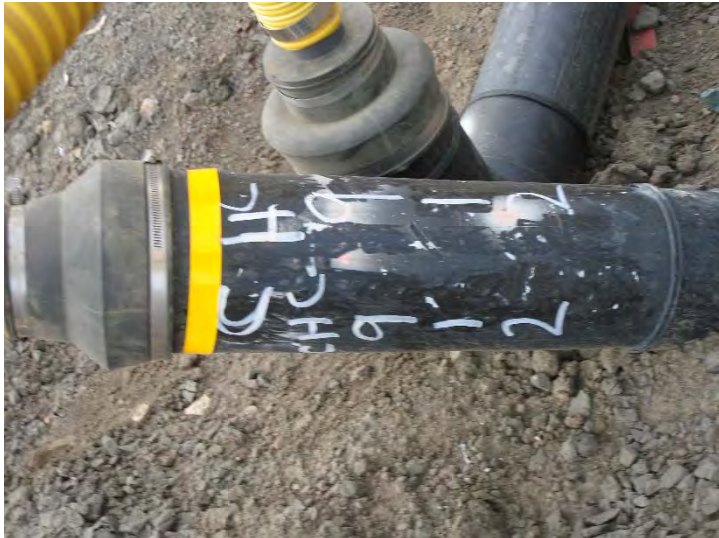
Photo 426: Site Working Area Slope Condensate Seep: October 28, 2015

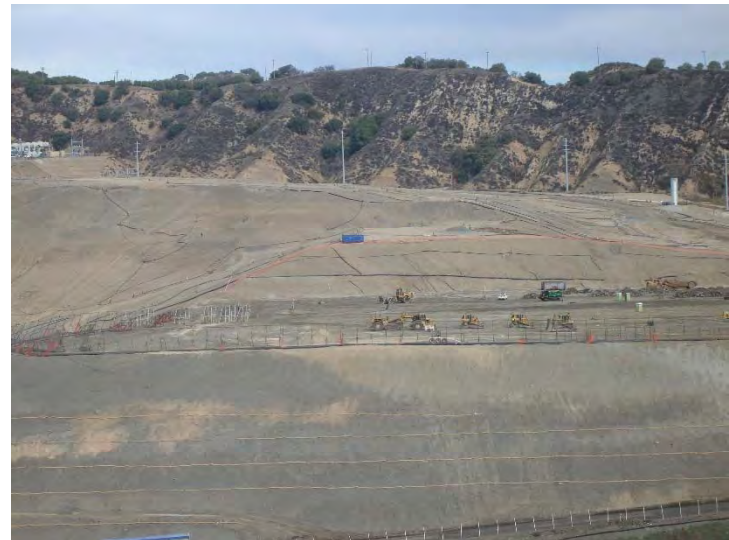
Photo 427: Site Working Area Slope Condensate Seep: October 28, 2015

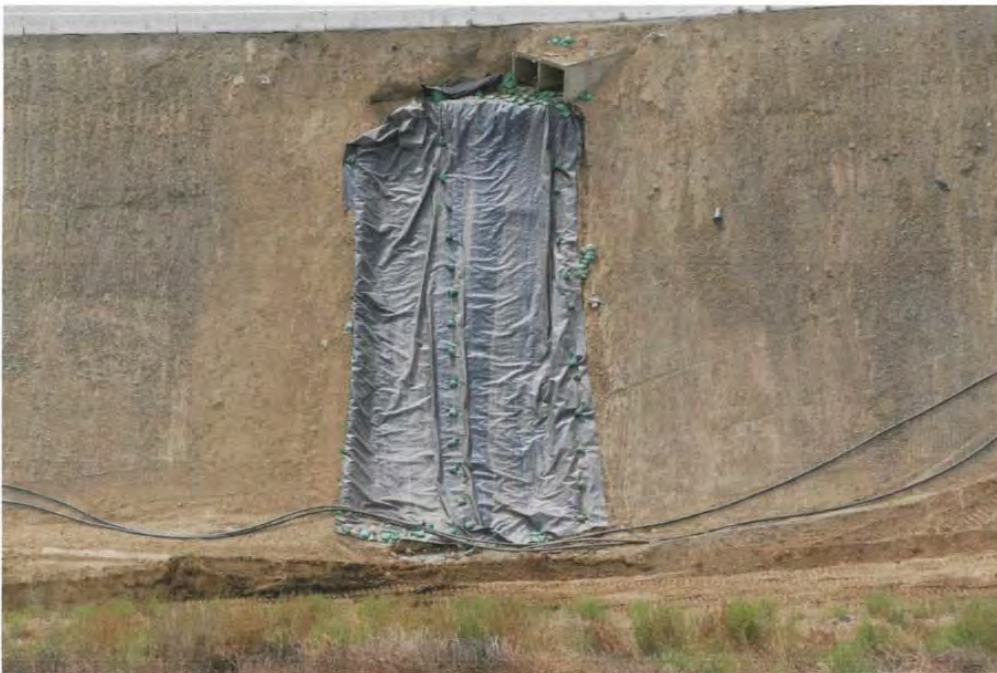
- Basin A riser drain rock was plugged with sediment. Drainage into the outlet risers may be impeded.
- The drainage channel out of Basin A was partially blocked with soil.
- The native hillsides in Basin A were clean and had no wind-blown litter.
- The main westside concrete drainage channel in one section has the floor continuing to lift and the sidewall cracks worsening.
- The native hillside drainage channel south of the material storage area and Basin D has the discharge into Basin D blocked by soil placed to have an access road. The hillside water in the channel has no controlled outlet. This blockage should be removed.
- Basin D drainage channel has portions of the channel blocked with tumbleweed. The channel has a HDPE liner with the leading edge only held down by sand bags. This liner may curl up under high water flows.

Figure 3: Channel out of Basin A Partially Blocked

FURTHER REVIEW NEEDED	
<ol style="list-style-type: none"> 1. Clear soil and pipes from Sediment Basin A east drainage channel. 2. Repair concrete cracks and uplifting along Westside Drainage. 3. Keep condensate tanks from being odorous. 	
COMMENTS	
Signed: <i>Michael W. Lindsay</i>

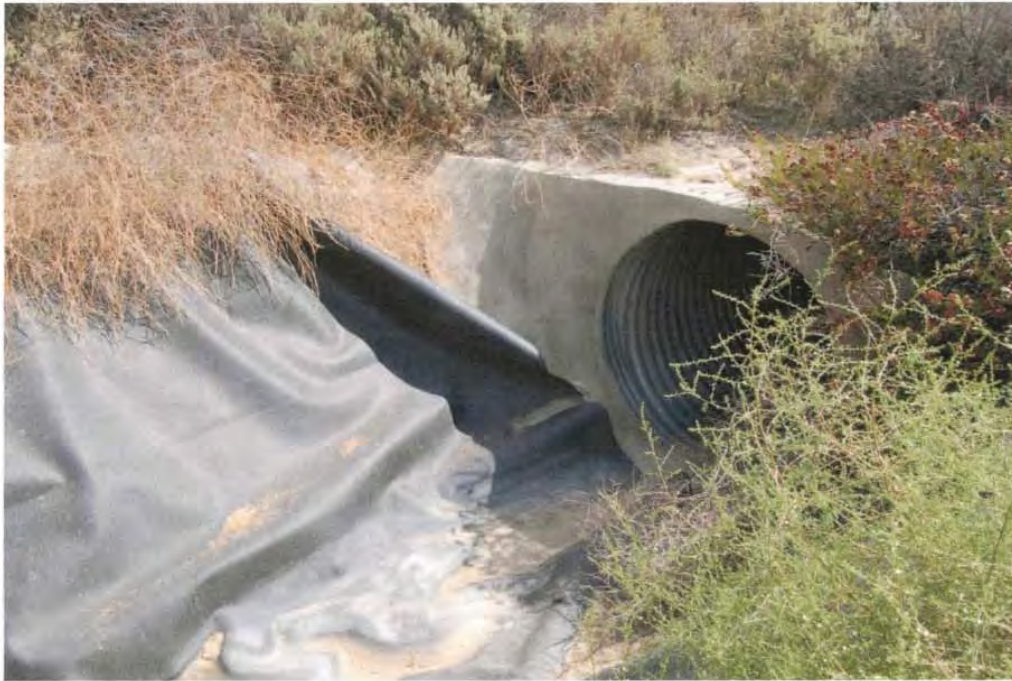
Photo 4: Geomembrane at Box Culver on Access Road

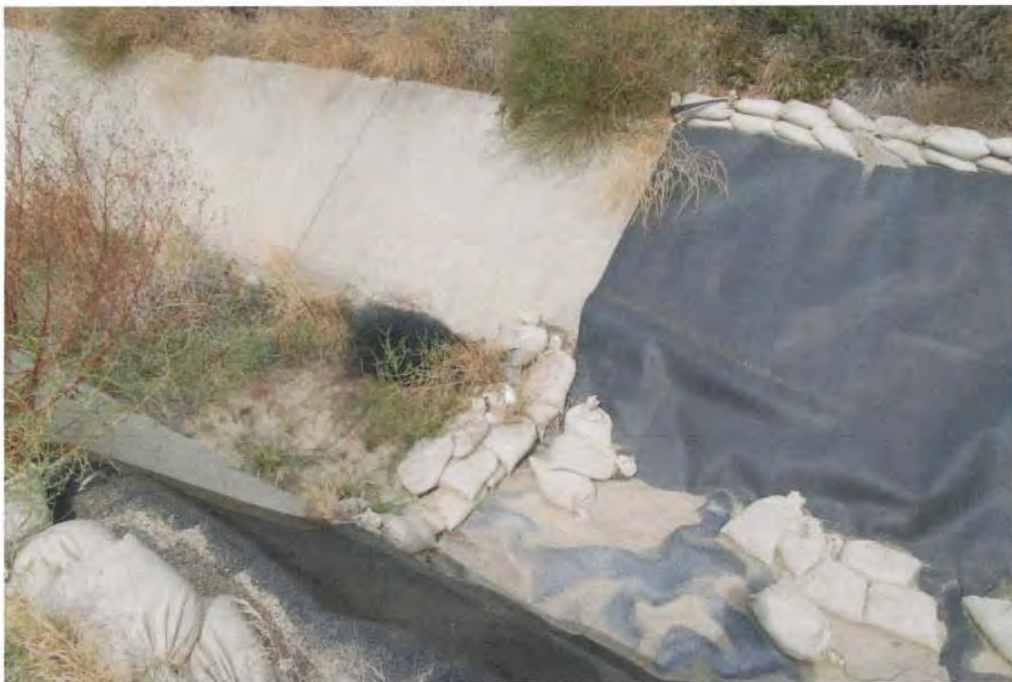
Photo 5: Geomembrane liner at entry to culvert near Flare 9-10 access road
