**Sunshine Canyon Landfill
Independent Monitor
Quarterly Site Monitoring Status Report
July 1, 2019 – September 30, 2019**

City of Los Angeles Department of City Planning

County of Los Angeles Department of Regional Planning

December 10, 2019

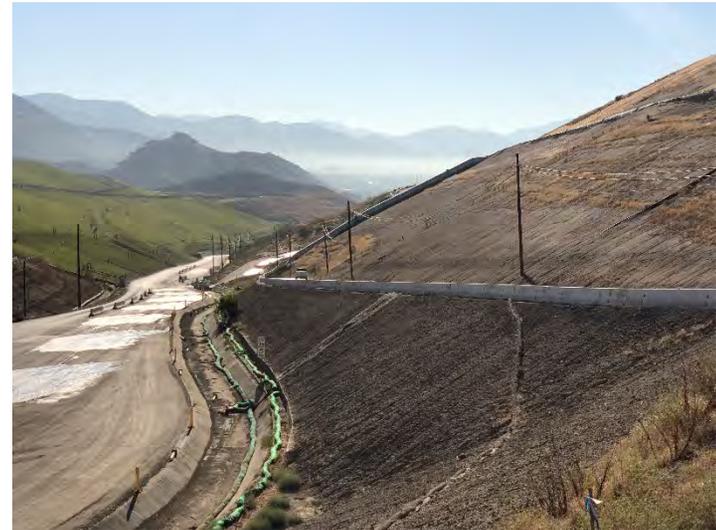
Photo 239: Old City South Stockpiled Soil Slump: August 13, 2019

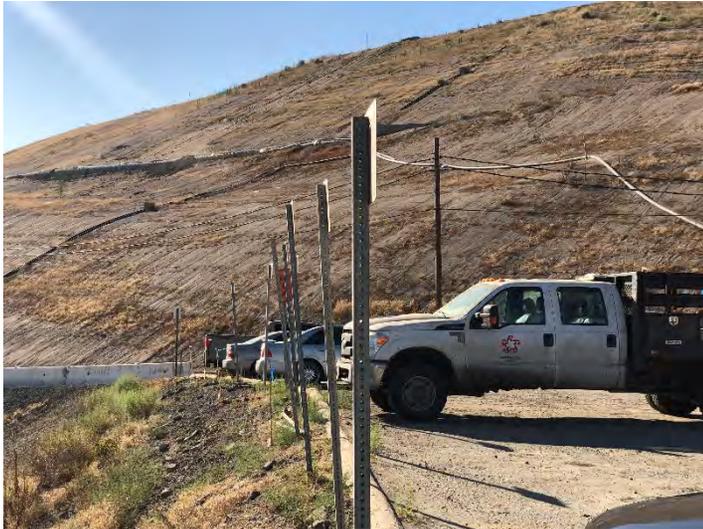
Photo 240: Old City South Stockpiled Soil Slump: August 13, 2019

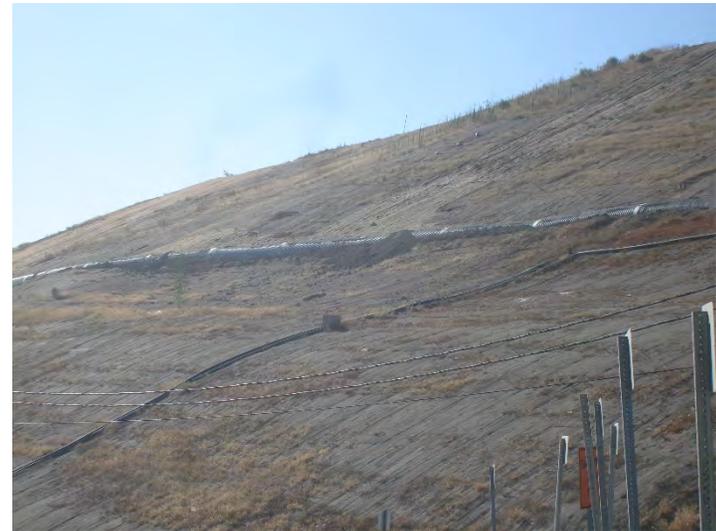
Photo 241: Old City South Stockpiled Soil Slump: August 13, 2019

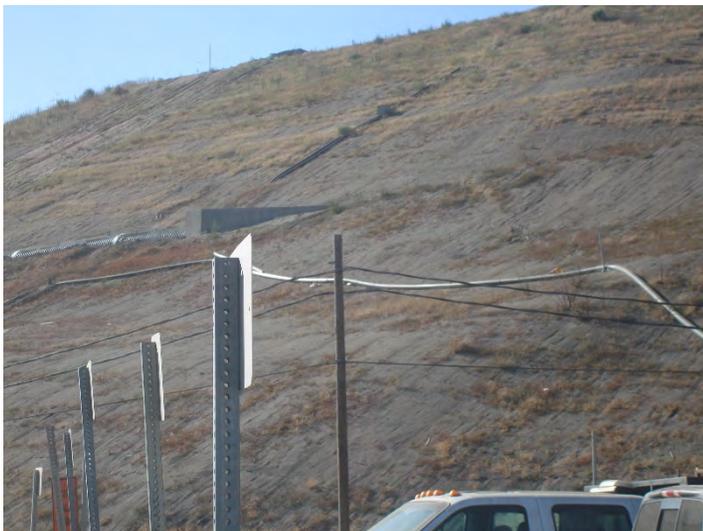
Photo 242: Old City South Stockpiled Soil Slump: August 13, 2019

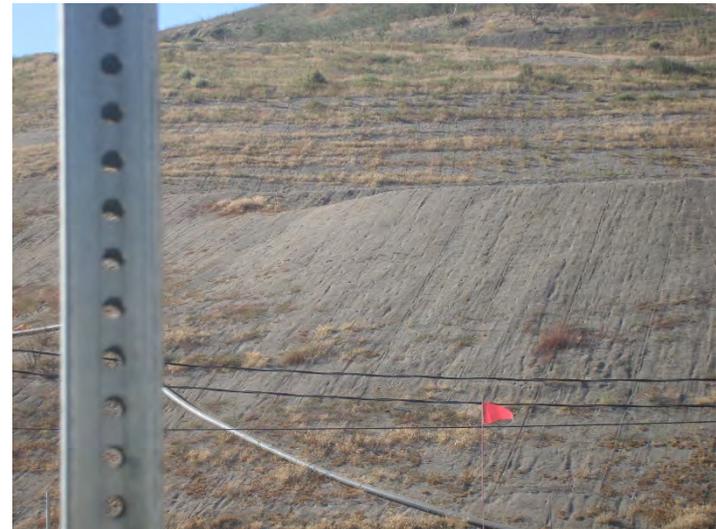
Photo 243: Old City South Stockpiled Soil Slump: August 13, 2019

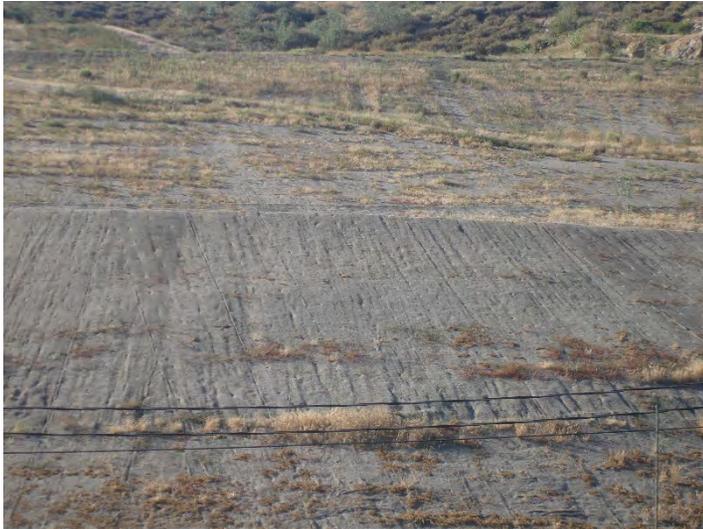
Photo 244: Old City South Stockpiled Soil Slump: August 13, 2019

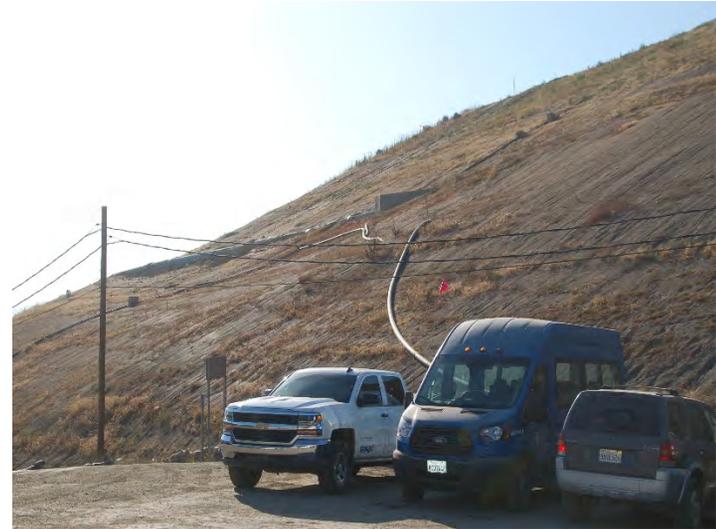
Photo 245: Old City South Stockpiled Soil Slump: August 13, 2019

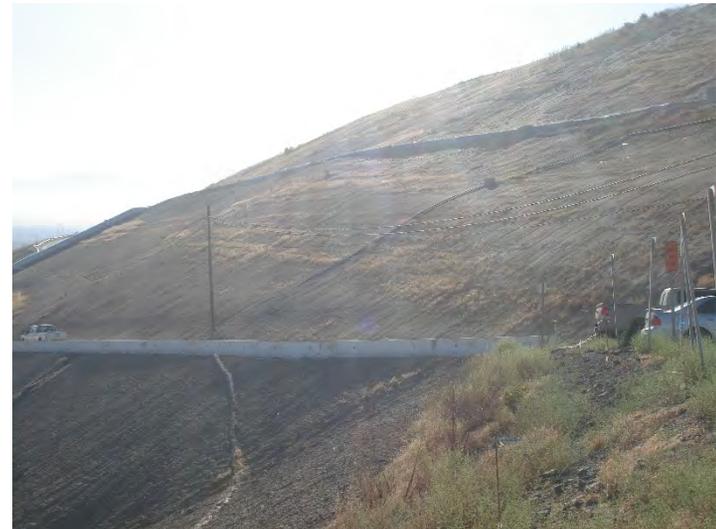
Photo 247: Old City South Stockpiled Soil Slump: September 25, 2019

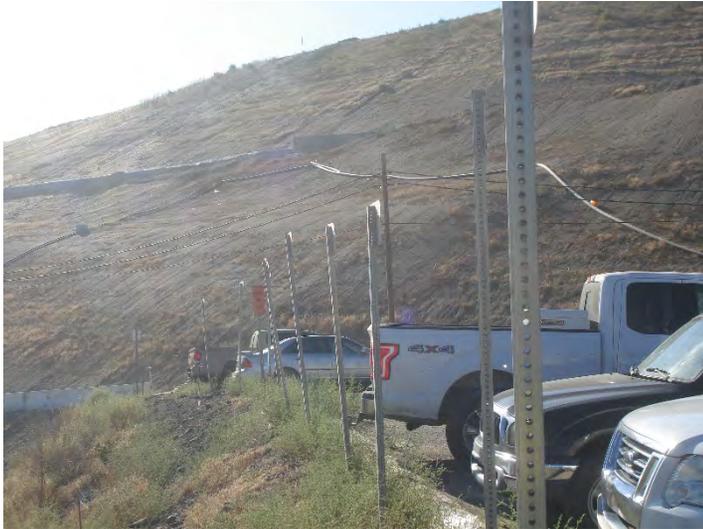
Photo 248: Old City South Stockpiled Soil Slump: September 25, 2019

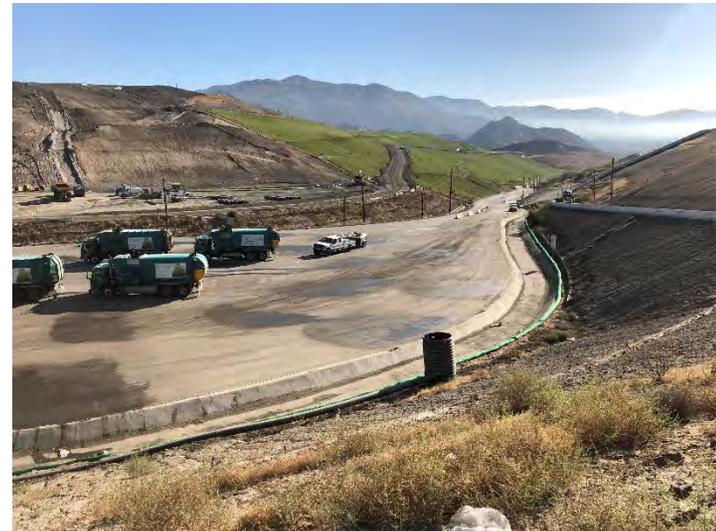
Photo 249: Old City South Stockpiled Soil Slump: September 25, 2019

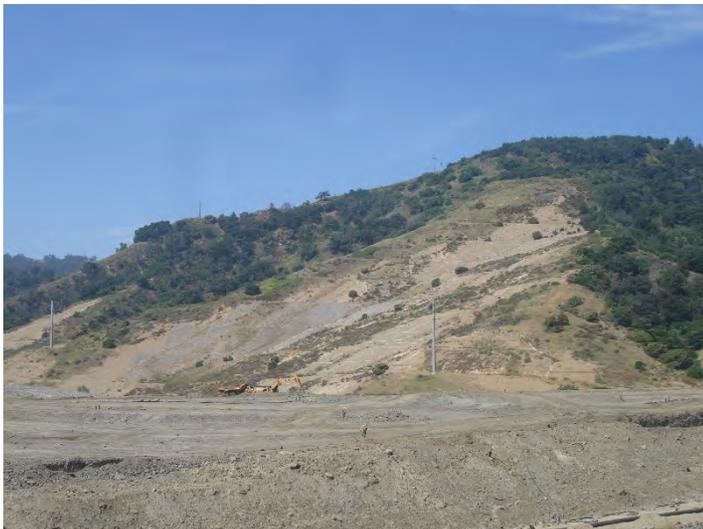
Photo 250: Old City South Stockpiled Soil Slump: September 25, 2019

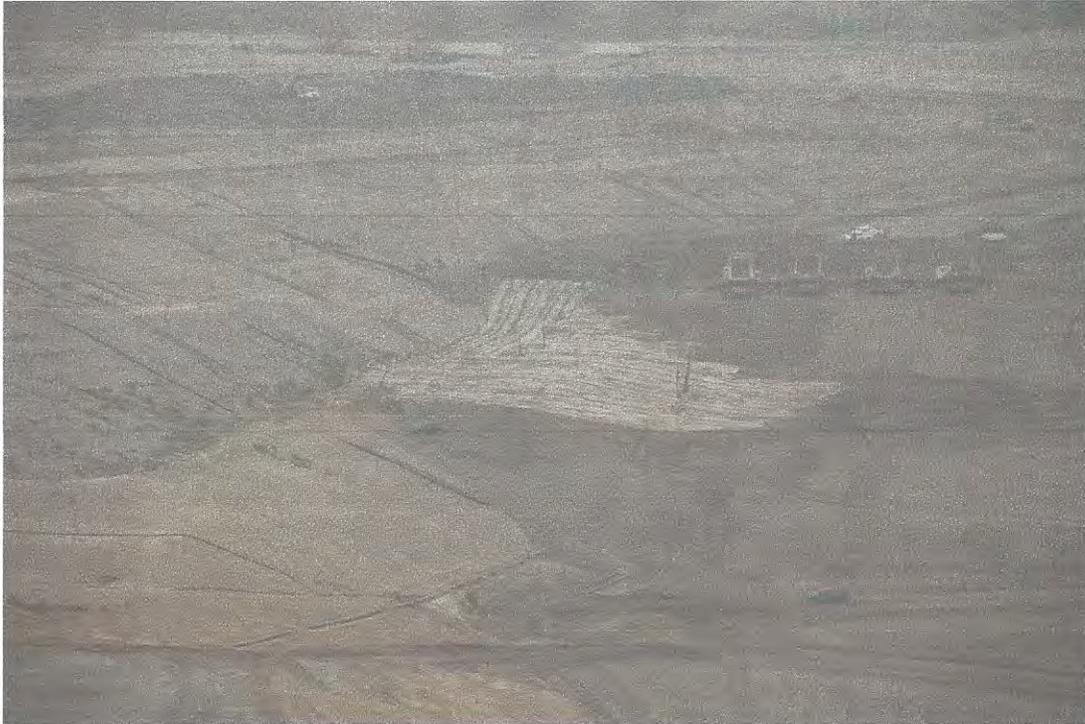
8:20– 2:00 Site inspection	
<ul style="list-style-type: none"> • Tour neighborhood to check for odor and illegal waste dumping • Tour of landfill • Access Roads • Waste placement • Drainage systems (Basins, channels) • Construction at Cell CC4 • Erosion protection system • Landfill for geotechnical and hydrological issues • Other observations • Meet with Republic staff 	
Access Roads.	
<ul style="list-style-type: none"> • Main access road: No additional sloughing observed on the embankment on the Terminal Basin side, just at the edge of the previously repaired area at the limit of the jute netting. No stability concerns • Access road to administration pad – no additional depression/settlement observed on slope. 	
Waste Placement	
<ul style="list-style-type: none"> • Two waste faces were active in Cells CC3 and CC4. • 4 Tilters were set-up (Photo 1) at Cell CC4 • ADC is in use at Cell CC4 (Photo 1)

Photo 1: Daily alternative cover and tippers at waste face on cell CC4

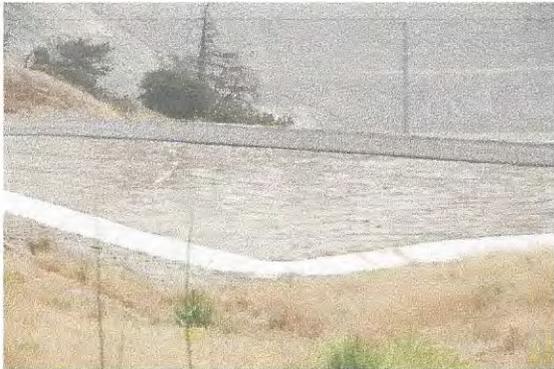
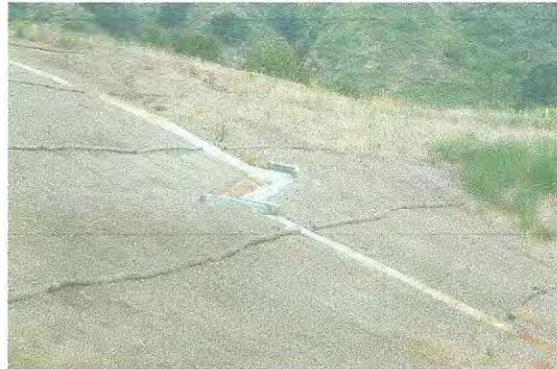
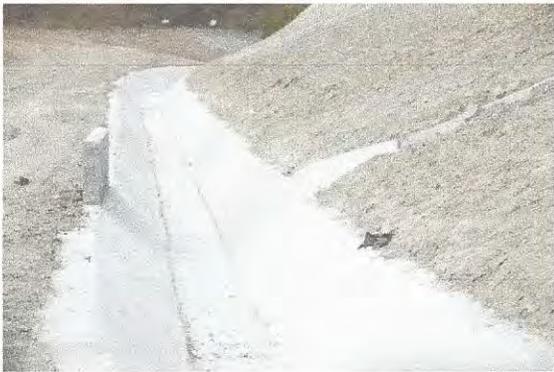
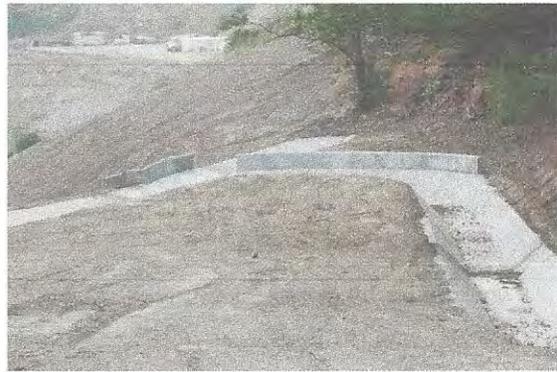
- Ditch along access road to Flare 9-11
 - The drain at the end of the concrete on side of road is plugged by sediments.
- Basin A
 - Basin held no water but still contains a fair amount of sediments (Photo 9)

Photo 9: Sediment accumulation in Basin A

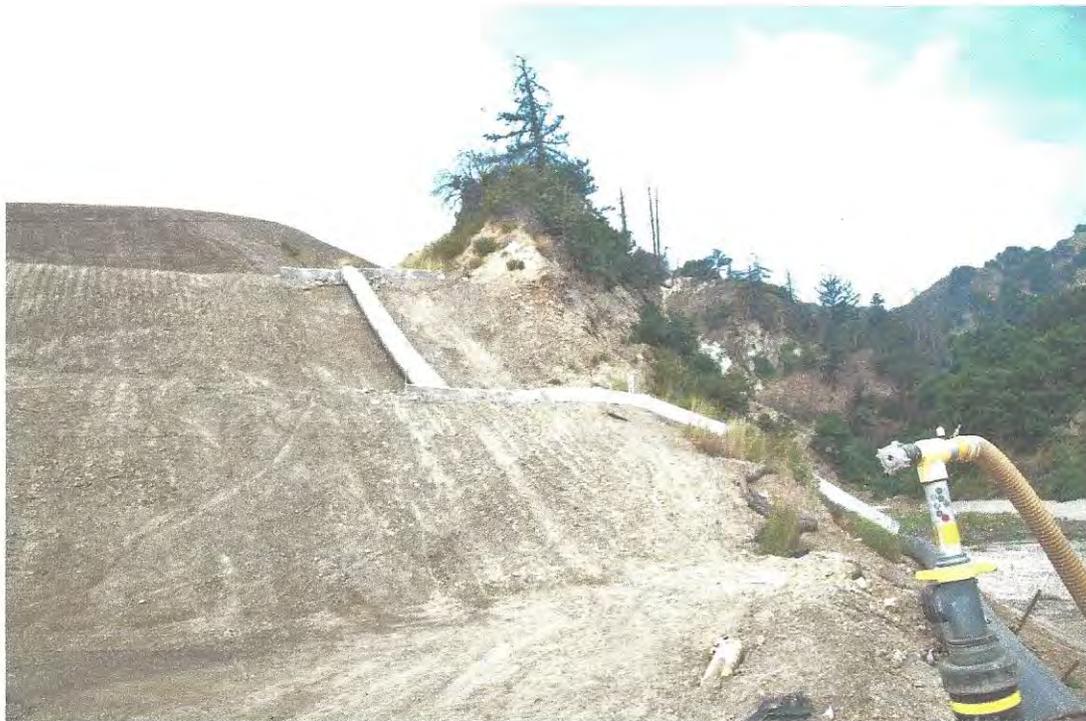
- New concrete ditches have been constructed along the road that will control drainage and reduce the potential for erosion of roadway (Photo 10)
 - A corrugate metal pipe down chute has been installed along the contact between the ridge separating the Basin from the graded slope to Flare 3 (Photo 11) an area where a deep erosion gully would forma after every significant rainstorm

Photo 10: Drainage works on graded slope below Flare 3

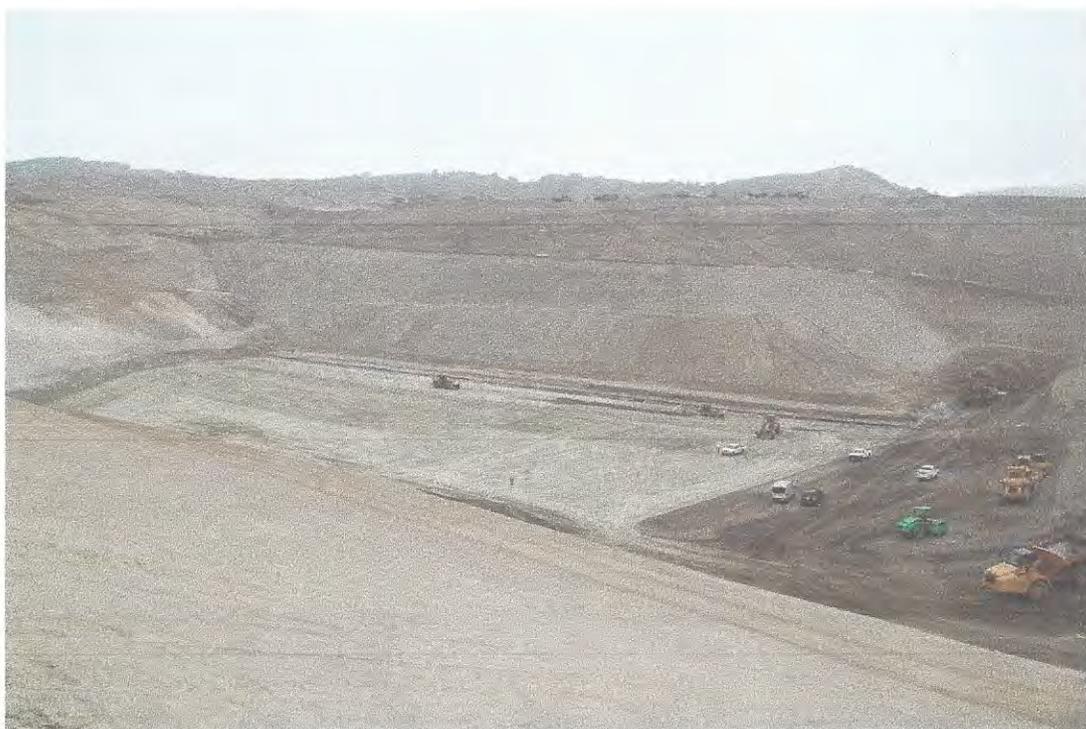
- The lower clay layer of the double composite liner system (Photo 13) was in place undergoing final grading and compaction (Photo 14)
 - The anchor trench for the geosynthetic component has been excavated along a bench on west side of the future cell. (Photo 15). The outside edge is properly rounded to minimizes risk of damage to the geosynthetics

Photo 14: Placement of lower clay layer of double composite liner system

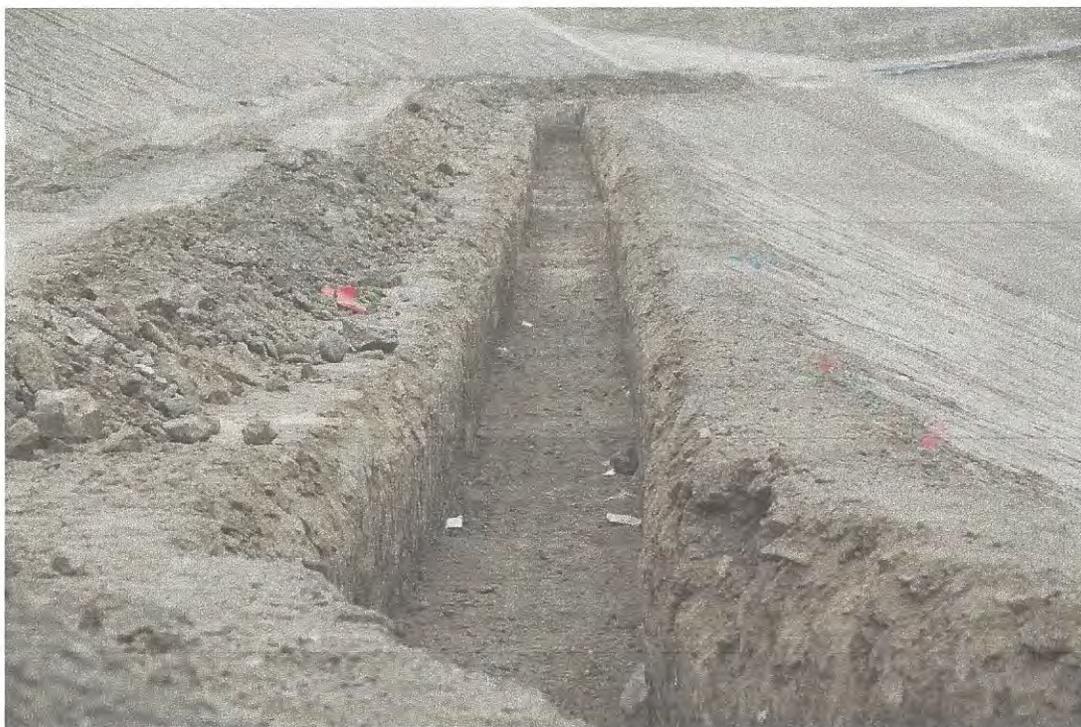
Photo 15: Anchor trench for geosynthetics at Cell CC4 Phase 4

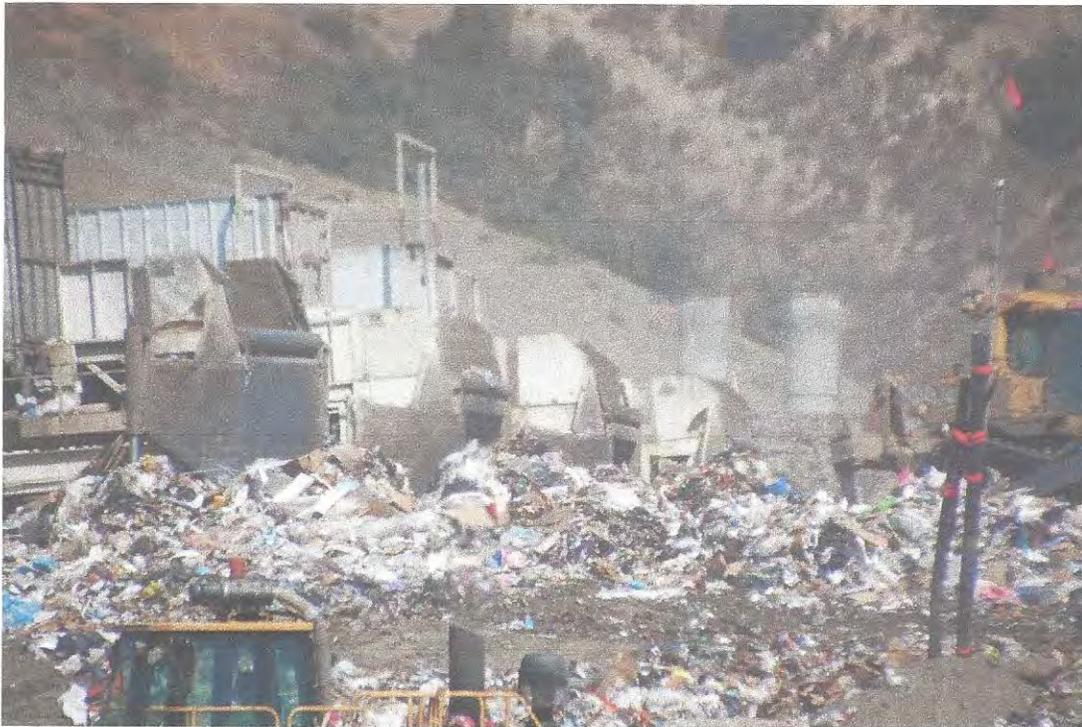
Photo 1: Four tippers in used at waste face on cell CC4

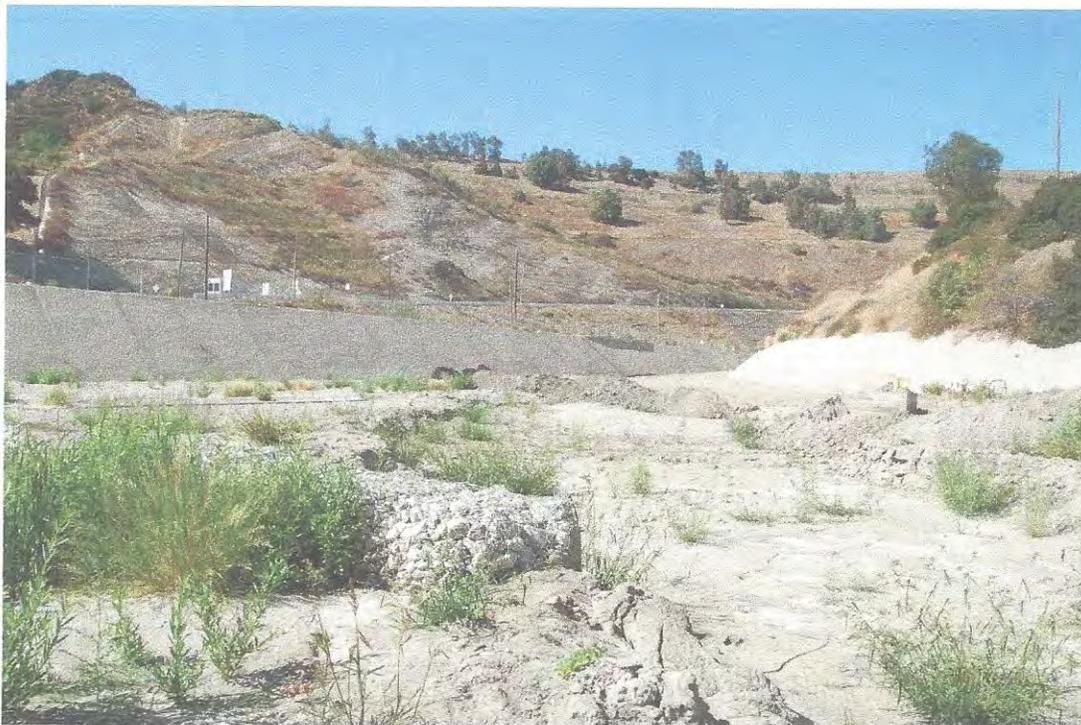
Drainage System	
<ul style="list-style-type: none"> • Terminal Basin (Photo 3) <ul style="list-style-type: none"> – Sediments have accumulated upstream of the separator gabion wall reaching over the gabion wall on the south side of the basin – Removal is taking place (Photo 4) – vegetation has sprouted on top of the sediments (Photo 5) – The three skimmers are still buried in sediments and will be repaired until the sediment are removed and the basin cleaned • Cell CC3 Earthen basin <ul style="list-style-type: none"> – The basin is clean and available for storage – We noted that the deep erosion swale mentioned in previous visit has been graded (Photo 6)

Photo 4: Sediment removal on-going at Terminal Basin

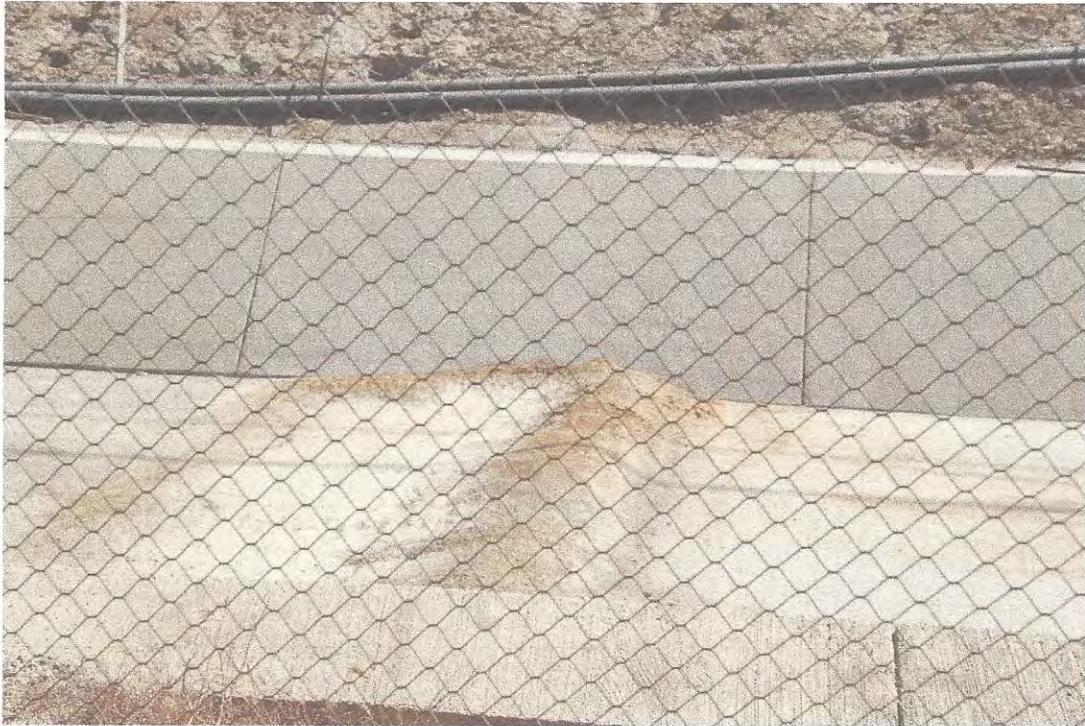
<ul style="list-style-type: none"> • East portion of the perimeter channel between Basin B and Terminal basin <ul style="list-style-type: none"> – Sediments and some detritus that had accumulated at the location of the asphalt berm have been removed (Photo 7) – Few areas still need cleaning, but the work is on-going and according to Republic staff all the channels will be cleaned by the beginning of the official rainy season • Basin B <ul style="list-style-type: none"> – Basin empty of water and the sediments noted during the last visit have been collected in a pile in the middle of the basin which is slated for removal before long (Photo 8). • Basin D <ul style="list-style-type: none"> – Basin is clean and available for water storage – We noted that some maintenance issues noted during the last visit still need to be addressed: still Southern Half <ul style="list-style-type: none"> ✓ There is a gap between the shotcrete and the soil at the spillway which may cause problem is additional undermining occurs (Photo 9). ✓ Vegetation is growing through crack in downstream side of spillway (Photo 9) – Northern Half <ul style="list-style-type: none"> ✓ Safety bars are missing on top of the decant towers (Photo 10) • Ditch along access road to Flare 9-11 <ul style="list-style-type: none"> – The drain at the end of the concrete on side of road is plugged by sediments. • Basin A <ul style="list-style-type: none"> – The sediments have been gathered in the middle of the basin and are ready for removal (Photo 11) • The new perimeter channel that will drain Basin A is under construction and will be finished by the beginning of the rainy season (photos 12 and 13) • Perimeter Channel between Basin A and Basin D <ul style="list-style-type: none"> – Channel in very good shape and clean, no vegetation and no cracks • Channel along the main access road <ul style="list-style-type: none"> – Accumulated sediments were being removed (Photo 14)

Photo 7: Cleaned north/east portion of perimeter channel

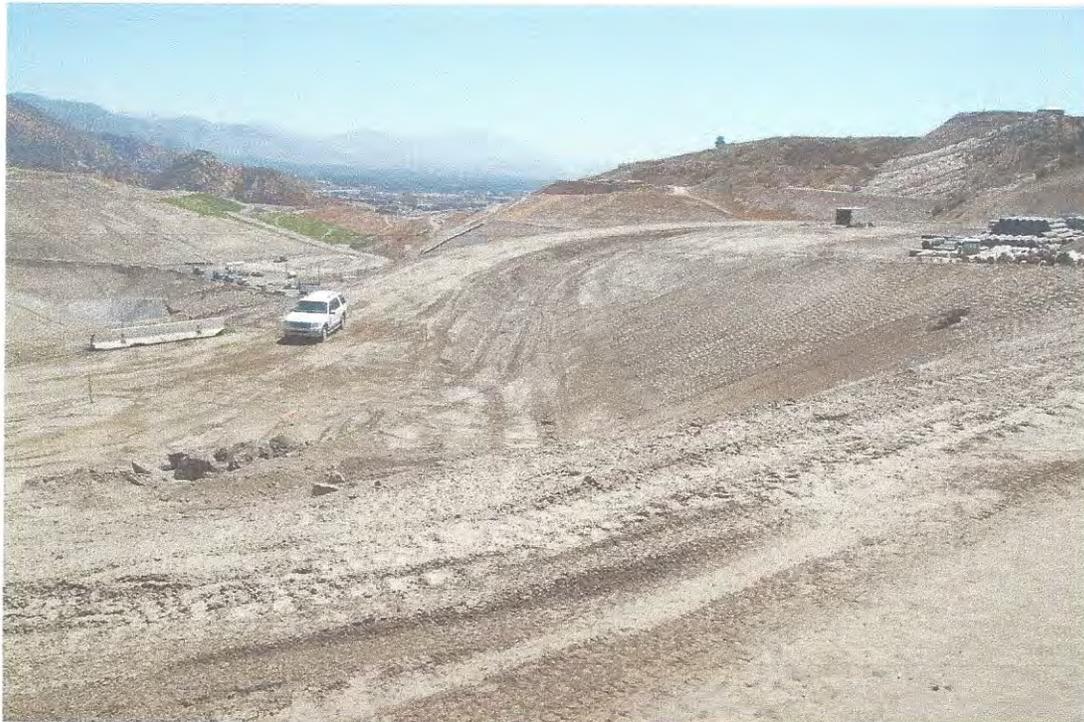
Photo 12: New Perimeter Channel on south side

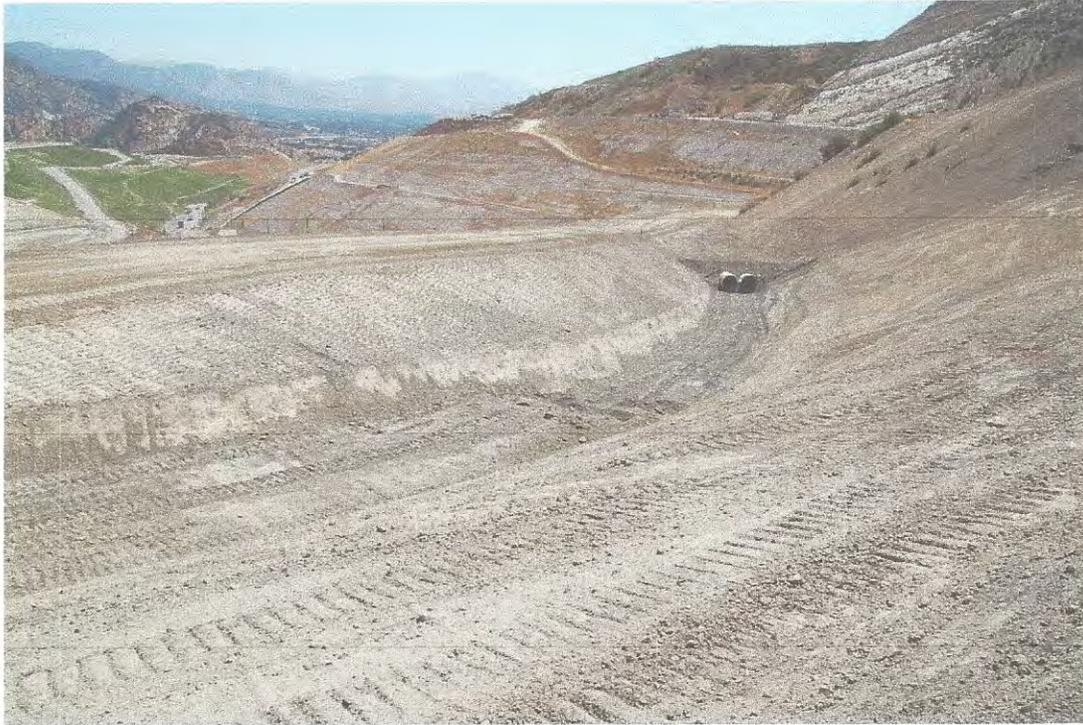
Photo 13: Detail of New Perimeter Channel on south side and perimeter road

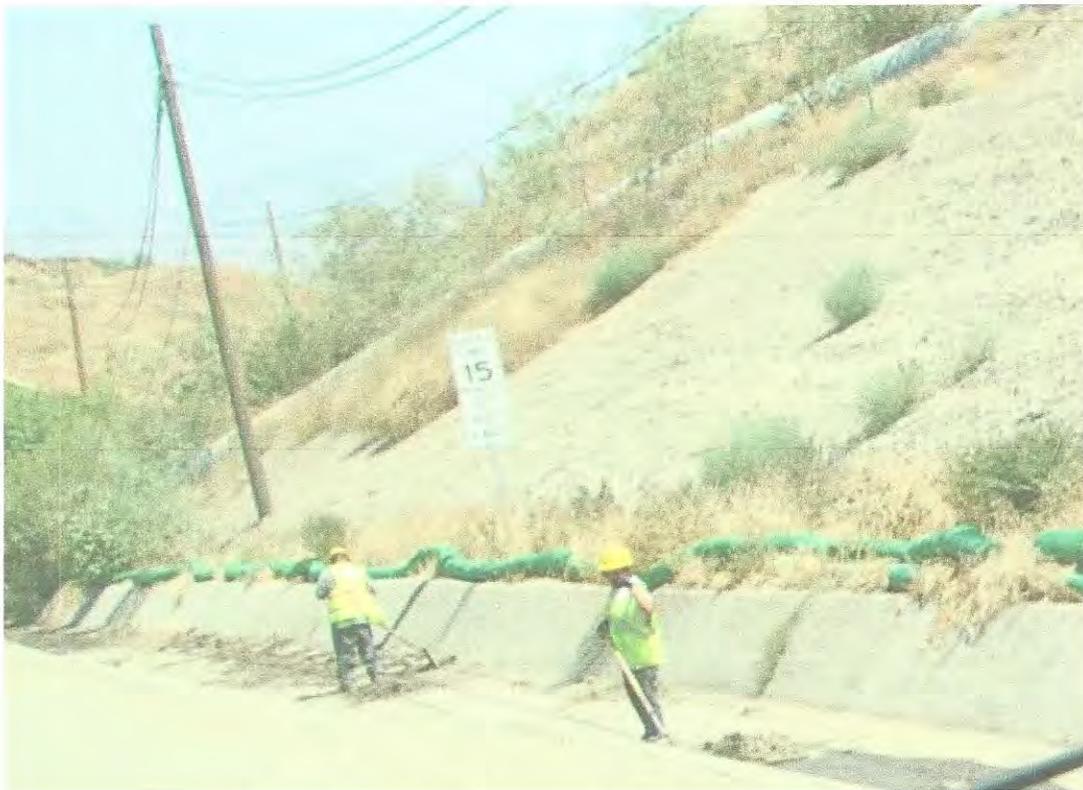
Photo 14: Clearing of channel along main access road

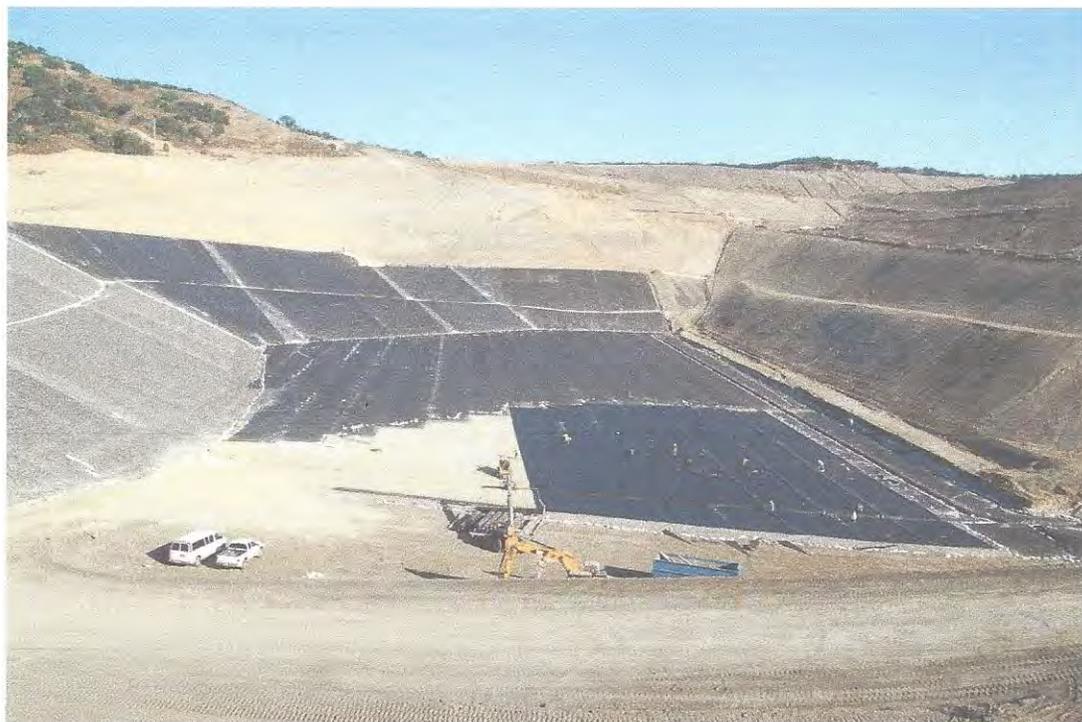
<p>Cell 4 Phase 3 Construction</p> <ul style="list-style-type: none"> • The upper geomembrane (80 mil) of the liner system (Photo 15) was being deployed (Photo 16) • Sand bags were placed in the trenches installed to keep the geomembrane from bridging in the leachate collection system due to temperature variation during the day (Photo 17) • Construction Quality Assurance was provided as demonstrated by air testing of seams and collection of destructive samples (Photo 18) • The line system on the slopes differs an include a geosynthetic clay liner in lieu of a clay layer because of constructability and stability issues (Photo 19) • The anchor trench for the geosynthetic component has been excavated along a bench on west side of the future cell. (Photo 20). The outside edge is properly rounded to minimizes risk of damage to the geosynthetics
<p>Erosion Protection Systems</p> <ul style="list-style-type: none"> • No changes since the last visit in May 2019, systems are in place.

Photo 16: Deployment of 80 mil geomembrane on top of 2ft-thick clay layer at Cell CC4 Phase 4

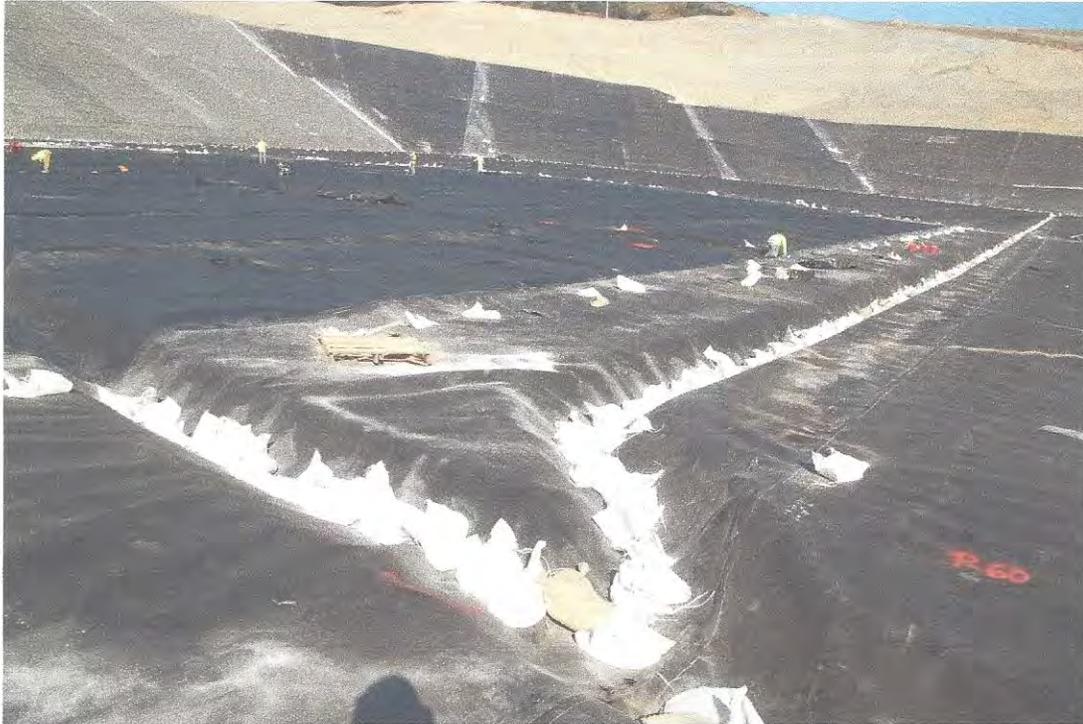
Photo 17: Sand bags in trenches for leachate collection piping at Cell CC4 Phase 4

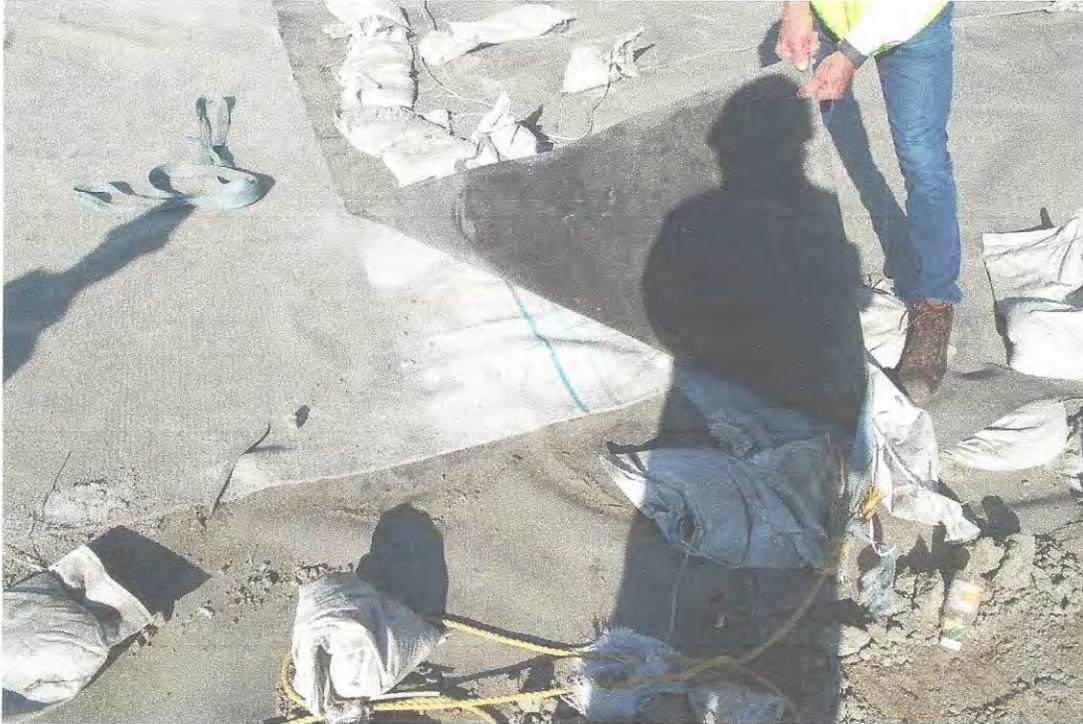
Photo 19: Liner system on slopes of Cell CC4 Phase including GCL

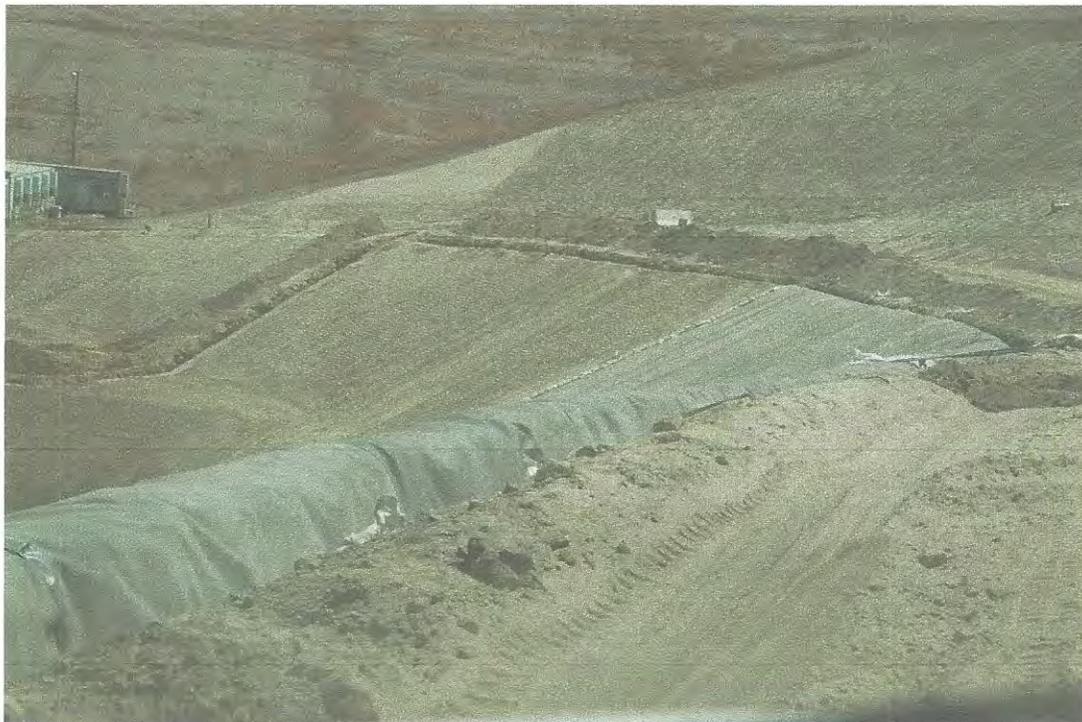
Photo 20: Anchor trench at bench of Cell CC4
