**Sunshine Canyon Landfill  
Independent Monitor  
Quarterly Site Monitoring Status Report  
July 1, 2013 – September 30, 2013**

**City of Los Angeles Department of City Planning**

**County of Los Angeles Department of Regional Planning**

October 28, 2013

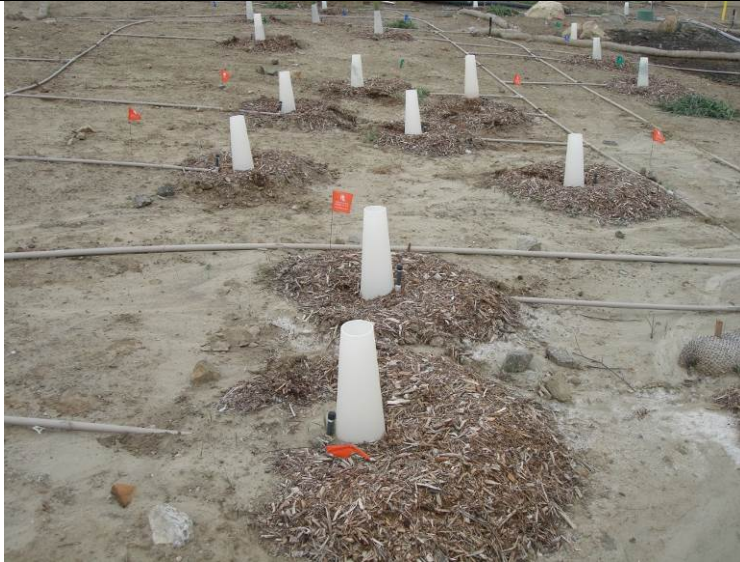
**Photo 80: City Sage Deck C: July 10, 2013**

Discipline	City Condition Reference # / Mitigation #	County Condition Reference #/ Mitigation #	Responsible Agency	Further Review Needed-Comments
Biologist	M - 4.4.1 / 60		City Planning	<p>I-l: The City Deck C Sage Mitigation was observed. The hydroseeded areas have not germinated. The black sage did not survive. The area was just planted, and cool weather, rain, and time is needed.</p> <p>I-m: City Deck C was observed to evaluate the success of the mitigation plantings. The irrigation system appears to be functioning well. All plants are being watered regularly, although there are a lot of weeds, mostly non-native grasses and forbs. The greatest threat to plantings at this time appears to be the high salt content in the soil. The irrigation regimen has resulted in salt crust formation in many areas. Nearly all coyote bush (<i>Baccharis pilularis</i>) is surviving, with few signs of stress. Elderberry (<i>Sambucus mexicanus</i>) is struggling. Approximately 50% of these plants have died and the remaining plants show signs of stress from salt. Approximately 70% of the coastal sagebrush (<i>Artemisia californica</i>) plantings are still alive, with most of these showing signs of stress from excessive salt. Nearly all black sage (<i>Salvia mellifera</i>) plantings have died. Deck C mitigation planting will be maintained now and replacement of dead plants will occur in the fall.</p> <p>I-n: The City South Deck</p>

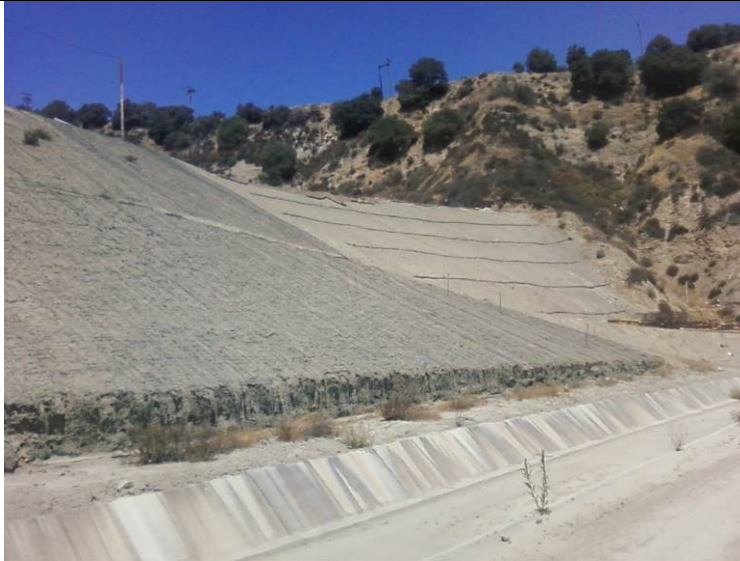
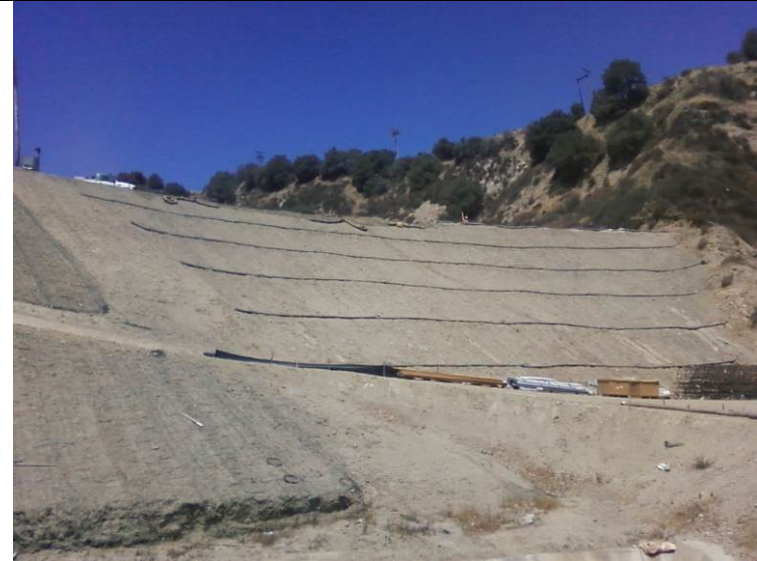
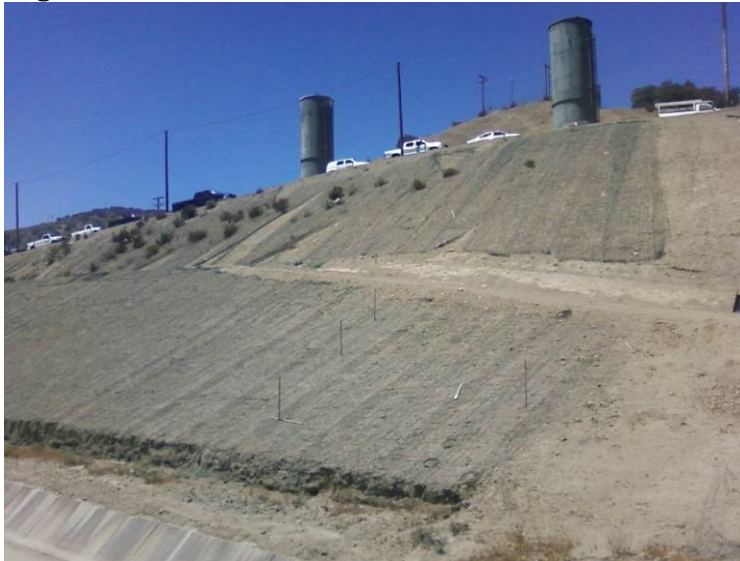
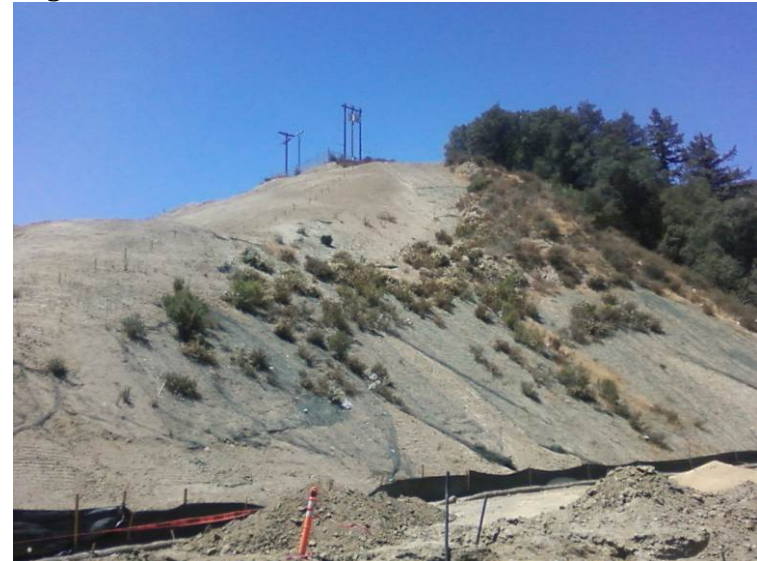
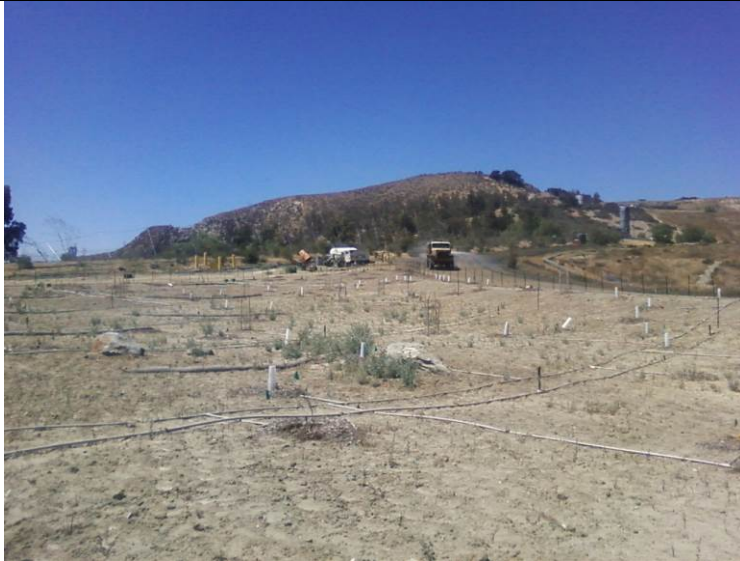
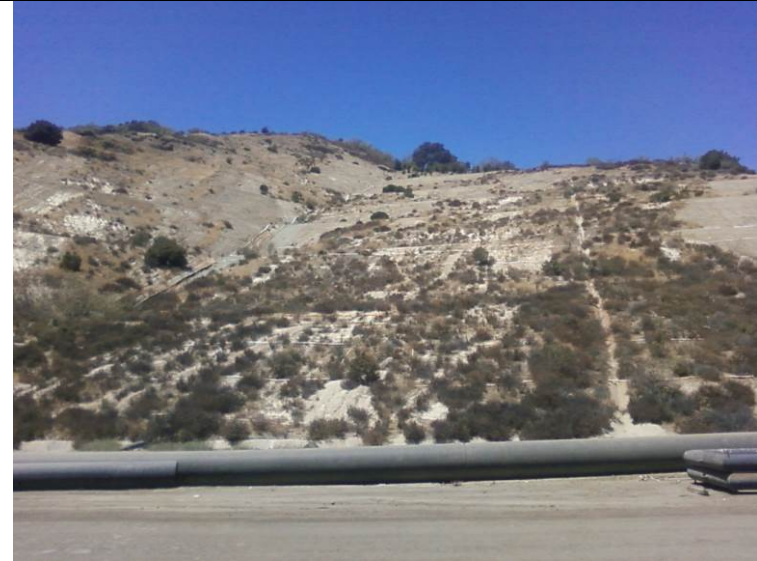
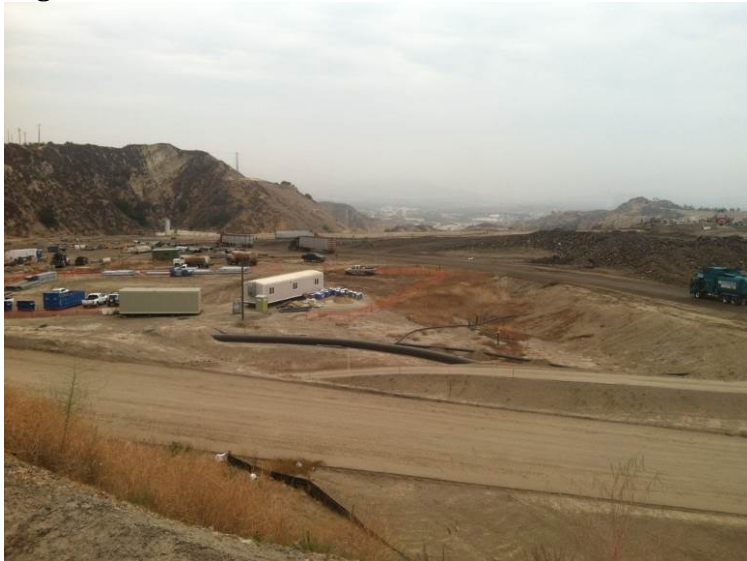
**Photo 132: Permanent Slopes at Flare 9 and 10 Locations: August 7, 2013**

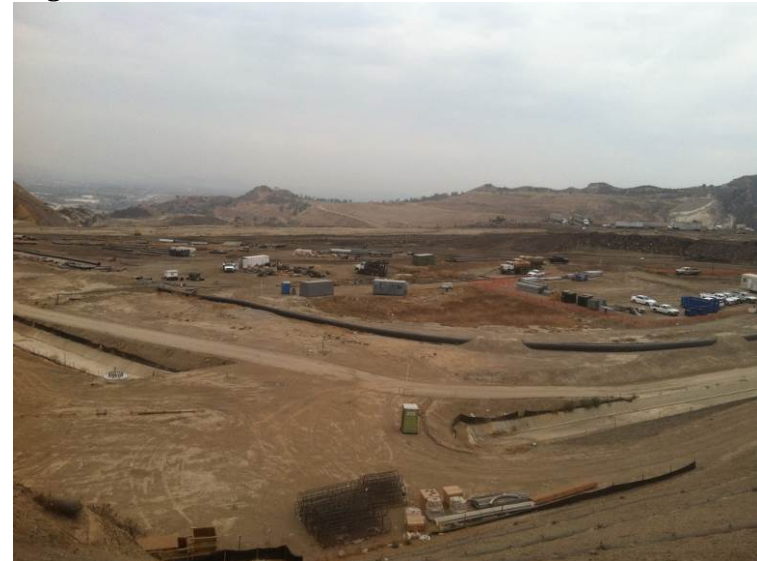
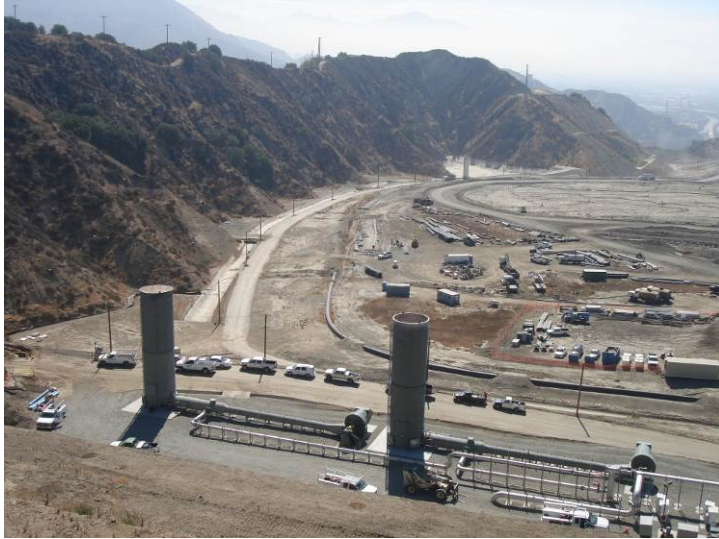
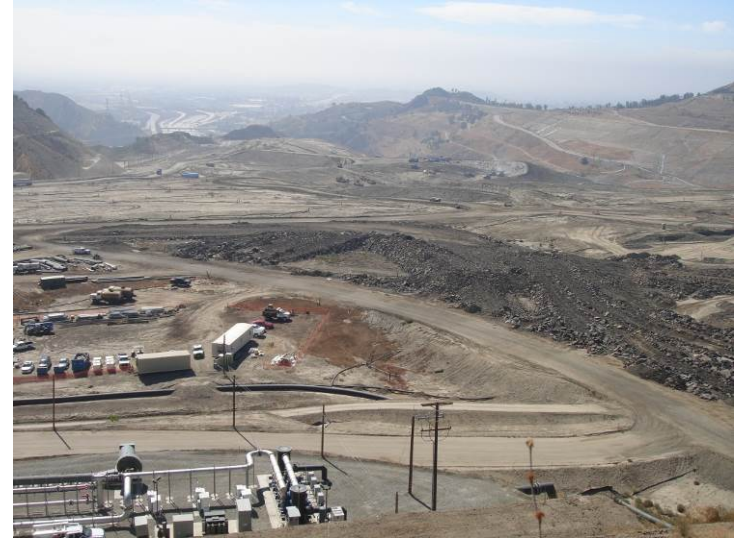
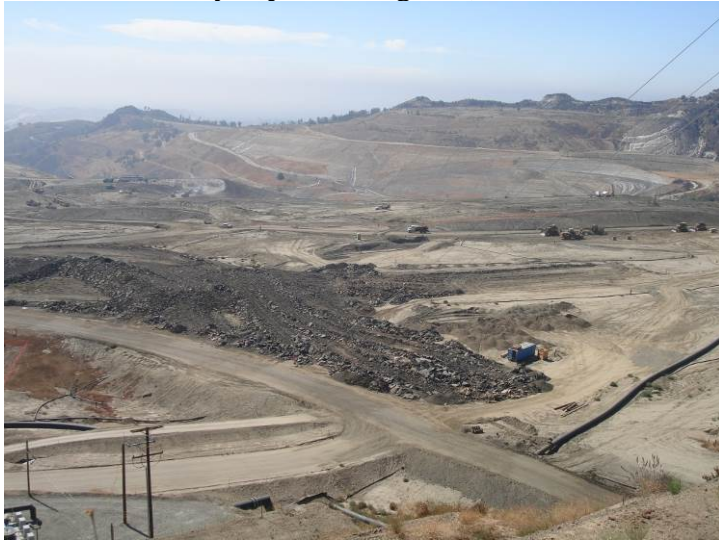
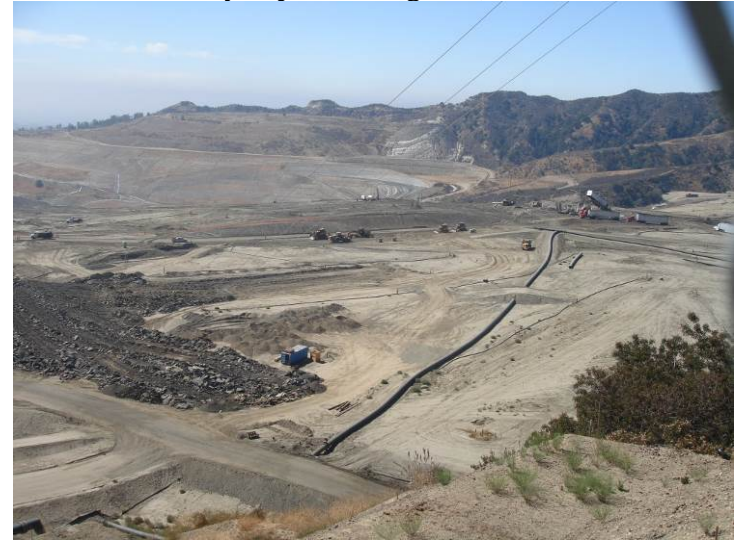
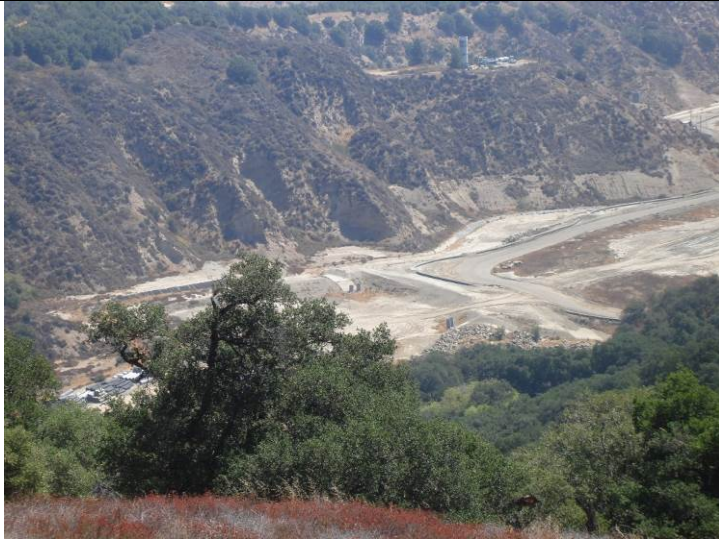
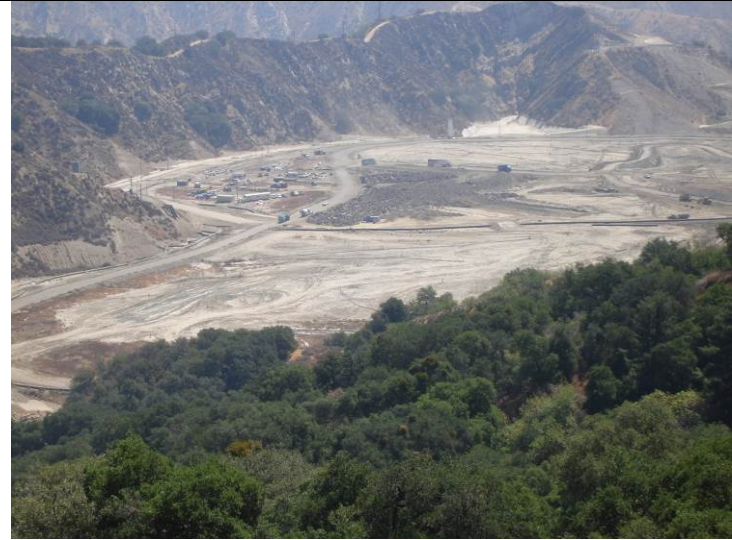
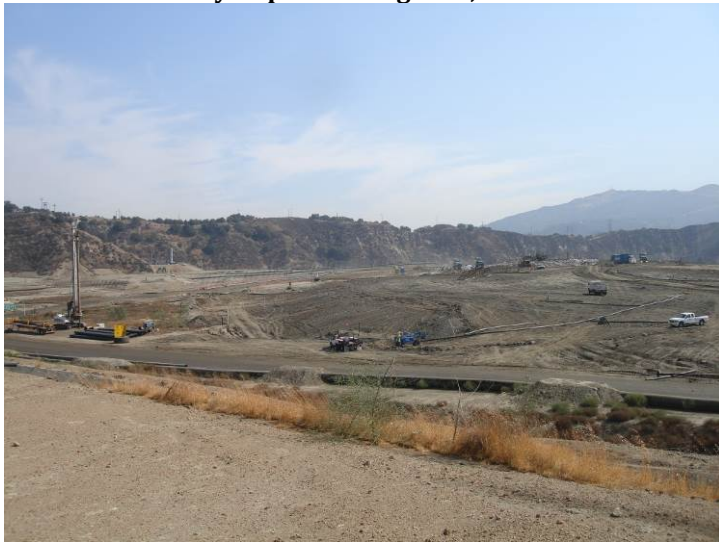
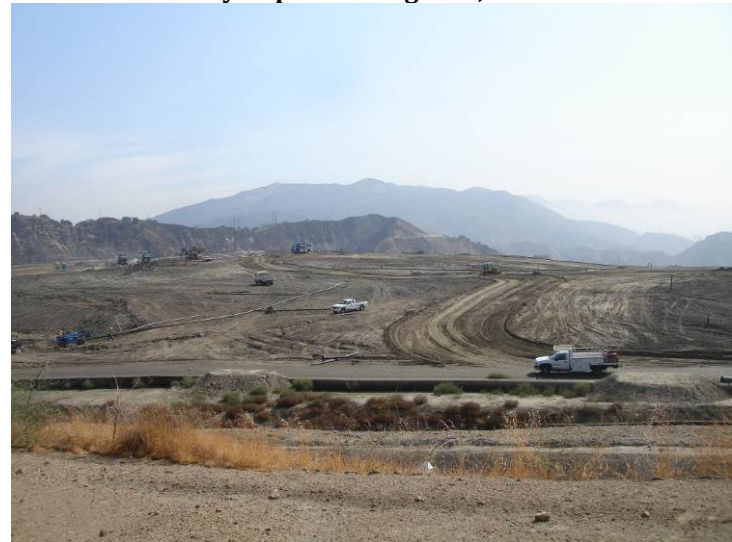
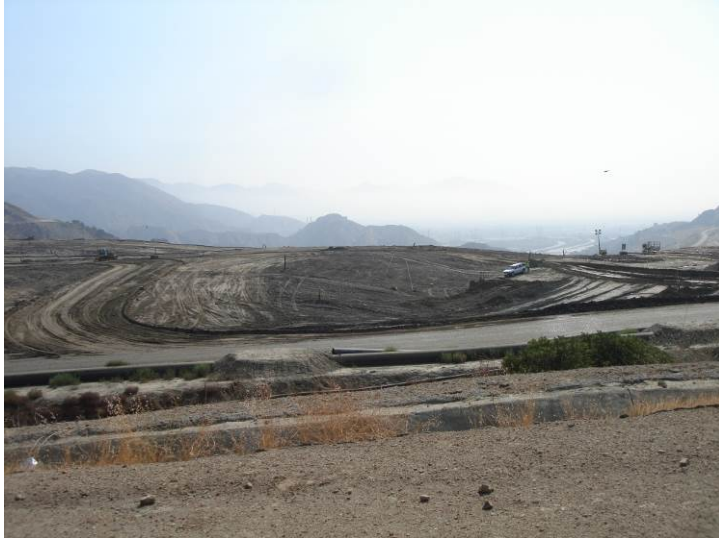
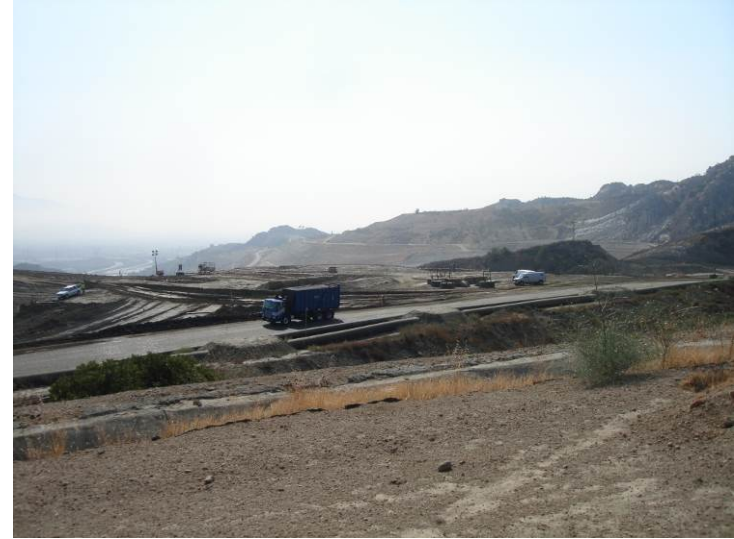
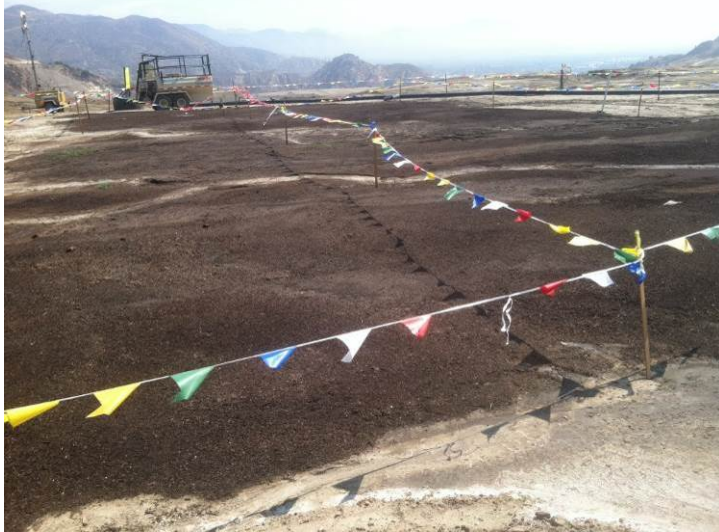
**Photo 139: County Top Deck: July 10, 2013**

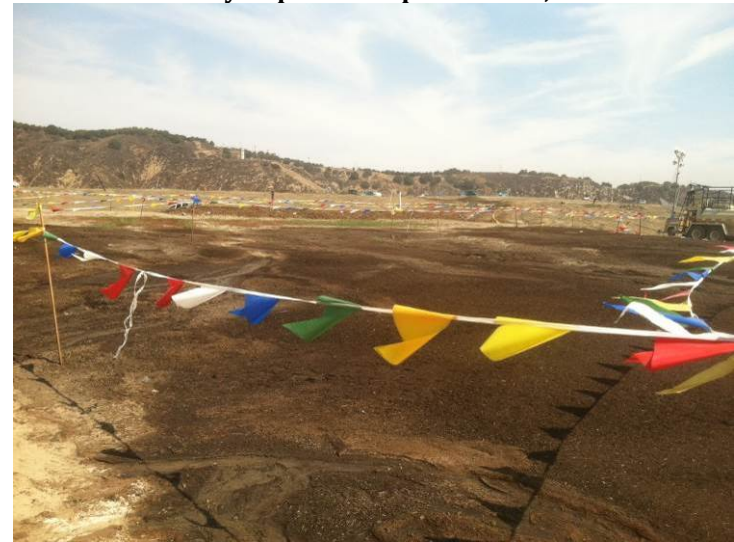
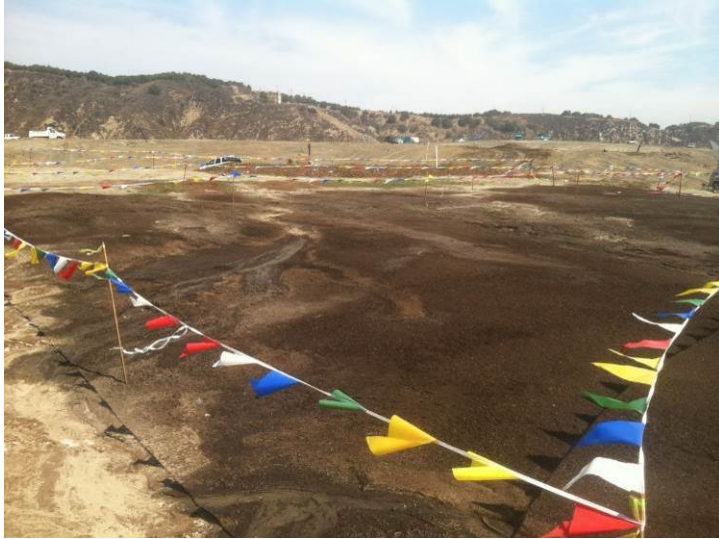
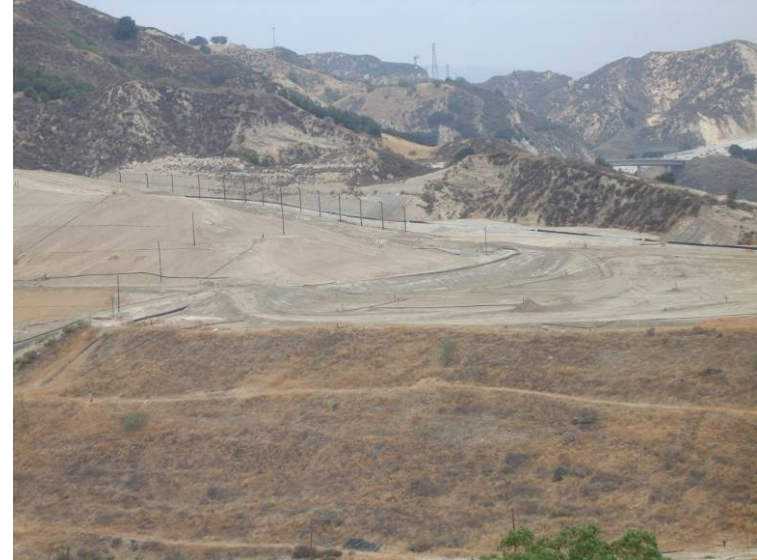
**Photo 151: County Top Deck Vegetation Test Plots: September 11, 2013**

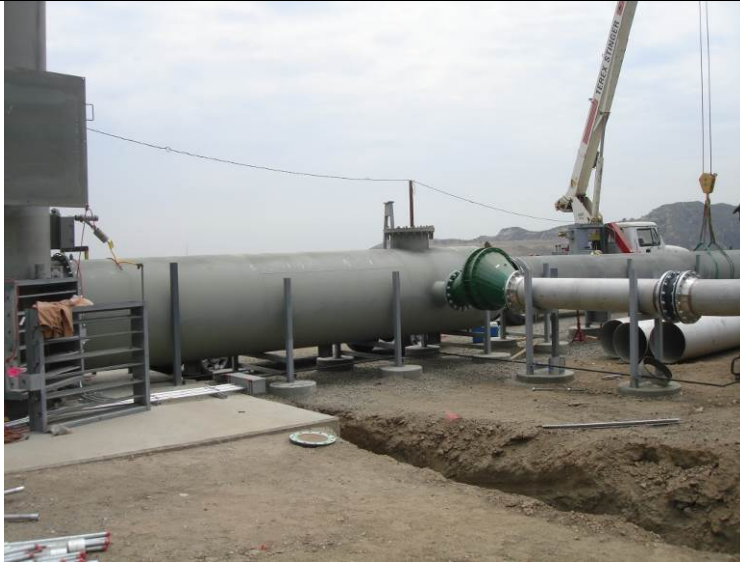
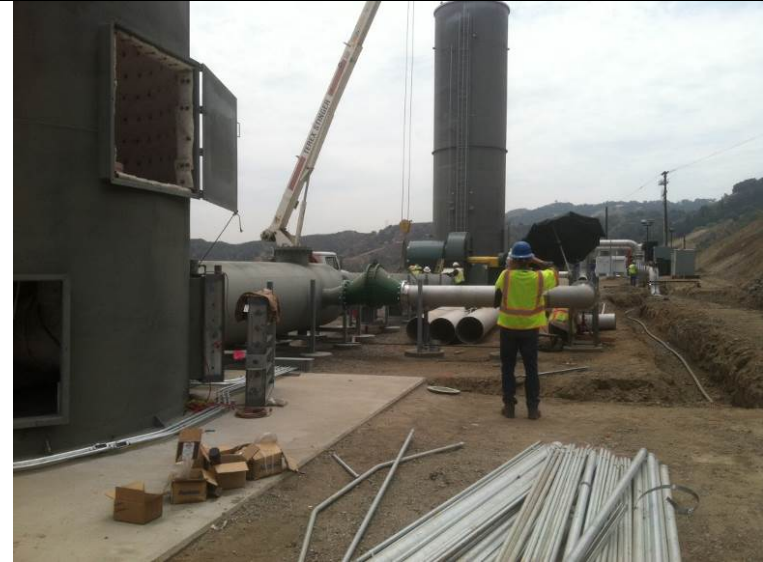
**Photo 156: Flare 10: July 10, 2013**

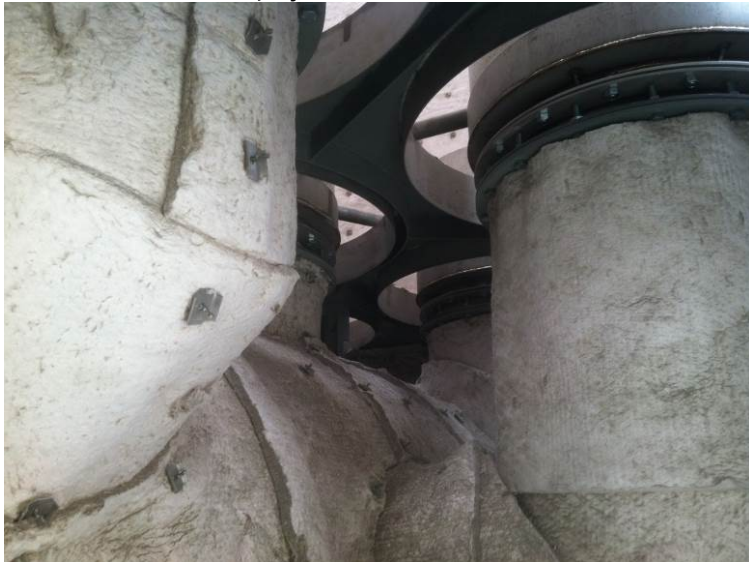
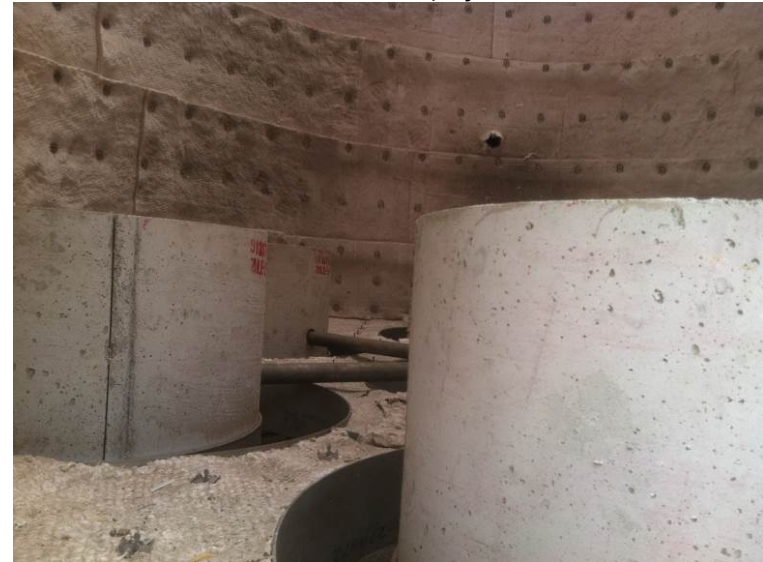
**Photo 158: Flare 10 Construction: July 10, 2013**

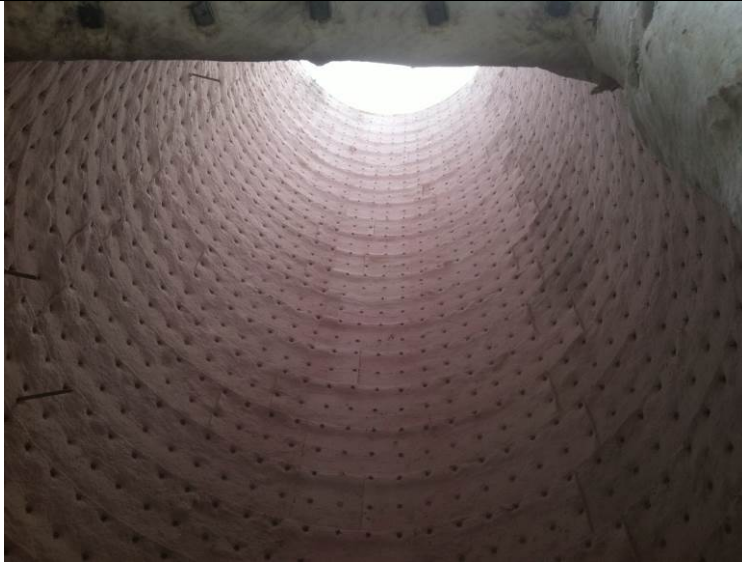
**Photo 160: Flare 10 Construction: July 10, 2013**

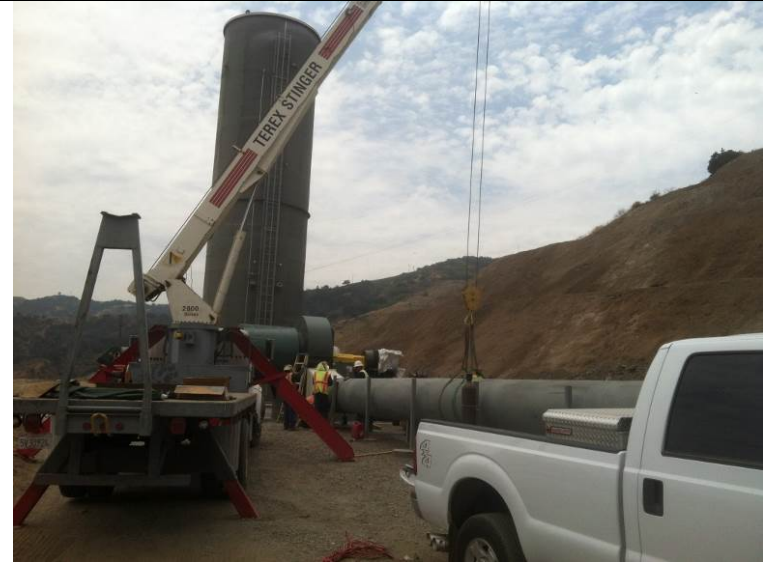
**Photo 161: Flare 10 Construction: July 10, 2013**

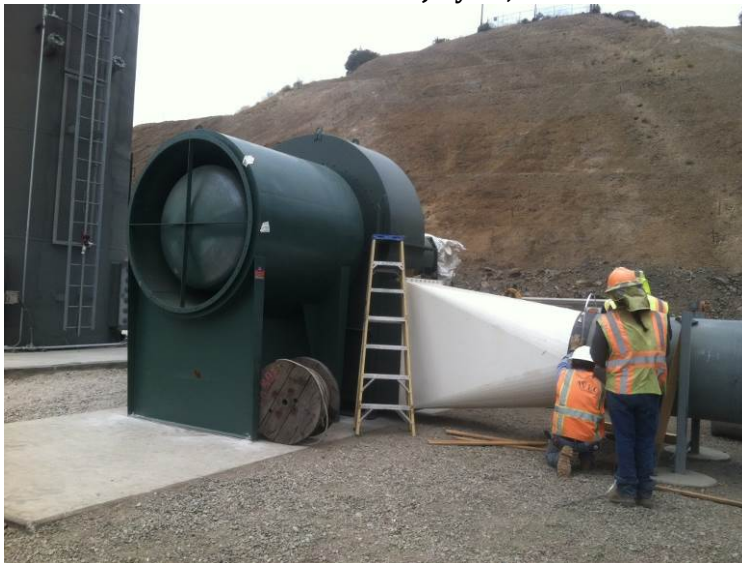
**Photo 162: Flare 10 Construction: July 10, 2013**

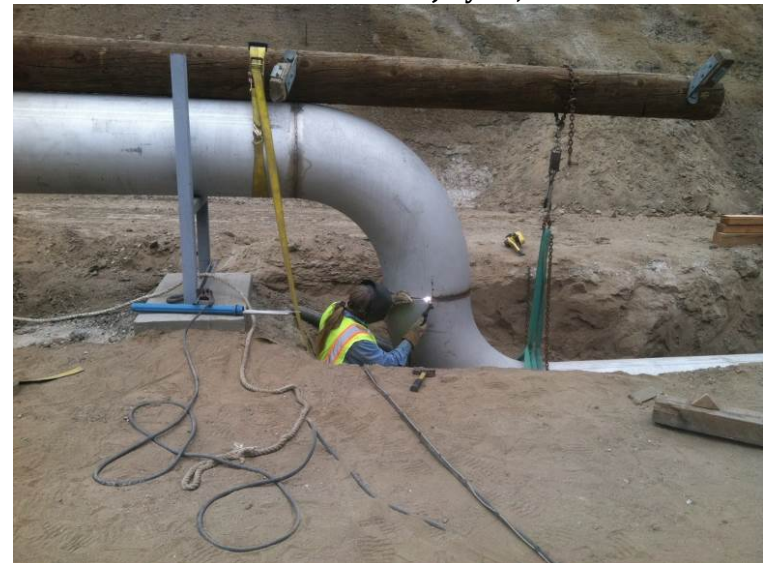
**Photo 163: Flare 10 Construction: July 10, 2013**

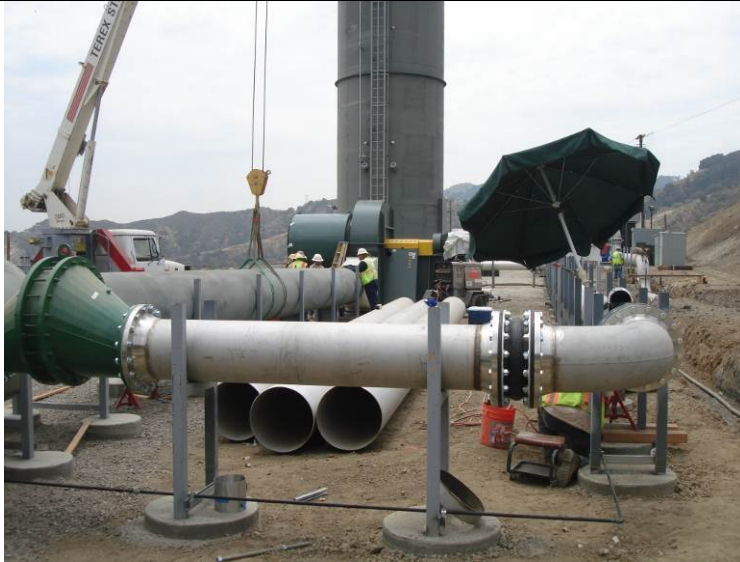
**Photo 164: Flare 10 Construction: July 10, 2013**

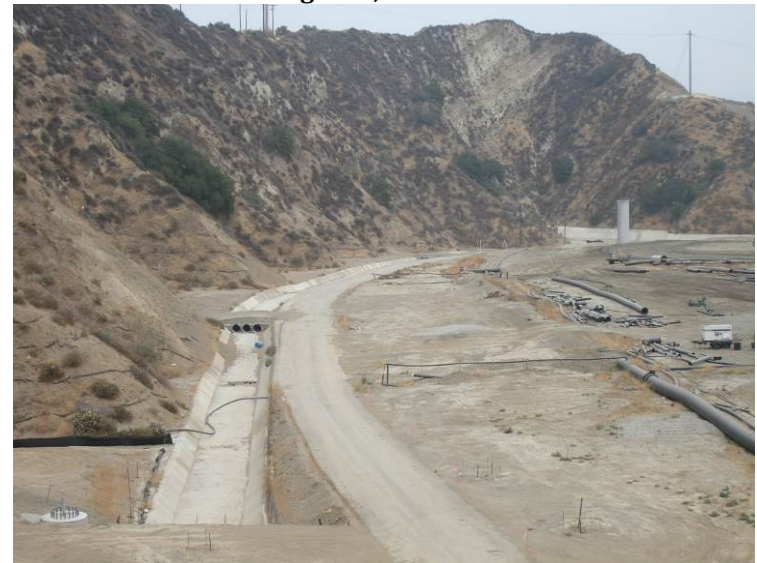
**Photo 167: Edison Equipment Site: July 10, 2013**

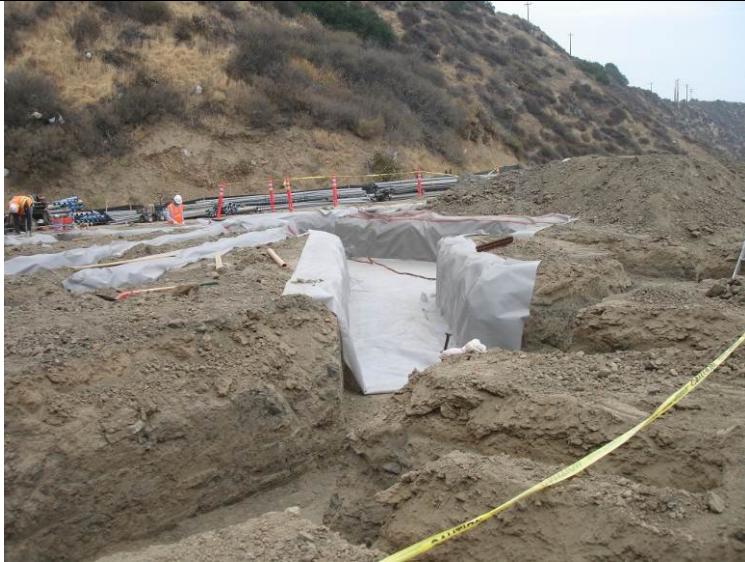
**Photo 168: Edison Pole Foundation: July 10, 2013**

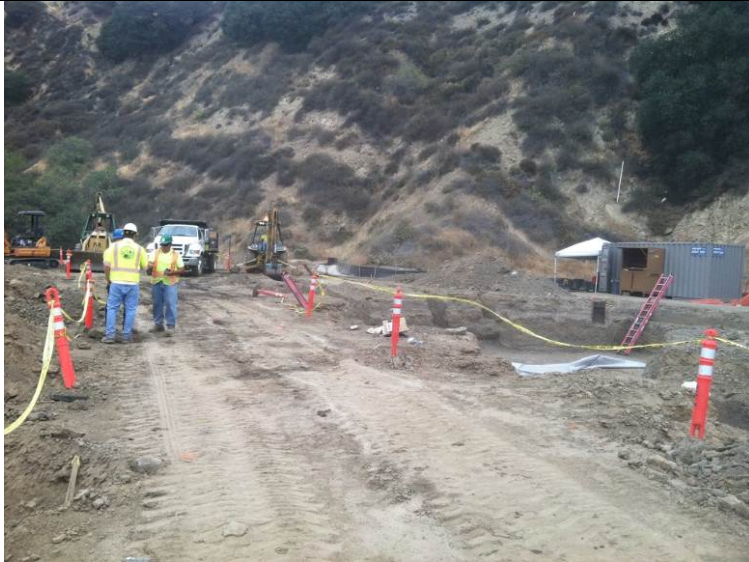
**Photo 176: Gas to Energy Facility Construction: July 10, 2013**

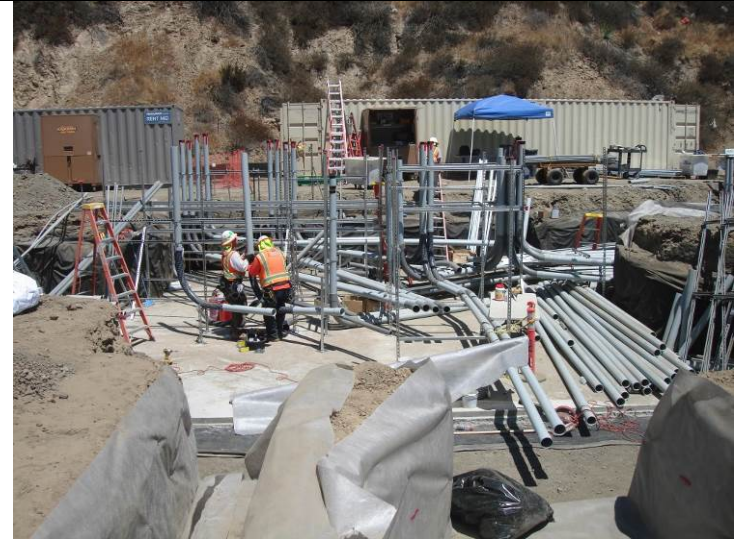
**Photo 185: Gas to Energy Facility Construction: August 7, 2013**

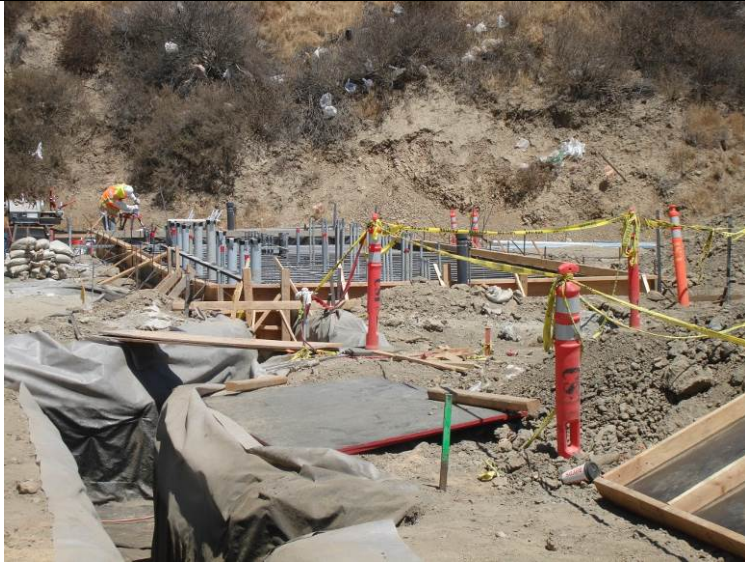
**Photo 192: Gas to Energy Facility Construction: August 20, 2013**

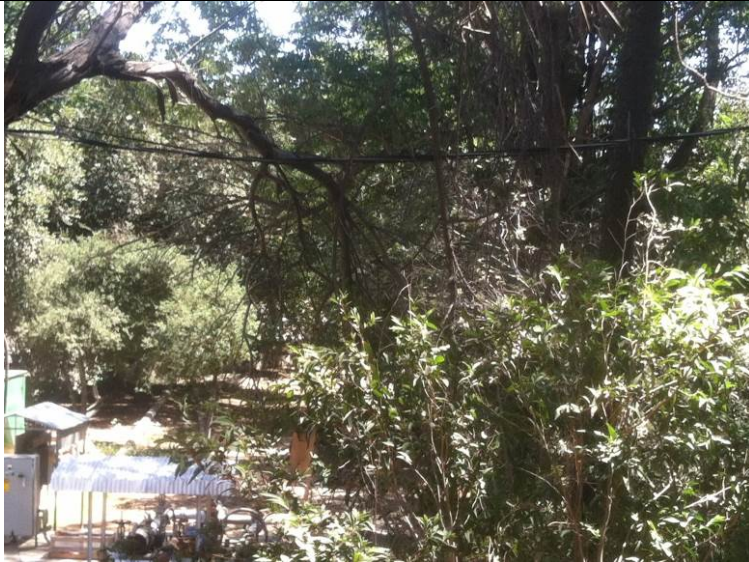
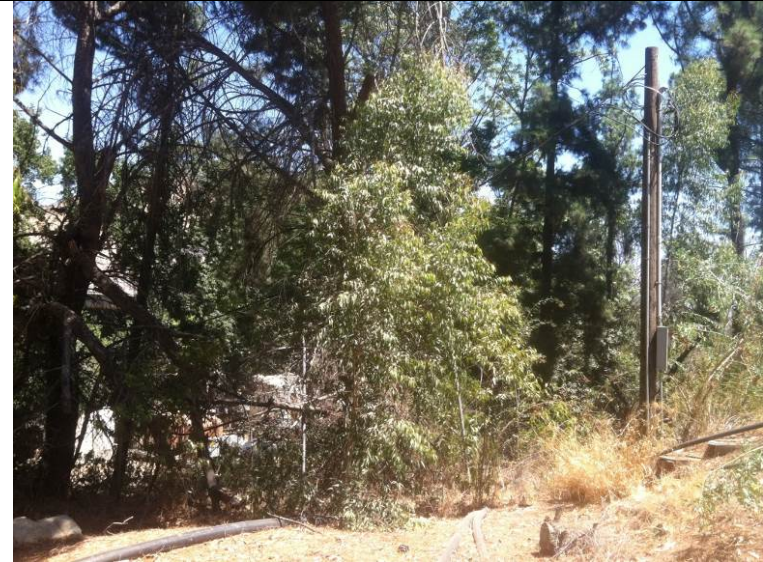
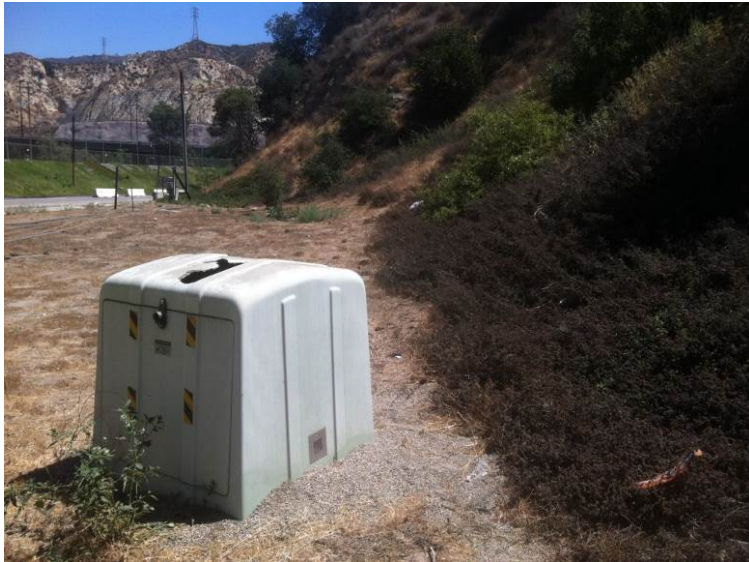
**Photo 219: Leachate Treatment Electrical Lines:  
August 20, 2013**

**Photo 220: Leachate Treatment Electrical Lines:  
August 20, 2013**

**Photo 221: Leachate Treatment Electrical Lines: August 20, 2013**

**Photo 222: Leachate Treatment Electrical Lines: August 20, 2013**

- There is no secondary access road now that the Flare 8 road has been eliminated.
- The leachate facility electrical lines are hanging on branches and pose a fire hazard.
- The terminal basin has sediment.
- When the realignment road design has been finalized and associated impacts analyzed, the monitors would request that a copy be provided.

- The terminal basin should be cleaned by October.
- The leachate electrical powerlines condition will be reported to maintenance.
- The gas-to-energy turbines will be on site in late September, with foundations in place by early December.
- There is a draft tree mitigation status report that has been submitted to the County Forrester Kelly Kim.
- The replacement designation of a secondary access has not been made.

1. Check on status of maintenance on accelerometer.
2. Check terminal basin for sediment removal.
3. Check electrical powerlines to the leachate facility.
4. Cracks on access road and City South slope should be investigated by Republic's geotechnical engineer.

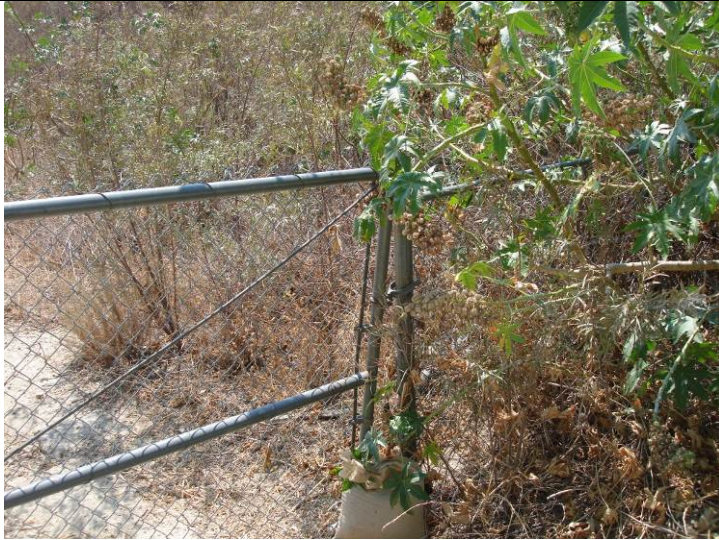
**Photo 228: Leachate Removal Sump Gas Leak: September 11, 2013**

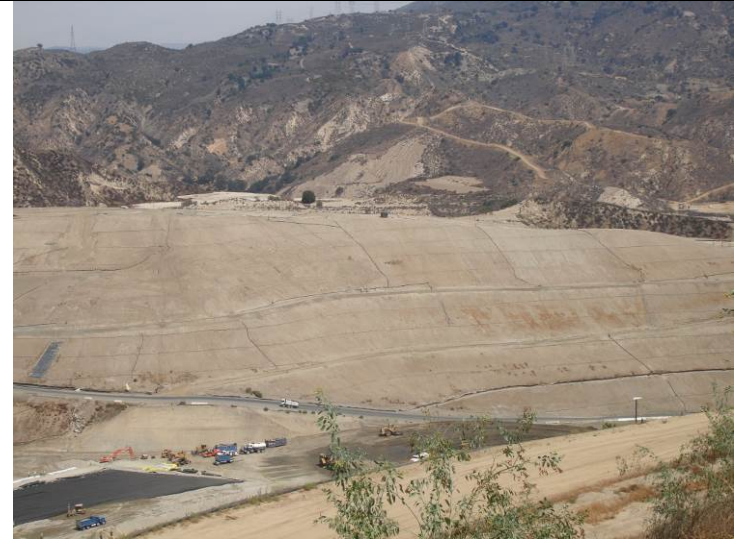
**Photo 289: City South Deck C Sage Mitigation: September 11, 2013**

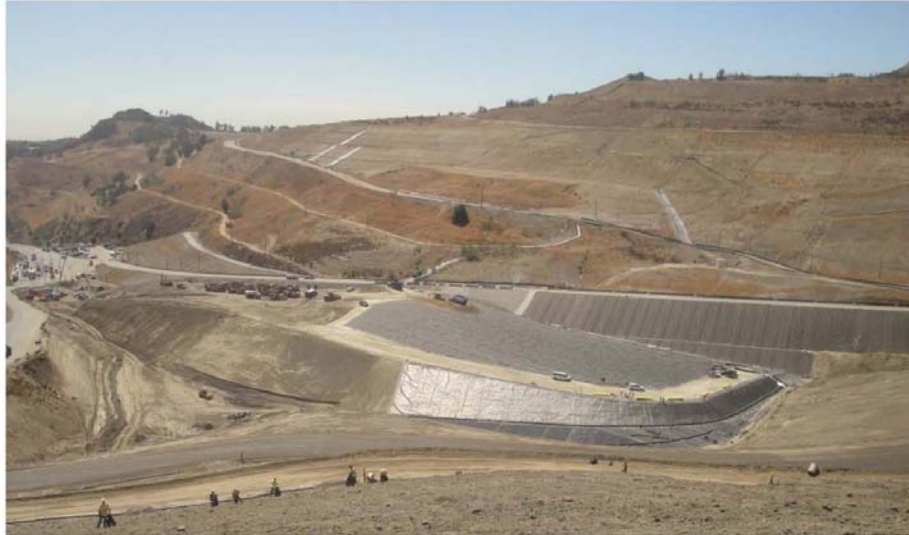
Monitor: Tarik Hadj-Hamou, Ph.D., P.E.	PAGE 2 OF 2
Discipline: Civil – Geotechnical	Date: August 20, 2013
Site Conditions: Sunny	
SITE LOG	
<p>Cell CC3 Phase II</p> <ul style="list-style-type: none"> <li>• The stability berm is in place (Photo 1)</li> <li>• The liner was installed over the berm and floor of the cell</li> <li>• The operation layer was being placed. We noted the use of the thick layer in the area where the dump truck rides. This extra thickness will lead to an acceptable stress level on the geosynthetics</li> </ul>	
<p>Geotechnical Issues</p> <ul style="list-style-type: none"> <li>• A crack was observed on the access road near the cell CC3 buttress (Photo 3). The photo shows some vertical offset at the crack and some horizontal offset of the concrete. Also when driving in the area one can feel a small depression. These indicia indicate some downward and outward movement</li> <li>• Fissures/cracks were also observed on the hillside (Photo 4)</li> </ul>

Photo 1: Berm for Cell CC3 Phase II

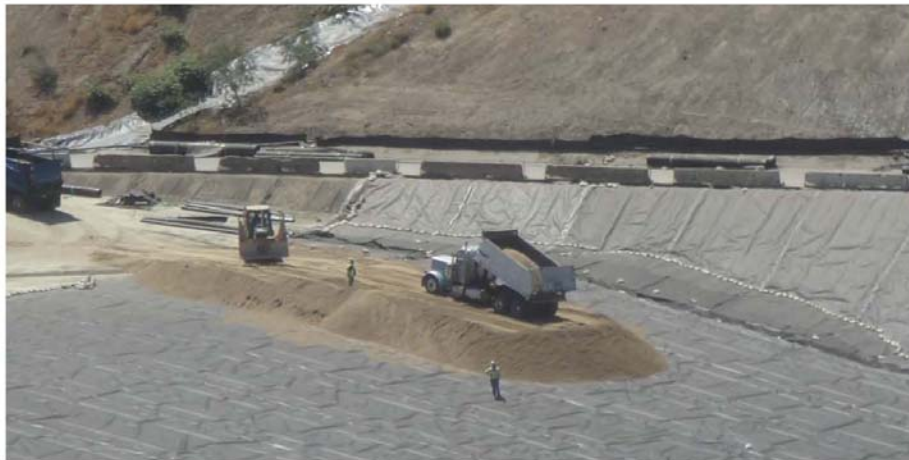
Photo 2: Thick layer under dump truck to reduce stresses on geosynthetics
