**Sunshine Canyon Landfill
Independent Monitor
Quarterly Site Monitoring Status Report
July 1, 2017 – September 30, 2017**

City of Los Angeles Department of City Planning

County of Los Angeles Department of Regional Planning

December 22, 2017

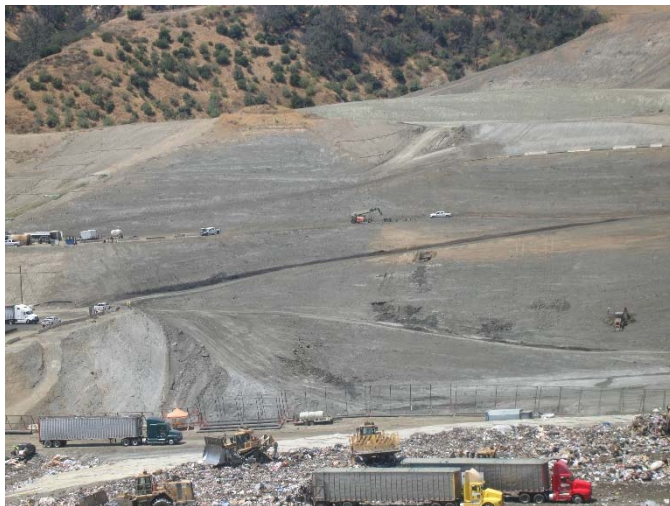
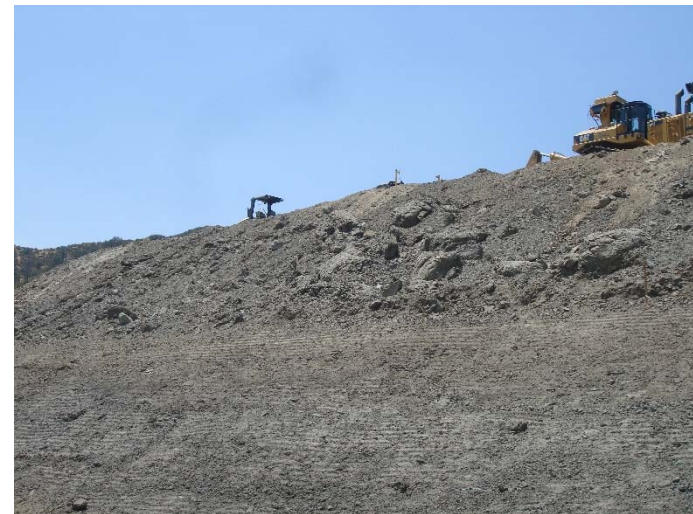
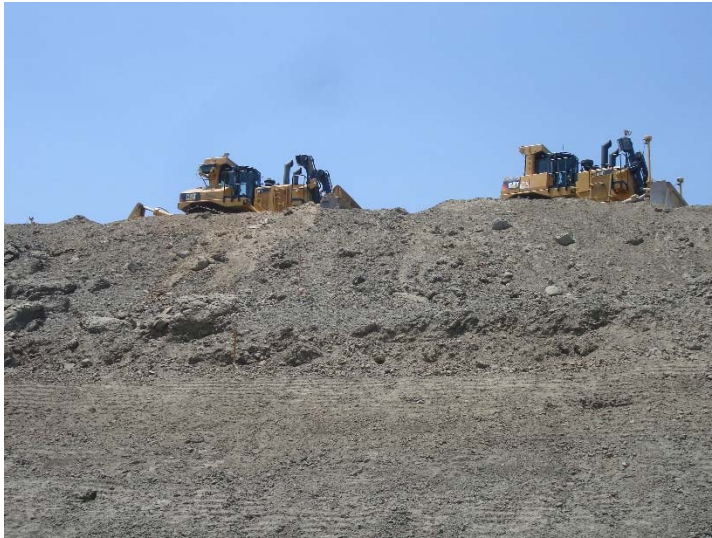
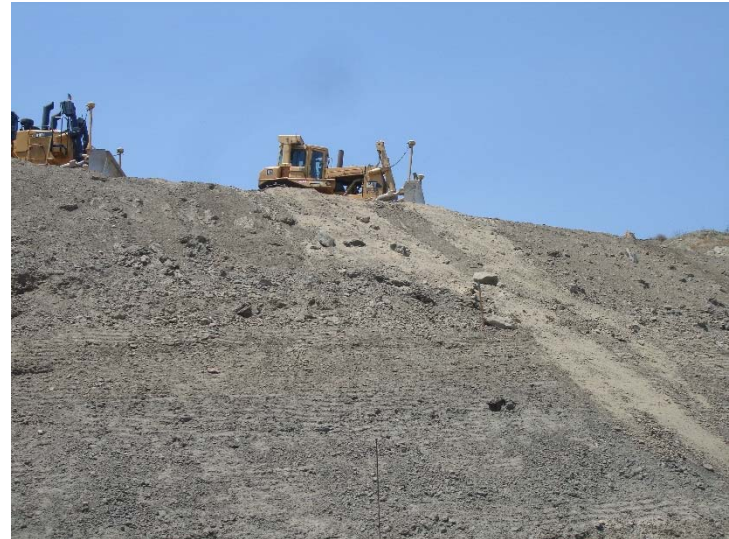
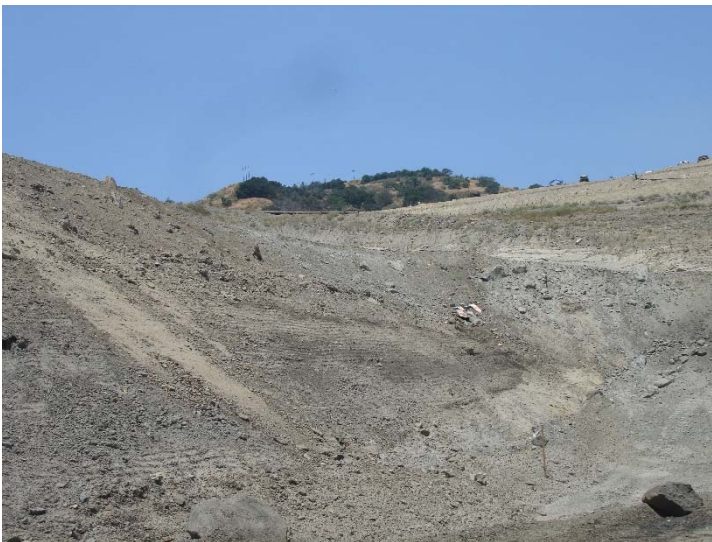
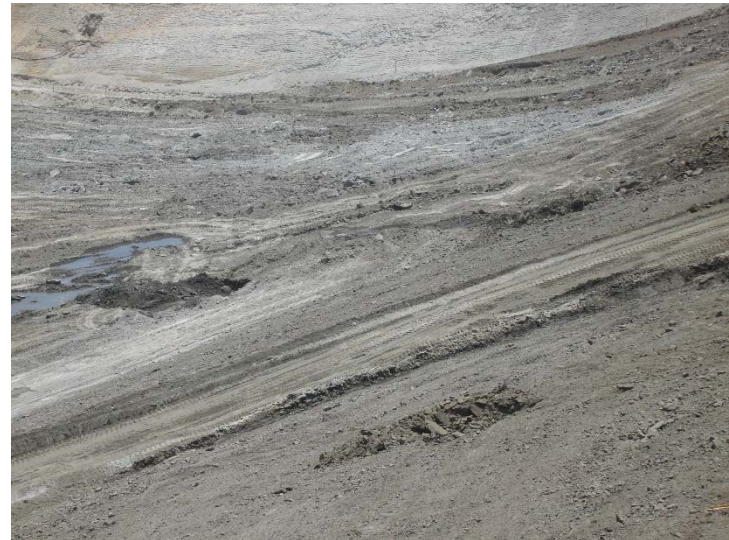
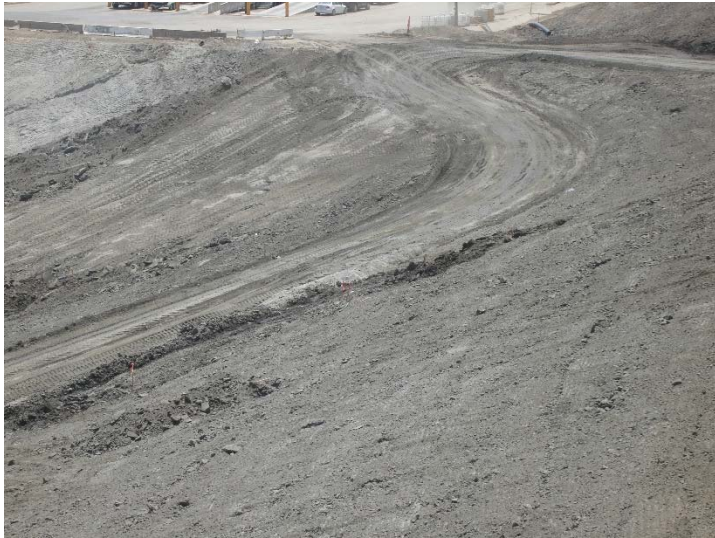
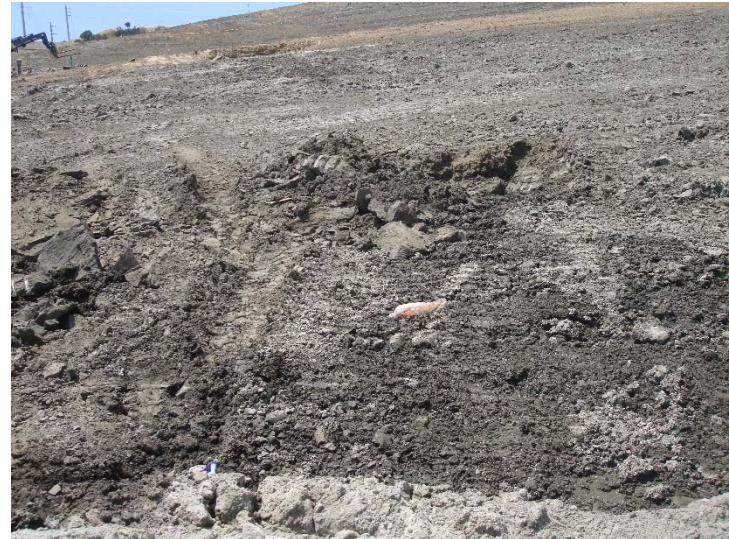
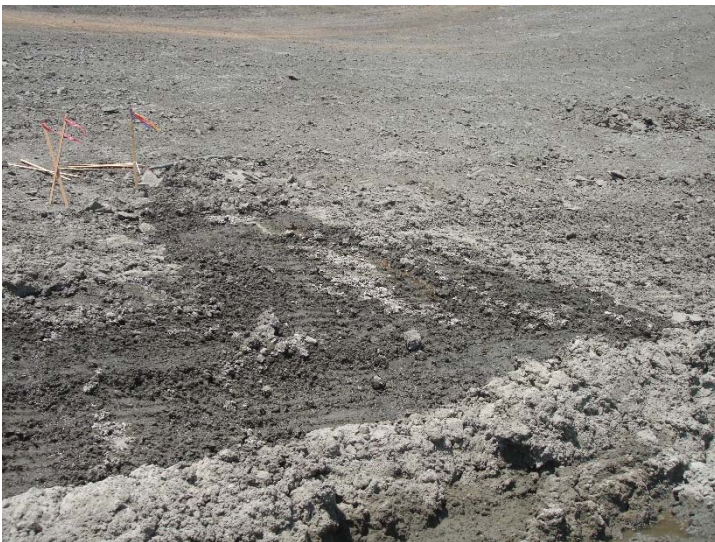
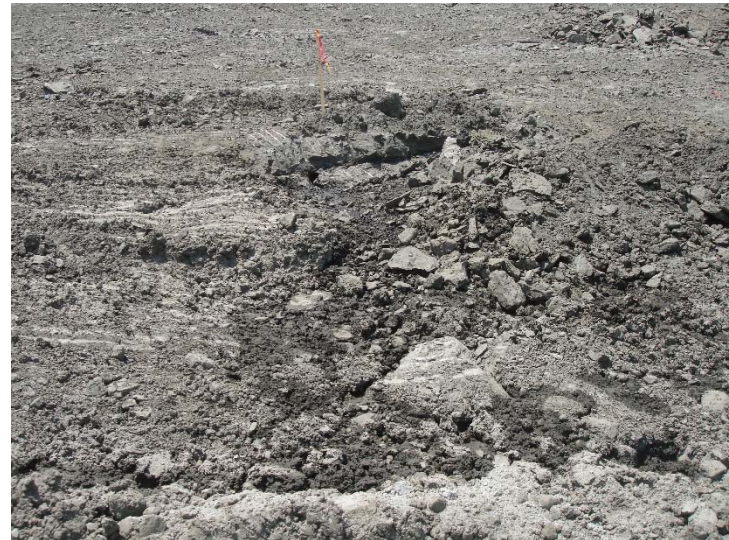
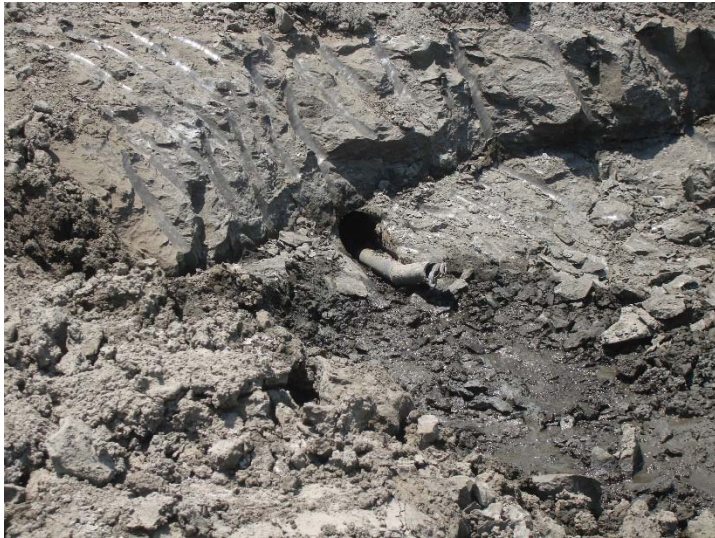
Photo 106: CC4A Part 2 Excavation Area Slide: July 11, 2017

Photo 107: CC4A Part 2 Excavation Area Slide: July 11, 2017

Photo 108: CC4A Part 2 Excavation Area Slide: July 11, 2017

Photo 109: CC4A Part 2 Excavation Area Slide: July 11, 2017

Photo 110: CC4A Part 2 Excavation Area Slide: July 11, 2017

Photo 111: CC4A Part 2 Excavation Area Slide: July 11, 2017

Photo 112: CC4A Part 2 Excavation Area Slide: July 11, 2017

Photo 113: CC4A Part 2 Excavation Area Slide: July 11, 2017

Photo 114: CC4A Part 2 Excavation Area Slide: July 11, 2017

Photo 115: CC4A Part 2 Excavation Area Slide: July 11, 2017

Photo 116: CC4A Part 2 Excavation Area Slide: July 11, 2017

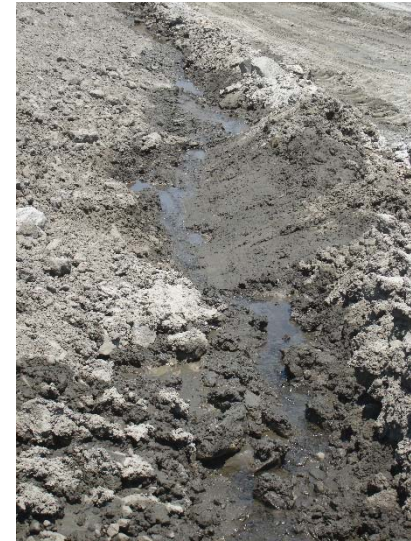
Photo 118: CC4A Part 2 Excavation Area Slide: July 11, 2017

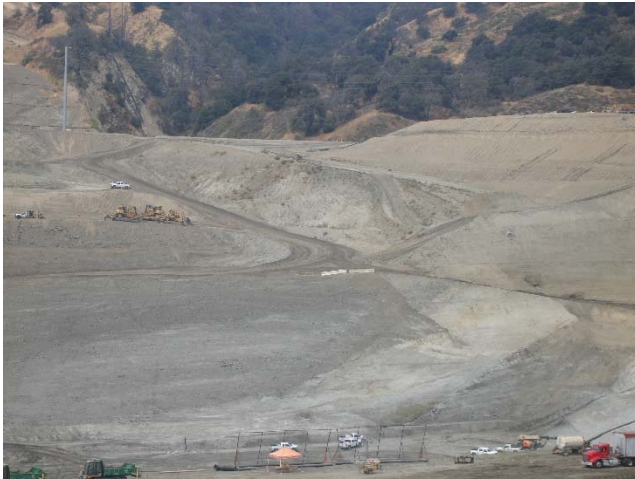
Photo 129: CC4A Part 2 Excavation Area Slide: July 25, 2017

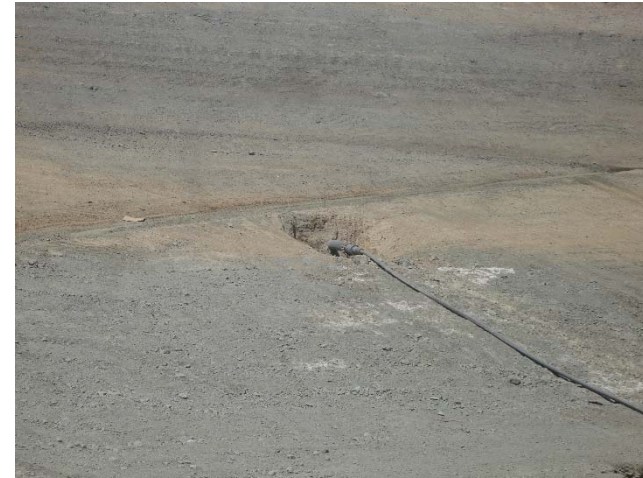
Photo 130: CC4A Part 2 Prior Slide Area: July 25, 2017

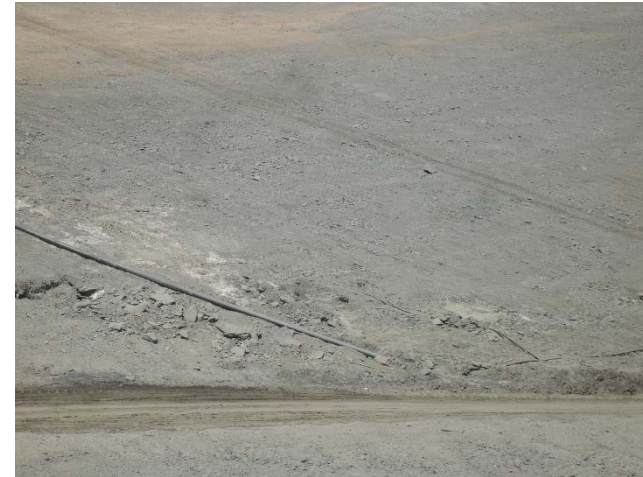
Photo 132: CC4A Part 2 Prior Slide Area: July 25, 2017

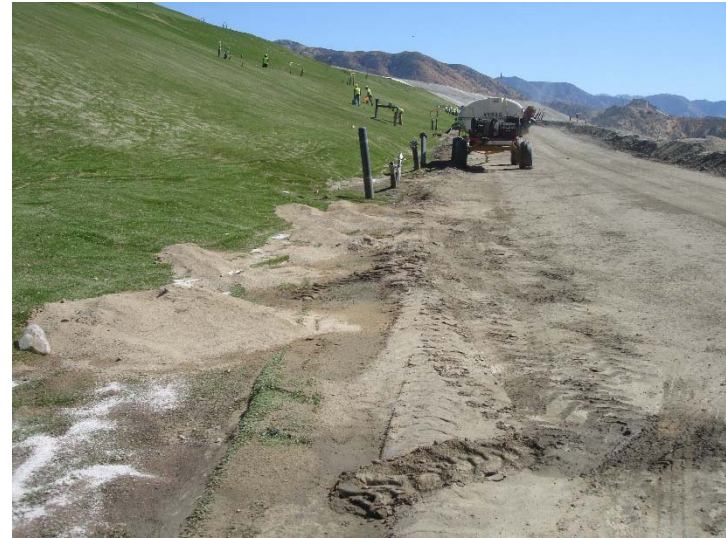
Photo 150: Cell CC3A Liquid Break-Out Area: July 11, 2017

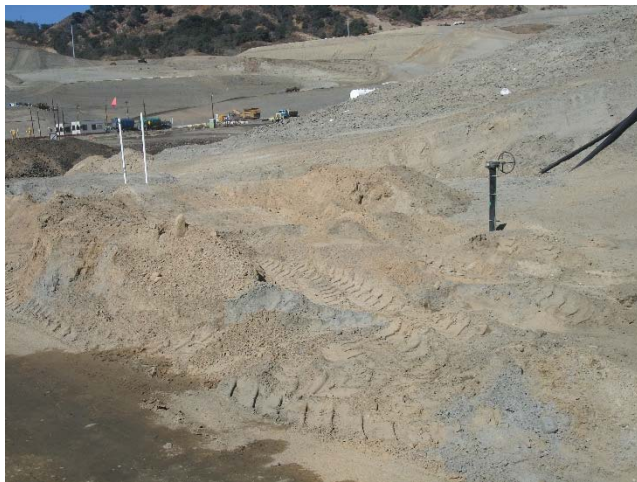
Photo 151: Cell CC3A Liquid Break-Out Area: July 11, 2017

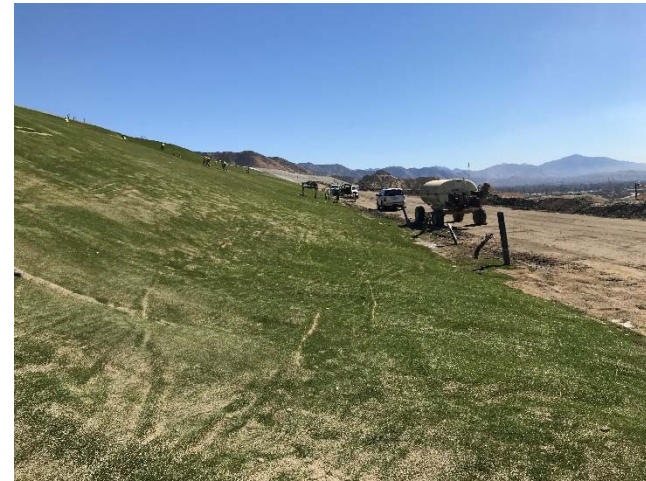
Photo 152: Cell CC3A Liquid Break-Out Area: July 11, 2017

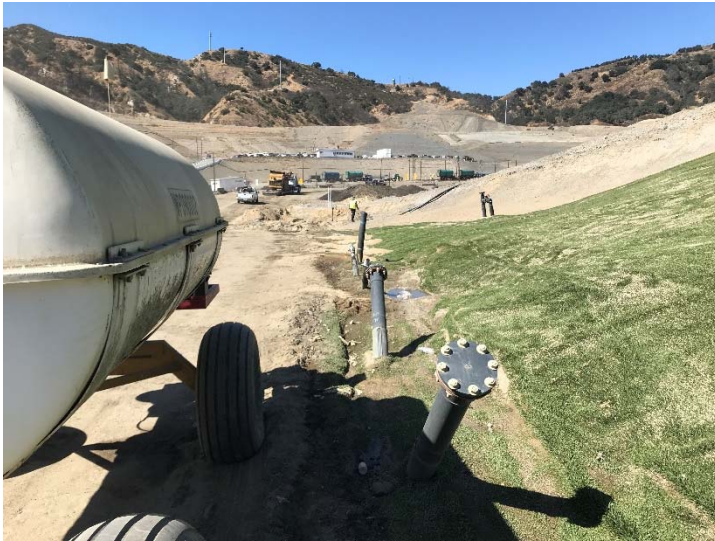
Photo 153: Cell CC3A Liquid Break-Out Area: July 11, 2017

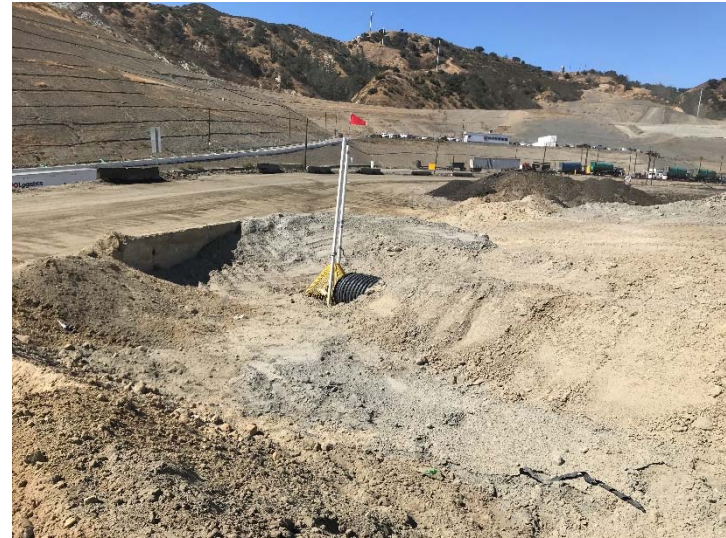
Photo 154: Cell CC3A Liquid Break-Out Area: July 11, 2017

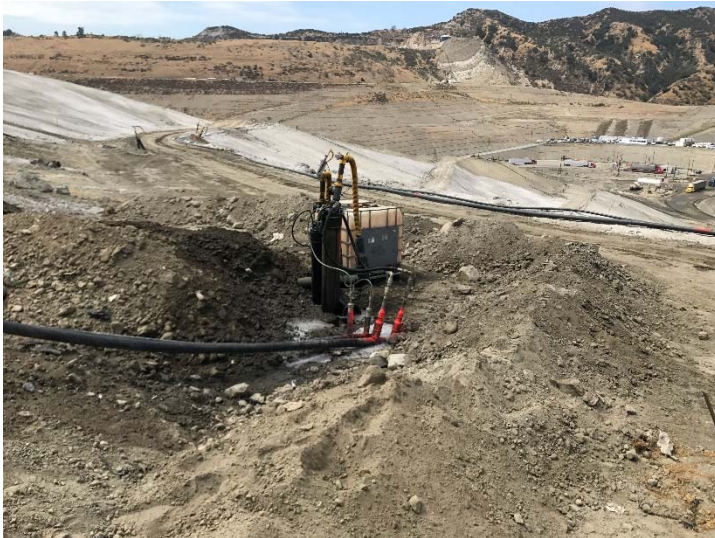
Photo 155: Cell CC3A Slope Gas Well Liquid Surge: July 25, 2017

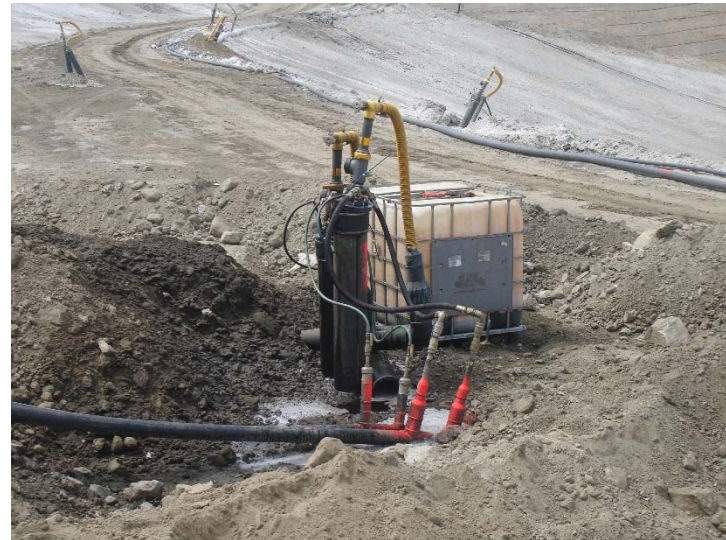
Photo 156: Cell CC3A Slope Gas Well Liquid Surge: July 25, 2017

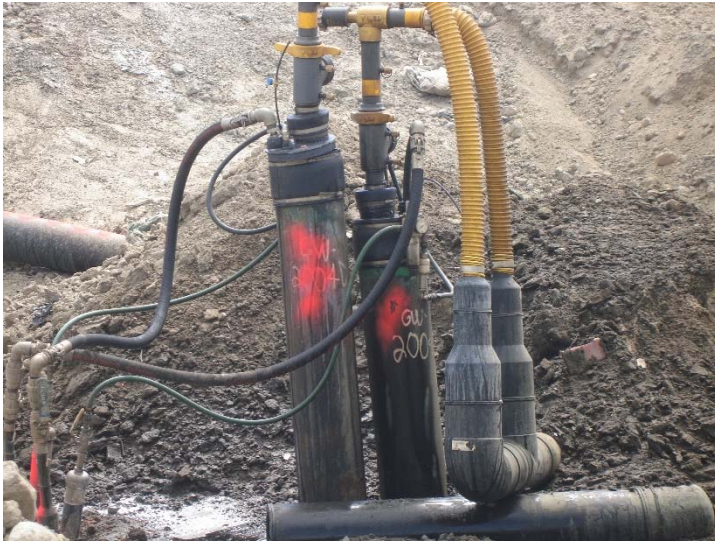
Photo 157: Cell CC3A Slope Gas Well Liquid Surge: July 25, 2017

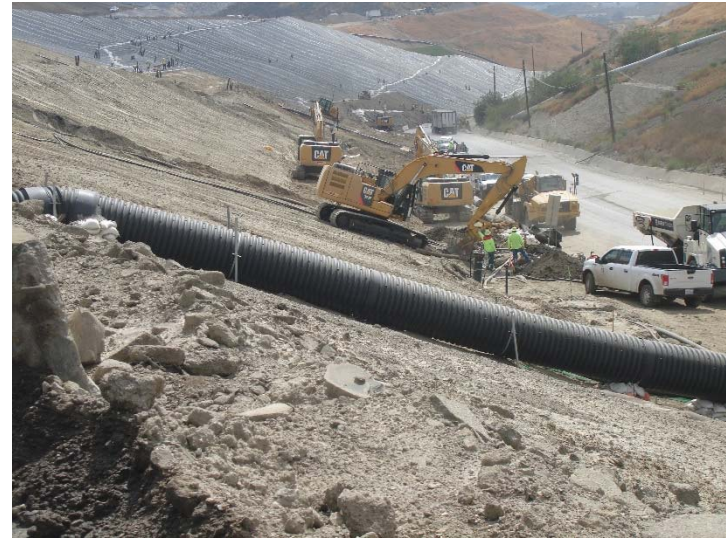
Photo 158: Cell CC3A Slope Work near Access Road: July 25, 2017

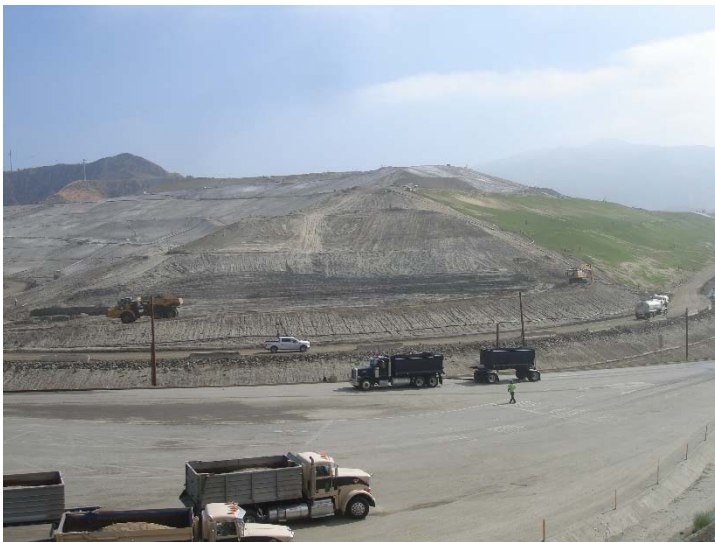
Photo 159: CC3A Stockpile Removal: August 14, 2017

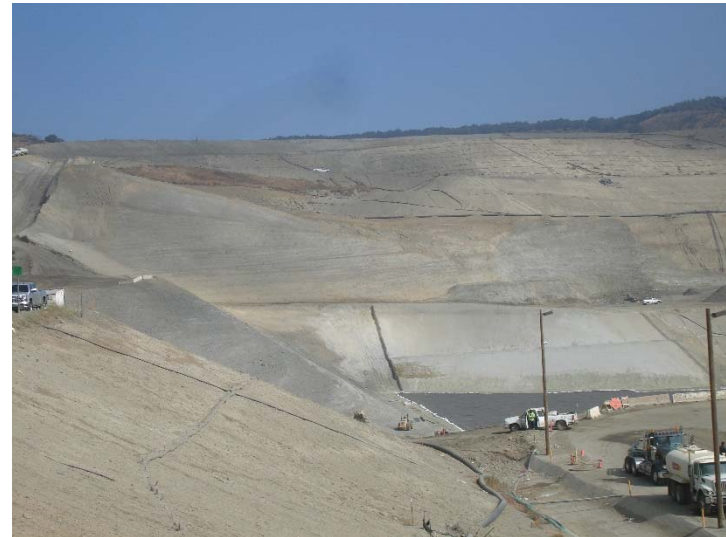
Photo 160: County South Slope: August 14, 2017

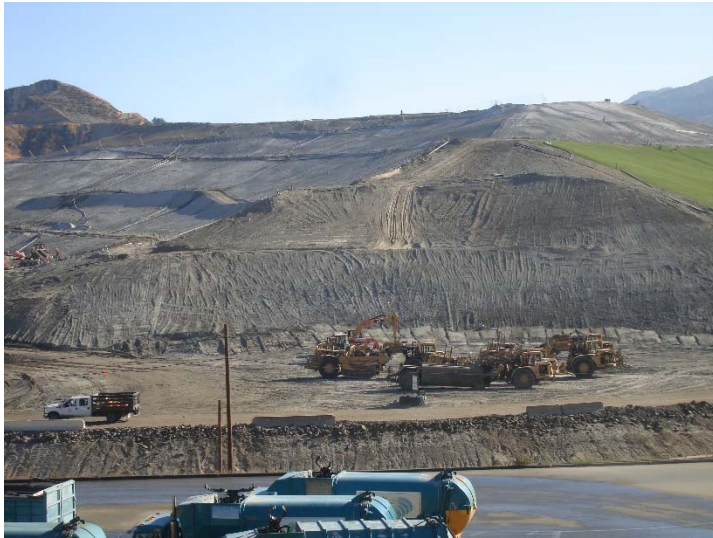
Photo 161: Cell CC3A Stockpile Removal 843AM: September 12, 2017

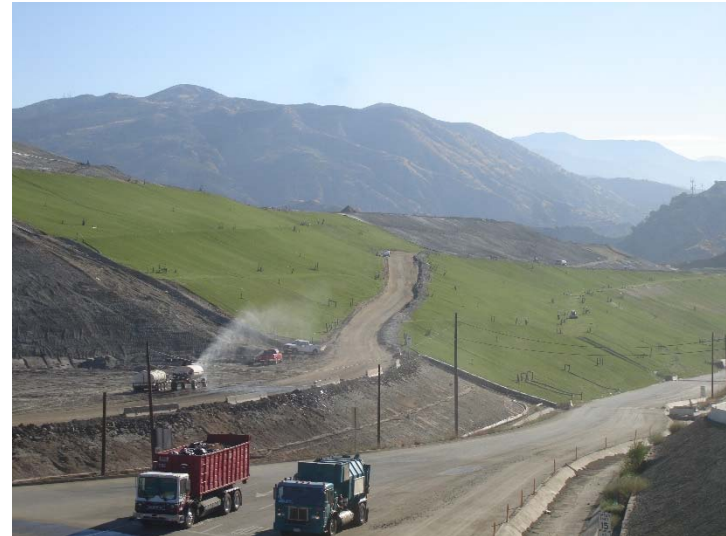
Photo 162: Cell CC3A Stockpile Removal 843AM: September 12, 2017

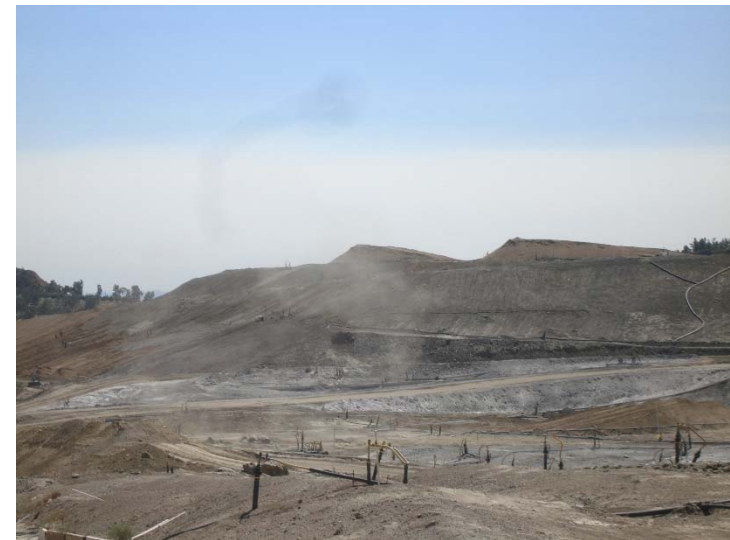
Photo 292: City Top Deck Dust: September 26, 2017

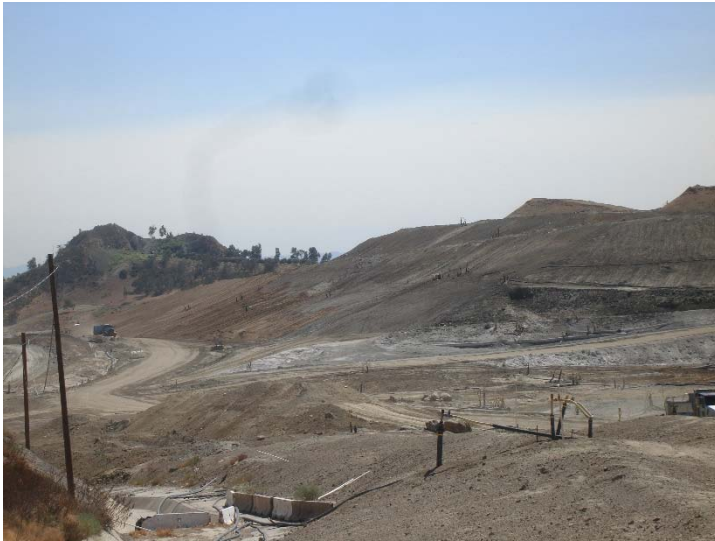
Photo 293: City Top Deck Dust: September 26, 2017

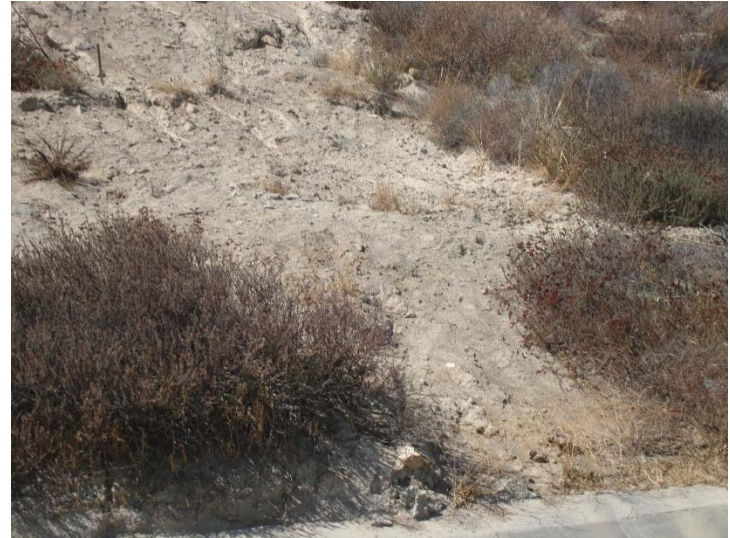
Photo 318: County Sage Mitigation Area Slope: September 26, 2017

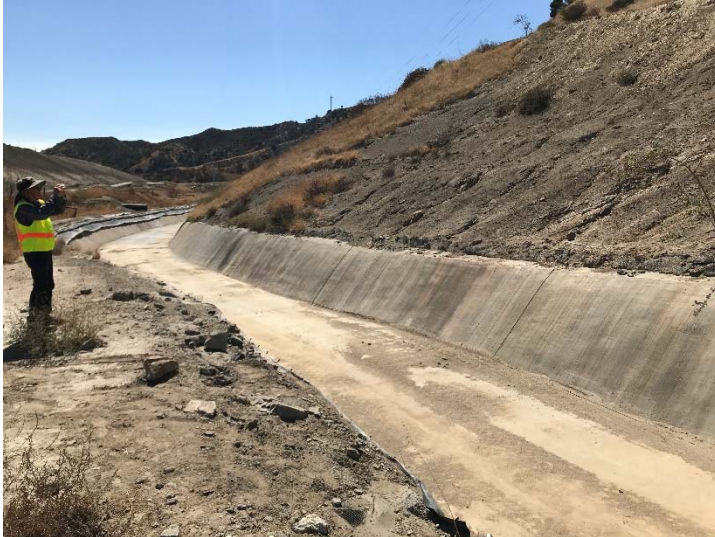
Photo 319: Westside Drainage Channel: September 26, 2017

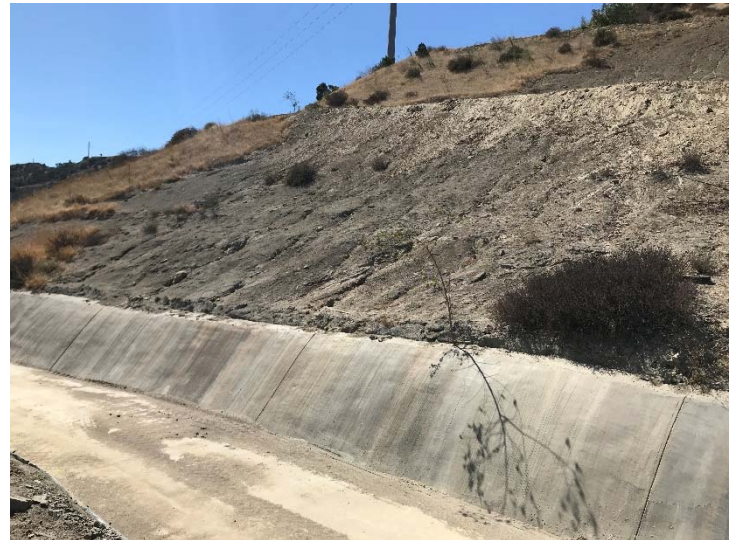
Photo 320: Westside Drainage Channel: September 26, 2017

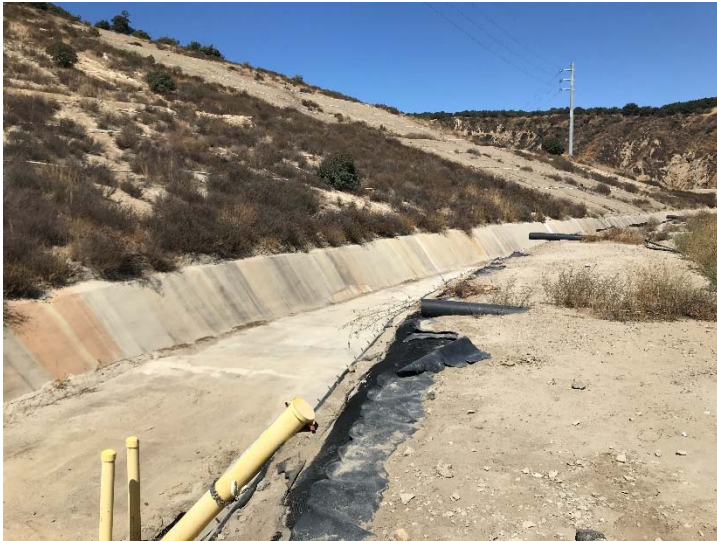
Photo 321: Westside Drainage Channel: September 26, 2017

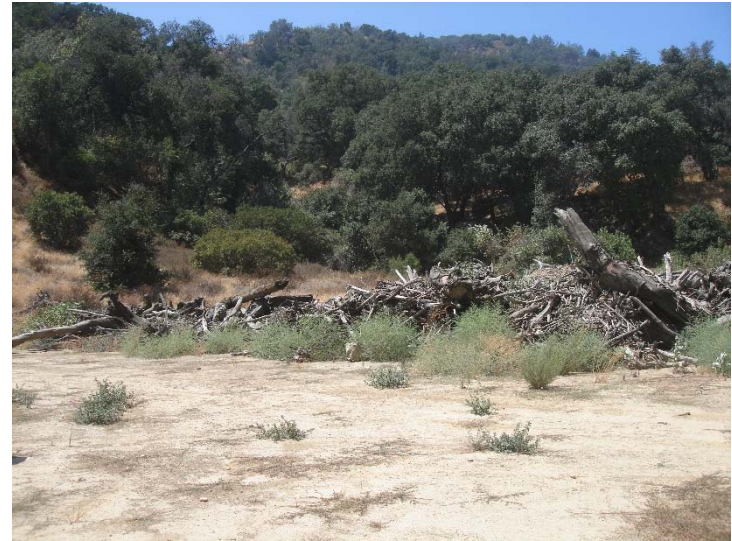
Photo 322: Waste Material near Basin D Storage Area: August 14, 2017

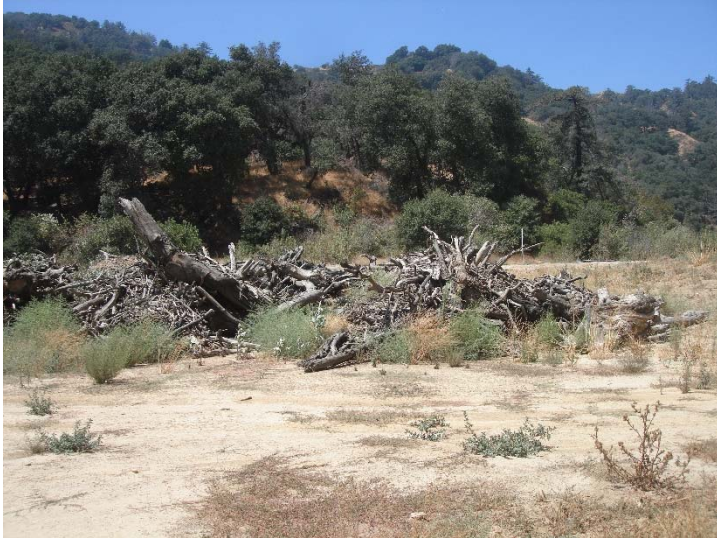
Photo 323: Waste Material near Basin D Storage Area: August 14, 2017

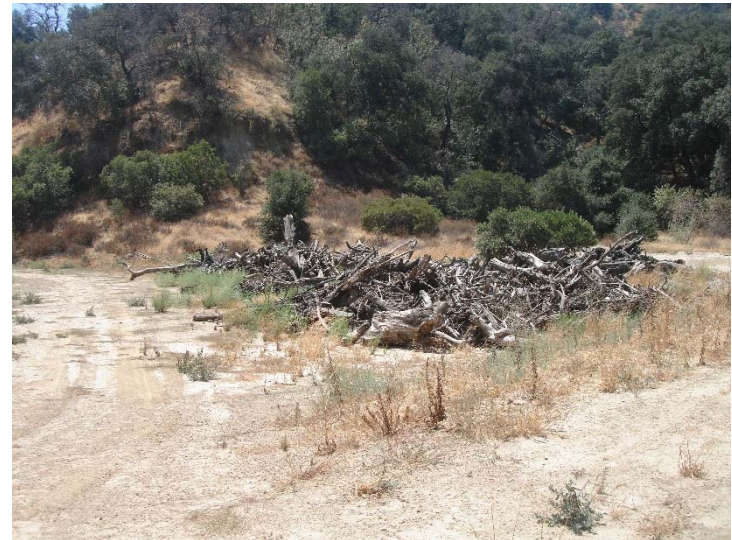
Photo 324: Waste Material near Basin D Storage Area: August 14, 2017

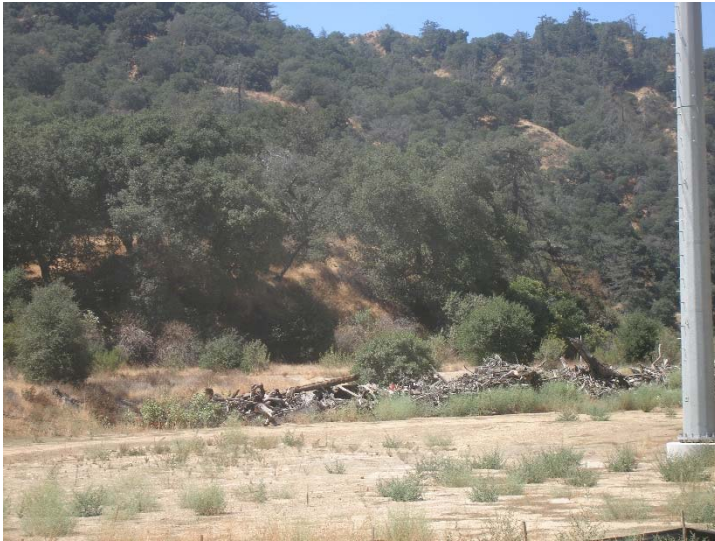
Photo 325: Waste Material near Basin D Storage Area: September 12, 2017

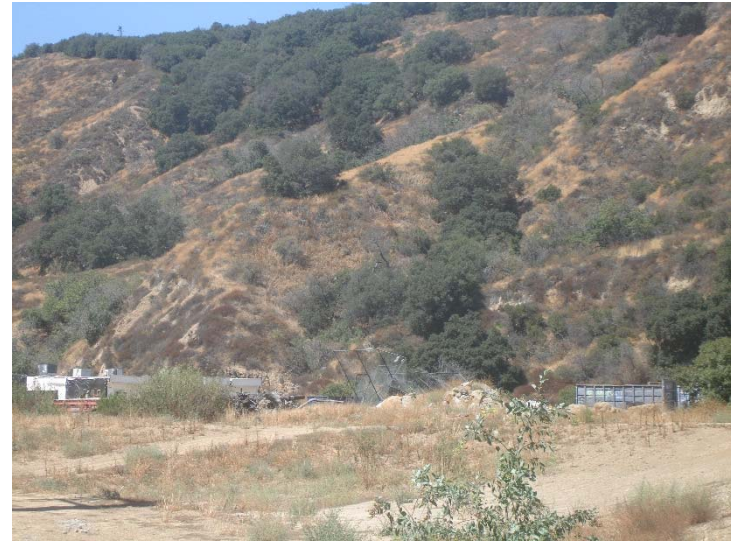
Photo 326: Waste Material near Basin D Storage Area: September 12, 2017

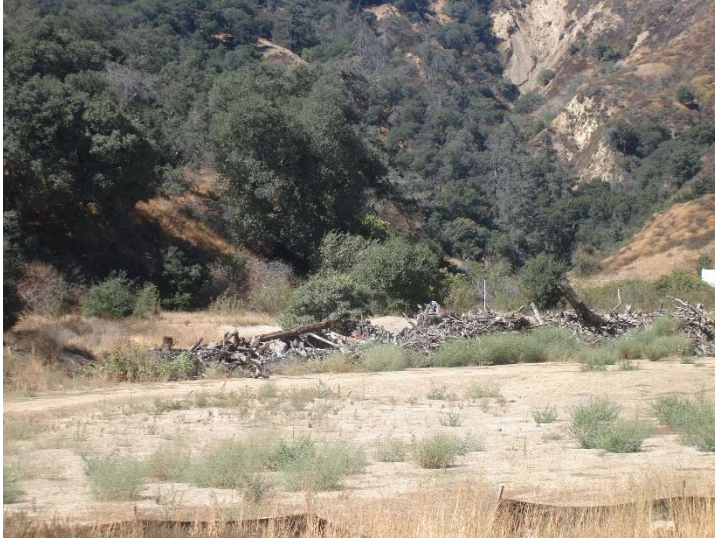
Photo 327: Waste Material near Basin D Storage Area: September 26, 2017

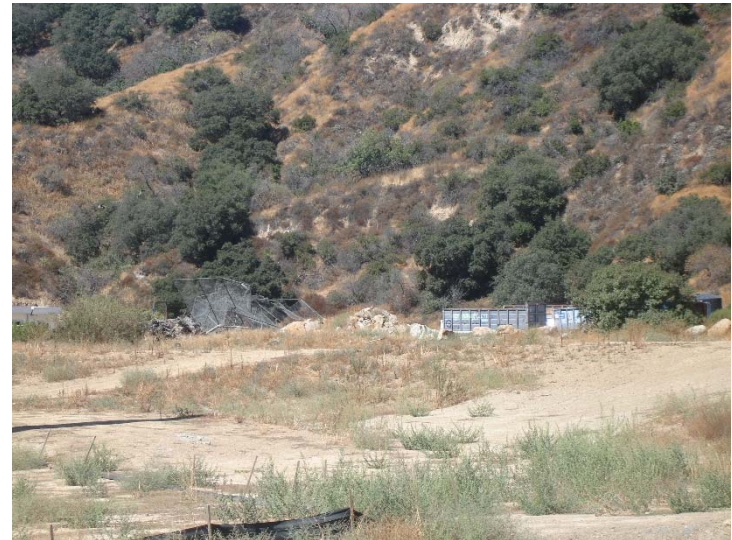
Photo 328: Waste Material near Basin D Storage Area: September 26, 2017

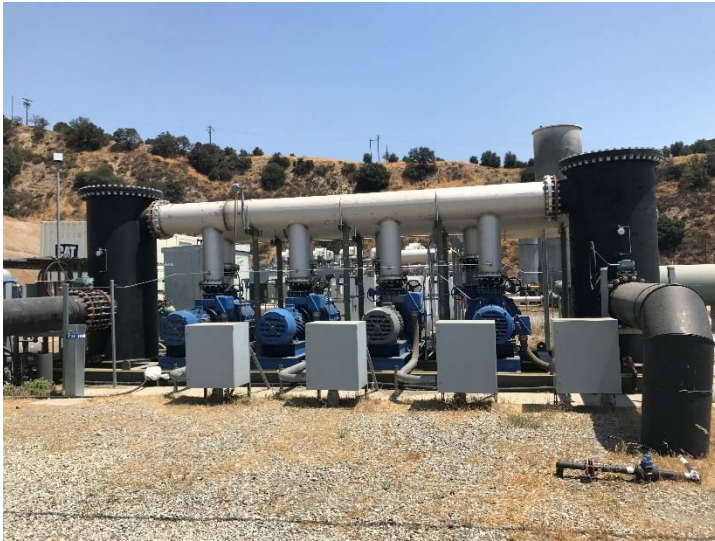
Photo 329: Flare 9 & 10 Blowers: July 11, 2017

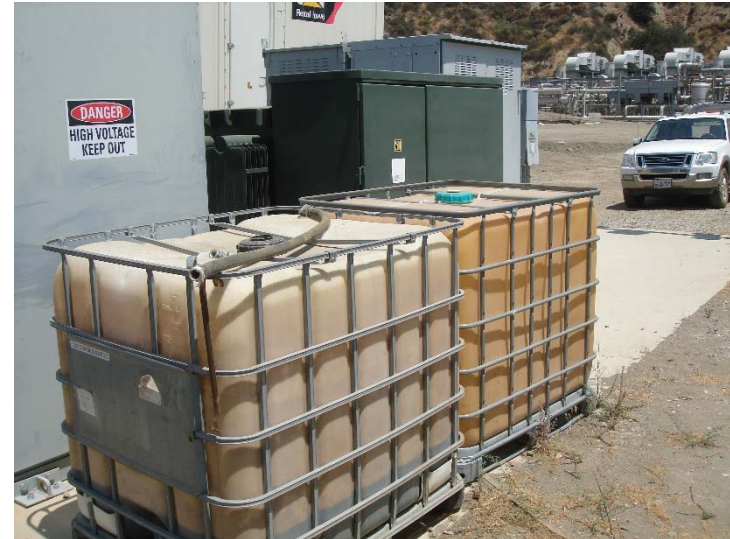
Photo 330: Flare 9 & 10 Blower Knockout Liquids: July 11, 2017

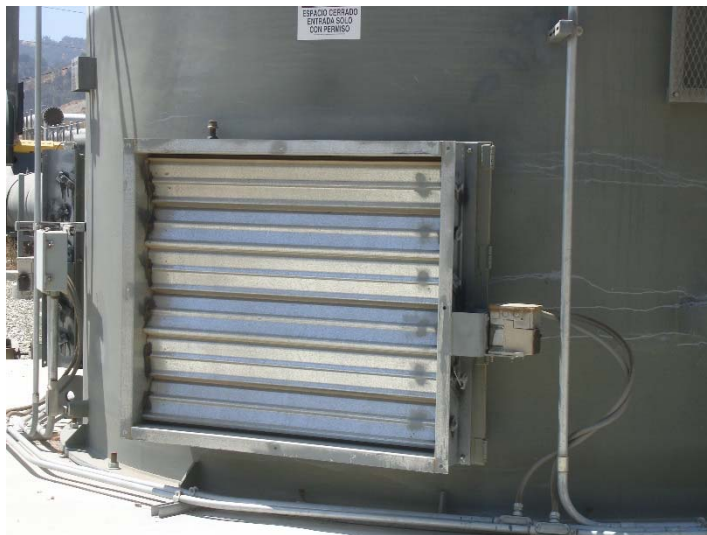
Photo 339: Flare 10 New Louvers: August 14, 2017

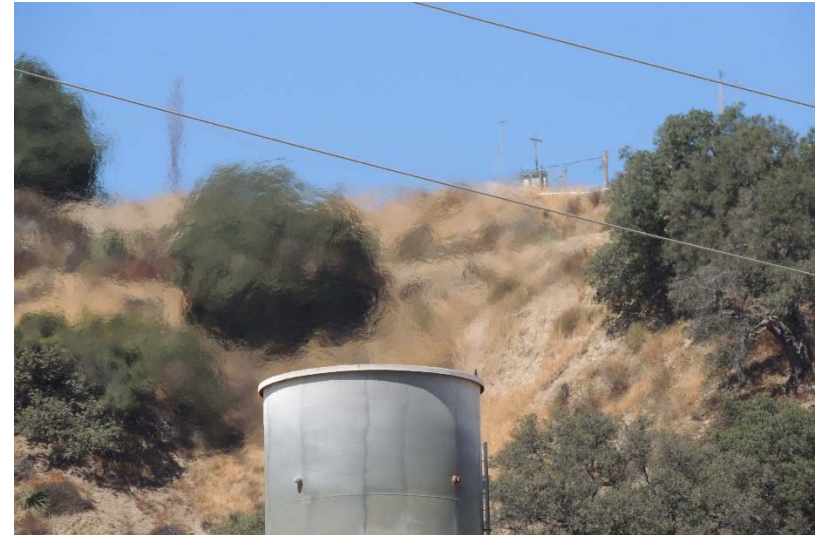
Photo 342: Flare 9 & 10 Thermic Plume: September 12, 2017

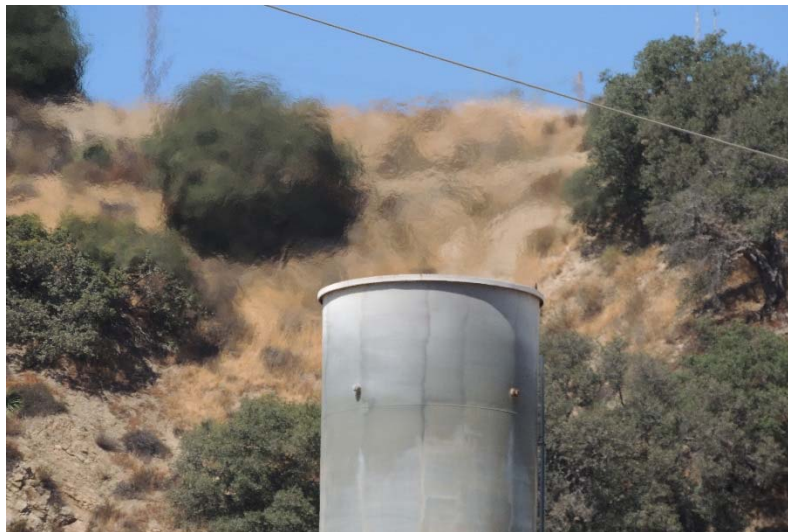
Photo 343: Flare 9 & 10 Thermic Plume: September 12, 2017

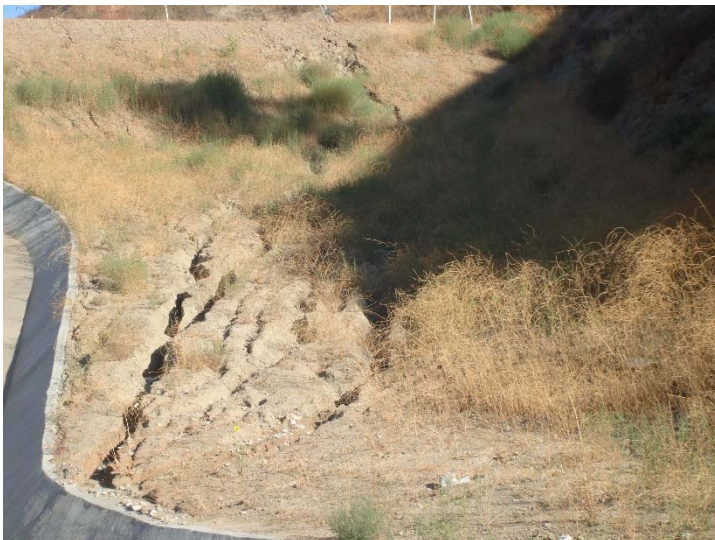
Photo 410: Terminal Basin Inlet Channel Deep Erosion: September 12, 2017

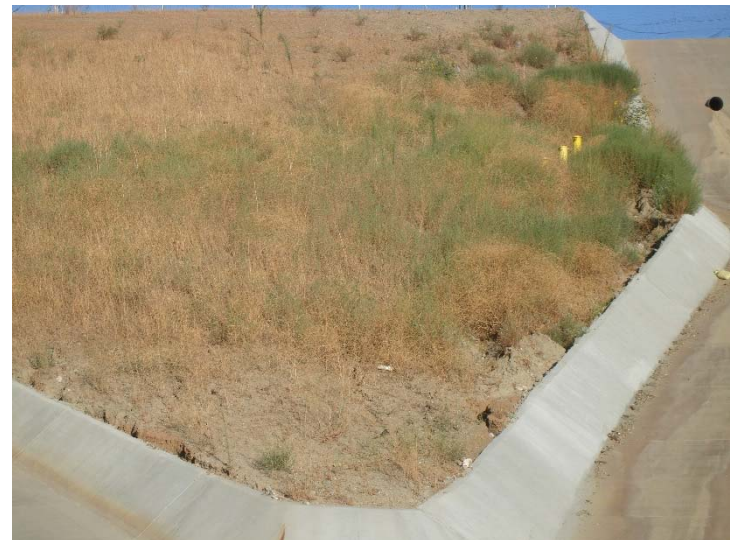
Photo 411: Terminal Basin Inlet Channel Deep Erosion: September 12, 2017

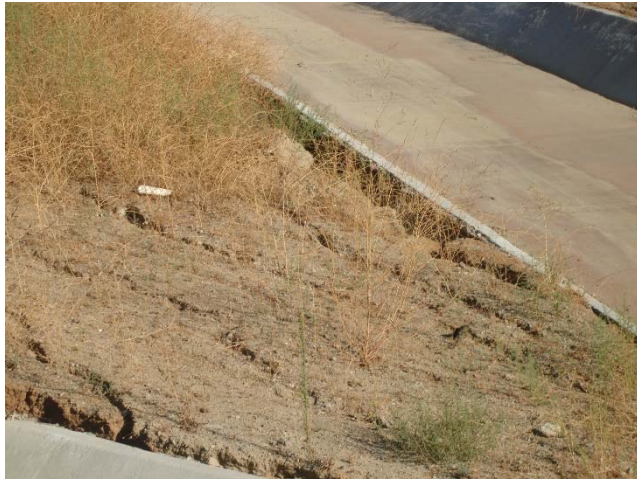
Photo 412: Terminal Basin Inlet Channel Deep Erosion: September 12, 2017

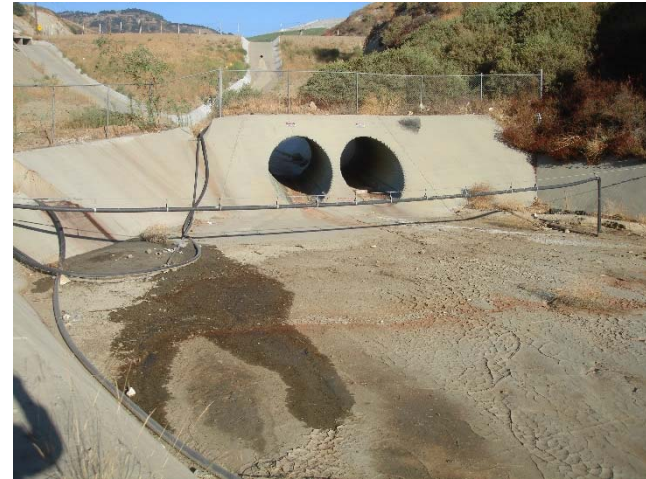
Photo 413: Terminal Basin Inlet Channel Deep Erosion: September 12, 2017

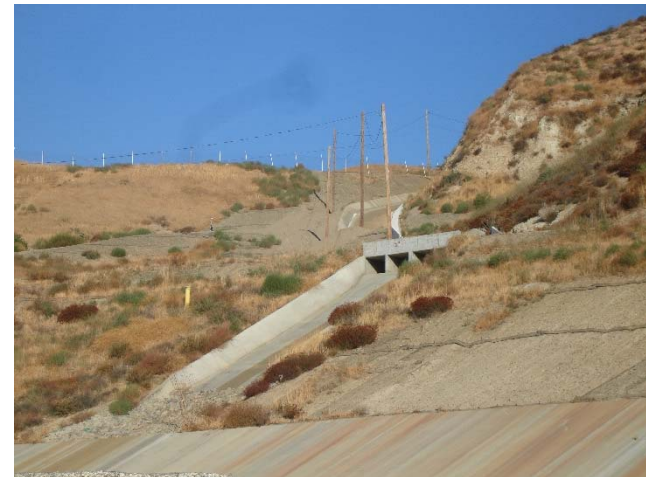
Photo 415: Terminal Basin Inlet Dirt Berm: September 12, 2017

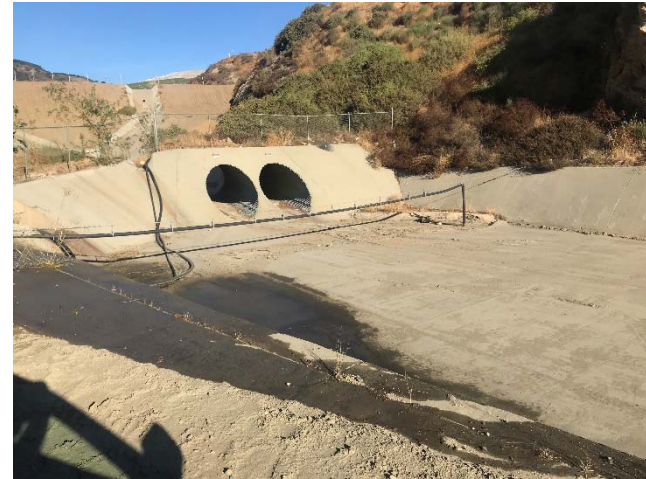
**Photo 421: Terminal Basin Inlet Channel Erosion Repaired:
September 26, 2017**

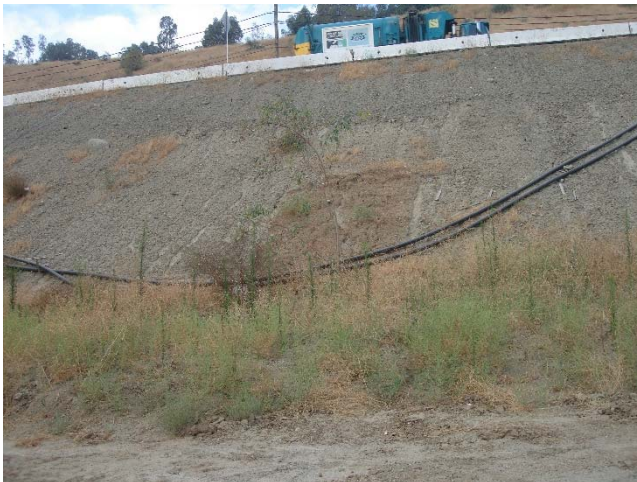
Photo 443: Access Road Slope Wet Area near Terminal Basin: July 25, 2017

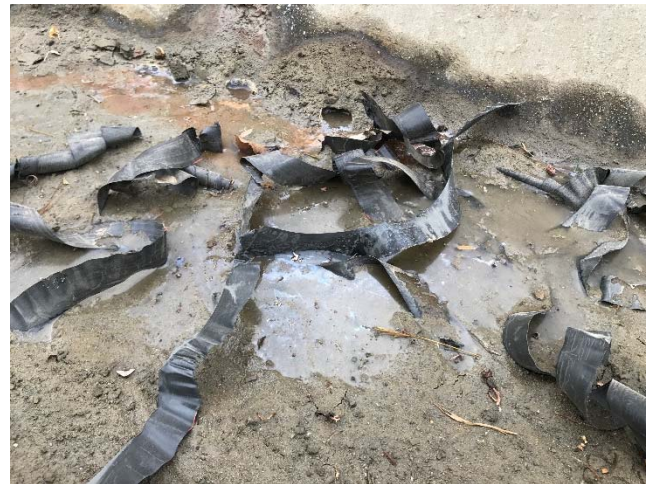
Photo 444: Terminal Basin Alluvial Water Seep: August 14, 2017

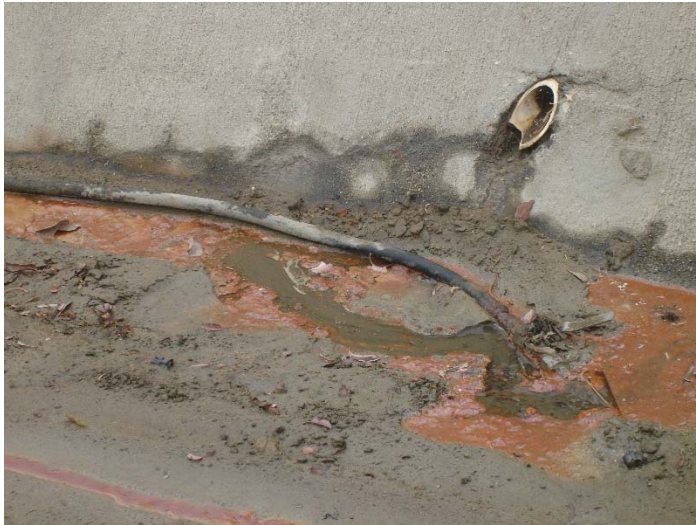
Photo 445: Terminal Basin Alluvial Water Seep: August 14, 2017

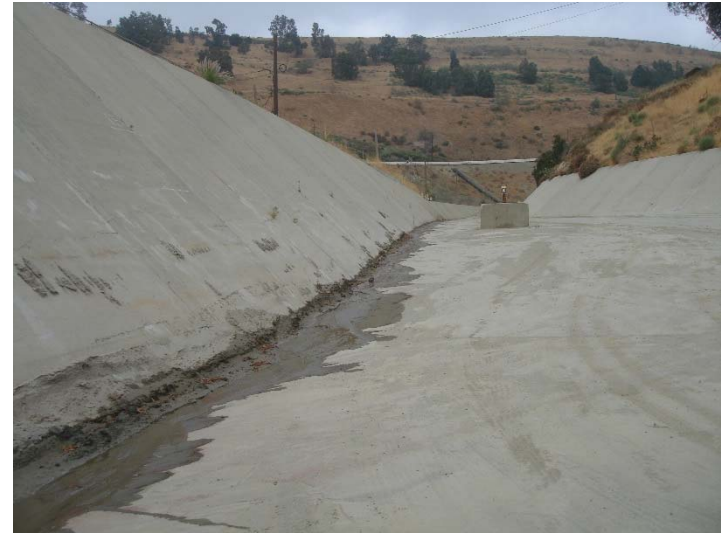
Photo 446: Terminal Basin Alluvial Water Seep: August 14, 2017

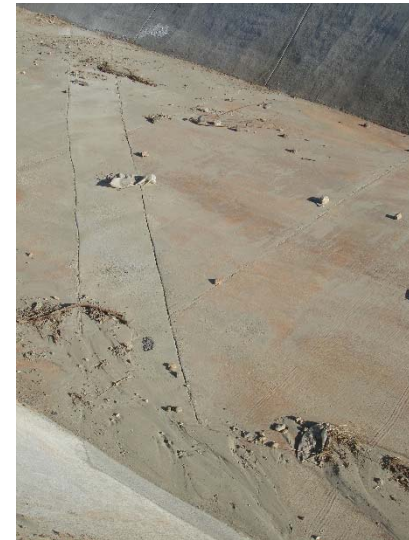
Photo 452: Terminal Basin Alluvial Water Seep Stopped: September 12, 2017

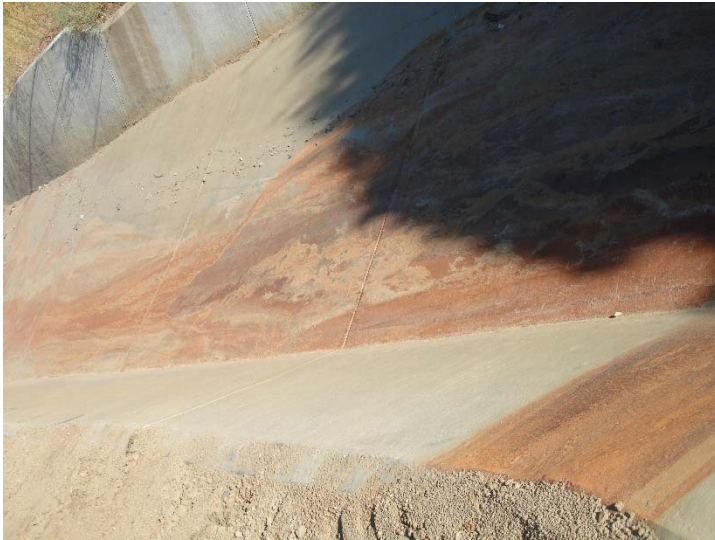
**Photo 453: Terminal Basin Alluvial Water Seep Stopped:
September 12, 2017**

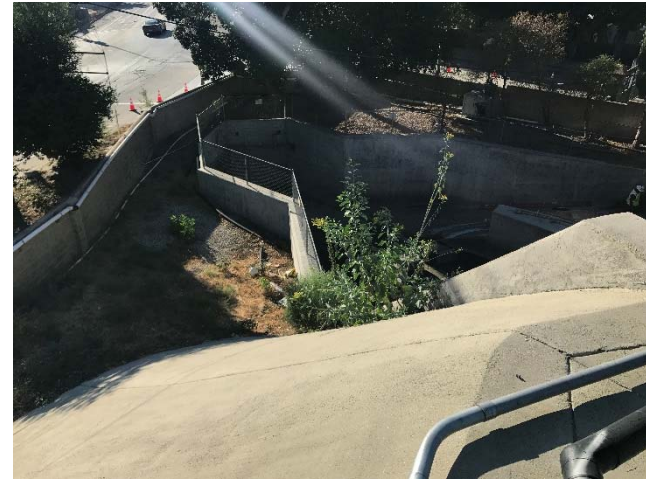
**Photo 462: Terminal Basin San Fernando Road Exterior Wall:
September 12, 2017**

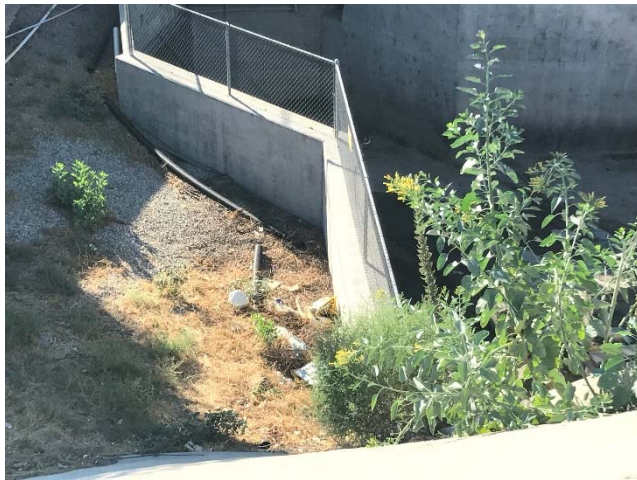
**Photo 463: Terminal Basin San Fernando Road Exterior Wall:
September 12, 2017**
