**Sunshine Canyon Landfill
Independent Monitor
Quarterly Site Monitoring Status Report
July 1, 2017 – September 30, 2017**

City of Los Angeles Department of City Planning

County of Los Angeles Department of Regional Planning

December 22, 2017

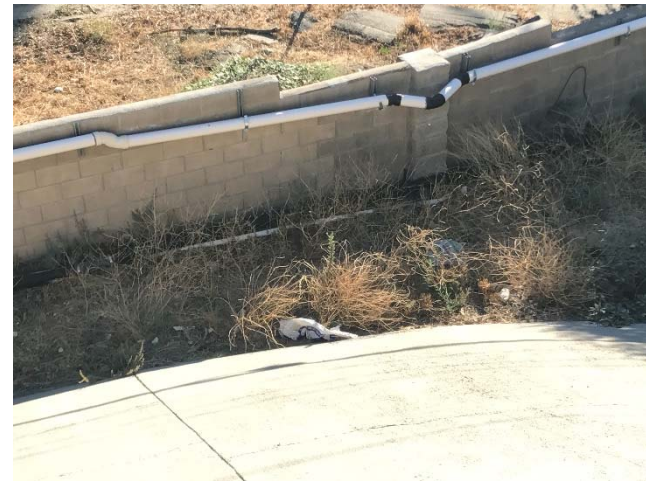
**Photo 464: Terminal Basin San Fernando Road Exterior Wall:
September 12, 2017**

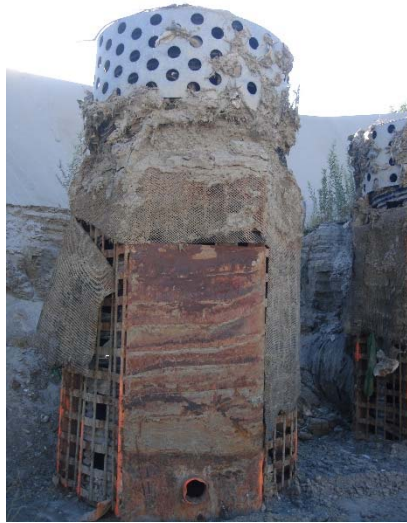
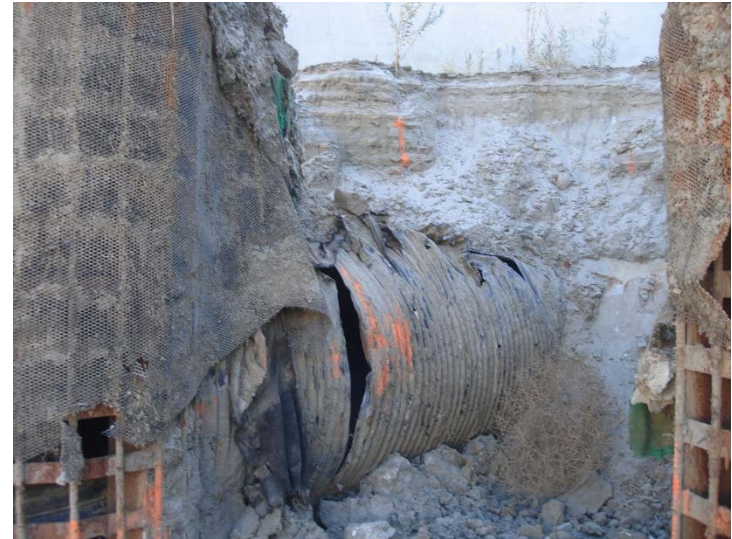
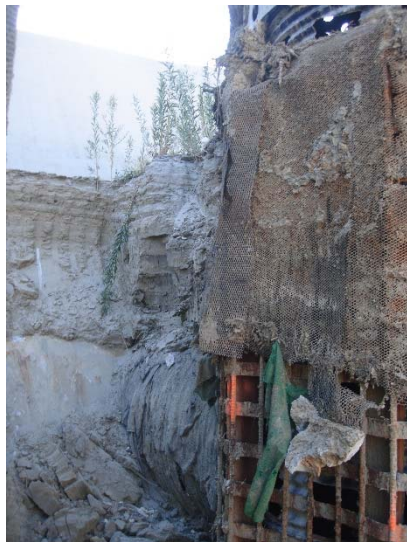
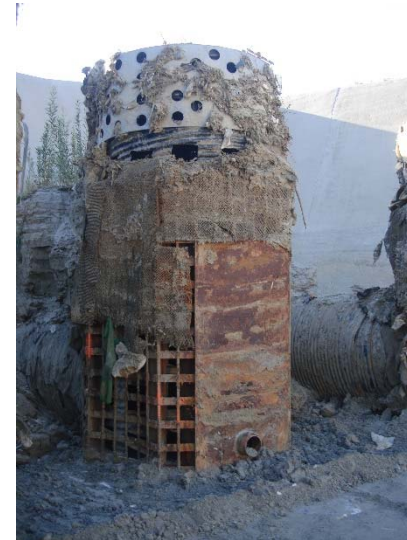
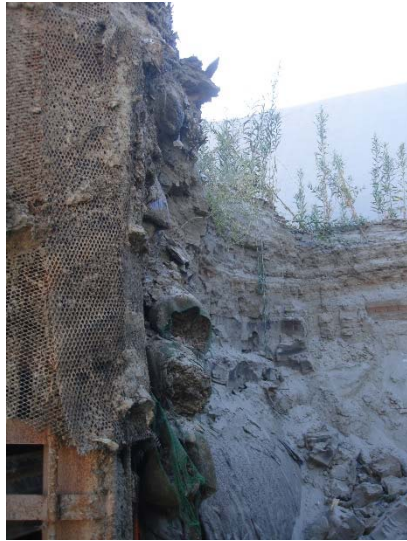
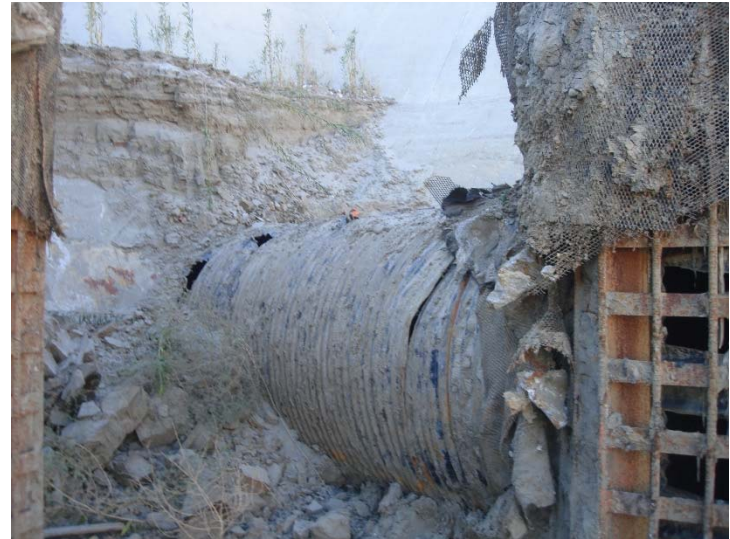
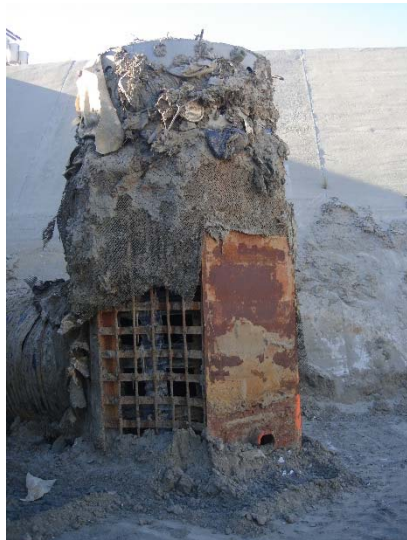
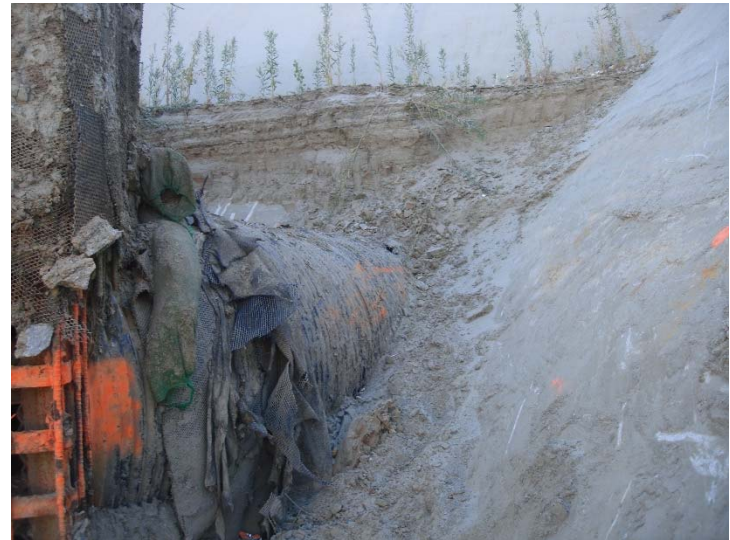
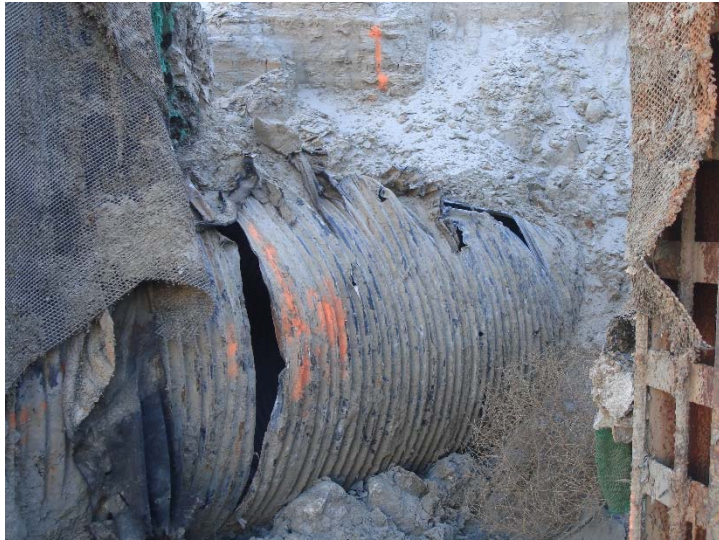
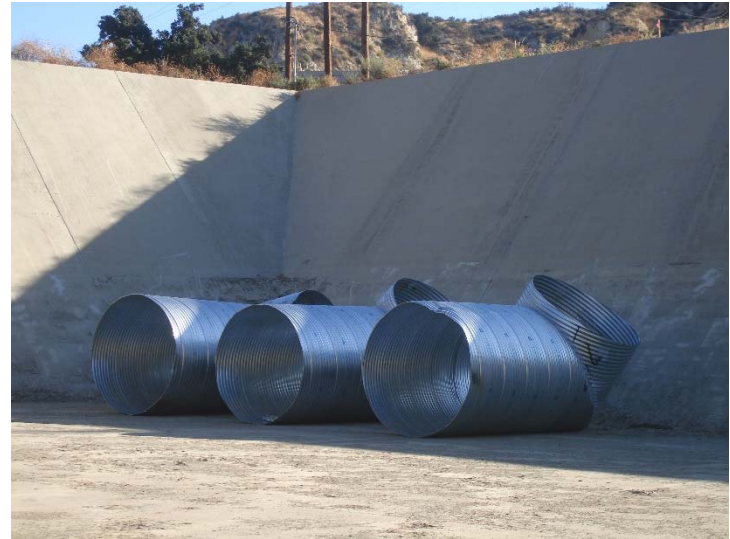
Photo 488: Terminal Basin Outlet Risers: September 26, 2017

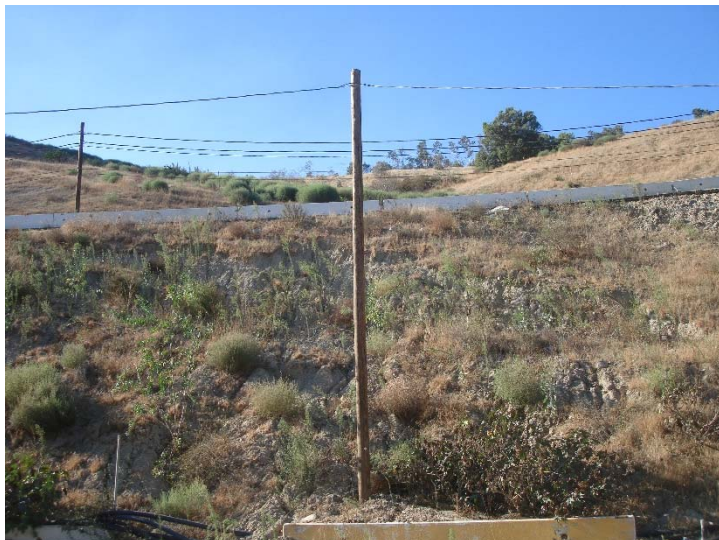
Photo 498: Terminal Basin Outlet Risers Modification Piping: September 26, 2017

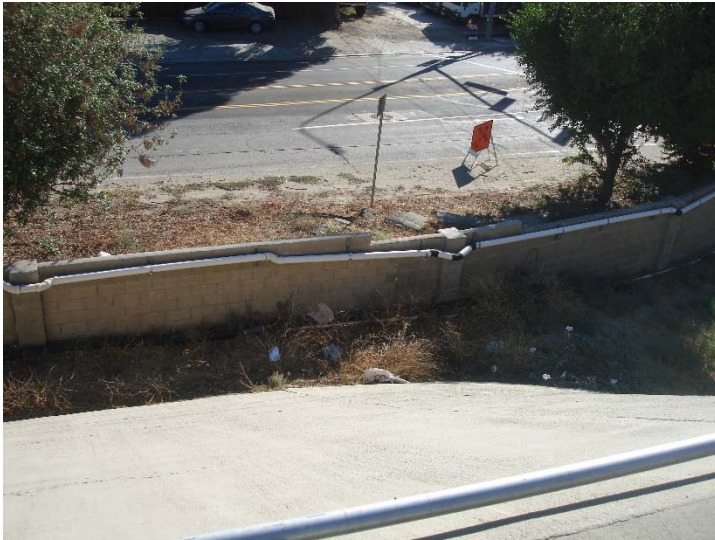
Photo 500: Wind Meter at Terminal Basin Removed: September 26, 2017

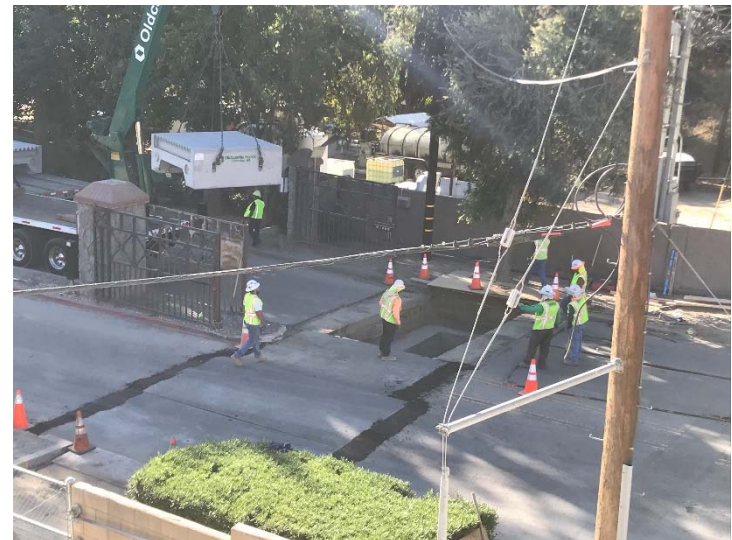
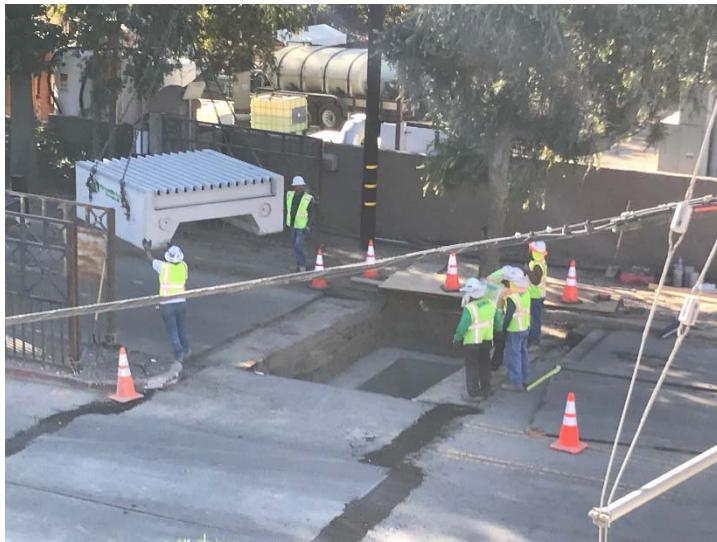
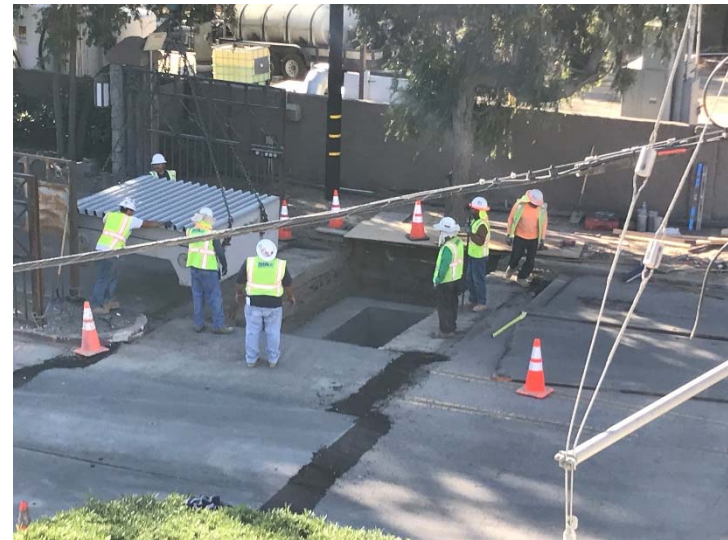
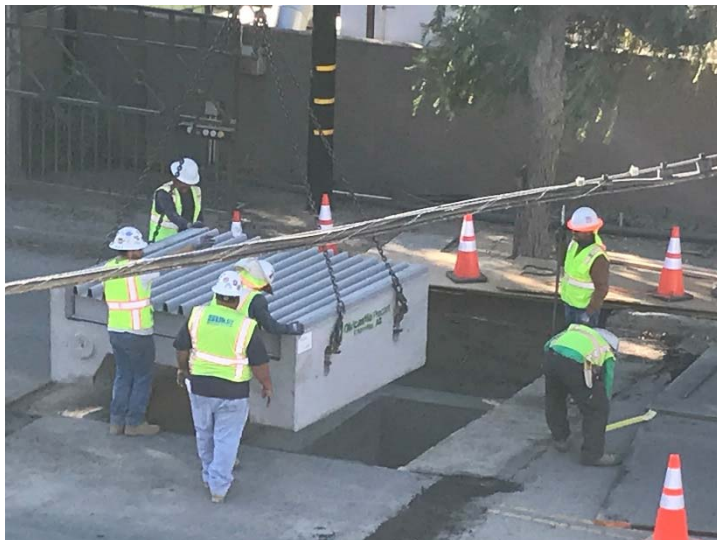
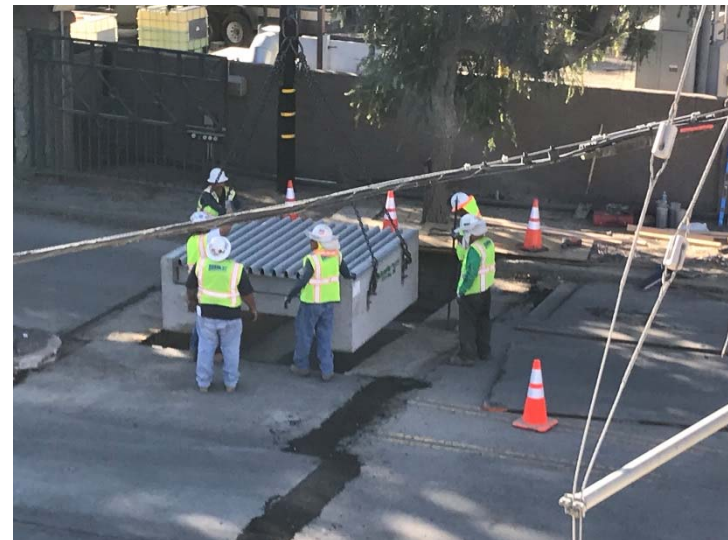
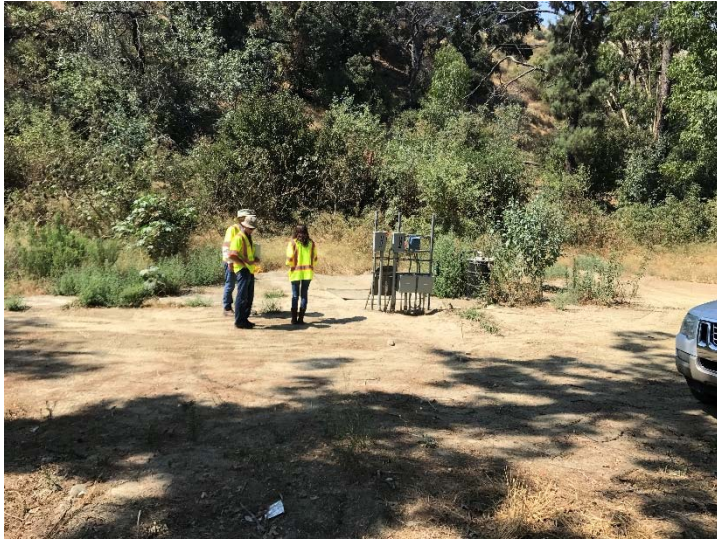
**Photo 503: Terminal Basin Outlet Roadway Cattleguard
Construction: September 26, 2017**

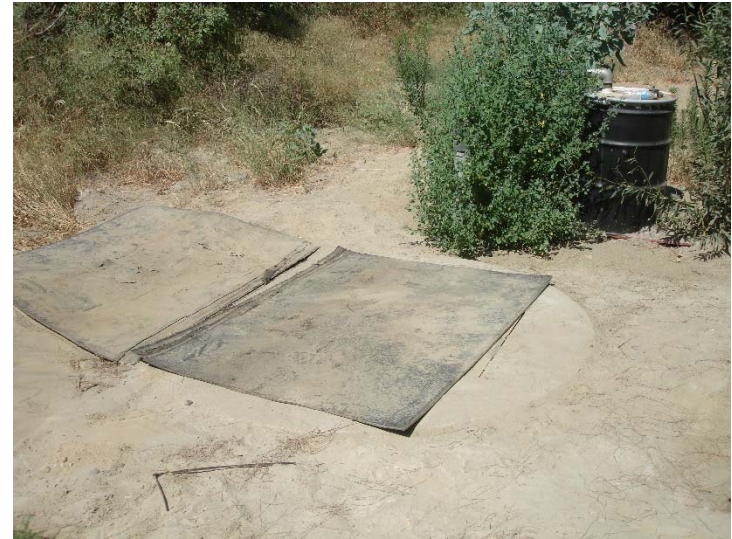
Photo 509: Odor from Uncovered Sewer Pump Access: August 14, 2017

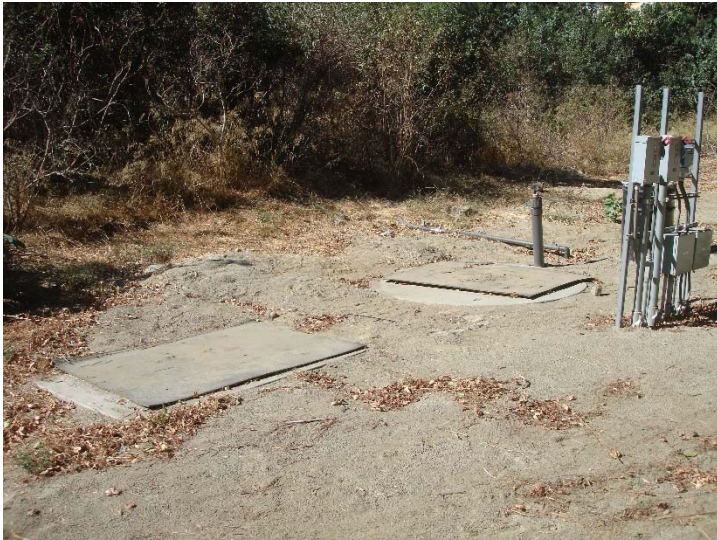
Photo 512: Localized Odor near Sewer Lift Pump: September 12, 2017

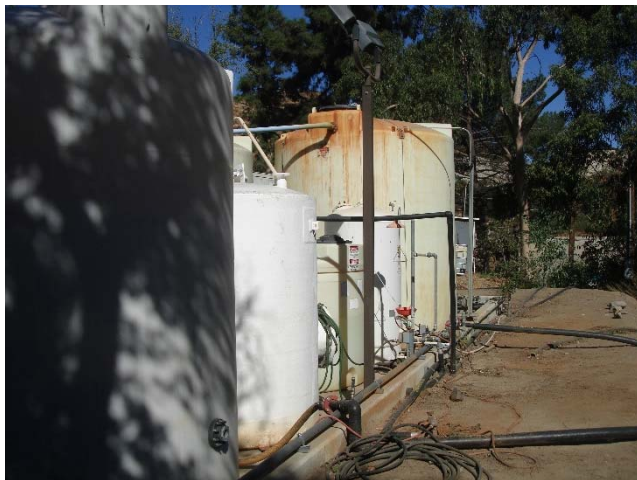
Photo 514: Leachate Treatment System Drainage Cleaned: September 26, 2017

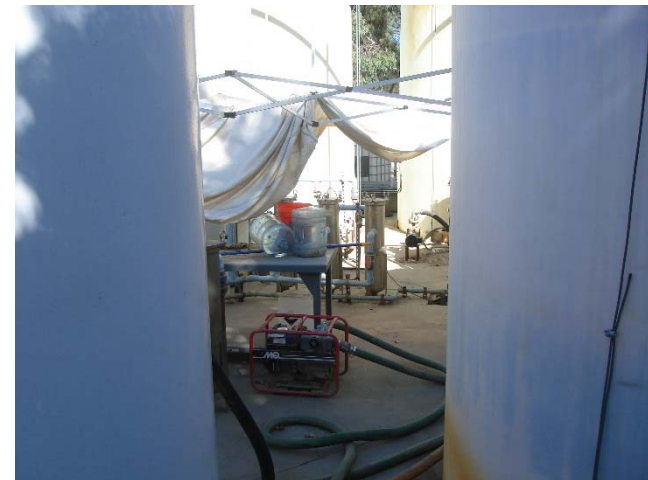
Photo 515: Leachate Treatment System General Area Cleaned: September 26, 2017

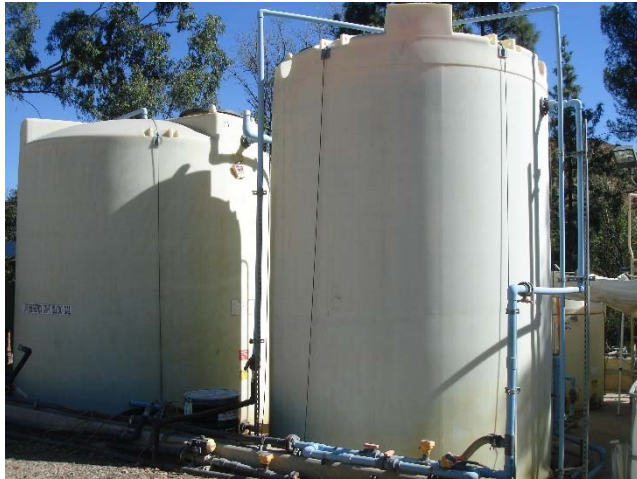
Photo 516: Leachate Treatment System Spill Containment Area Cleaned: September 26, 2017

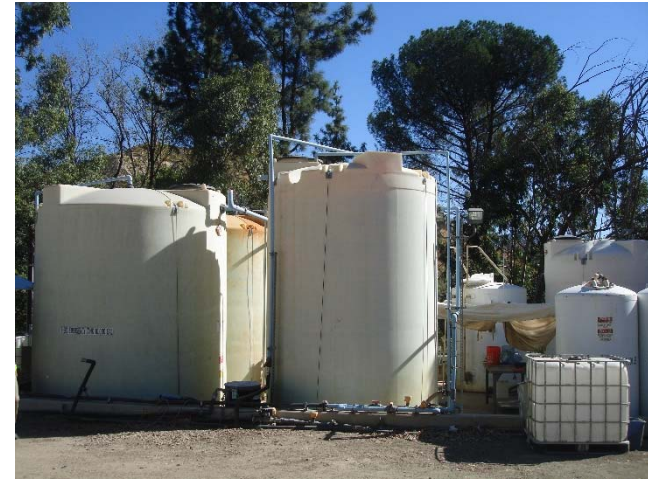
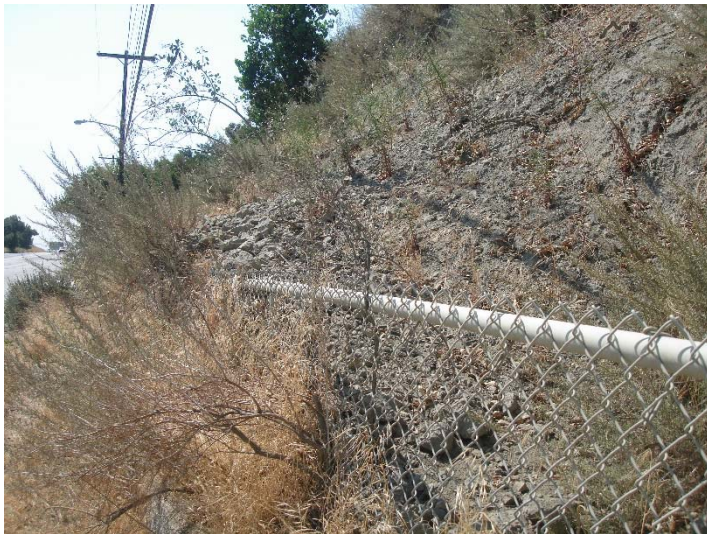
Photo 517: Leachate Treatment System Temporary Strong Localized Odor: September 26, 2017

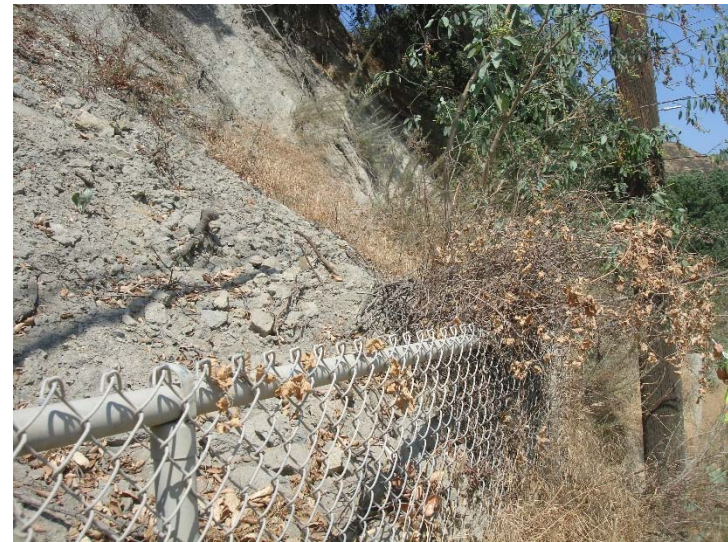
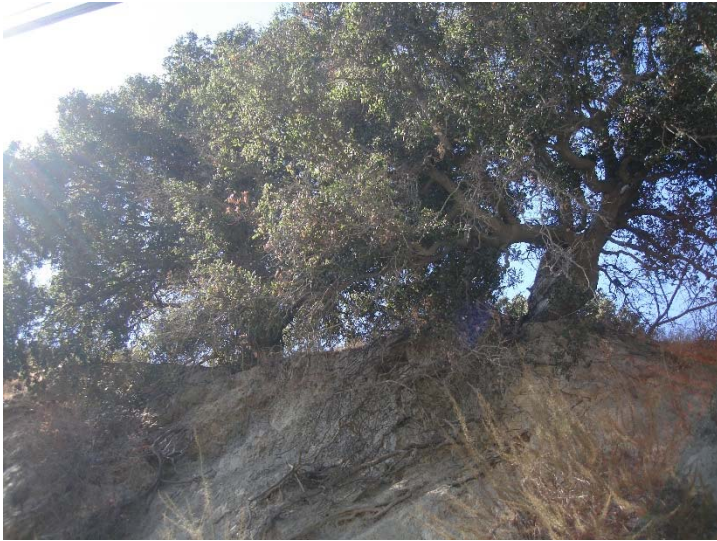
Photo 519: Retaining Wall Slope on San Fernando Road: July 11, 2017

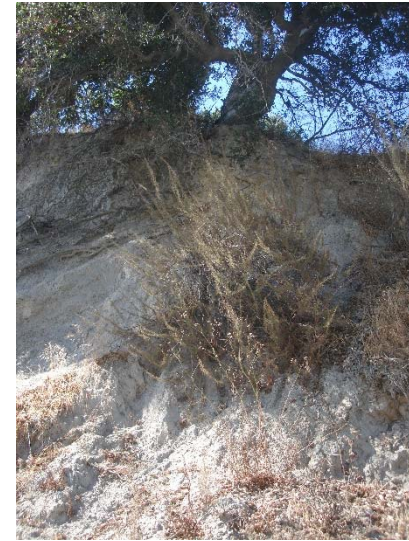
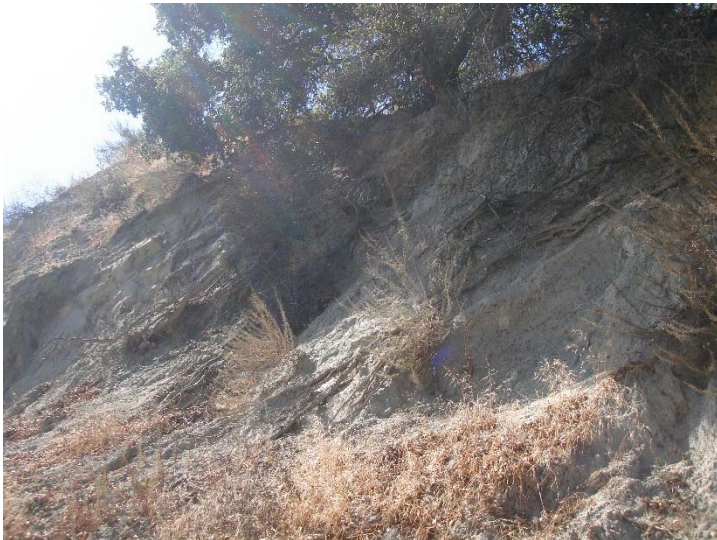
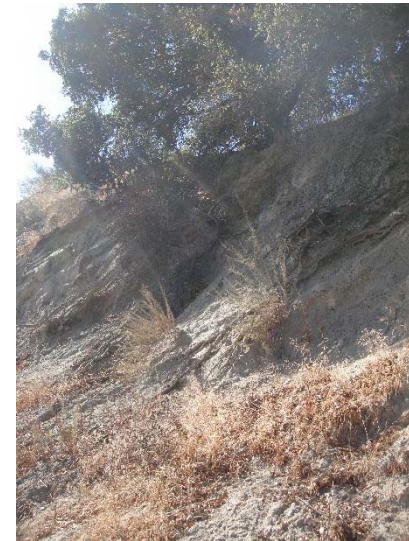
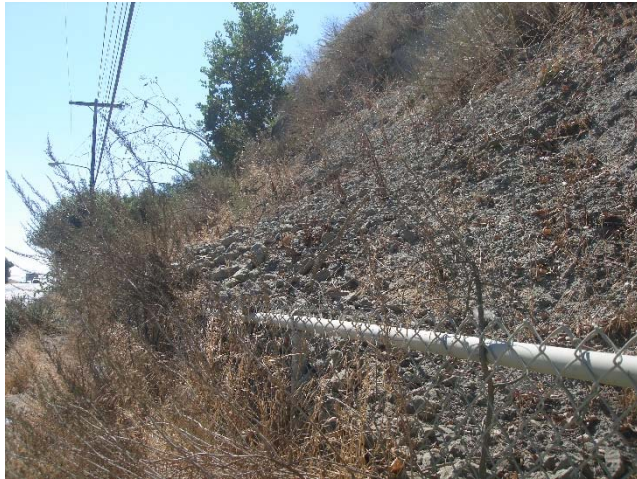
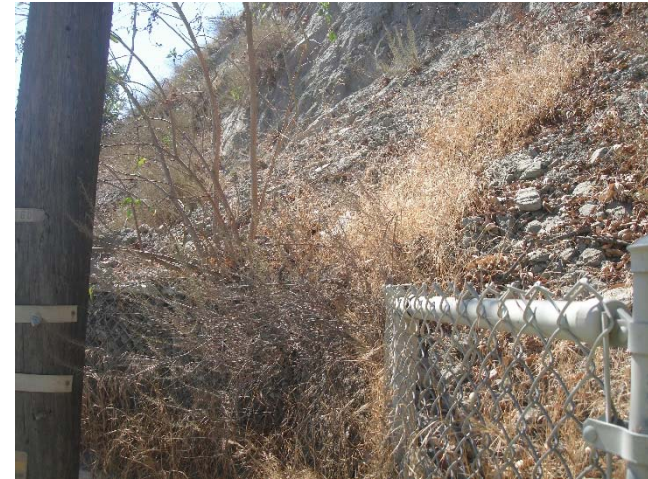
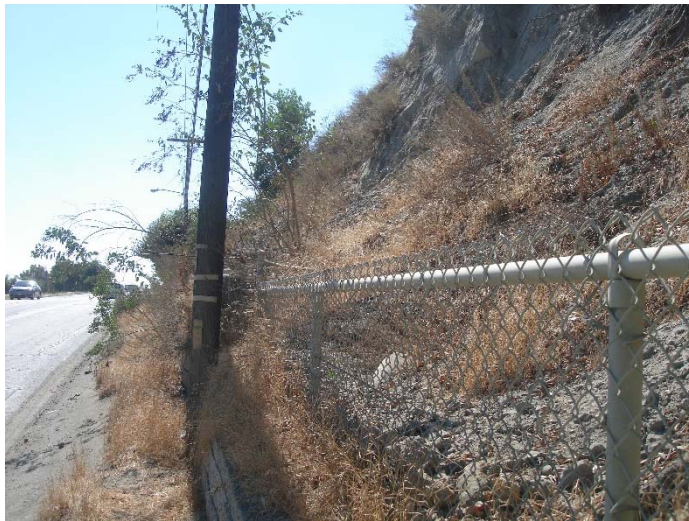
**Photo 521: Frontage Retaining Wall Slope on San Fernando Road:
September 12, 2017**

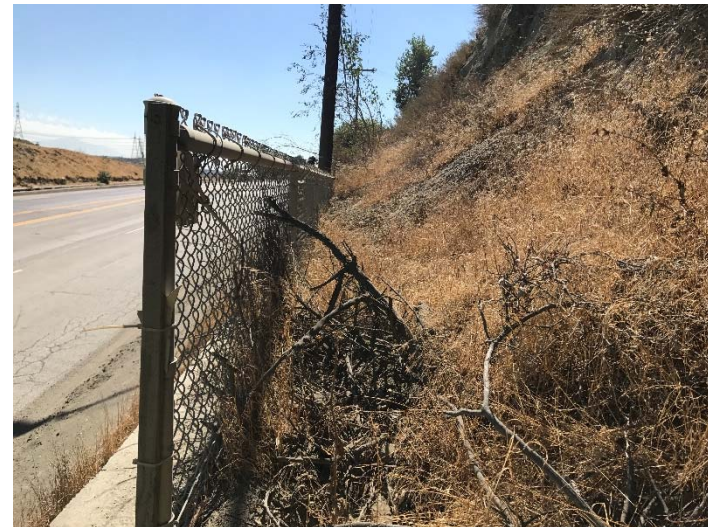
**Photo 528: Frontage Retaining Wall Slope on San Fernando
Road: September 12, 2017**

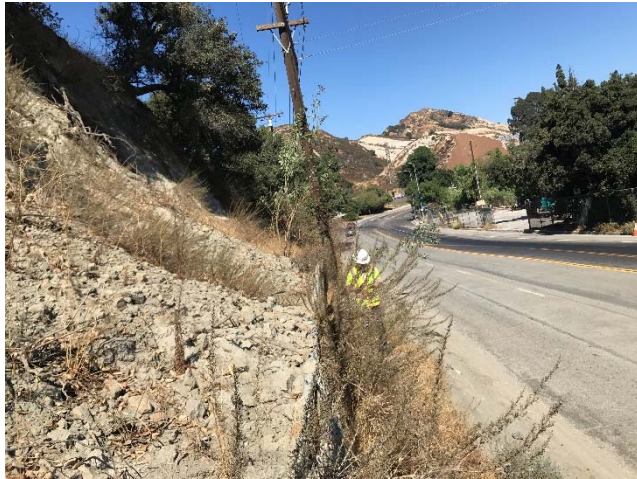
**Photo 529: Frontage Retaining Wall Slope on San Fernando Road:
September 12, 2017**

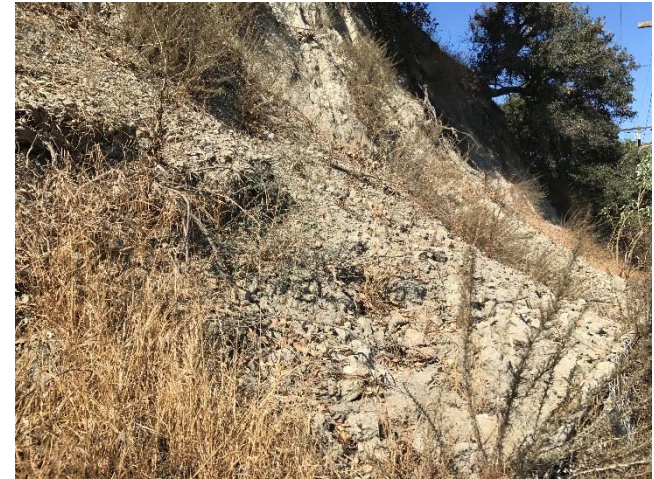
**Photo 530: Frontage Retaining Wall Slope on San Fernando
Road: September 12, 2017**

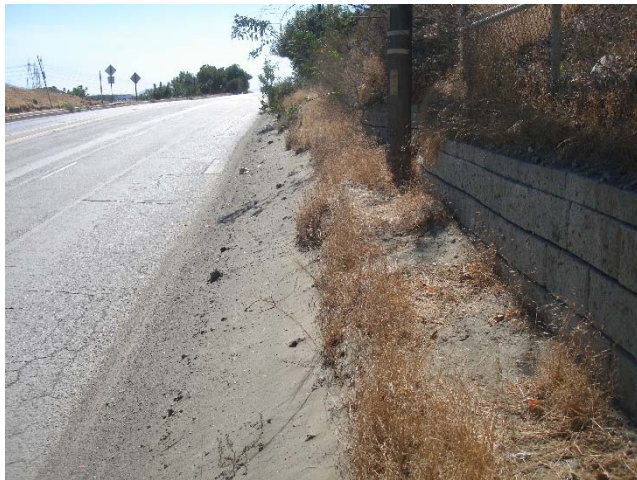
**Photo 531: Frontage Retaining Wall Slope on San Fernando Road:
September 26, 2017**

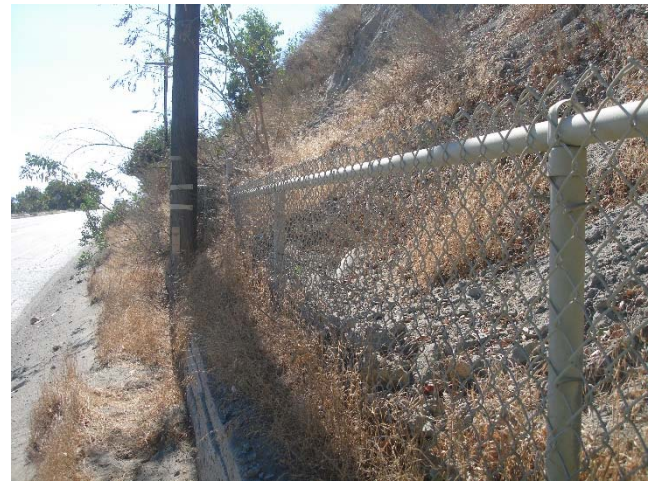
**Photo 532: Frontage Retaining Wall Slope on San Fernando
Road: September 26, 2017**

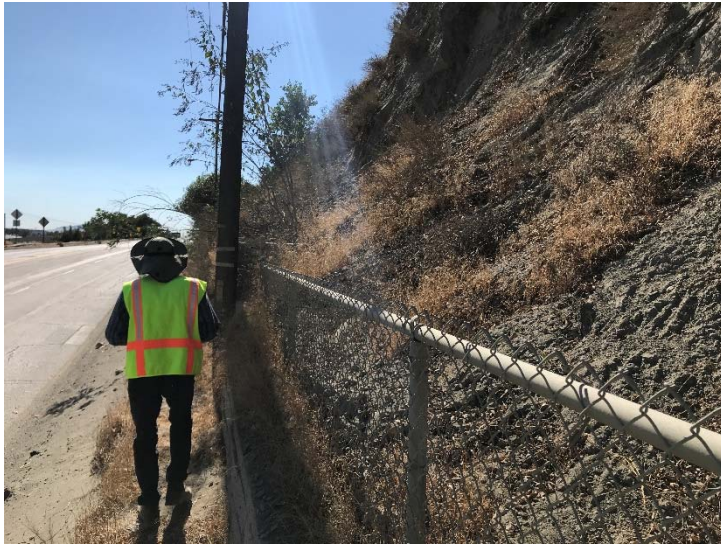
**Photo 533: Frontage Retaining Wall Slope on San Fernando Road:
September 26, 2017**

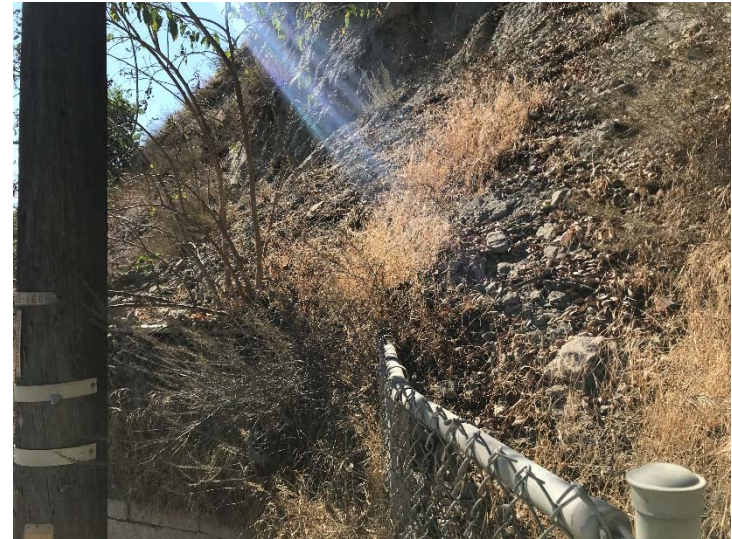
**Photo 534: Frontage Retaining Wall Slope on San Fernando
Road: September 26, 2017**

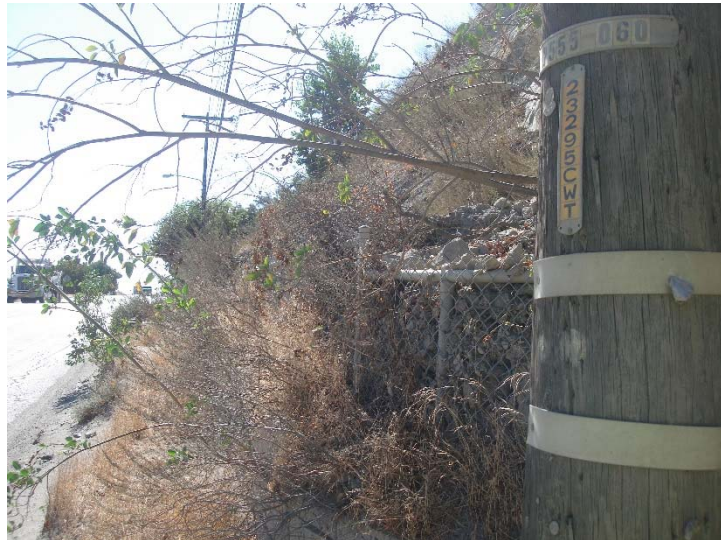
**Photo 535: Frontage Retaining Wall Slope on San Fernando Road:
September 26, 2017**

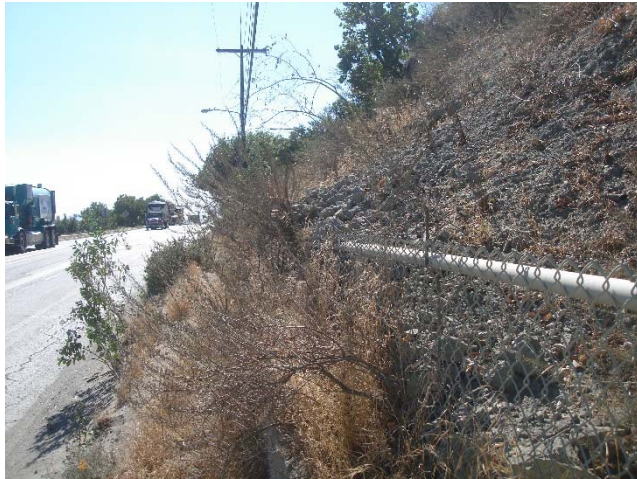
**Photo 537: Frontage Retaining Wall Slope on San Fernando Road:
September 26, 2017**

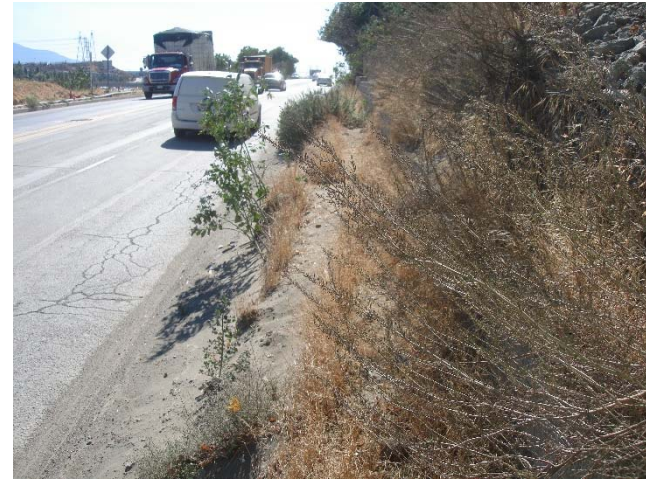
**Photo 538: Frontage Retaining Wall Slope on San Fernando
Road: September 26, 2017**

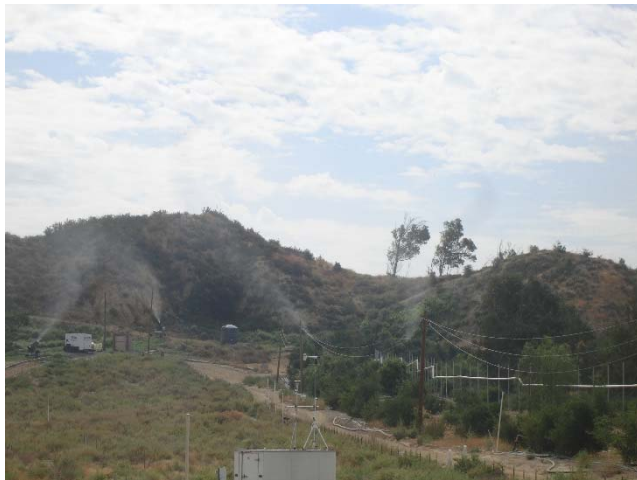
Photo 539: Deck C Sage Mitigation Area: July 26, 2017

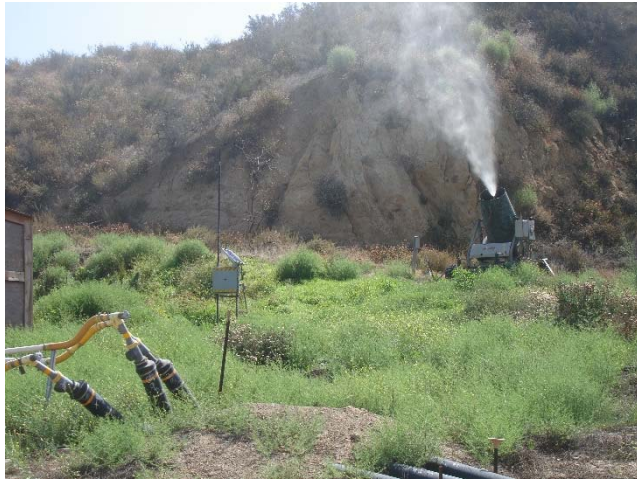
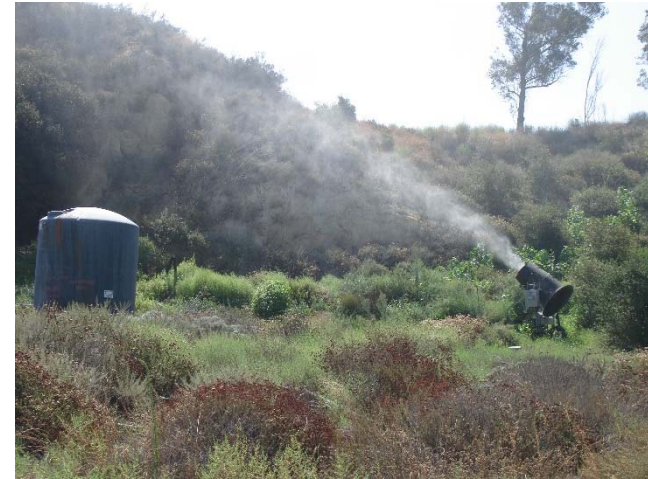
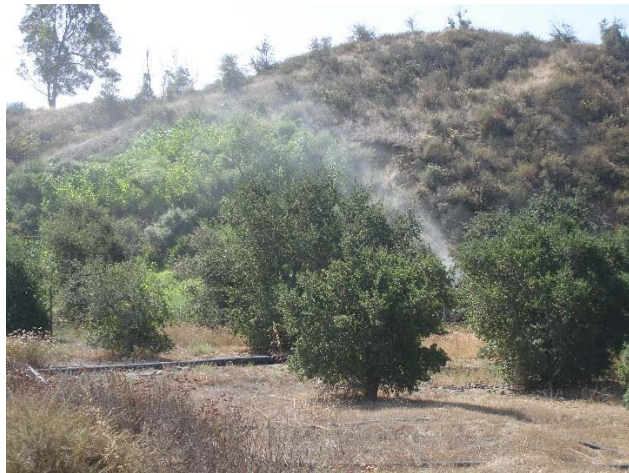
Photo 561: Deck C Sage Mitigation Area: August 14, 2017

Photo 562: Deck C Sage Mitigation Area: August 14, 2017

Photo 563: Deck C PM10 Oak Trees: August 14, 2017

- Deck C sage mitigation was doing well. There were some areas that needed removal of invasive and non-native plants. Bobcat tracks were observed in the PM-10 tree area.

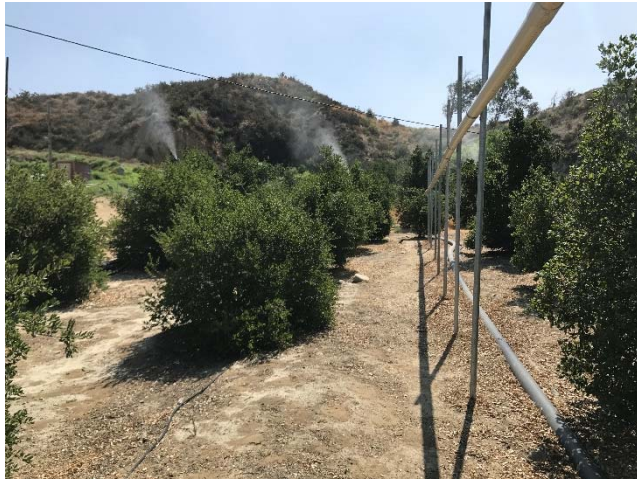
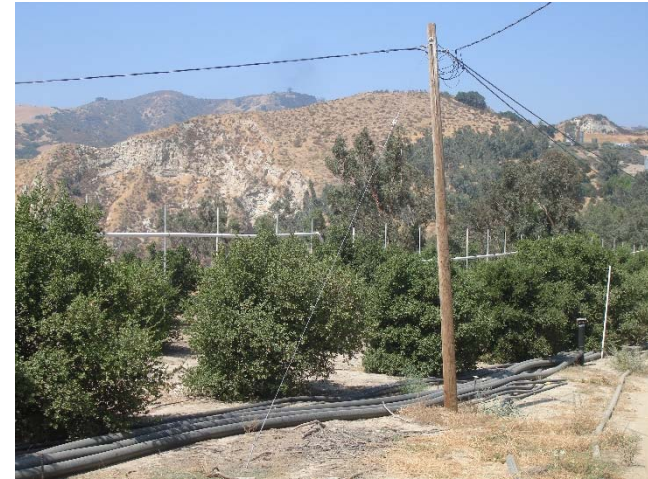
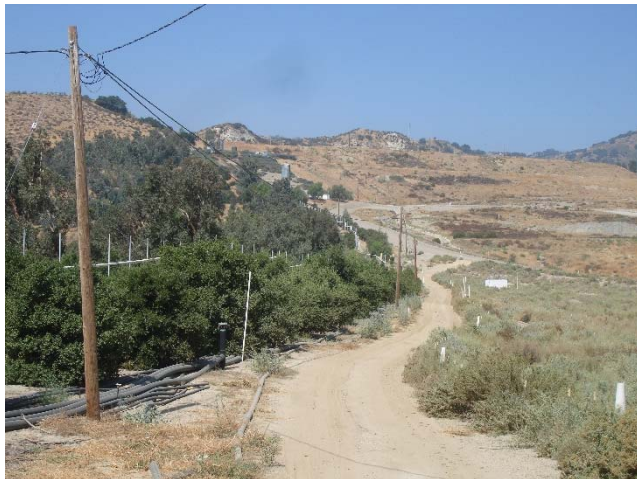
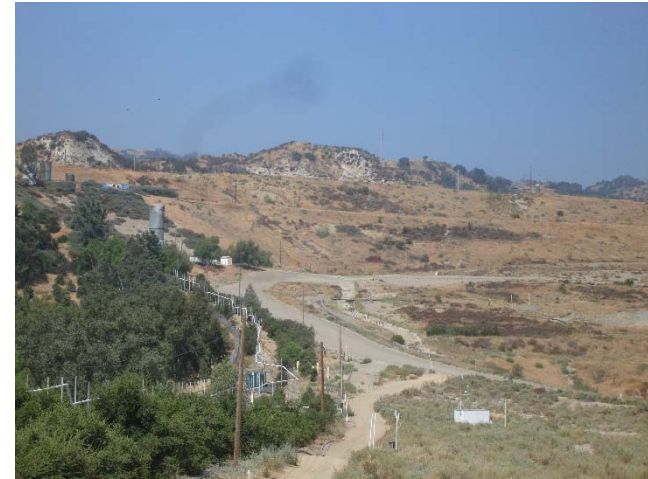
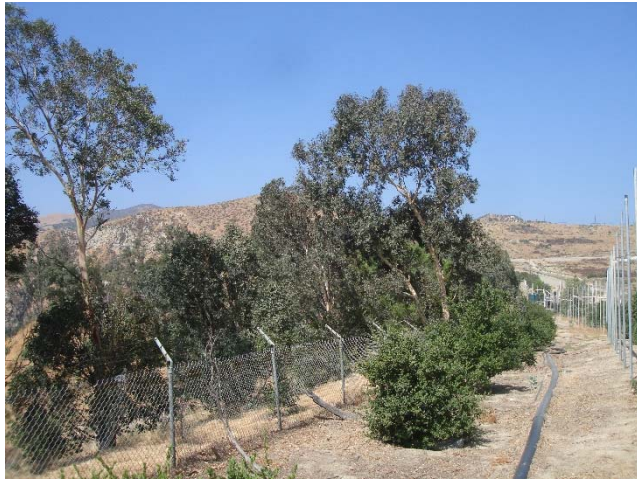
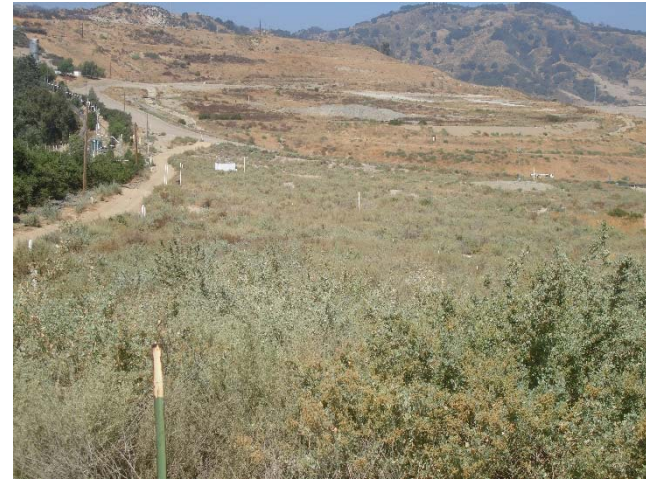
Photo 568: Deck C PM10 Oak Trees: August 14, 2017

Photo 569: Deck C PM10 Oak Trees: August 14, 2017

Photo 570: Deck C PM10 Oak Trees: August 14, 2017

Photo 571: Deck C PM10 Oak Trees: August 14, 2017

Photo 572: Deck C PM10 Oak Trees: August 14, 2017

Photo 573: Deck C PM10 Oak Trees: August 14, 2017

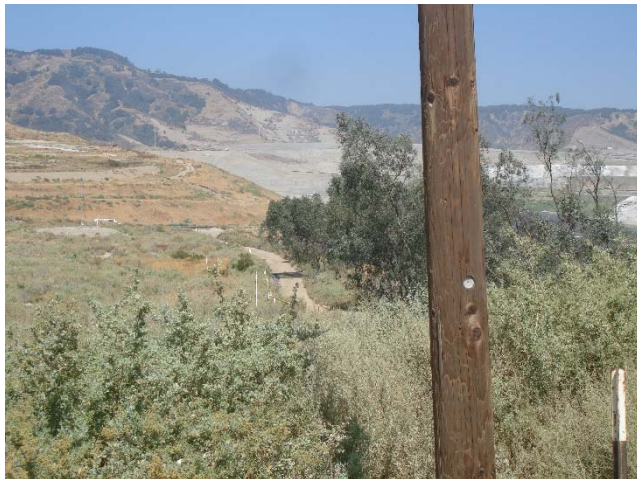
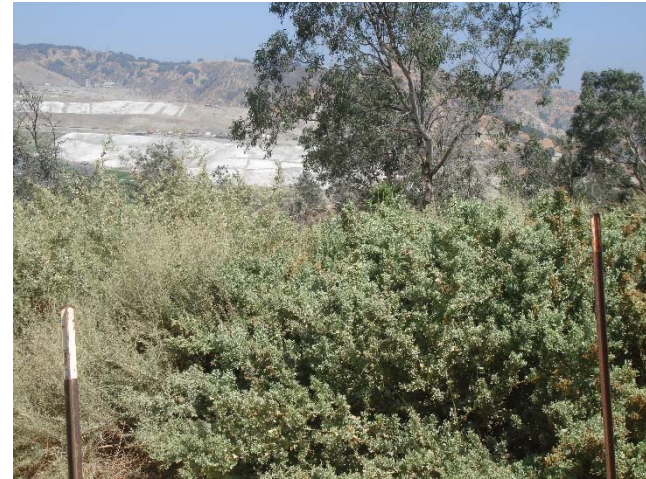
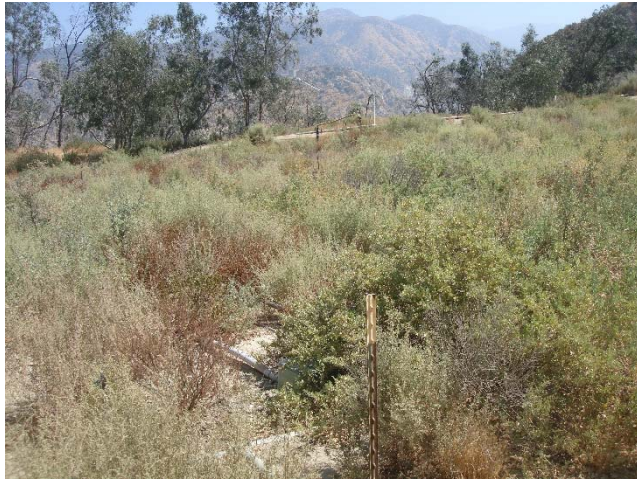
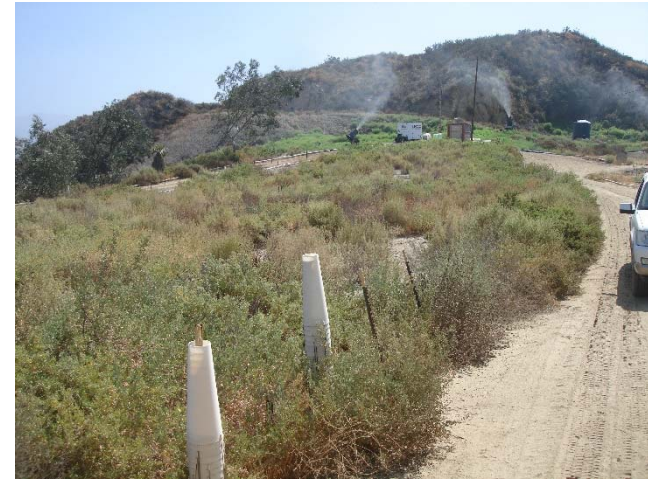
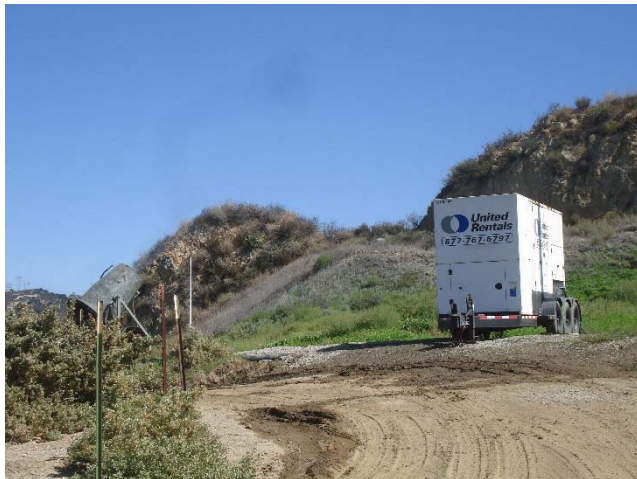
Photo 574: Deck C Sage Mitigation Area: August 14, 2017

Photo 575: Deck C Sage Mitigation Area: August 14, 2017

Photo 576: Deck C Sage Mitigation Area: August 14, 2017

Photo 577: Deck C Sage Mitigation Area: August 14, 2017

Photo 578: Deck C Sage Mitigation Area: August 14, 2017
