**Sunshine Canyon Landfill
Independent Monitor
Quarterly Site Monitoring Status Report
July 1, 2017 – September 30, 2017**

City of Los Angeles Department of City Planning

County of Los Angeles Department of Regional Planning

December 22, 2017

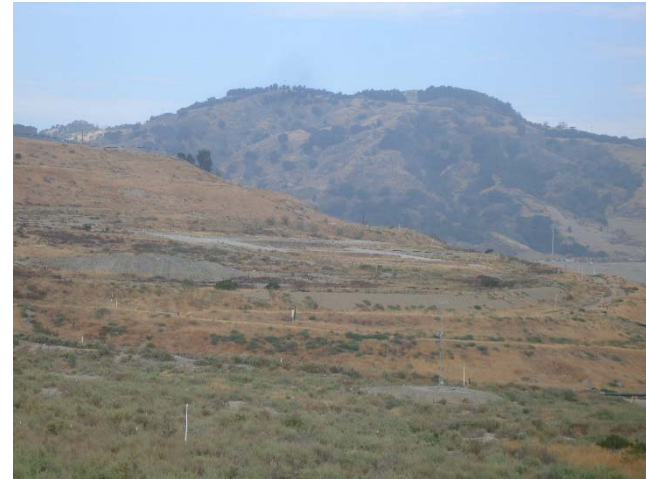
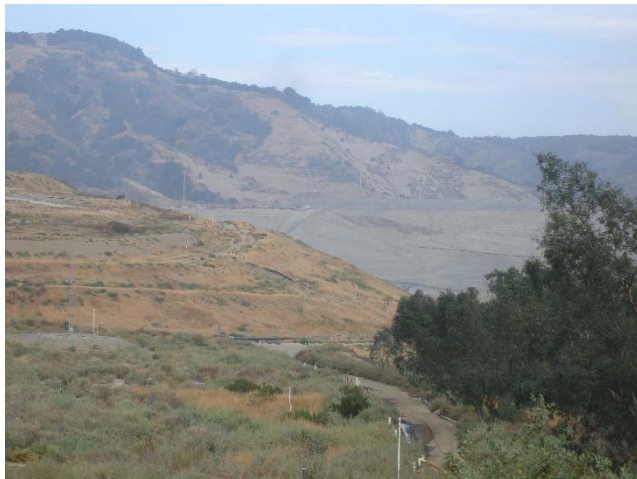
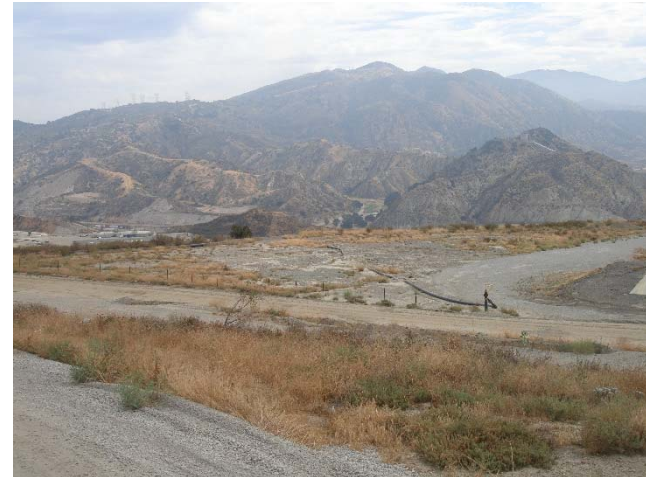
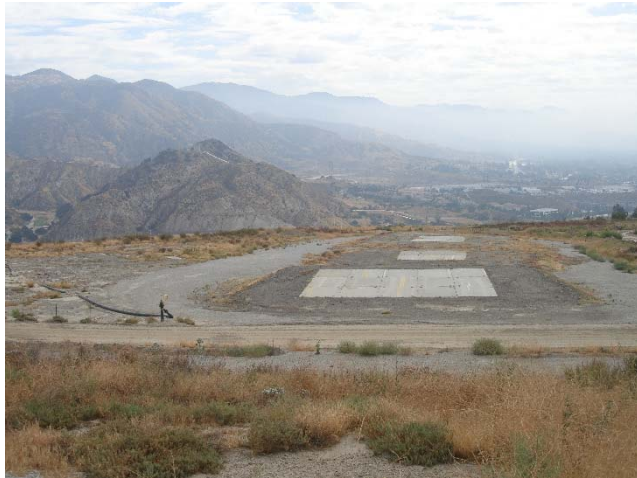
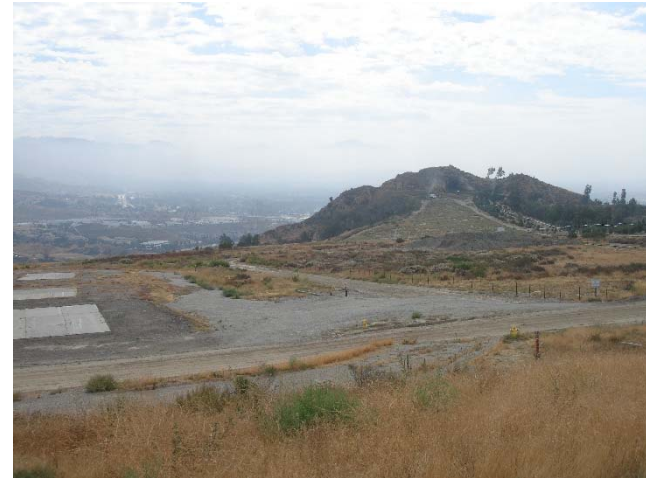
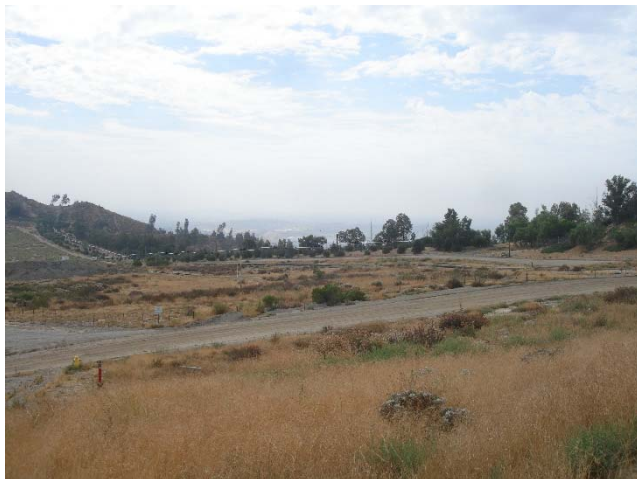
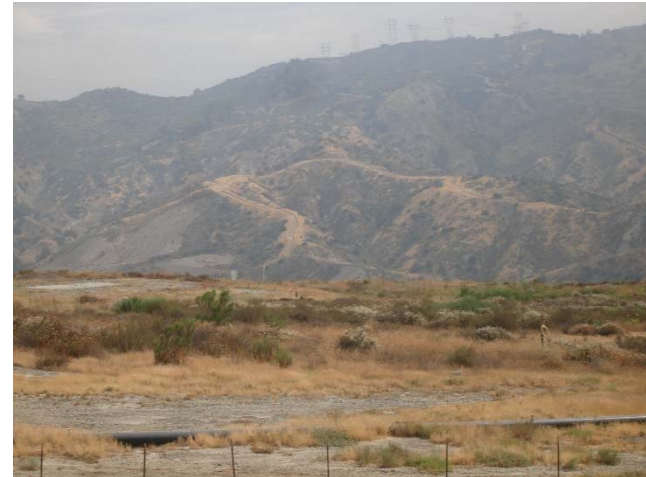
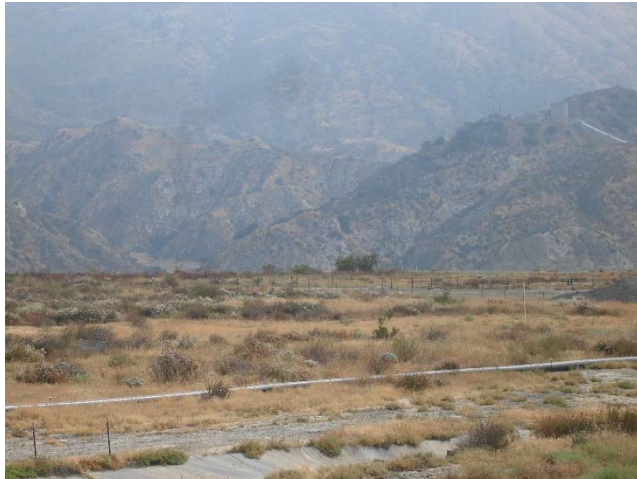
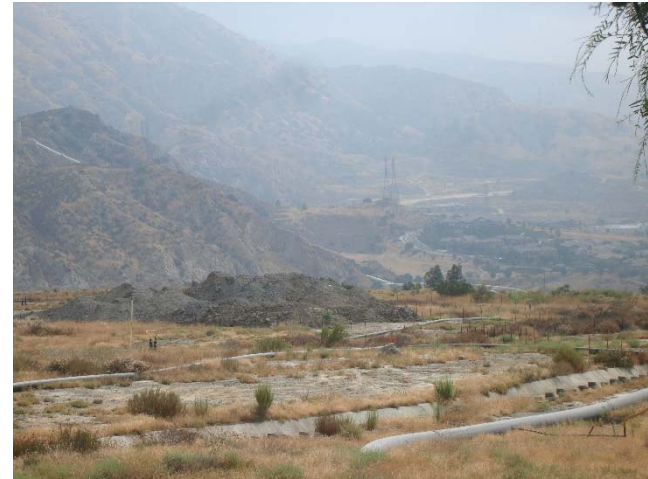
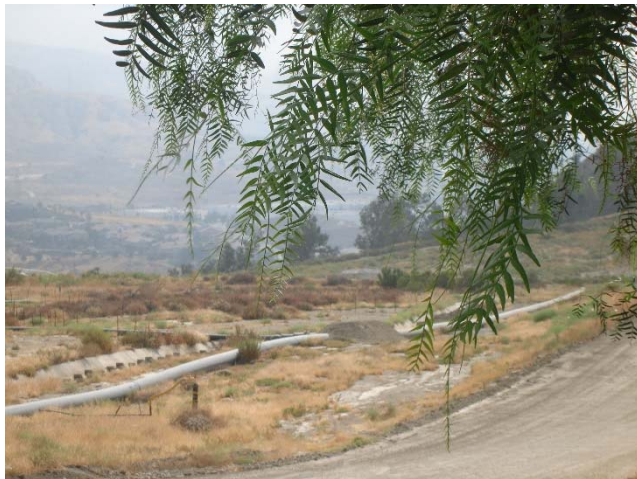
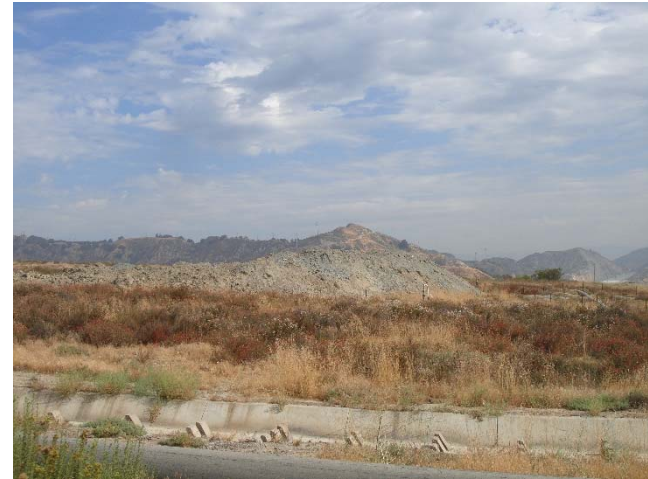
Photo 597: Deck B Sage Mitigation Area: July 25, 2017

Photo 598: Deck B Sage Mitigation Area: July 25, 2017

Photo 599: Deck B Sage Mitigation Area: July 25, 2017

Photo 600: Deck B Sage Mitigation Area: July 25, 2017

Photo 601: Deck B Sage Mitigation Area: July 25, 2017

Photo 602: Deck B Sage Mitigation Area: July 25, 2017

Photo 603: Deck B Sage Mitigation Area: July 25, 2017

Photo 604: Deck B Sage Mitigation Area: July 25, 2017

Photo 605: Deck B Sage Mitigation Area: July 25, 2017

Photo 606: Deck B Sage Mitigation Area: July 25, 2017

Photo 607: Deck B Sage Mitigation Area: July 25, 2017

- Basin B was clean and dry. The outlet risers area has not had the sediment removed from the rock and risers. The back native hillside had windblown litter.
- The County sage mitigation area had no mitigation activity. The deep gullies on the slopes were not repaired, and soil erosion systems were not installed.
- Basin A is clean and dry. The outlet risers area has not had sediment removed from the rock or risers.

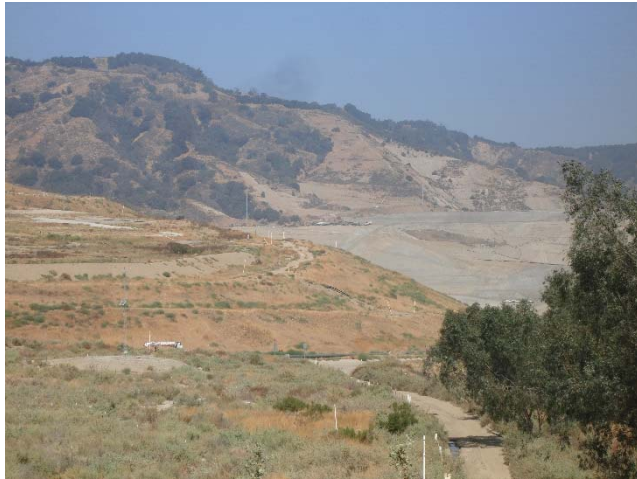
Photo 616: Deck B Sage Mitigation Area: August 14, 2017

- Decks B and A native plants area need non-native plant removed.
- There was no work being done in the Deck B sage area except for stockpiling soil.
- Basin A was cleared of sediment and dry. Litter and debris was observed in the back area of the basin.

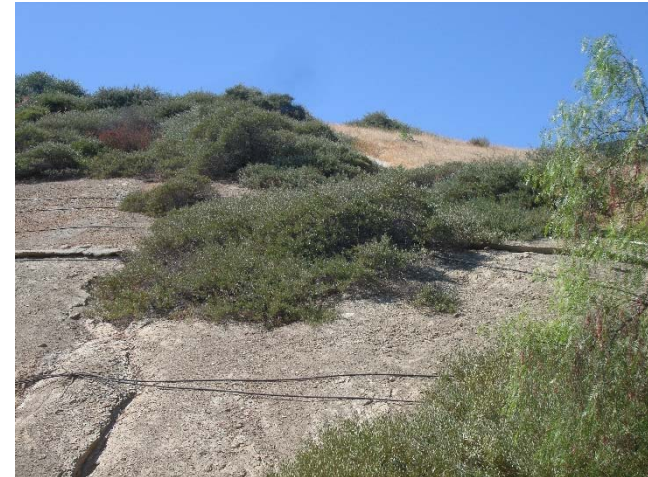
Photo 635: Slope Drainage above Flare 1 Erosion: September 12, 2017

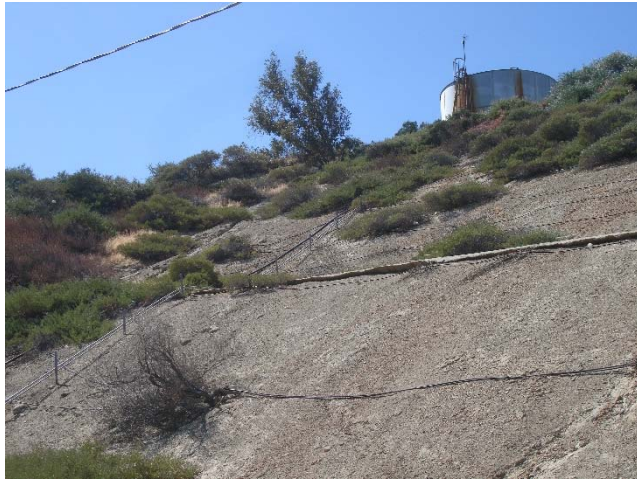
Photo 636: Slope Drainage above Flare 1 Erosion: September 12, 2017

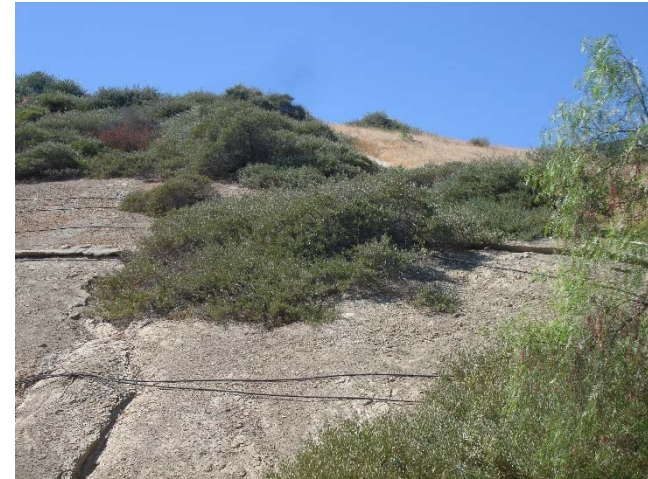
Photo 637: Slope Drainage above Flare 1 Erosion: September 26, 2017

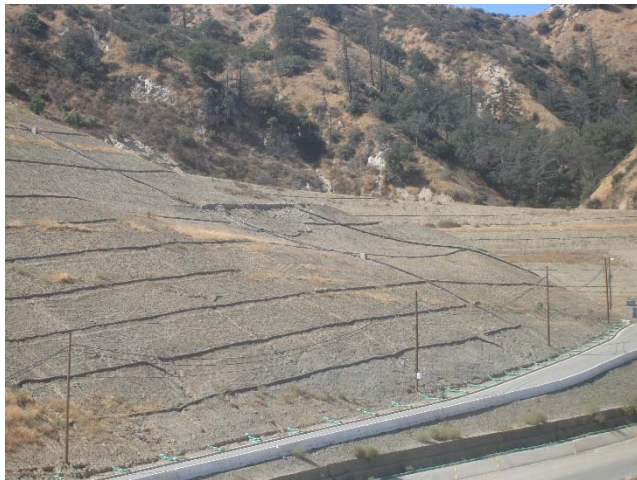
Photo 638: Slope Drainage above Flare 1 Erosion: September 26, 2017

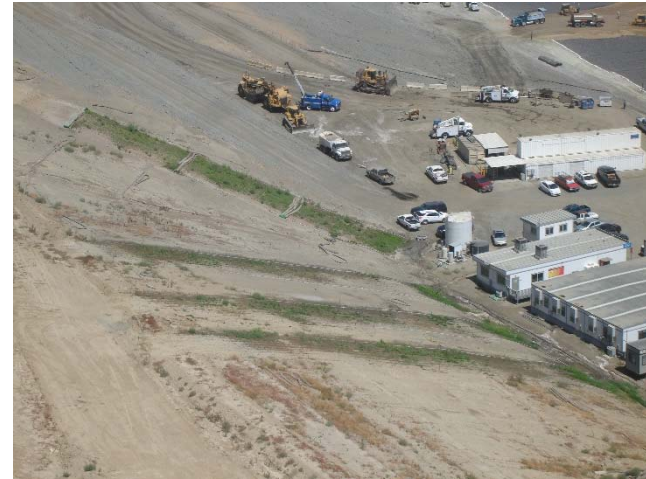
Photo 650: Vegetation Test Area: August 14, 2017

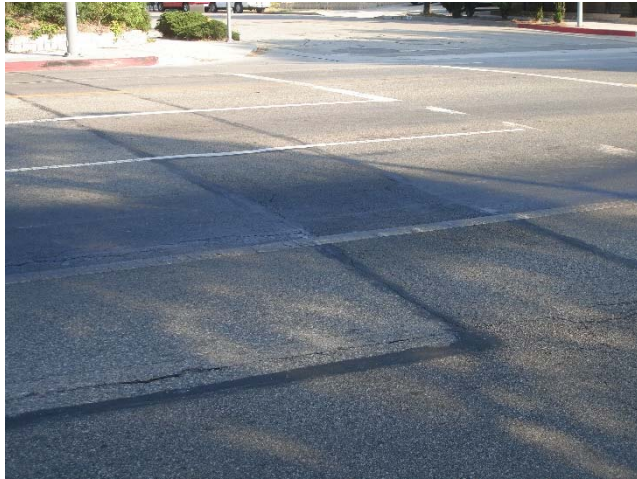
Photo 653: Liquids on Pavement- Balboa Blvd at Woodley Ave: July 11, 2017

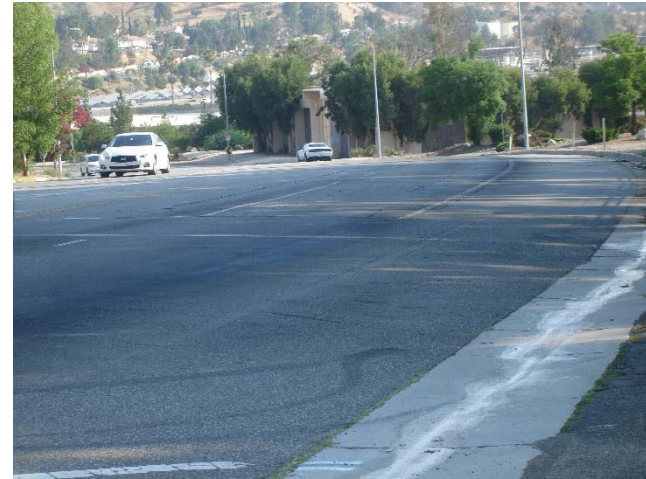
Photo 654: Liquids on Pavement- Balboa Blvd at Woodley Ave: July 11, 2017

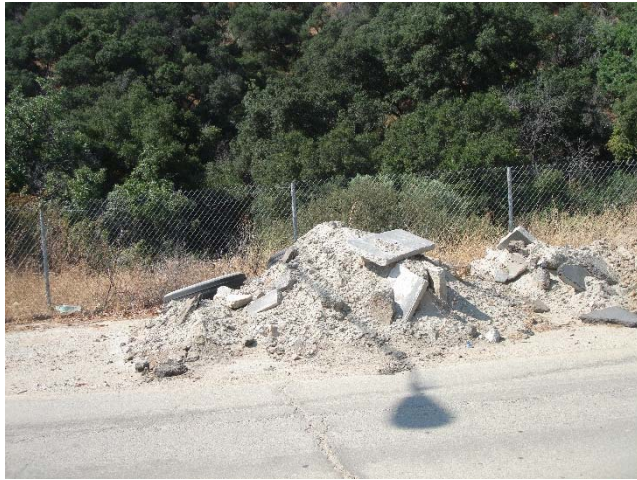
Photo 655: Illegal Dumping at Sierra Highway near I-14 Overpass: July 11, 2017

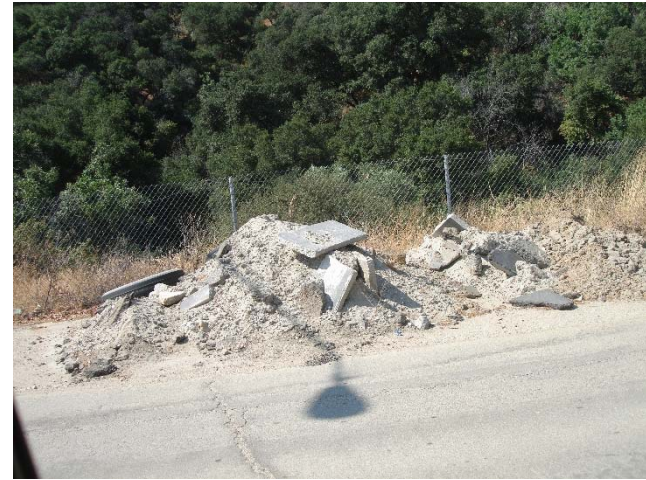
Photo 656: Illegal Dumping at Sierra Highway near I-14 Overpass: July 11, 2017

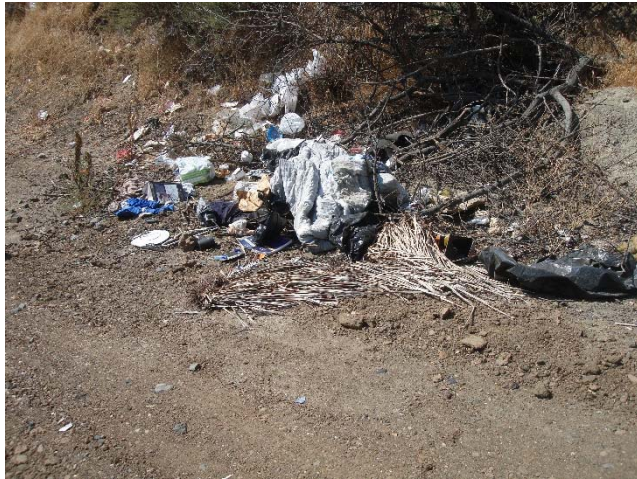
**Photo 657: Illegal Dumping at Sierra Highway near I-14 Overpass:
July 11, 2017**

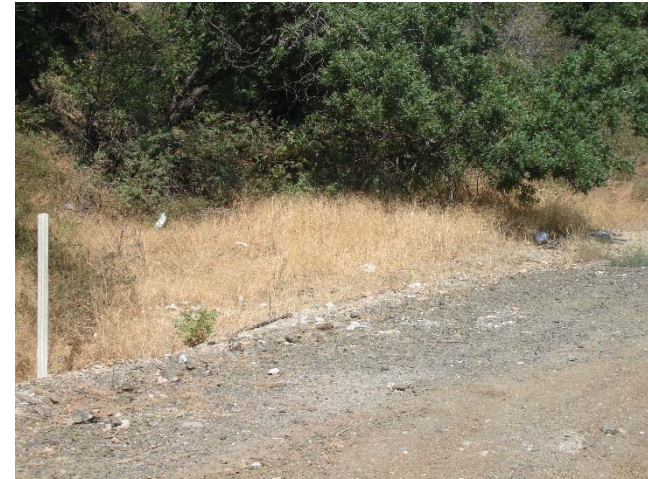
**Photo 658: Litter at Sierra Highway near I-14 Overpass: July 11,
2017**

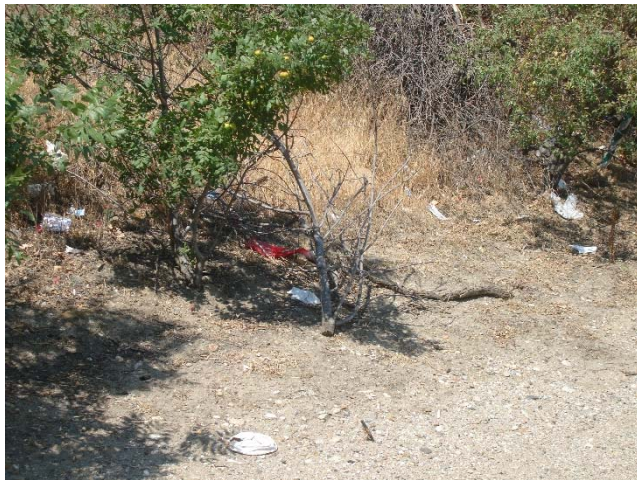
**Photo 659: Litter at Sierra Highway near I-14 Overpass: July 11,
2017**

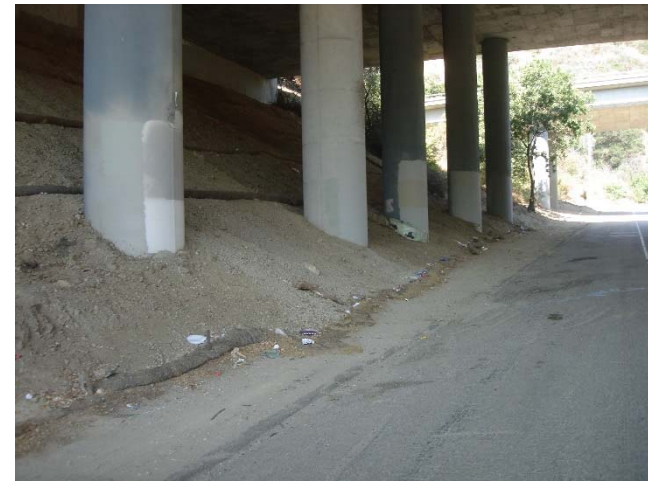
**Photo 660: Litter at Sierra Highway near I-14 Overpass: July 11,
2017**

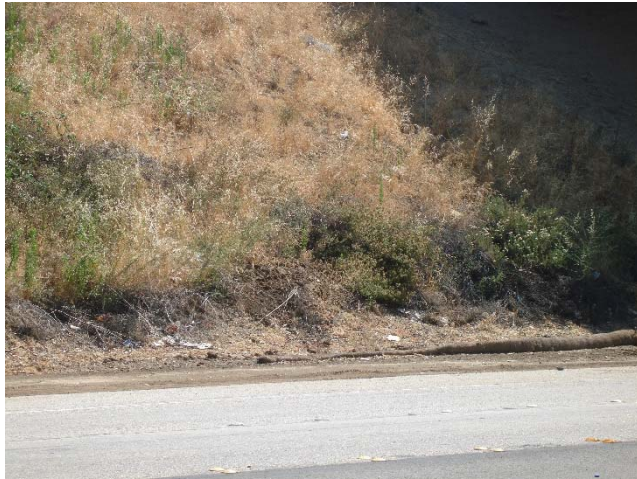
Photo 661: Litter at Sierra Highway near I-14 Overpass: July 11, 2017

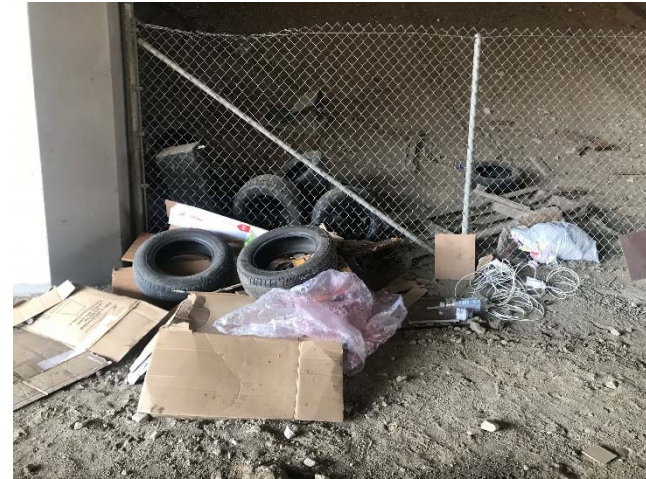
Photo 662: Illegal Dumping on San Fernando Road near I-5 Overpass: July 11, 2017

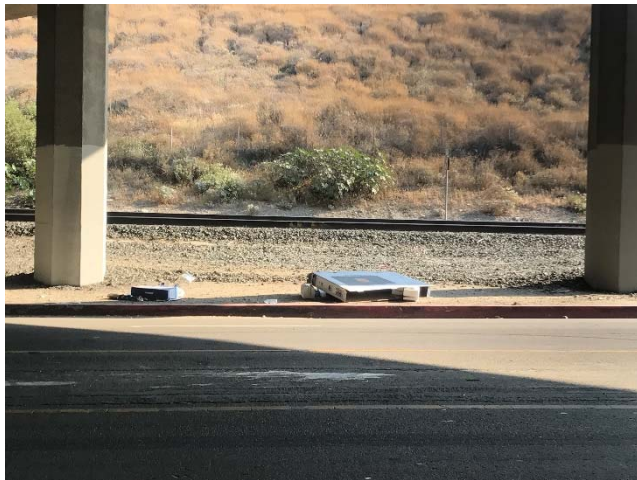
Photo 663: Illegal Dumping on San Fernando Road near I-5 Overpass: July 11, 2017

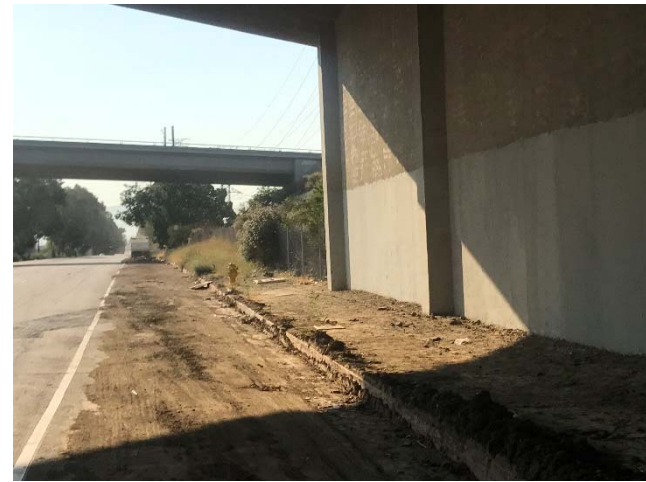
Photo 664: Illegal Dumping on San Fernando Road near I-5 Overpass: July 11, 2017

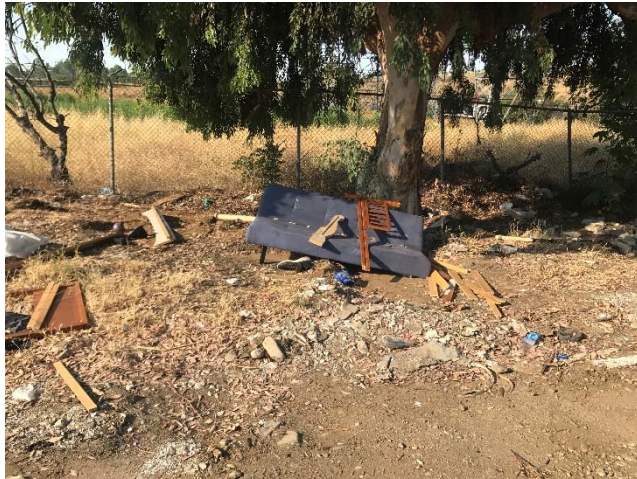
Photo 665: Illegal Dumping on San Fernando Road near I-5 Overpass: July 11, 2017

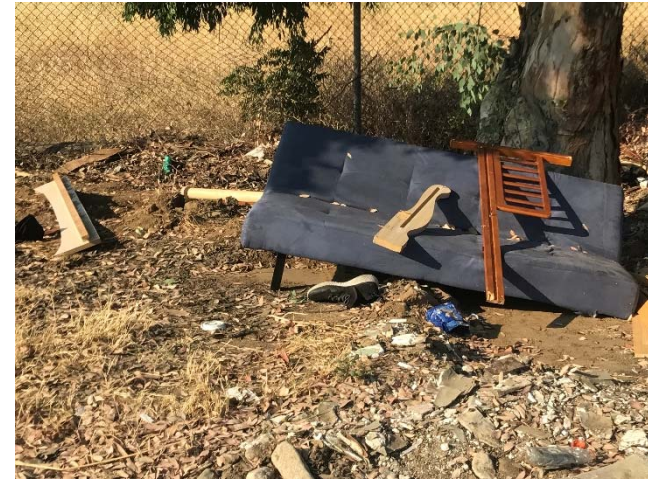
Photo 666: Illegal Dumping on San Fernando Road near I-5 Overpass: July 11, 2017

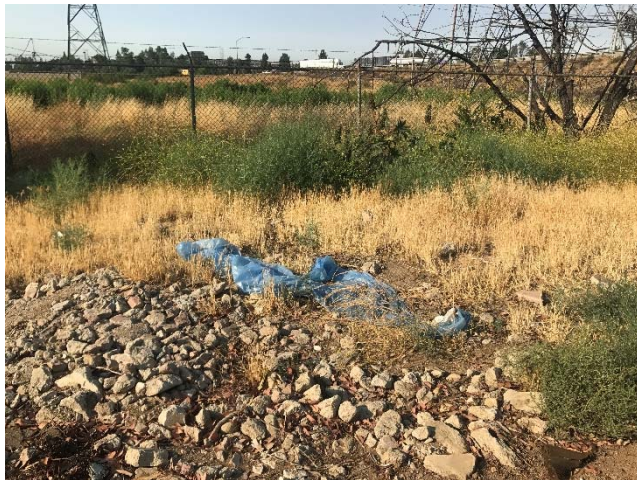
Photo 667: Illegal Dumping on San Fernando Road near I-5 Overpass: July 11, 2017

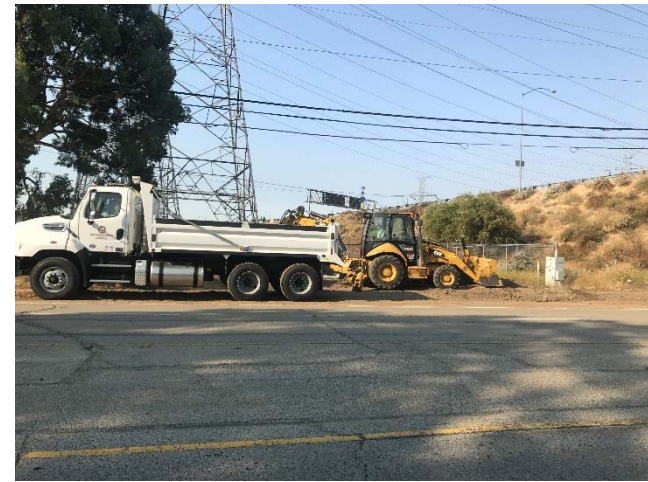
Photo 668: Illegal Dumping on San Fernando Road near I-5 Overpass: July 11, 2017

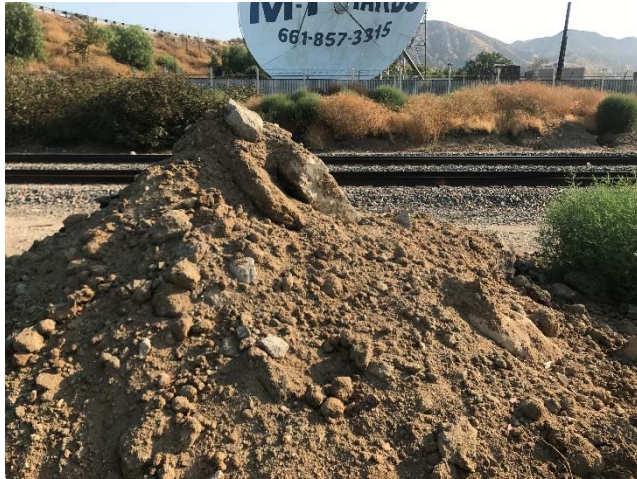
Photo 669: Illegal Dumping on San Fernando Road near I-5 Overpass: July 11, 2017

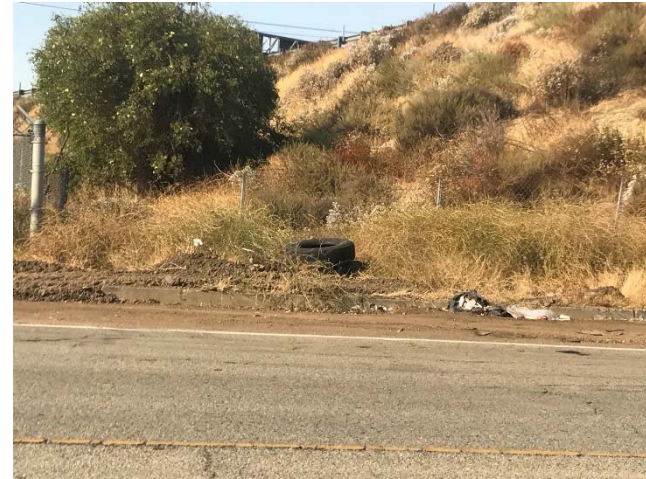
Photo 670: Illegal Dumping on San Fernando Road near I-5 Overpass: July 11, 2017

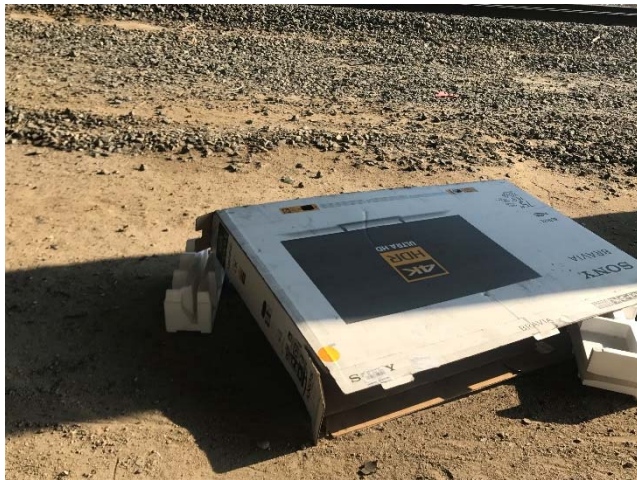
Photo 671: Illegal Dumping on San Fernando Road near I-5 Overpass: July 11, 2017

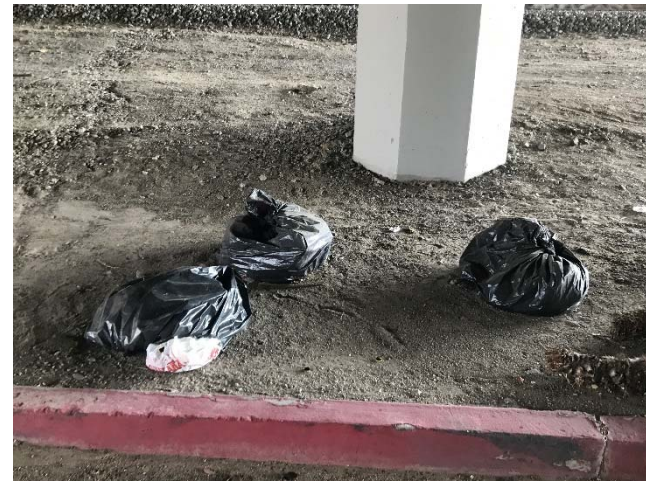
Photo 672: Illegal Dumping on San Fernando Road near I-5 Overpass: July 11, 2017

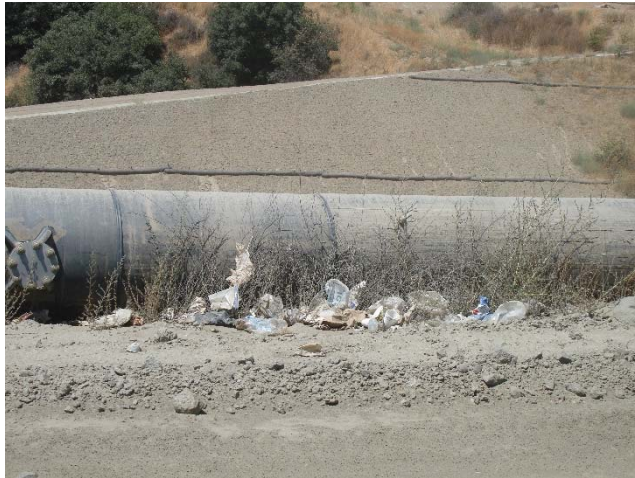
Photo 673: Blown Litter against Westside Header: August 14, 2017

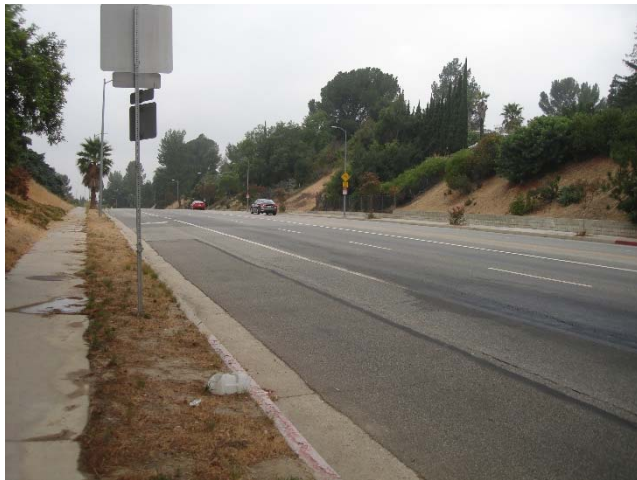
**Photo 679: Liquids on Pavement- Balboa Blvd at Woodley Ave:
August 14, 2017**

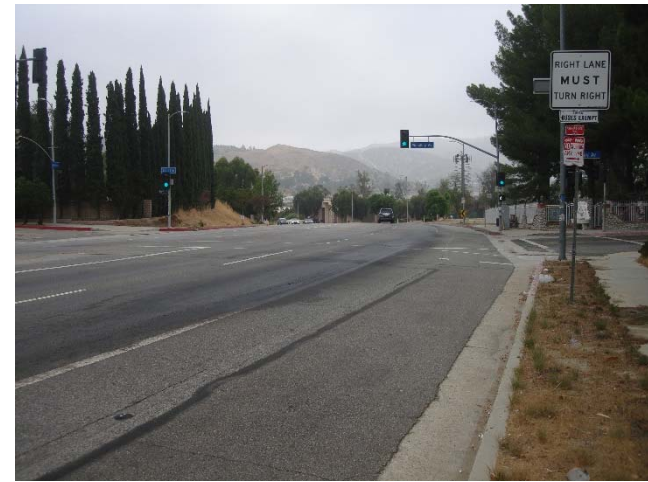
**Photo 680: Liquids on Pavement- Balboa Blvd at Woodley Ave:
August 14, 2017**

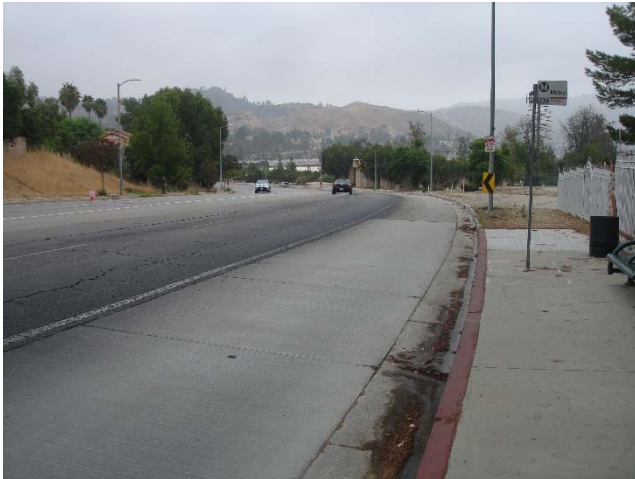
**Photo 681: Liquids on Pavement- Balboa Blvd at Woodley Ave:
August 14, 2017**

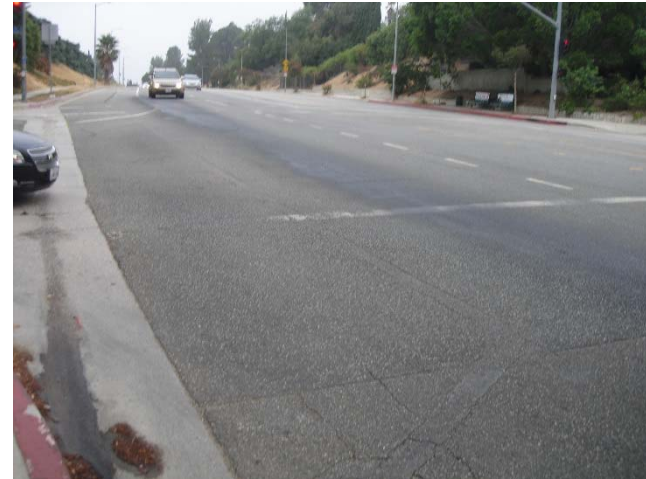
**Photo 682: Liquids on Pavement- Balboa Blvd at Woodley Ave:
August 14, 2017**

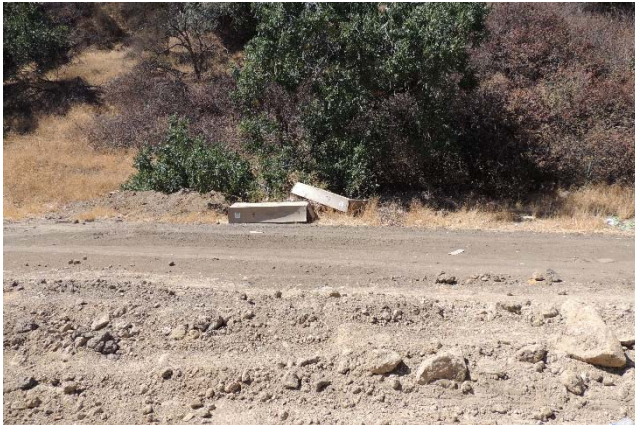
**Photo 683: Illegal Dumping at Sierra Highway near I-14 Overpass:
September 12, 2017**

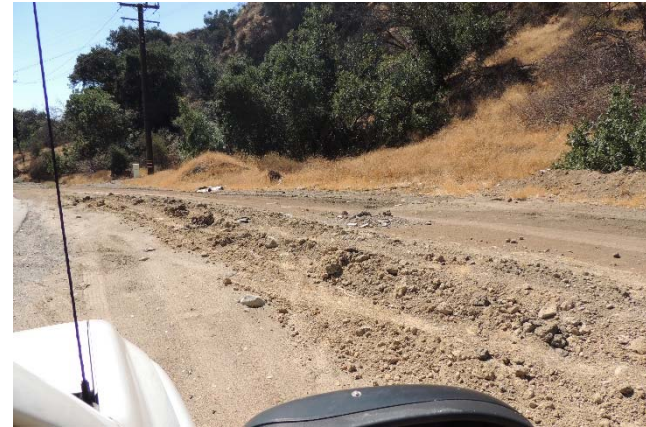
**Photo 684: Illegal Dumping at Sierra Highway near I-14
Overpass: September 12, 2017**

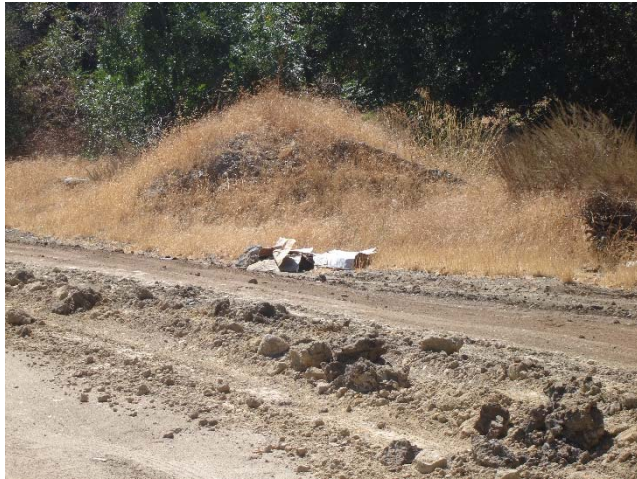
**Photo 685: Illegal Dumping at Sierra Highway near I-14 Overpass:
September 12, 2017**

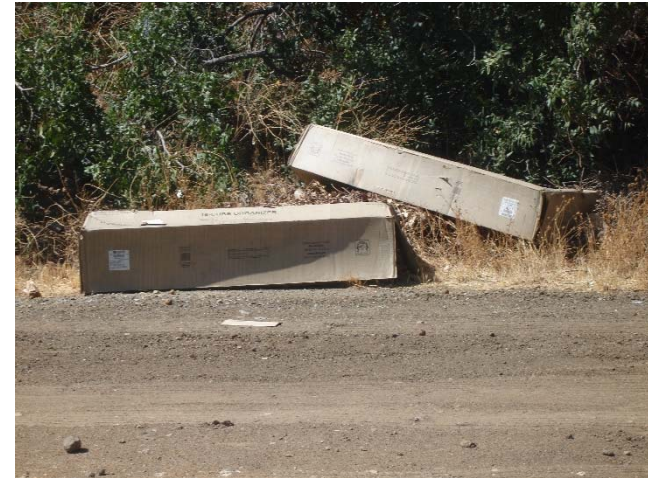
**Photo 686: Illegal Dumping at Sierra Highway near I-14
Overpass: September 12, 2017**

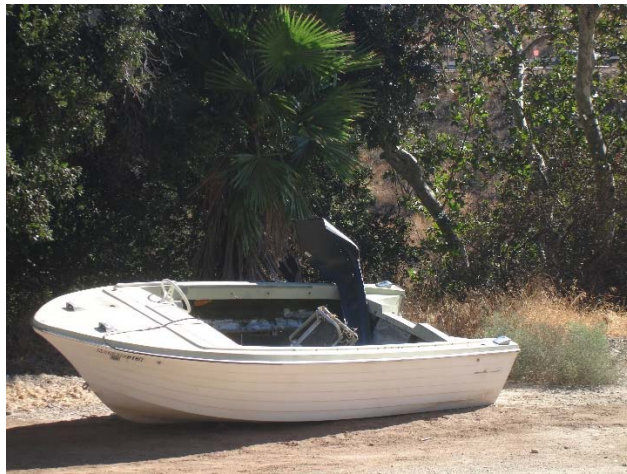
**Photo 687: Illegal Dumping at Sierra Highway near I-14 Overpass:
September 26, 2017**

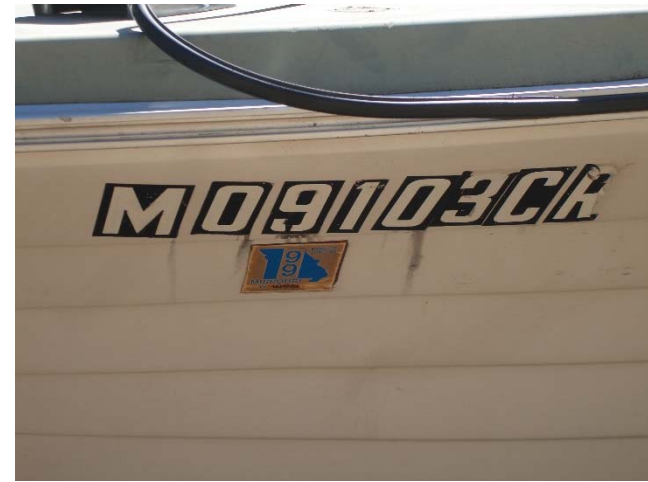
**Photo 688: Illegal Dumping at Sierra Highway near I-14
Overpass: September 26, 2017**

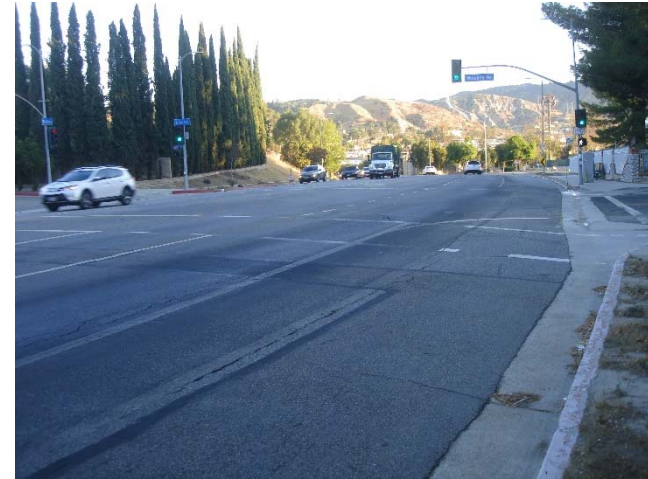
**Photo 690: Liquids on Pavement - Balboa Blvd at Woodley Ave:
September 26, 2017**

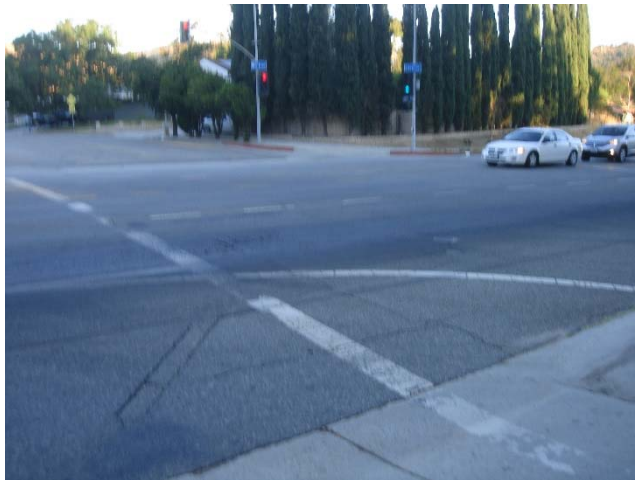
**Photo 691: Liquids on Pavement - Balboa Blvd at Woodley Ave:
September 26, 2017**

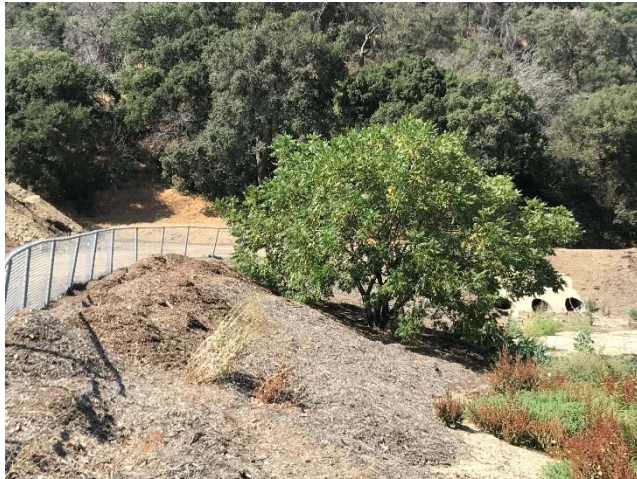
**Photo 692: No Offsite Odors Detected at Foothill Compost
Facility: July 11, 2017**

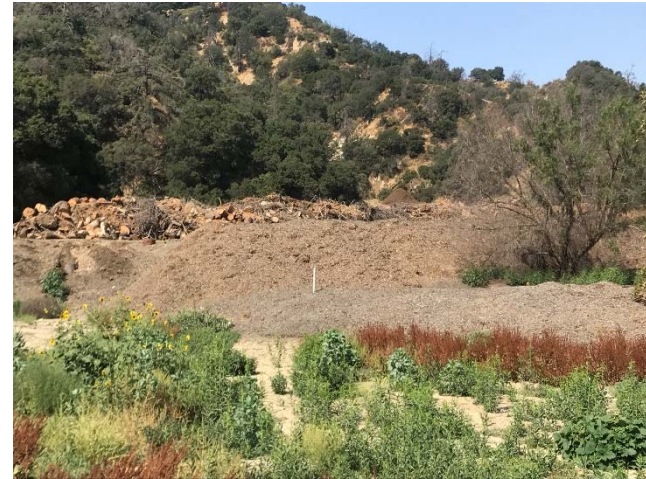
**Photo 693: No Offsite Odors Detected at Foothill Compost Facility:
July 11, 2017**

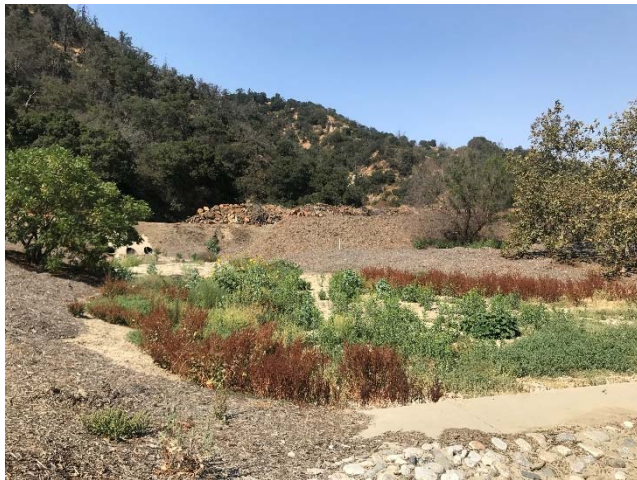
**Photo 694: No Offsite Odors Detected at Foothill Compost
Facility: July 11, 2017**

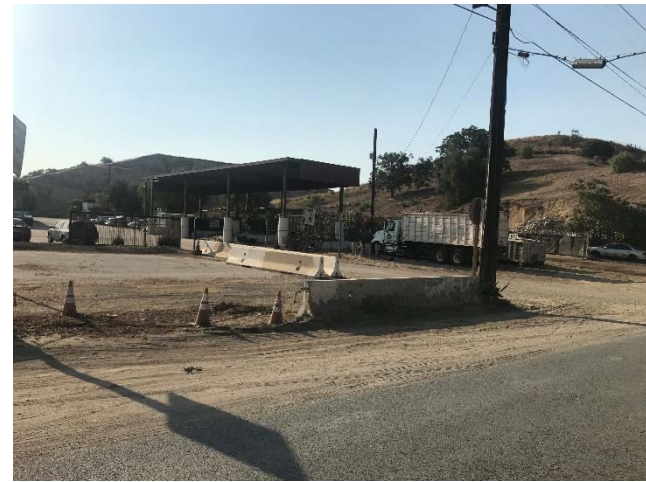
**Photo 695: No Offsite Odors Detected at Foothill Compost Facility:
July 11, 2017**

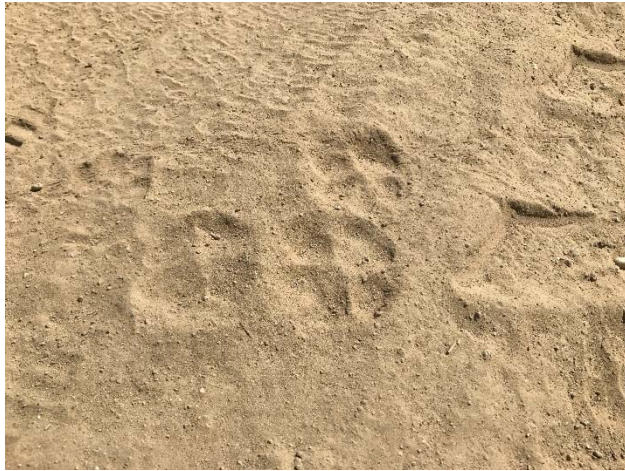
Photo 736: Cat Footprint: August 14, 2017

- Deck C sage mitigation was doing well. There were some areas that needed removal of invasive and non-native plants. Bobcat tracks were observed in the PM-10 tree area.

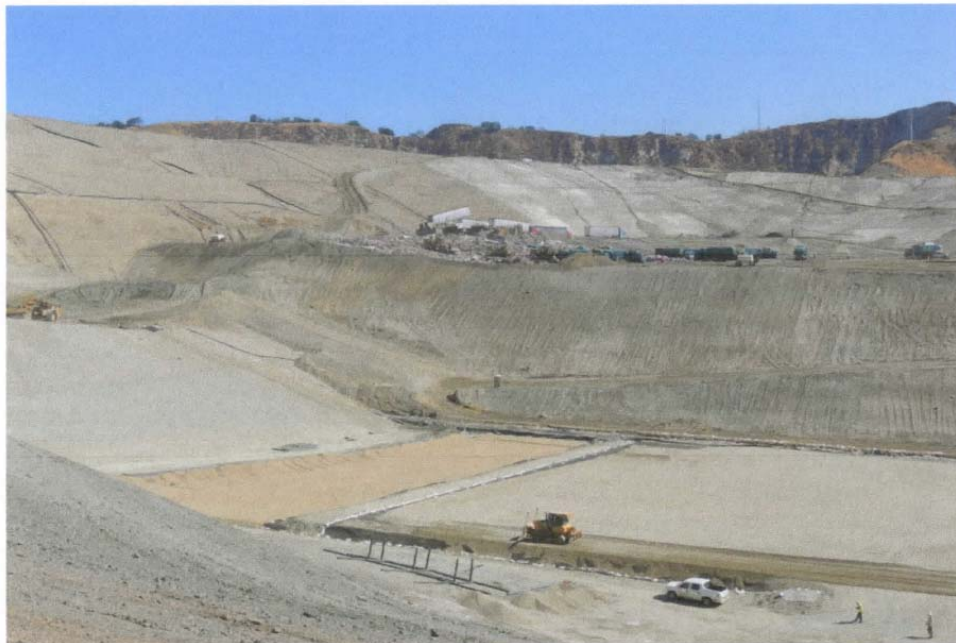
Photo 9: Closure turf on slope of cell CC3 and concrete block retaining wall
