**Sunshine Canyon Landfill  
Independent Monitor  
Quarterly Site Monitoring Status Report  
July 1, 2018 – September 30, 2018**

**City of Los Angeles Department of City Planning**

**County of Los Angeles Department of Regional Planning**

November 5, 2018

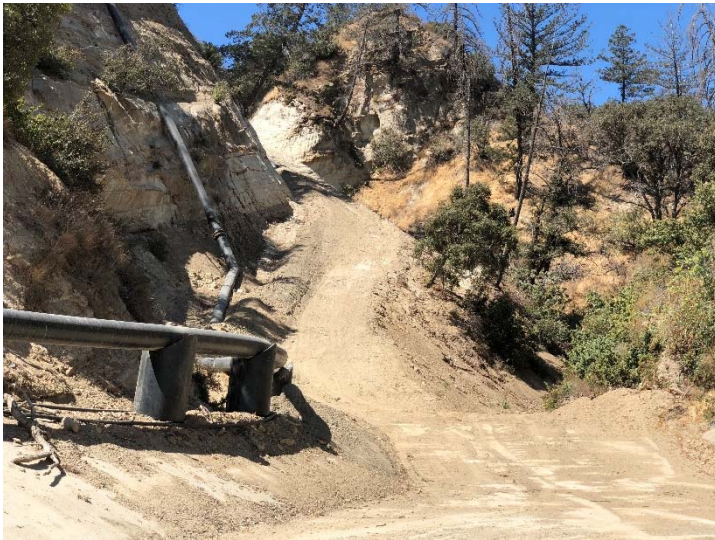
**Photo 7: Basin A Windblown Litter: August 29, 2018**

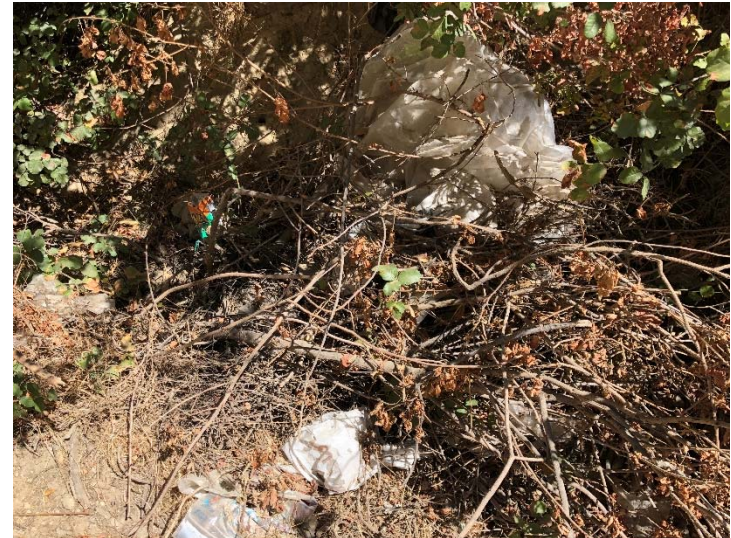
**Photo 8: Basin A Windblown Litter: August 29, 2018**

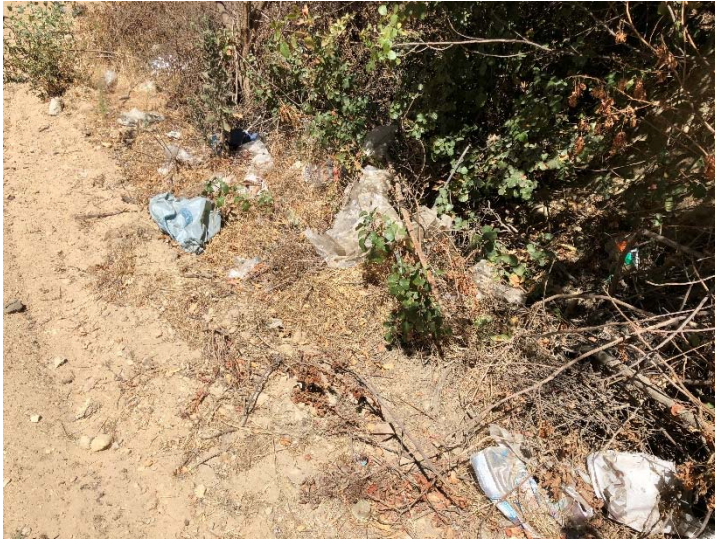
**Photo 9: Basin A Windblown Litter: August 29, 2018**

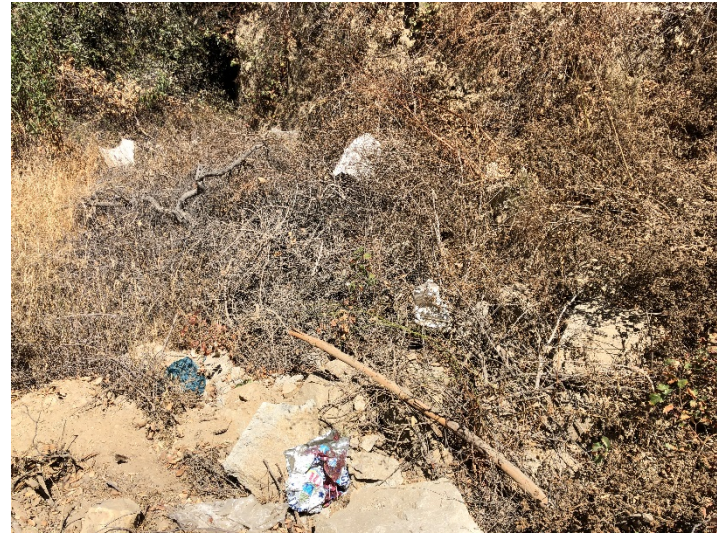
**Photo 10: Basin A Windblown Litter: August 29, 2018**

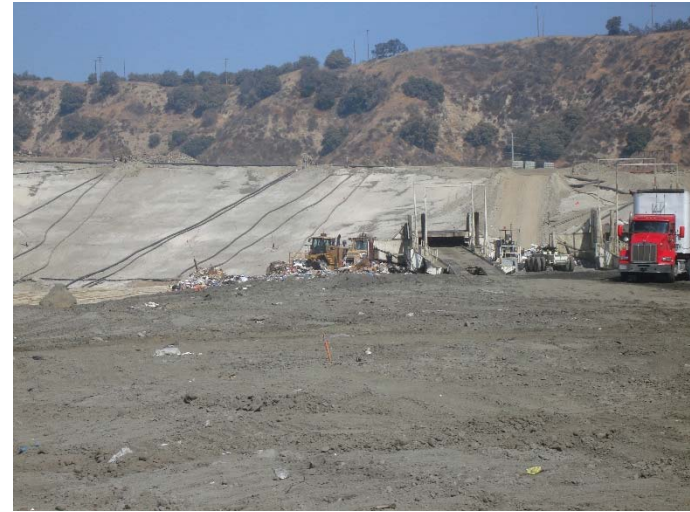
**Photo 117: Working Area CC4 Part 1: September 25, 2018**

Discipline	City Condition Reference # / Mitigation #	County Condition Reference # / Mitigation #	Responsible Agency	Further Review Needed – Comments
Project Manager	Q – B.2.c		City Planning	<p>I-j through I-n: The CC-4 Part 3 buttress grading was occurring during the 3rd Quarter of 2018. The consulting biologist confirmed that there were no nesting birds in early July, and gave clearance for removal of all vegetation in the planned grading area. This grading and buttress construction is the only grading being done outside of the prior-approved landfill footprint.</p> <p>I-j: Excavation was ongoing for the Cell CC-4 Part 3 buttress. A paleontological monitor was onsite observing grading in undisturbed areas. Cell CC-4 Part 1 and Part 2 were accepting waste. No operational issues were noted.</p> <p>I-k: CC-4 Part 3 buttress excavation was underway and seep water was being controlled. A Paleo monitor was observing the excavation. Cell CC-4 Part 1 was accepting waste; Part 2 was inactive.</p> <p>I-l: Excavation was ongoing for the Cell CC-4 Part 3 buttress. A paleontological monitor was observing the excavation. The buttress soils were being stockpiled on the County far north top deck. Cell CC-4 Part 1 was accepting waste; Part 2 was idle. No operating concerns were noted.</p> <p>I-m: The CC-4 Part 3 buttress was nearing completion of the toe excavation. The buttress soils were being stockpiled on the County far north top deck. Excavation at the toe of the slide was proceeding carefully as to not cause an accidental movement of the slide area. A laser and prism movement detection system to monitor the excavation, with action required levels at 1/4", 1/2", and 1" was installed. CC-4 Part 1 was accepting waste; Part 2 was idle.</p> <p>I-n: The excavation of the toe of the slide for the CC-4 Part 3 buttress was nearing completion. CC-4 Part 1 and Part 2 were active accepting waste.</p>

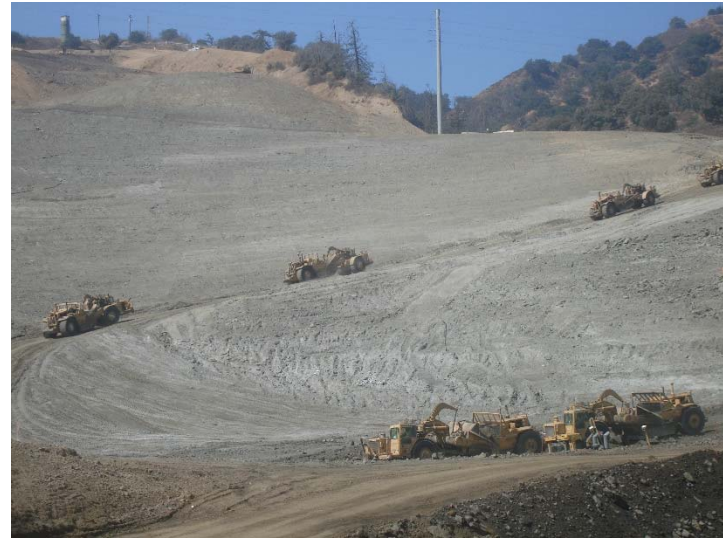
**Photo 158: CC4 Part 3 & Buttress Excavation Area: September 25, 2018**

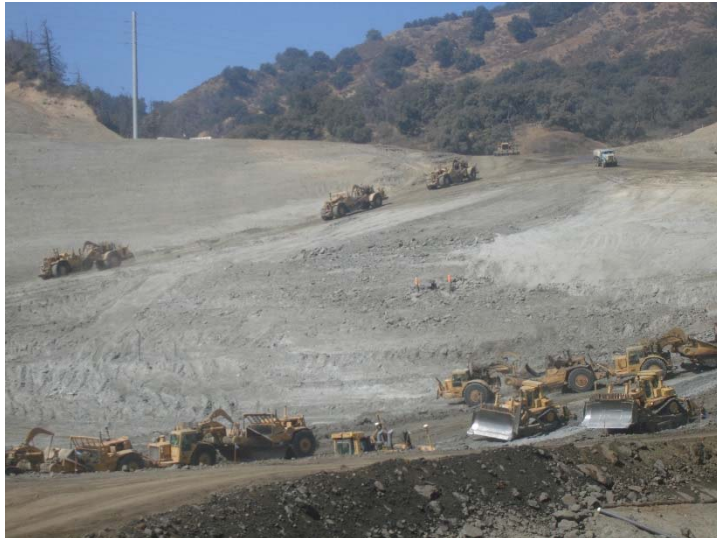
**Photo 159: CC4 Part 3 & Buttress Excavation Area: September 25, 2018**

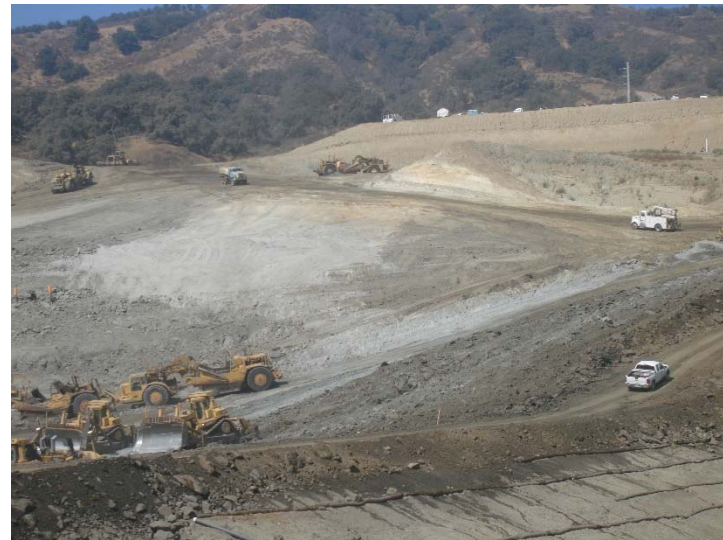
**Photo 160: CC4 Part 3 & Buttress Excavation Area: September 25, 2018**

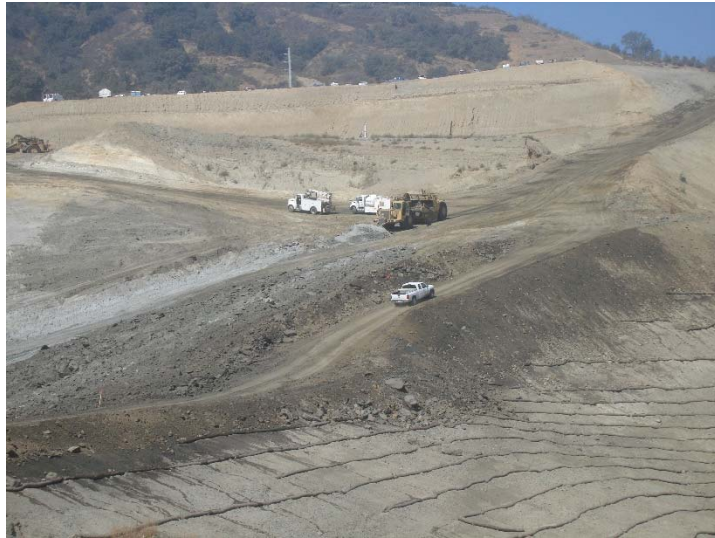
**Photo 161: CC4 Part 3 & Buttress Excavation Area: September 25, 2018**

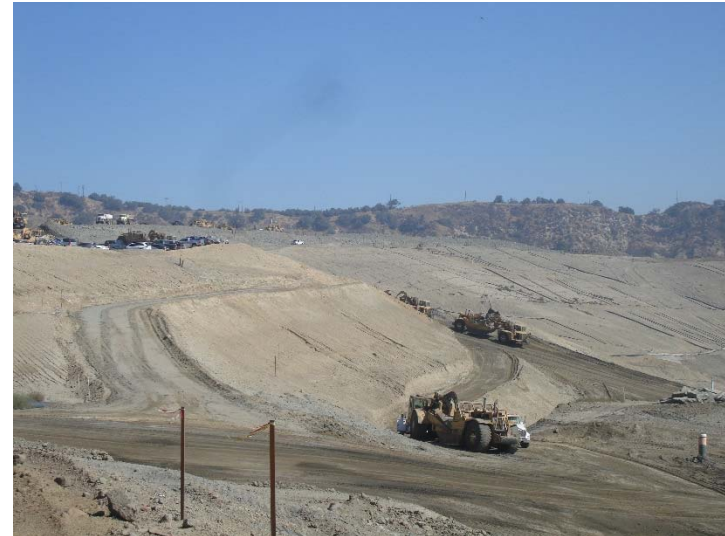
**Photo 162: CC4 Part 3 & Buttress Excavation Area: September 25, 2018**

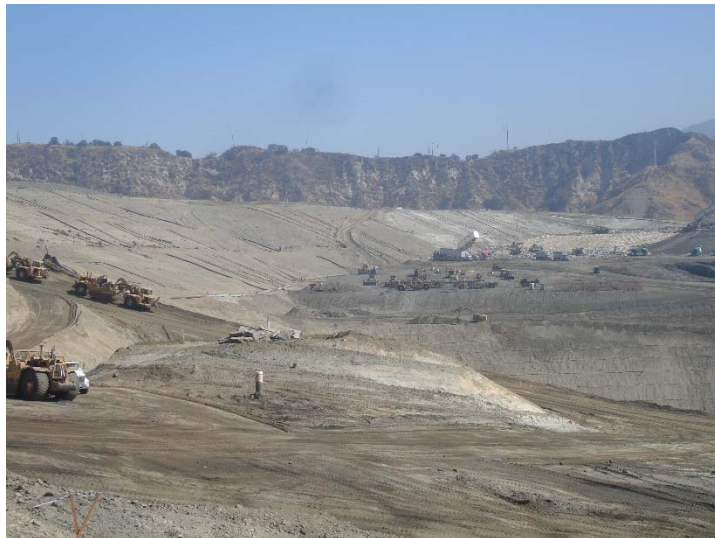
**Photo 163: CC4 Part 3 & Buttress Excavation Area: September 25, 2018**

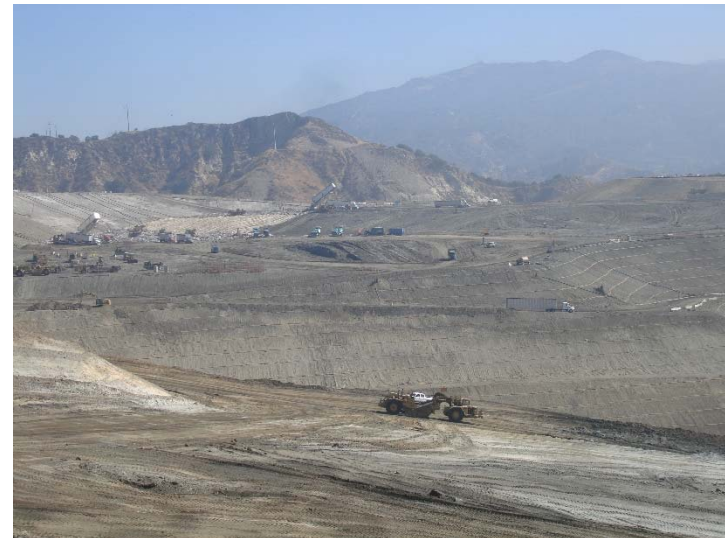
**Photo 164: CC4 Part 3 & Buttress Excavation Area: September 25, 2018**

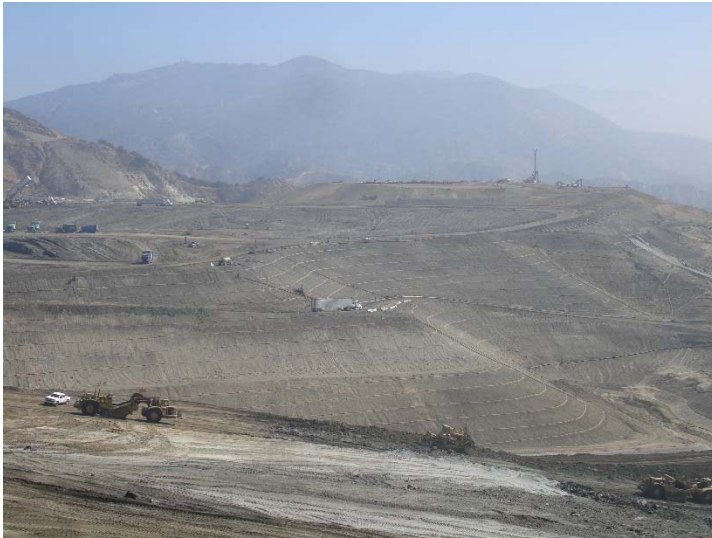
**Photo 165: CC4 Part 3 & Buttress Excavation Area: September 25, 2018**

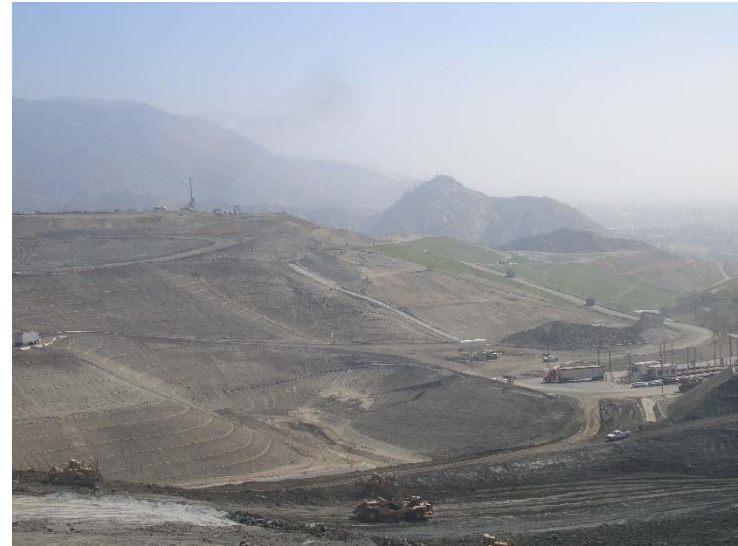
**Photo 166: CC4 Part 3 & Buttress Excavation Area: September 25, 2018**

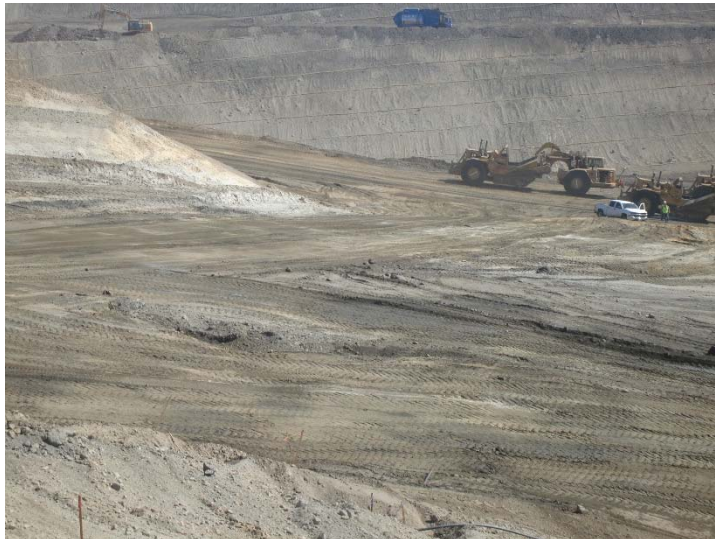
**Photo 167: CC4 Part 3 & Buttress Excavation Area: September 25, 2018**

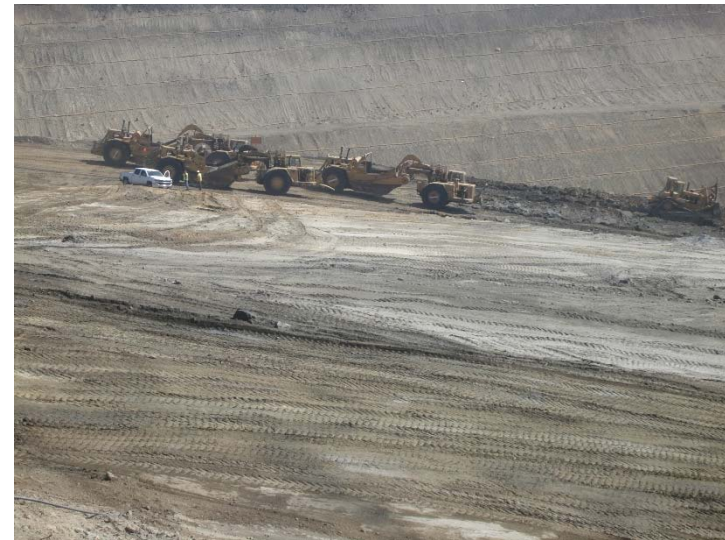
**Photo 168: CC4 Part 3 & Buttress Excavation Area: September 25, 2018**

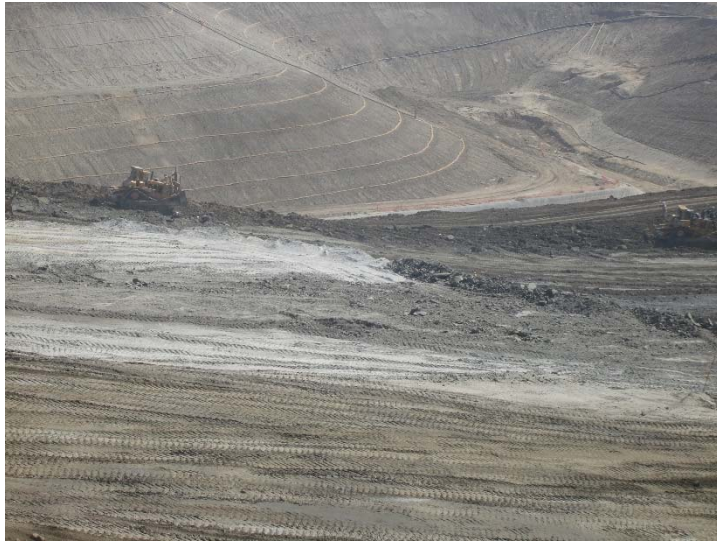
**Photo 169: CC4 Part 3 & Buttress Excavation Area: September 25, 2018**

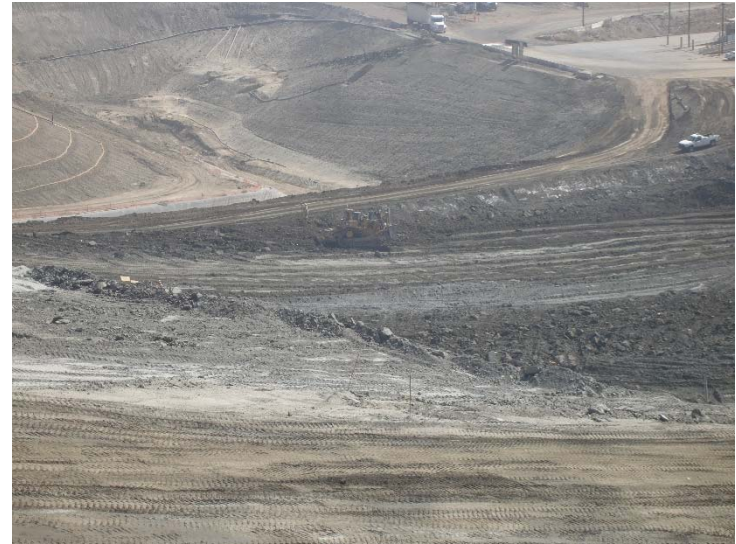
**Photo 170: CC4 Part 3 & Buttress Excavation Area: September 25, 2018**

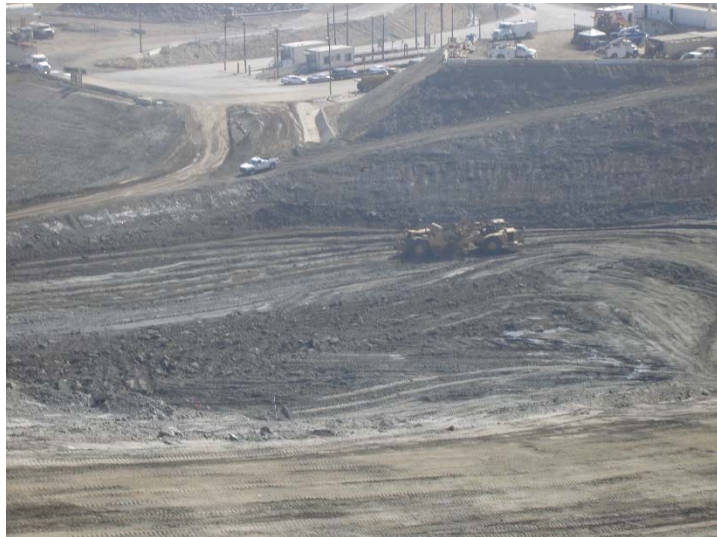
**Photo 171: CC4 Part 3 & Buttress Excavation Area: September 25, 2018**

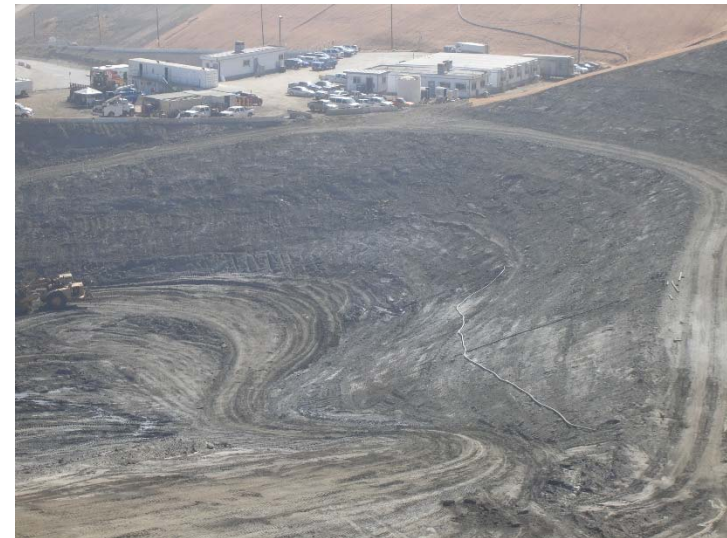
**Photo 172: CC4 Part 3 & Buttress Excavation Area: September 25, 2018**

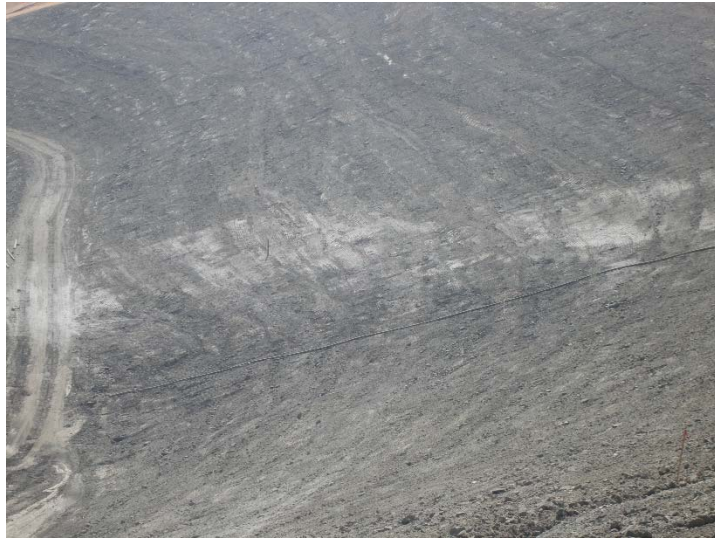
**Photo 173: CC4 Part 3 & Buttress Excavation Area: September 25, 2018**

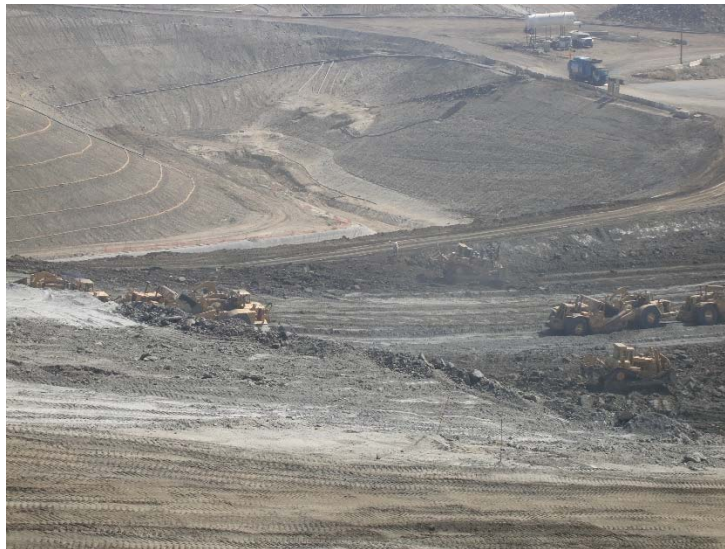
**Photo 175: CC4 Part 3 & Buttress Excavation Area: September 25, 2018**

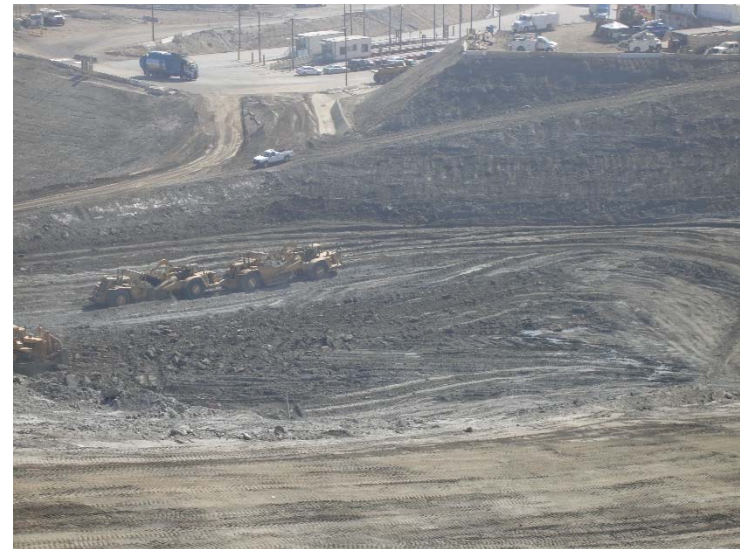
**Photo 176: CC4 Part 3 & Buttress Excavation Area: September 25, 2018**

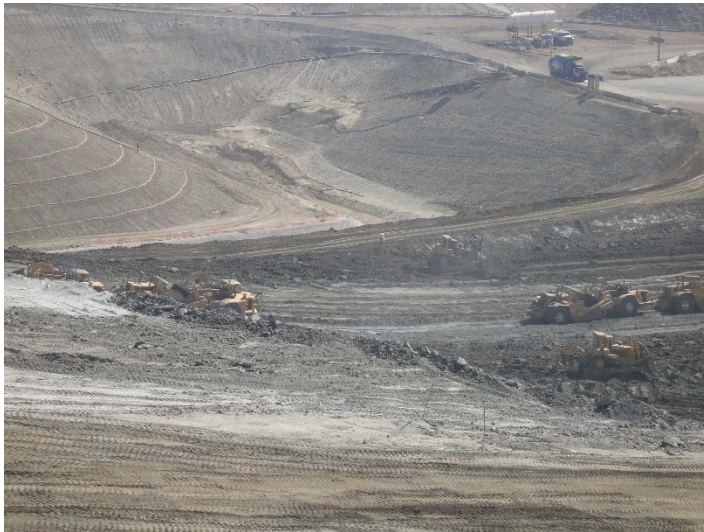
**Photo 177: CC4 Part 3 & Buttress Excavation Area: September 25, 2018**

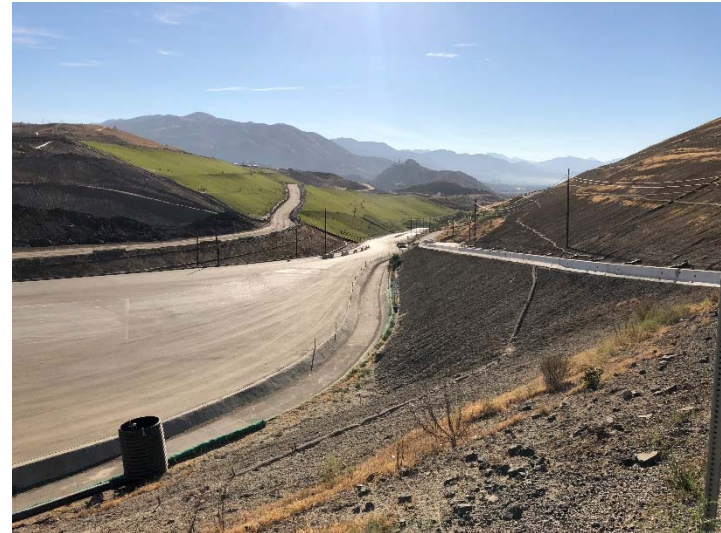
**Photo 178: Posi-Shell & Closure Turf: July 5, 2018**

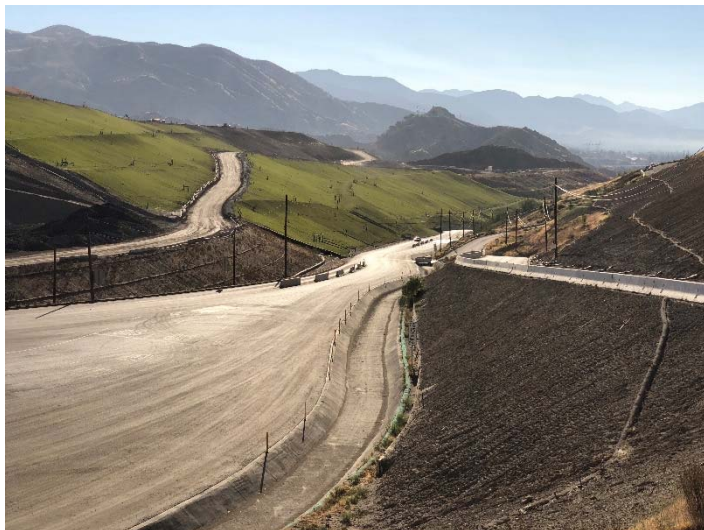
**Photo 179: Posi-Shell & Closure Turf: July 5, 2018**

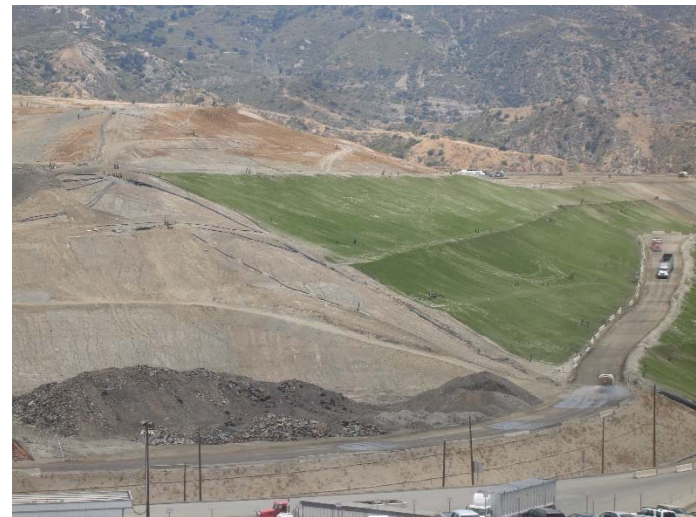
**Photo 180: Posi-Shell & Closure Turf: July 5, 2018**

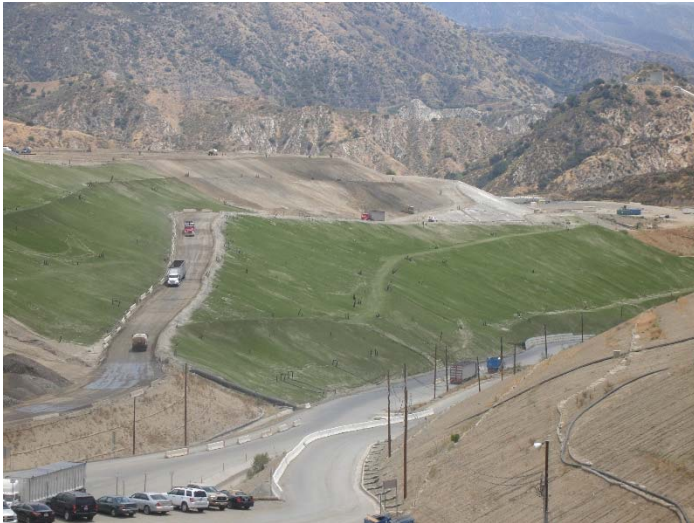
**Photo 181: Posi-Shell & Closure Turf: July 5, 2018**

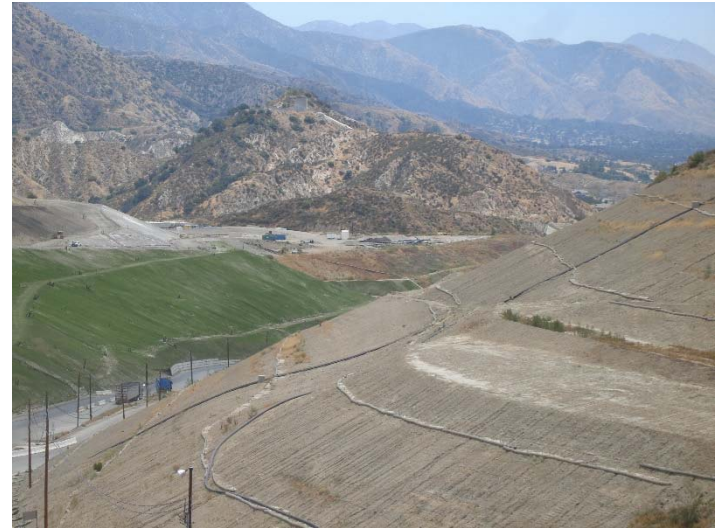
**Photo 182: Posi-Shell & Closure Turf: July 5, 2018**

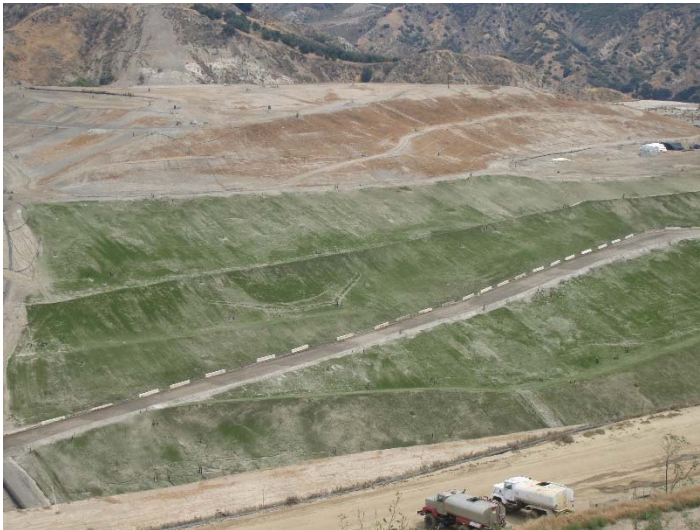
**Photo 183: Posi-Shell & Closure Turf: July 5, 2018**

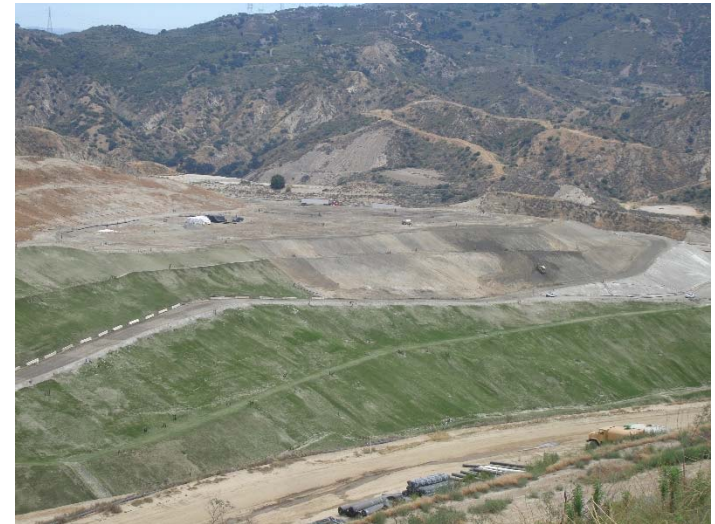
**Photo 184: Posi-Shell & Closure Turf: July 5, 2018**

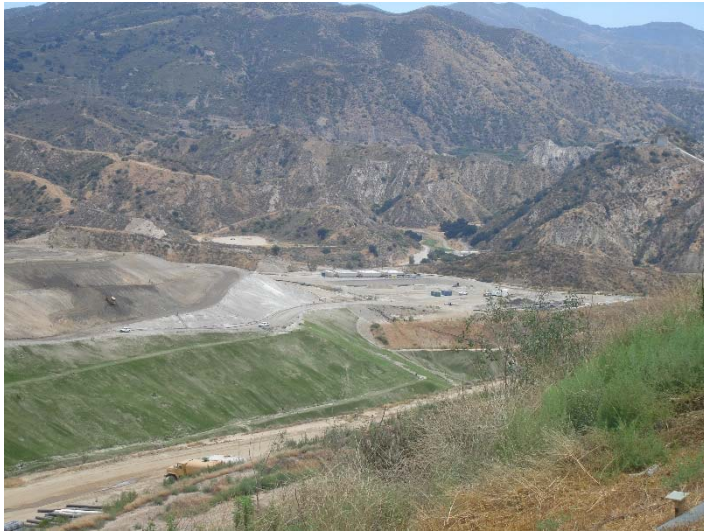
**Photo 185: Posi-Shell & Closure Turf: July 5, 2018**

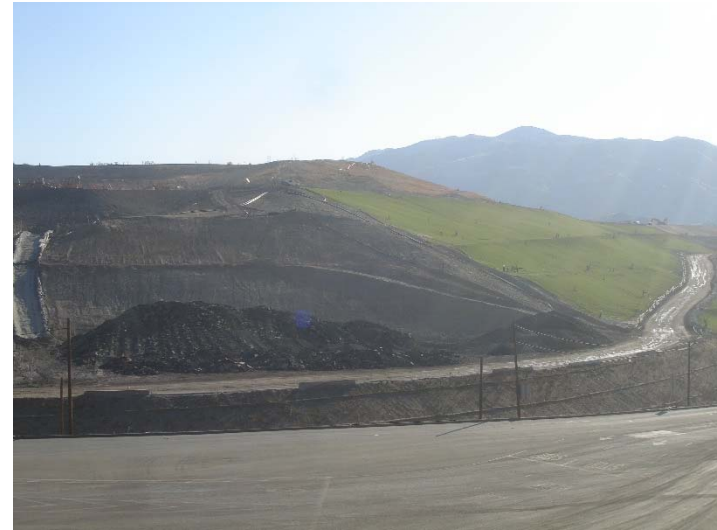
**Photo 186: Posi-Shell and Closure Turf: July 24, 2018**

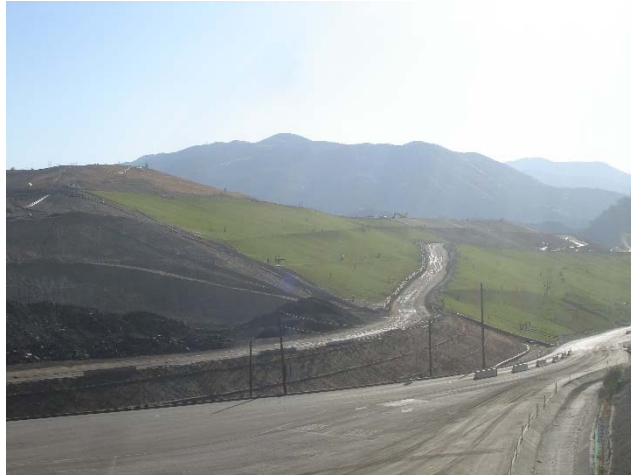
**Photo 187: Posi-Shell and Closure Turf: July 24, 2018**

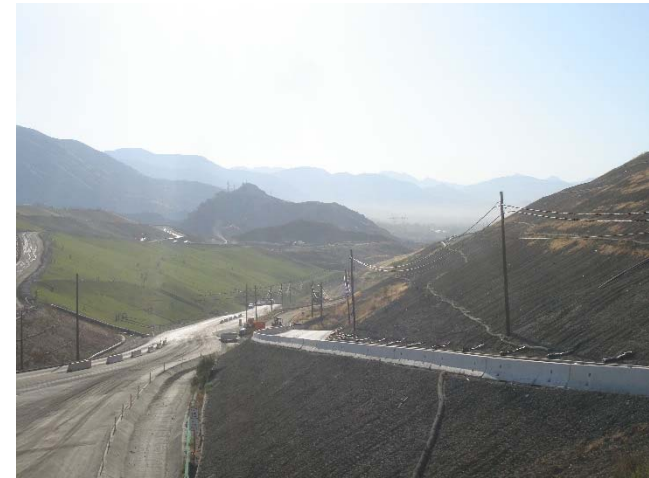
**Photo 188: Posi-Shell and Closure Turf: July 24, 2018**

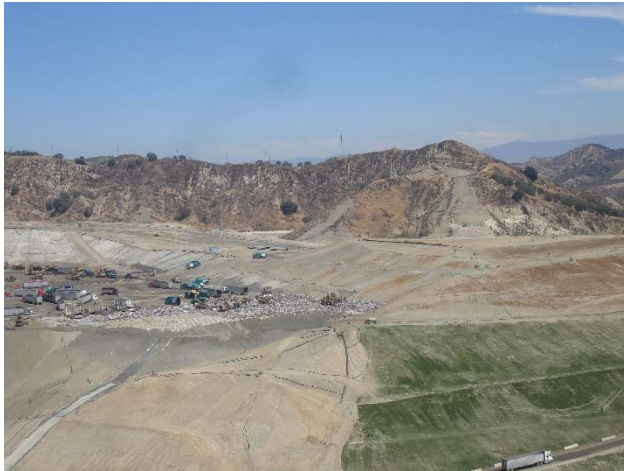
**Photo 189: Posi-Shell and Closure Turf: August 29, 2018**

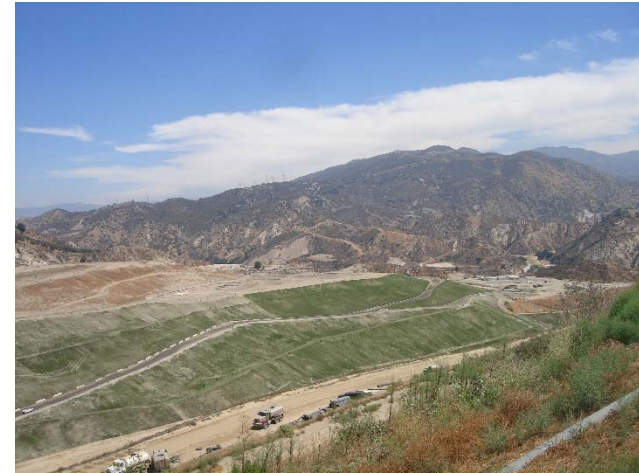
**Photo 190: Posi-Shell and Closure Turf: August 29, 2018**

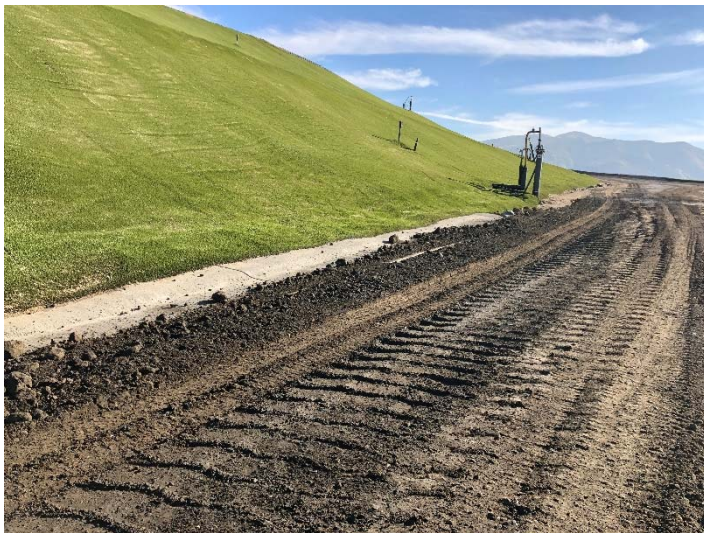
**Photo 191: Closure Turf: August 29, 2018**

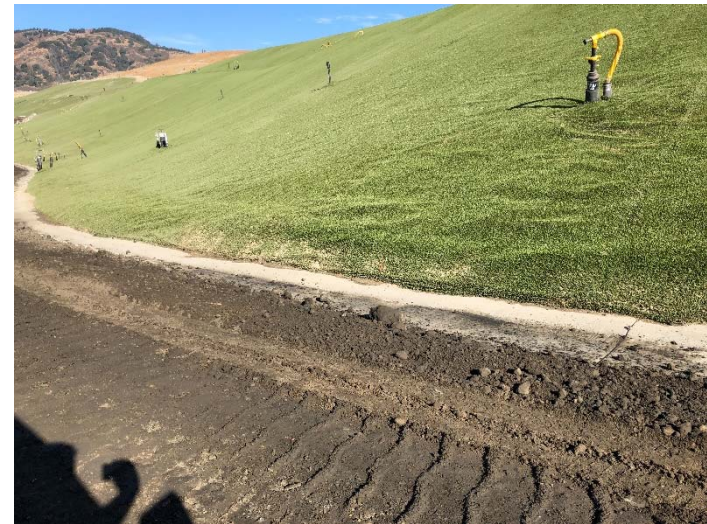
**Photo 192: Closure Turf: August 29, 2018**

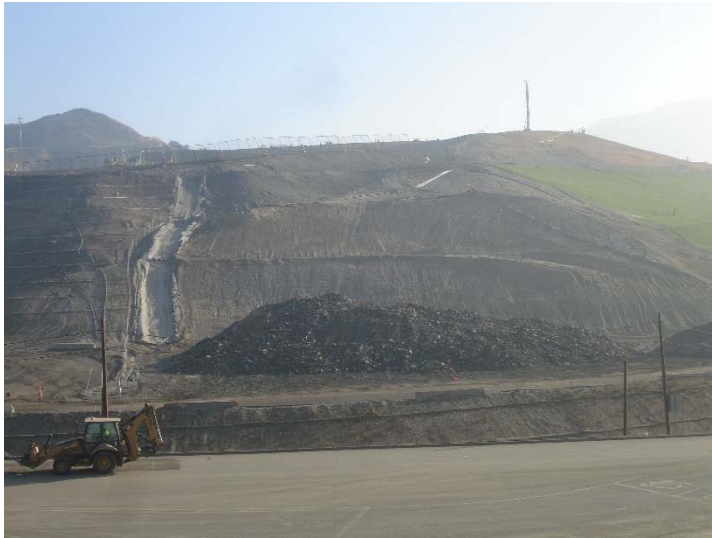
**Photo 193: Posi-Shell and Closure Turf: September 12, 2018**

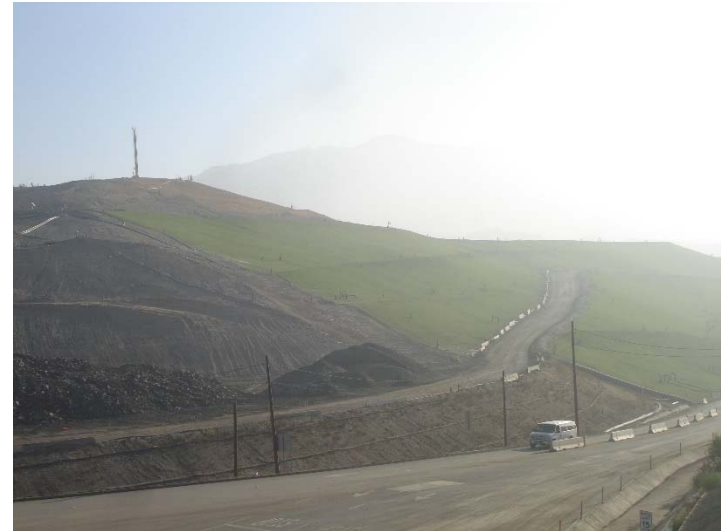
**Photo 194: Posi-Shell and Closure Turf: September 12, 2018**

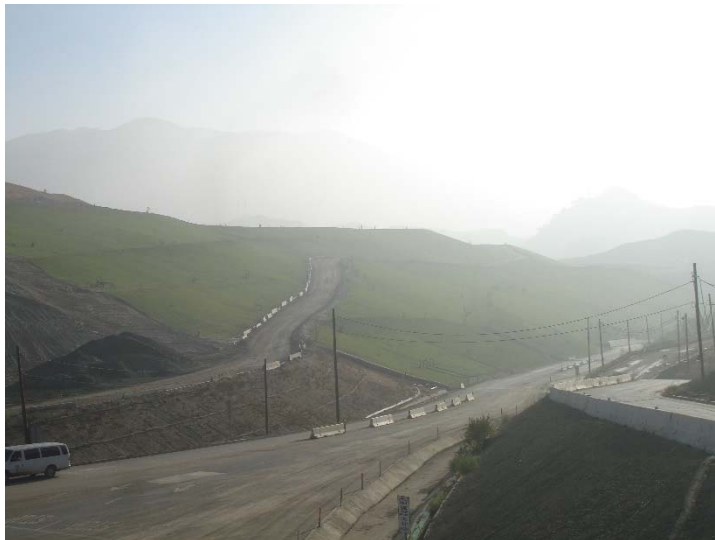
**Photo 195: Posi-Shell and Closure Turf: September 12, 2018**

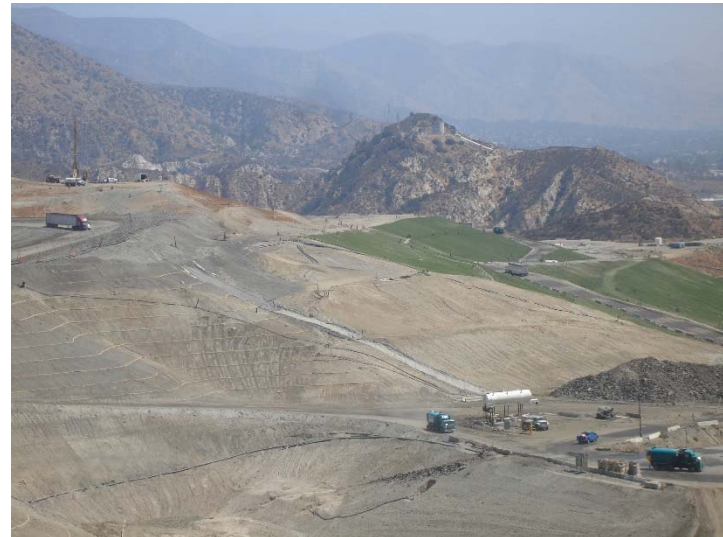
**Photo 196: Posi-Shell and Closure Turf: September 12, 2018**

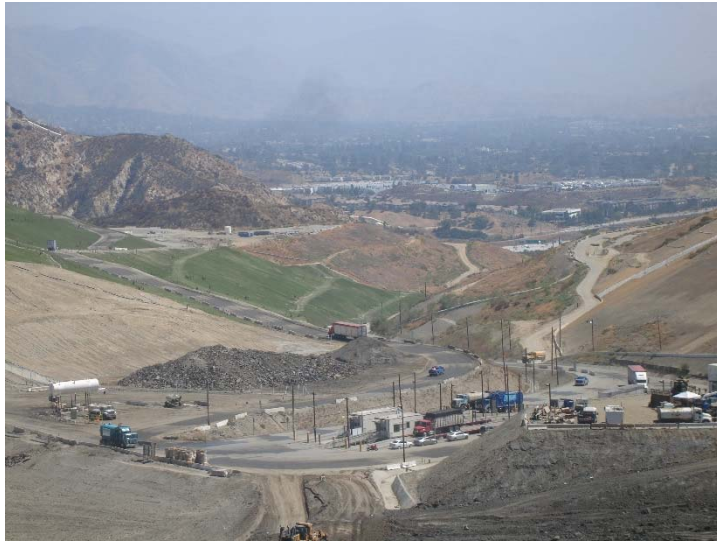
**Photo 197: Posi-Shell and Closure Turf: September 12, 2018**

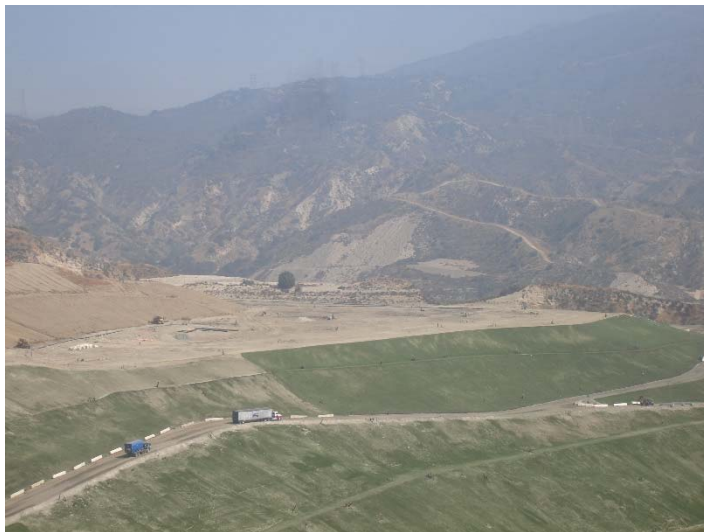
**Photo 199: Posi-Shell and Closure Turf: September 25, 2018**

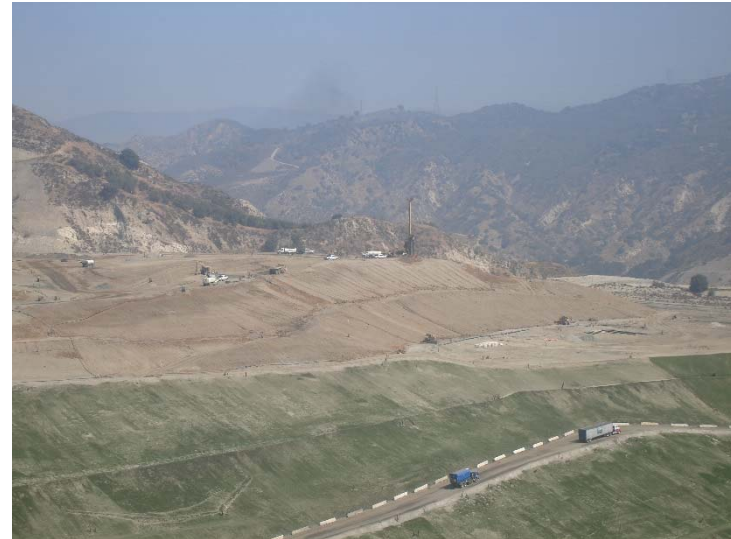
**Photo 198: Posi-Shell and Closure Turf: September 25, 2018**

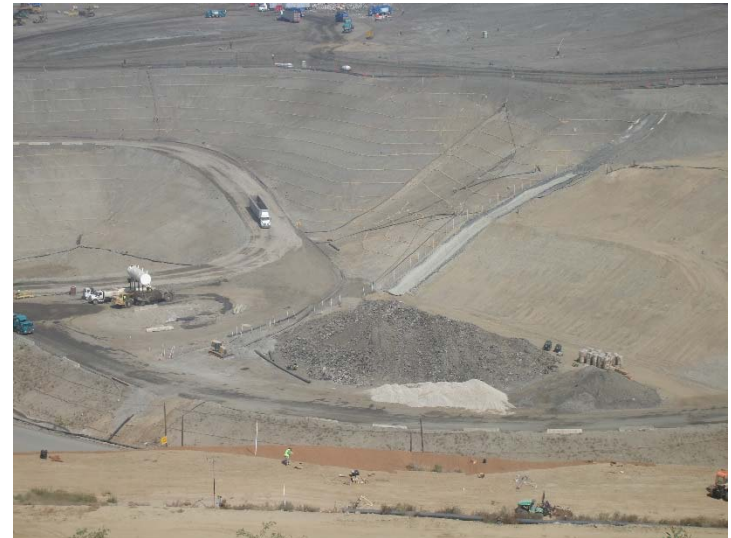
**Photo 200: Posi-Shell and Closure Turf: September 25, 2018**

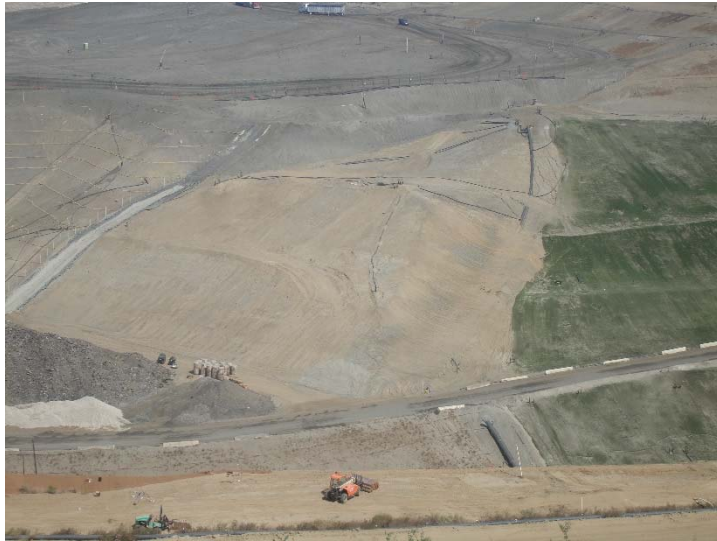
**Photo 201: Posi-Shell and Closure Turf: September 25, 2018**

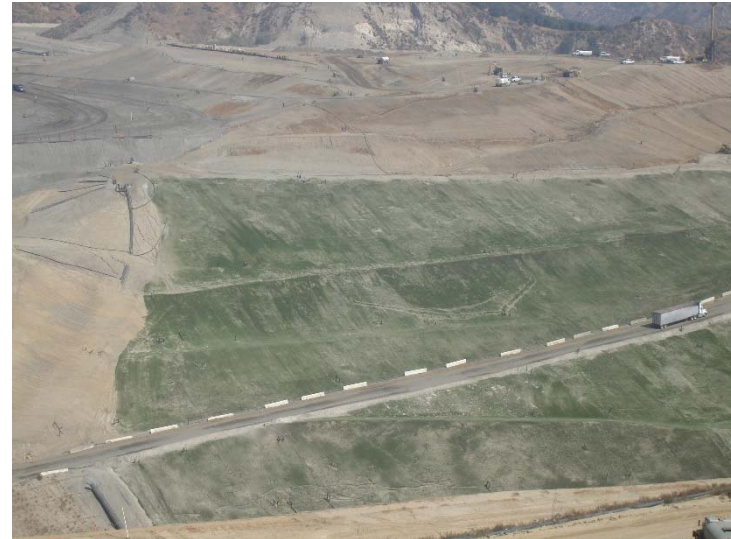
**Photo 202: Posi-Shell and Closure Turf: September 25, 2018**

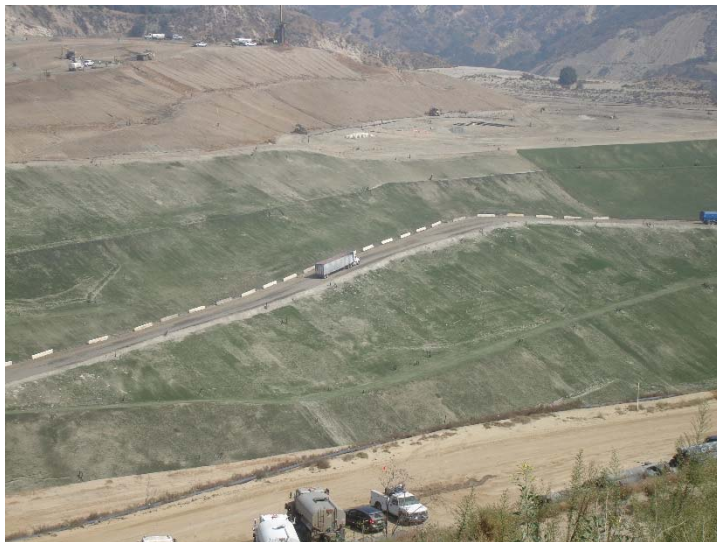
**Photo 203: Posi-Shell and Closure Turf: September 25, 2018**

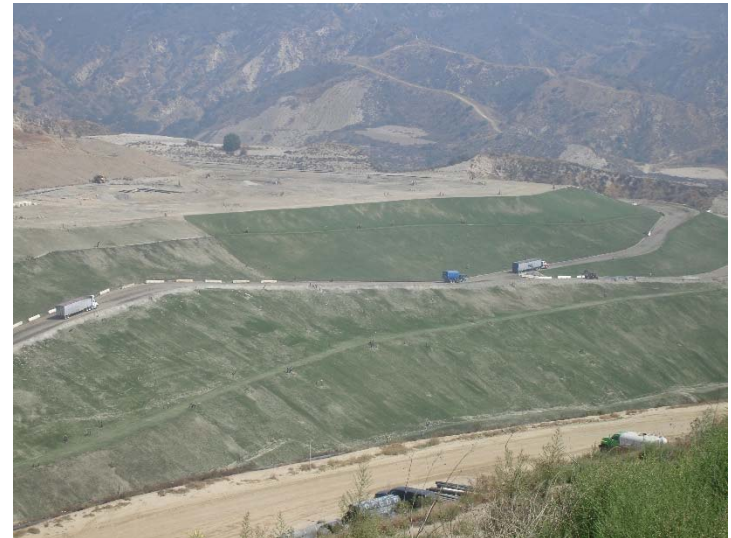
**Photo 204: Posi-Shell and Closure Turf: September 25, 2018**

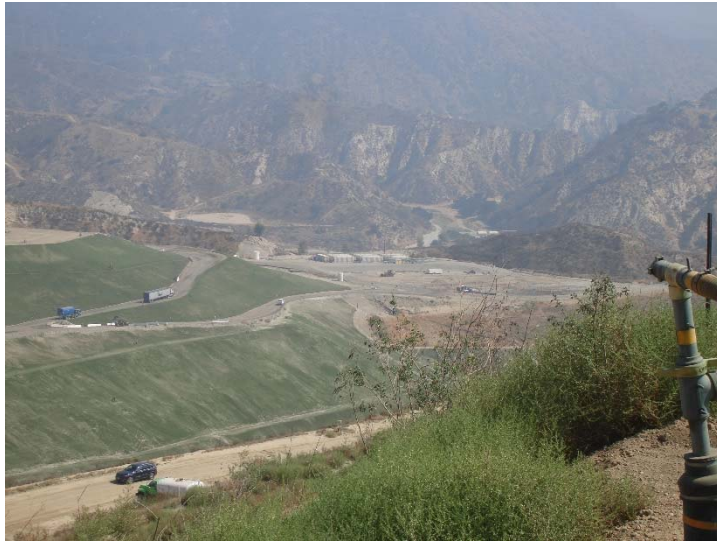
**Photo 205: Posi-Shell and Closure Turf: September 25, 2018**

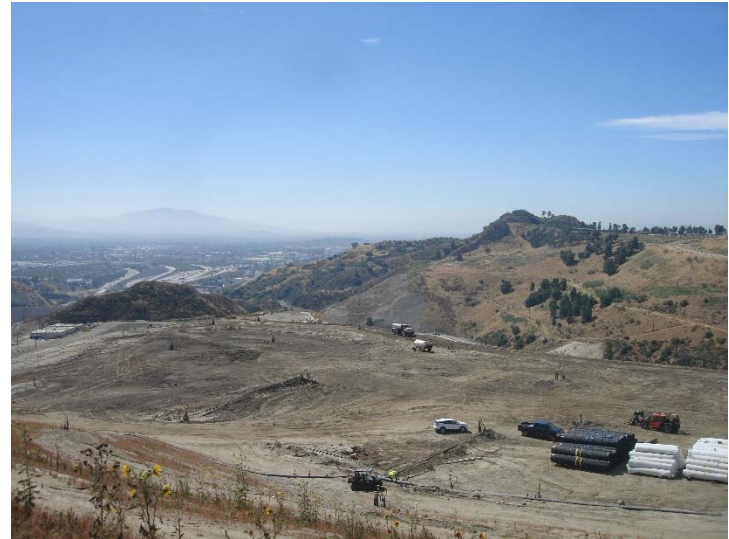
**Photo 206: CC3B Top Deck: July 5, 2018**

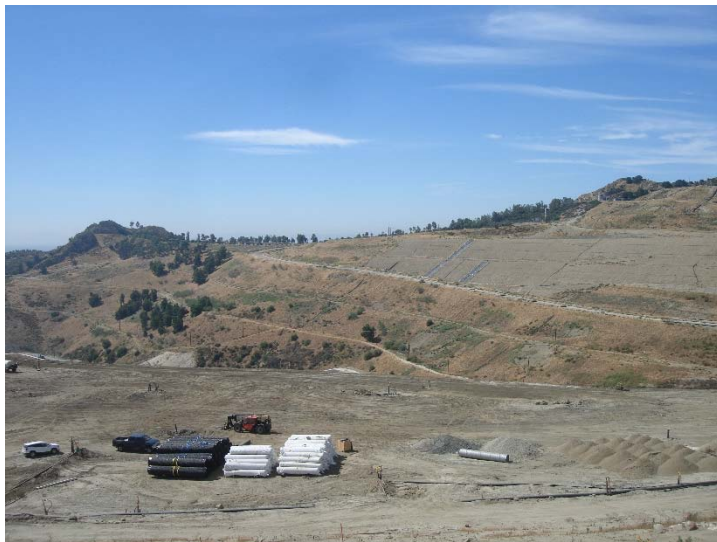
**Photo 207: CC3B Top Deck: July 5, 2018**

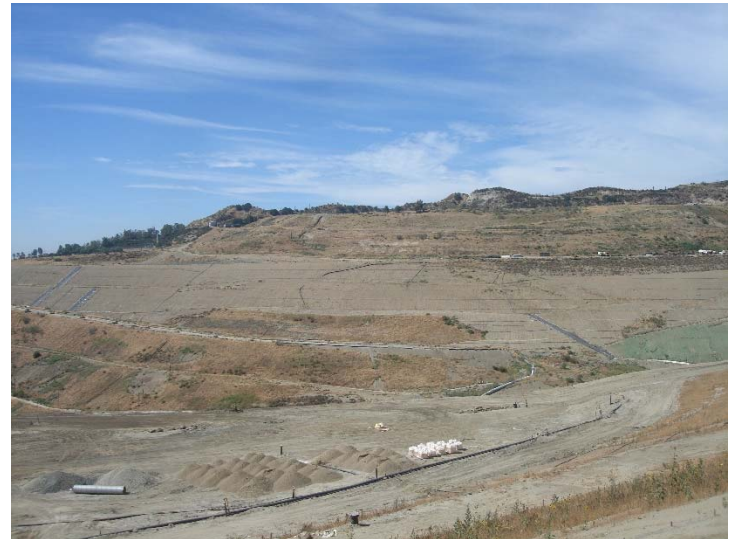
**Photo 208: CC3B Top Deck: July 5, 2018**

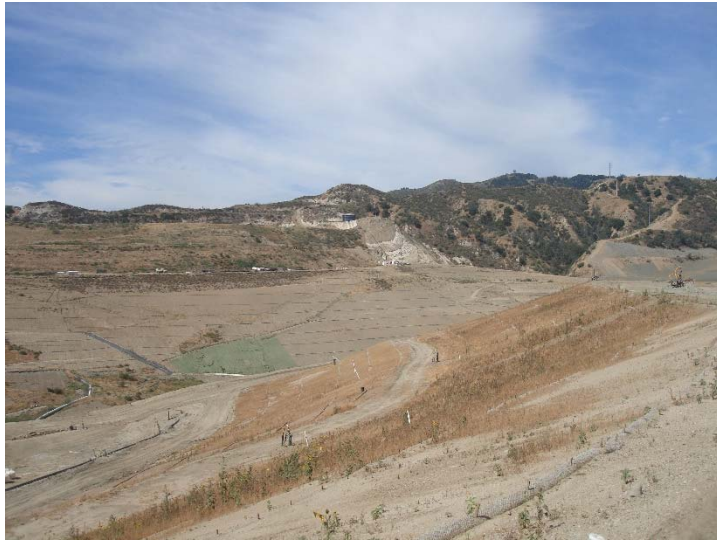
**Photo 209: CC3B Top South Slope: July 5, 2018**

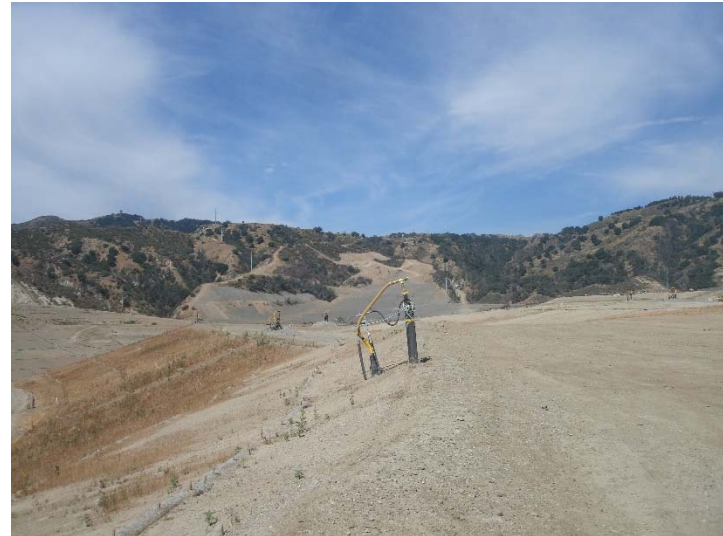
**Photo 210: CC3B Top South Slope: July 5, 2018**
