**Sunshine Canyon Landfill  
Independent Monitor  
Quarterly Site Monitoring Status Report  
July 1, 2018 – September 30, 2018**

**City of Los Angeles Department of City Planning**

**County of Los Angeles Department of Regional Planning**

November 5, 2018

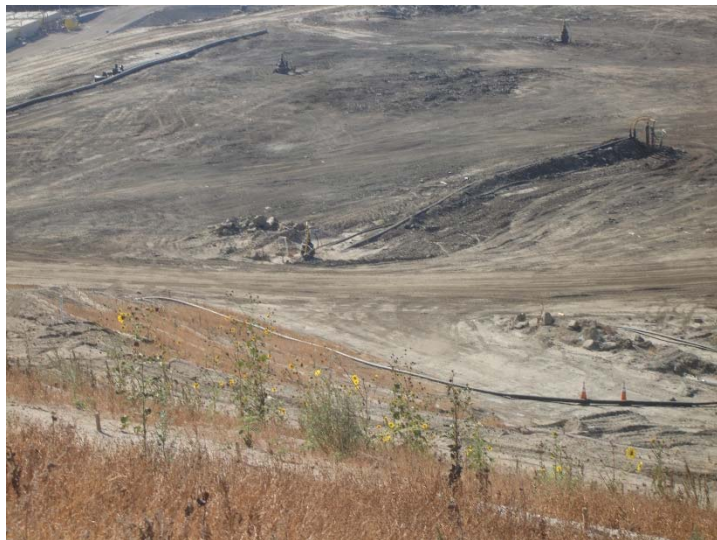
**Photo 211: CC3A Top Slope: July 24, 2018**

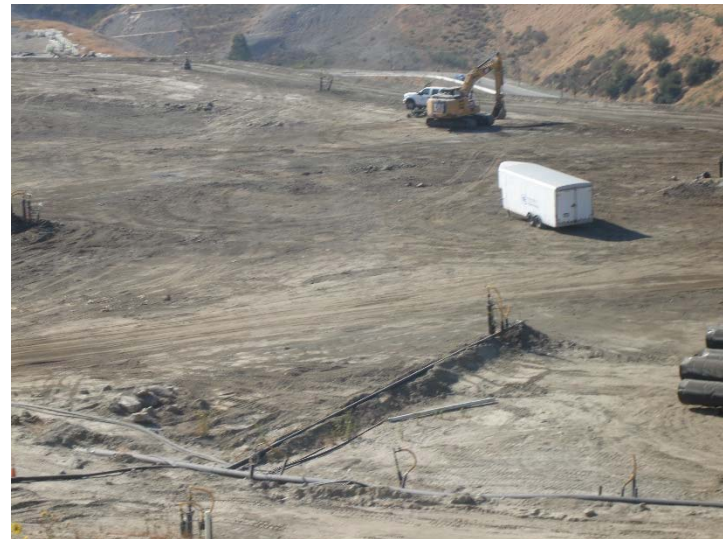
**Photo 212: CC3A Top Slope: July 24, 2018**

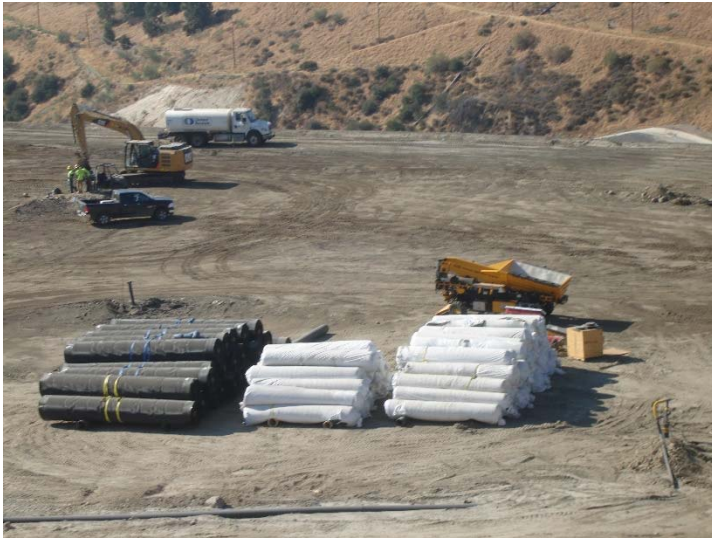
**Photo 213: CC3A Top Slope: July 24, 2018**

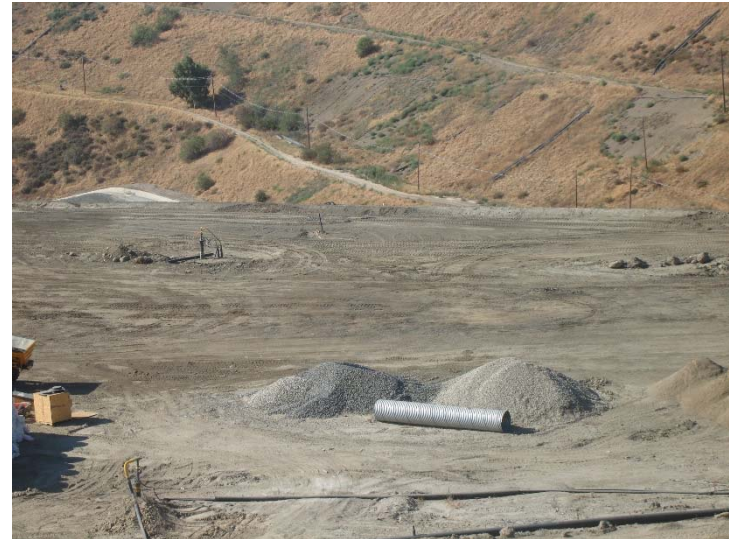
**Photo 214: CC3A Top Slope: July 24, 2018**

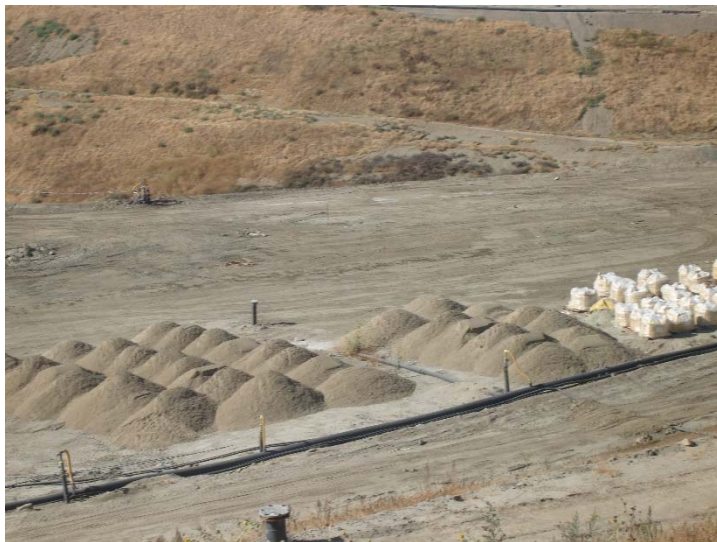
**Photo 215: CC3A Top Slope: July 24, 2018**

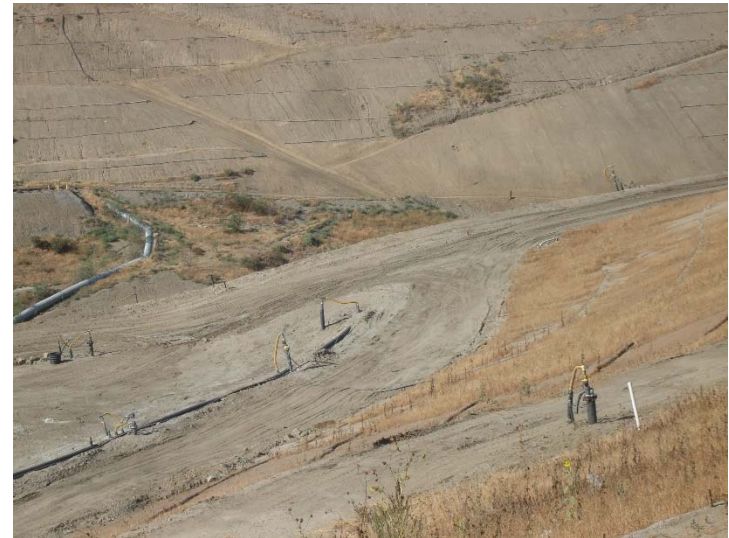
**Photo 216: CC3A Top Slope: July 24, 2018**

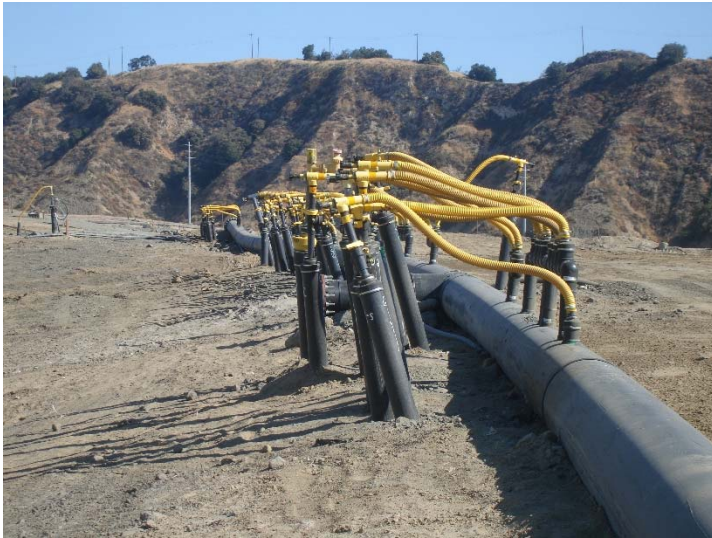
**Photo 217: CC3A Top Slope: July 24, 2018**

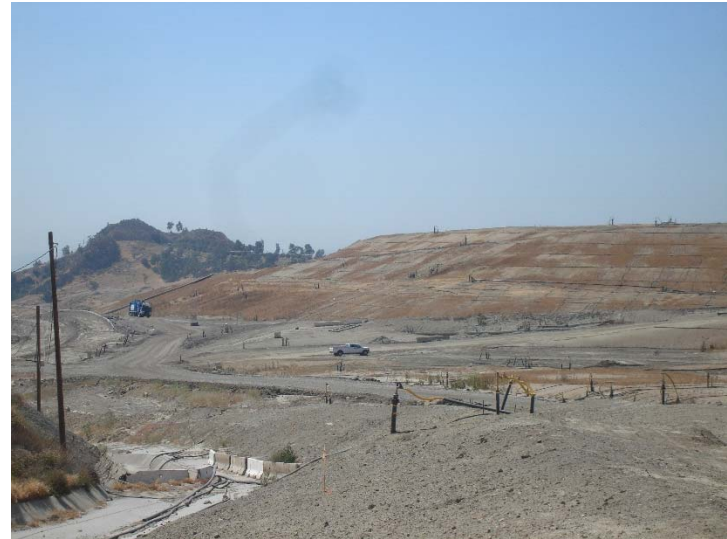
**Photo 218: CC3A Slope Revegetation: July 24, 2018**

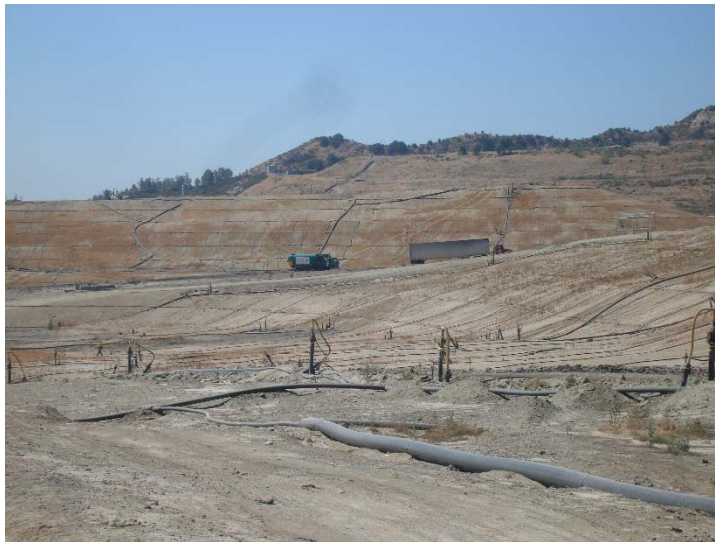
**Photo 219: CC3A Slope Revegetation: July 24, 2018**

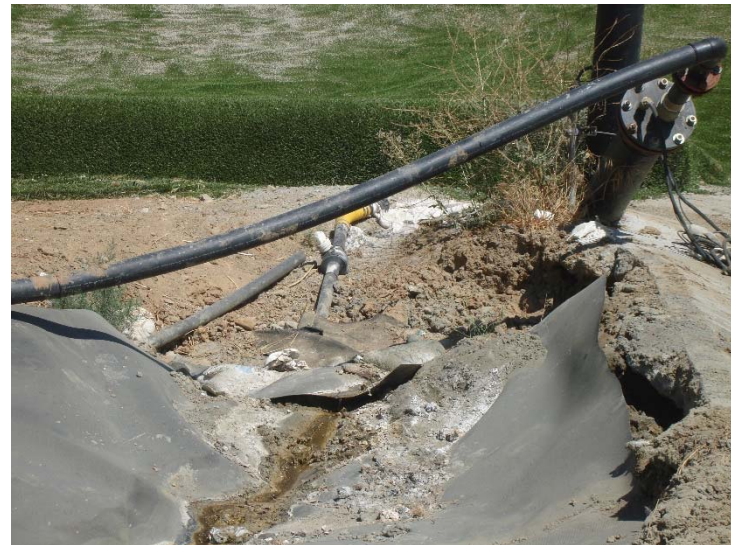
**Photo 220: CC3B Alluvial Slope Leak: July 24, 2018**

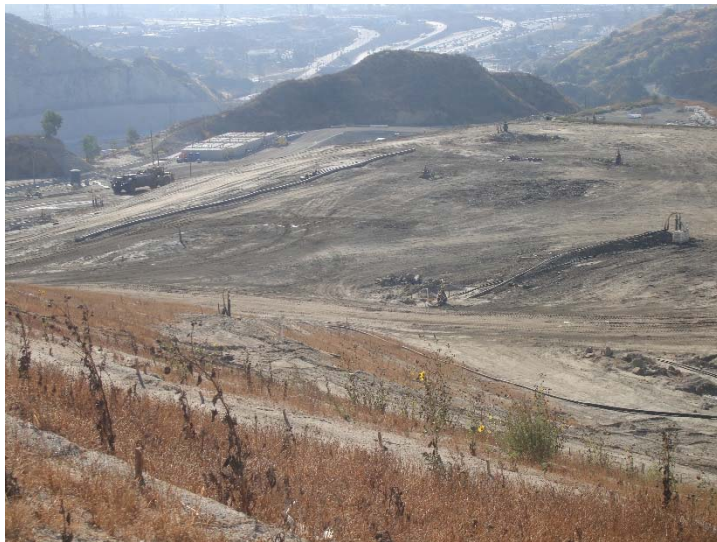
**Photo 223: CC3B Top Deck: August 29, 2018**

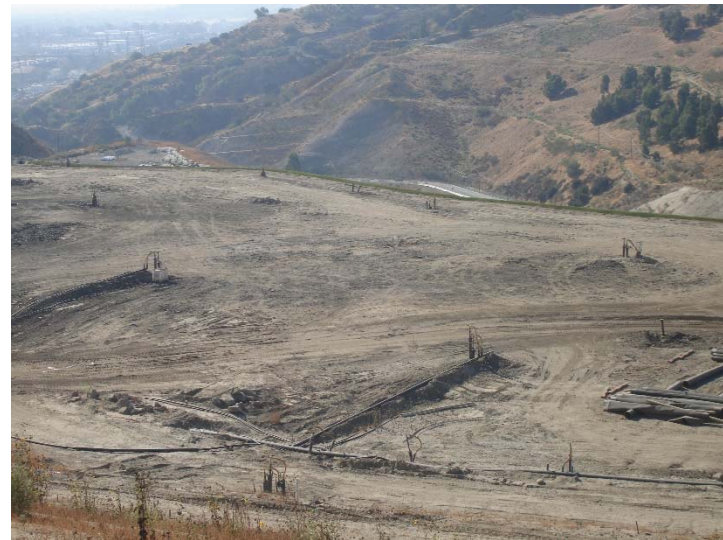
**Photo 224: CC3B Top Deck: August 29, 2018**

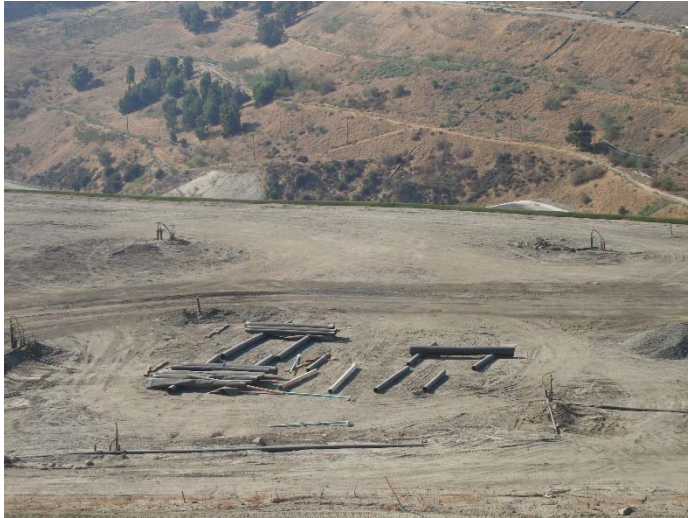
**Photo 225: CC3B Top Deck: August 29, 2018**

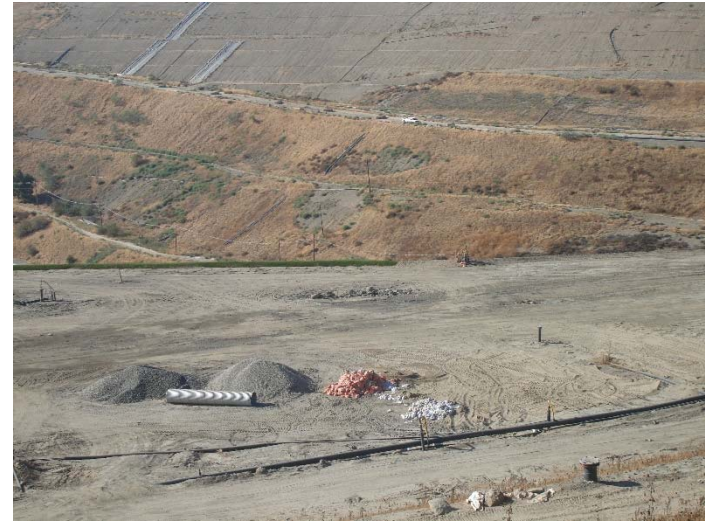
**Photo 226: CC3B Top Deck: August 29, 2018**

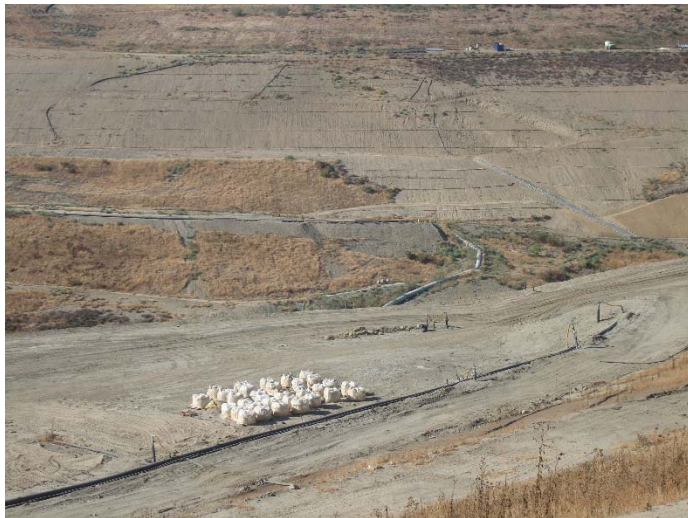
**Photo 227: CC3B Top Deck: August 29, 2018**

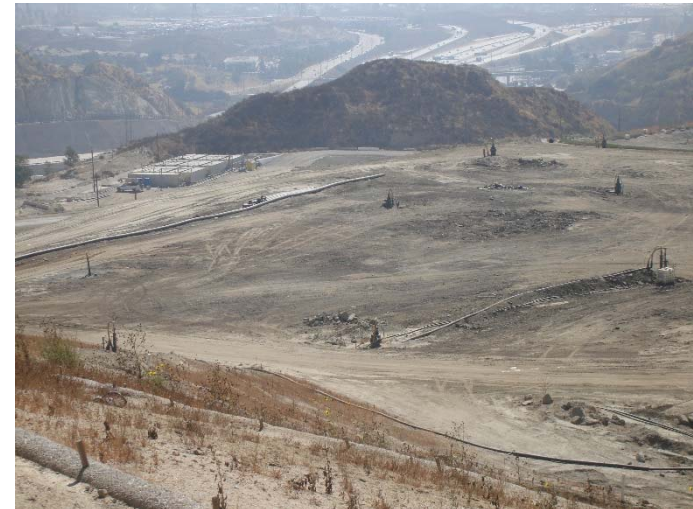
**Photo 228: CC3B Top Deck: September 12, 2018**

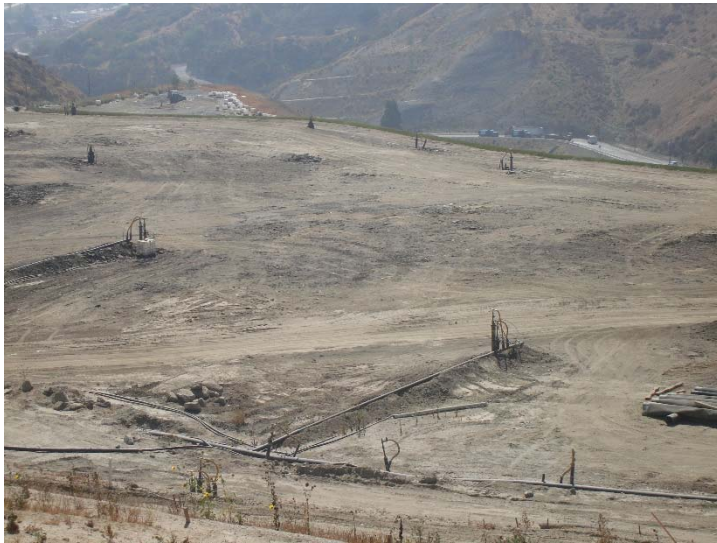
**Photo 229: CC3B Top Deck: September 12, 2018**

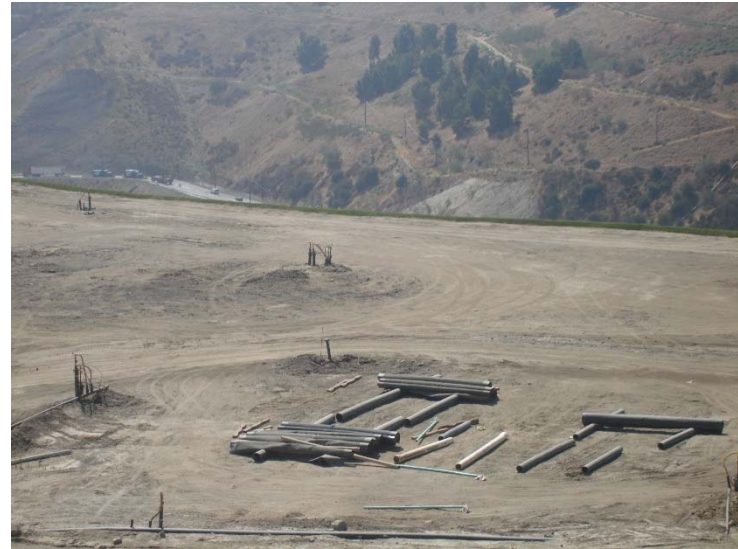
**Photo 230: CC3B Top Deck: September 12, 2018**

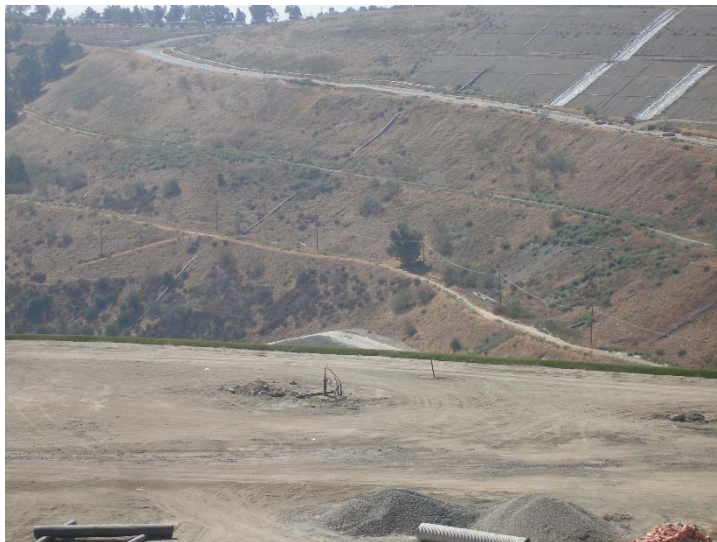
**Photo 231: CC3B Top Deck: September 12, 2018**

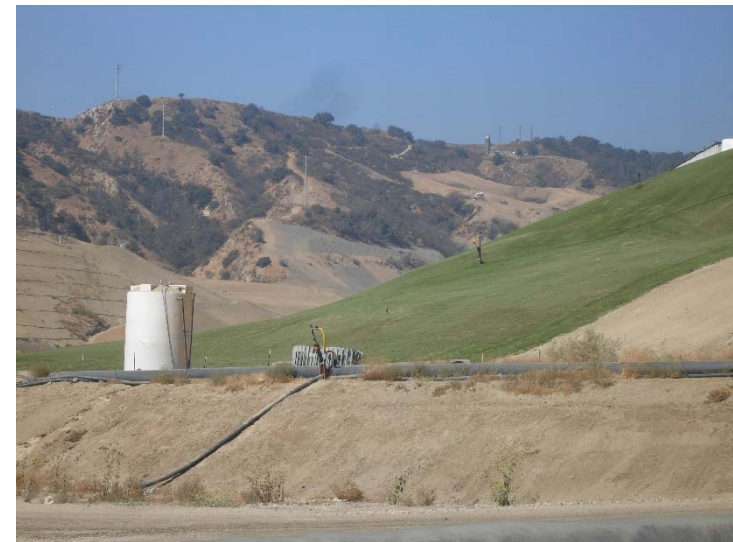
**Photo 232: CC3B South Slope: September 12, 2018**

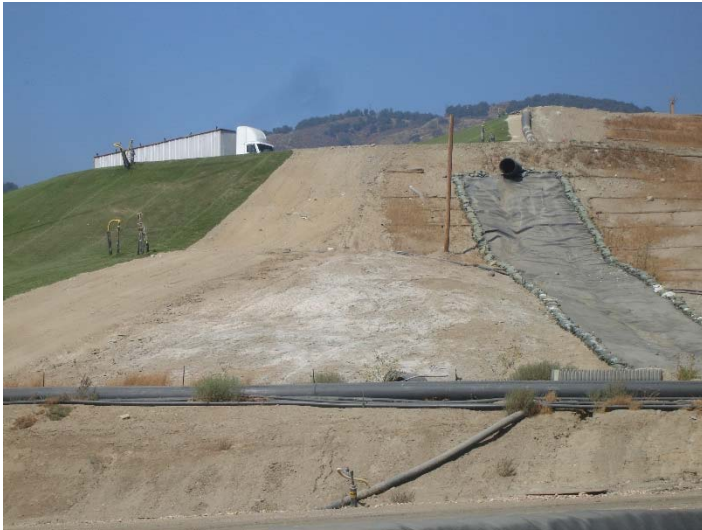
**Photo 233: CC3B South Slope: September 12, 2018**

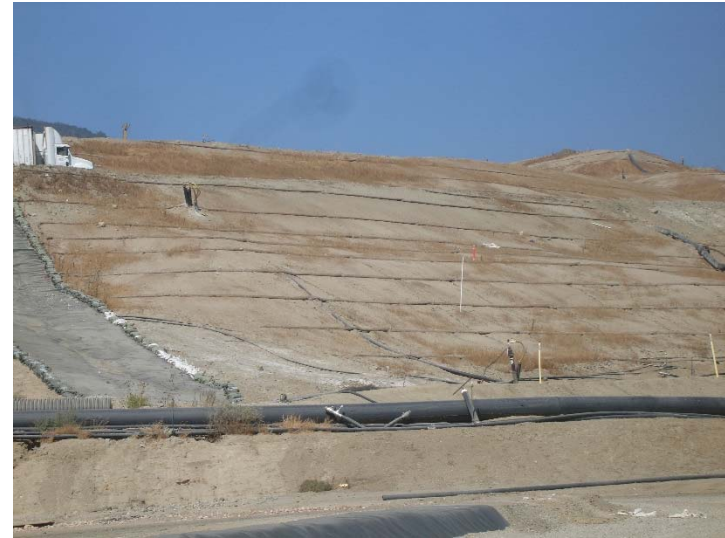
**Photo 234: CC3B South Slope: September 12, 2018**

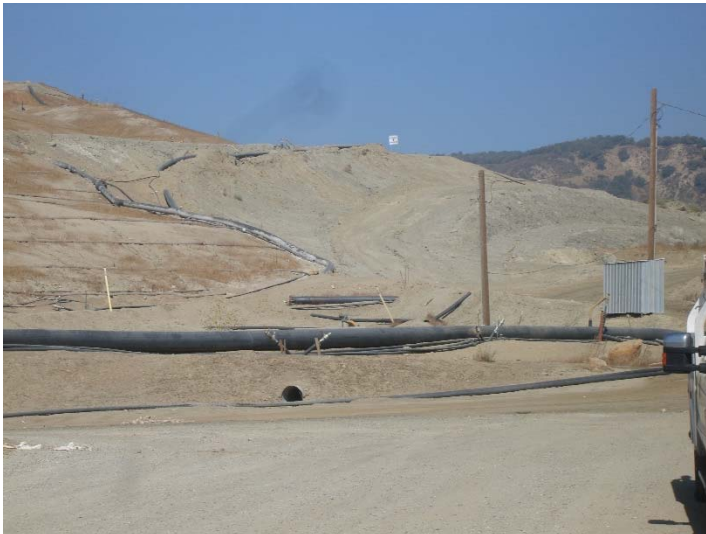
**Photo 235: CC3B South Slope: September 12, 2018**

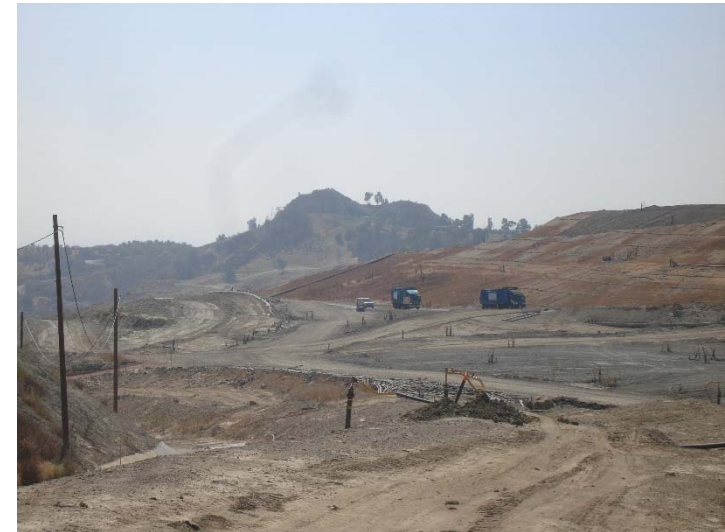
**Photo 236: CC3A CC3B Slope Revegetation: September 12, 2018**

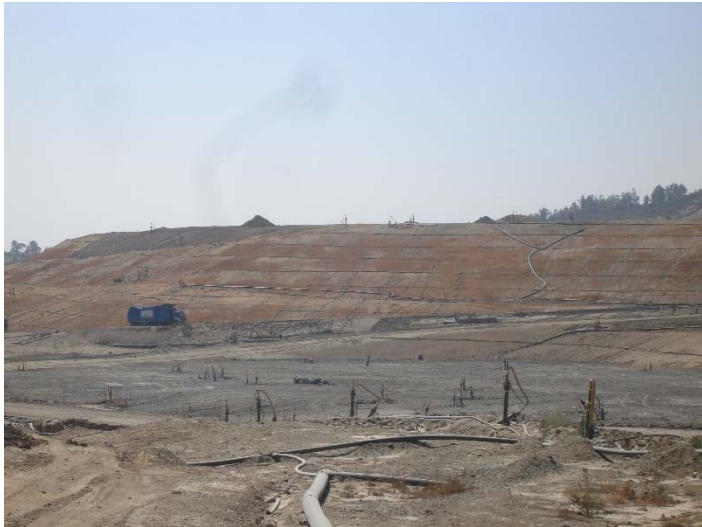
**Photo 237: CC3B Slope Revegetation: September 12, 2018**

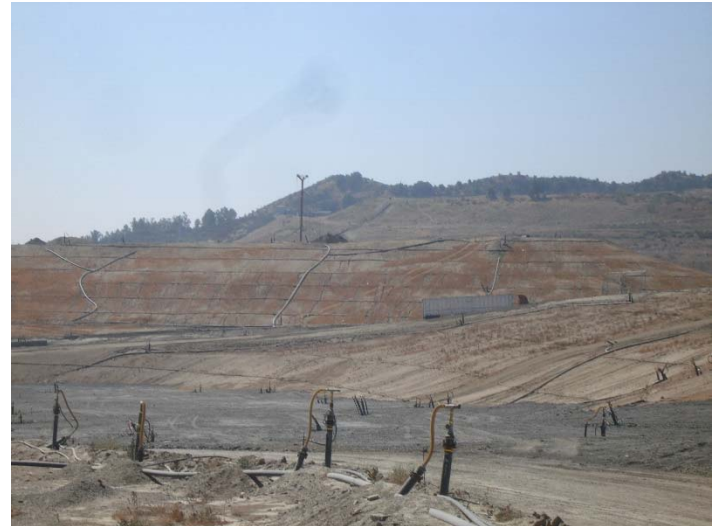
**Photo 238: CC3B Slope Revegetation: September 12, 2018**

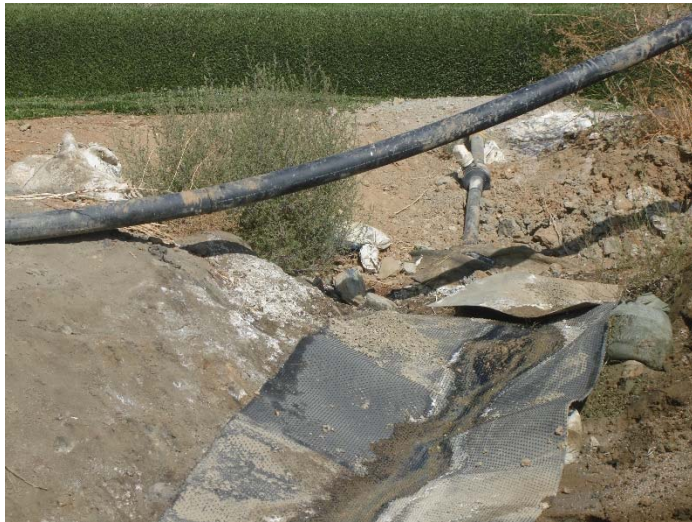
**Photo 239: CC3B Alluvial Slope Leak: September 12, 2018**

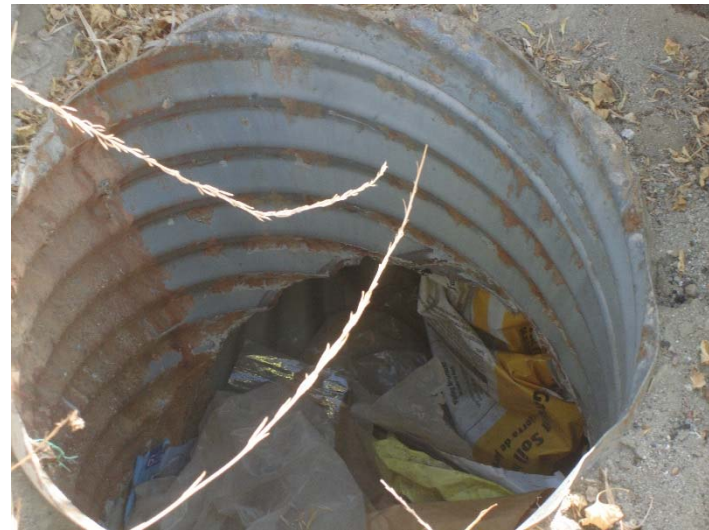
**Photo 243: CC3B Low Flow Drain: September 12, 2018**

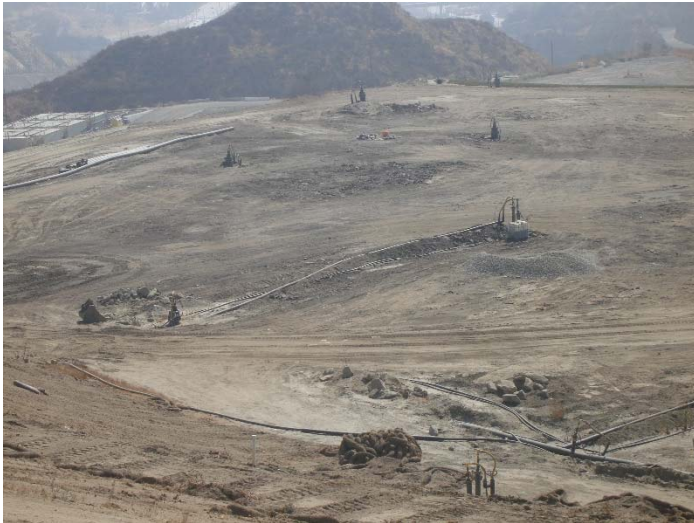
**Photo 244: CC3B Low Flow Drain: September 12, 2018**

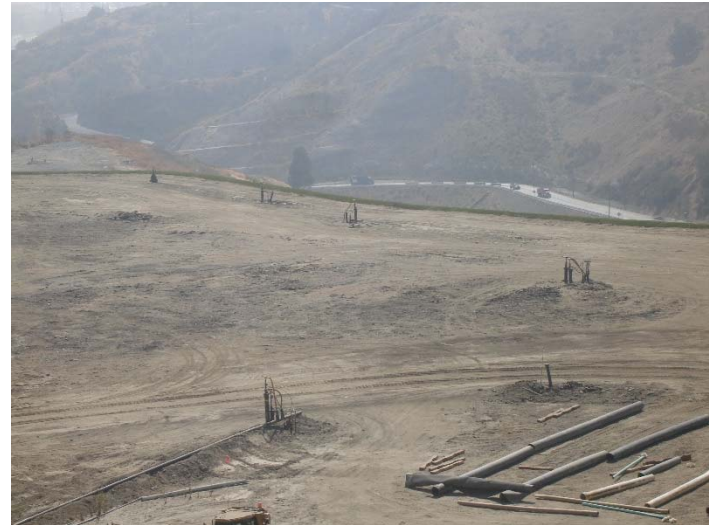
**Photo 245: CC3B Top Deck: September 25, 2018**

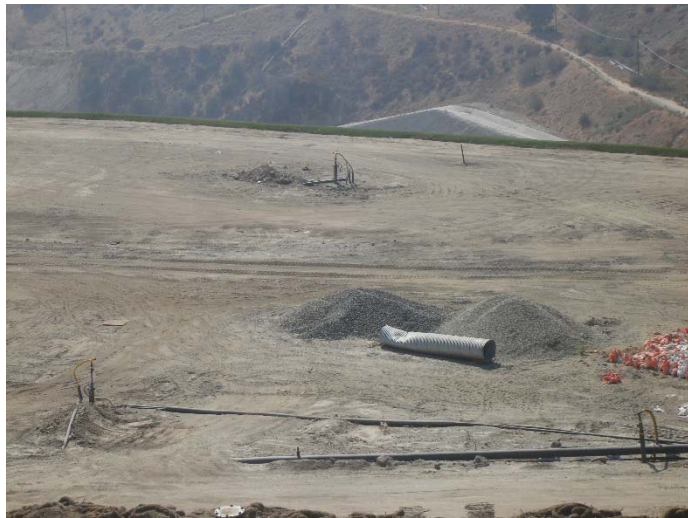
**Photo 246: CC3B Top Deck: September 25, 2018**

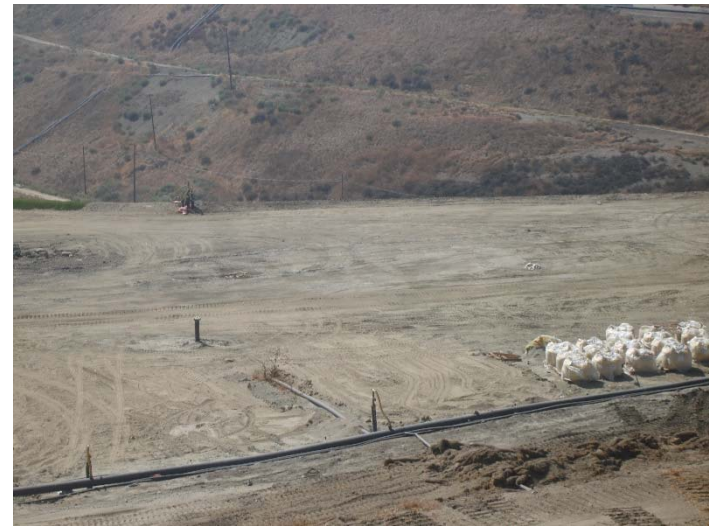
**Photo 247: CC3B Top Deck: September 25, 2018**

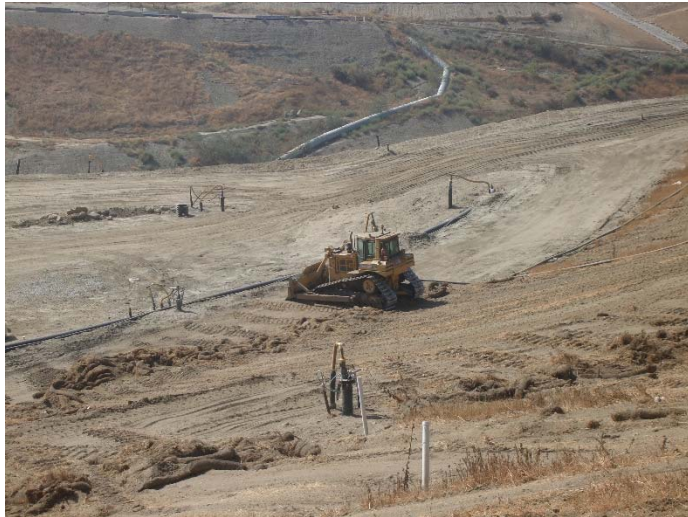
**Photo 248: CC3B Top Deck: September 25, 2018**

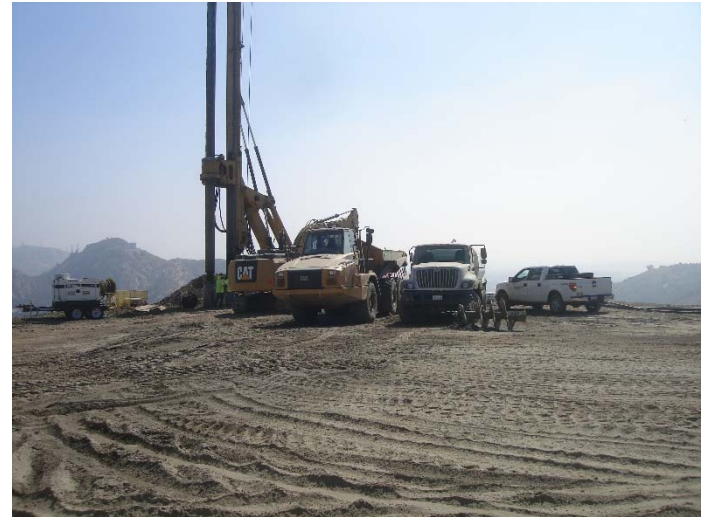
**Photo 249: CC3B Top Deck: September 25, 2018**

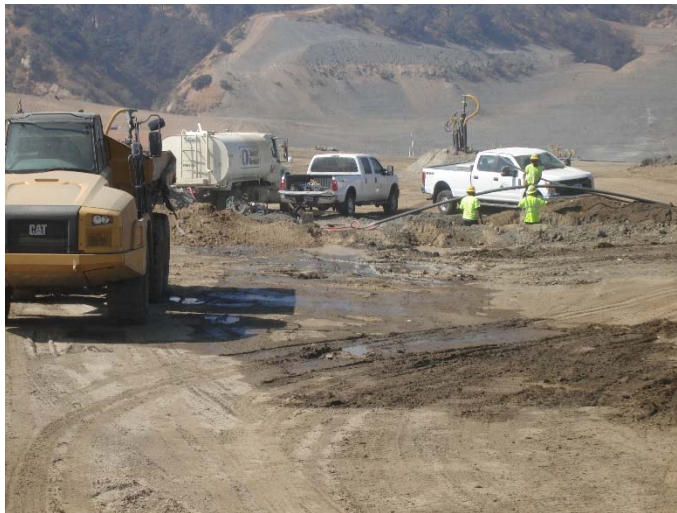
**Photo 250: CC3A Top Deck Drilling: September 25, 2018**

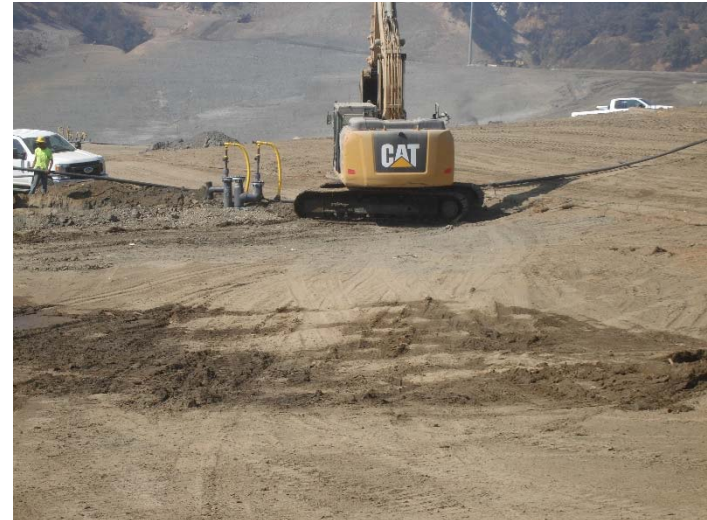
**Photo 251: CC3A Top Deck Liquids Recovery Pipe Installation:  
September 25, 2018**

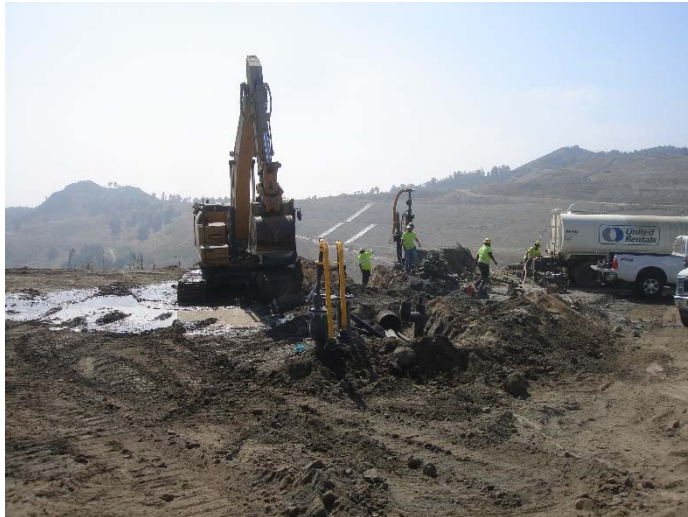
**Photo 252: CC3A Top Deck Liquids Recovery Pipe Installation:  
September 25, 2018**

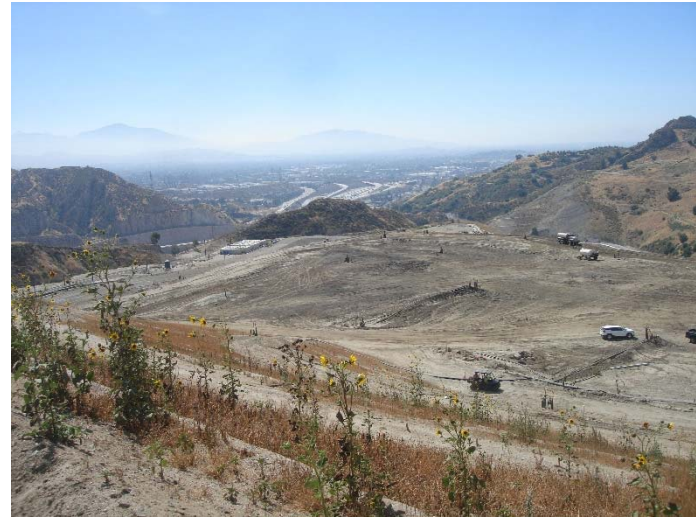
**Photo 253: CC3A Top Deck Liquids Recovery Pipe Installation: September 25, 2018**

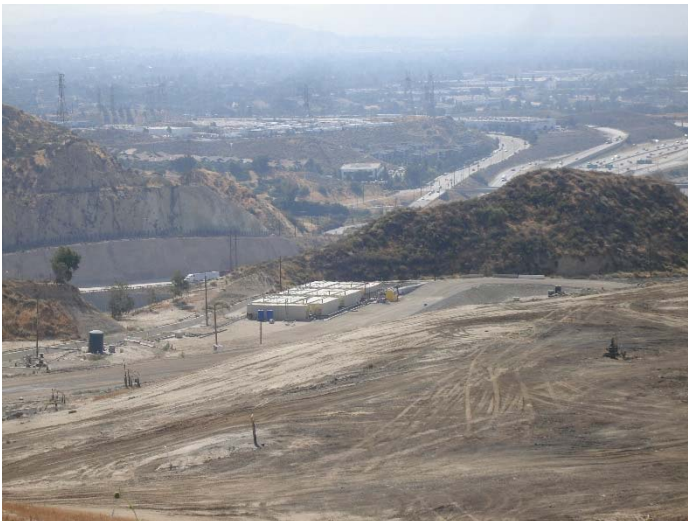
**Photo 254: Old City North Top Deck Liquids Handling Facility: July 5, 2018**

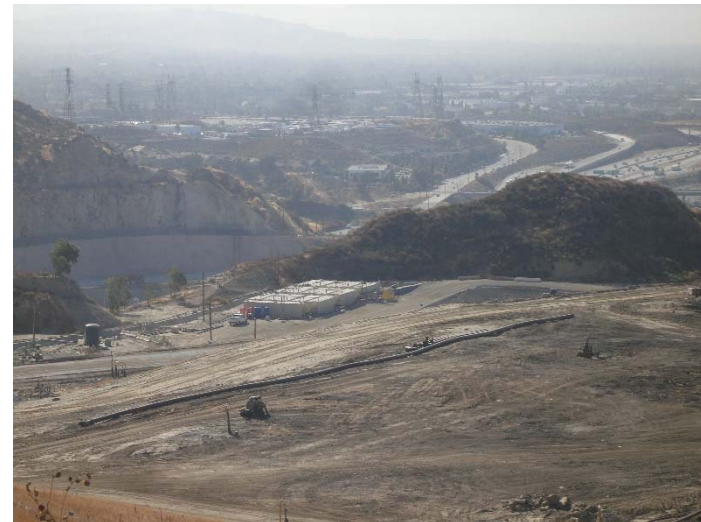
**Photo 255: Old City North Top Deck Liquids Handling Facility: July 5, 2018**

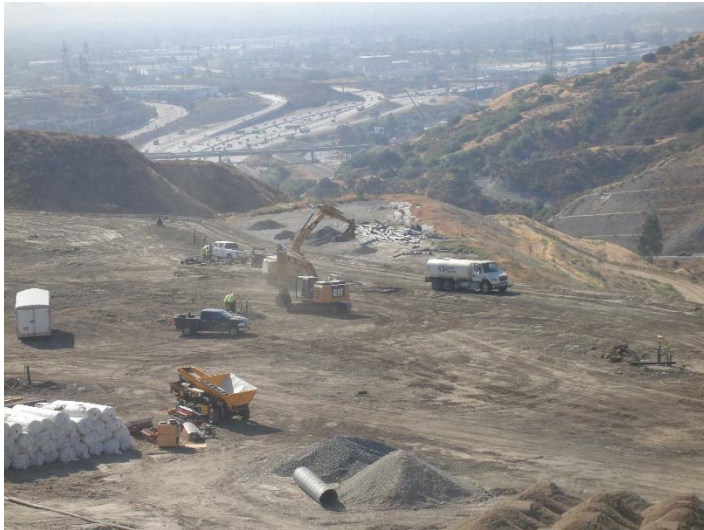
**Photo 256: Old City North Top Deck Liquids Handling Facility: July 24, 2018**

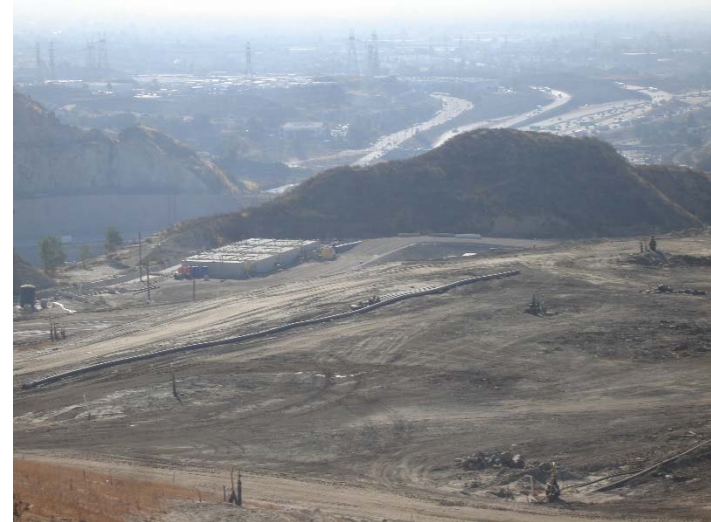
**Photo 257: Old City North Top Deck: July 24, 2018**

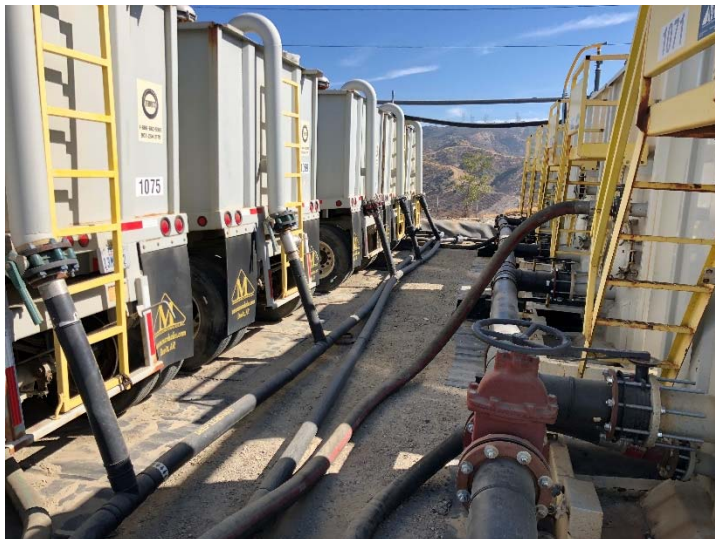
**Photo 258: Old City North Top Deck Liquids Handling Facility:  
August 29, 2018**

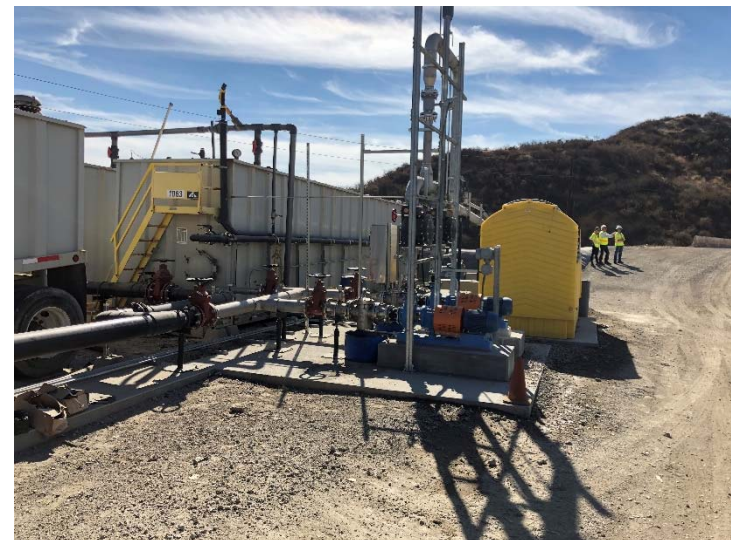
**Photo 259: Liquids Handling Facility: August 29, 2018**

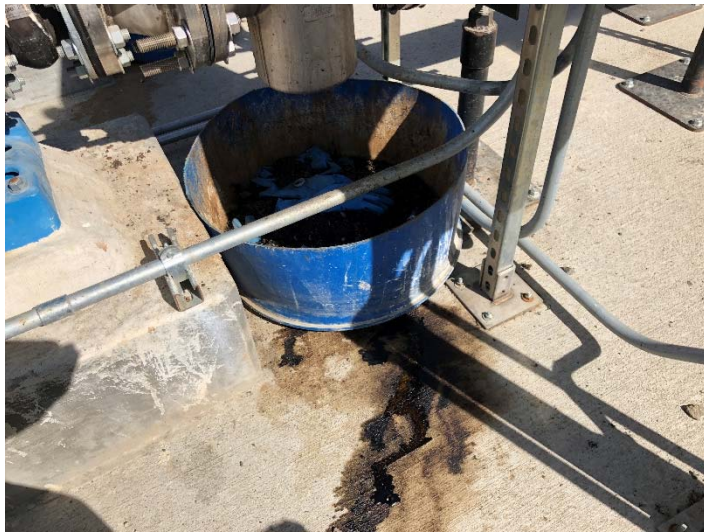
**Photo 260: Liquids Handling Facility: August 29, 2018**

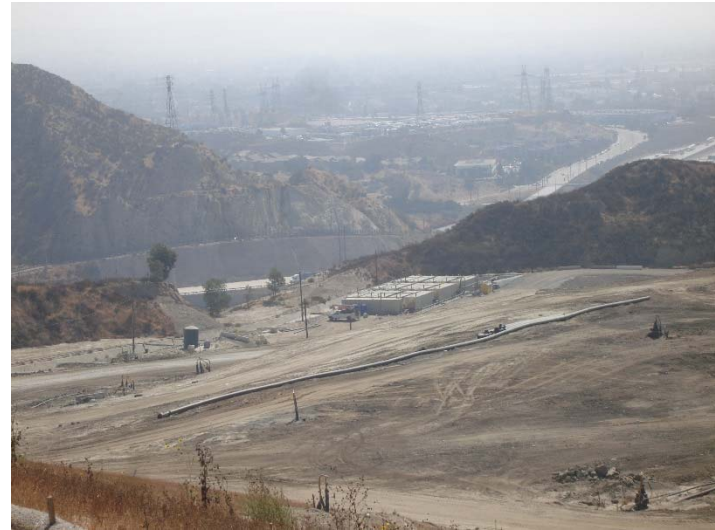
**Photo 261: Liquids Handling Facility: August 29, 2018**

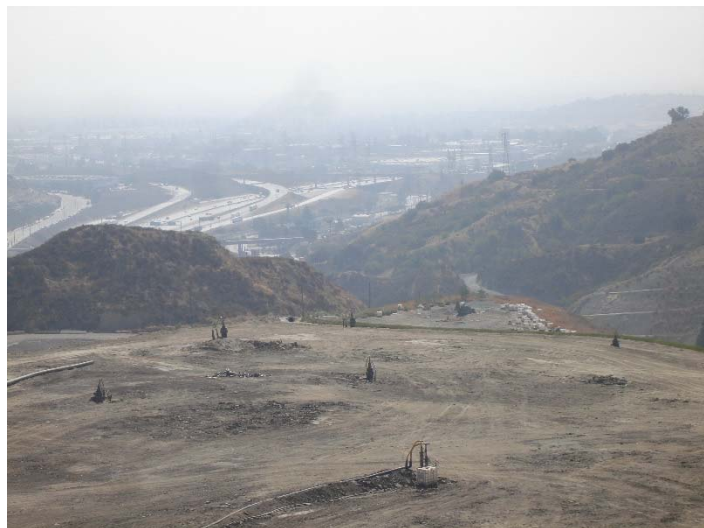
**Photo 262: Old City North Top Deck Liquids Handling Facility:  
September 12, 2018**

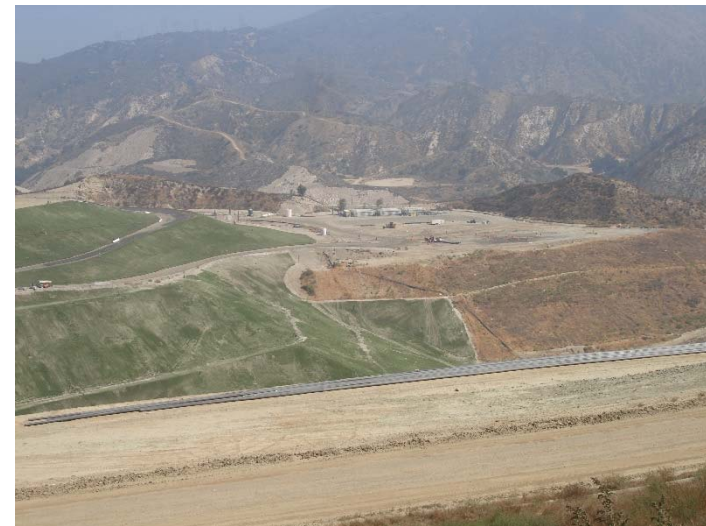
**Photo 263: Old City North Top Deck Liquids Handling Facility:  
September 12, 2018**

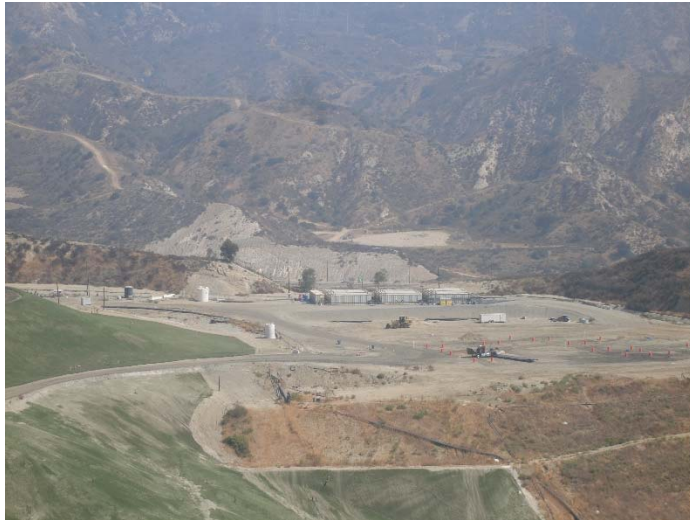
**Photo 264: Old City North Top Deck Liquids Handling Facility:  
September 25, 2018**

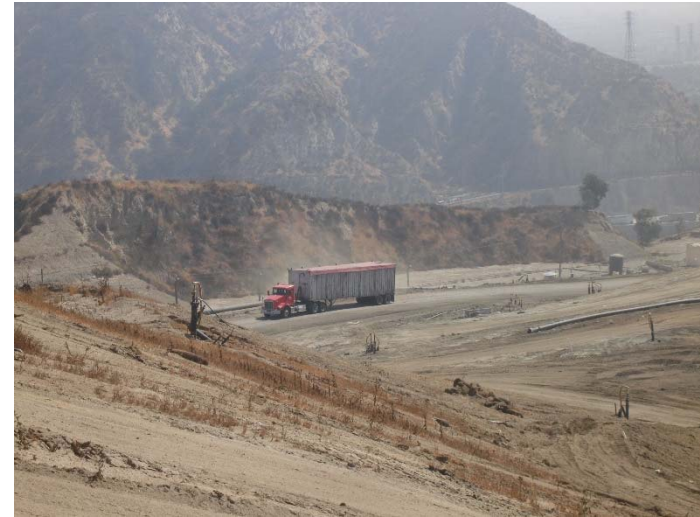
**Photo 265: Old City North Top Deck Liquids Handling Facility:  
September 25, 2018**

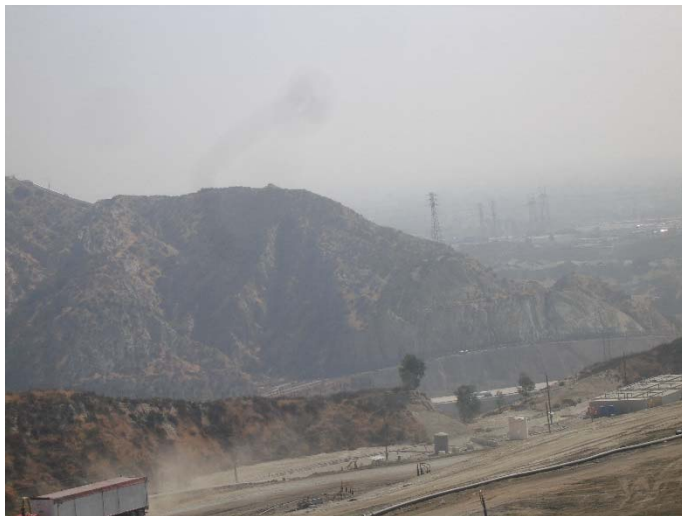
**Photo 266: Old City North Top Deck: September 25, 2018**

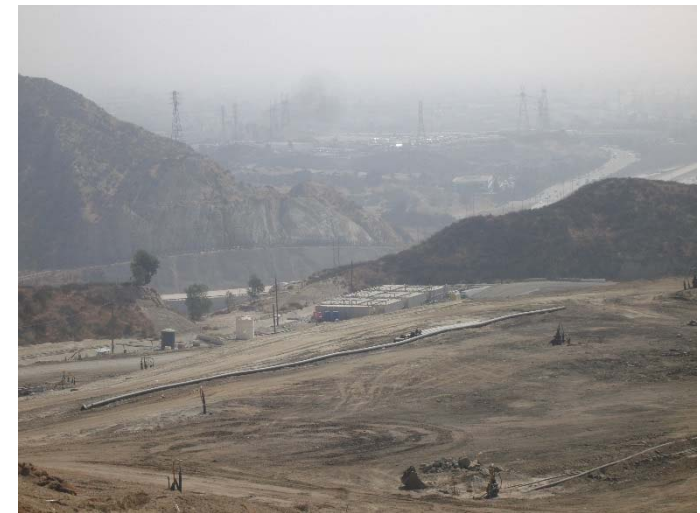
**Photo 267: Old City North Top Deck: September 25, 2018**

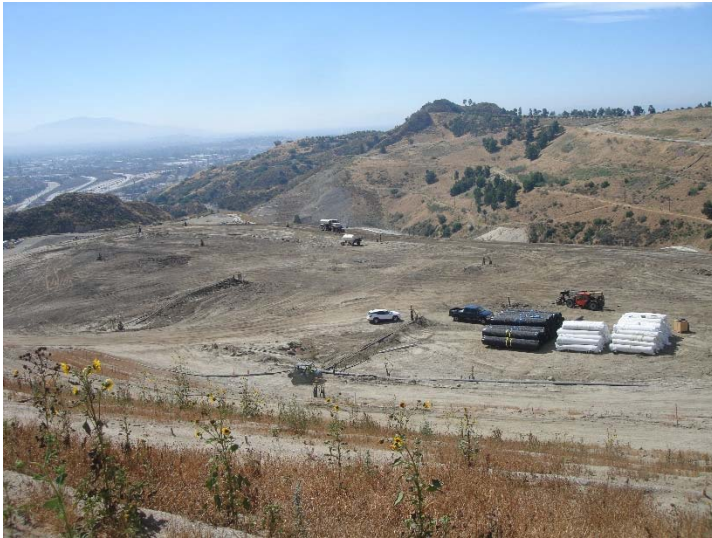
**Photo 268: Old City North Top Deck Liquids Handling Facility:  
September 25, 2018**

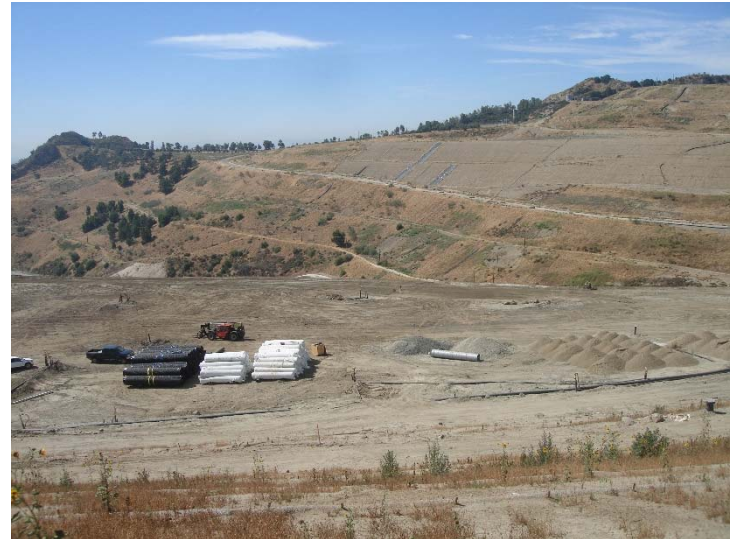
**Photo 269: Old City South Slopes: July 5, 2018**

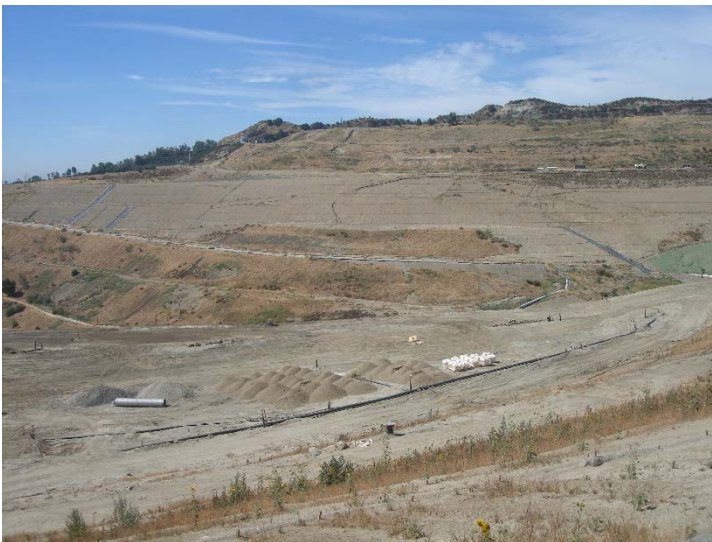
**Photo 270: Old City South Slopes: July 5, 2018**

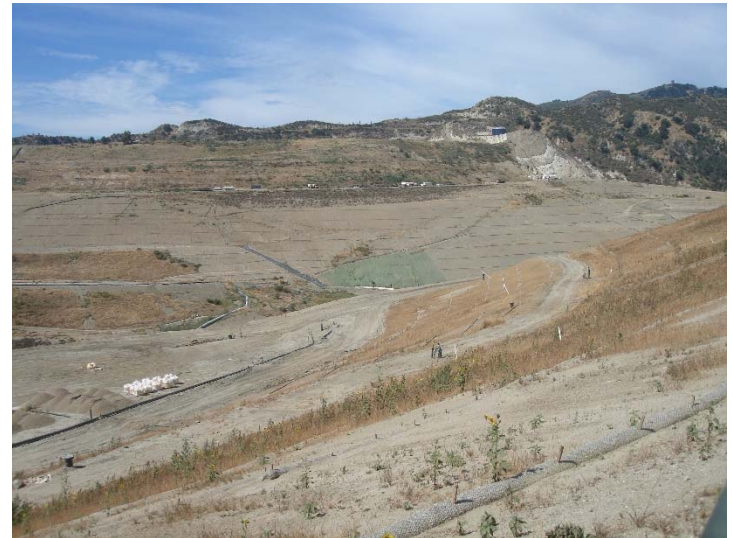
**Photo 271: Old City South Slopes: July 5, 2018**

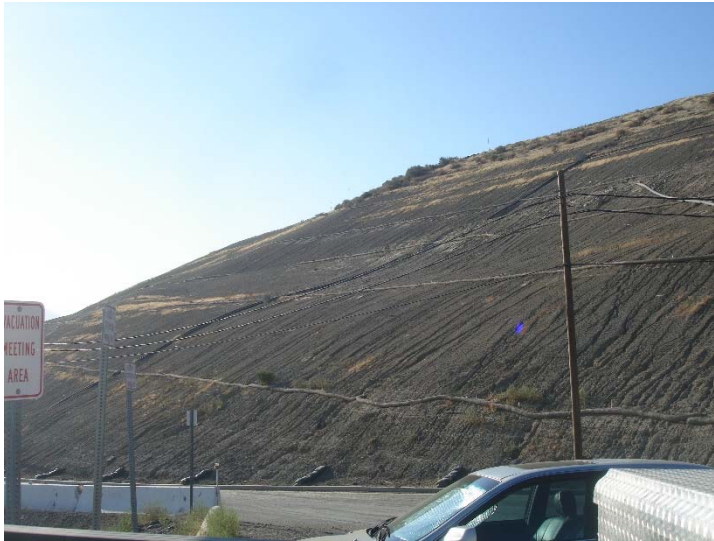
**Photo 272: Old City South Slopes: July 5, 2018**

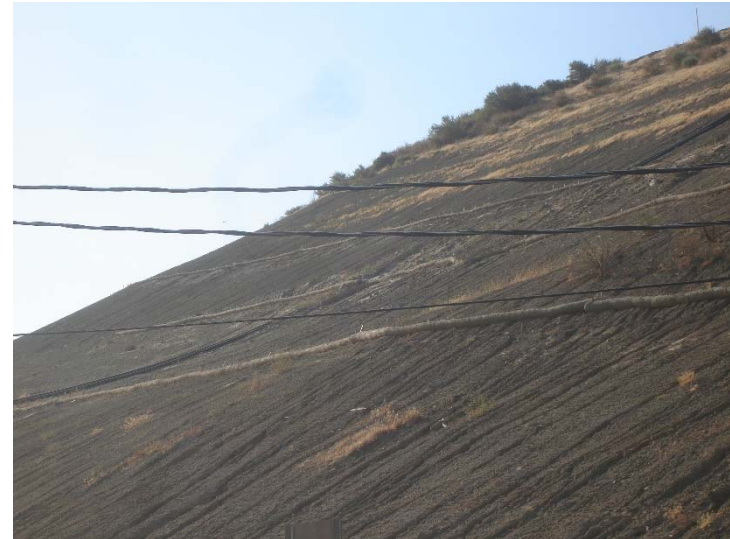
**Photo 273: Old City South Soil Stockpile: July 24, 2018**

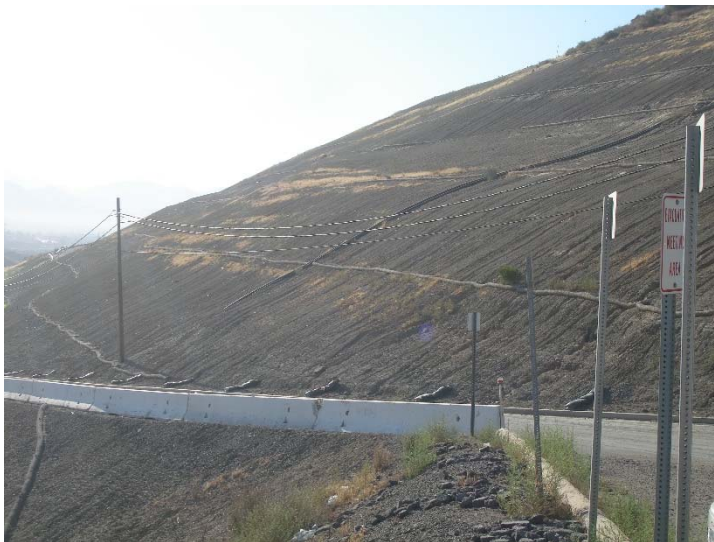
**Photo 274: Old City South Soil Stockpile: July 24, 2018**
