**Sunshine Canyon Landfill  
Independent Monitor  
Quarterly Site Monitoring Status Report  
July 1, 2018 – September 30, 2018**

**City of Los Angeles Department of City Planning**

**County of Los Angeles Department of Regional Planning**

November 5, 2018

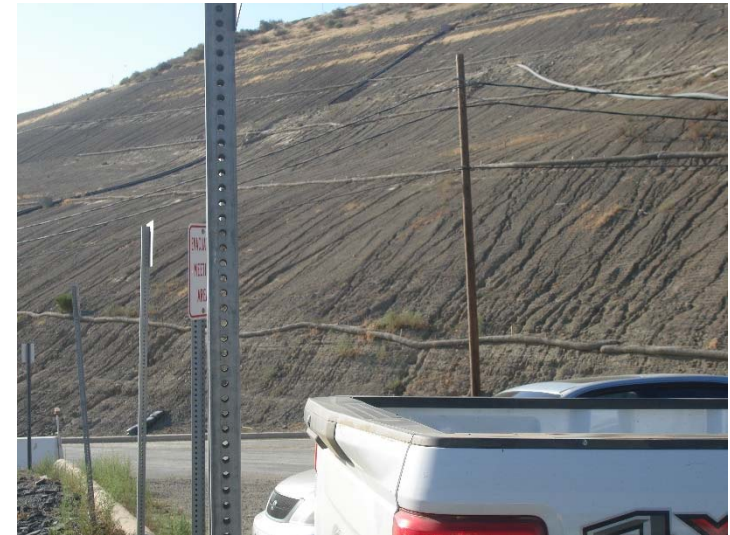
**Photo 275: Old City South Soil Stockpile: July 24, 2018**

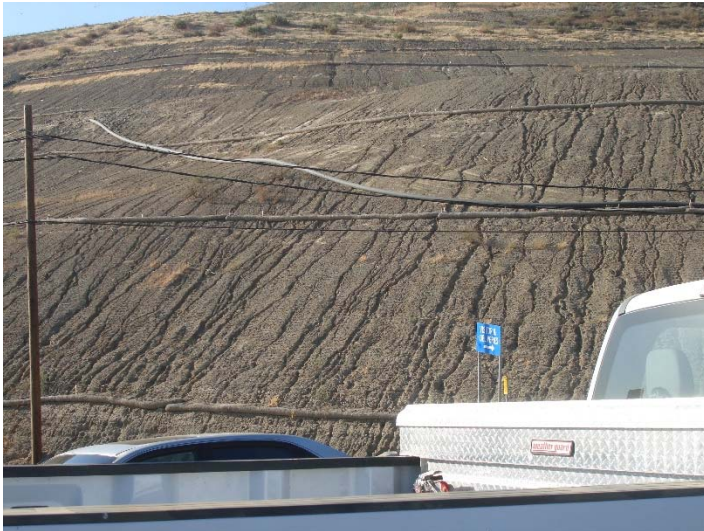
**Photo 276: Old City South Soil Stockpile: July 24, 2018**

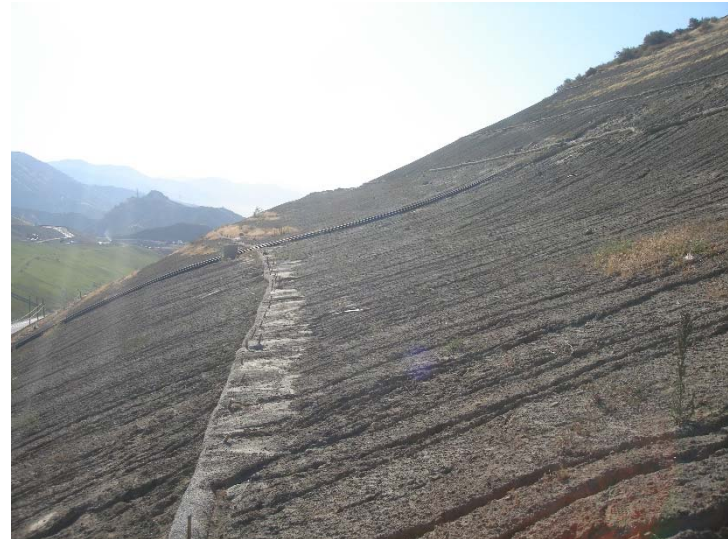
**Photo 277: Old City South Soil Stockpile: July 24, 2018**

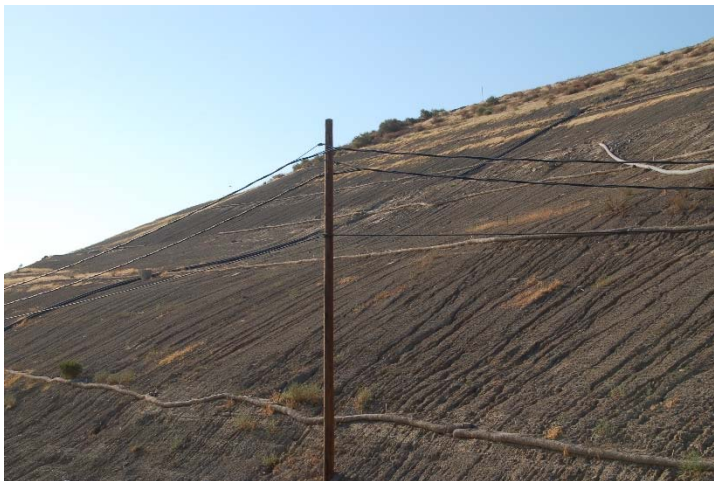
**Photo 278: Old City South Soil Stockpile: July 24, 2018**

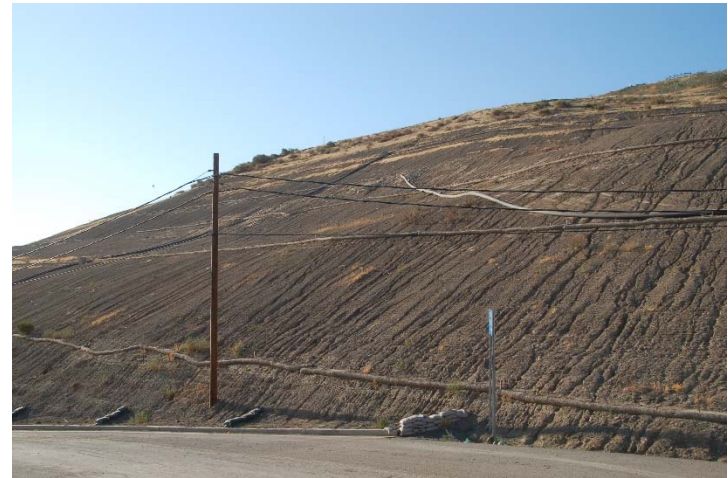
**Photo 279: Old City South Soil Stockpile: July 24, 2018**

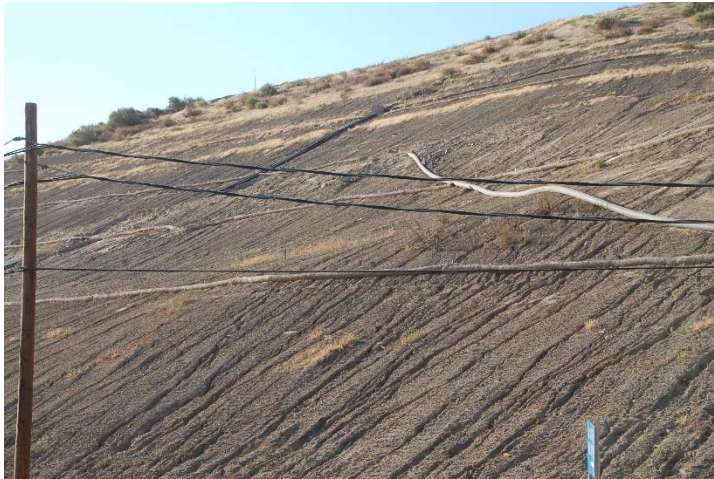
**Photo 280: Old City South Soil Stockpile: July 24, 2018**

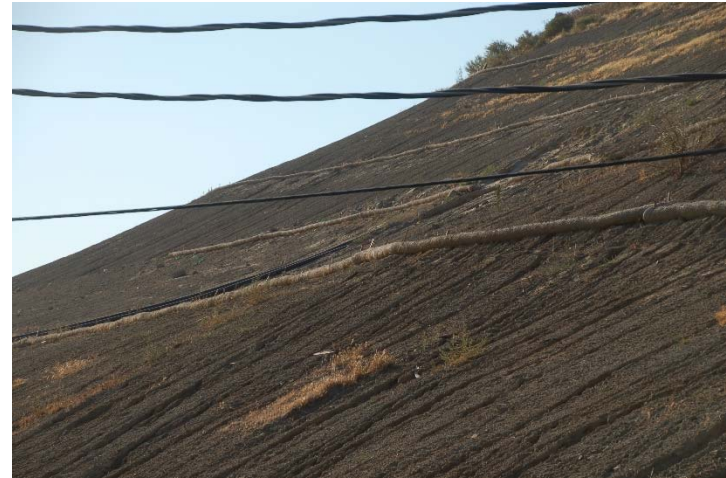
**Photo 281: Old City South Soil Stockpile: July 24, 2018**

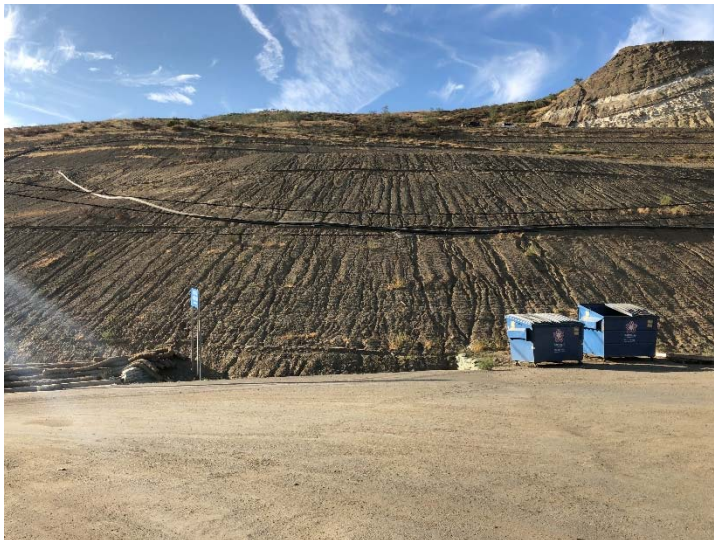
**Photo 282: Old City South Soil Stockpile: July 24, 2018**

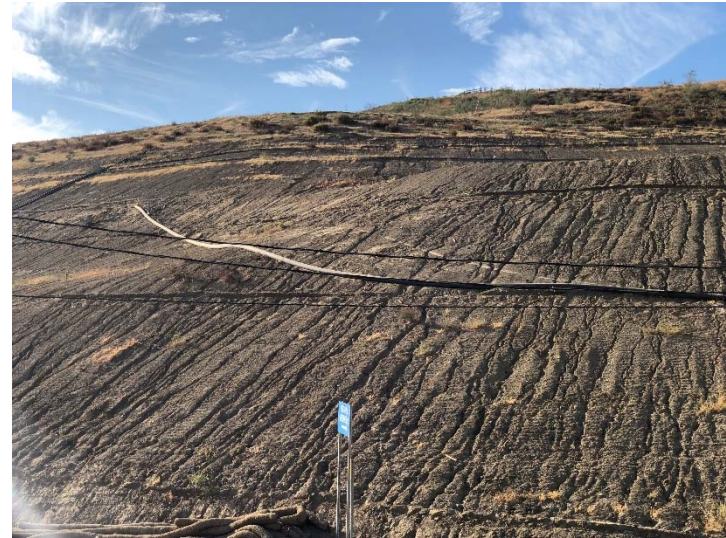
**Photo 283: Old City South Stockpile: August 29, 2018**

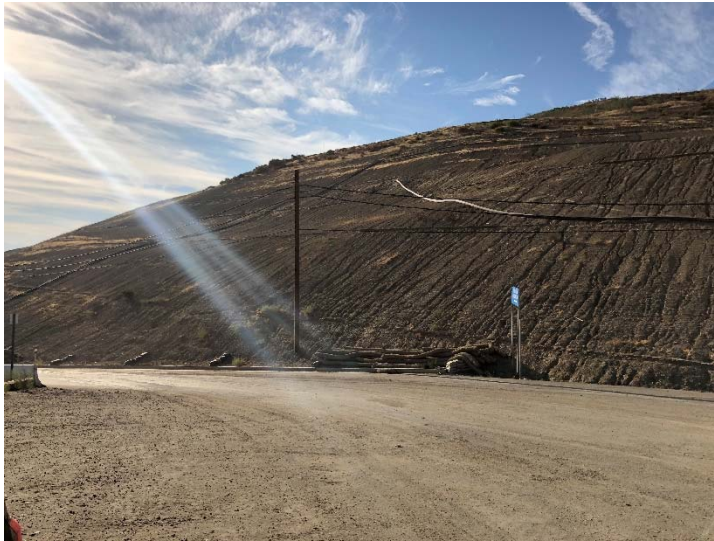
**Photo 284: Old City South Stockpile: August 29, 2018**

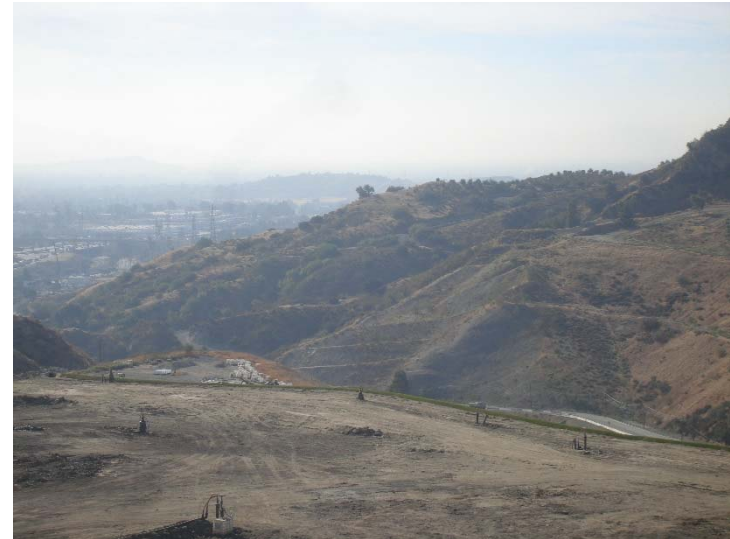
**Photo 285: Old City South Stockpile: August 29, 2018**

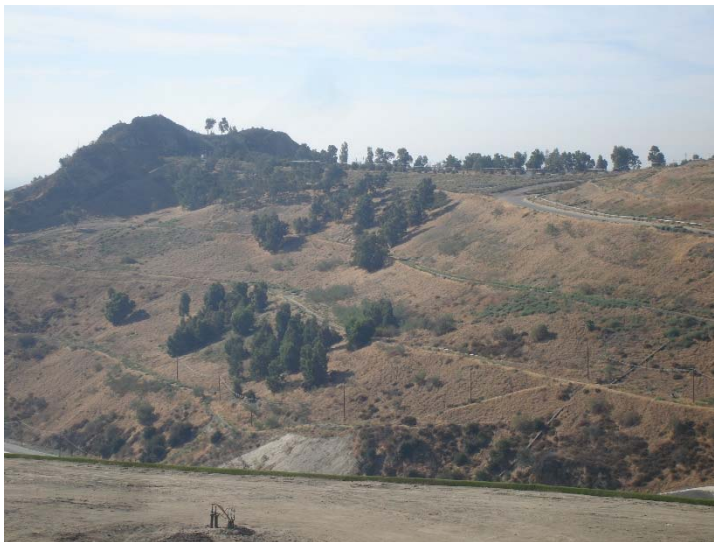
**Photo 286: Old City South Slopes: August 29, 2018**

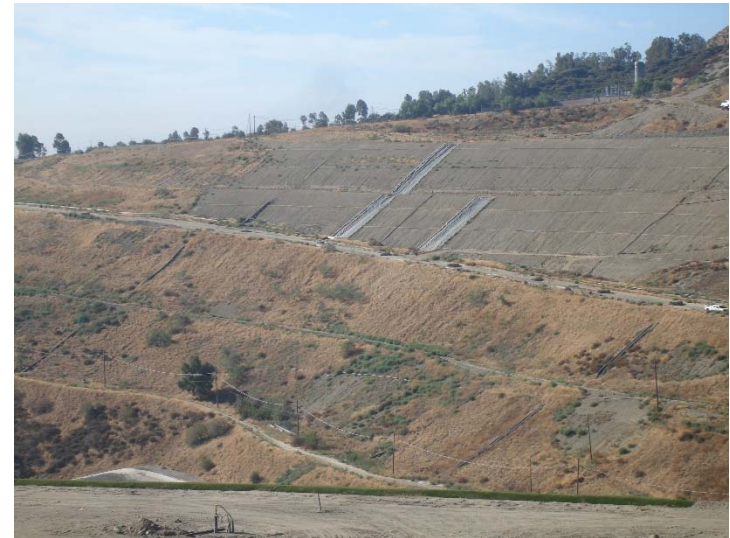
**Photo 287: Old City South Slopes: August 29, 2018**

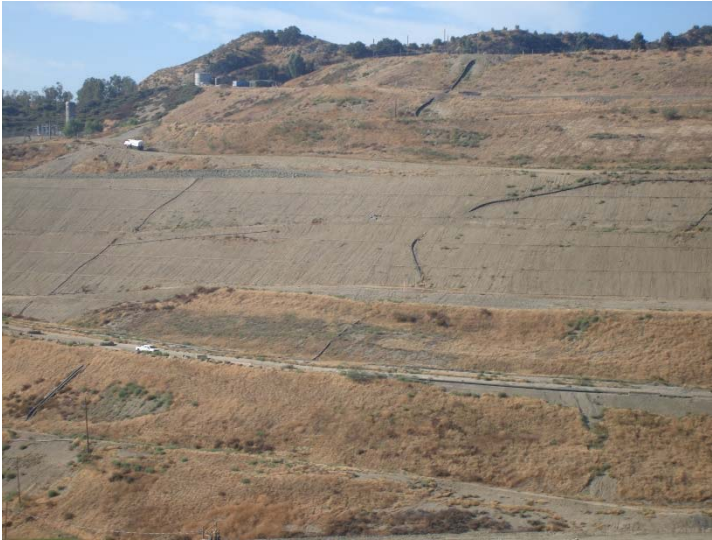
**Photo 288: Old City South Slopes: August 29, 2018**

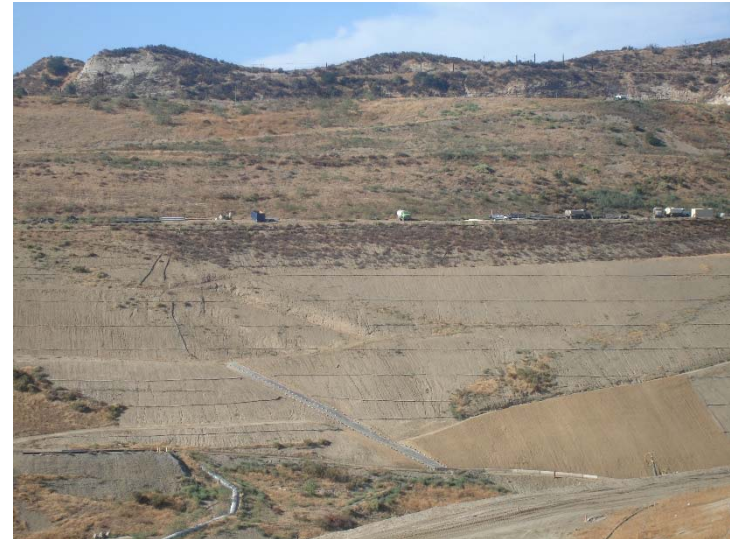
**Photo 289: Old City South Slopes: August 29, 2018**

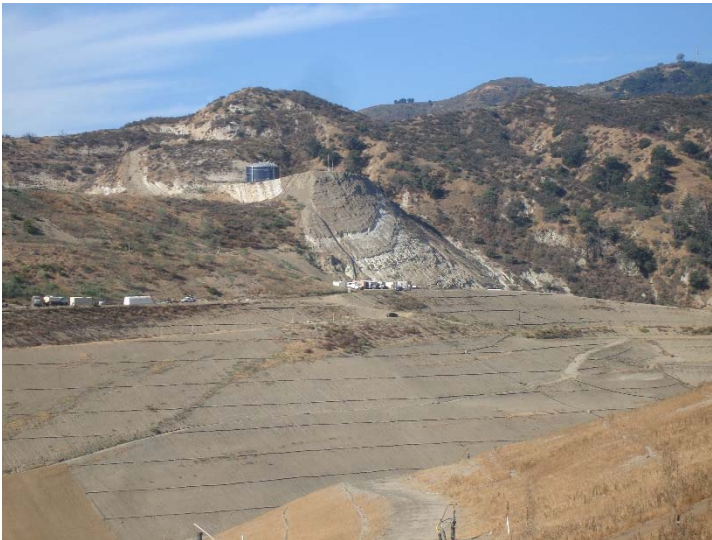
**Photo 290: Old City South Slopes: August 29, 2018**

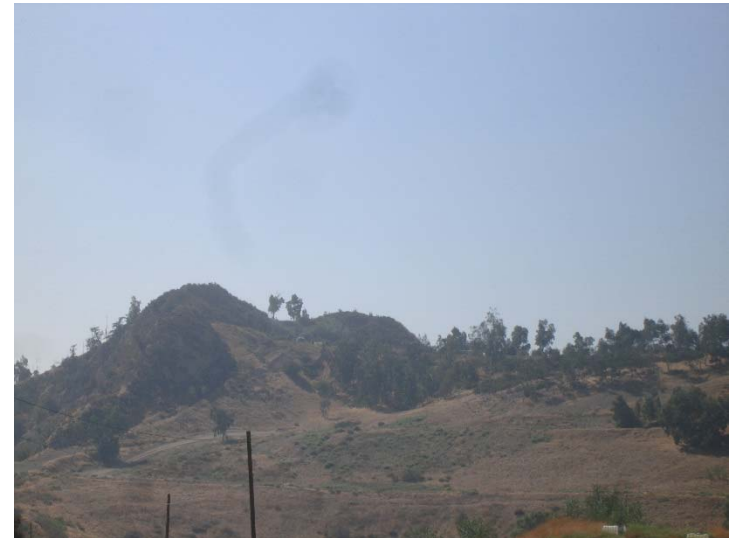
**Photo 291: Old City South Slopes: August 29, 2018**

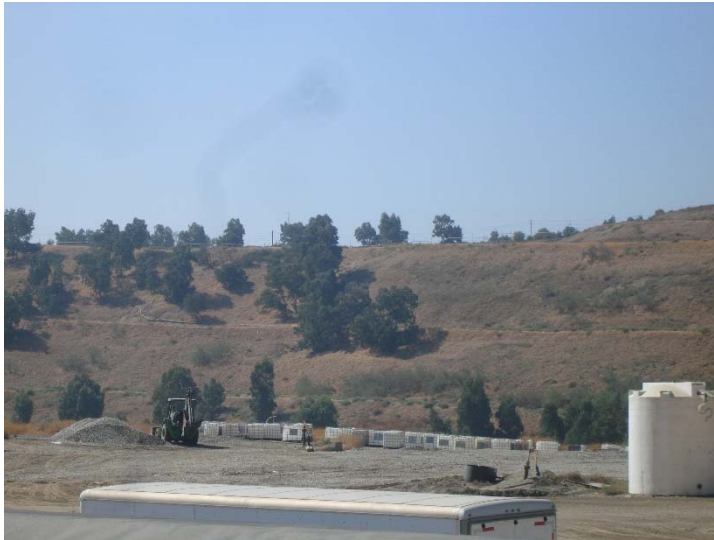
**Photo 292: Old City South Slope: September 12, 2018**

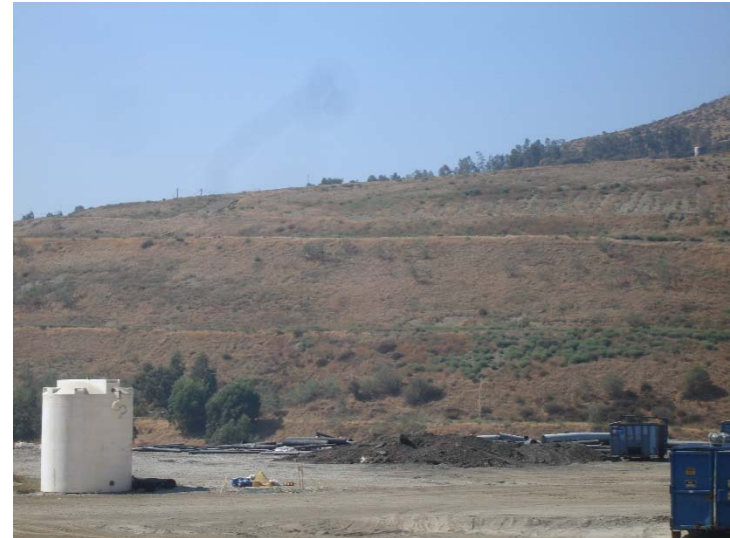
**Photo 293: Old City South Slope: September 12, 2018**

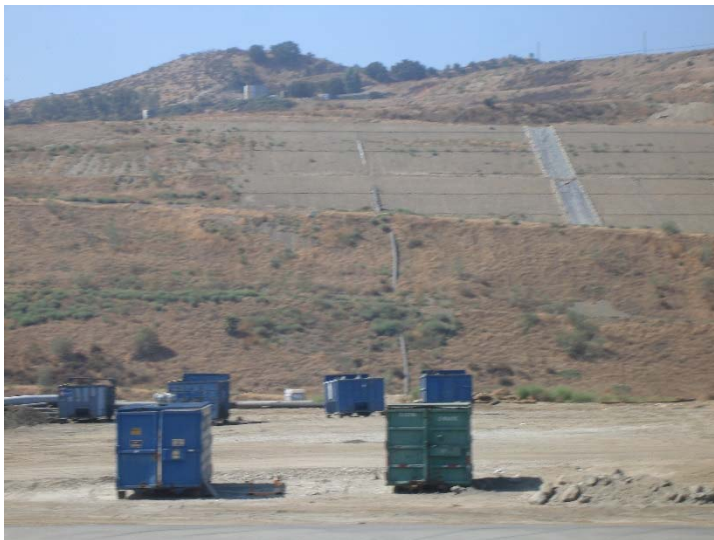
**Photo 294: Old City South Slope: September 12, 2018**

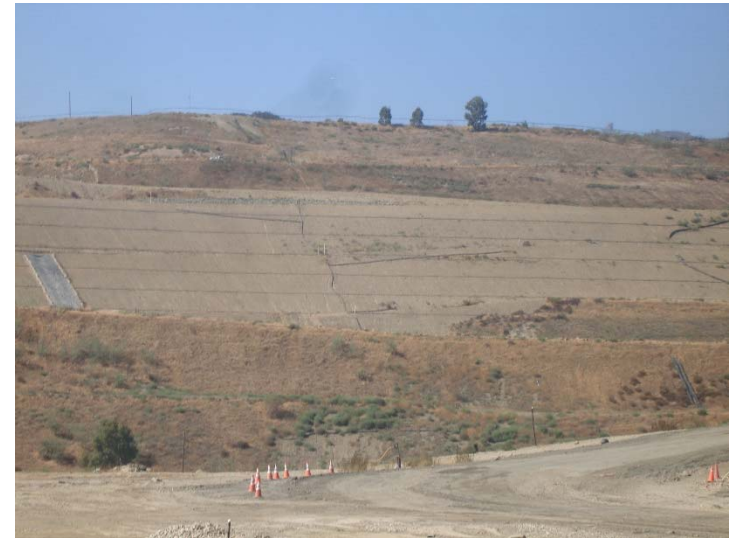
**Photo 295: Old City South Slope: September 12, 2018**

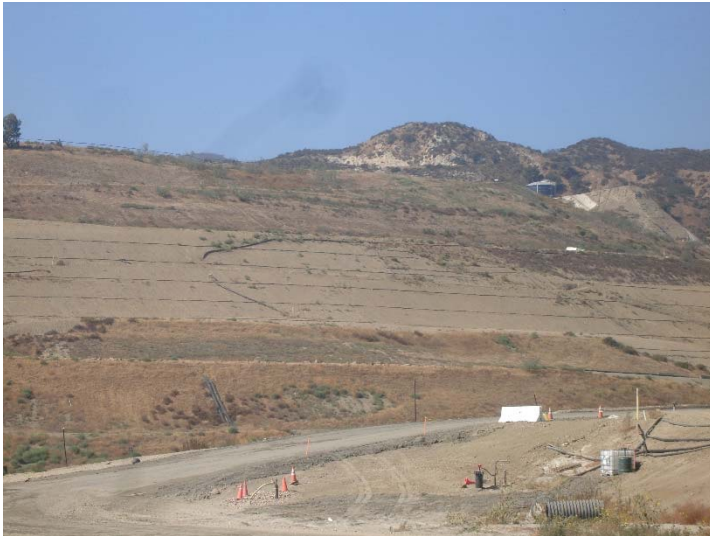
**Photo 296: Old City South Slope: September 12, 2018**

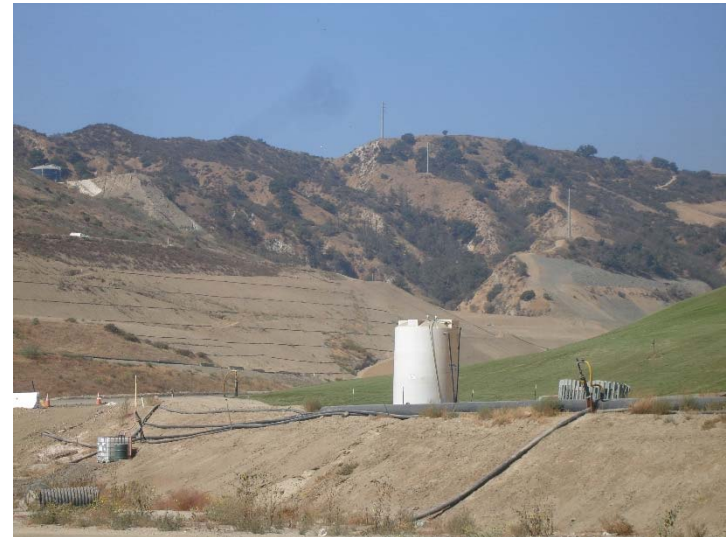
**Photo 297: Old City South Slope: September 12, 2018**

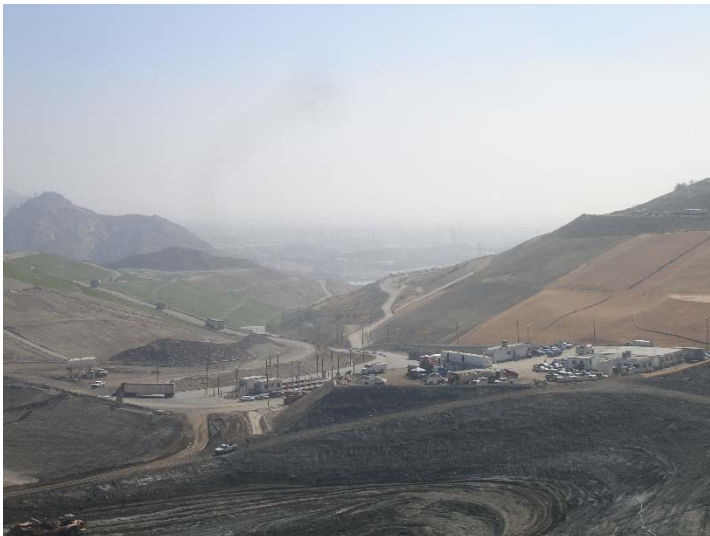
**Photo 298: Old City South Slope: September 12, 2018**

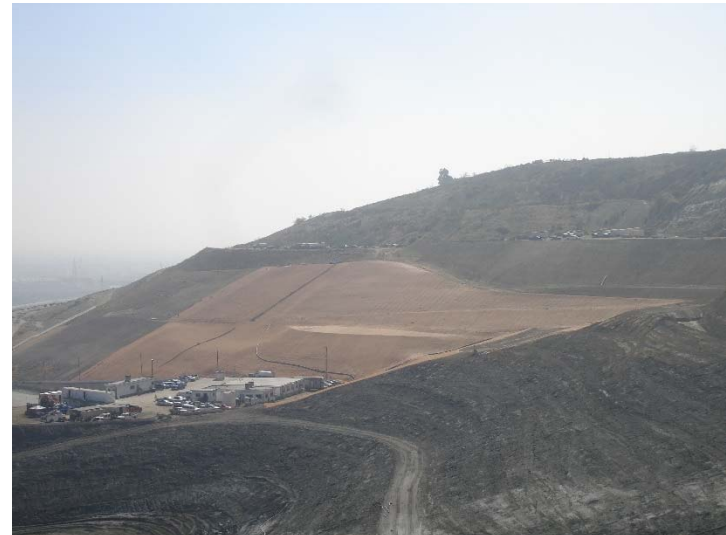
**Photo 299: Old City South Stockpile Slopes South of Office:  
September 25, 2018**

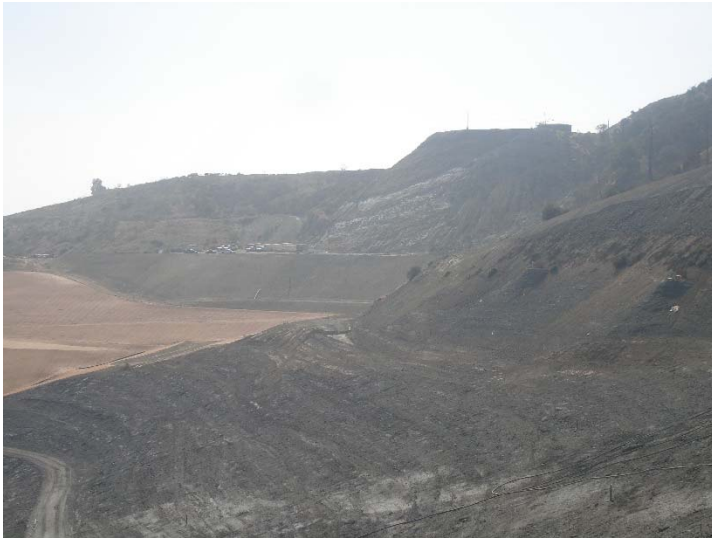
**Photo 300: Old City South Stockpile Slopes South of Office:  
September 25, 2018**

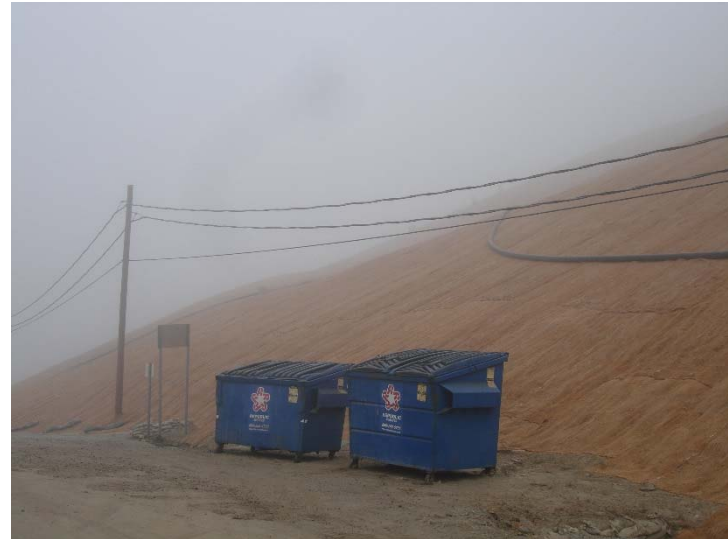
**Photo 301: Old City South Stockpile Slopes South of Office:  
September 25, 2018**

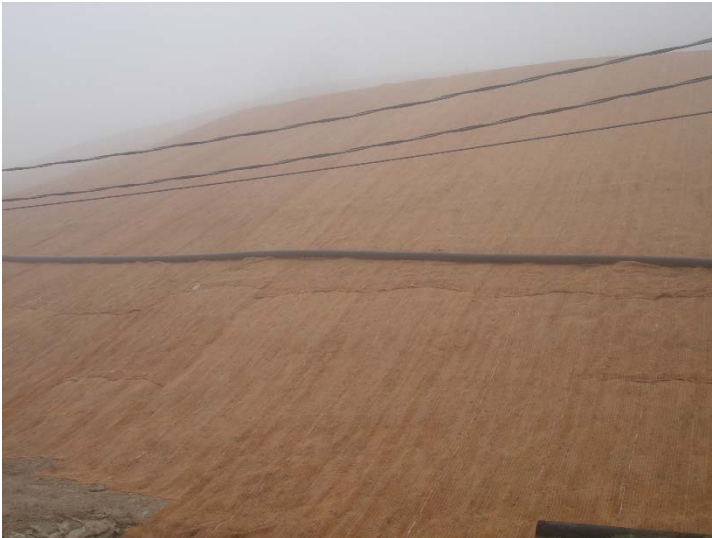
**Photo 302: Old City South Stockpile Slopes South of Office:  
September 25, 2018**

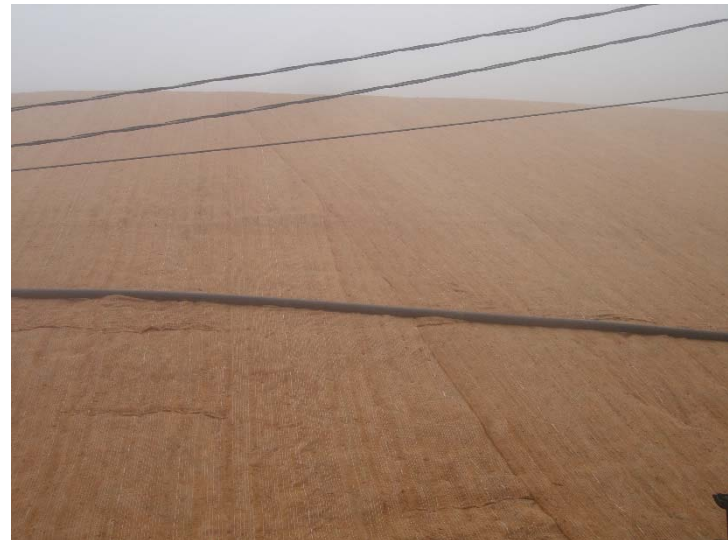
**Photo 303: Old City South Stockpile Slopes South of Office:  
September 25, 2018**

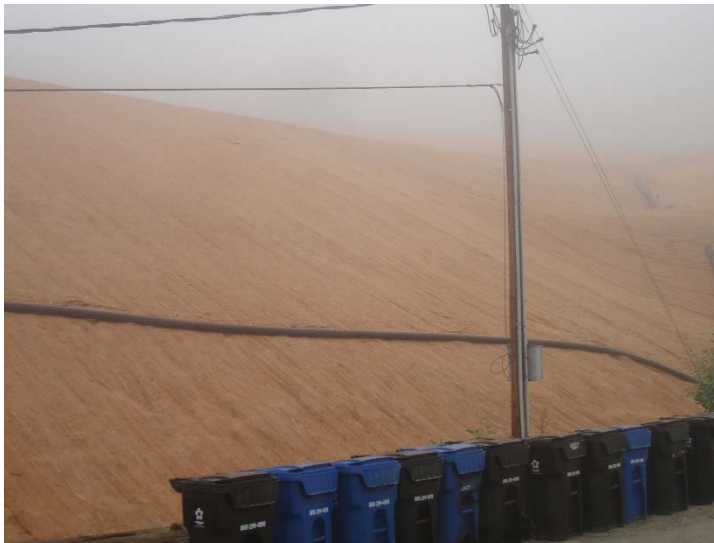
**Photo 304: Old City South Stockpile Slopes South of Office:  
September 25, 2018**

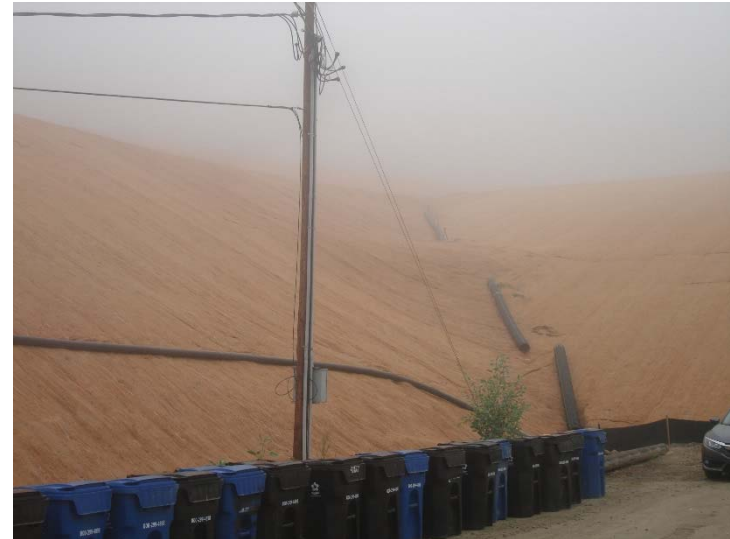
**Photo 305: Old City South Stockpile Slopes South of Office:  
September 25, 2018**

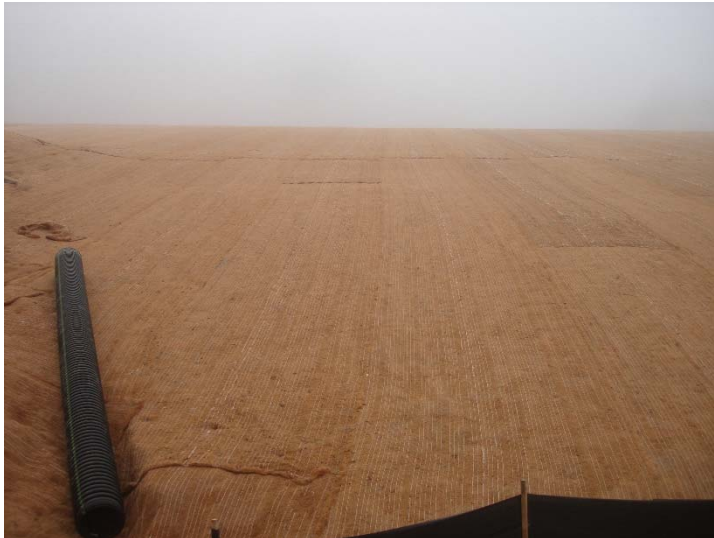
**Photo 306: Old City South Stockpile Slopes South of Office:  
September 25, 2018**

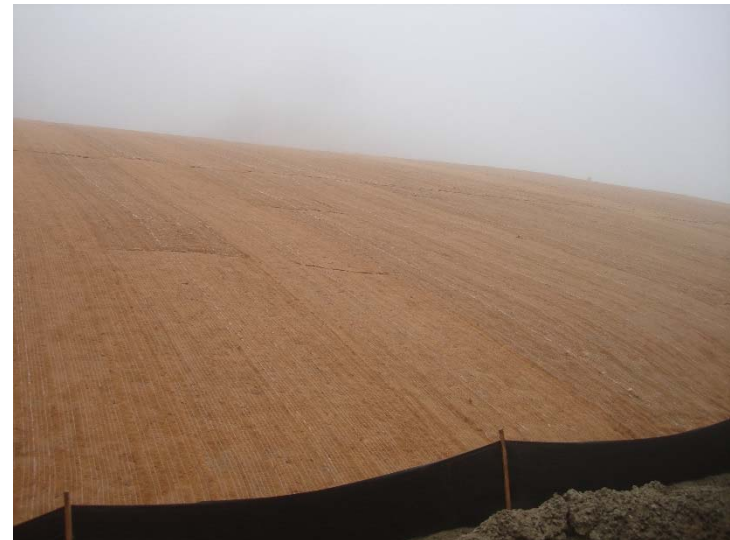
**Photo 307: Old City South Stockpile Slopes South of Office:  
September 25, 2018**

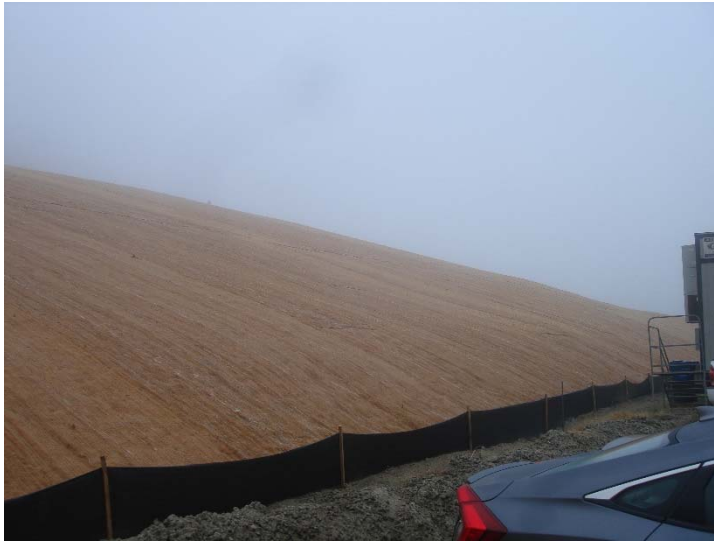
**Photo 308: Old City South Stockpile Slopes South of Office:  
September 25, 2018**

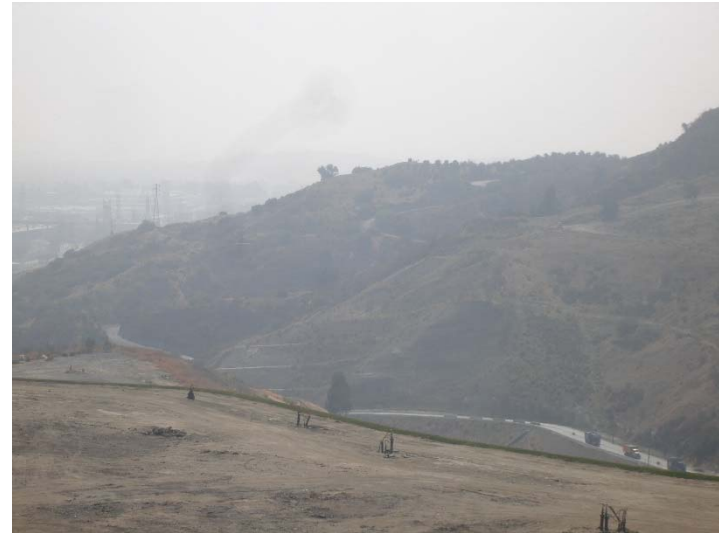
**Photo 309: Old City South Stockpile Slopes South of Office:  
September 25, 2018**

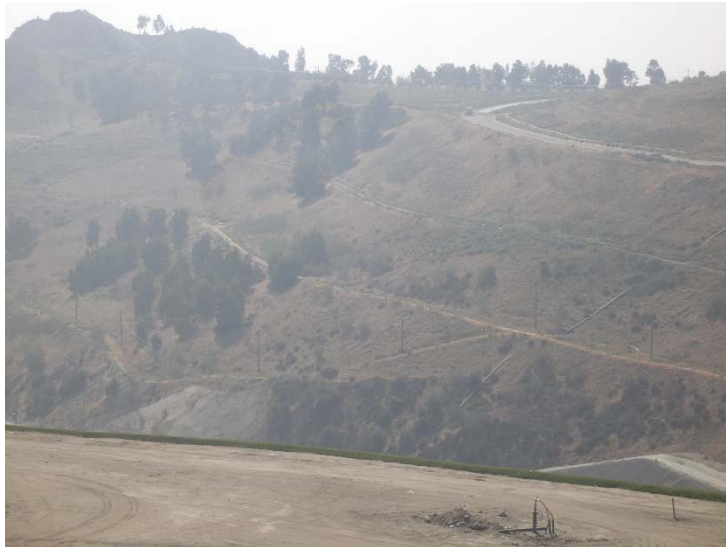
**Photo 310: Old City South Slopes: September 25, 2018**

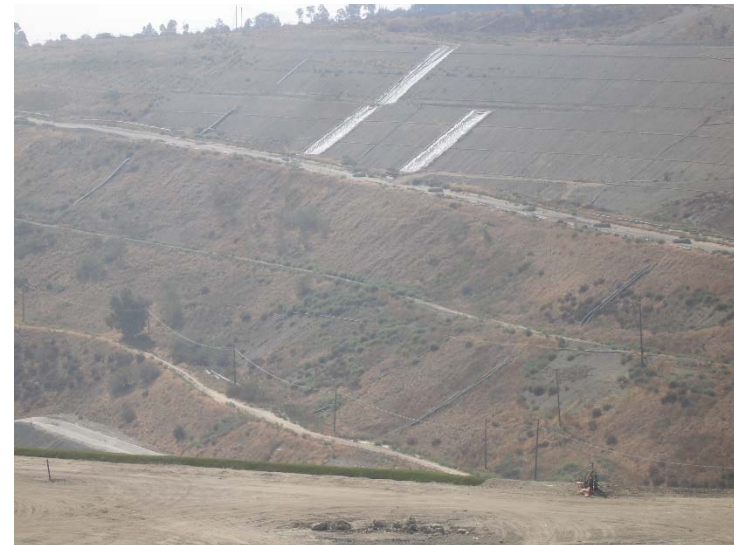
**Photo 311: Old City South Slopes: September 25, 2018**

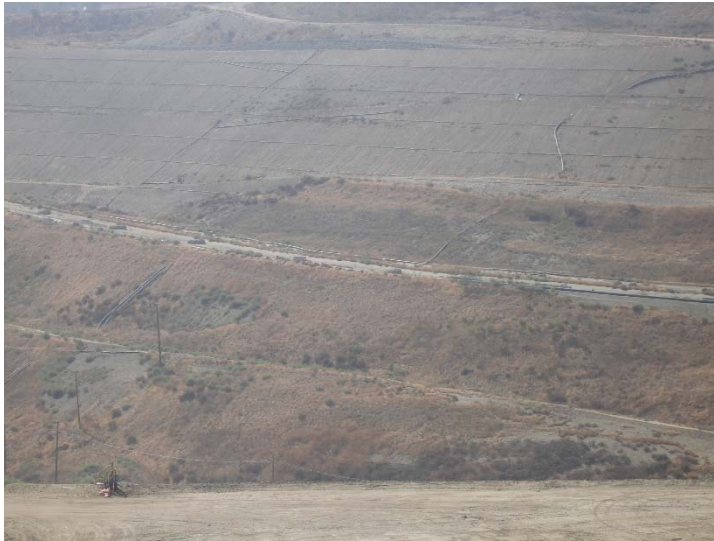
**Photo 312: Old City South Slopes: September 25, 2018**

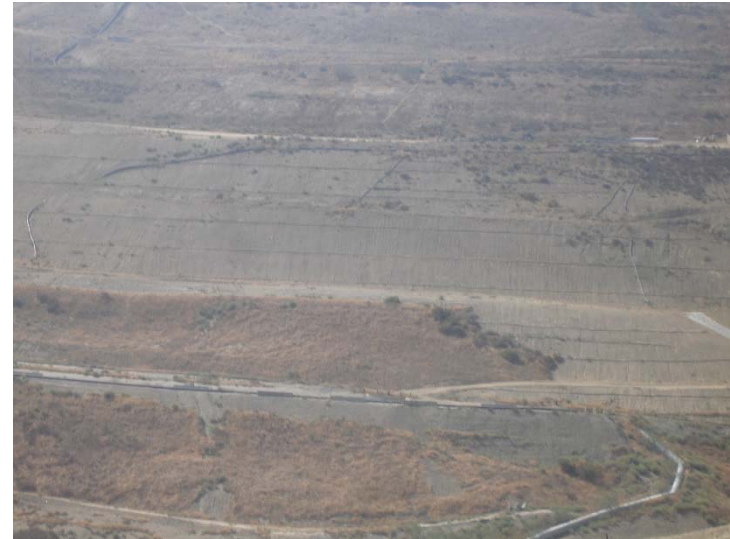
**Photo 313: Old City South Slopes: September 25, 2018**

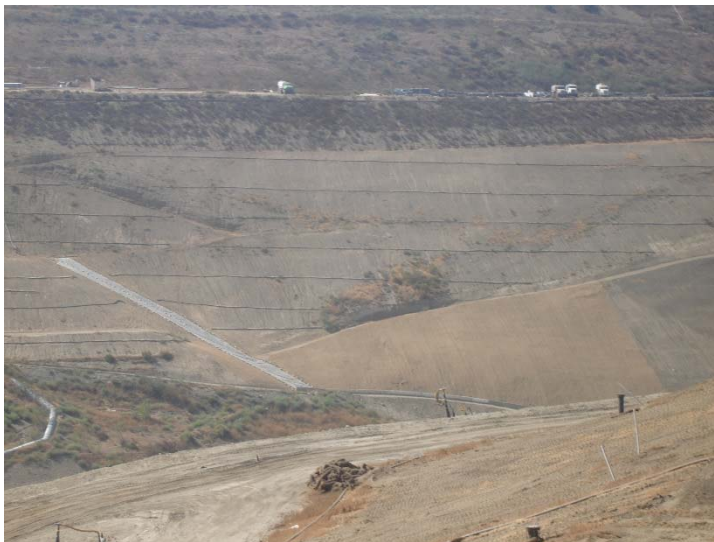
**Photo 314: Old City South Slopes: September 25, 2018**

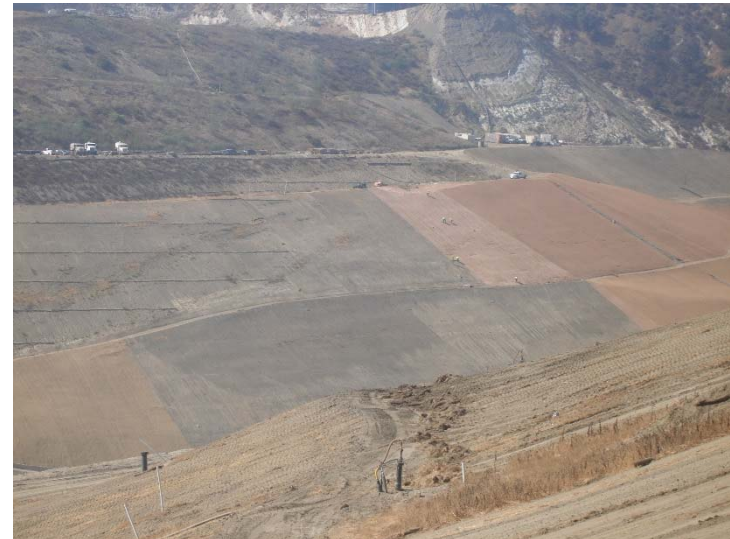
**Photo 315: Old City South Slopes: September 25, 2018**

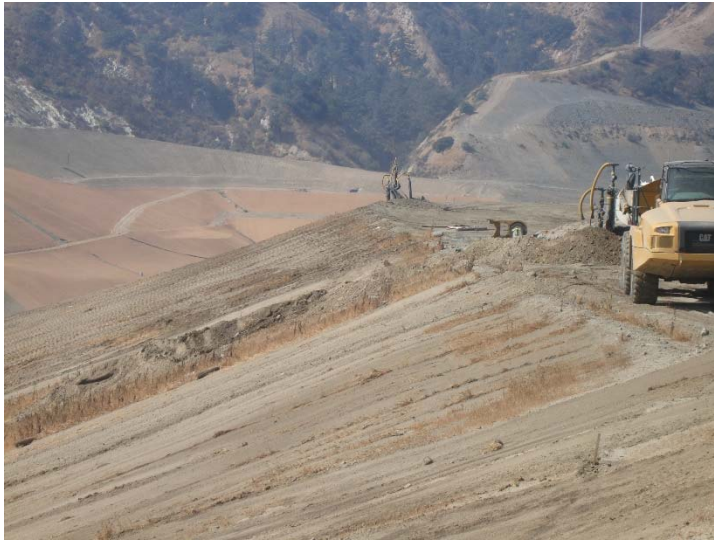
**Photo 316: Old City South Slopes: September 25, 2018**

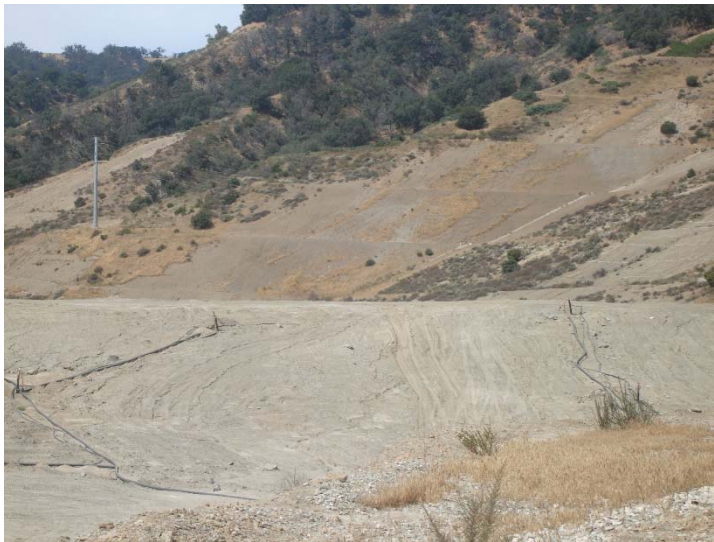
**Photo 317: Old City South Slopes: September 25, 2018**

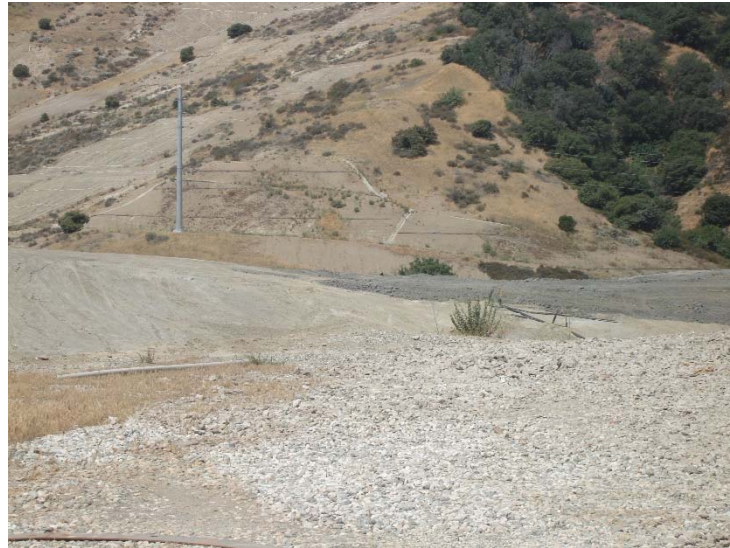
**Photo 318: County Sage Mitigation Area Slope: July 5, 2018**

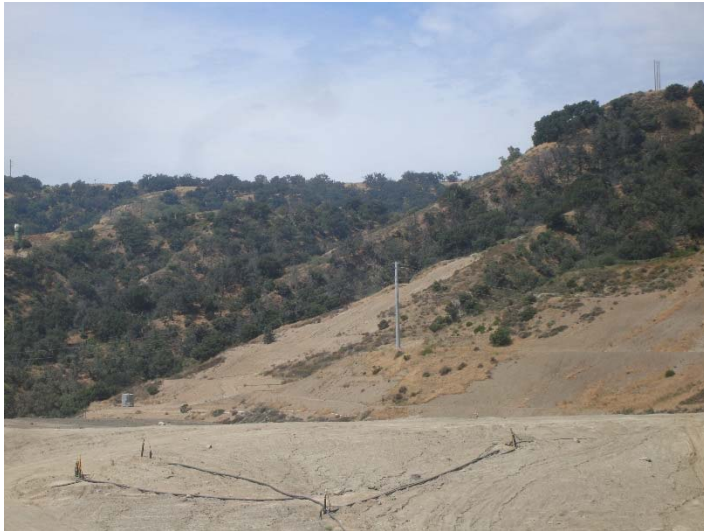
**Photo 320: County Sage Mitigation Area Slope: July 5, 2018**

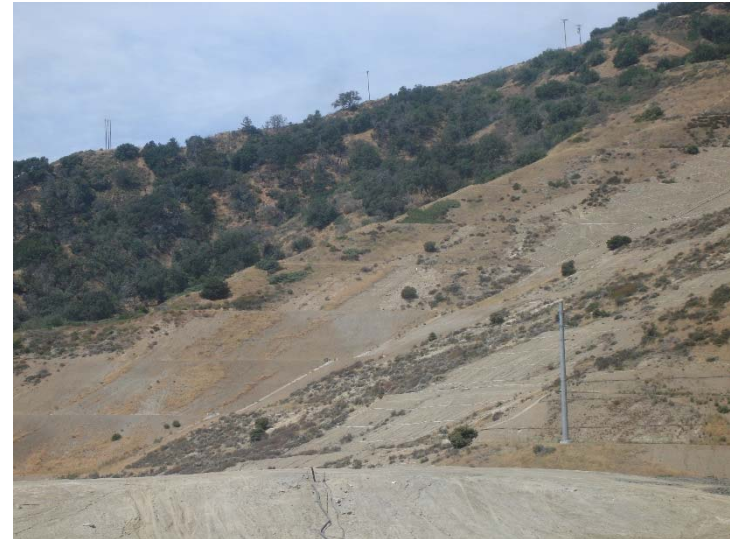
**Photo 321: County Sage Mitigation Area Slope: July 5, 2018**

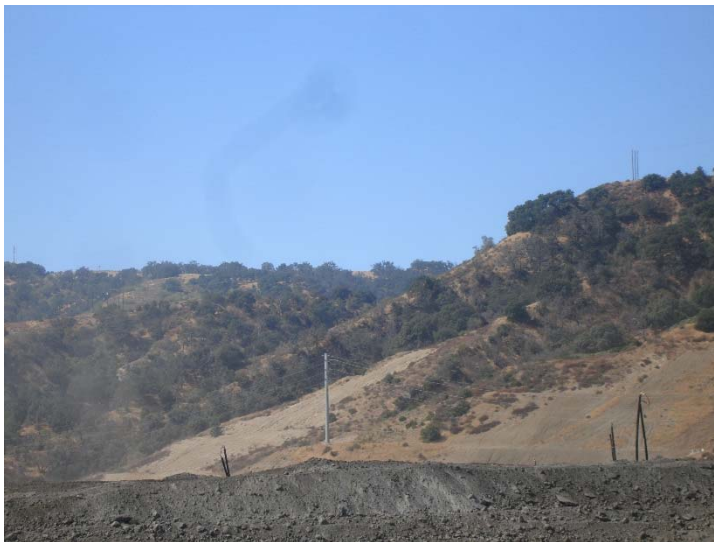
**Photo 322: County Sage Mitigation Area Slope: July 5, 2018**

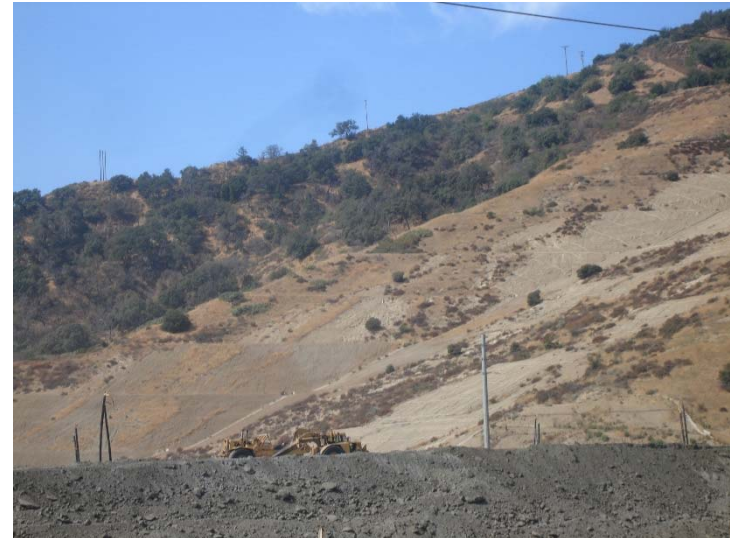
**Photo 324: County Sage Mitigation Area Slope: August 29, 2018**

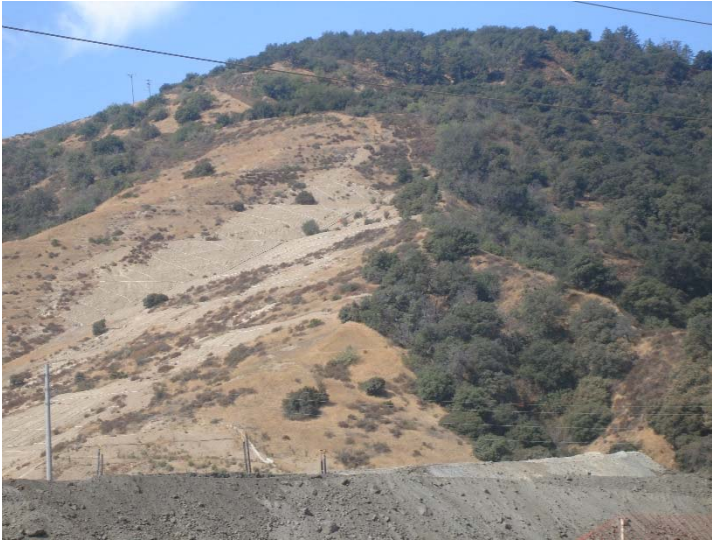
**Photo 325: County Sage Mitigation Area Slope: August 29, 2018**

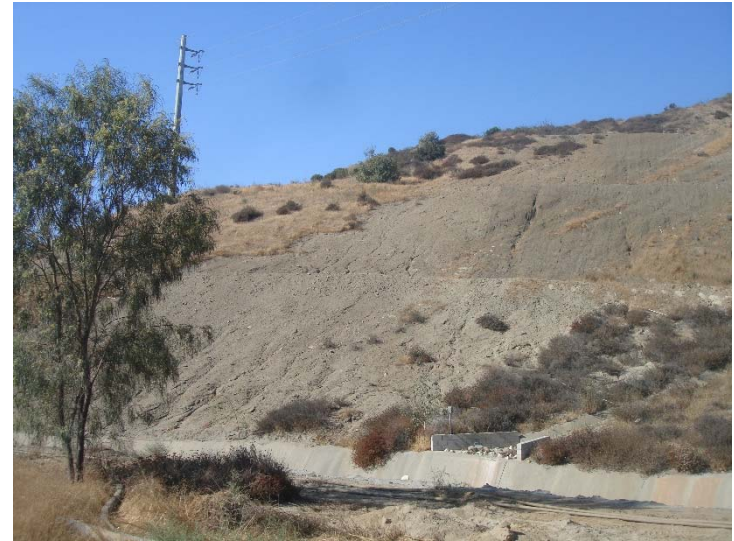
**Photo 326: County Sage Mitigation Area Slope: September 25, 2018**

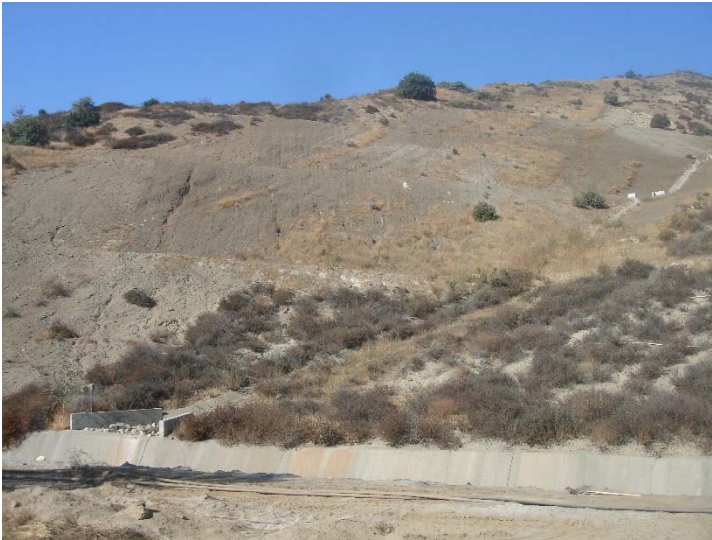
**Photo 327: County Sage Mitigation Area Slope: September 25, 2018**

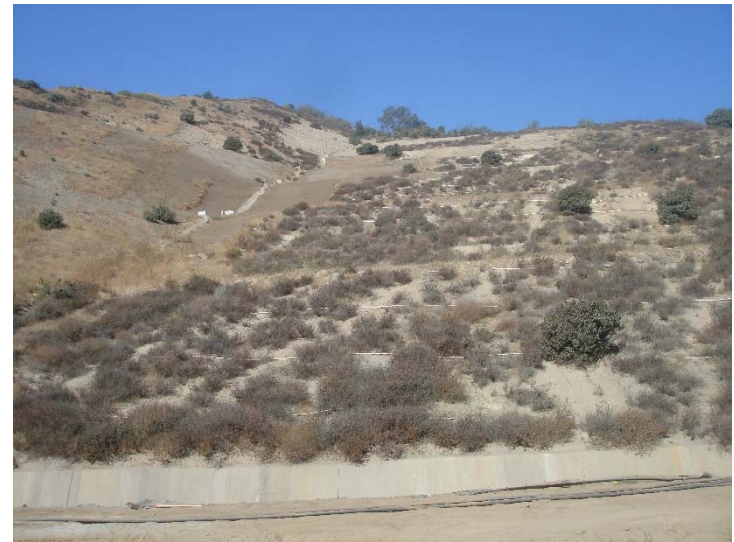
**Photo 328: County Sage Mitigation Area Slope: September 25, 2018**

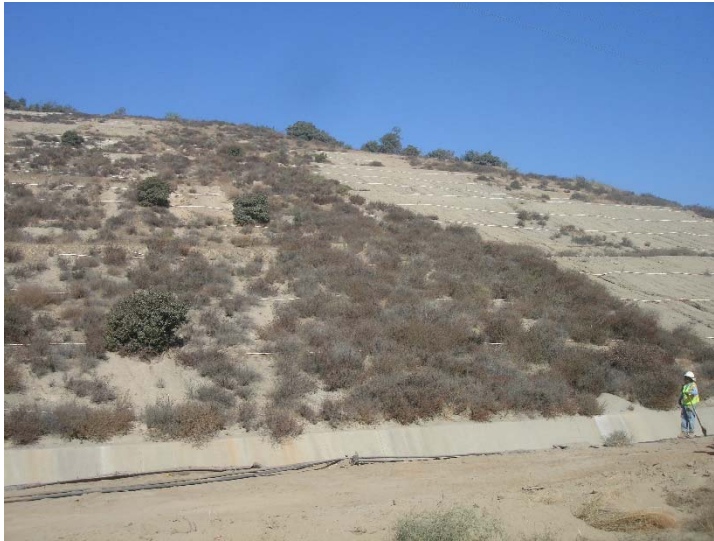
**Photo 329: County Sage Mitigation Area Slope: September 25, 2018**

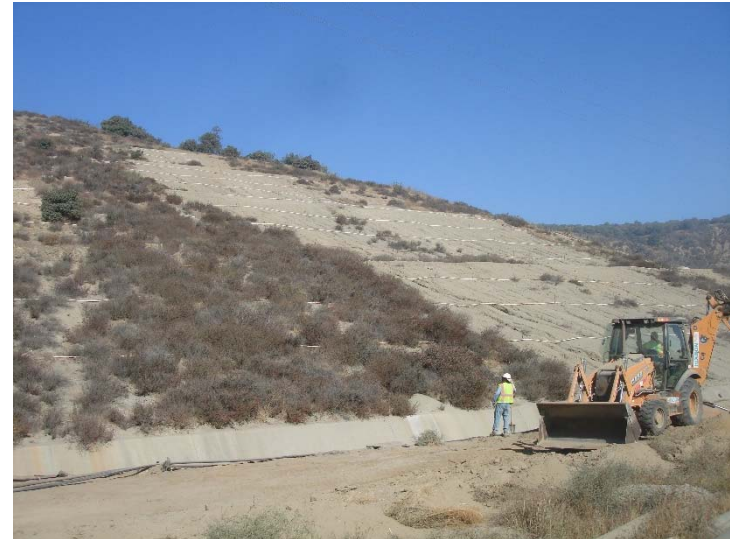
**Photo 330: County Sage Mitigation Area Slope: September 25, 2018**

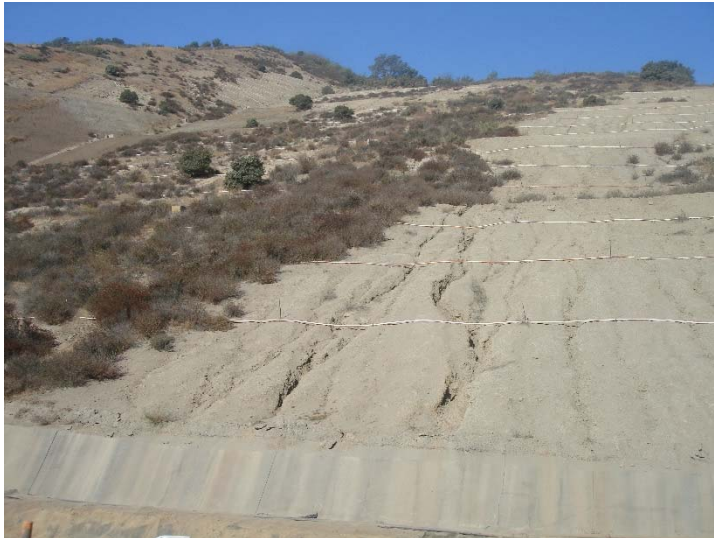
**Photo 331: County Sage Mitigation Area Slope: September 25, 2018**

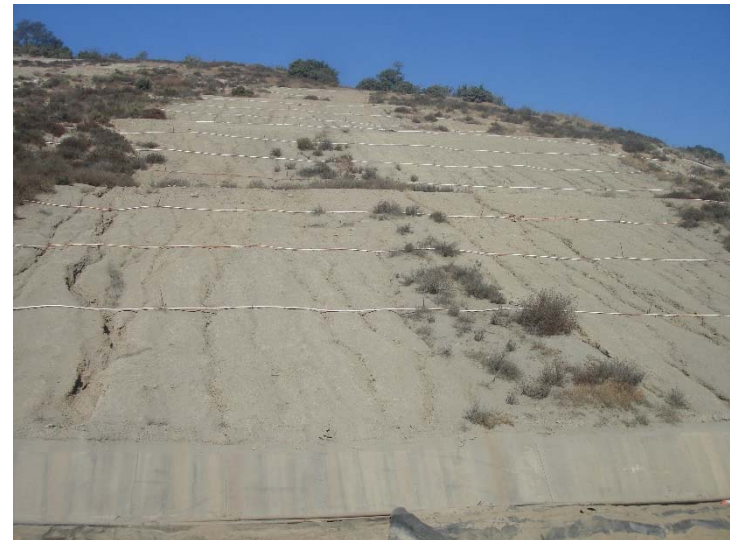
**Photo 332: County Sage Mitigation Area Slope: September 25, 2018**

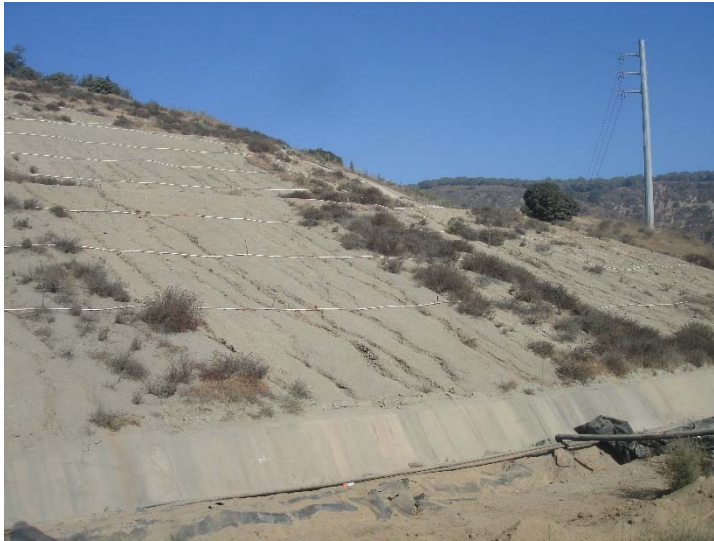
**Photo 333: Sacrificial Liner Replacement Near County Sage Mitigation Area: September 25, 2018**
