**Sunshine Canyon Landfill  
Independent Monitor  
Quarterly Site Monitoring Status Report  
July 1, 2018 – September 30, 2018**

**City of Los Angeles Department of City Planning**

**County of Los Angeles Department of Regional Planning**

November 5, 2018

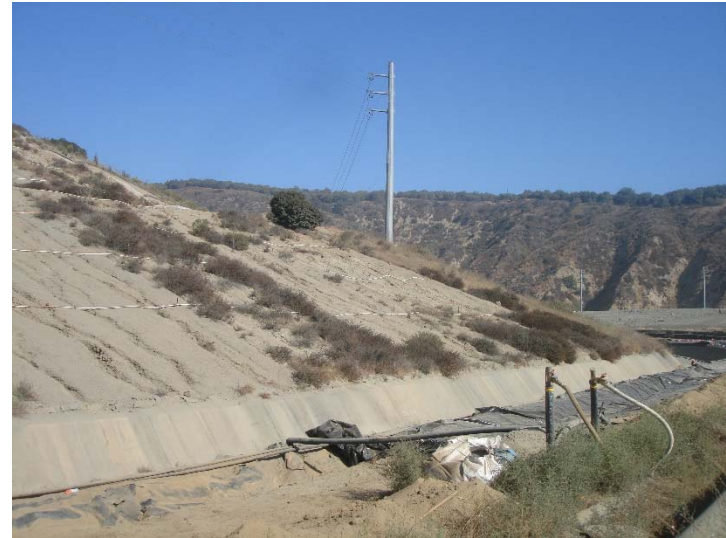
**Photo 334: Sacrificial Liner Replacement Near County Sage Mitigation Area: September 25, 2018**

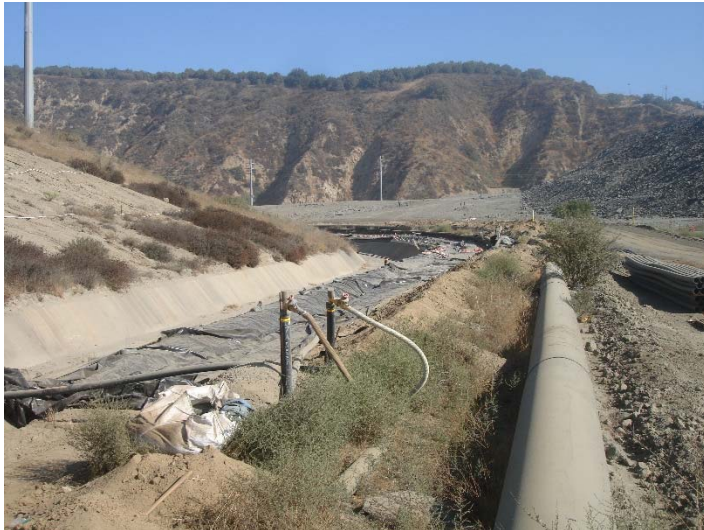
**Photo 335: Sacrificial Liner Replacement Near County Sage Mitigation Area: September 25, 2018**

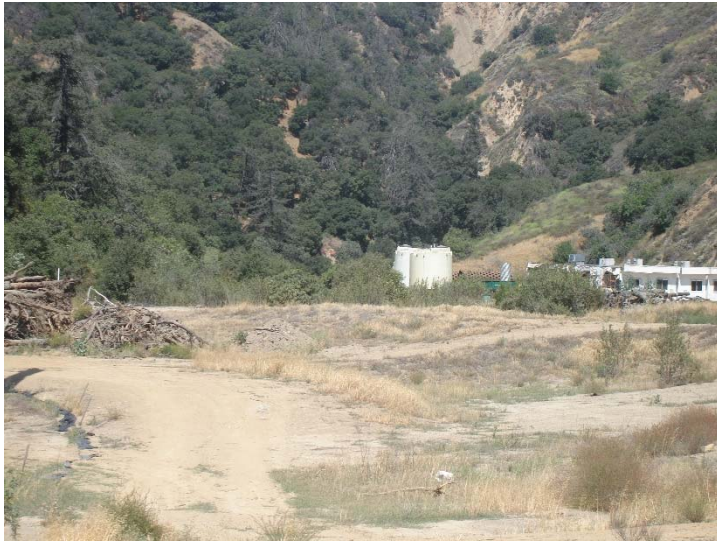
**Photo 337: Basin D Deck Wood Waste Stockpile: July 5, 2018**

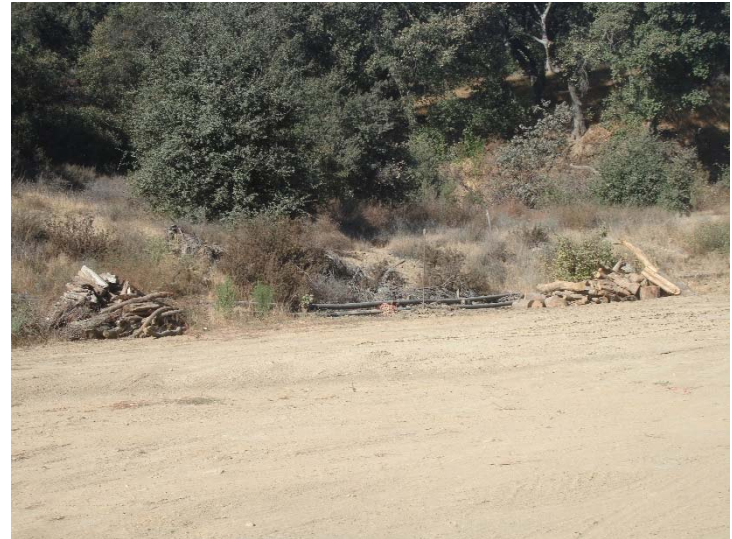
**Photo 338: Basin D Deck Wood Waste Stockpile: September 25, 2018**

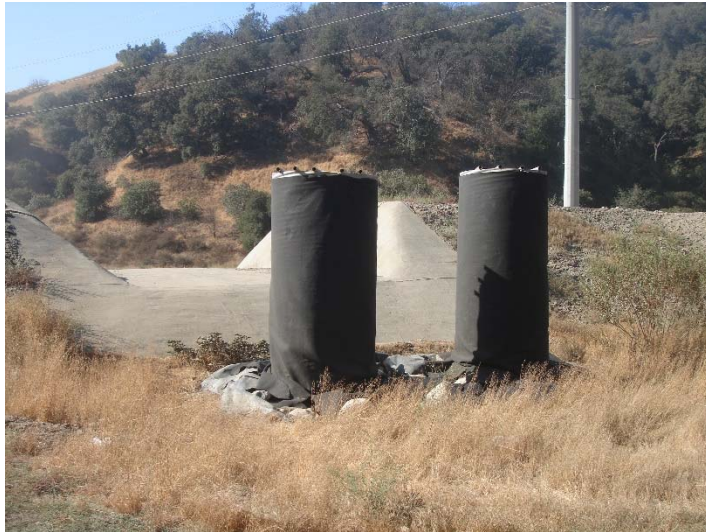
**Photo 339: Basin D: September 25, 2018**

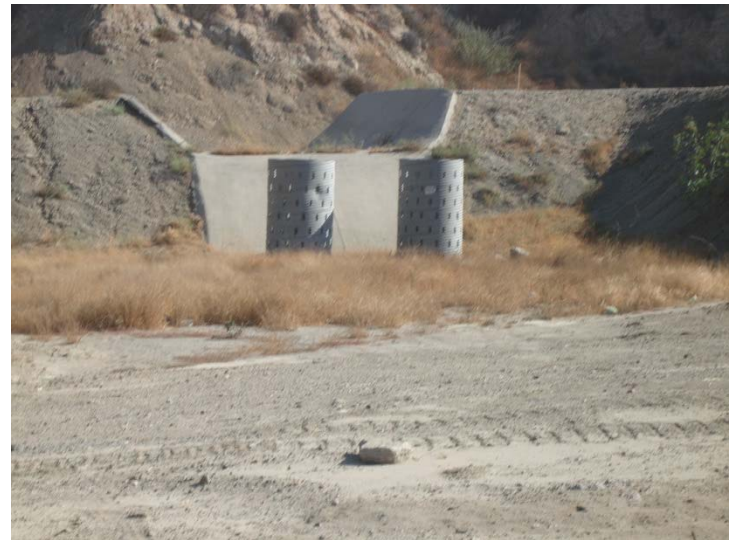
**Photo 340: Basin D: September 25, 2018**

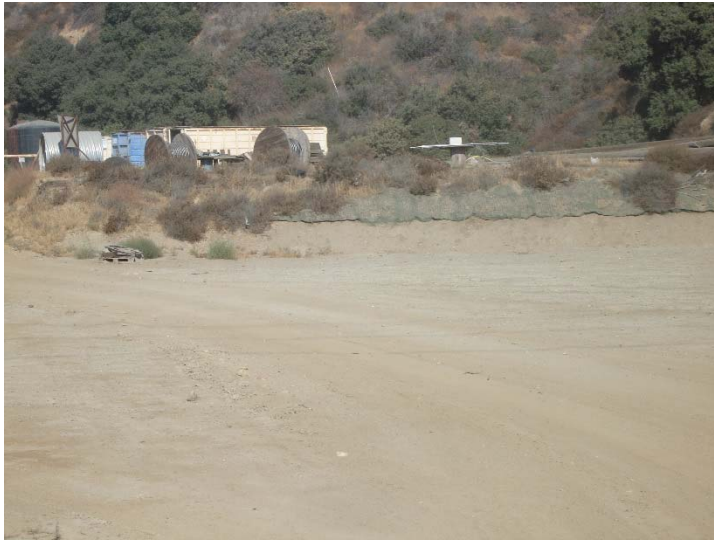
**Photo 341: Basin D: September 25, 2018**

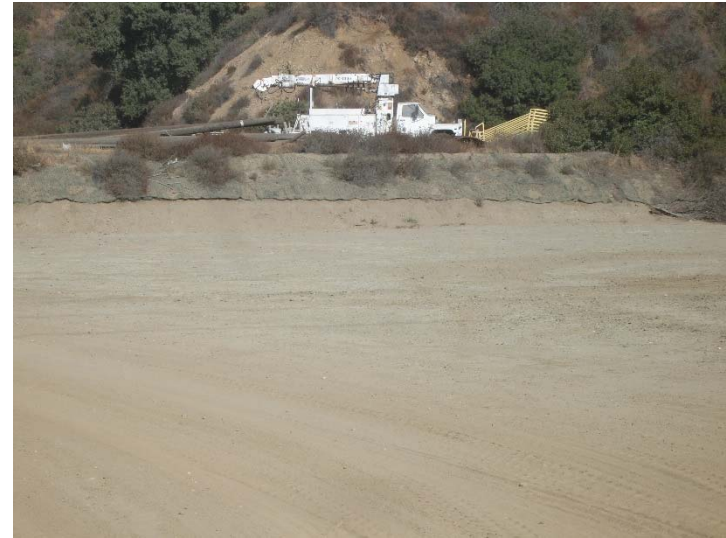
**Photo 342: Basin D: September 25, 2018**

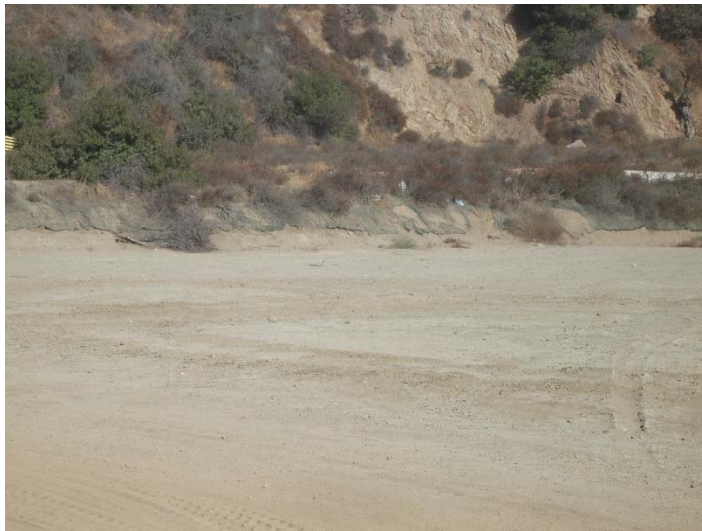
**Photo 343: Basin D: September 25, 2018**

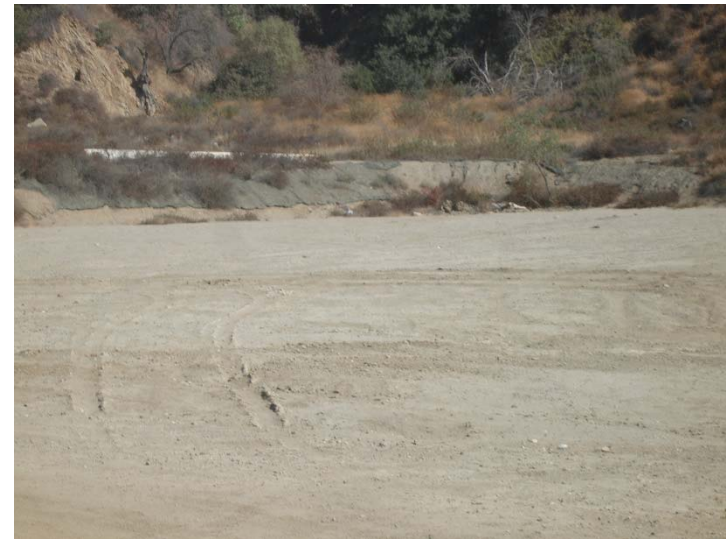
**Photo 344: Basin D: September 25, 2018**

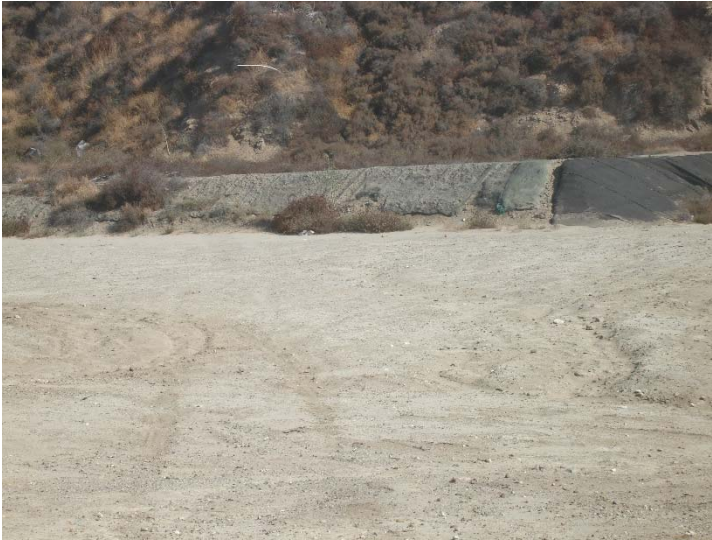
**Photo 345: Basin D: September 25, 2018**

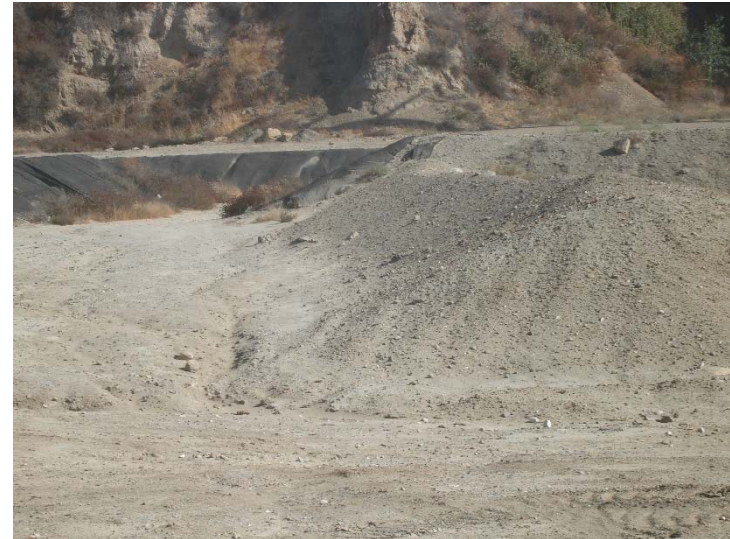
**Photo 346: Basin D: September 25, 2018**

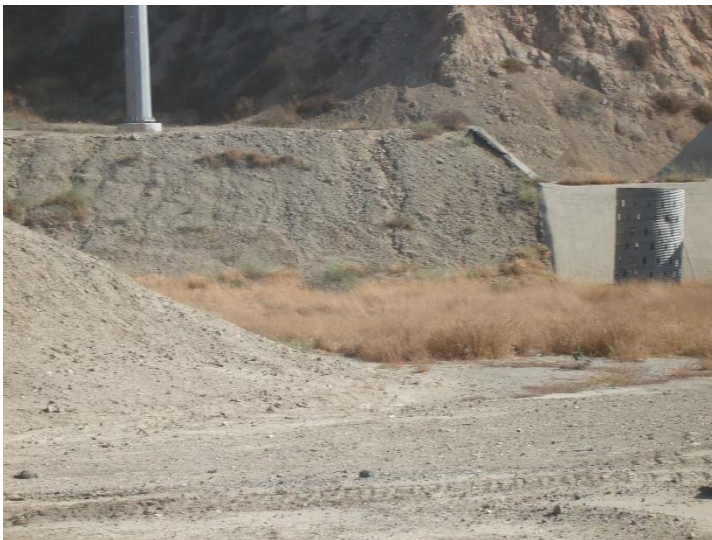
**Photo 347: Basin D: September 25, 2018**

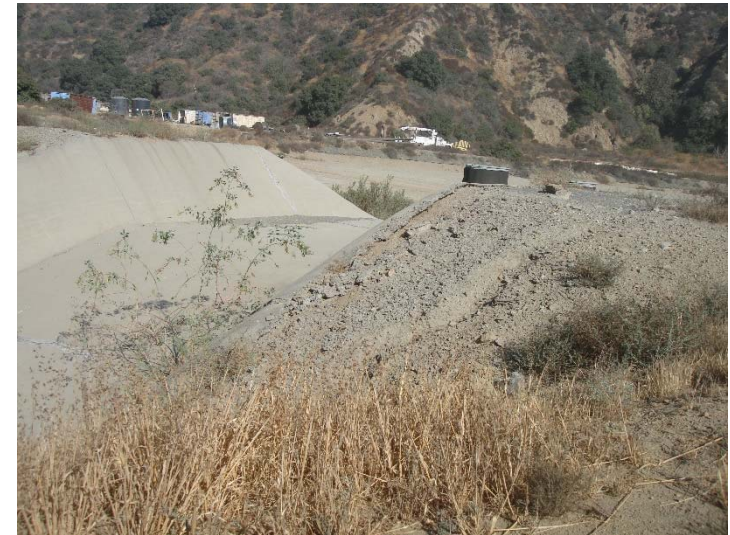
**Photo 348: Basin D Westside Channel High Flow Outlet:  
September 25, 2018**

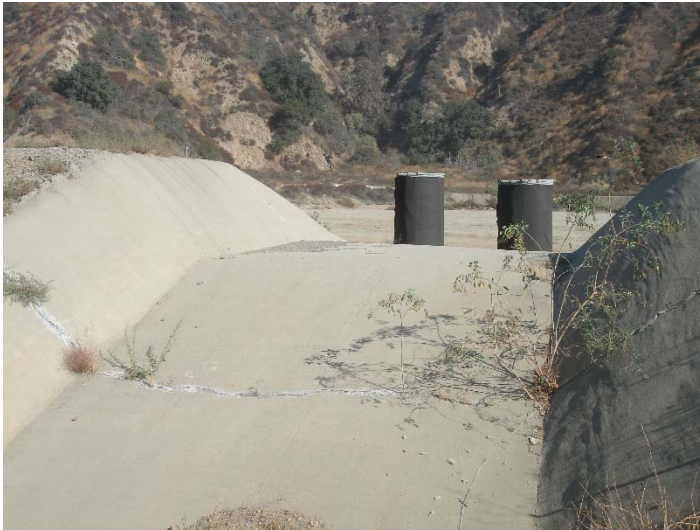
**Photo 349: Basin D Westside Channel High Flow Outlet: September 25, 2018**

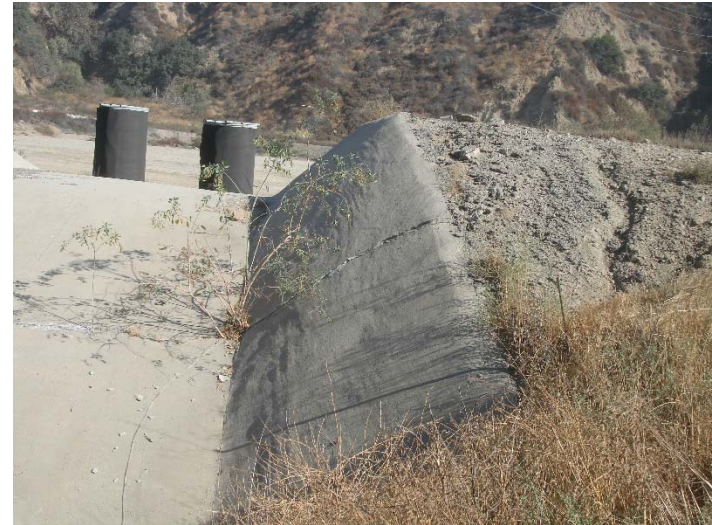
**Photo 350: Basin D Westside Channel High Flow Outlet: September 25, 2018**

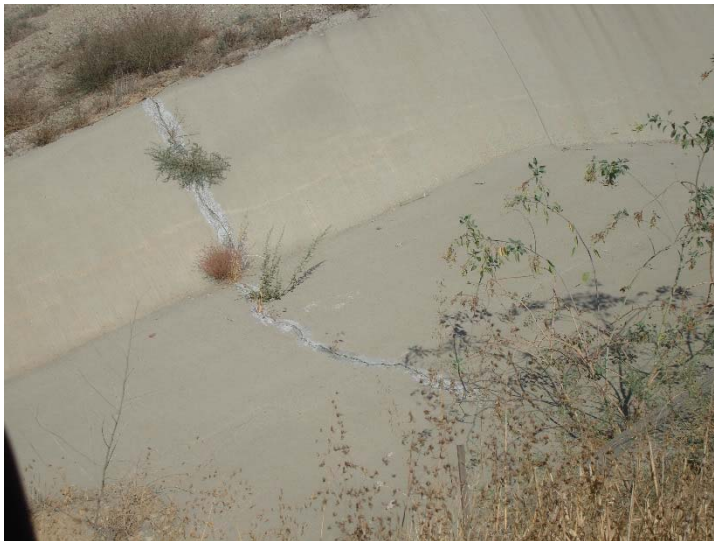
**Photo 351: Basin D Westside Channel High Flow Outlet: September 25, 2018**

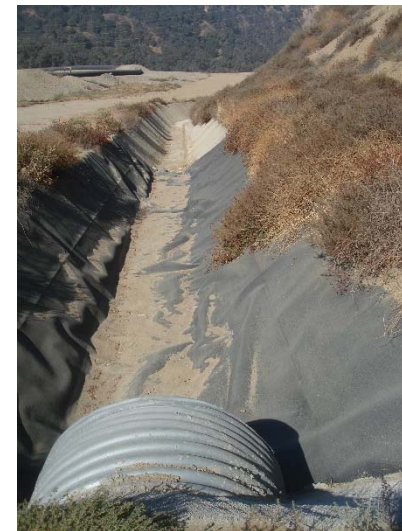
**Photo 352: Basin D Eastside Channel Outlet: September 25, 2018**

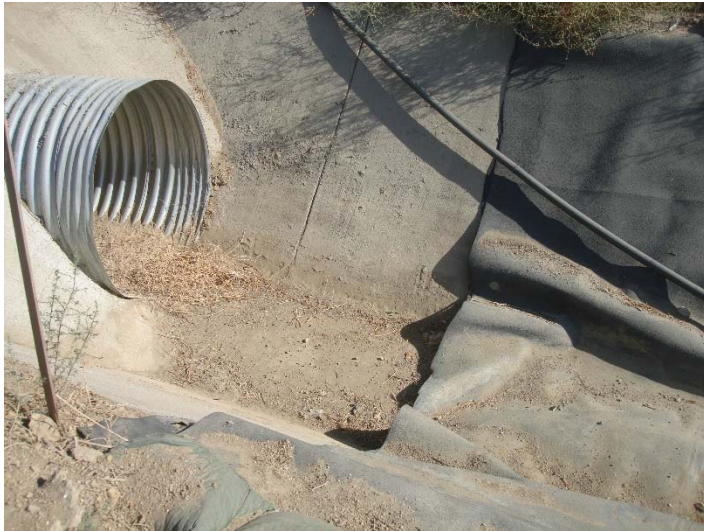
**Photo 353: Basin D Eastside Channel Outlet: September 25, 2018**

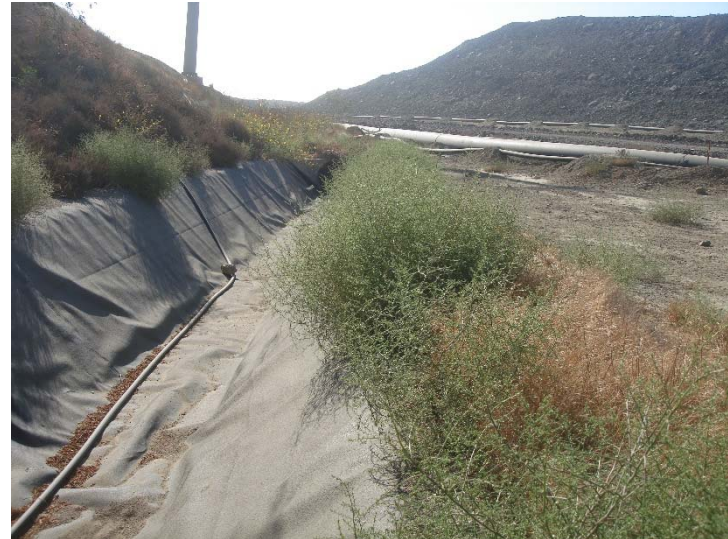
**Photo 354: Basin D Eastside Channel Outlet: September 25, 2018**

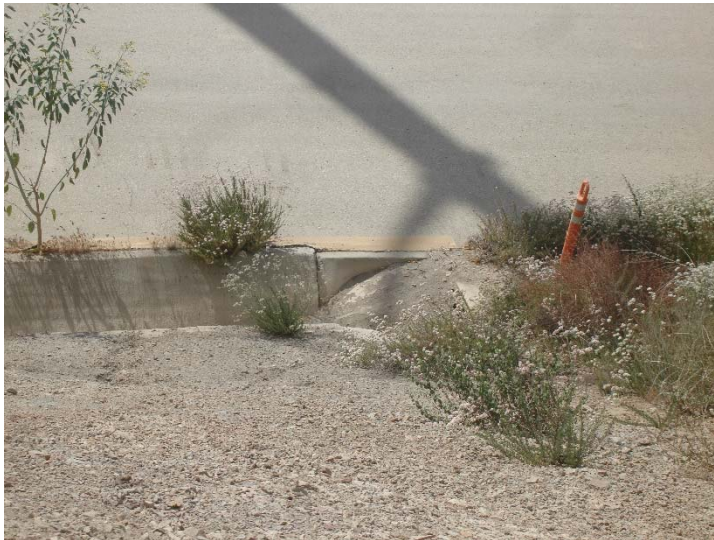
**Photo 355: Plugged Drains at Bottom of Flare 9 Access Road: July 5, 2018**

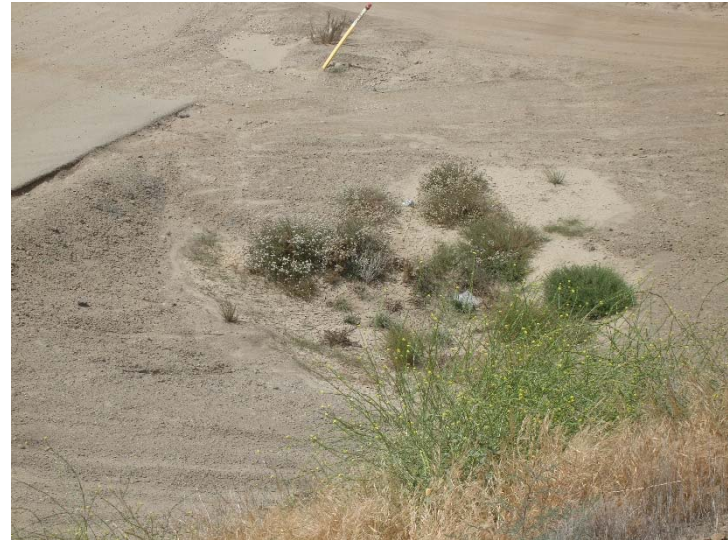
**Photo 356: Plugged Drains at Bottom of Flare 9 Access Road: July 5, 2018**

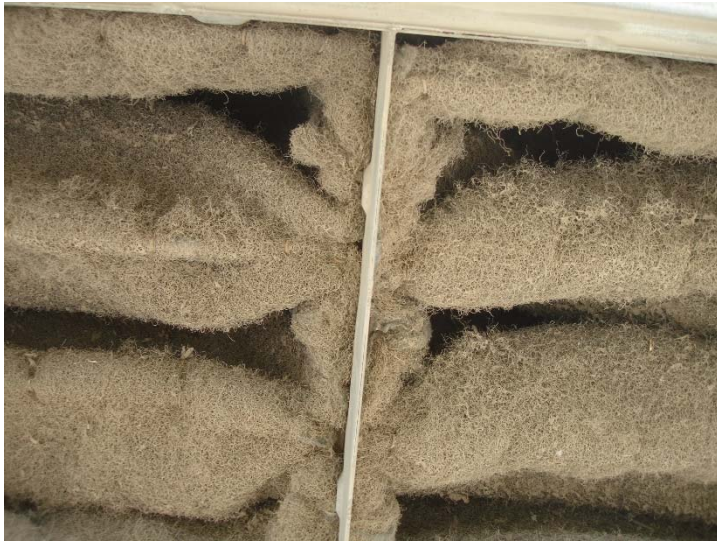
**Photo 357: Old Flare 9 Blower Intake Air Filter: July 5, 2018**

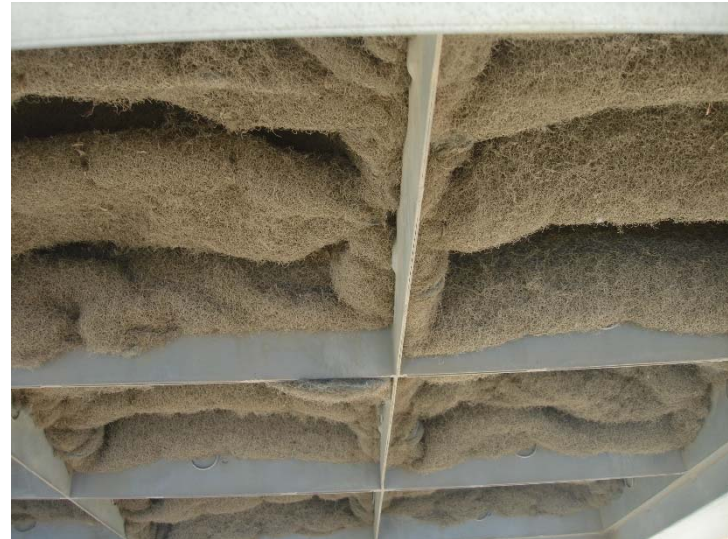
**Photo 358: Old Flare 9 Blower Intake Air Filter: July 5, 2018**

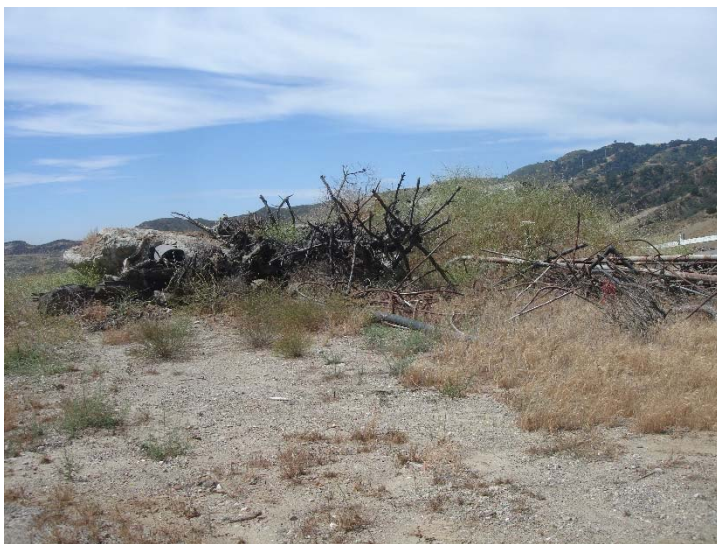
**Photo 359: Old Flare 8 Site Waste Material Stockpile: July 5, 2018**

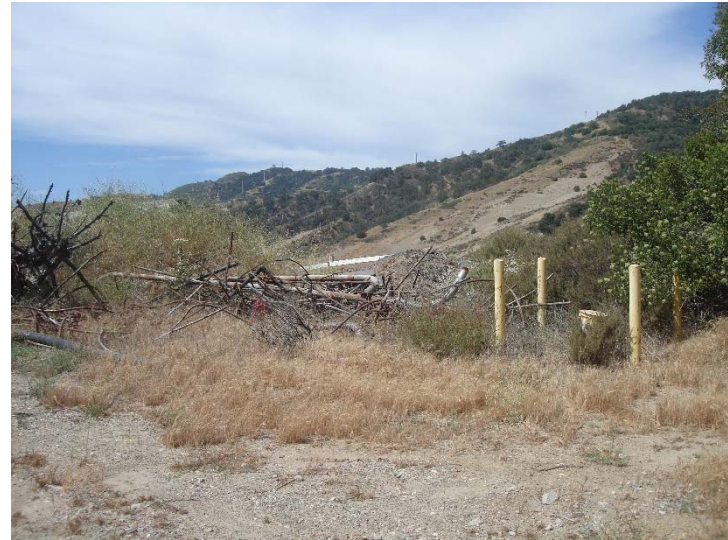
**Photo 360: Old Flare 8 Site Waste Material Stockpile: July 5, 2018**

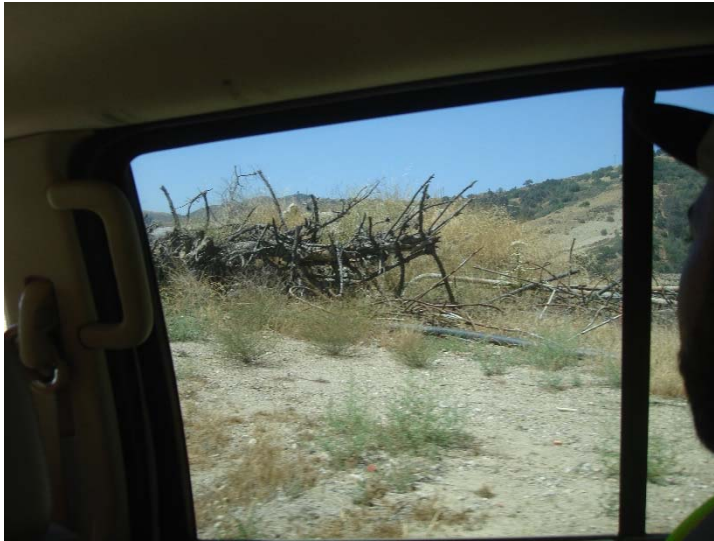
**Photo 361: Old Flare 8 Site Waste Material Stockpile: July 24, 2018**

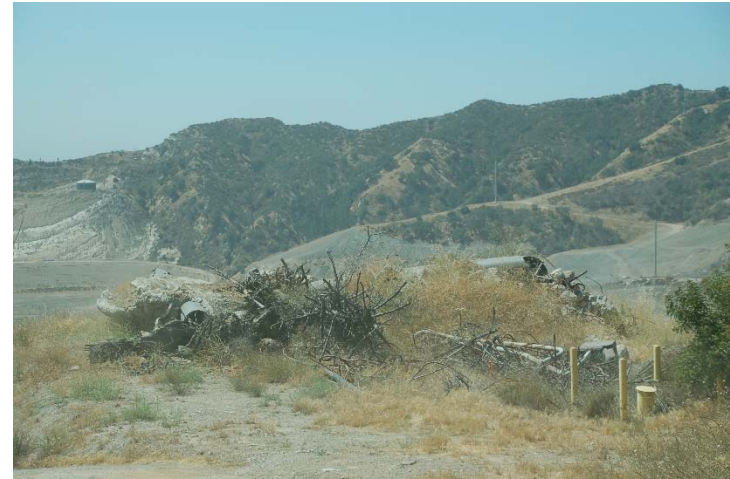
**Photo 362: Old Flare 8 Site Waste Material Stockpile: July 24, 2018**

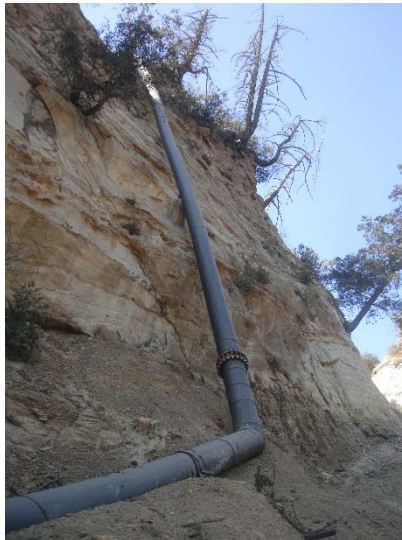
**Photo 363: Flare 3 Pipeline Cut at Basin A: September 25, 2018**

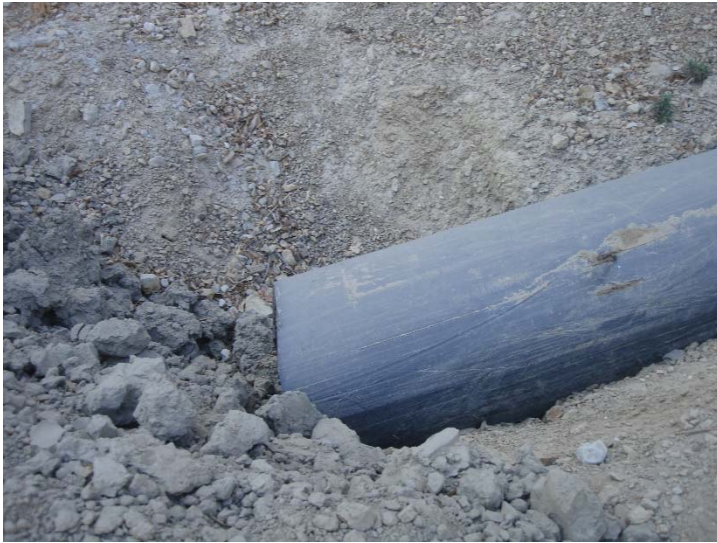
**Photo 364: Flare 3 Pipeline Cut at Basin A: September 25, 2018**

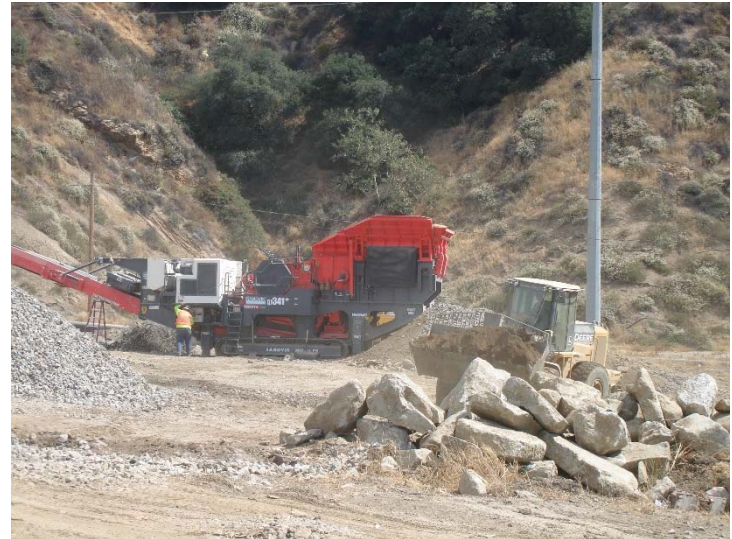
**Photo 377: County Top Deck Material Processing: July 5, 2018**

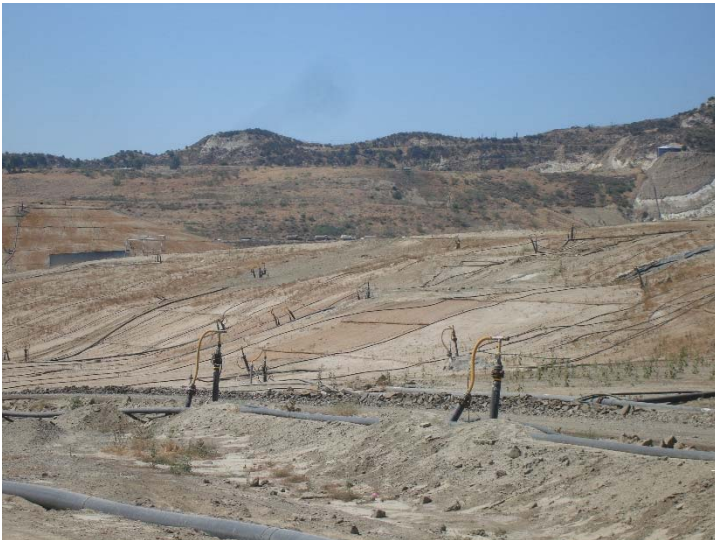
**Photo 378: County Top Deck Material Processing: July 5, 2018**

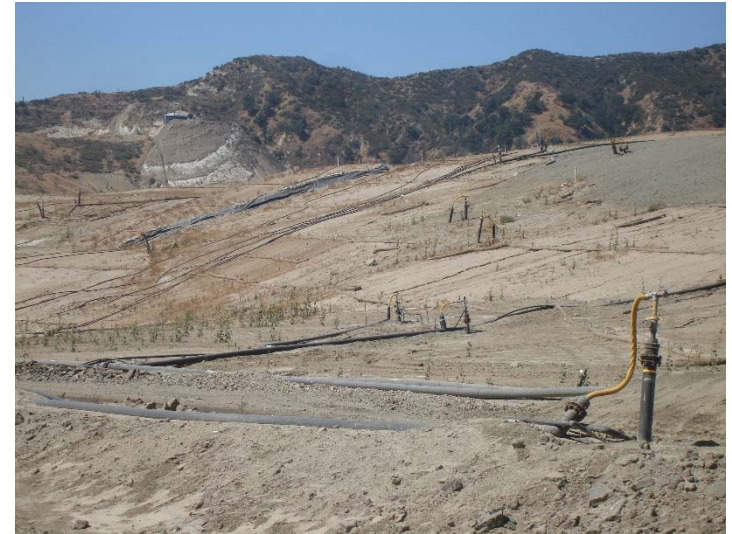
**Photo 379: County Top Deck (Bowl) & Slope Revegetation: July 24, 2018**

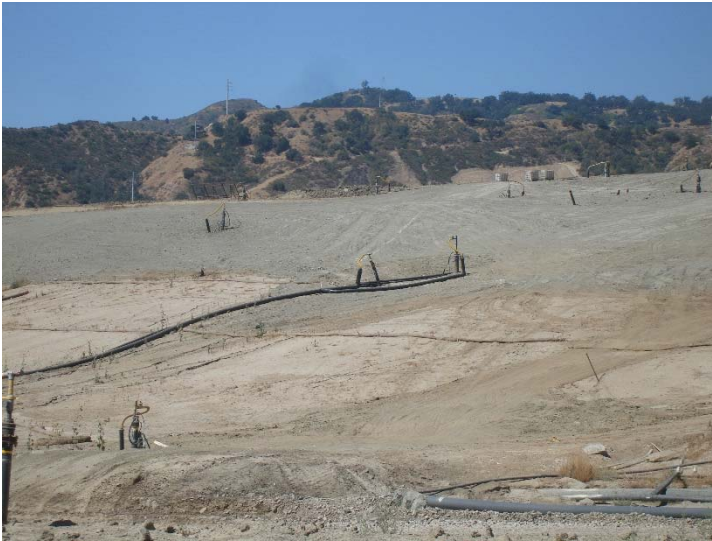
**Photo 380: County Top Deck (Bowl) & Slope Revegetation: July 24, 2018**

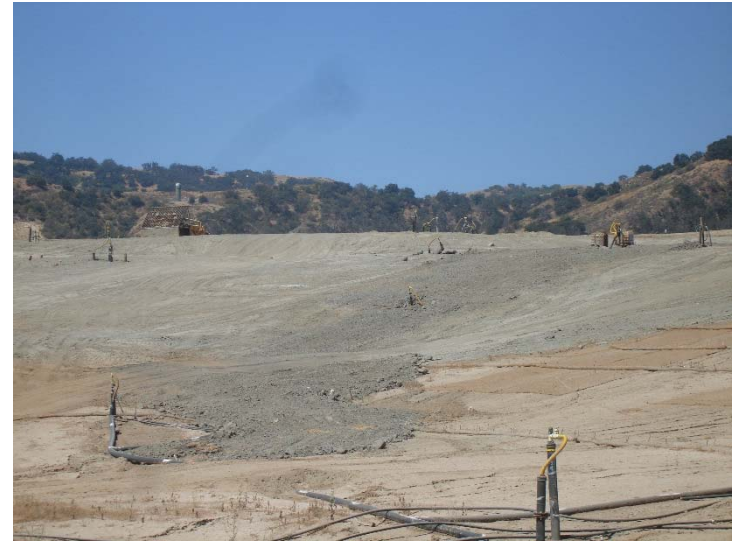
**Photo 381: County Top Deck (Bowl) & Slope Revegetation: July 24, 2018**

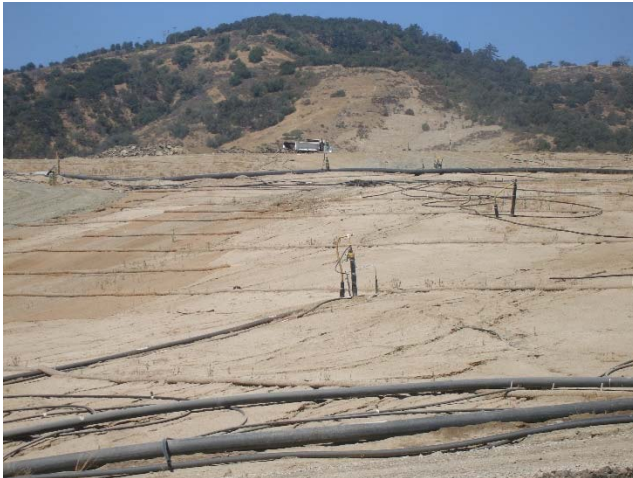
**Photo 382: County Top Deck (Bowl) & Slope Revegetation: July 24, 2018**

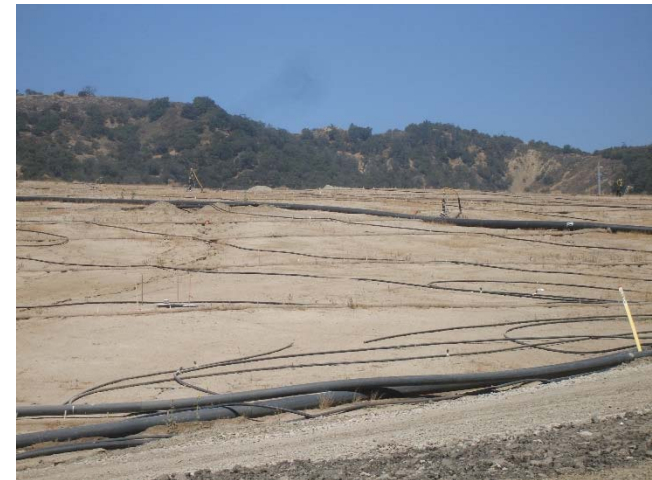
**Photo 383: County Top Deck (Bowl) & Slope Revegetation: July 24, 2018**

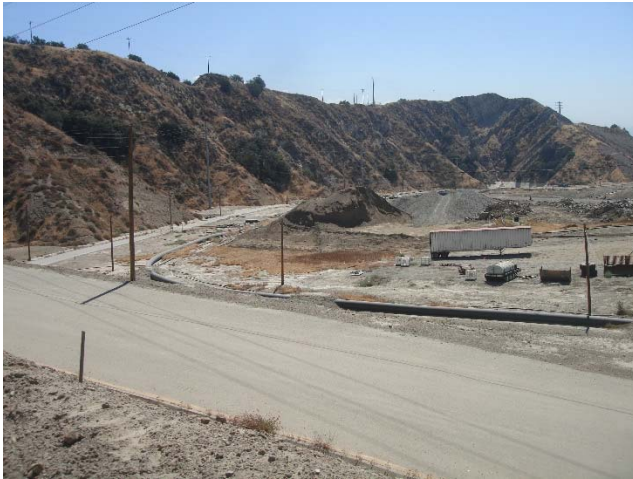
**Photo 384: County Top Deck (Bowl) & Slope Revegetation: July 24, 2018**

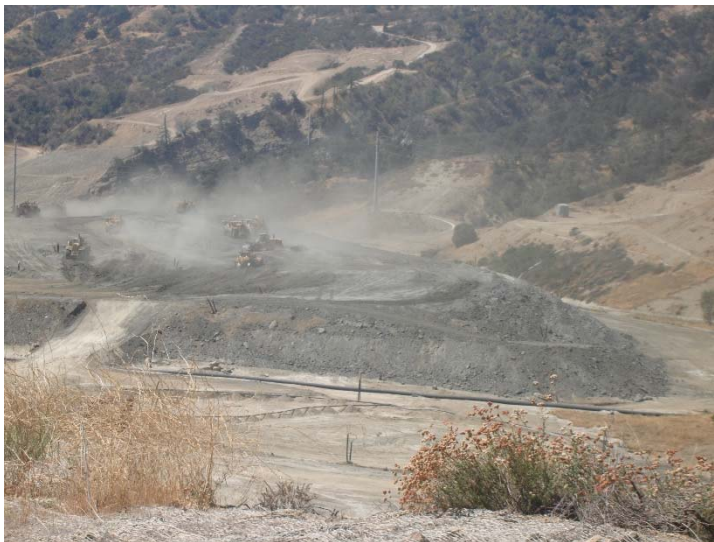
**Photo 394: County Top Deck Buttress Soils Stockpile: July 24, 2018**

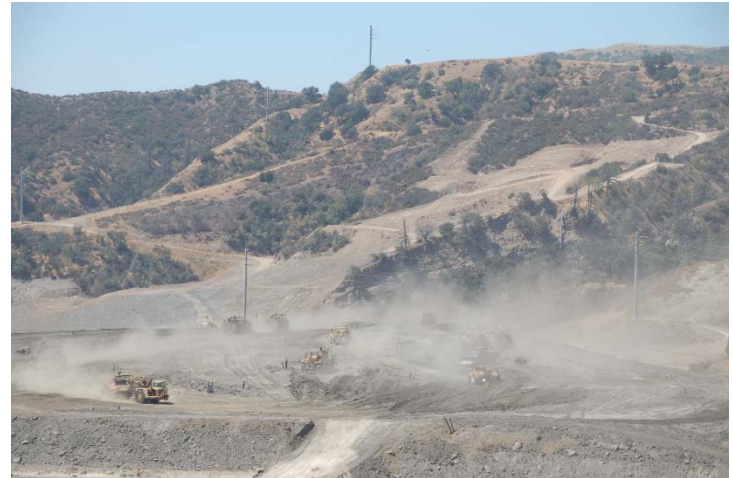
**Photo 395: County Top Deck Buttress Soils Stockpile: July 24, 2018**

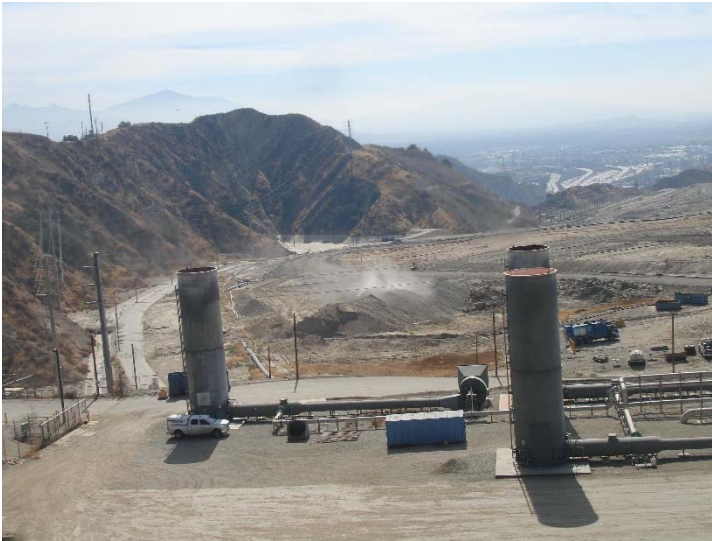
**Photo 396: County Top Deck Buttress Soils Stockpile: July 24, 2018**

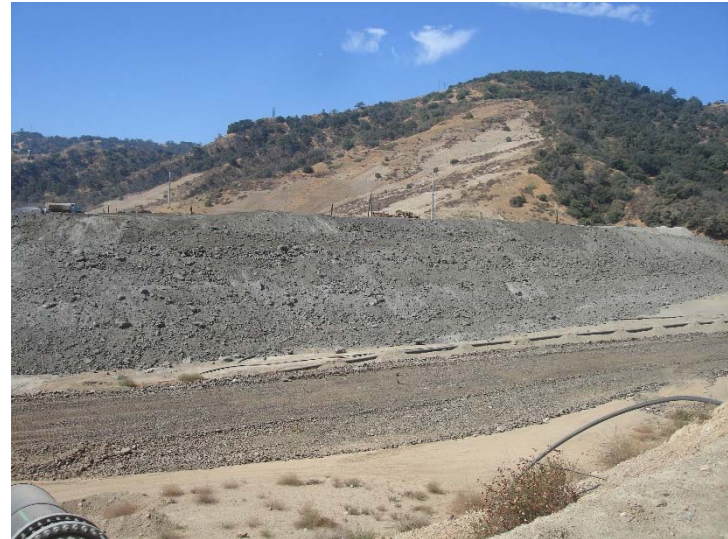
**Photo 401: County Top Deck Buttress Soils Stockpile: August 29, 2018**

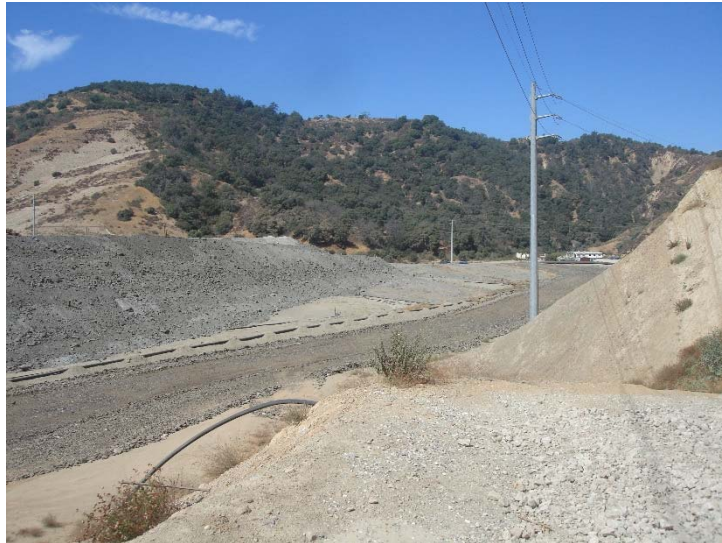
**Photo 402: County Top Deck Buttress Soils Stockpile: August 29, 2018**

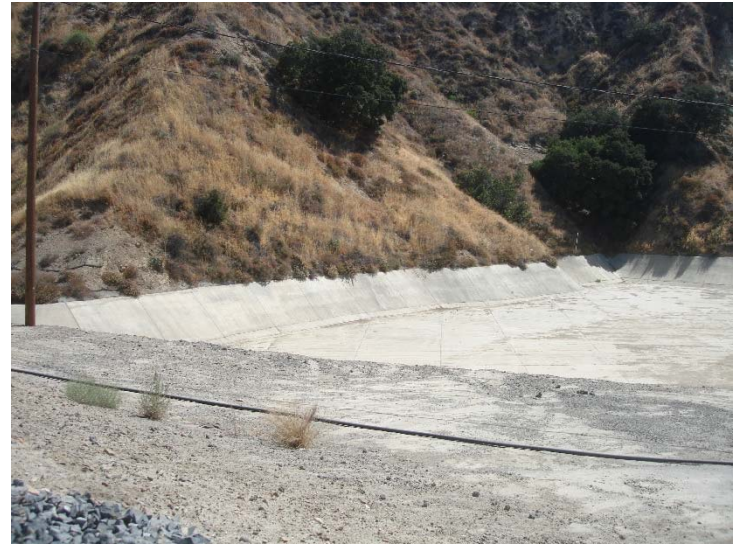
**Photo 433: Basin B Windblown Litter in Native Vegetation: July 5, 2018**

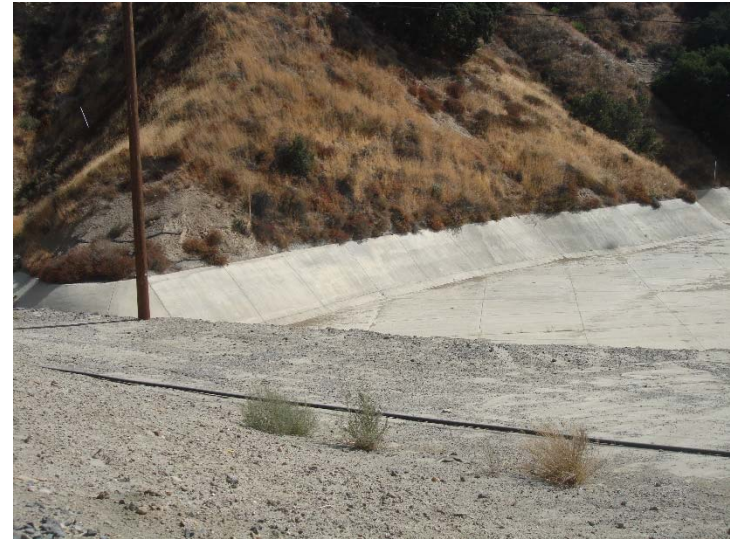
**Photo 437: Basin B Windblown Litter in Native Vegetation: July 24, 2018**

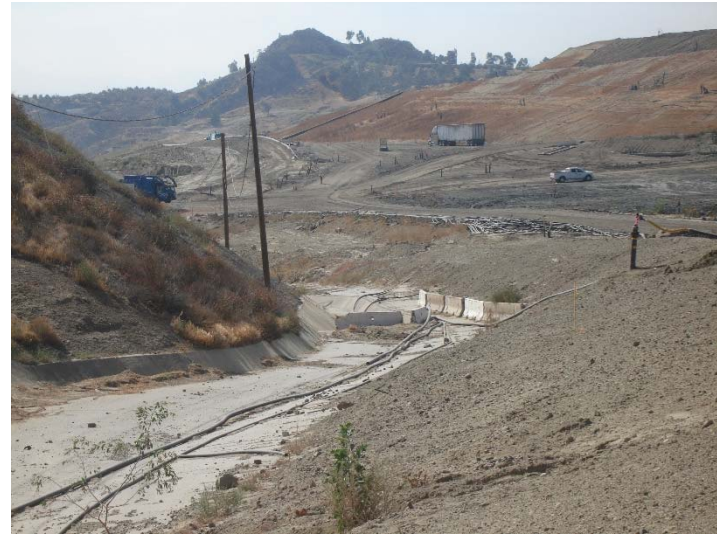
**Photo 445: Basin B Windblown Litter in Native Vegetation: August 29, 2018**

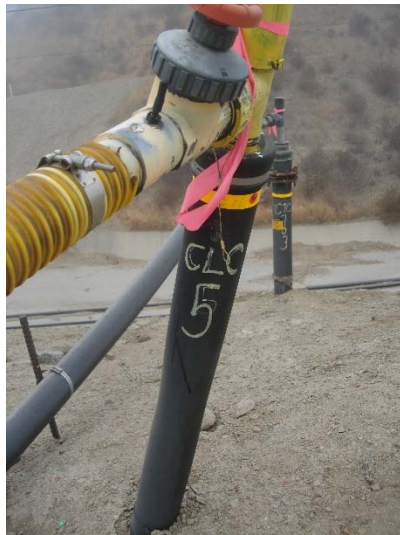
**Photo 470: Odorous Well South of Basin B: September 25, 2018**

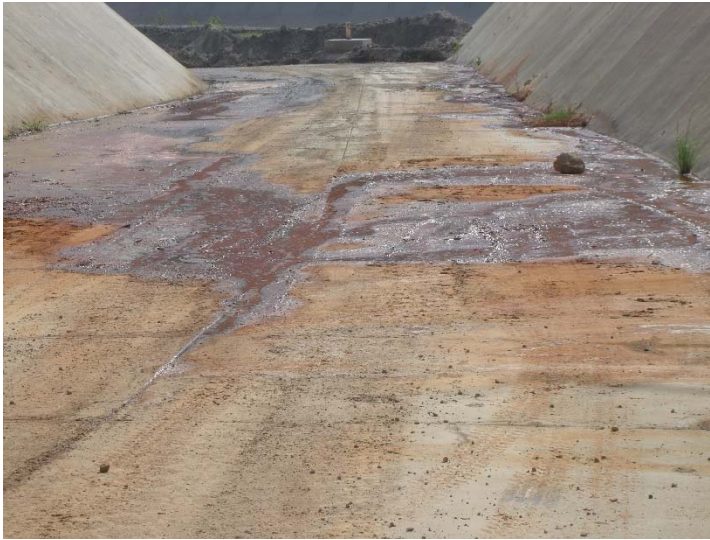
**Photo 472: Alluvial Seep Flow into Terminal Basin: July 5, 2018**

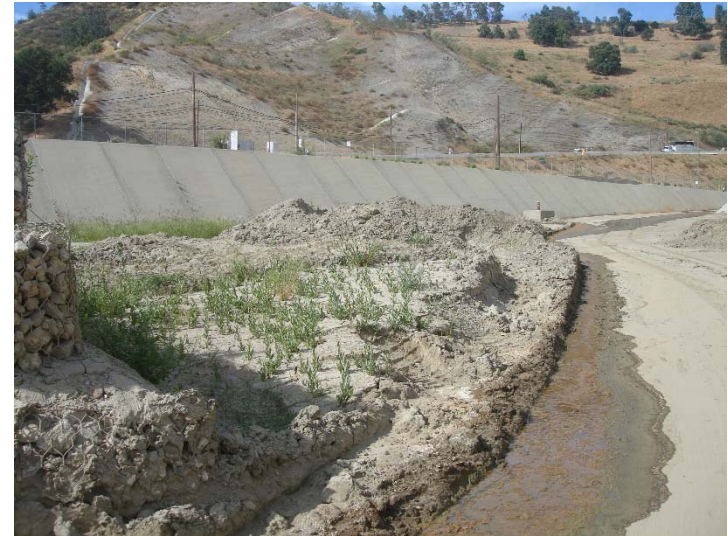
**Photo 473: Alluvial Seep Flow into Terminal Basin: July 5, 2018**

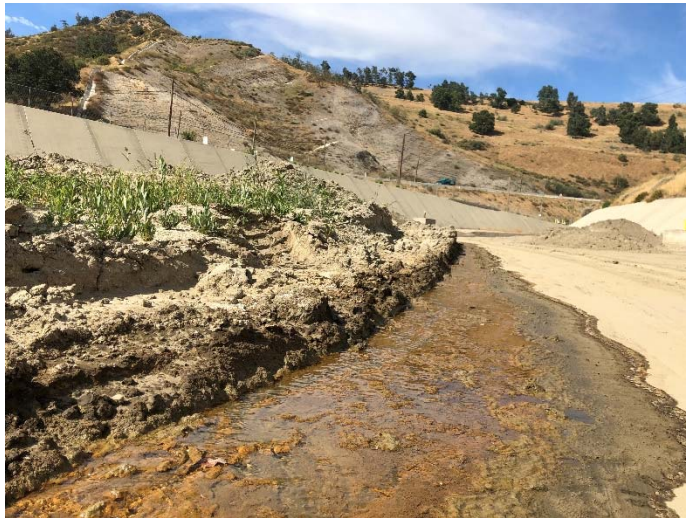
**Photo 474: Alluvial Seep Flow into Terminal Basin: July 5, 2018**

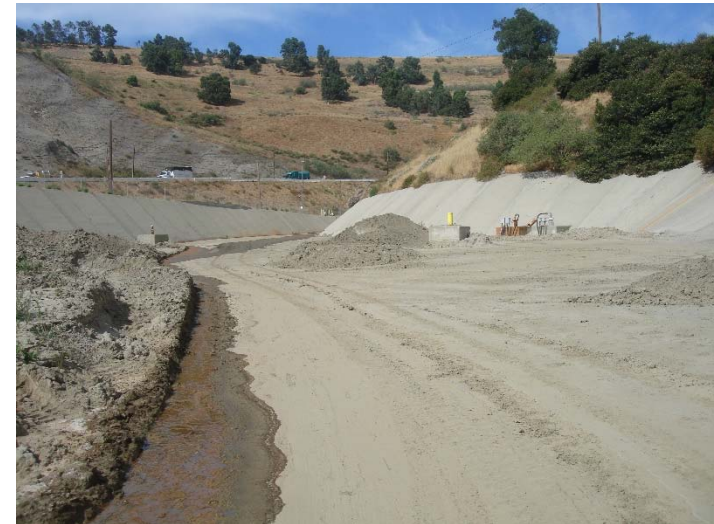
**Photo 475: Alluvial Seep Flow into Terminal Basin: July 5, 2018**

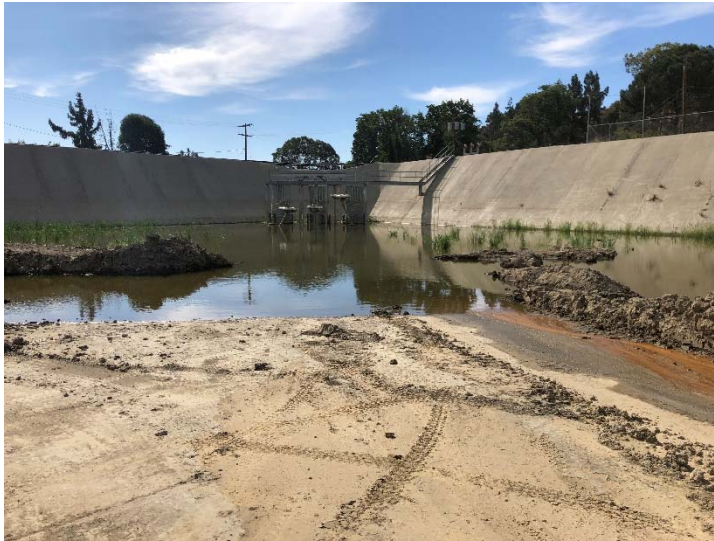
**Photo 476: Alluvial Seep Flow into Terminal Basin: July 5, 2018**

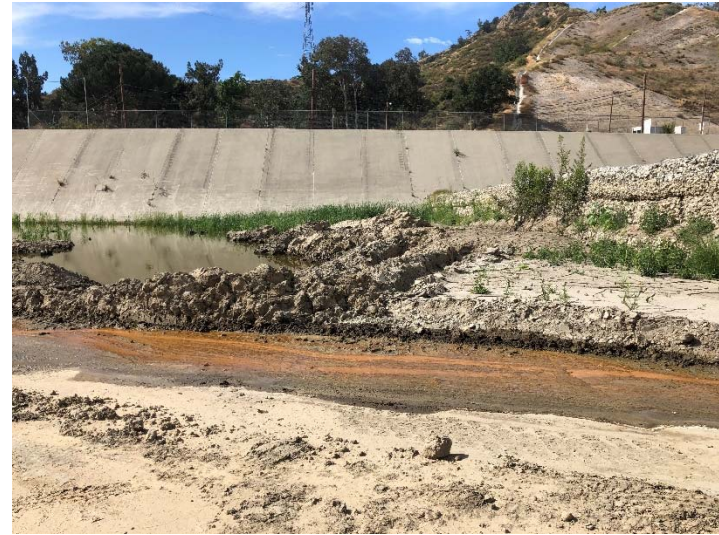
**Photo 477: Alluvial Seep Flow into Terminal Basin: July 5, 2018**

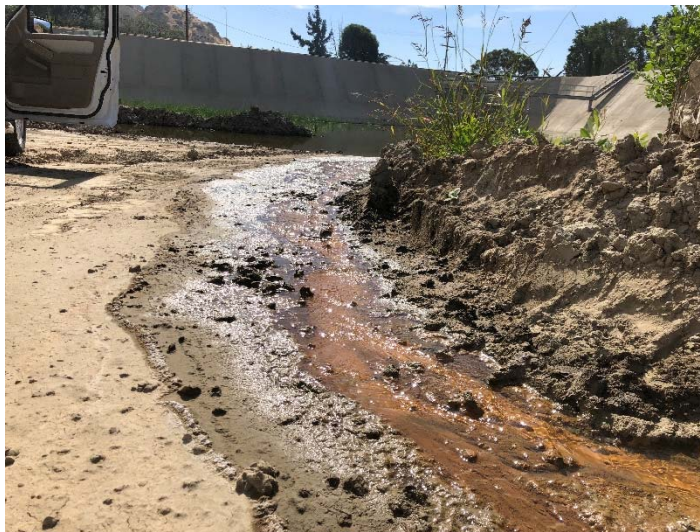
**Photo 478: Alluvial Seep Flow into Terminal Basin: July 5, 2018**

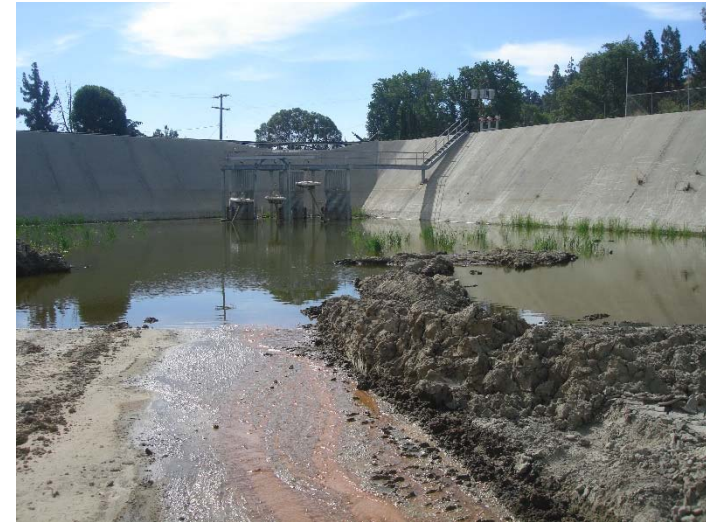
**Photo 479: Alluvial Seep Flow into Terminal Basin: July 5, 2018**

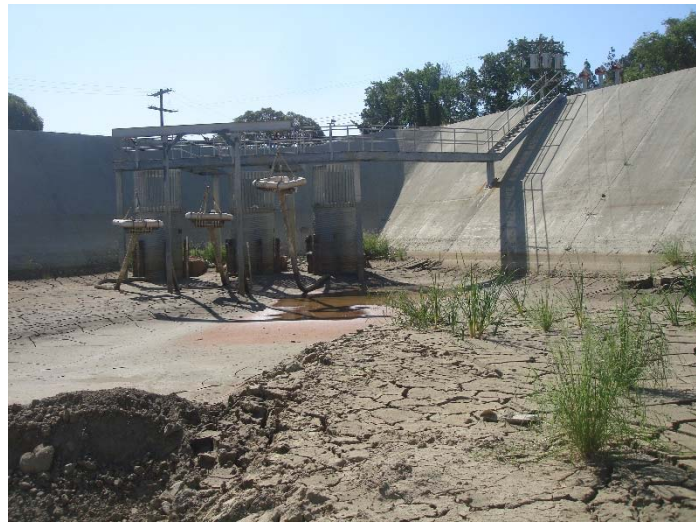
**Photo 526: Terminal Basin: July 24, 2018**

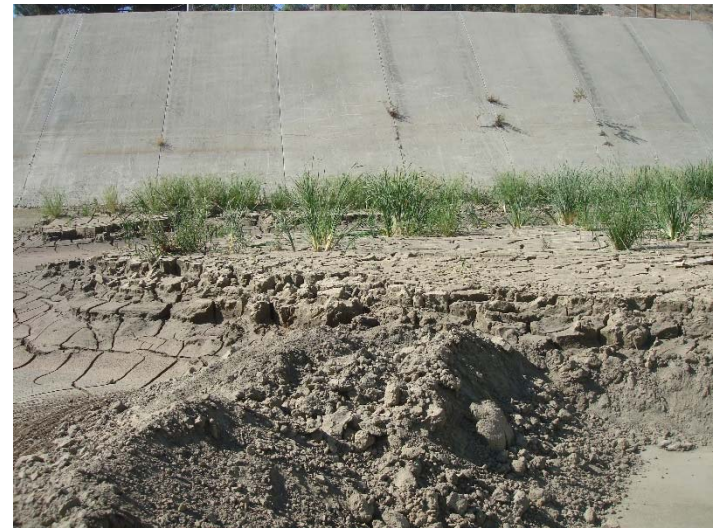
**Photo 527: Terminal Basin: July 24, 2018**

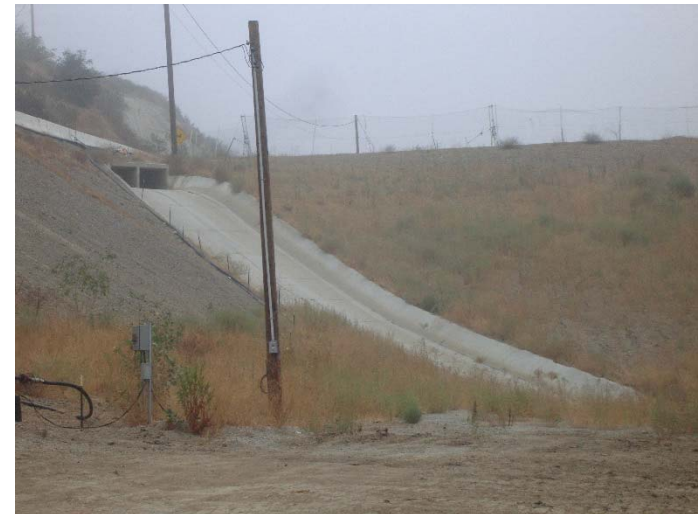
**Photo 551: Terminal Basin Outlet: September 12, 2018**

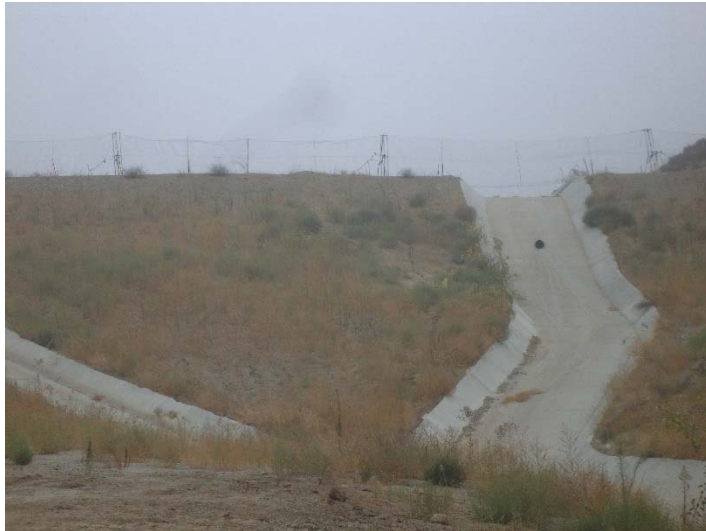
**Photo 552: Terminal Basin Westside Drainage Channel Inlet:  
September 25, 2018**
