**Sunshine Canyon Landfill  
Independent Monitor  
Quarterly Site Monitoring Status Report  
July 1, 2018 – September 30, 2018**

**City of Los Angeles Department of City Planning**

**County of Los Angeles Department of Regional Planning**

November 5, 2018

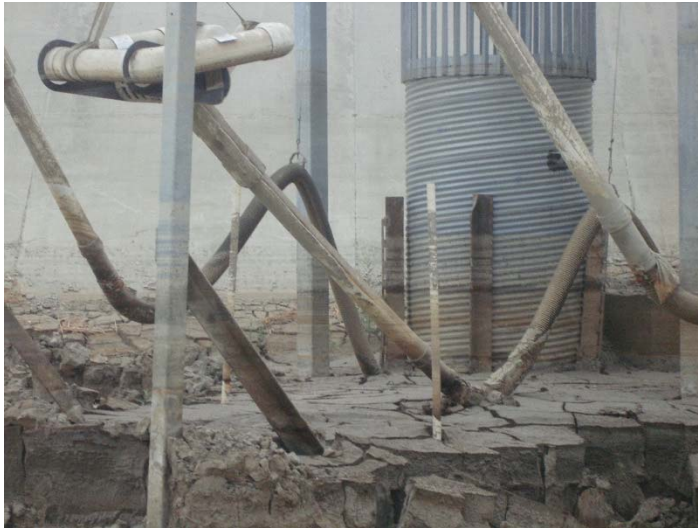
**Photo 564: Terminal Basin Outlet Risers: September 25, 2018**

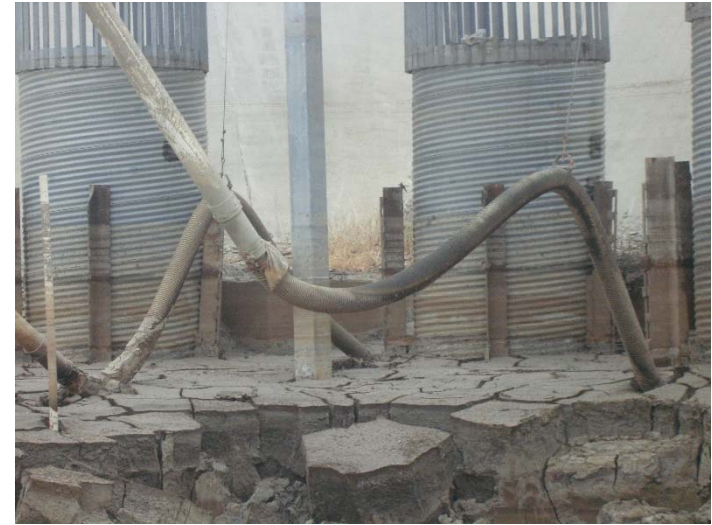
**Photo 565: Terminal Basin Outlet Risers: September 25, 2018**

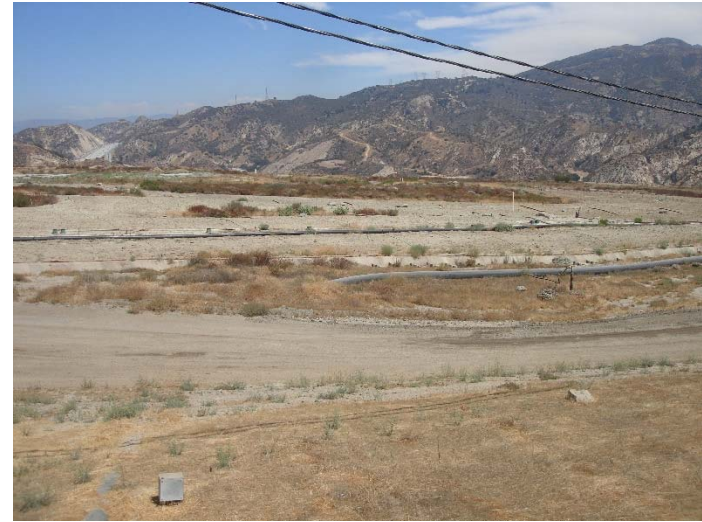
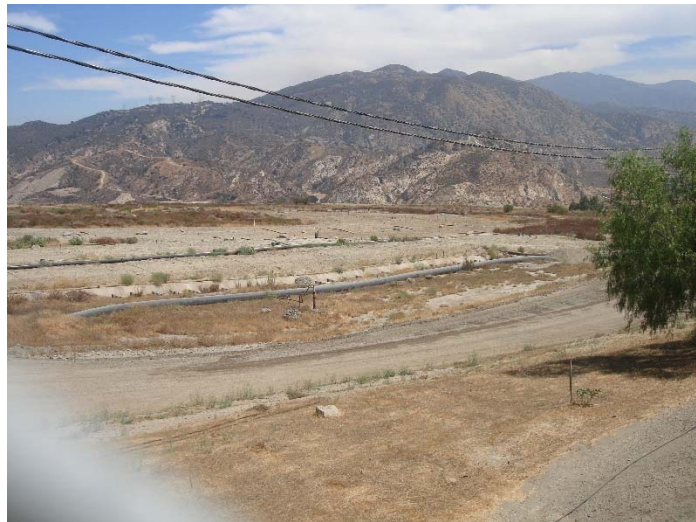
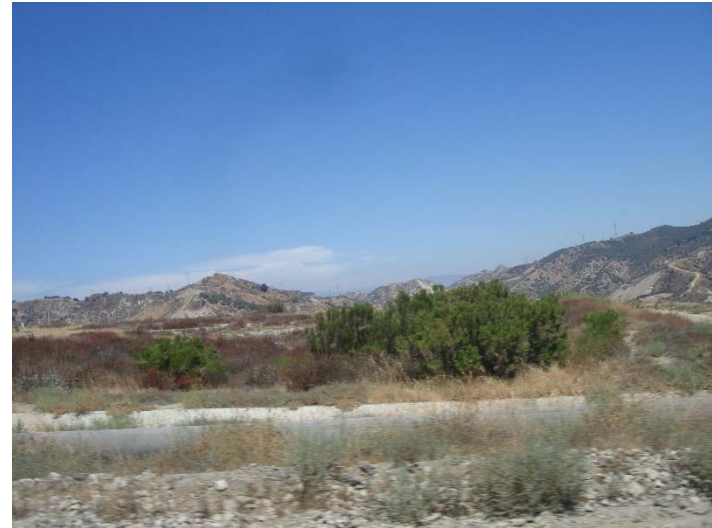
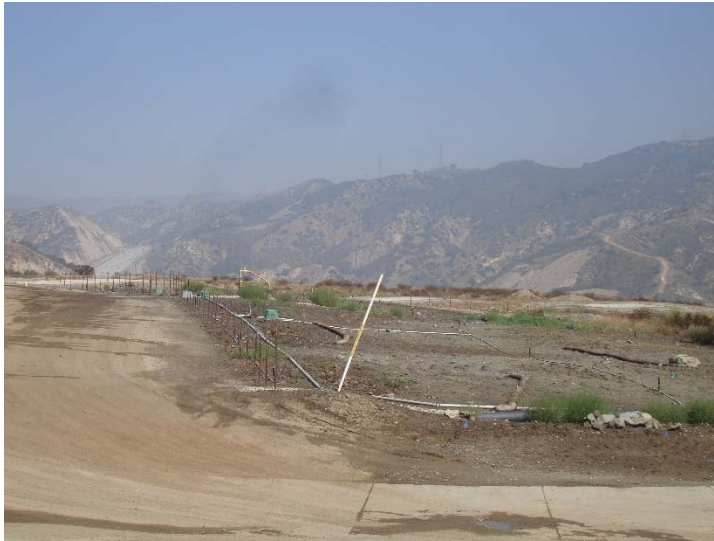
**Photo 621: Deck B Sage Mitigation Area: August 29, 2018**

**Photo 622: Deck B Sage Mitigation Area: August 29, 2018**

**Photo 623: Deck B Sage Mitigation Area: August 29, 2018**

**Photo 624: Deck B Sage Mitigation Area: August 29, 2018**

- The eastside channel had a significant amount of sediment and gabion rock removed. The channel south of Basin B had portions of the wall cracking and spalling.
- The north secondary access gate was locked.
- CC-4A Part 3 buttress soils were being stockpiled on the County far north top deck.
- No re-vegetation or slope stability activities had occurred on the County sage mitigation slopes.
- Basin A had all but one pile of sediment removed. The rock around the outlet risers was not cleaned.
- The back portion of Basin A had dead cut brush and litter in the native vegetation.
- Excavation was ongoing for the Cell CC-4 Part 3 buttress. A paleontological monitor was onsite.
- Deck C sage mitigation area was going through summer die-back.
- Deck B sage mitigation area was ready for fall planting.

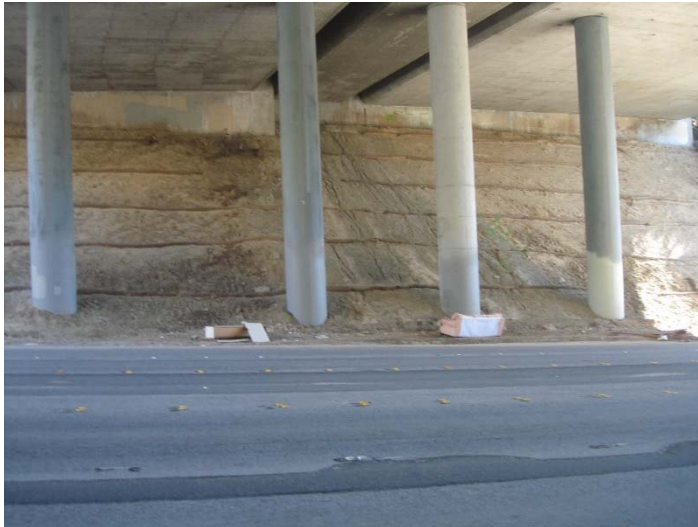
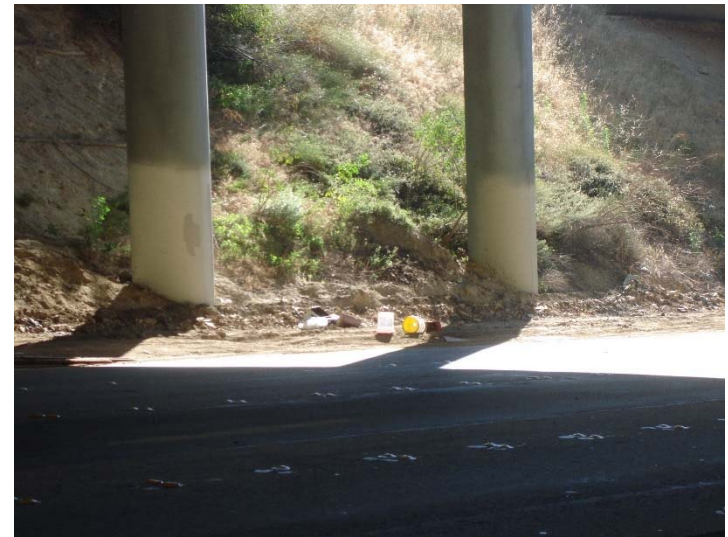
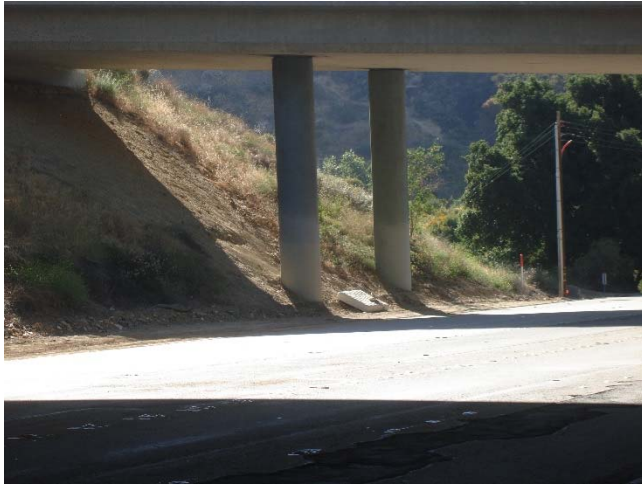
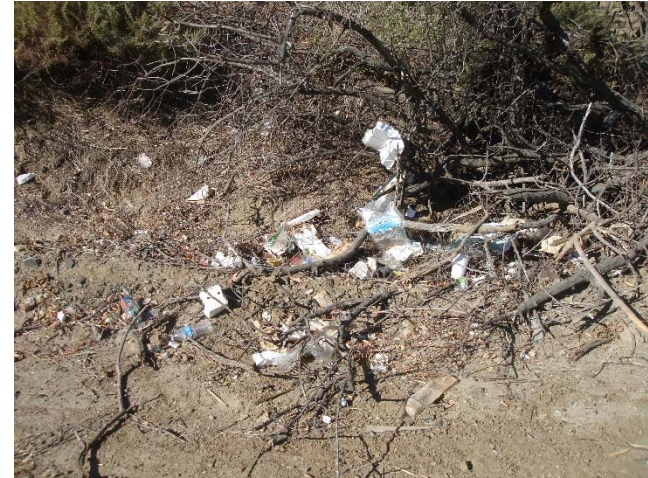
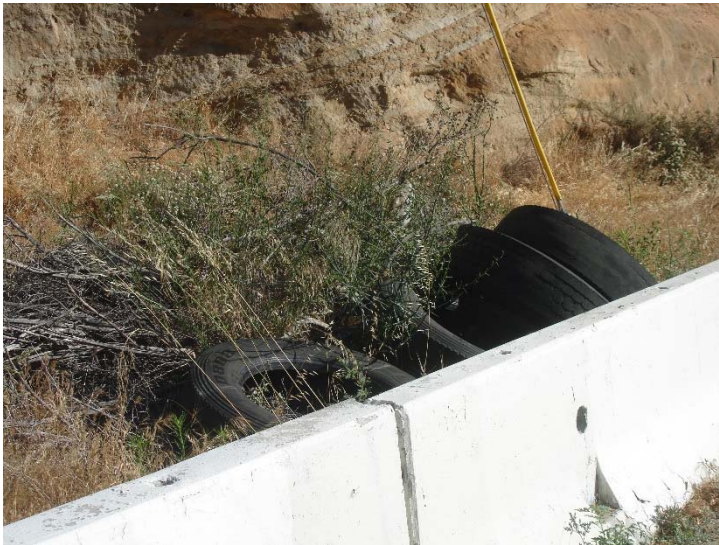
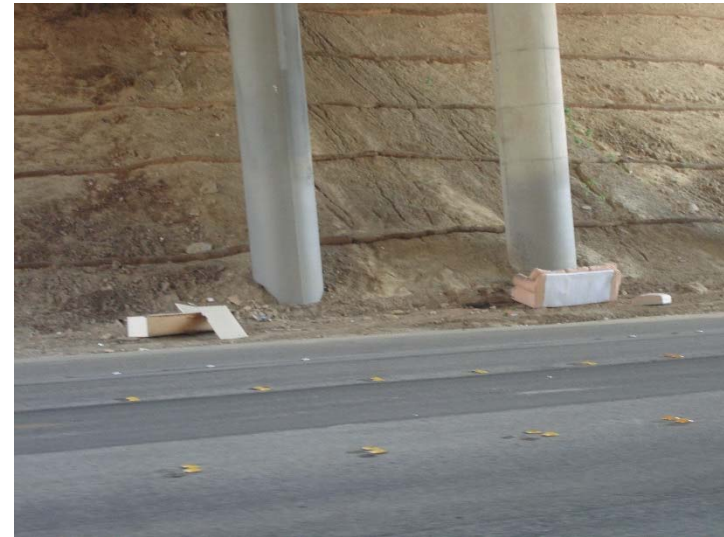
**Photo 634: Illegal Dumping at Sierra Highway Near I-14 Overpass:  
July 5, 2018**

**Photo 635: Illegal Dumping at Sierra Highway Near I-14 Overpass:  
July 5, 2018**

**Photo 636: Illegal Dumping at Sierra Highway Near I-14 Overpass:  
July 5, 2018**

**Photo 637: Illegal Dumping at Sierra Highway Near I-14 Overpass:  
July 5, 2018**

**Photo 638: Illegal Dumping at Sierra Highway Near I-14 Overpass:  
July 5, 2018**

**Photo 639: Illegal Dumping at Sierra Highway Near I-14 Overpass:  
July 5, 2018**

1. Eliminate gas odor at Cell CC-3B.
2. Remove debris along Sierra Highway.
3. Install a trash guard in low-flow drain at sediment basin CC-3B.
4. Remove erosion ruts at secondary access road.
5. Eliminate gas odor at well 2098.
6. Repair gabion blocks at eastside drainage channel.

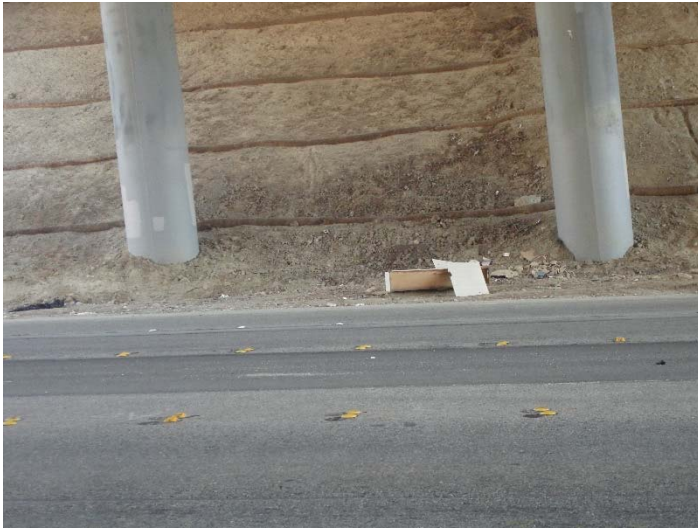
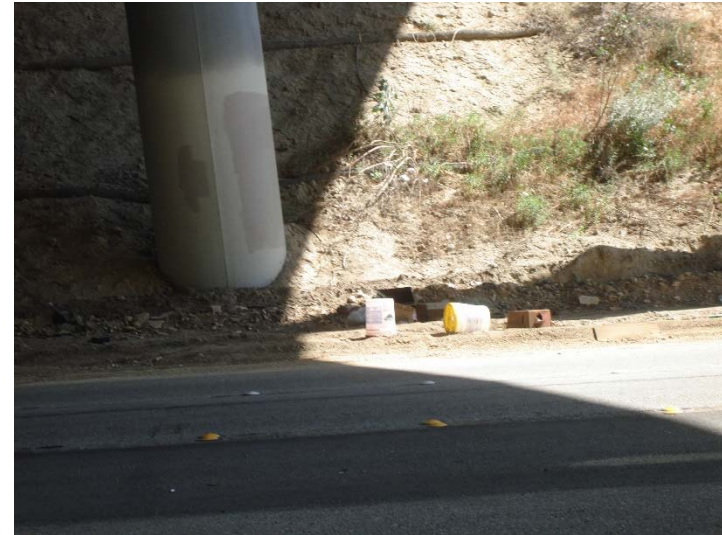
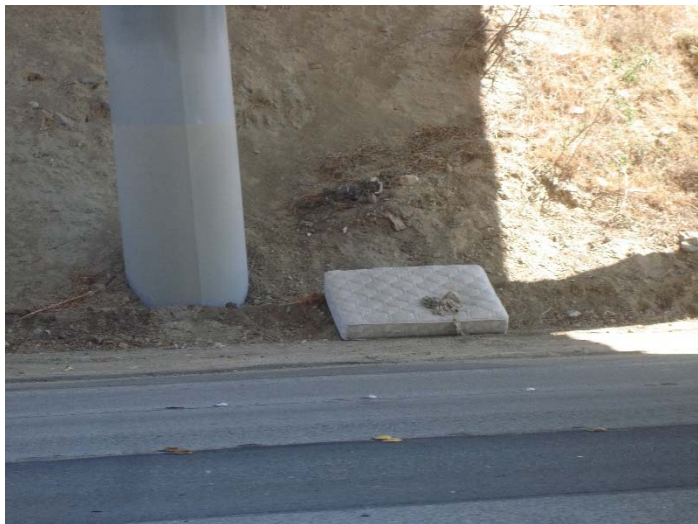
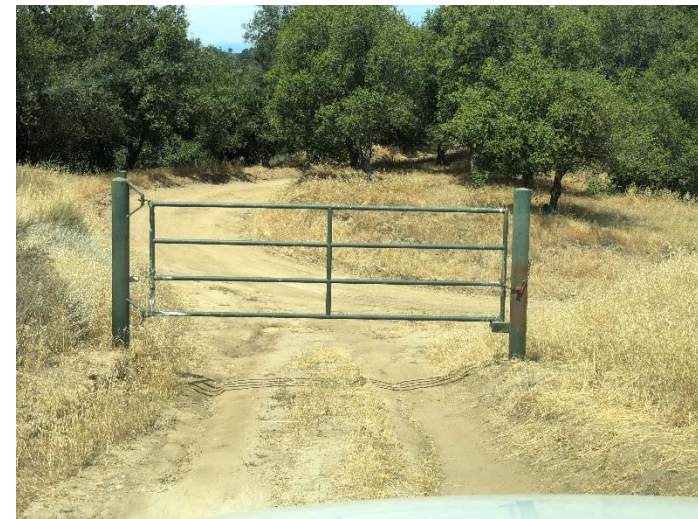
**Photo 640: Illegal Dumping at Sierra Highway Near I-14 Overpass:  
July 24, 2018**

**Photo 641: Illegal Dumping at Sierra Highway Near I-14 Overpass:  
July 24, 2018**

**Photo 642: Illegal Dumping at Sierra Highway Near I-14 Overpass:  
July 24, 2018**

**Photo 643: Illegal Dumping at Sierra Highway Near I-14 Overpass:  
July 24, 2018**

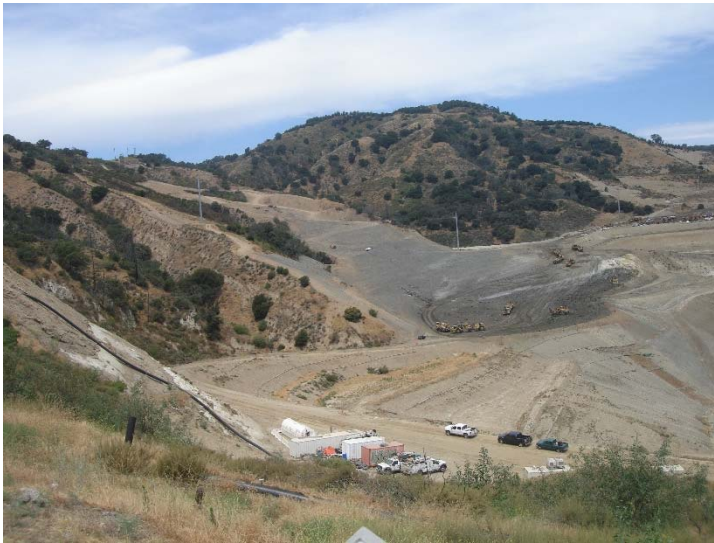
**Photo 644: Northern Access Road Locked Gate: July 5, 2018**

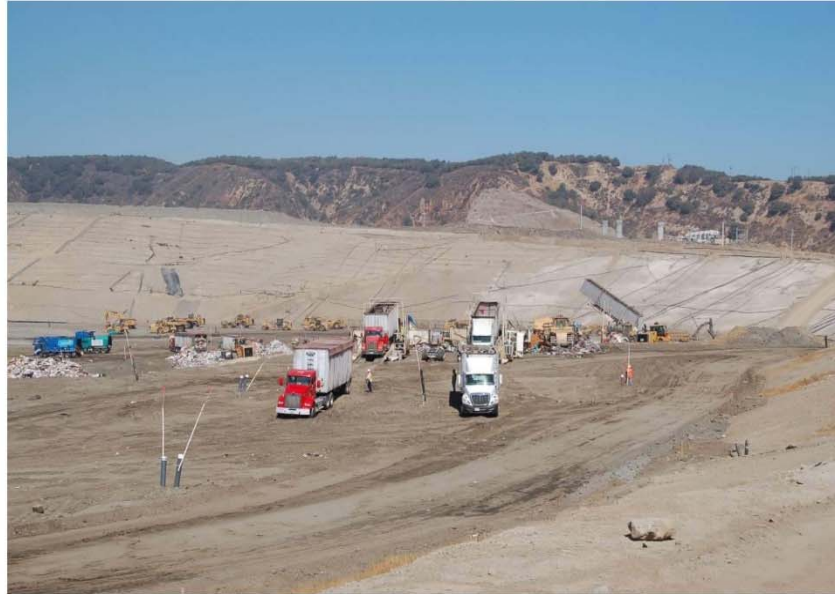
8:00 Meet Gabriel Esparza and Gladys Gallardo of L.A. County	
8:00 – 1:00 Site inspection	
<ul style="list-style-type: none"> <li>• Tour of landfill</li> <li>• Access Roads</li> <li>• Waste placement</li> <li>• Erosion protection system</li> <li>• Drainage systems (Basins, channels)</li> <li>• Excavation area for Cell CC4 Phase 3</li> <li>• Landfill for geotechnical and hydrological issues</li> <li>• Other observations</li> </ul>	
Access Roads.	
<ul style="list-style-type: none"> <li>• Access road to administration pad. The slump observed near the end of the road on the hill on south side of the road during past visits is still there – Republic notified us that their consultant is now monitoring the slump. The slopes in the area have been groomed to allow installation of erosion protection systems</li> </ul>	
Waste Placement in Cell CC4	
<ul style="list-style-type: none"> <li>• Waste was placed in Part 1 (Photo 1) <ul style="list-style-type: none"> <li>– 2 Tilters were in used (Photo 1)</li> <li>– interim daily cover was used and being covered (Photo 2)</li> </ul> </li> </ul>

Photo 1: Landfilling in Cell CC4 – Part 1

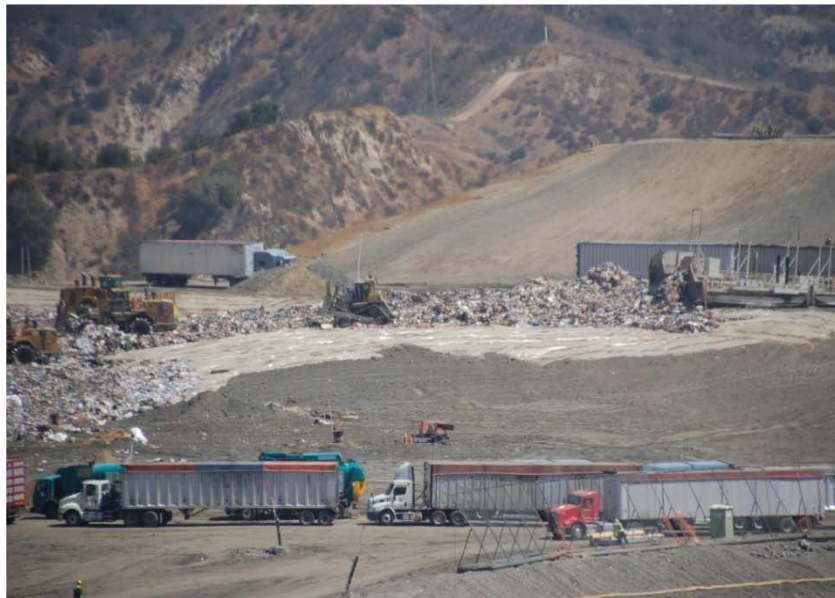
Photo 2: Alternative daily cover at Cell CC4 – Part 1

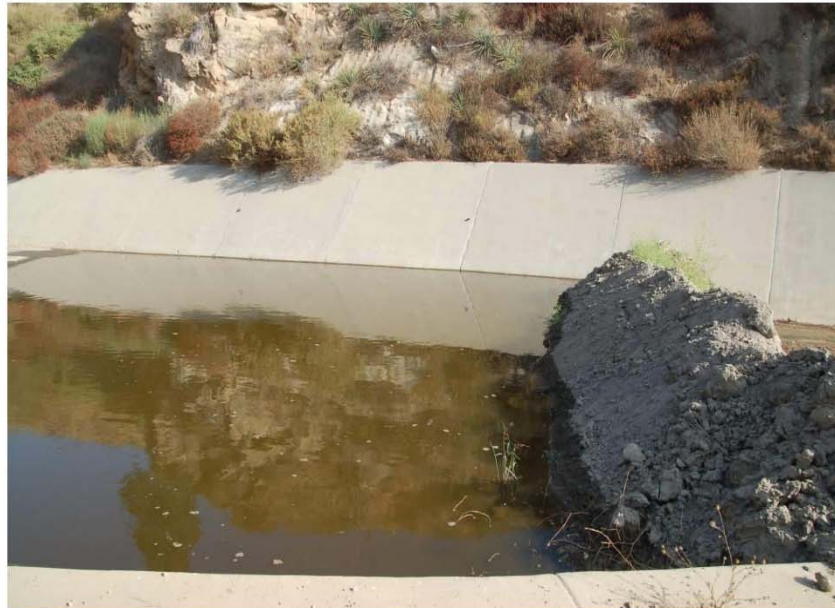
Drainage System	
<ul style="list-style-type: none"> <li>• Terminal Basin <ul style="list-style-type: none"> <li>– The basin still contains some sediment (Photo 3) but we understand it is being hauled off as soon as dry.</li> <li>– An earth check dam has been installed at the entrance of basin in front of the 96 inch pipe stubs to control water to allow for sediments to dry (Photo 4).</li> <li>– The three skimmers were raised</li> <li>– Seeps of reddish water observed between the bottom and the side slabs and through the weep holes during previous visits have stopped.</li> <li>– plants are growing in the cracks between panels on both the inside and outside sidewalls of the basin (Photo 5)</li> </ul> </li> <li>• Basin A</li> </ul>

Photo 4: Earth check dam at entrance of terminal basin

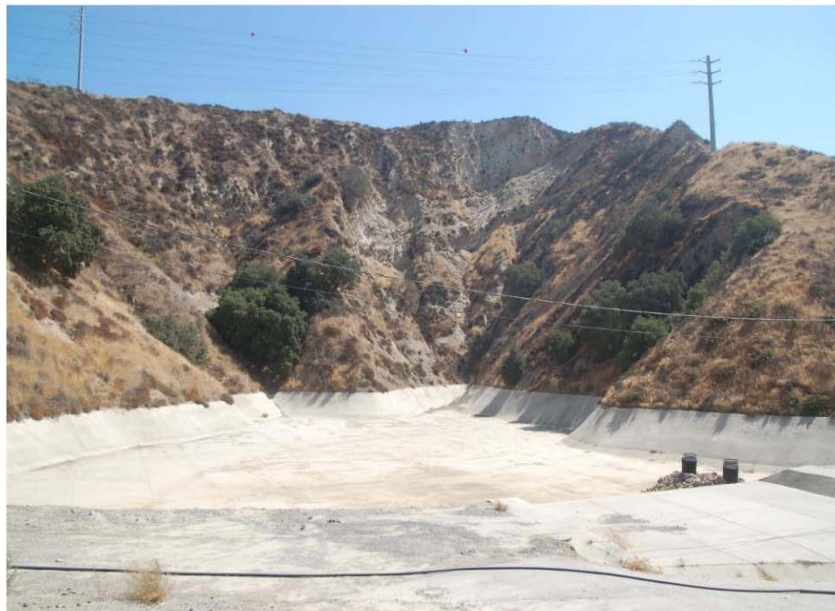
Photo 8: Basin B

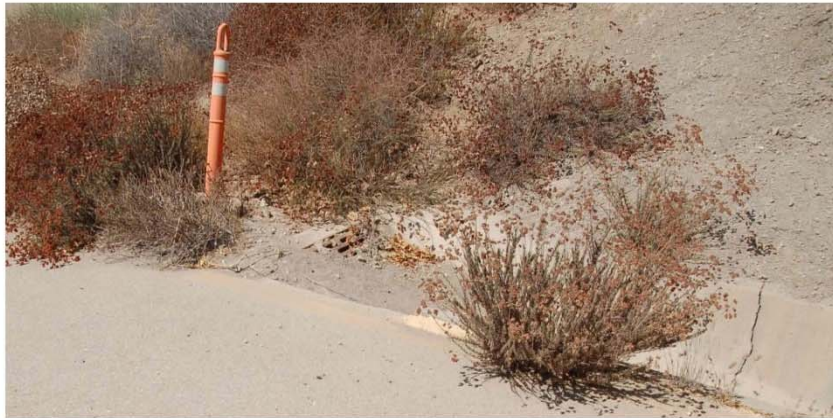
Photo 13: Sediments blocking the outlet drain of channel along the access road to the Flares 9-11

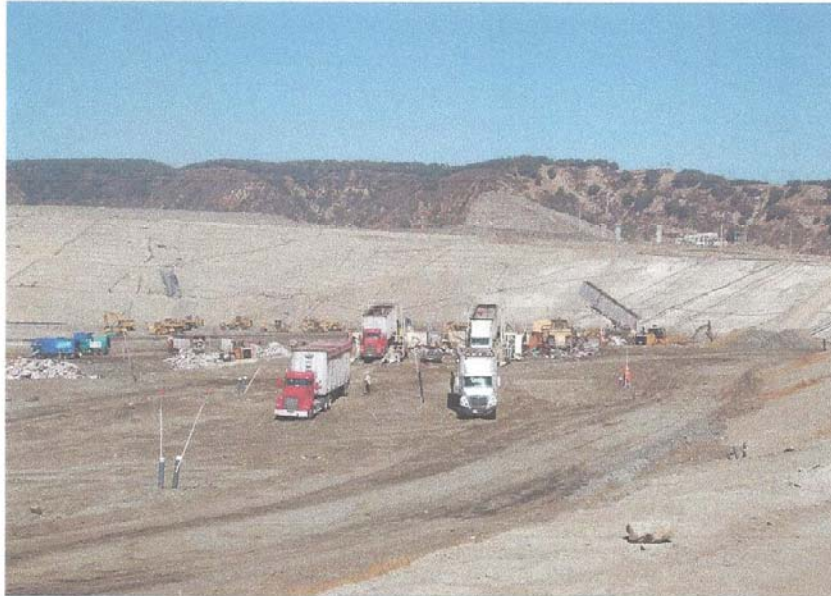
8:00 Meet Gabriel Esparza and Gladys Gallardo of L.A. County	
8:00 – 1:00 Site inspection <ul style="list-style-type: none"> <li>• Tour of landfill</li> <li>• Access Roads</li> <li>• Waste placement</li> <li>• Erosion protection system</li> <li>• Drainage systems (Basins, channels)</li> <li>• Excavation area for Cell CC4 Phase 3</li> <li>• Landfill for geotechnical and hydrological issues</li> <li>• Other observations</li> </ul>	
Access Roads. <ul style="list-style-type: none"> <li>• Access road to administration pad. The slump observed near the end of the road on the hill on south side of the road during past visits is still there – Republic notified us that their consultant is now monitoring the slump. The slopes in the area have been groomed to allow installation of erosion protection systems</li> </ul>	
Waste Placement in Cell CC4 <ul style="list-style-type: none"> <li>• Waste was placed in Part 1 (Photo 1) <ul style="list-style-type: none"> <li>– 2 Tilters were in used (Photo 1)</li> <li>– Interim daily cover was used and being covered (Photo 2)</li> </ul> </li> </ul>

Photo 1: Landfilling in Cell CC4 – Part 1

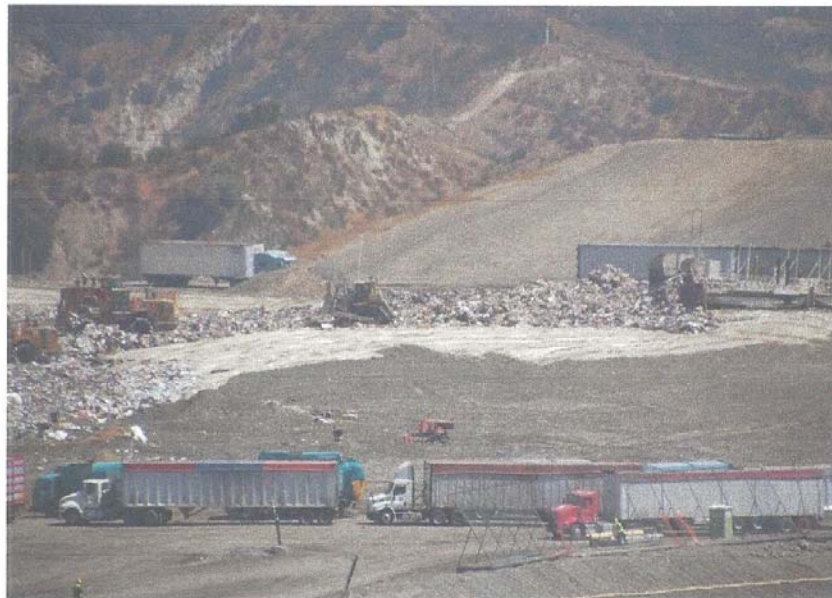
Photo 2: Alternative daily cover at Cell CC4 – Part 1

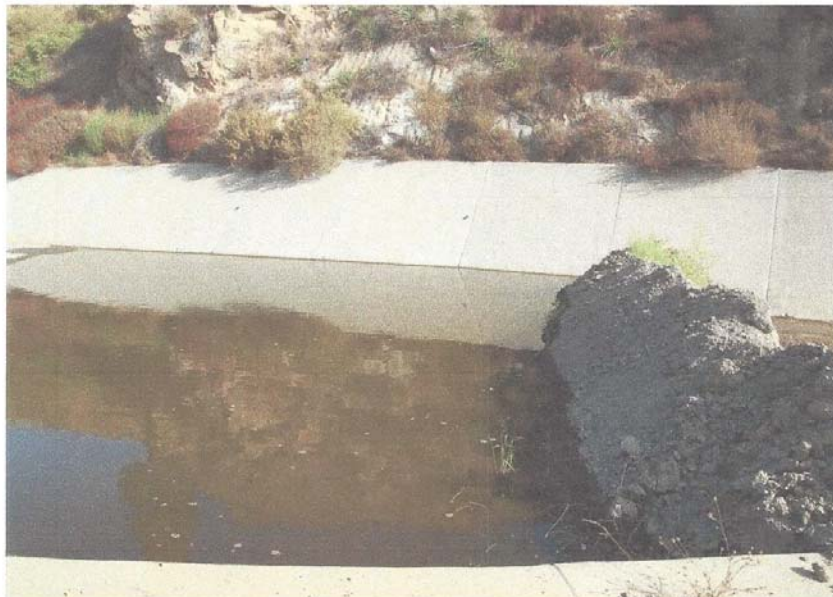
Drainage System <ul style="list-style-type: none"> <li>• Terminal Basin <ul style="list-style-type: none"> <li>– The basin still contains some sediment (Photo 3) but we understand it is being hauled off as soon as dry.</li> <li>– An earth check dam has been installed at the entrance of basin in front of the 96 inch pipe stubs to control water to allow for sediments to dry (Photo 4).</li> <li>– The three skimmers were raised</li> <li>– Seeps of reddish water observed between the bottom and the side slabs and through the weep holes during previous visits have stopped.</li> <li>– plants are growing in the cracks between panels on both the inside and outside sidewalls of the basin (Photo 5)</li> </ul> </li> <li>• Basin A</li> </ul>

Photo 4: Earth check dam at entrance of terminal basin

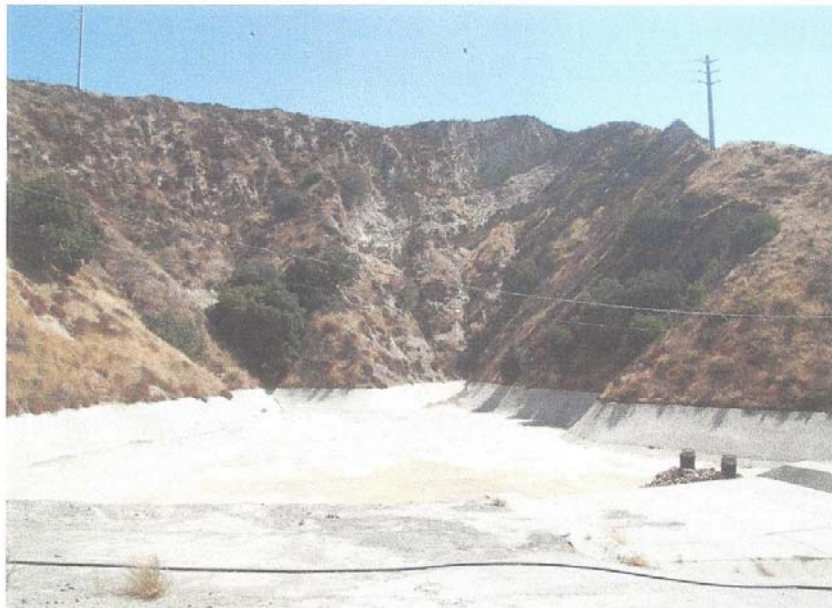
Photo 8: Basin B
