**Sunshine Canyon Landfill
Independent Monitor
Quarterly Site Monitoring Status Report
January 1, 2016 – March 31, 2016**

City of Los Angeles Department of City Planning

County of Los Angeles Department of Regional Planning

May 16, 2016

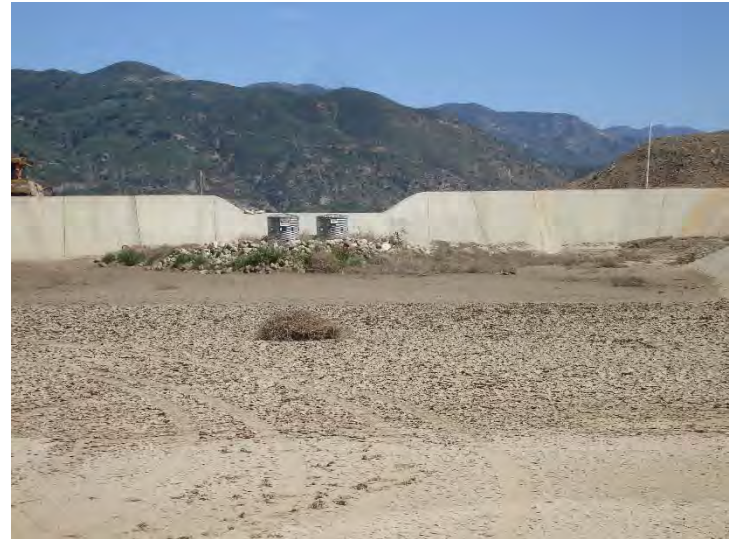
Photo 37: Basin A: March 23, 2016

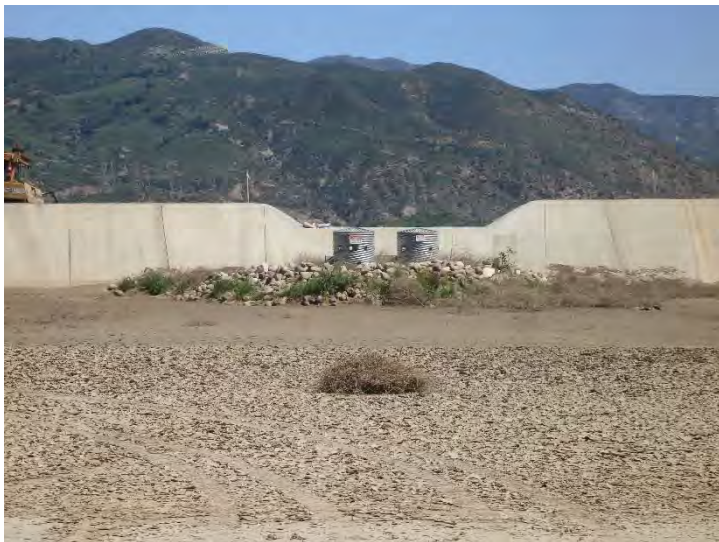
Photo 38: Basin A: March 23, 2016

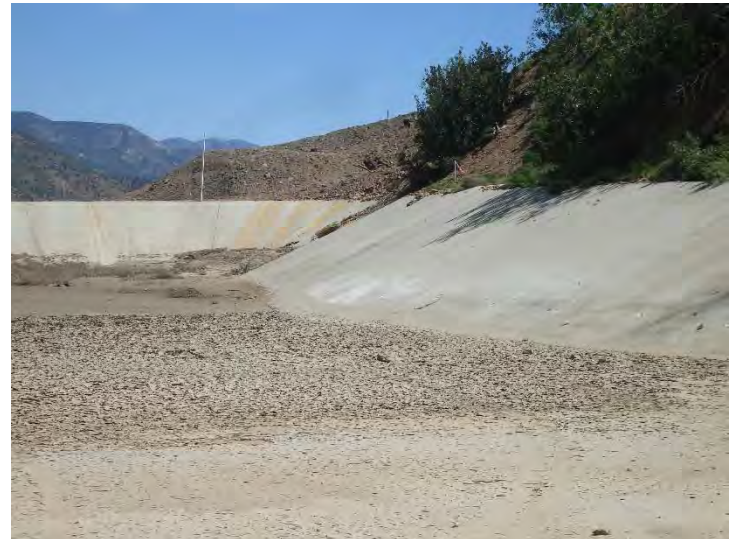
Photo 39: Basin A: March 23, 2016

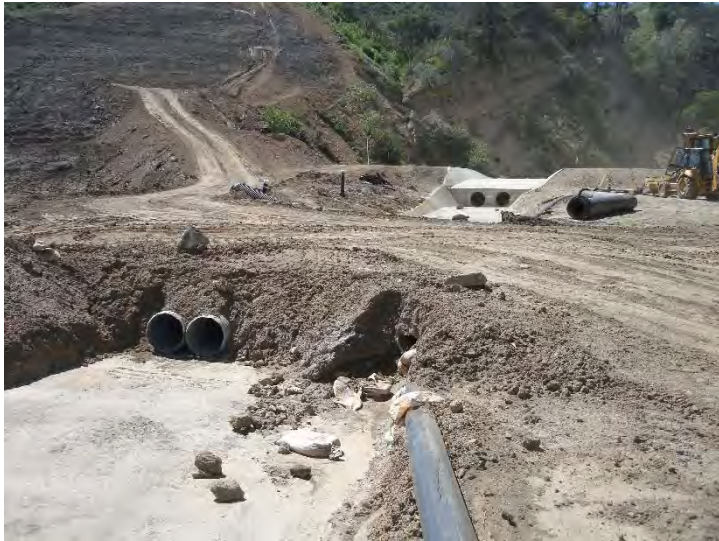
Photo 40: Basin A: March 23, 2016

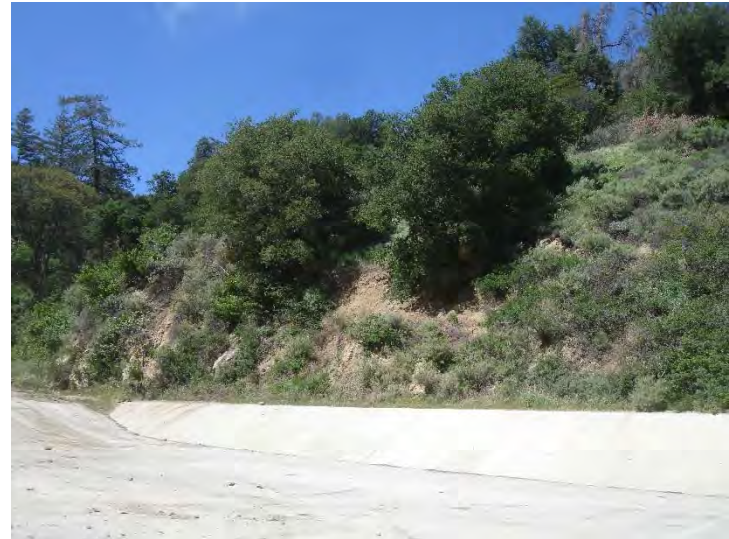
Photo 41: Basin A Outlet: March 23, 2016

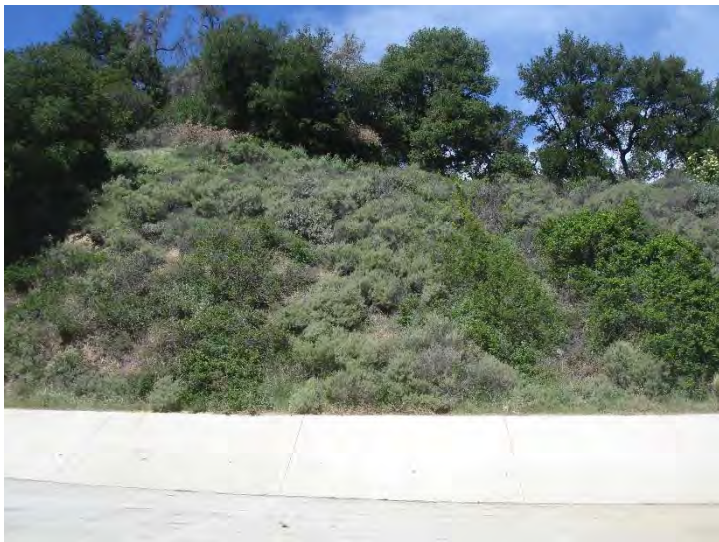
Photo 42: Basin A Native Hillside: March 23, 2016

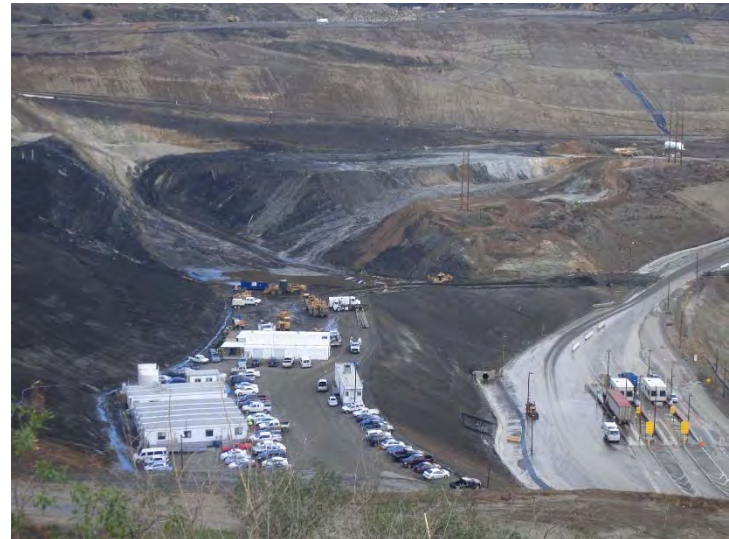
Photo 43: Basin A Native Hillside: March 23, 2016

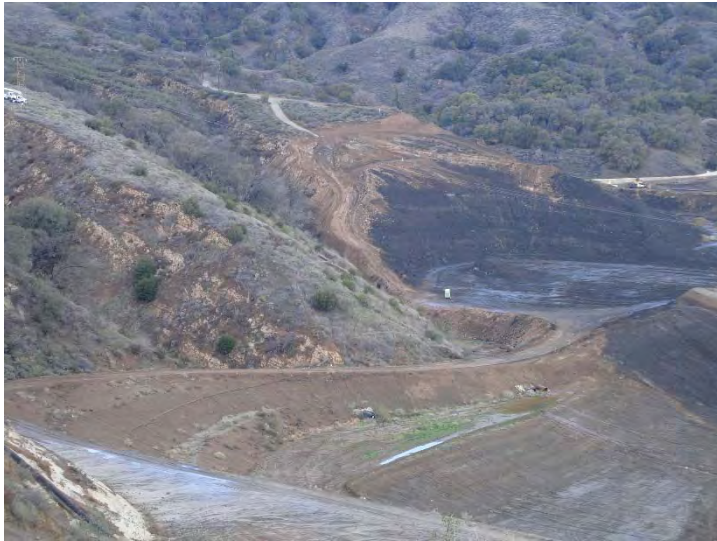
Photo 44: Site Grading South of Basin A: January 7, 2016

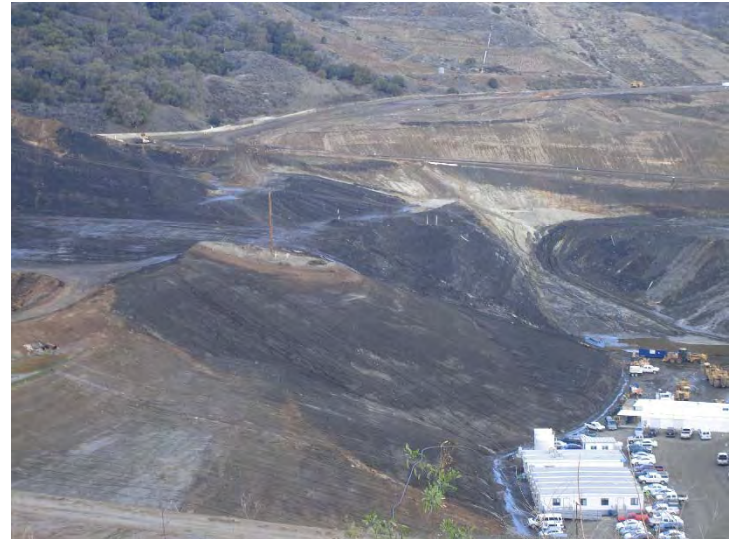
Photo 45: Site Grading South of Basin A: January 7, 2016

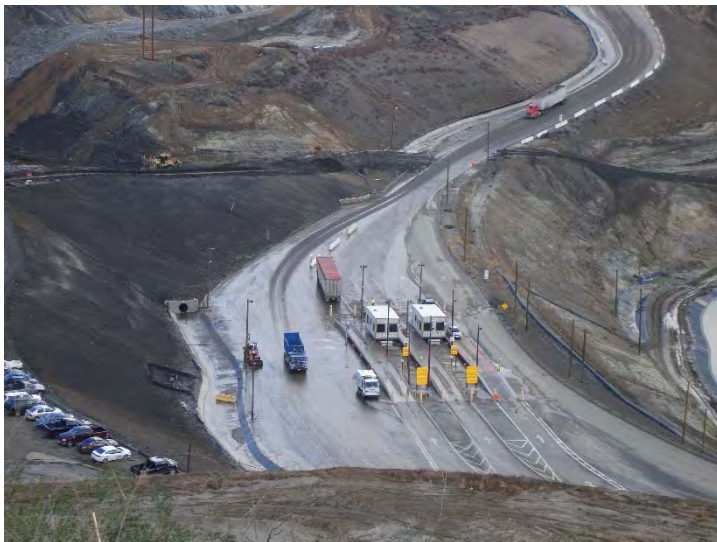
Photo 46: Site Grading South of Basin A: January 7, 2016

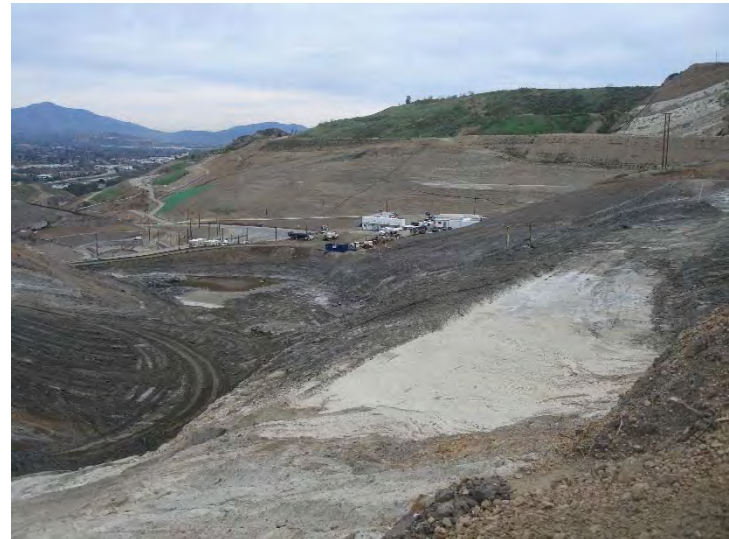
Photo 47: Site Scale Facilities: January 7, 2016

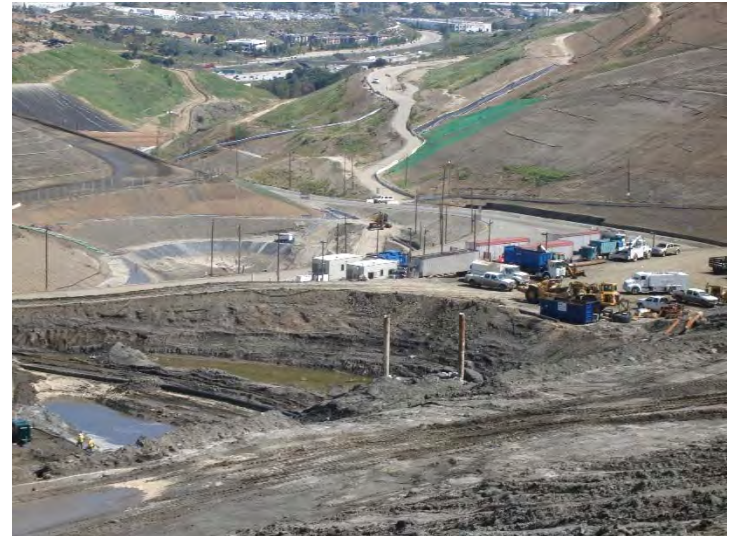
M - 4.1.1 / 7	Re-abandonment Procedures	County Forester	I-a, I-b, I-c, I-d and I-e: The two old, previously abandoned oil wells in the future Cell CC-4 have not been lowered as additional grading is required in that area before they can be lowered and re-abandoned. Current tests show no oil or gas emissions.
	M - 4.2.12 / 28		Fire Warden	<p>I-a, I-b, I-c, I-d and I-e: El Niño rains provided the moisture to germinate the areas along the realigned access road that had jute netting and were hydroseeded. Other areas in the landfill that were hydroseeded in 2014 had some of those areas germinate. The old City South Landfill had the existing plants and their seeds filled in and green-up from the rains.</p> <p>Alternatives to hydroseeding on interim and inactive slopes and decks for slope stability and dust control were being used due to the drought. Jute netting and plastic netting was being used on slopes. No hydroseeding was done in the fall of 2015.</p> <p>The majority of the slope erosion control was being done by straw wattles and they performed well in most areas. During the extremely heavy rain events, the HDPE-lined down-comers and bench V-ditches east of Cell CC-3B had washed away. The terminal basin performed well and controlled sediment from leaving the site.</p>

Photo 73: Oil Well Casings to be Abandoned: March 9, 2016

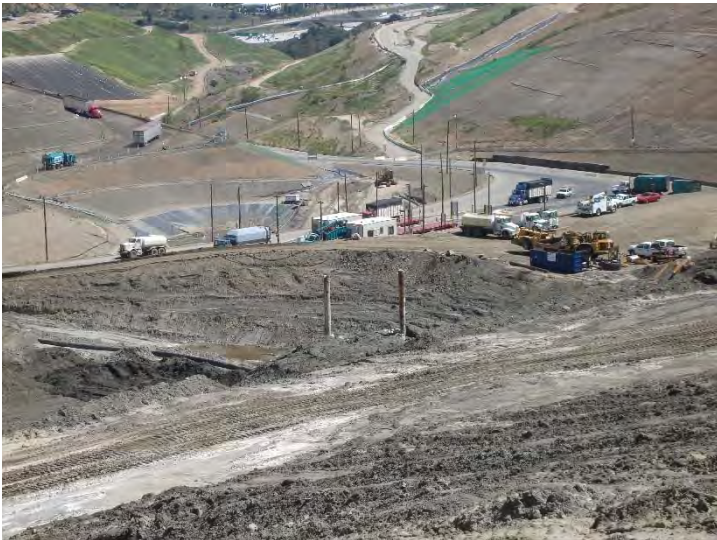
Photo 74: Oil Well Casings to be Abandoned: March 9, 2016

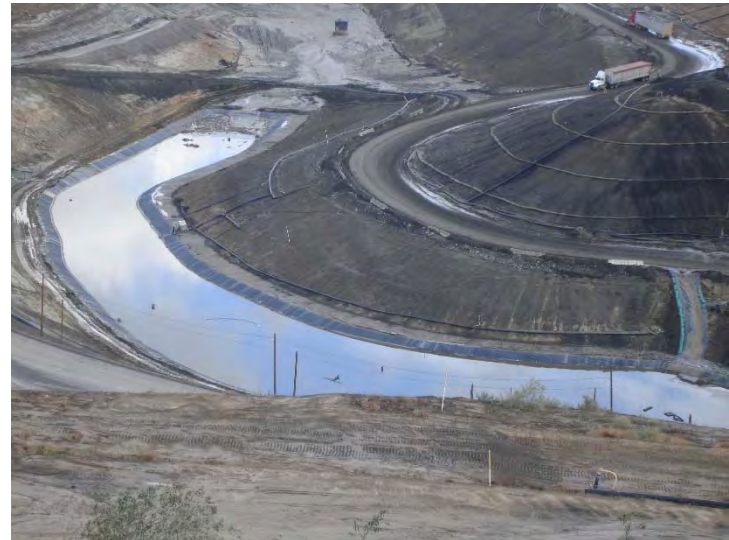
Photo 75: Oil Well Casings to be Abandoned: March 23, 2016

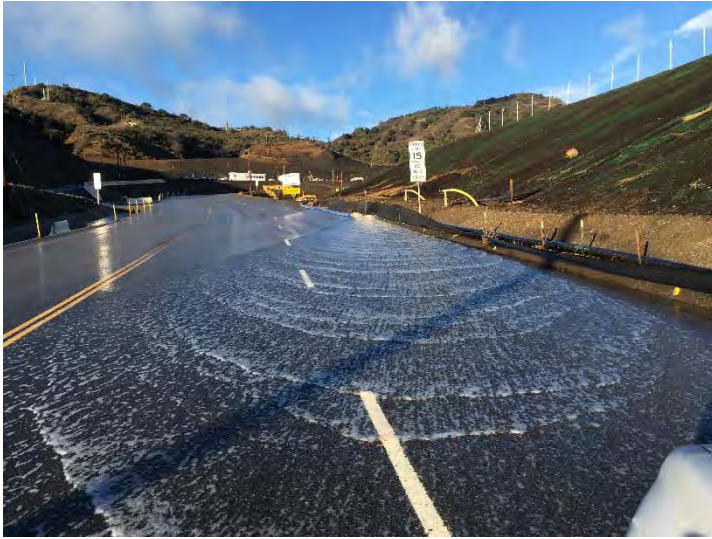
Photo 76: City Lined Drainage Lift Area: January 7, 2016

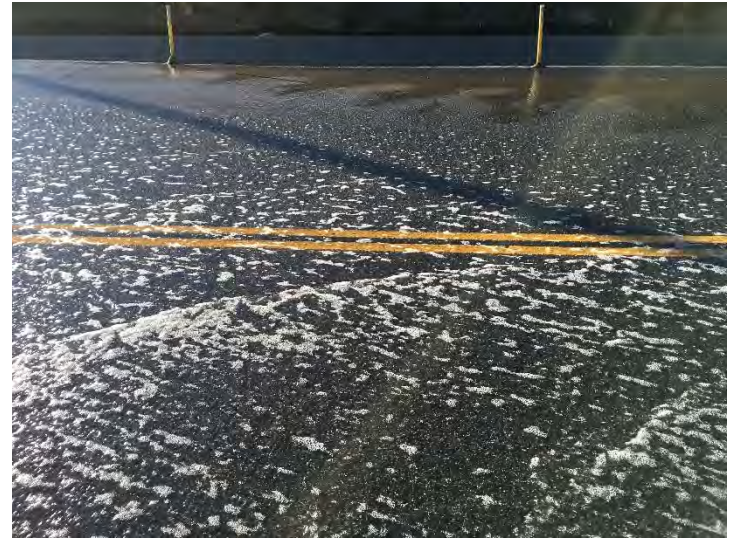
**Photo 77: Water Removal at City Lined Drainage Lift Area:
January 7, 2016**

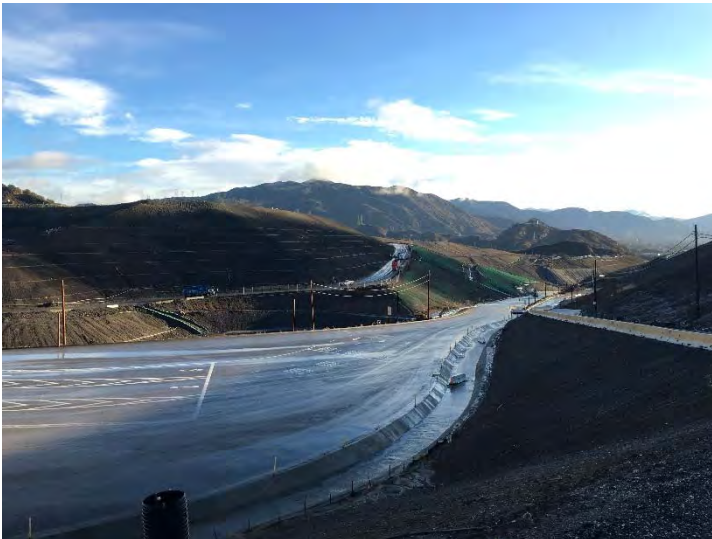
**Photo 78: Water Removal at City Lined Drainage Lift Area:
January 7, 2016**

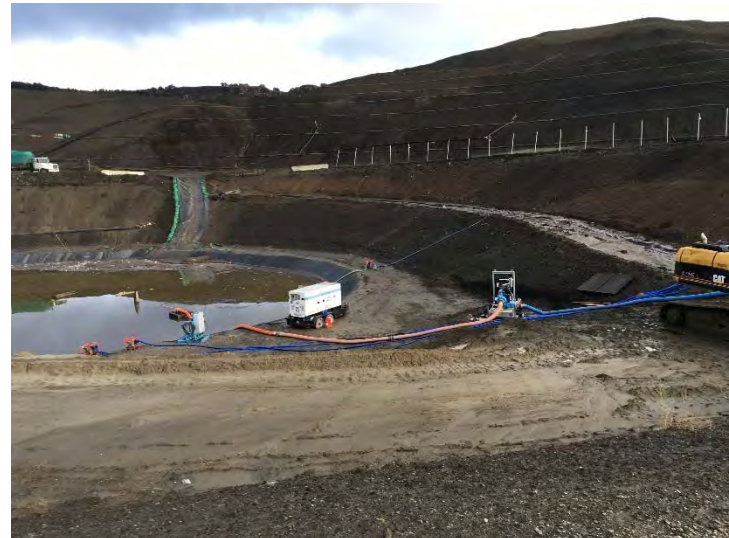
**Photo 79: Water Removal at City Lined Drainage Lift Area:
January 7, 2016**

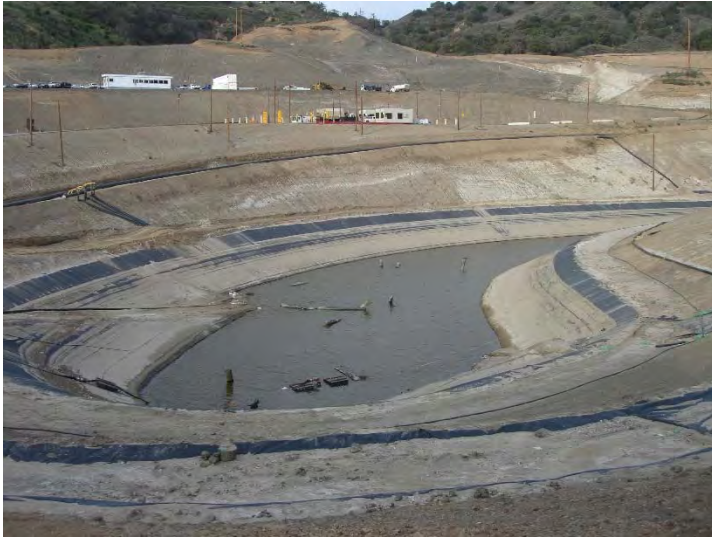
**Photo 80: Water Removal at City Lined Drainage Lift Area:
January 7, 2016**

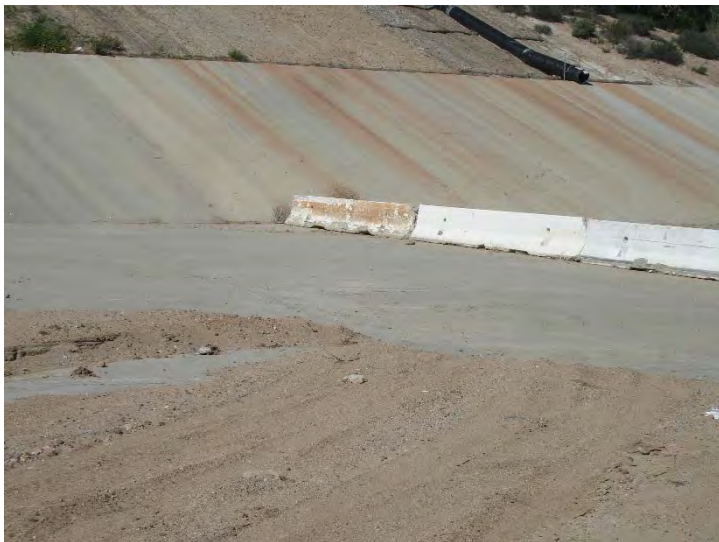
Photo 239: Terminal Basin: February 24, 2016

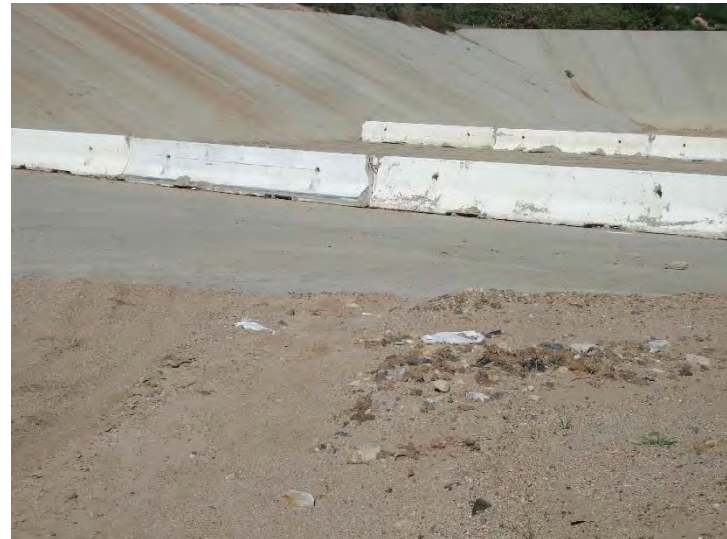
Photo 240: Terminal Basin: February 24, 2016

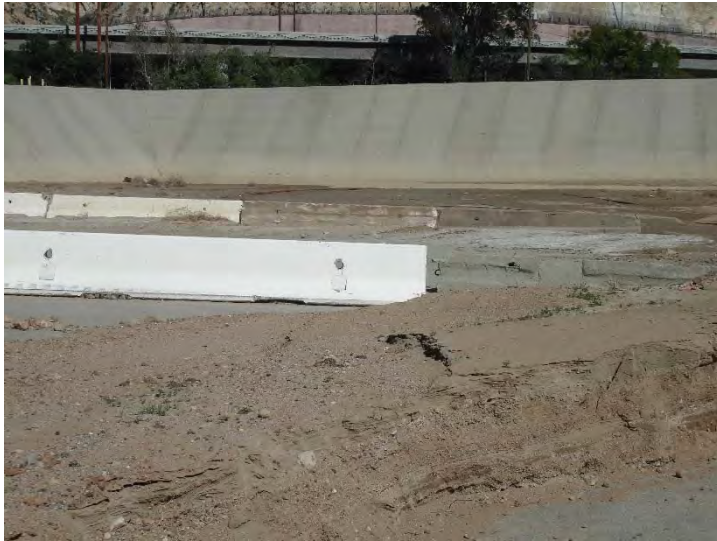
Photo 241: Terminal Basin: February 24, 2016

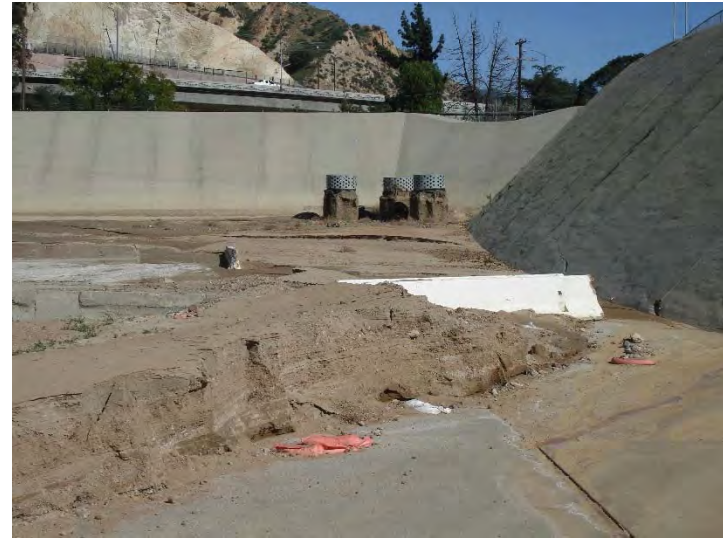
Photo 242: Terminal Basin: February 24, 2016

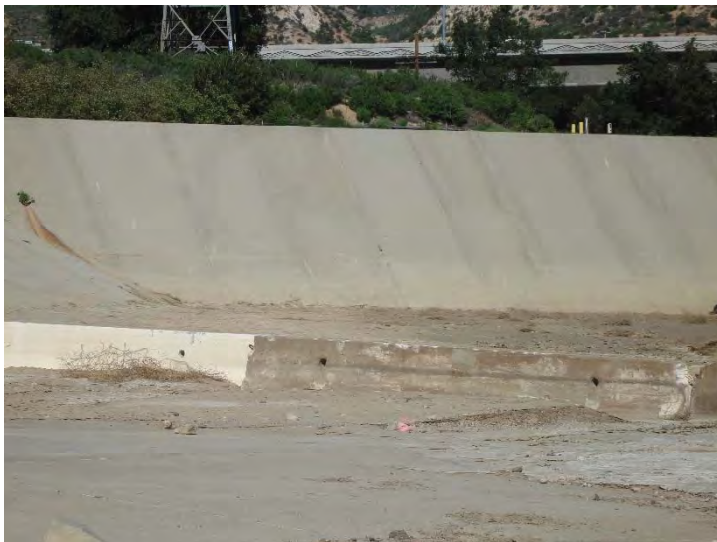
Photo 243: Terminal Basin: February 24, 2016

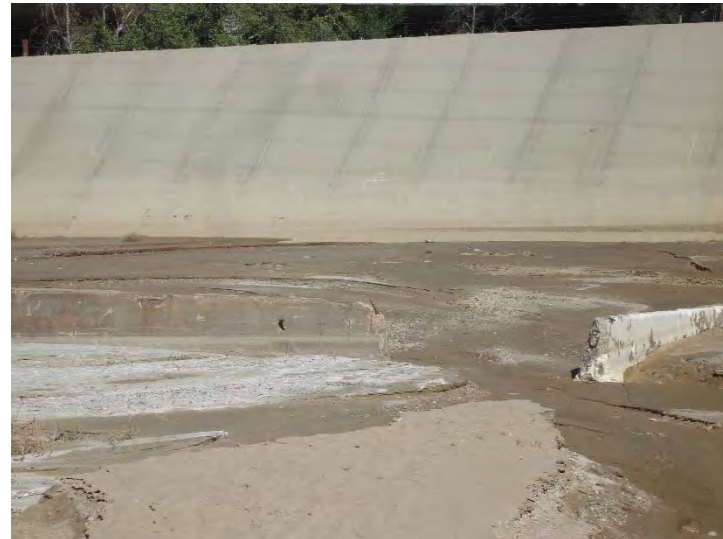
Photo 244: Terminal Basin: February 24, 2016

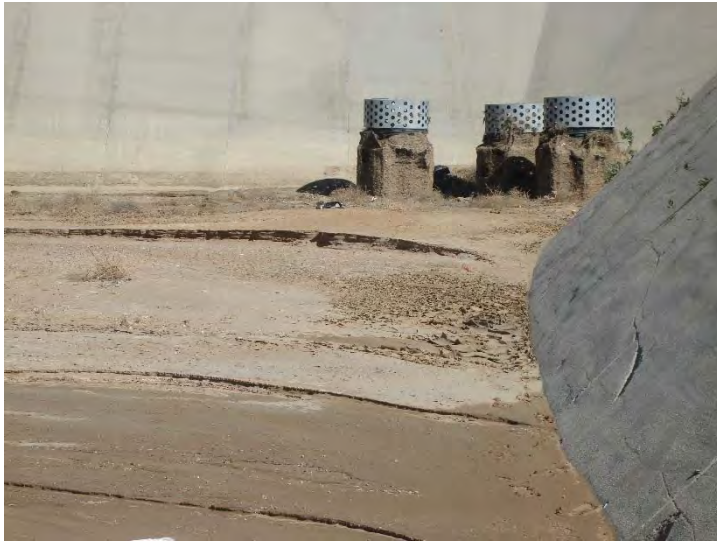
Photo 245: Terminal Basin: February 24, 2016

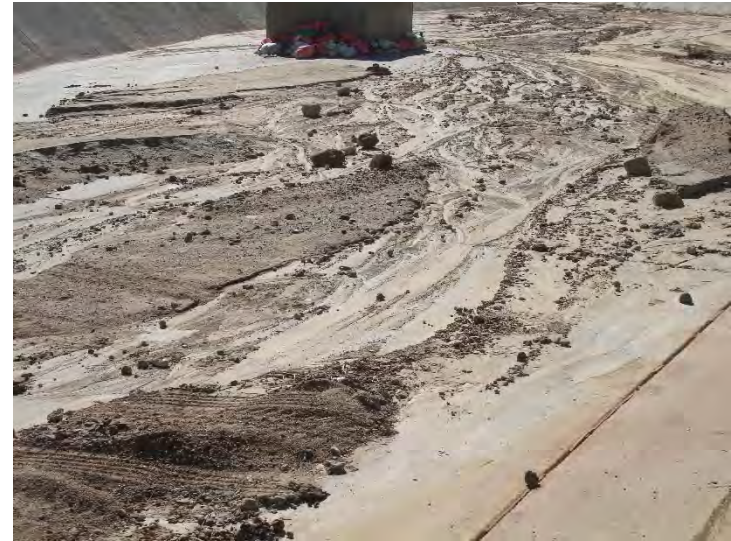
Photo 246: Terminal Basin: February 24, 2016

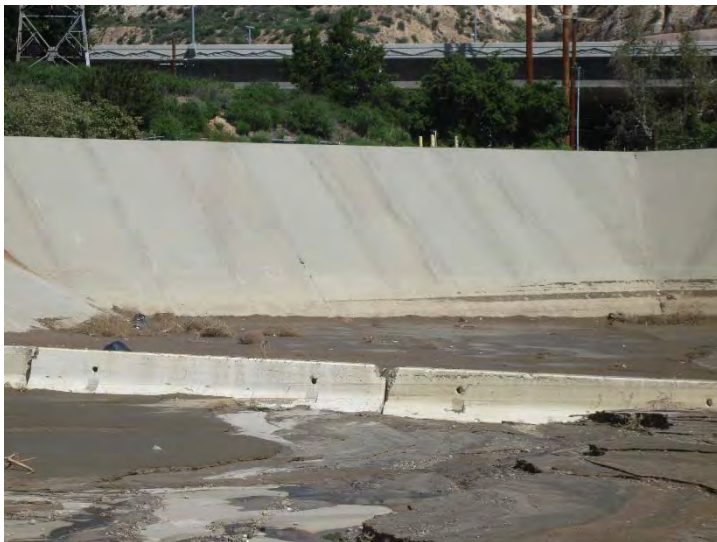
Photo 247: Terminal Basin: March 9, 2016

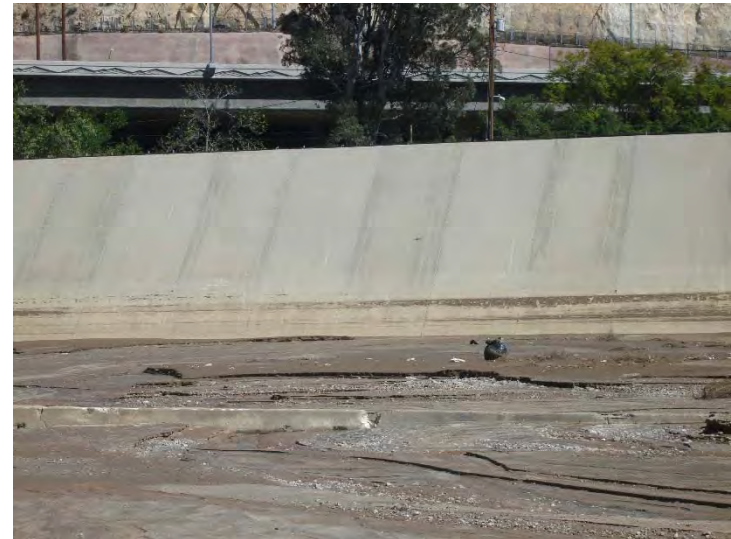
Photo 248: Terminal Basin: March 9, 2016

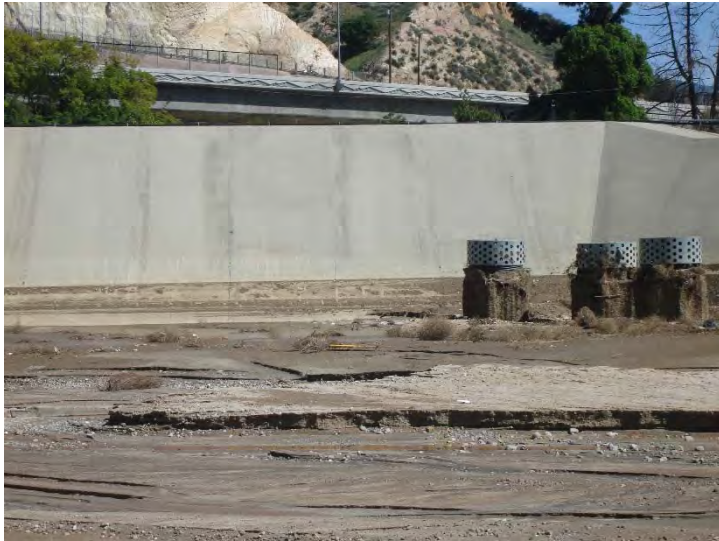
Photo 249: Terminal Basin: March 9, 2016

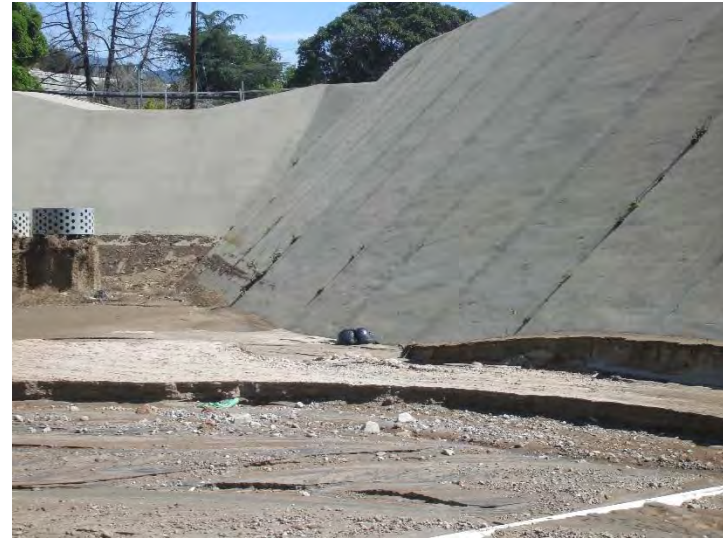
Photo 250: Terminal Basin: March 9, 2016

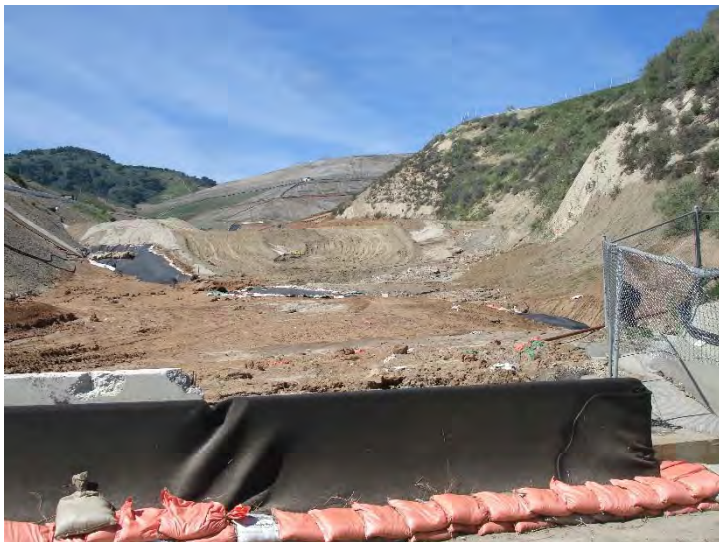
Photo 251: Drainage into Terminal Basin: March 9, 2016

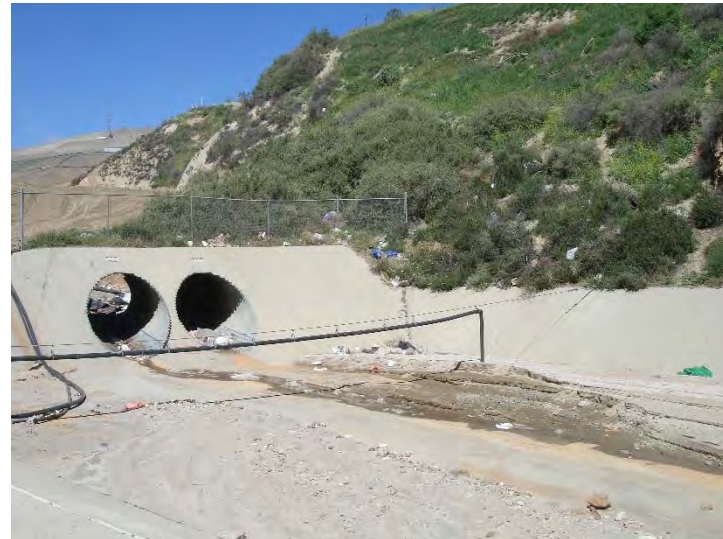
Photo 252: Terminal Basin Inlet: March 23, 2016

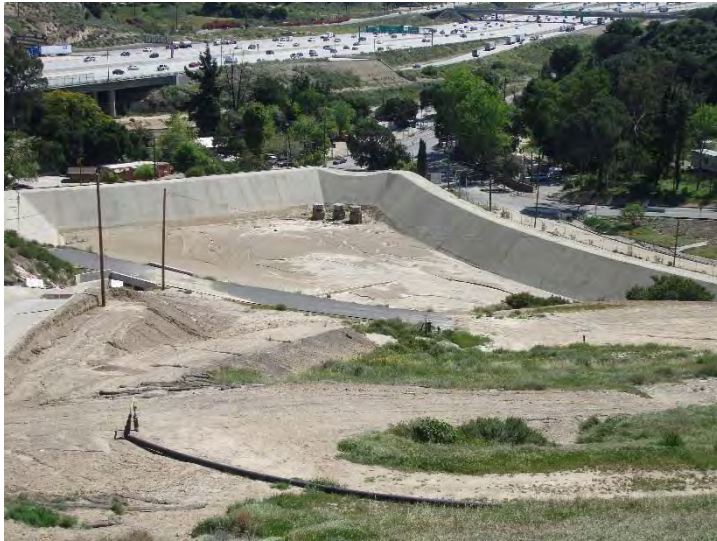
Photo 253: Terminal Basin: March 23, 2016

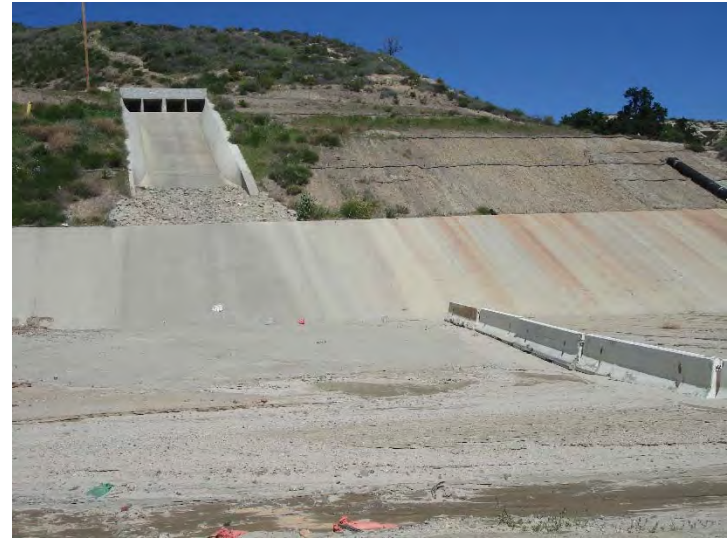
Photo 254: Terminal Basin: March 23, 2016

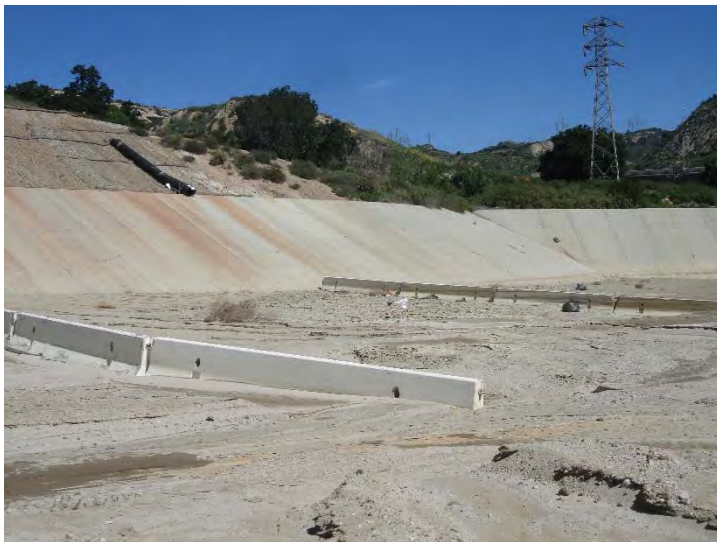
Photo 255: Terminal Basin: March 23, 2016

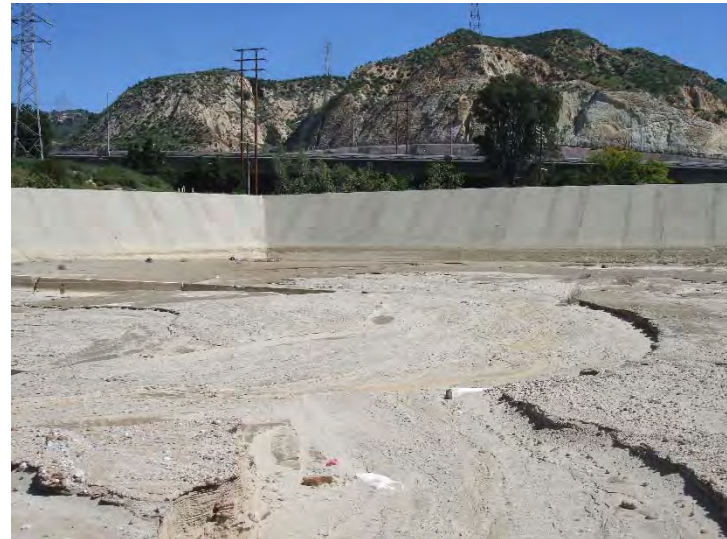
Photo 256: Terminal Basin: March 23, 2016

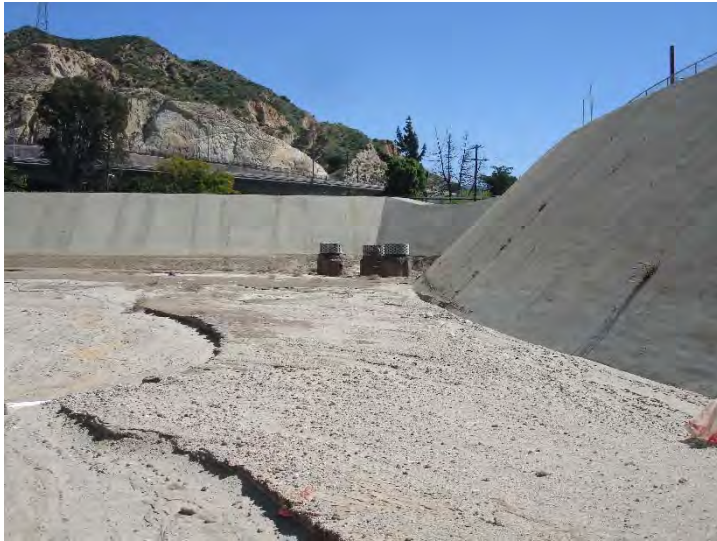
Photo 257: Terminal Basin: March 23, 2016

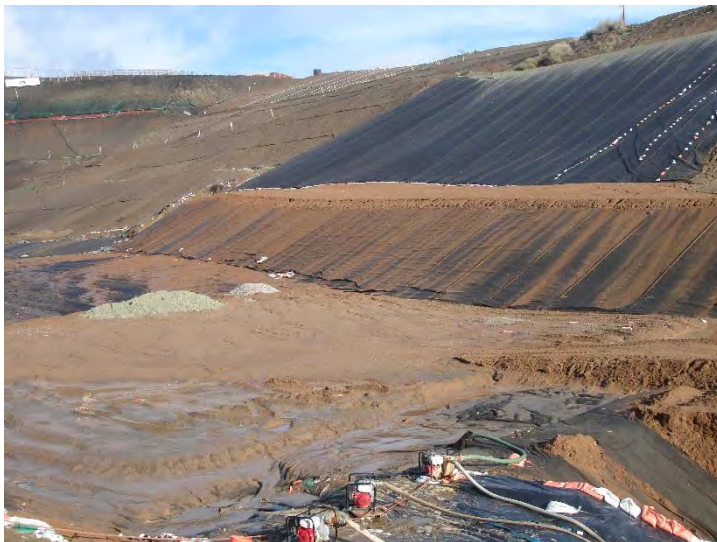
Photo 259: City Cell CC3B Construction: January 7, 2016

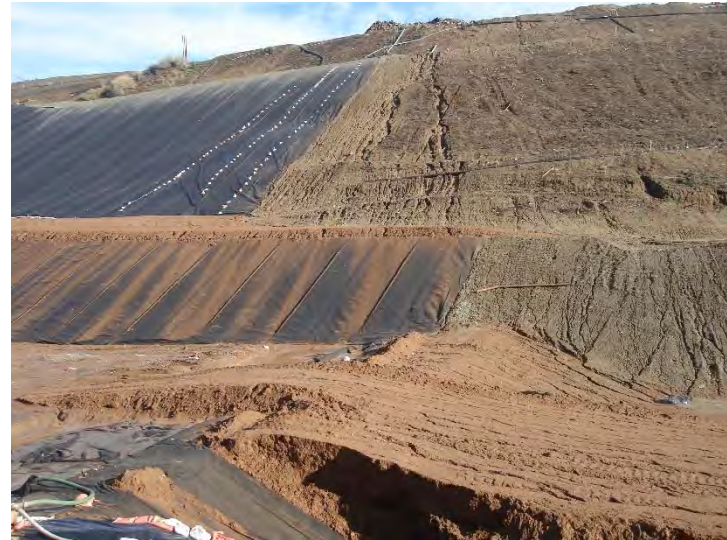
Photo 260: City Cell CC3B Construction: January 7, 2016

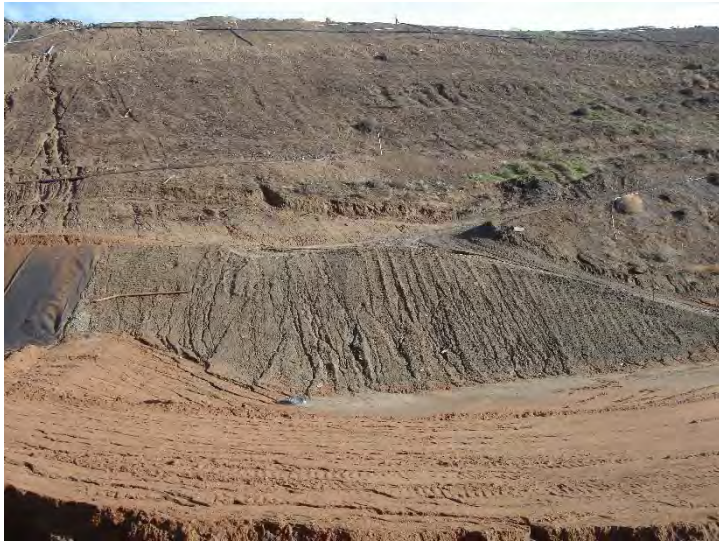
Photo 261: City Cell CC3B Construction: January 7, 2016

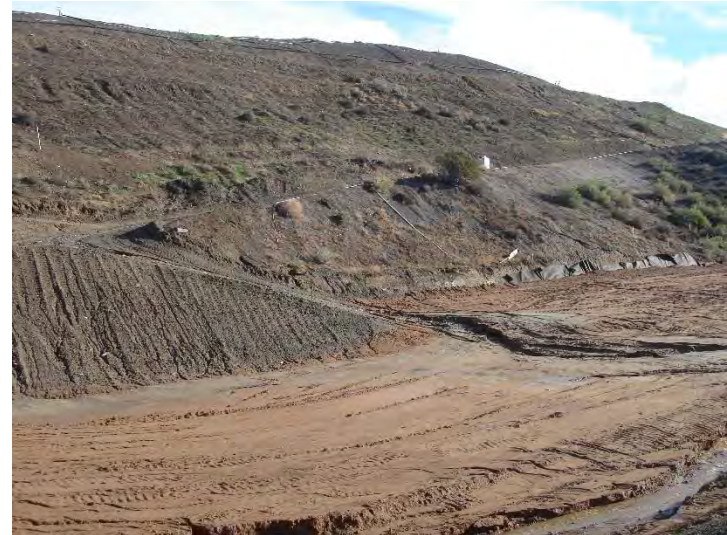
Photo 262: City Cell CC3B Construction: January 7, 2016

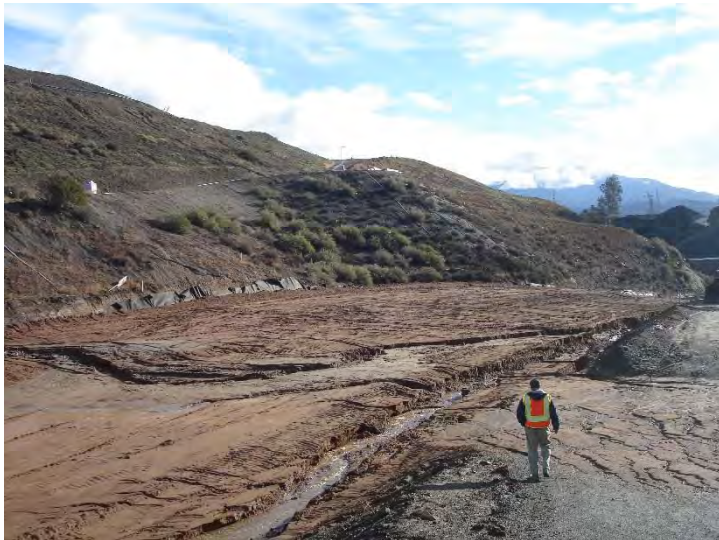
Photo 263: City Cell CC3B Construction: January 7, 2016

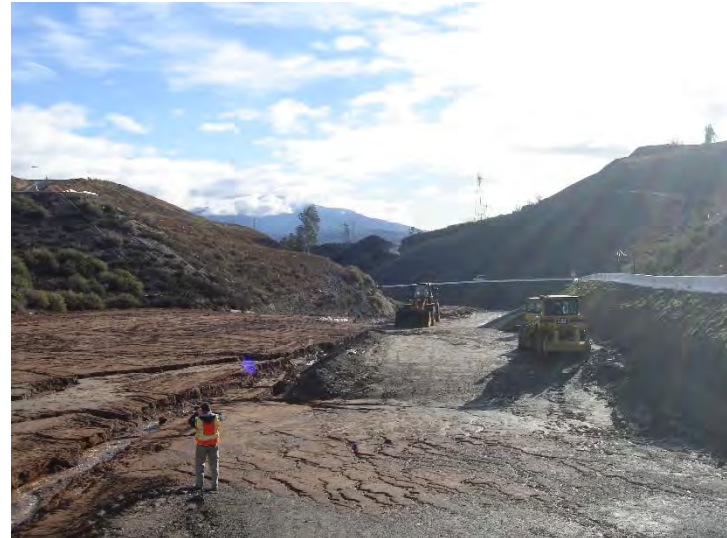
Photo 264: City Cell CC3B Construction: January 7, 2016

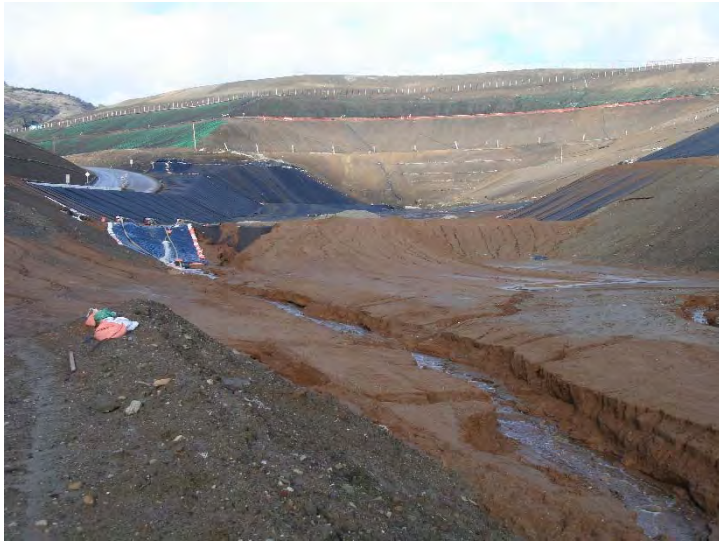
Photo 265: City Cell CC3B Construction: January 7, 2016

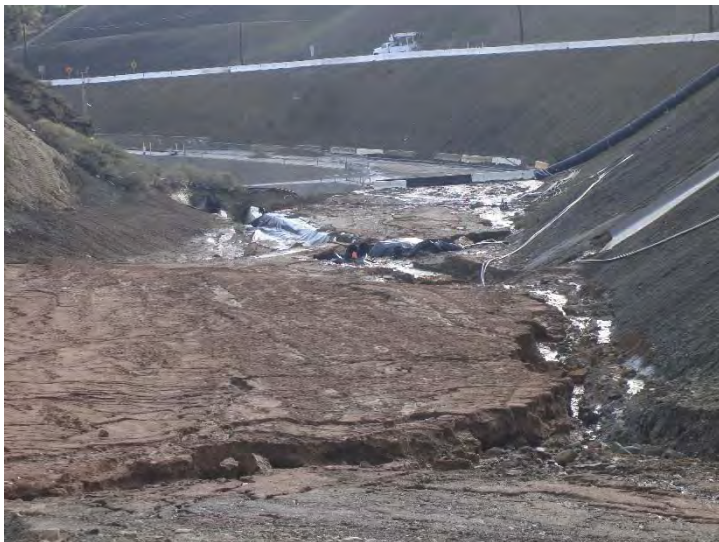
Photo 267: City Cell CC3B Construction: January 7, 2016

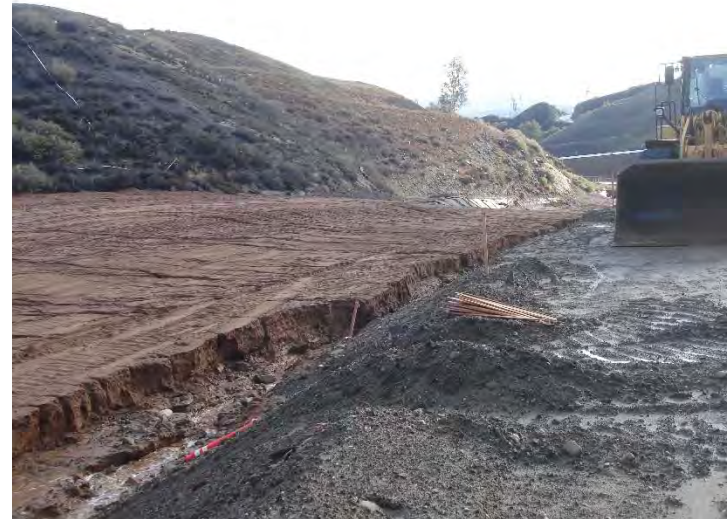
Photo 266: City Cell CC3B Construction: January 7, 2016

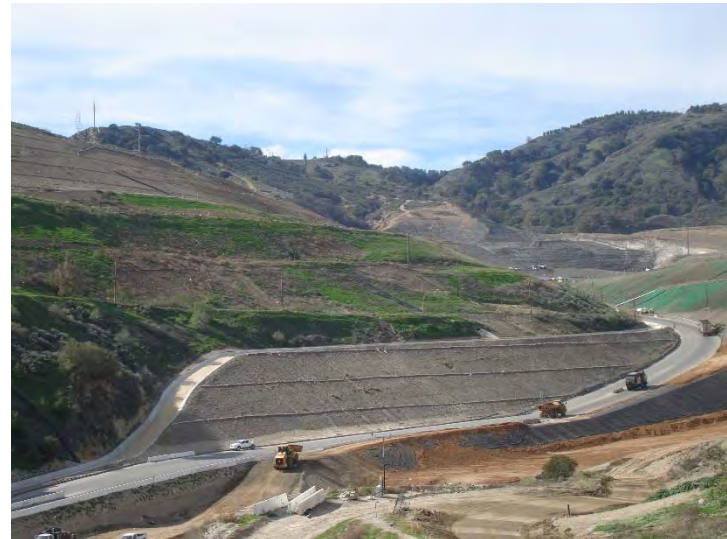
Photo 268: City Cell CC3B Construction: January 27, 2016

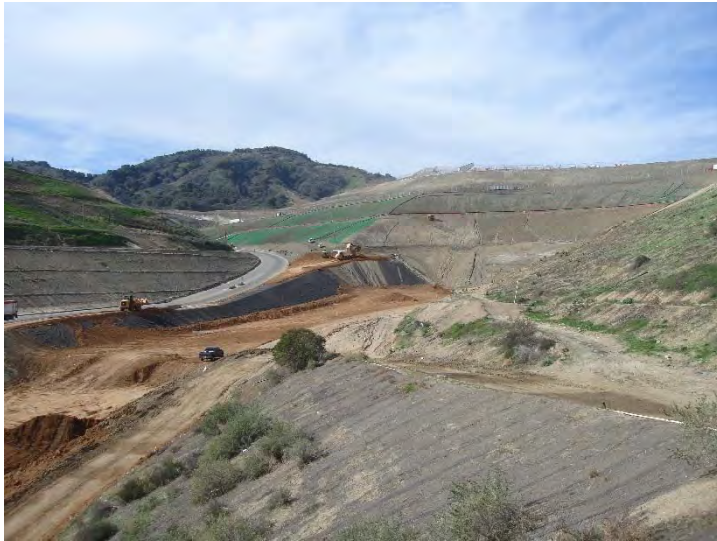
Photo 269: City Cell CC3B Construction: January 27, 2016

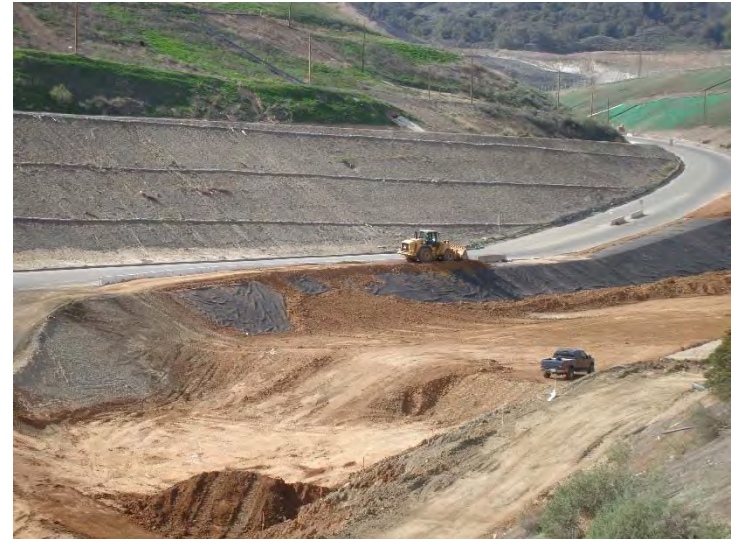
Photo 270: City Cell CC3B Construction: January 27, 2016

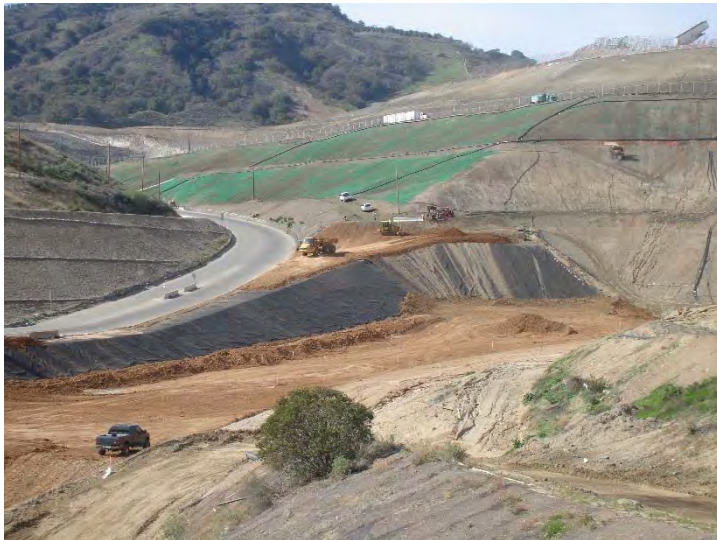
Photo 271: City Cell CC3B Construction: January 27, 2016

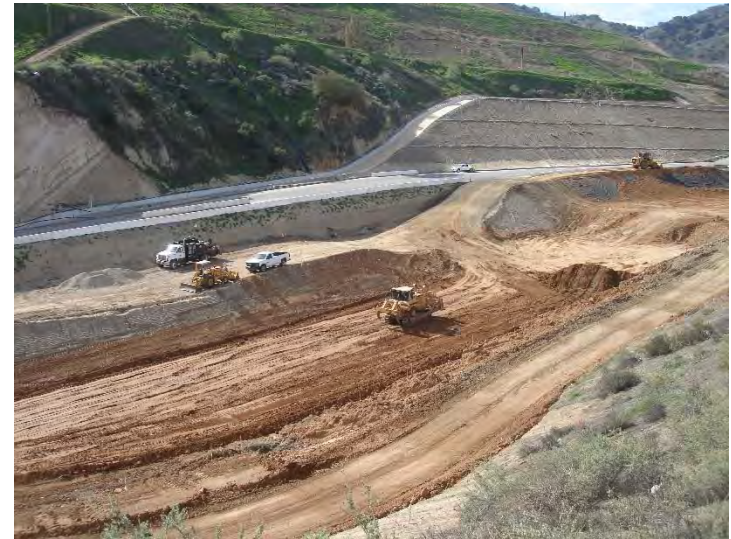
Photo 272: City Cell CC3B Construction: January 27, 2016

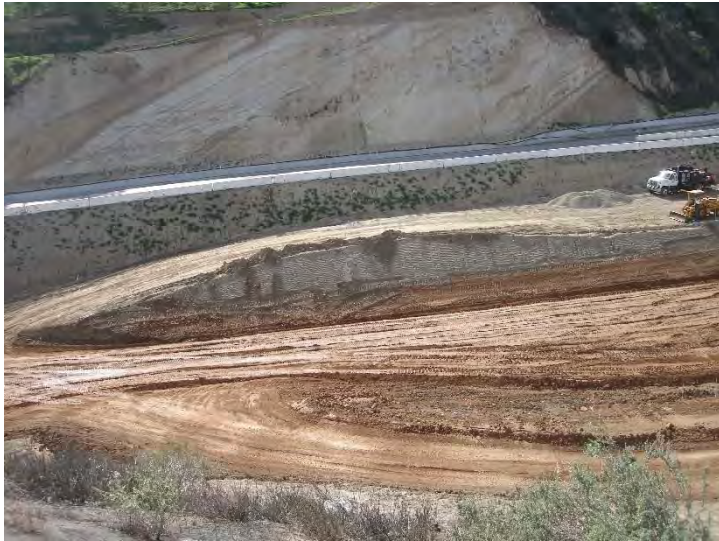
Photo 273: City Cell CC3B Construction: January 27, 2016

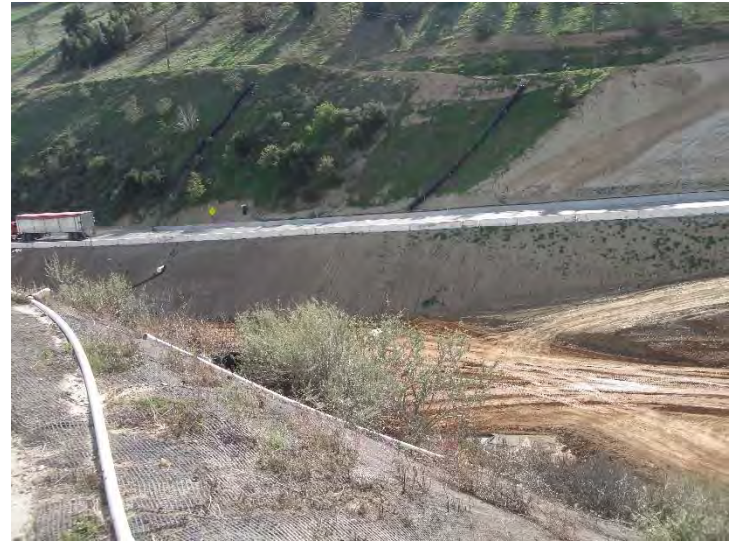
Photo 274: City Cell CC3B Construction: January 27, 2016

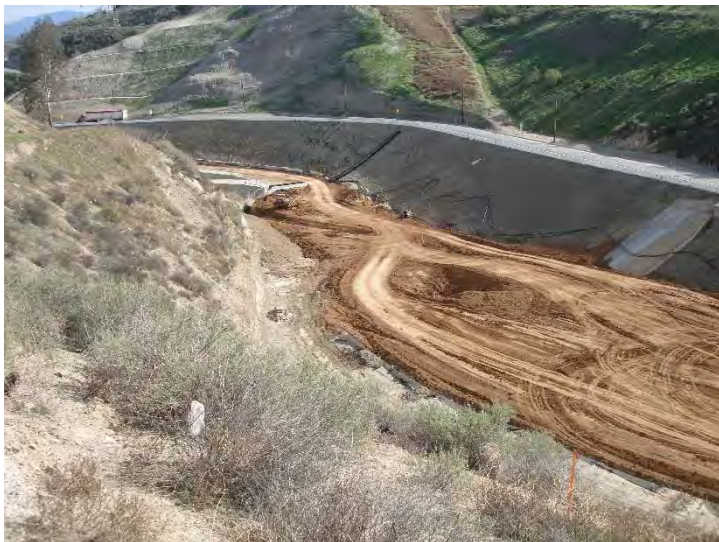
Photo 275: City Cell CC3B Construction: January 27, 2016

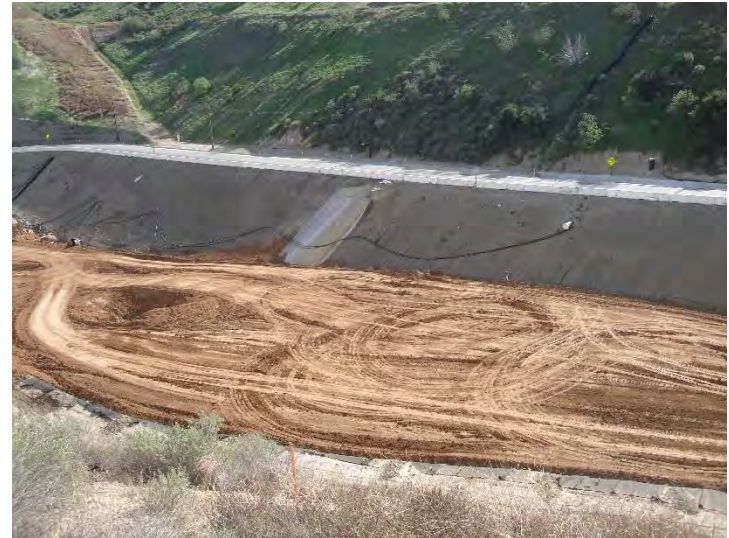
Photo 276: City Cell CC3B Construction: January 27, 2016
