**Sunshine Canyon Landfill
Independent Monitor
Quarterly Site Monitoring Status Report
January 1, 2016 – March 31, 2016**

City of Los Angeles Department of City Planning

County of Los Angeles Department of Regional Planning

May 16, 2016

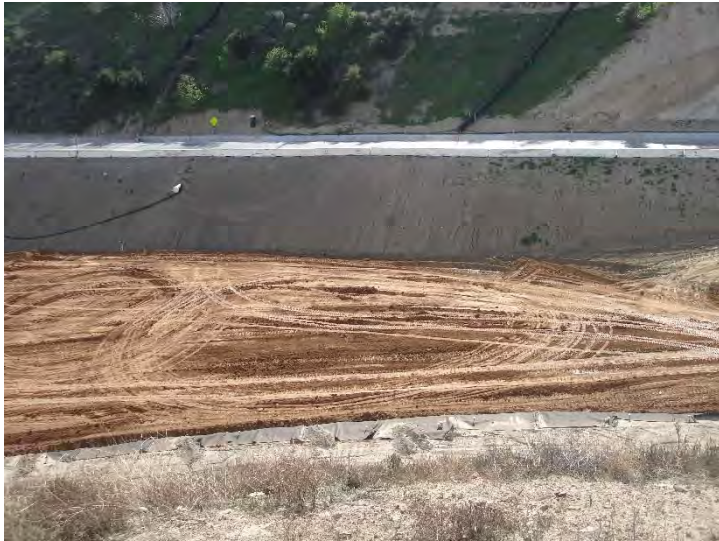
Photo 277: City Cell CC3B Construction: January 27, 2016

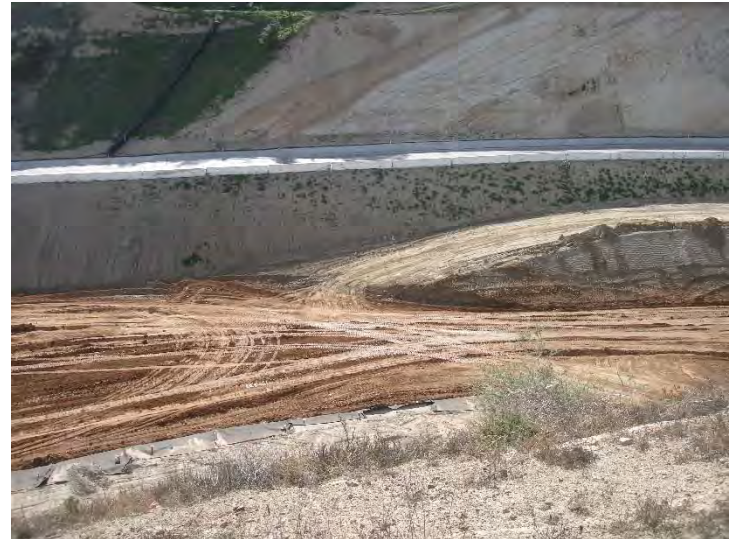
Photo 278: City Cell CC3B Construction: January 27, 2016

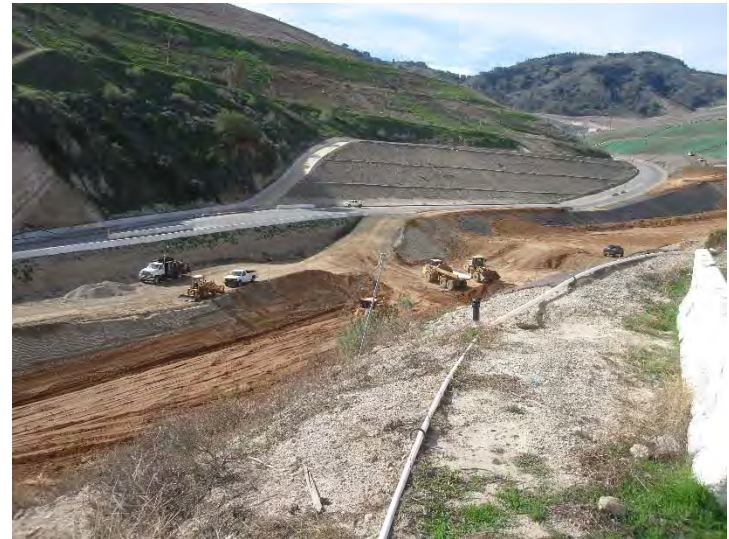
Photo 279: City Cell CC3B Construction: January 27, 2016

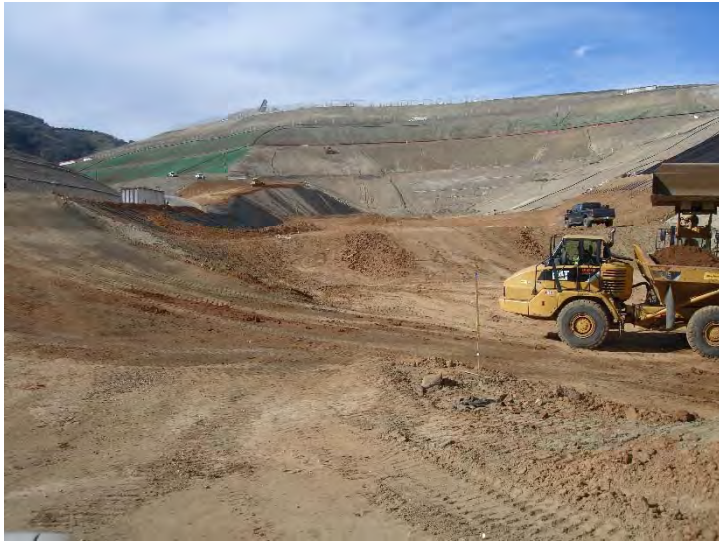
Photo 280: City Cell CC3B Construction: January 27, 2016

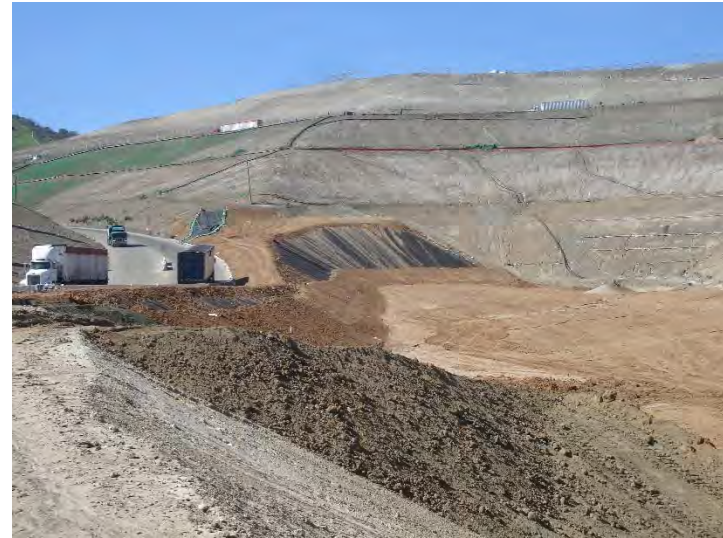
Photo 281: City Cell CC3B Construction: January 27, 2016

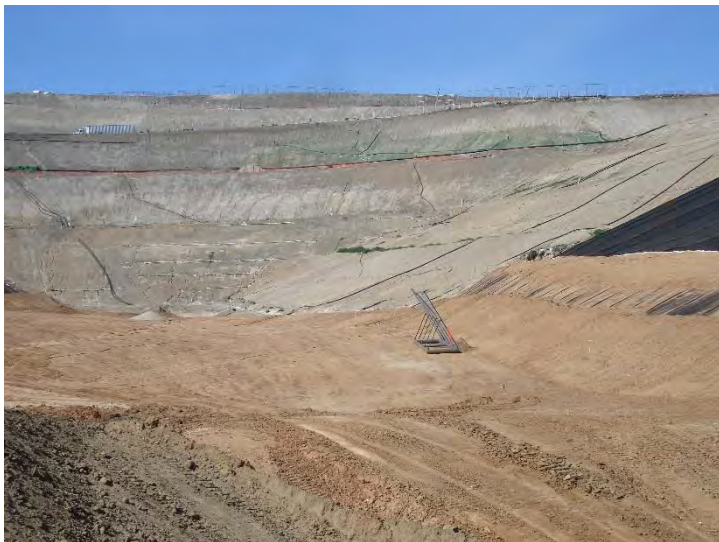
Photo 282: City Cell CC3B Construction: February 24, 2016

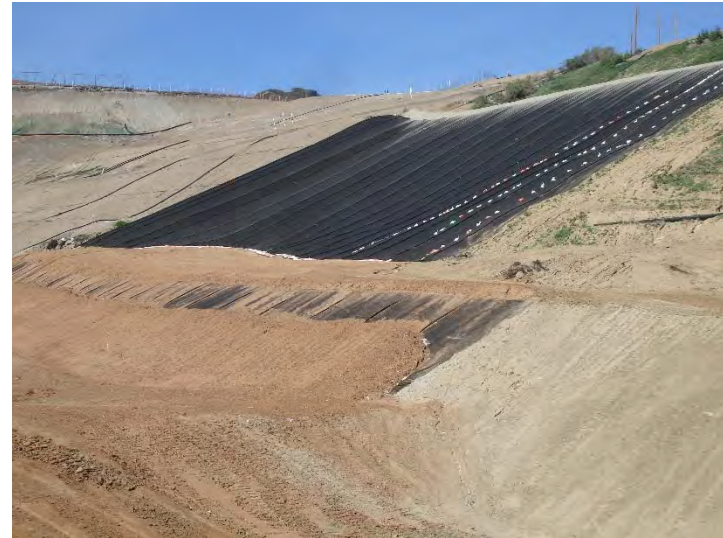
Photo 283: City Cell CC3B Construction: February 24, 2016

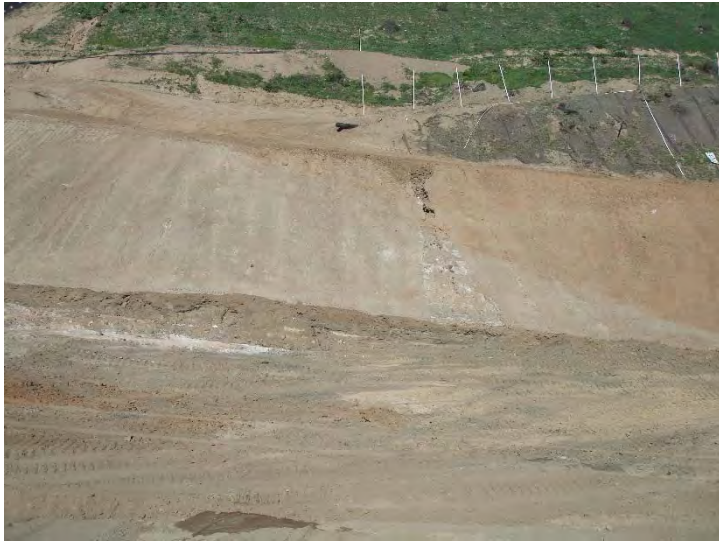
Photo 284: City Cell CC3B Construction: February 24, 2016

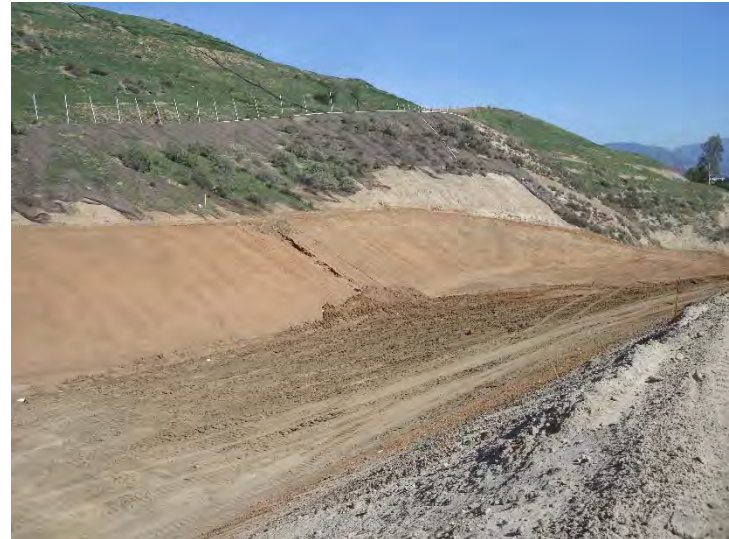
Photo 285: City Cell CC3B Construction: February 24, 2016

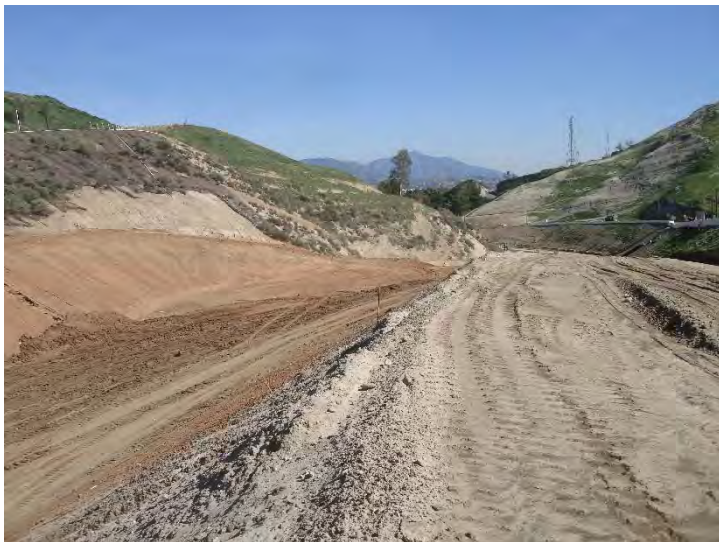
Photo 286: City Cell CC3B Construction: February 24, 2016

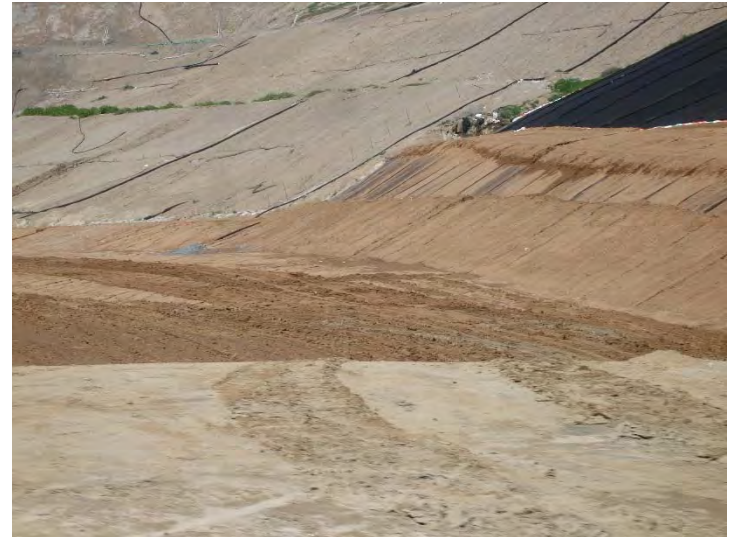
Photo 287: City Cell CC3B Construction: February 24, 2016

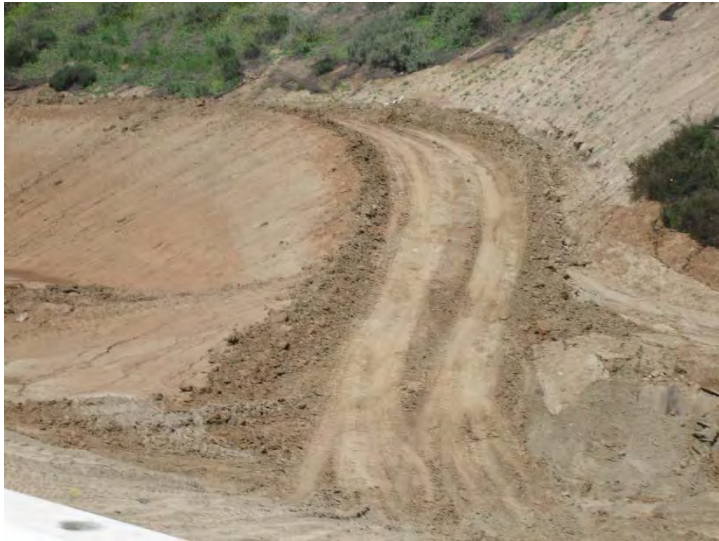
Photo 288: City Cell CC3B: March 9, 2016

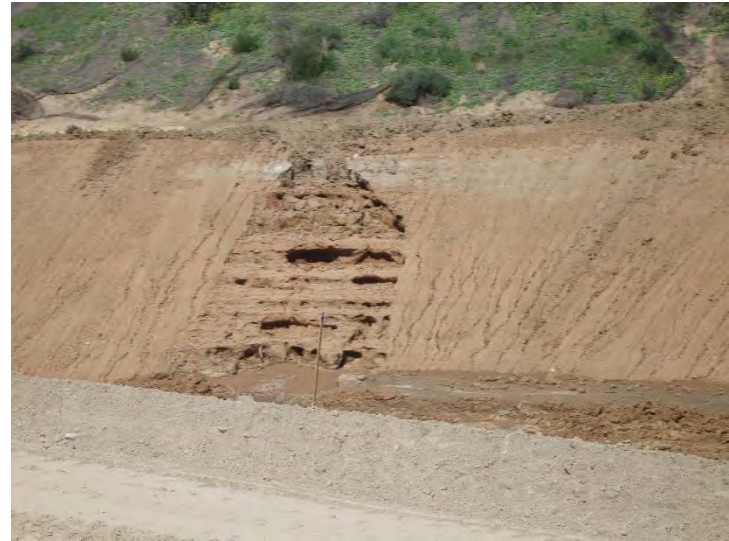
Photo 289: City Cell CC3B: March 9, 2016

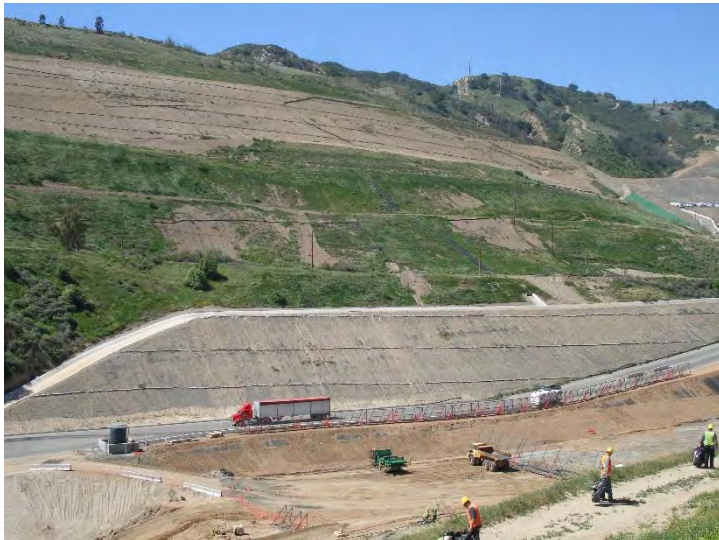
Photo 290: City Cell CC3B: March 9, 2016

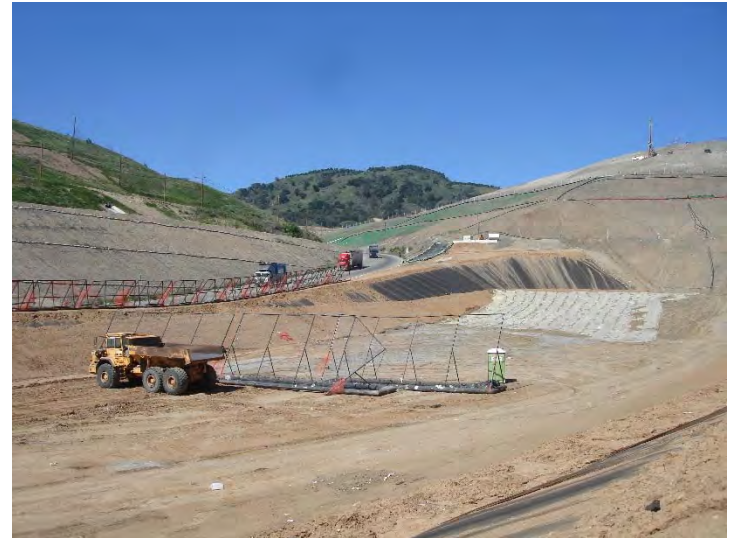
Photo 291: City Cell CC3B: March 23, 2016

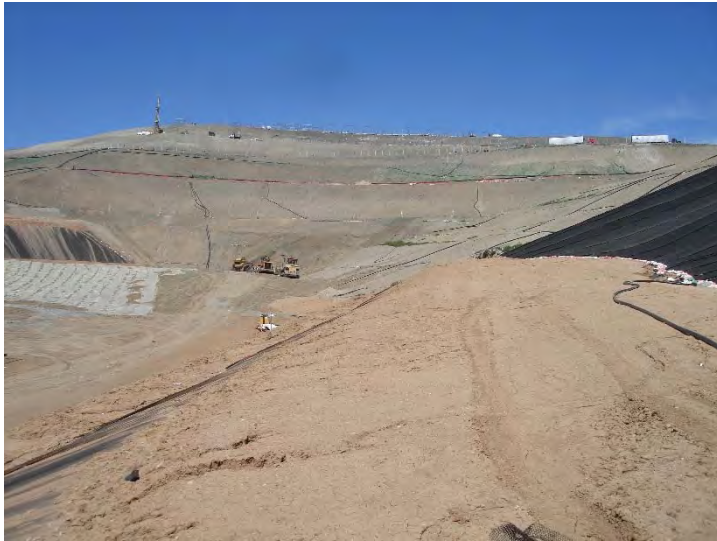
Photo 292: City Cell CC3B: March 23, 2016

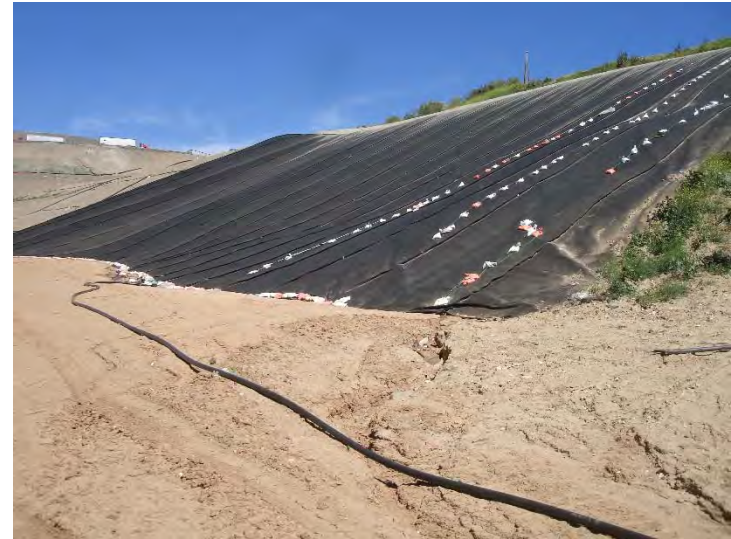
Photo 293: City Cell CC3B: March 23, 2016

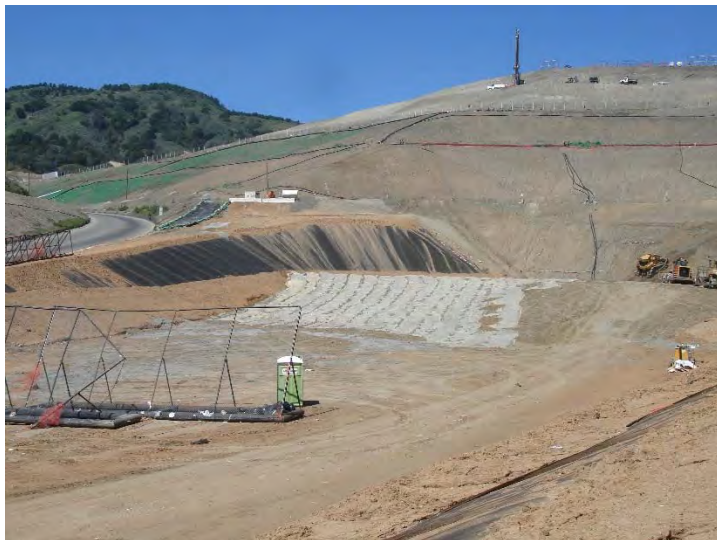
Photo 294: City Cell CC3B: March 23, 2016

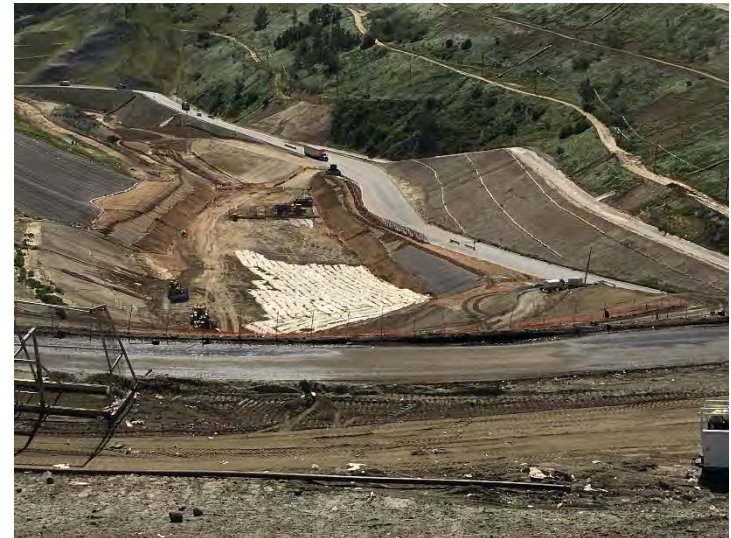
Photo 295: City Cell CC3B: March 23, 2016

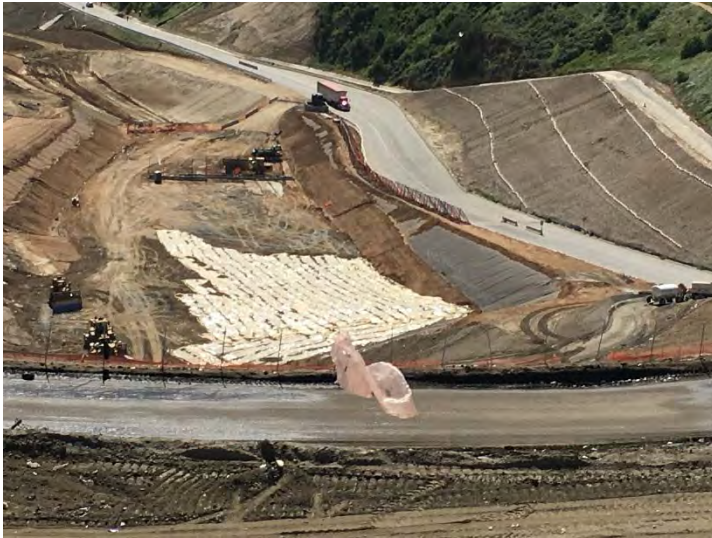
Photo 296: City Cell CC3B: March 23, 2016

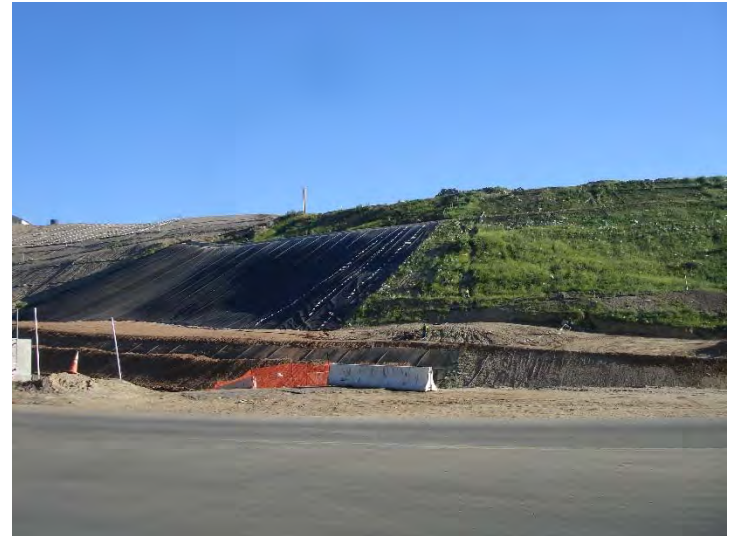
Photo 297: City Cell CC3B: March 23, 2016

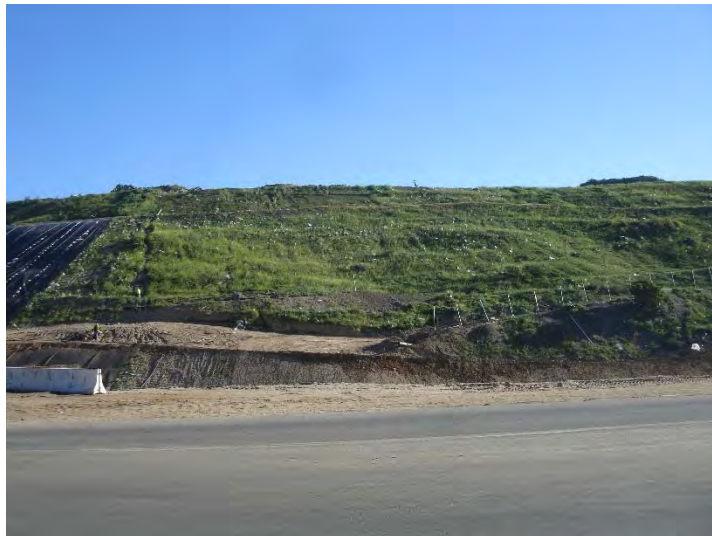
Photo 298: City Cell CC3B Slope Litter: March 23, 2016

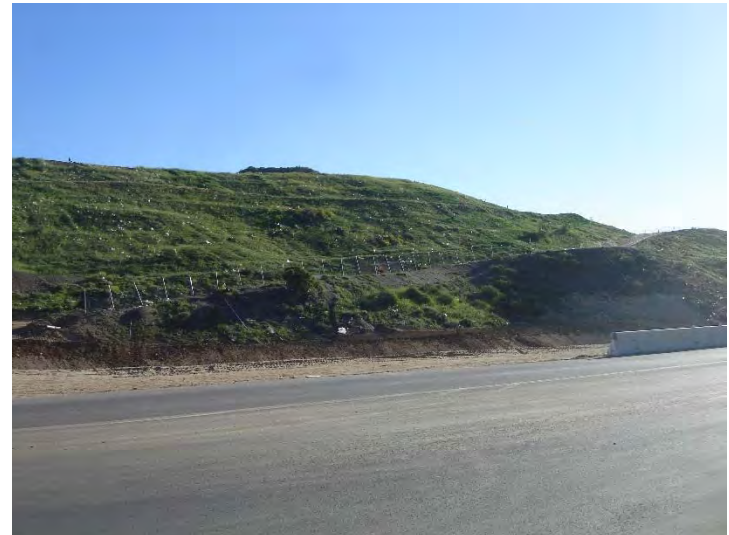
Photo 299: City Cell CC3B Slope Litter: March 23, 2016

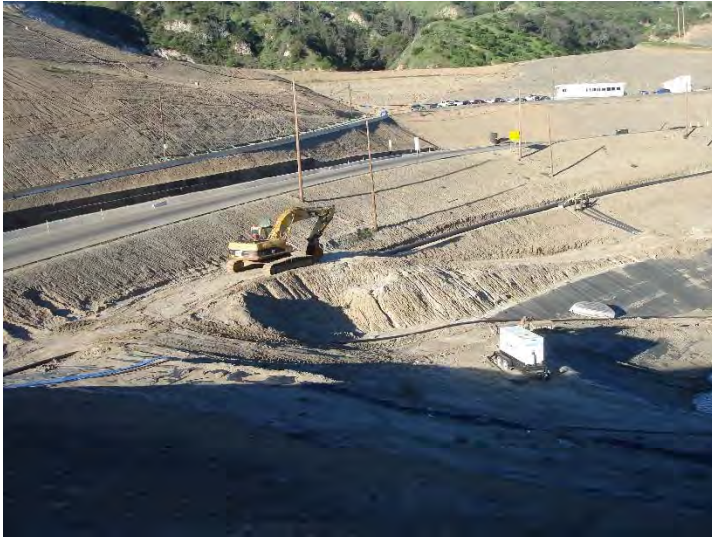
Photo 300: City Cell CC3B Slope Litter: March 23, 2016

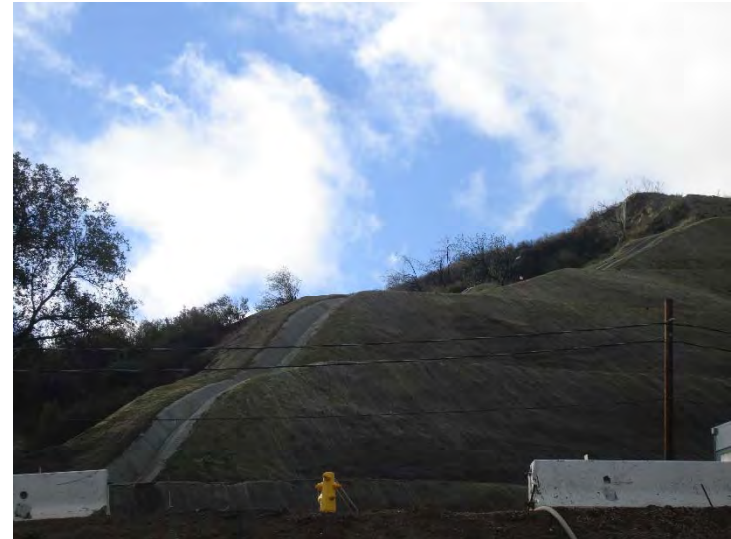
Photo 301: City South Access Road Drainage Control: January 7, 2016

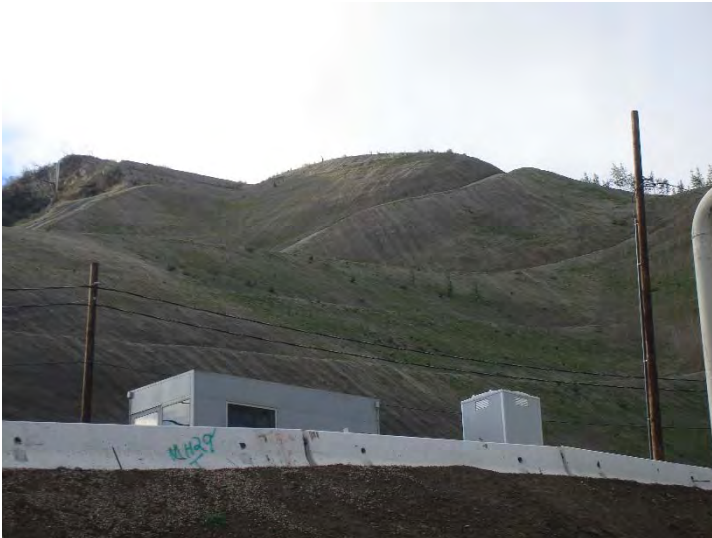
Photo 302: City South Access Road Drainage Control: January 7, 2016

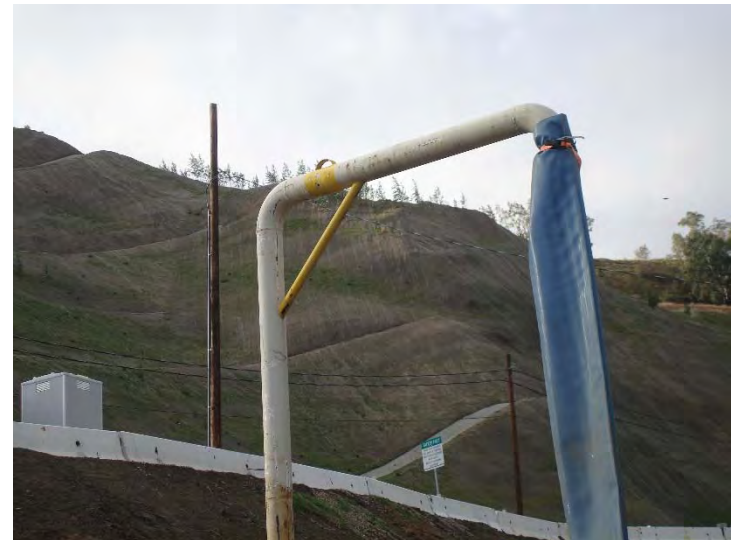
Photo 303: City South Access Road Drainage Control: January 7, 2016

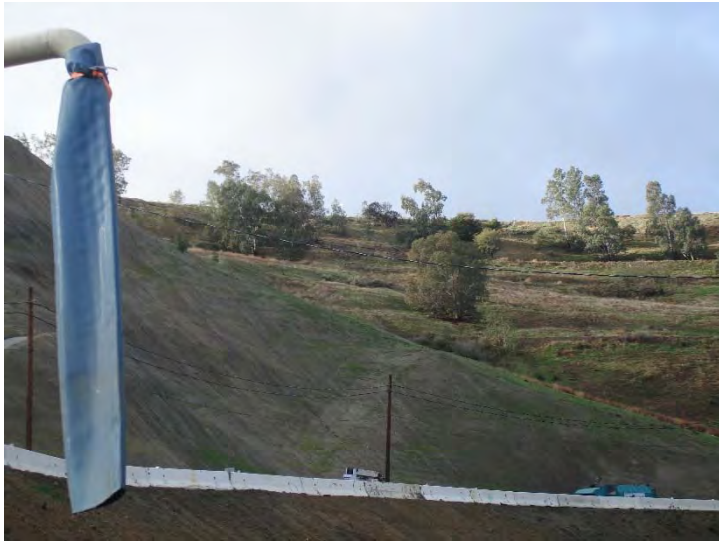
Photo 304: City South Access Road Drainage Control: January 7, 2016

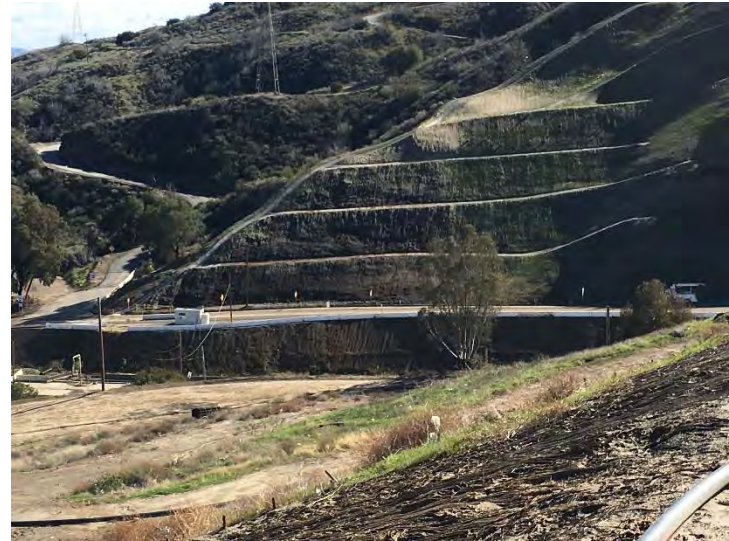
Photo 305: City South Access Road Drainage Control: January 7, 2016

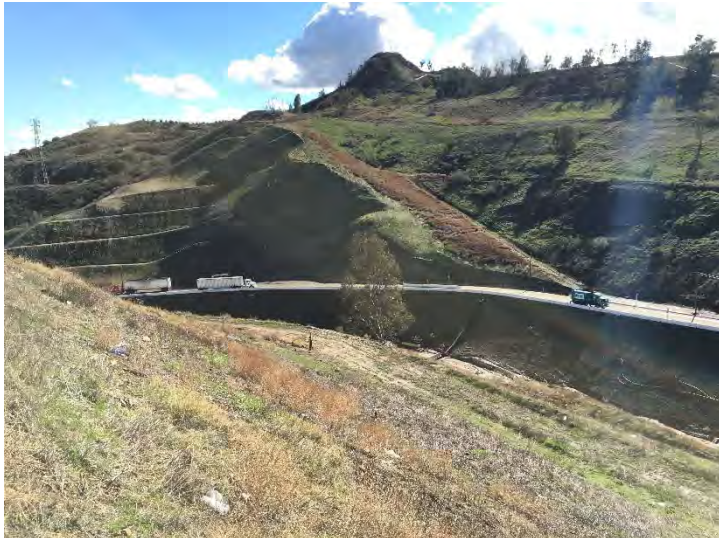
Photo 306: City South Access Road Drainage Control: January 7, 2016

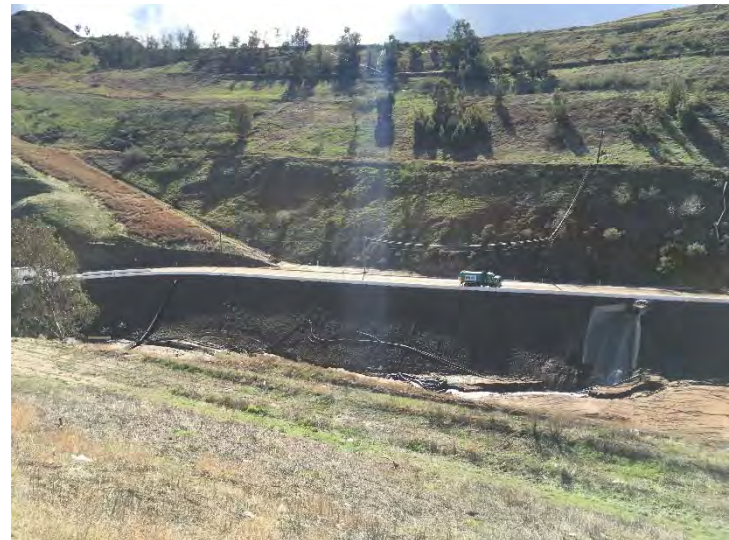
Photo 307: City South Access Road Drainage Control: January 7, 2016

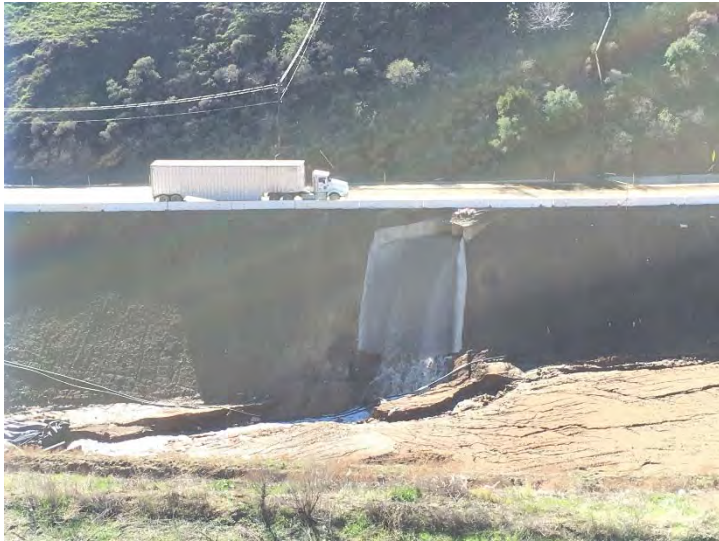
Photo 308: City South Access Road Drainage Control: January 7, 2016

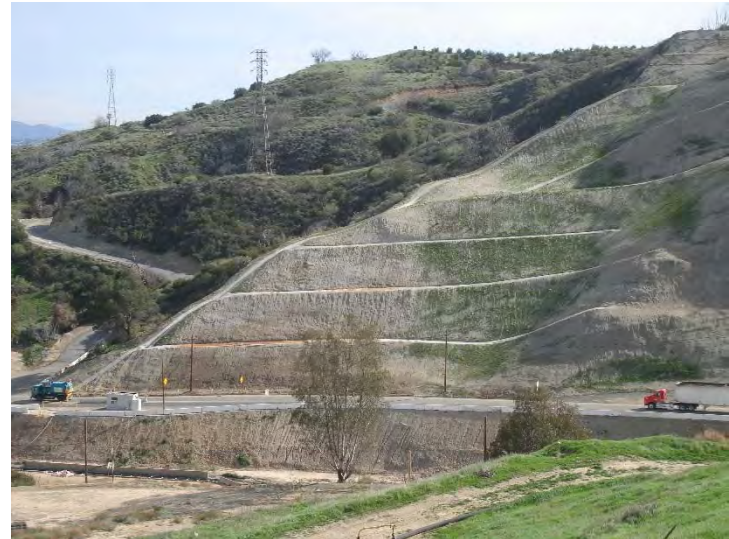
Photo 309: City South Access Road Drainage Control: January 7, 2016

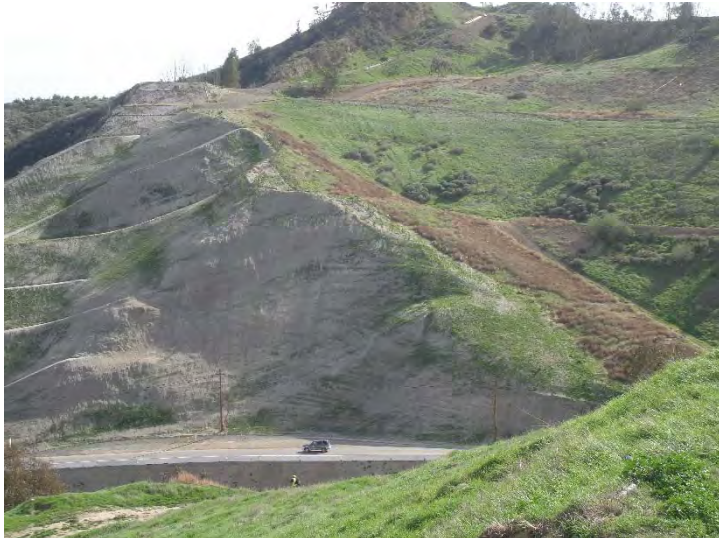
Photo 310: Main Access Road: January 27, 2016

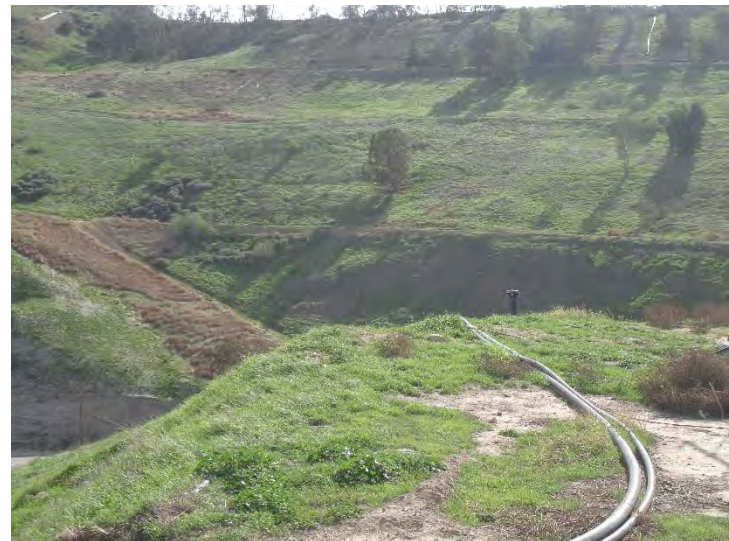
Photo 311: Main Access Road: January 27, 2016

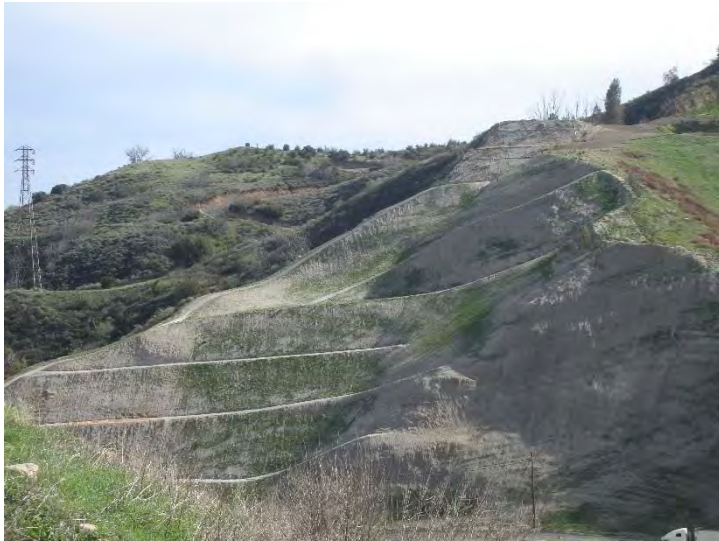
Photo 312: Main Access Road: January 27, 2016

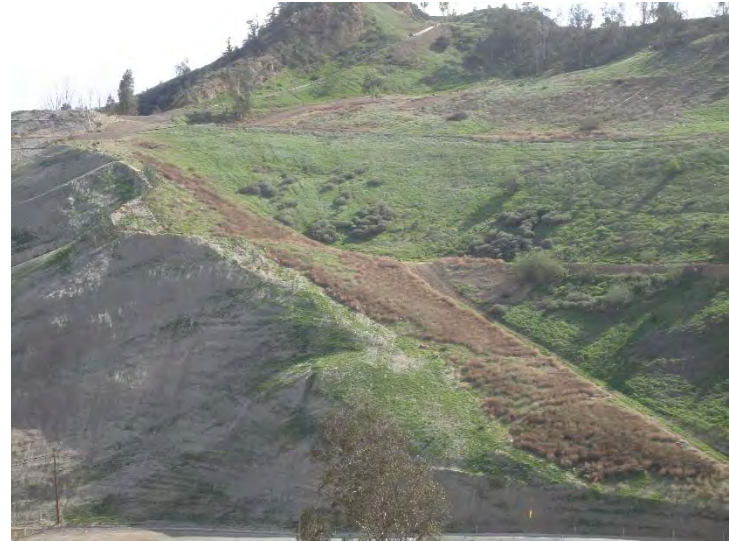
Photo 313: Main Access Road: January 27, 2016

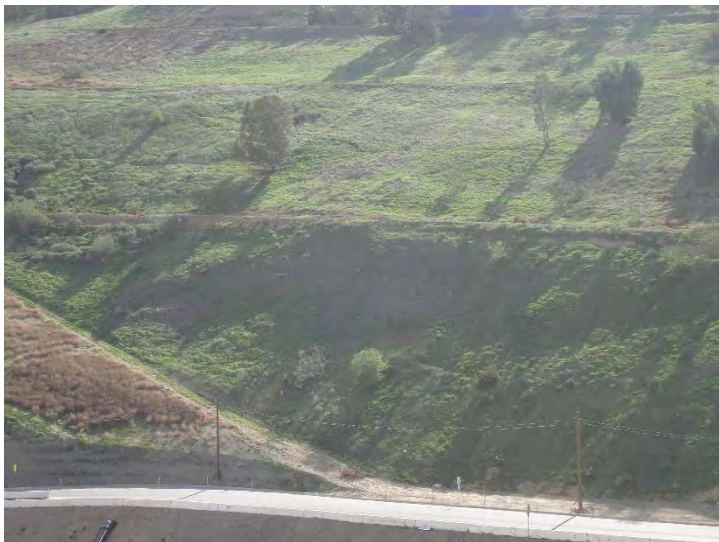
Photo 314: Main Access Road: January 27, 2016

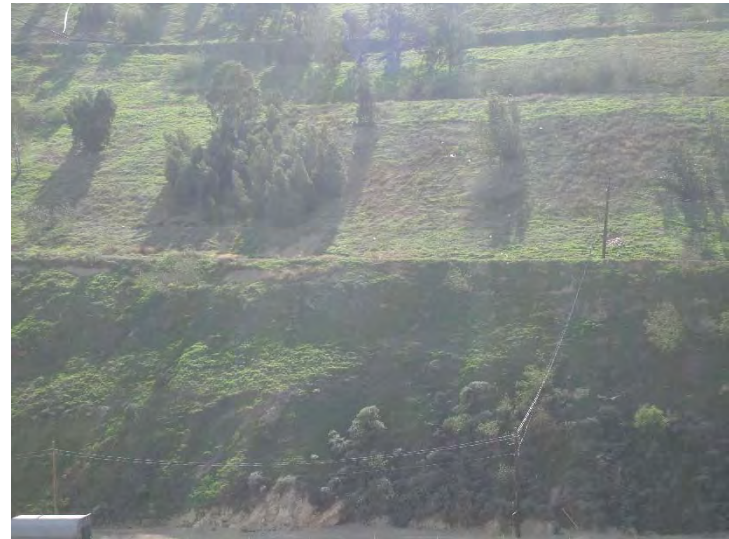
Photo 315: Main Access Road: January 27, 2016

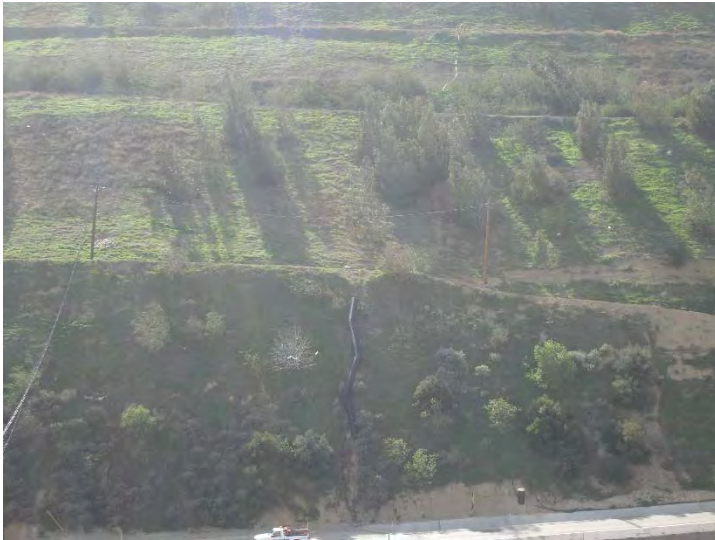
Photo 316: Main Access Road: January 27, 2016

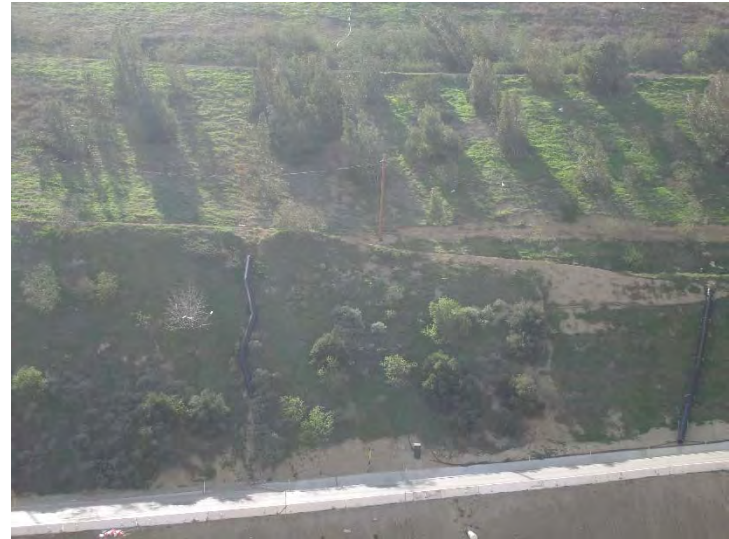
Photo 317: Main Access Road: January 27, 2016

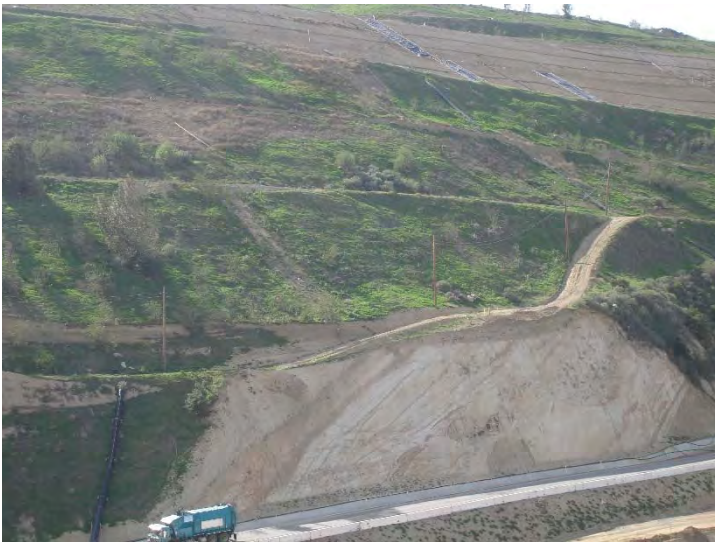
Photo 319: Main Access Road: January 27, 2016

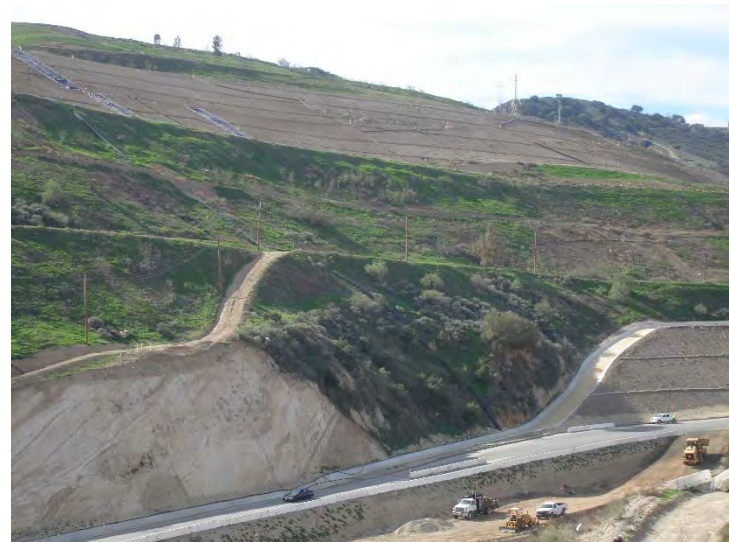
Photo 320: Main Access Road: January 27, 2016

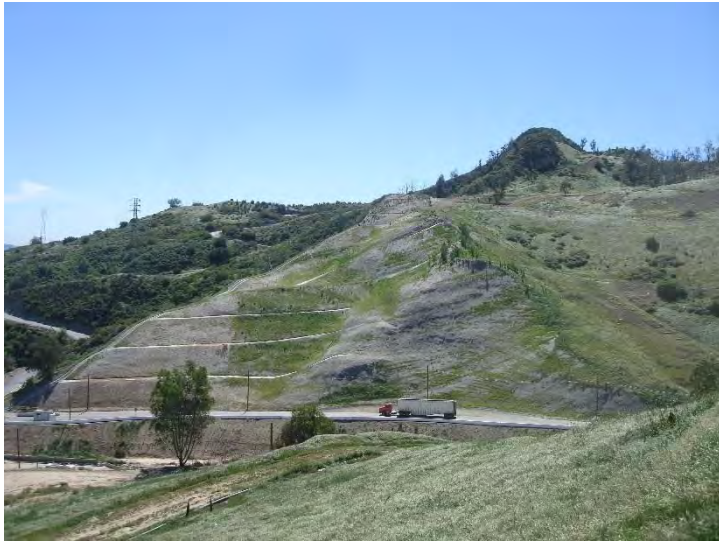
Photo 321: Main Access Road: March 23, 2016

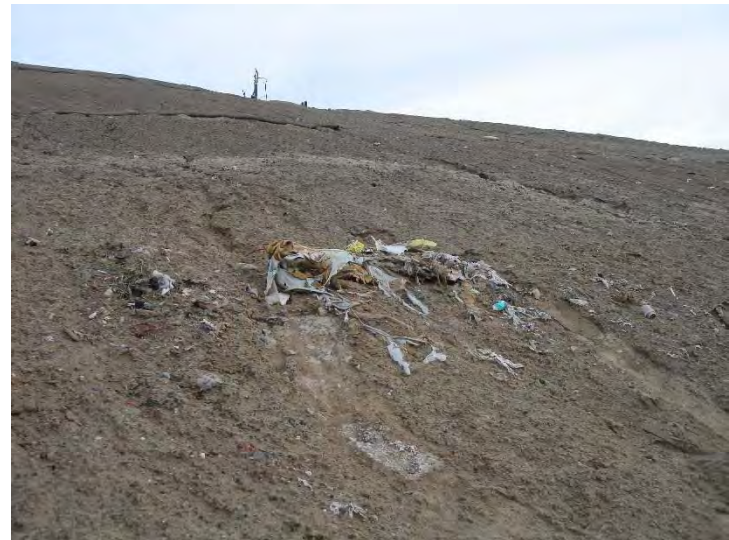
Photo 332: County South Slope Inert Waste Exposed: January 27, 2016

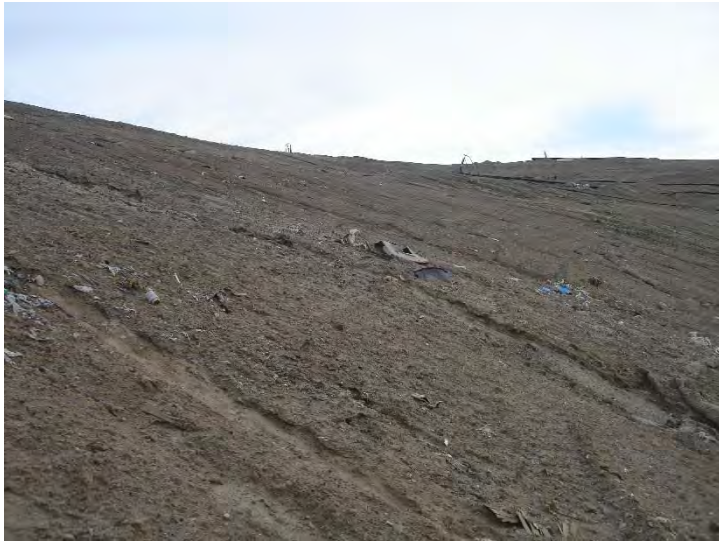
Photo 333: County South Slope Inert Waste Exposed: January 27, 2016

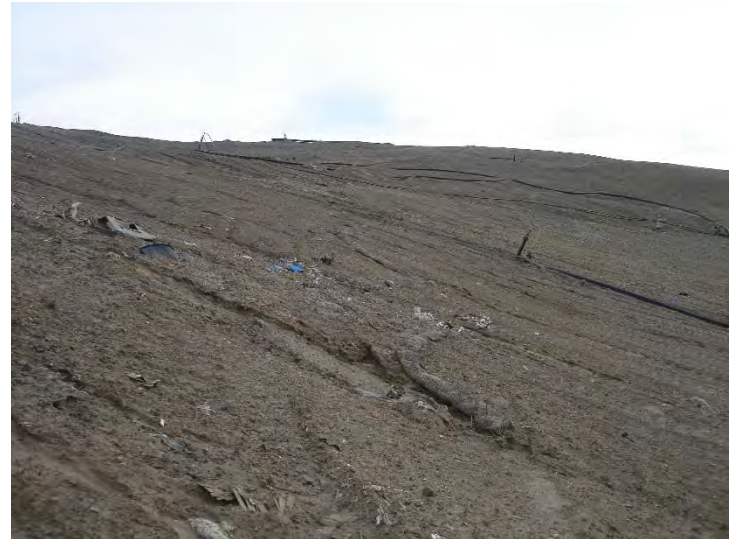
Photo 334: County South Slope Inert Waste Exposed: January 27, 2016

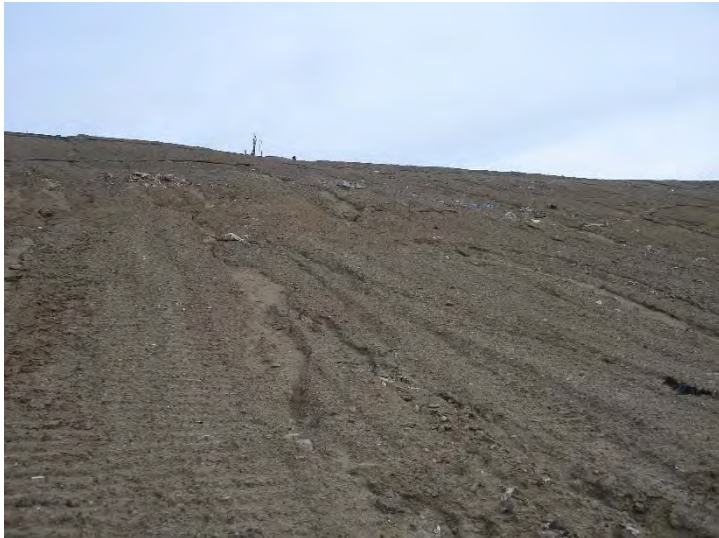
Photo 335: County South Slope Inert Waste Exposed: January 27, 2016

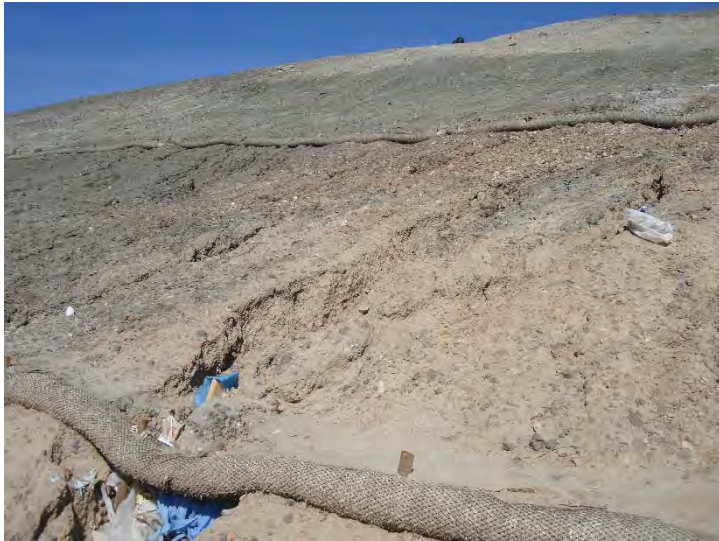
**Photo 349: County South Facing Slope, Inert Waste Exposed:
February 24, 2016**

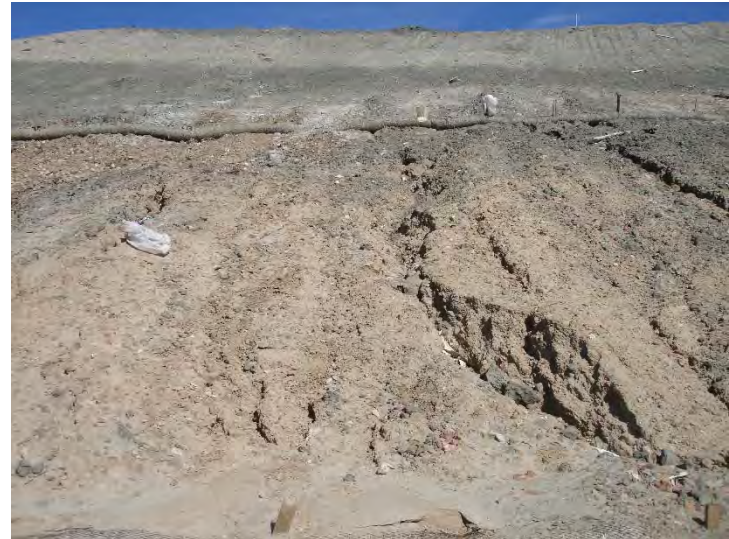
**Photo 350: County South Facing Slope, Inert Waste Exposed:
February 24, 2016**

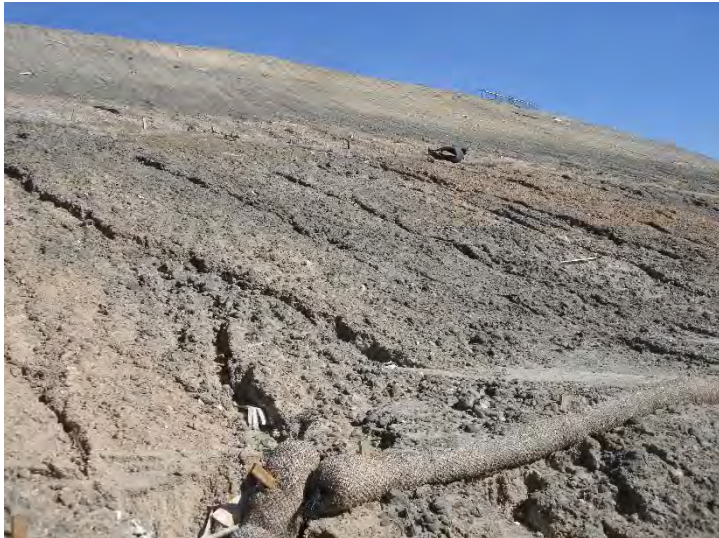
**Photo 351: County South Facing Slope, Inert Waste Exposed:
February 24, 2016**

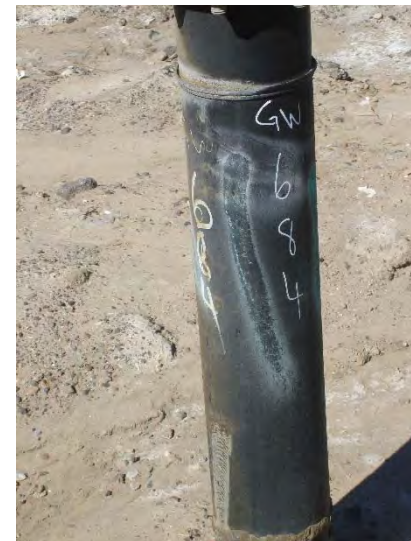
Photo 352: Localized Condensate Odor: February 24, 2016

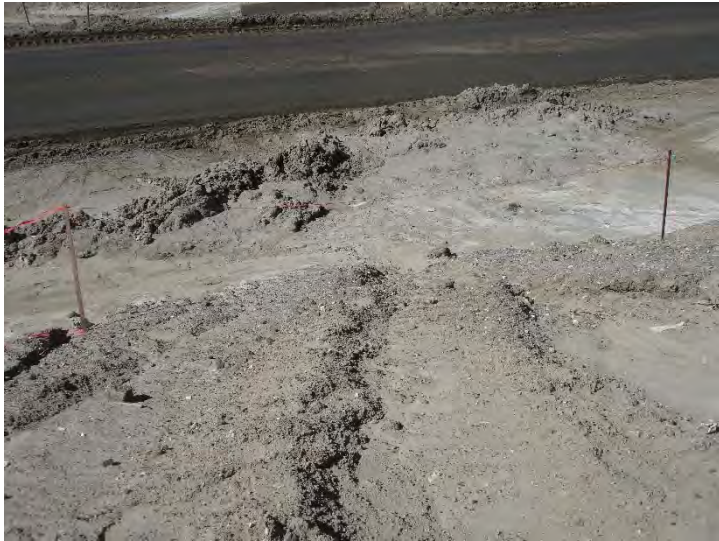
Photo 353: Localized Condensate Odor February 24, 2016

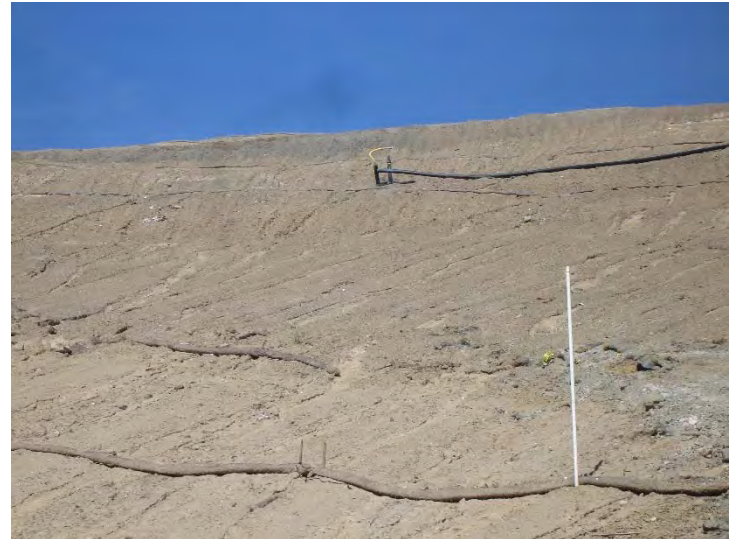
Photo 354: City Slope Erosion: February 24, 2016

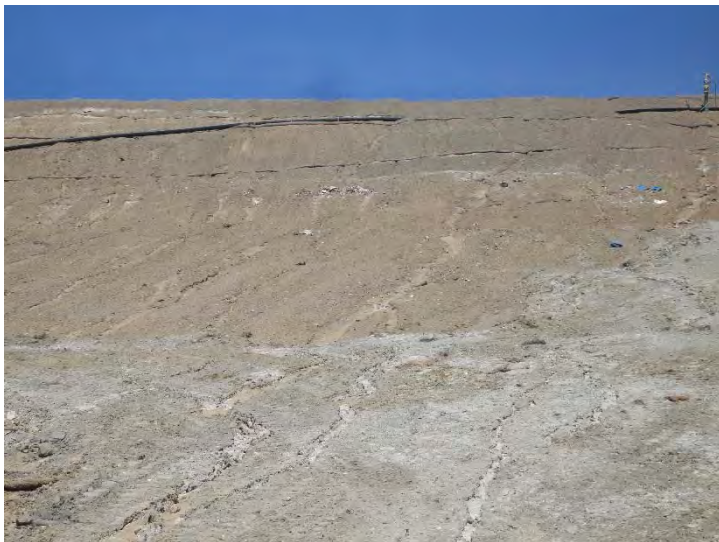
Photo 355: City Slope Erosion, Inert Waste Exposed: February 24, 2016

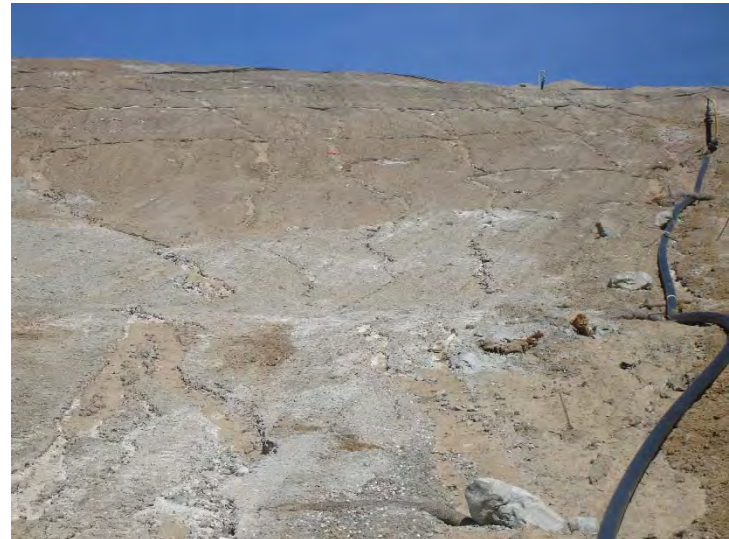
Photo 356: City Slope Erosion, Inert Waste Exposed: February 24, 2016

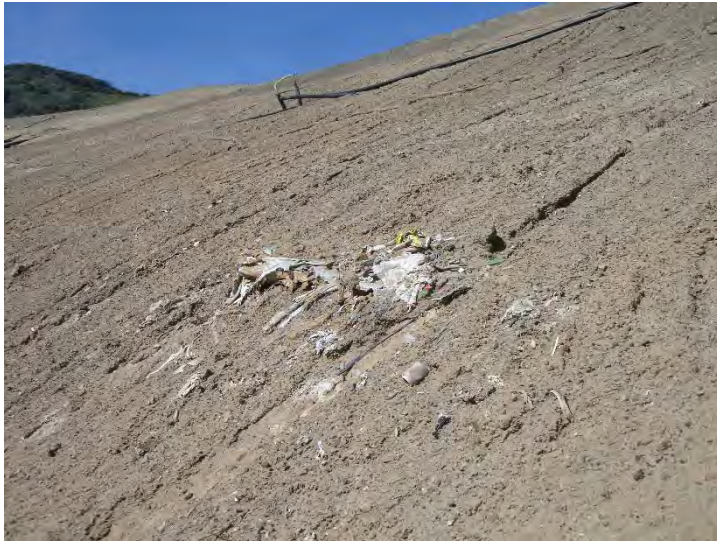
Photo 357: City Slope Erosion, Inert Waste Exposed: February 24, 2016
