**Sunshine Canyon Landfill
Independent Monitor
Quarterly Site Monitoring Status Report
January 1, 2016 – March 31, 2016**

City of Los Angeles Department of City Planning

County of Los Angeles Department of Regional Planning

May 16, 2016

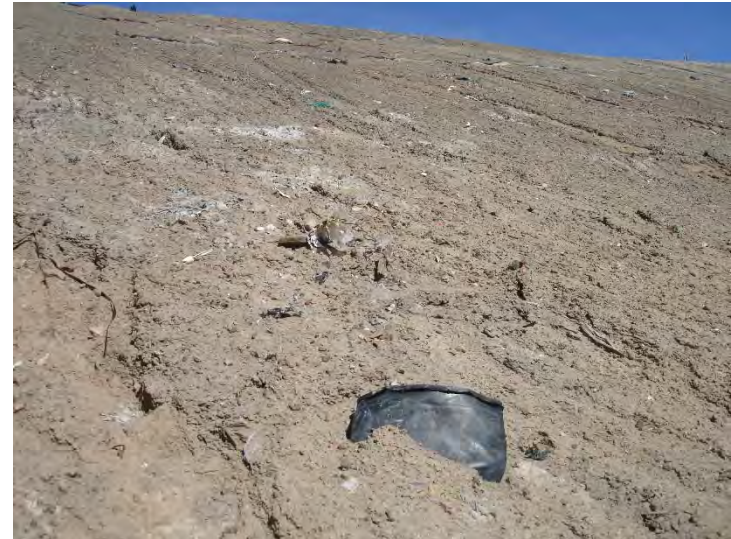
Photo 358: City Slope Erosion, Inert Waste Exposed: February 24, 2016

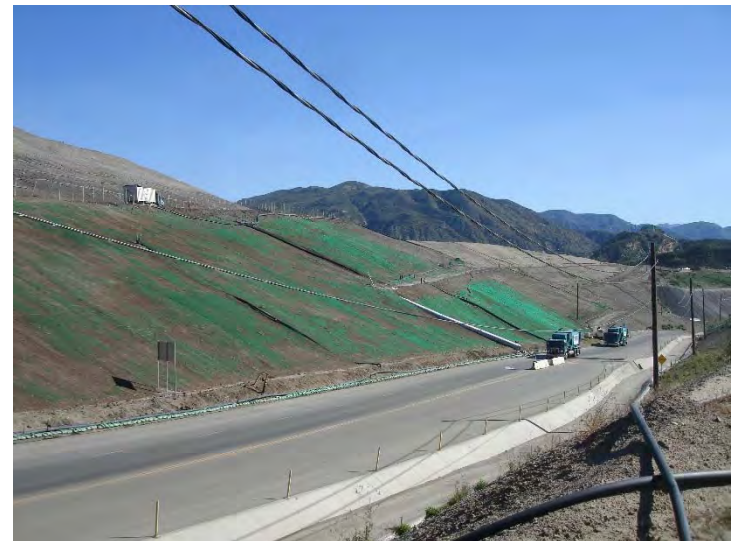
Photo 360: City Slope Erosion Control: February 24, 2016

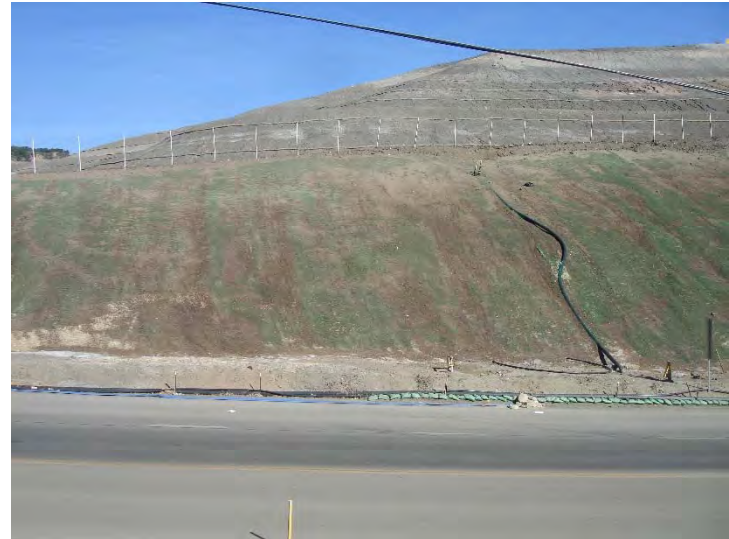
Photo 361: City Slope Erosion Control: February 24, 2016

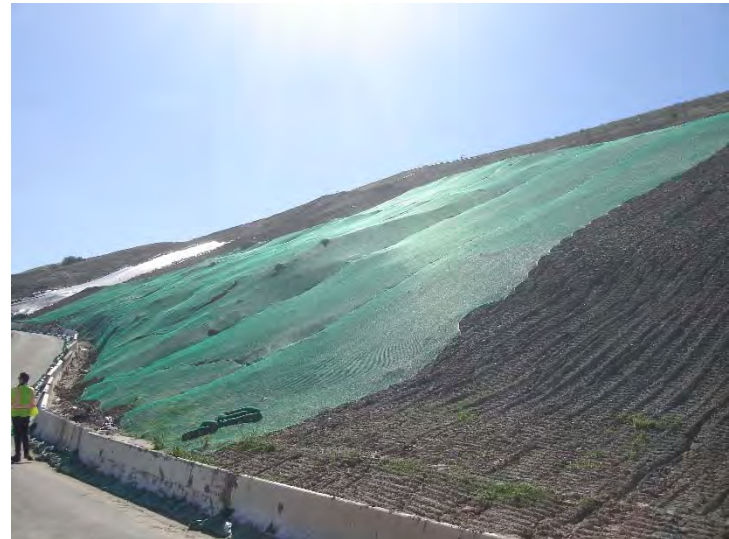
Photo 363: City Slope Erosion Control: February 24, 2016

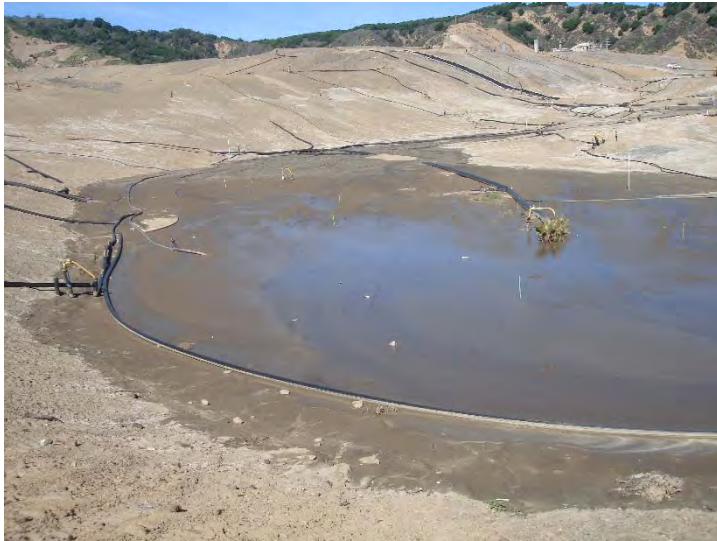
Photo 364: City Slope Erosion Control: February 24, 2016

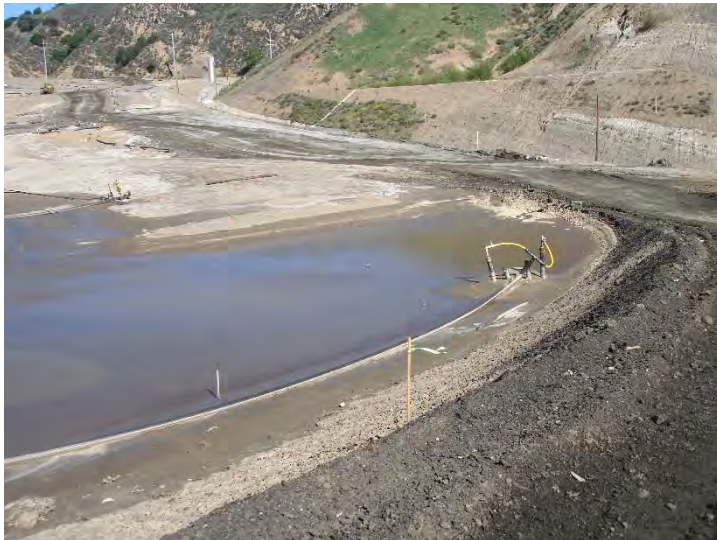
Photo 366: Ponding on City Top Deck: March 9, 2016

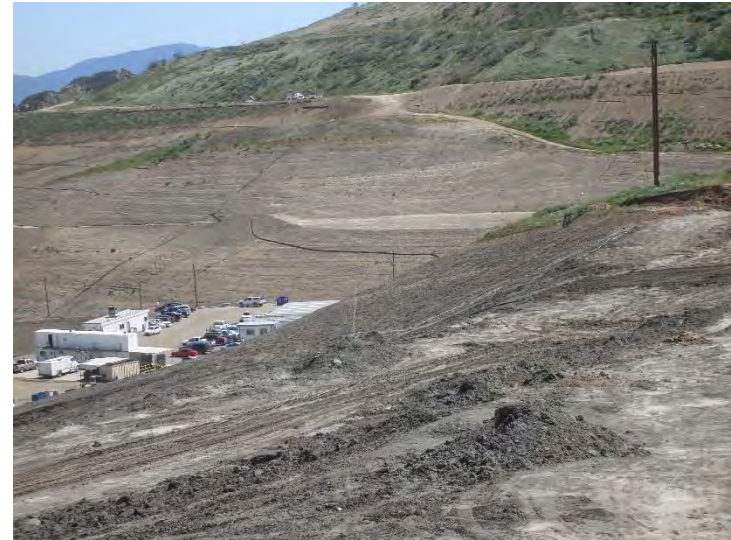
Photo 367: Ponding on City Top Deck: March 9, 2016

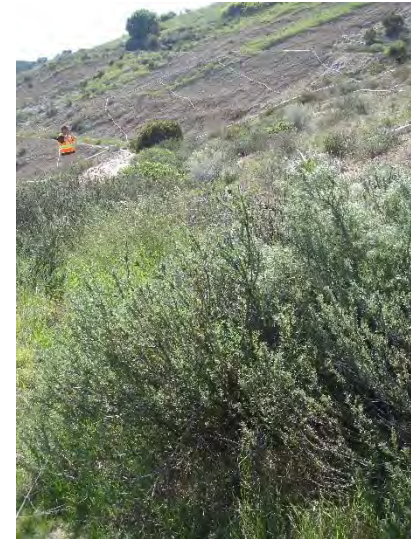
Photo 442: County Sage Mitigation Area: February 24, 2016

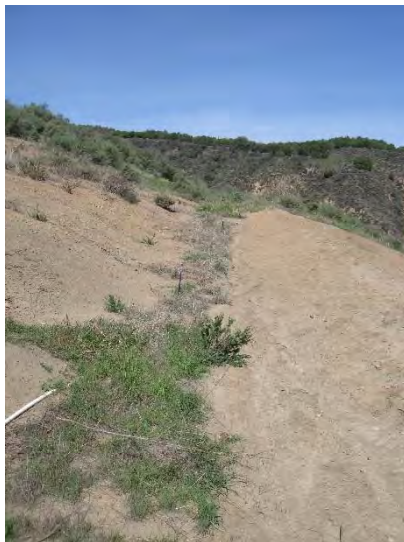
Photo 443: County Sage Mitigation Area: February 24, 2016

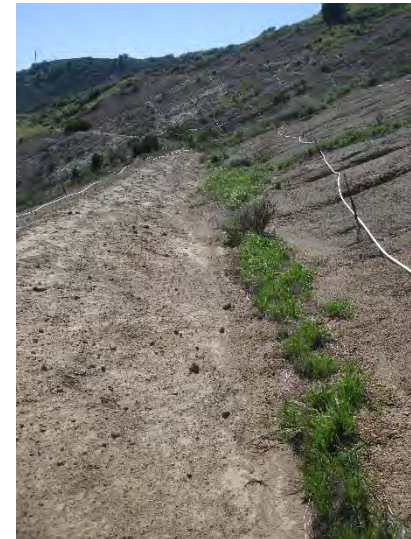
Photo 444: County Sage Mitigation Area: February 24, 2016

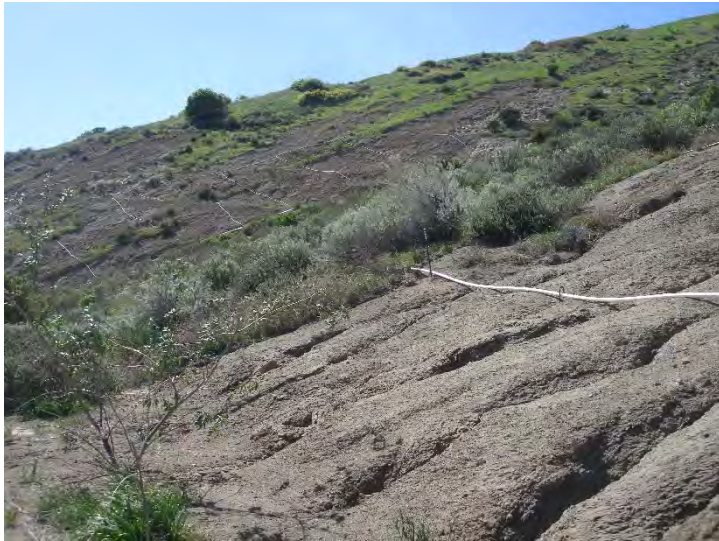
Photo 445: County Sage Mitigation Area: February 24, 2016

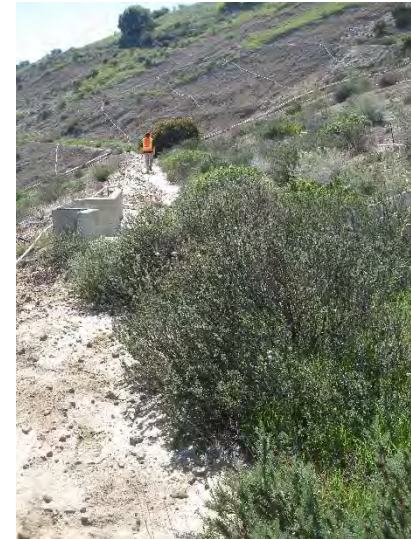
Photo 446: County Sage Mitigation Area: February 24, 2016

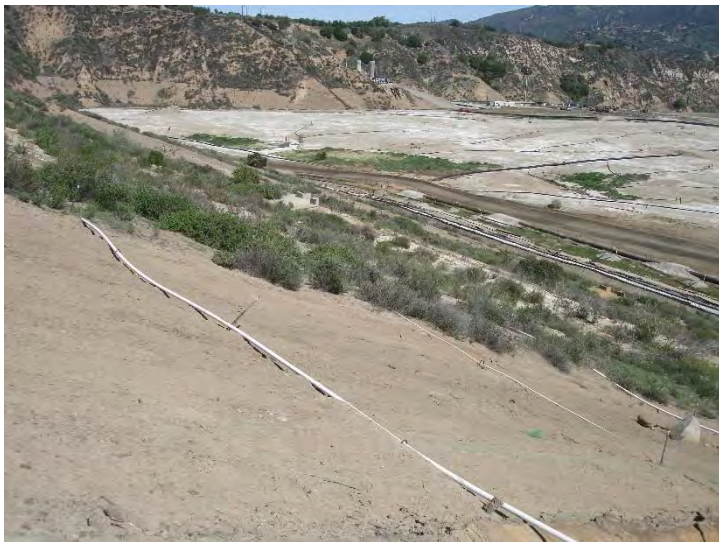
Photo 447: County Sage Mitigation Area: February 24, 2016

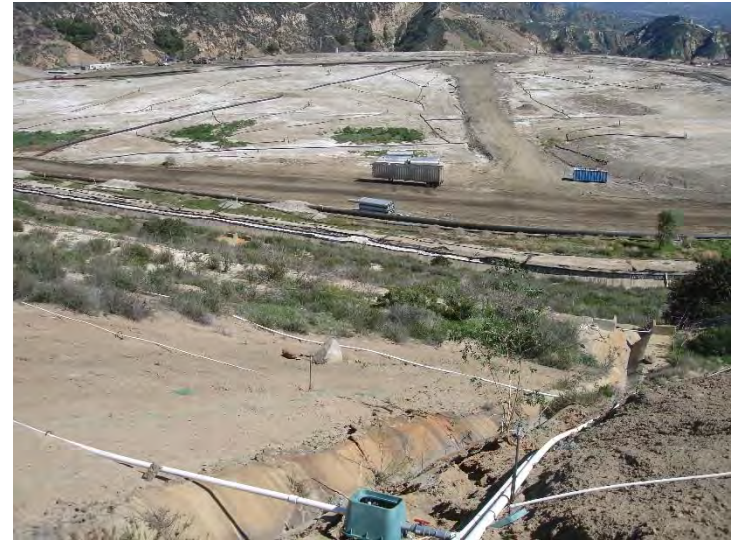
Photo 448: County Sage Mitigation Area: February 24, 2016

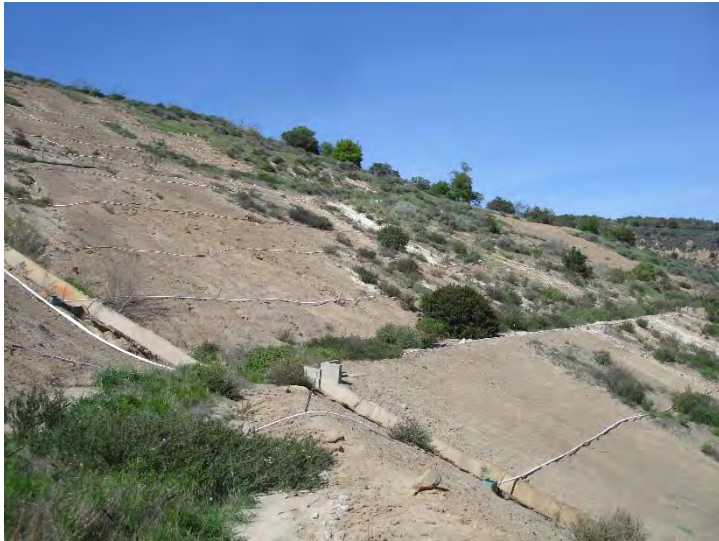
Photo 449: County Sage Mitigation Area: February 24, 2016

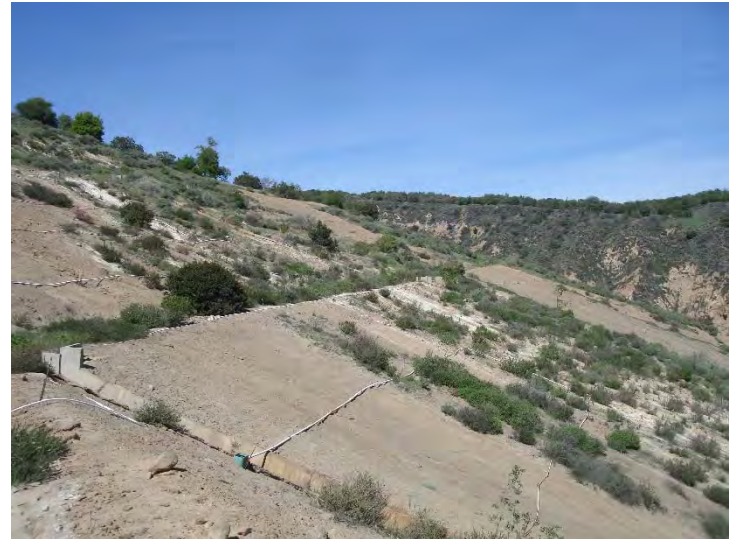
Photo 450: County Sage Mitigation Area: February 24, 2016

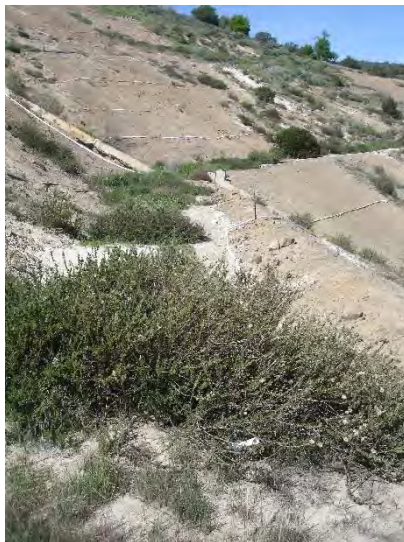
Photo 451: County Sage Mitigation Area: February 24, 2016

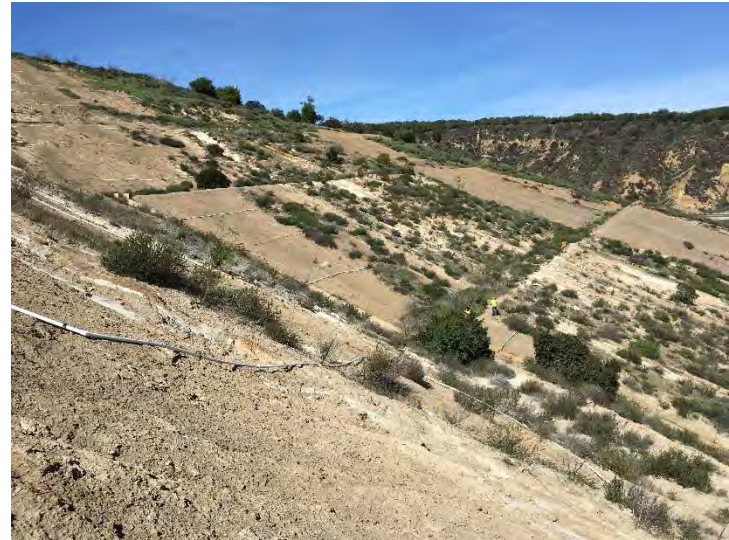
Photo 452: County Sage Mitigation Area: February 24, 2016

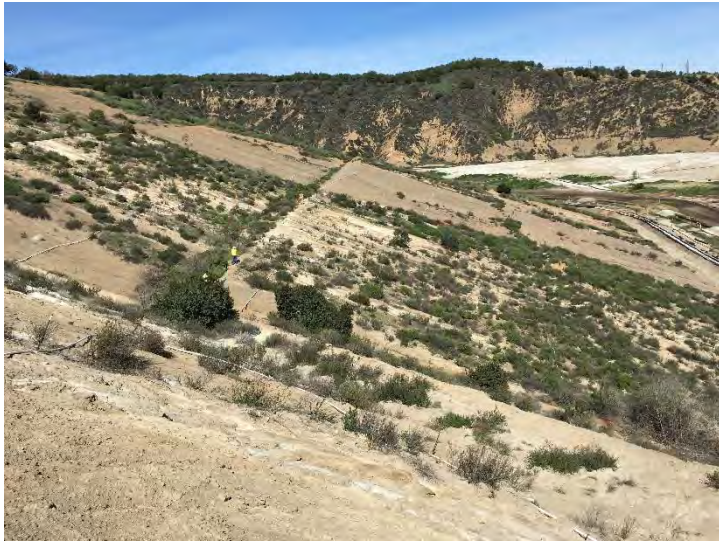
Photo 453: County Sage Mitigation Area: February 24, 2016

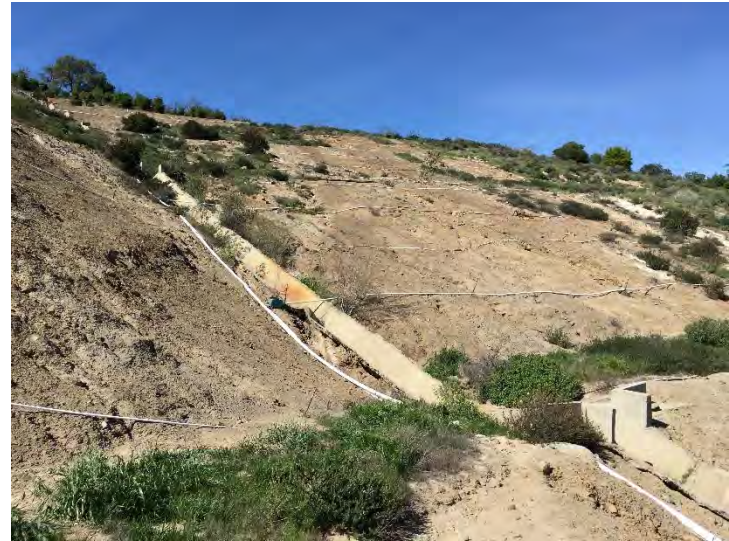
Photo 454: County Sage Mitigation Area: February 24, 2016

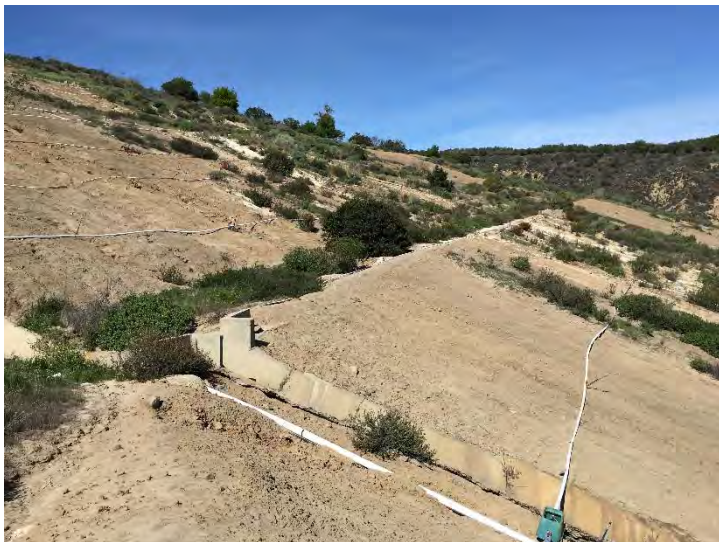
Photo 455: County Sage Mitigation Area: February 24, 2016

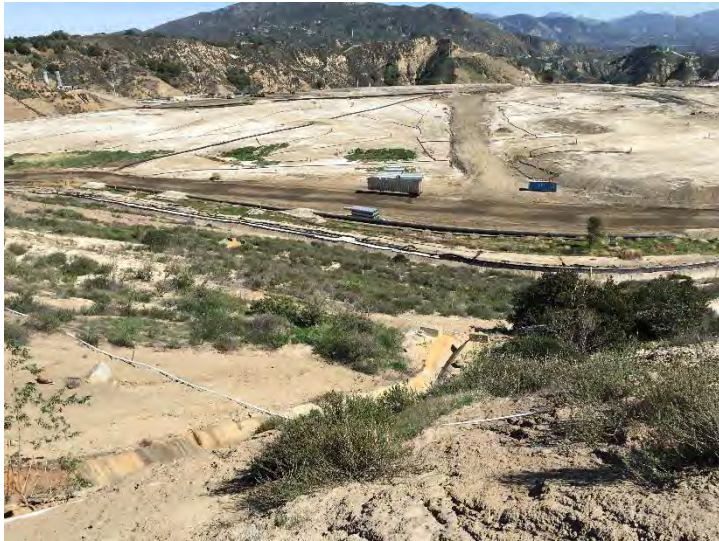
Photo 457: County Sage Mitigation Area: February 24, 2016

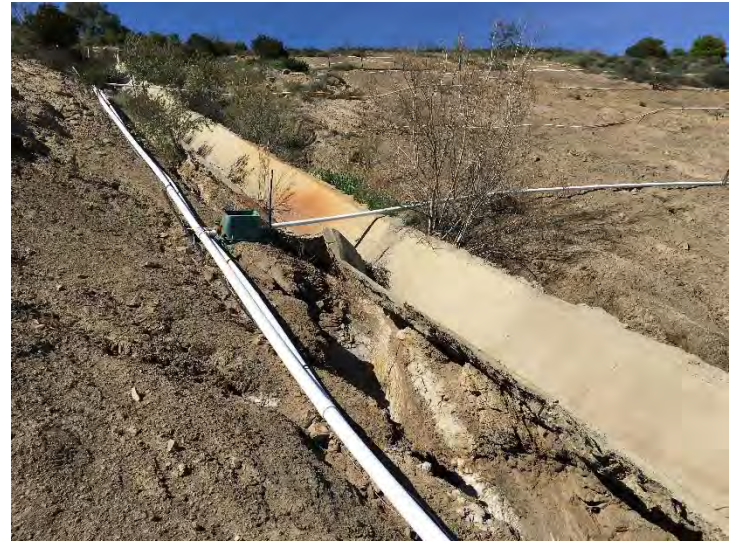
Photo 458: County Sage Mitigation Area: February 24, 2016

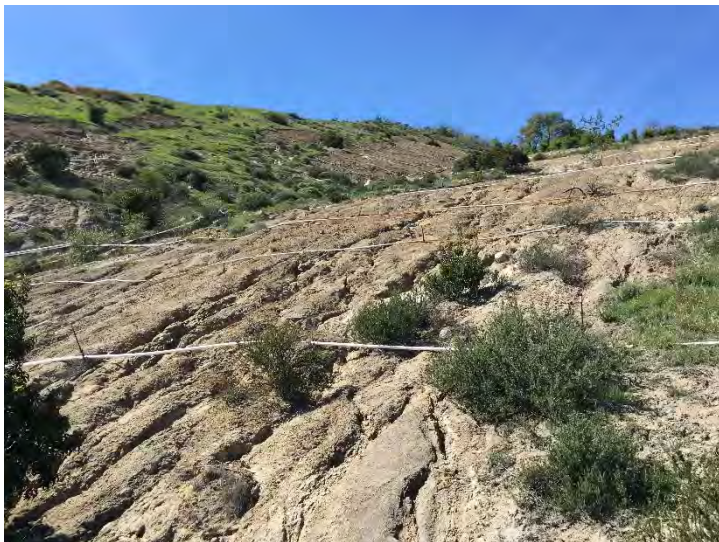
Photo 459: County Sage Mitigation Area: February 24, 2016

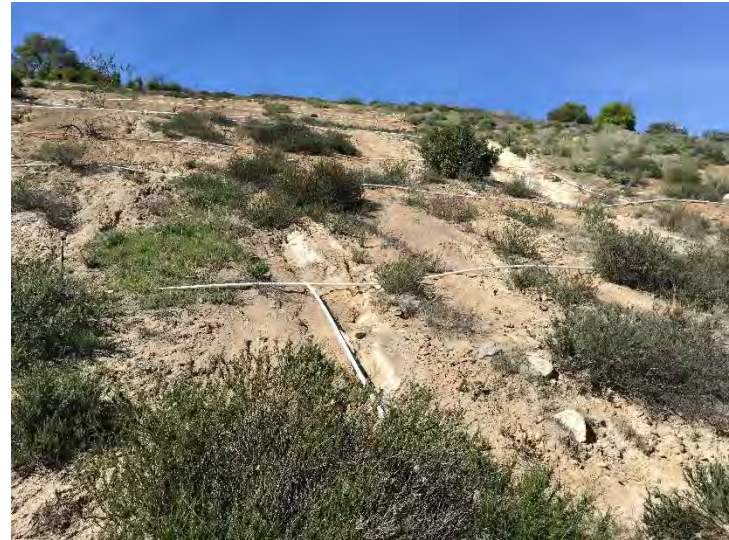
Photo 460: County Sage Mitigation Area: February 24, 2016

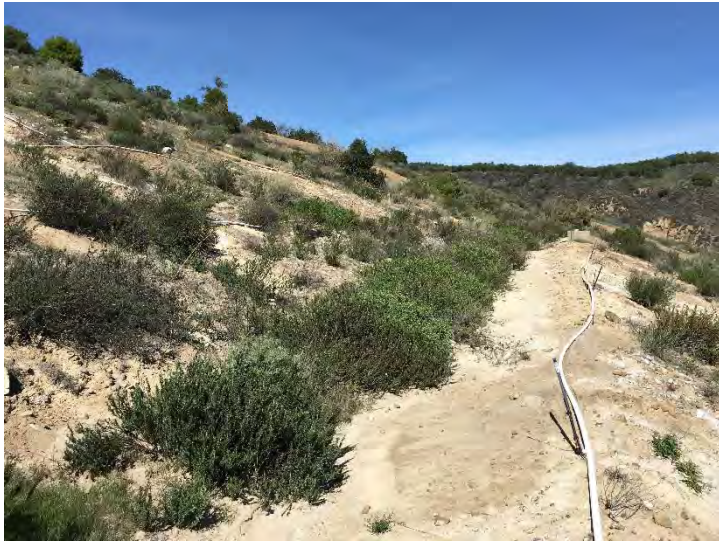
Photo 461: County Sage Mitigation Area: February 24, 2016

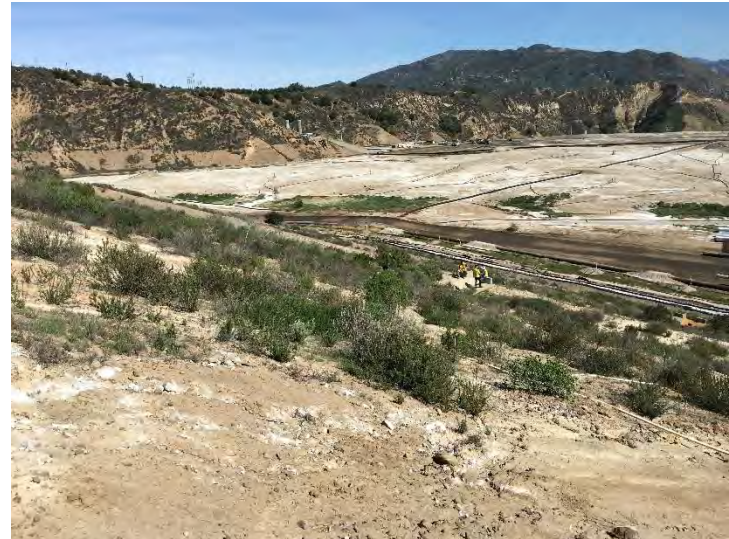
Photo 462: County Sage Mitigation Area: February 24, 2016

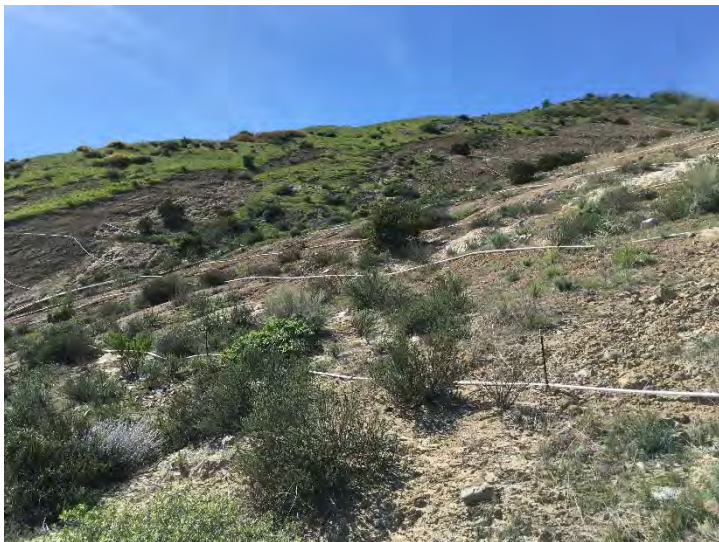
Photo 463: County Sage Mitigation Area: February 24, 2016

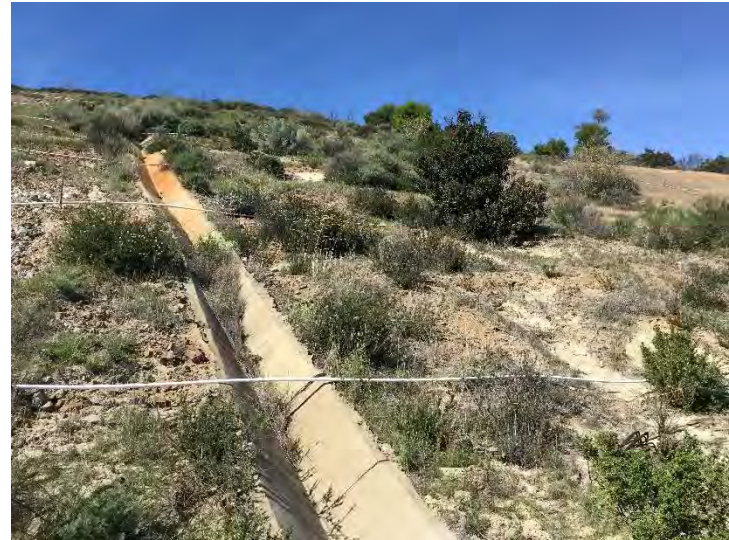
Photo 464: County Sage Mitigation Area: February 24, 2016

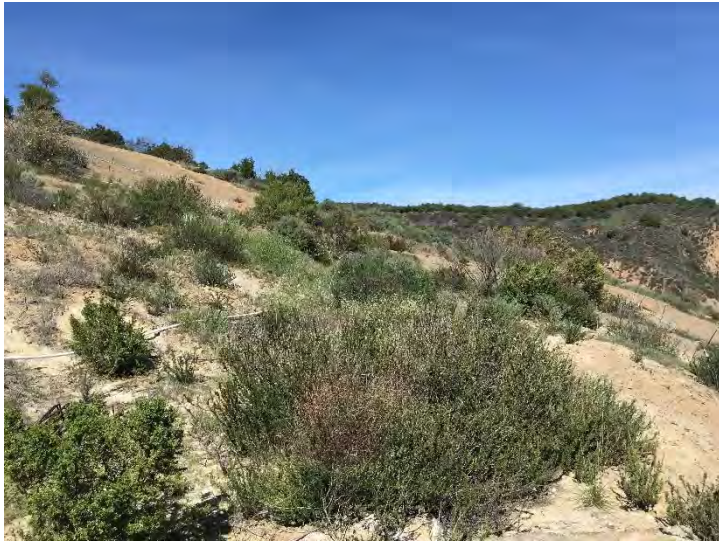
Photo 465: County Sage Mitigation Area: February 24, 2016

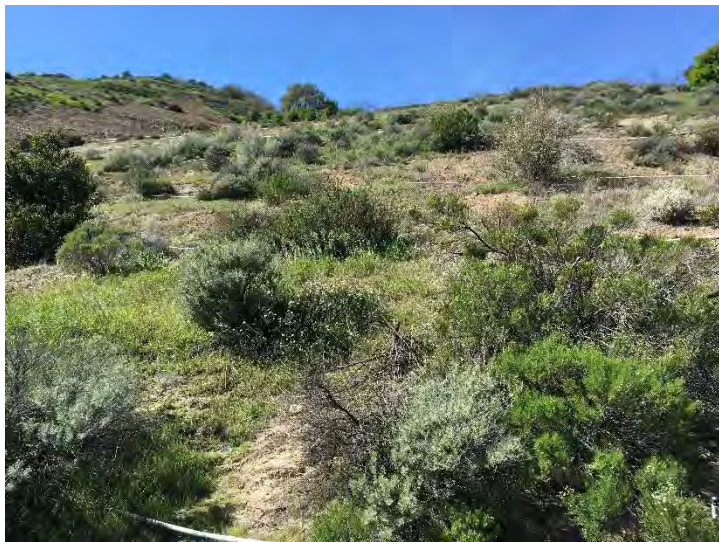
Photo 467: County Sage Mitigation Area: February 24, 2016

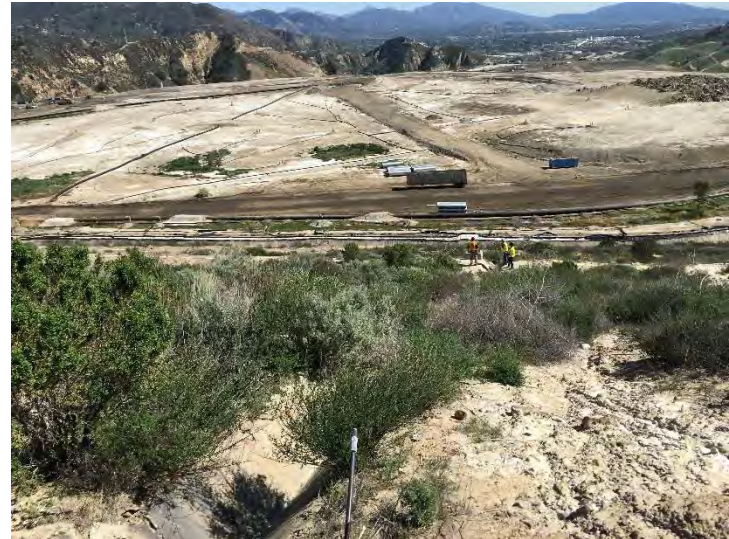
Photo 466: County Sage Mitigation Area: February 24, 2016

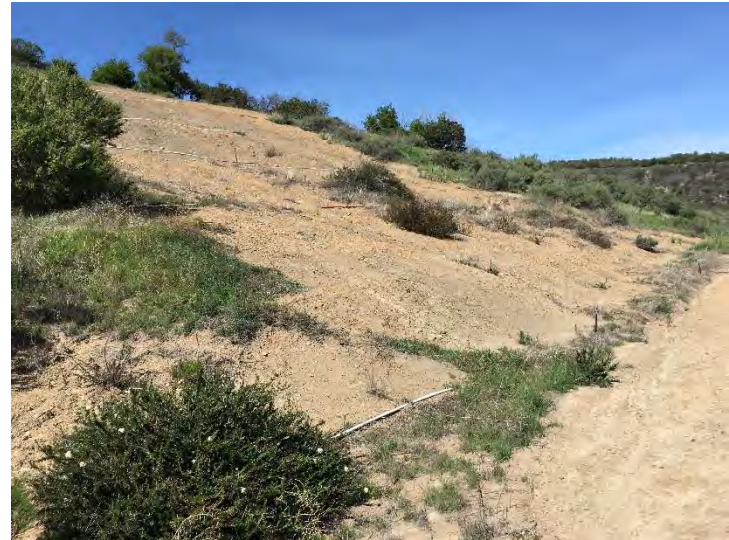
Photo 468: County Sage Mitigation Area: February 24, 2016

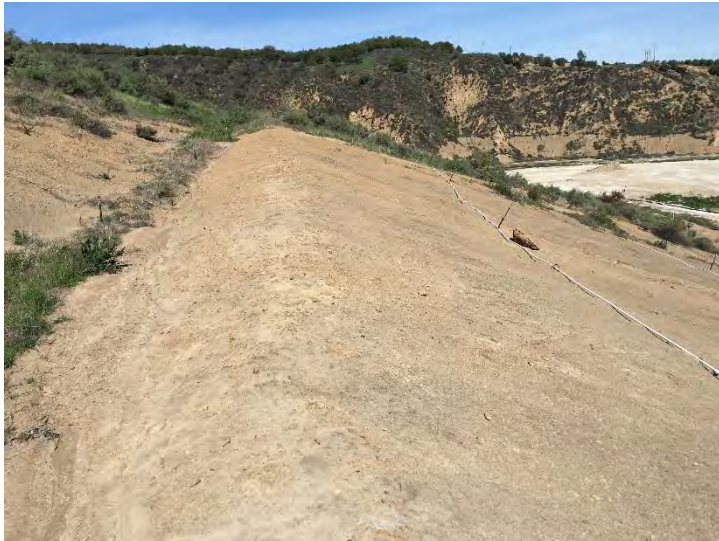
Photo 469: County Sage Mitigation Area: February 24, 2016

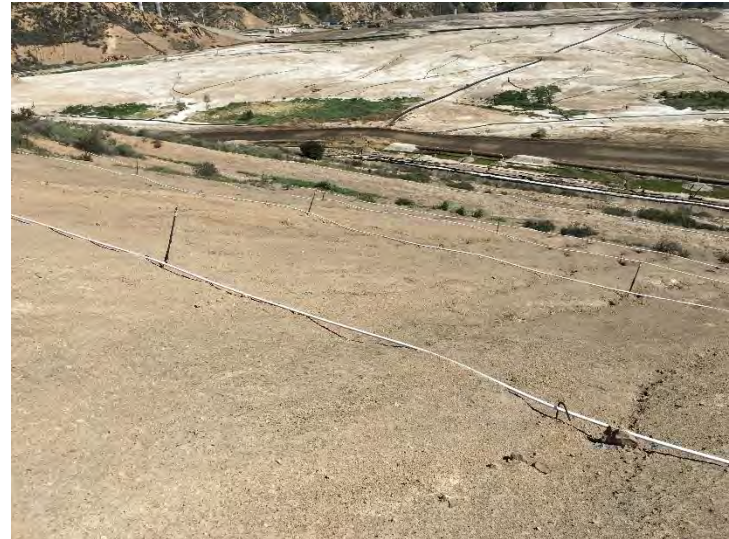
Photo 470: County Sage Mitigation Area: February 24, 2016

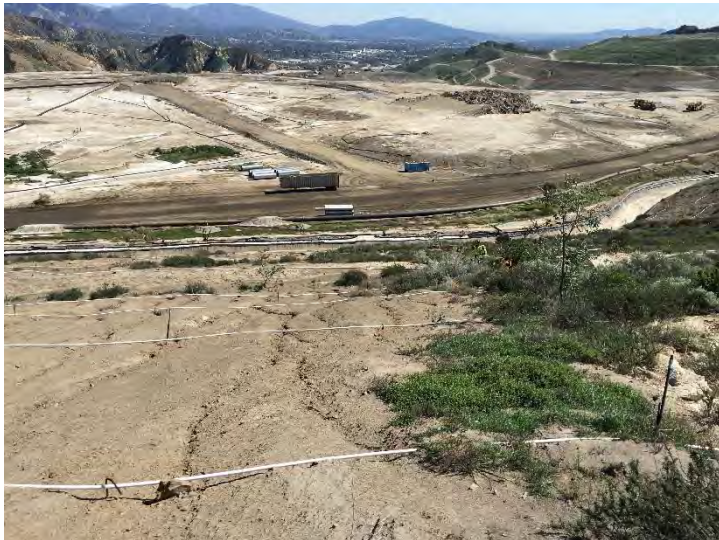
Photo 471: County Sage Mitigation Area: February 24, 2016

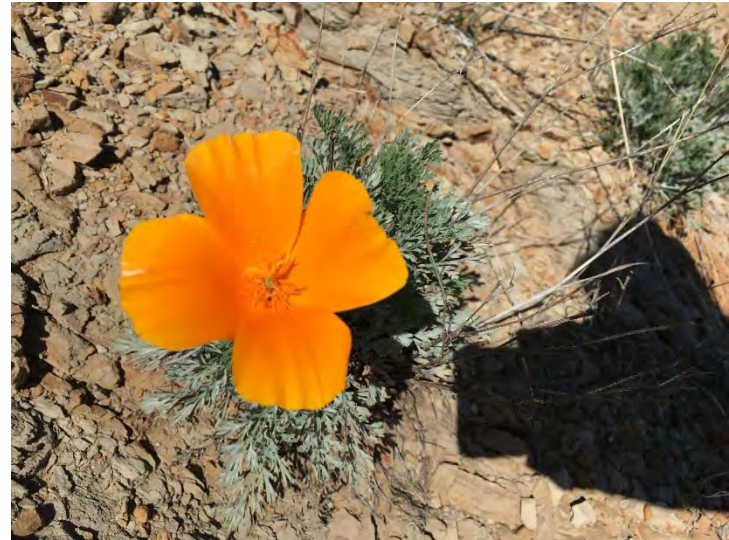
Photo 472: County Sage Mitigation Area: February 24, 2016

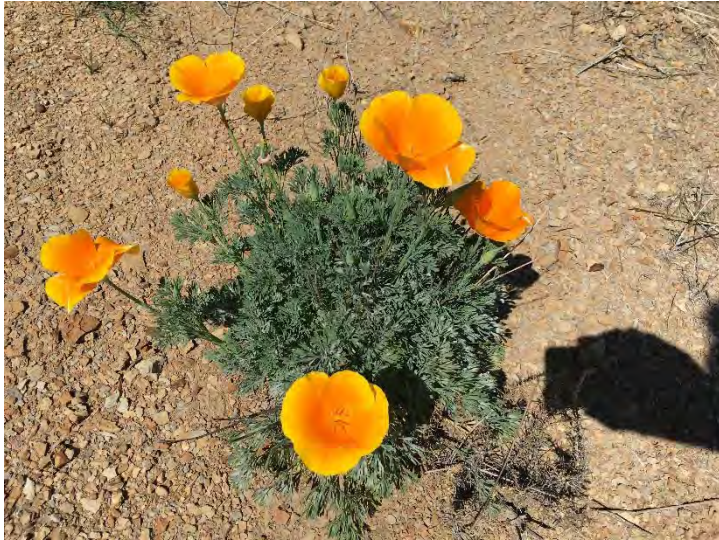
Photo 473: County Sage Mitigation Area: February 24, 2016

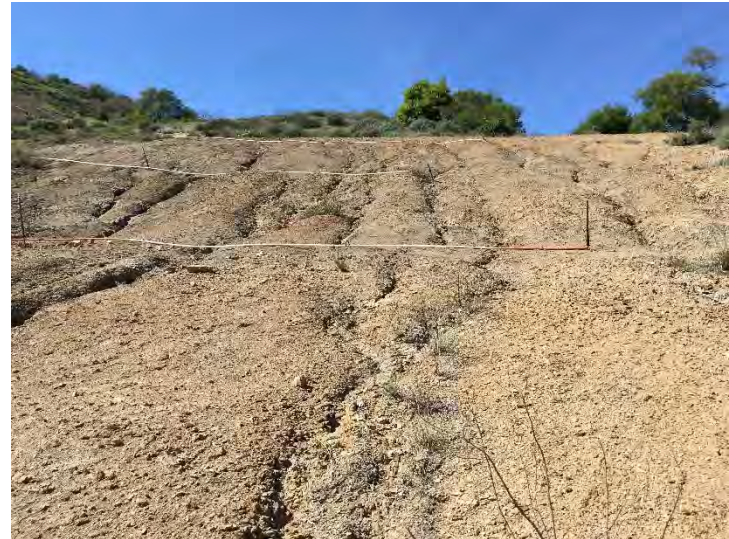
Photo 474: County Sage Mitigation Area: February 24, 2016

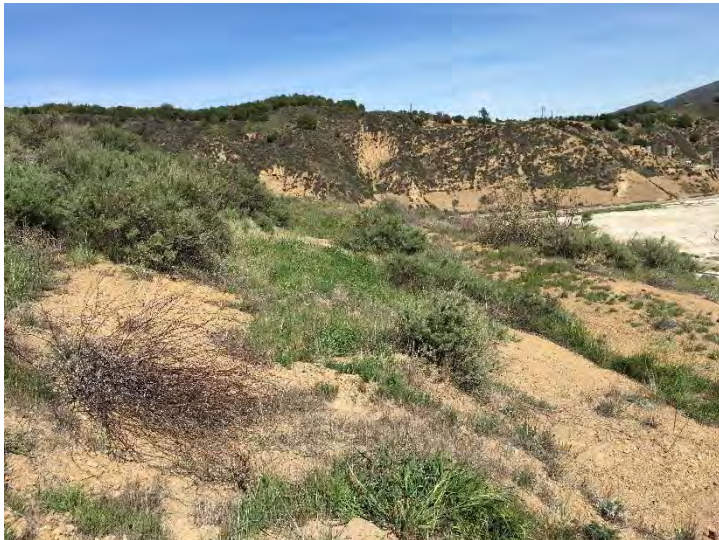
Photo 475: County Sage Mitigation Area: February 24, 2016

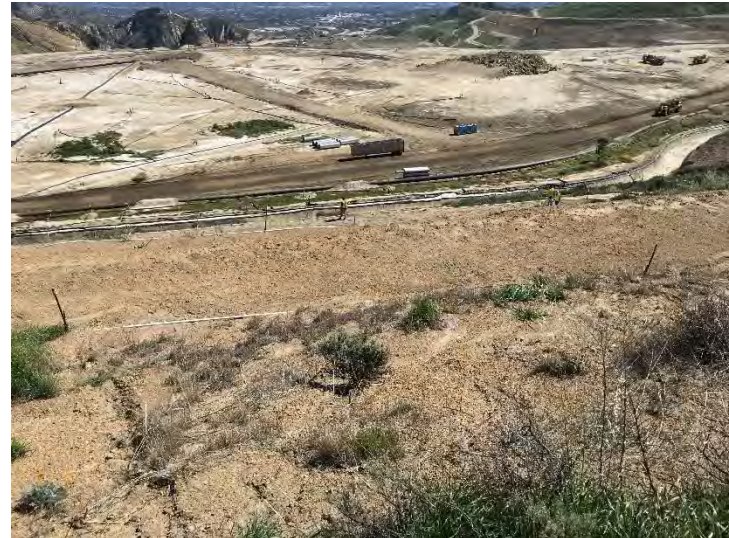
Photo 476: County Sage Mitigation Area: February 24, 2016

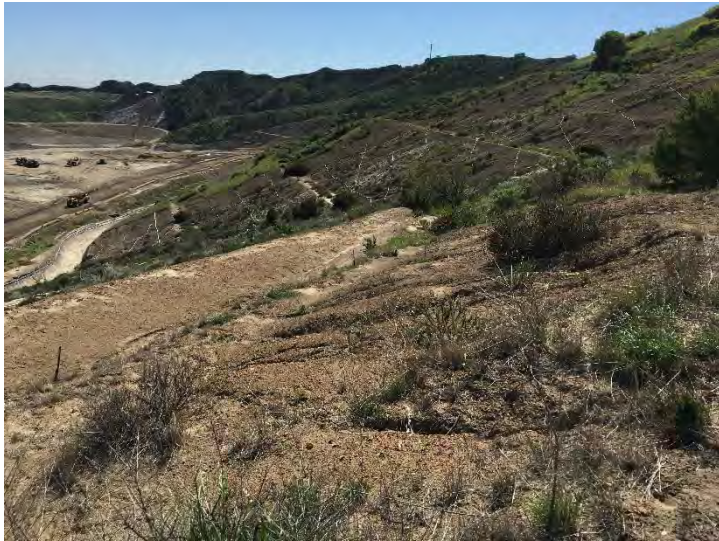
Photo 477: County Sage Mitigation Area: February 24, 2016

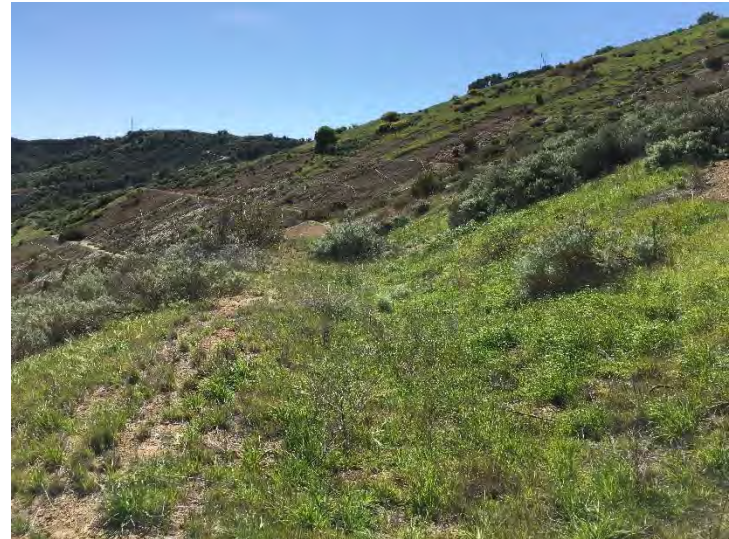
Photo 478: County Sage Mitigation Area: February 24, 2016

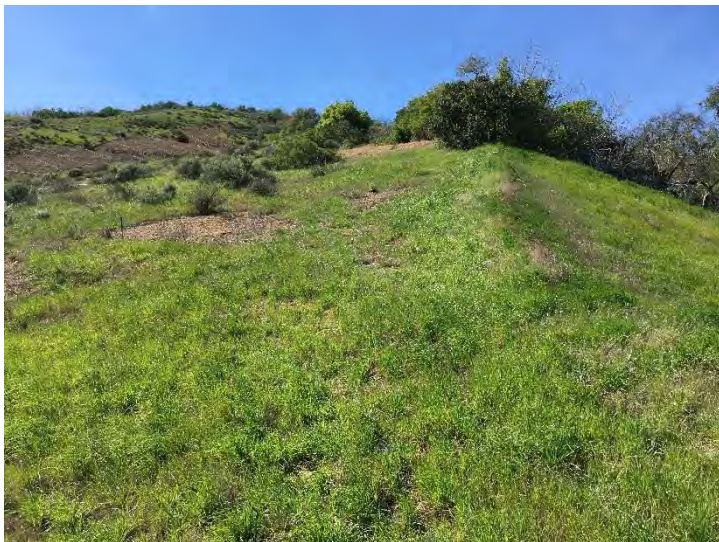
Photo 479: County Sage Mitigation Area: February 24, 2016

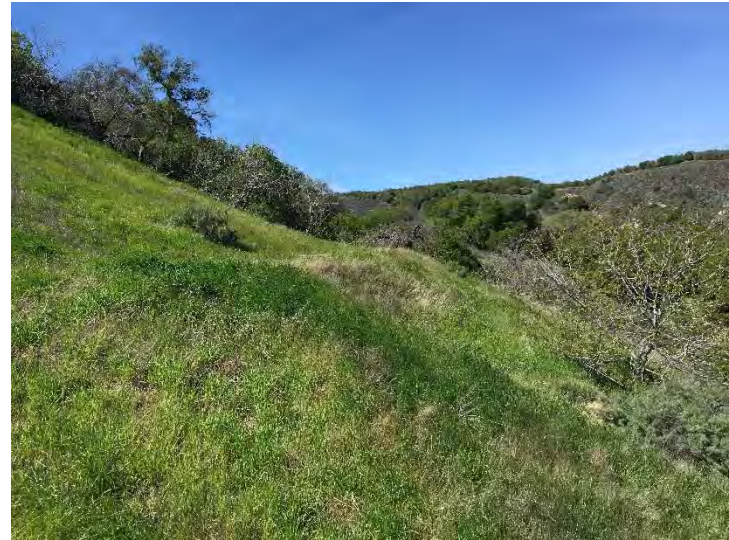
Photo 480: County Sage Mitigation Area: February 24, 2016

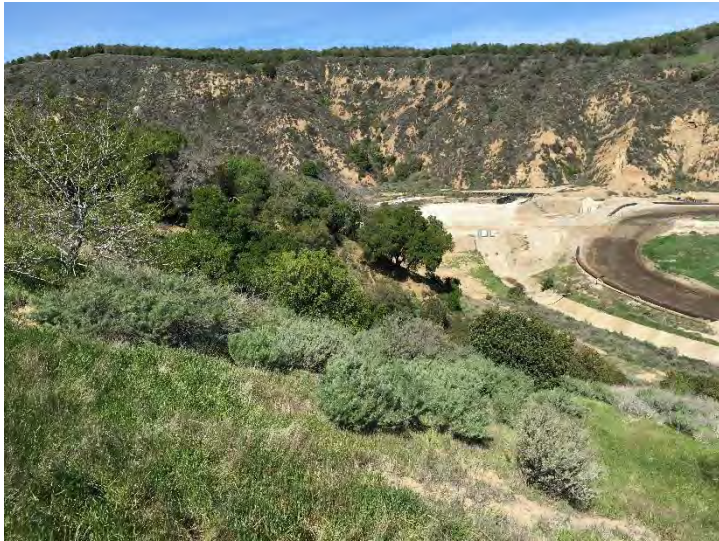
Photo 481: County Sage Mitigation Area: February 24, 2016

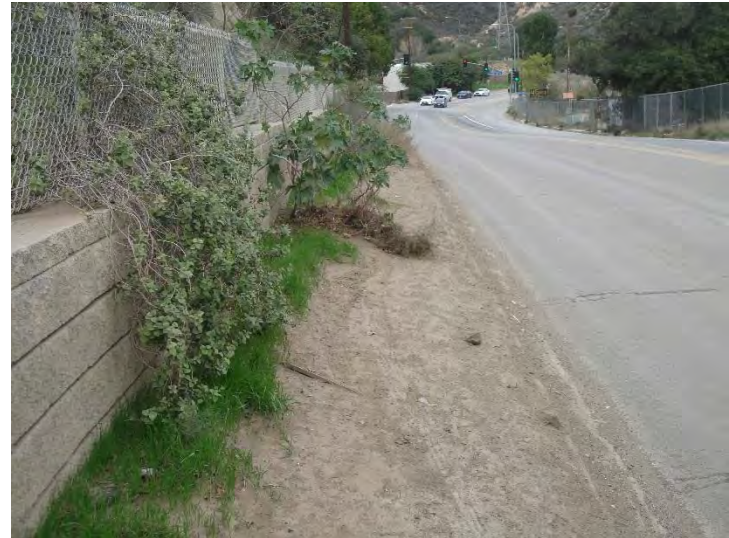
**Photo 511: Frontage Retaining Wall on San Fernando Road:
January 27, 2016**

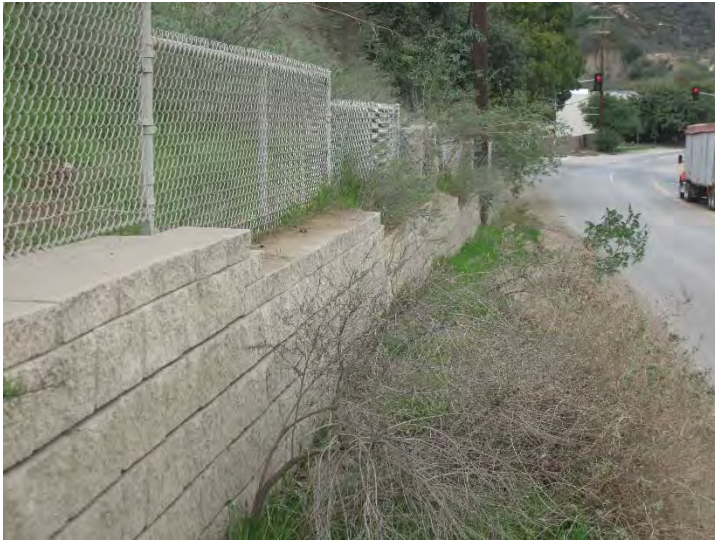
**Photo 512: Frontage Retaining Wall on San Fernando Road:
January 27, 2016**

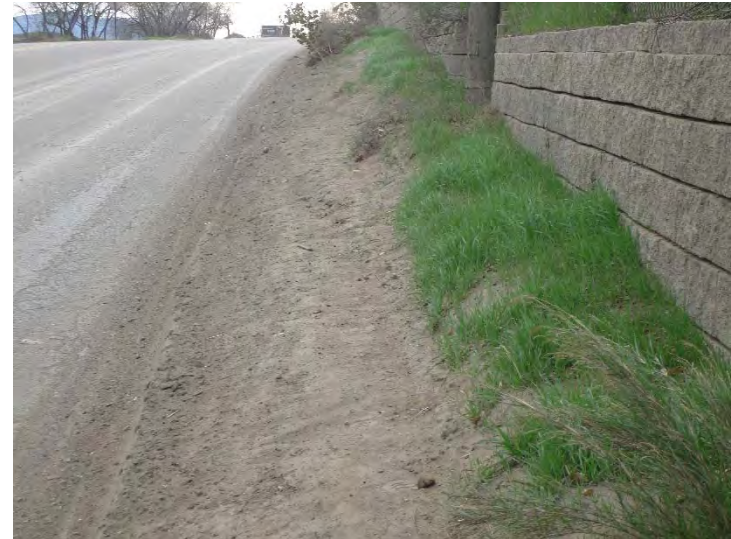
**Photo 513: Frontage Retaining Wall on San Fernando Road:
January 27, 2016**

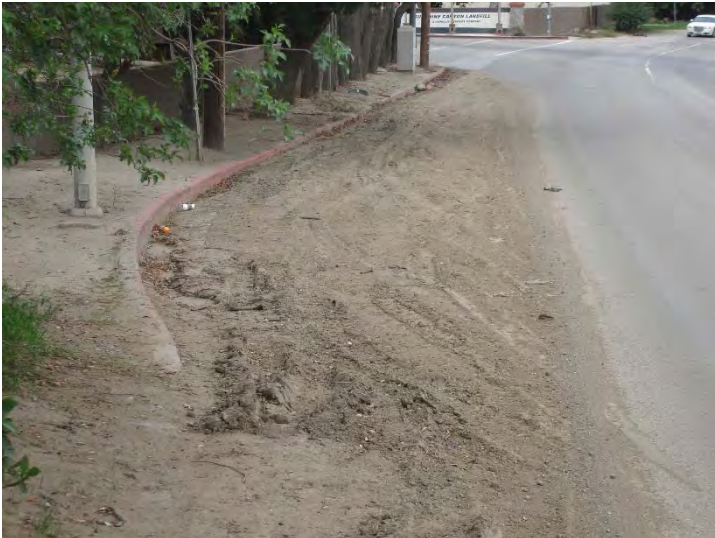
**Photo 514: Soil in Front of Frontage Retaining Wall on San
Fernando Road: January 27, 2016**

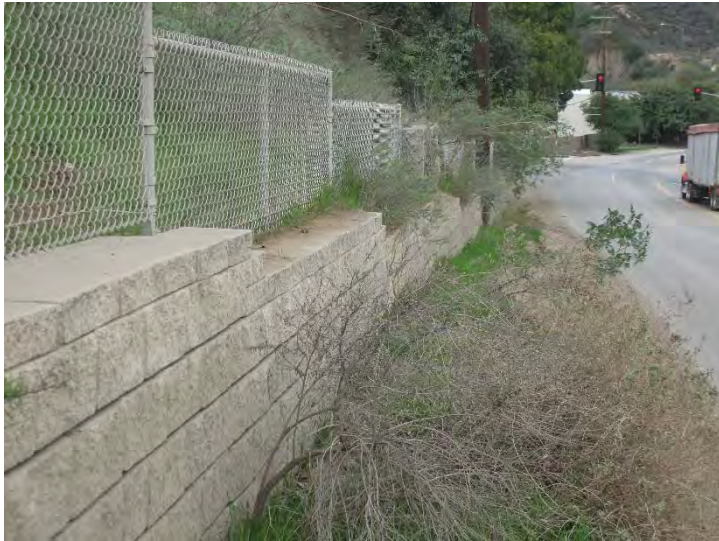
**Photo 516: Frontage Retaining Wall on San Fernando Road:
January 27, 2016**

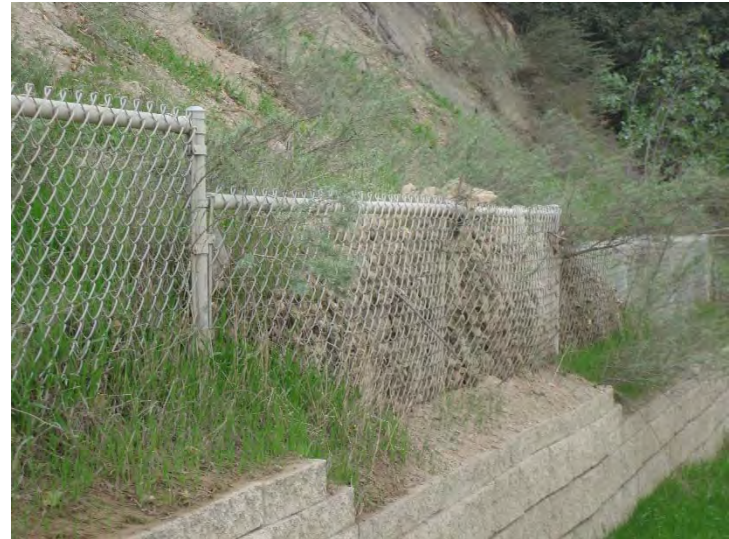
**Photo 517: Frontage Retaining Wall on San Fernando Road:
January 27, 2016**

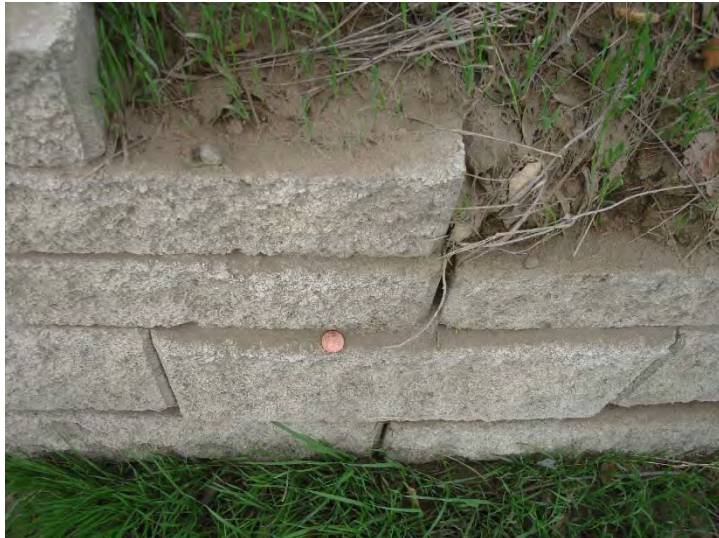
**Photo 518: Frontage Retaining Wall on San Fernando Road:
January 27, 2016**

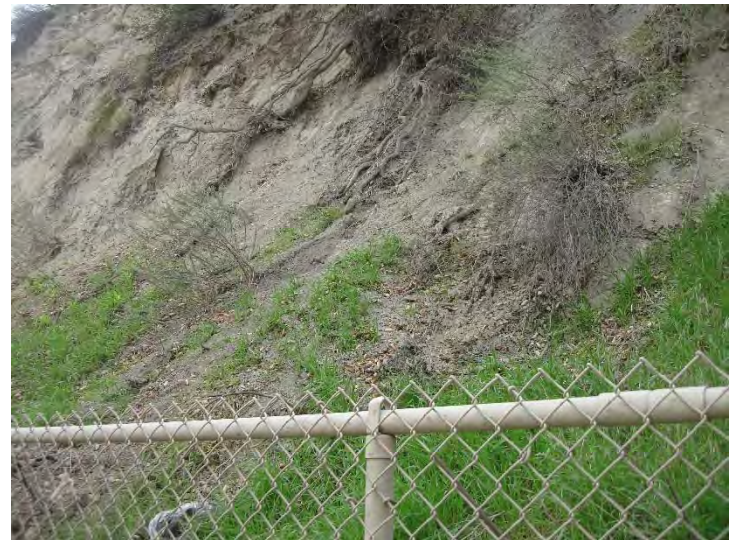
**Photo 519: Frontage Retaining Wall on San Fernando Road:
January 27, 2016**

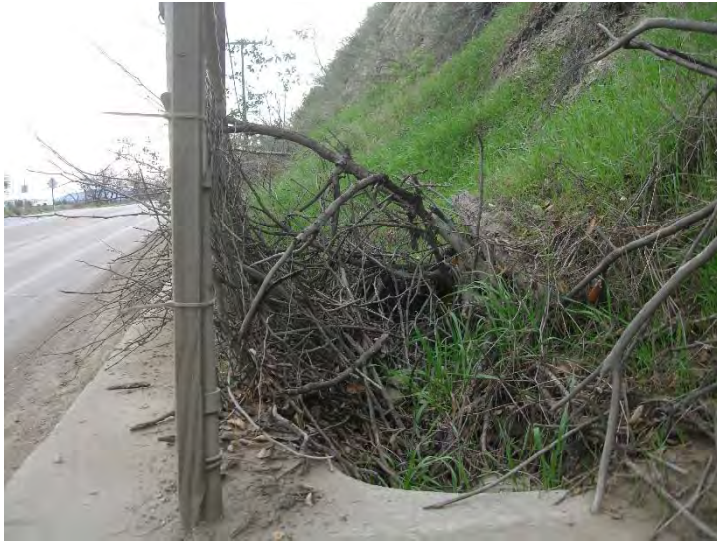
**Photo 520: Frontage Retaining Wall on San Fernando Road:
January 27, 2016**

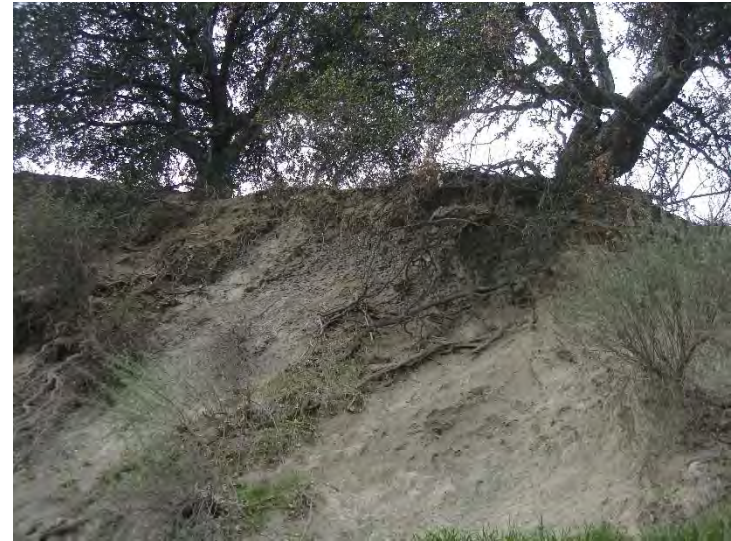
**Photo 521: Frontage Retaining Wall on San Fernando Road:
January 27, 2016**

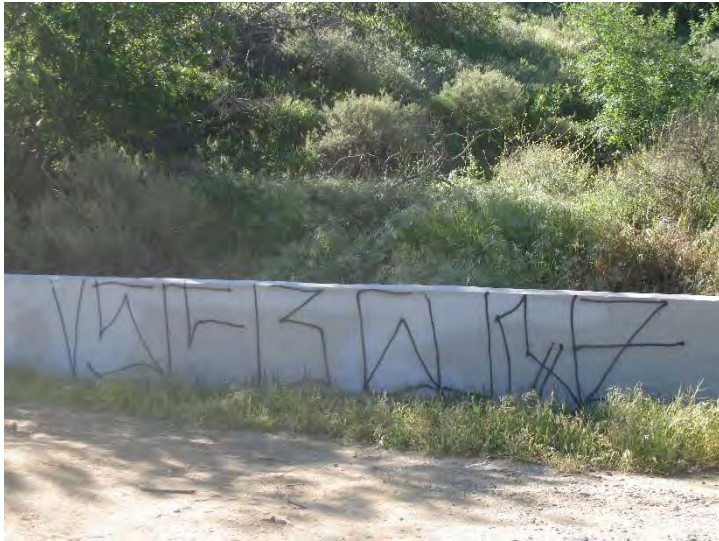
Photo 532: Graffiti Frontage Wall on San Fernando Road: January 27, 2016

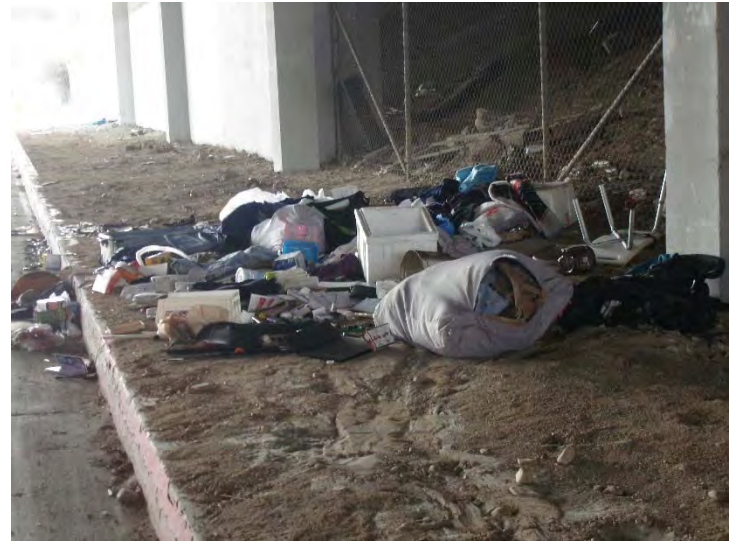
Photo 533: Frontage Wall on San Fernando Road Graffiti: March 23, 2016

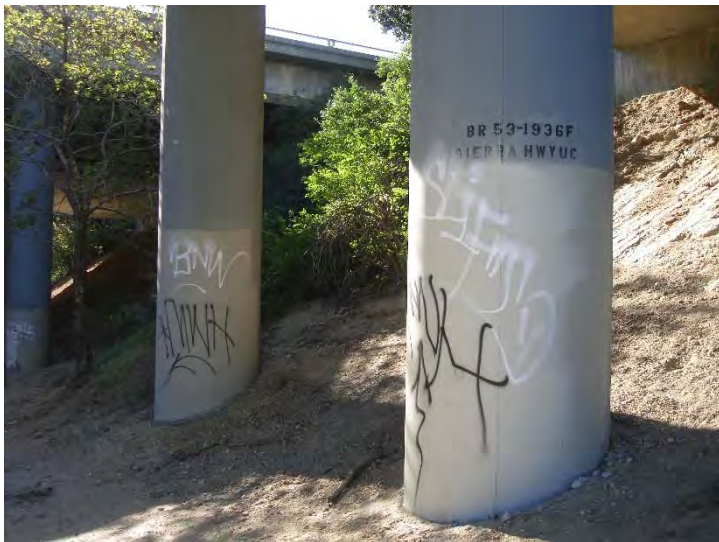
Photo 563: San Fernando Road Near I-5 Overpass: March 23, 2016
