**Sunshine Canyon Landfill
Independent Monitor
Quarterly Site Monitoring Status Report
January 1, 2016 – March 31, 2016**

City of Los Angeles Department of City Planning

County of Los Angeles Department of Regional Planning

May 16, 2016

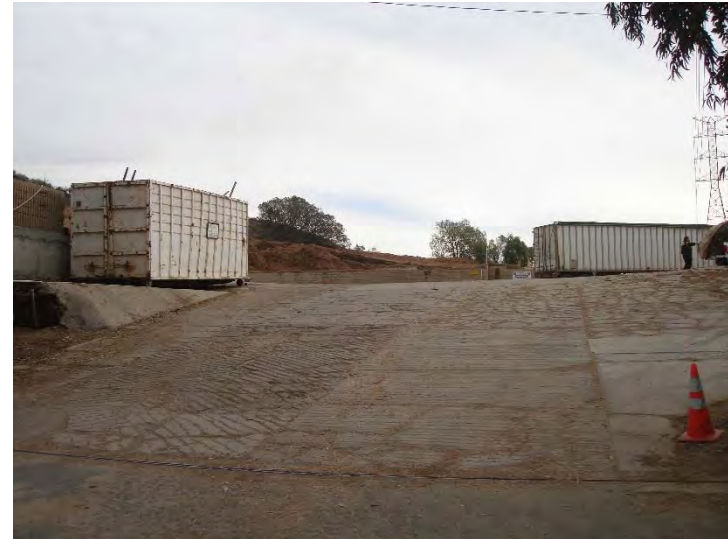
Photo 566: Greenwaste Odor Source: January 27, 2016

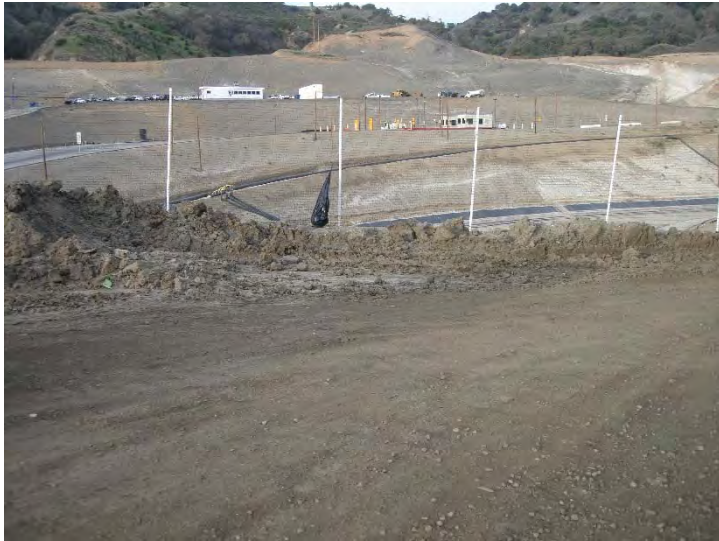
Photo 576: Haul Road Liquids Odor Area: January 27, 2016

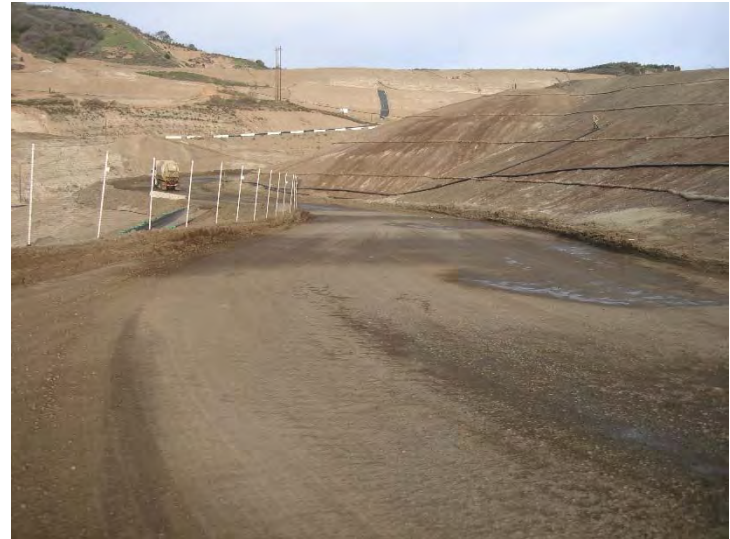
Photo 577: Haul Road Liquids Odor Area: January 27, 2016

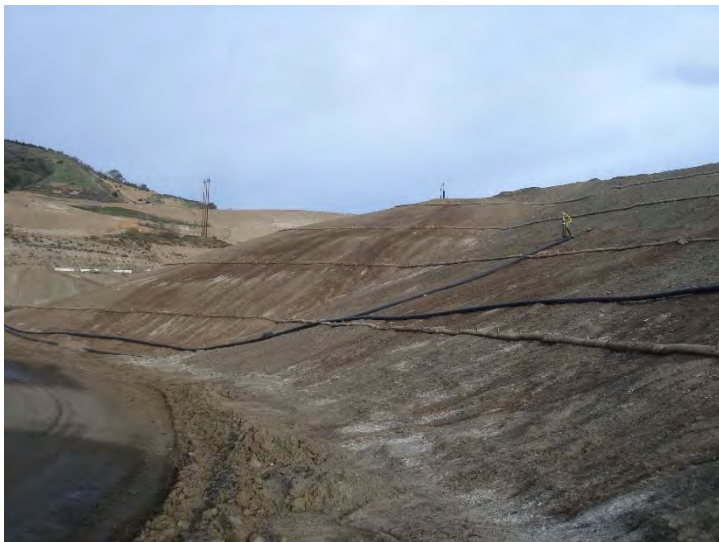
Photo 578: Haul Road Liquids Odor Area: January 27, 2016

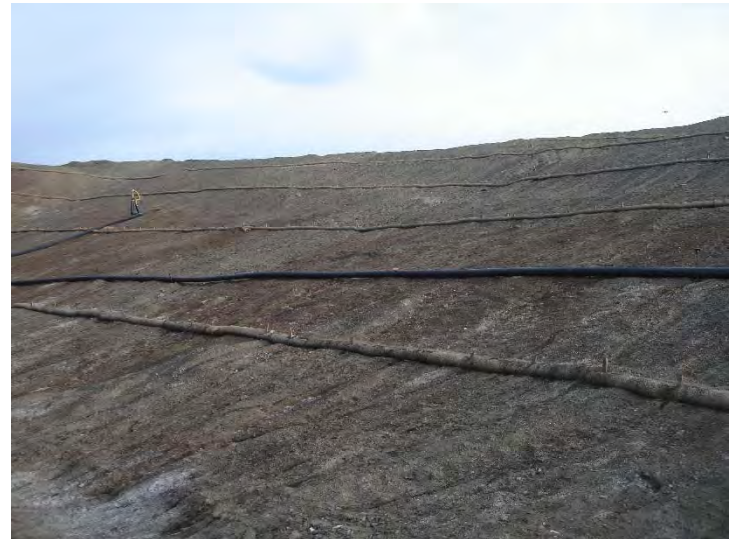
Photo 579: Haul Road Liquids Odor Area: January 27, 2016

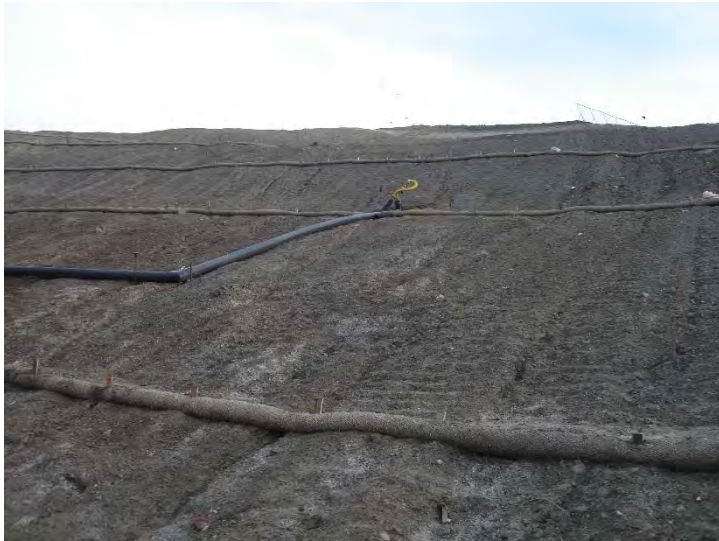
Photo 580: Haul Road Liquids Odor Area: January 27, 2016

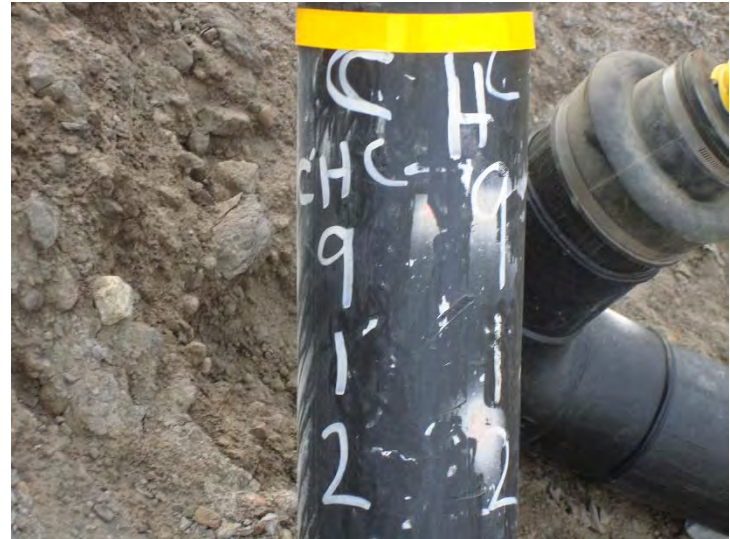
Photo 581: Haul Road Liquids Odor Area: January 27, 2016

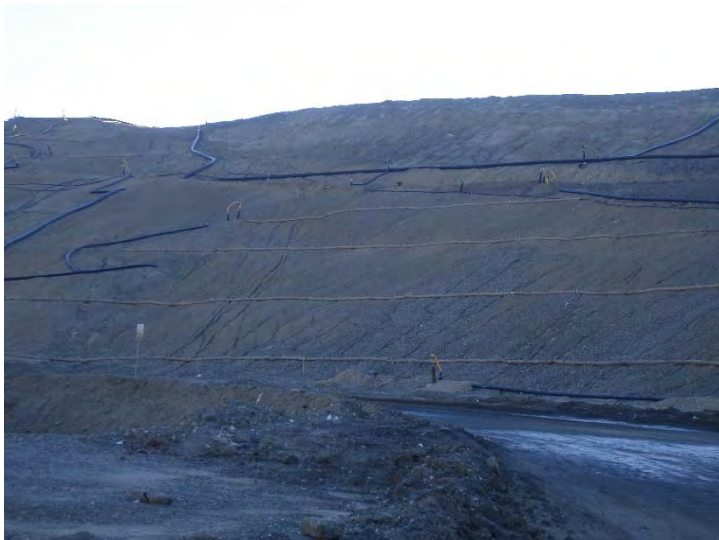
Photo 582: Haul Road Liquids Odor Area: January 27, 2016

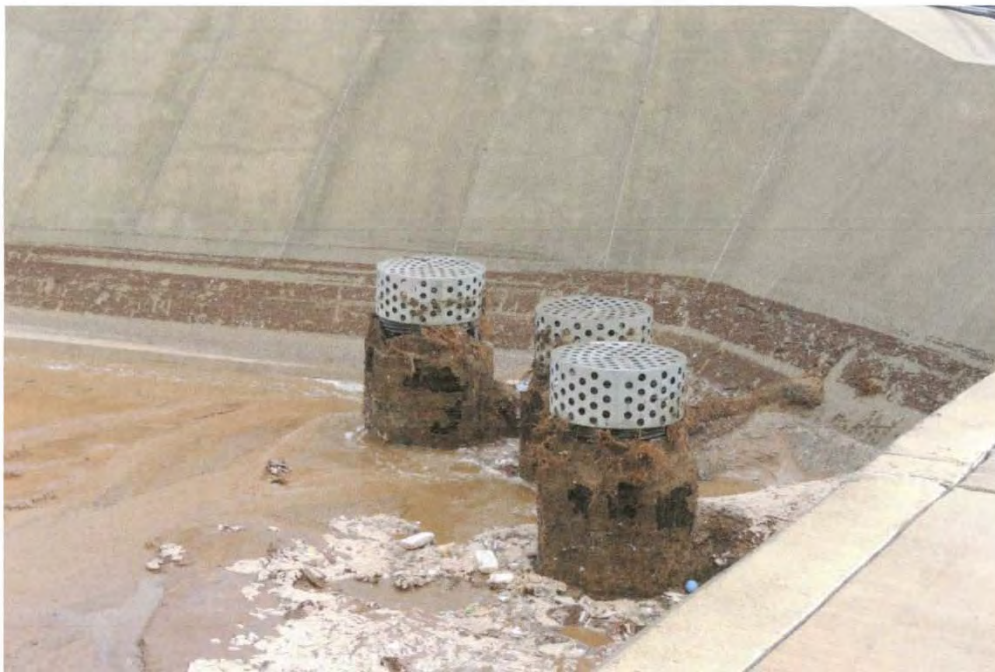
7:15 – 9:15 Initial inspection	
<ul style="list-style-type: none"> • tour the neighborhood to detect potential odors – None • it was the tail end of rainstorm, water still flowing down the main western ditch into the terminal basin, water is clear (Photo 1). A large amount of fines have accumulated in the basin (Photo 2). Source of the fines is runoff from cell CC3B under construction. The temporary lined diversion trench towards the remnants of the 96 inch-culvert draining into the basin failed (Photo 3) and muddy water flew into the basin. The K-rails (Photo 2) in the basin slowed down the muddy water leading to a limited build-out against the risers (Photo 4)

Figure 4: Risers in Terminal Basin

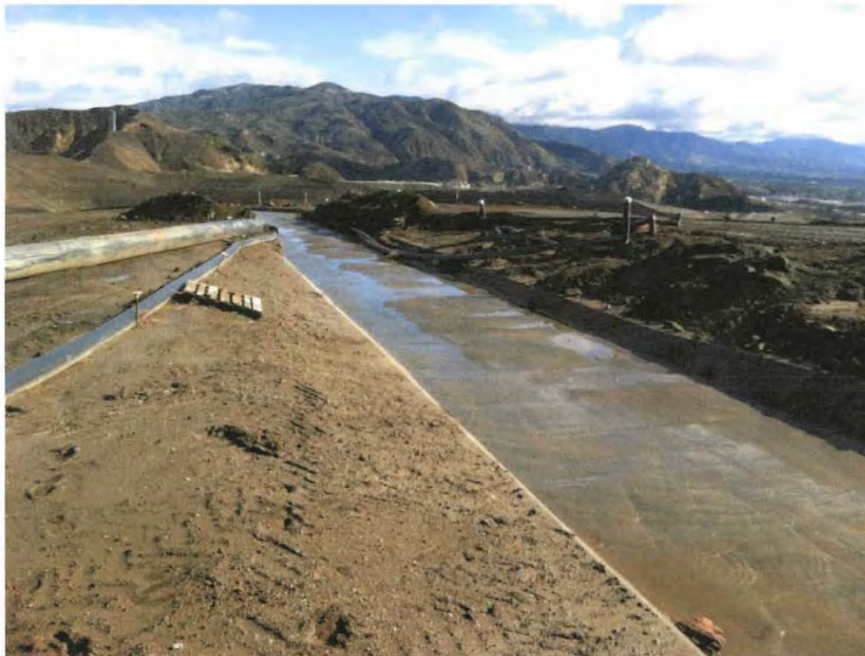
Flares
<ul style="list-style-type: none"> No civil or geotechnical issues noted
Drainage system
<ul style="list-style-type: none"> Basin A: <ul style="list-style-type: none"> The drainage channel out of basin observed in previous visits to be partially filled up with soil was cleaned and flowing (Photo 5). Section of channel on west side between Basin A and Basin D previously noted: <ul style="list-style-type: none"> Bottom slab held well (Photo 6) Erosion on the cut slope above brought a fair amount of oil in the channel (Photo 7) that will have to be cleaned. The southern side drainage channel in the canyon at Basin D/boneyard noted in previous visit as blocked was opened (Photo 8) allowing drainage into Basin D Geomembrane liner on section of drainage channel between basin D and the access road to the Flare 9 and 10: <ul style="list-style-type: none"> membrane held well during storm However for long term reliability it is still recommended to <ul style="list-style-type: none"> Attach the geomembrane to the sides of the channel to reduce the risk of underflow (Photo 9). fix the flap at entry to culvert to the shotcrete (Photo 10) upper portion of channel draining the access road to the power generating station and Flares 9 and 10 should be cleaned prior to next storm (Photo 11) Basin B (Photo 12): <ul style="list-style-type: none"> limited amount of fine in basin the rock check dam around the risers are functioning well in retaining the fines and letting water through North drainage channel near current staging area for cell CC3B construction on city landfill deck: <ul style="list-style-type: none"> erosion along the concrete edge should be fixed before next large storm (Photo 13)

Photo 5: Drainage ditch out of Basin A cleaned and flowing

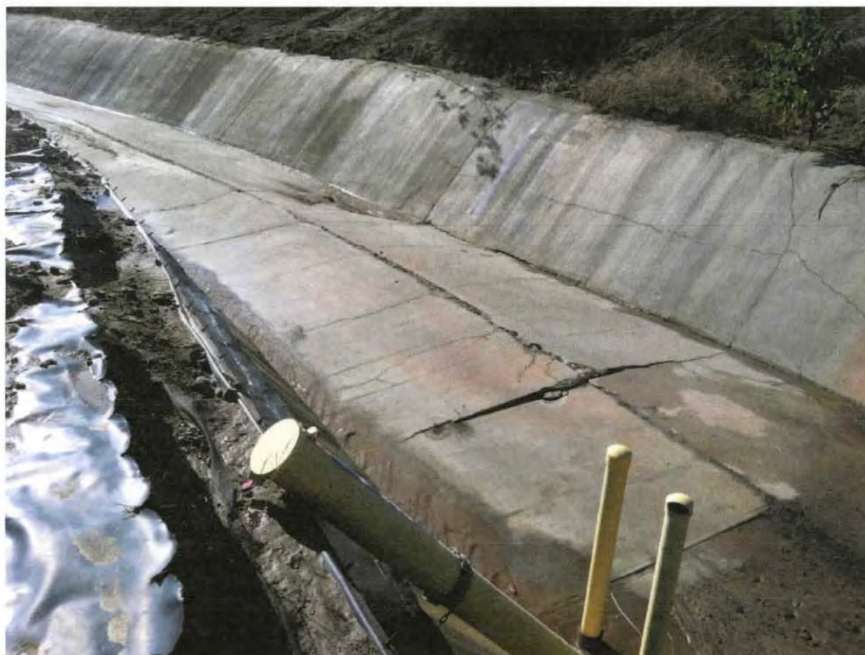
Photo 6: Channel between Basin A and Basin D

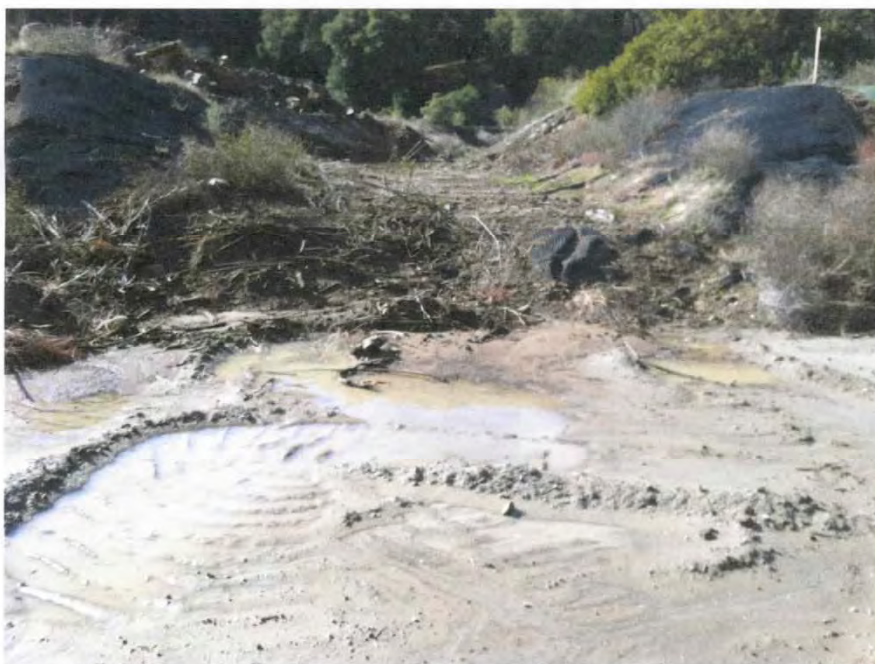
Photo 8: Cleared and opened southern side ditch at Basin D

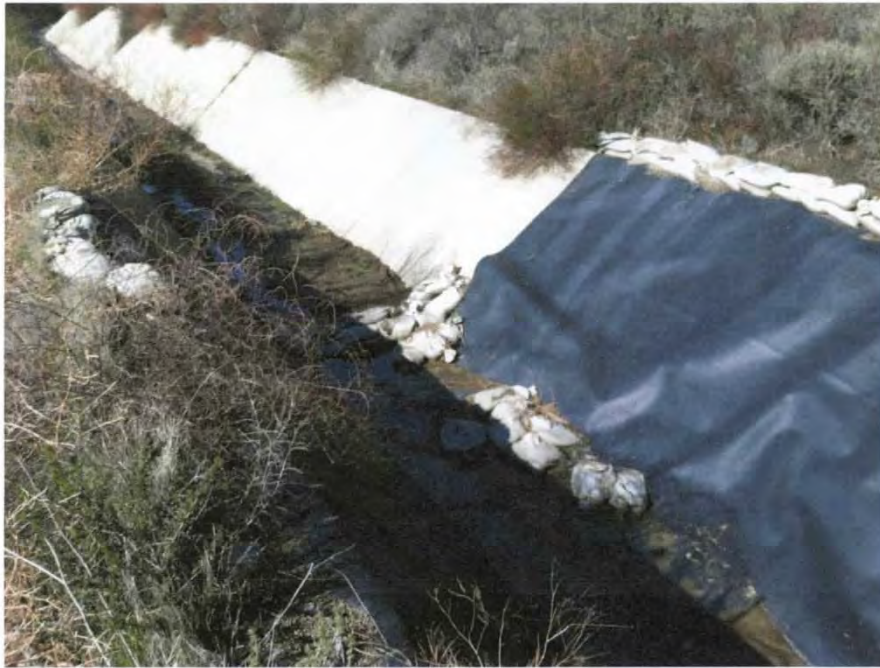
Photo 9: Geomembrane liner at beginning of lined portion between Basin D and Flare 9-10 access road

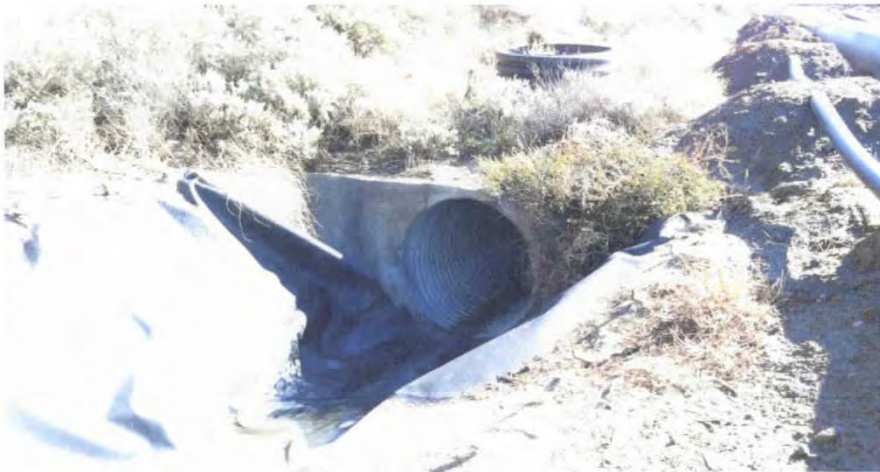
Photo 10: Geomembrane liner at entry to culvert near Flare 9-10 access road

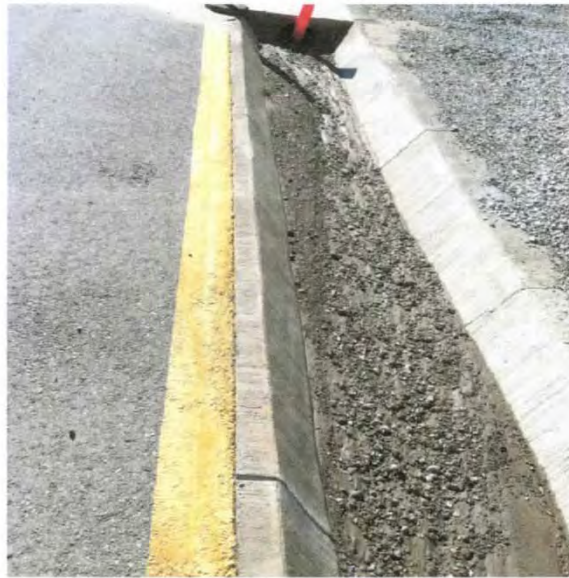
Photo 11: Drainage ditch along access road to Flares 9 and 10

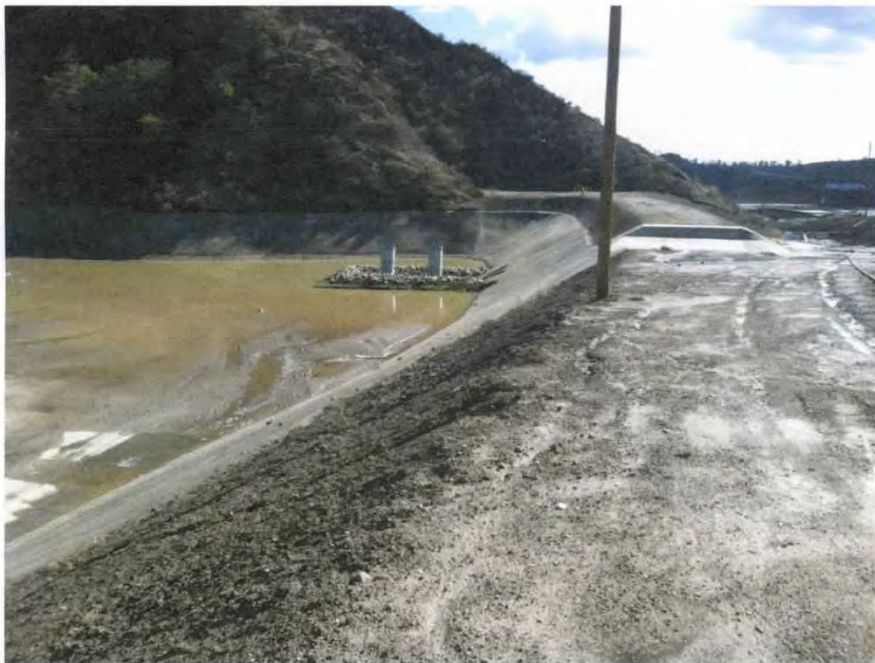
Photo 12: Basin D

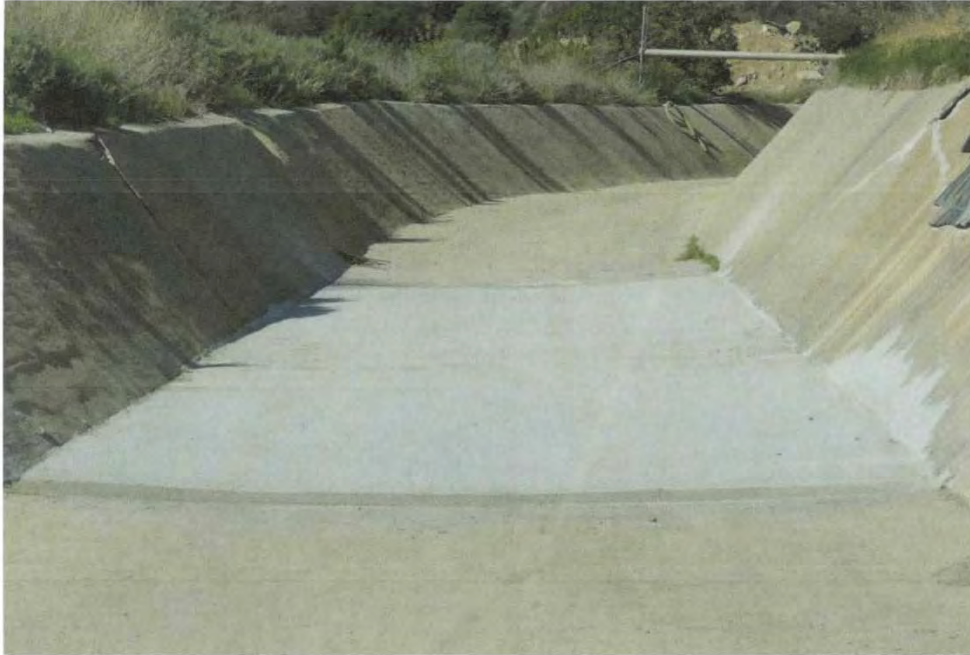
Photo 1: repaired bottom of channel between Basin A and Basin D

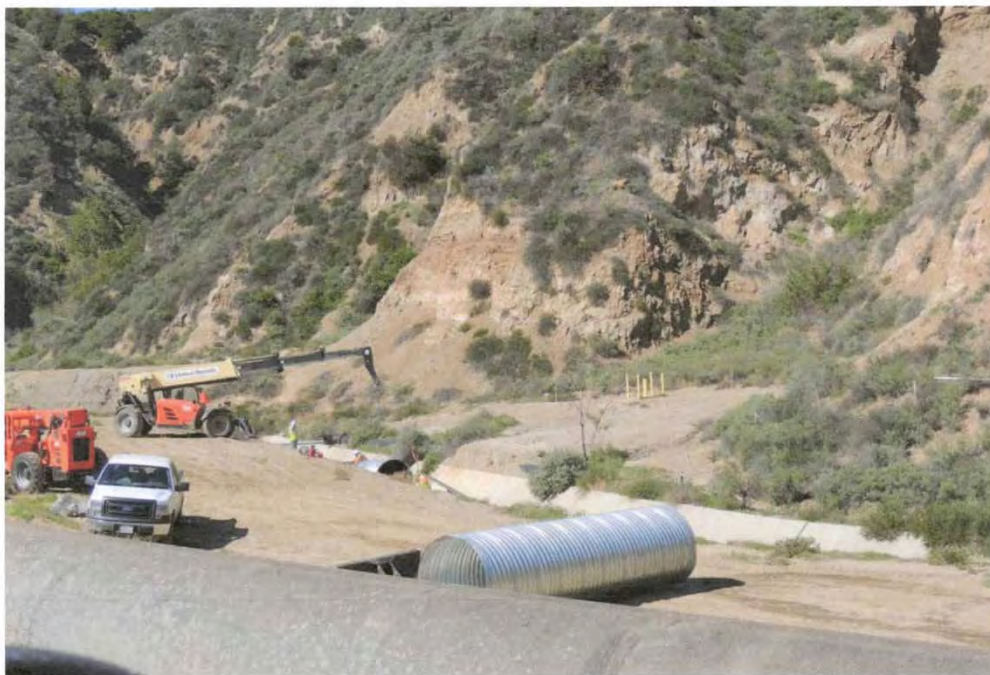
Photo 3: New CSP between Basin D and access road to Flare 9-10

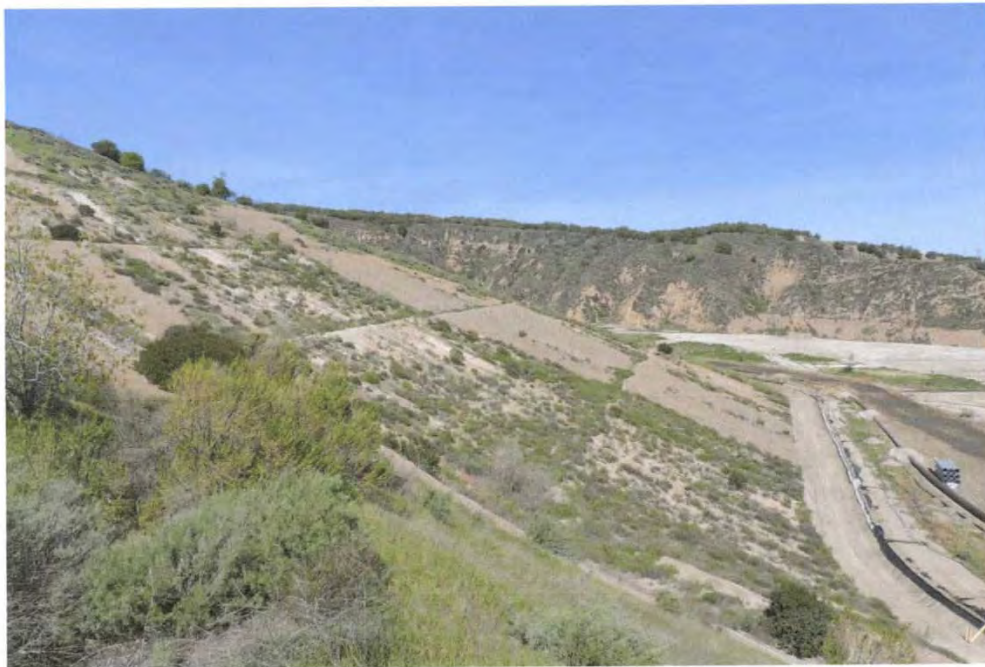
<p>Coastal sage mitigation area</p> <ul style="list-style-type: none"> the area includes 5 slopes and 4 benches (Photo 8) the benches are connected with concrete down chutes the benches are sloped back into the slope to create drainage ditches long the toe of the up-slope Erosion gullies are present on the bare areas and none on the vegetated areas. it was noted that the base geologic formation is different in the vegetated and non-vegetated areas which may contribute to the difference in behavior the down chute show some signs of distress <ul style="list-style-type: none"> cracks where observed but with limited displacements(Photo 9) so the down chute is still functioning erosion along the edge on the downslopes(Photo 10)
<p>Waste face</p> <ul style="list-style-type: none"> ADC is holding very well under windy conditions –no rips or pullout at edges. However there is some waste uncovered along the edge (Photo 11). No civil or geotechnical issues noted

Photo 8: Overall view of coastal sage mitigation area
