**Sunshine Canyon Landfill
Independent Monitor
Quarterly Site Monitoring Status Report
October 1, 2016 – December 31, 2016**

UltraSystems
environmental | management | planning

April 19, 2017

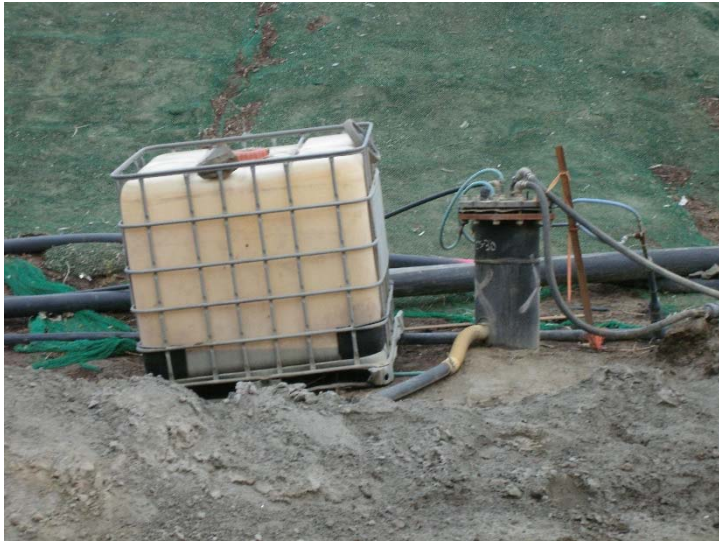
Photo 45: Liquids Handling for CC3A Slopes

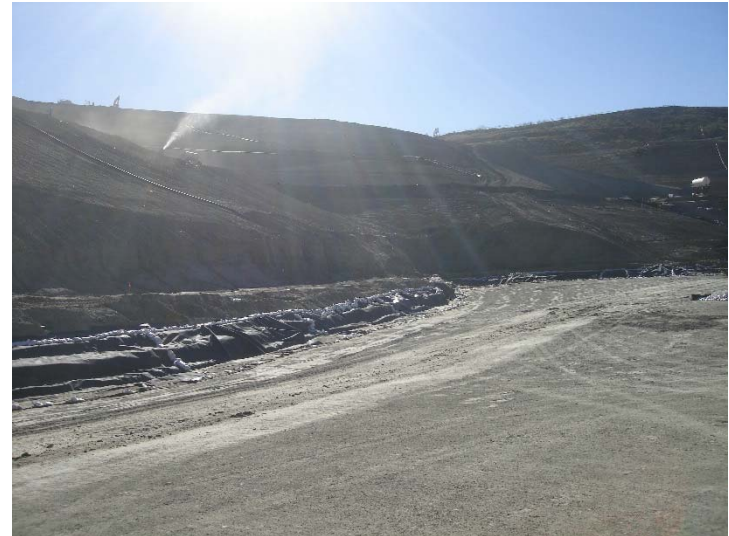
Photo 78: CC4 Liner Tie-in Area: November 29, 2016

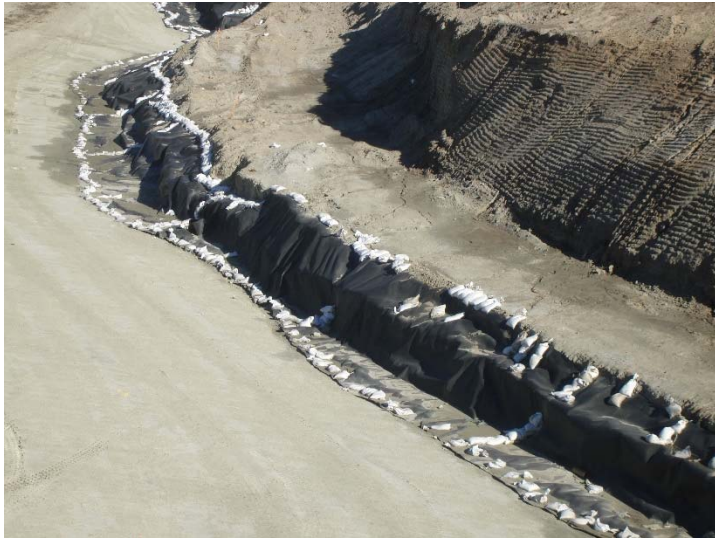
Photo 85: Drainage into Terminal Basin: November 1, 2016

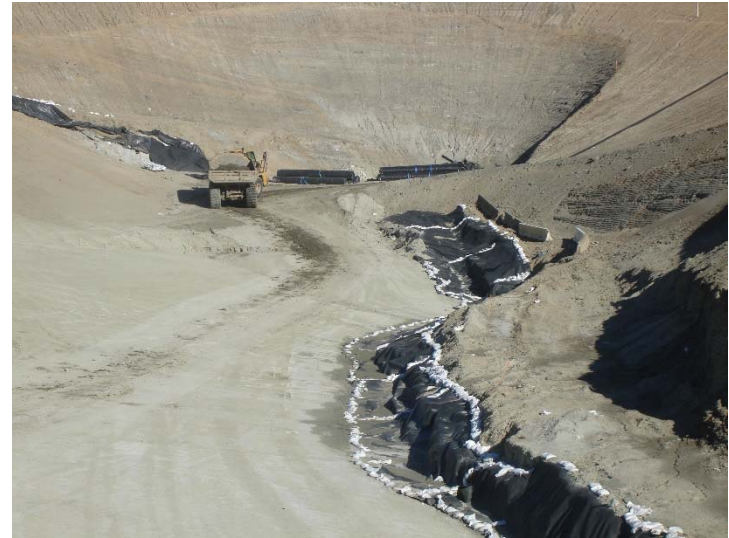
Photo 86: CC4 Adjacent Slopes to Liner Tie-in Area: November 29, 2016

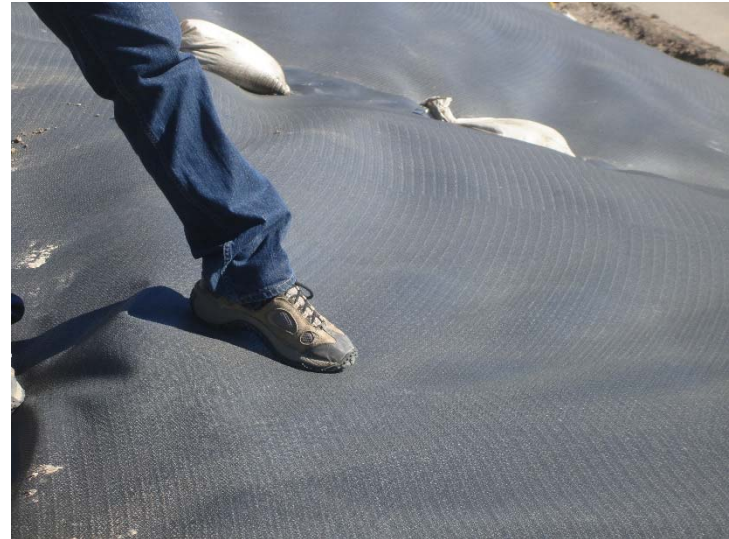
Photo 94 Slope Gas Control Liner Puffing at CC3A: November 29, 2016

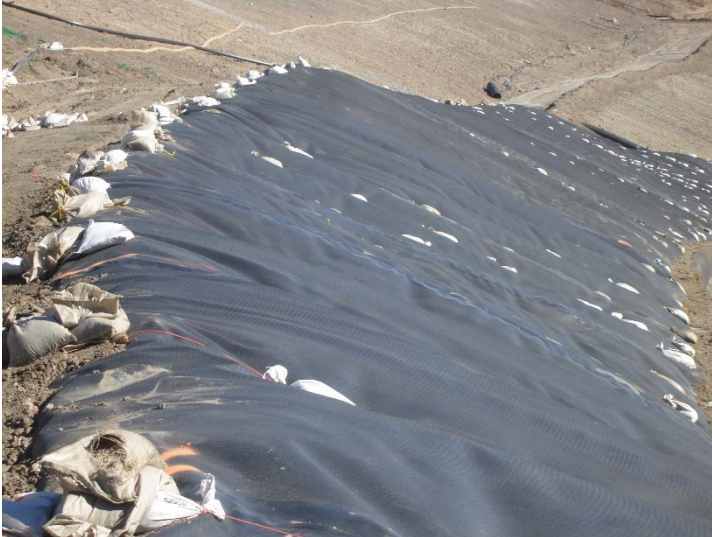
Photo 95: Slope Gas Control Liner Puffing at CC3A: November 29, 2016

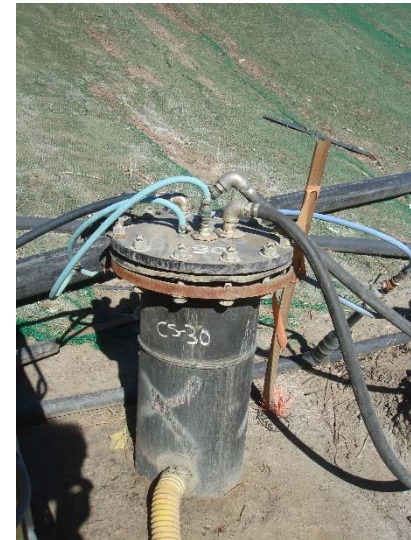
Photo 96: Well at Slope CC3a with Localized Odor: November 29, 2016

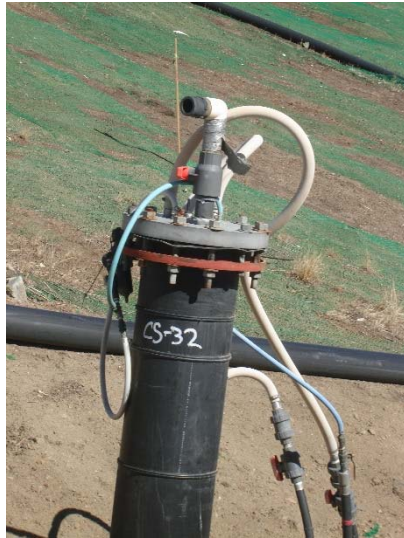
Photo 97: Well at Slope CC3a with Localized Odor: November 29, 2016

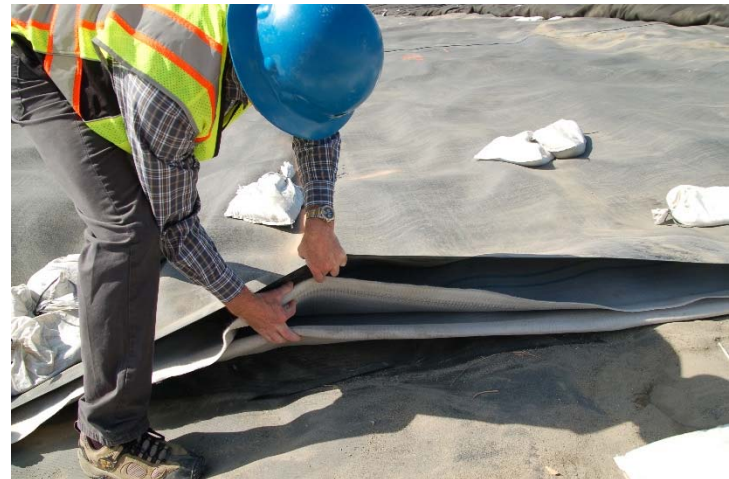
Photo 120: CC4 Liner Area: December 14, 2016

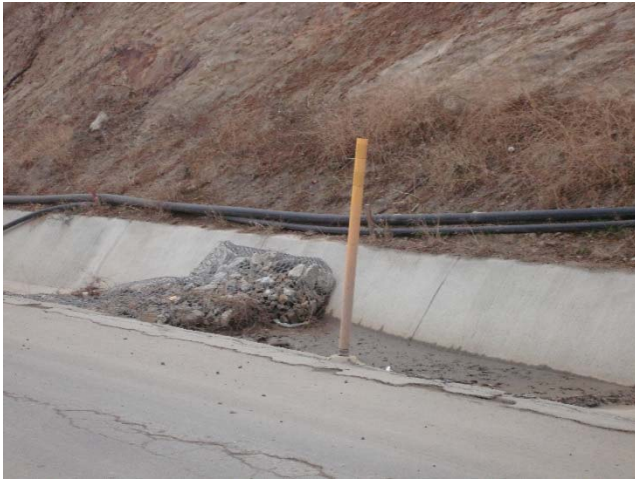
Photo 141: Westside Drainage Channel: November 1, 2016

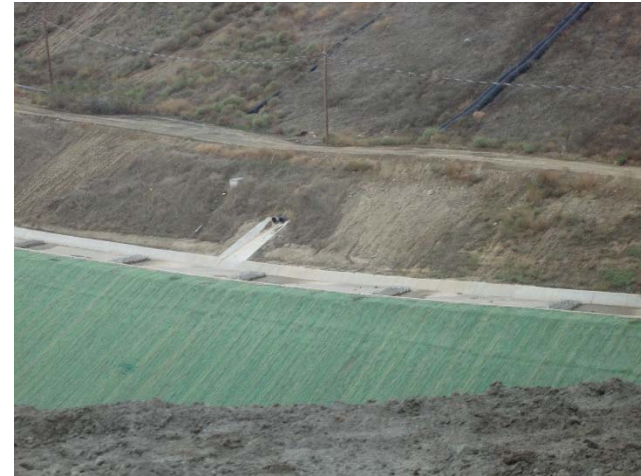
Photo 142: Westside Drainage Channel: November 1, 2016

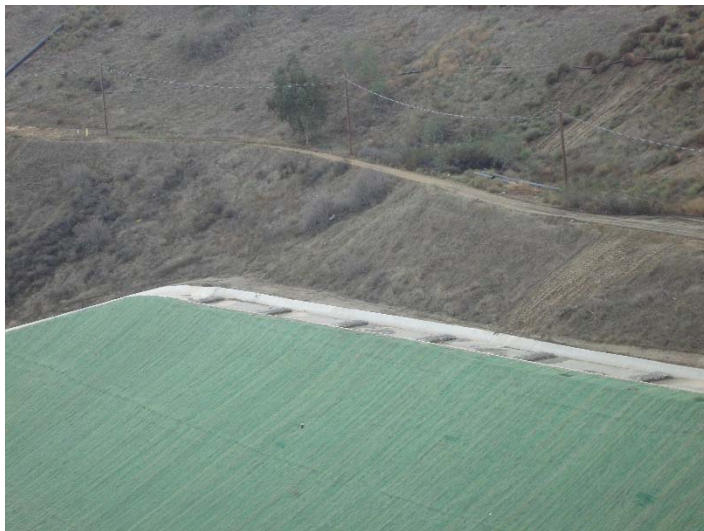
Photo 143: Westside Drainage Channel: November 1, 2016

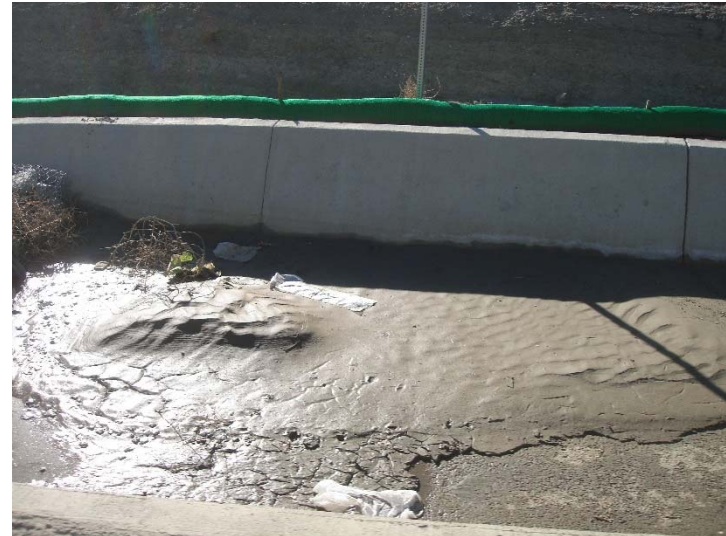
Photo 144: Westside Drainage Channel: November 29, 2016

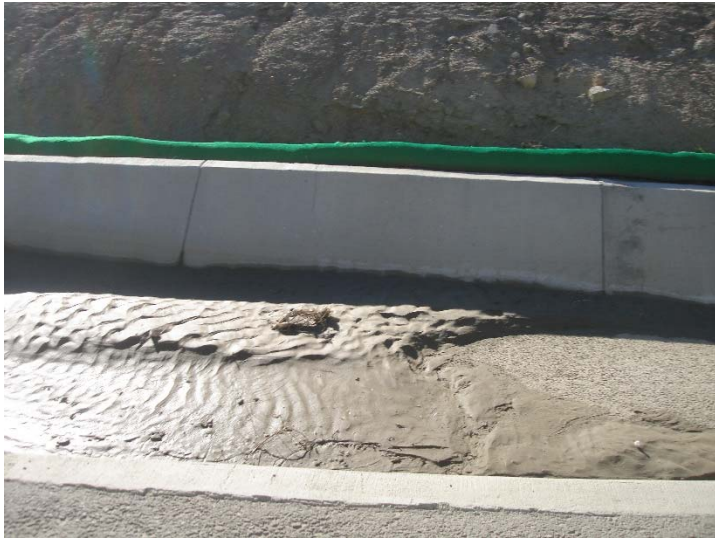
Photo 145: Westside Drainage Channel: November 29, 2016

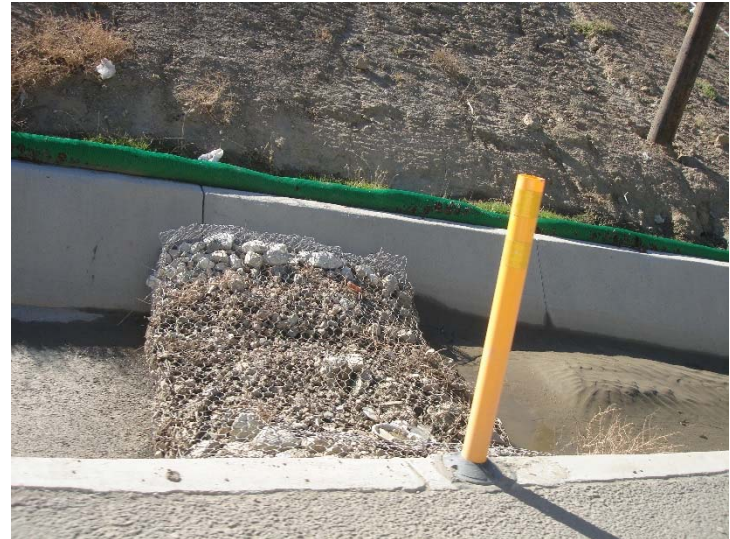
Photo 146: Westside Drainage Channel: November 29, 2016

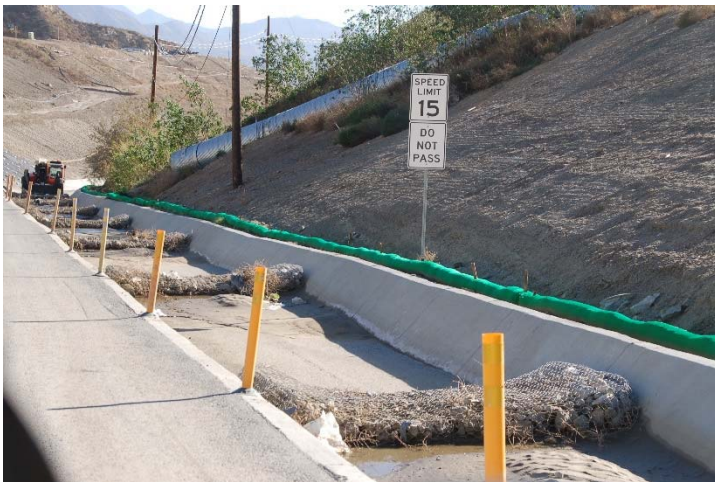
Photo 147: Westside Drainage Channel: November 29, 2016

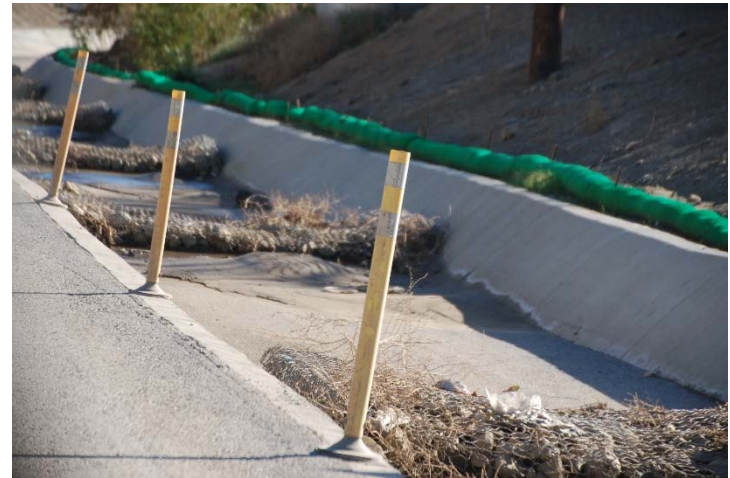
Photo 148: Westside Drainage Channel: November 29, 2016

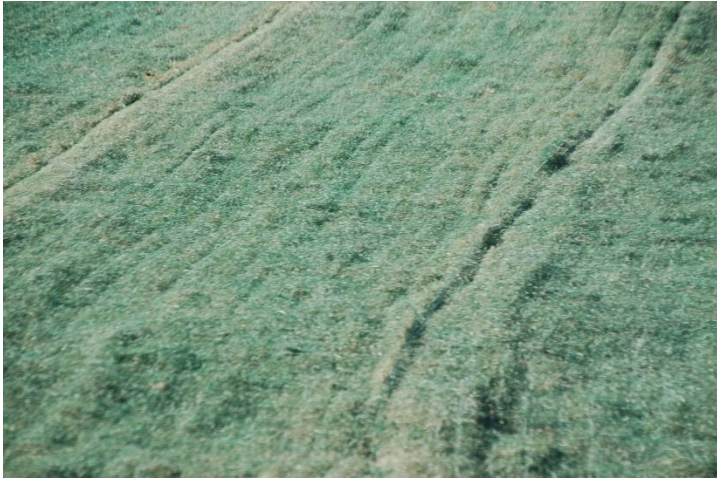
**Photo 149: Seeded Slope Mat above Westside Drainage:
November 29, 2016**

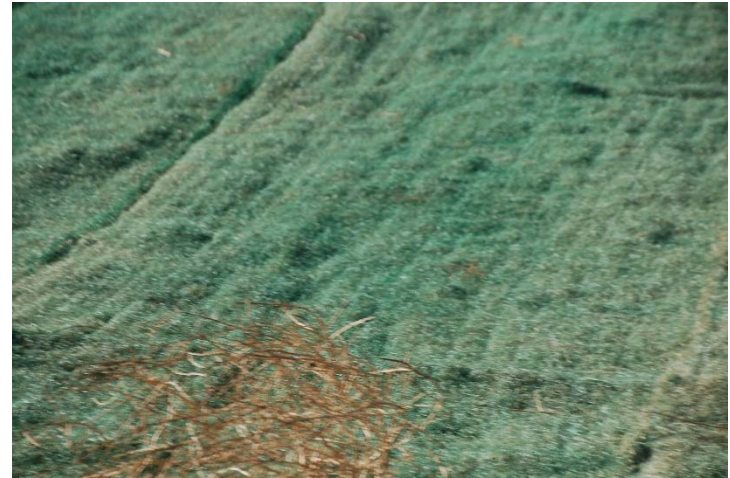
**Photo 150: Seeded Slope Mat above Westside Drainage:
November 29, 2016**

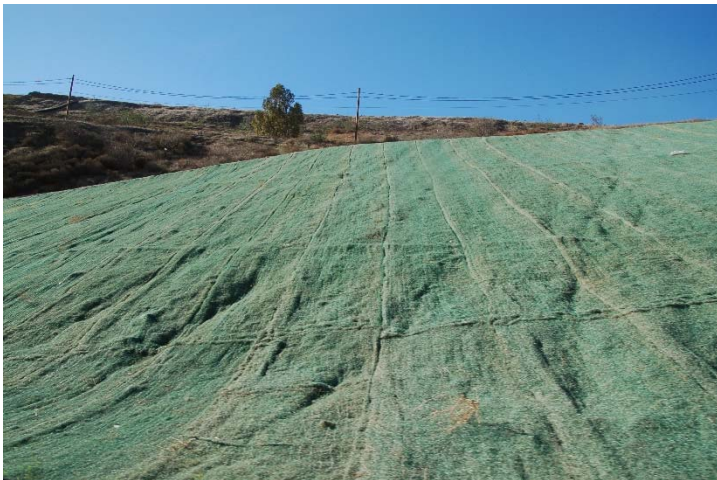
**Photo 151: Seeded Slope Mat above Westside Drainage:
November 29, 2016**

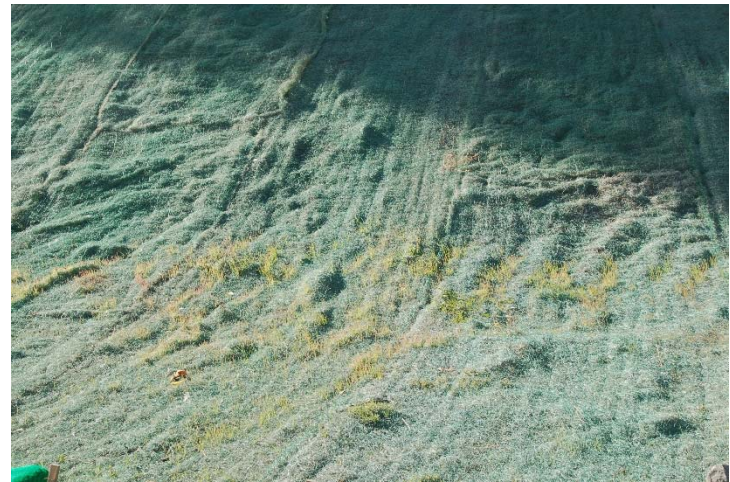
**Photo 152: Seeded Slope Mat above Westside Drainage:
November 29, 2016**

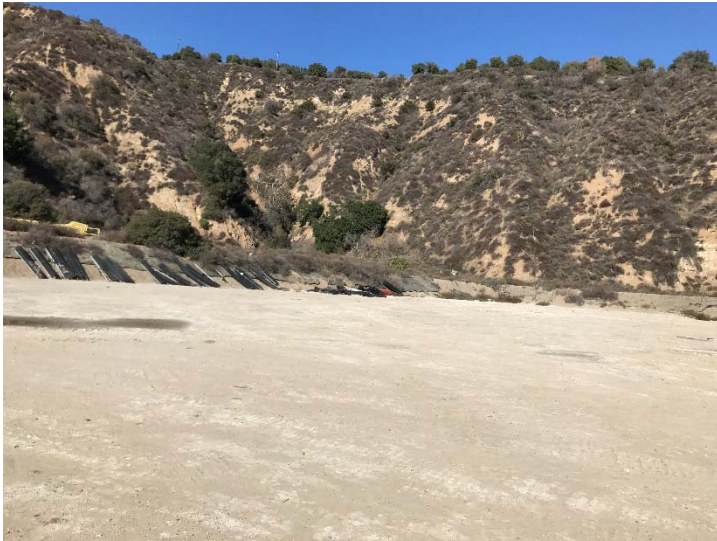
Photo 153: Basin D: November 29, 2016

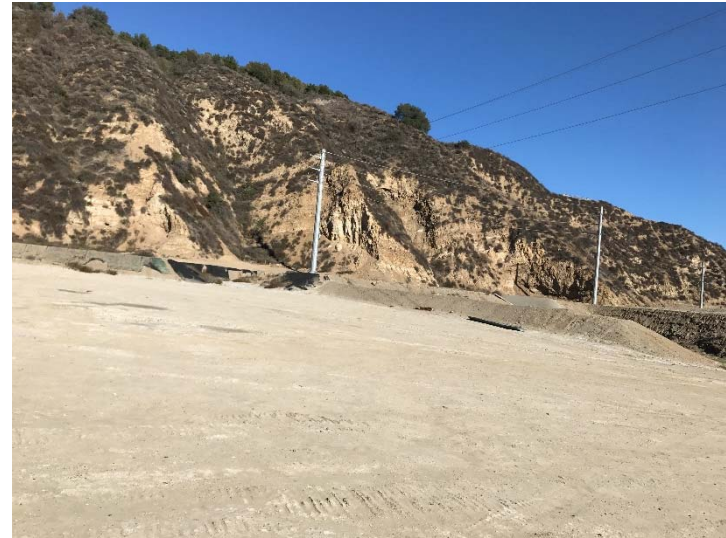
Photo 154: Basin D: November 29, 2016

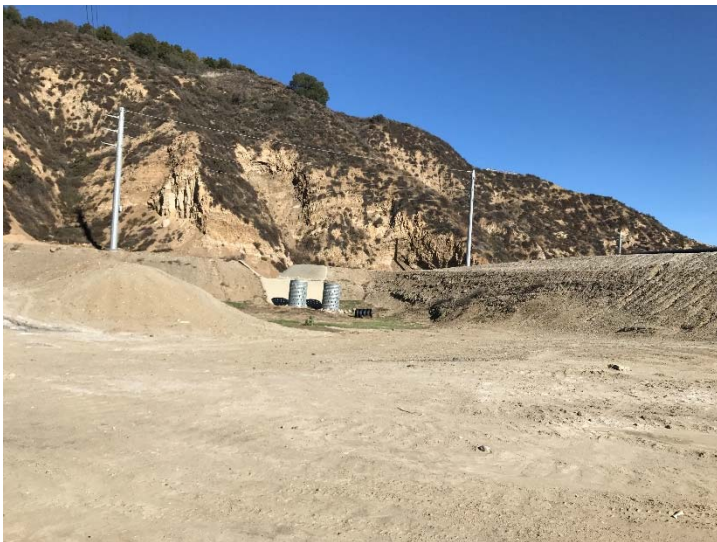
Photo 155: Basin D: November 29, 2016

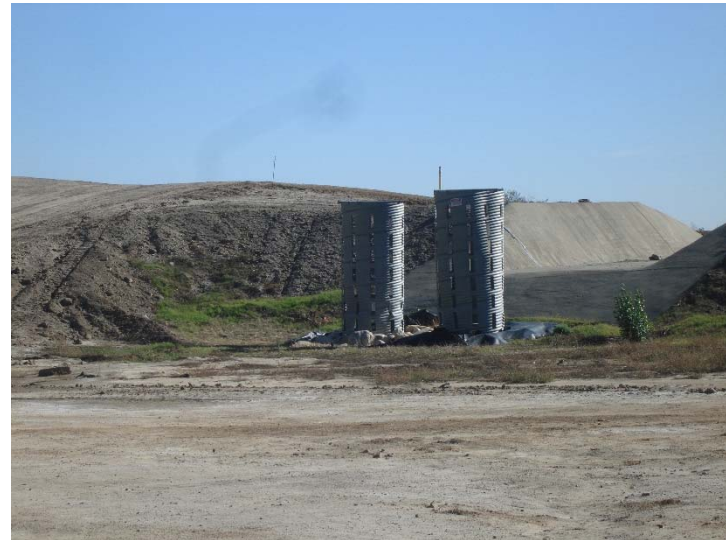
Photo 156: Basin D: November 29, 2016

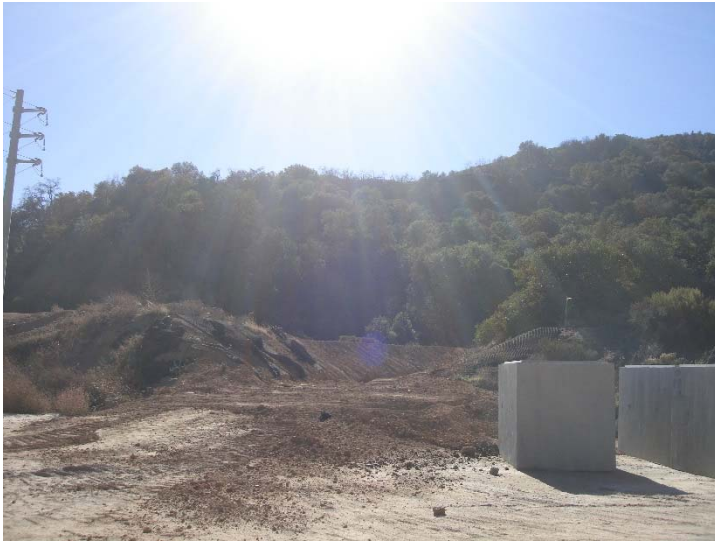
Photo 157: Basin D: November 29, 2016

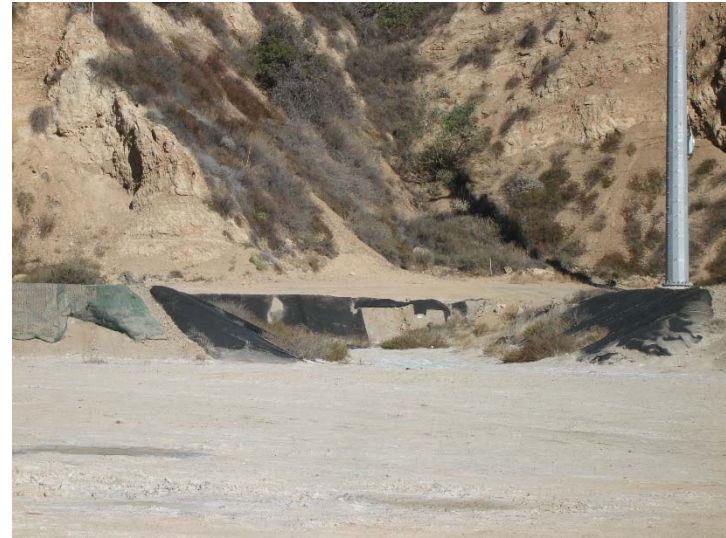
Photo 158: Basin D: November 29, 2016

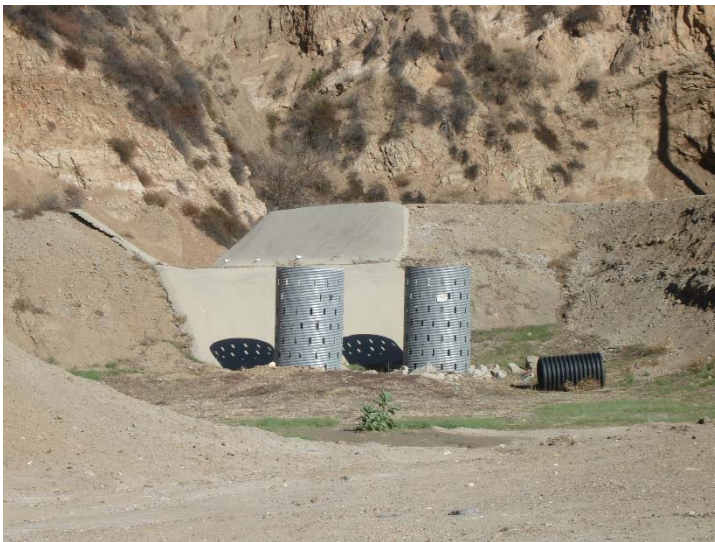
Photo 159: Basin D: November 29, 2016

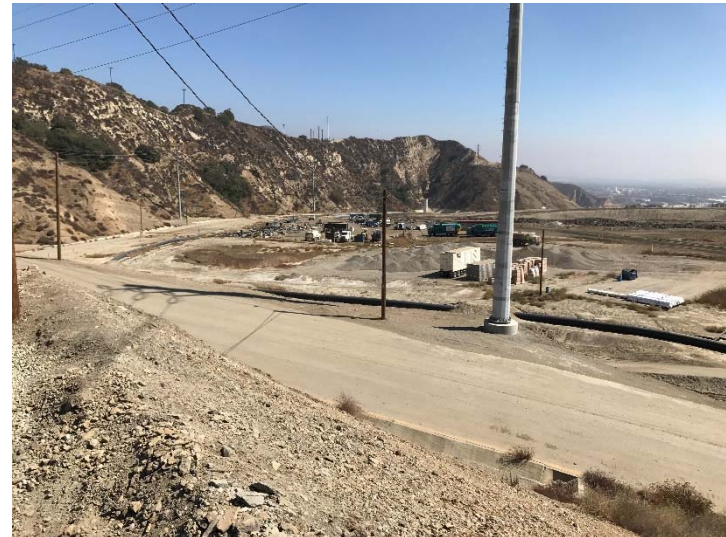
Photo 160: County Top Deck: October 11, 2016

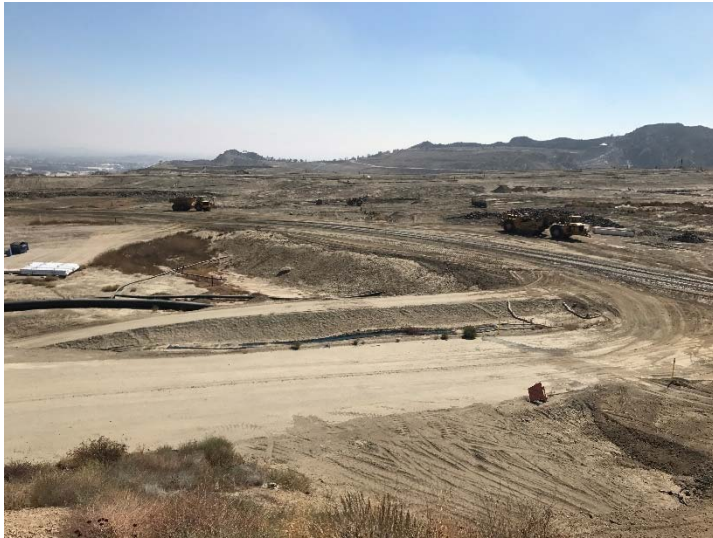
Photo 161: County Top Deck: October 11, 2016

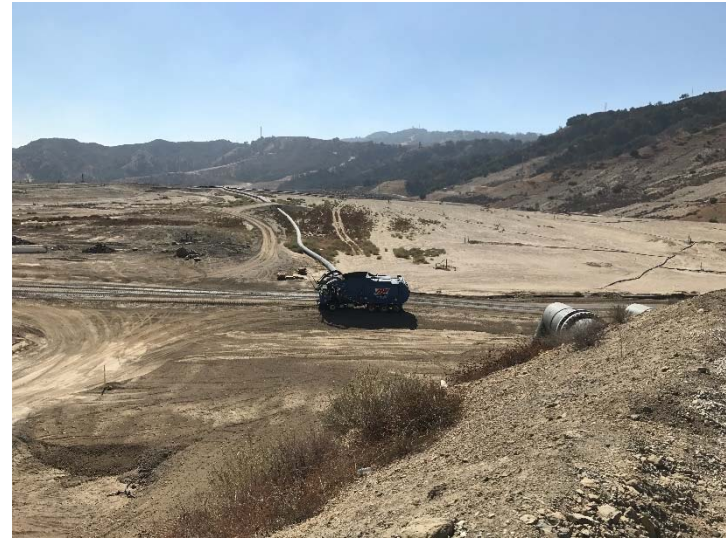
Photo 162: County Top Deck: October 11, 2016

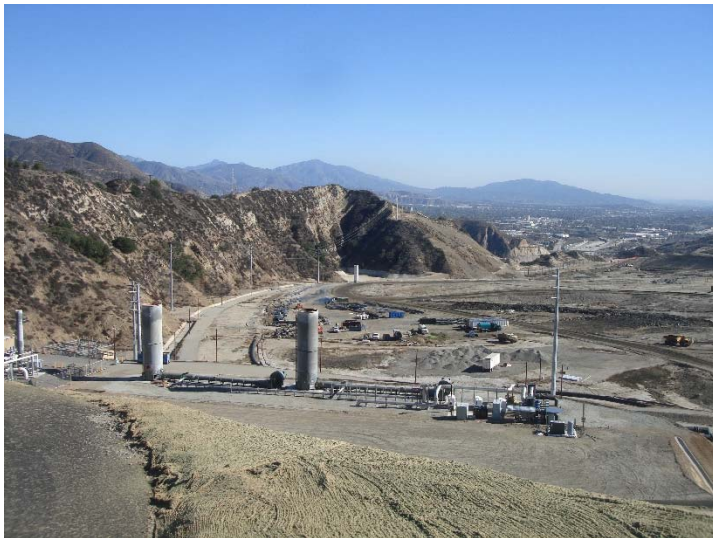
Photo 163: County Top Deck: November 29, 2016

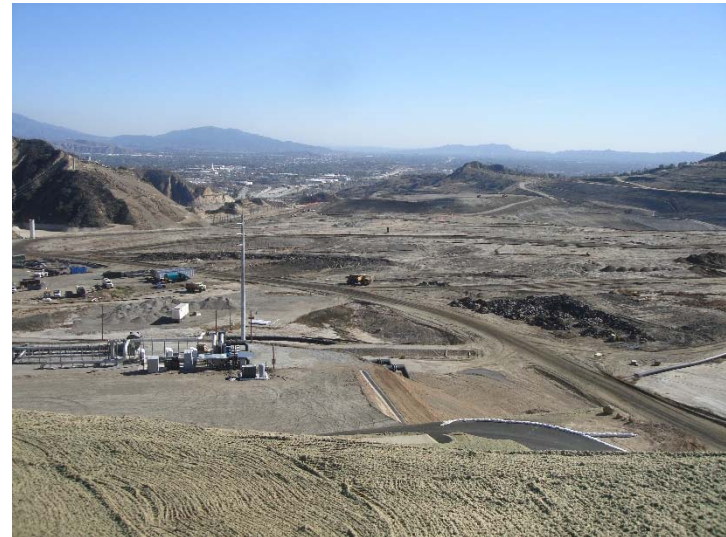
Photo 164: County Top Deck: November 29, 2016

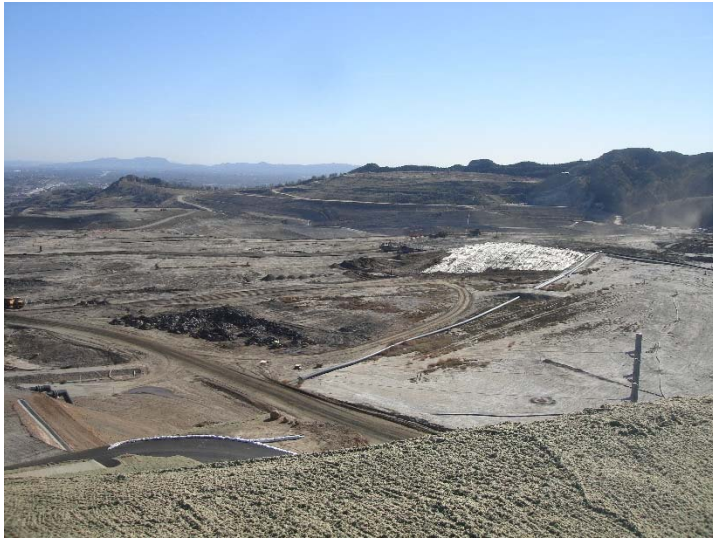
Photo 165: County Top Deck: November 29, 2016

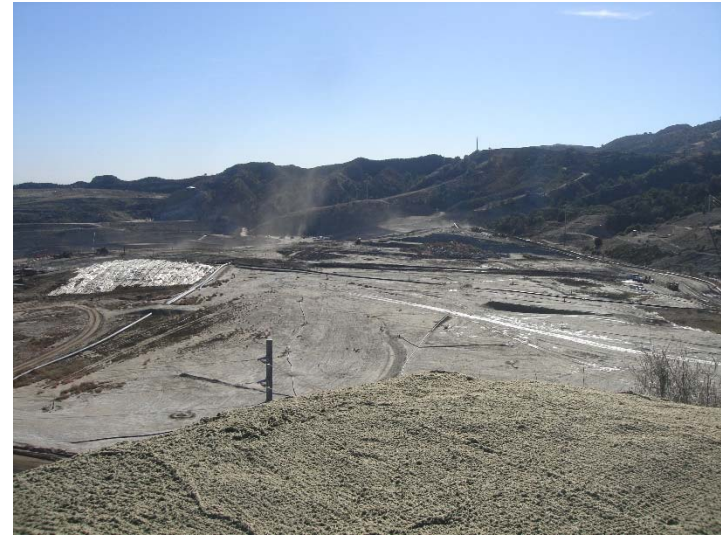
Photo 166: County Top Deck: November 29, 2016

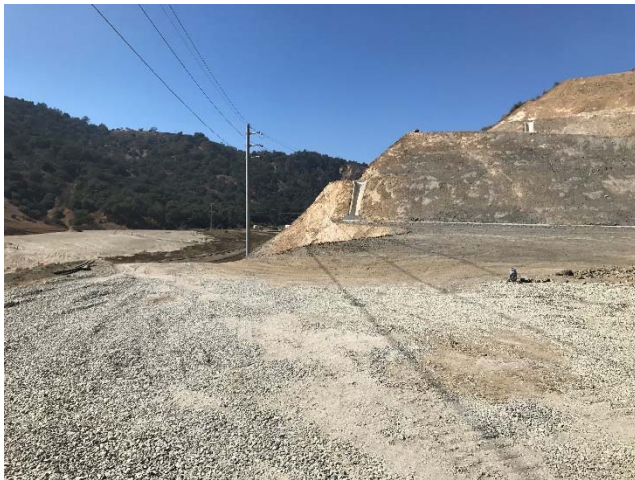
M - 4.1.6 / 18			I-o through I-r: The landfill perimeter boundary survey PVC pipe markers have been removed in areas where Edison pole grading took place, as well as near the Flare 11 site pad grading. These boundary markers have not been replaced. All markers should be replaced once the CC-3A Part 4 landslide buttress is installed.
	M - 4.14.1 / 155		City Planning/Cal Recycle PW-BOE LADBS City LEA	I-o through I-r: Access roads are being maintained around the working area for emergency access.
	M - 4.18 / 178		City Planning/City LEA	I-o through I-r: A map showing areas that are at the final elevations and which should have final cover should be available for review. Documents showing current filled elevations should also be available onsite for review. These conditions were not monitored.
		Visual - 10.01 Visual - 10.02	County DPW EPD/ LARWQCB SCL-LEA	I-o through I-r: See M - 4.18 / 178 above.

Photo 167: Flare 11 Site Grading: October 11, 2016

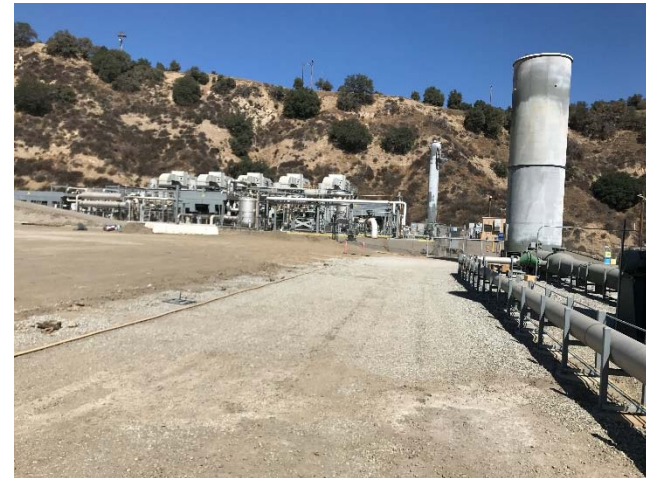
Photo 168: Flare 11 Site Grading: October 11, 2016

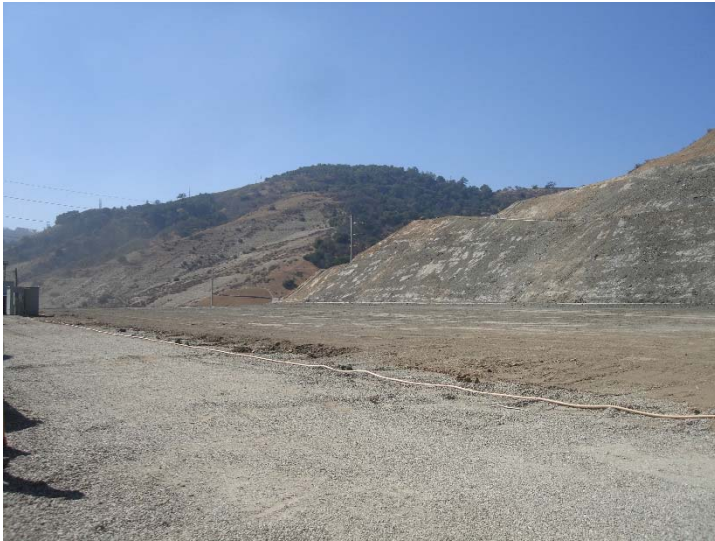
Photo 169: Flare 11 Site Grading: October 11, 2016

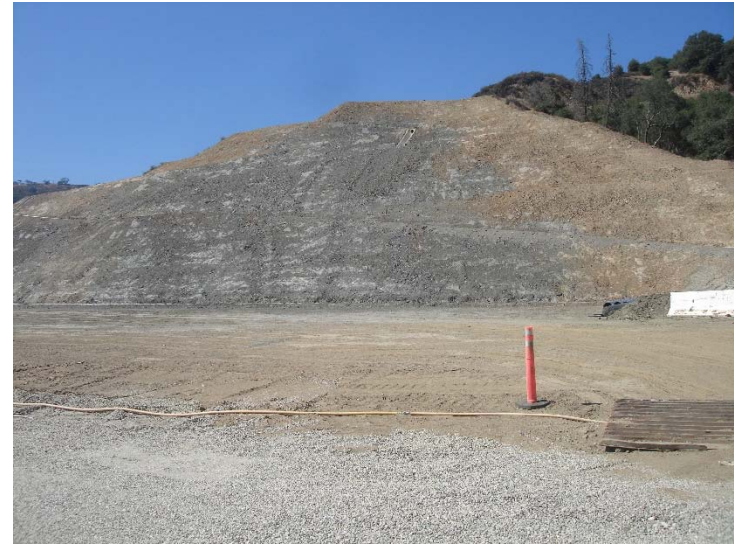
Photo 170: Flare 11 Site Grading: October 11, 2016

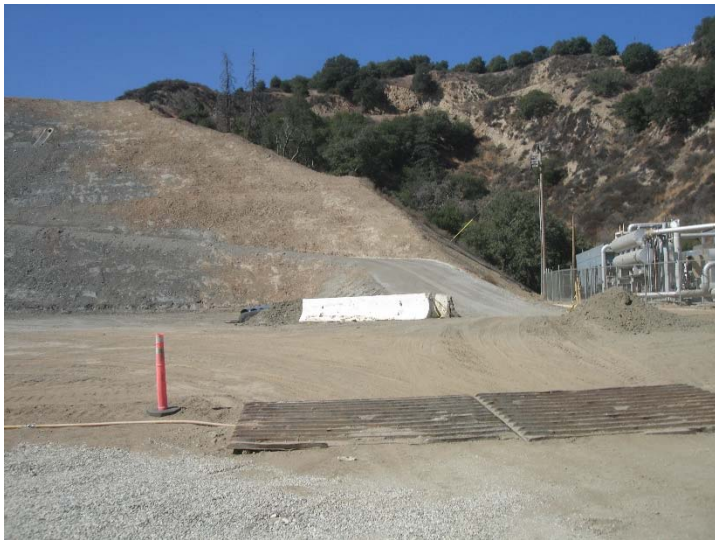
Photo 171: Flare 11 Site Grading: October 11, 2016

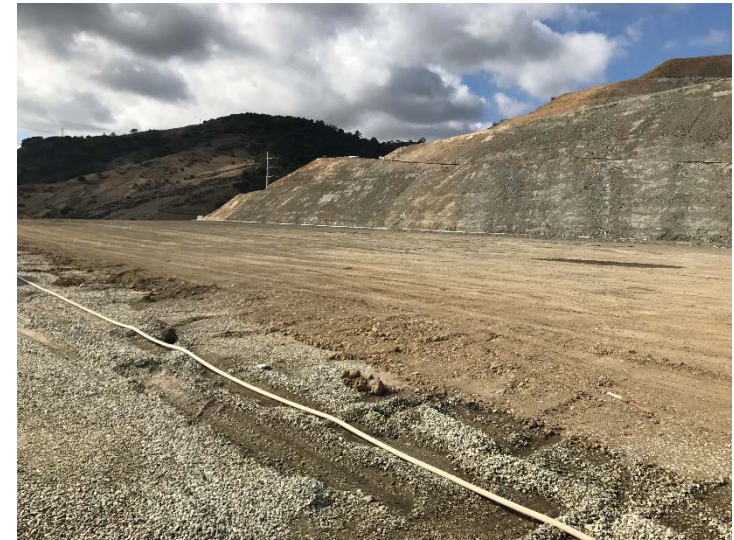
Photo 172: Flare 11 Site Grading: November 1, 2016

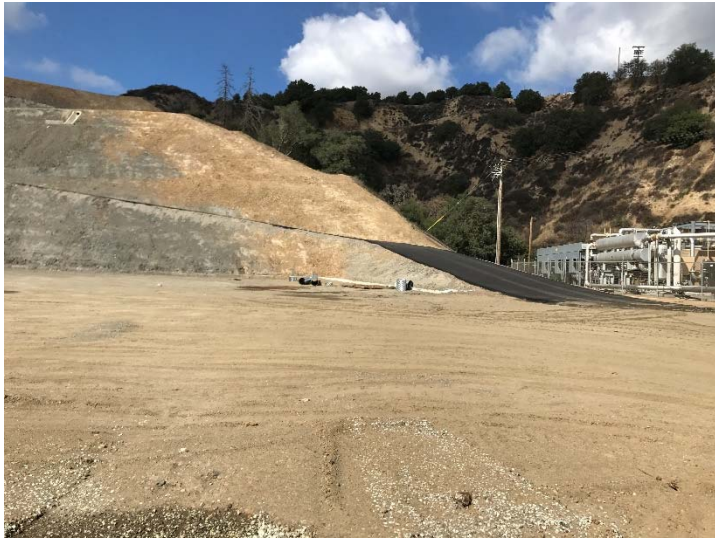
Photo 173: Flare 11 Site Grading: November 1, 2016

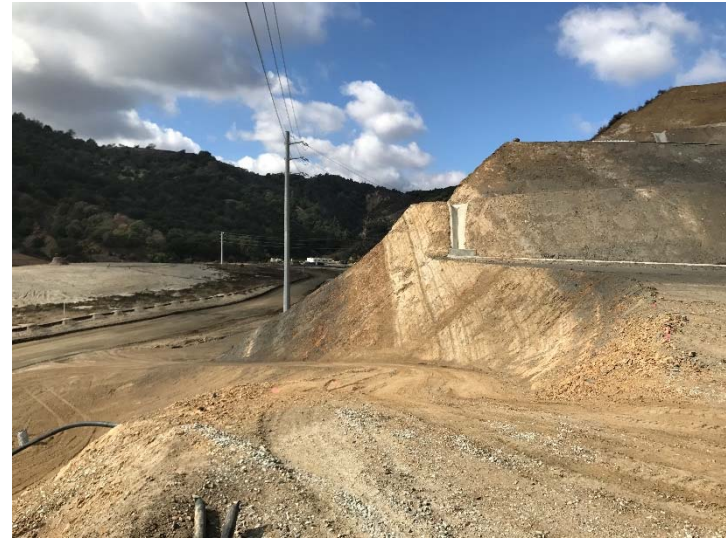
Photo 174: Flare 11 Site Grading: November 1, 2016

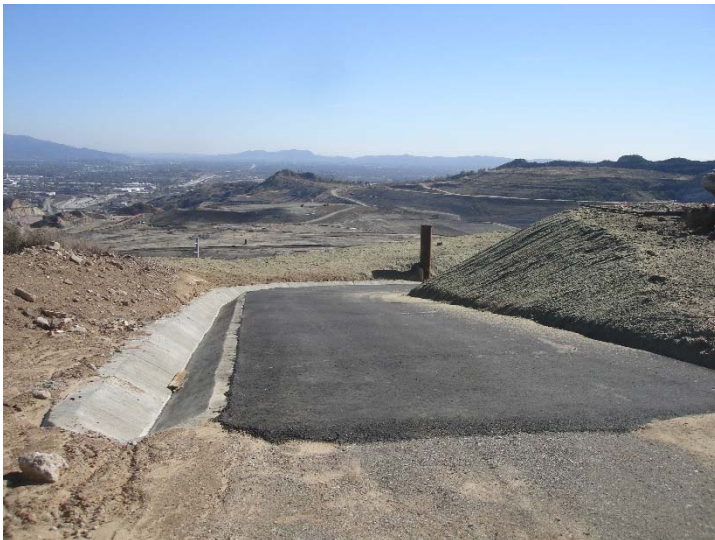
**Photo 175: New Emergency Access Road to I-5 Freeway:
November 29, 2016**

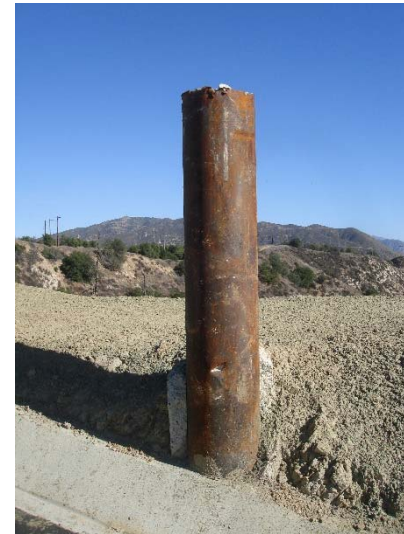
**Photo 176: New Emergency Access Road to I-5 Freeway:
November 29, 2016**

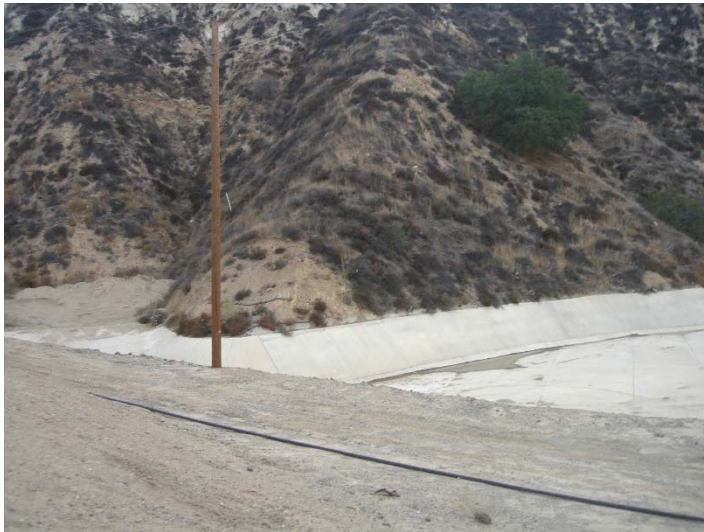
Photo 177: Basin B: November 1, 2016

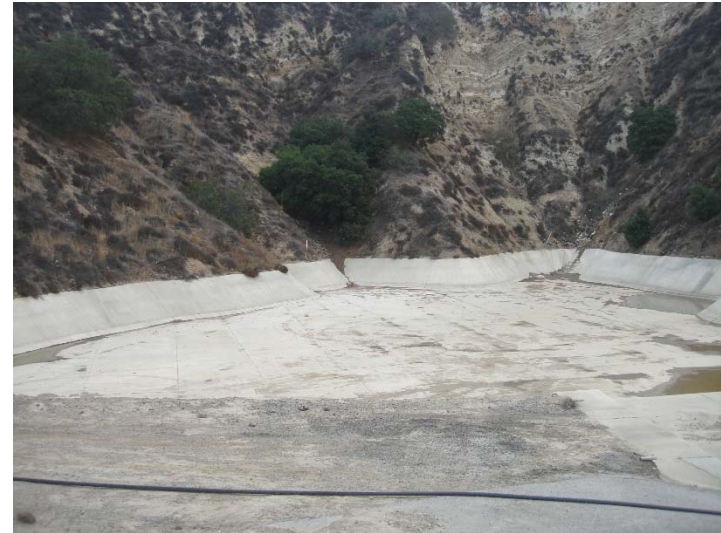
Photo 178: Basin B: November 1, 2016

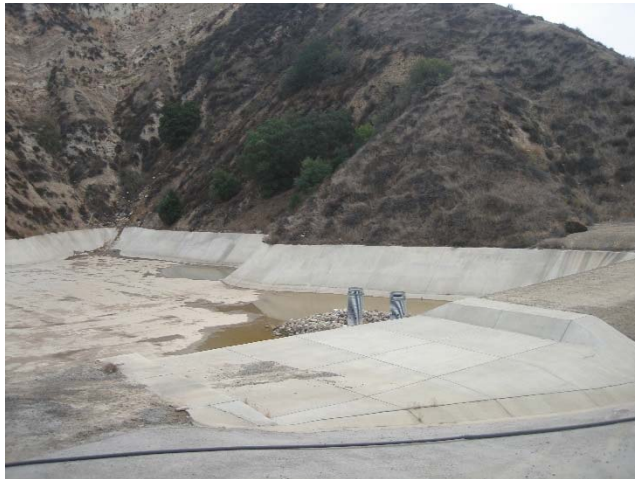
Photo 179: Basin B: November 1, 2016

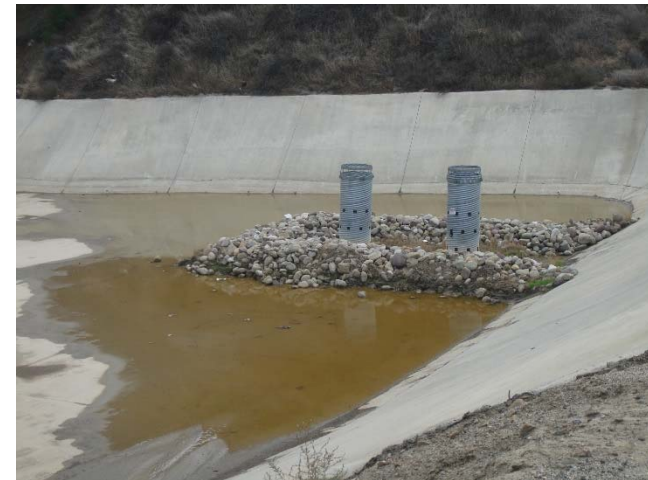
Photo 180: Basin B: November 1, 2016

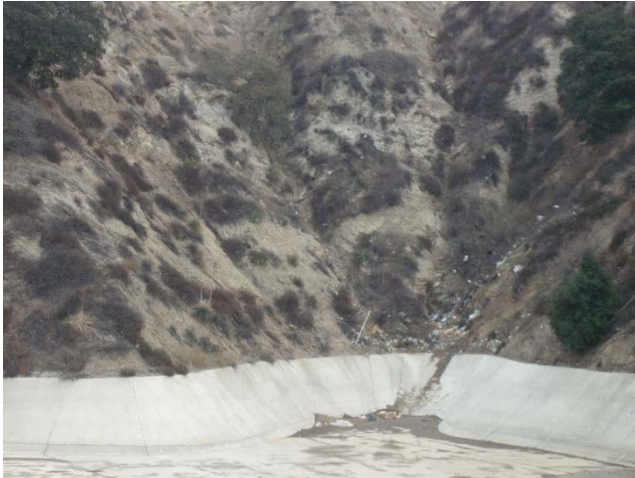
Photo 181: Basin B Native Hillside: November 1, 2016

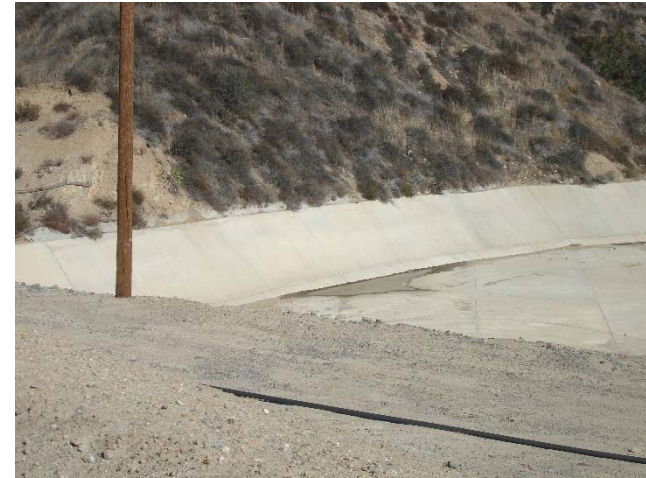
Photo 182: Basin B: November 29, 2016

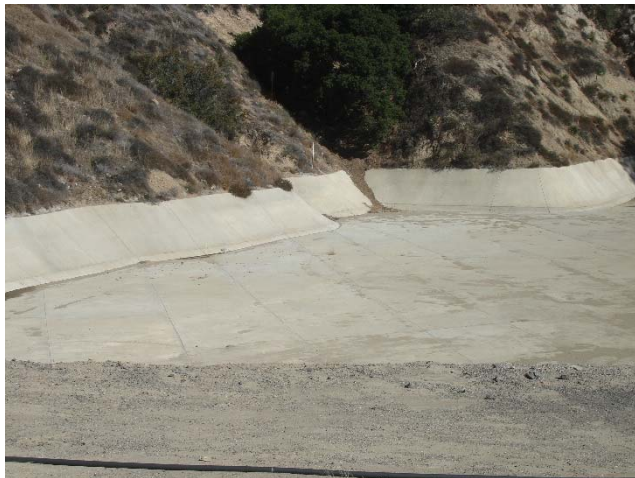
Photo 183: Basin B: November 29, 2016

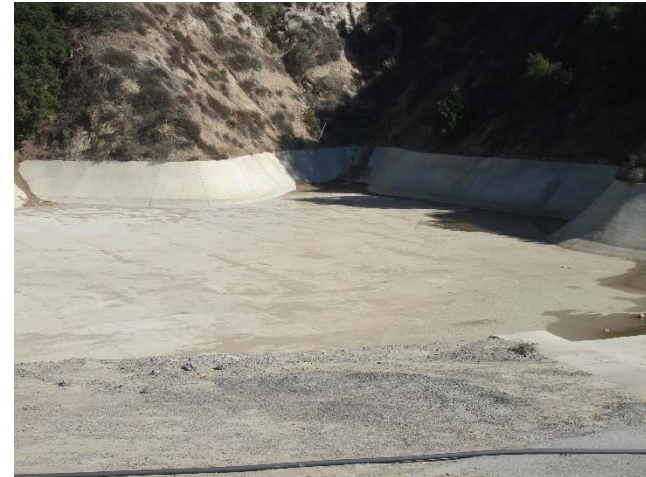
Photo 184: Basin B: November 29, 2016

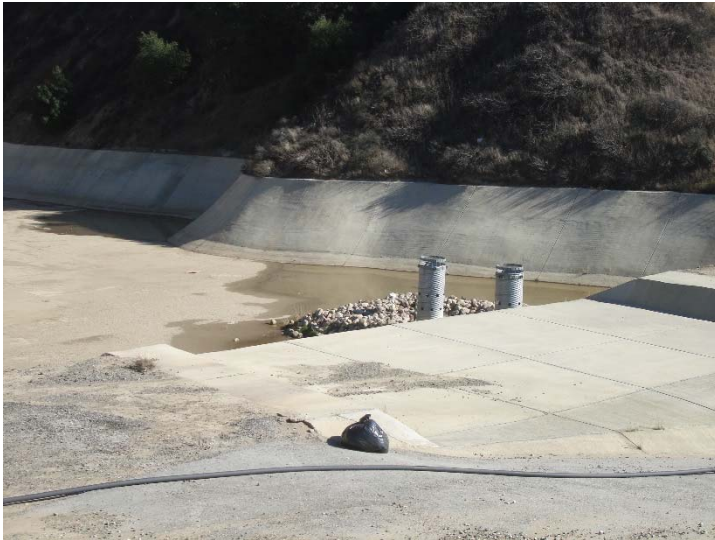
Photo 185: Basin B: November 29, 2016

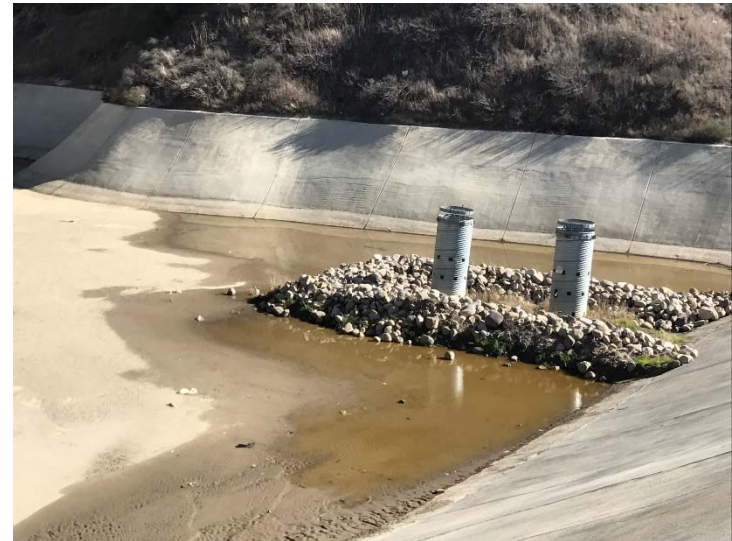
Photo 186: Basin B: November 29, 2016

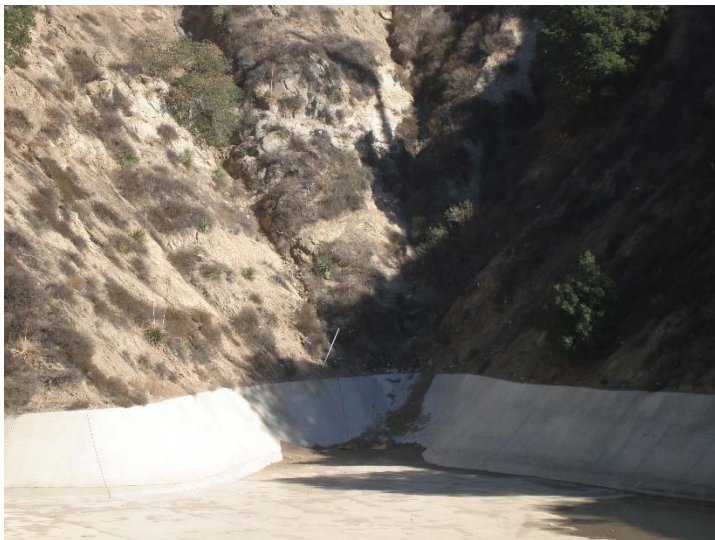
Photo 187: Basin B Native Hillside: November 29, 2016

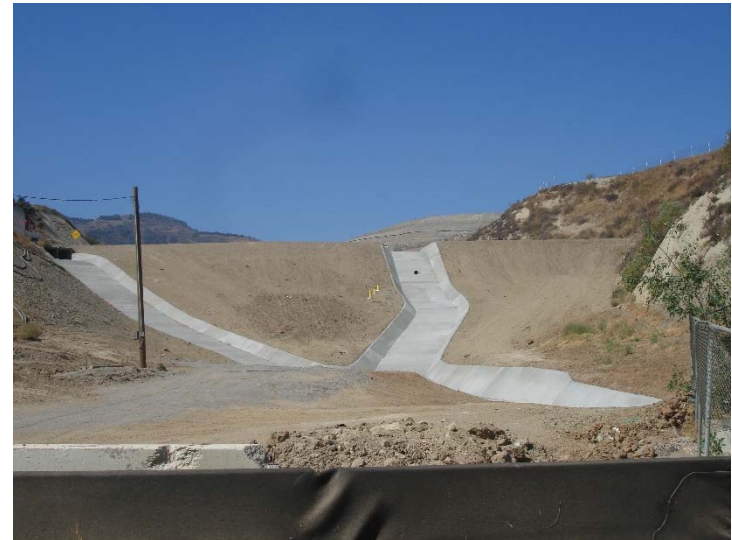
Photo 188: CC3B Drainage to Terminal Basin: October 11, 2016

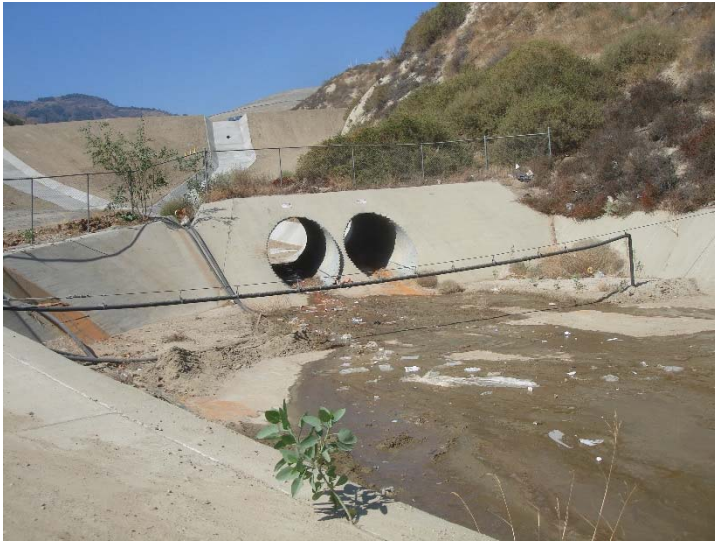
Photo 189: CC3B Drainage to Terminal Basin: October 11, 2016

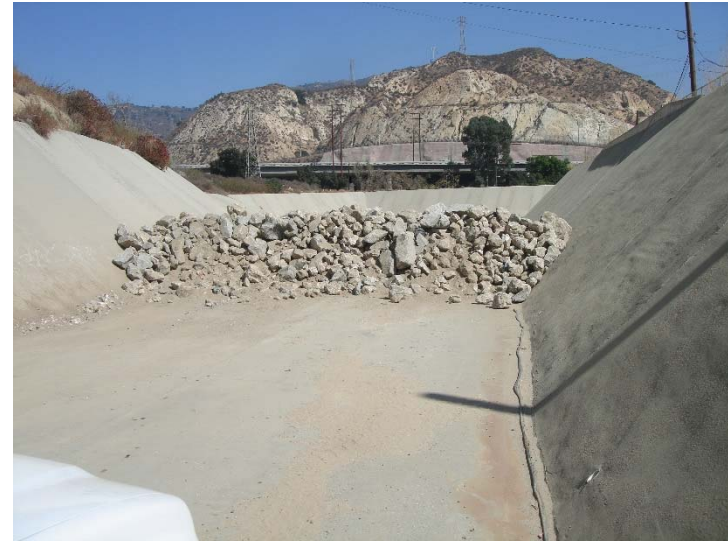
Photo 190: CC3B Drainage to Terminal Basin: October 11, 2016

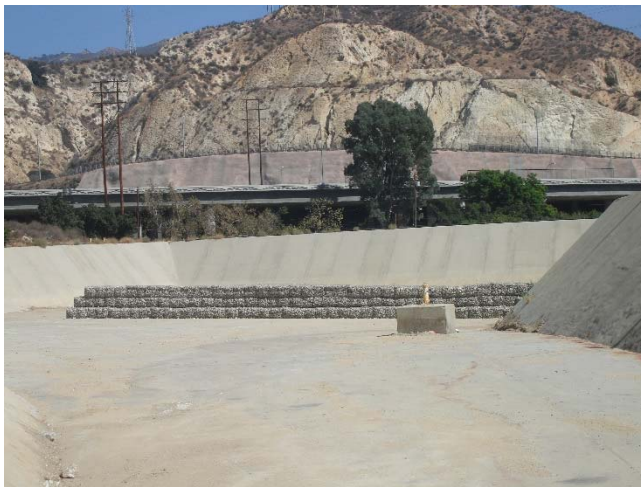
Photo 191: Terminal Basin: October 11, 2016

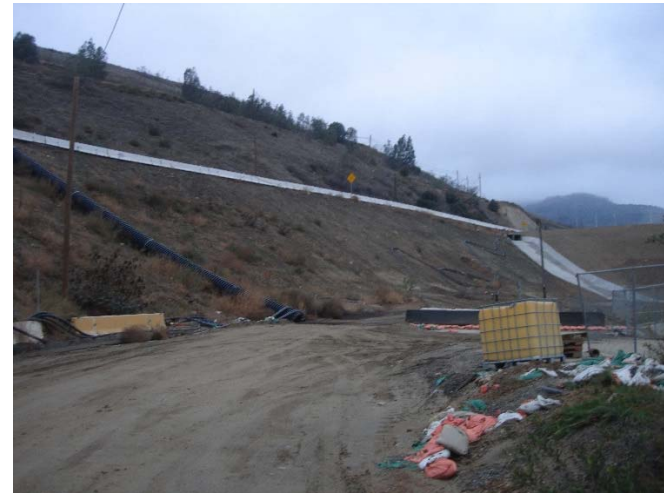
Photo 192: Drainage into Terminal Basin: November 1, 2016
