**Sunshine Canyon Landfill
Independent Monitor
Quarterly Site Monitoring Status Report
October 1, 2016 – December 31, 2016**

UltraSystems
environmental | management | planning

April 19, 2017

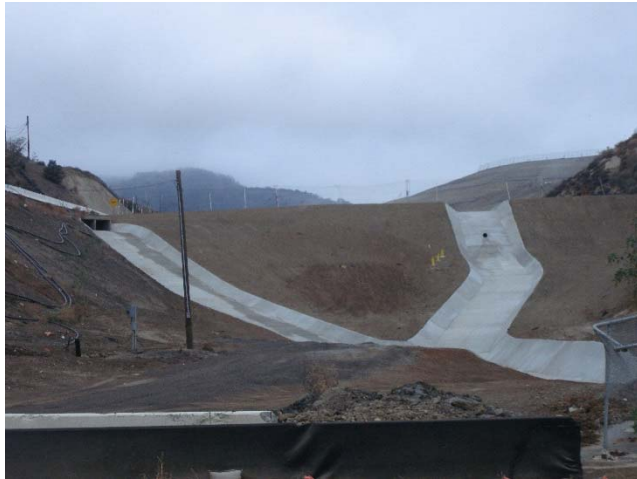
Photo 193: Drainage into Terminal Basin: November 1, 2016

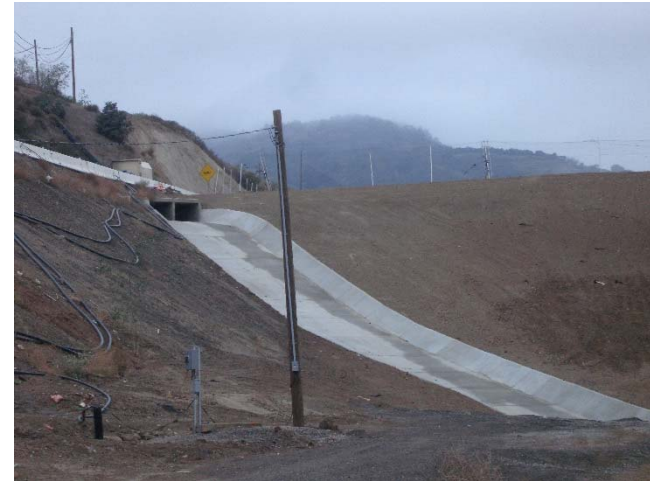
Photo 194: Drainage into Terminal Basin: November 1, 2016

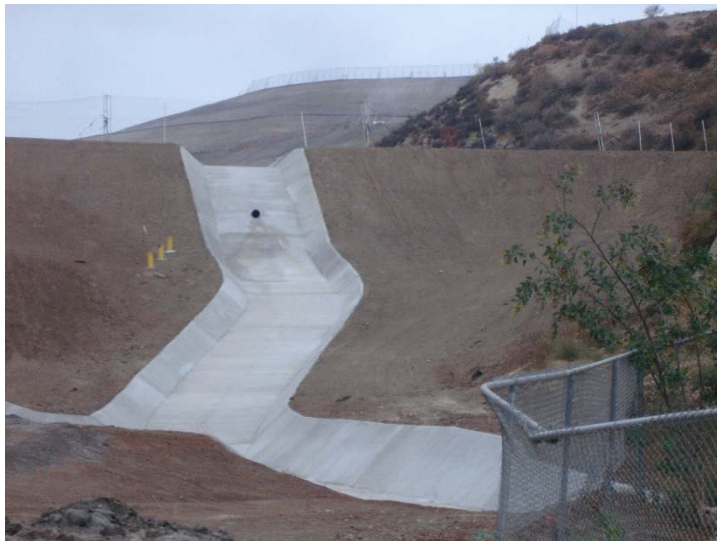
Photo 195: Drainage into Terminal Basin: November 1, 2016

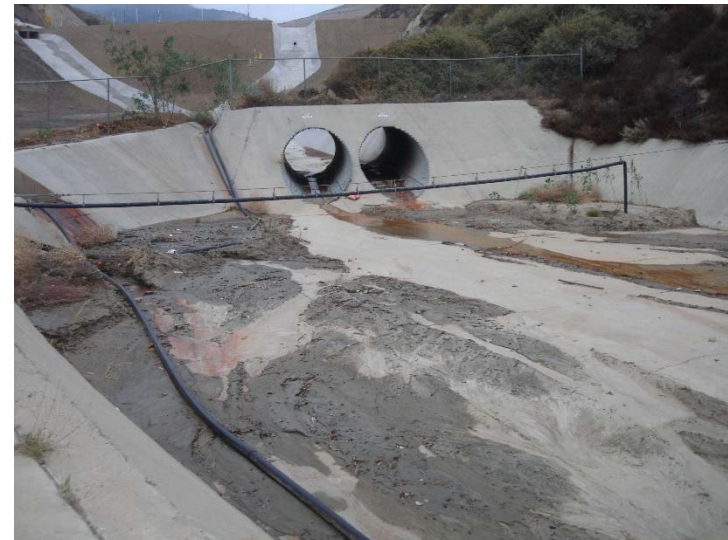
Photo 196: Drainage into Terminal Basin: November 1, 2016

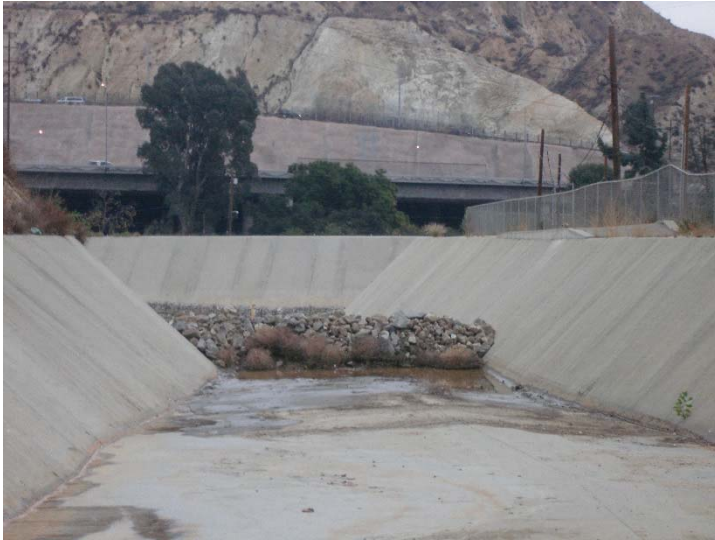
Photo 197: Terminal Basin: November 1, 2016

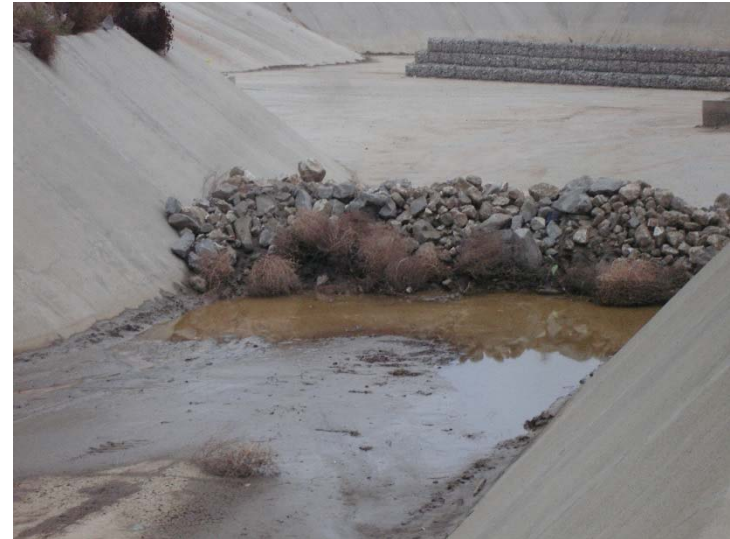
Photo 198: Terminal Basin: November 1, 2016

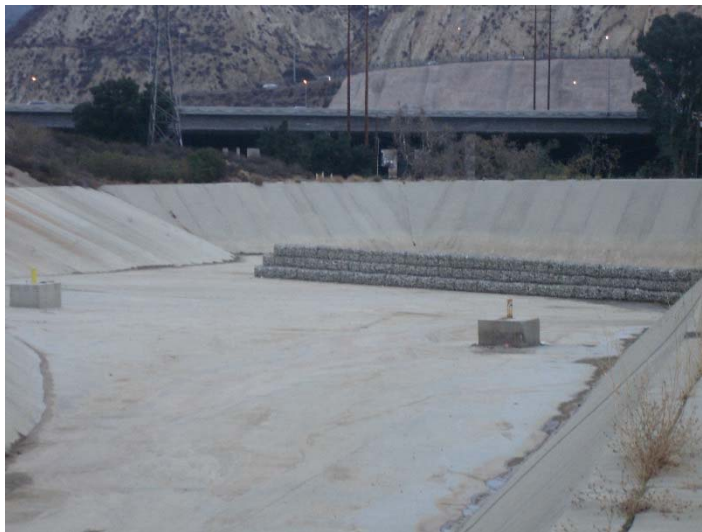
Photo 199: Terminal Basin: November 1, 2016

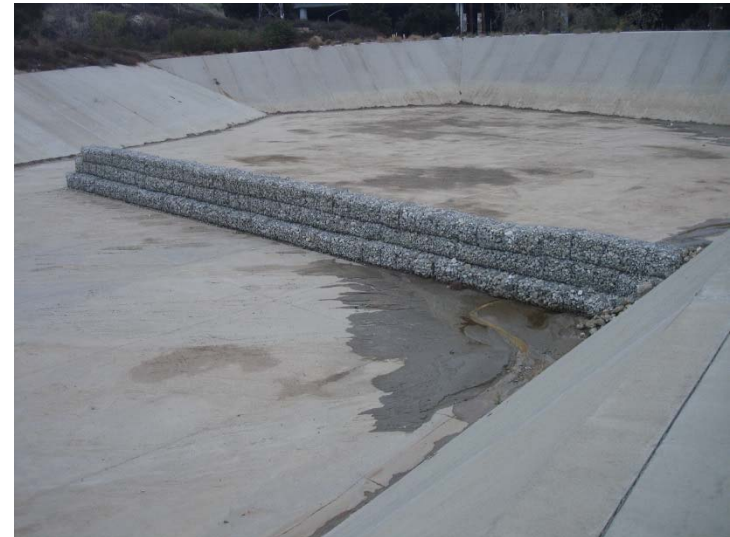
Photo 200: Terminal Basin: November 1, 2016

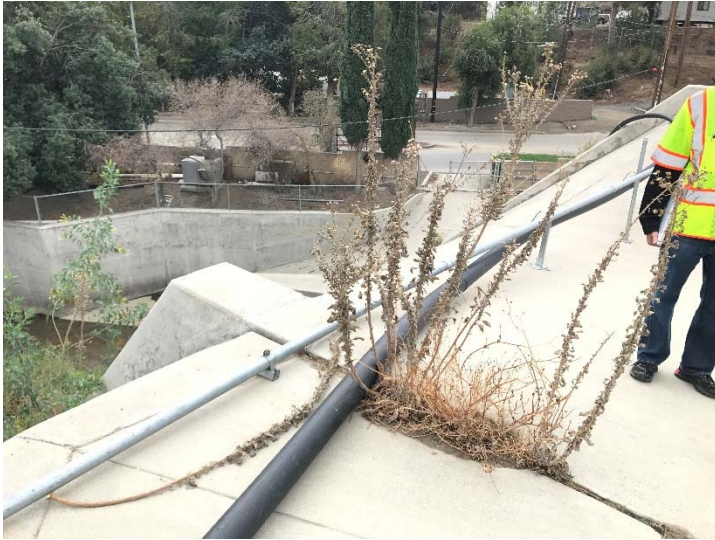
**Photo 209: Vegetation in Concrete on Terminal Basin Wall:
November 1, 2016**

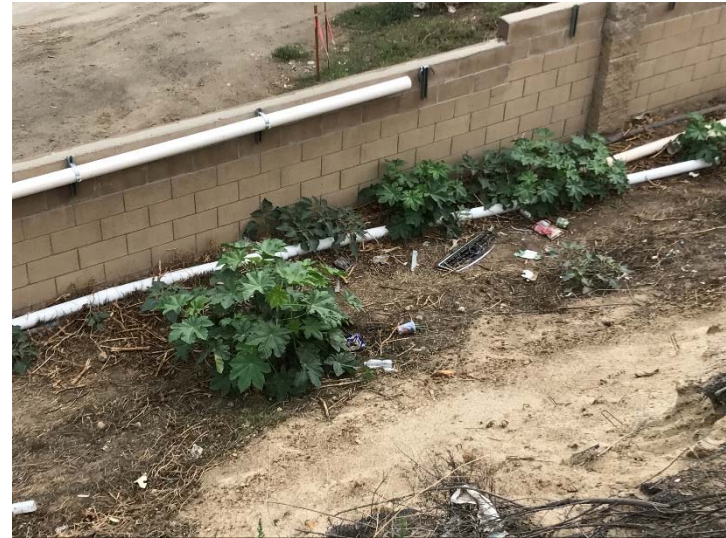
**Photo 210: Debris near Terminal Basin Front Wall: November 1,
2016**

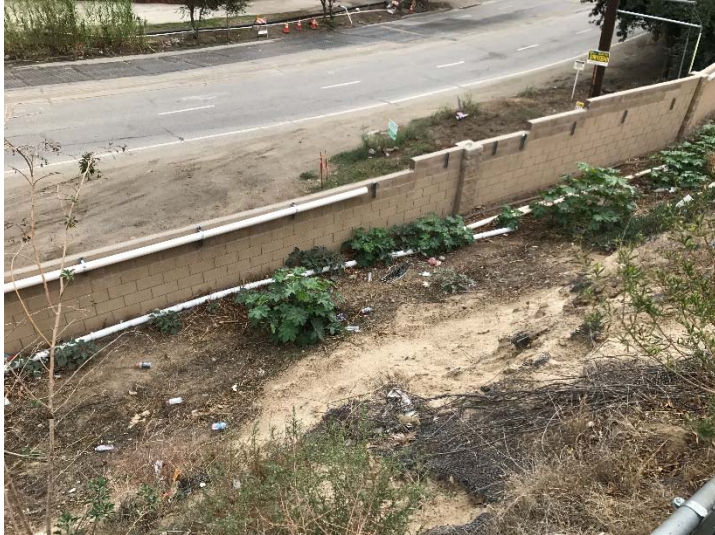
**Photo 211: Debris near Terminal Basin Front Wall: November 1,
2016**

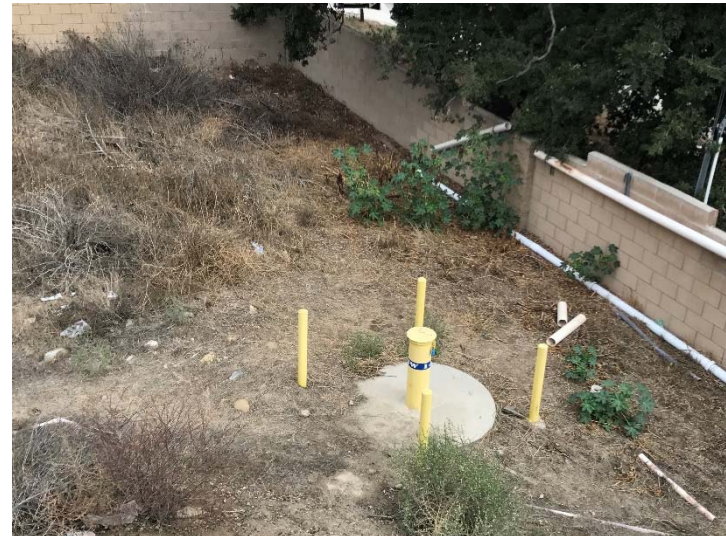
**Photo 212: Debris near Terminal Basin Front Wall: November 1,
2016**

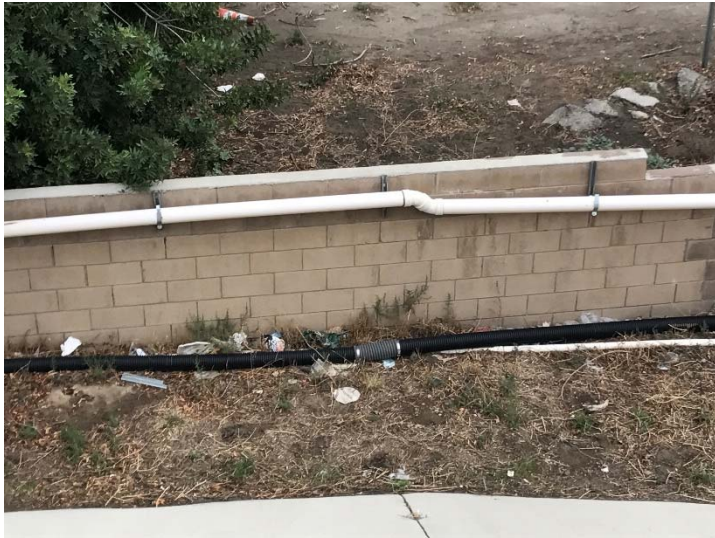
Photo 213: Debris near Terminal Basin Front Wall: November 1, 2016

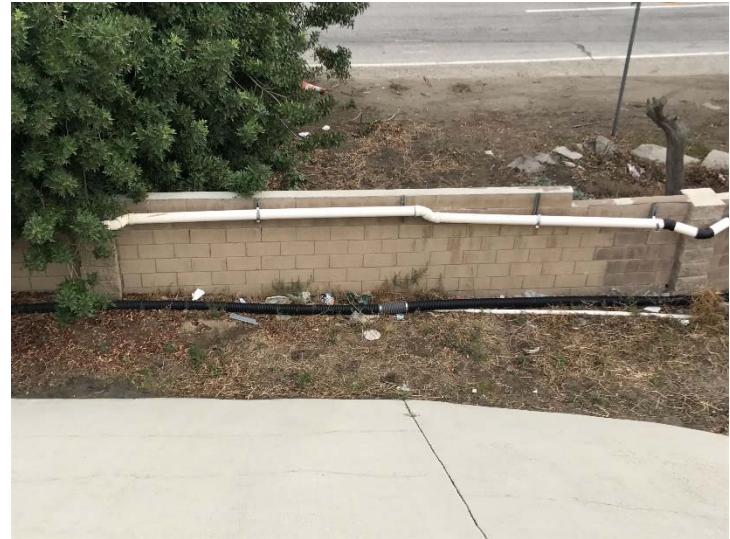
Photo 214: Debris near Terminal Basin Front Wall: November 1, 2016

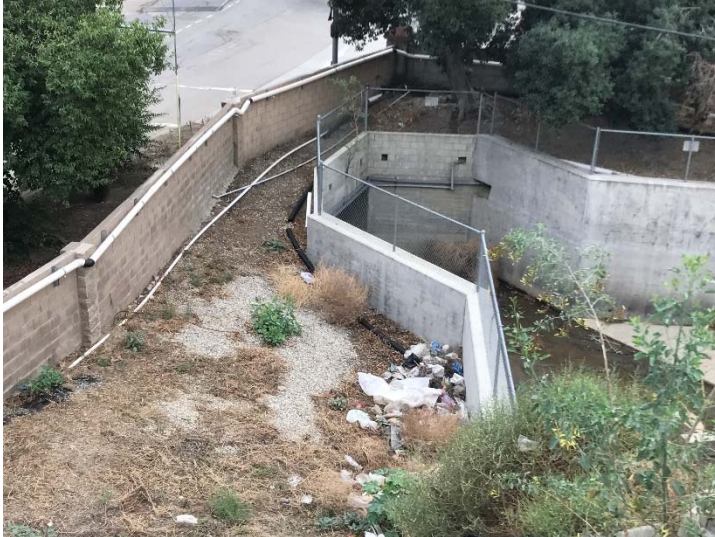
Photo 215: Debris near Terminal Basin Front Wall: November 1, 2016

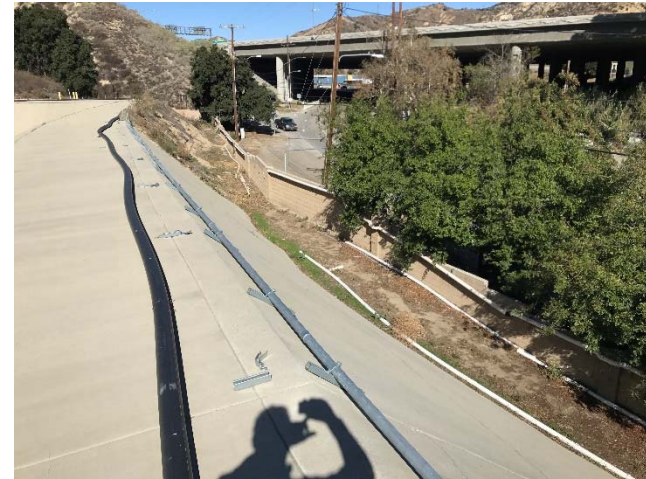
Photo 238: Terminal Basin Front Wall Cleaned: November 29, 2016

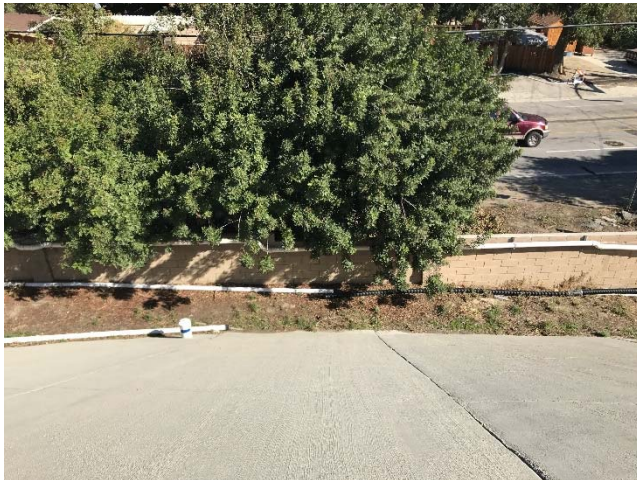
Photo 239: Terminal Basin Front Wall Cleaned: November 29, 2016

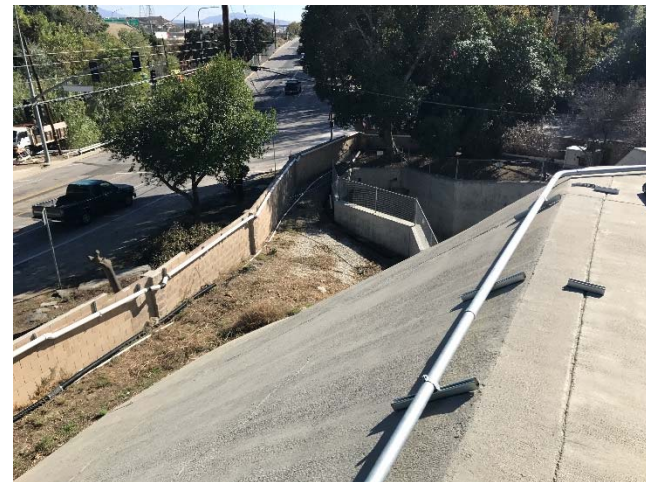
Photo 240: Terminal Basin Front Wall Cleaned: November 29, 2016

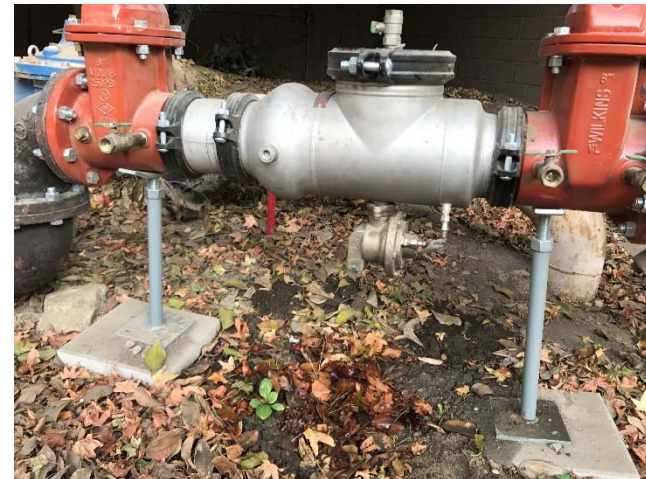
**Photo 248: Potable Water Leak in Graywater Handling area:
October 11, 2016**

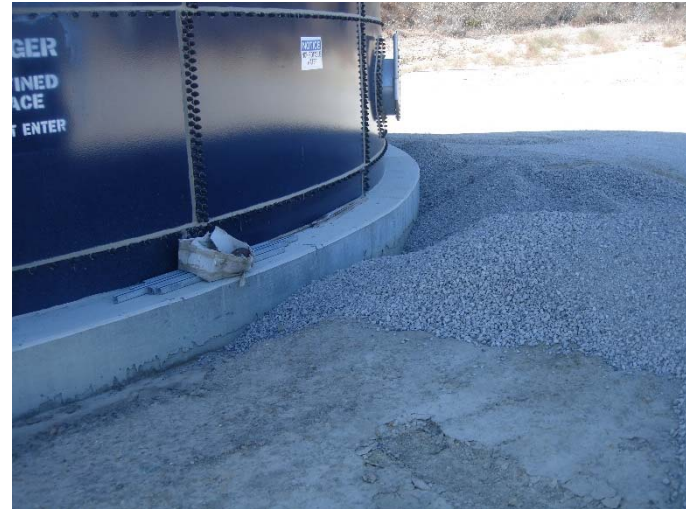
**Photo 258: Deck A Water Tank Foundation Not Backfilled:
October 11, 2016**

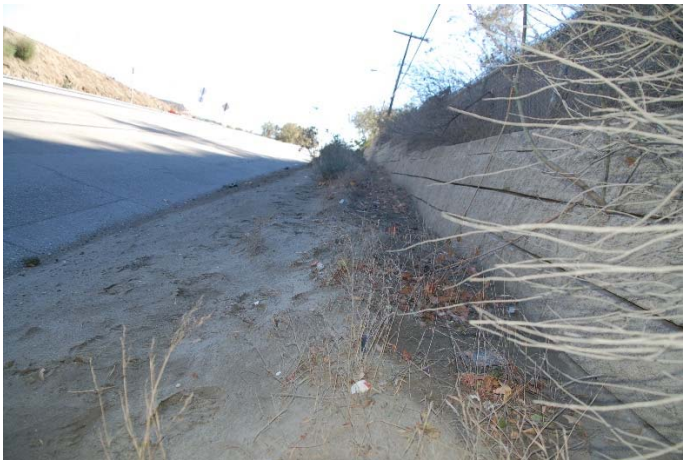
**Photo 338: Frontage Retaining Wall Slope on San Fernando
Road: November 29, 2016**

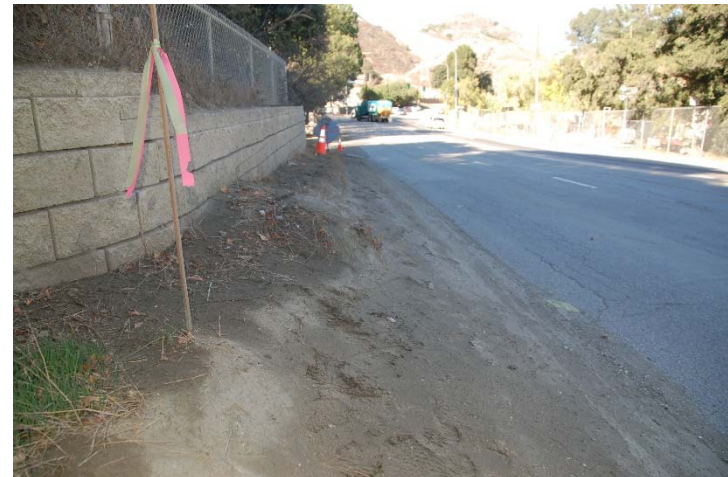
**Photo 339: Frontage Retaining Wall Slope on San Fernando Road:
November 29, 2016**

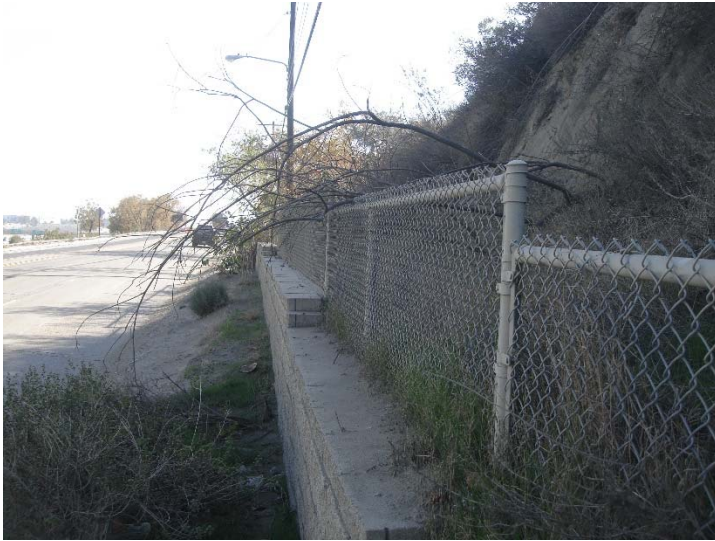
**Photo 340: Frontage Retaining Wall Slope on San Fernando
Road: November 29, 2016**

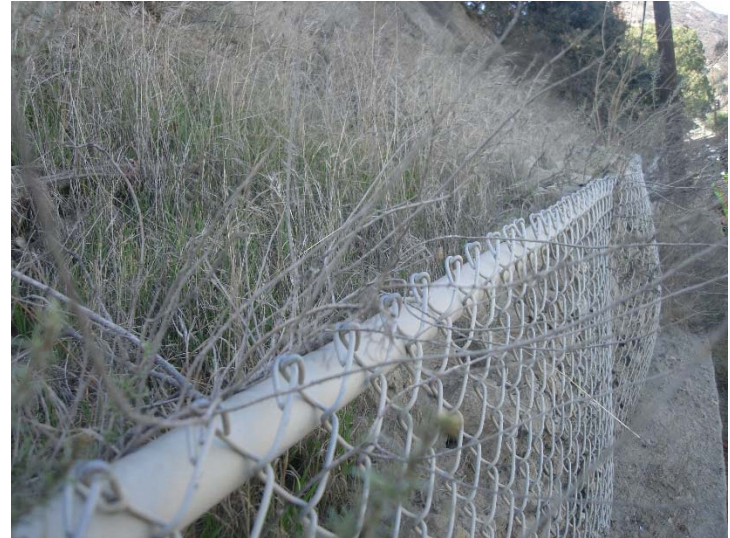
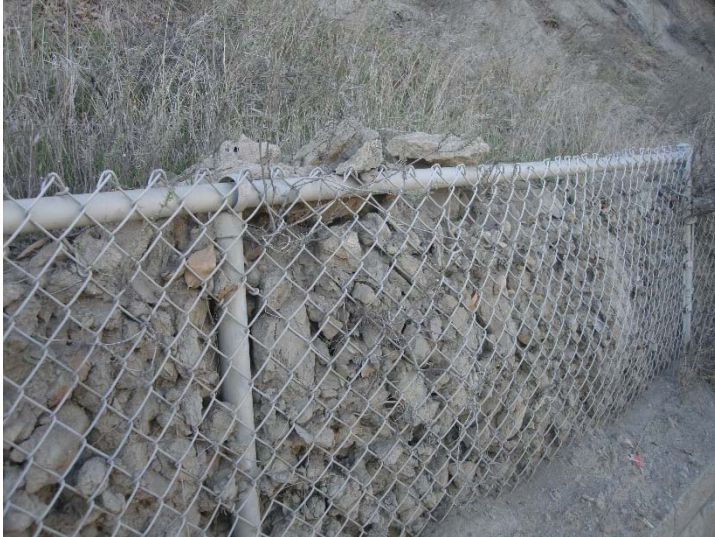
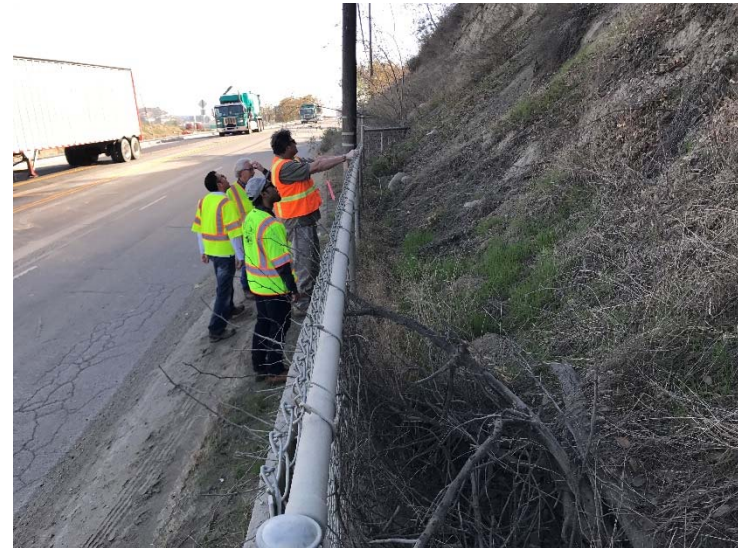
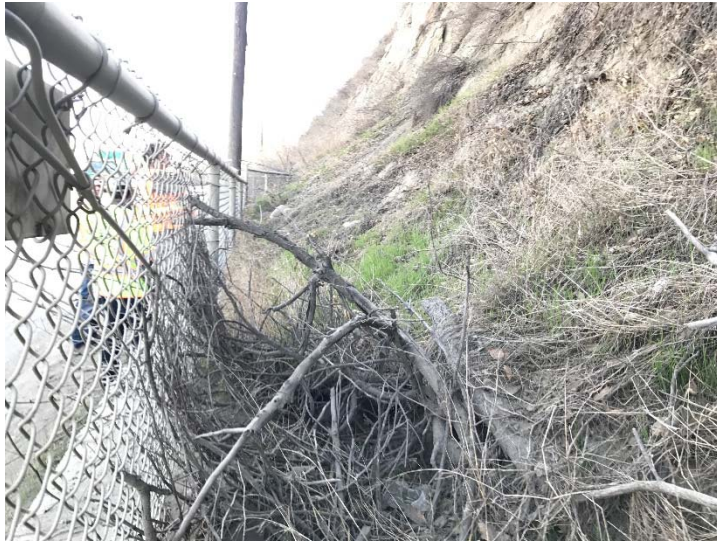
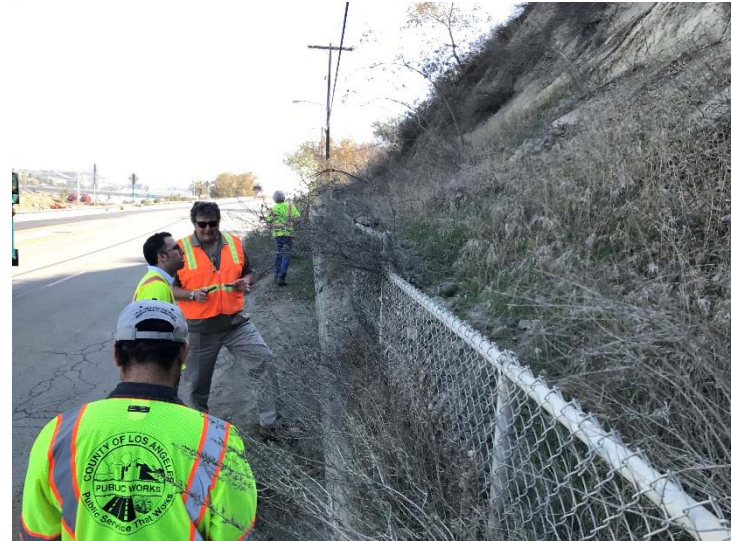
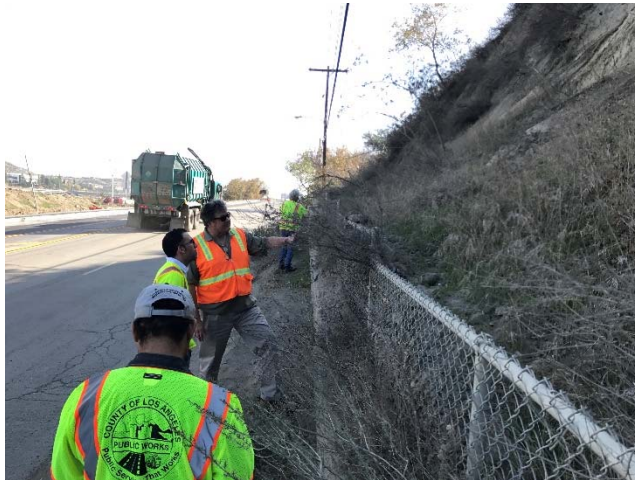
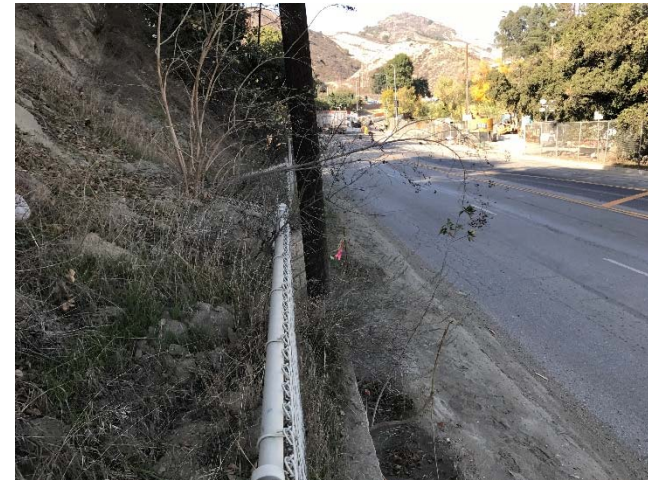
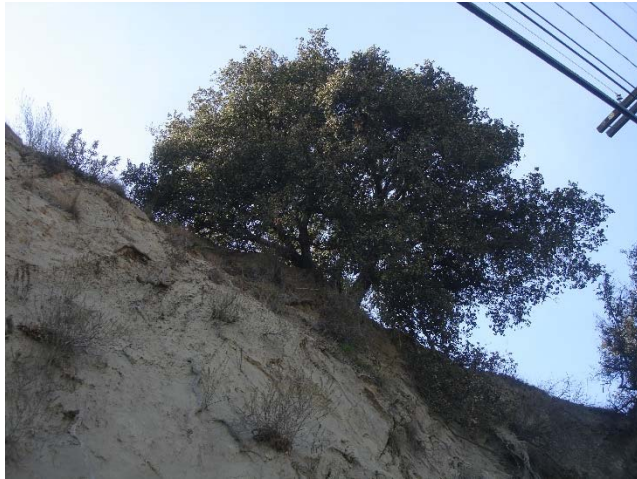
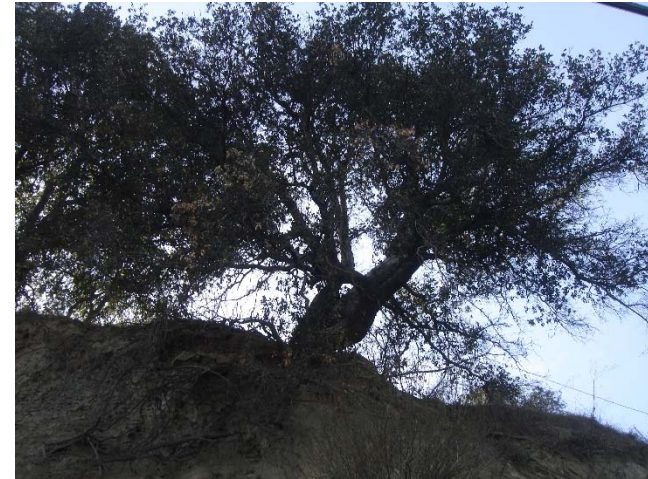
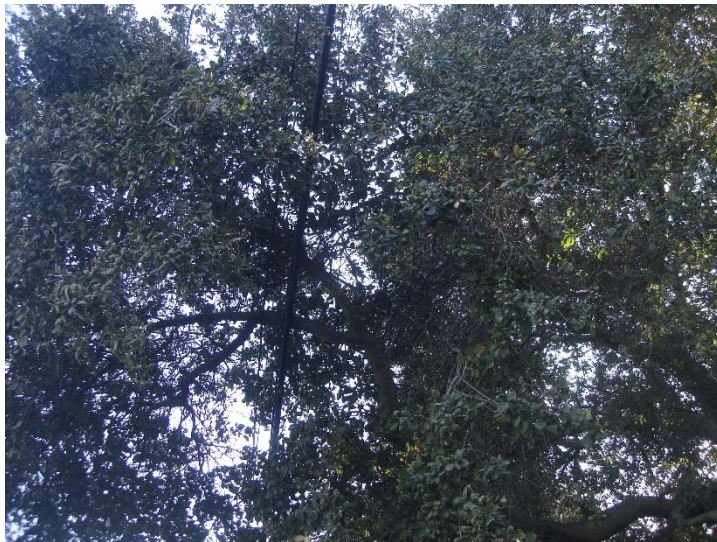
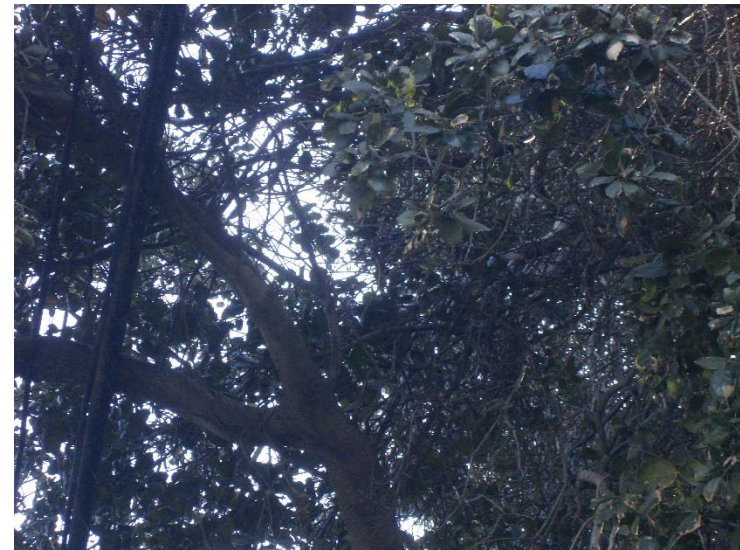
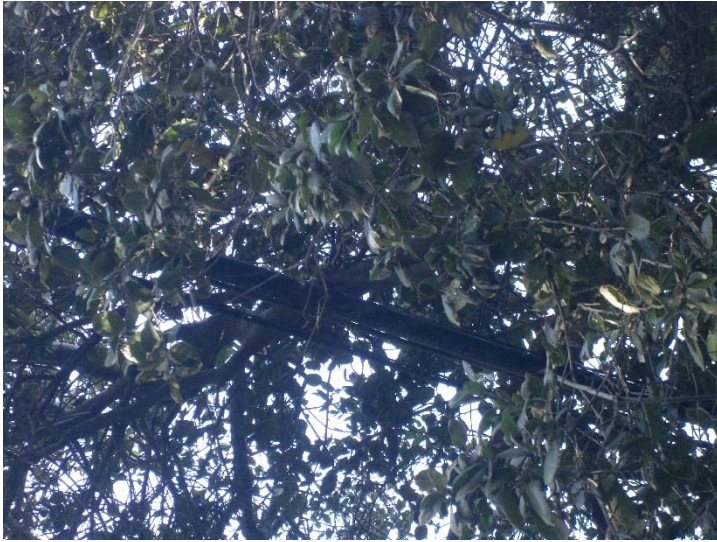
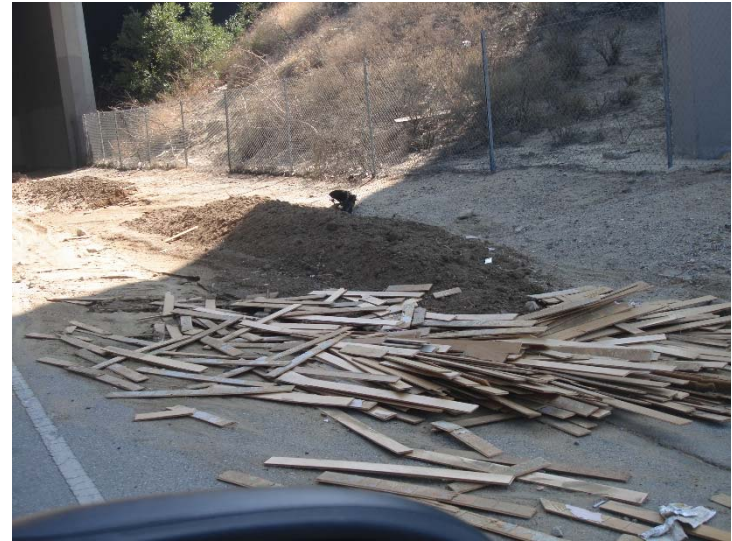
**Photo 341: Frontage Retaining Wall on San Fernando Road:
December 14, 2016**

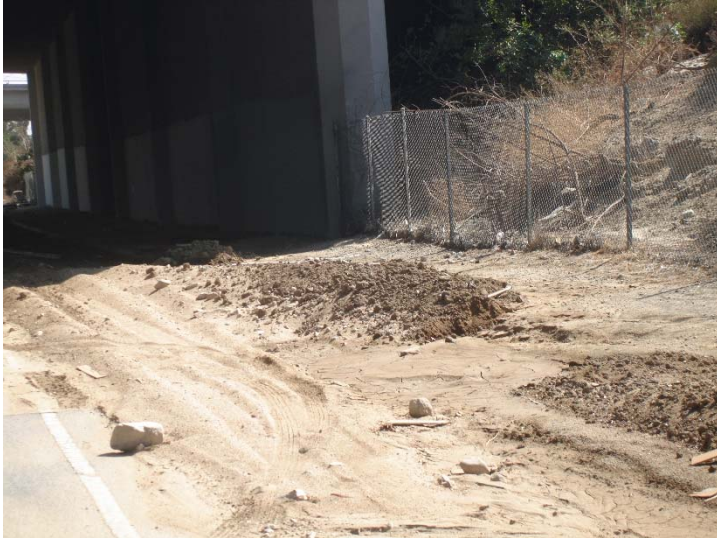
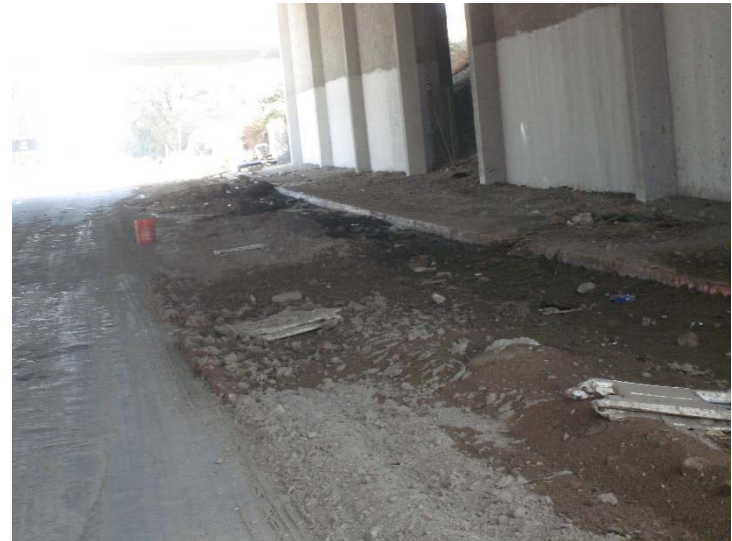
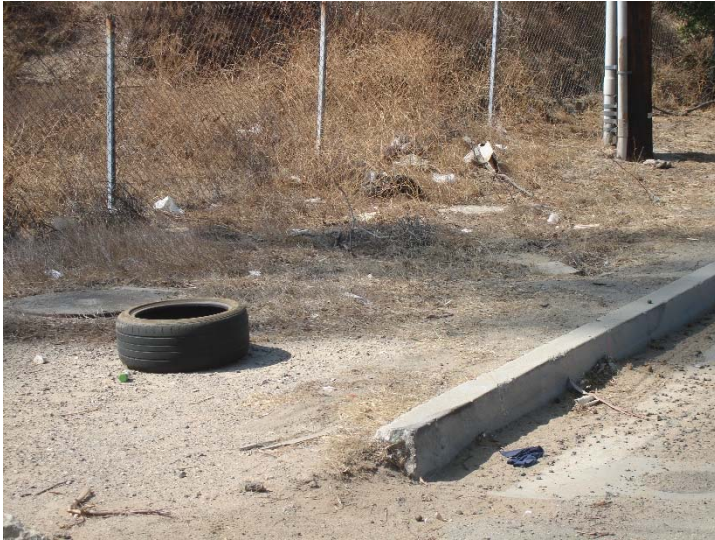
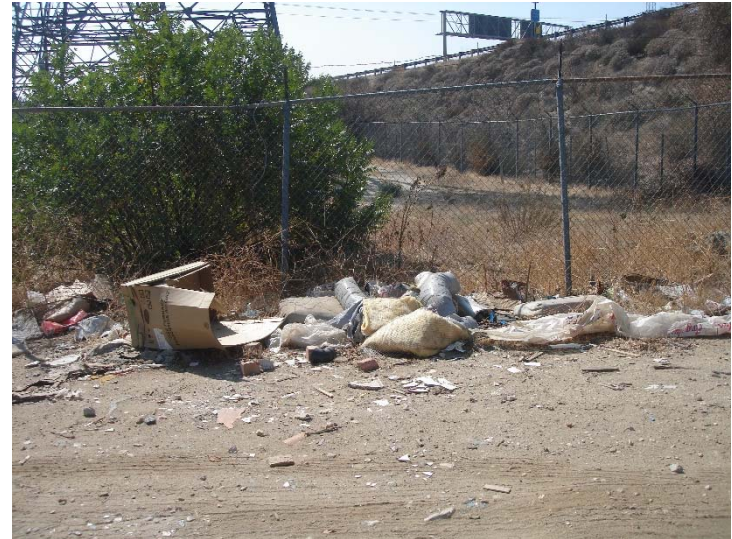
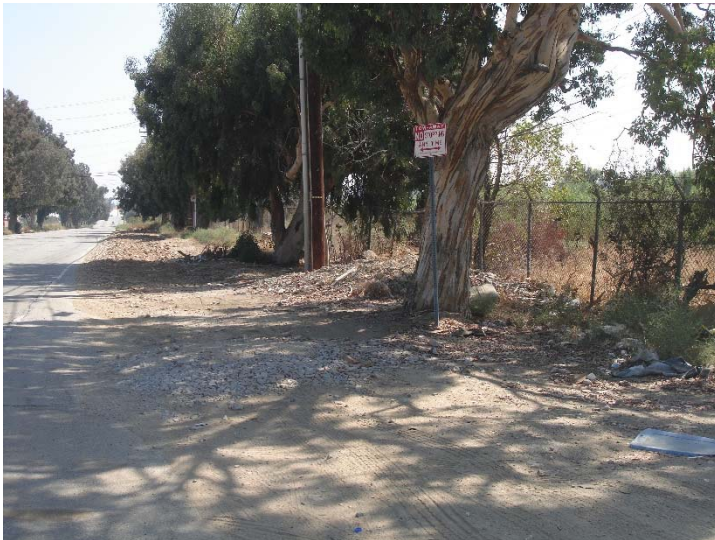
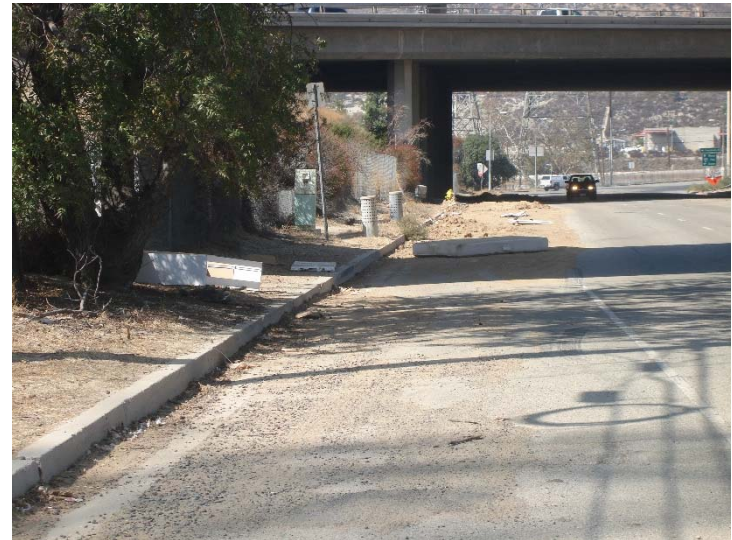
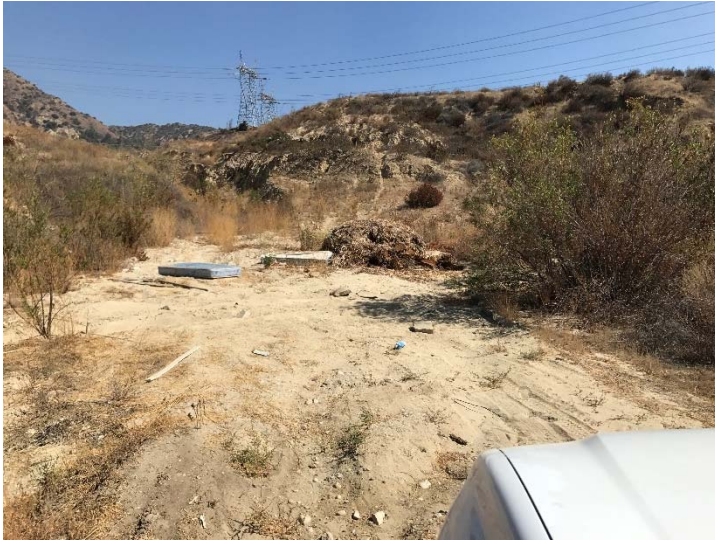
**Photo 354: San Fernando Road near I-5 Overpass: October 11,
2016**

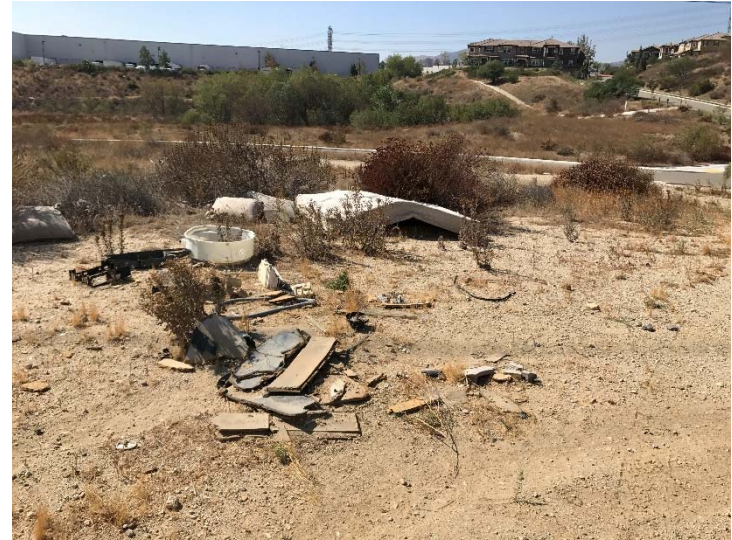
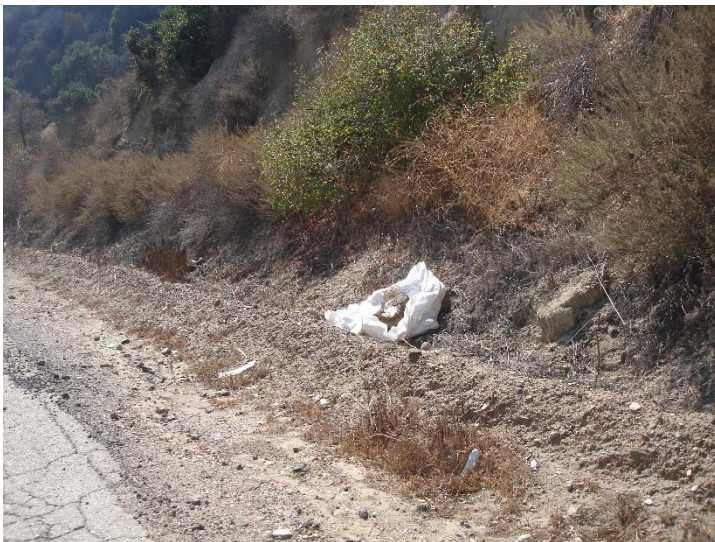
Photo 361: Nicholas Ave in Rancho Cascades: October 11, 2016

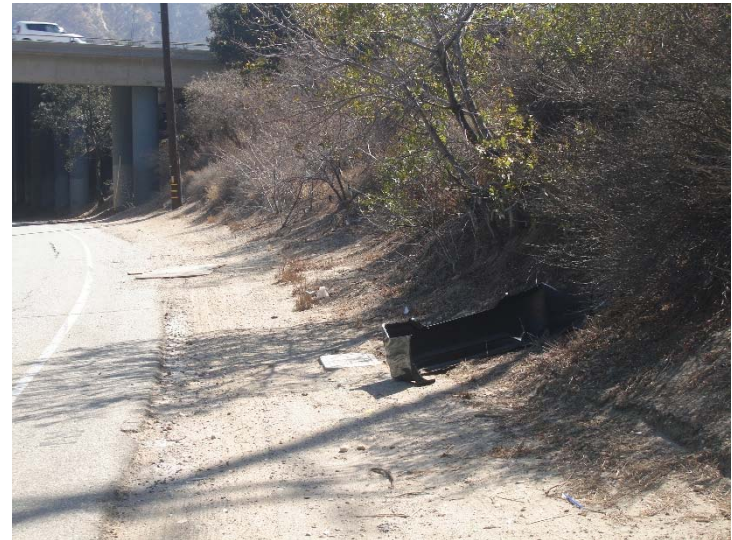
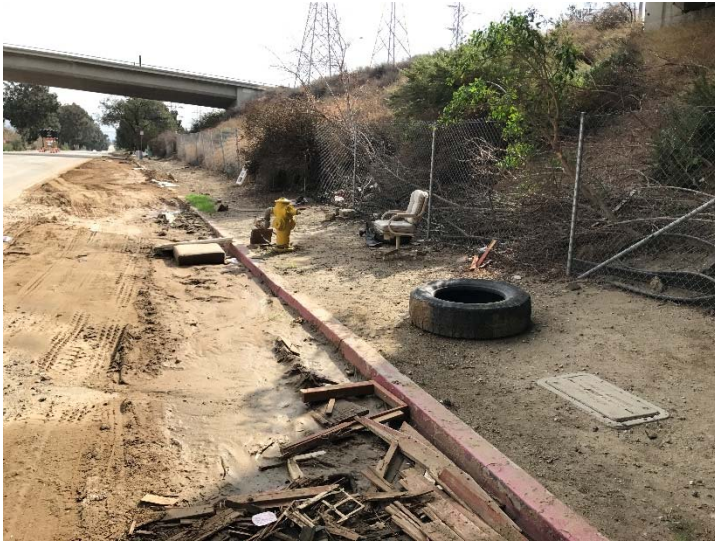
Photo 363: Sierra Highway I-14 Overpass: October 11, 2016

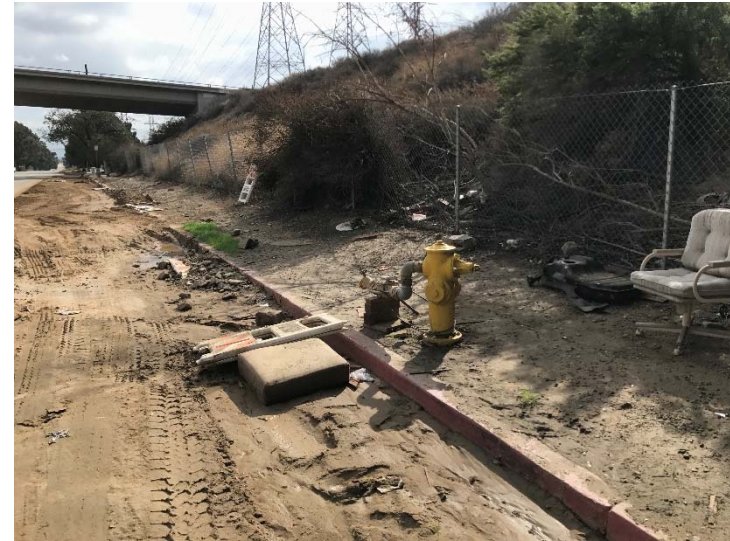
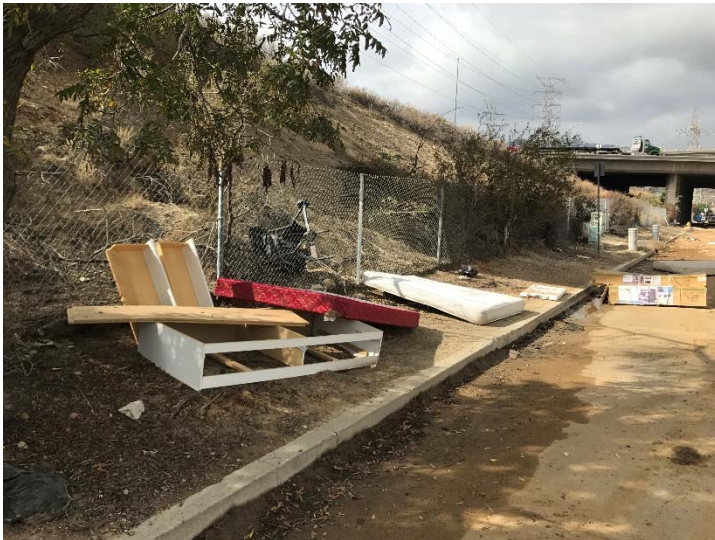
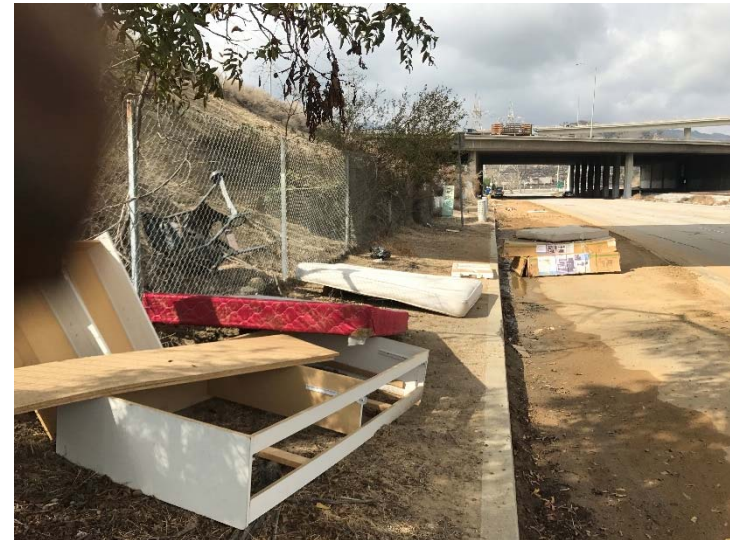
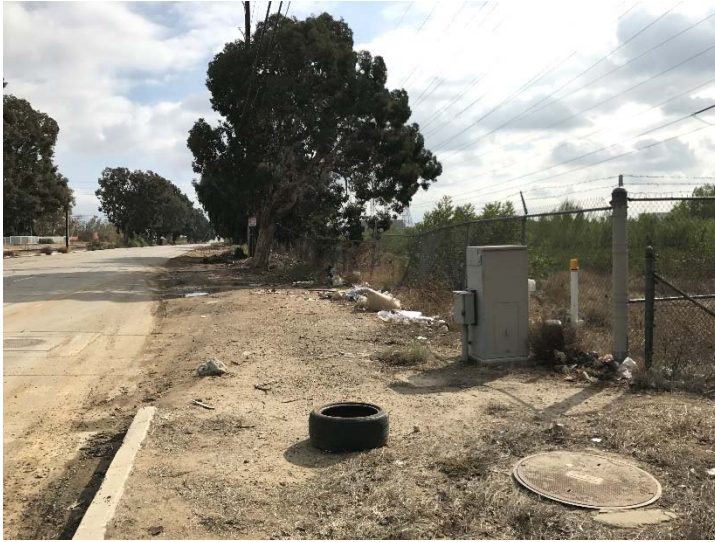
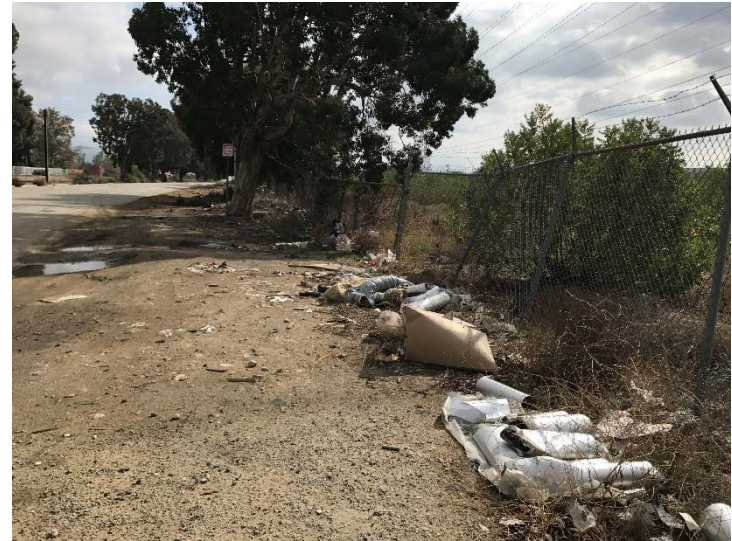
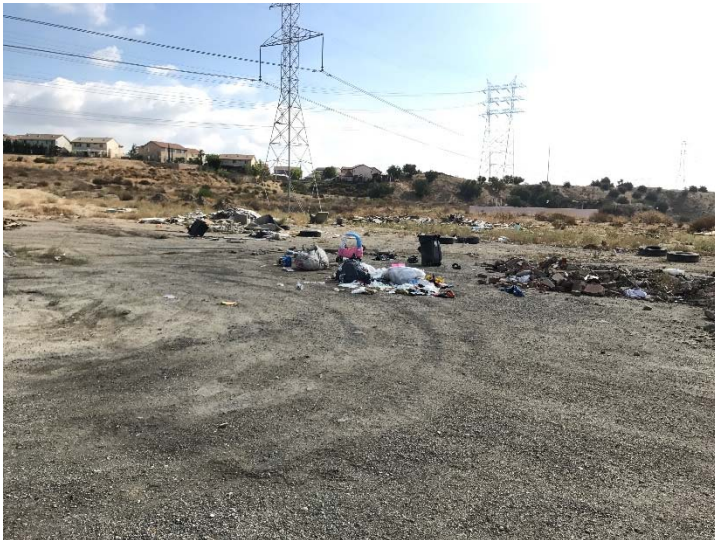
Photo 365: San Fernando Road near I-5 Overpass: November 1, 2016

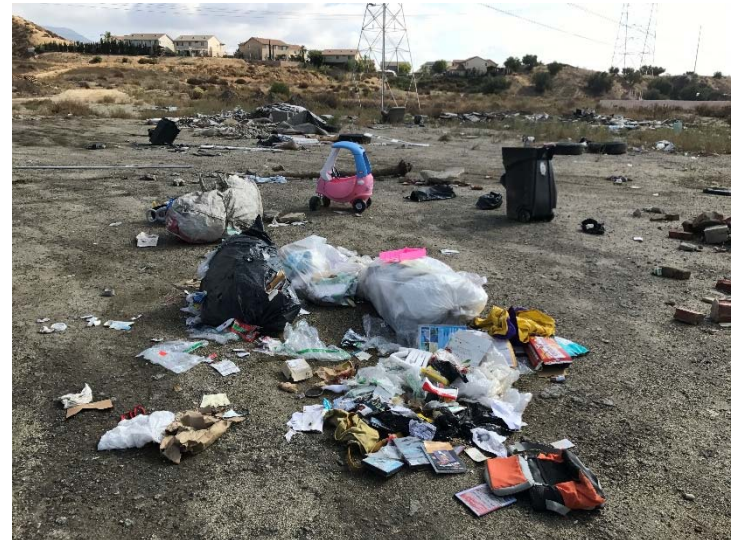
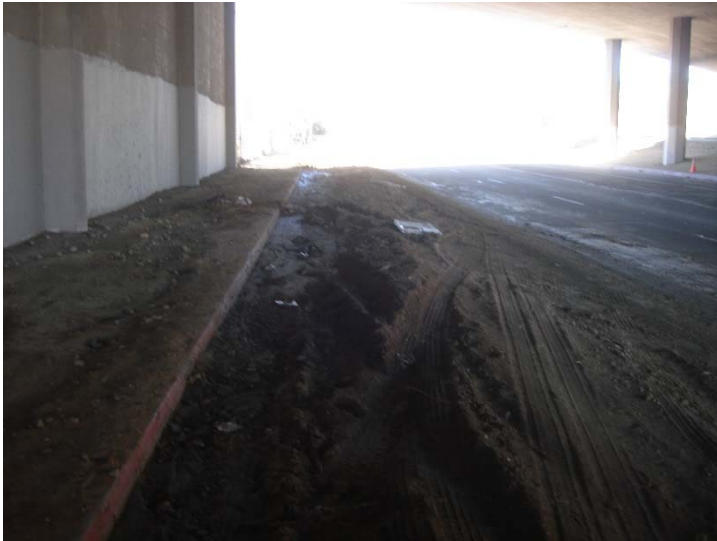
Photo 371: Nicholas Ave in Rancho Cascades: November 1, 2016

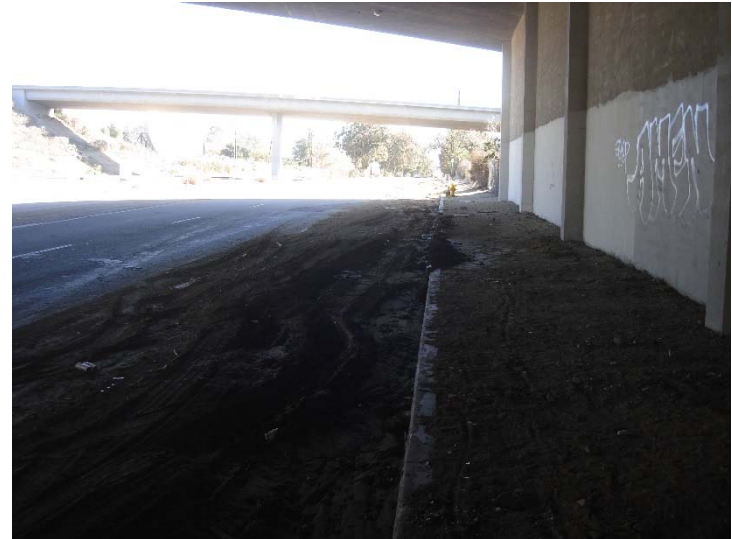
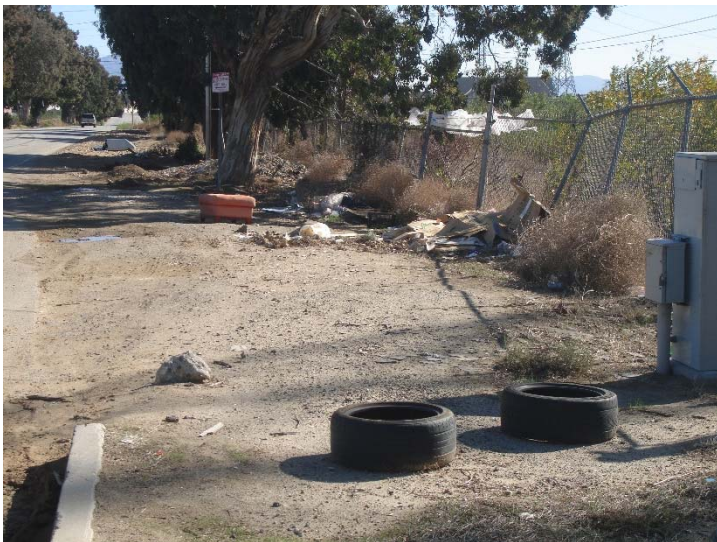
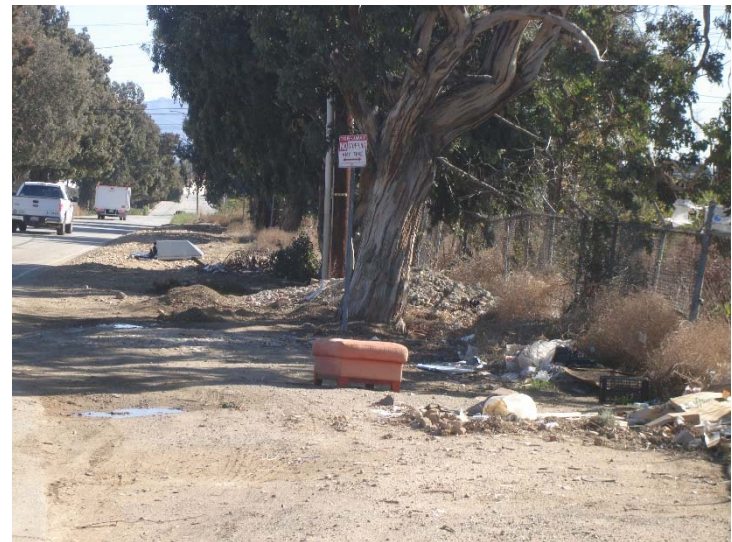
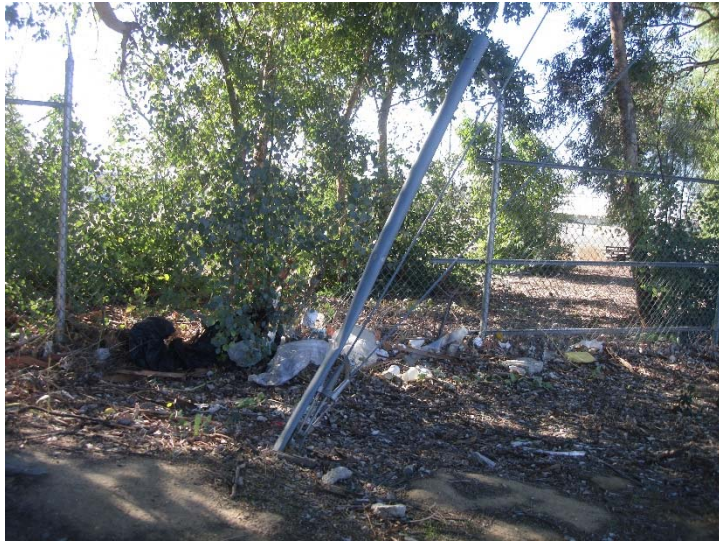
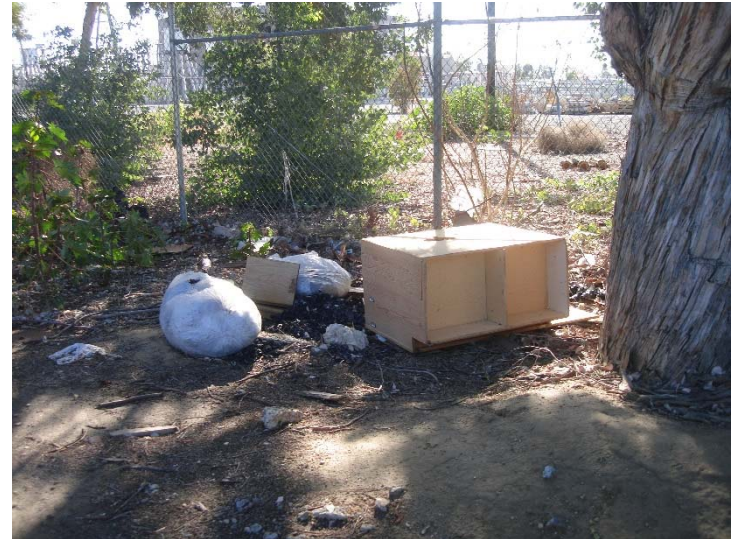
Photo 373: San Fernando Road near I-5 Overpass: November 29, 2016
