**Sunshine Canyon Landfill
Independent Monitor
Quarterly Site Monitoring Status Report
October 1, 2016 – December 31, 2016**

UltraSystems
environmental | management | planning

April 19, 2017

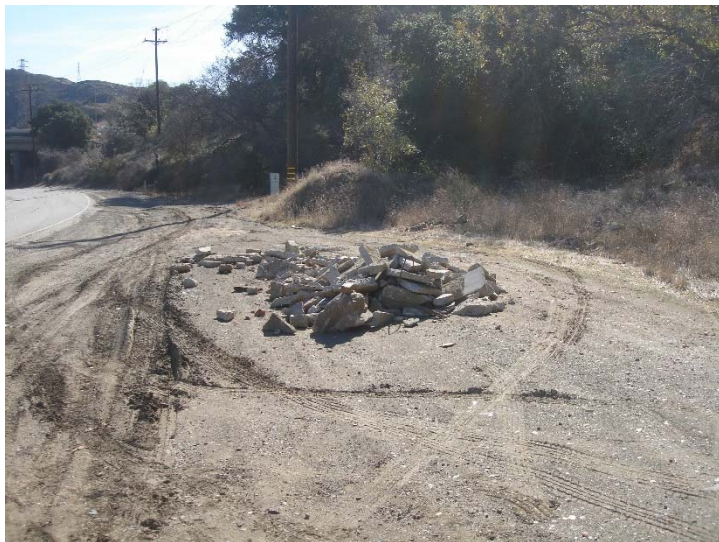
Photo 379: Sierra Highway I-14 Overpass: November 29, 2016

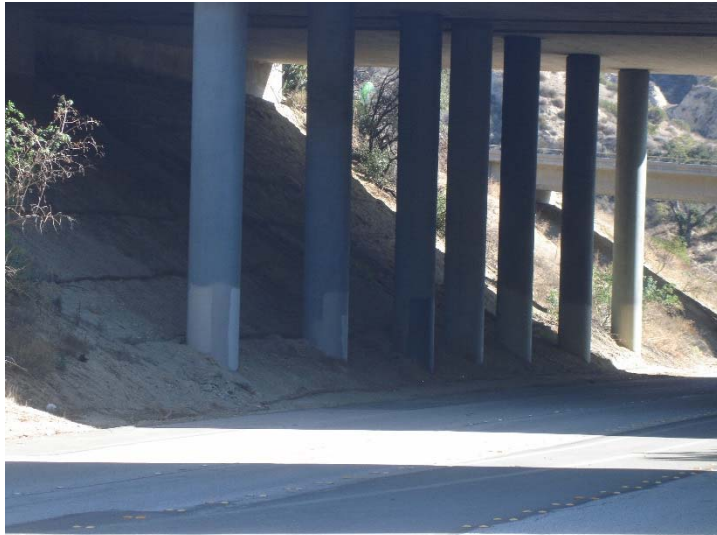
Photo 381: Sierra Highway I-14 Overpass: November 29, 2016

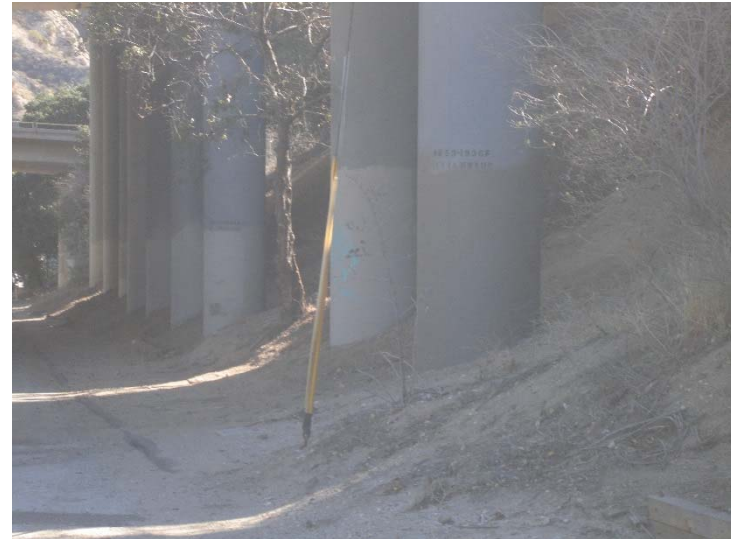
Photo 382: Sierra Highway I-14 Overpass: November 29, 2016

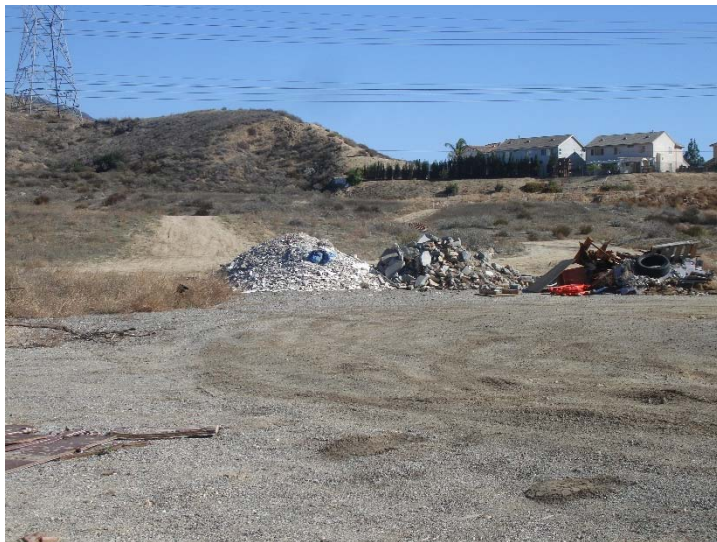
Photo 383: Rancho Cascades Illegal Dumping: November 29, 2016

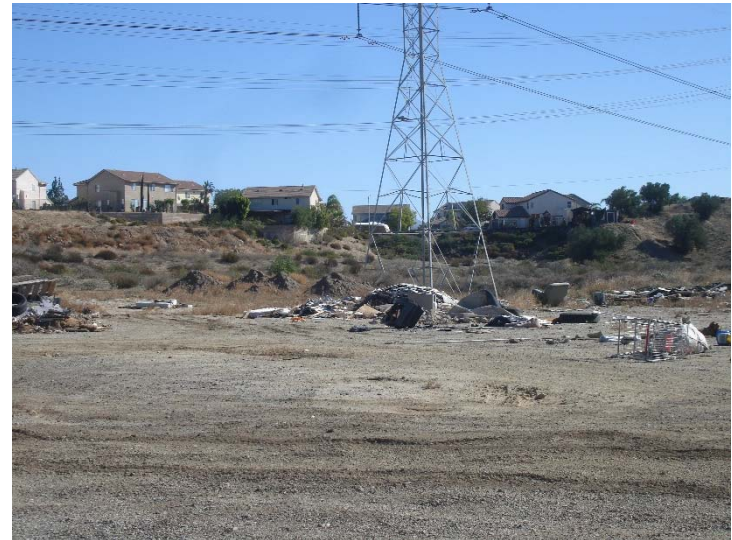
Photo 384: Rancho Cascades Illegal Dumping: November 29, 2016

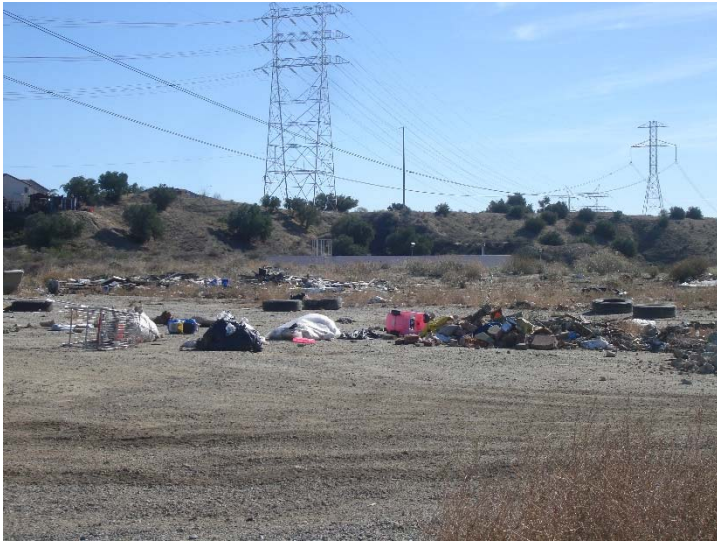
Photo 385: Rancho Cascades Illegal Dumping: November 29, 2016

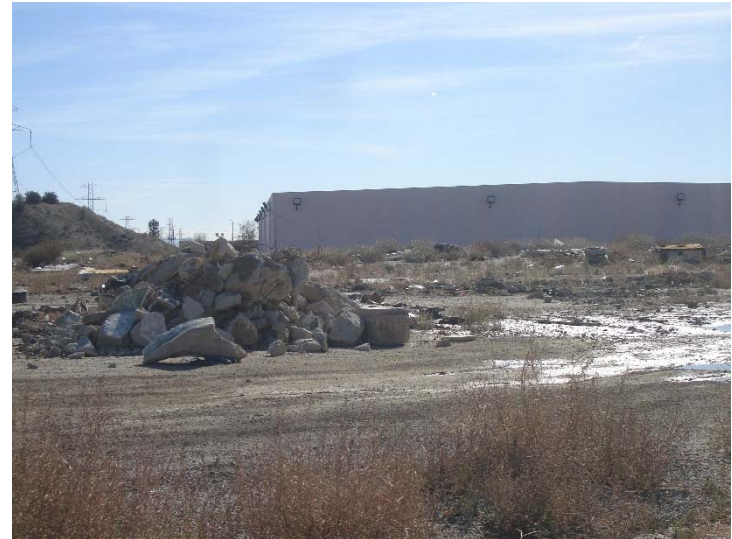
Photo 386: Rancho Cascades Illegal Dumping: November 29, 2016

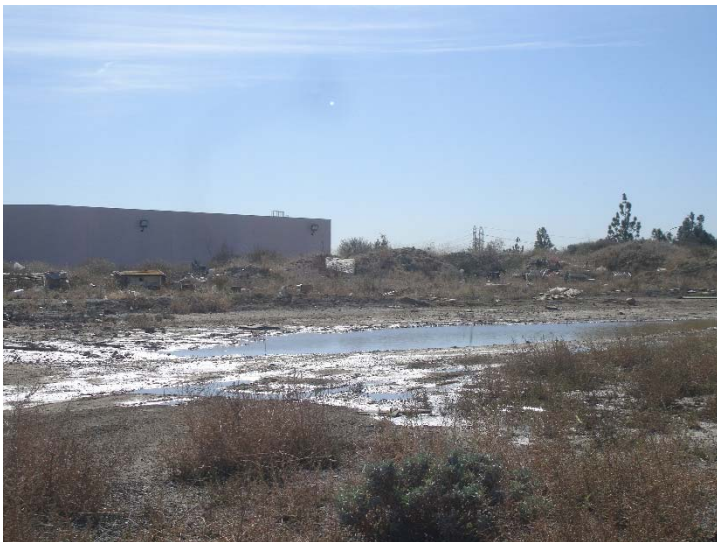
Photo 387: Rancho Cascades Illegal Dumping: November 29, 2016

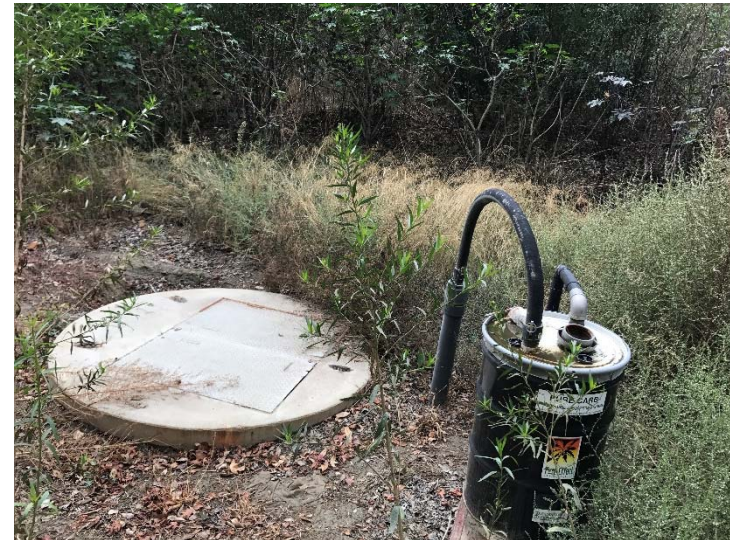
Photo 396: Odor at Sewer Deep Well Pump: November 1, 2016

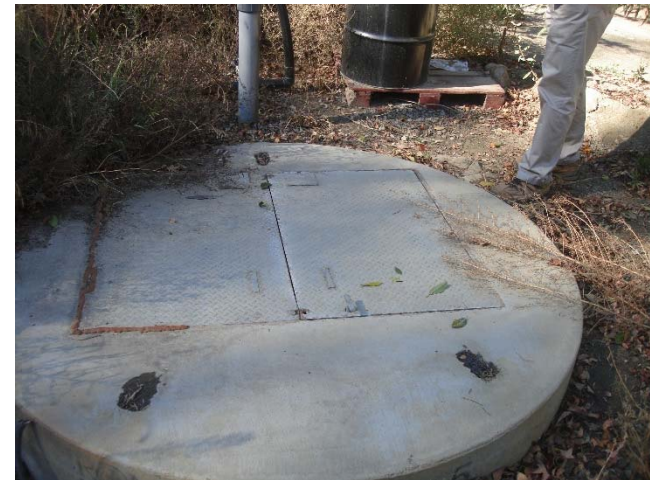
Photo 400: Odor Detected at Sewer Connection Point: November 29, 2016

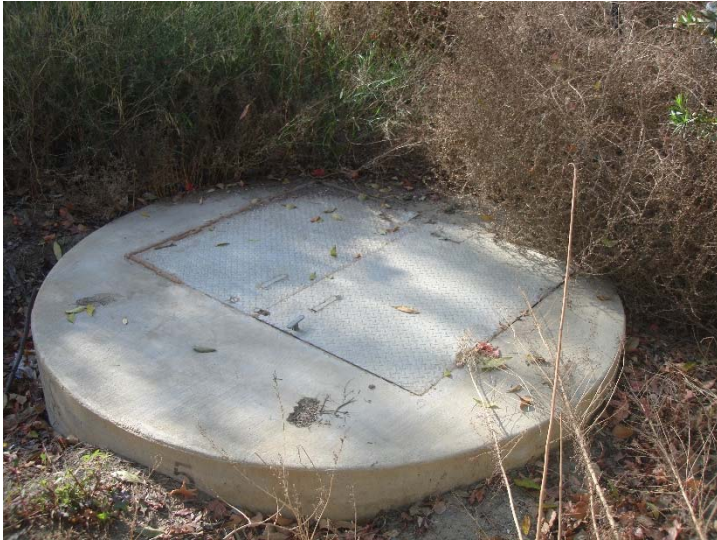
Photo 405: Odor Detected at Sewer Connection Point: December 14, 2016

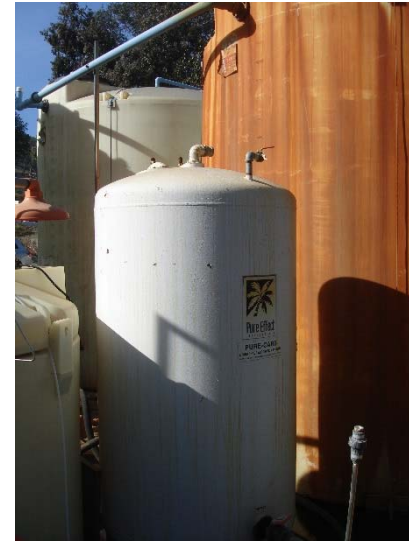
Photo 406: Odor Detected coming from Tank Vent: December 14, 2016

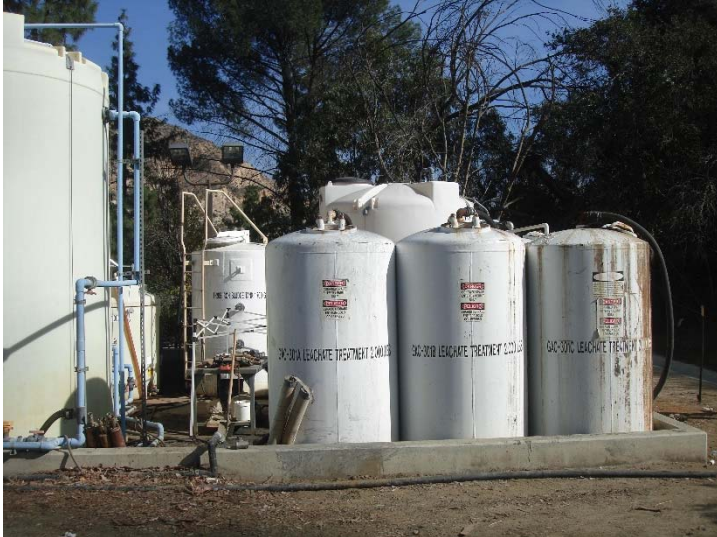
Photo 407: Odor Detected coming from Tank Vent: December 14, 2016

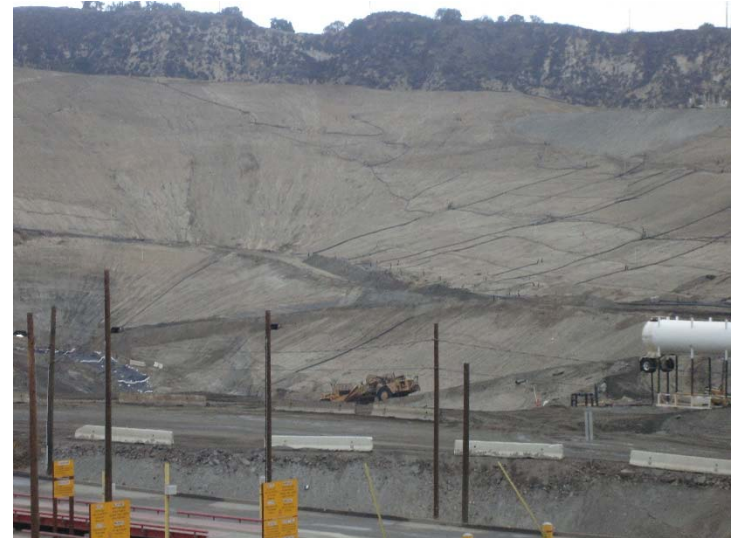
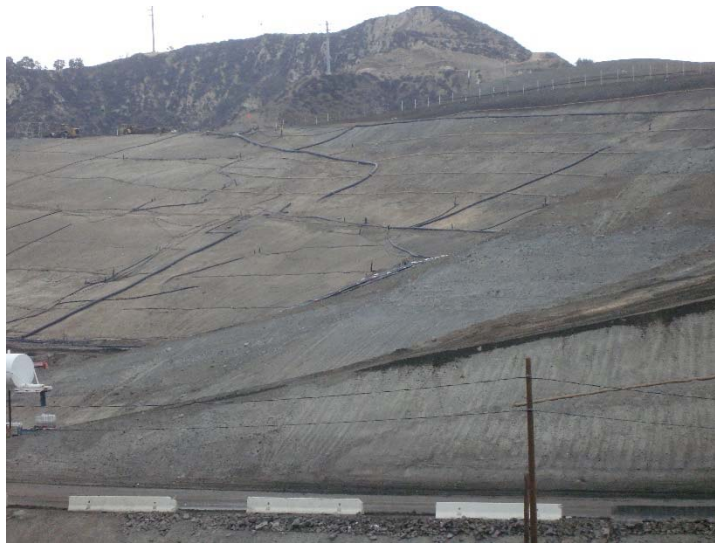
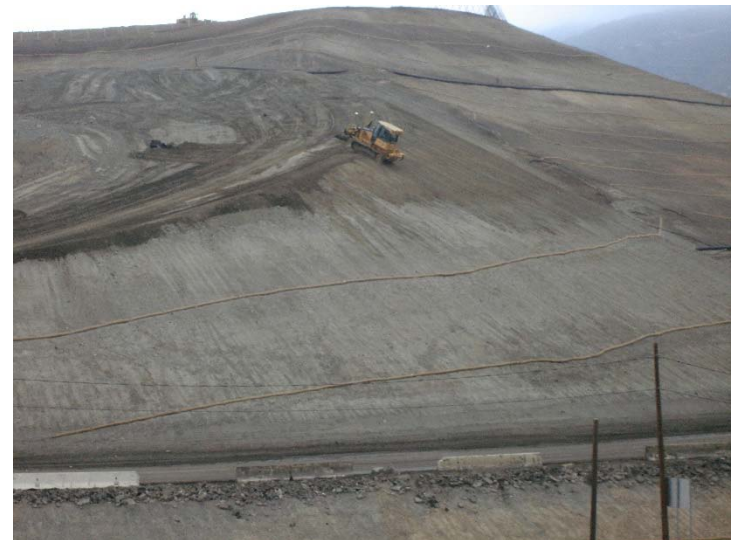
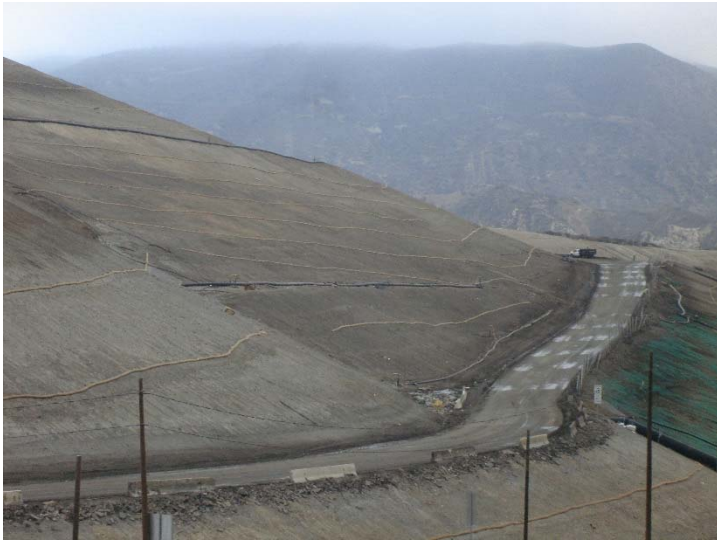
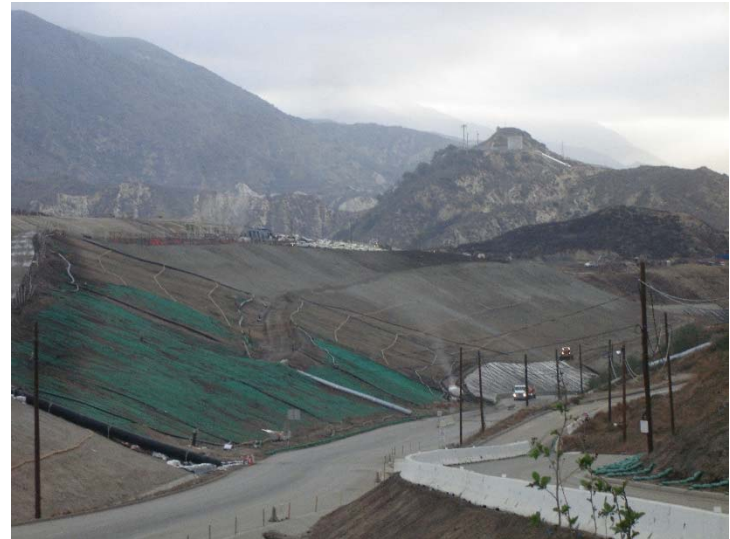
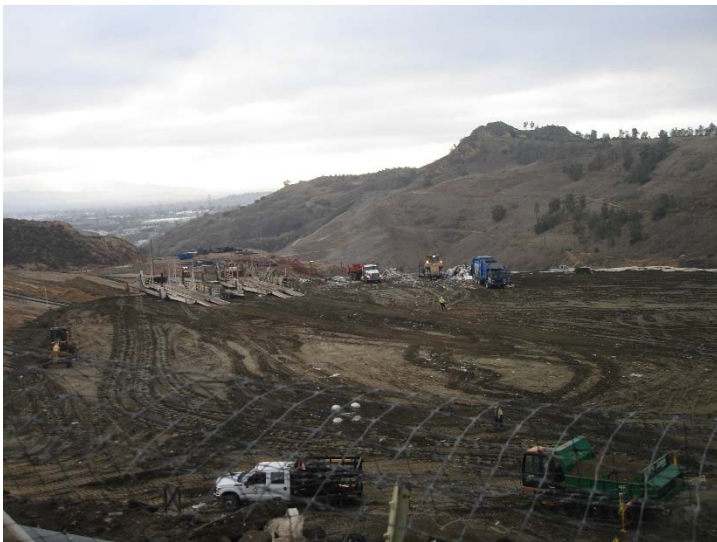
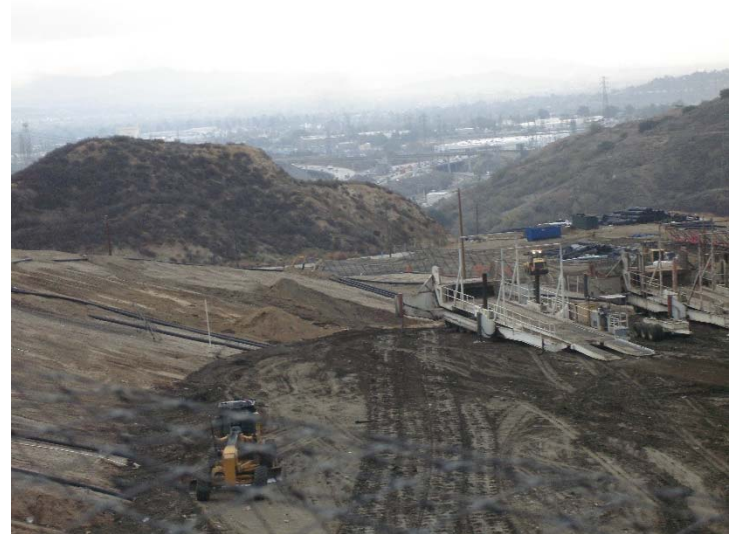
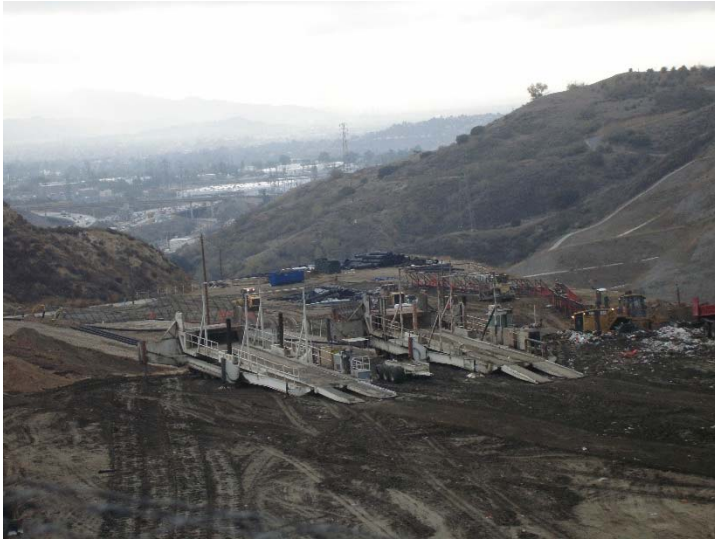
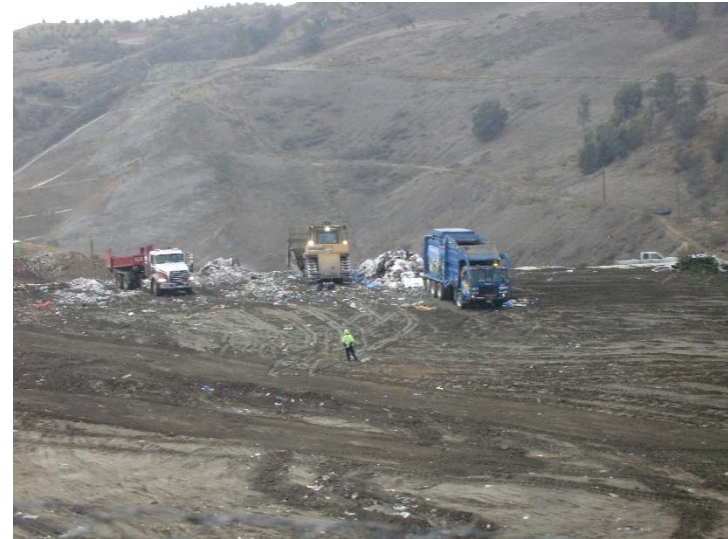
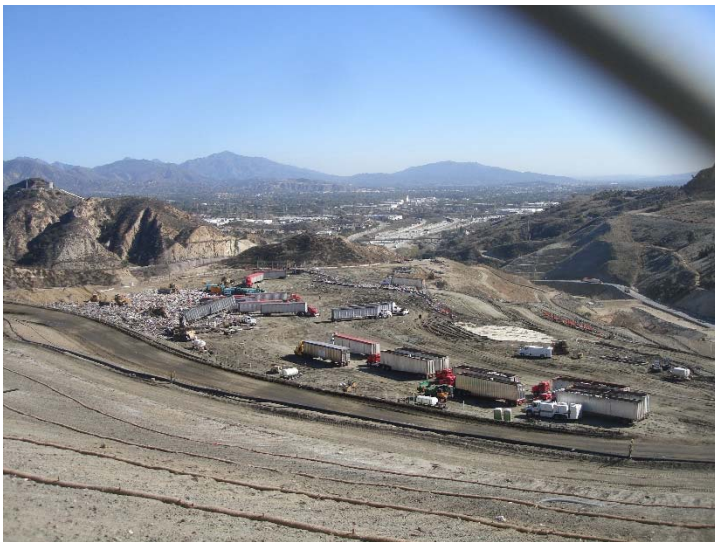
Photo 421: Site Working Area CC3B 800am: November 1, 2016

Monitor: James Aidukas	Page: 1 of 2
Discipline: Project Manager	Date: 11/1/16
Site Conditions: Cloudy, 55-70°F with 0-10 MPH wind	
SITE LOG	
<p>Republic Site Manager - Rob Sherman</p> <p>Drove the Granada Hills neighborhood and school area from 6:10 to 7:15 a.m. Did not detect any landfill odors. Drove to Balboa and Woodley and detected a faint odor coming off the pavement at the stop light. The pavement appears to have been previously washed by a street sweeper. There was a recent spilling of liquids at the intersection, which had a faint garbage smell. The Rancho Cascades area was monitored and no landfill odors were detected.</p> <p>Met with Mike Lindsay (UltraSystems) and signed in at the office and had a brief update on current landfill activities from Michael Stewart and Ricky Dhupar (Republic.) We then proceeded to monitor the site and observed the following:</p> <ul style="list-style-type: none"> • The slopes below and above the main access road performed well during the recent rains. There was only minor erosion. • The recently installed concrete drainage channel from the access road box culverts and also from the temporary basin below Cell CC-3B appeared to have performed well. • The gabions in the westside drainage channel detained sediment and prevented the sediment from going into the terminal basin. • There was a rock gabion approximately 10-12' high installed across the entrance to the terminal basin. This gabion detained most of the sediment entering the basin. There were minor amounts of sediment at the internal gabion wall and very little at the outlet risers. The new system to control sediment performed well. • The liquid handling system along the main access road adjacent to Cell CC-3A slopes was being worked on. Localized liquid odors were detected. • The future CC-4 was being worked on. Liner tie-ins and grading were being performed. Localized gas or liquids odors were detected at liner tie-in points that were being worked on. • Cell CC-3A slopes had straw wattles installed. • The roadway to the active areas was graded and surfaced for wet weather. • The top deck of CC-3A was active and had two tippers. Packer trucks were only observed depositing waste. Water misters were operating. ADC was being used. • The old City landfill slopes had new HDPE liner drainage downcomers in place. • Cell CC-3B was active and had two tippers. Water misters were operating ADC was being used and approximately 50-60% was covered by 8:30 a.m.

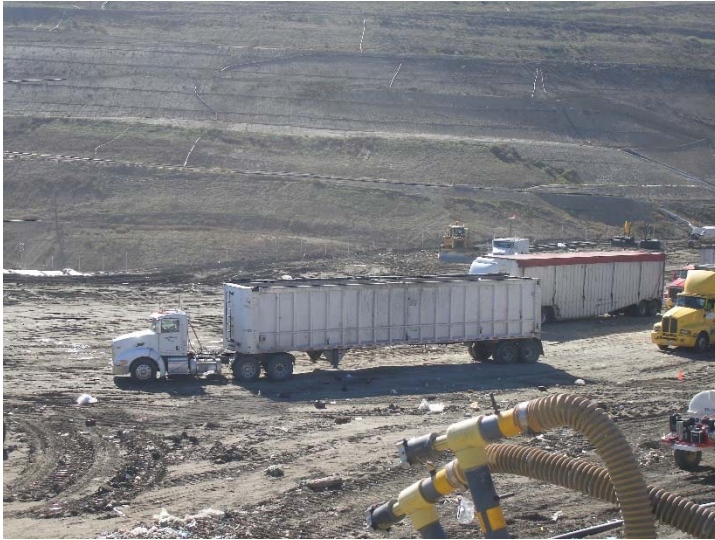
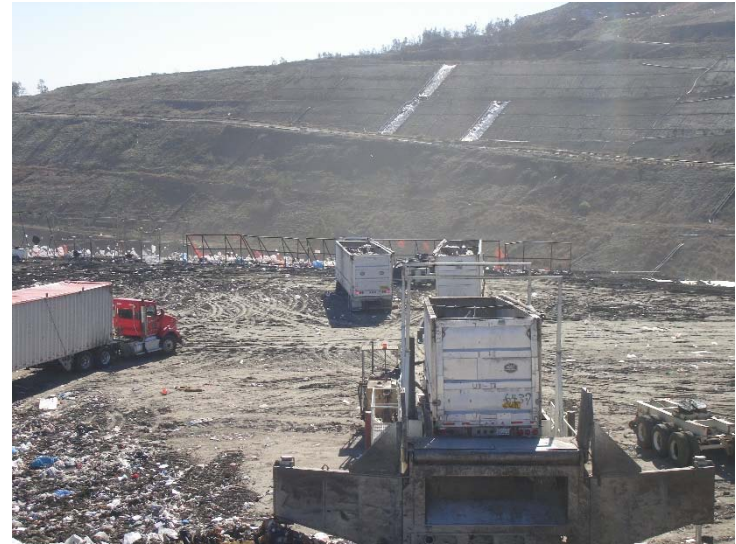
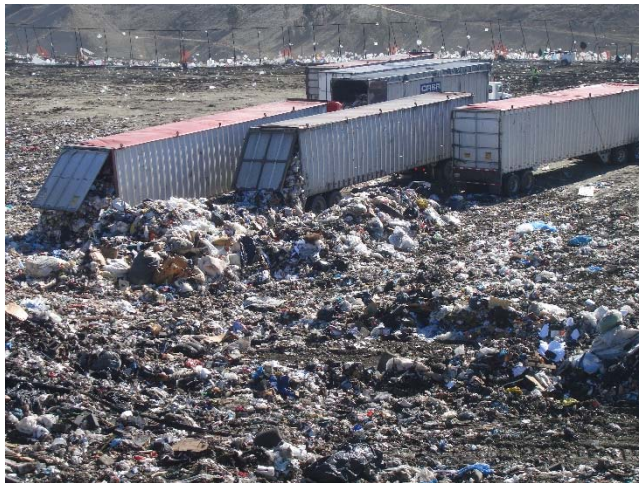
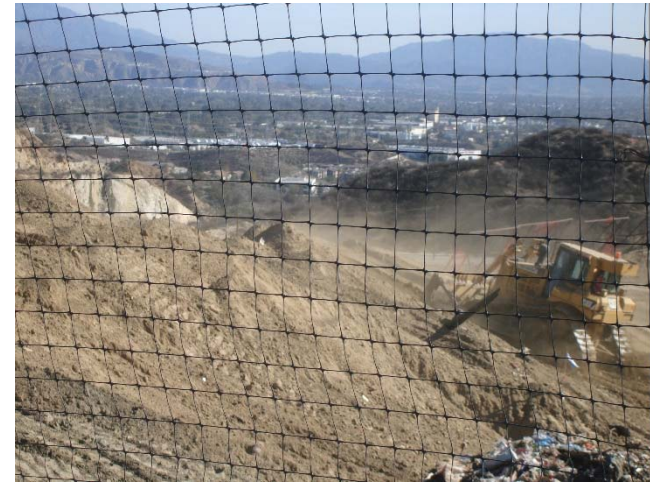
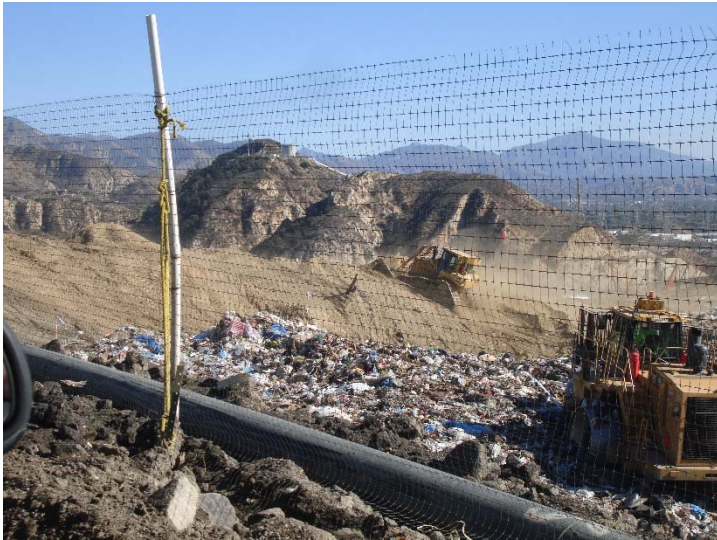
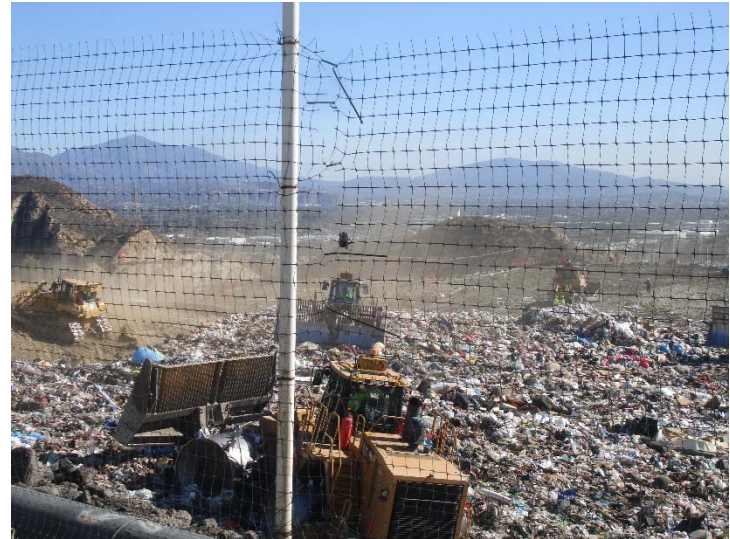
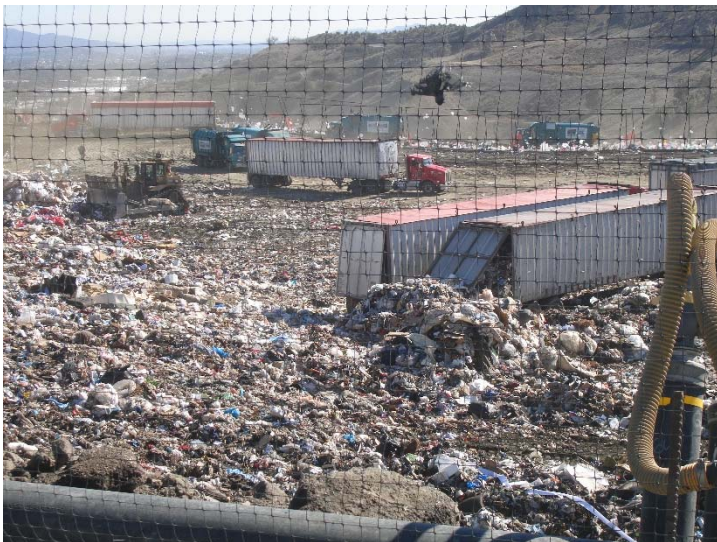
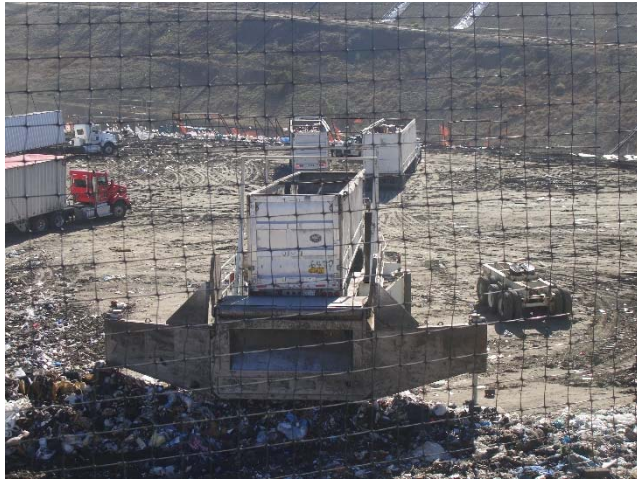
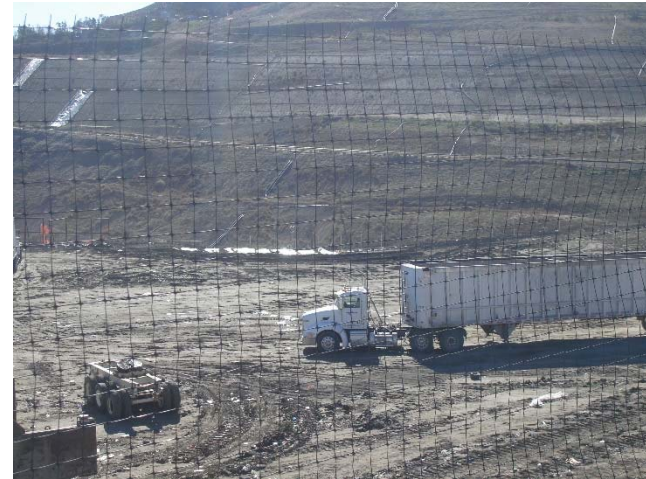
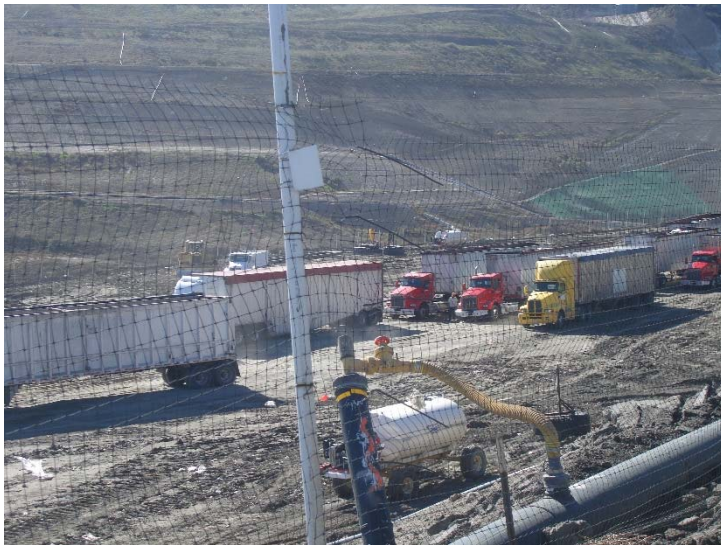
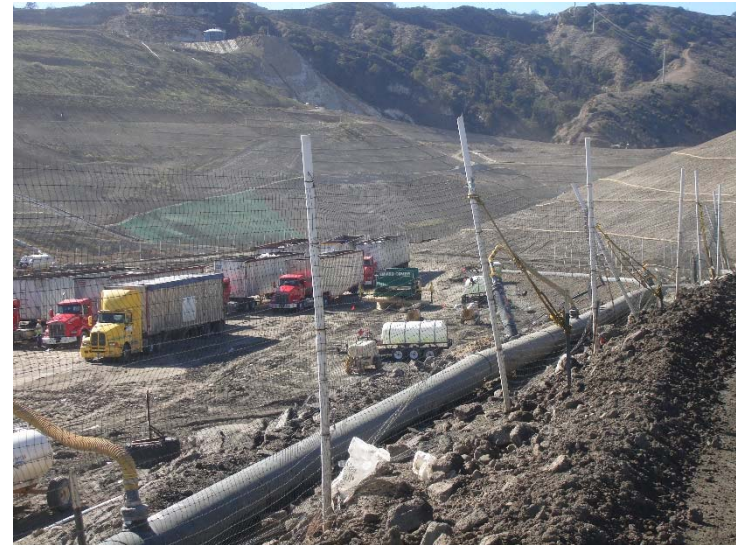
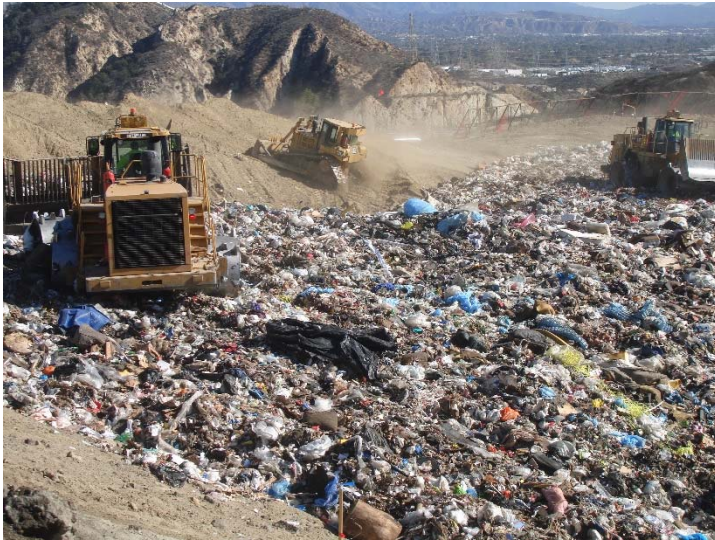
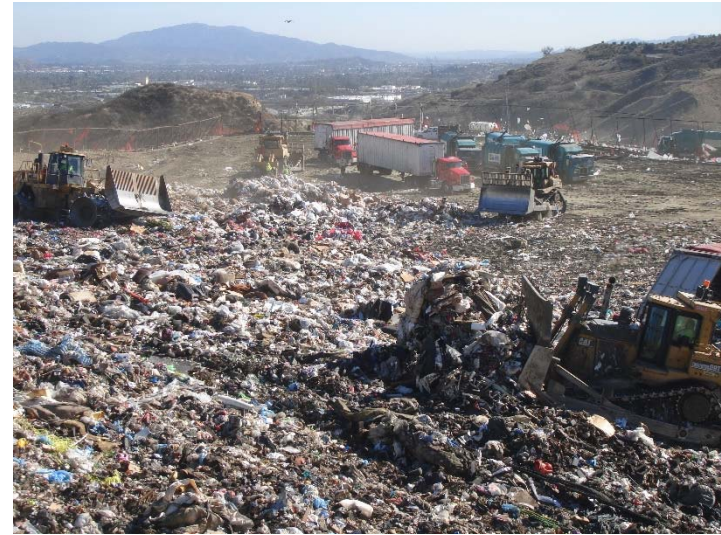
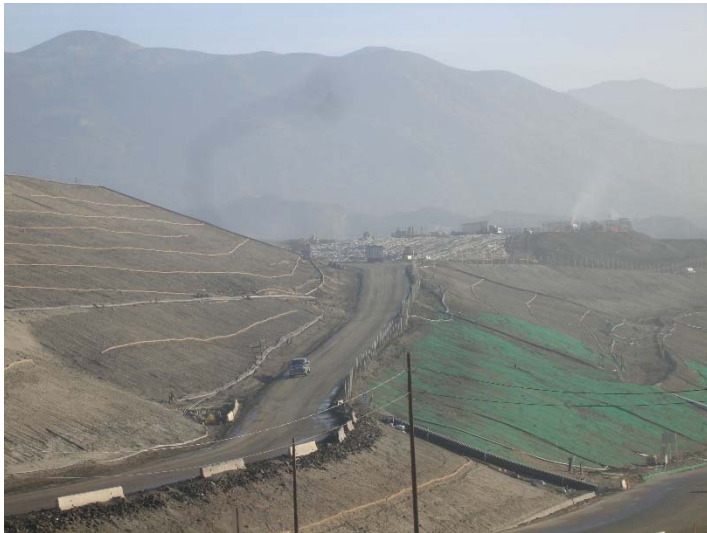
Photo 431: Site Working Area CC3B 115pm: November 29, 2016

- CC-3B was active with approximately 75% of the ADC covered by 10:30 a.m. Tipper and misters were in operation.
- A 12" HDPE gas header on a Cell CC-3A slope was leaking gas with duct tape being used to stop the leak.

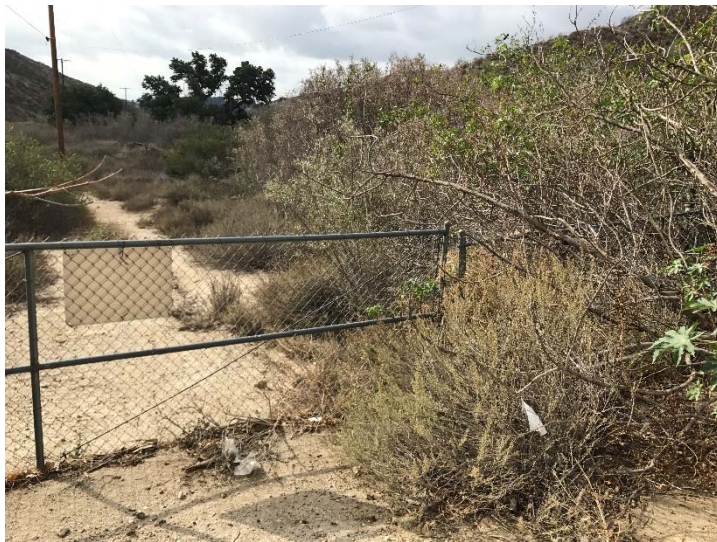
Photo 514: Oil Field South Gate Locked: November 1, 2016

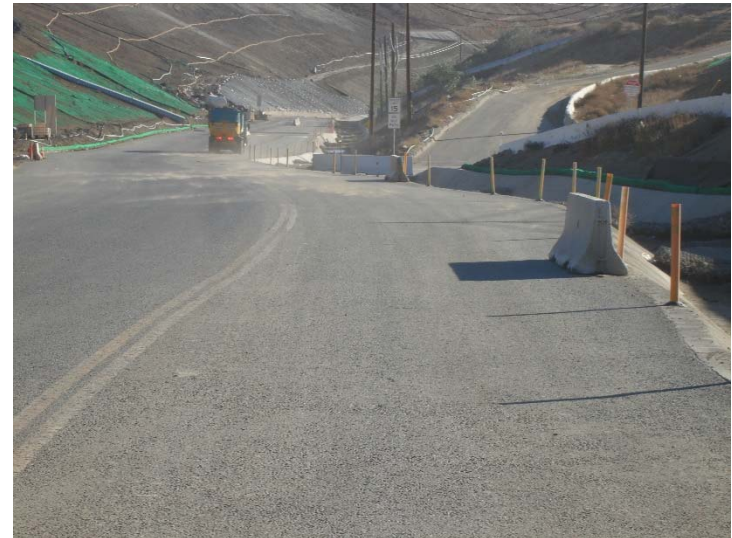
Photo 523: Site Dust 930am: November 29, 2016

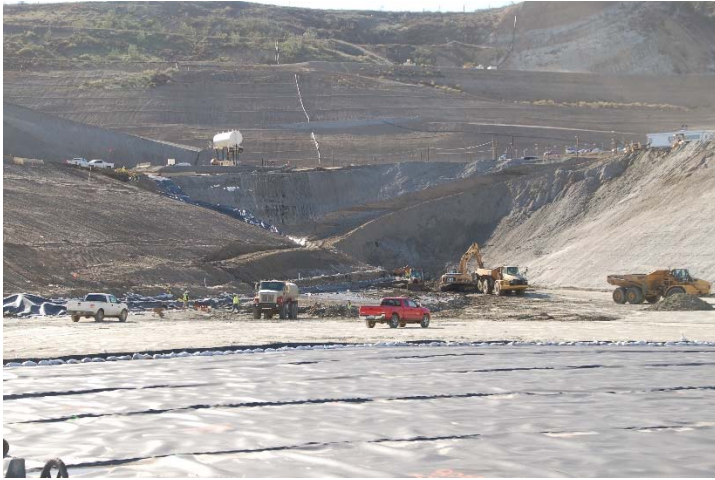
Photo 524: Site Dust 930am: November 29, 2016

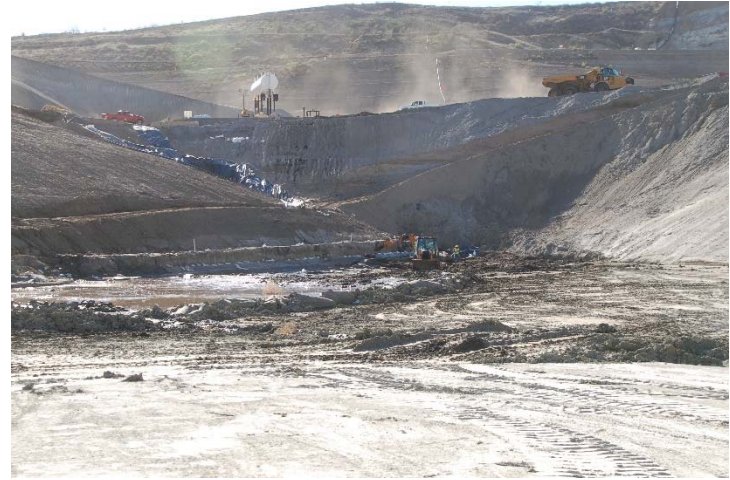
Photo 525: Site Dust: November 29, 2016

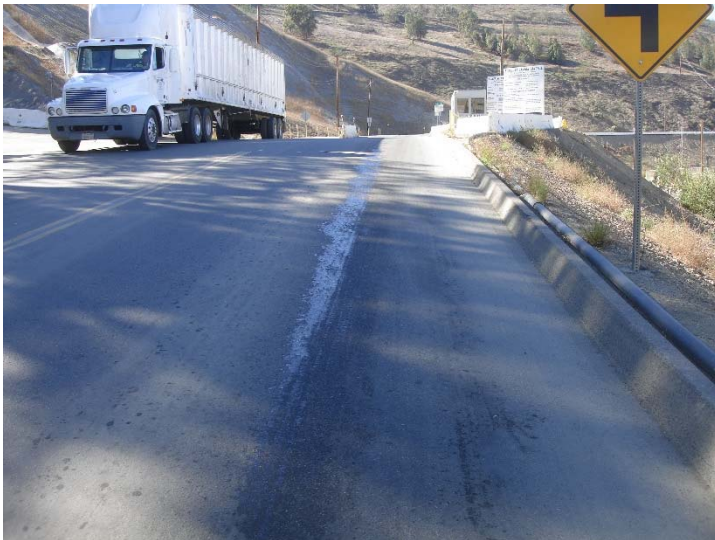
Photo 526: Site Dust: November 29, 2016

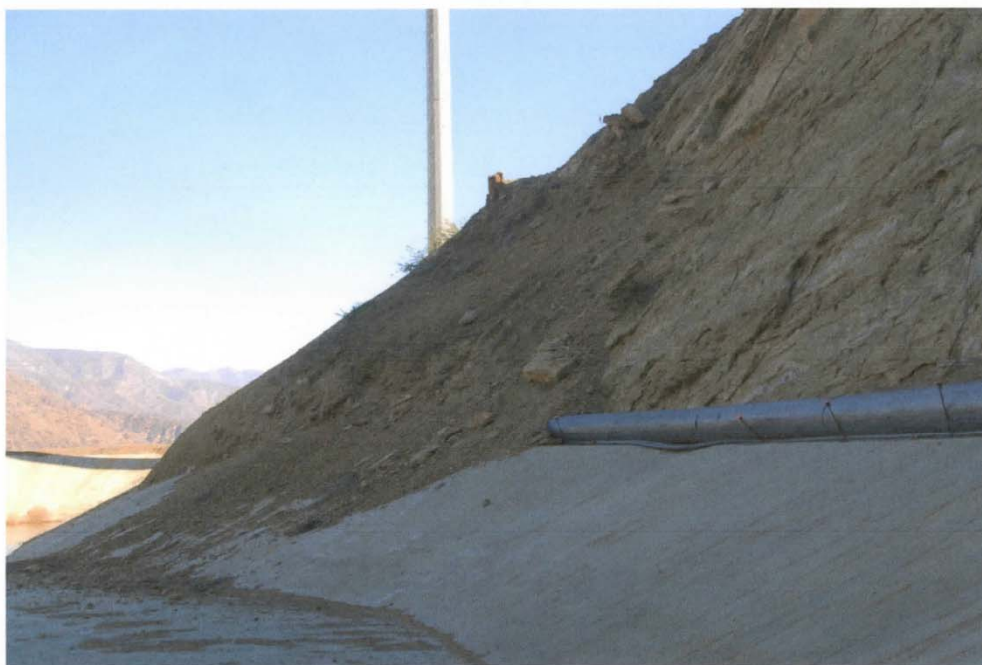
Photo 4: Basin A – little to no slough-off of soil

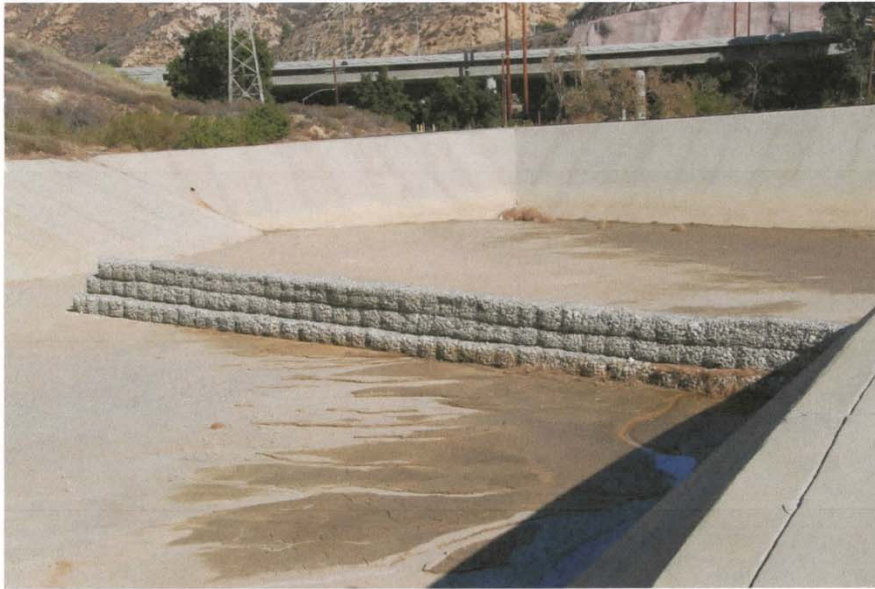
Photo 7: Gabion Structure in Terminal Basin retained fines

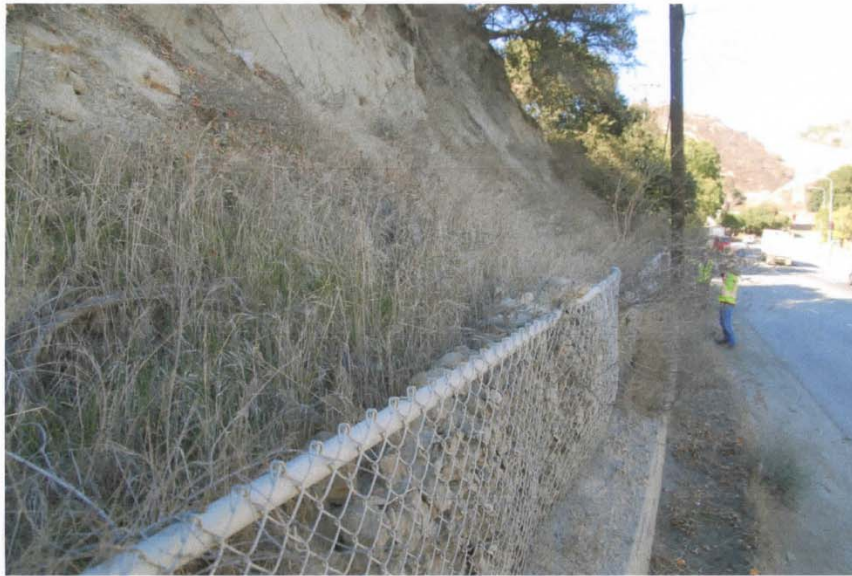
Overall landfill inspection.
<ul style="list-style-type: none">• No slope stability issues were noted during the site tour.• The retaining wall outside the property on San Fernando road has not been fixed (Photo 9).
1:00 – 1:15 Close-out meeting with Republic Staff
FURTHER REVIEW NEEDED
Concern about the outside retaining wall if the debris resting against the chicken wire fence becomes waterlogged.
COMMENTS
Signed:

Photo 9: Retaining wall along San Fernando Road

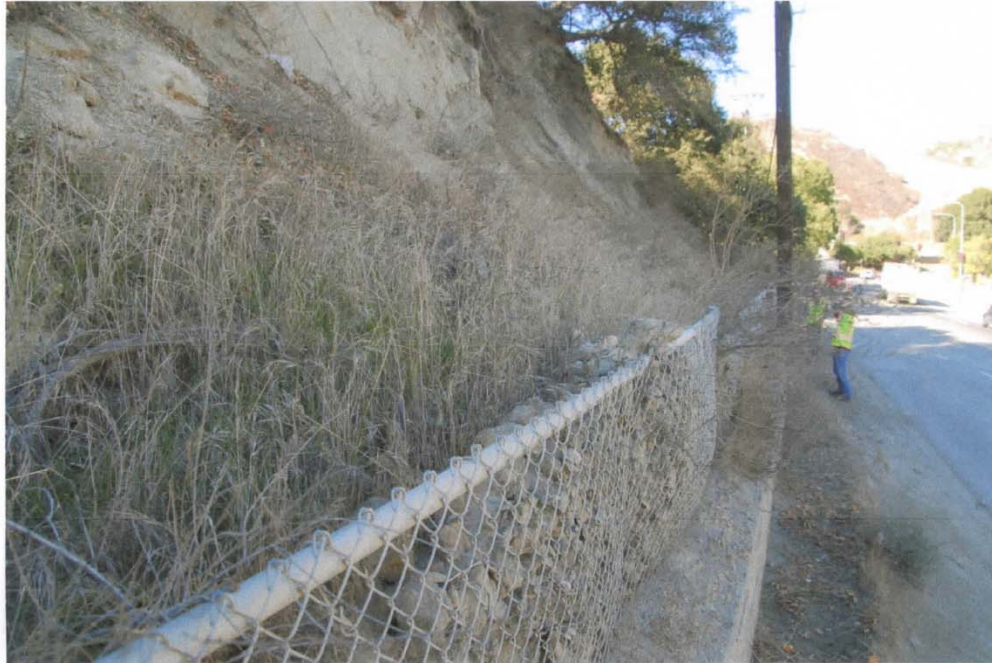
Photo 5: Outside retaining wall along San Fernando Road

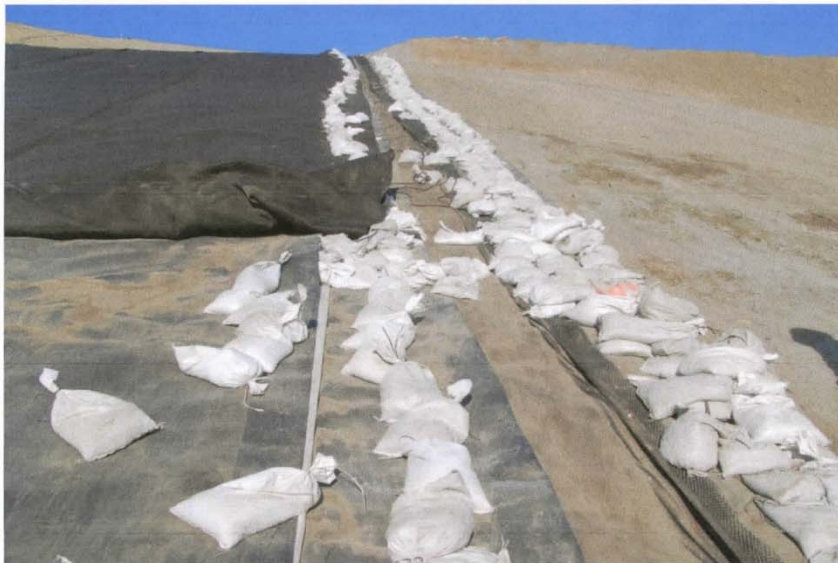
9:30 - 1:00 landfill tour Observed the following areas:	
<ul style="list-style-type: none"> • Construction of Cell CC4 • Placement of waste on Cell CC3B and on top of County Deck • Drainage systems • Landfill for geotechnical and hydrological issues 	
Cell CC4 The cell is under construction, we monitored the on-going installation of the liner system <ul style="list-style-type: none"> • approximately 90% of the cell is covered by geosynthetics (Photo 1) • The base geomembrane of cell CC3 was exposed for connection to the base geomembrane from Cell CC4 (Photo 2) • The installer applied great care at the connection by brushing, cleaning (brush and blower), and sanding the edge of the Cell CC3 geomembrane prior to welding to the new geomembrane (Photo 3) • The liner installed on the slope include all the geosynthetics required per the approved liner design system as shown on Photos 4 and 5 • The upper geotextile is exposed to sunlight and should be protected with soil within the timeframe recommended by the manufacturer

Photo 4: Liner system on slope of CC4

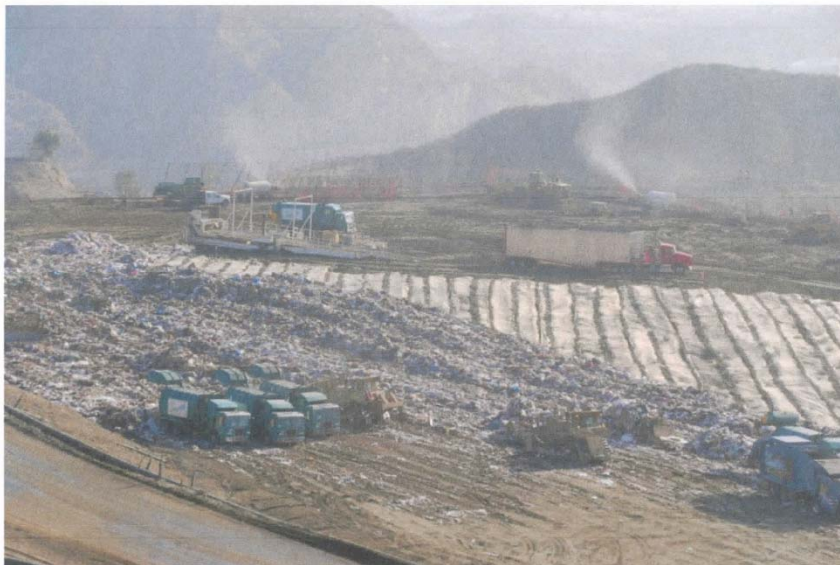
Waste Placement <ul style="list-style-type: none"> • Cell CC3 <ul style="list-style-type: none"> – Waste was placed in the cell – Waste was placed directly on top of the plastic filter alternate daily cover (ADC) of CC3 (Photo 6) – Some of the ADC was visible but does not appear to be punctured or torn under weight of new waste (Photo 7) – No civil or geotechnical issues noted • Deck of County Landfill <ul style="list-style-type: none"> – Waste was placed on deck of the County Landfill – we did not observe the operations closely 	
Erosion Protection systems <ul style="list-style-type: none"> • All systems installed at site are in good shape • Grass is growing through the erosion protection mesh (Photo 8) • The slopes of the new drainage channels towards the final sediment basin (Photo 9) could be protected against erosion by installation of wattles

Photo 6: Placement of waste at CC3

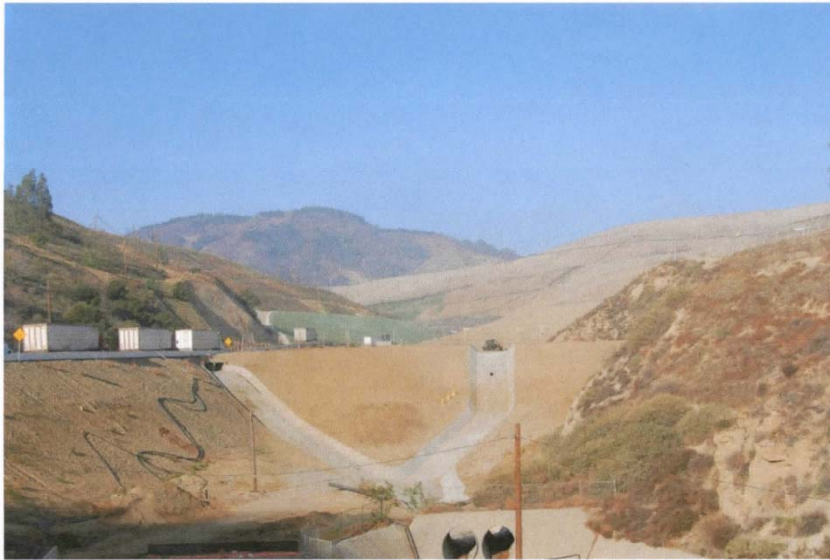
Photo 9: Slopes at new drainage channels

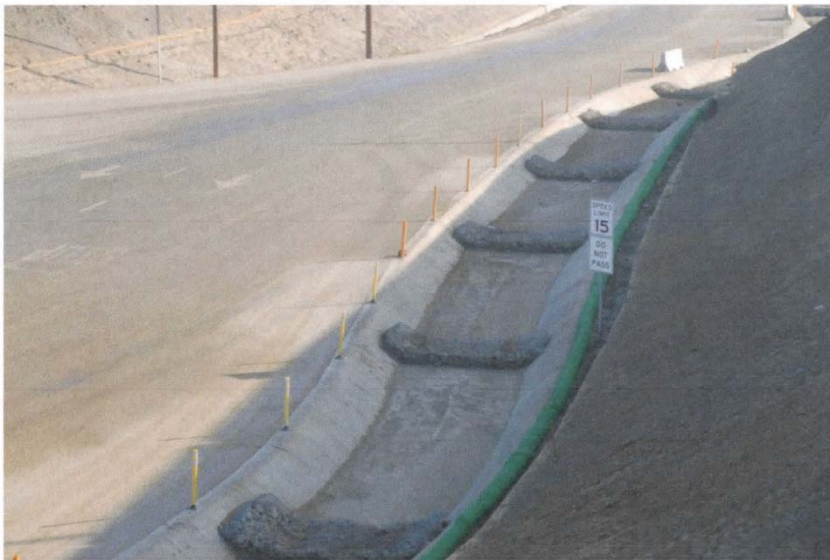
<p>Drainage system</p> <ul style="list-style-type: none"> • All the channels are clean of debris and sediments • Gabion mats installed in the channel along the access road did a great job retaining fines, minimizing the load in the Terminal basin (Photo 10) • Terminal Basin <ul style="list-style-type: none"> – The basin is cleaned-up. – The row of gabions midway in the basin have worked well in slowing down water and retaining sediment ahead of the decant towers. –
<p>Overall landfill inspection.</p> <ul style="list-style-type: none"> • No slope stability issues were noted during the site tour • The retaining wall outside the property on San Fernando road has not been fixed. • The open trench around the water tank ring foundation noted in previous visits is getting filled with gravel (Photo 11)
<p>1:00 – 1:15 Close-out meeting with Republic Staff</p>
<p>FURTHER REVIEW NEEDED</p> <ul style="list-style-type: none"> • Concern about the outside retaining wall if the debris resting against the chicken wire fence becomes waterlogged during rainstorms. • Exposed geotextile liner system on slope of Cell CC4

Photo 10: Gabion heads in main channel along access road
